GILBOA DAM

Post-Hurricane Briefing

September 6, 2011

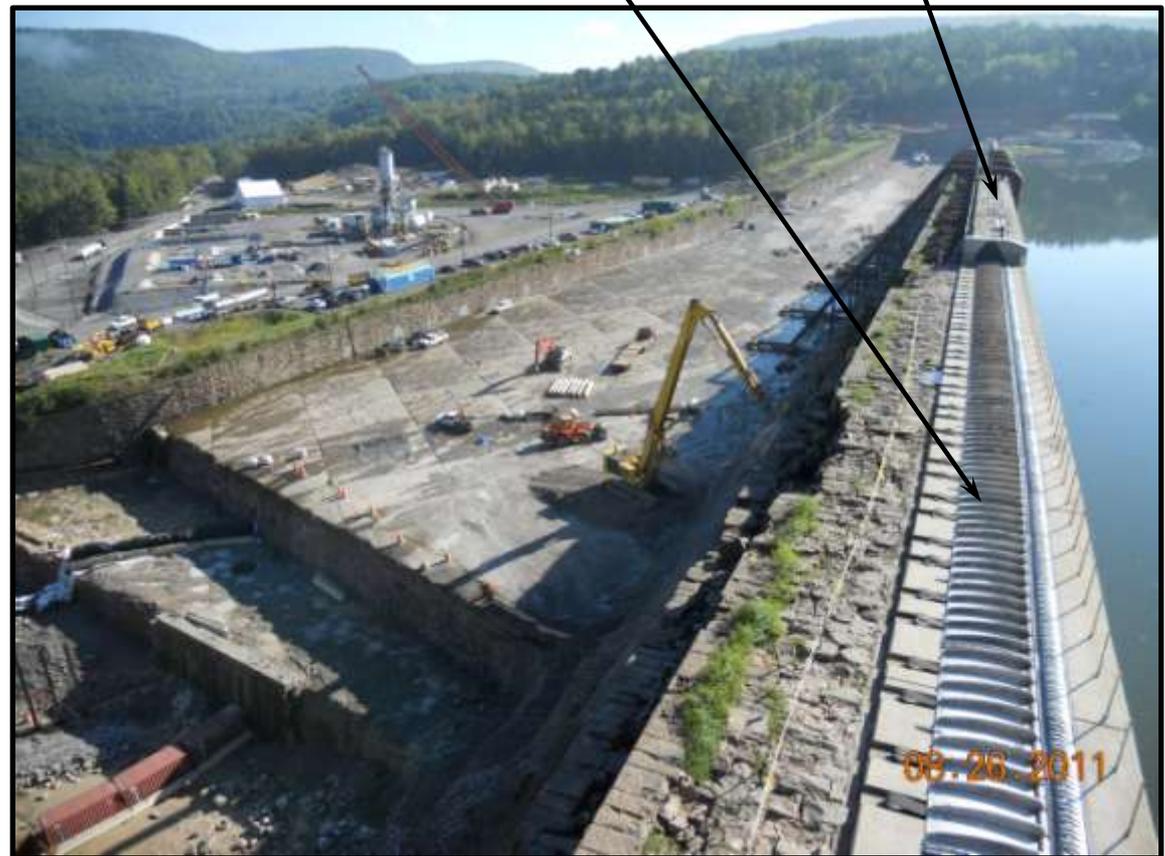
Original Crest,
~900' intact

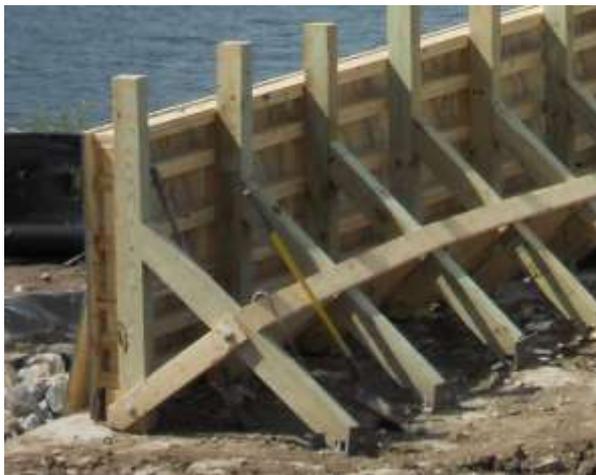
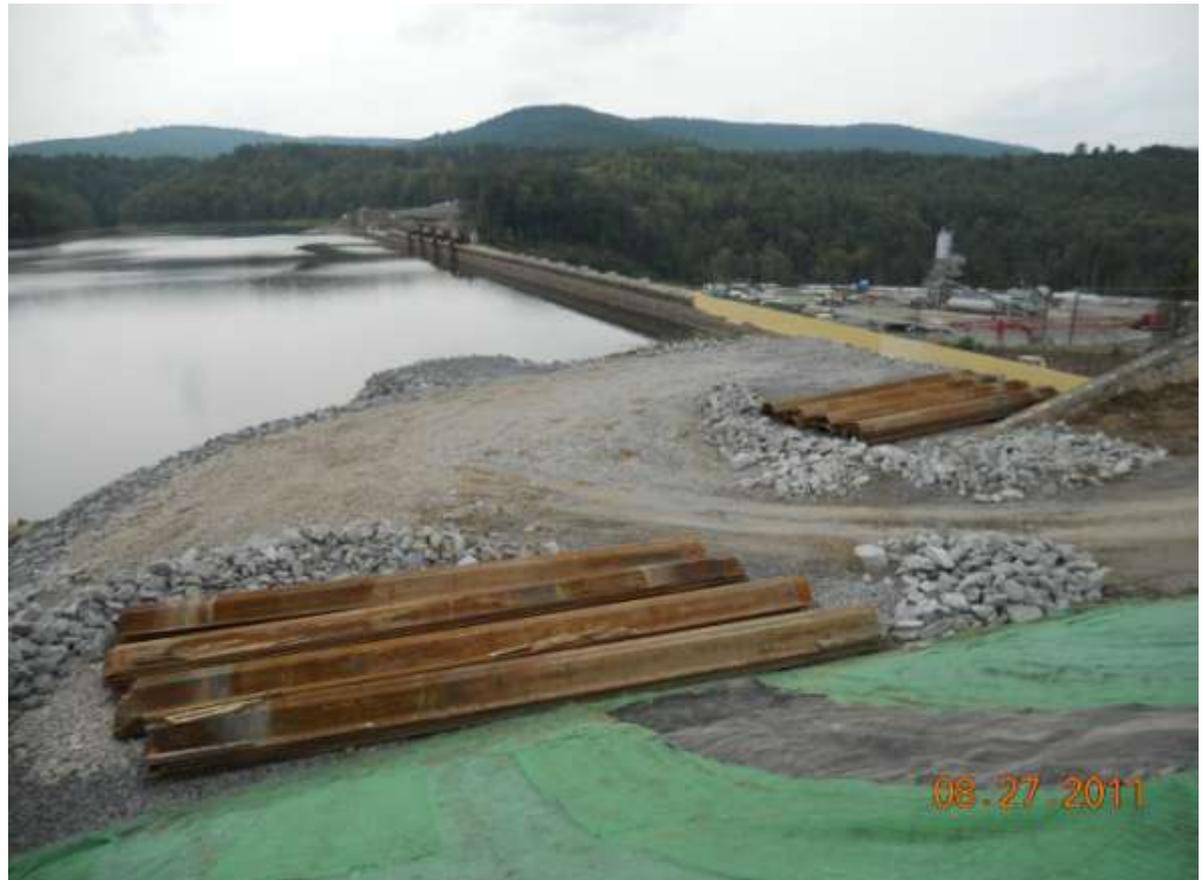
Bulkhead Configuration

- Erected in Monoliths M0-M3, approx. 200' long
- Approx. 4½' high, top Elev. 1130.0 ft
- Upstream fill to ~Elev. 1132 ft
- Upstream rock protection

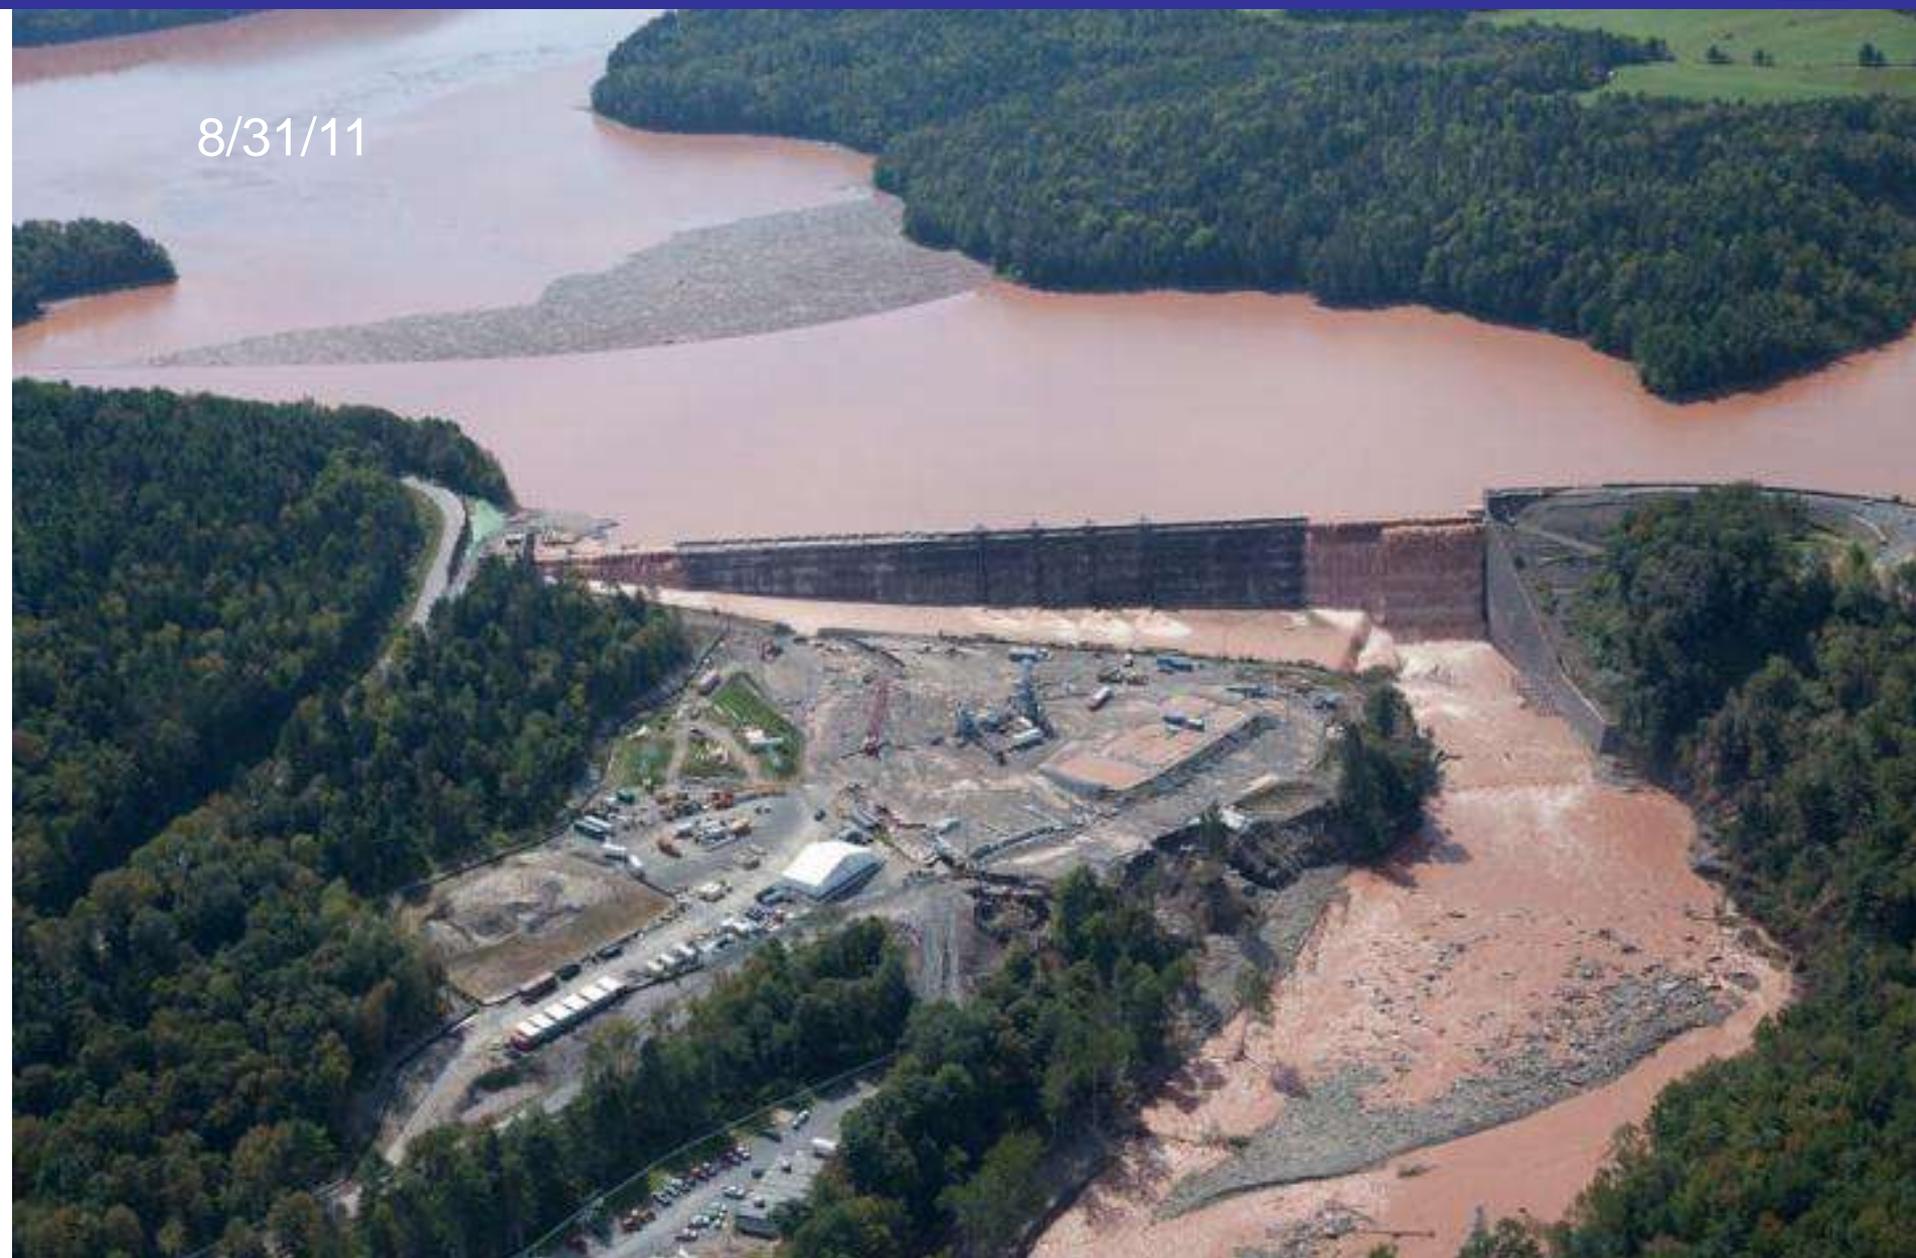
- Inspection of Dam – Sun thru Wed (Aug 28-31)
- Incident Report submitted Friday, September 2nd
- Conditions observed:
 - Loss of power and instrumentation feed at site
 - No apparent damage to spillway control section or embankment
 - Erosion in certain areas of Spillway Channel (3 locations)
 - Significant damage to Contractor work area and temporary on-site facilities
 - Significant stream channel and bank erosion
 - Significant debris accumulation in reservoir

- Initial structural inspection of dam (Aug 28-31)
- Enhanced monitoring plans
- Instrumentation feed damage assessment
- Emergency contract initiation:
 - Spillway Channel and Siphon Repairs
 - Staging Area Debris Removal
 - Staging Area Restoration
- Continued operation of siphons
- Reservoir debris removal
