# Neversink River East Branch

## MANAGEMENT UNIT 7

EAST BRANCH MANAGEMENT UNIT 7  
BETWEEN STATION 28000 AND STATION 25030

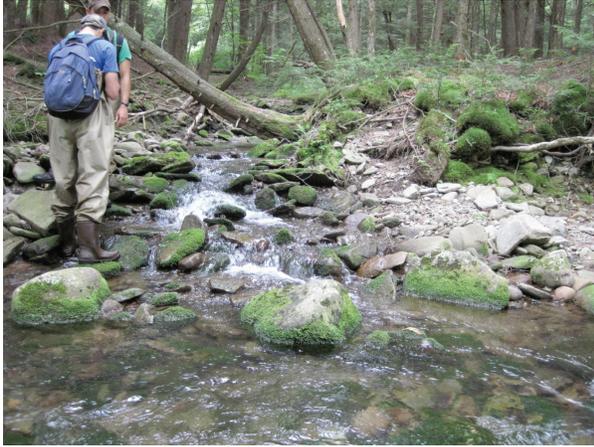
*Tributary entering on left bank (B2)*

An unnamed tributary enters from the left at Station 27400, contributing a perennial flow that is significant even under low flow conditions. (B2) This tributary drains through a densely forested section of the valley and is likely well filtered through natural processes. Small feeder streams such as this often play an integral role in ecosystem integrity, as they are a source of the cold and well oxygenated water that is necessary to support a diversity of aquatic life.

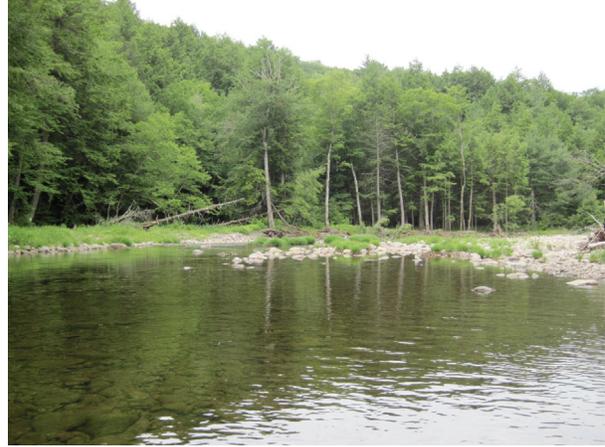
*Overwidening of channel due to aggradation (B5)*

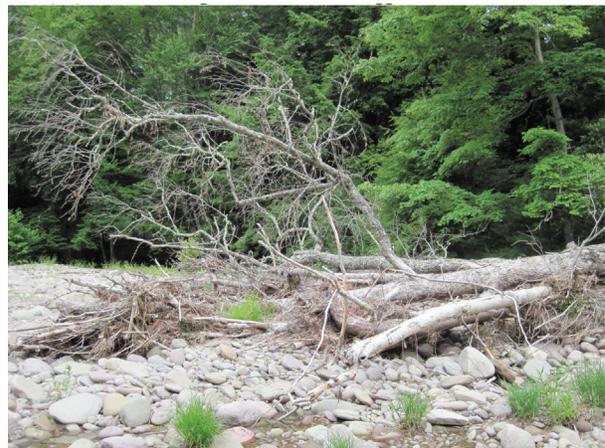
*Obstruction on right bank contributing to development of point bar (B11)*

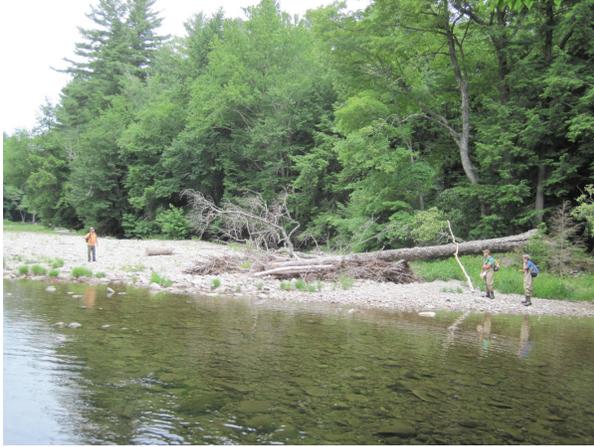
Continuing downstream, the deposition of large woody debris and sediment becomes evident at Station 27000 and continues until approximately Station 26060. Excessive amounts of sediment storage mark this reach in the form of depositional bars and full channel aggradation. At Station 27000, the entire width of the channel has become aggraded with cobble sized materials, causing overwidening of the channel as well as increased elevation of the stream bed. (B5) Along the right side of the stream in the same location a large tree has deposited, obstructing high flows and contributing to the development of a point bar along the right bank. (B11) This bar continues for approximately 480-feet until Station 26520. (B6) Aside from some sedges along the left side, this bar does not have established mature vegetation on it.

*Point bar along right bank (B6)*

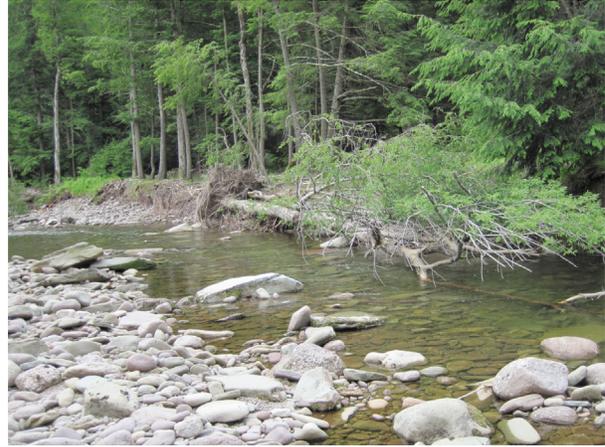
The stream meanders slightly to the left as it flows past the point bar but stays over 200-feet from contact with the left valley wall. A fallen tree is causing a flow obstruction at Station 26650. (B17) This tree spans 70-feet with its root ball still attached, which is facing upstream and directly into direct flow. During high

*Fallen tree causing flow obstruction (B17)*

flows, this tree is forcing the water into the left bank, resulting in minor erosion just upstream of the obstruction. At Station 26500, a cobble side bar has formed on the left side of the stream which continues approximately 250-feet to Station 26250. (B20) This bar appears to be actively forming and has no established vegetation on it. Large woody debris has deposited as an obstruction at the downstream end of the bar, contributing to the backwater effect that has resulted in the development of this bar. (A5)

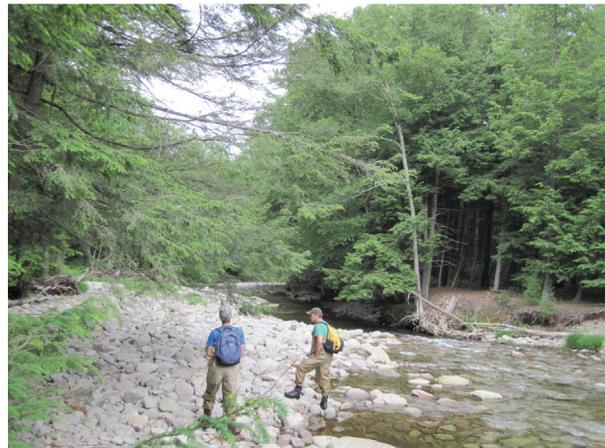
*Cobble sidebar on left side of stream (B20)*

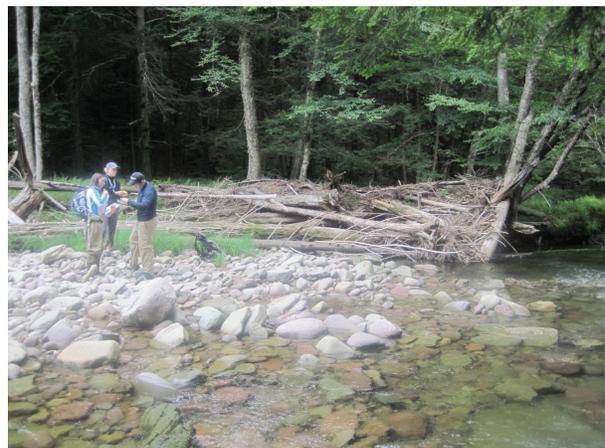
*Obstruction contributing to side bar development (A5)*

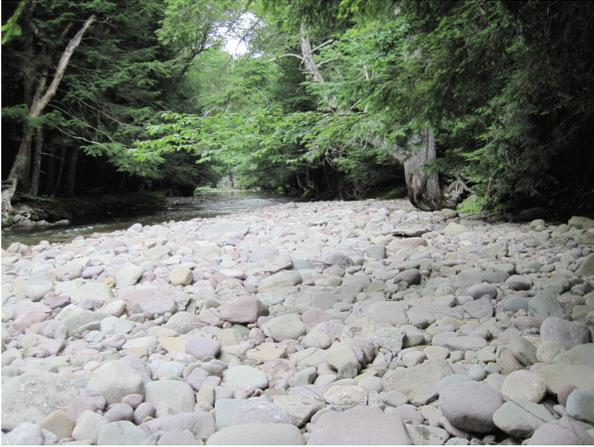
On the right side of the stream, another cobble side bar has formed at Station 26200. This bar is approximately 140-feet in length, ending at Station 26060. (B28)

*Cobble sidebar on right side of stream (B28)*

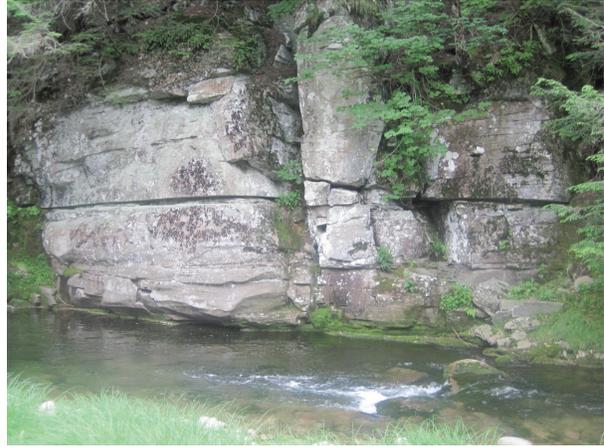
*Exposed bedrock controlling flow (A12)*

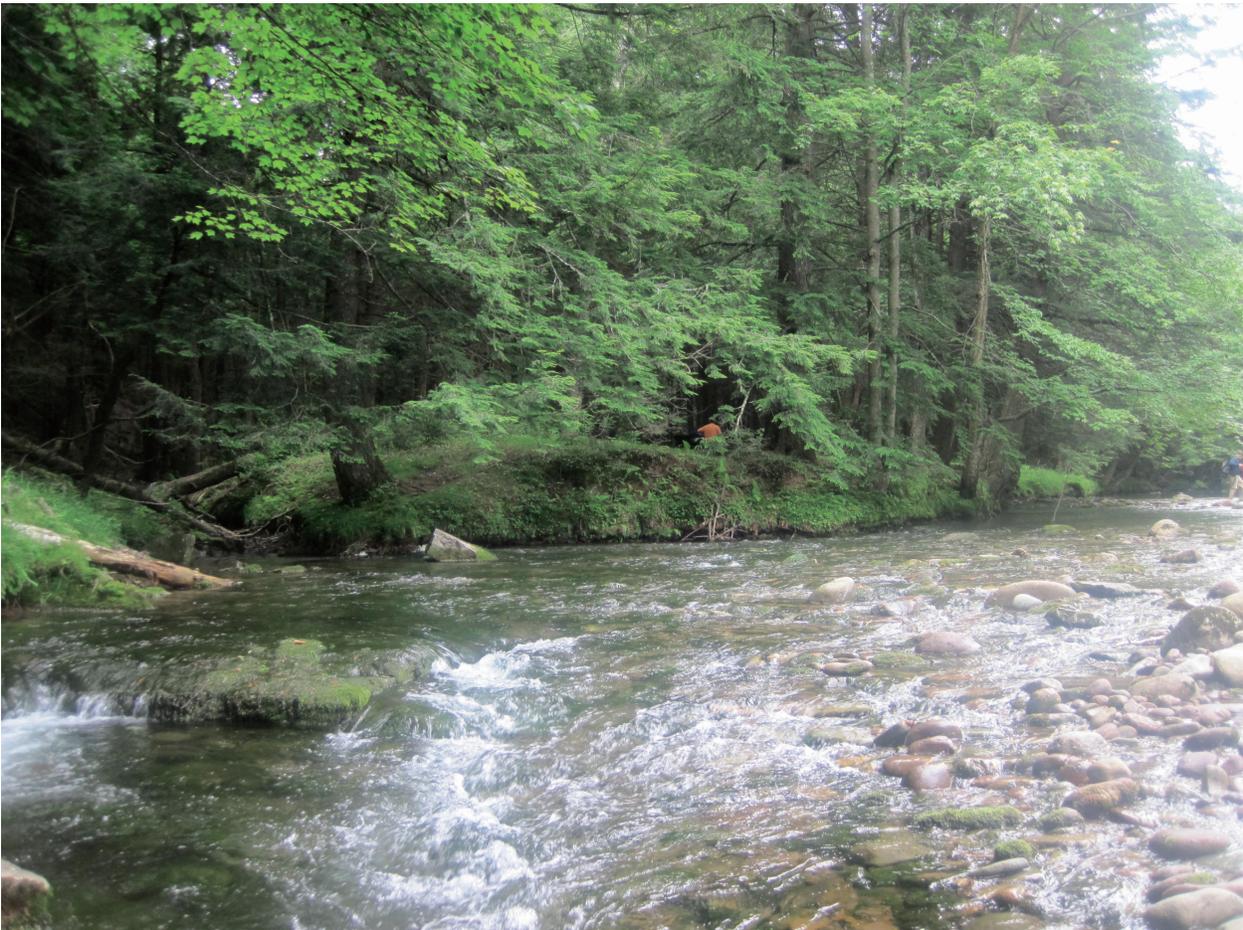
*Small tributary entering on right bank (A9)*

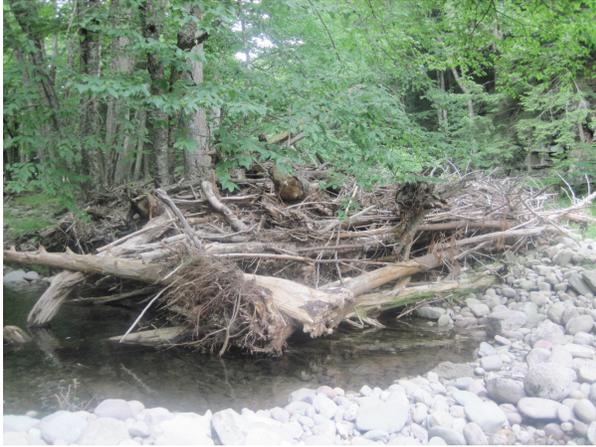
*Large woody debris jam causing divergence (A17)*

At Station 25390, large woody debris has deposited and is causing a divergence of a small portion of the flow into a side channel to the right. (A17) Although this side channel flows in the direction of Denning Road, the steep bedrock wall keeps it confined on the right side and prevents any potential flood threats. A small tributary drains in from the right through the bedrock wall near this same location. (A19)

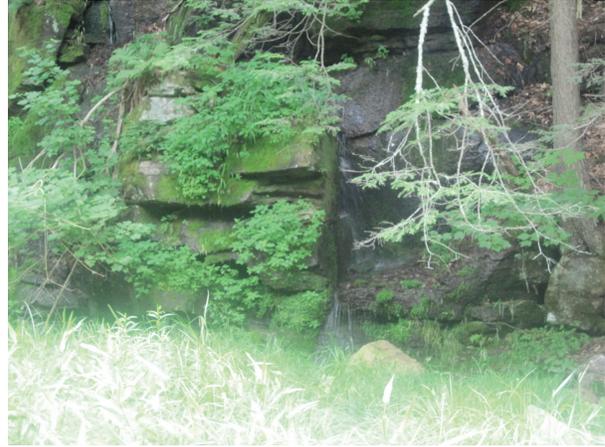
*Small tributary entering on right through bedrock (A19)*

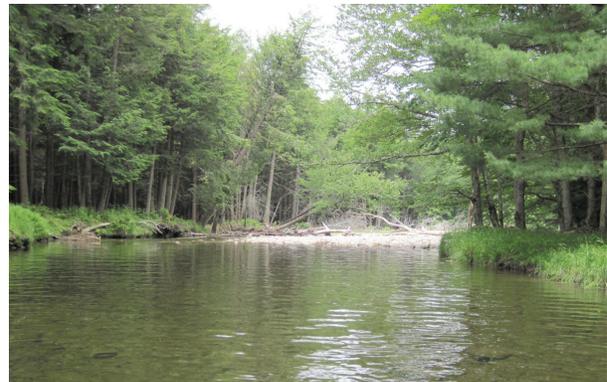
EBMU7 ends at Station 25030 where the stream begins to move away from the valley walls and the floor opens up, representing a change in valley type and associated channel morphology. Like most of EBMU7, the downstream end of this management unit does not transport sediment effectively. Aggradation of the full channel with cobble sized materials was documented at Station 25100. (B34)

*Full channel aggradation (B34)*

To better understand sediment transport and sediment transport dynamics a baseline survey of channel form and function is recommended for this management unit.
