NEW YORK CITY DEPARTMENT OF CORRECTION

ADDENDUM # 1

**Re: PIN 072201607CPD for Bakery/Laundry Building Roof
Replacement at Rikers Island**

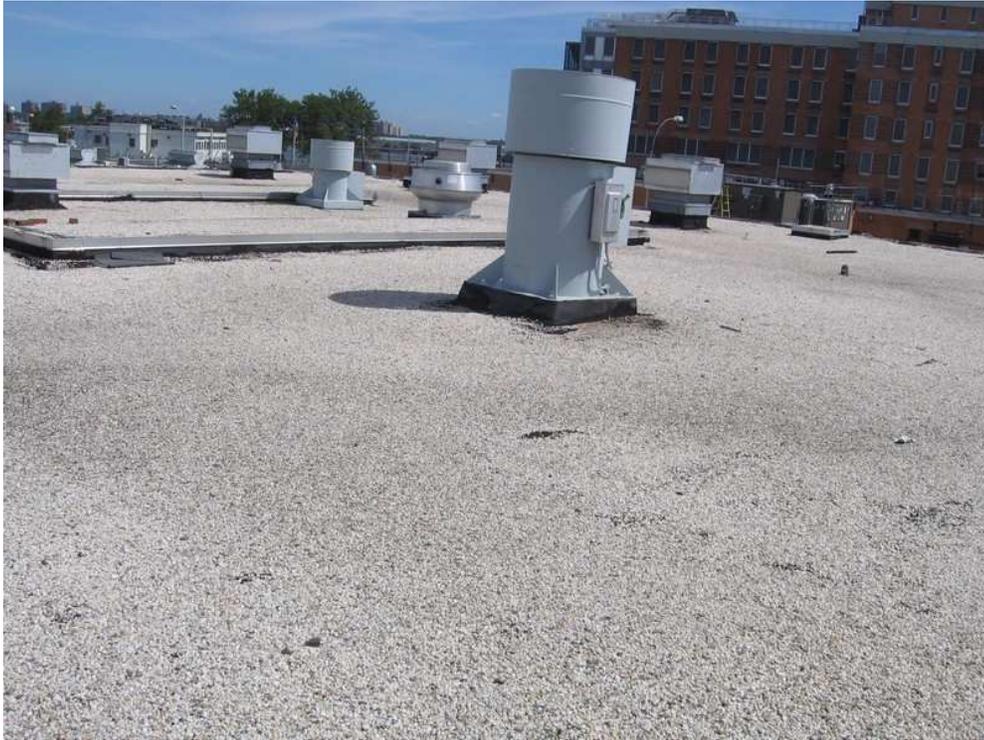
01 – Laundry Bldg. – General view of Roof A (built-up roofing w/ gravel ballast)

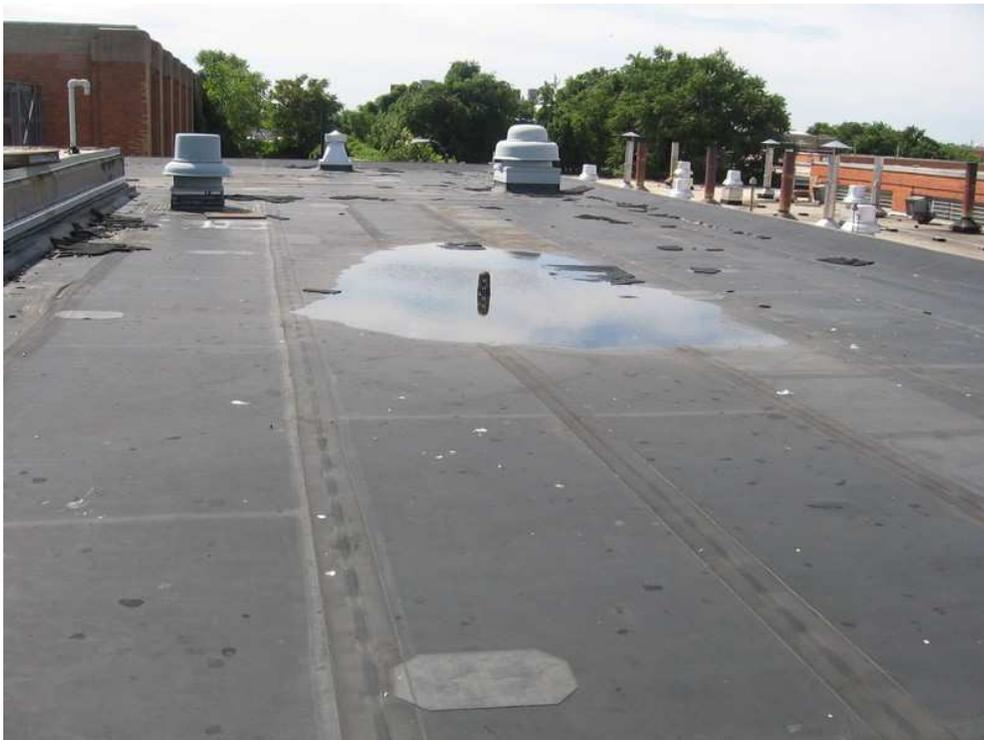
02 – Laundry Bldg. – General view of Roof B (single-ply EPDM roofing)

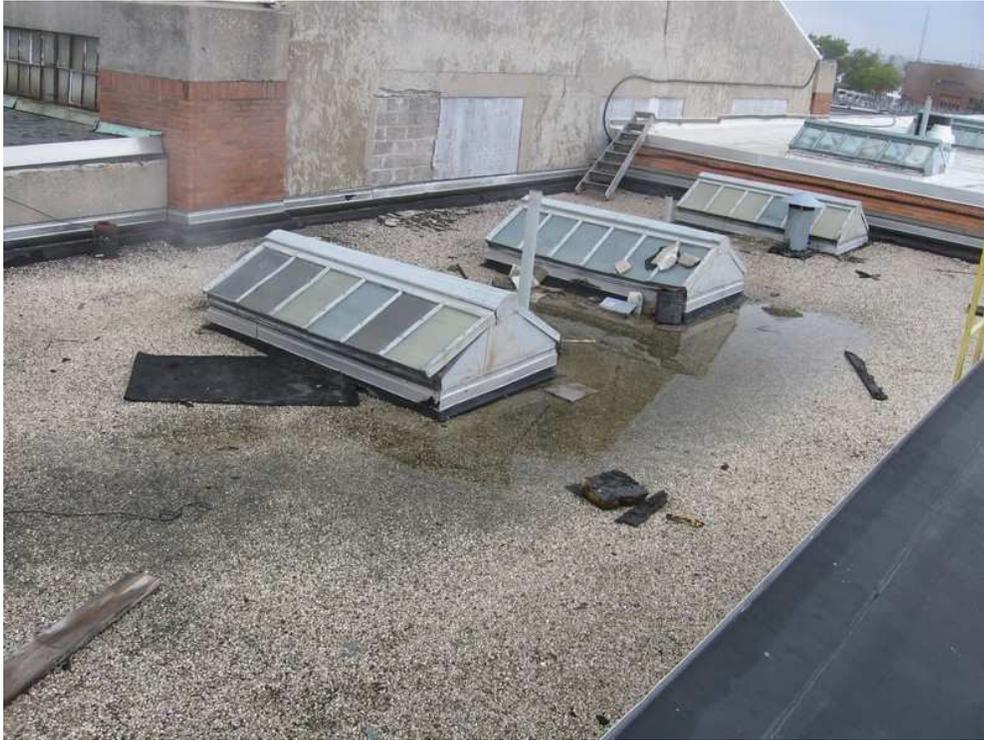
03 – General view of Roof C, between Laundry & Bakery Bldgs. (built-up roofing w/ gravel ballast), showing ponding water from impeded drainage

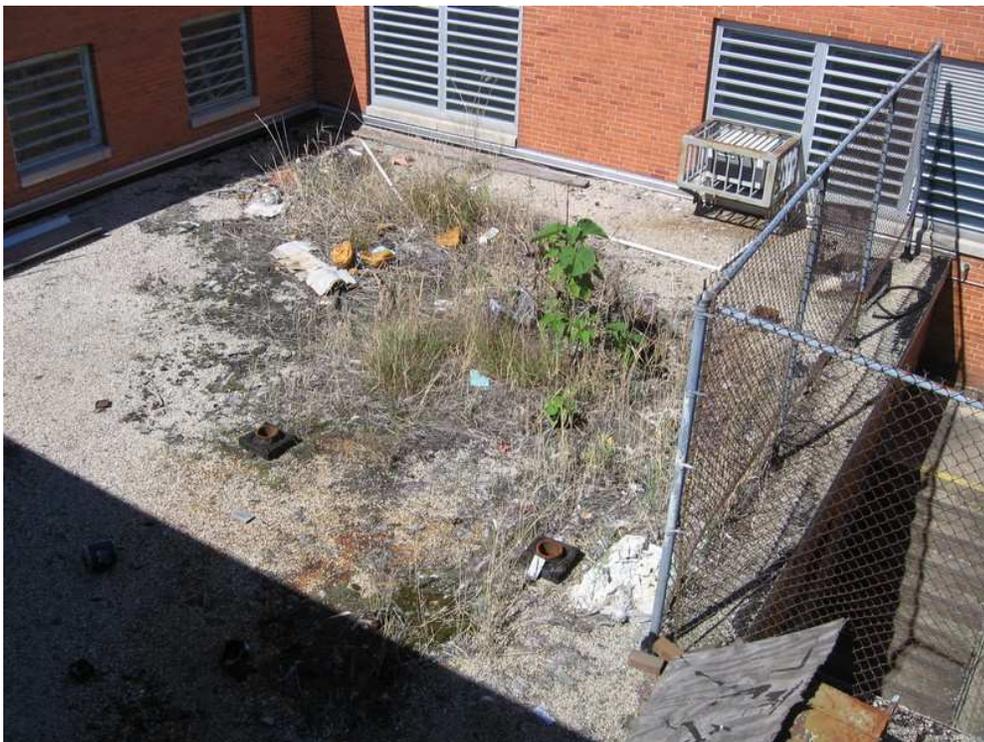
04 – Laundry Bldg. – General view of Roof D (built-up roofing w/ gravel ballast)

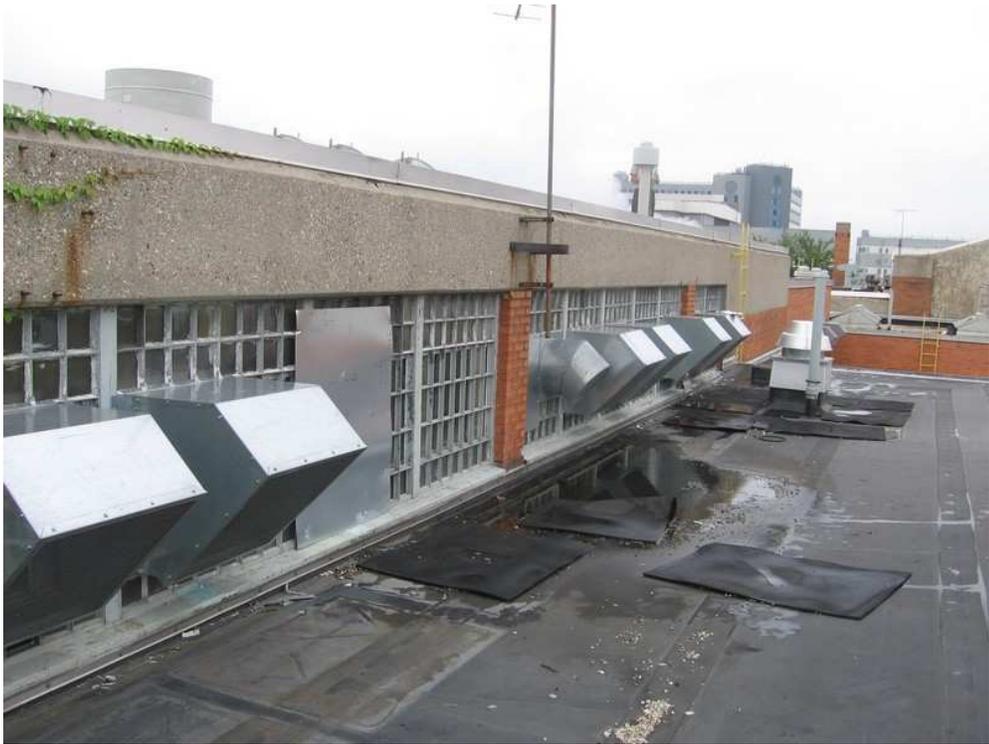
05 – Laundry Bldg. – General view of Roof E (single-ply EPDM roofing)

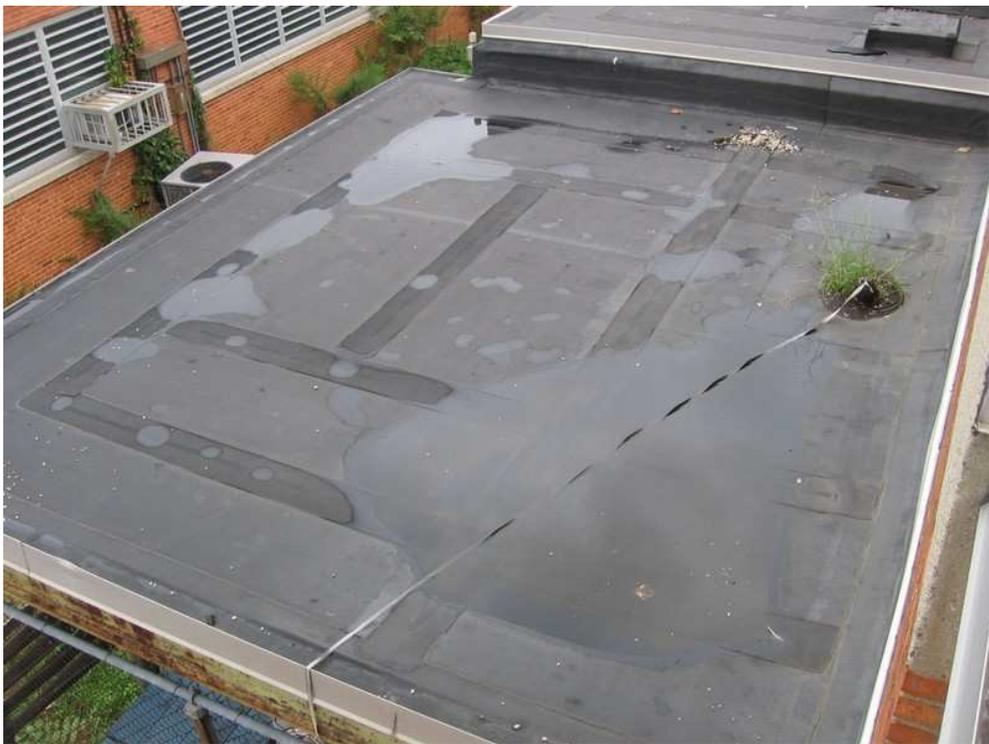
06 – Laundry Bldg. – General view of canopy Roof F (single-ply EPDM roofing)

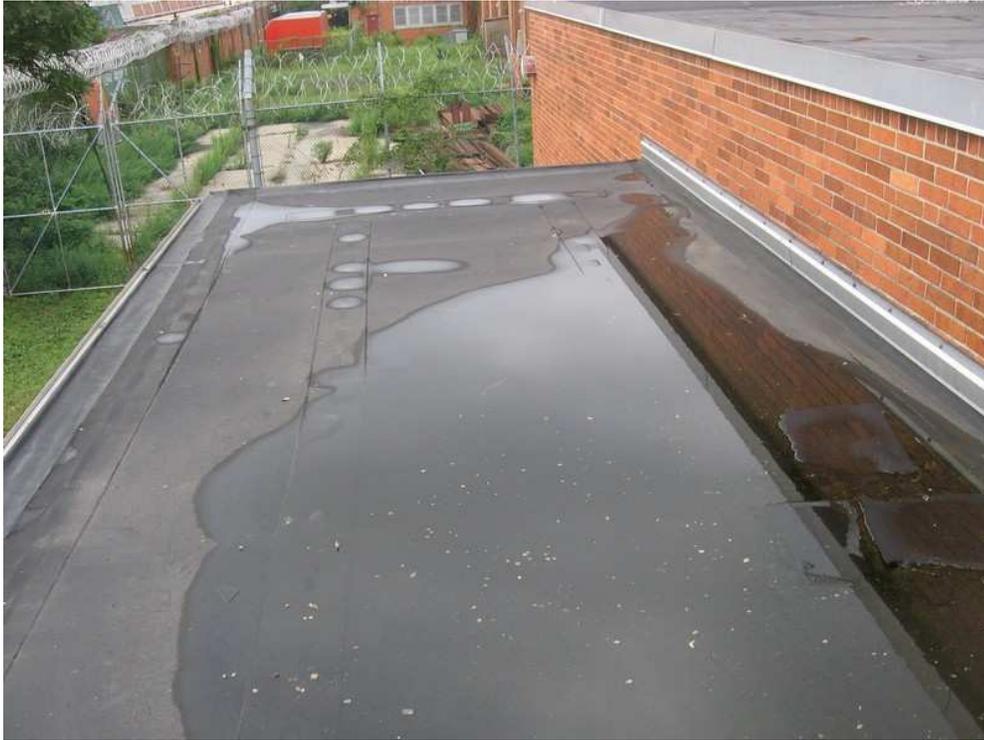
07 – Laundry Bldg. – General view of canopy Roof G (single-ply EPDM roofing), showing impeded drainage

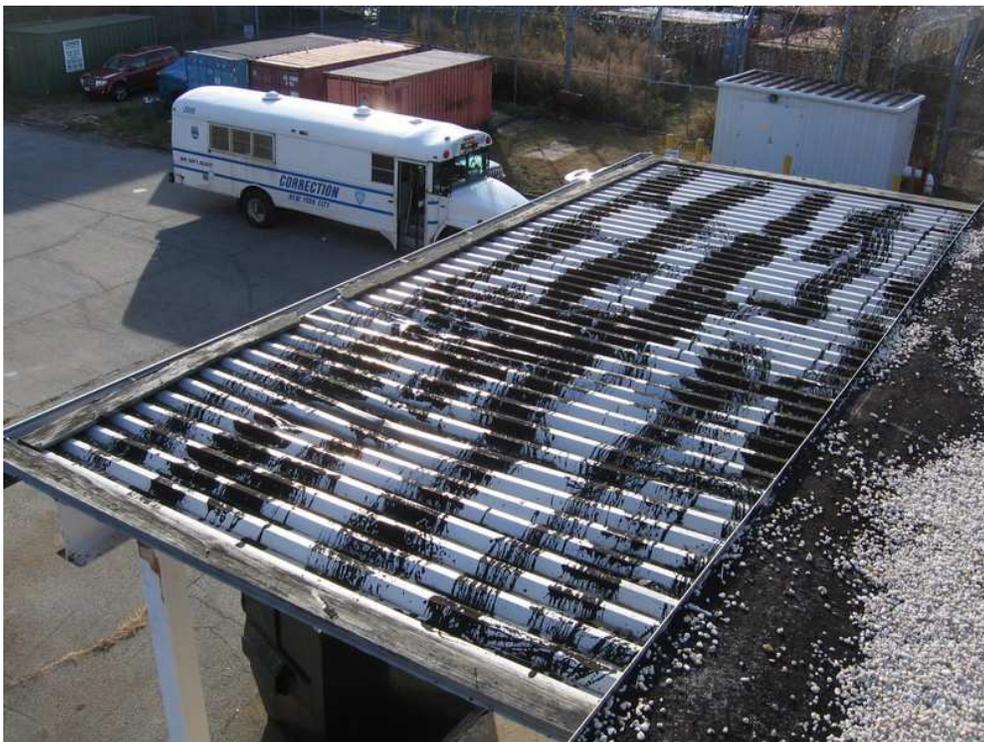
08 – Laundry Bldg. – View of metal awning

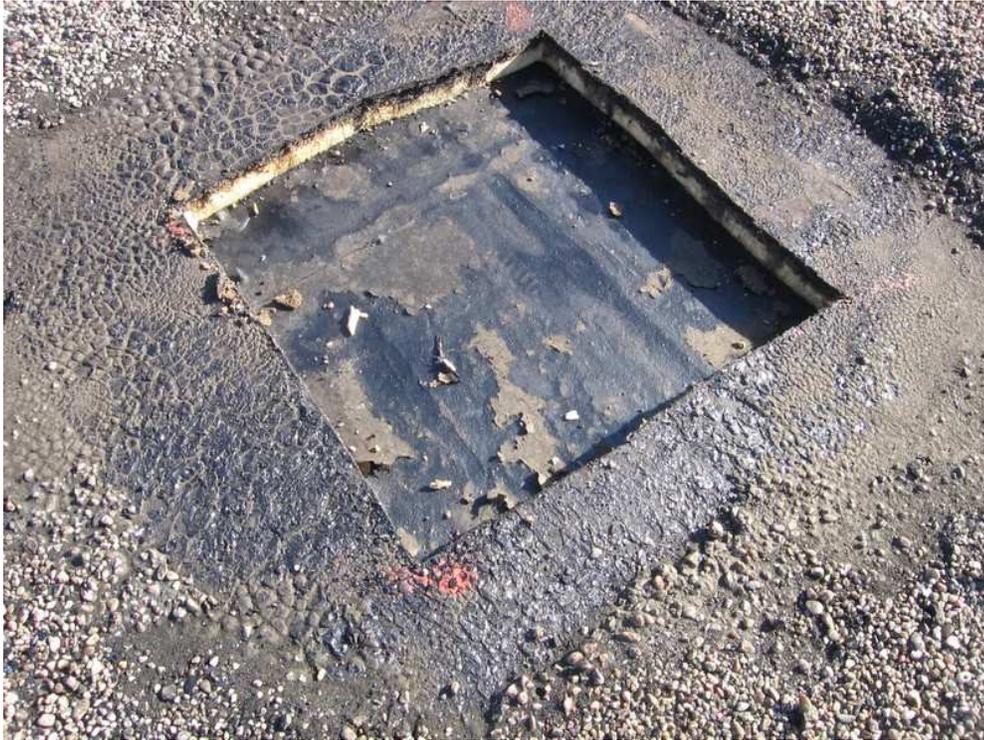
09 – Laundry Bldg. – Alligatoring cracks at membrane surface of existing built-up roofing

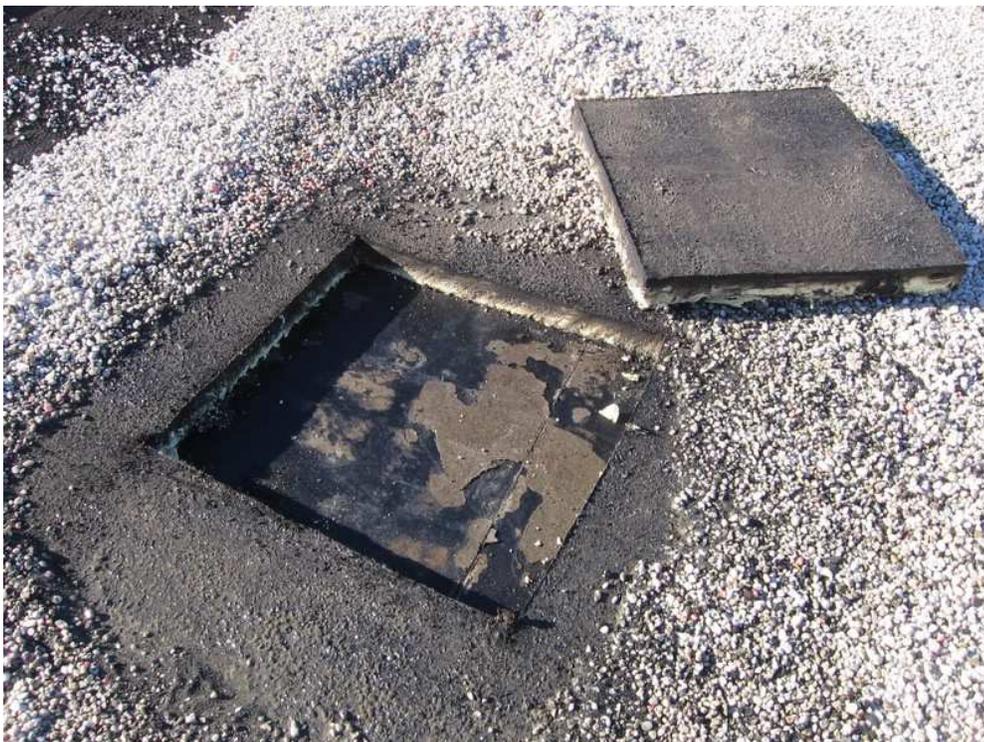
10 – Laundry Bldg. – View of existing built-up roofing, showing wet insulation at exploratory roof cut

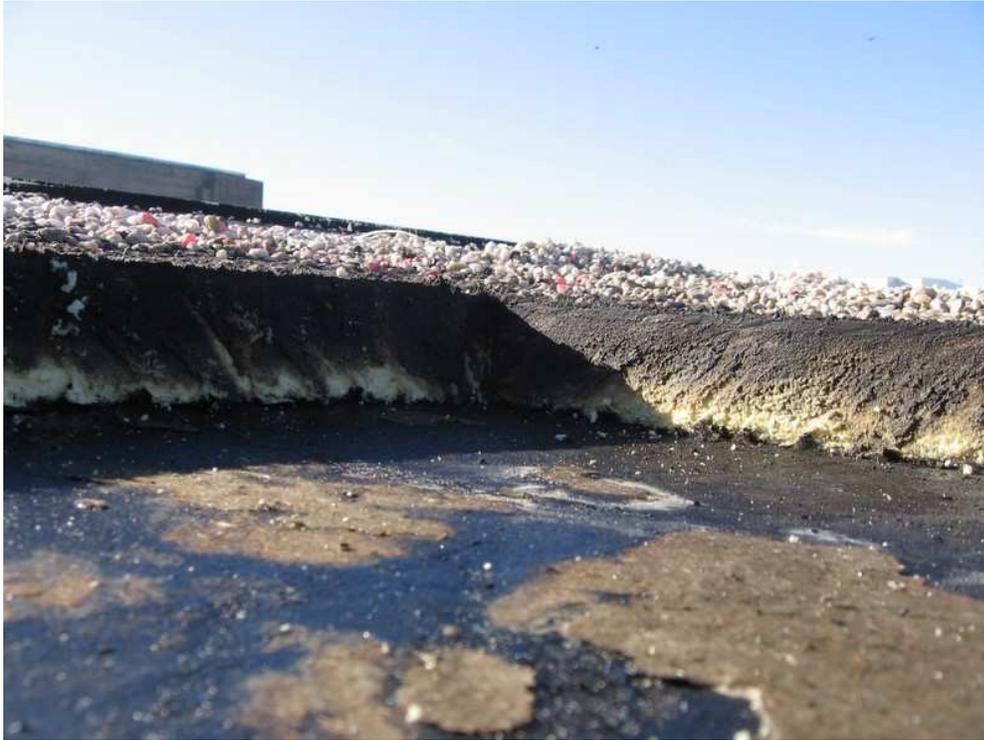
11 – Laundry Bldg. – Closeup view of saturated insulation, indicating moisture within the roofing system

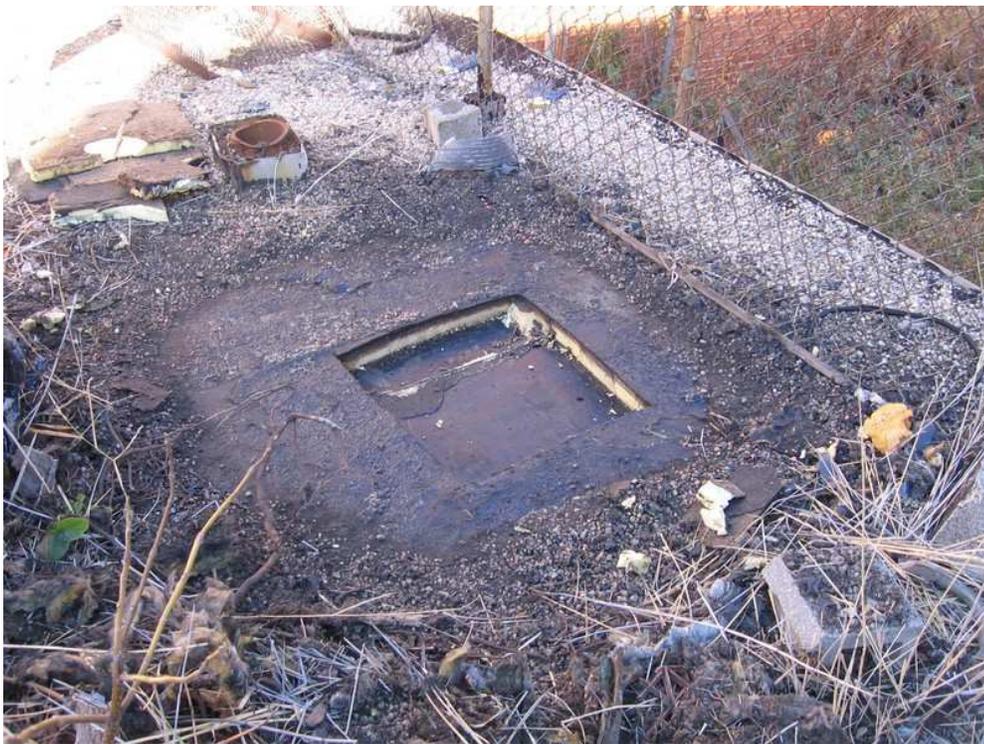
12 – Laundry Bldg. – Roof cut at Roof D, with excessive vegetation growth

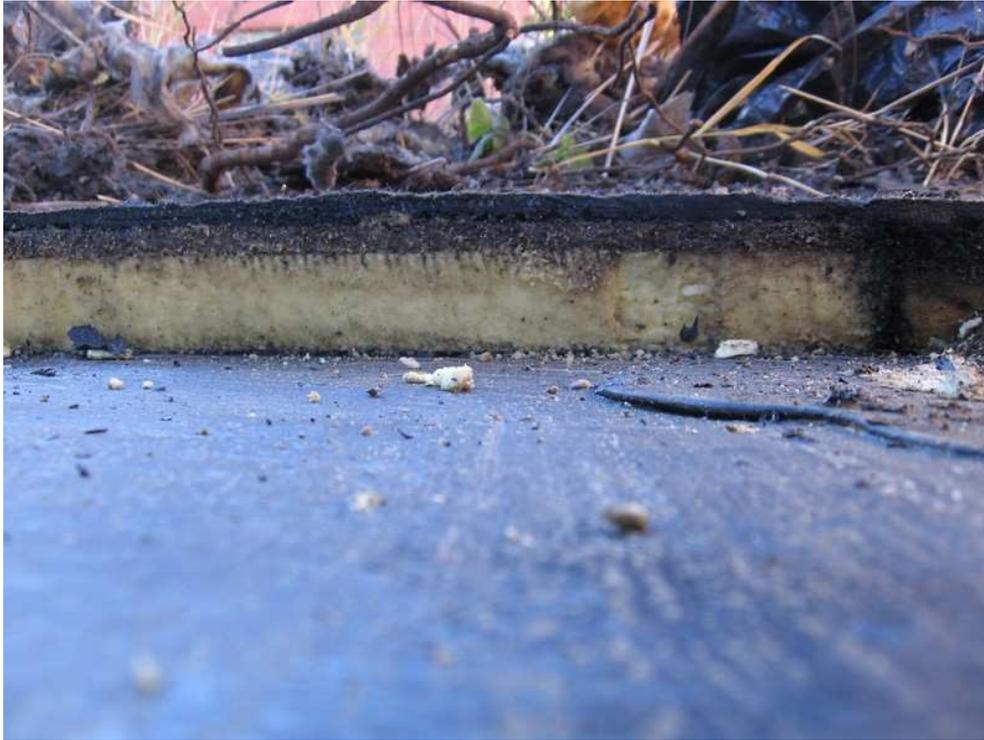
13 – Laundry Bldg. – Roof cut at Roof D, showing vegetation growth and heavily saturated insulation

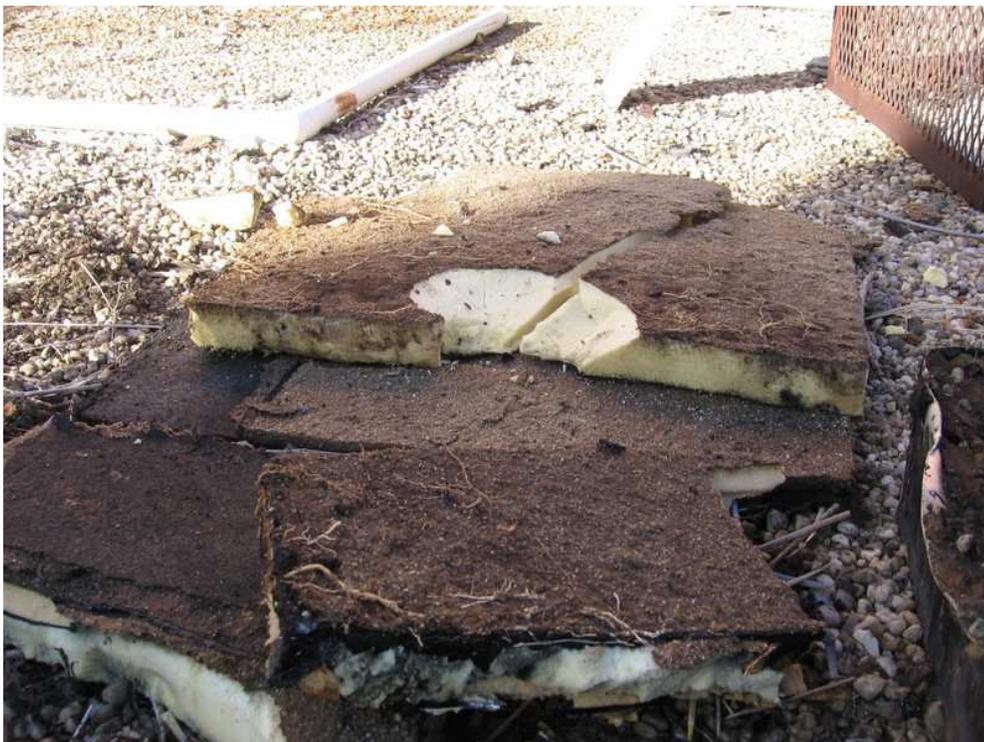
14 – Laundry Bldg. – Heavily saturated insulation with root structure from excessive vegetation at Roof D

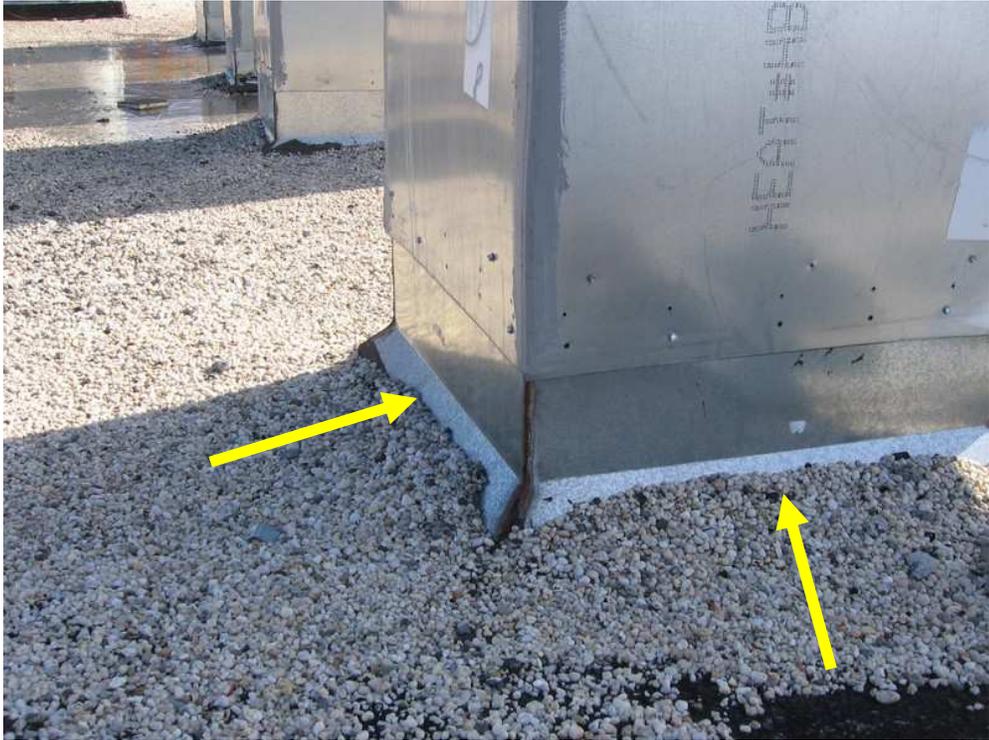
15 – Laundry Bldg. – Recently installed vents/ducts with no visible flashing at Roof A

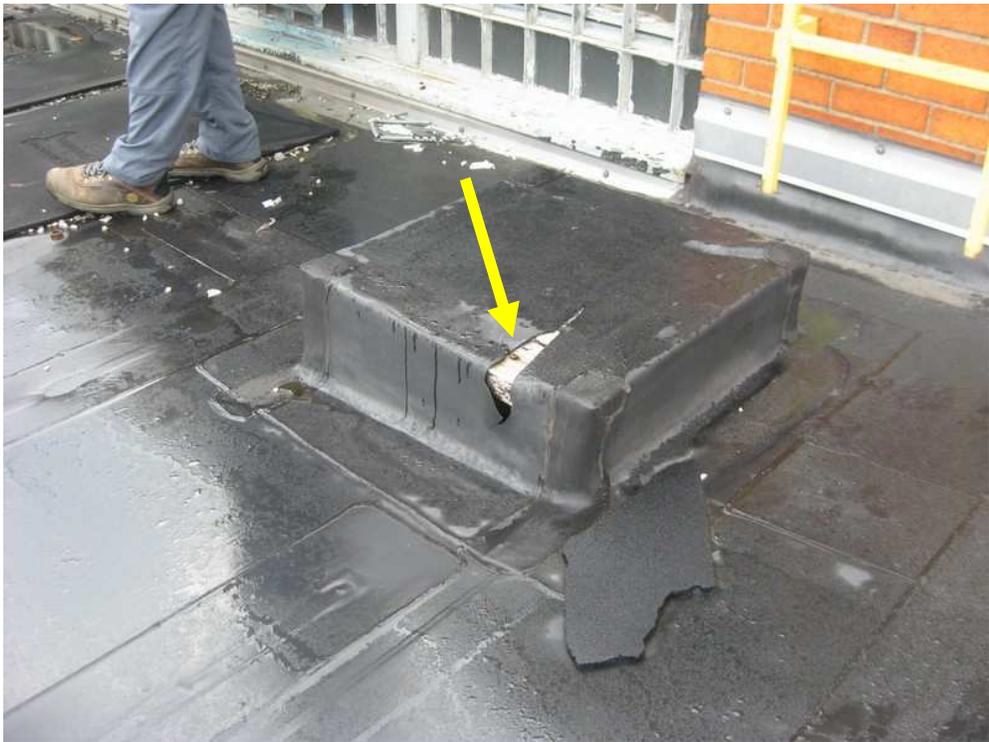
16 – Laundry Bldg. – Existing EPDM roofing system at Roof E showing torn membrane

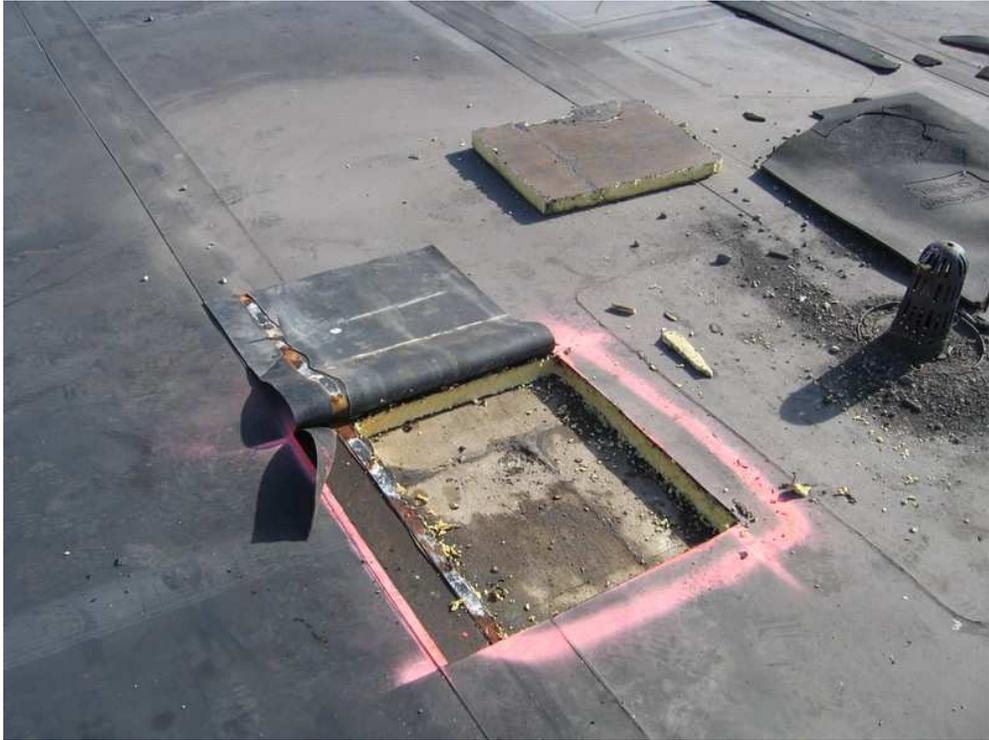
17 – Laundry Bldg. – Roof cut through existing EPDM system at Roof B

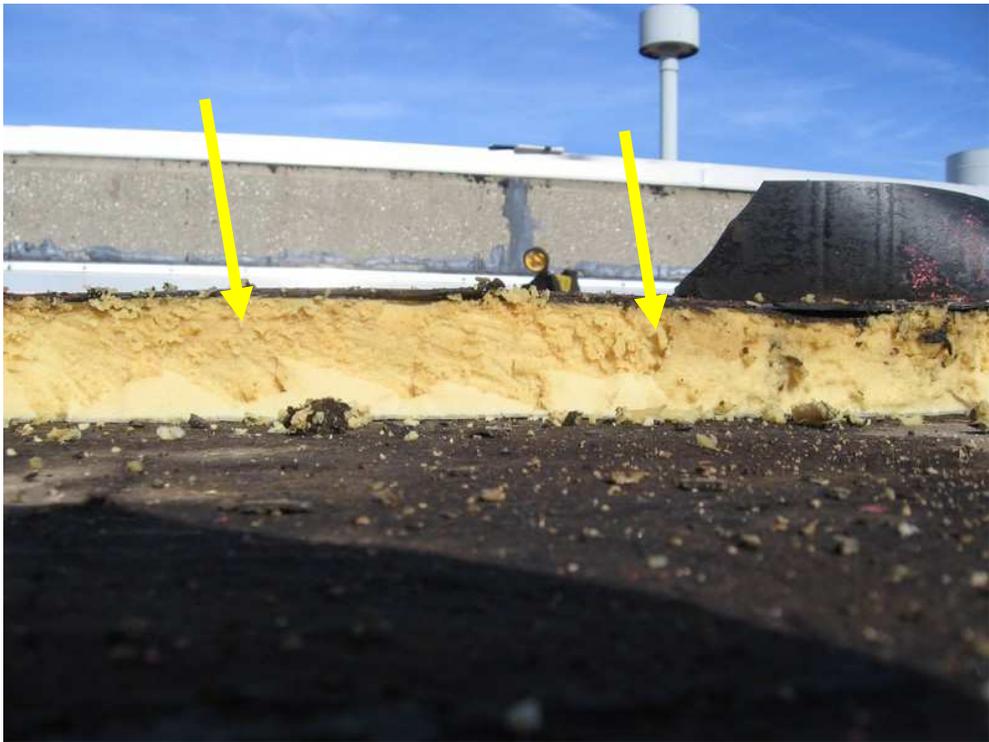
18 – Laundry Bldg. – View of saturated insulation from trapped moisture inside roof cut at Roof B

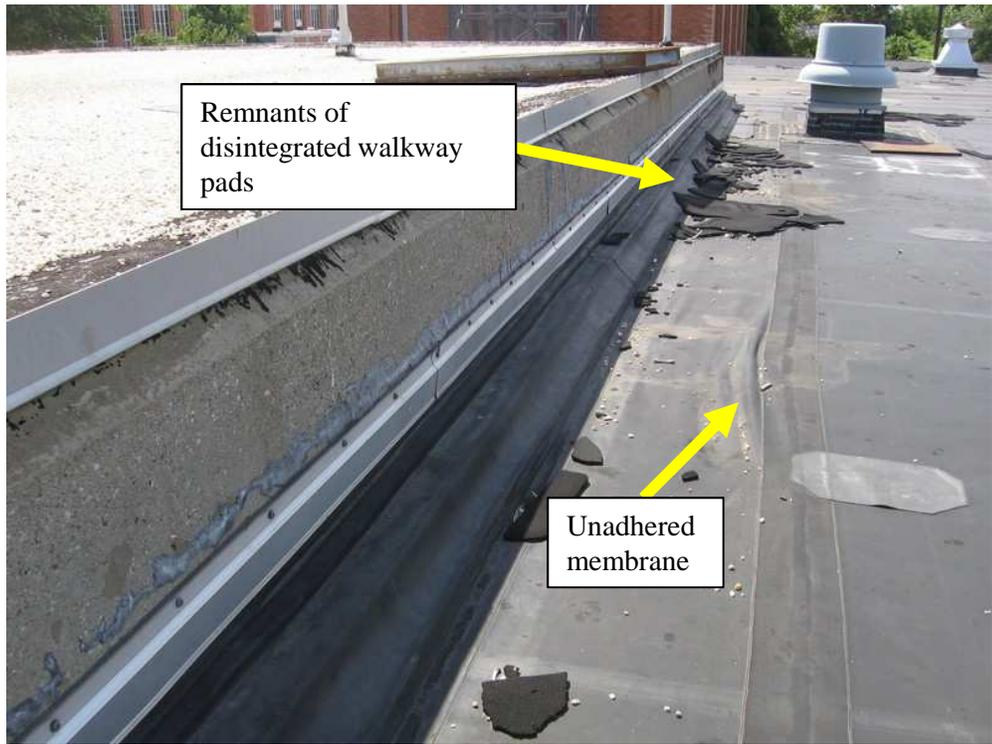
19 – Laundry Bldg. – View of unadhered membrane and walkway pad remnants at Roof B

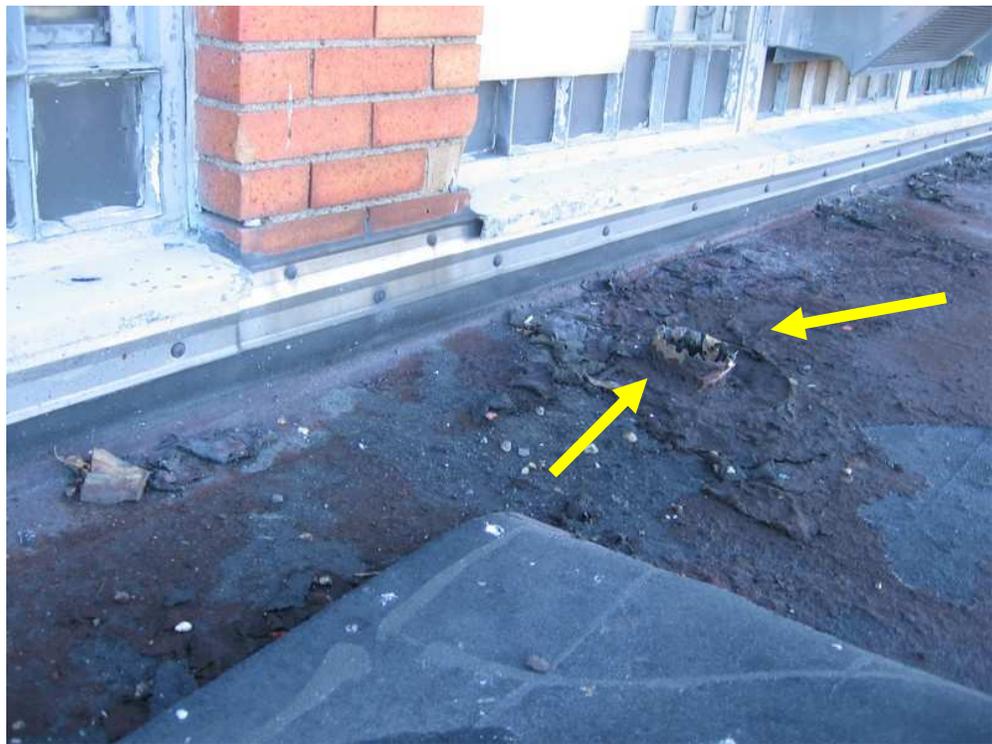
20 – Laundry Bldg. – View of poorly maintained drain at Roof E

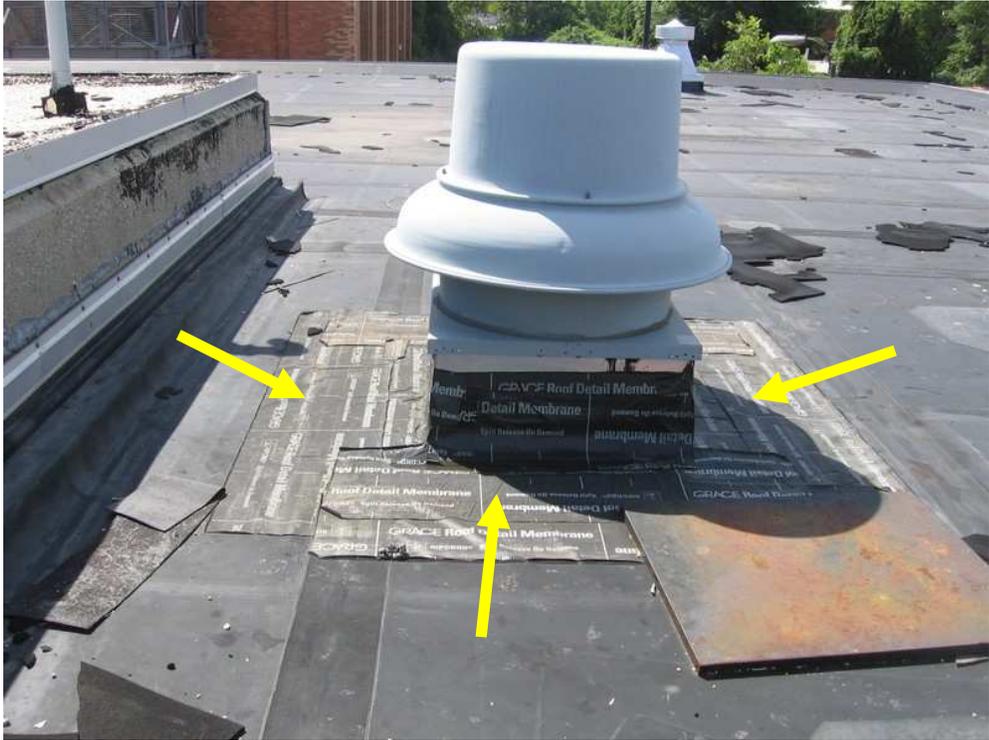
21 – Laundry Bldg. – View of inadequate, ad hoc flashing installation at HVAC unit on Roof B

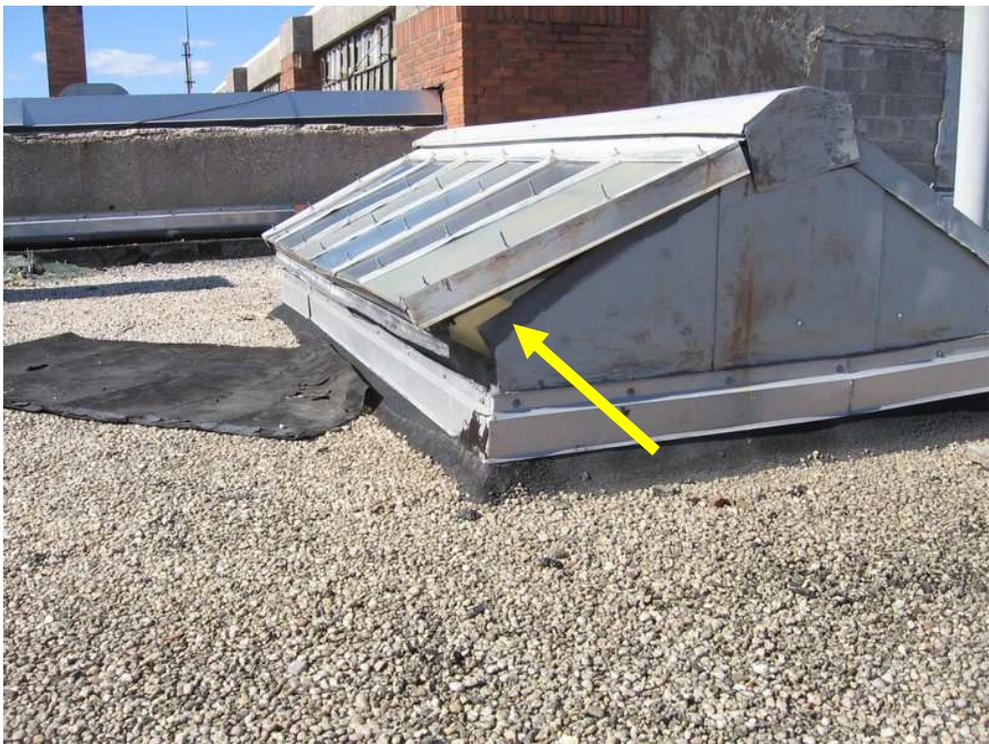
22 – View of existing skylight on Roof C, with panel left in partially open position

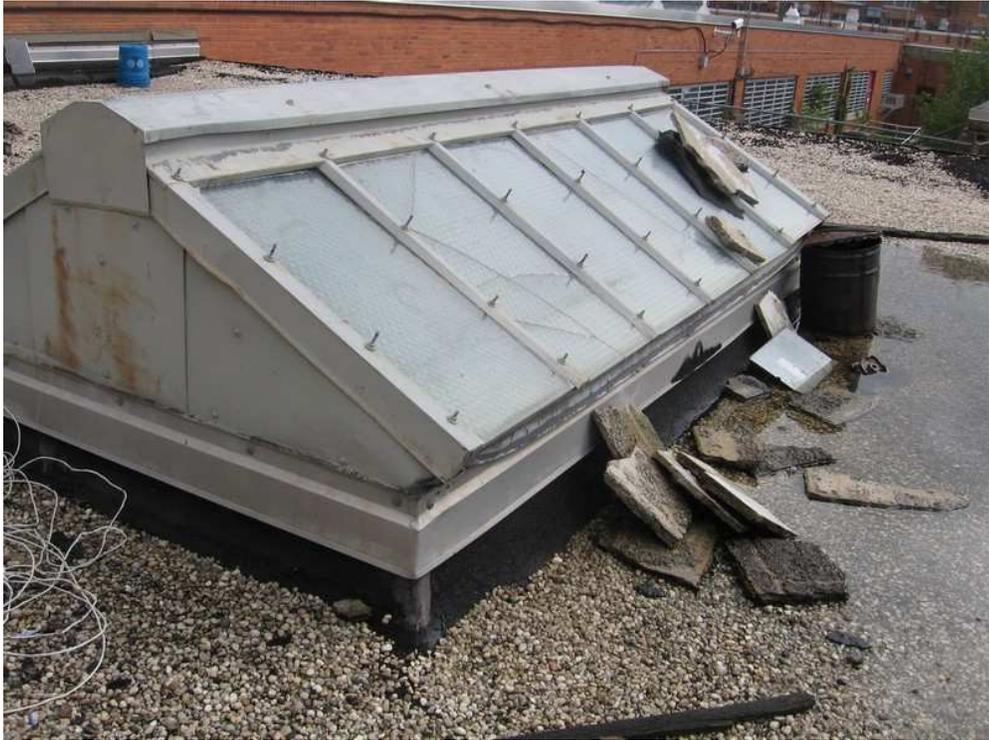
23 – View of existing skylight on Roof C, with cracked glazing

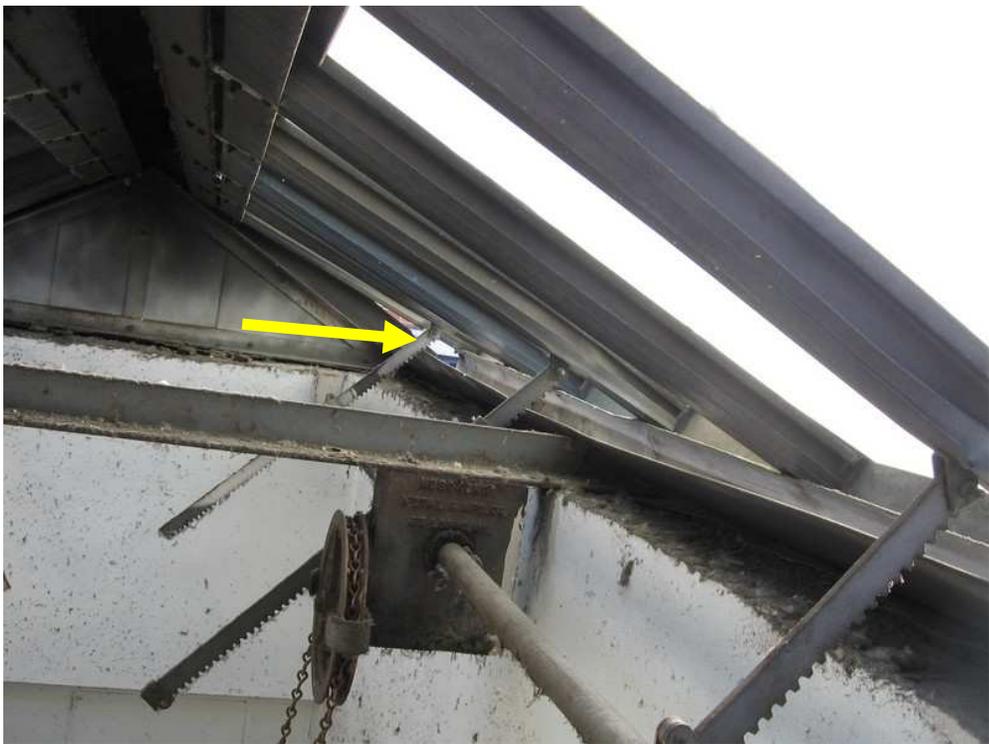
24 – Inside view of existing skylight assembly at Roof C, showing opening at far end

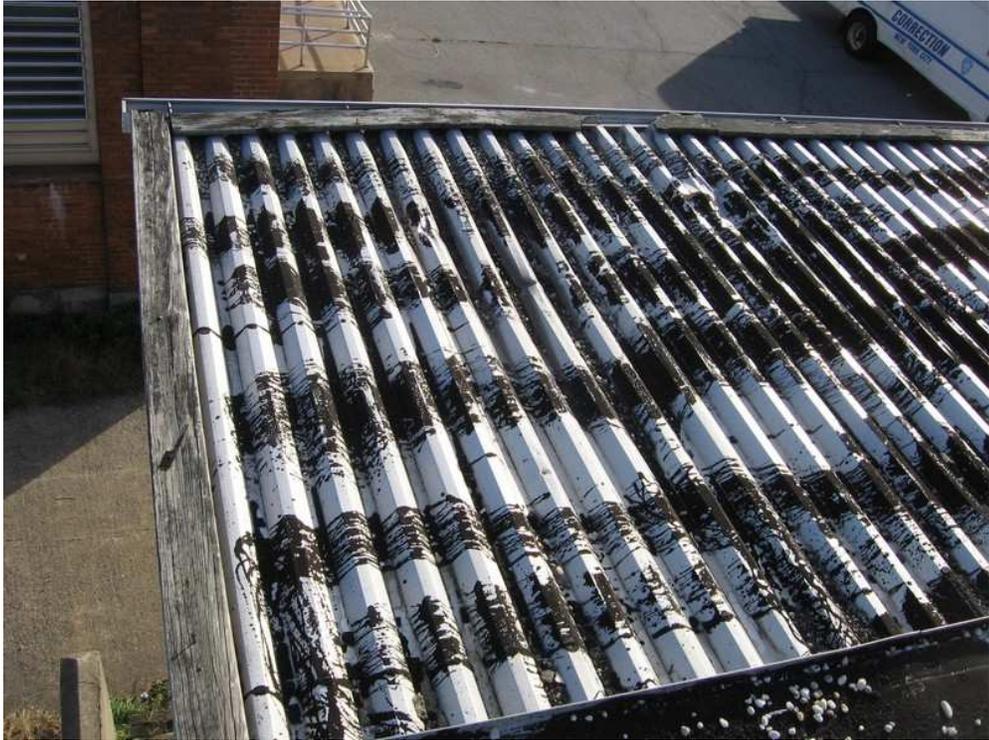
25 – Laundry Bldg. – Top view of damaged, exposed metal decking at awning

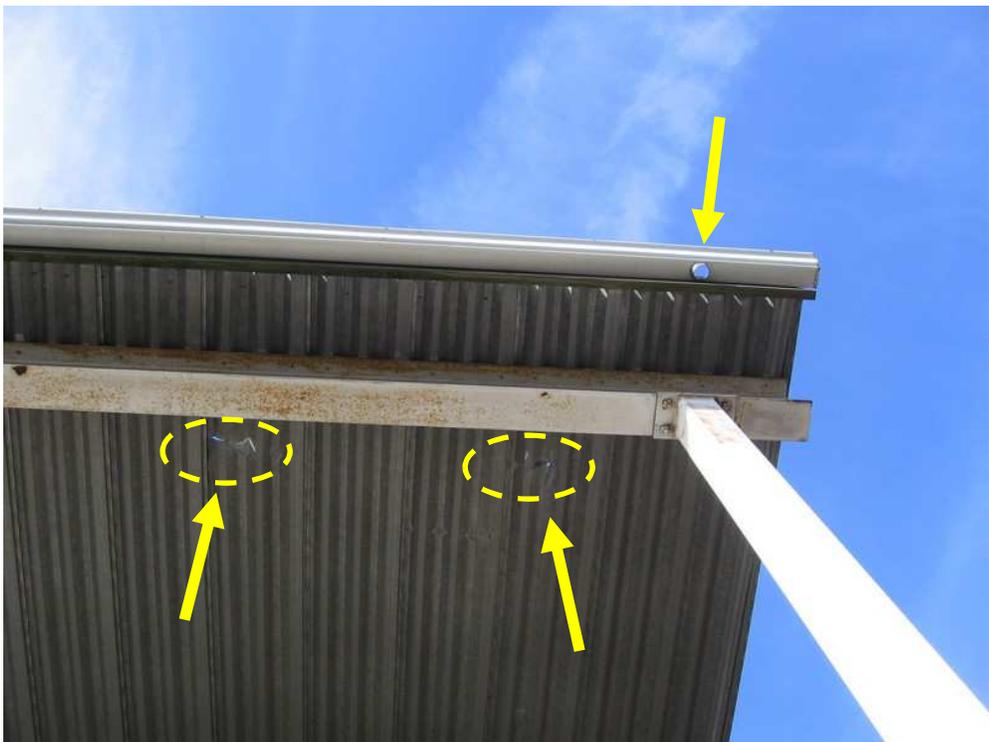
26 – Laundry Bldg. – Underside view of metal awning, showing incomplete gutter assembly and holes in deck

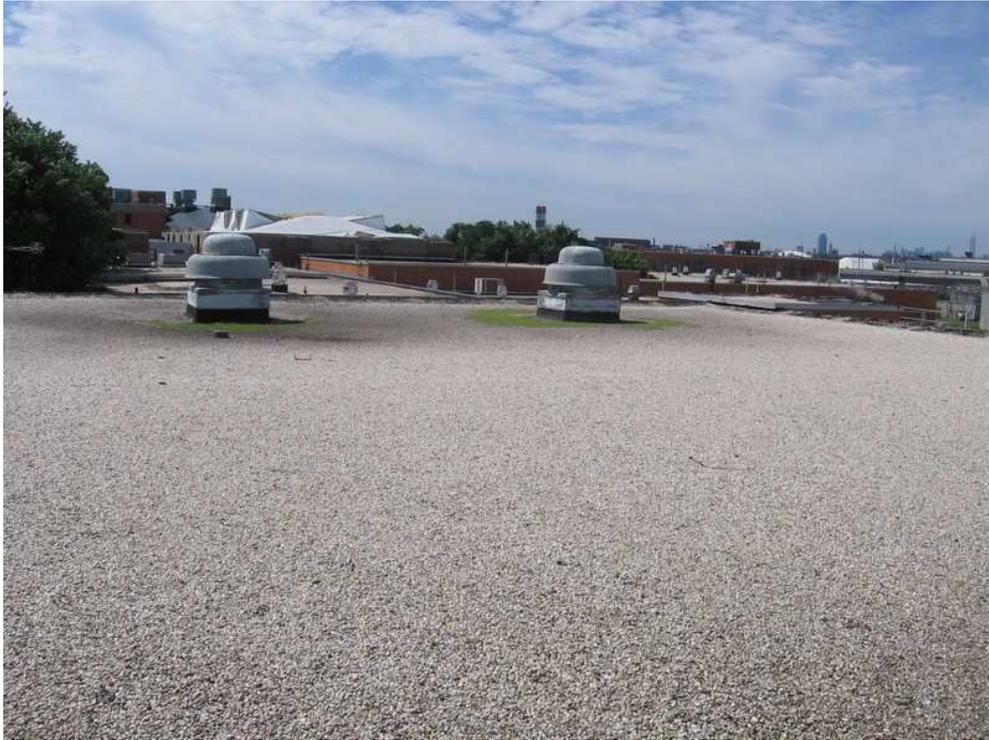
27 – Bakery Bldg. – General view of Roof H

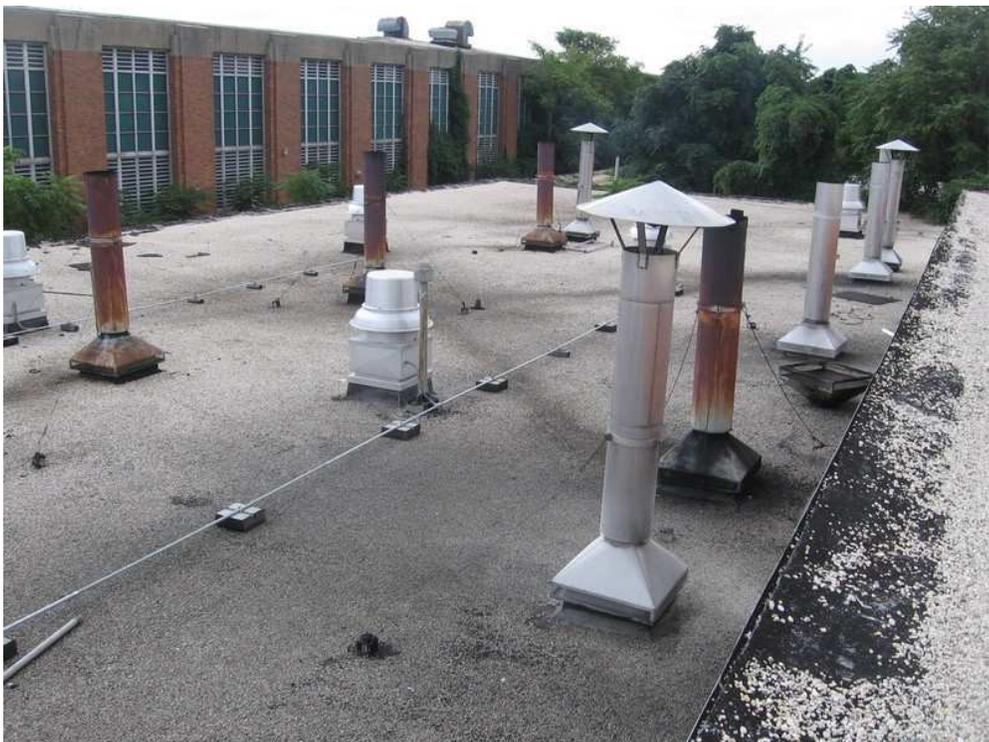
28 – Bakery Bldg. – General view of Roof I showing metal chimney stacks

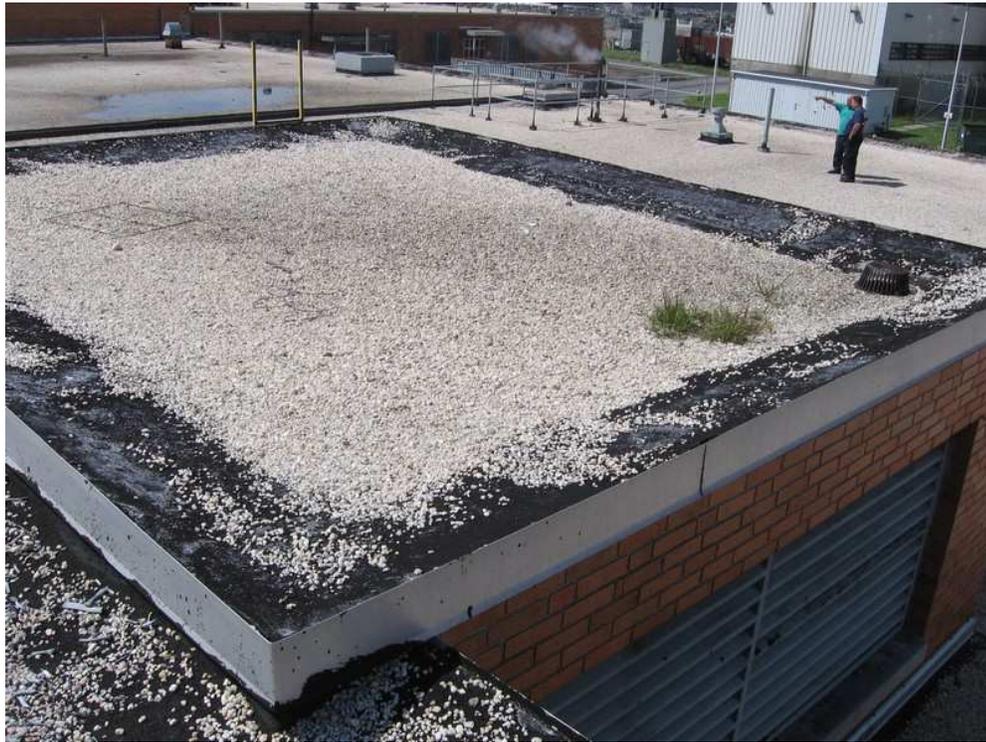
29 – Bakery Bldg. – View of Roof J showing vegetation growth near drain

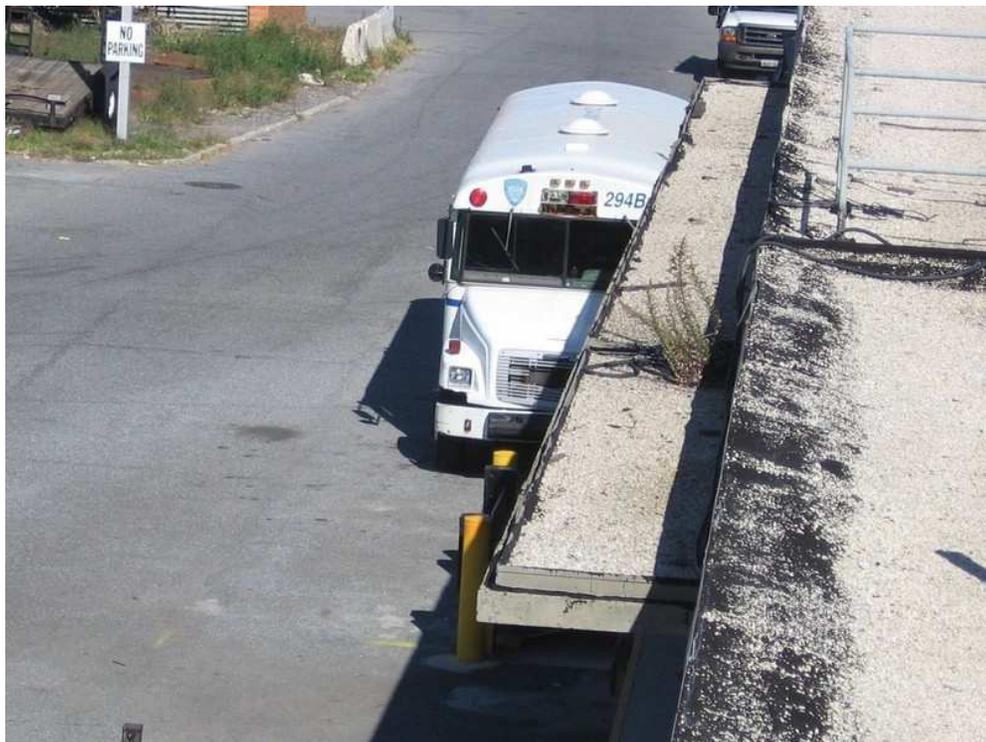
30 – Bakery Bldg. – View of canopy Roof K showing vegetation growth from impeded drainage
