NEW YORK CITY DEPARTMENT OF CORRECTION

ADDENDUM # 1

**Re: PIN 072201607CPD for Bakery/Laundry Building Roof
Replacement at Rikers Island**

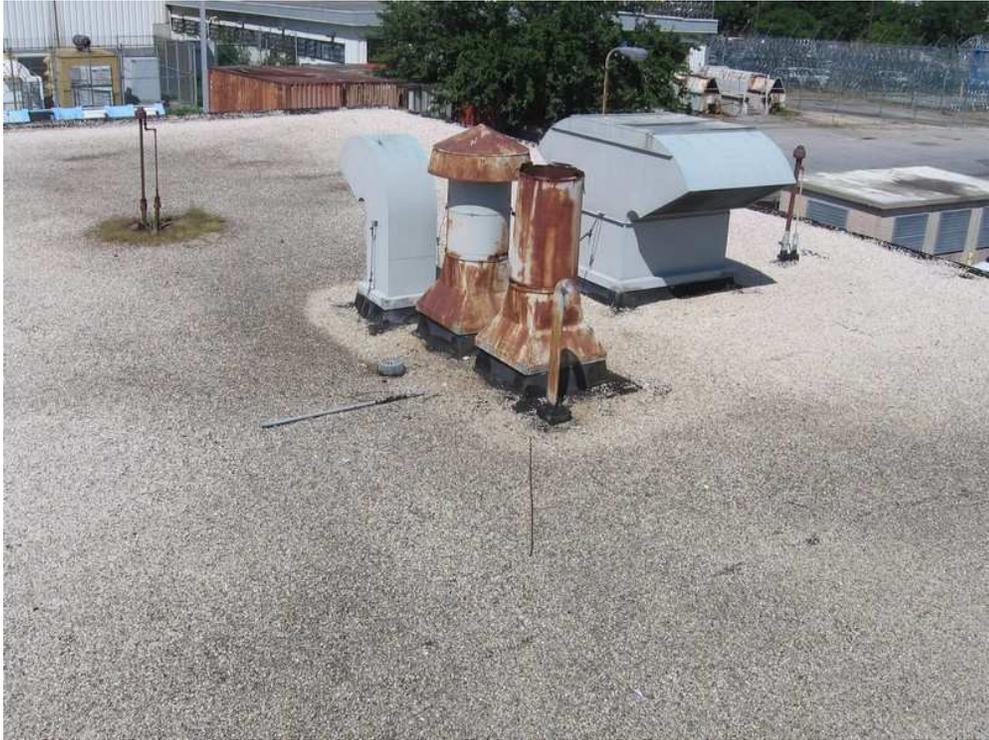
31 – Bakery Bldg. – View of Roof I showing vegetation growth at existing pipe penetration; and mechanical penetrations in close proximity to roof drain

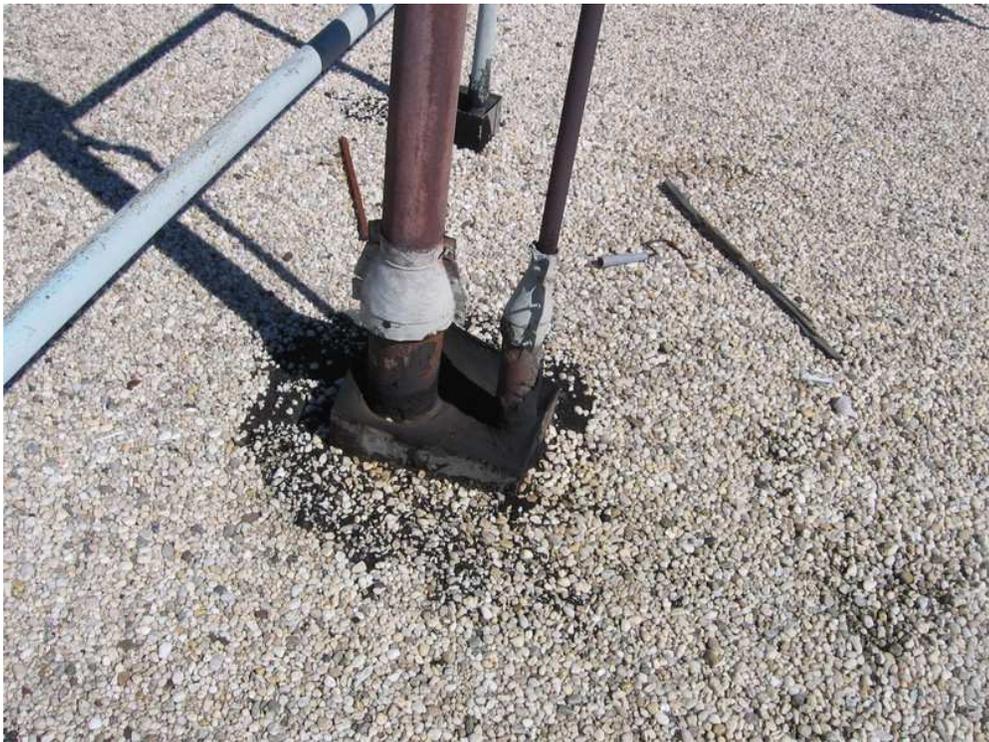
32 – Bakery Bldg. – Existing typical deteriorated penetration flashing (pitch pocket) at Roof I

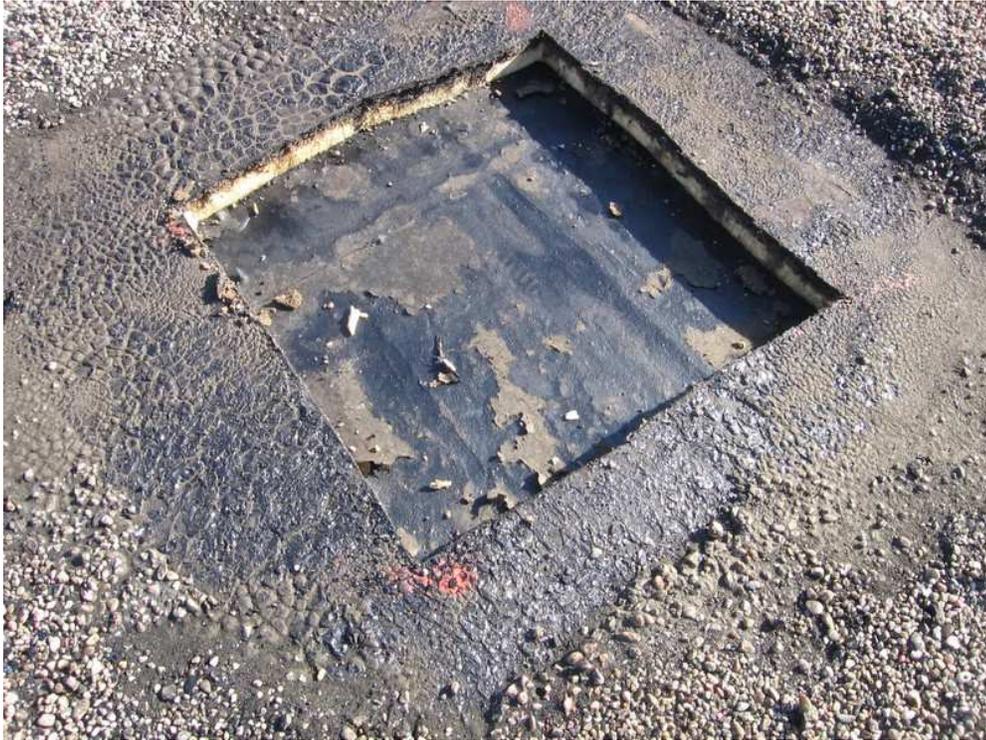
33 – Bakery Bldg. – Alligatoring cracks at membrane surface of existing built-up roofing at Roof I

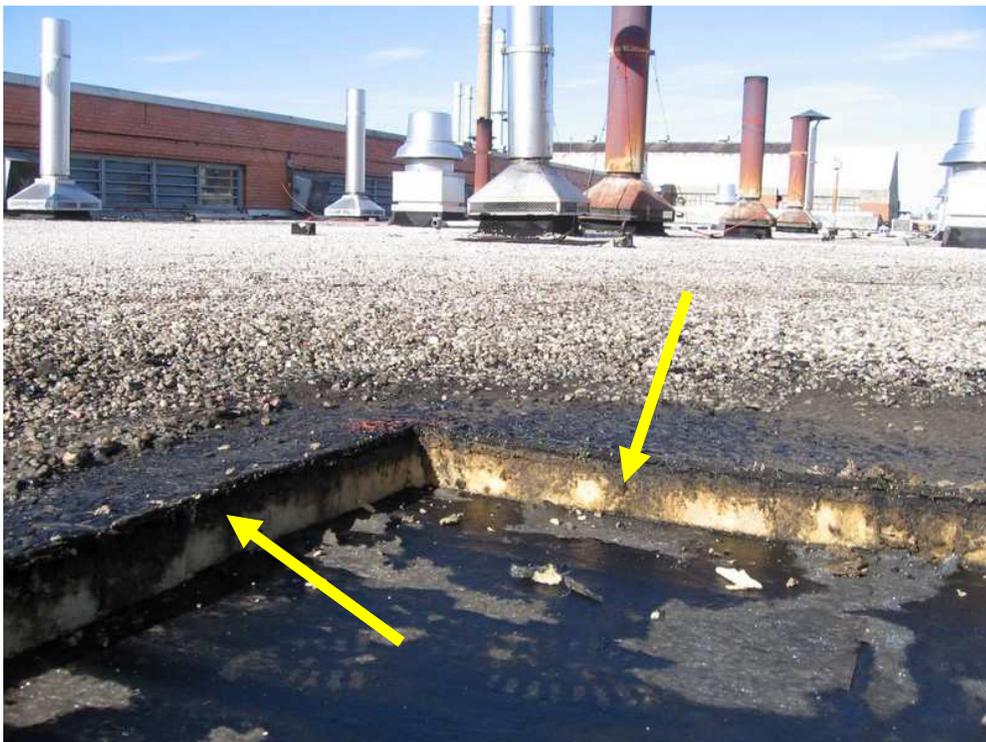
34 – Bakery Bldg. – View of saturated insulation from trapped moisture within roof cut at Roof I
