**New York City Department of Transportation
Office of School Safety Engineering**

School Safety Engineering Project

FINAL REPORT: P.S. 18 (John Greenleaf Whittier School), Staten Island

Prepared by
The RBA Group/Urbitrans Associates

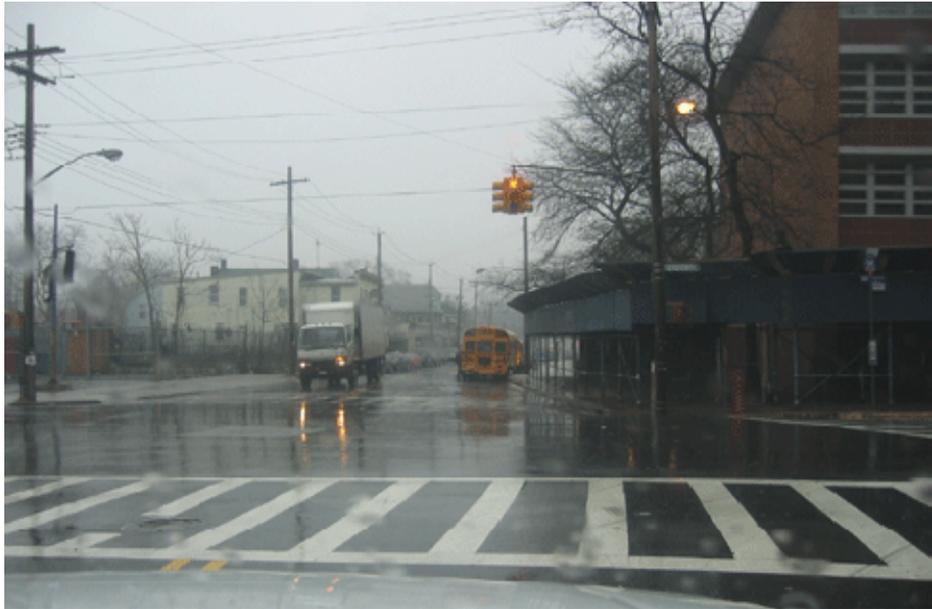
According to school representatives approximately 100 students ride a yellow school bus to school. Bus transportation for the students consists of two yellow school buses, as well as two small and five large special buses, for a total of seven special buses. The yellow buses drop off students on Henderson Avenue near the corner of Broadway (see Figure 1).

Figure 1: Looking east on Henderson Avenue across the intersection with Broadway at school bus activity (P.S. 18 is shown to the right)

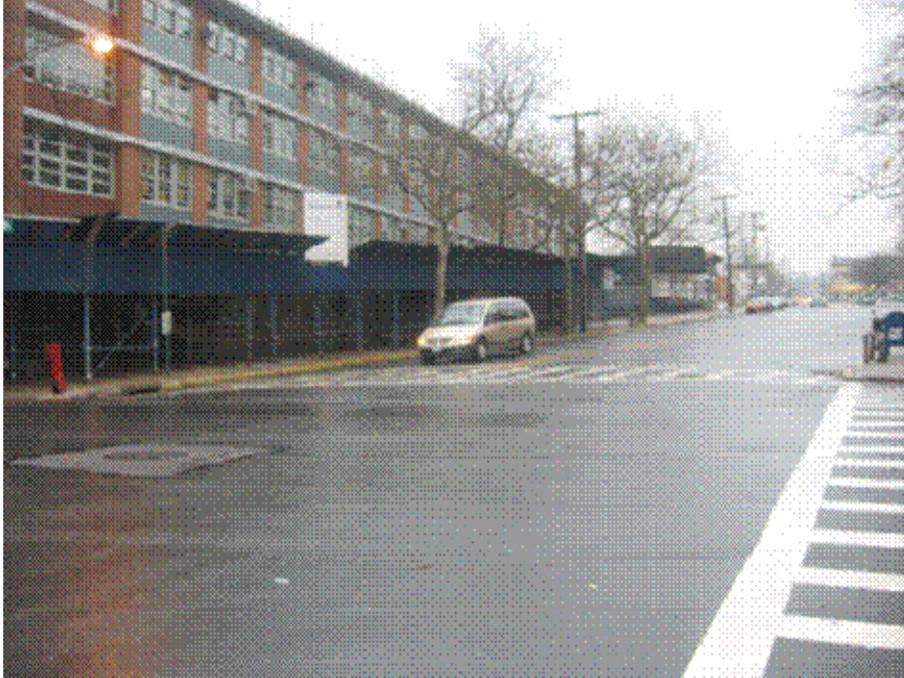
According to school representatives, approximately nine percent of the students are being dropped off. Parents typically double park across from the school entrances on Henderson Avenue and Broadway while dropping off students in the morning, or awaiting the afternoon student dismissal. The double parking results in slower traffic movements on Henderson Avenue, but did not appear to have a significant impact on the speed of traffic on Broadway, because Broadway has sufficient width to accommodate double parking (see Figure 2).

*Figure 2: Looking south on Broadway from across the intersection with Henderson Avenue
(P.S. 18 is shown to the left)*

- A pedestrian ramp is missing on the southeast corner of the Broadway and Henderson Avenue intersection (see Figures 2 and 9).
- Pedestrian ramps are missing on the northeast, southeast, and southwest corners of the Campbell Avenue and Henderson Avenue intersection (see Figures 3 and 5).

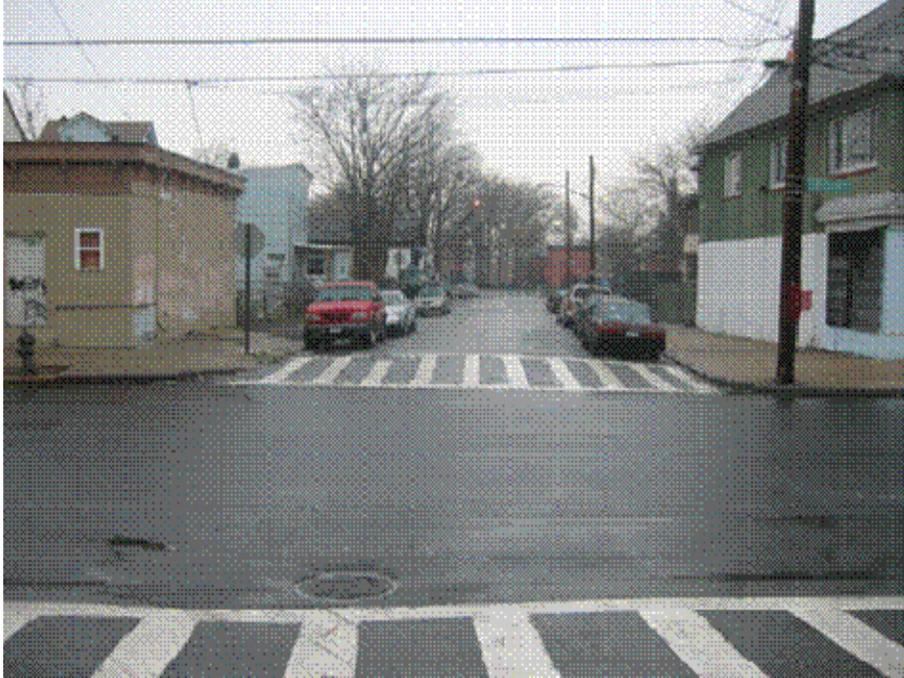
Figure 3: Looking north along Campbell Avenue from across the intersection with Henderson Avenue

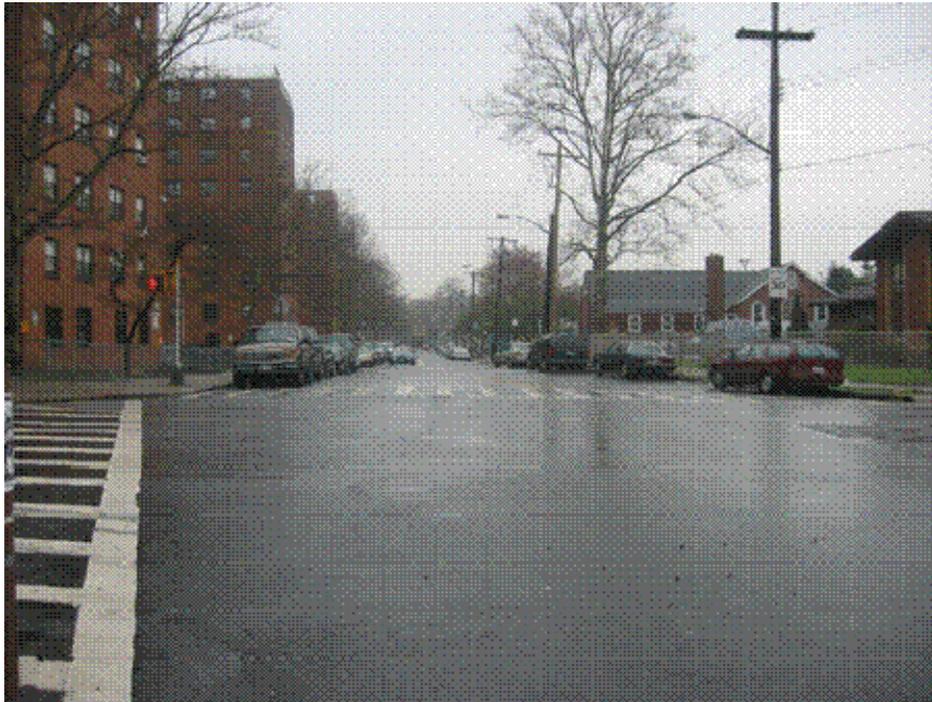
Figure 4: Looking west along Henderson Avenue from across the intersection with Broadway

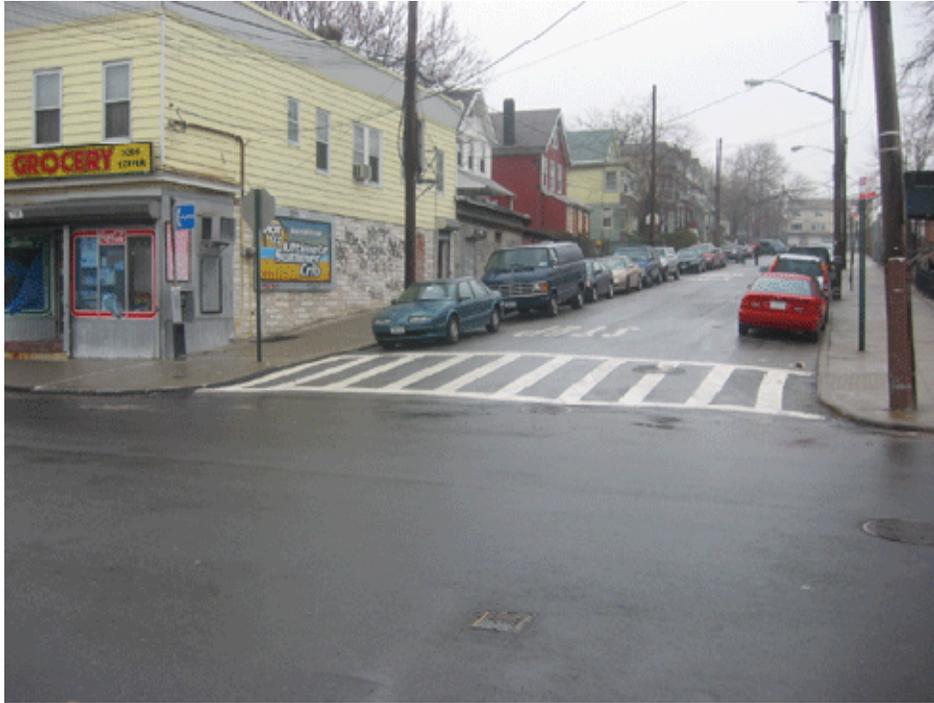
Figure 5: Looking south along Campbell Avenue from across the intersection with Henderson Avenue

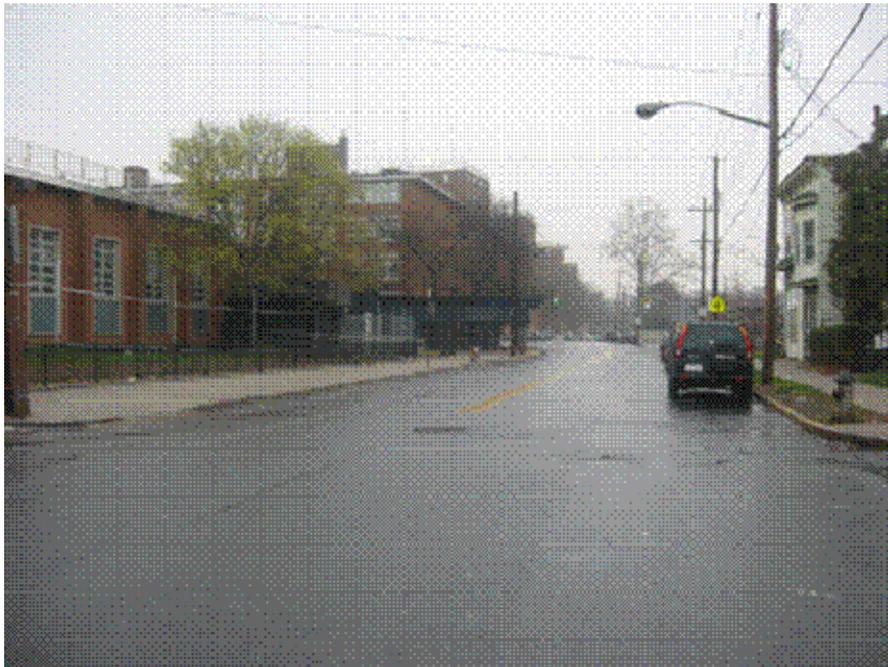
*Figure 6: Looking west along Henderson Avenue from the intersection with Campbell Avenue
(P.S. 18 is shown to the left)*

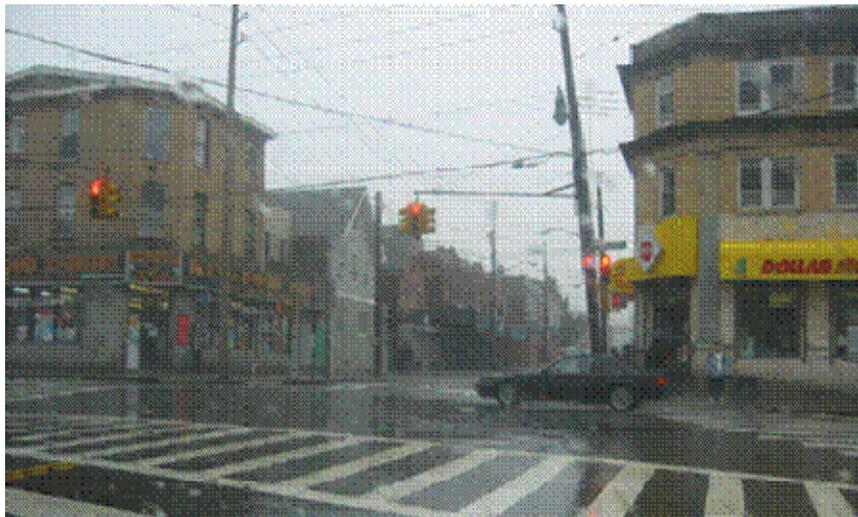
Figure 7: Looking south on Broadway across the intersection with Castleton Avenue

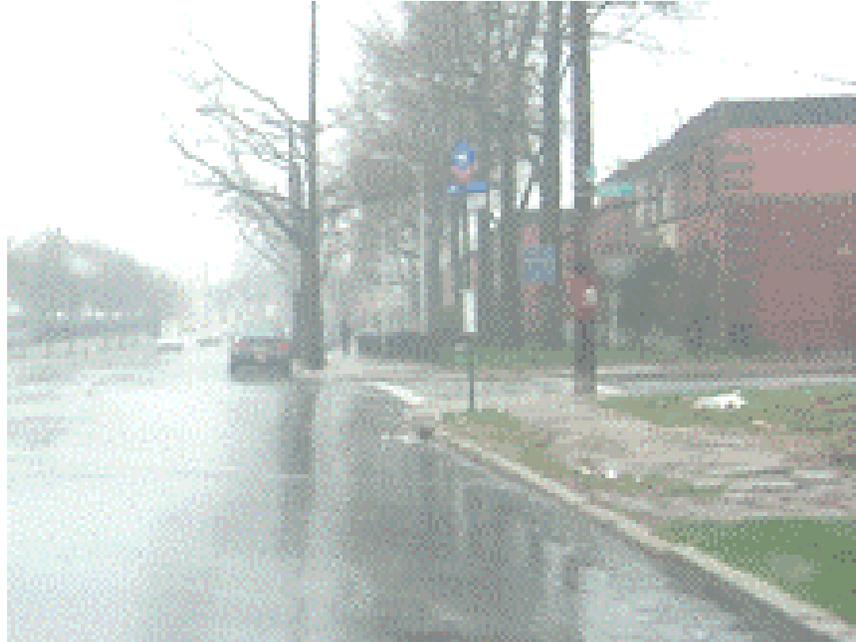
Figure 8: Looking north along Broadway toward the intersection with Market Street

The roadways and sidewalks in the vicinity of P.S. 18 were found to be in good condition with the exception of one sidewalk location on the east side of Broadway, south of Market Street which is cracked and broken (see Figure 8). Sidewalk widths range between 10 and 15 feet on the block faces surrounding P.S. 18.

The sidewalk along the east side of Broadway, south of Market Street, is cracked and broken (see Section 3.8.1 and Figure 8) and should be replaced. Therefore, the following action is recommended:

- Replace the broken and cracked section of sidewalk along the east side of Broadway, south of Market Street.

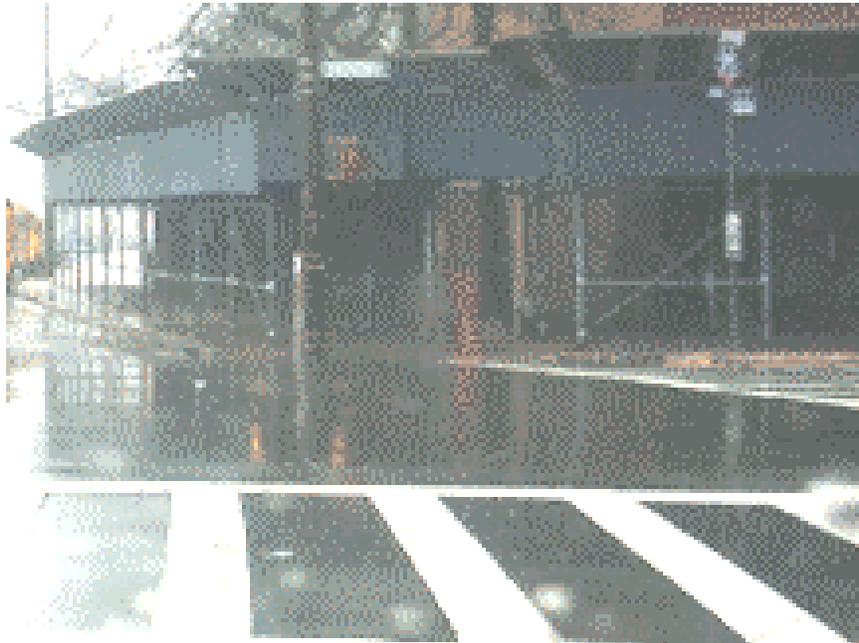
Figure 9: Missing pedestrian ramp on the southeast corner of the Broadway and Henderson Avenue intersection

Pedestrian ramps were found to be missing at several locations identified in Section 3.8.2. Therefore, it is recommended to:
