1009 FIFTH AVENUE

WJE Engineers & Architects, P.C.

INITIAL LPC SUBMISSION: 3.23.2016
REVISED LPC SUBMISSION: 4.05.2016

BACKGROUND: RETAINING WALL PROBLEMS

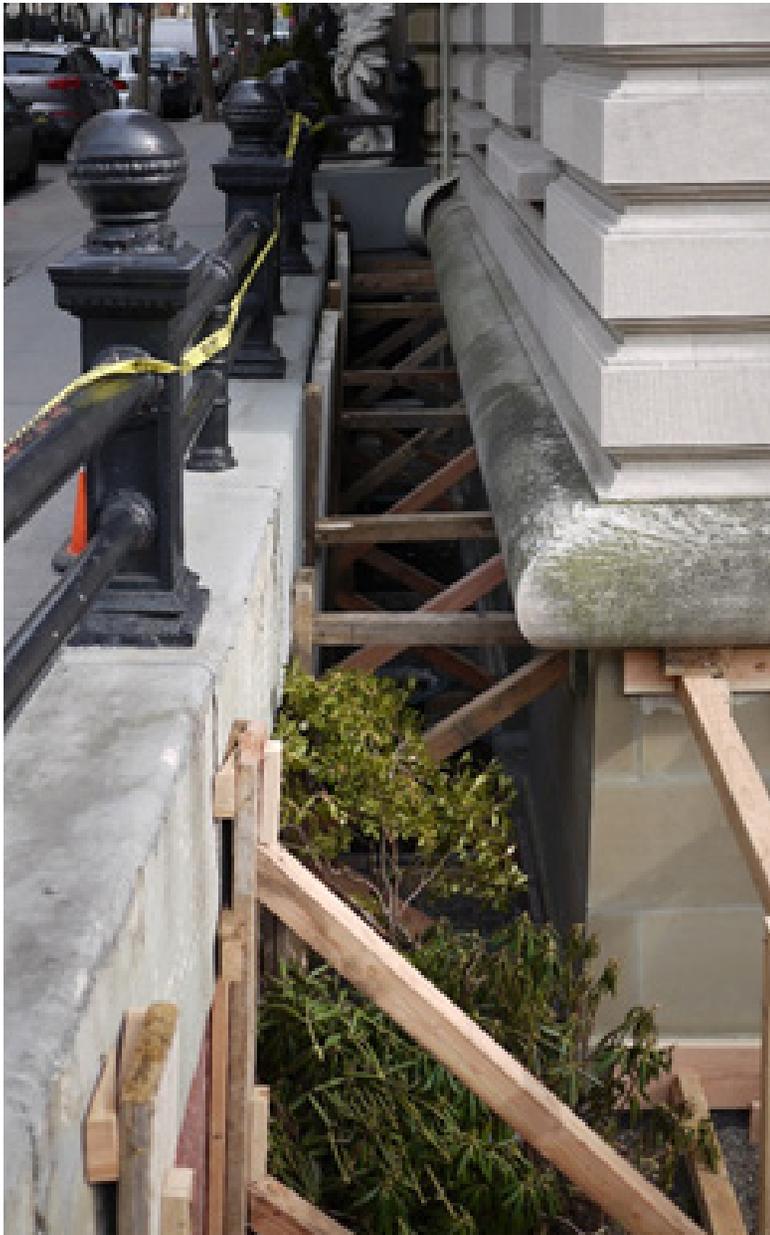
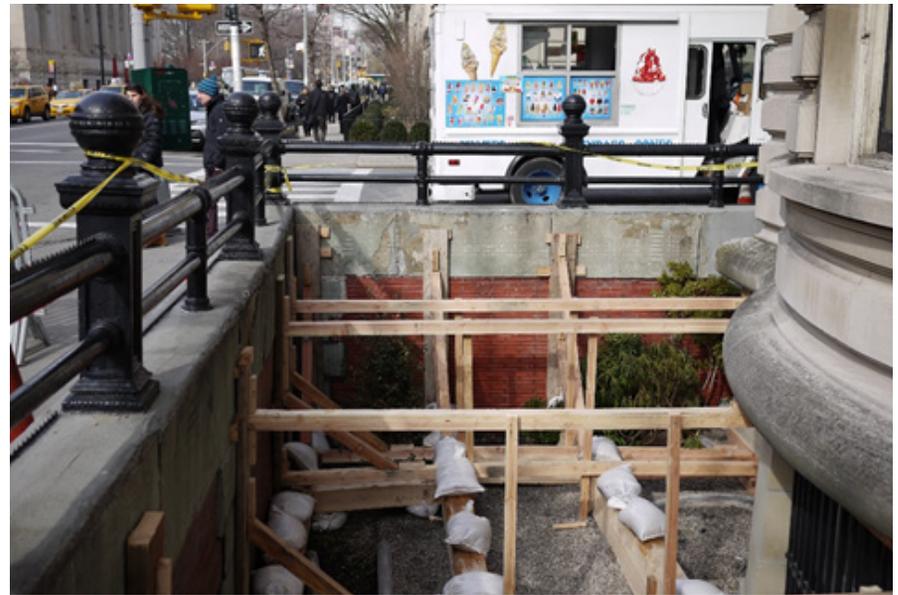
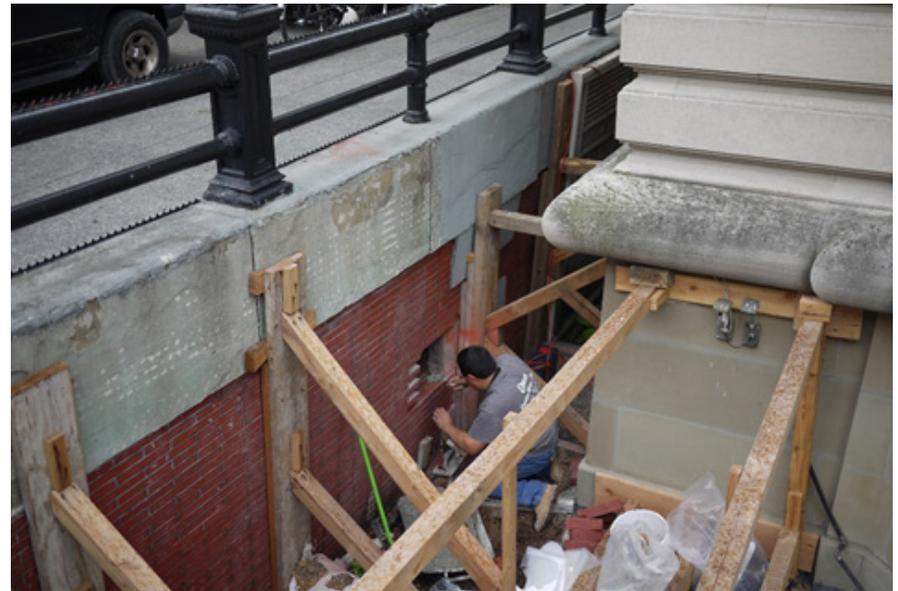
CONDITIONS: STONE MASONRY

- THE COPINGS AND ASHLAR BLOCKS AT THE INBOARD WALL ARE BLUESTONE
- DUE TO DETERIORATION THE STONE IS CURRENTLY CRACKED, DELAMINATING AND SPALLING

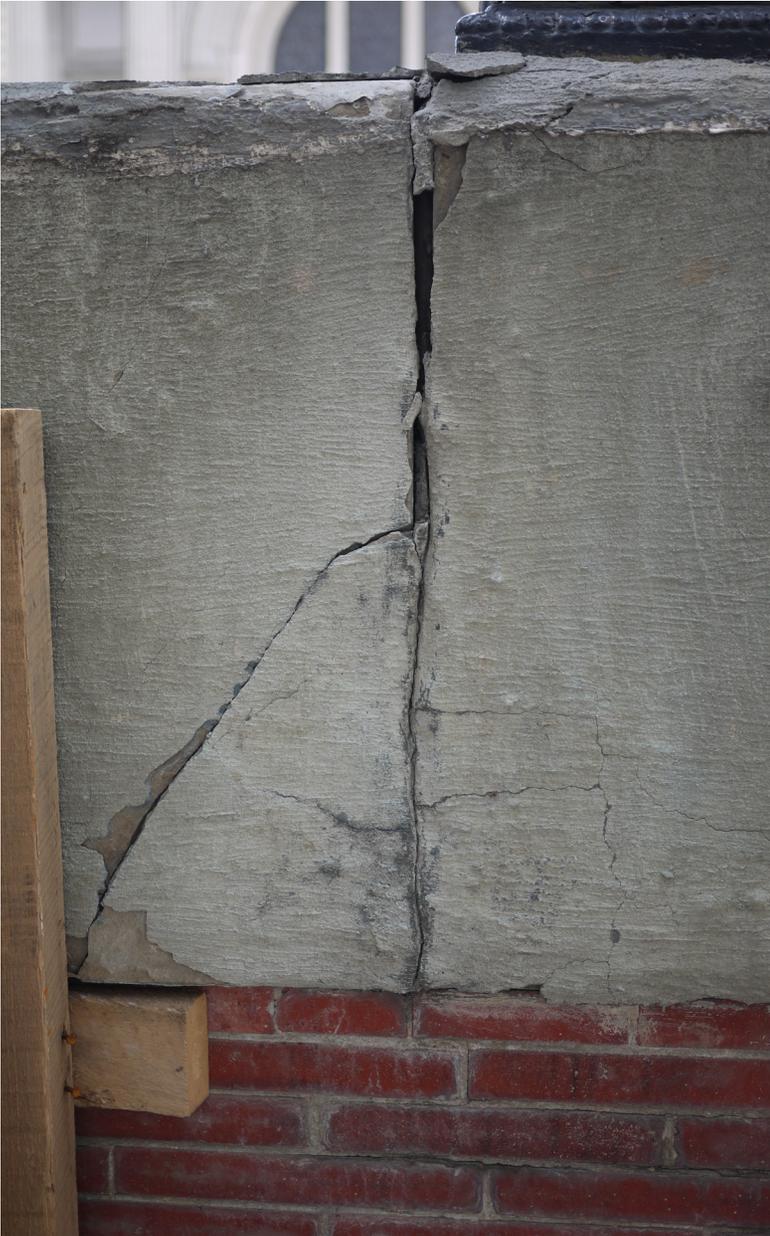
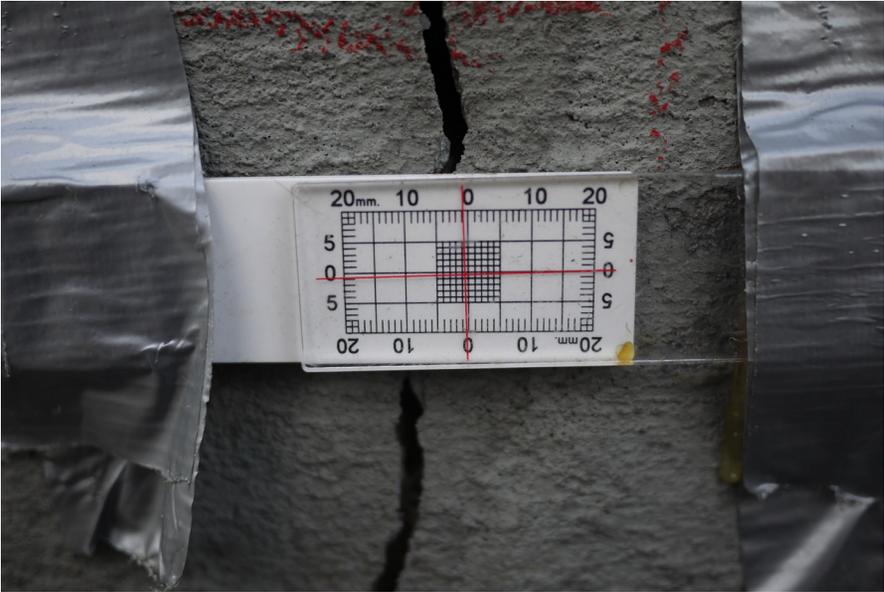
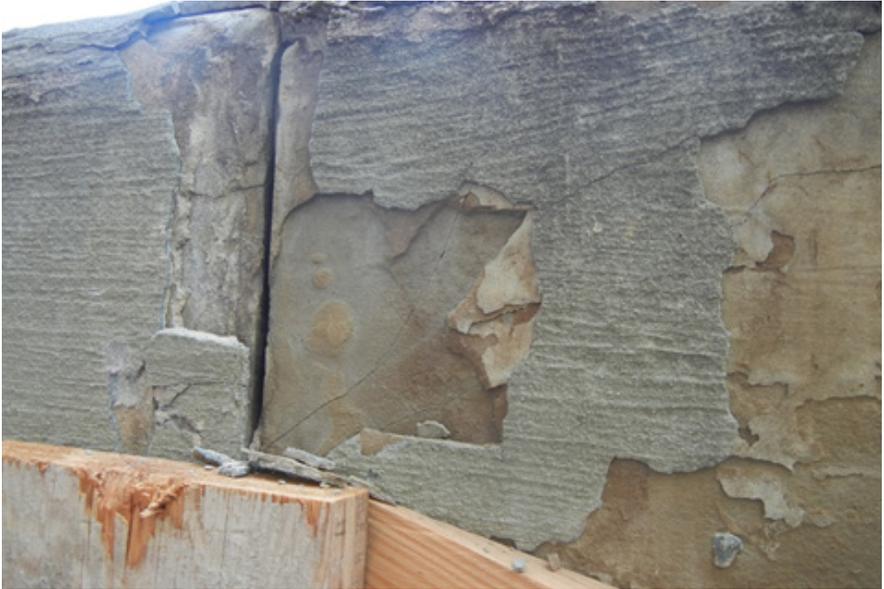
CONDITIONS: BRICK MASONRY

- THE INNER WYTHE OF BRICK MASONRY IS DETACHED FROM THE WALL BUT IN FAIR CONDITION. CRACKING AND DETERIORATED MORTAR JOINTS WERE MOSTLY NOTED
