462 BROADWAY
MERINGOFF PROPERTIES
FACADE
RESTORATION

DRAFT

OCTOBER 06, 2017

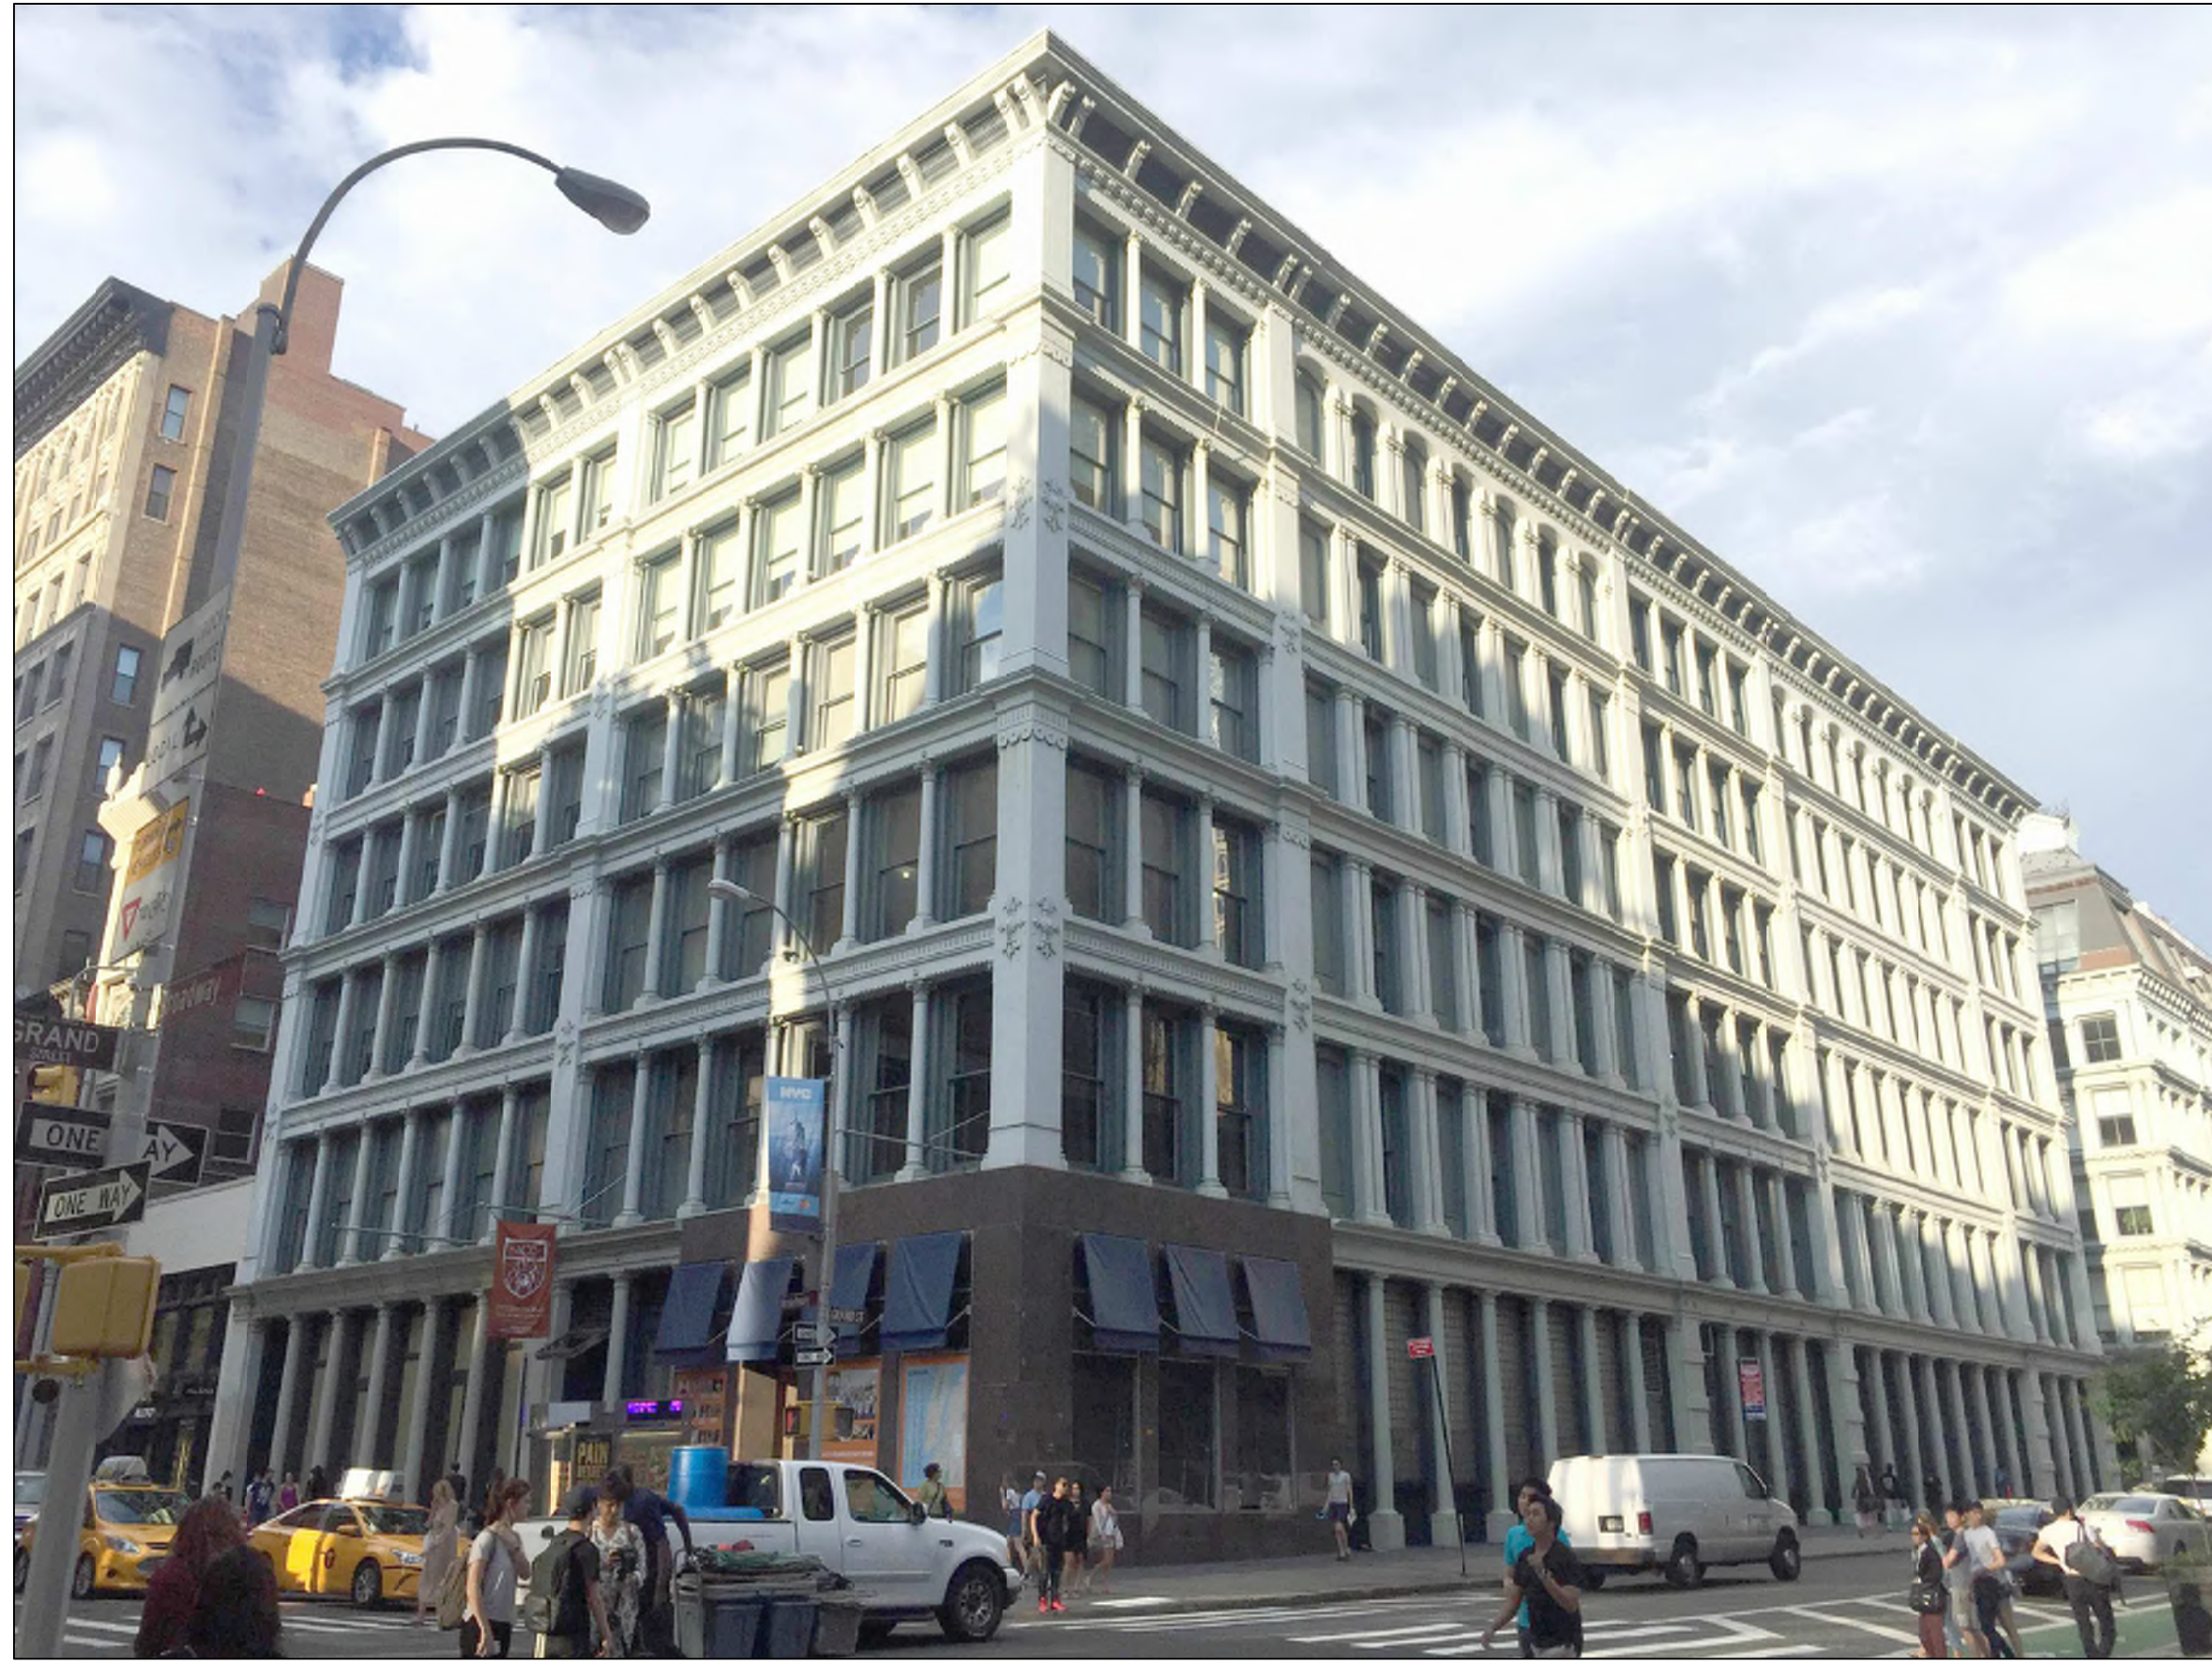
NON-HISTORIC STOREFRONT AT CORNER OF GRAND ST & BROADWAY

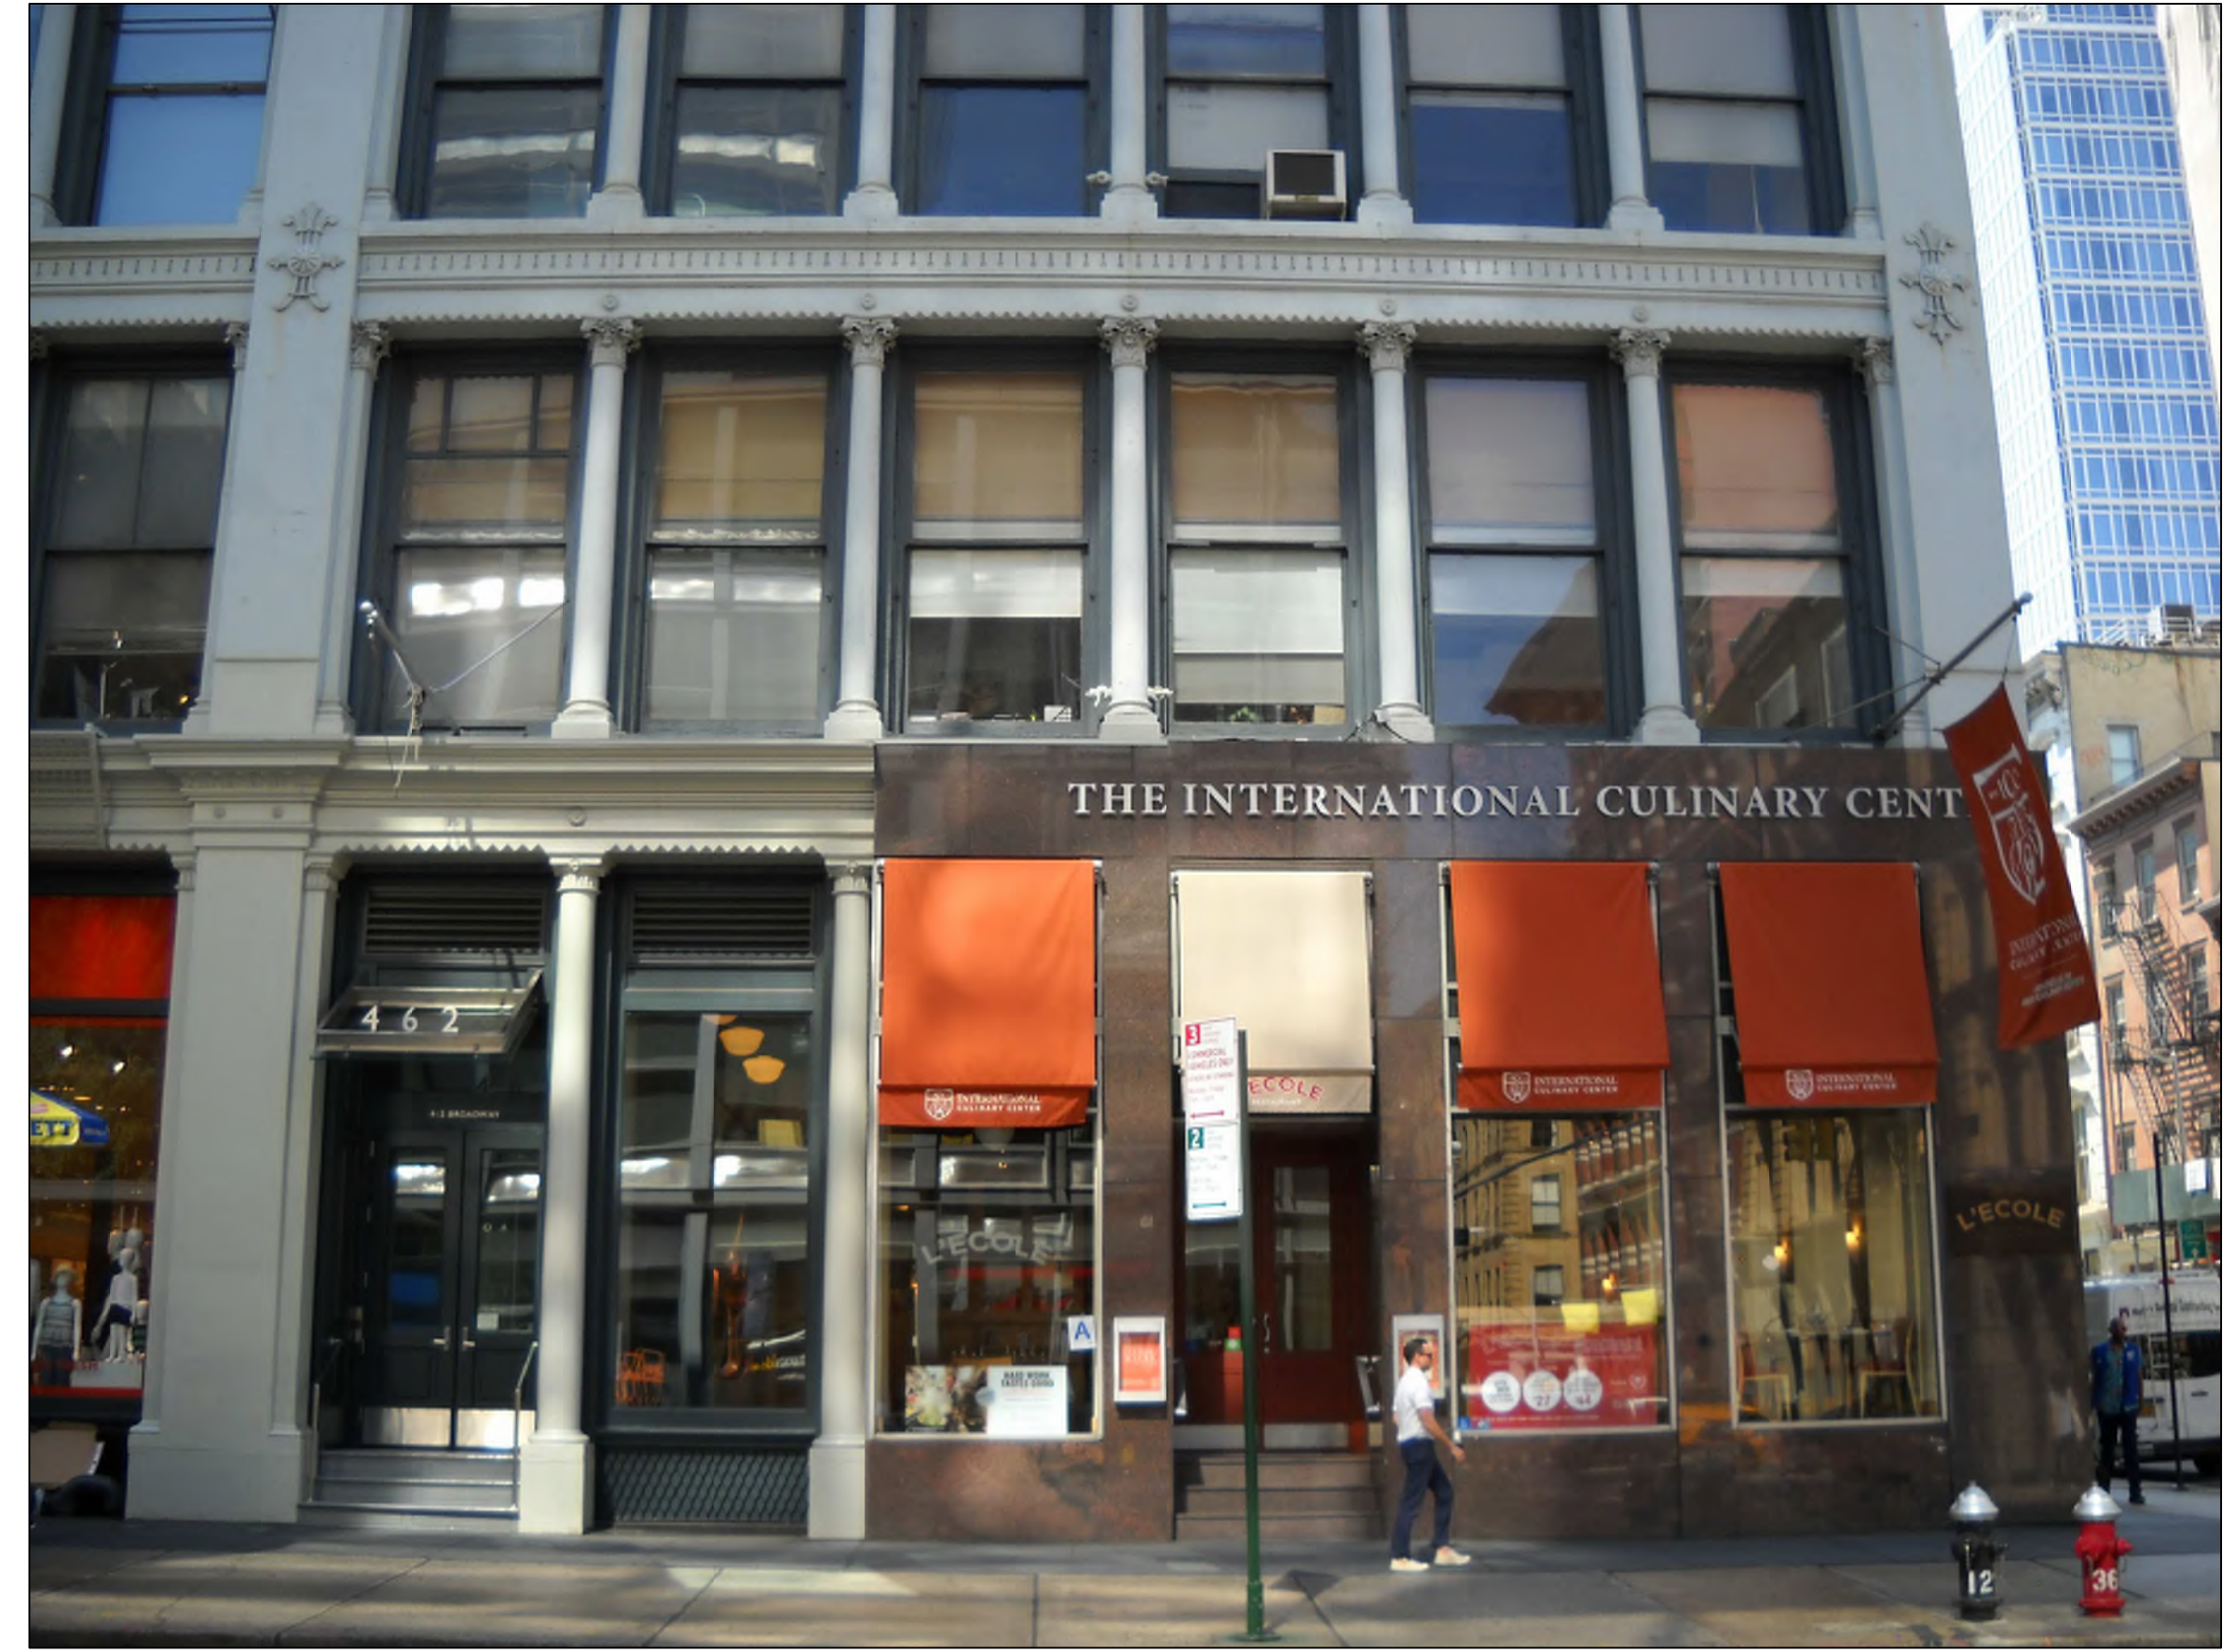
RECENTLY RESTORED BUILDING ENTRY & NON-HISTORIC STOREFRONT ON BROADWAY

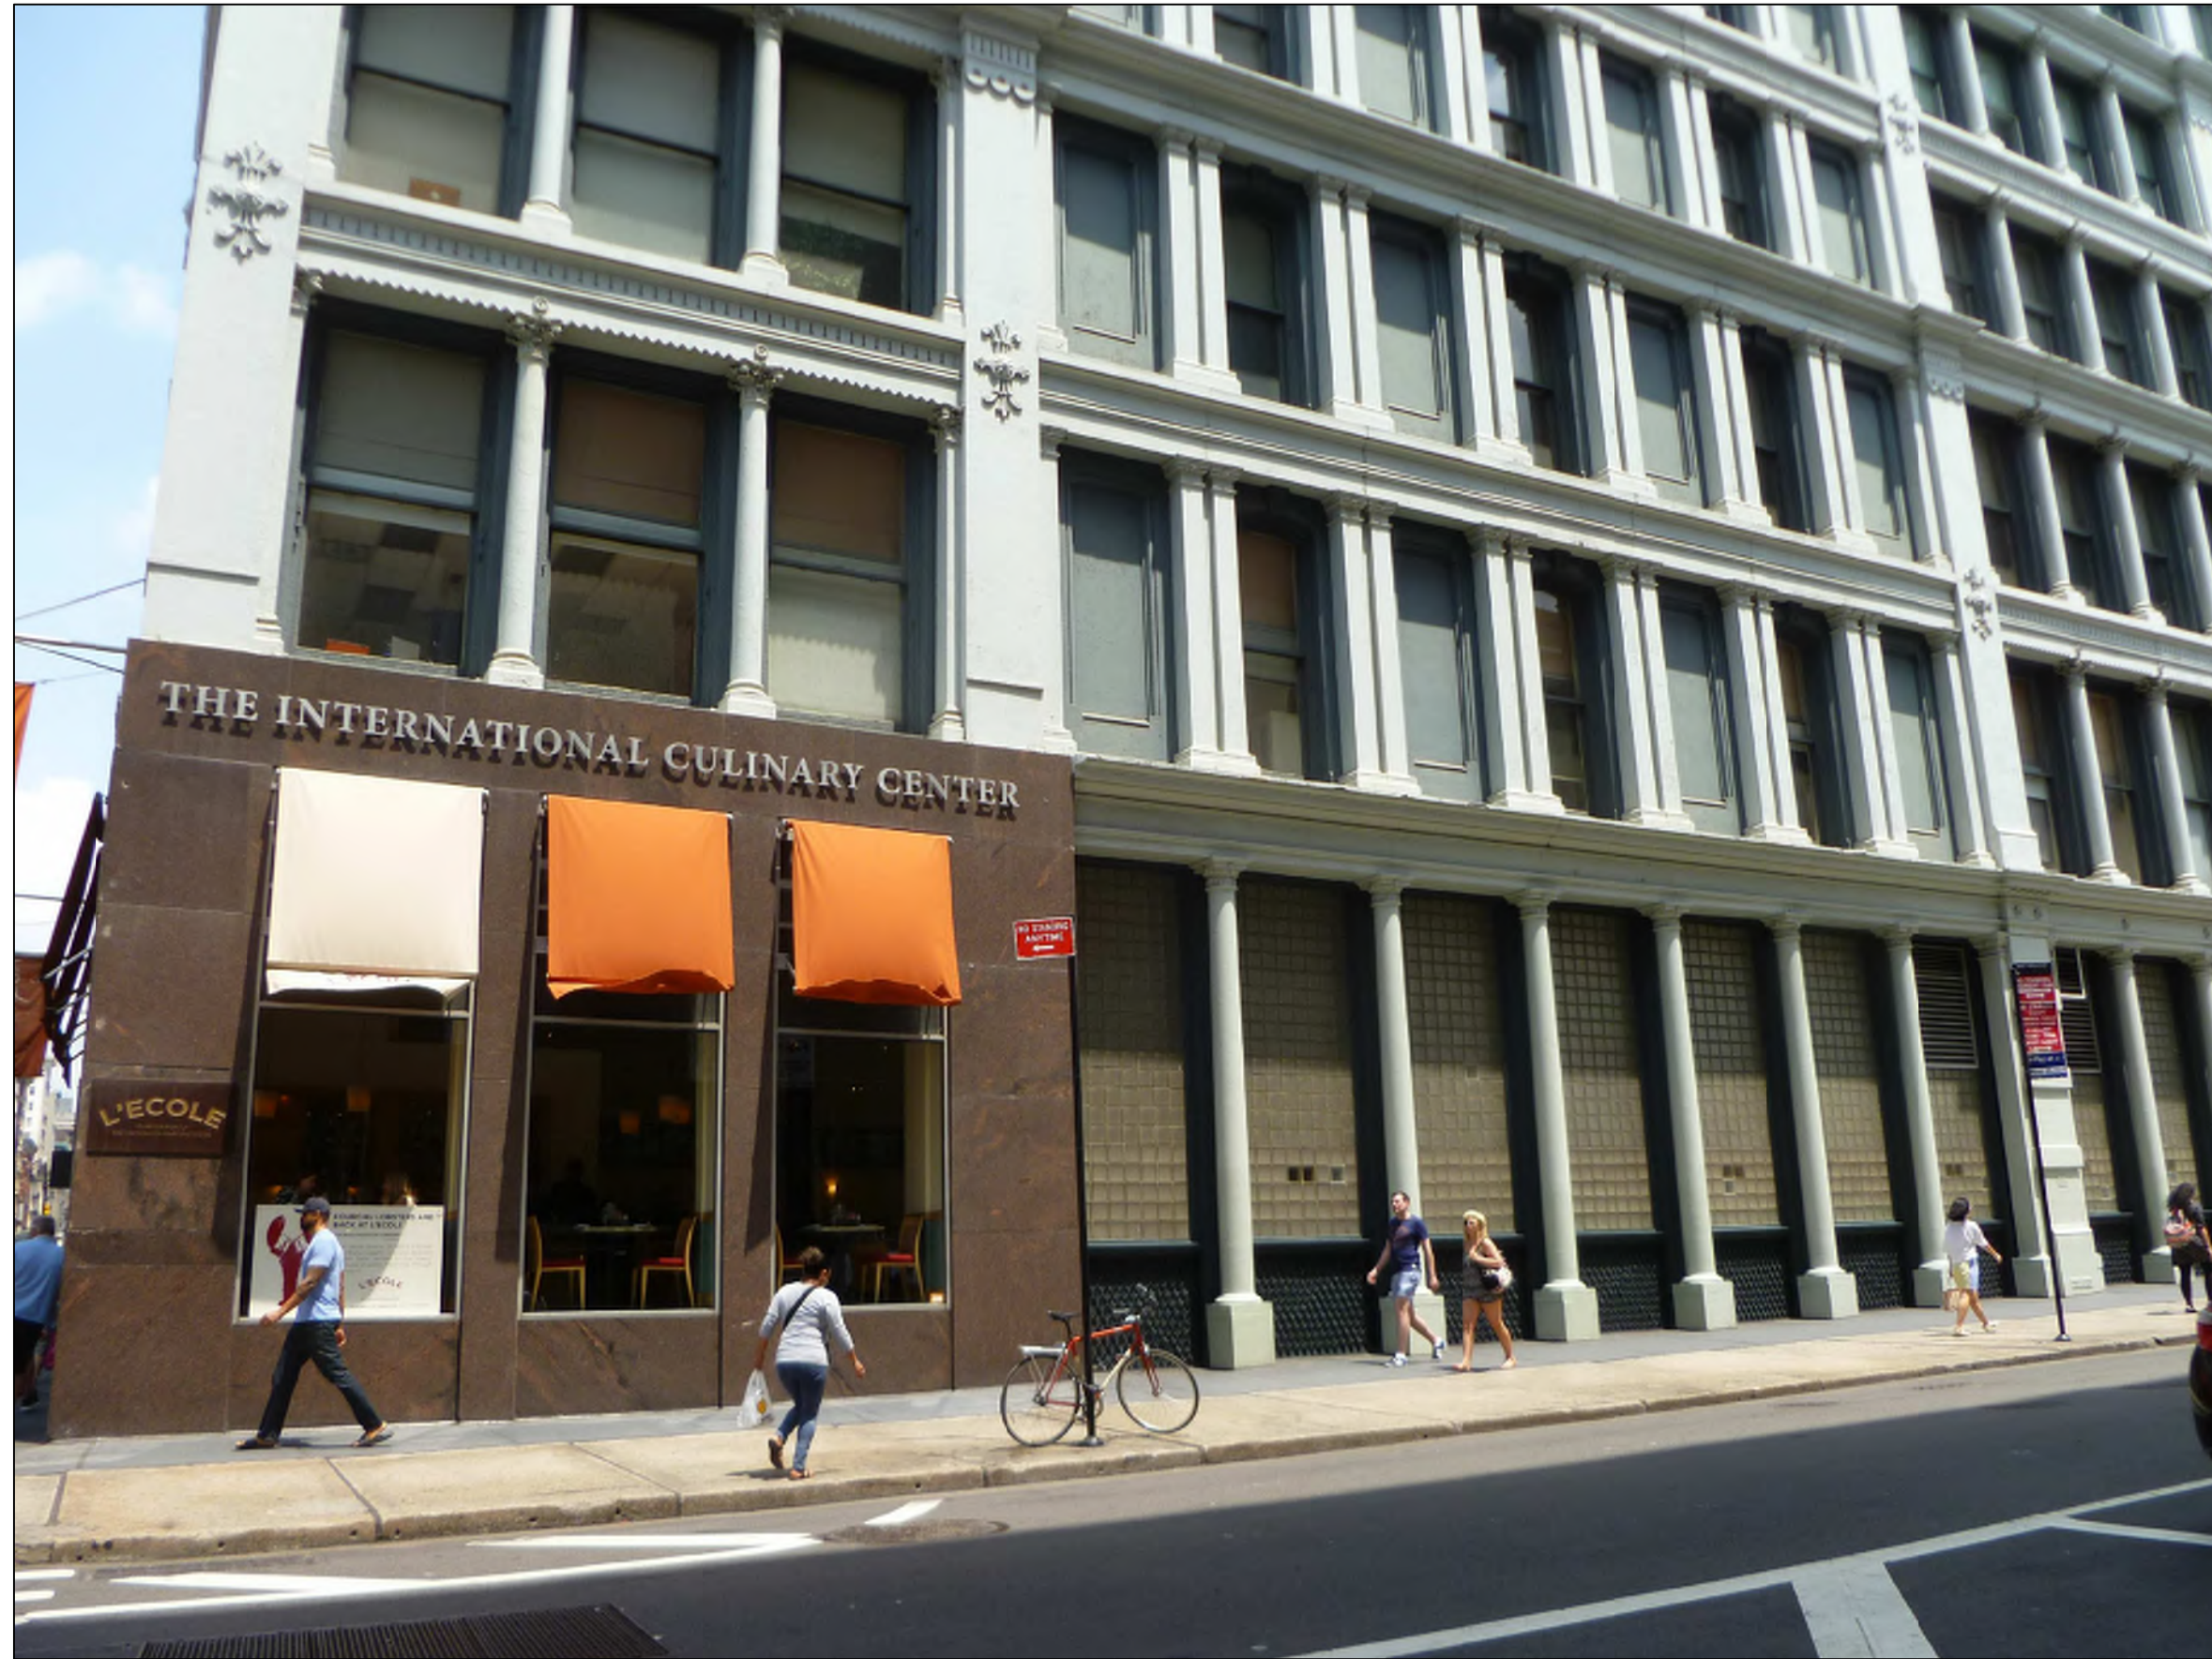
NON-HISTORIC STOREFRONT AT CORNER OF GRAND ST & BROADWAY

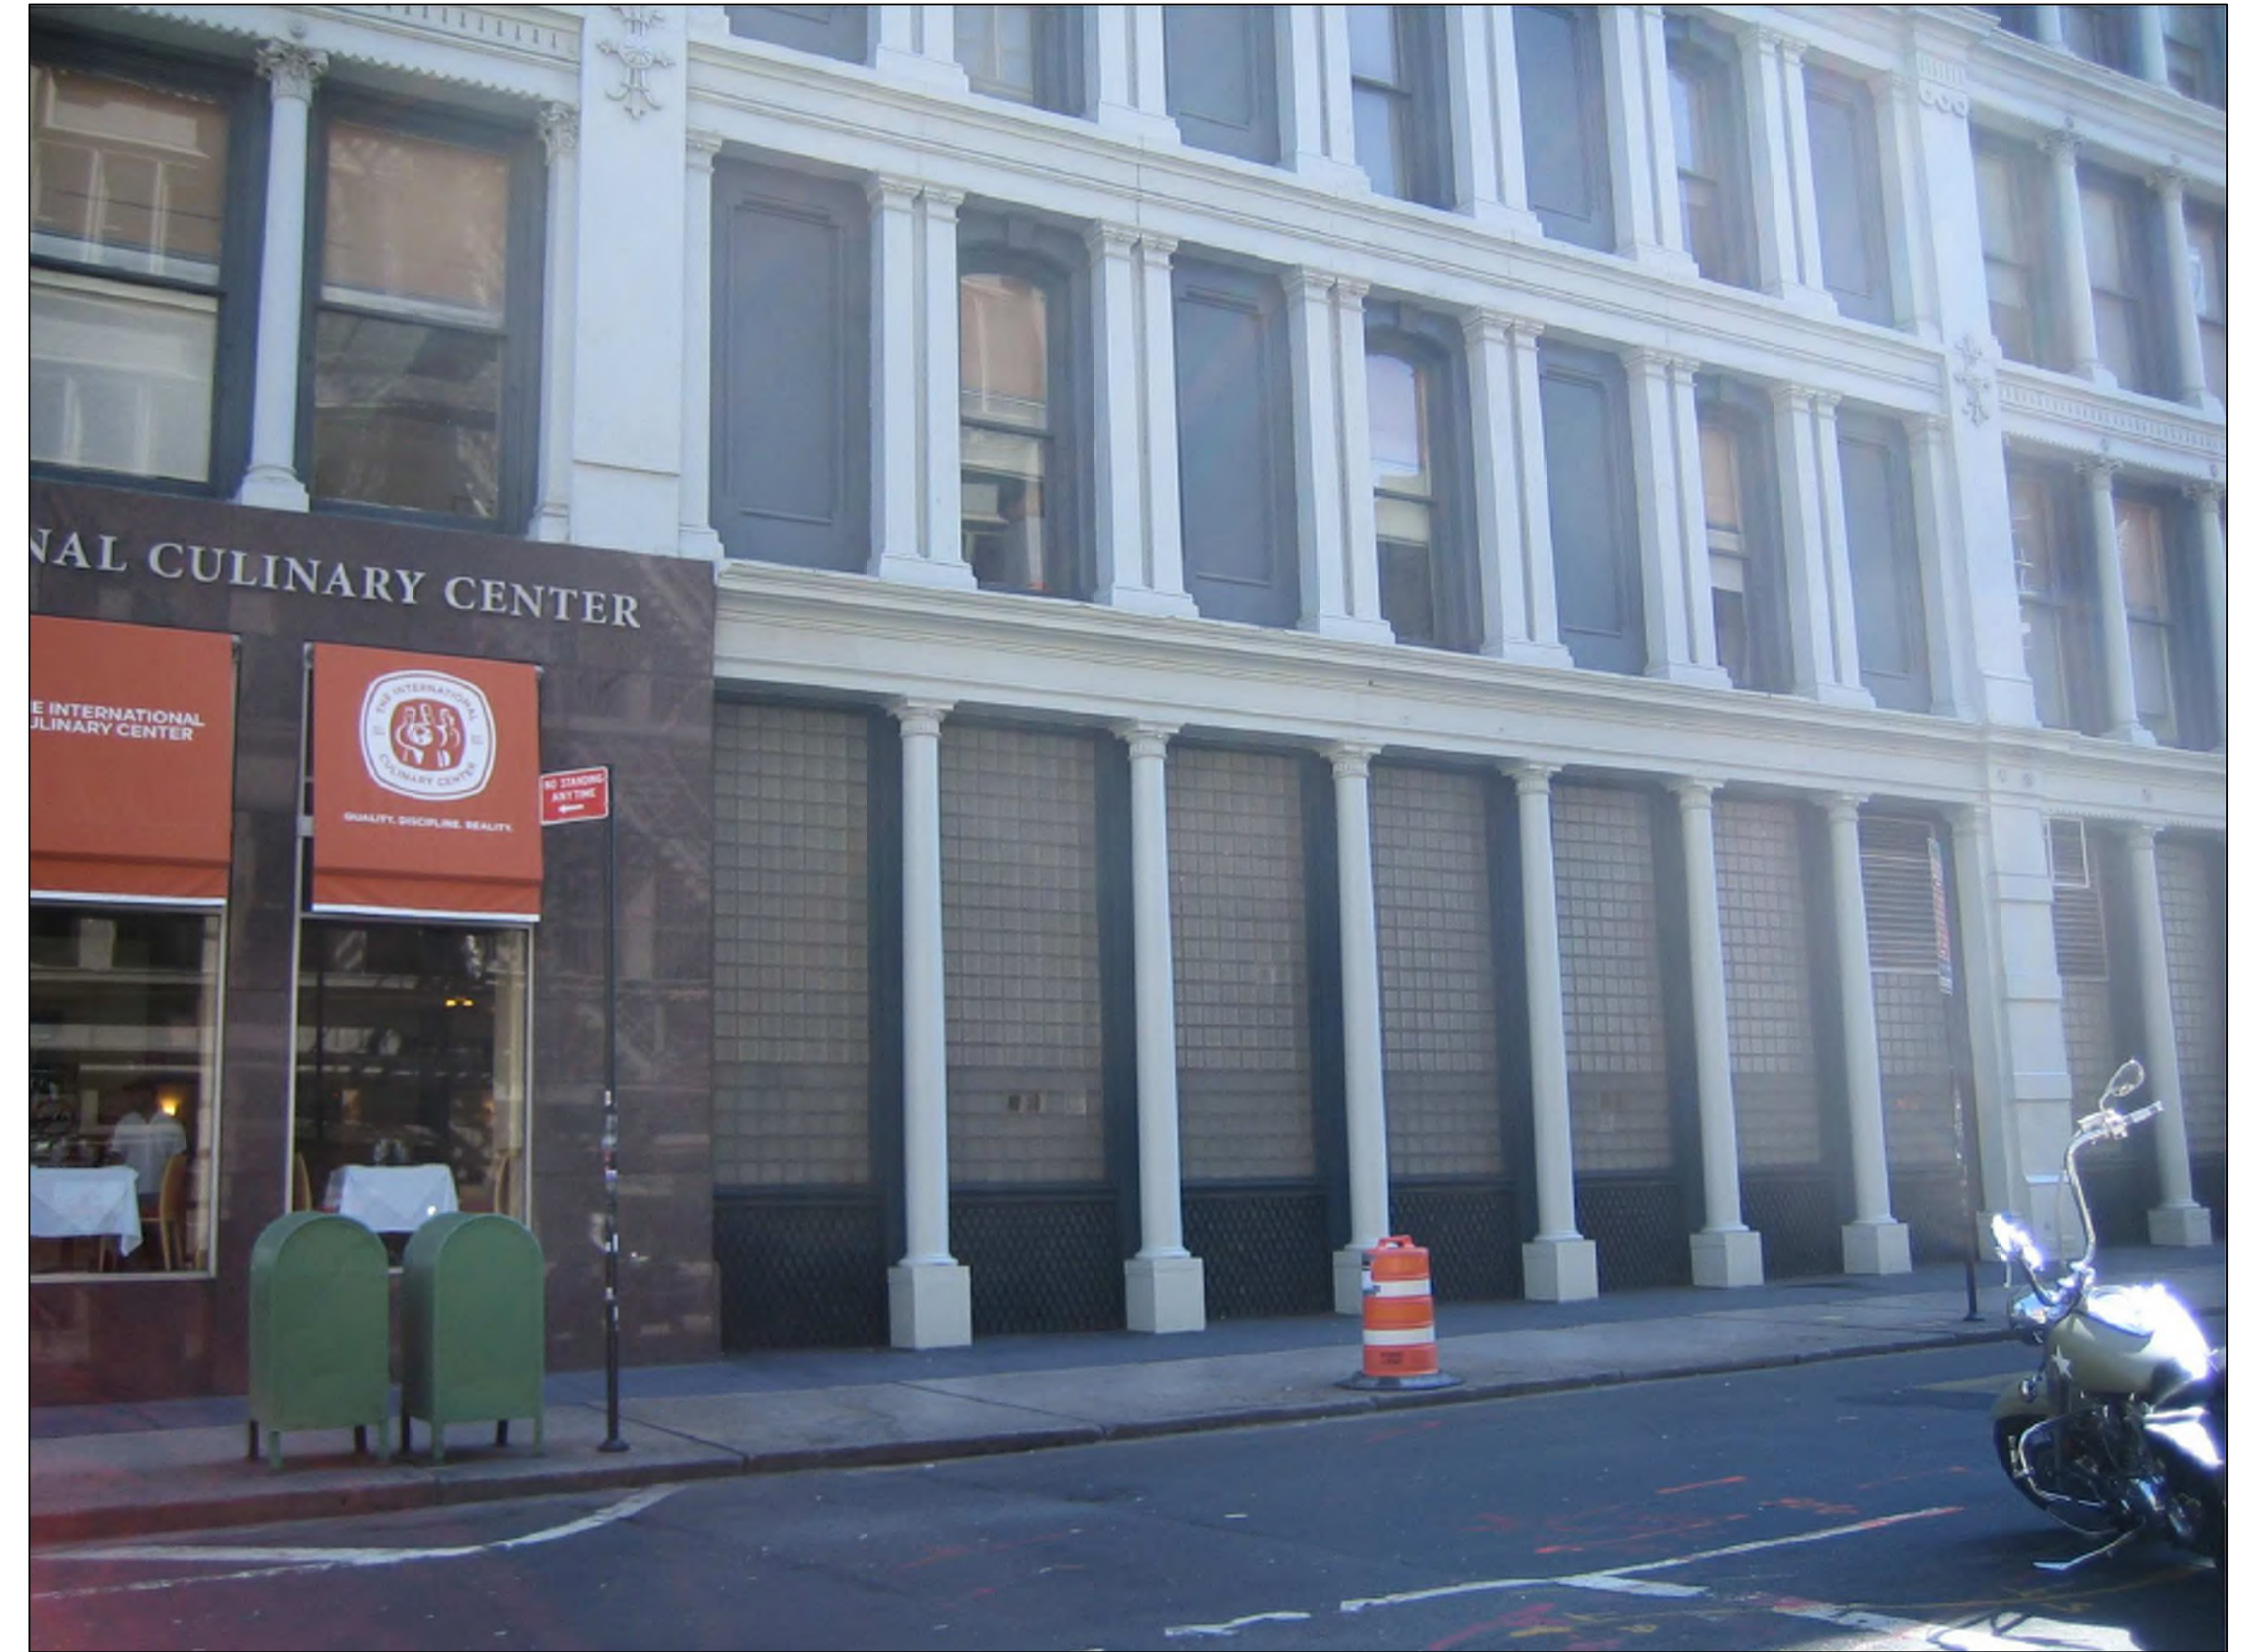
NON-HISTORIC STOREFRONT VIEW ON GRAND ST

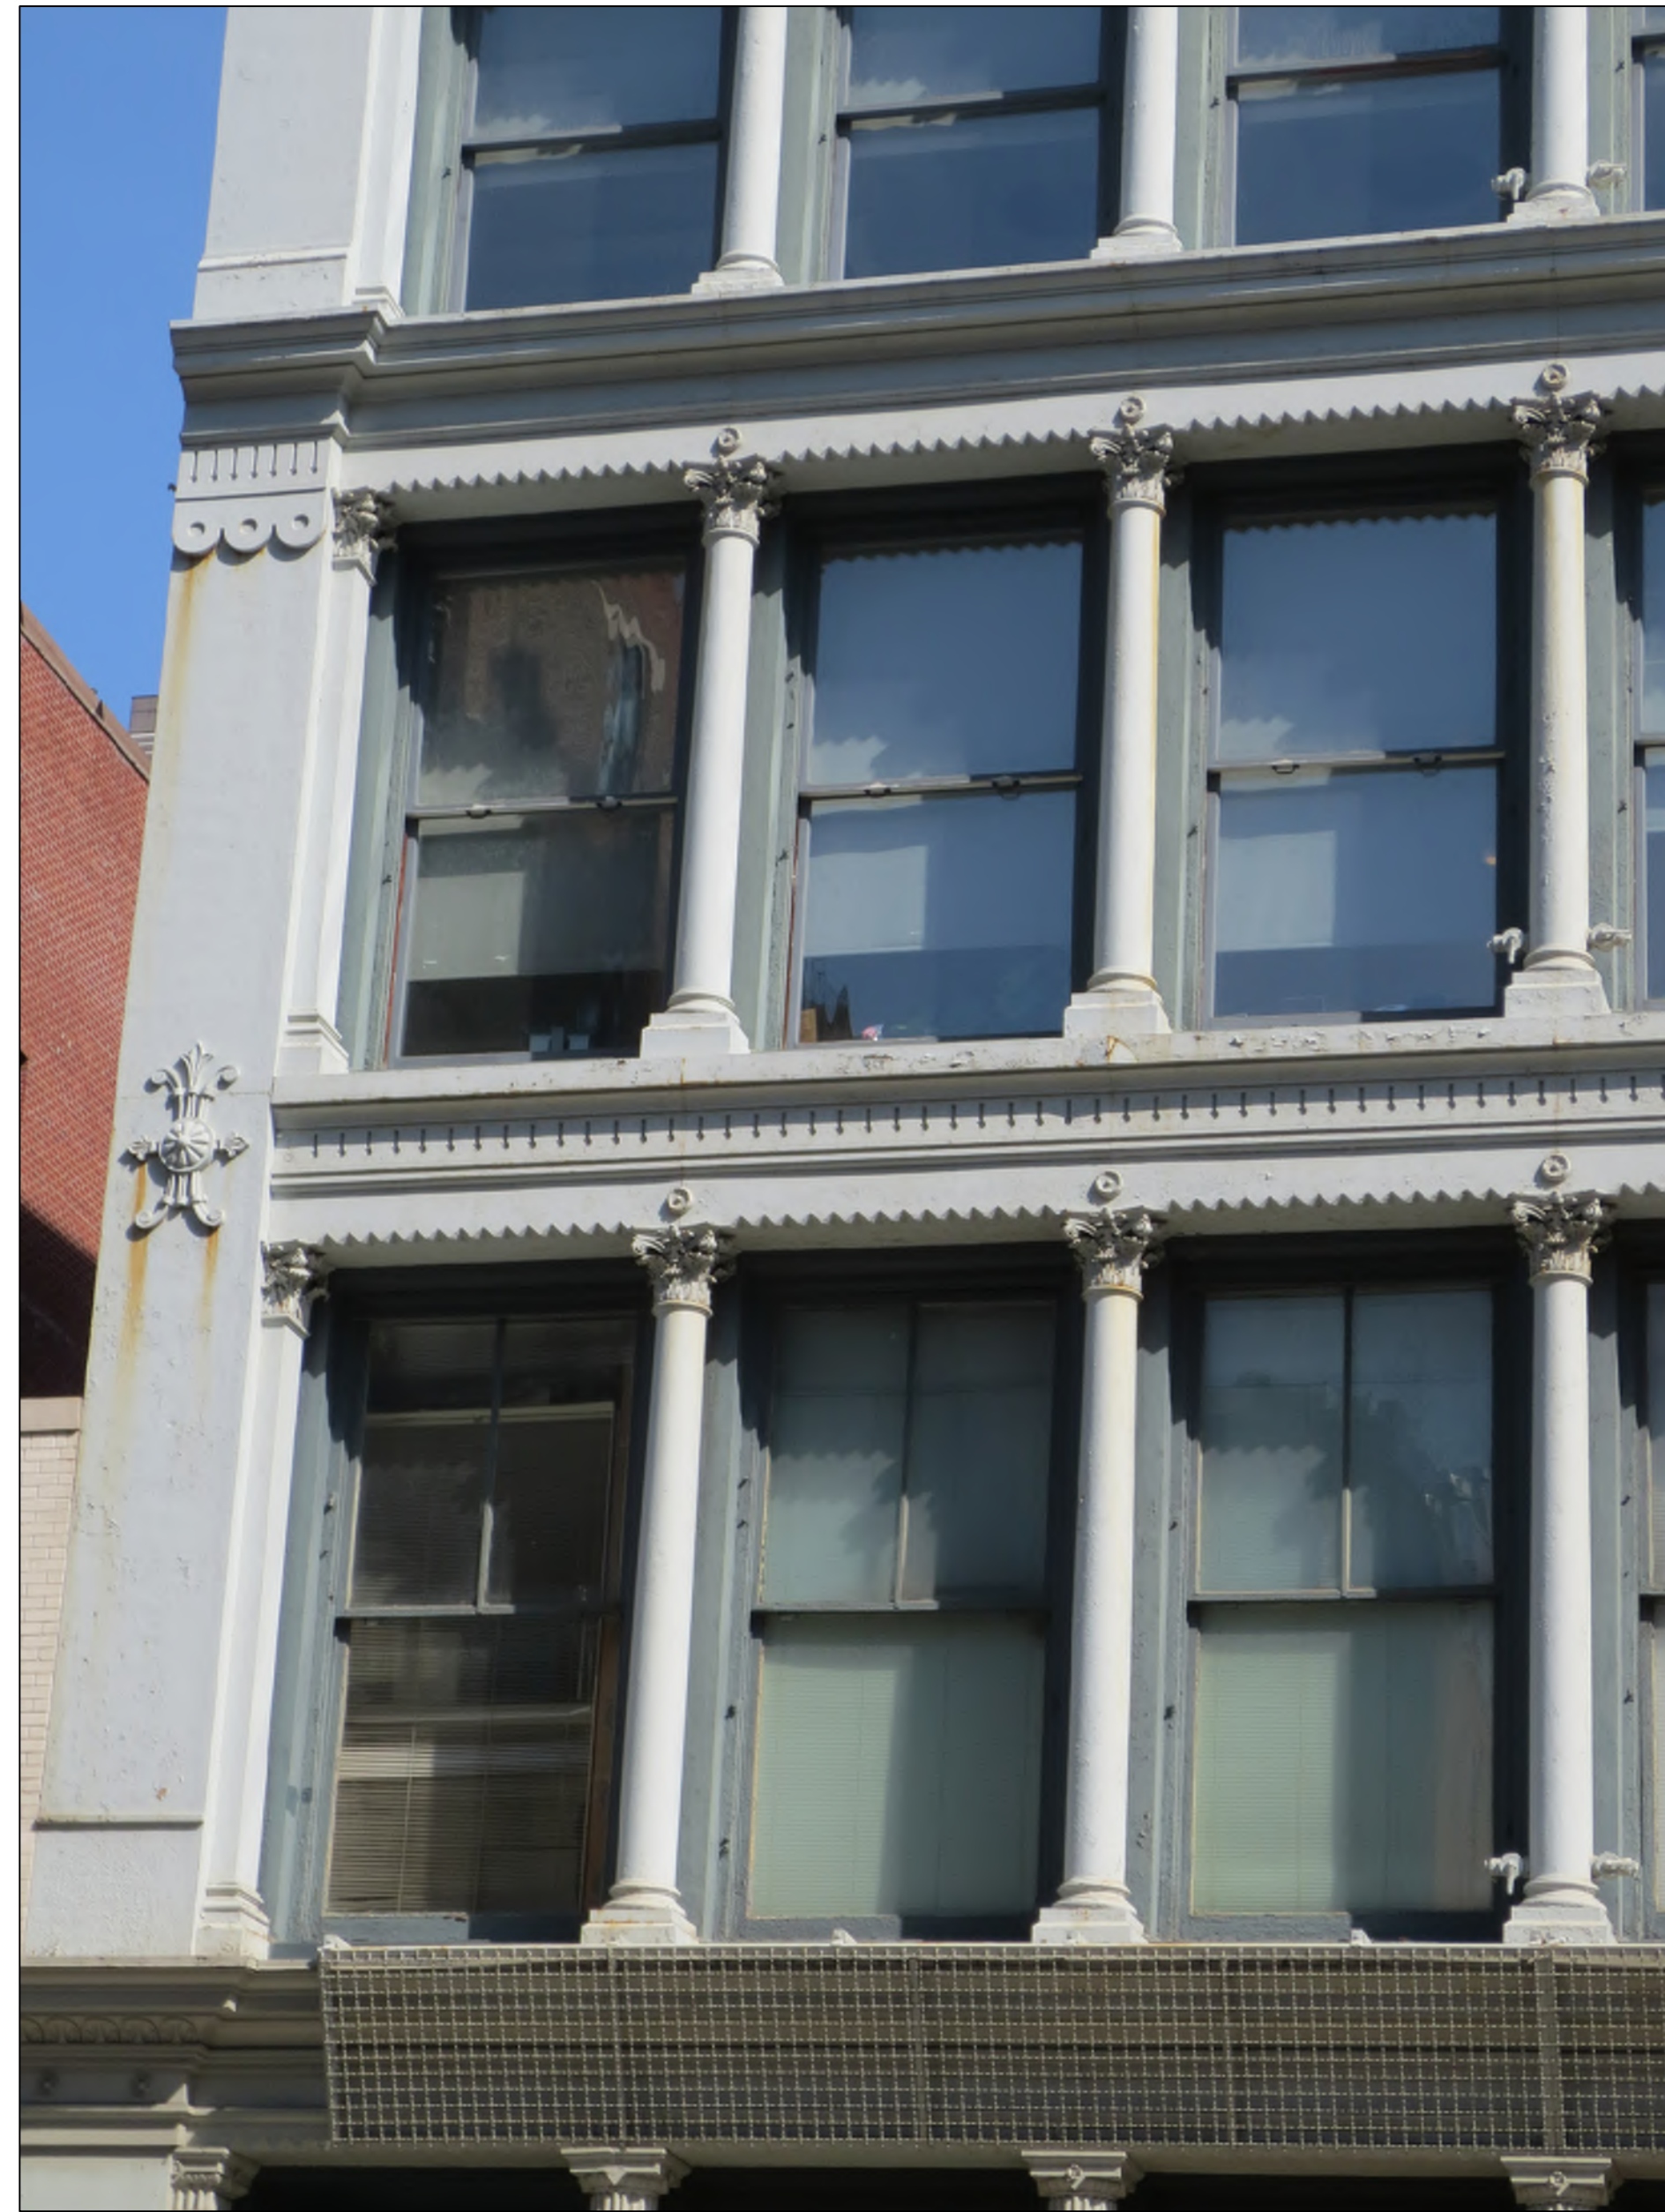
FACADE CONDITIONS

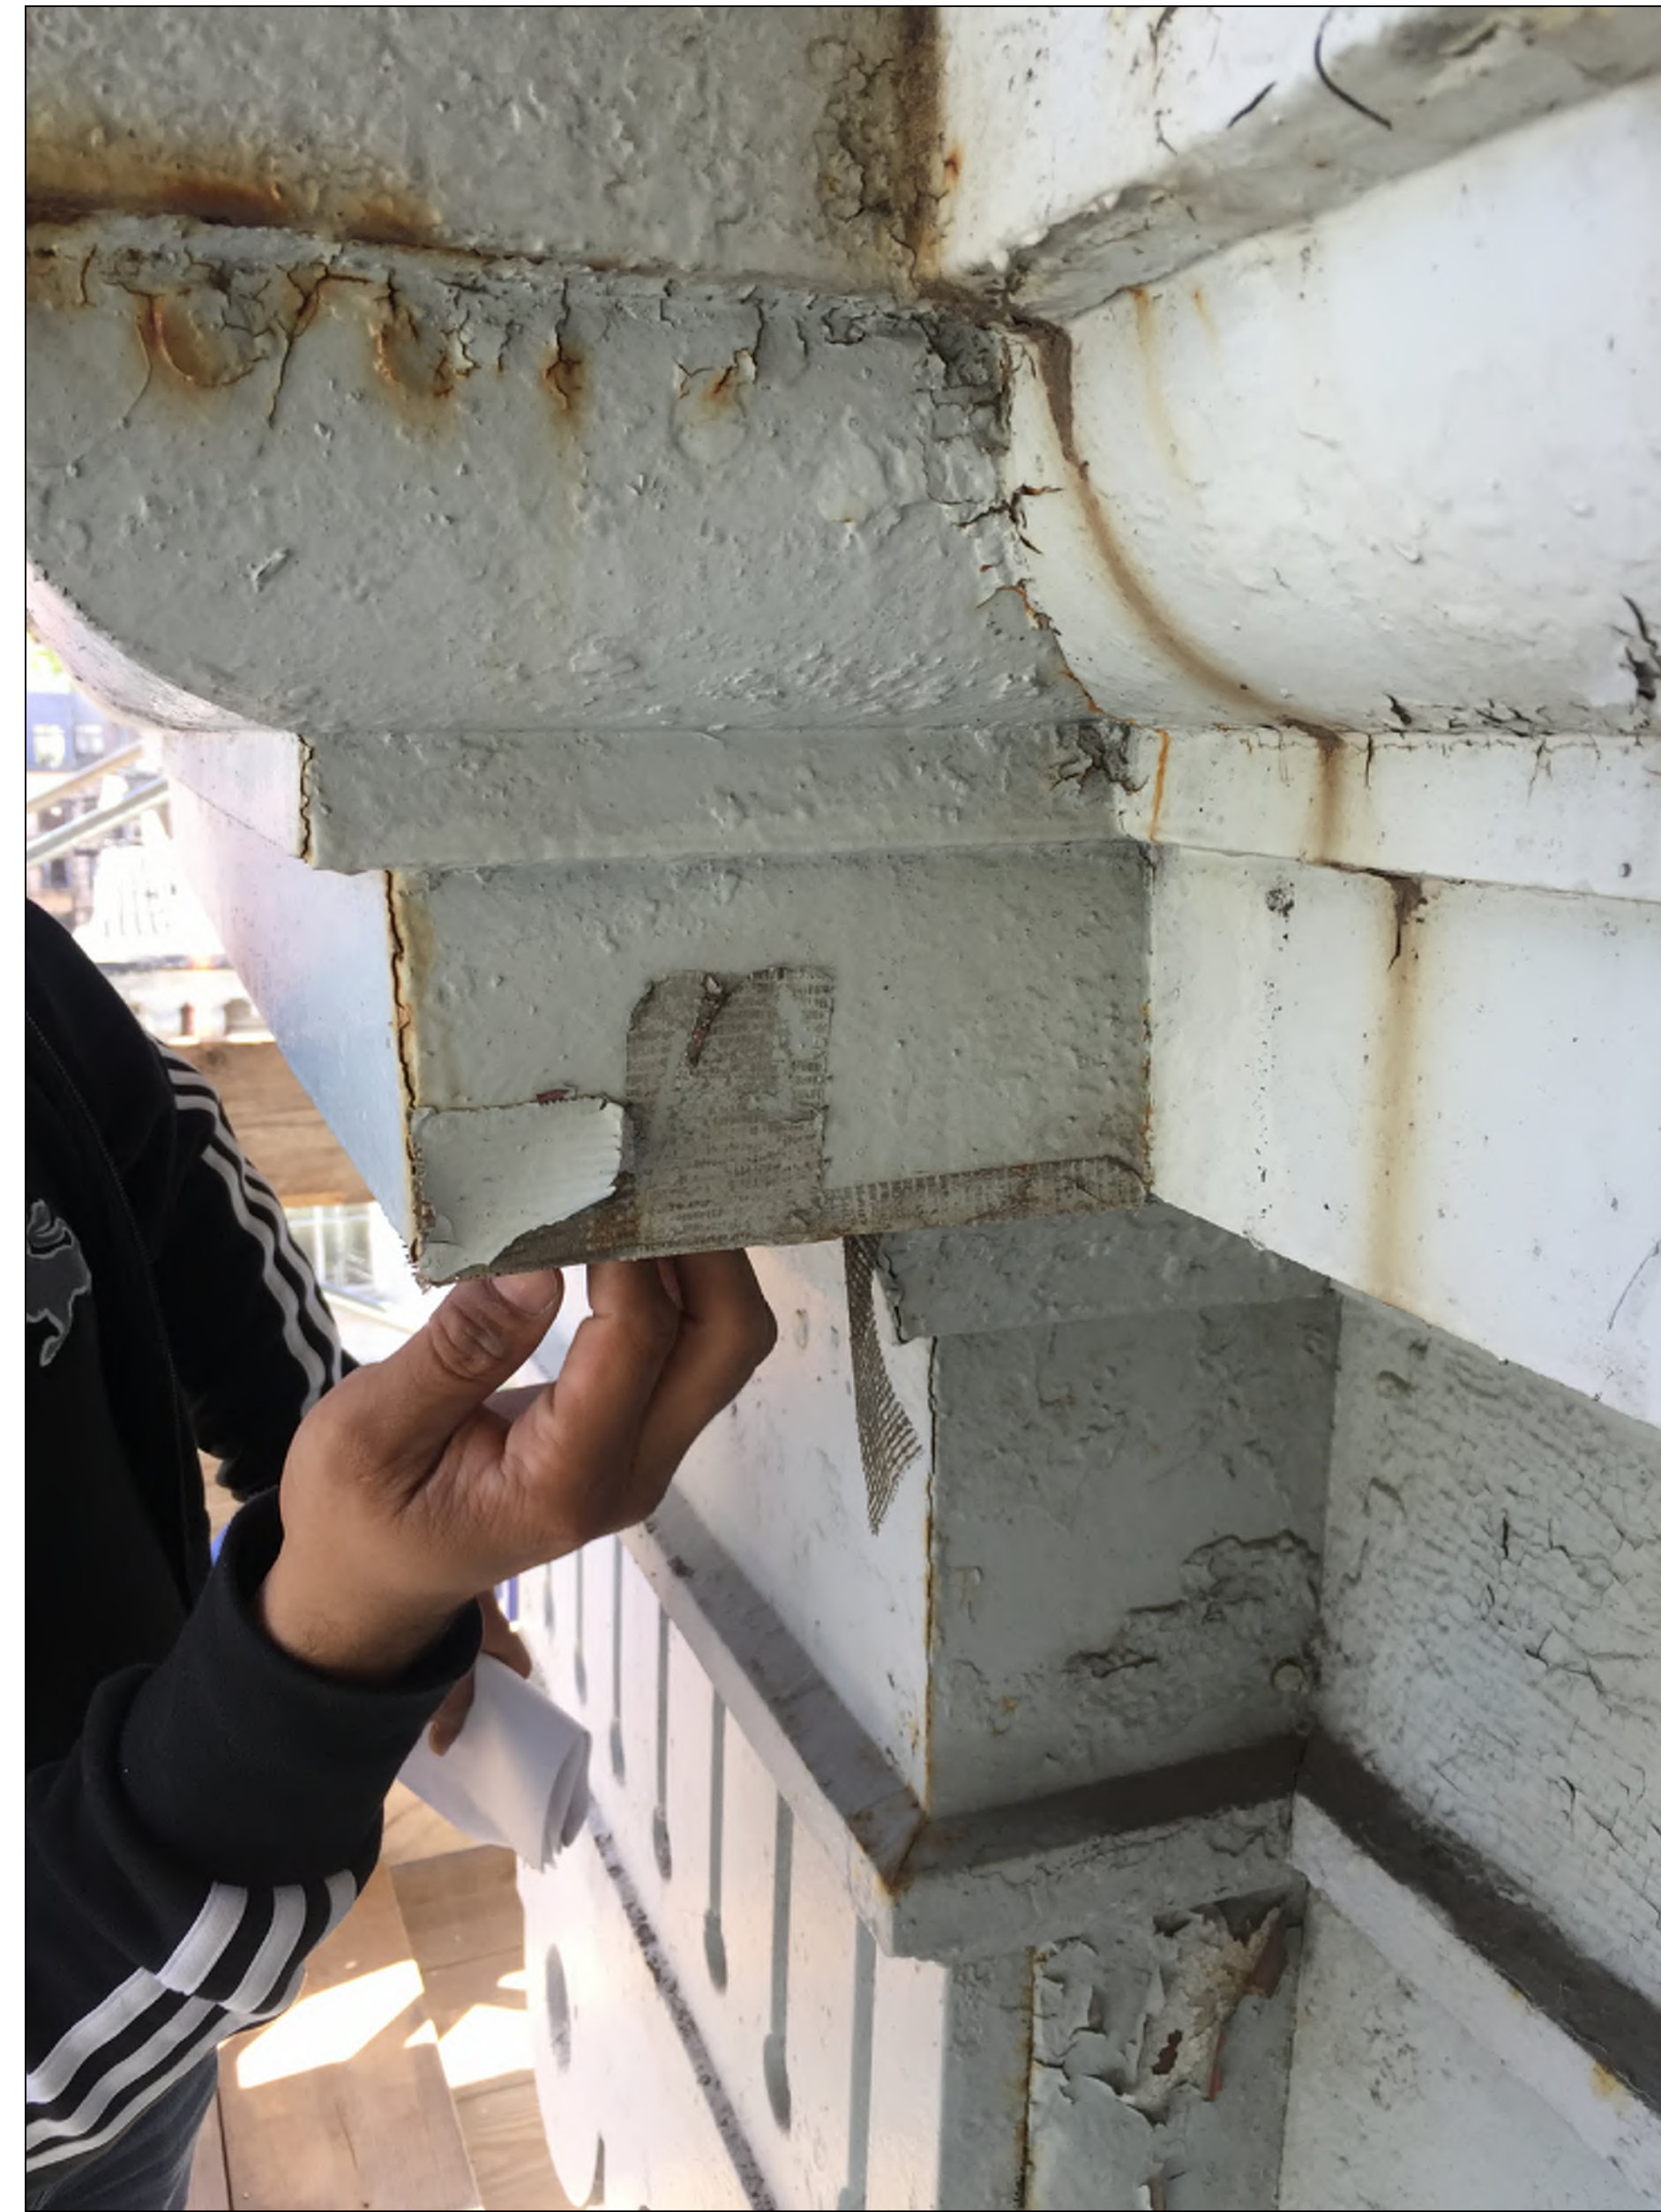
CORNICE CONDITIONS
