462 BROADWAY
MERINGOFF PROPERTIES
FACADE
RESTORATION

DRAFT

OCTOBER 06, 2017

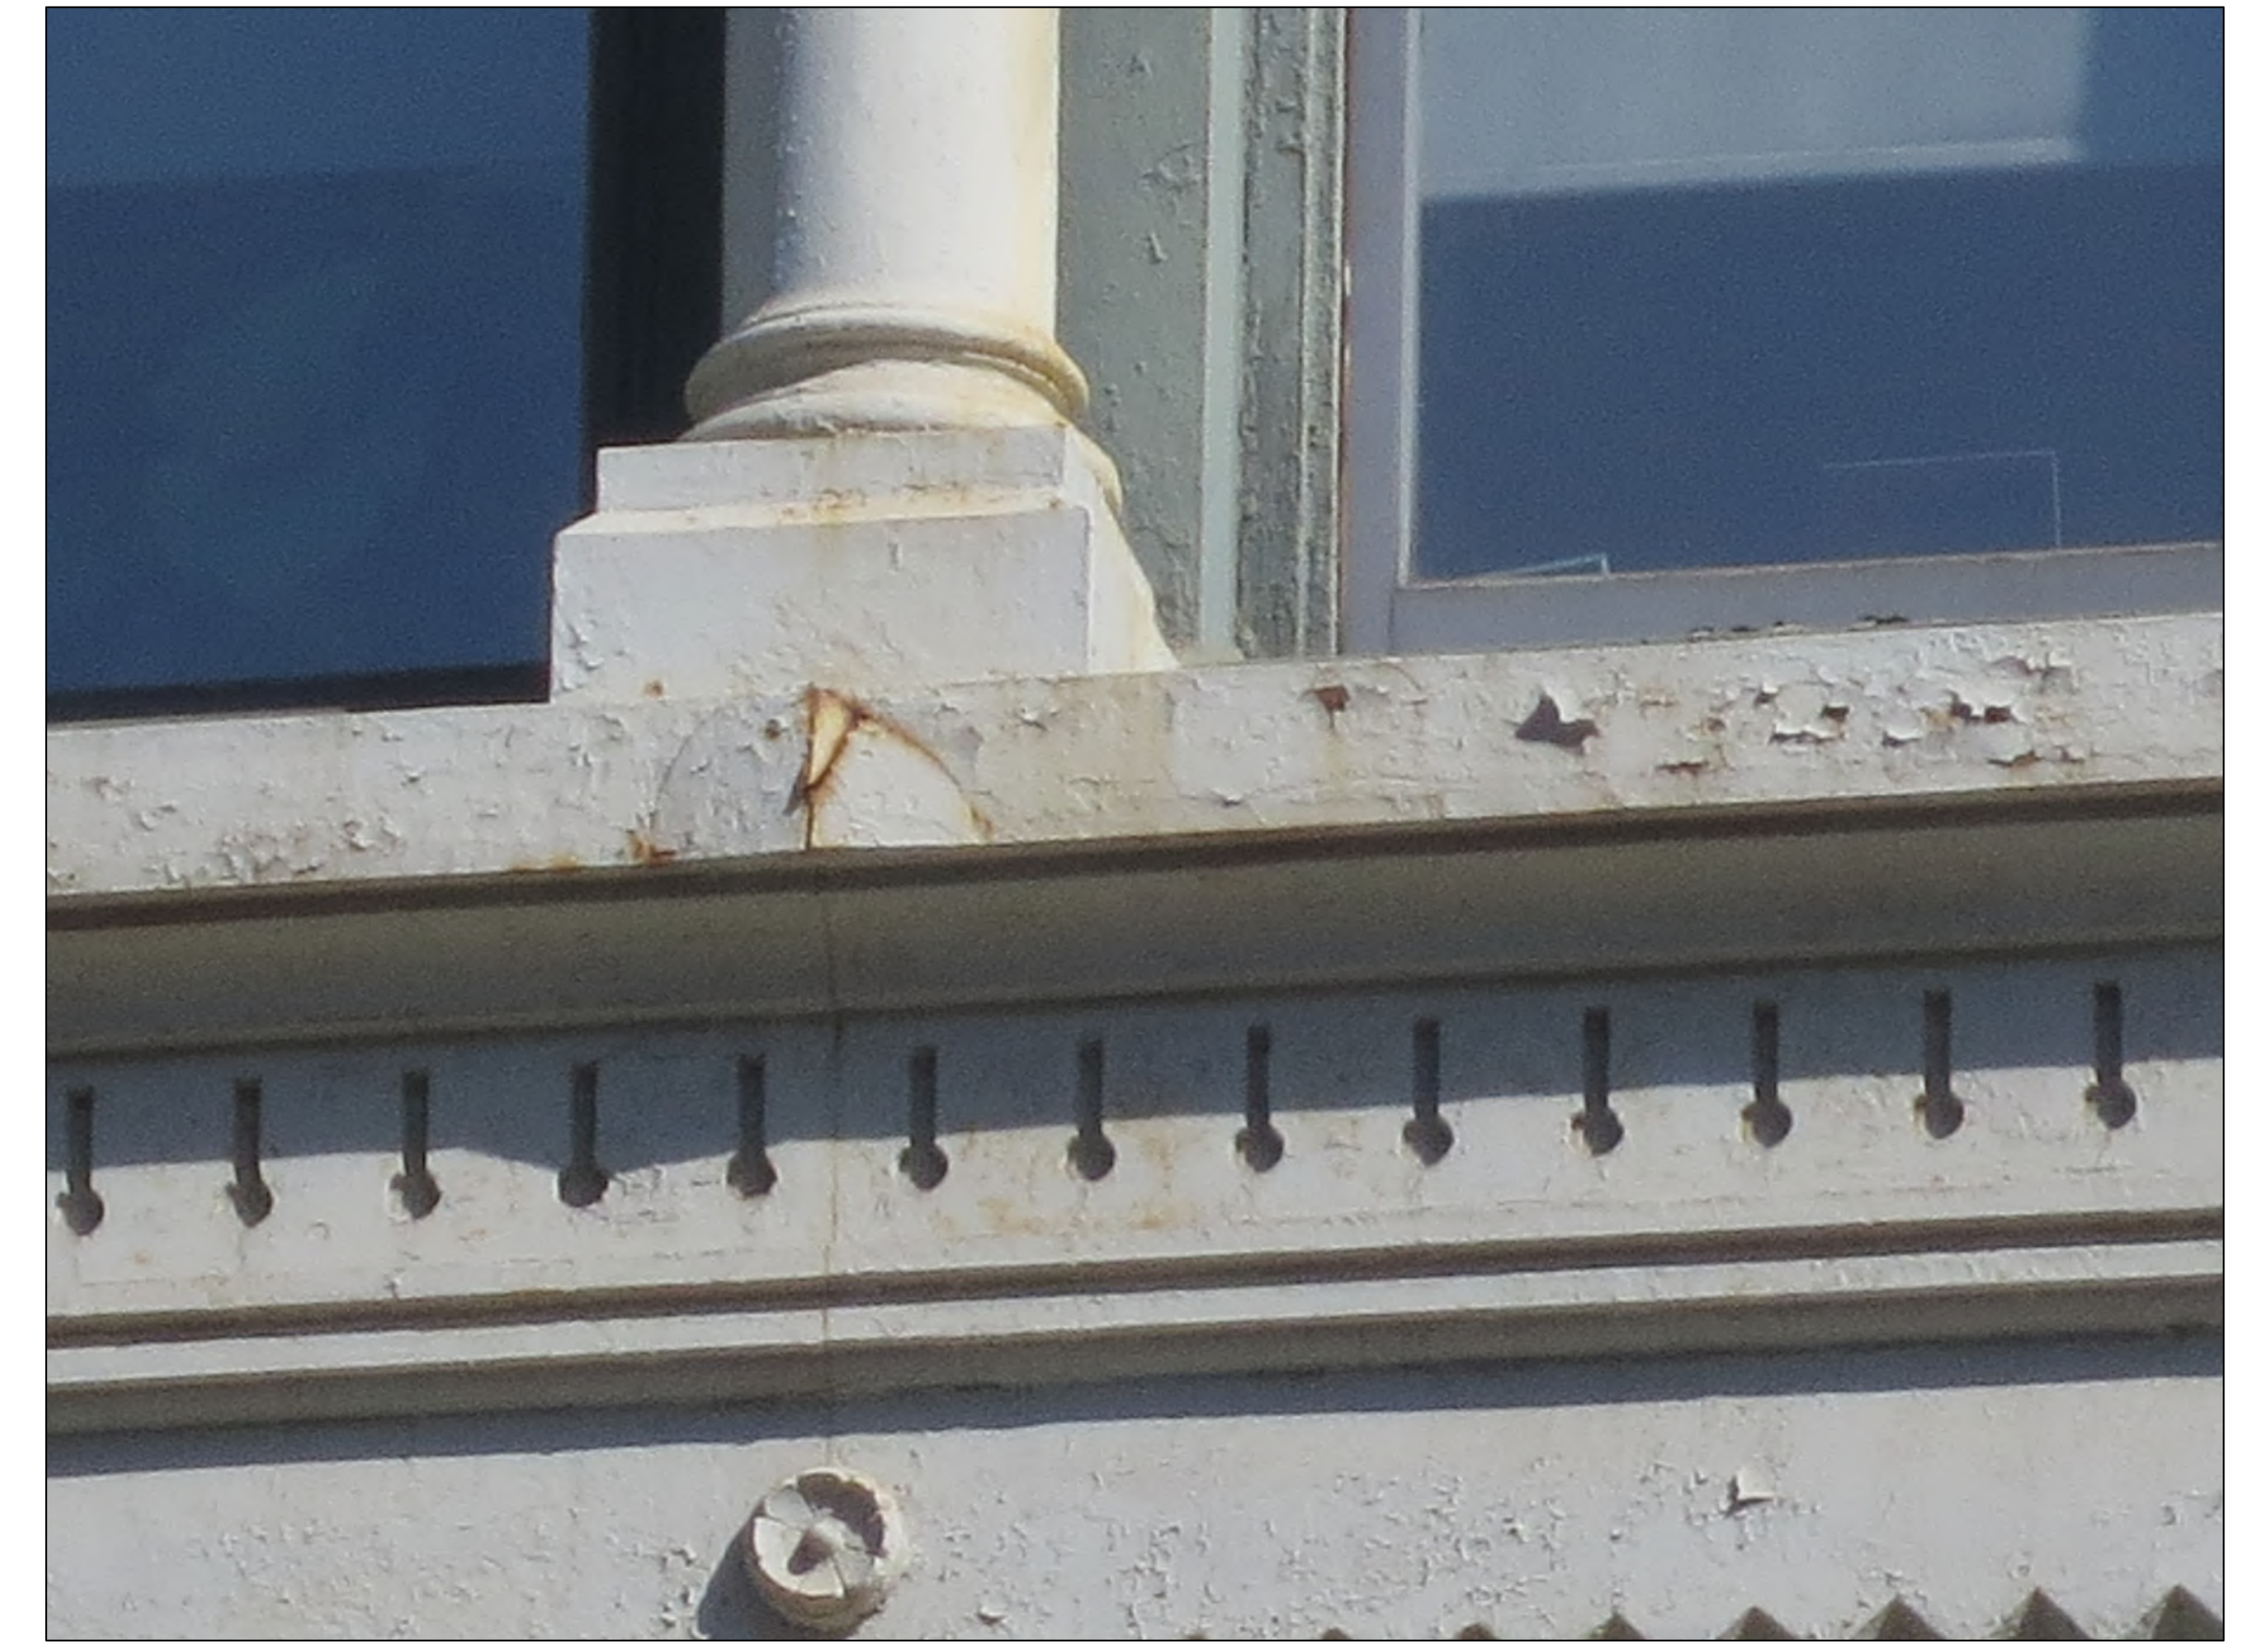
WINDOW SILL & CAST IRON CONDITIONS

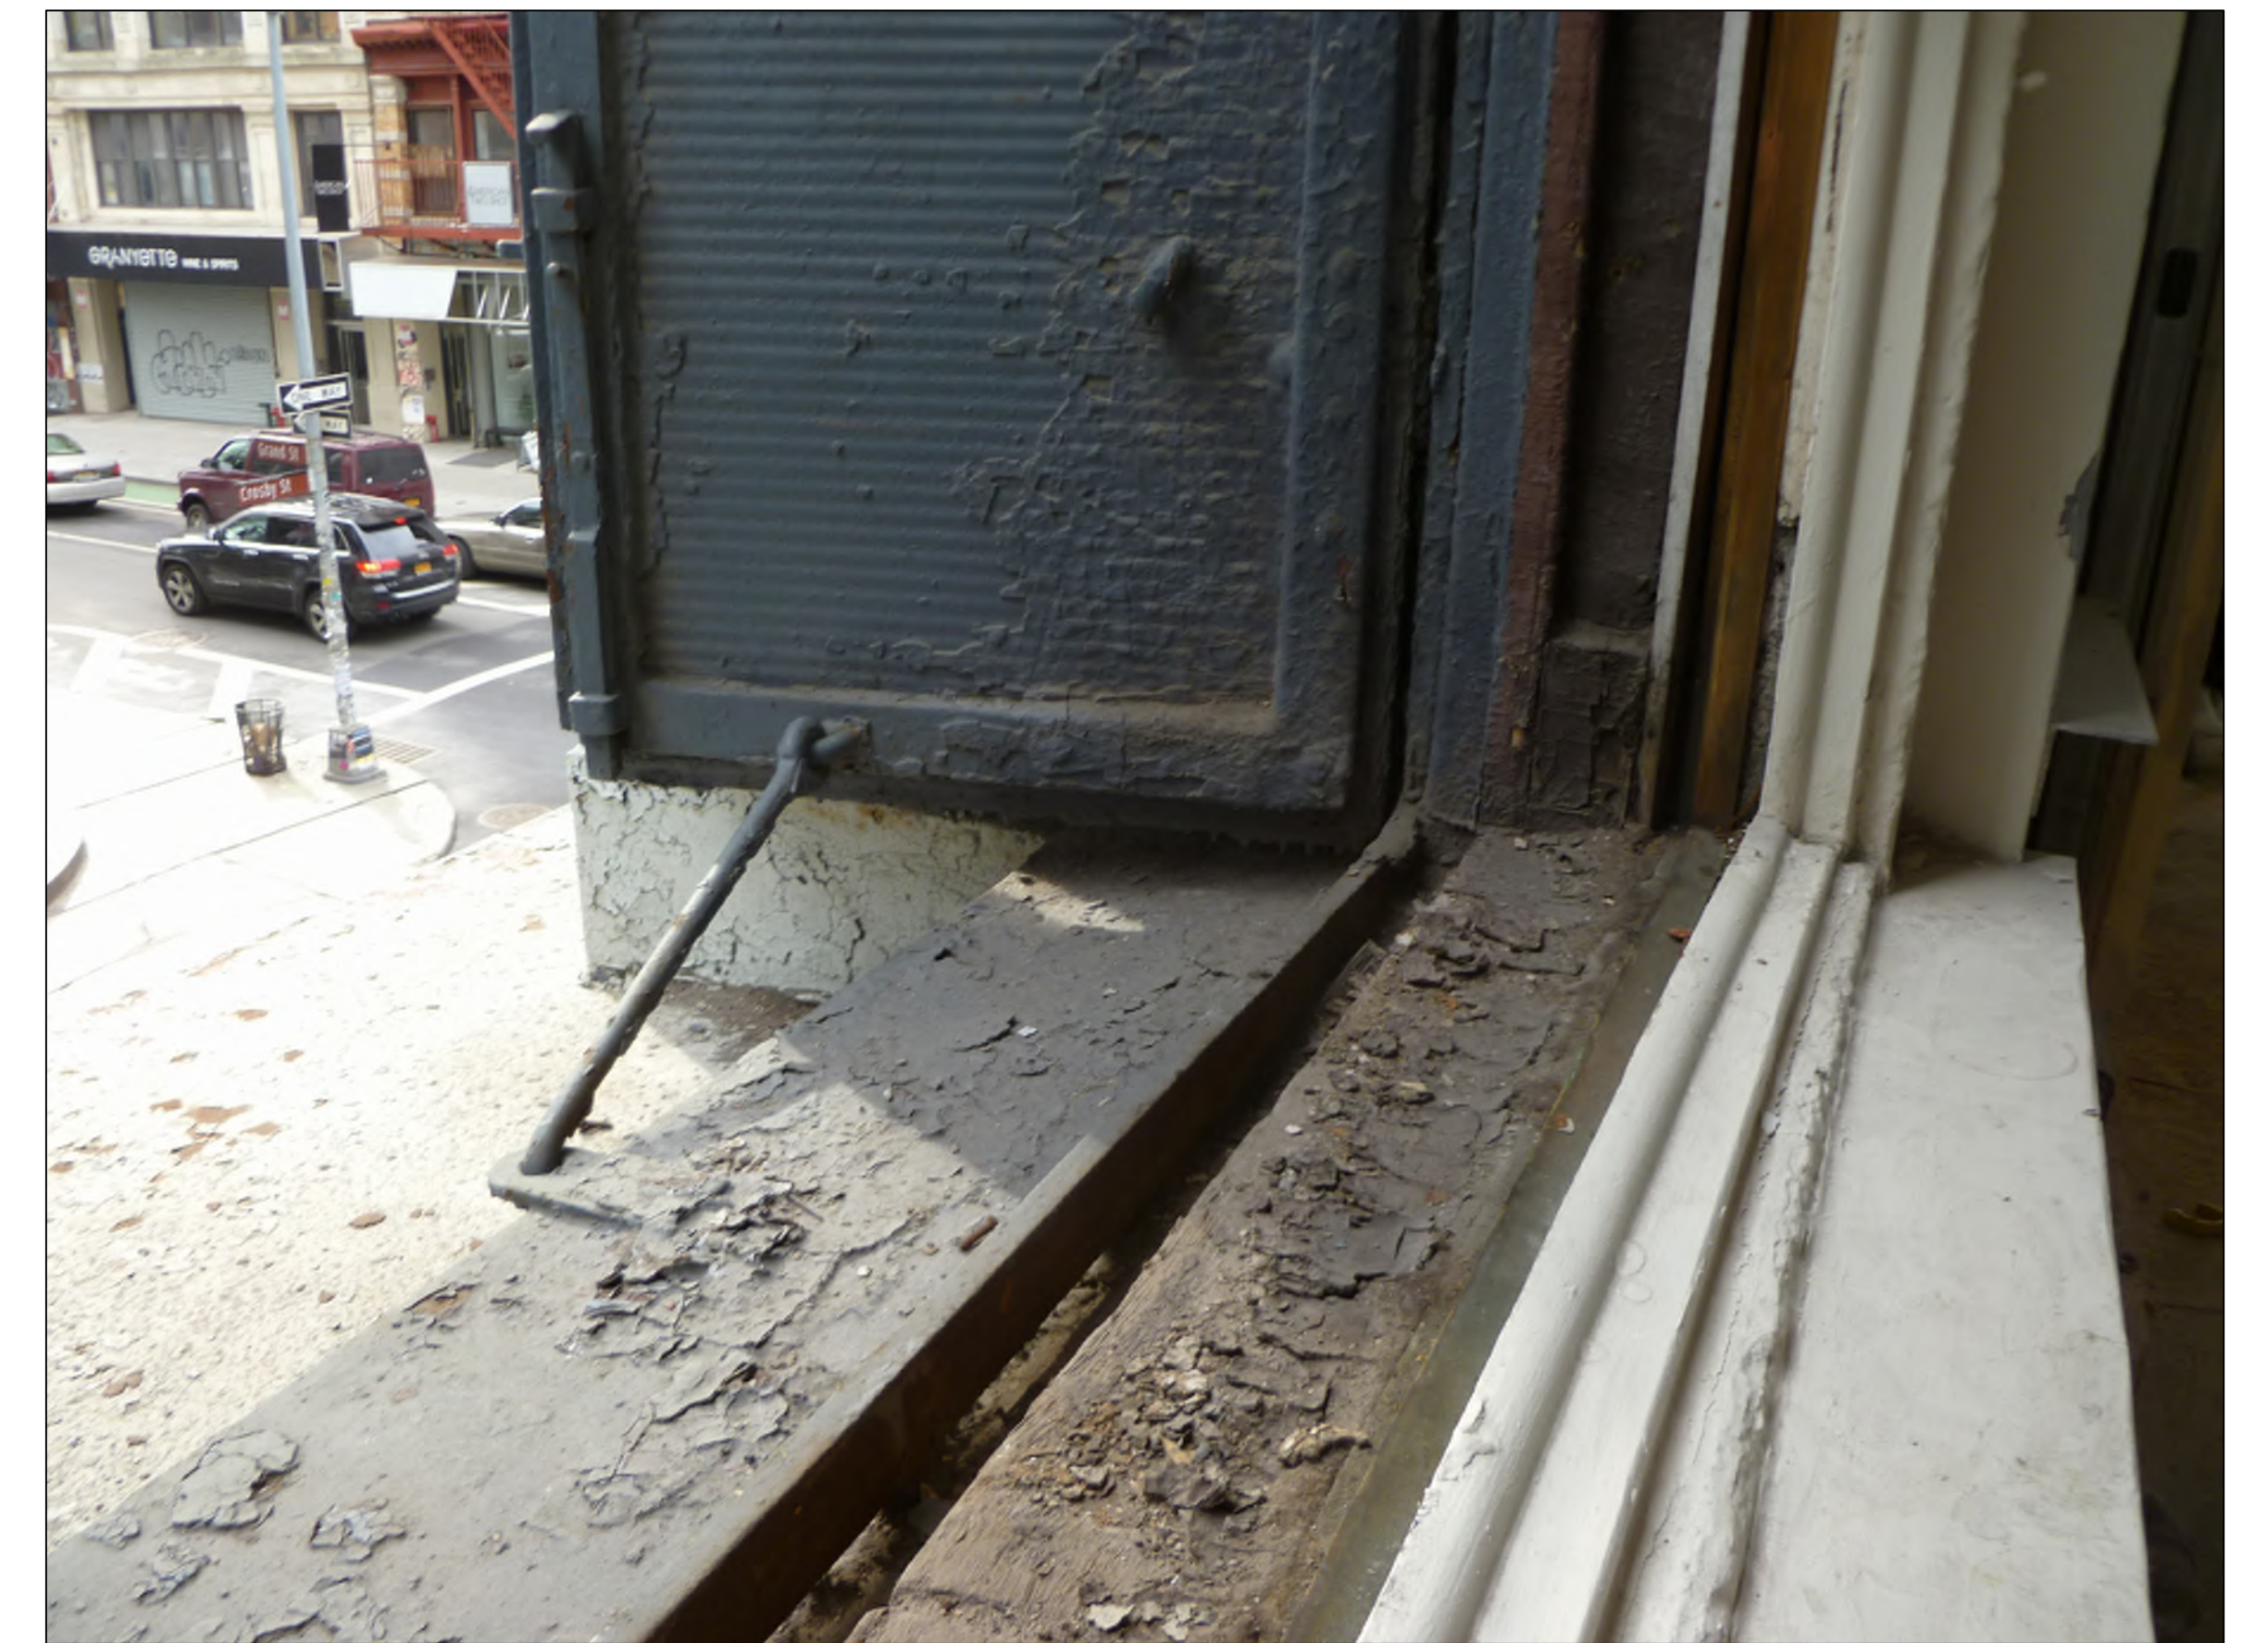
WINDOW CONDITIONS

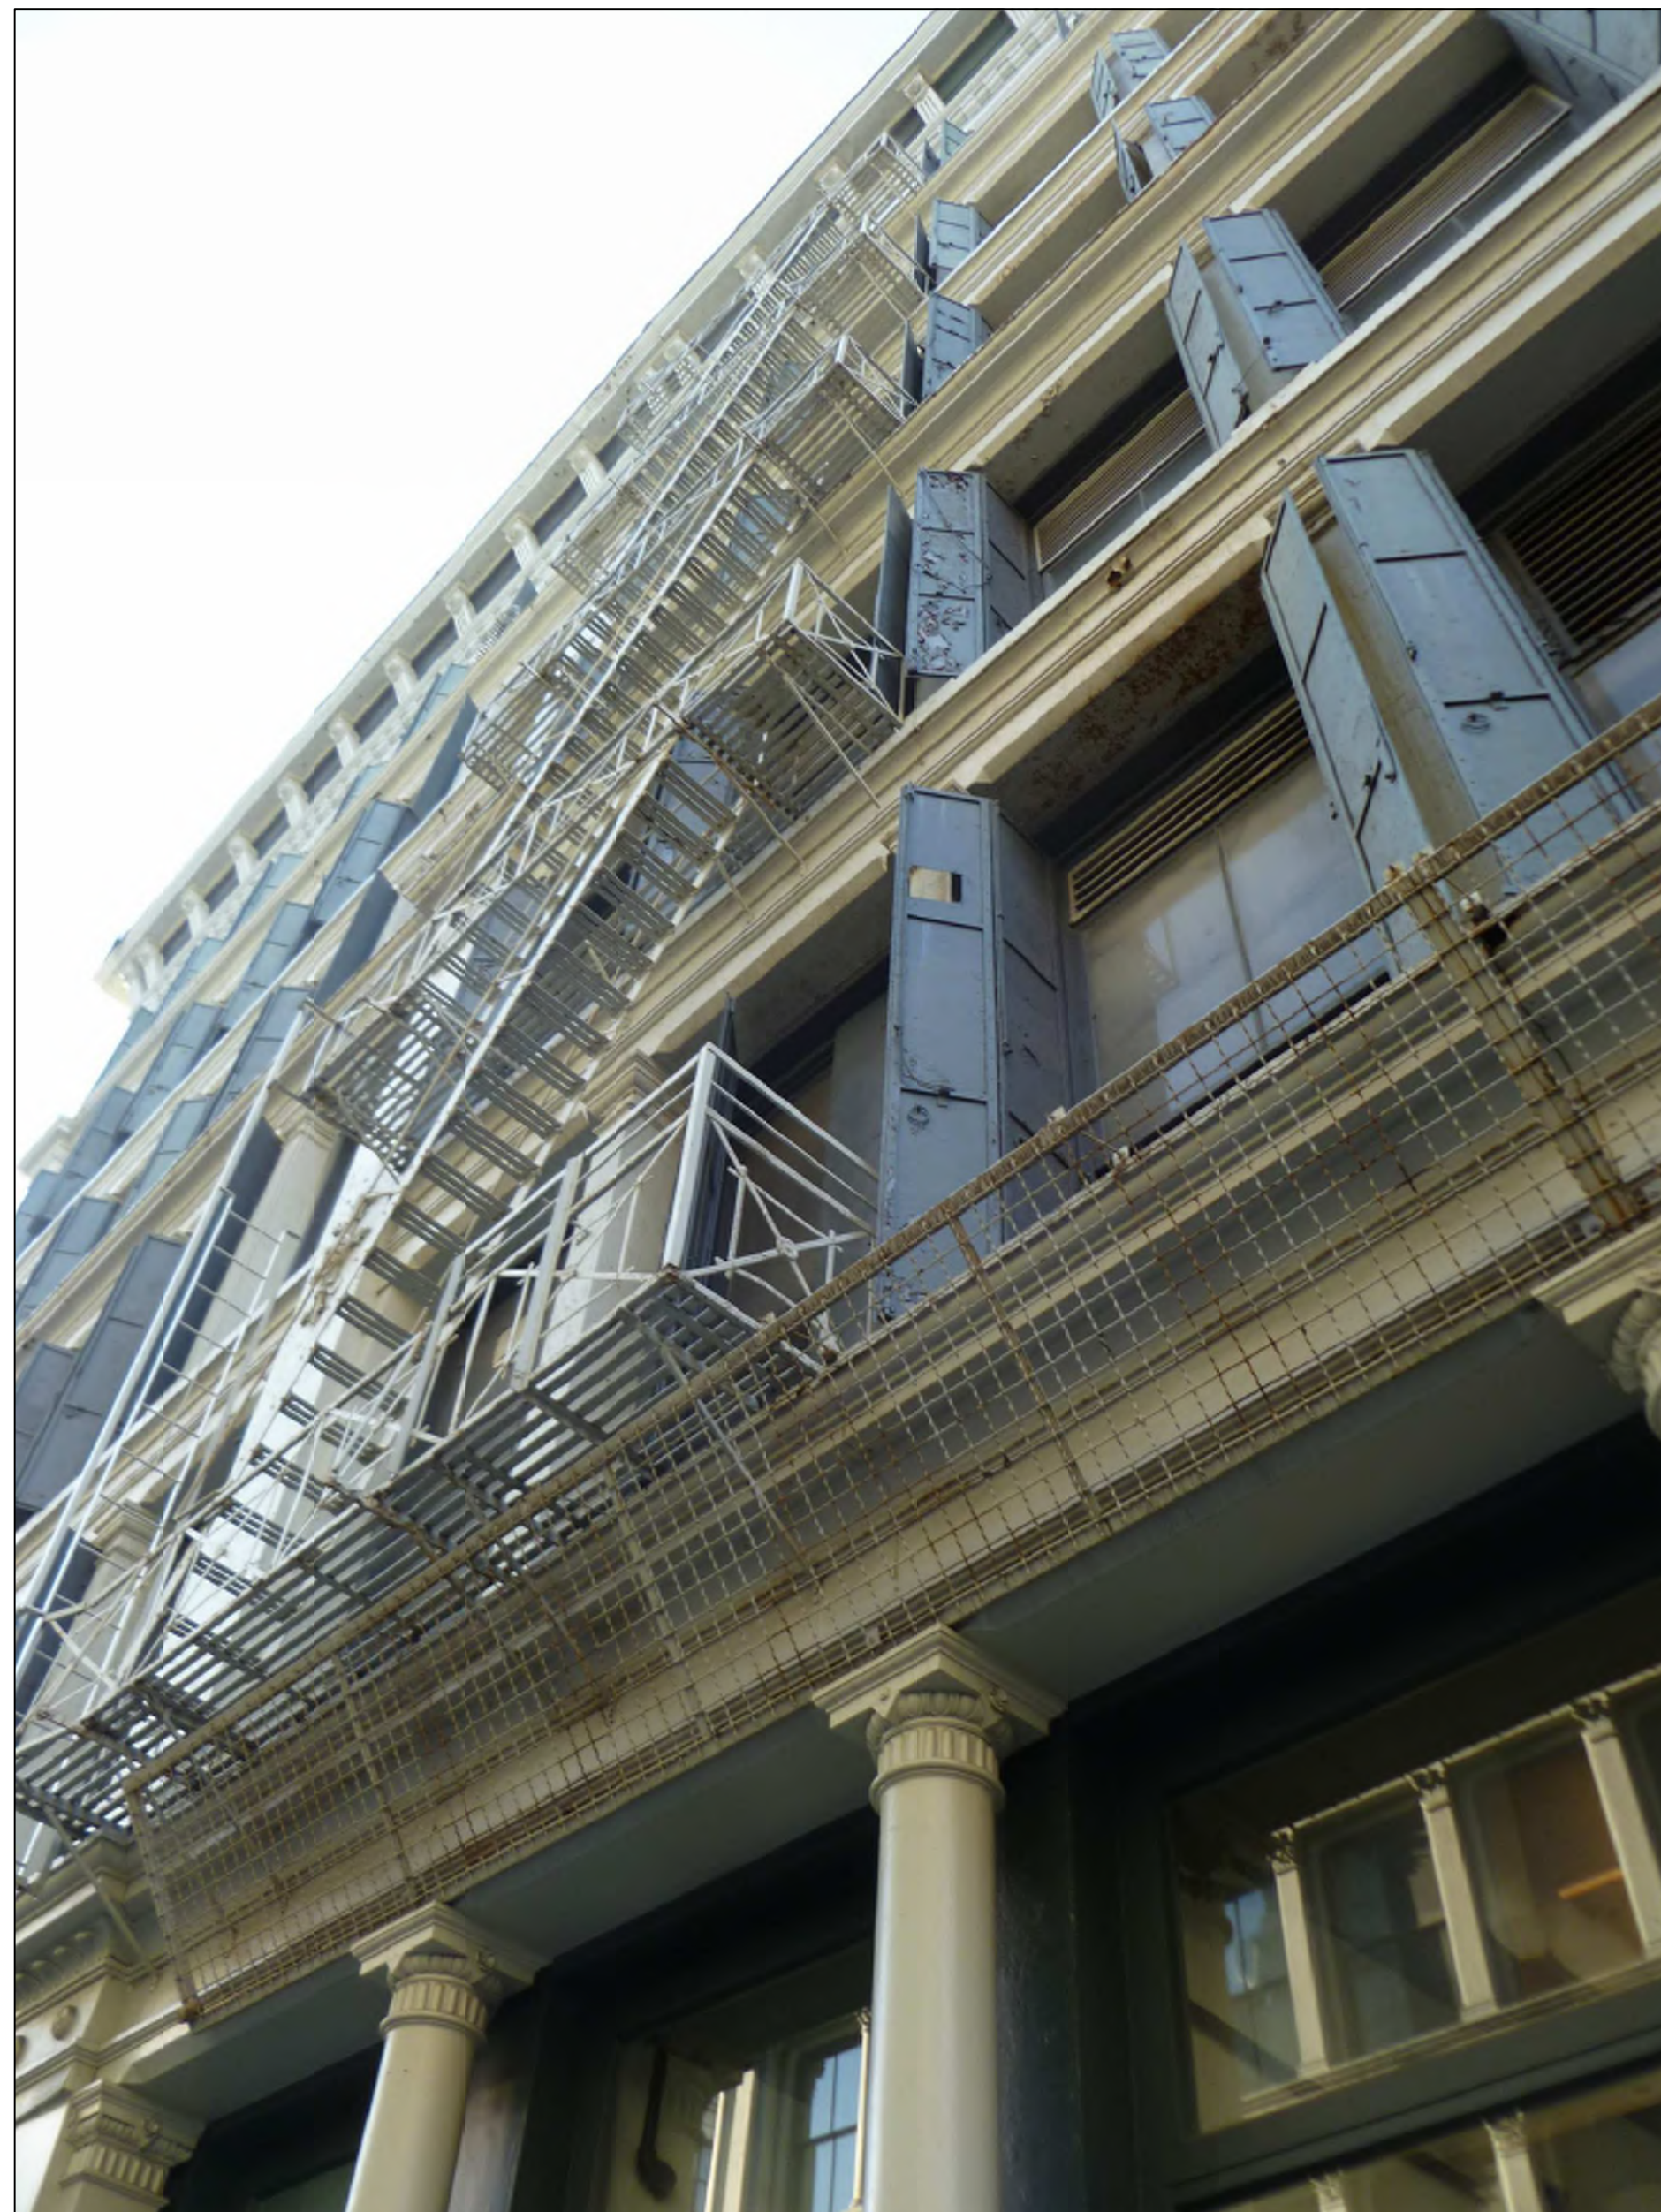
CROSBY STREET FACADE,
EXISTING SHUTTER CONDITIONS.

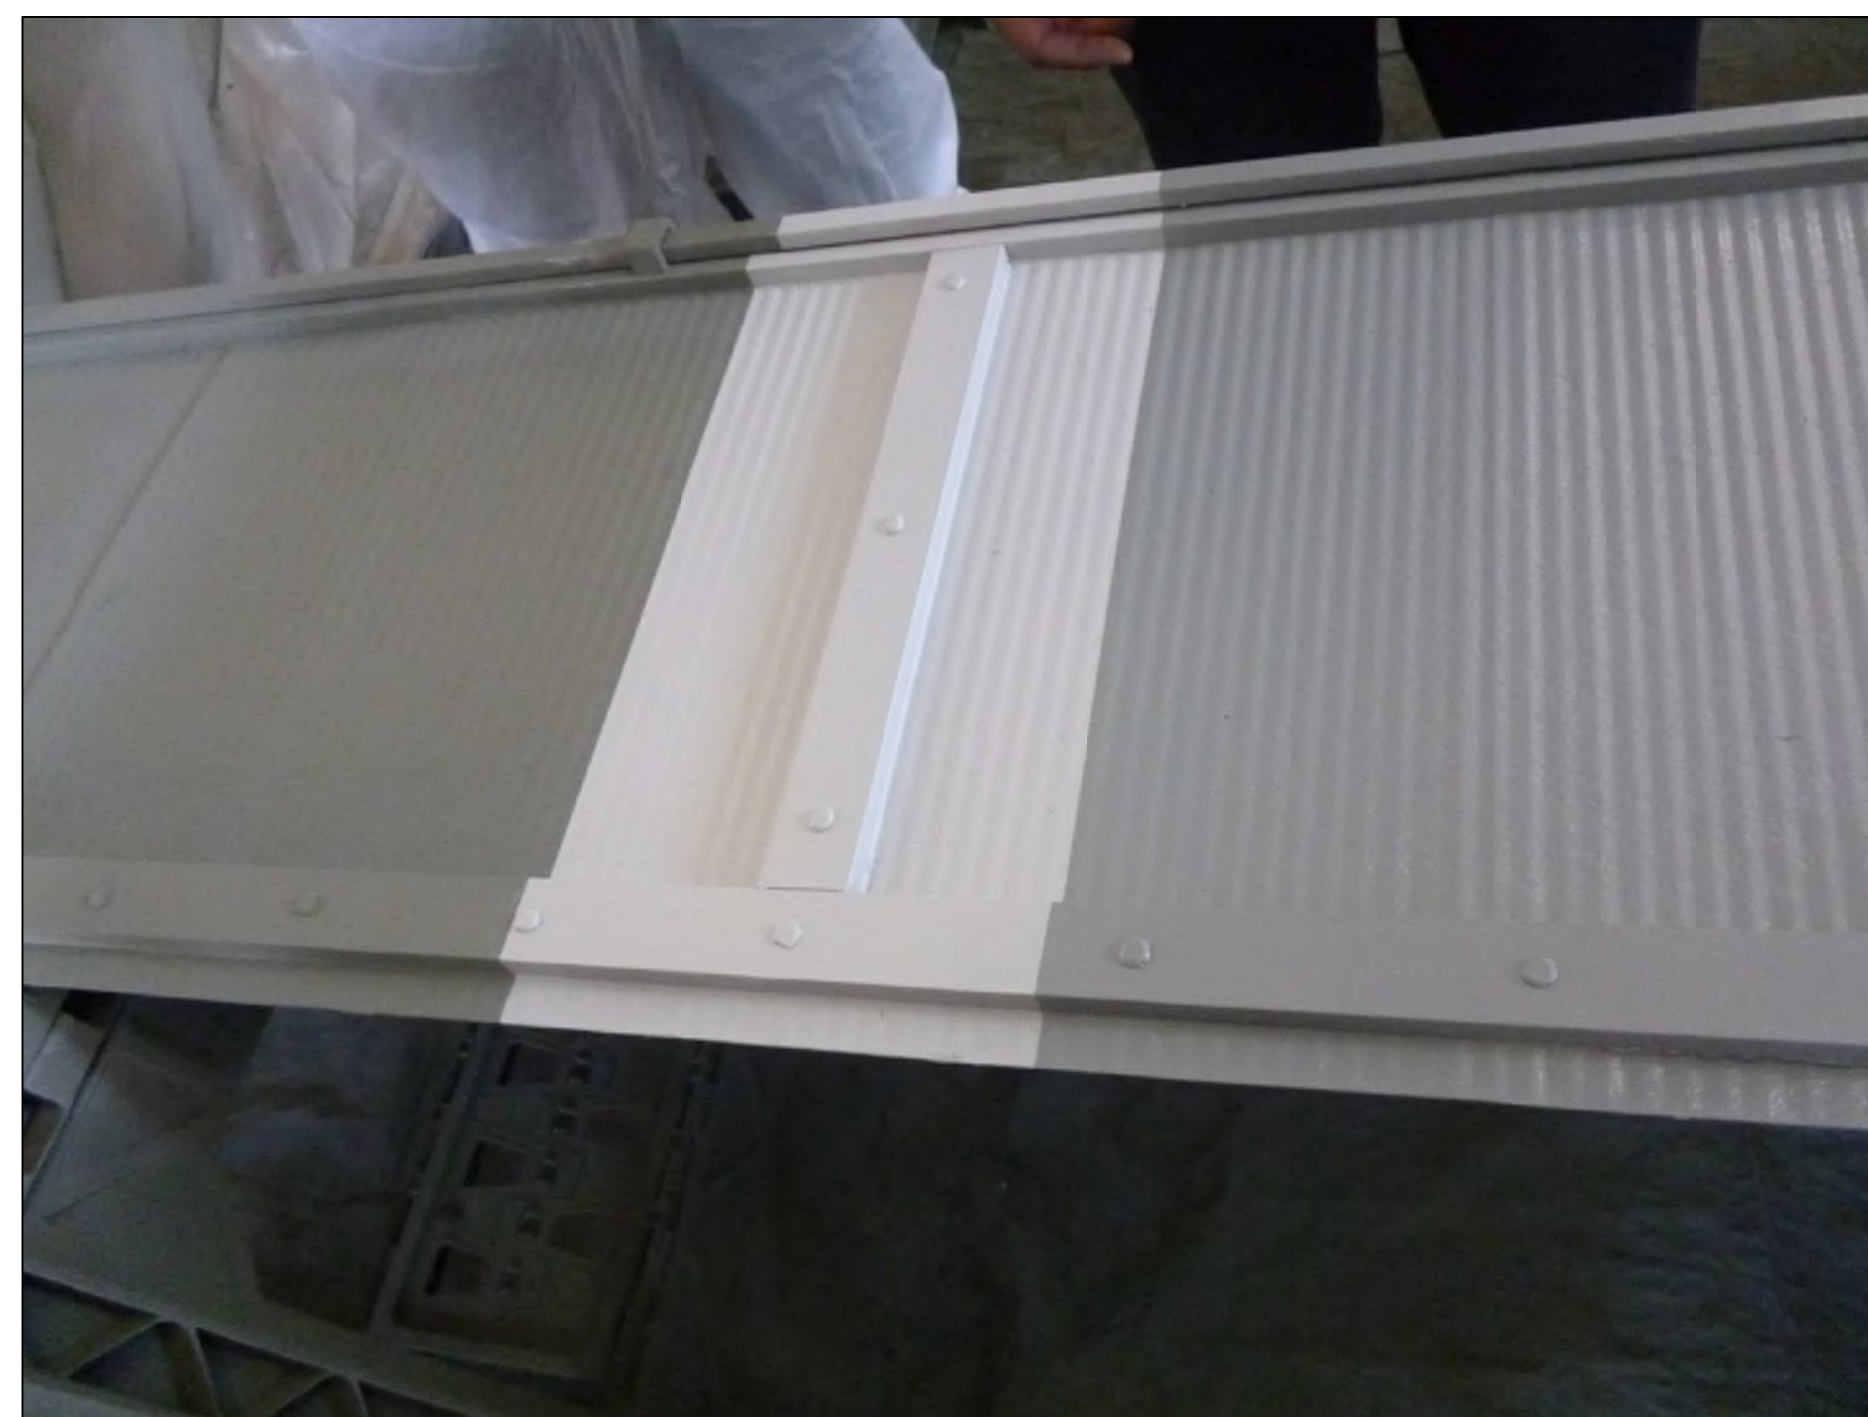
SHUTTER IN PROGRESS OF RESTORATION
SECONDARY AND TOP COAT PAINT

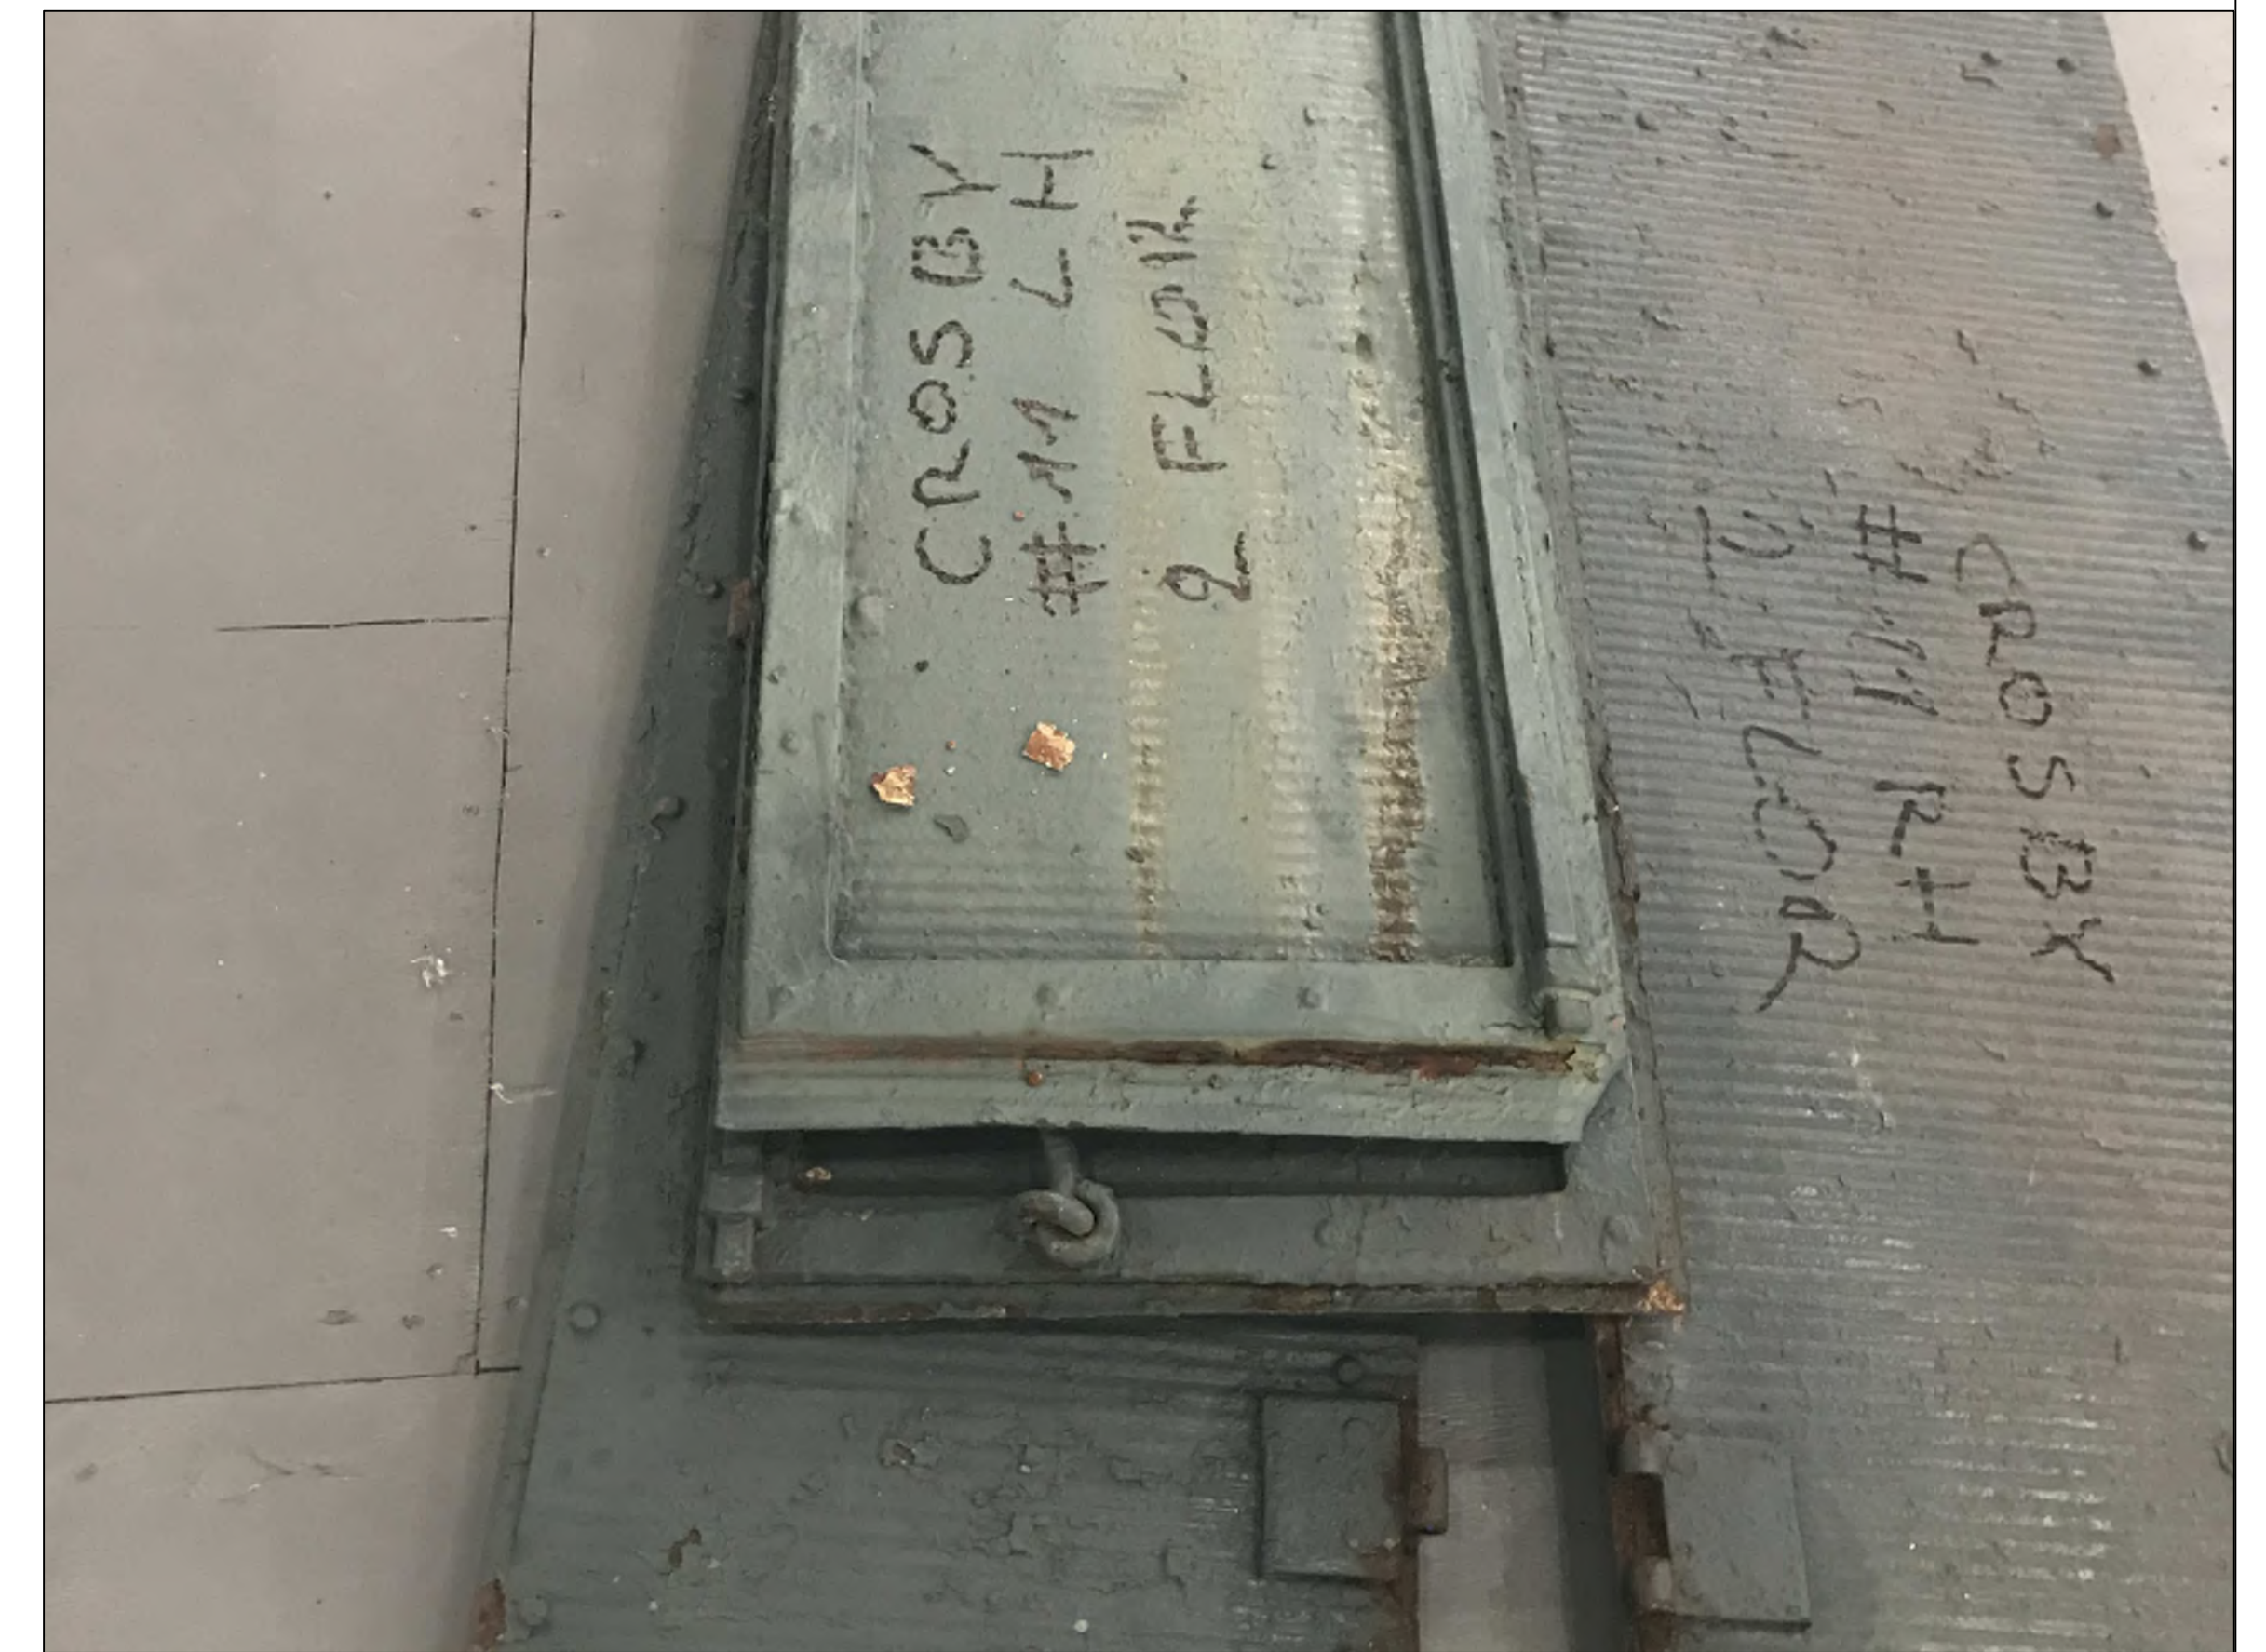
PRE-RESTORATION SHUTTER CONDITIONS

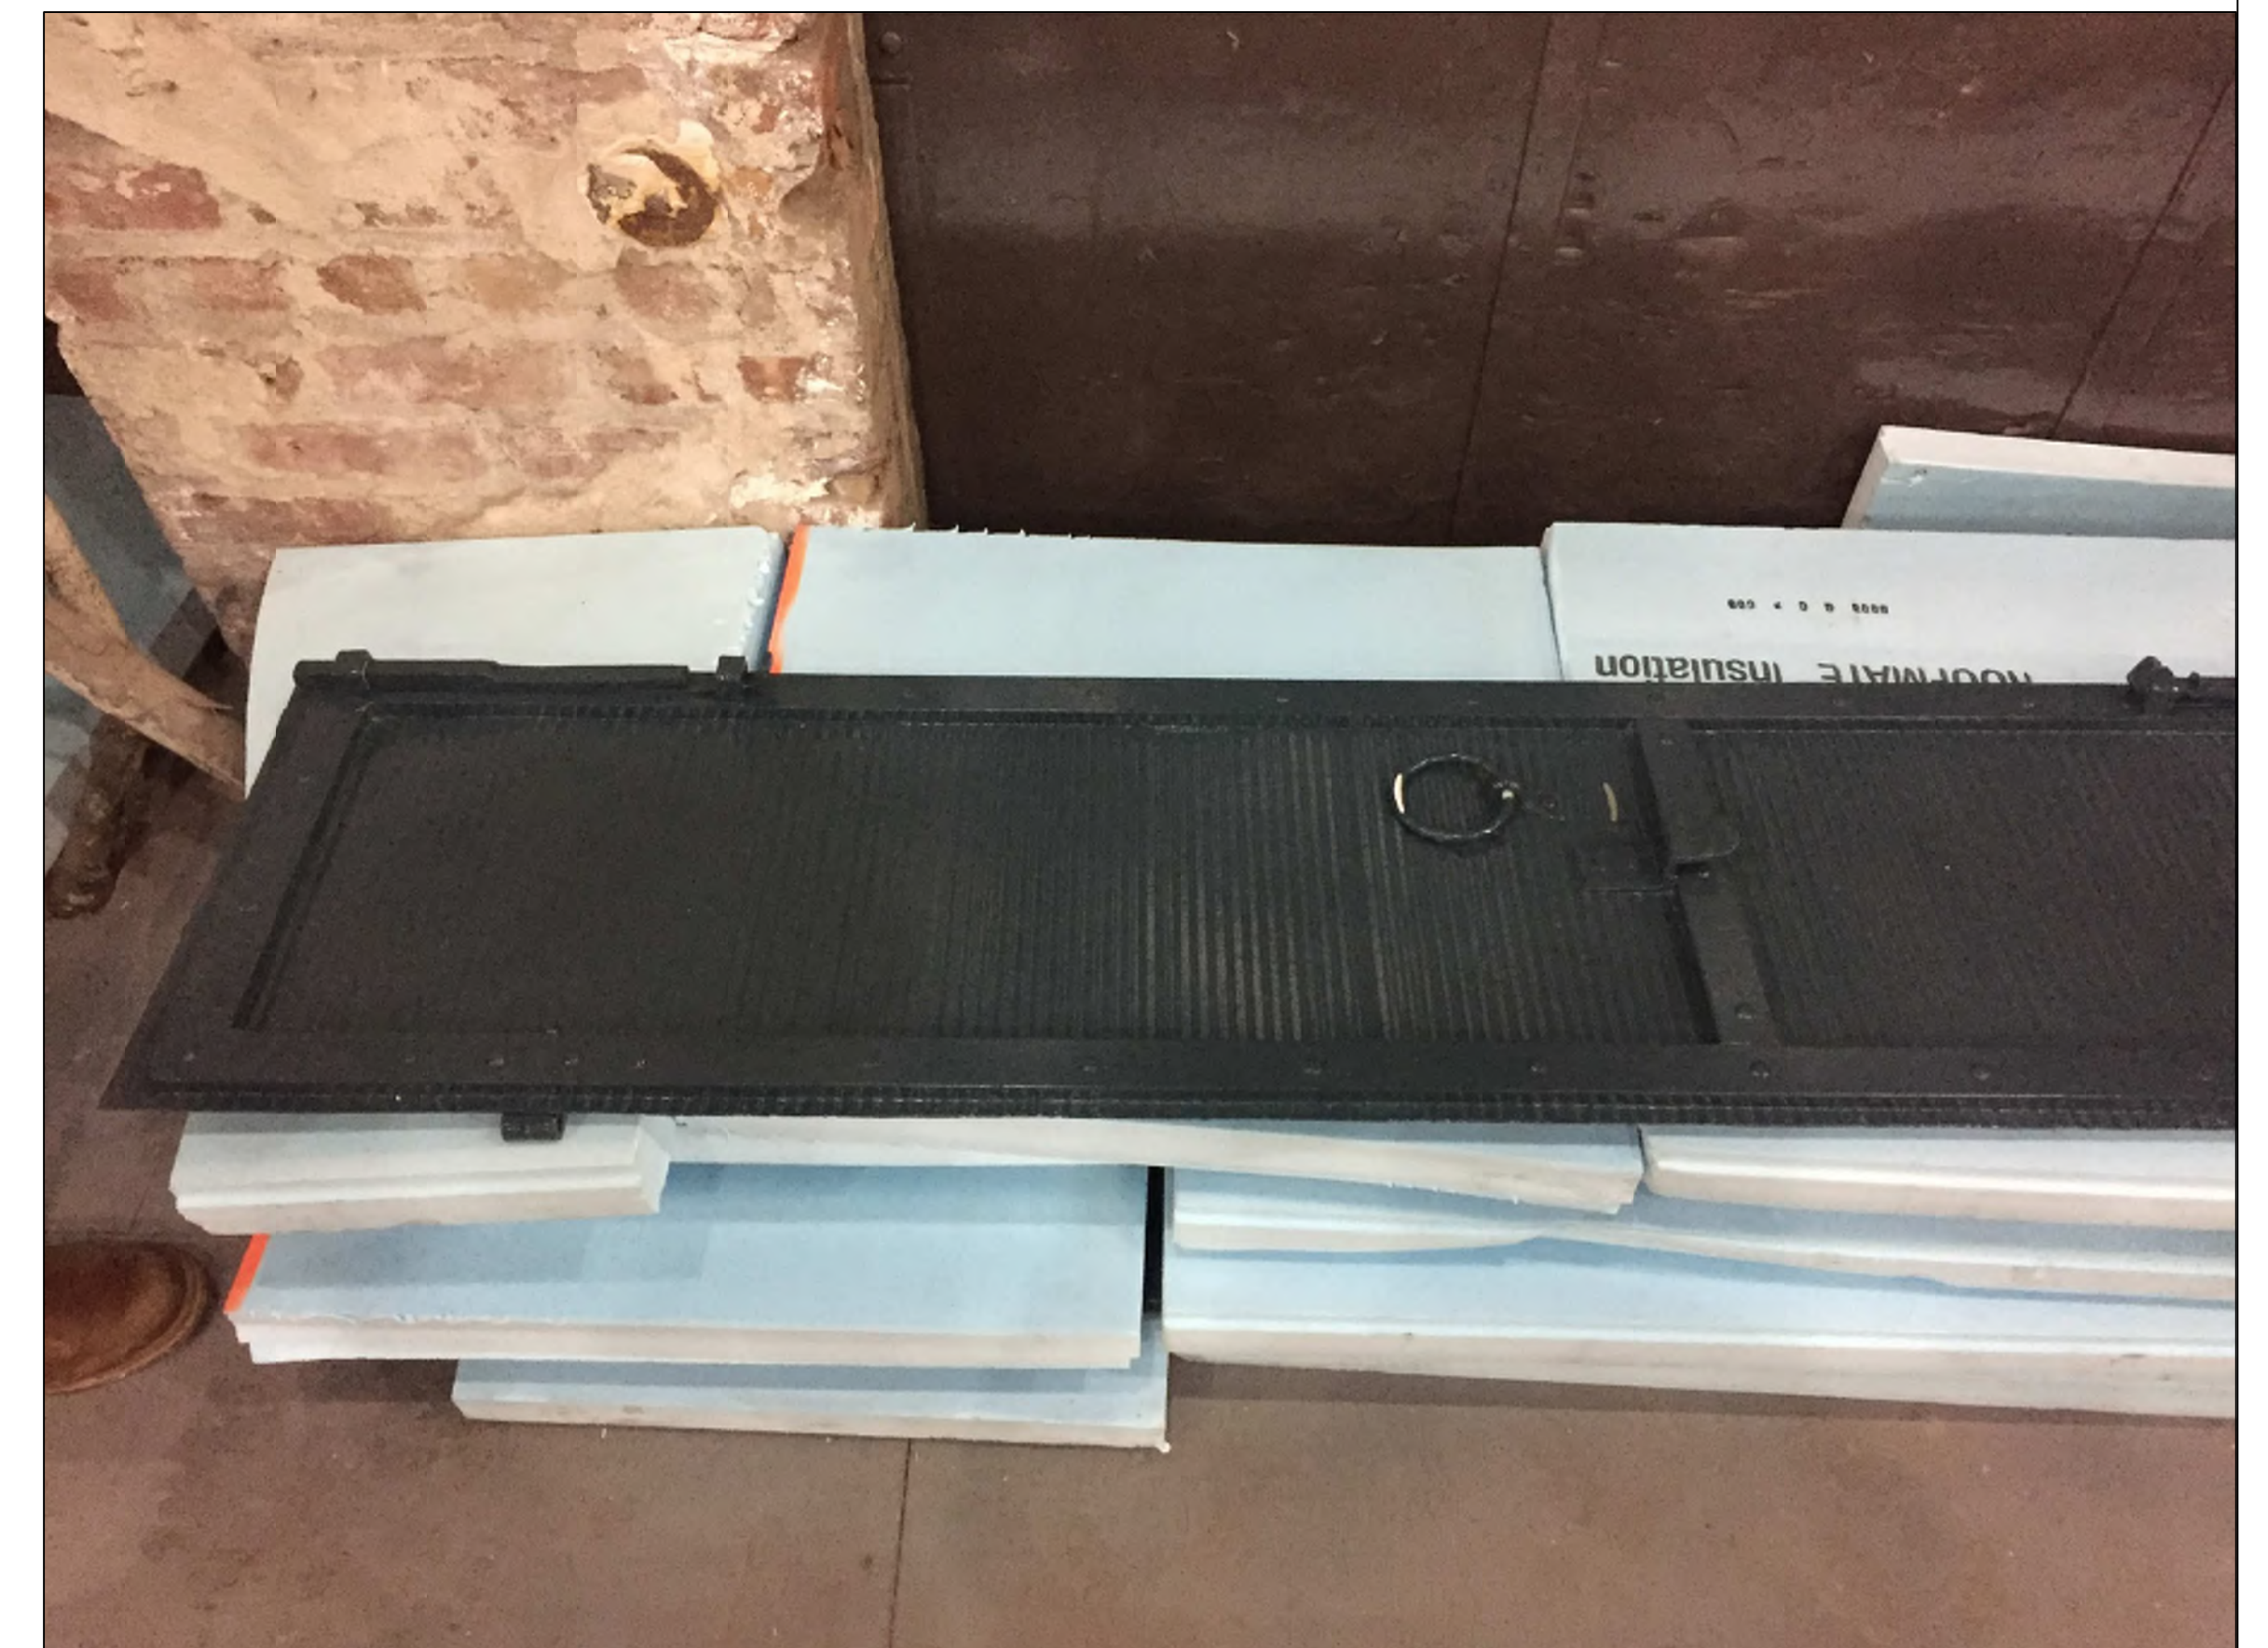
RESTORED SHUTTER
