462 BROADWAY
MERINGOFF PROPERTIES
FACADE
RESTORATION

DRAFT

OCTOBER 06, 2017

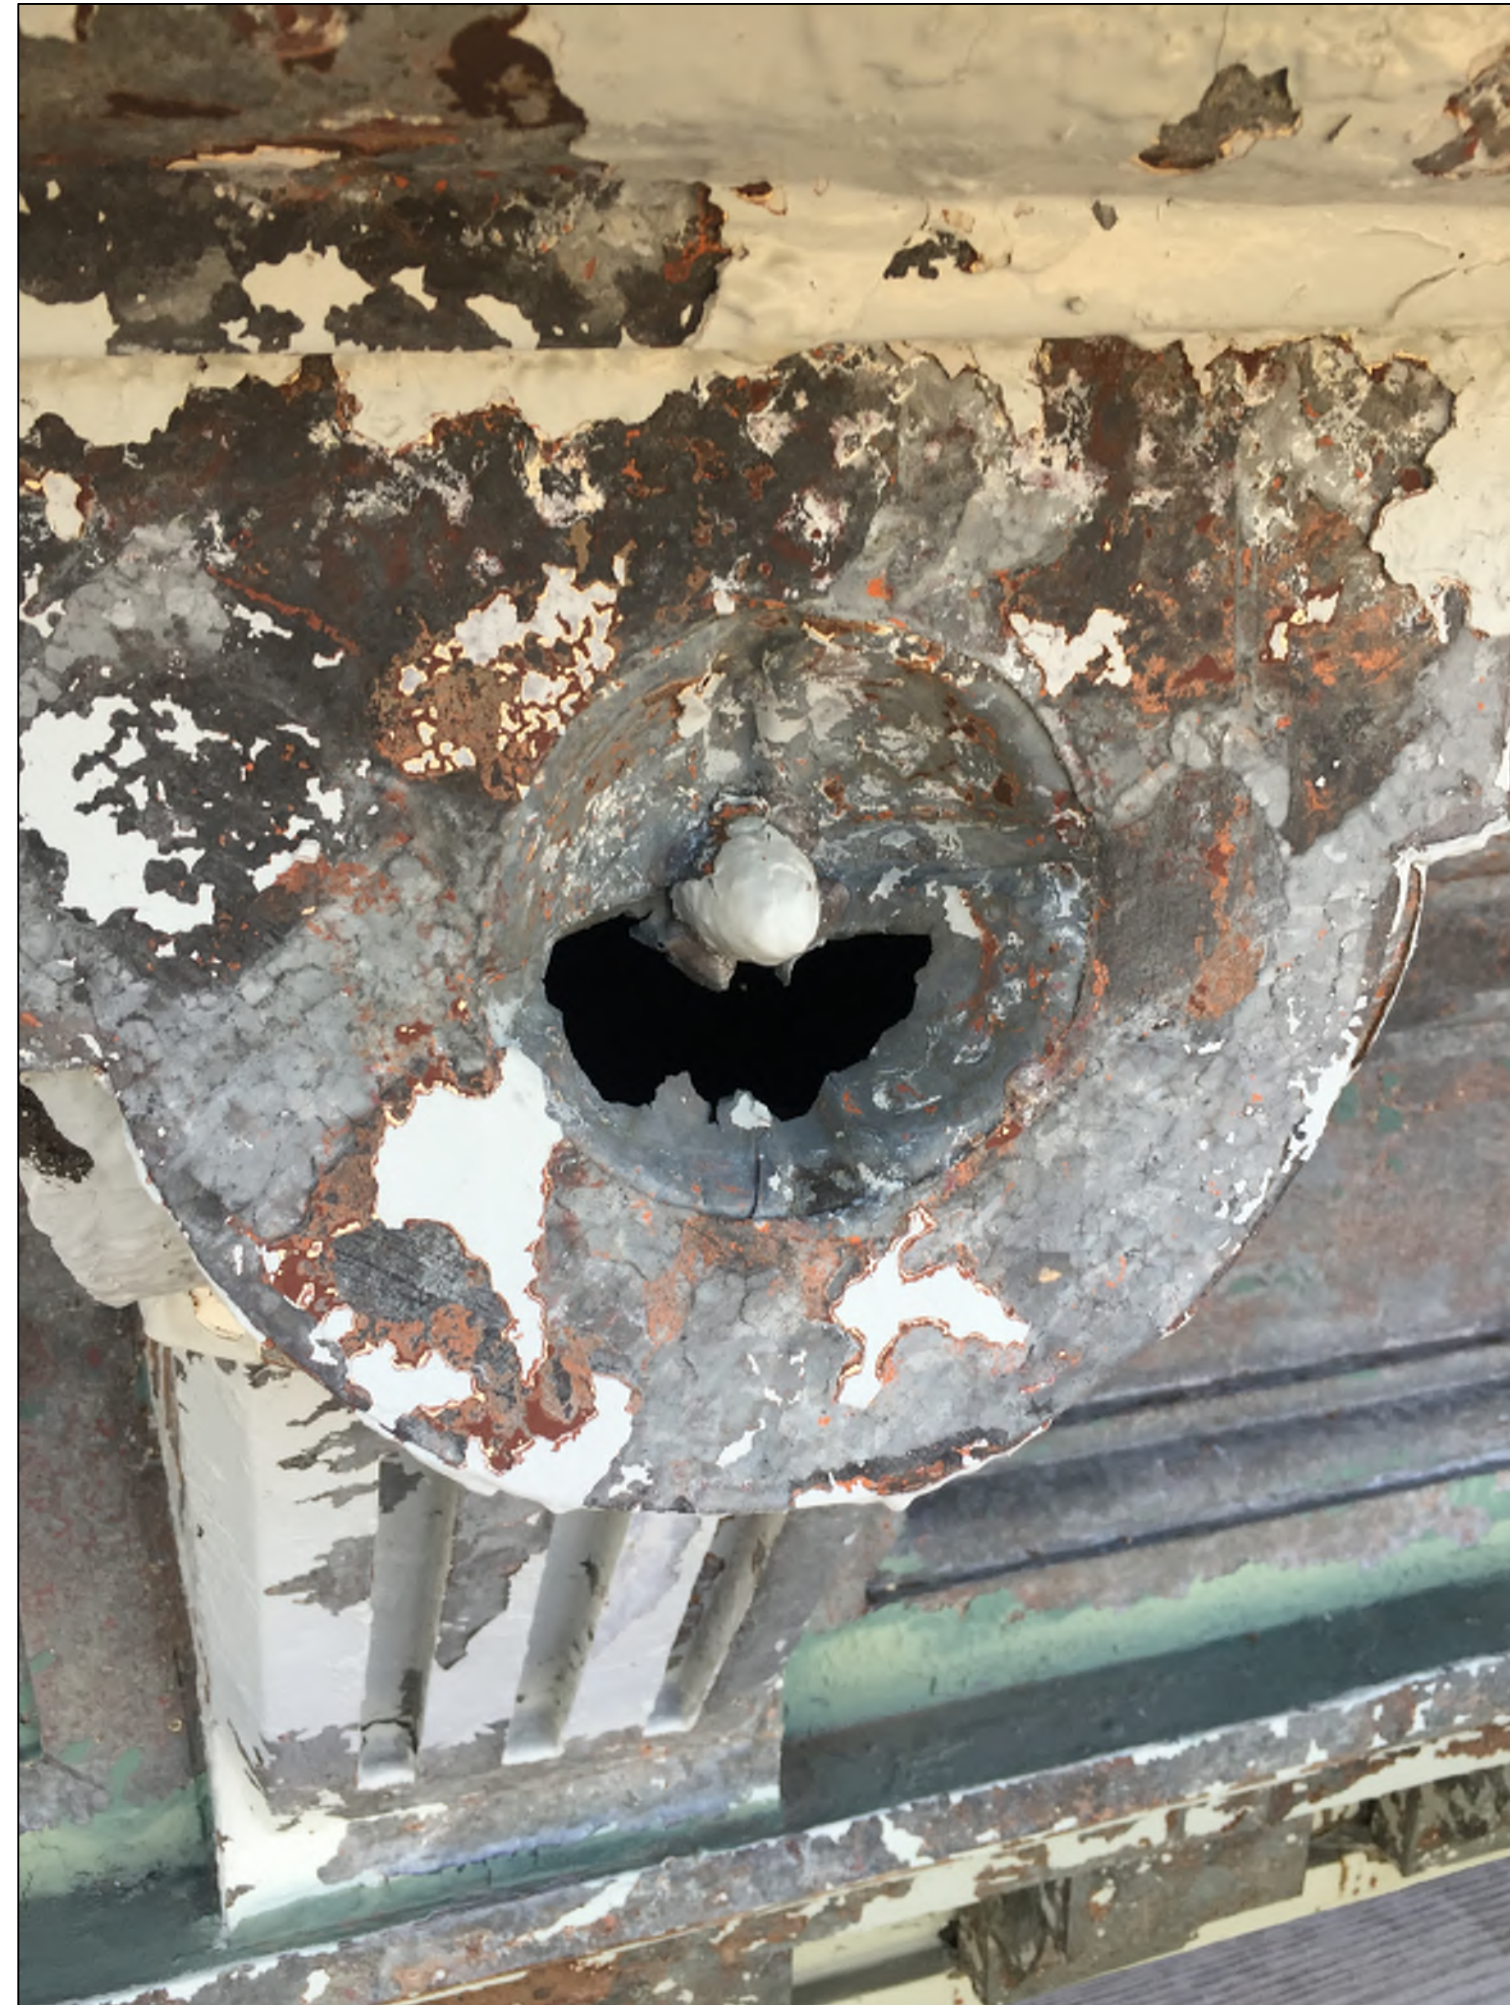
CORNICE CONDITIONS PRIOR TO REPAIR

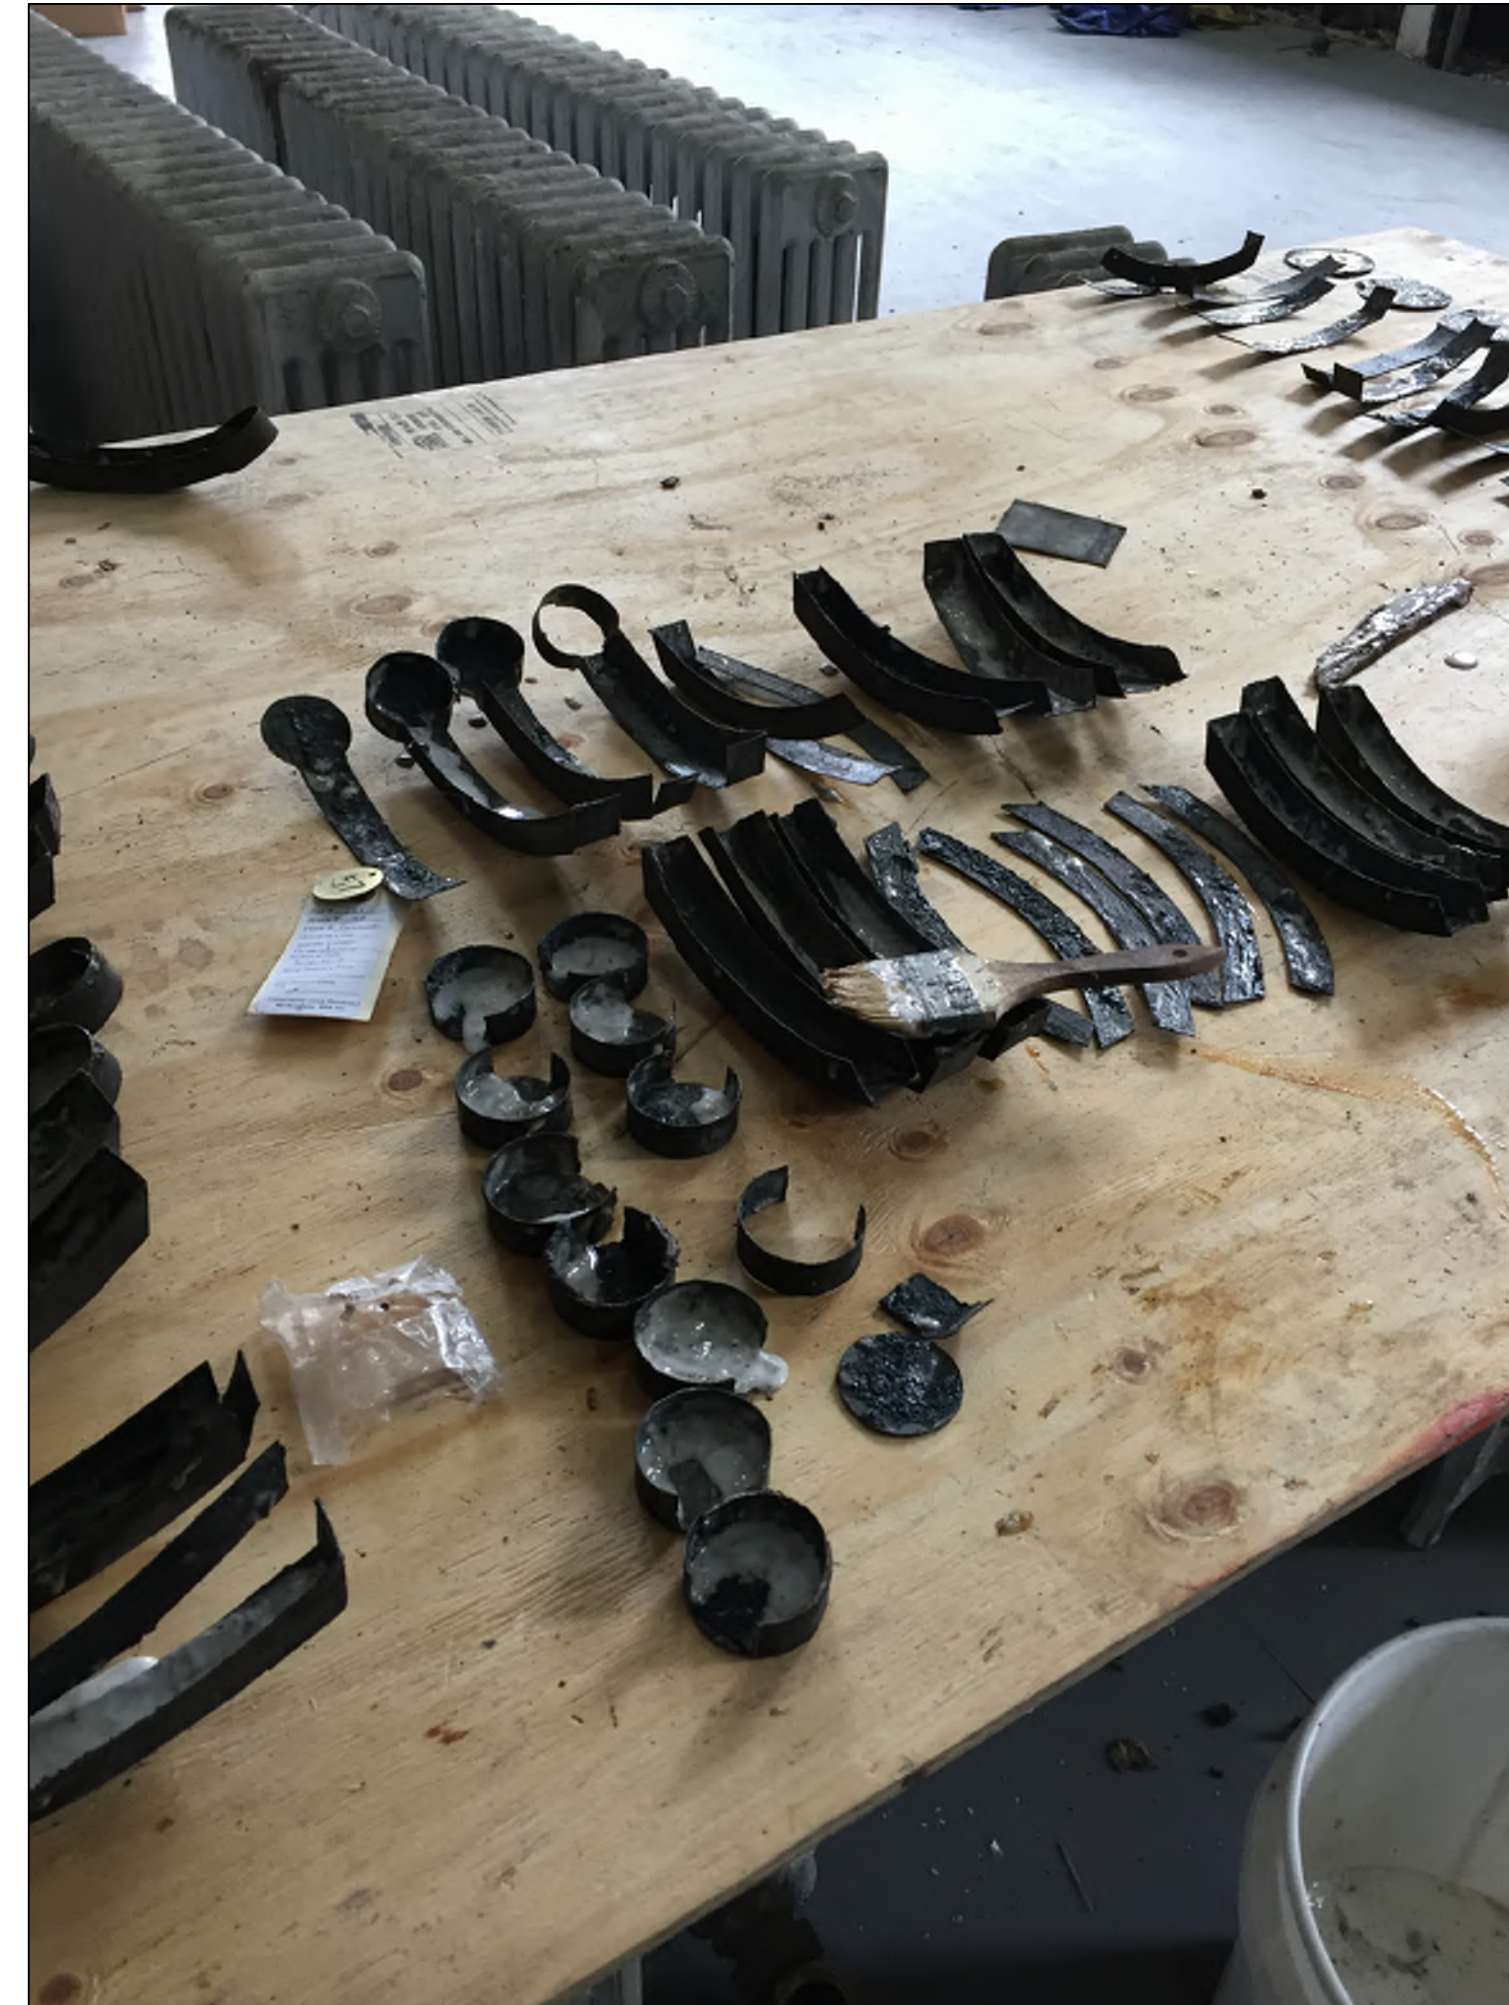
CORNICE COMPONENTS DURING RESTORATION

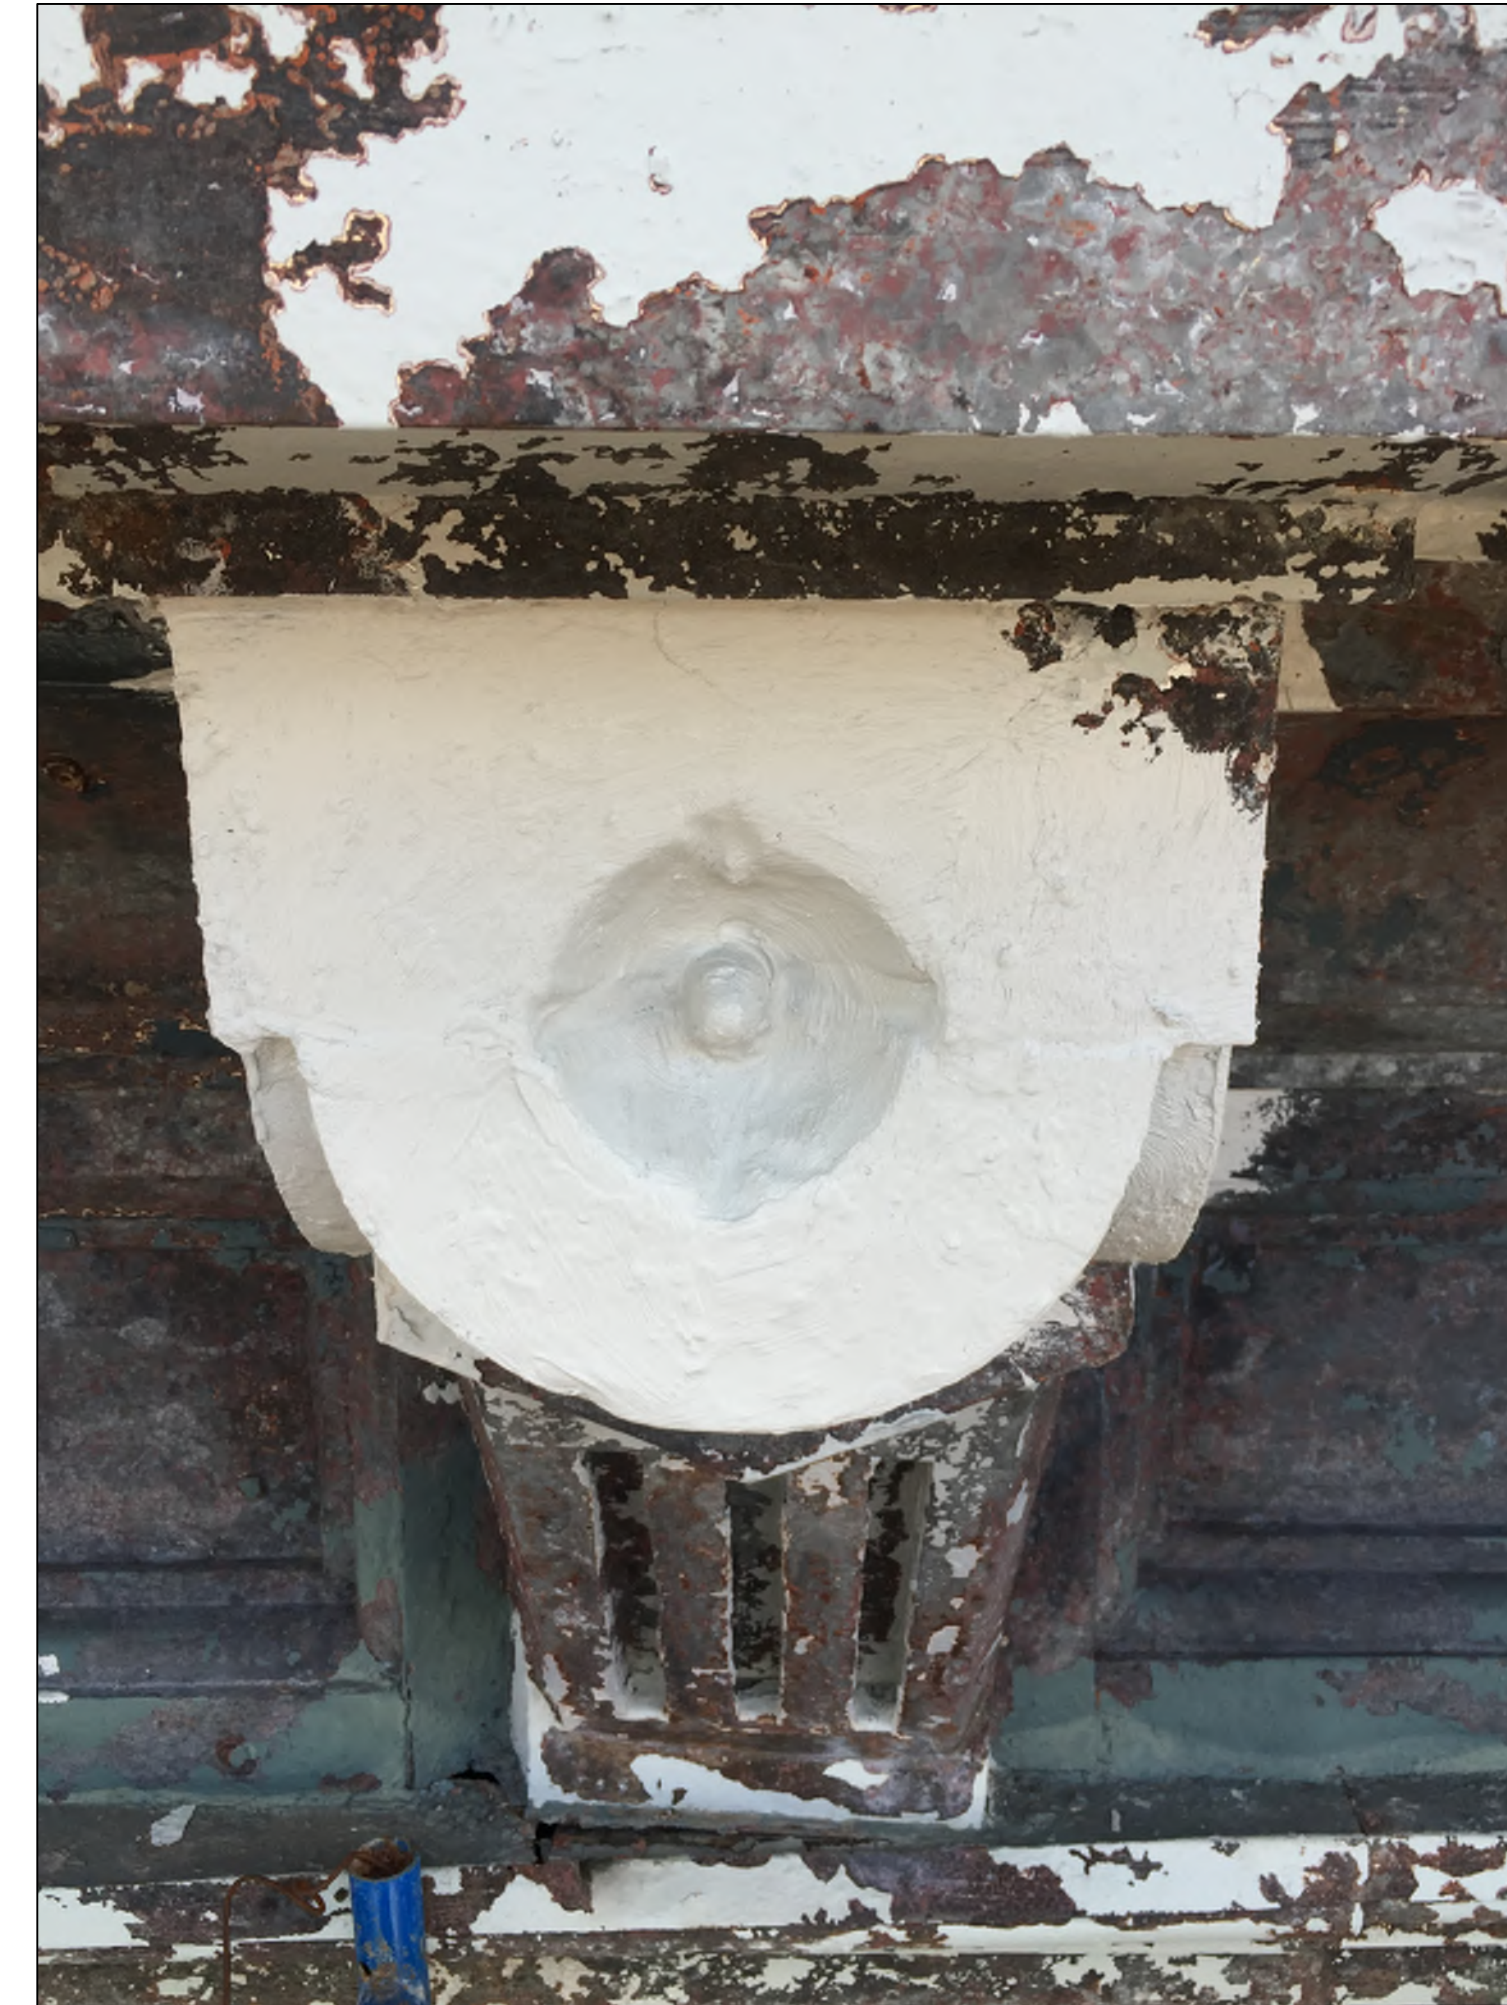
CORNICE IN PROGRESS OF RESTORATION

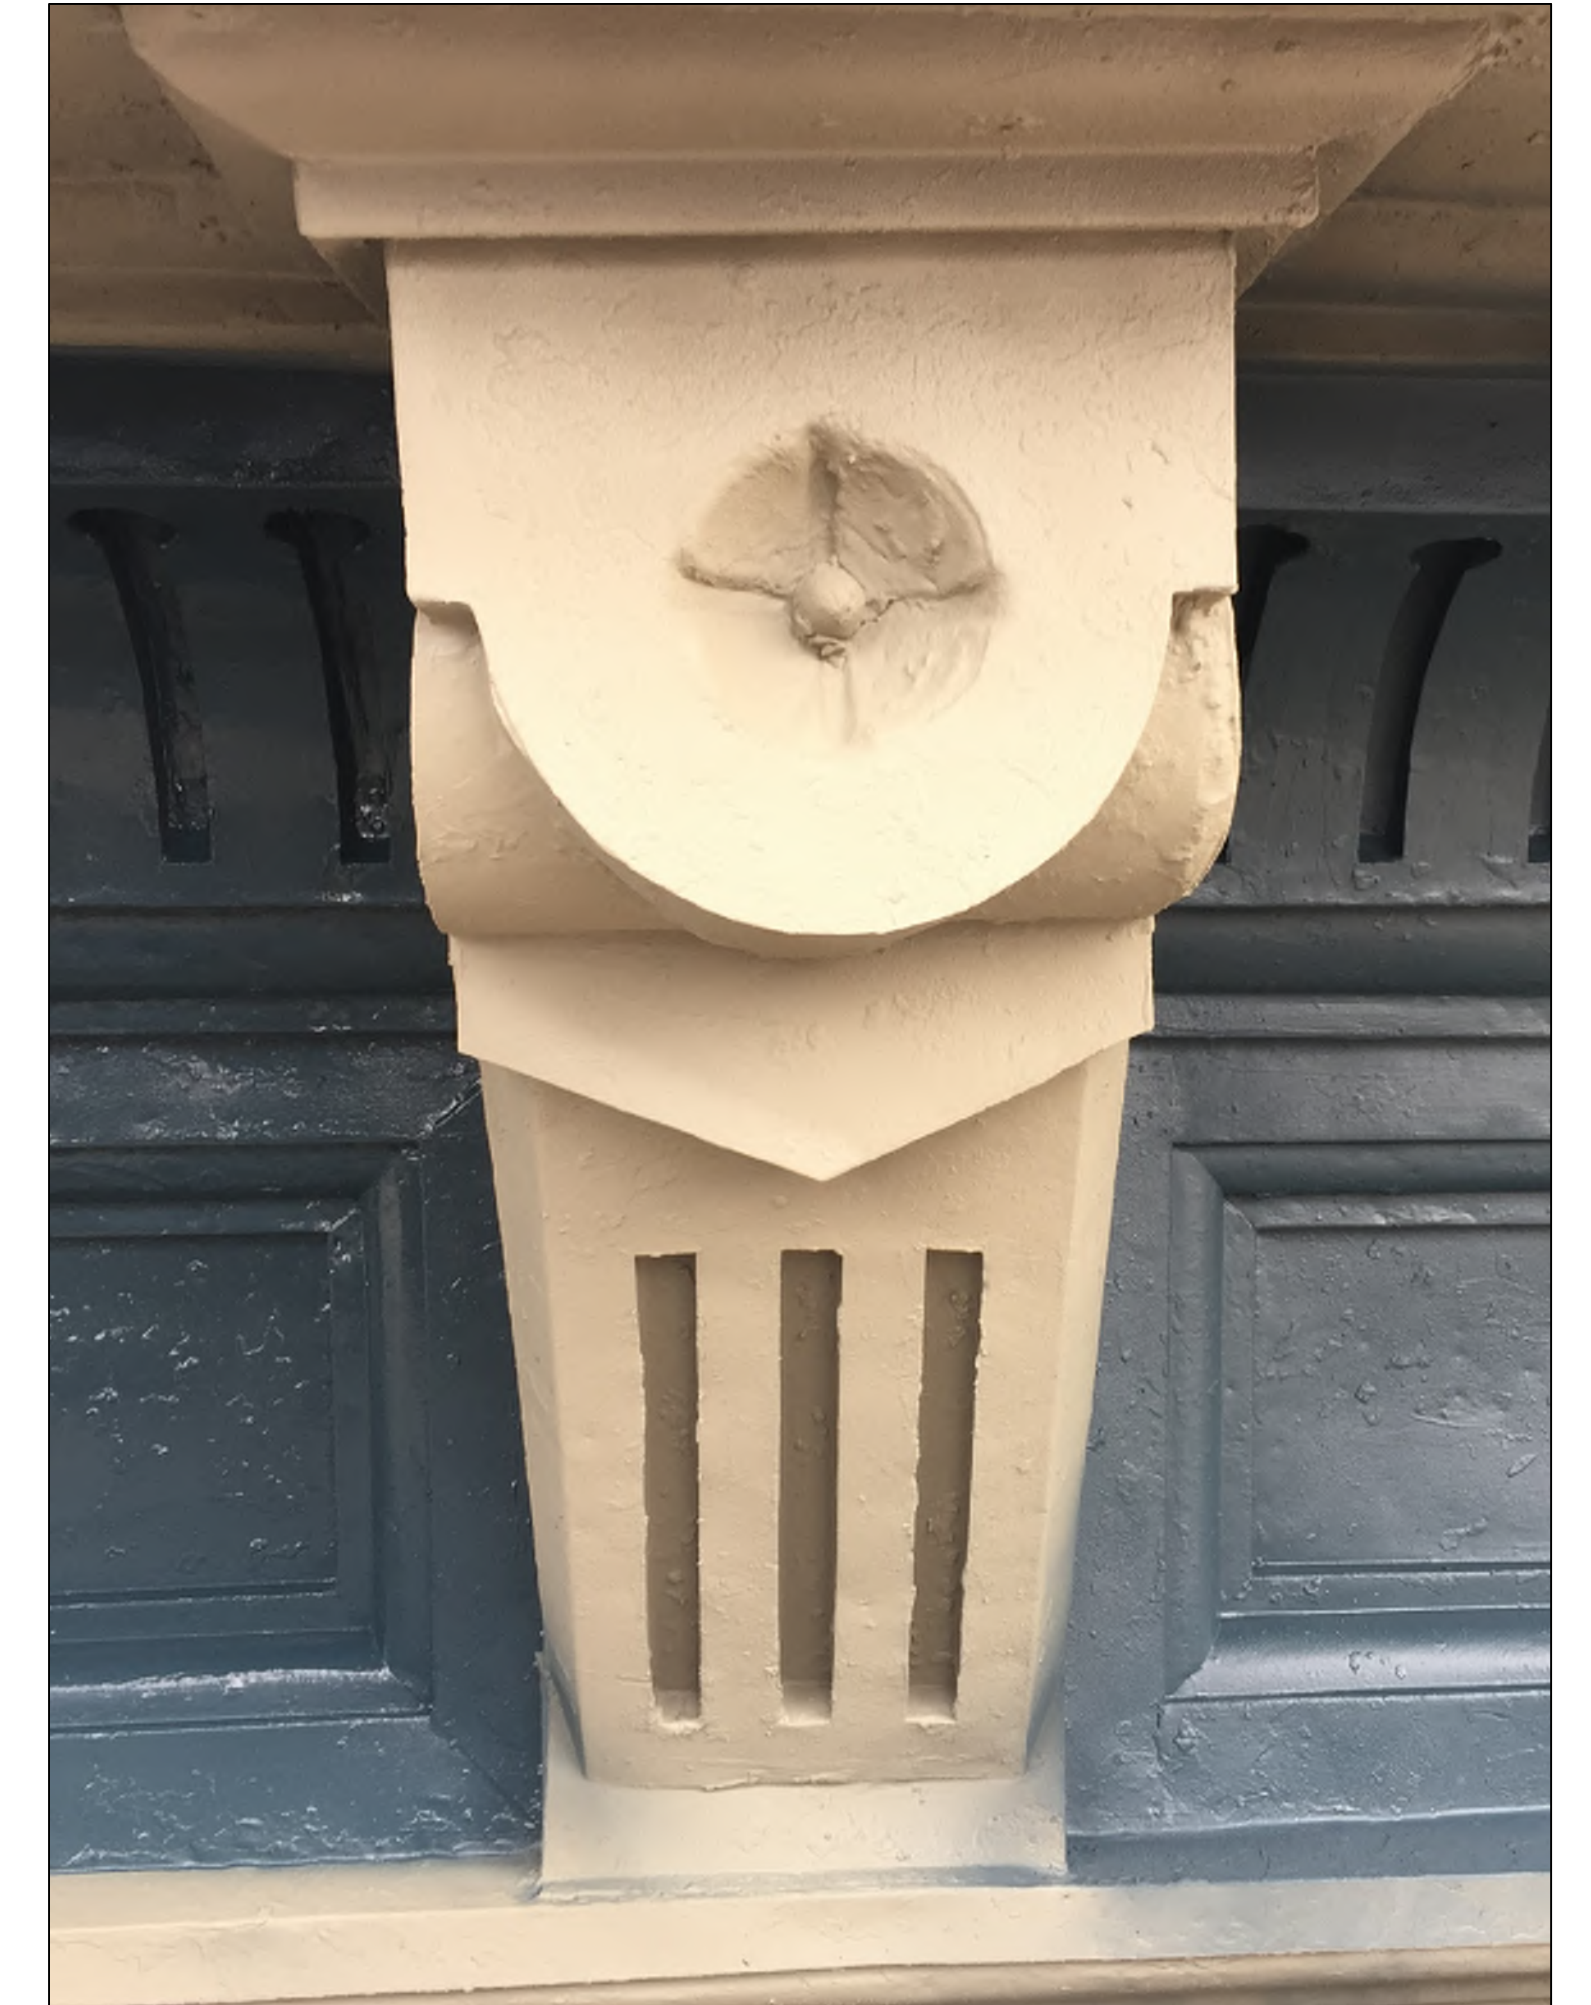
CORNICE CONDITION AFTER RESTORATION PRIOR TO TOP COAT

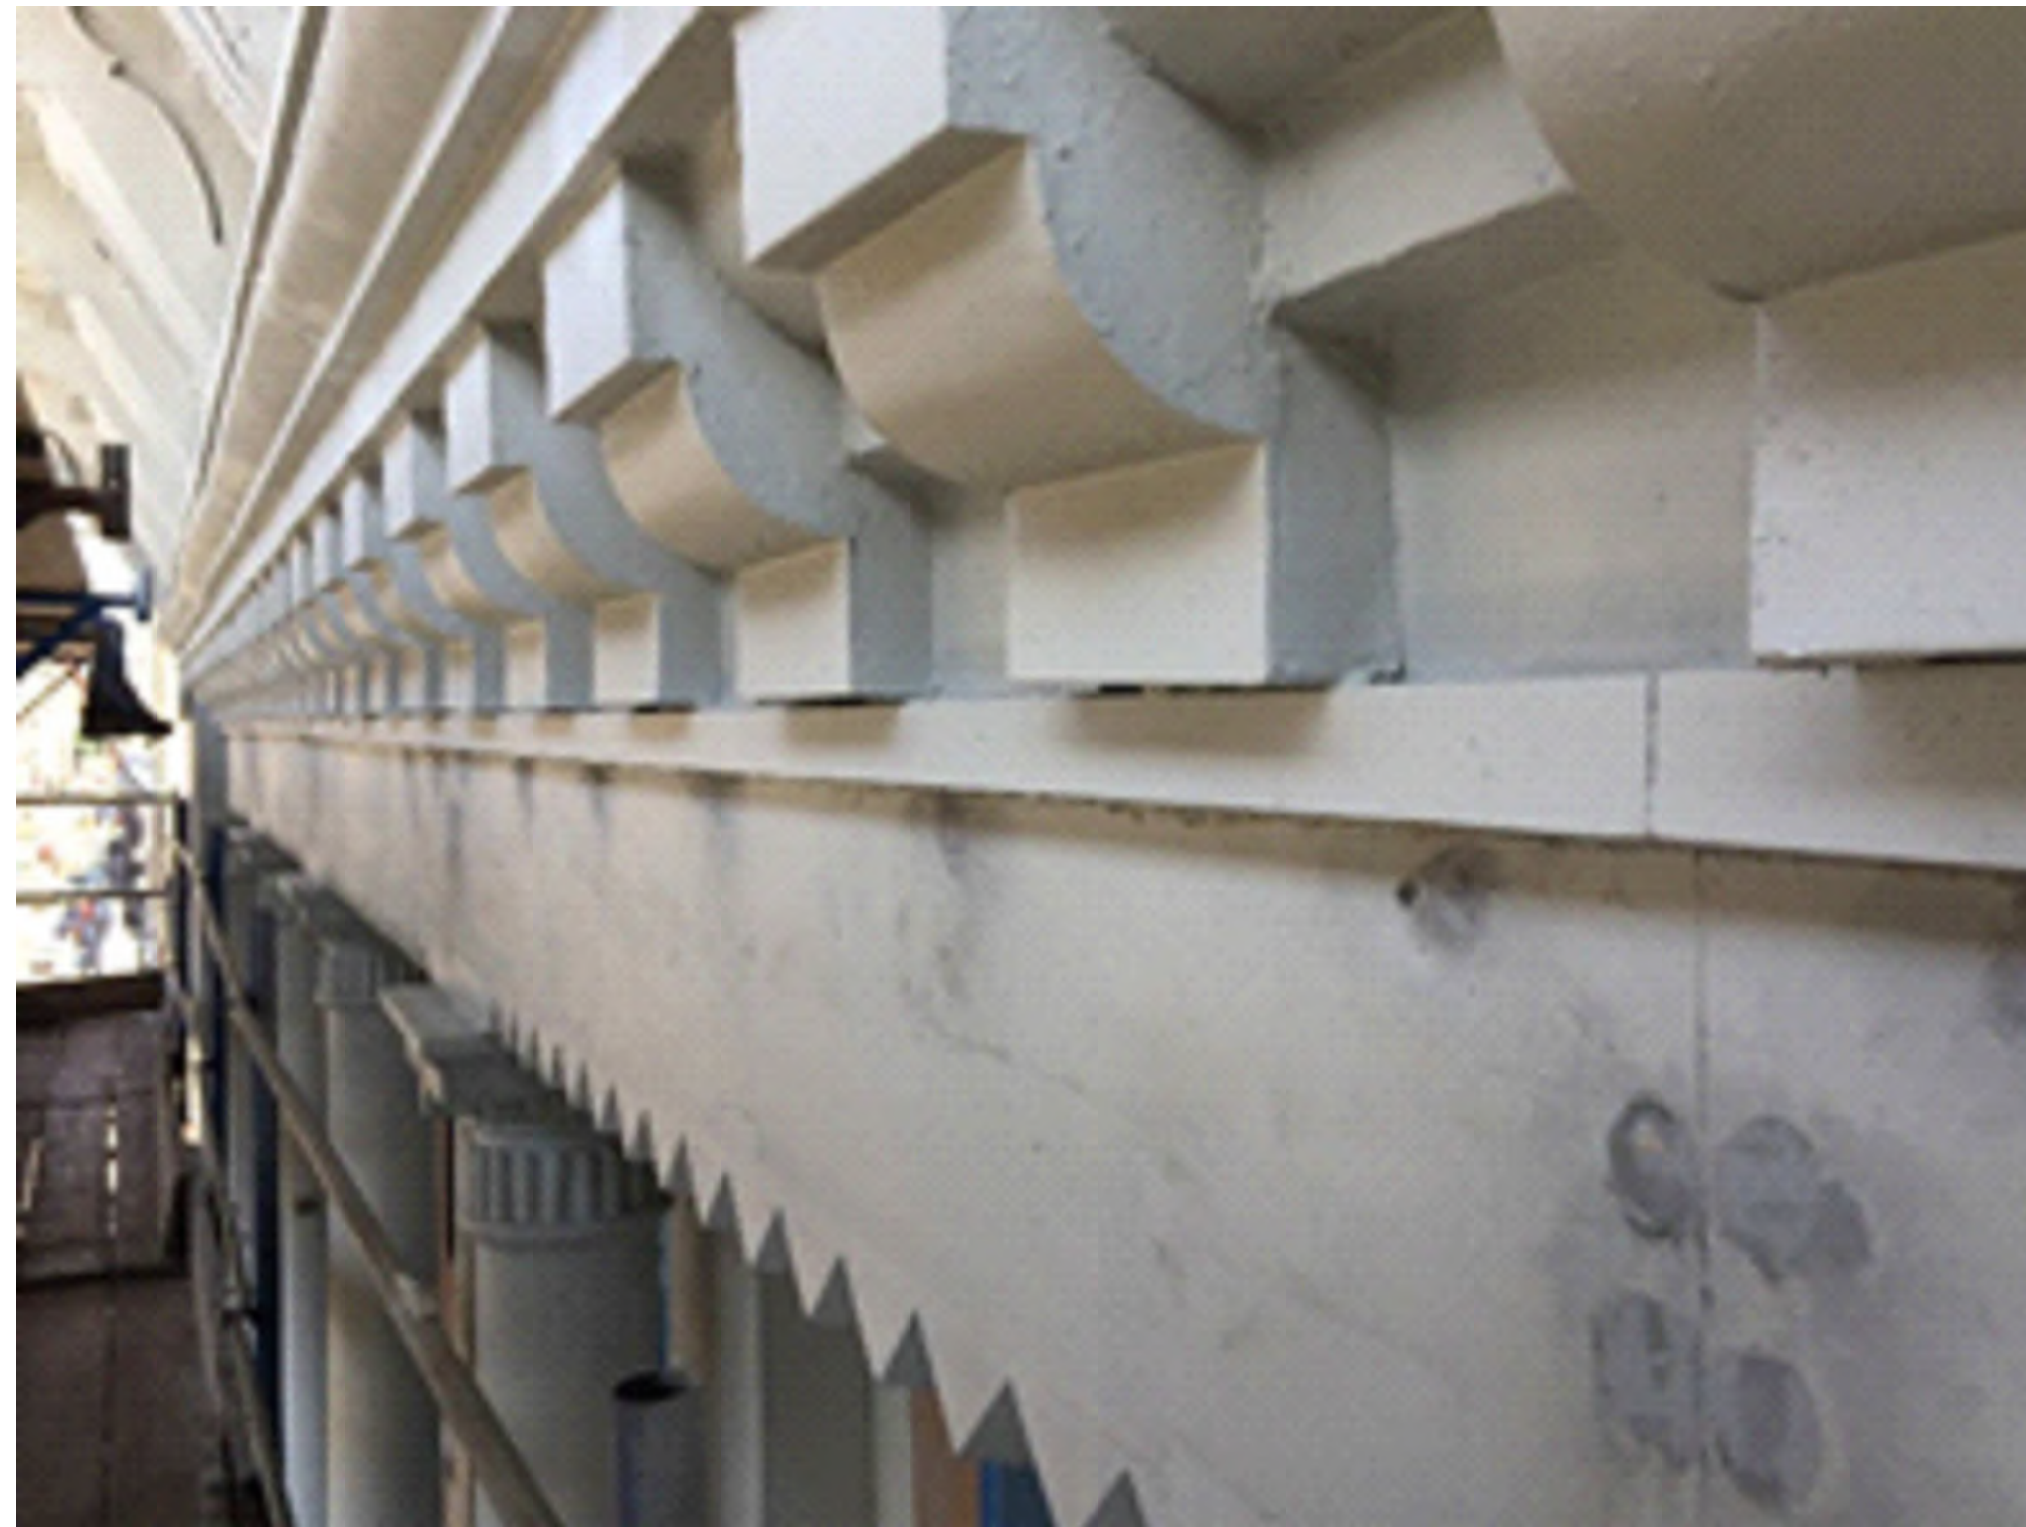
CAST IRON PATCHES PRIOR TO TOP COAT

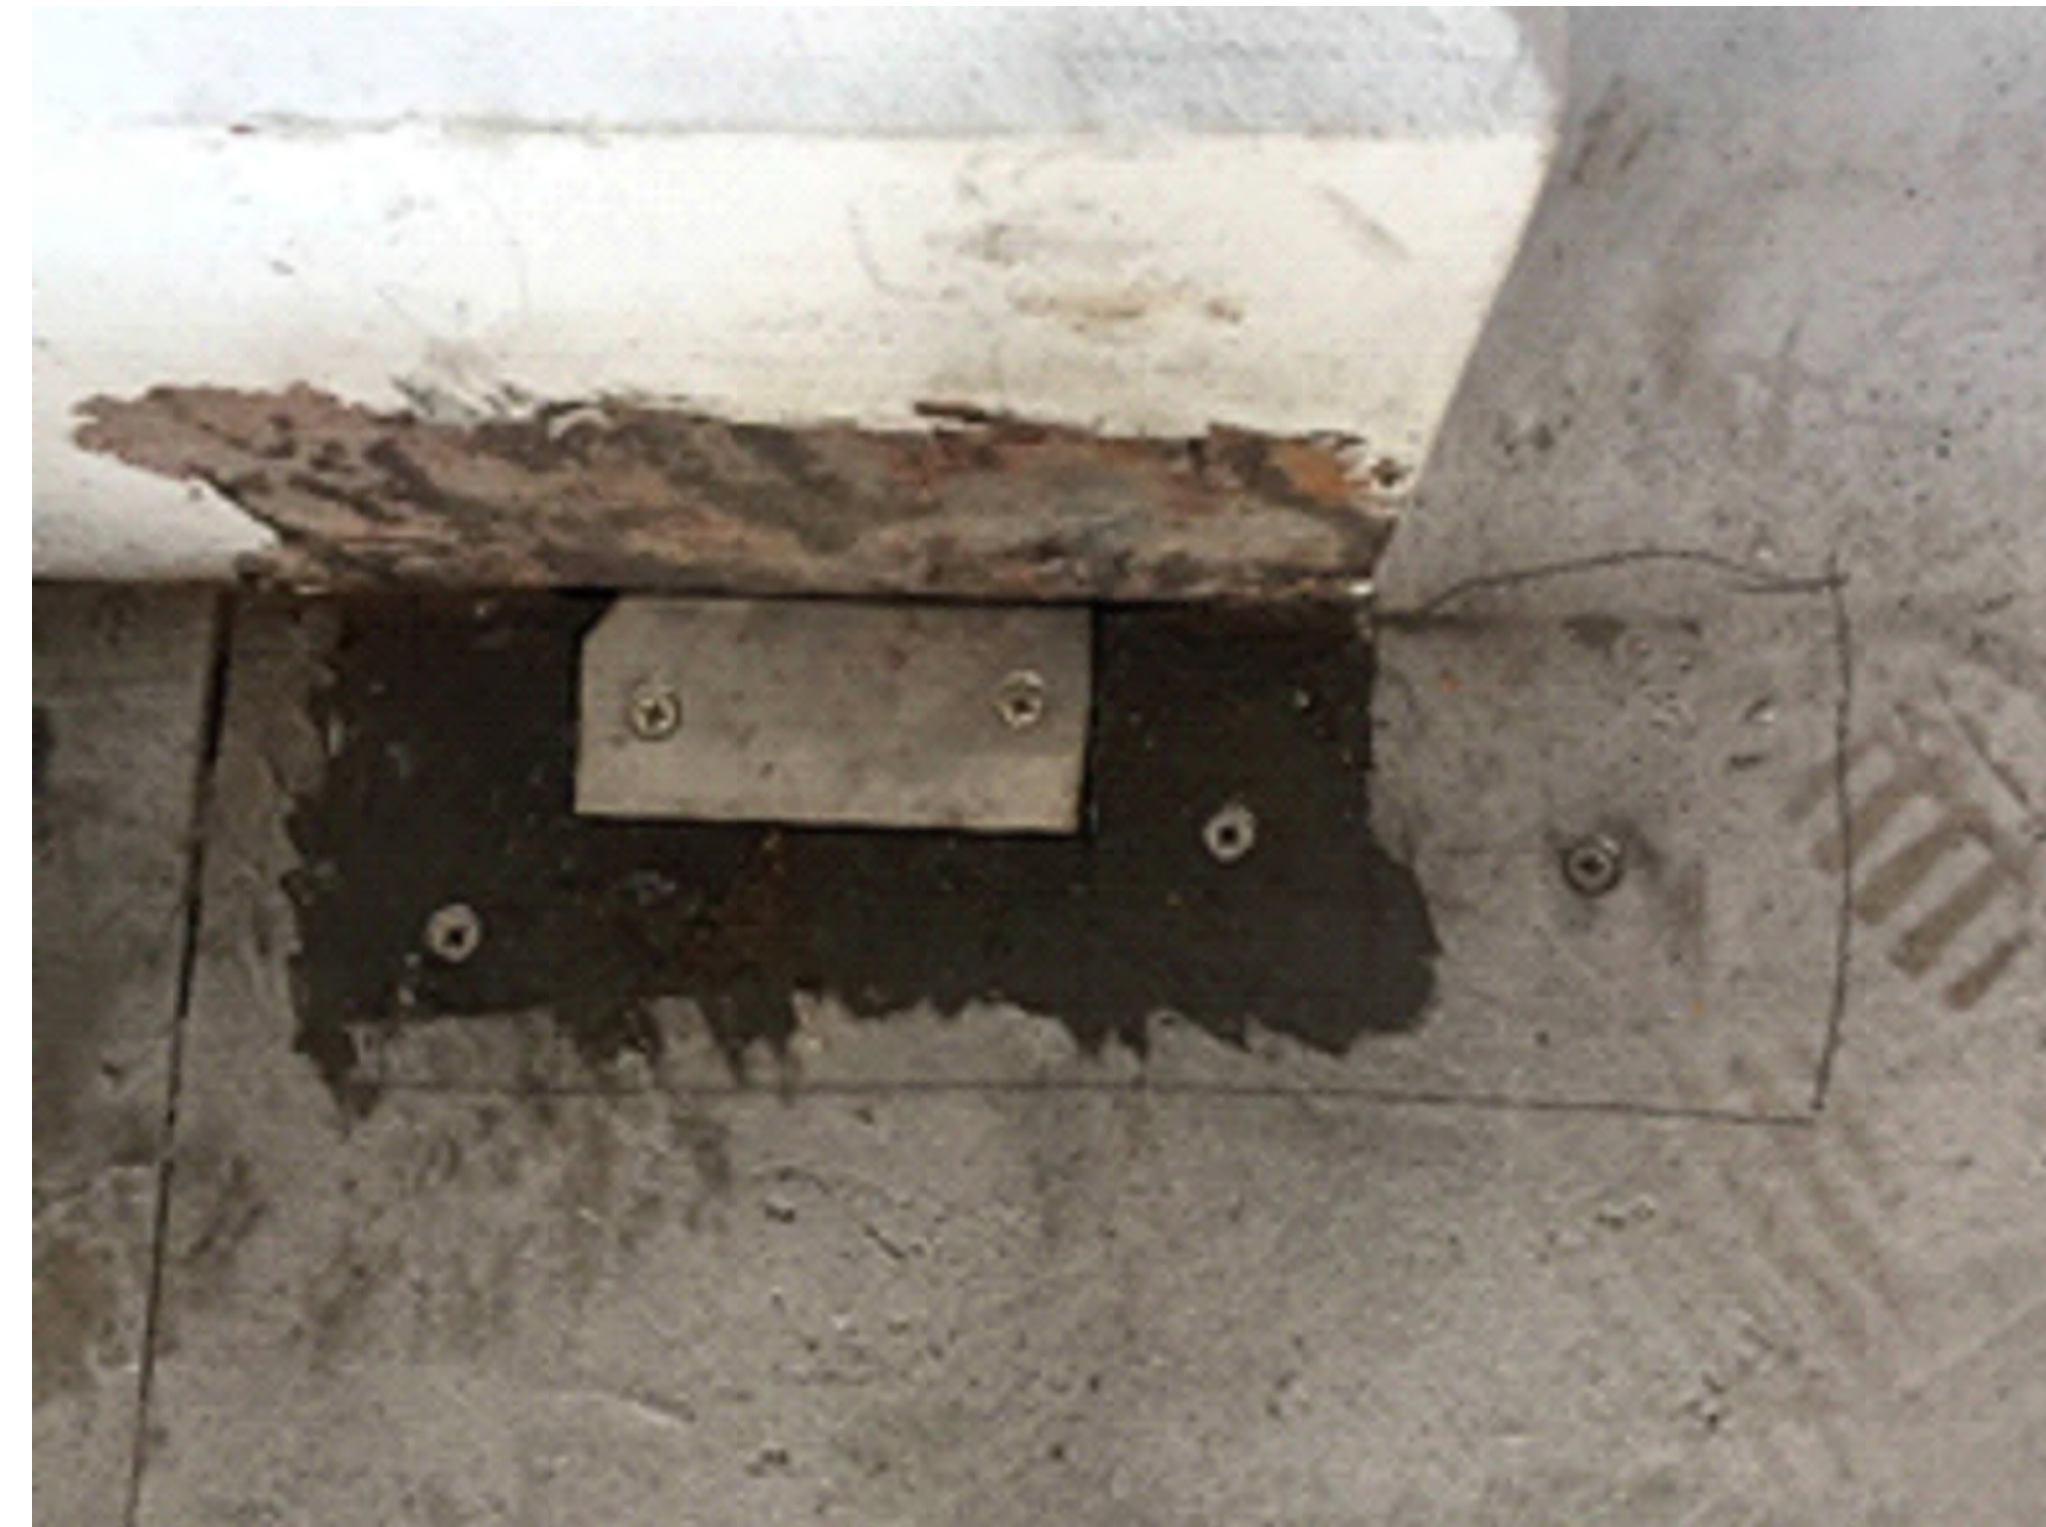
CAST IRON REPAIR - STAINLESS STEEL PLATE

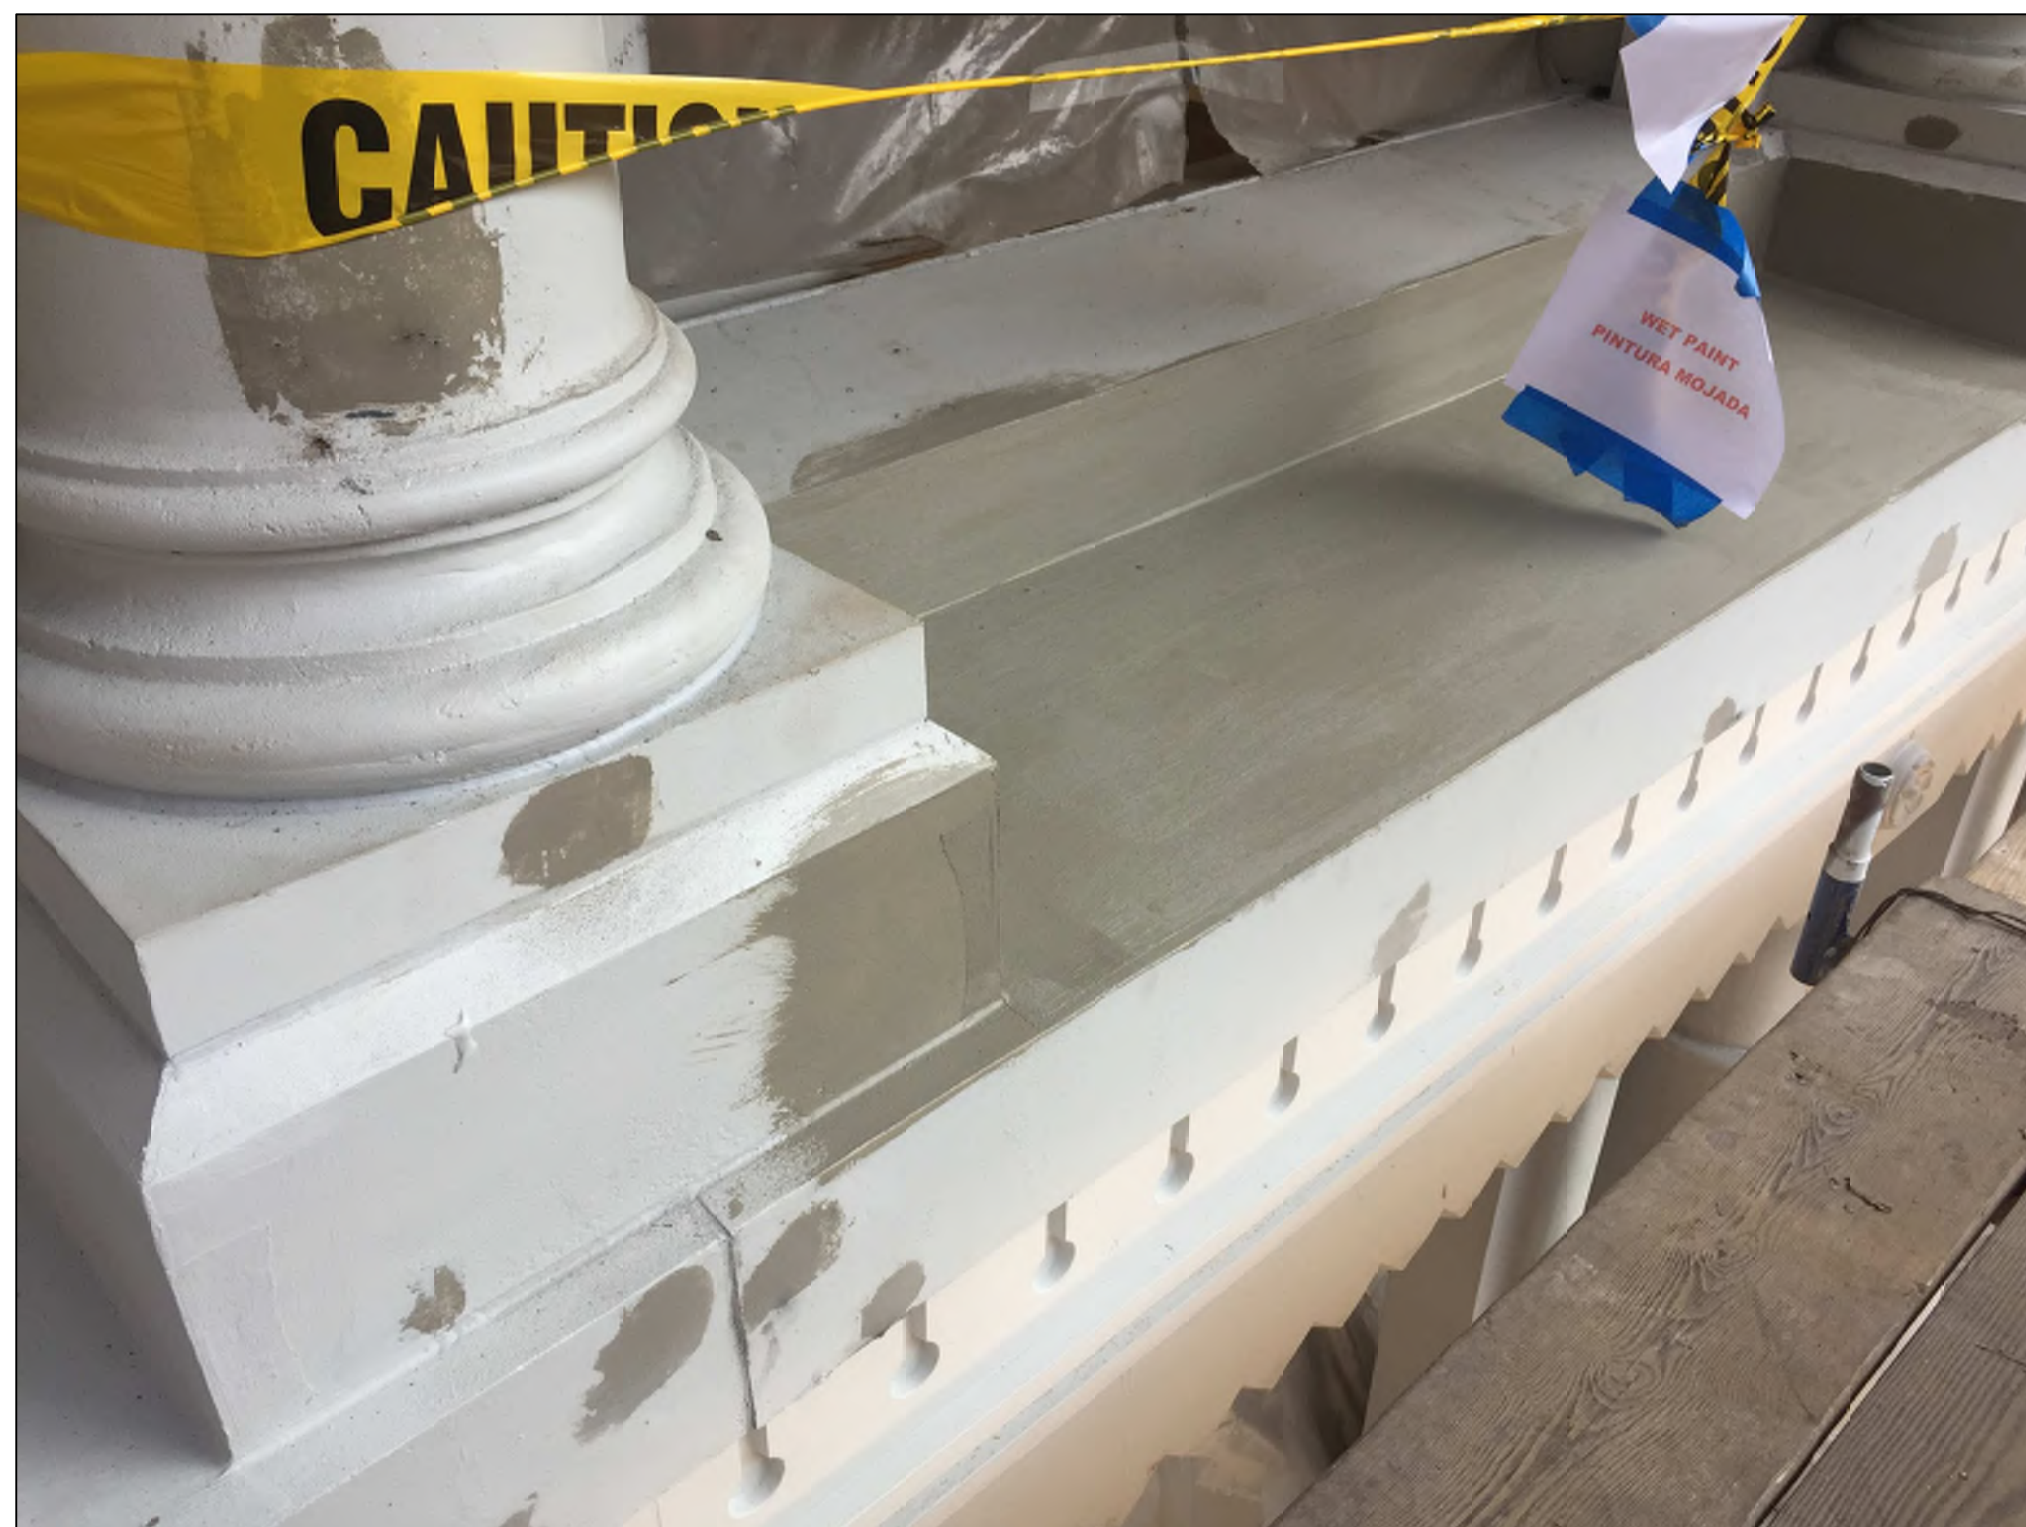
CAST IRON REPAIR AFTER PATCHING PRIOR TO FINAL PAINT.
