462 BROADWAY
MERINGOFF PROPERTIES
FACADE
RESTORATION

DRAFT

OCTOBER 06, 2017

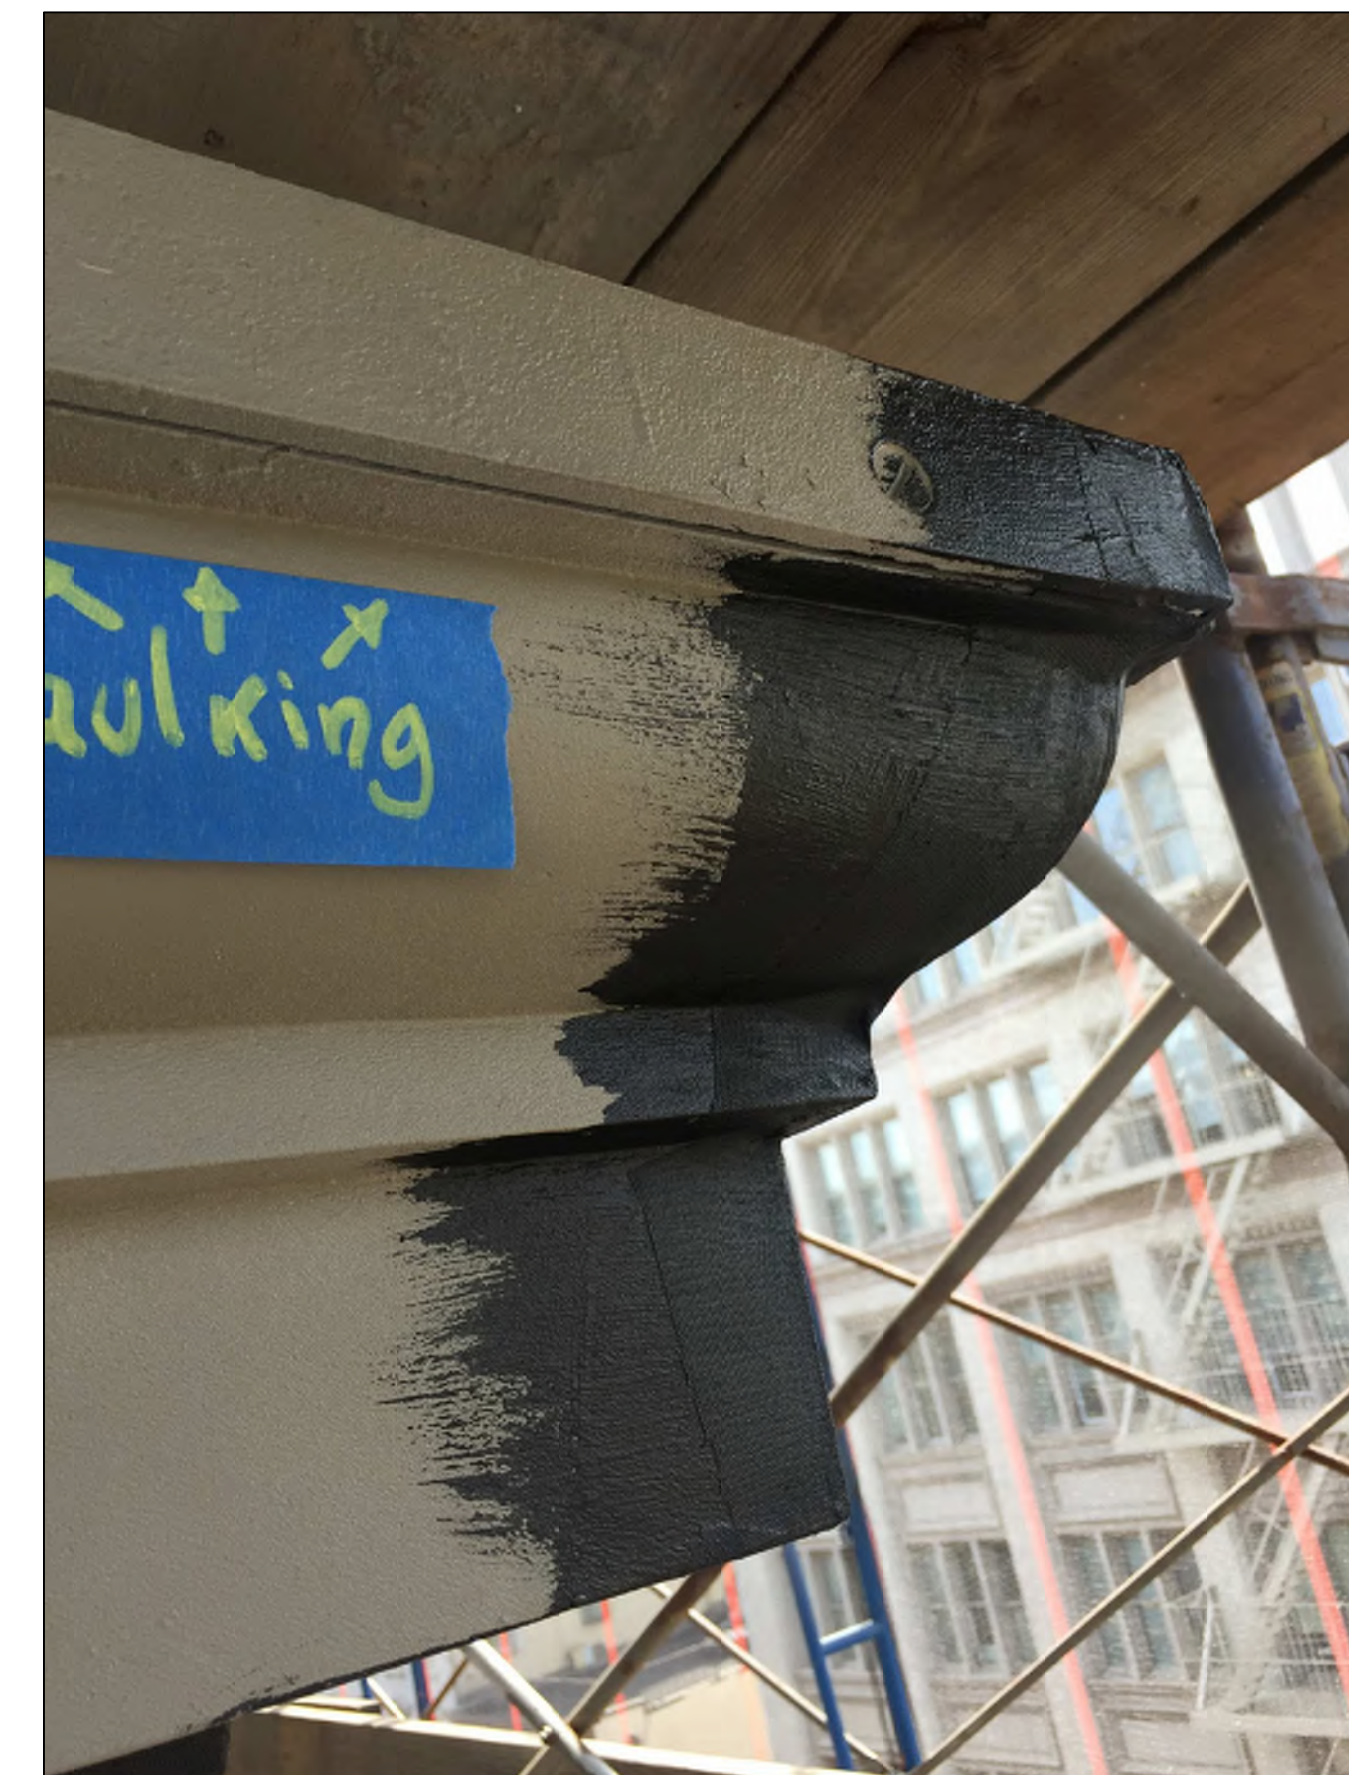
CORNICE DURING SECONDARY COATING

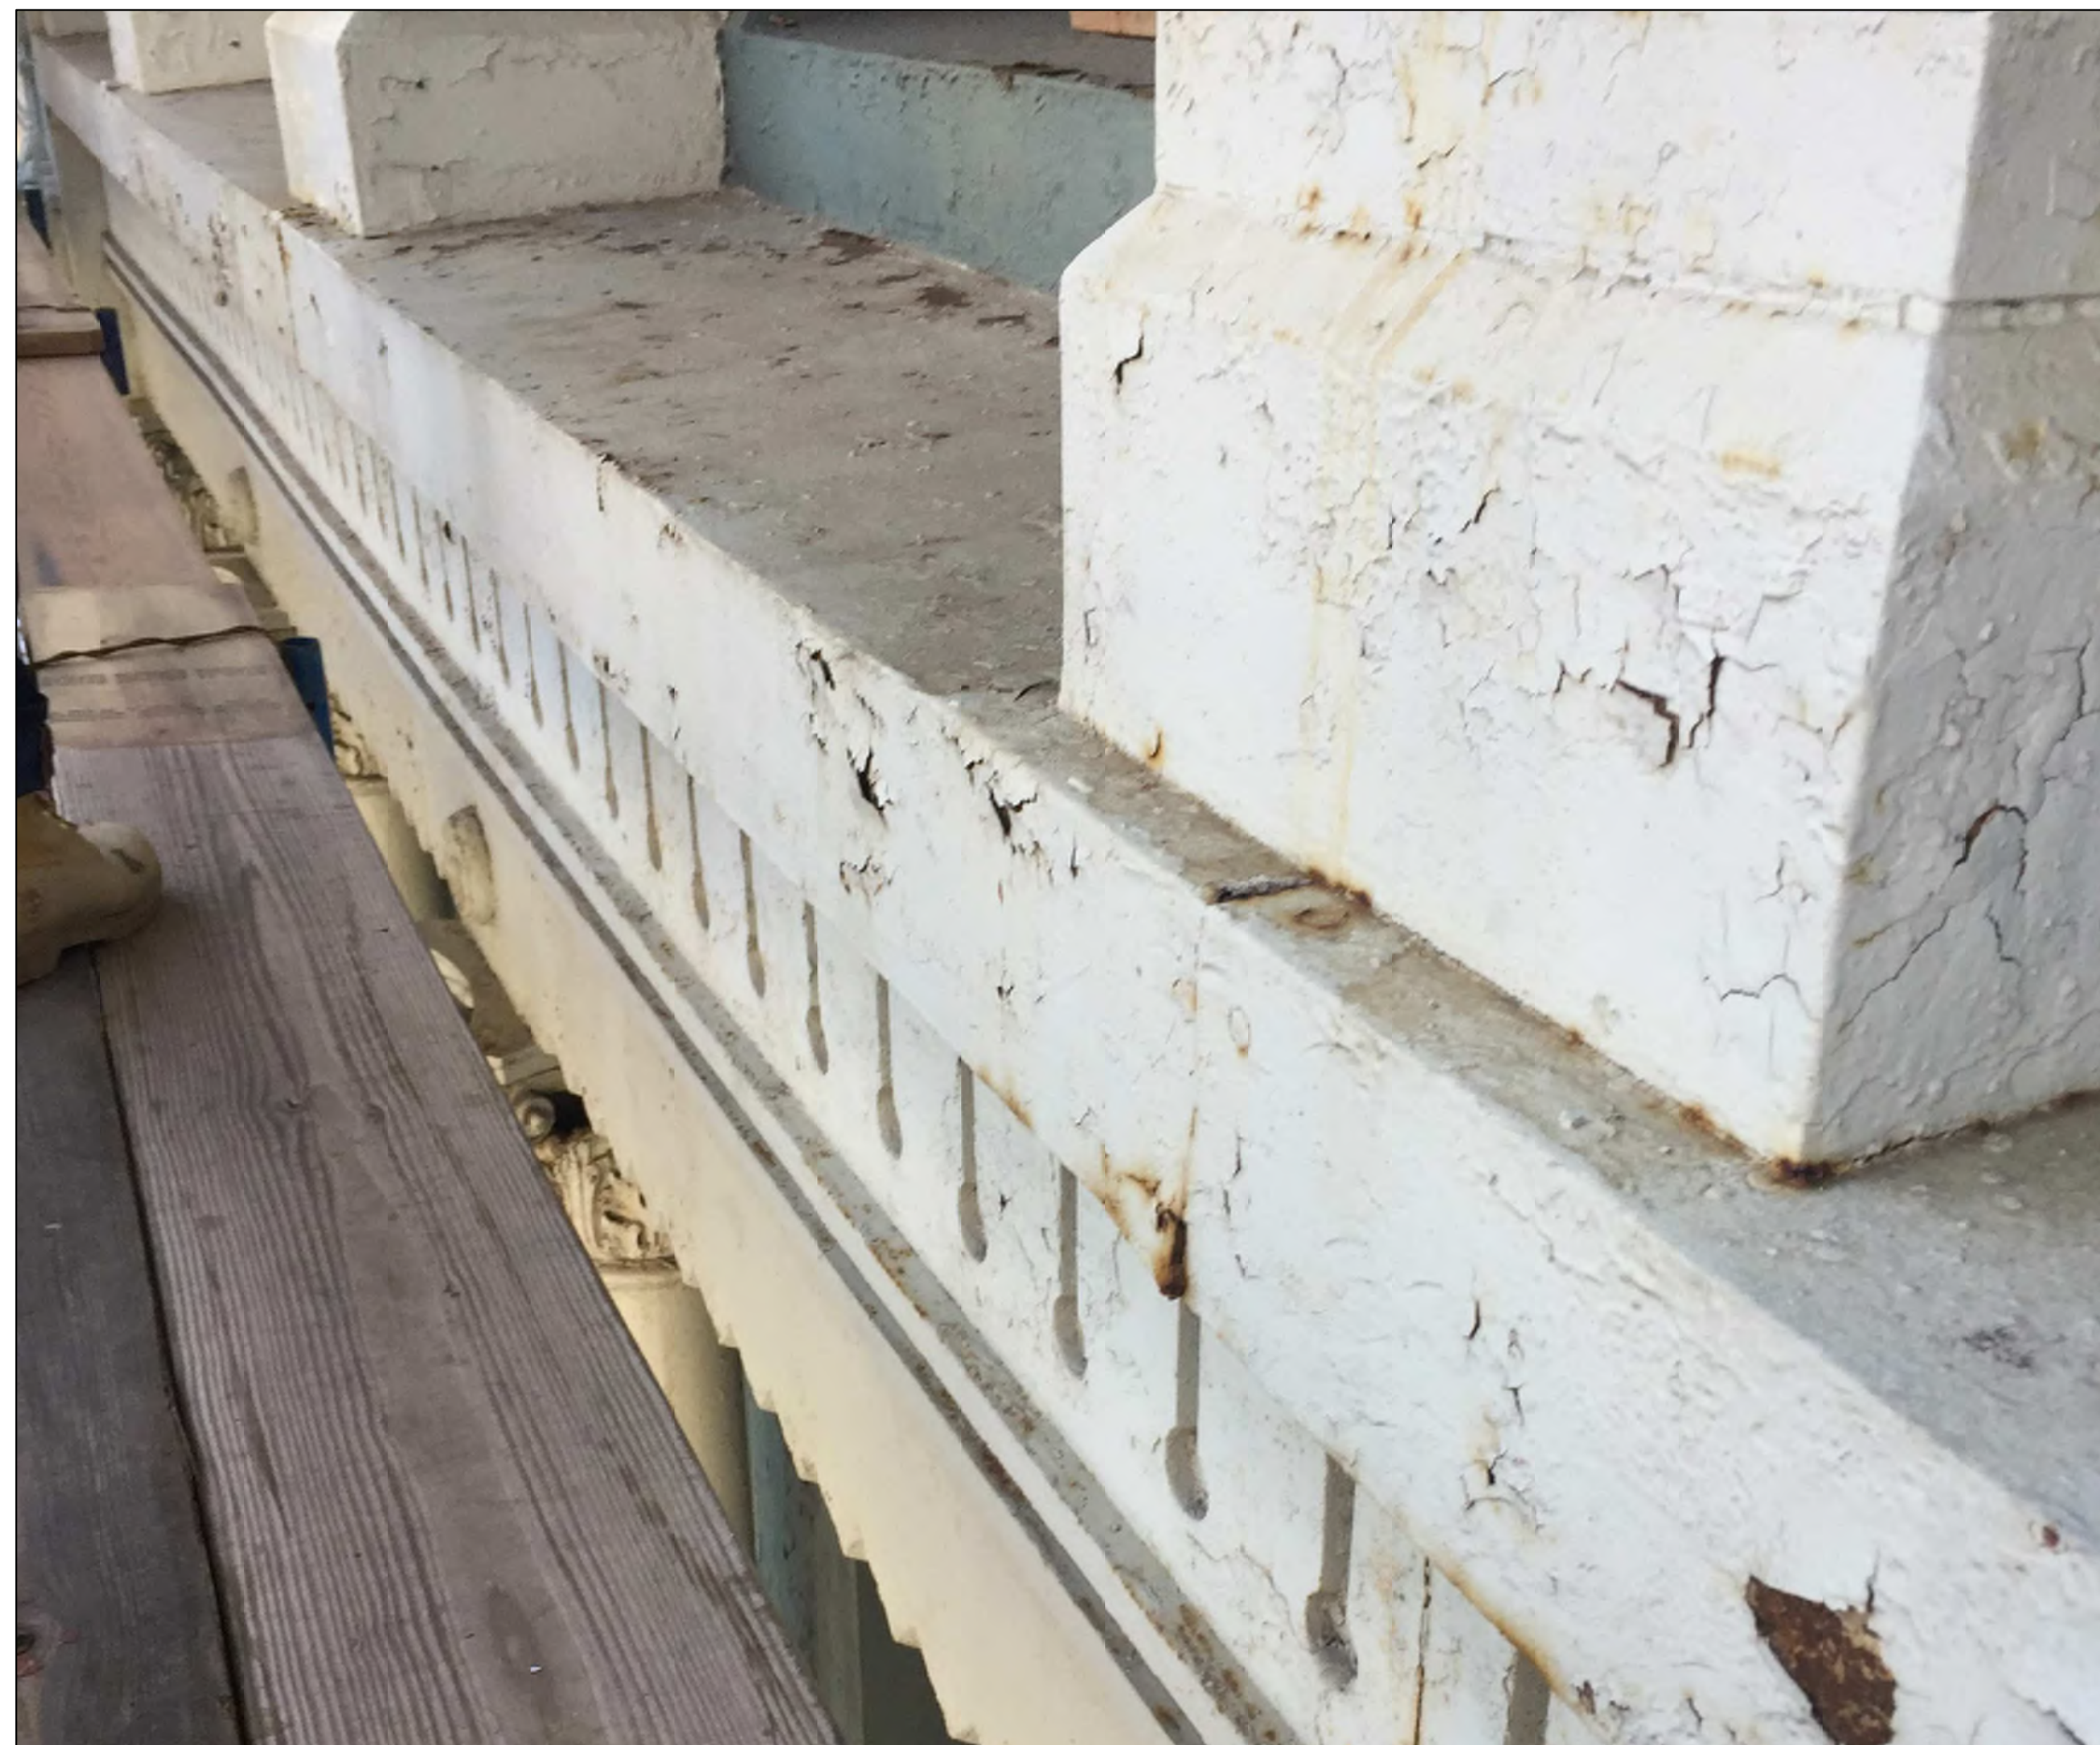
CAST IRON BEFORE PAINT REPAIR

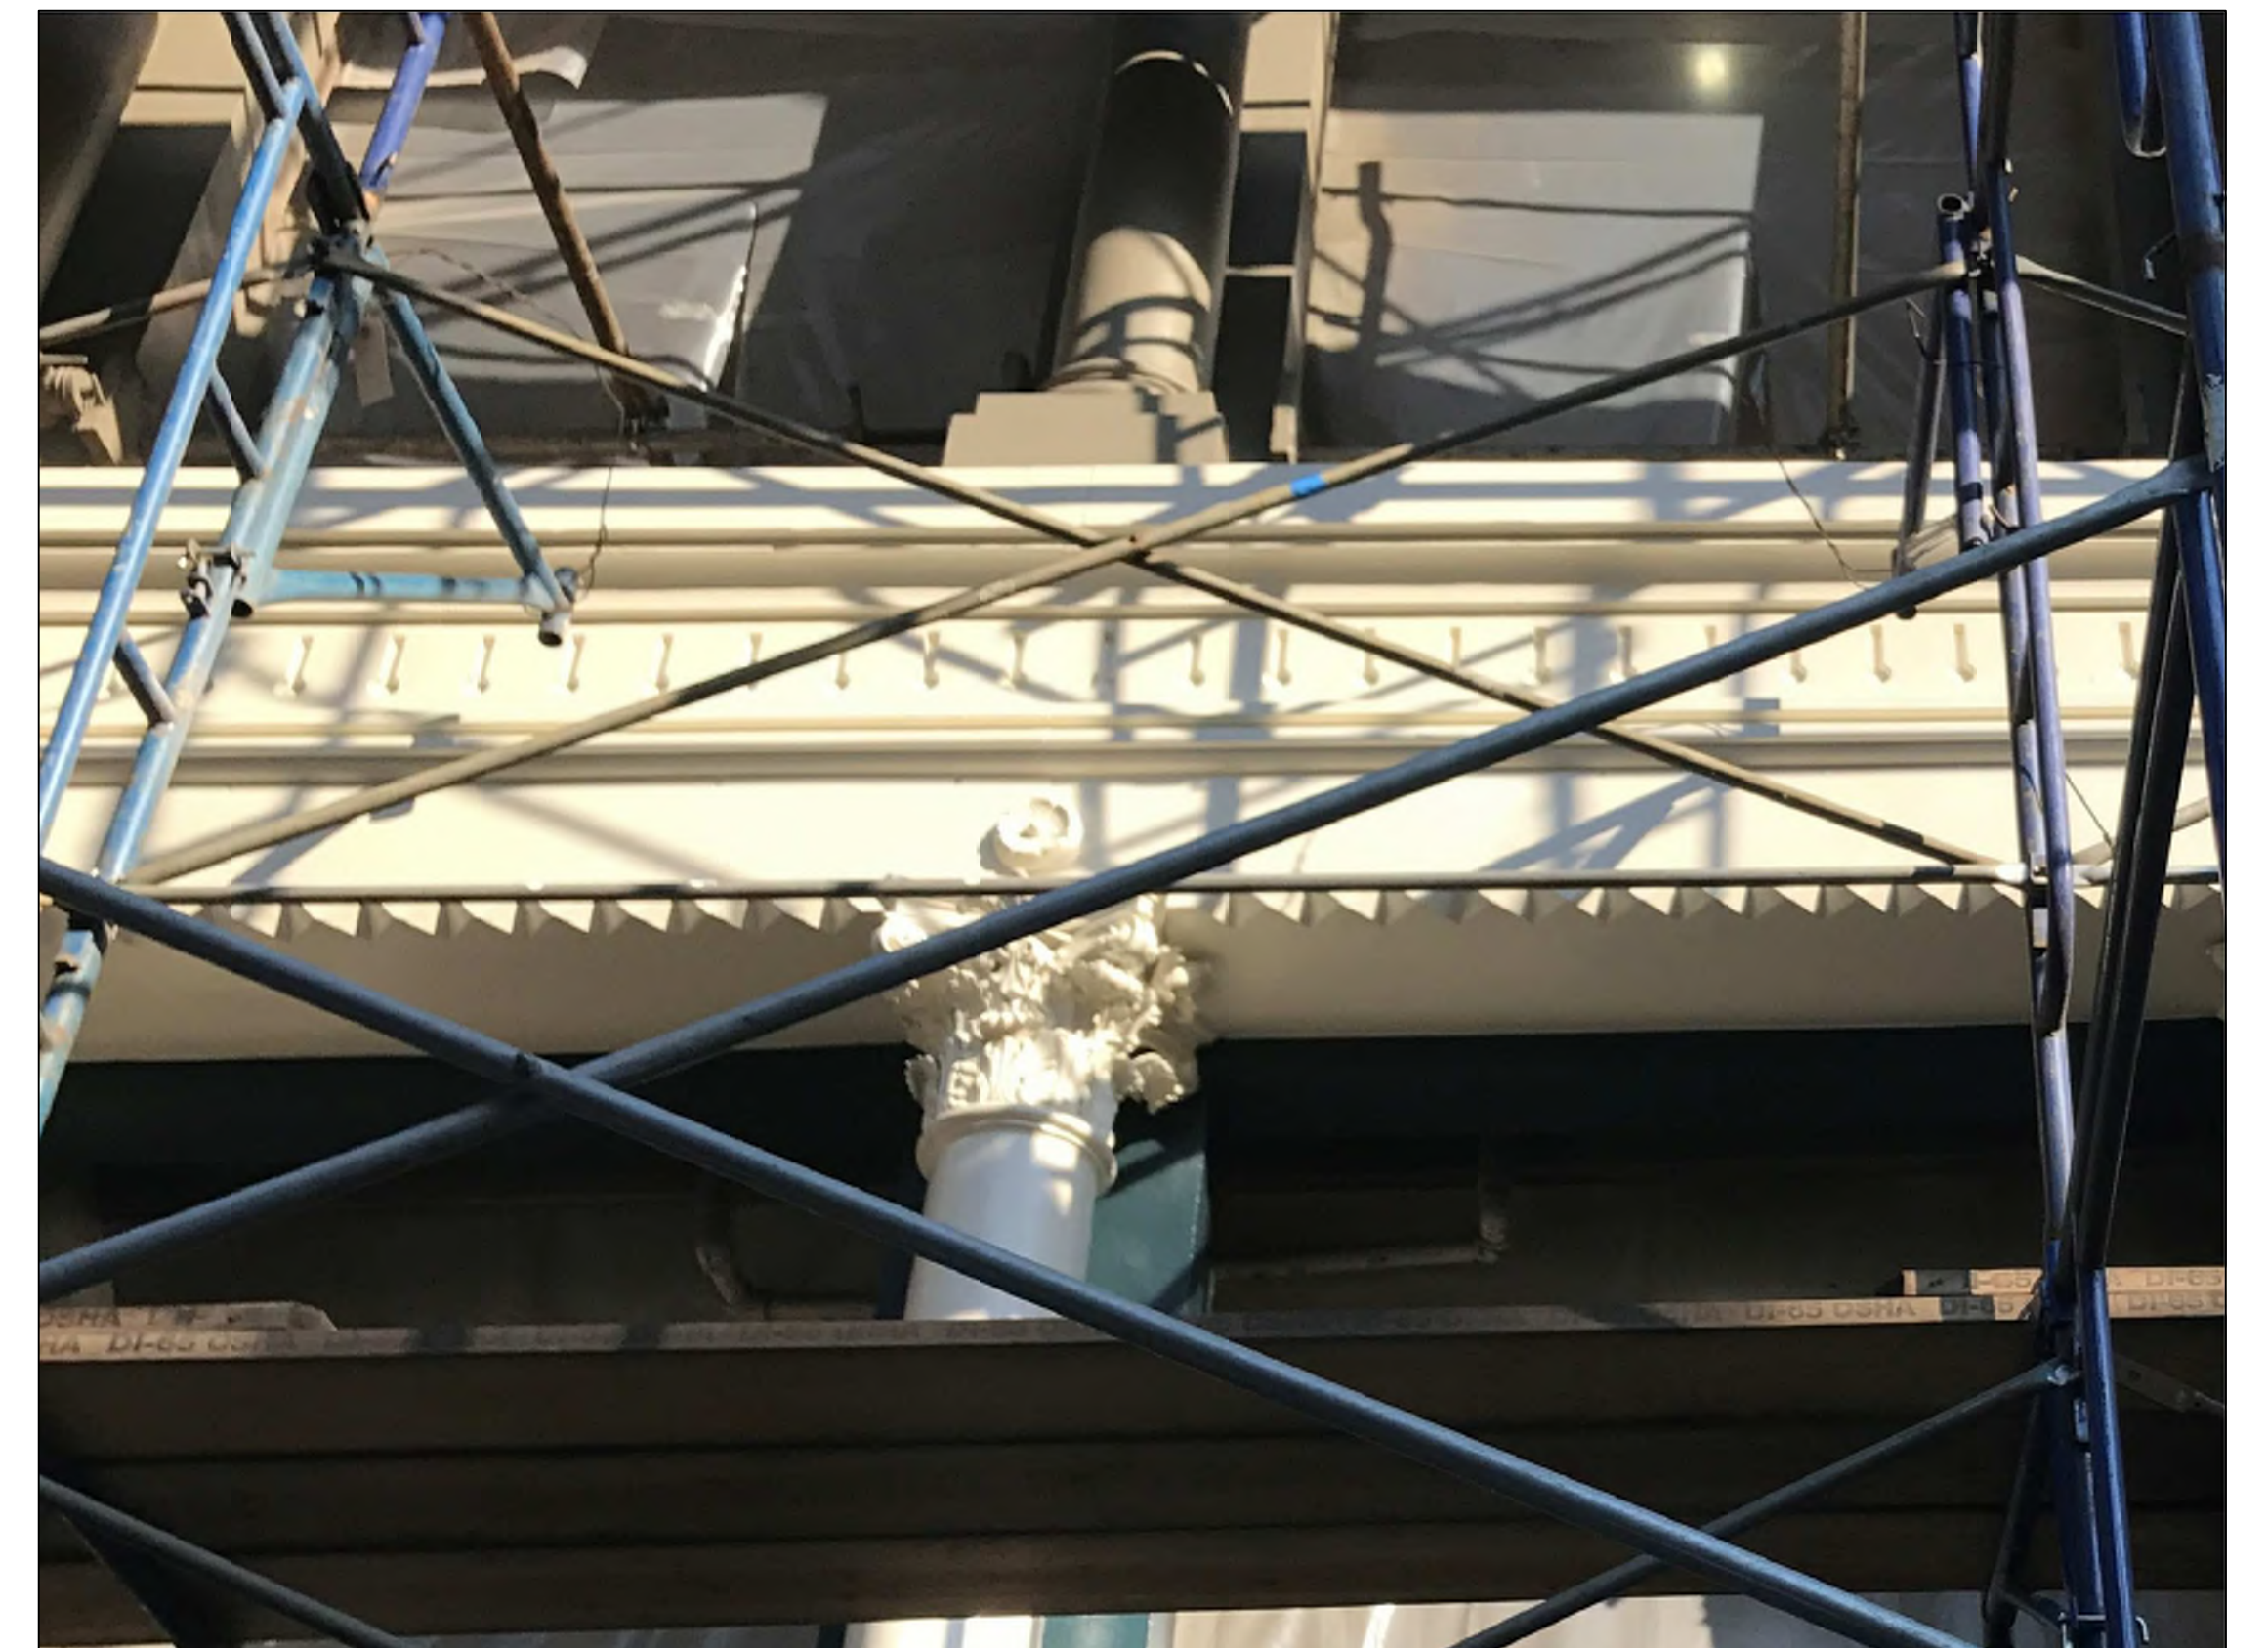
WATERPROOFING, SECONDARY AND TOP COAT FINISH PAINT

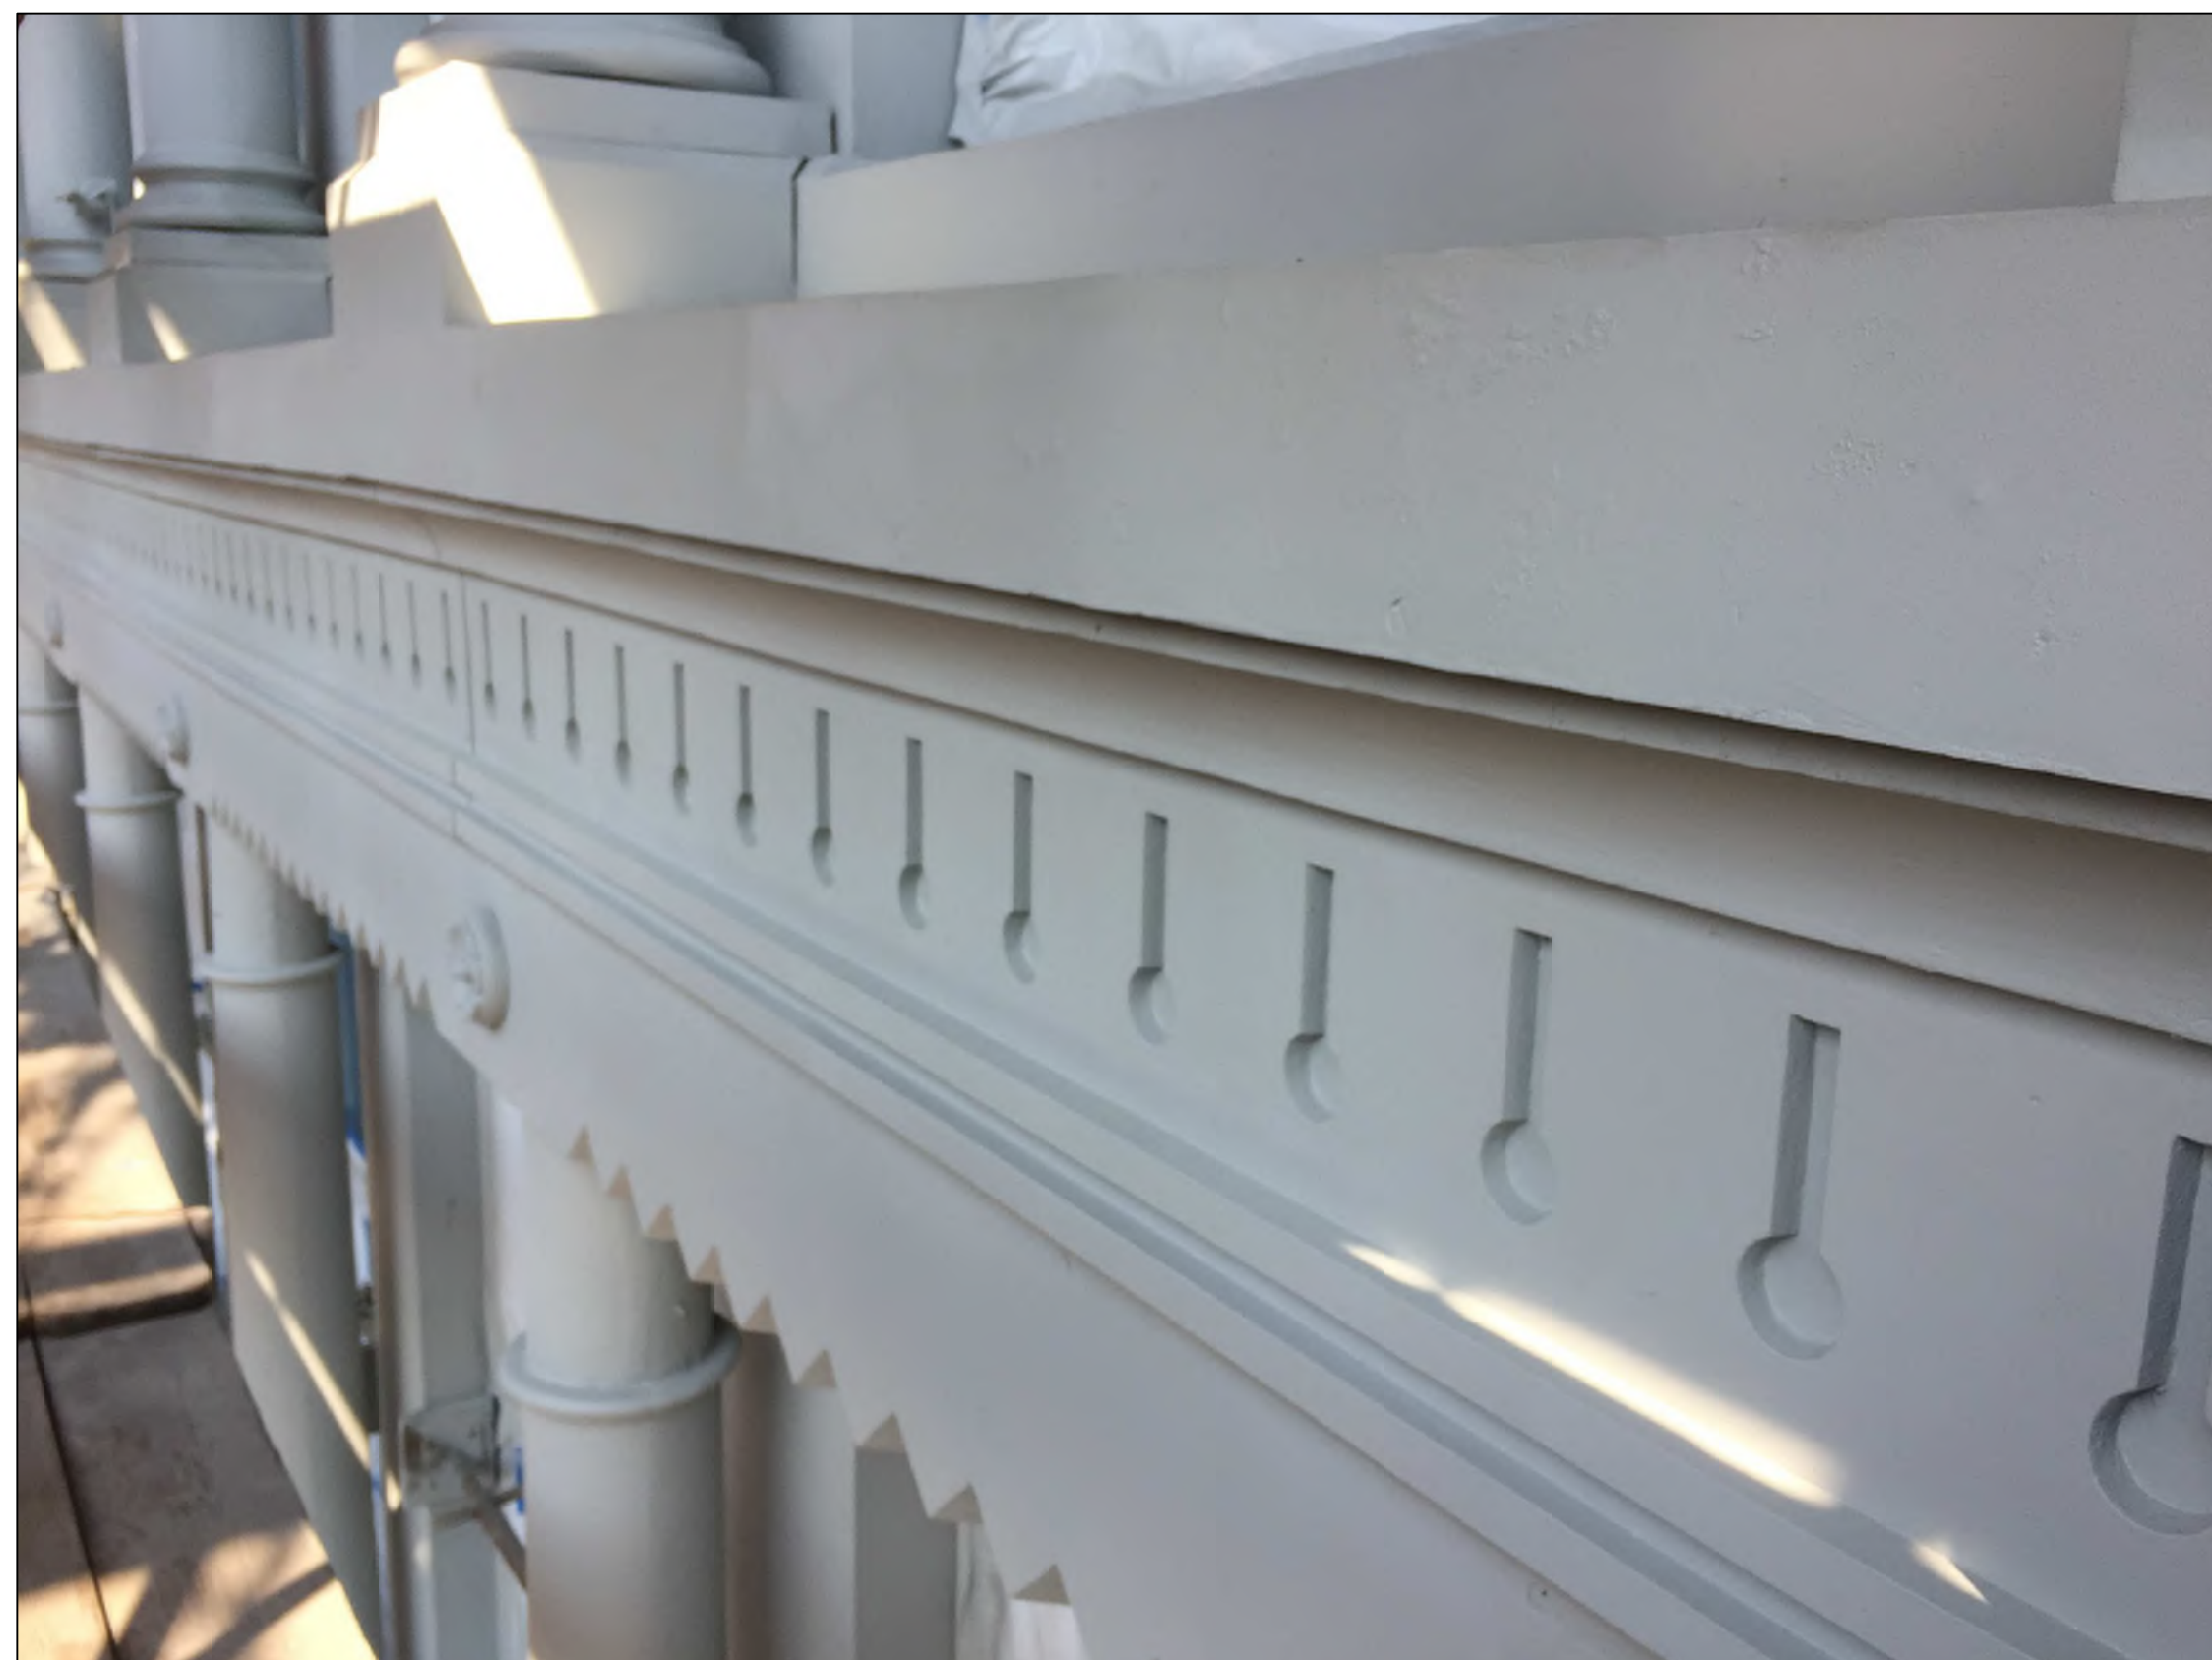
CAST IRON AFTER PAINT REPAIR

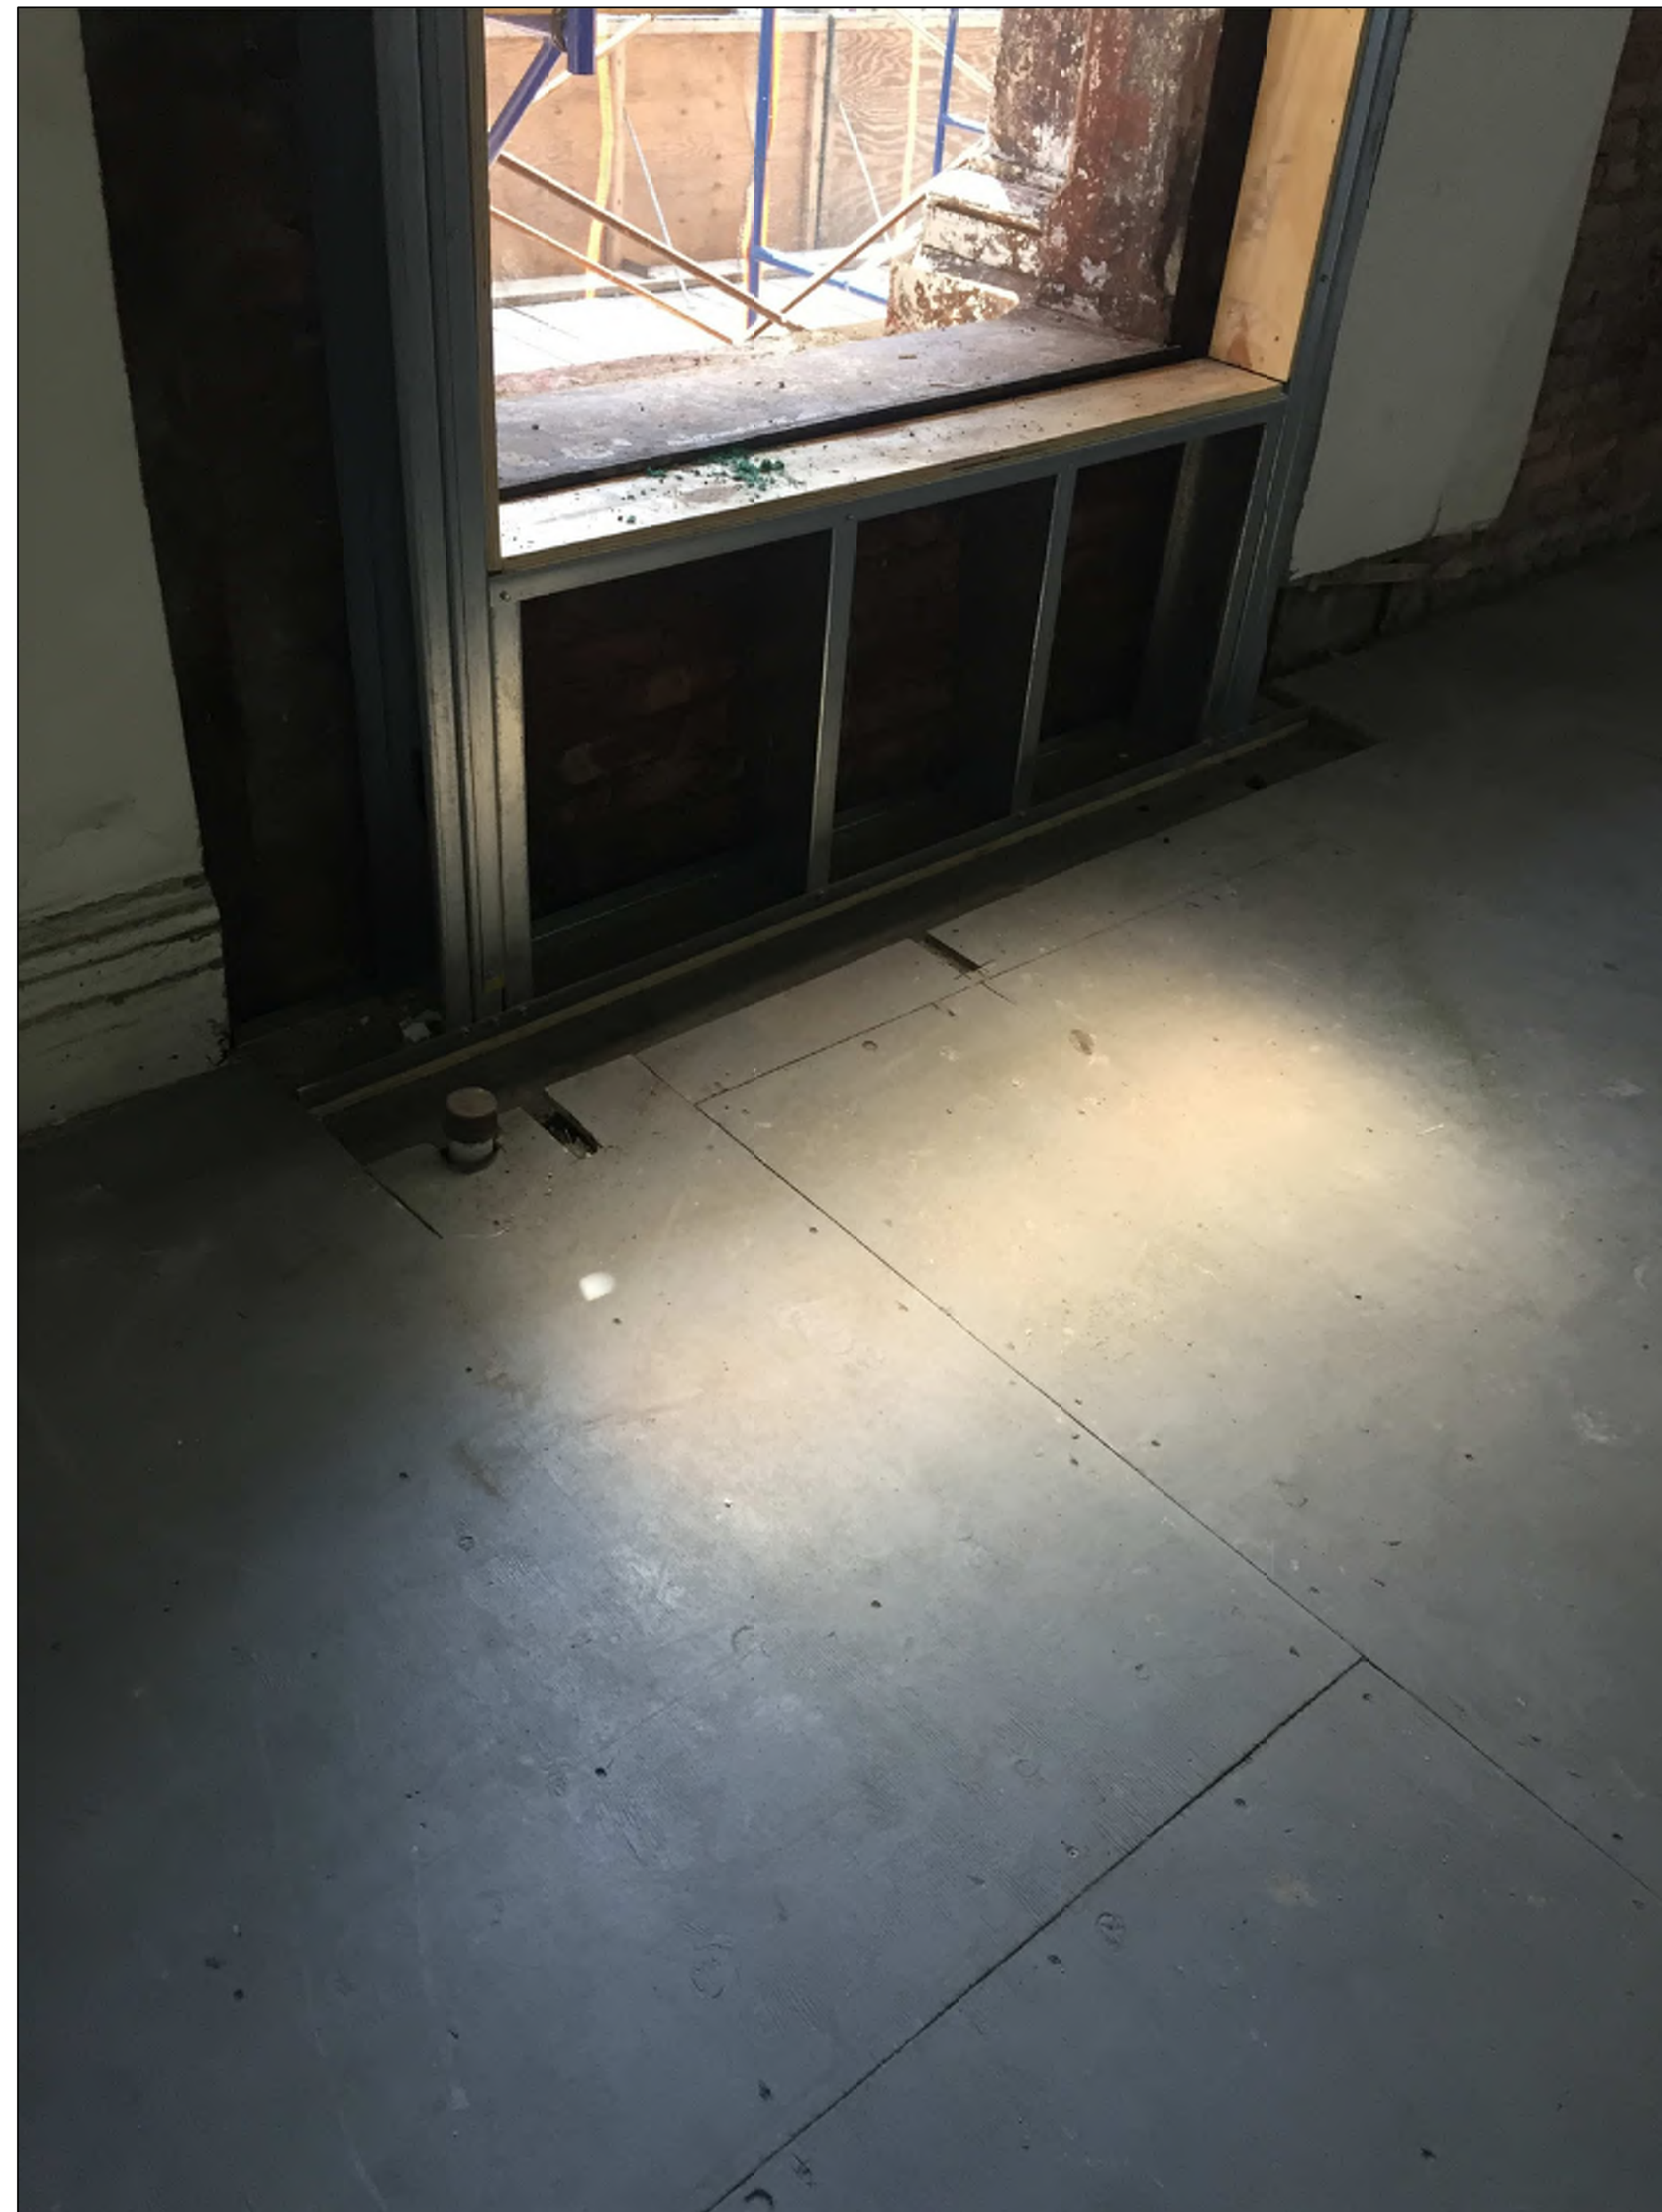
NEW FRAMING TO SUPPORT NEW WOOD WINDOWS

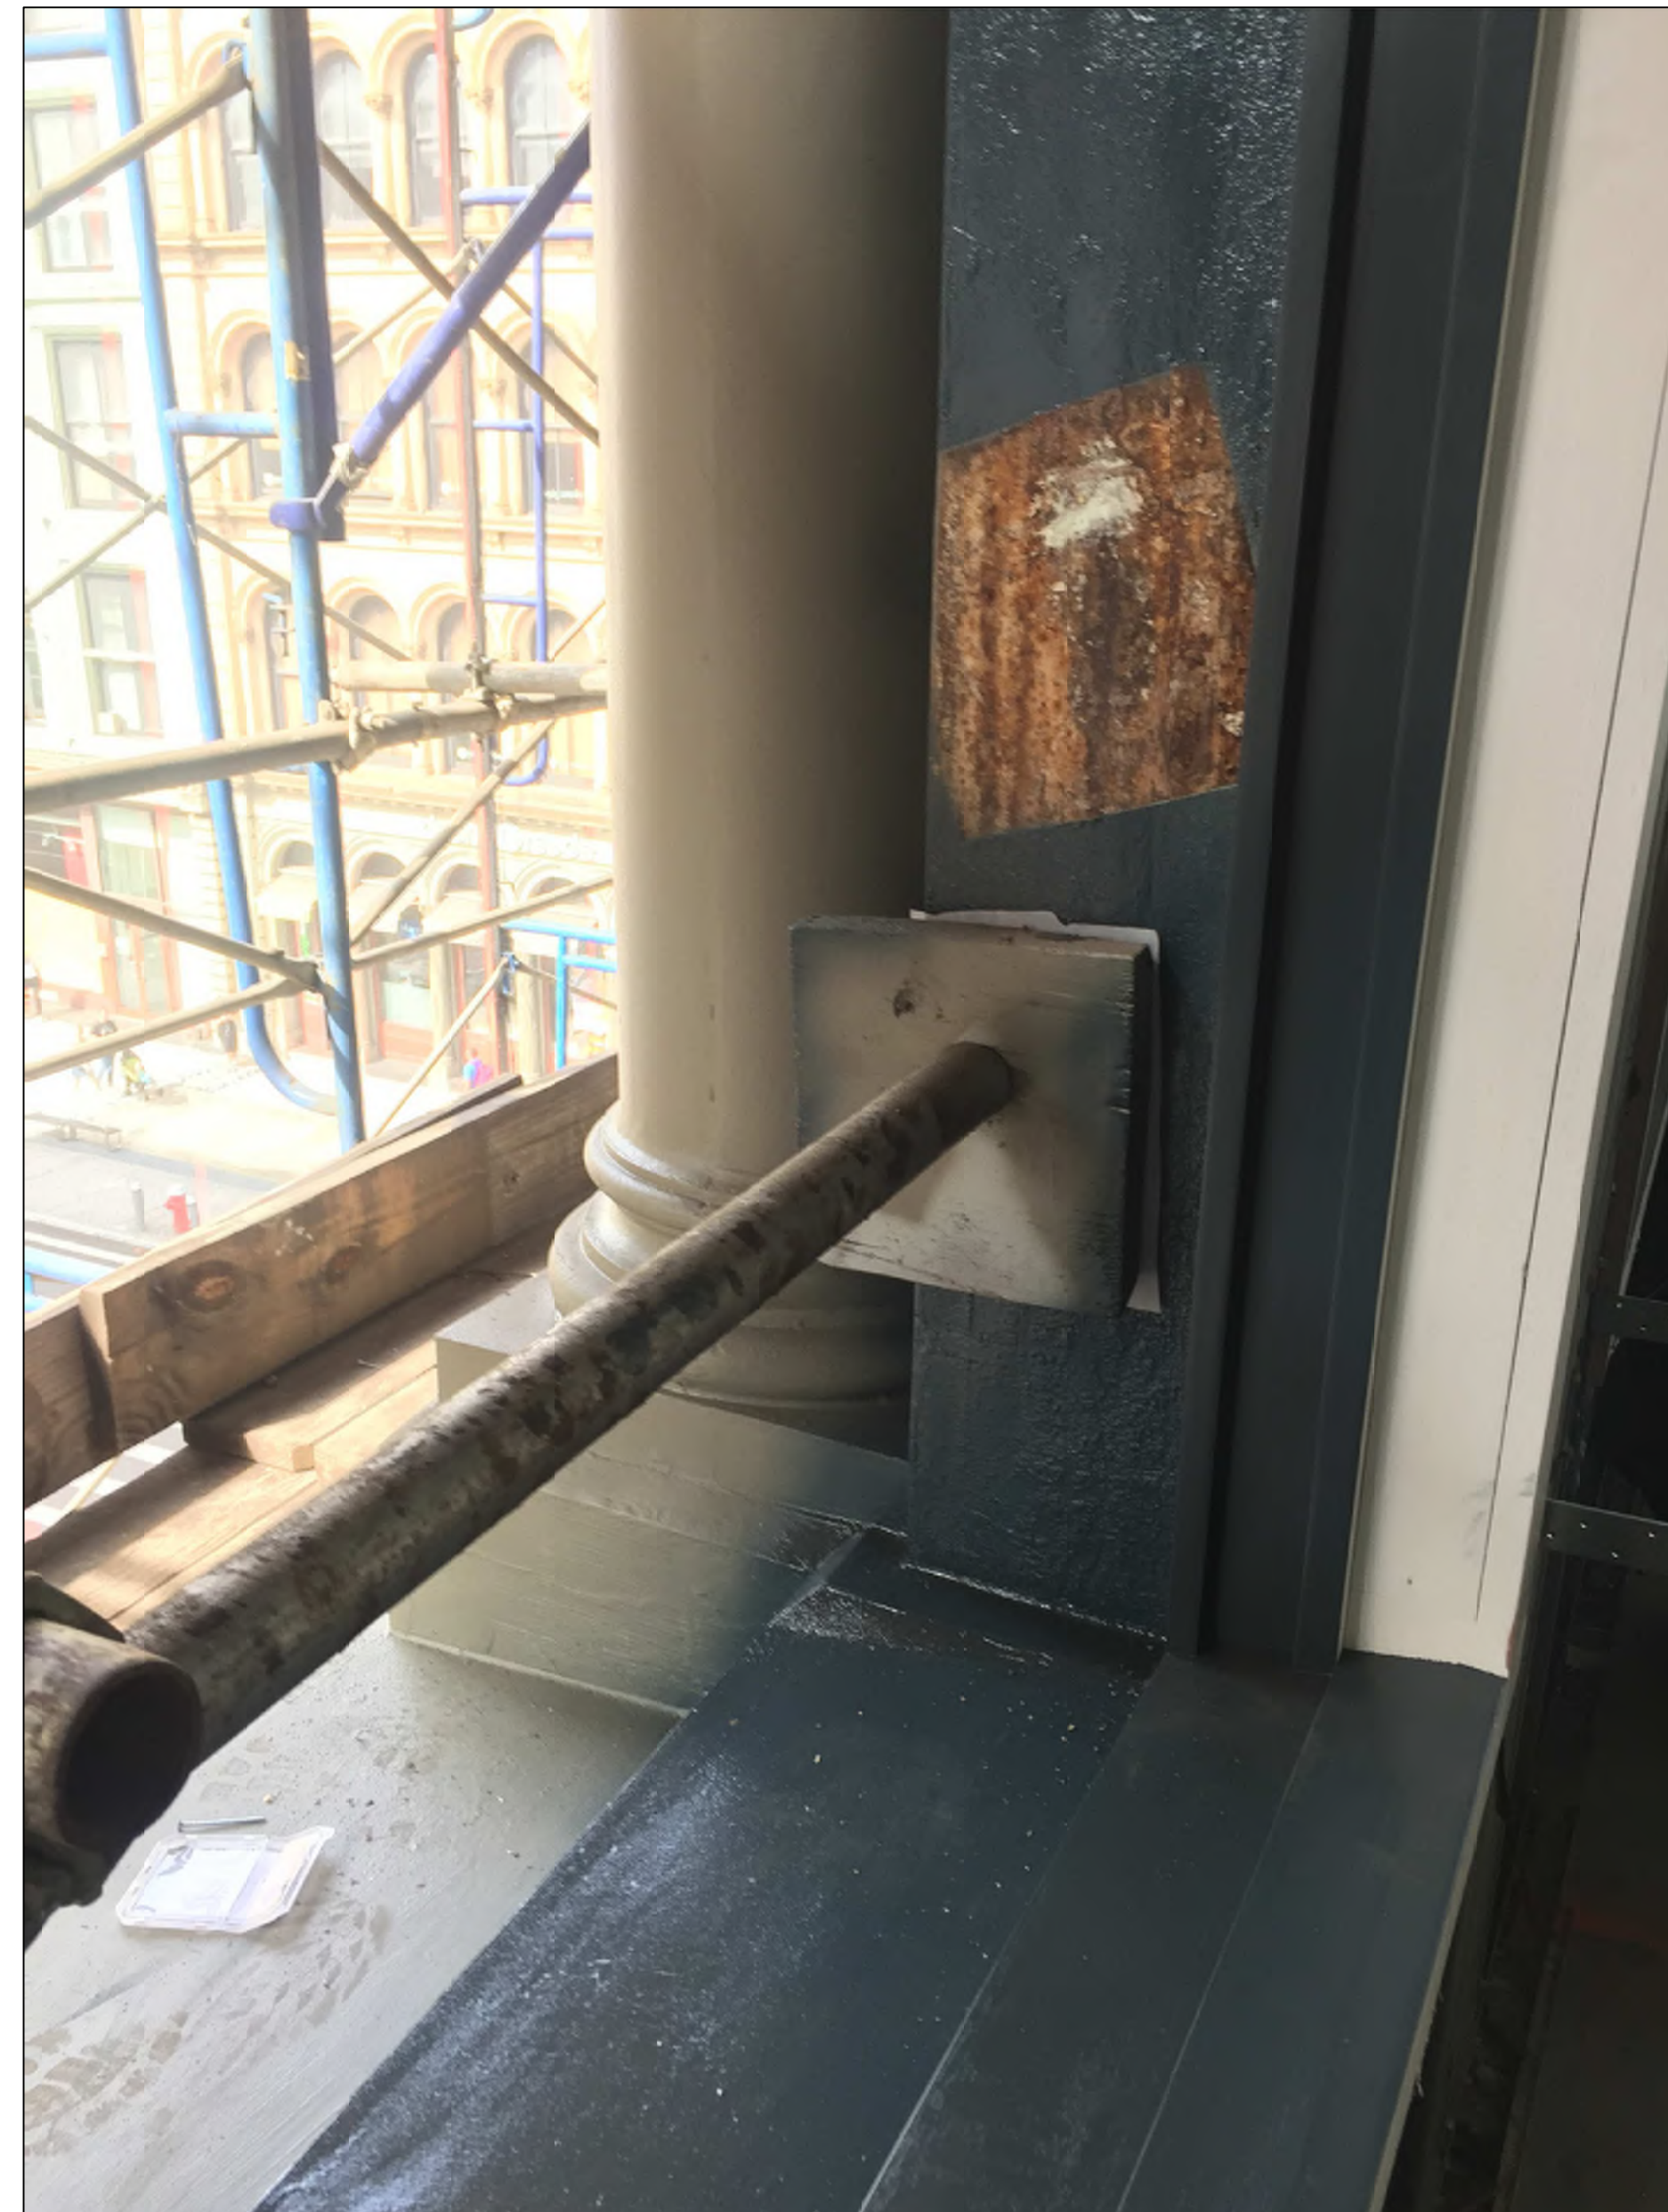
NEW WATERPROOFING AT CAST IRON SILL
