462 BROADWAY
MERINGOFF PROPERTIES
FACADE
RESTORATION

DRAFT

OCTOBER 06, 2017

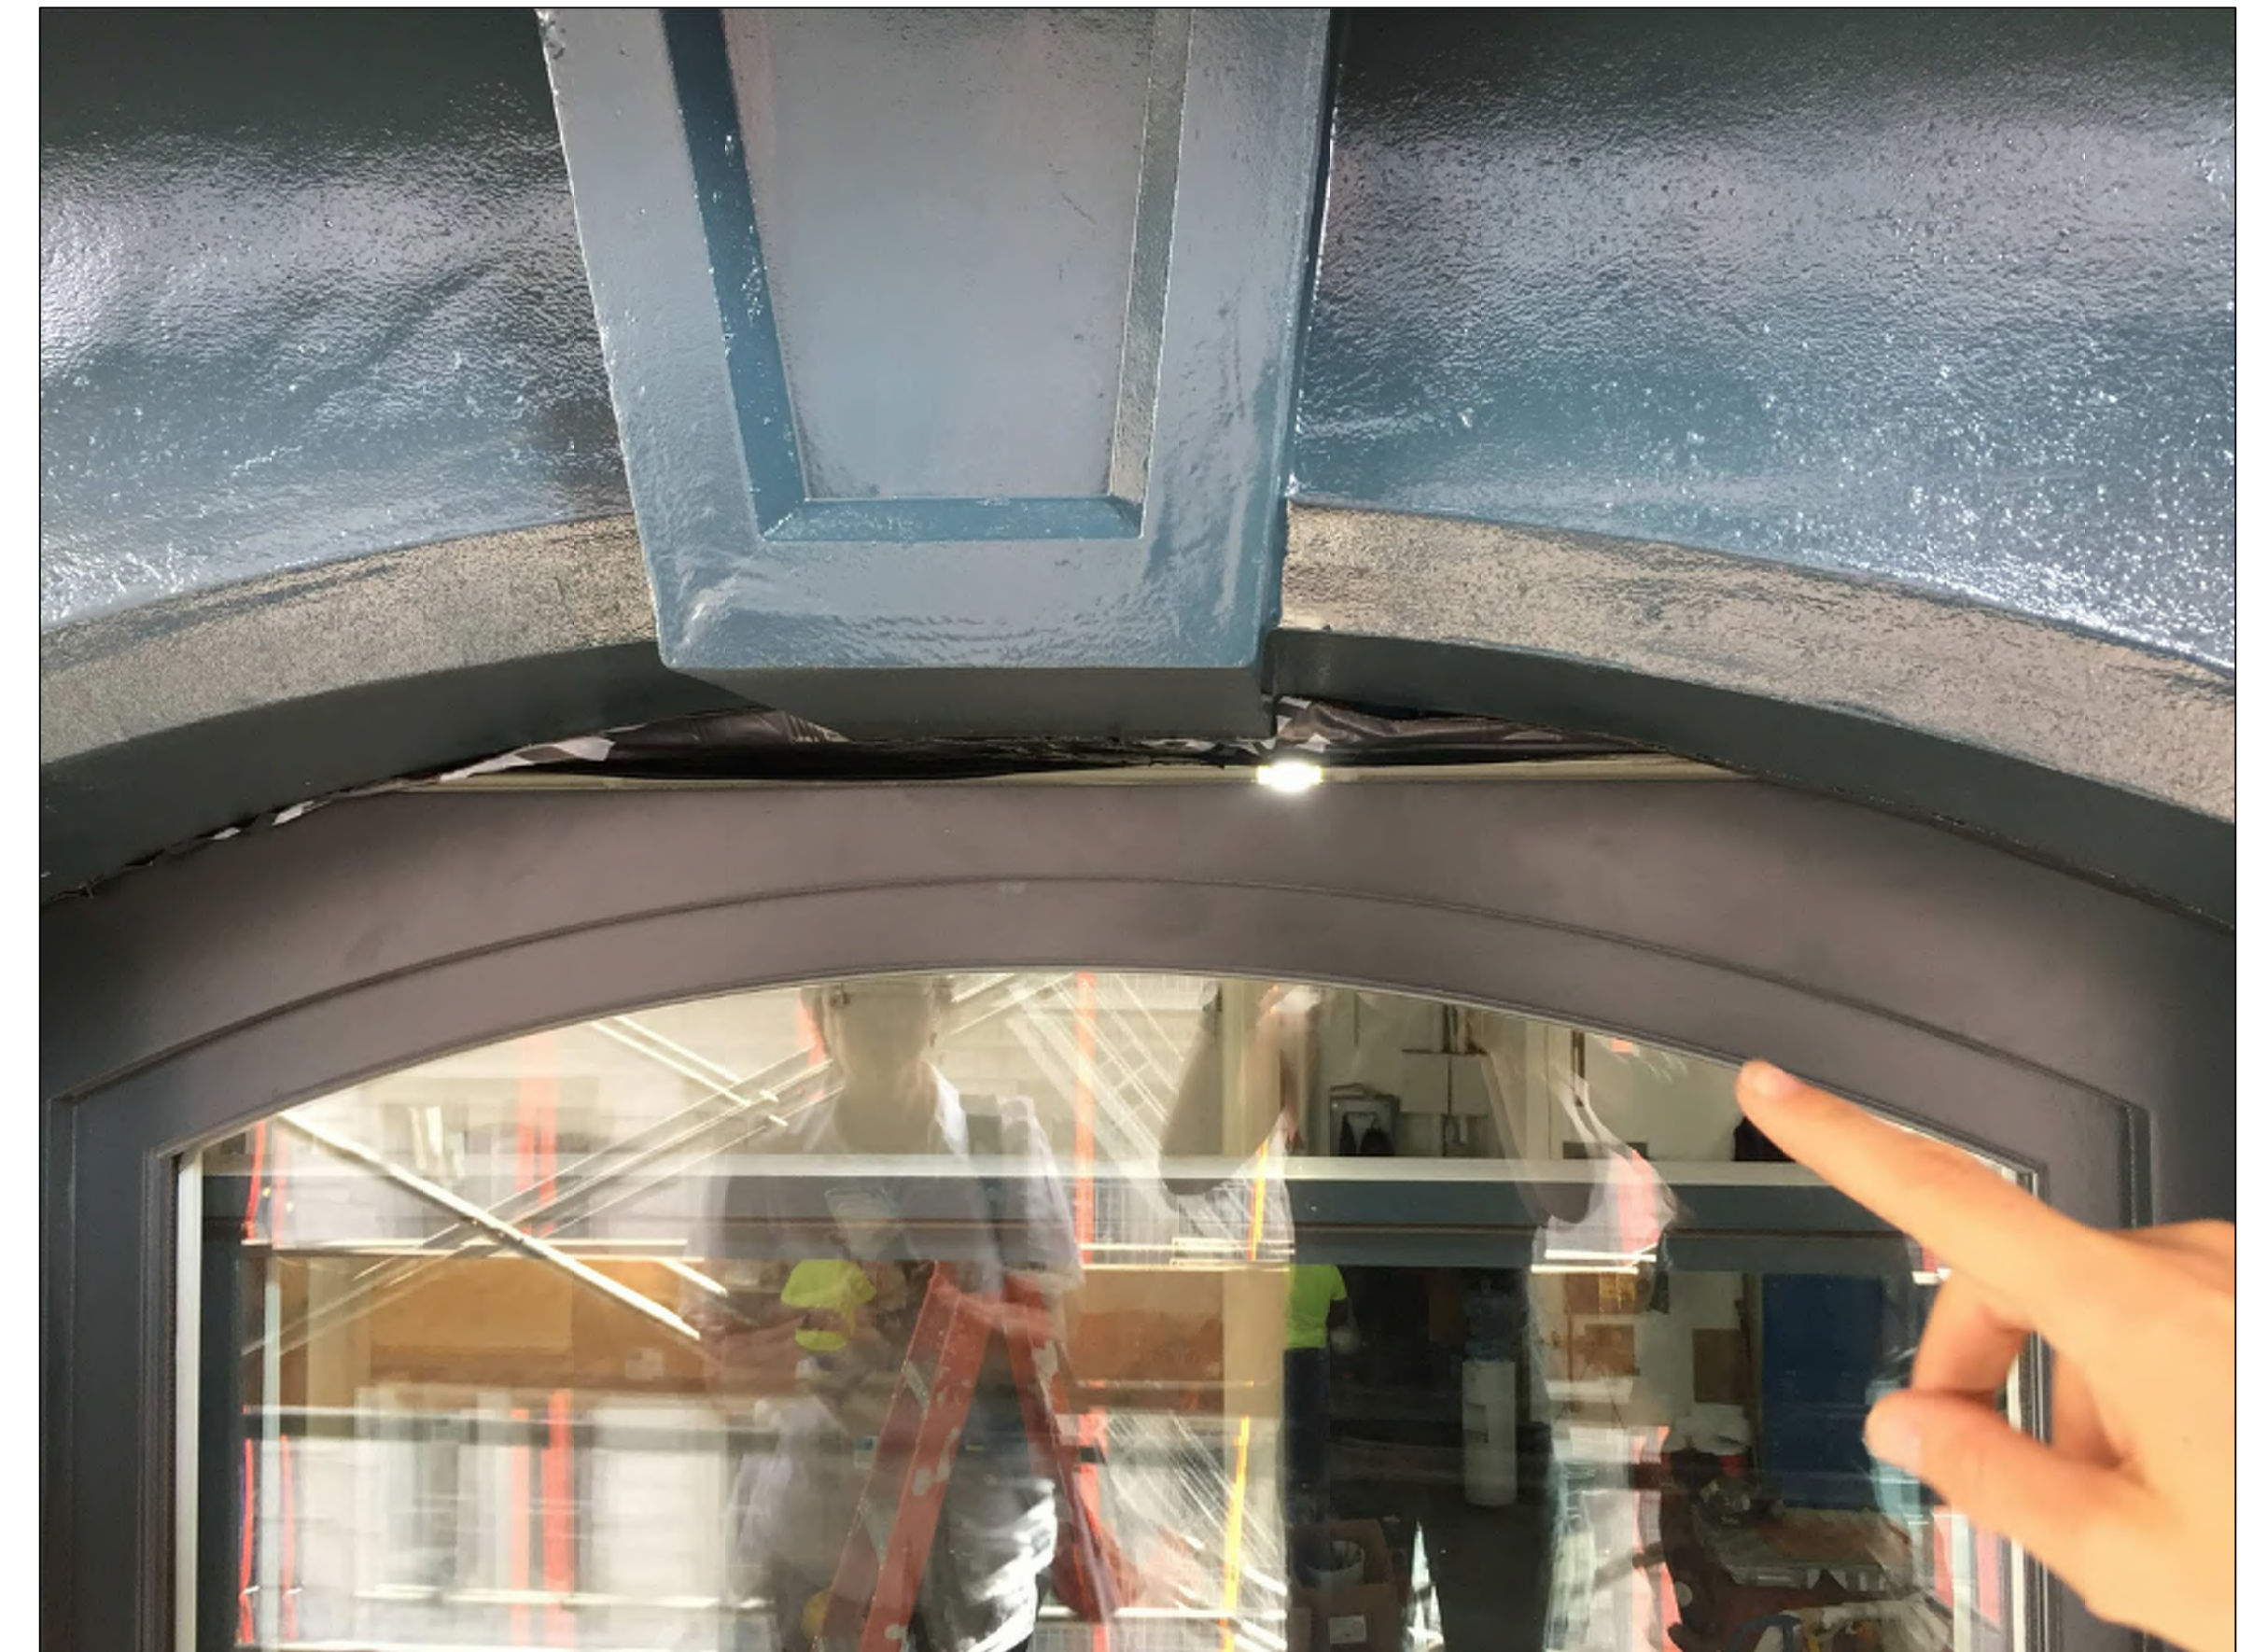
NEW CUSTOM ARCH WOOD WINDOW PRIOR TO BRICK MOLD

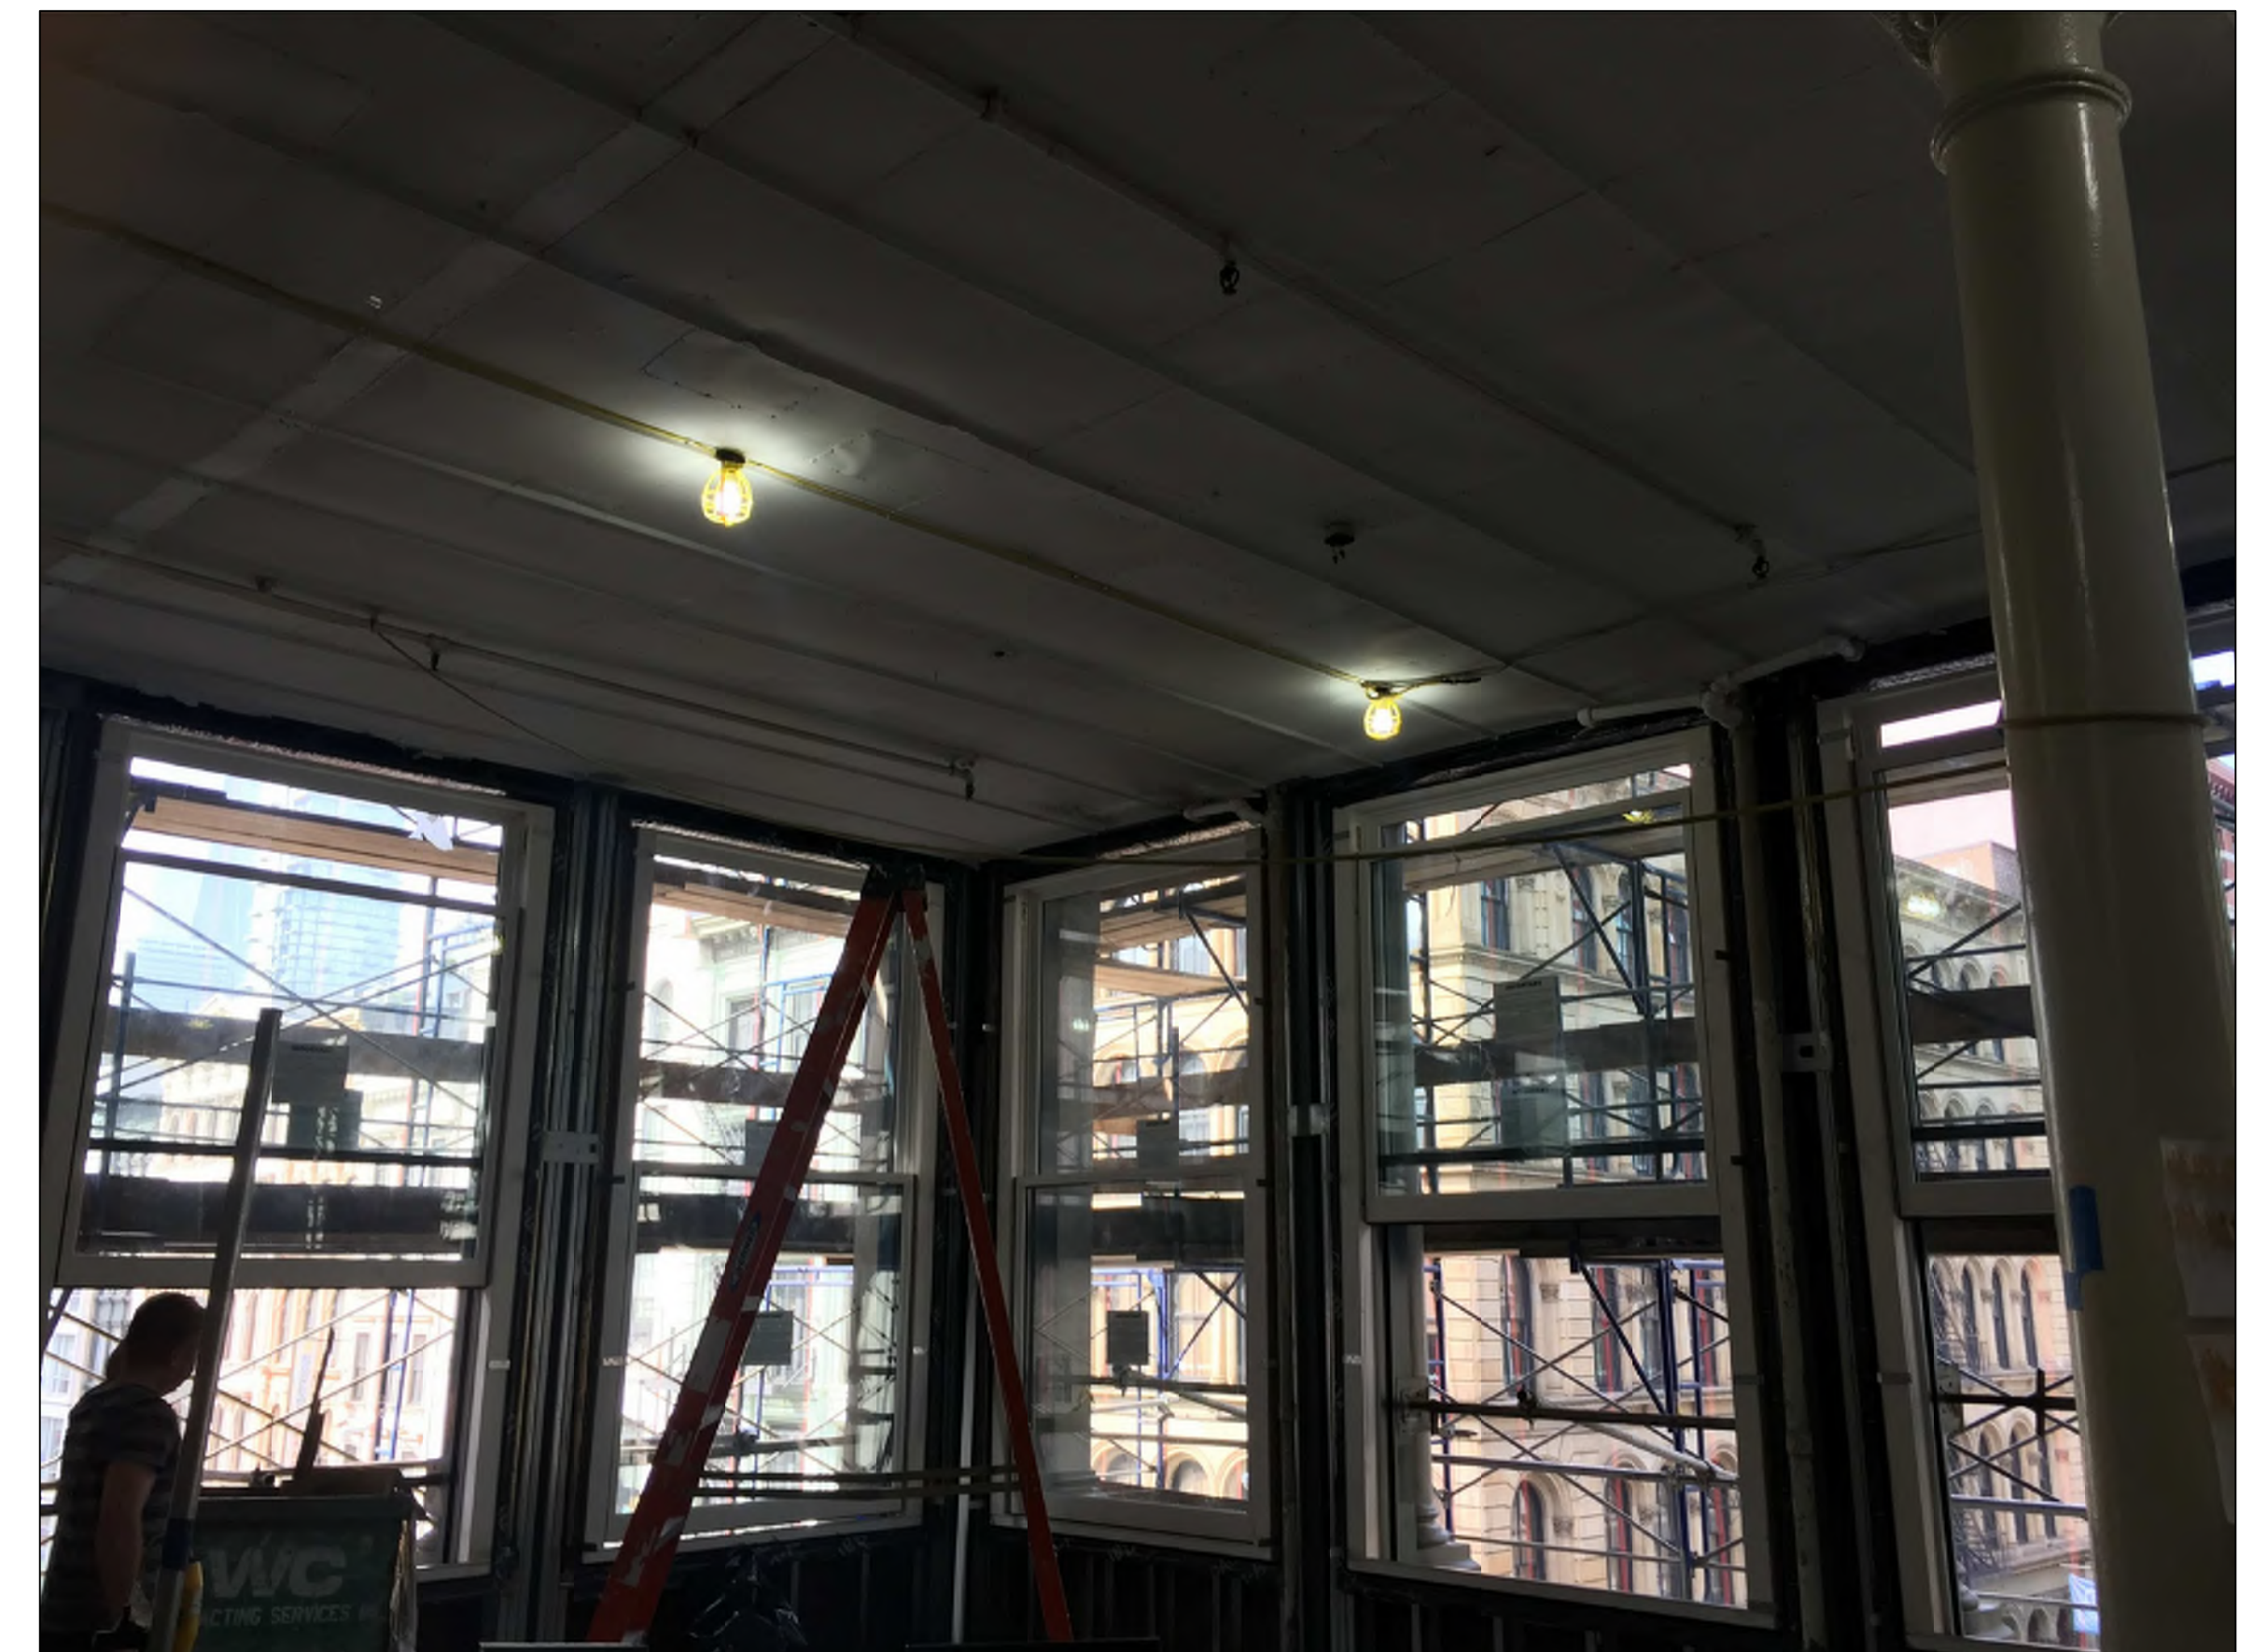
NEW WOOD WINDOWS INSTALLED

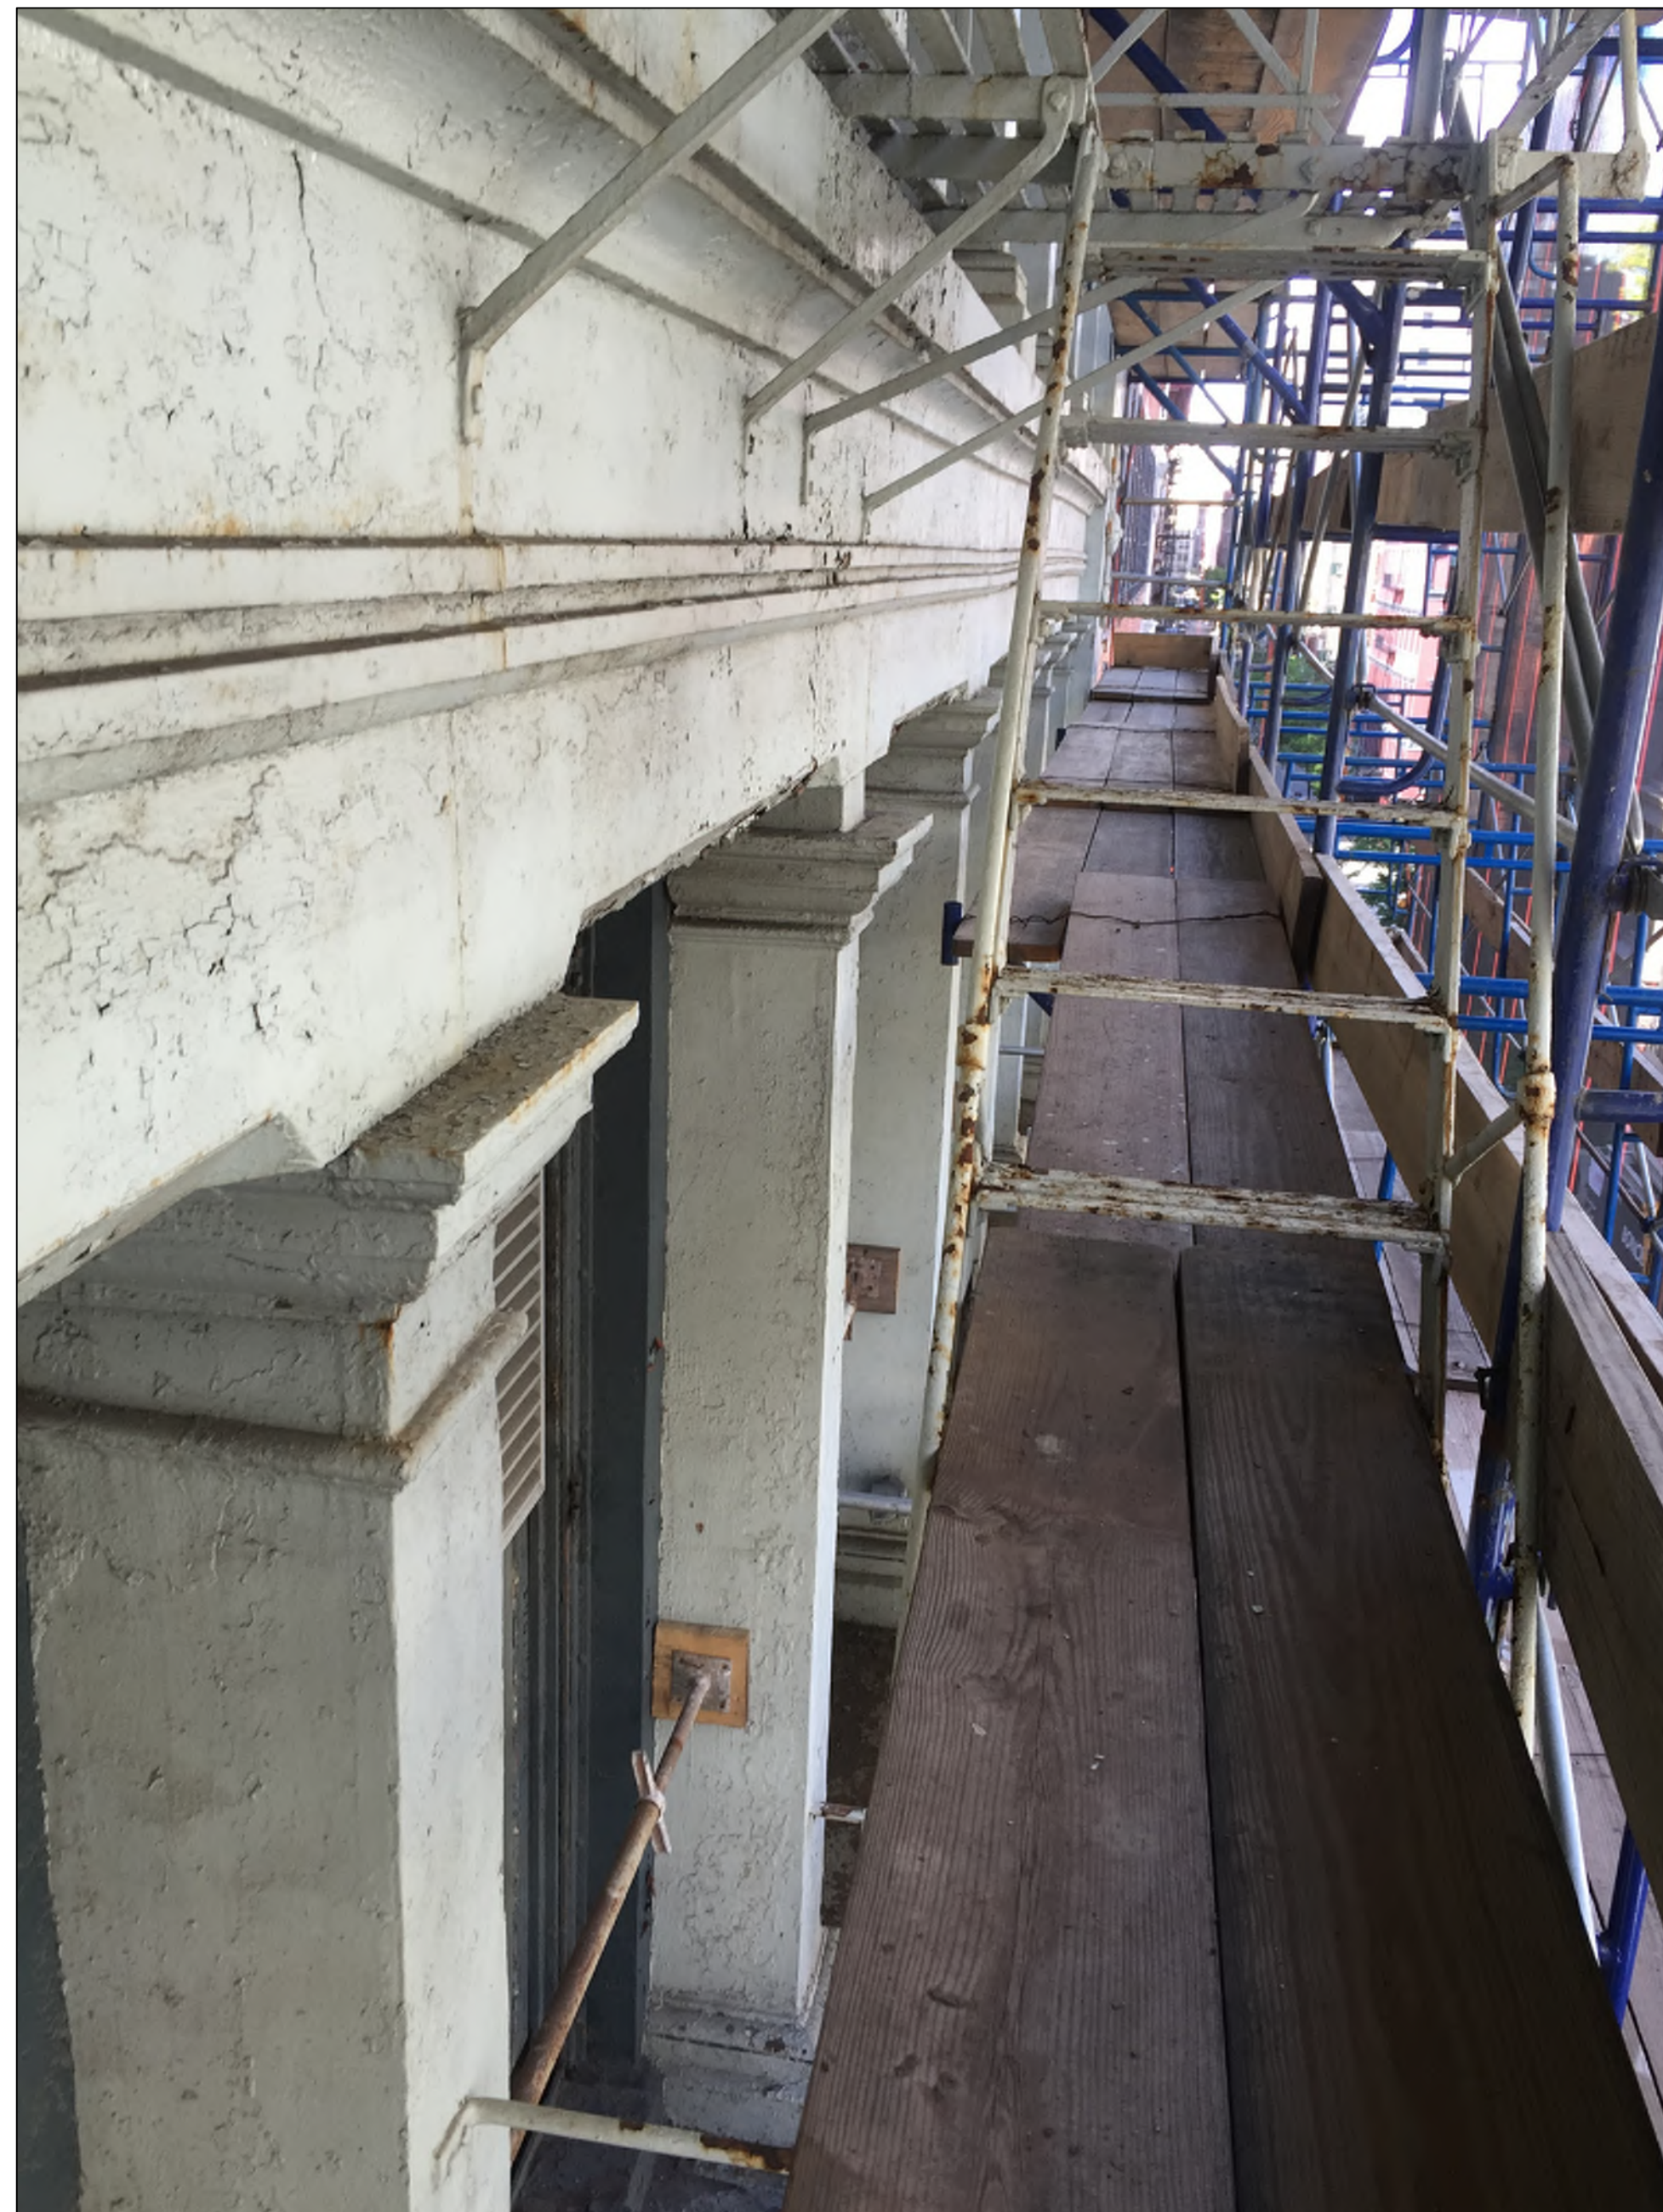
PRE-RESTORATION CAPITALS ON CROSBY FACADE

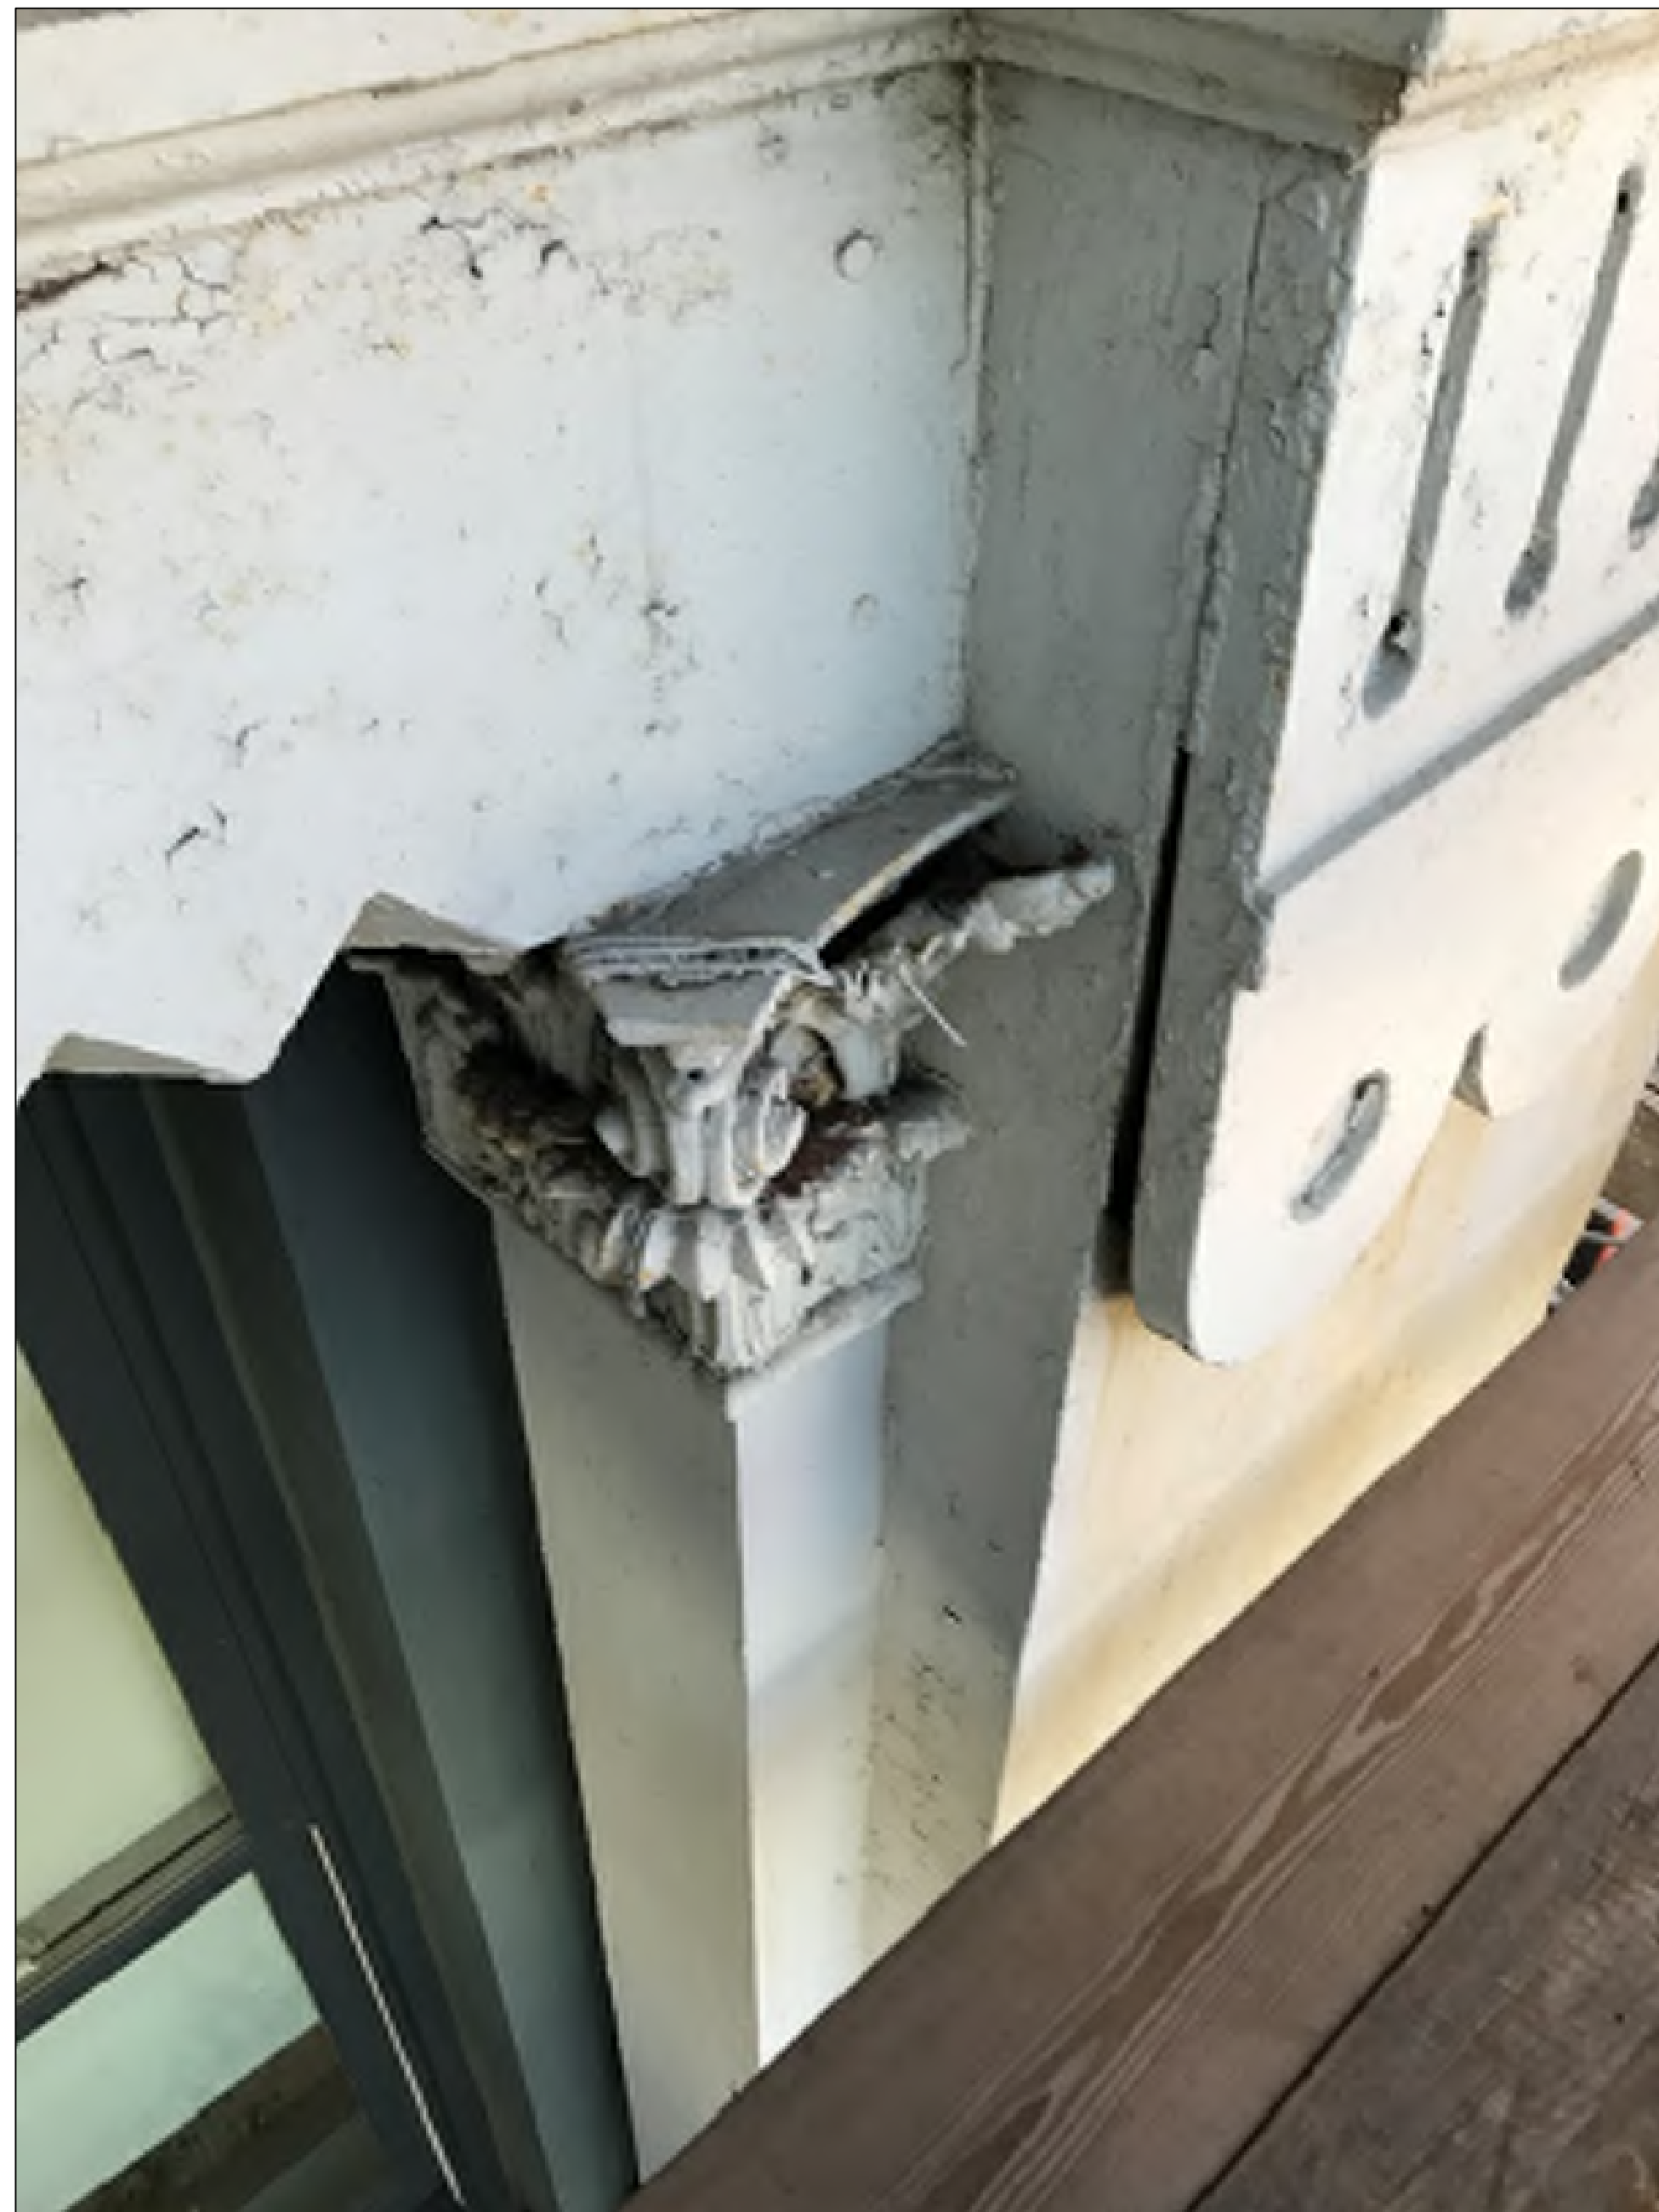
HALF SQUARE CAPITAL PRIOR TO REMOVAL

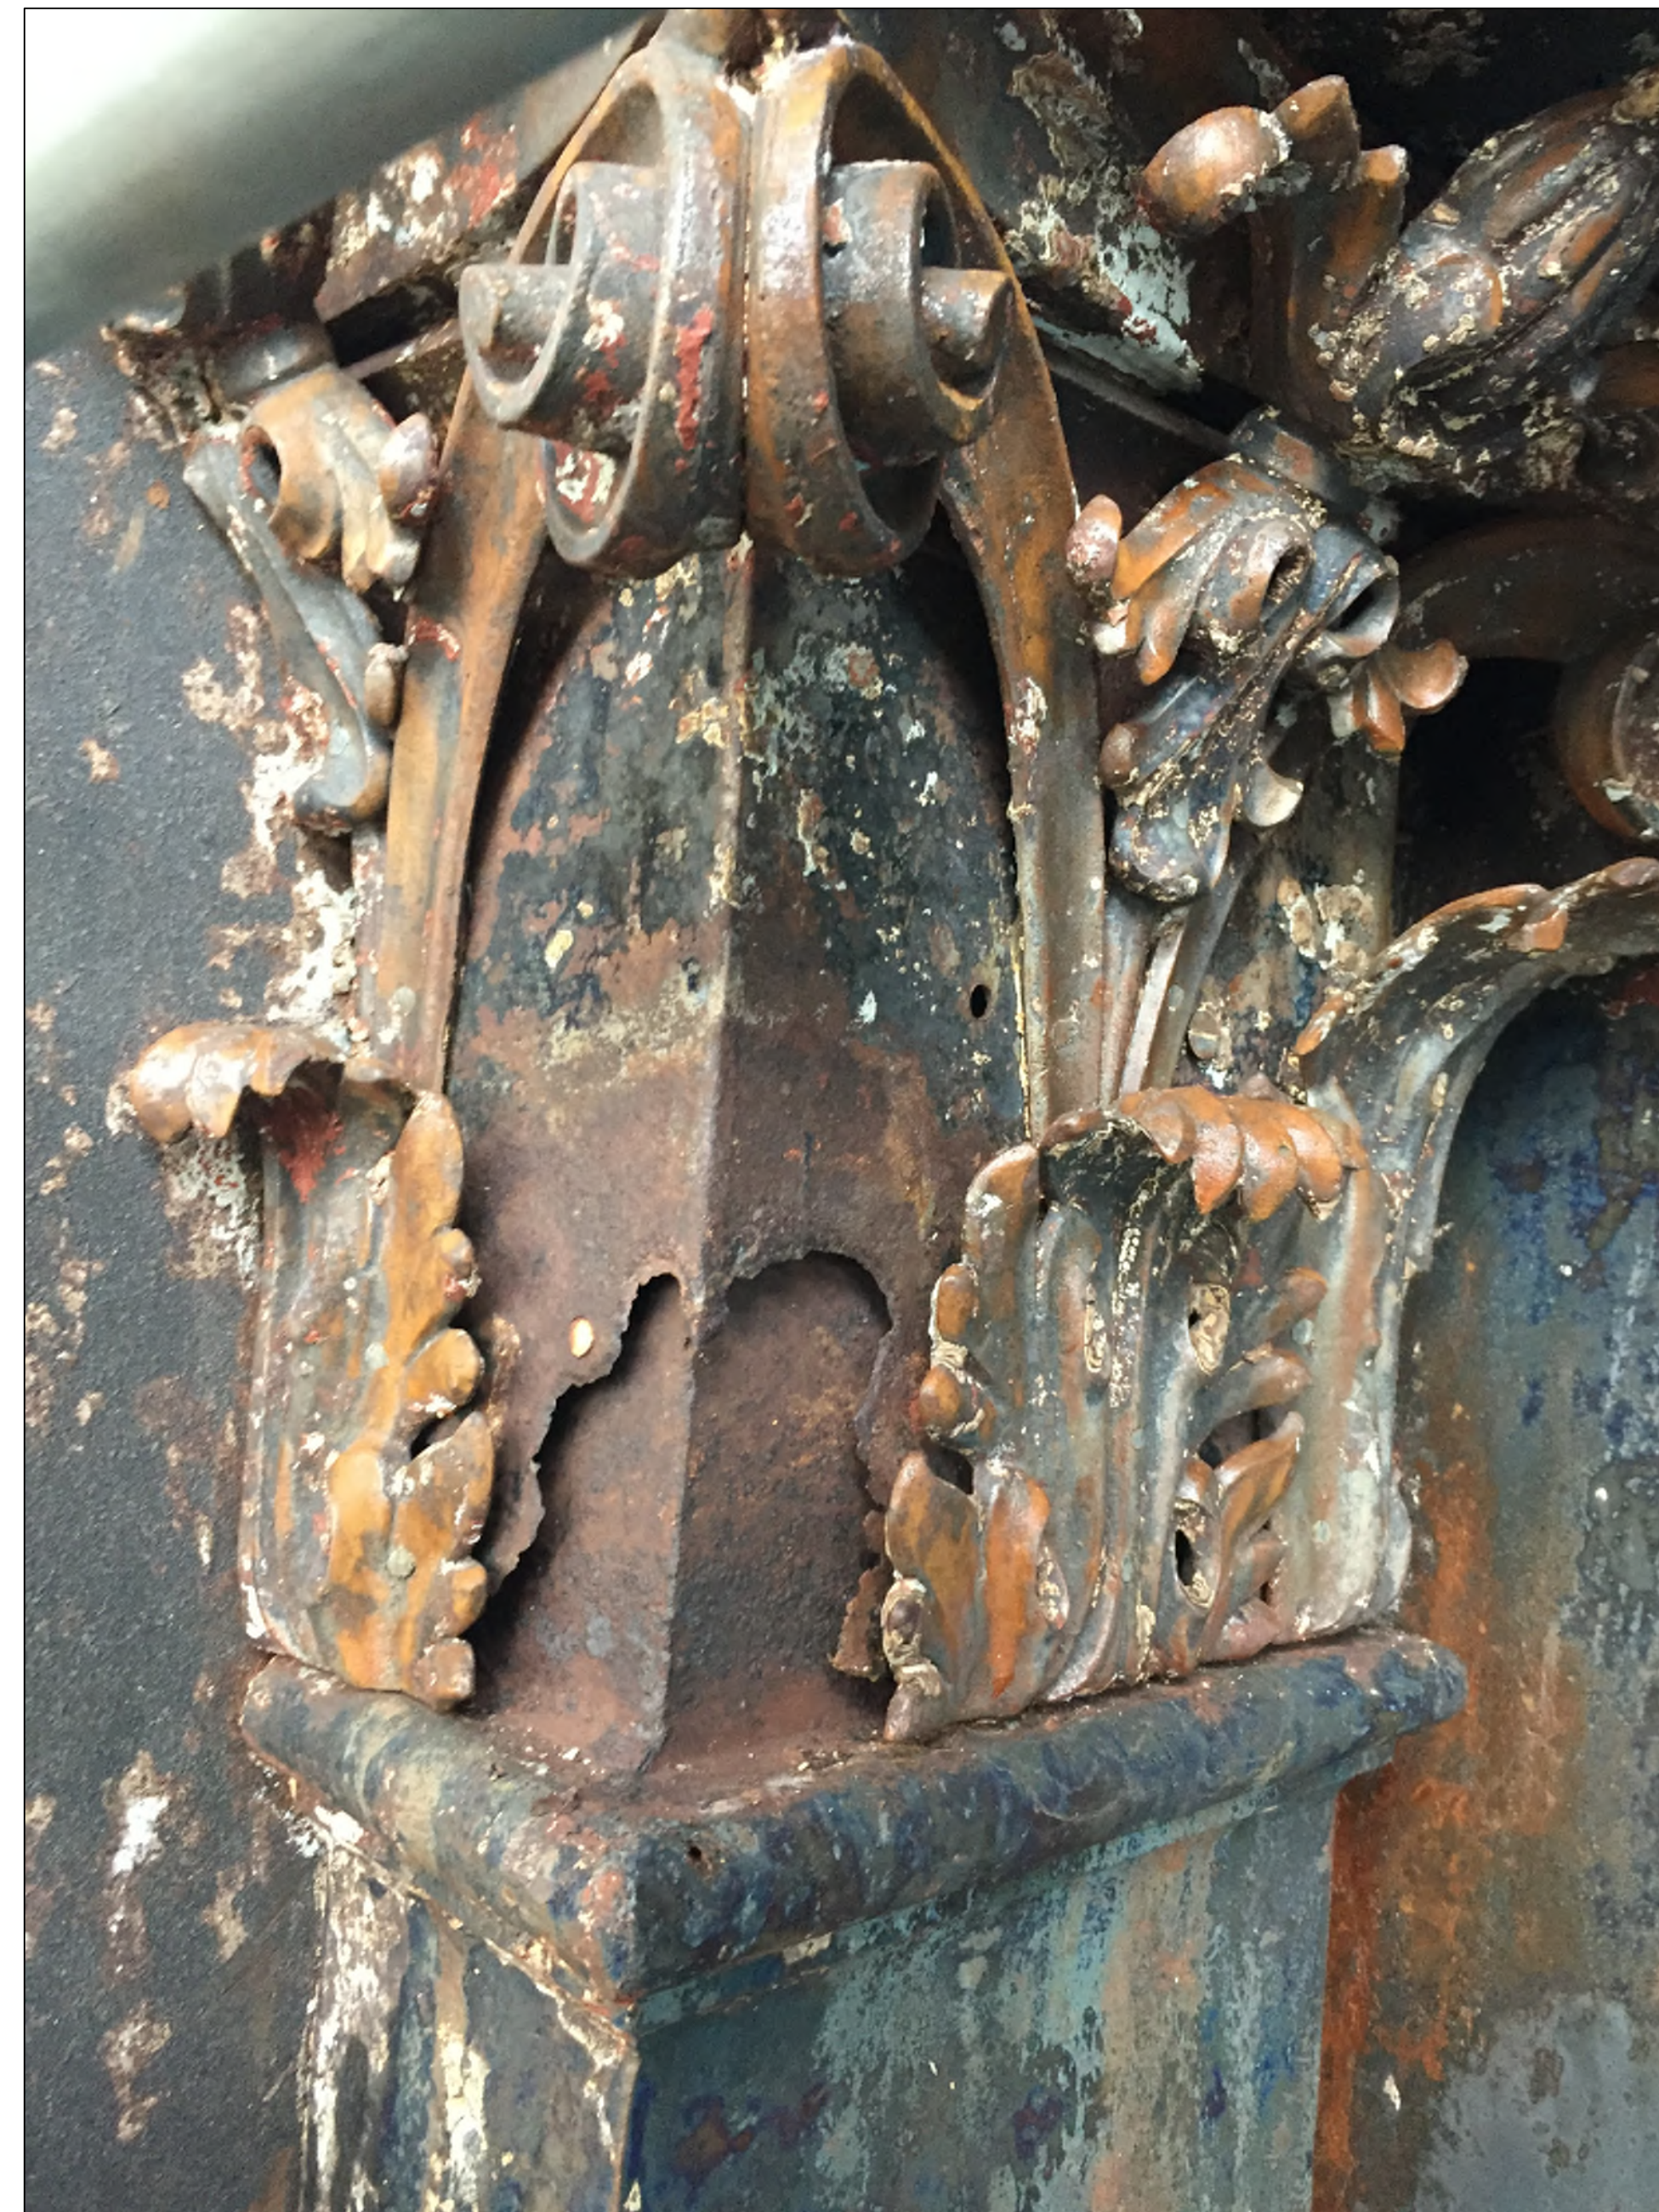
PRIOR TO REMOVAL SHOWING DETERIORATED BELL HOUSING

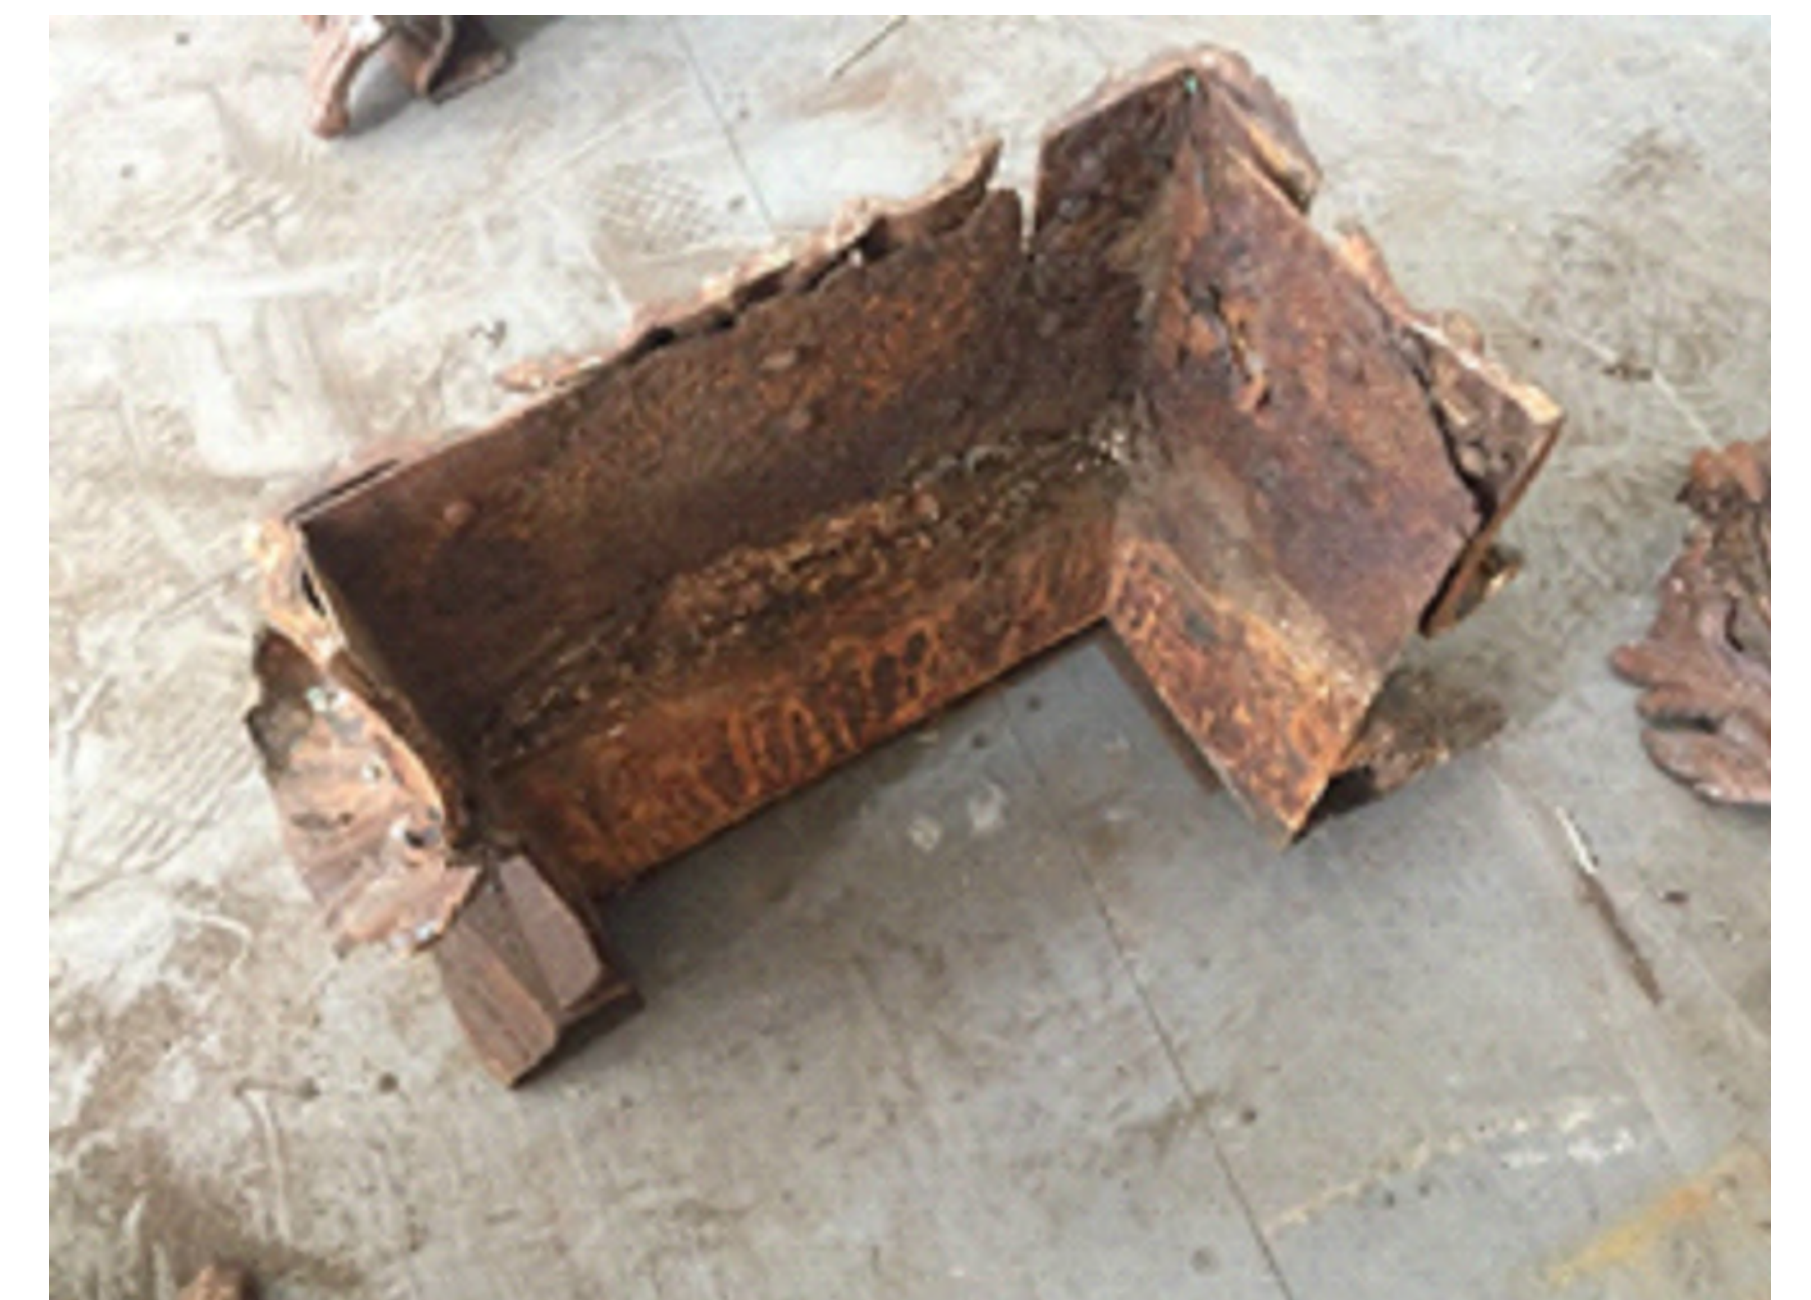
DETAIL OF BELL HOUSING
