462 BROADWAY
MERINGOFF PROPERTIES
FACADE
RESTORATION

DRAFT

OCTOBER 06, 2017

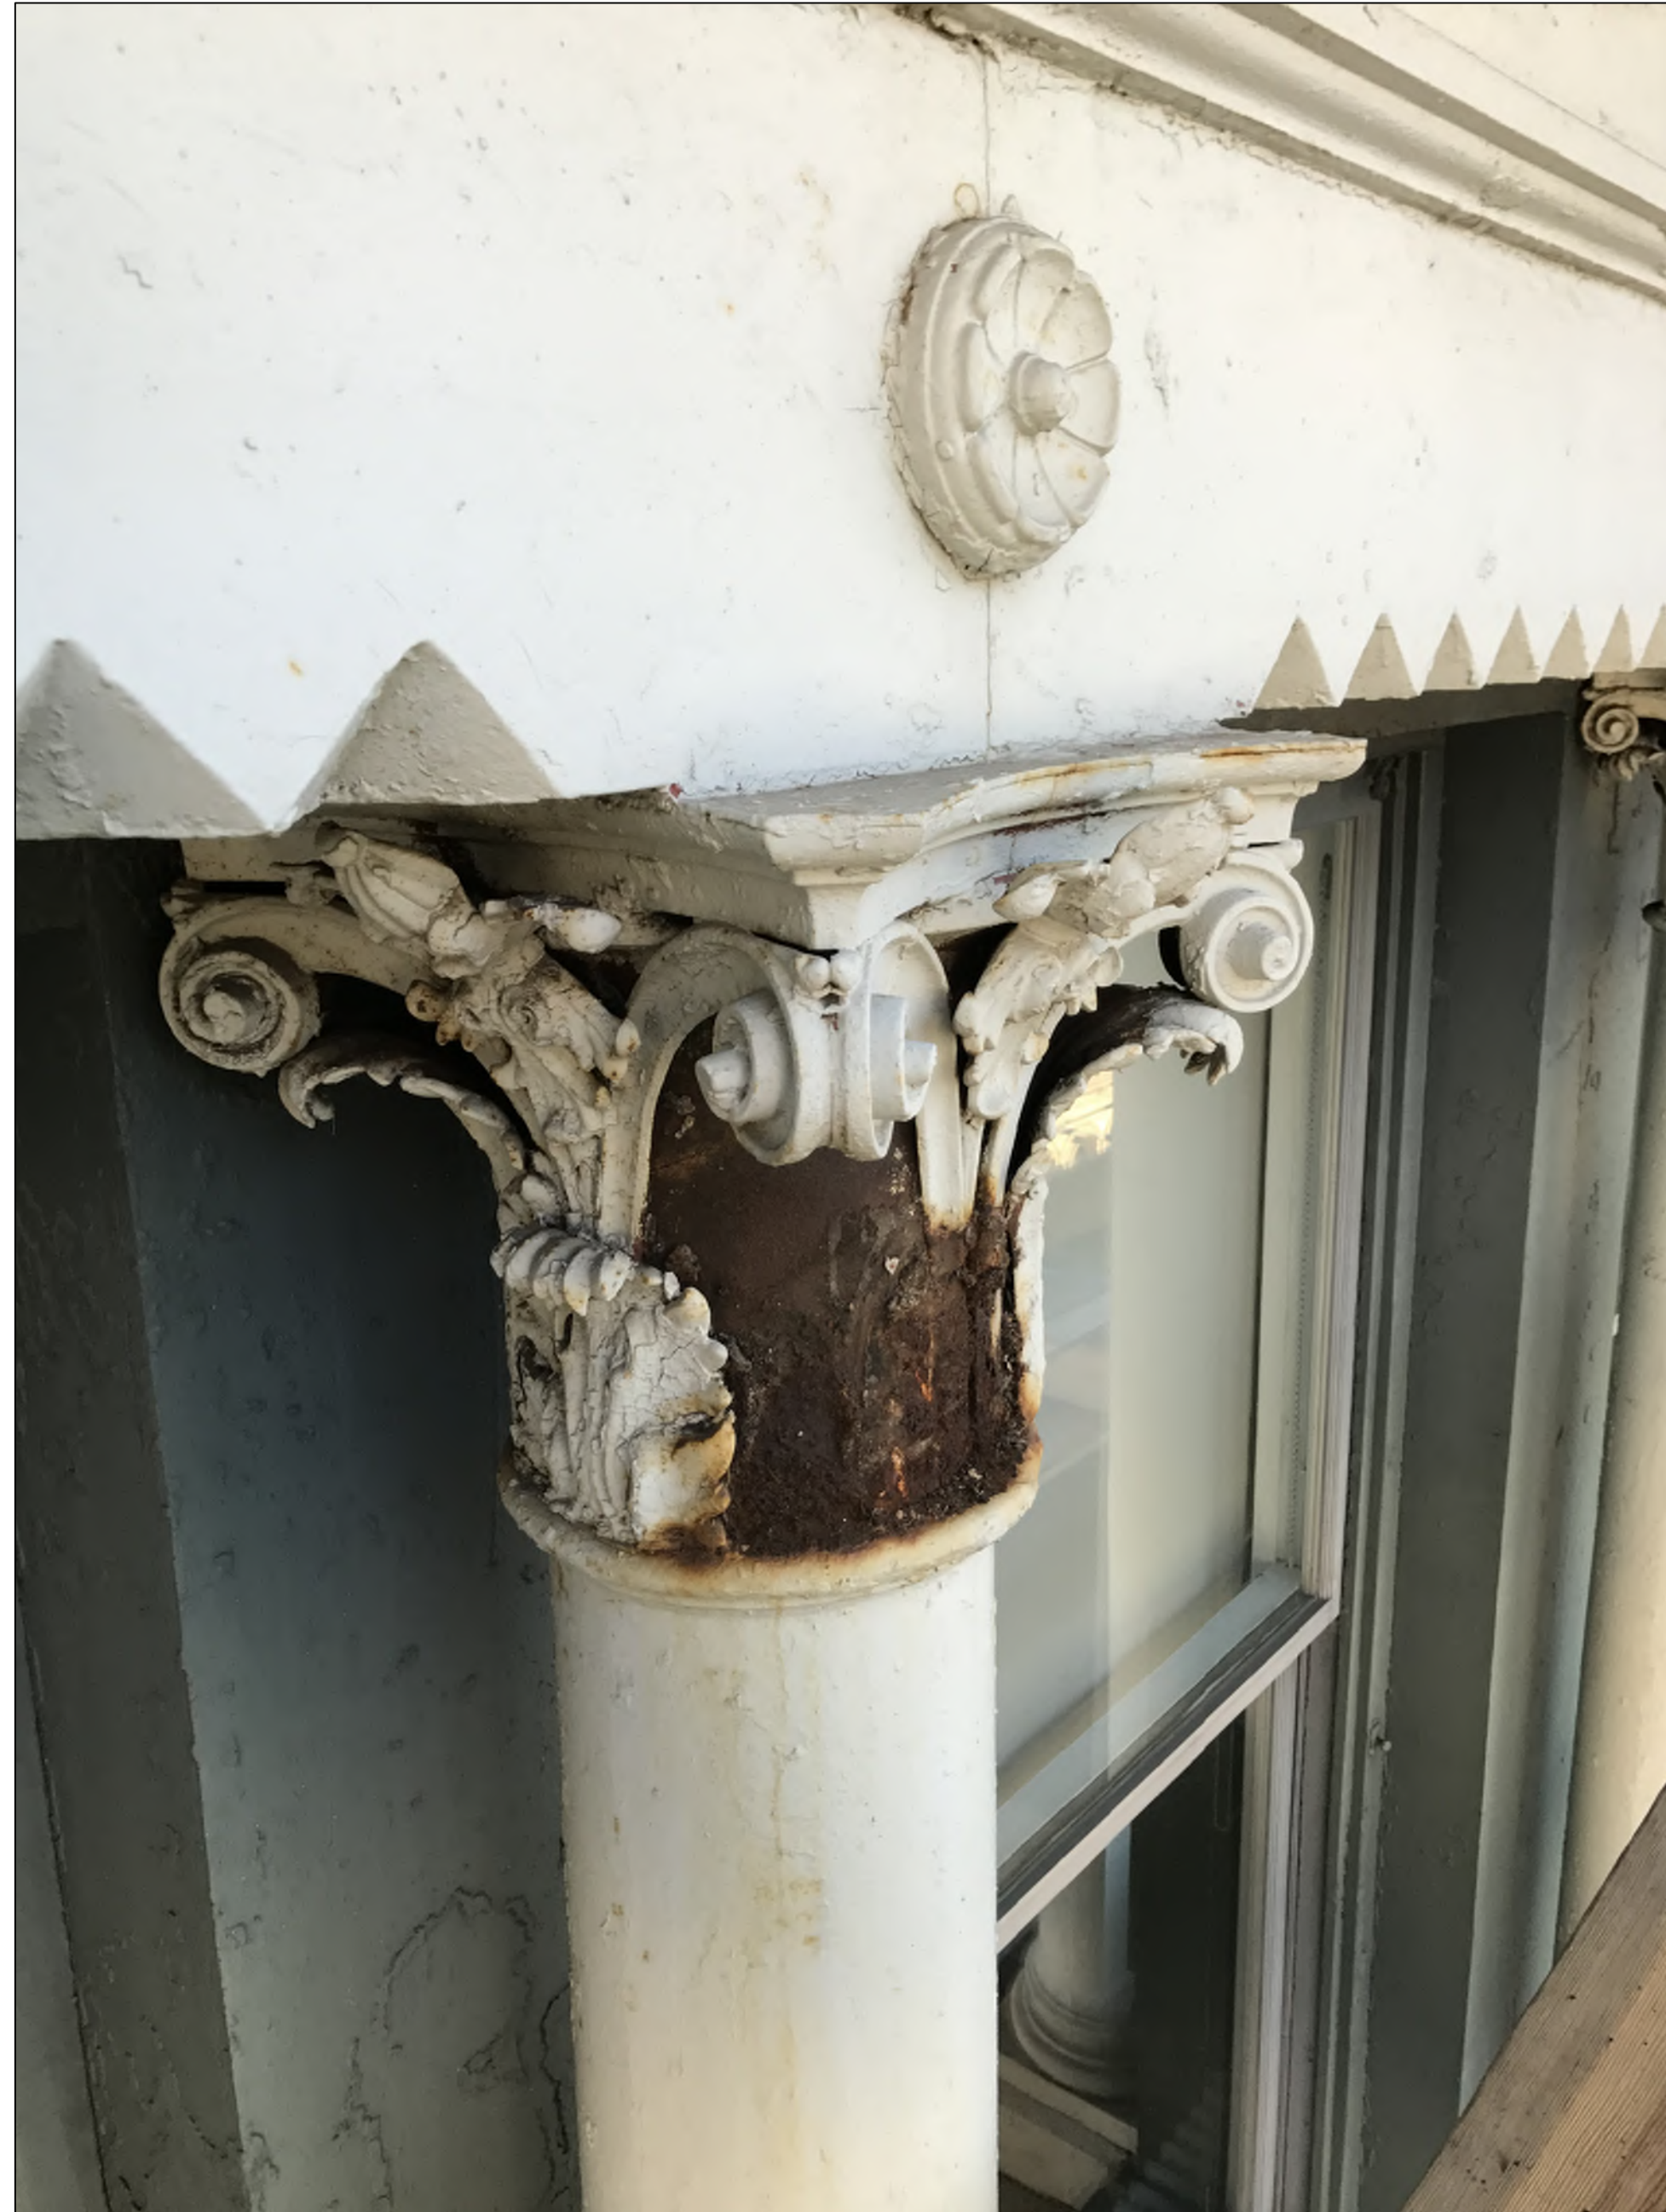
FULL ROUND CAPITAL PRIOR TO REMOVAL

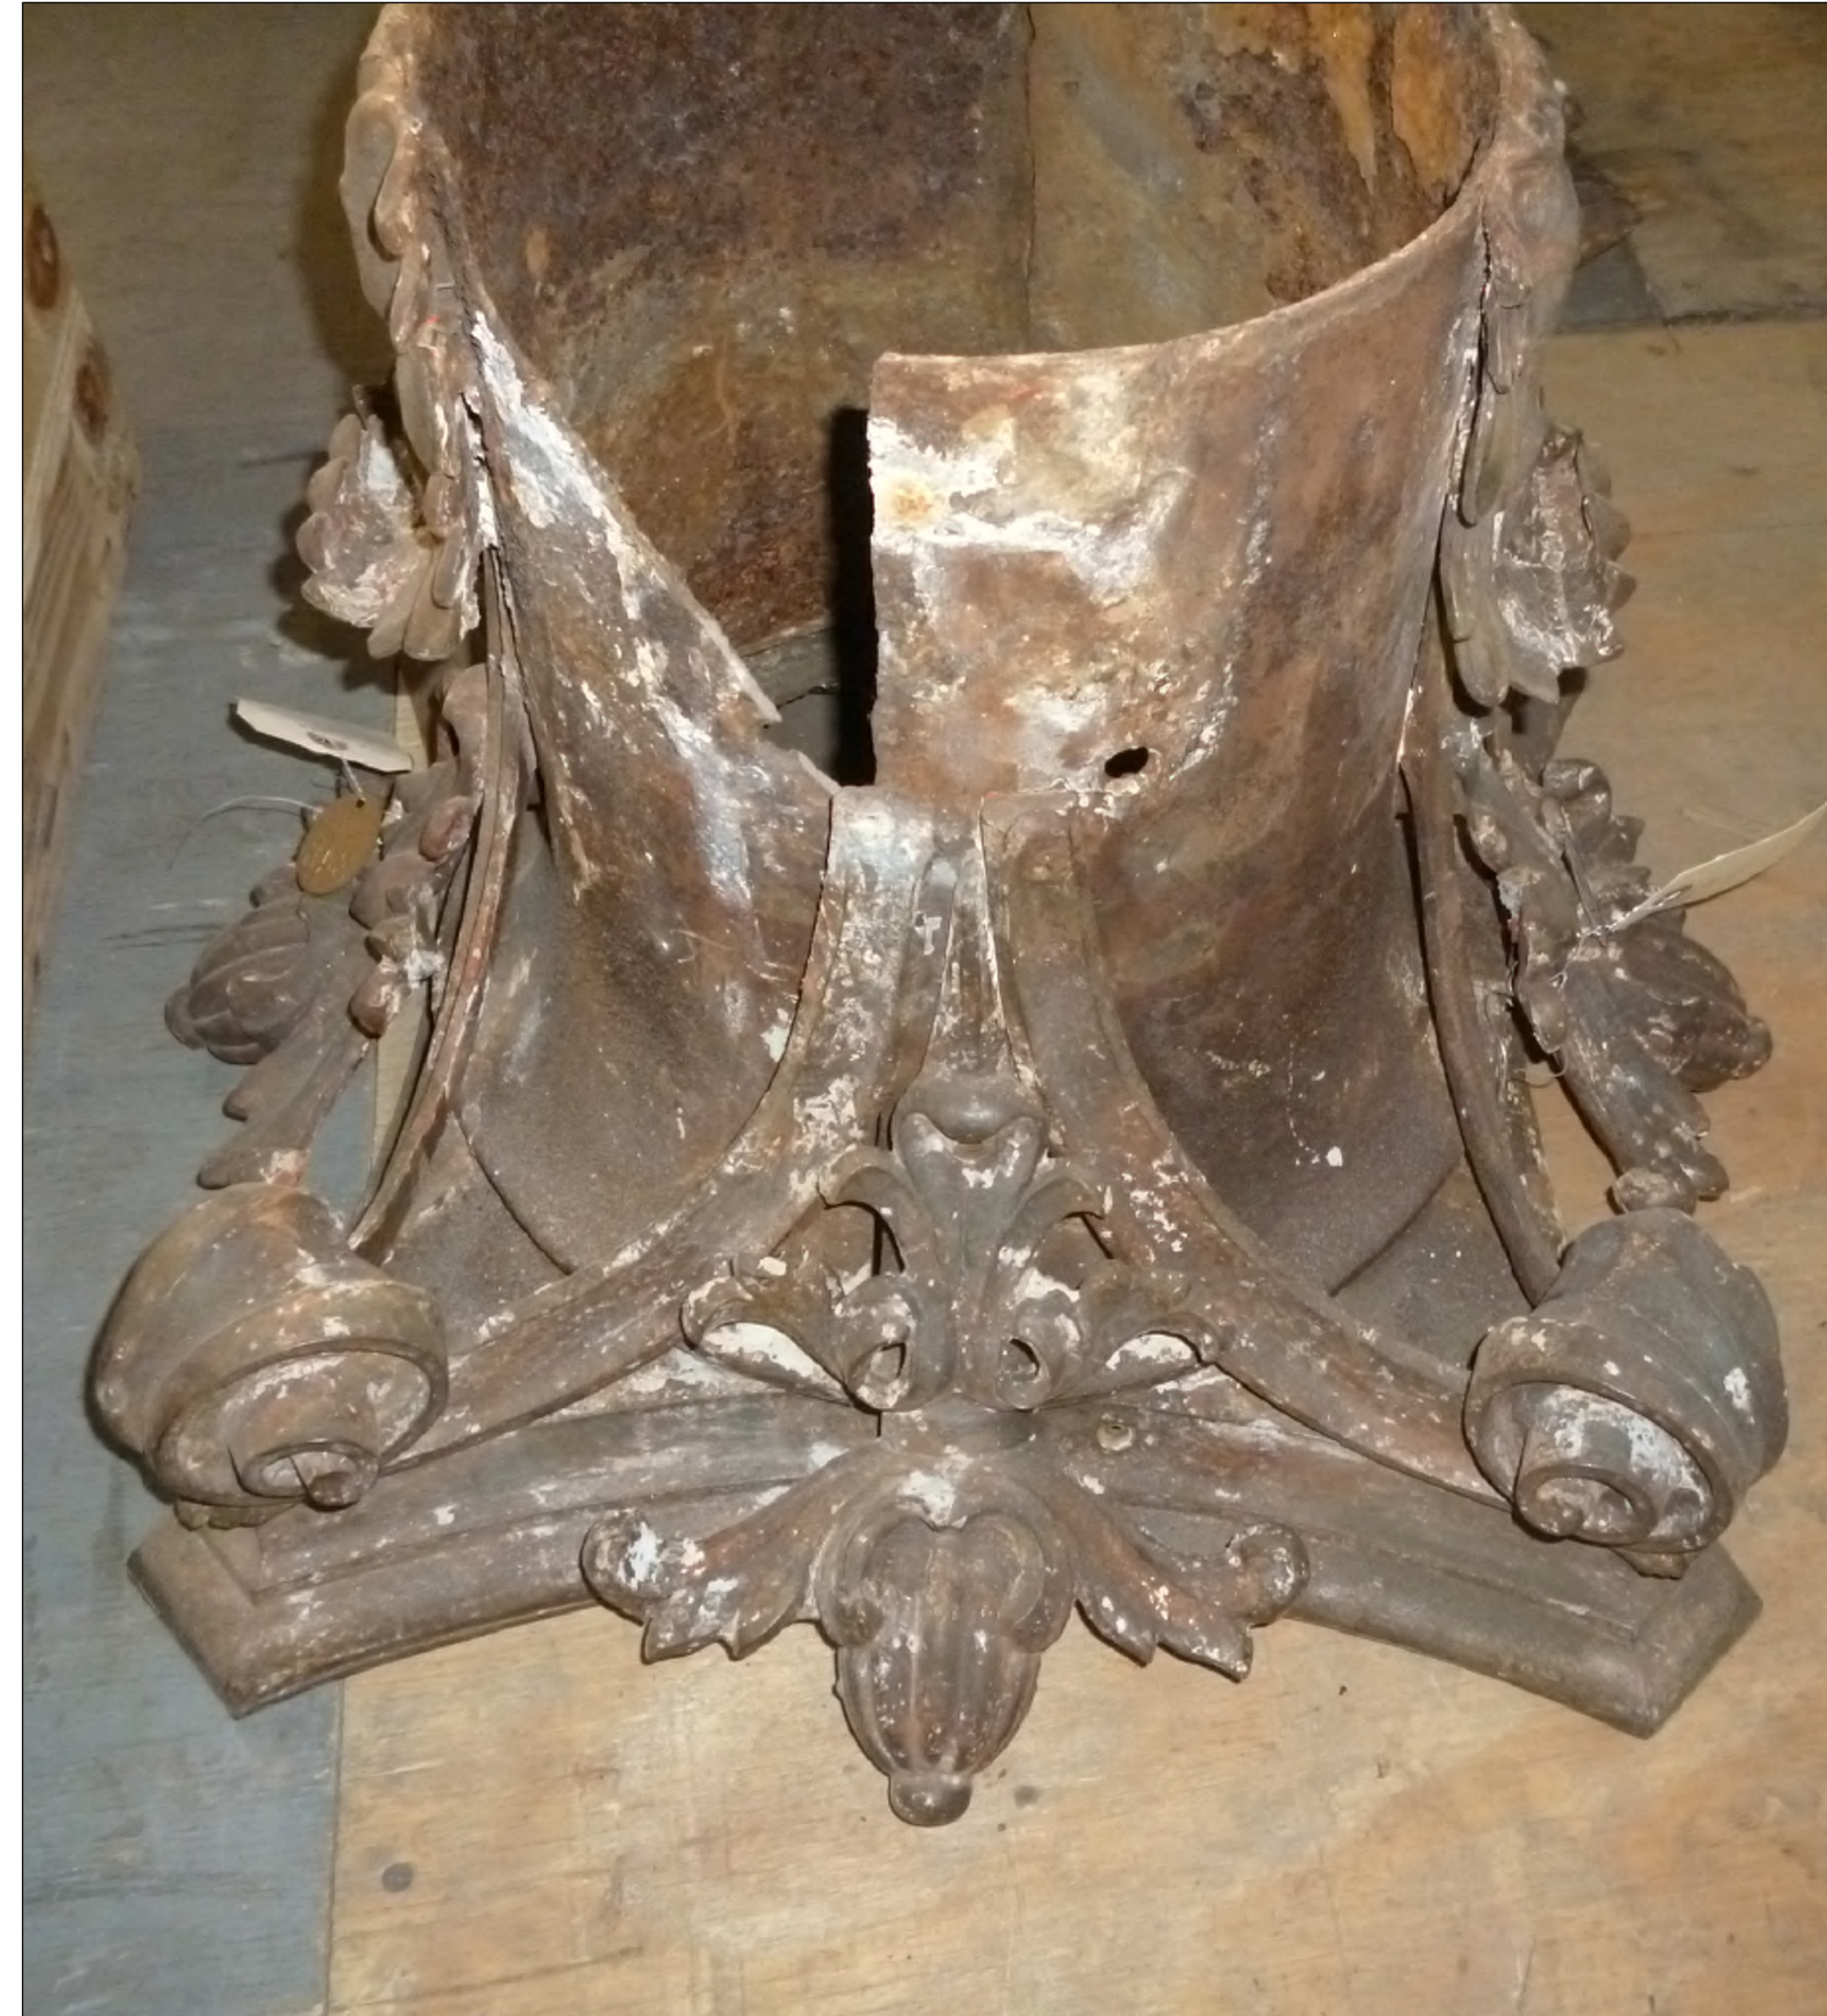
REMOVED CAPITAL SHOWING CRACKED BELL HOUSING

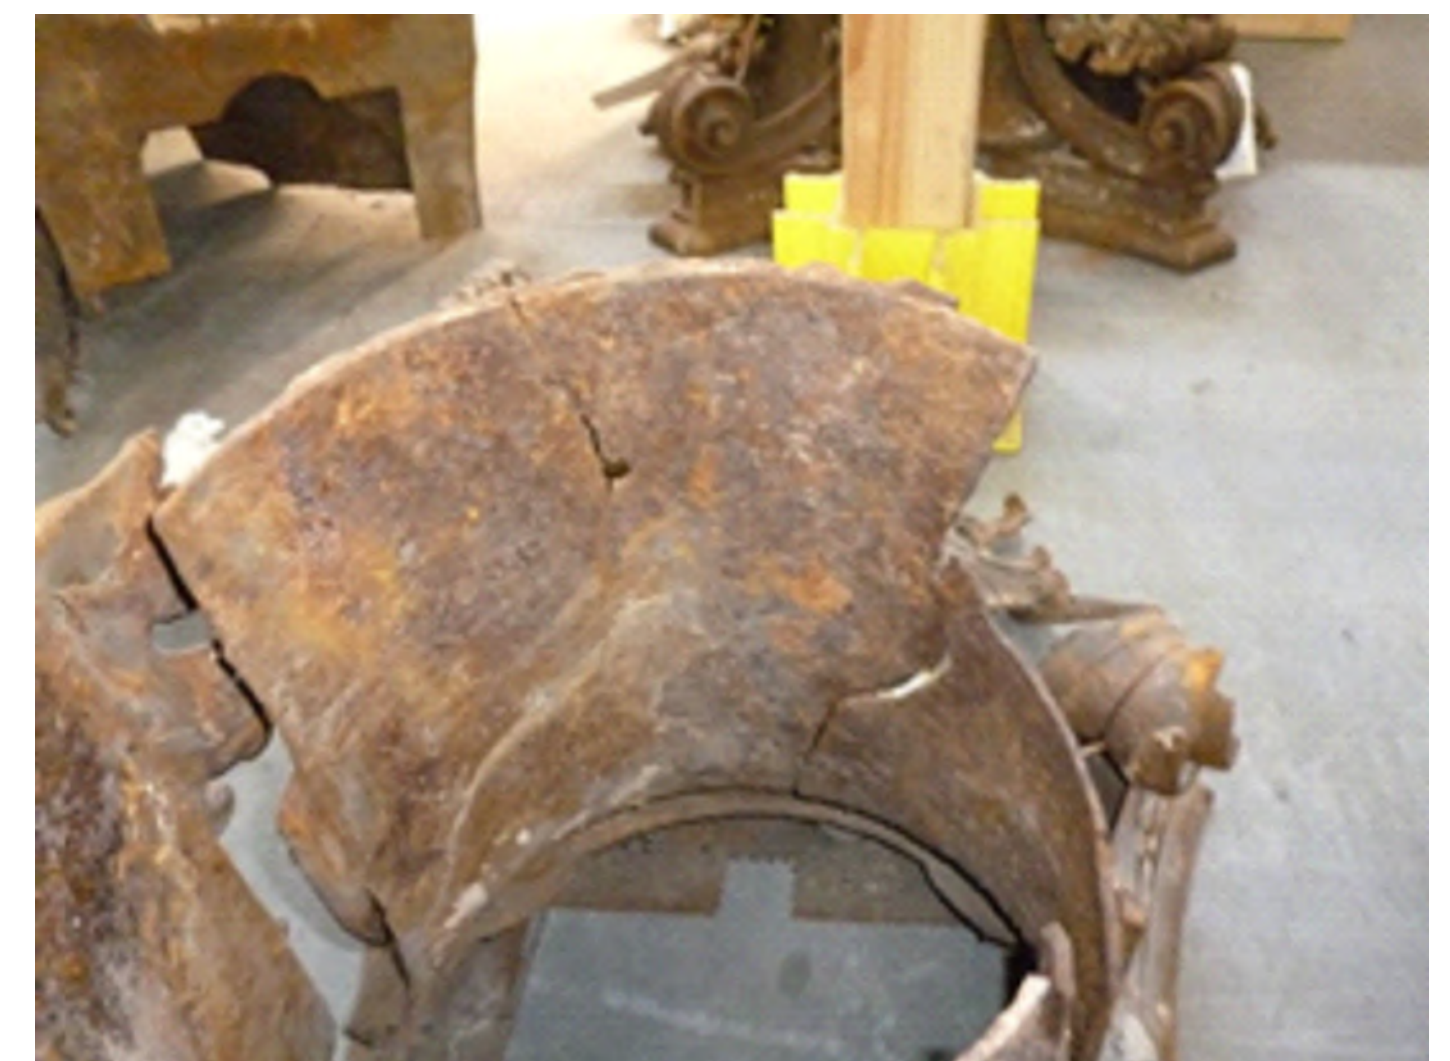
REMOVED CAPITAL SHOWING CRACKED BELL HOUSING
