INVESTIGATION REPORT:

JANUARY 14, 2008 SHORING COLLAPSE
AT 9 DOMINICK ST. (AKA 246 SPRING ST.)
MANHATTAN

EXECUTIVE SUMMARY

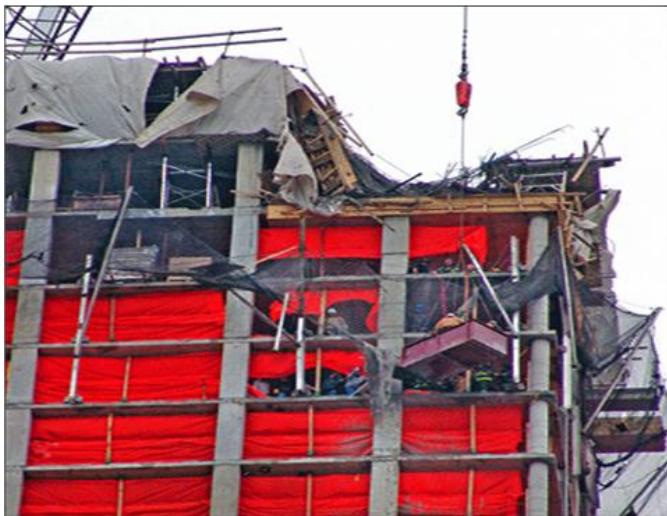
Photo 1 Collapse Area - Looking West

Investigation around the boundaries of the debris field allowed a better understanding of the general construction layout. Observations in that area revealed instances of improper installation that are described in the report. The investigators strongly believe that such improprieties also existed in the area that completely collapsed. One of the main observations based on the layout of the debris, was that whatever the initiating cause, the extent of the total failure was limited to the two-level of shores installation. Clearly, the failure did not progress in any manner past the edge of the already poured 41st floor (see Photo 1).

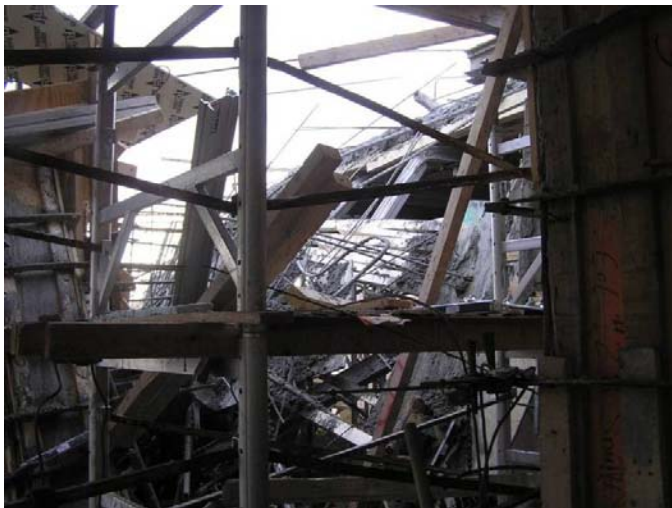
Photo 2 Debris Field 41st fl.

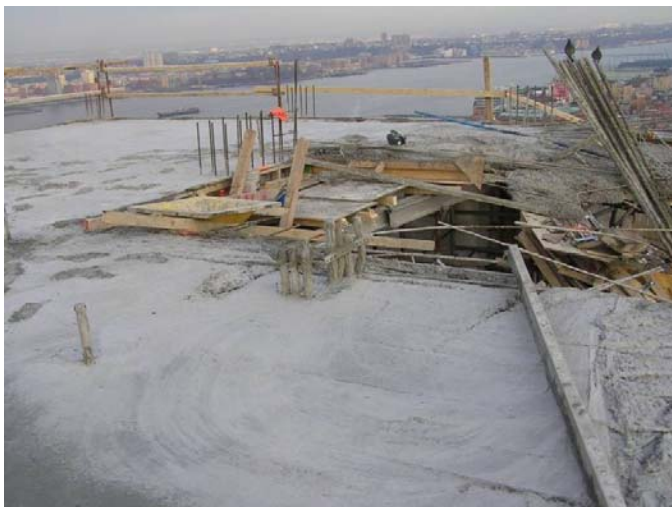
Photo 3 42nd Fl. Debris - Looking North East

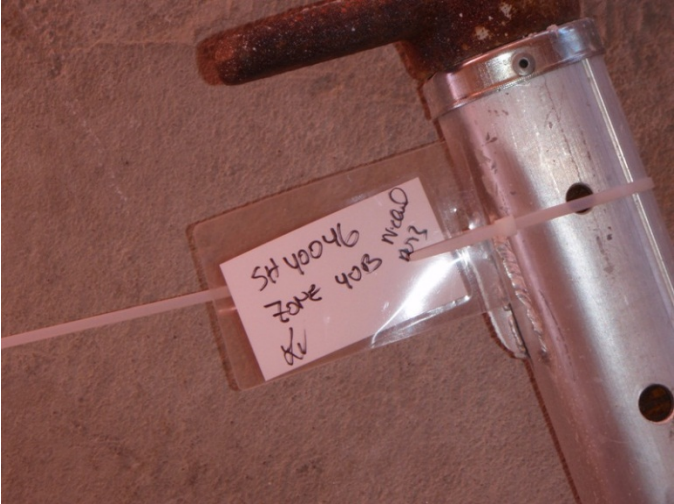
Photo 4 Typical Tag and Failure at Connection
Note Name, Zone and Signature

- Failure of the tube next to the weld connecting the horizontal or diagonal elements to the vertical legs. While a special failure analysis of the weld was not performed, it appears that in most cases the tube walls sheared at the weld. In one or two cases there might

have been separation of the weld from the tube material (see Photo 4 Typical Tag and Photo 10 Fracture Near Weld).

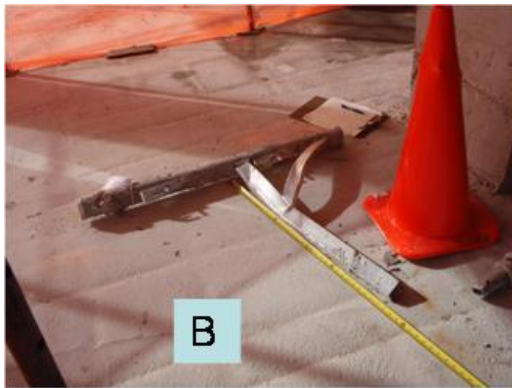
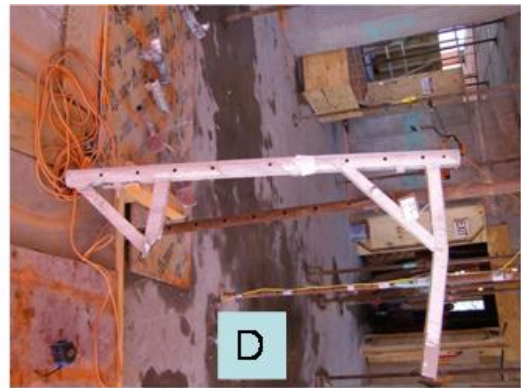
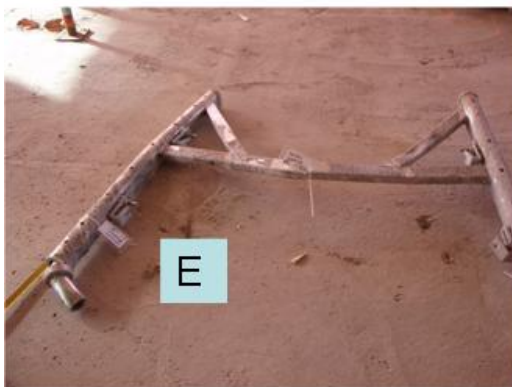
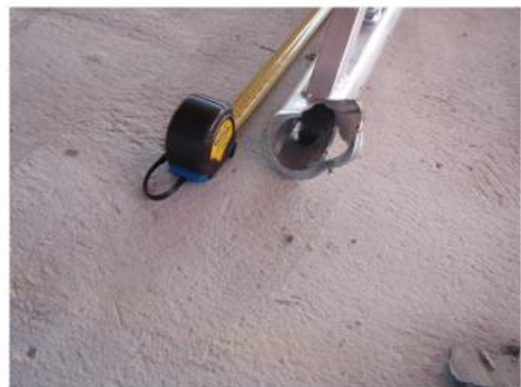
- Failure of the tubes (diagonal or horizontal). This might have occurred at connections of horizontals with diagonals or in the aluminum tube at the weld line to the vertical leg (see Photo 8 –Failure Modes).

Photo 8 Failure Modes

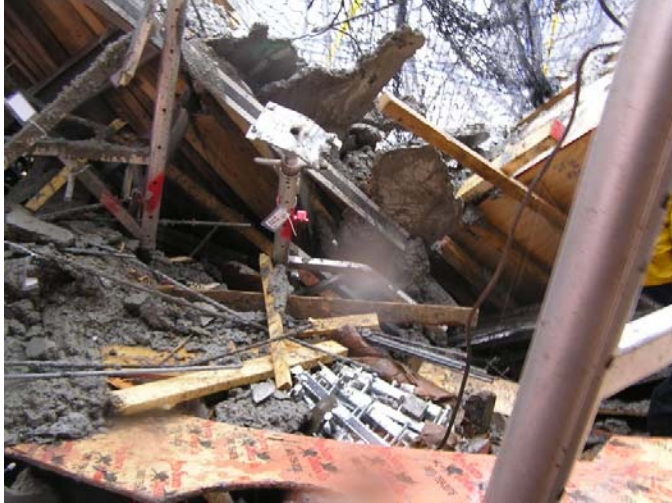
Several top plates were found bent (see Photo 9 Bent Top Plate). Also, two or three locking cams were found broken.

Photo 9 Bent Top Plate

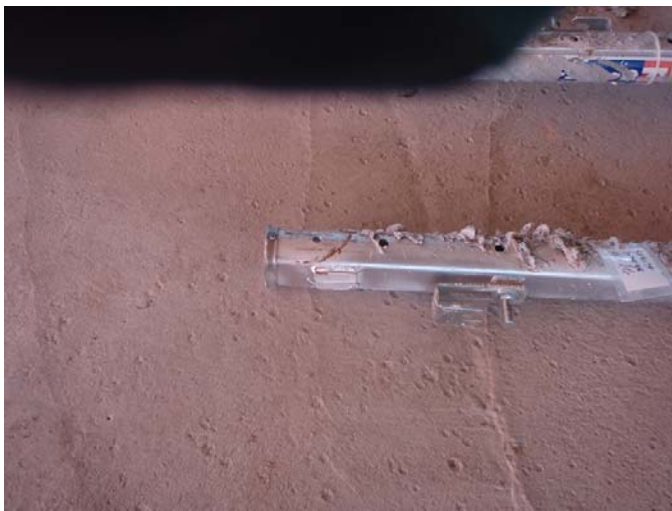
Photo 10 Fracture near Weld

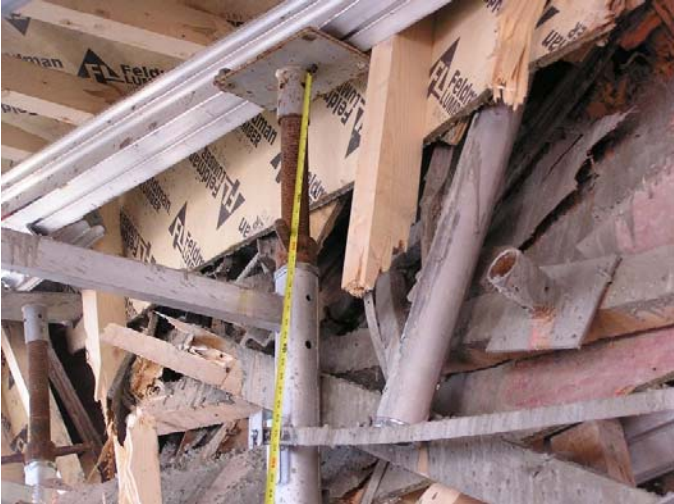
Photo 11 Adjustment Screw with Extension Over 12"

The typical mode of failure of the plywood was through bending at locations corresponding with the failure of the supporting dimension lumber underneath (see Photo 11). In several locations, punching of the plywood was observed. Local failure at edges was observed also.

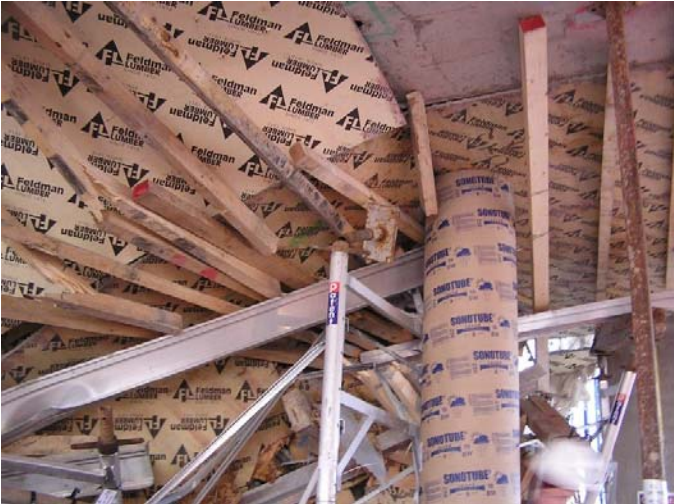
The investigation noted several cases where the extension legs fractured at the line of insertion to the vertical aluminum leg (see Photo 12 Fractured Adjustment Screw Failed extension leg. Note lack of attachment of wood joists to stringer).

Photo 12 Fractured Adjustment Screw

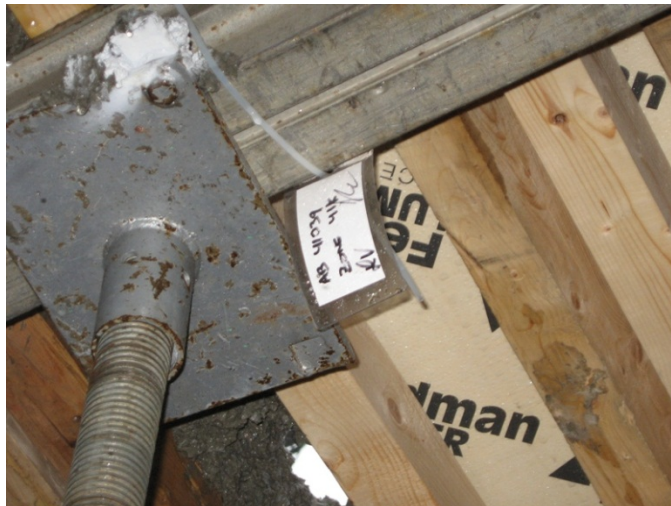
Photo 13 Stringer Set Eccentric on Head Does Not Follow Patent Instructions

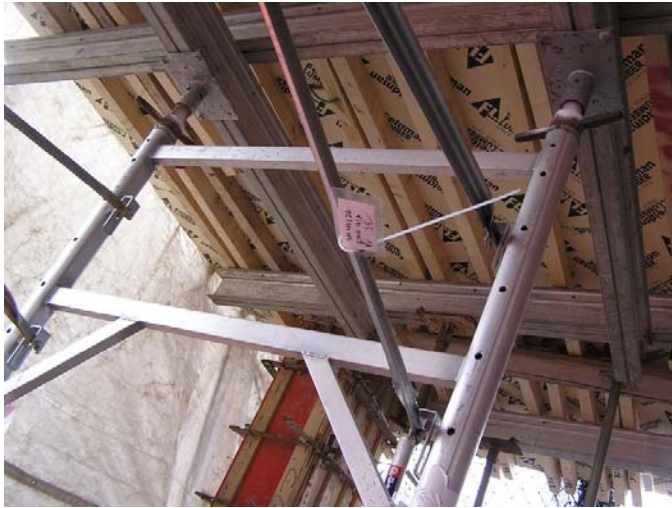
Photo 14 Stringer Supporting Stringer

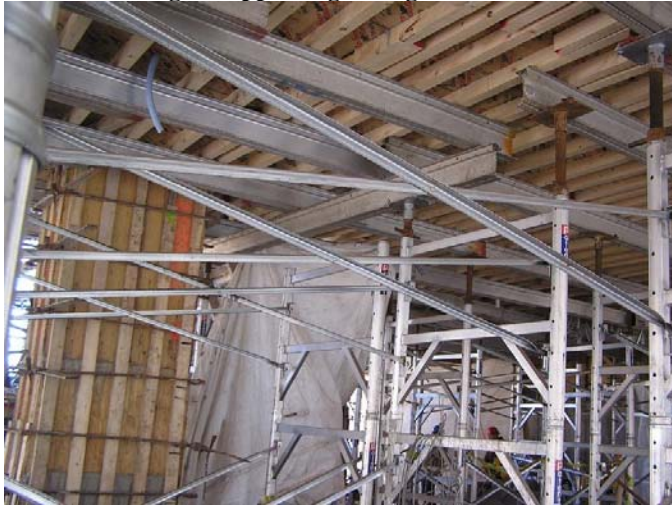
Photo 15 Improper Stringer Setting

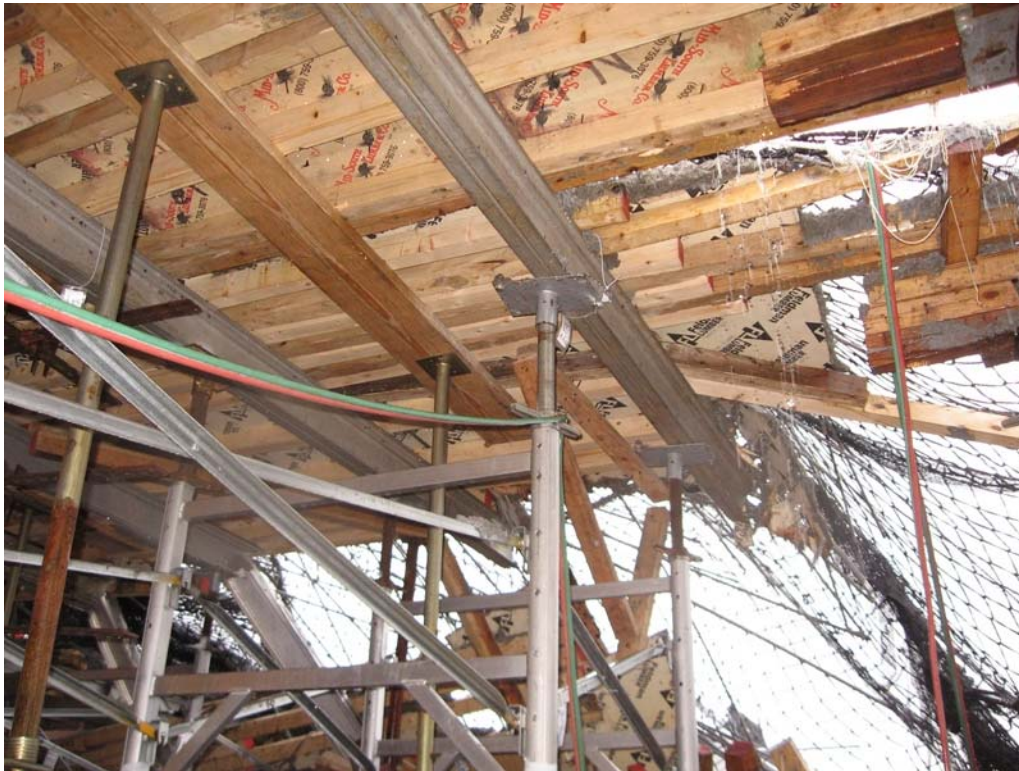
When the stringers are laid using the improper method described above, there will be a 2 inch eccentricity in the application of the stringer reaction to the leg support. The resulting moment will reduce the carrying capacity of the leg, hence the manufacturer interdiction for such a layout.

Photo 20 Eccentric Stringer Position on Head

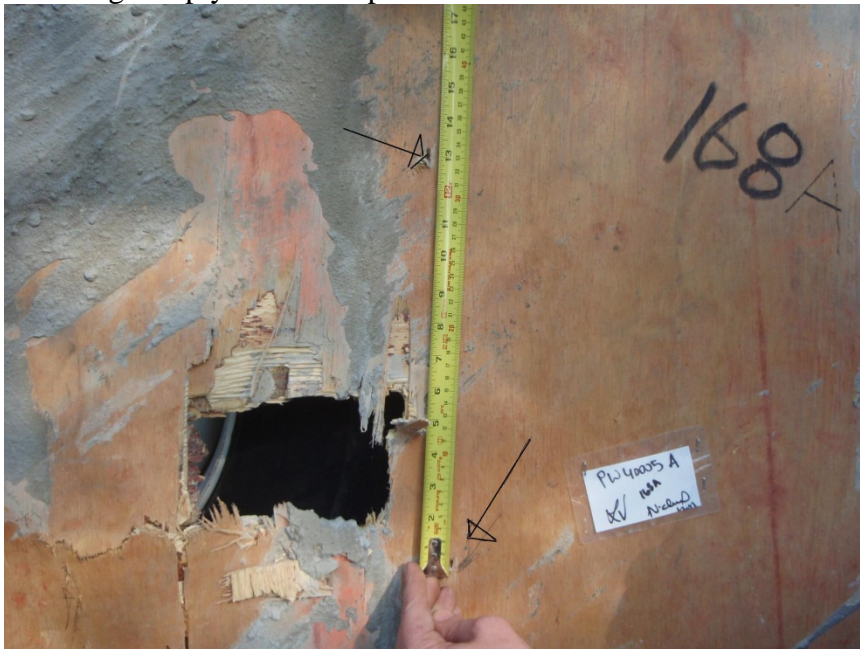
Our calculations (Appendix A 3.3.3) show that a deflection of .8 at the plywood level of 41st floor would have caused the failure of an aluminum tower. Such deflection could be the result of a leg punching the plywood, or even of an excessive displacement of the joist plywood system without any actual breakage, either of which would be the likely consequence of the placement of the legs on plywood midspan.

Photo 21 Plywood Penetrated by Leg Base

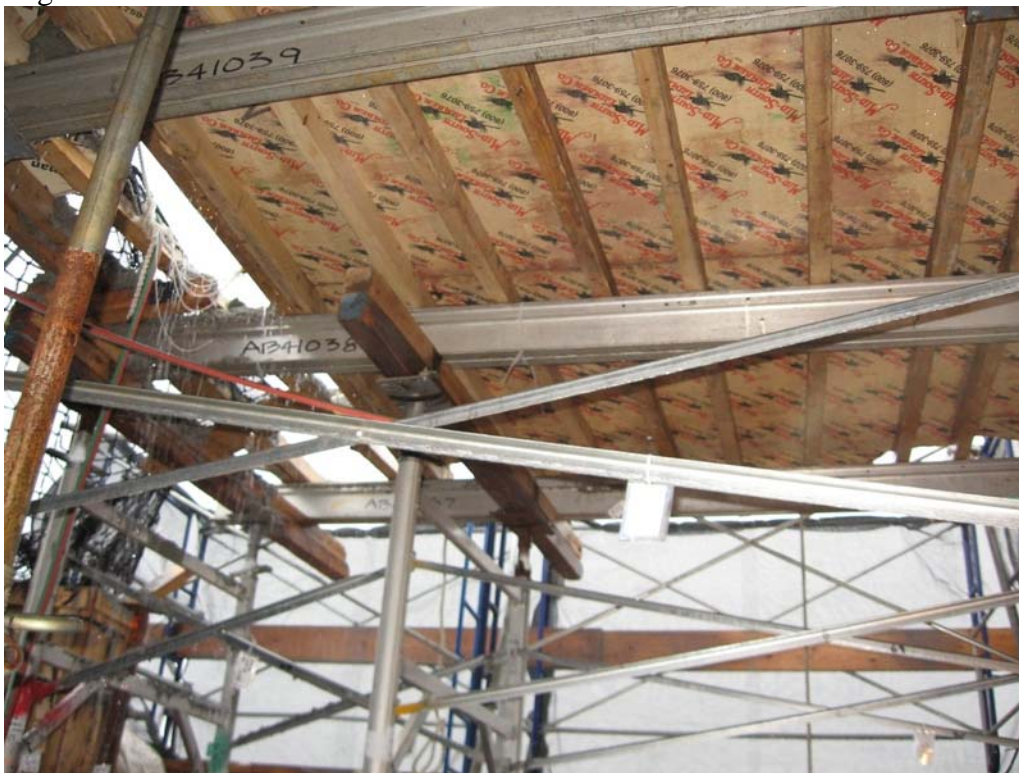
Photo 22 Shoring at the East Side.

Note absence of ties

At the site's east side the formwork relied on a cantilever system that was loosely set. Only one tie-back was positively identified in the debris when each frame at both levels should have been tied back. Our calculations show that the system as installed failed analysis required by the code (27-1035).

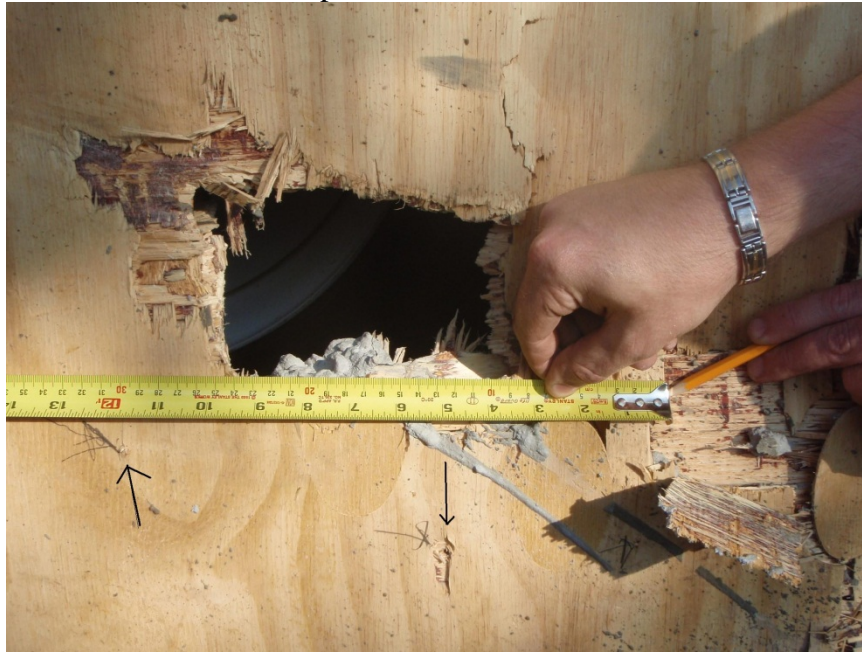
In the investigators' opinion punching of the plywood was most likely the initial failure that started the chain of collapse.

Photo 25 Punched Plywood

Our calculations show that the shoring towers were likely to fail when the punching of the plywood occurred at the 41st floor, which corresponds with the punched plywood observed in the debris (Photo 25 and Appendix B). Engineering calculations (see discussion at 7.2.4) prove that the load on the leg far exceeded the capacity of the plywood to resist punching. The intensity of loads that were capable of punching the plywood was determined by Wood Advisory, which performed tests on plywood found at the site. Photo 21 is a clear example of punched plywood. It also demonstrates that the leg was not atop a joist.

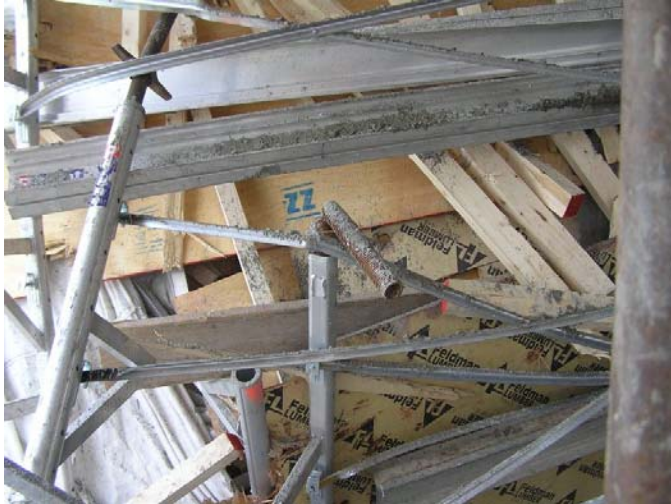
Photo 26 Broken Adjustment Screw Extension

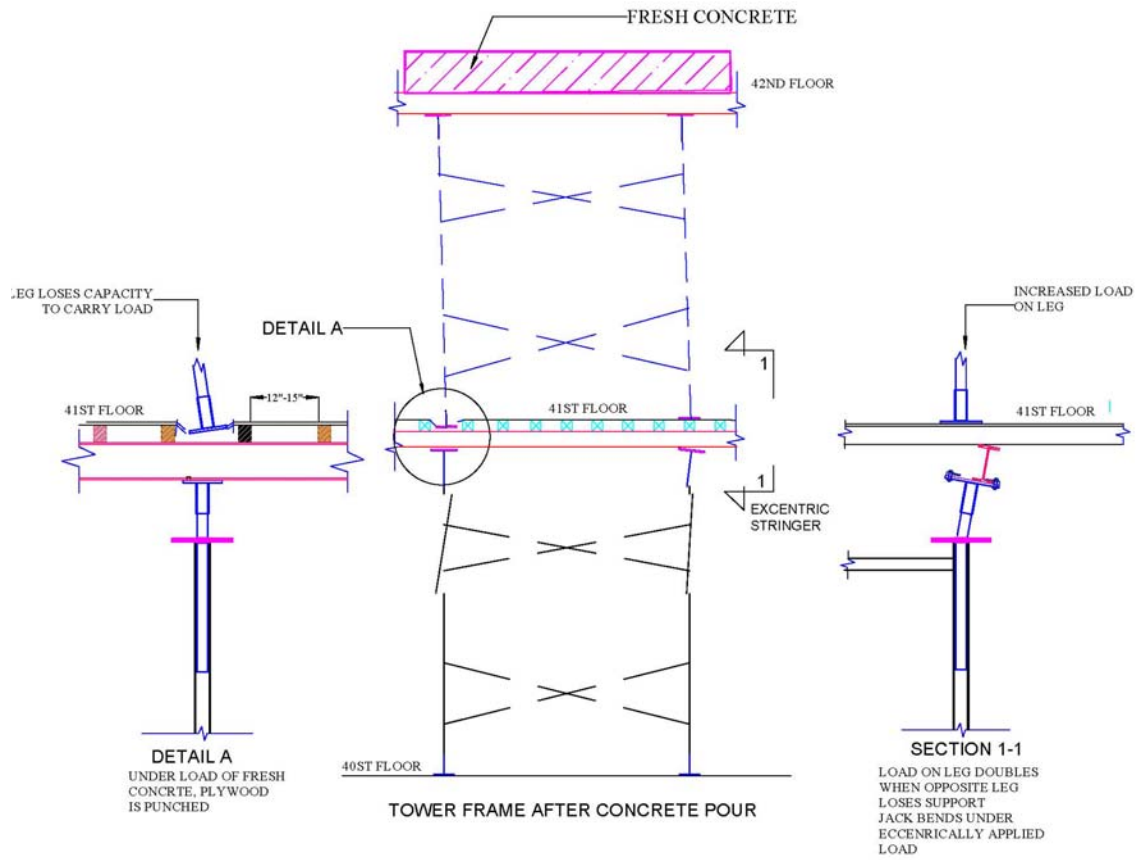
Figure 11 Scenario of Failure Following Concrete Pour
