**808 COLUMBUS AVENUE  
REPORT OF INVESTIGATION  
FEBRUARY 15, 2008**

**DAN ESCHENASY, PE  
DEPUTY ASSISTANT COMMISSIONER  
FORENSIC ENGINEERING UNIT**

## I. EXECUTIVE SUMMARY

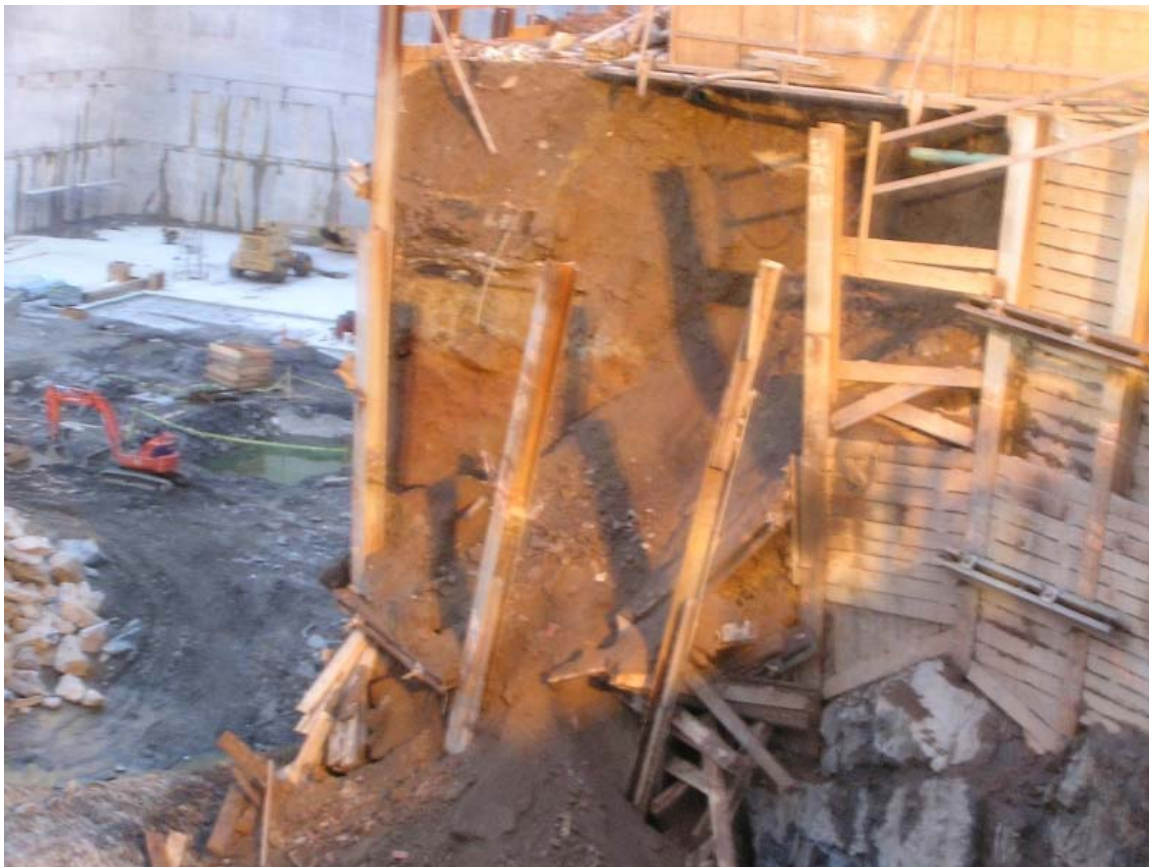
**Photo 1 – The Collapsed Sheeting**

The piles were stabilized in the adjacent soil through the use of anchors (also commonly referred to as “tiebacks”) embedded in the soil behind the sheeting (**Figure 6**). The anchor heads are still visible in **Photo 1** in the wales that are exposed. There is a poor image of an anchor exposed in the soil wall between pile #1 and #2 sloping down to the right at approximate elevation 65. All anchors heads were recovered, some of which appear to have been torn during the remedial work. One anchor head might have failed before the remedial work.

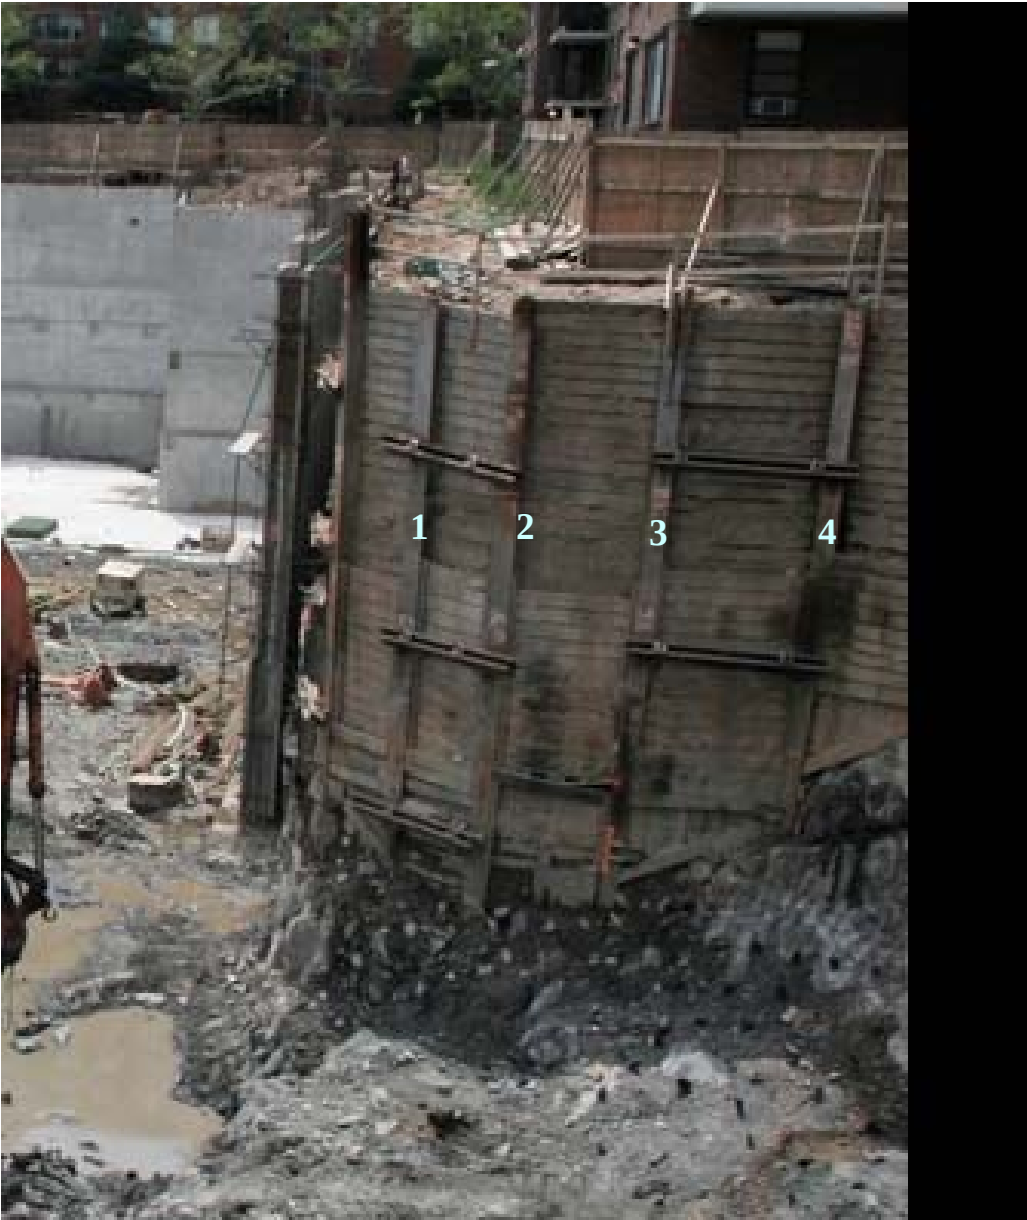
Photo 4 – The Sheetting Wall Pre-Collapse –Bernstein photo 7/20/2007

The Bernstein July 20 (photograph 4) is unclear but it appears that the toe of the wall is covered with rubble. The debris is more typical of blast rock rather than the larger blocks typically produced by a hydraulic breaker. It is unknown what method was used to excavate the rock in this area prior to July 20.

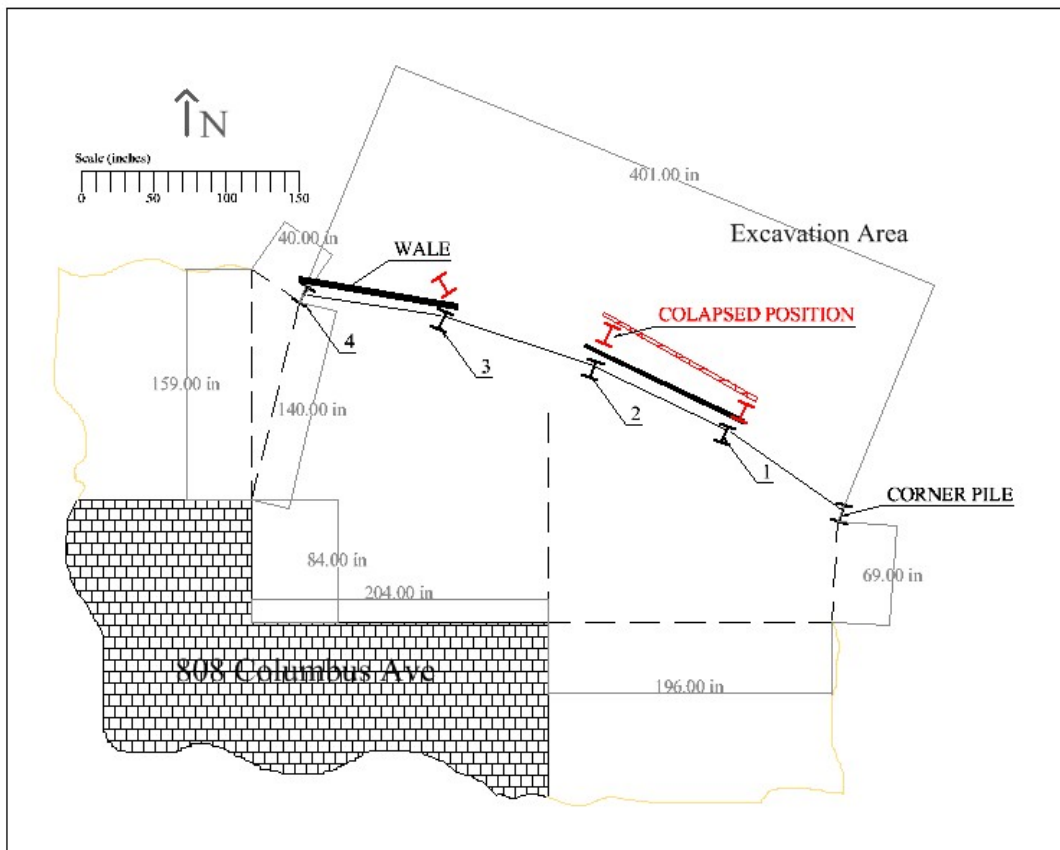
**Figure 2 – Approximate Layout of Sheet Piling Before and After Collapse. The number identifying each pile is for this investigation only.**

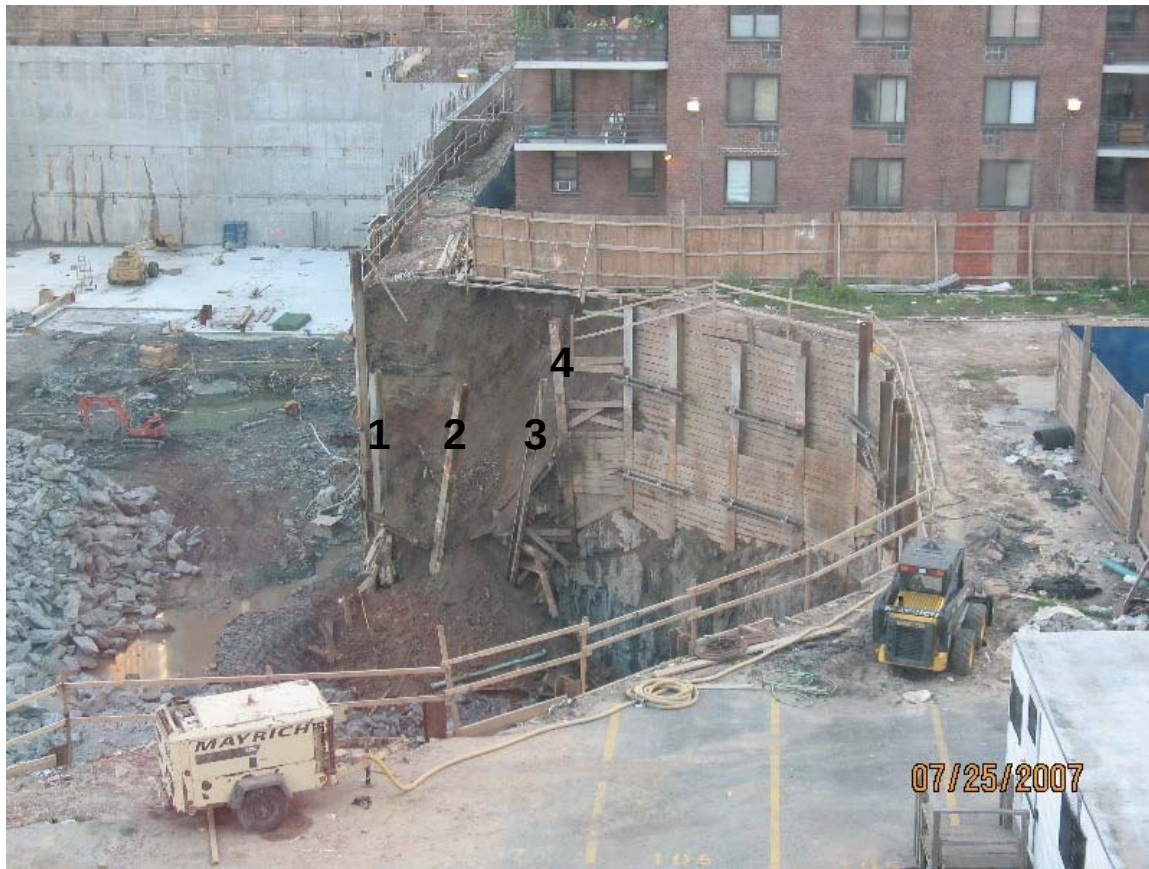
Debris layout is shown in photo 5 and figure 4. Only pictures produced immediately after the

**Photo 5 – Collapsed Sheeting**

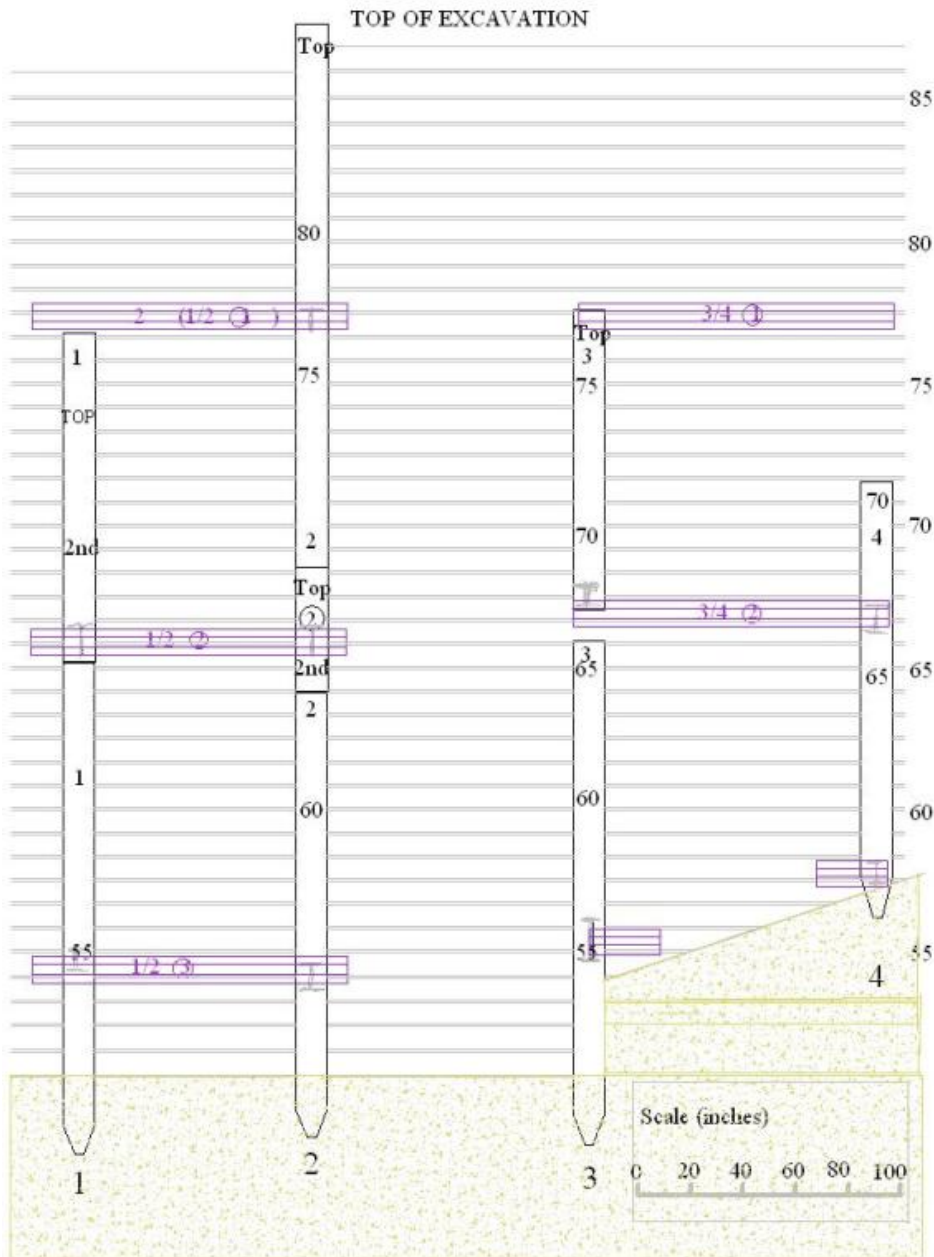
contained any essential data. The welds around the plates connecting the wales to the soldier piles failed. The welds measured 3/16 of one inch.

**Figure 3 Recovered Pile Segments -Set-up**

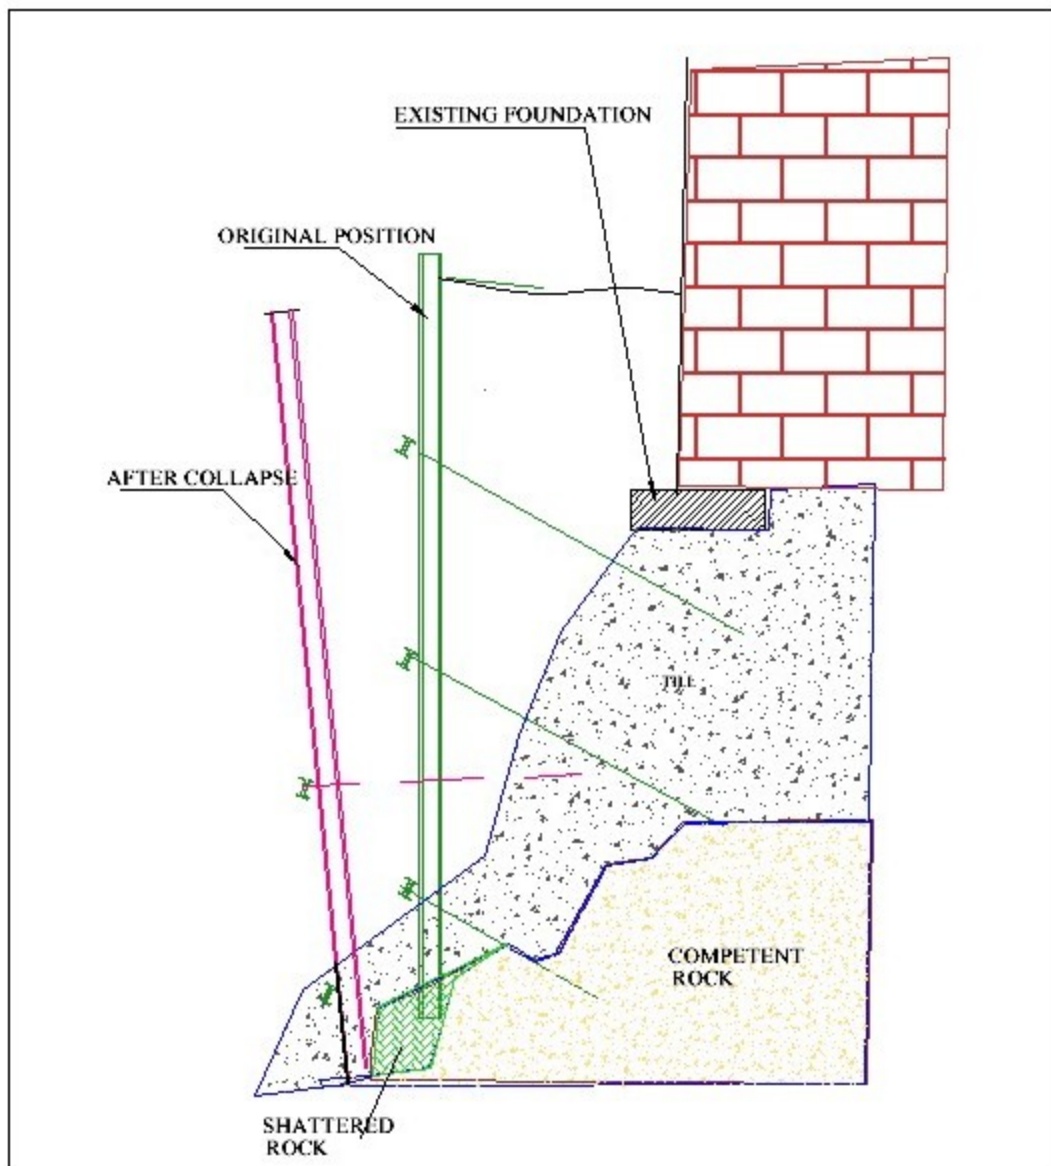
The wood planking that is installed between the piles is known as “lagging.” From examination of the photographs after the collapse, all of the wooden lagging between the piles was out of place except between Pile #4 and Pile #5 below elevation 73. The lagging between #1 and #2 appears to be in front of the piles. Most of the lagging is obscured by the debris pile between Pile #2 and #3 and the lagging between Pile #3 and #4 appears to be behind Pile #3. In many cases, the lagging lies close to the piles is partly fixed. The lagging was significantly damaged when the berm was built because heavy rocks were dropped on top of the debris.

**Figure 4 Rendering Section Looking East –Sheeting before and after collapse.**

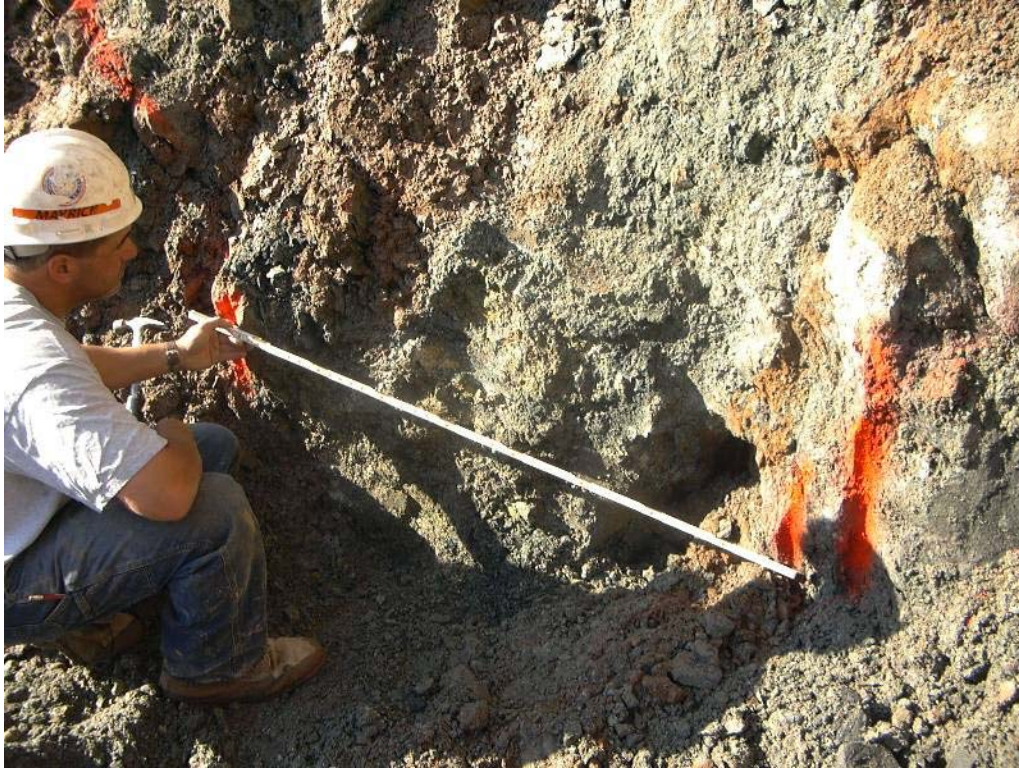
The investigation revealed that the area of the collapse coincided with a geological structure trending approximately north-south. The feature is most likely a complex fault due to intersection of more than one fault, possibly a conjugate system. The faulting has caused extensive fracturing and reworking of the material to produce angular sand to coarse gravel size fragments of rock to platy shards of brittle rock bordered by closely spaced blocky rock. The fault extends from between the corner pile and #1 pile and almost to #3 pile which is nearly 20 feet wide. The fault is made up of two distinct components: an altered region and a shattered region.

**Photo 6 – Weathered Rock Below Sheeting**

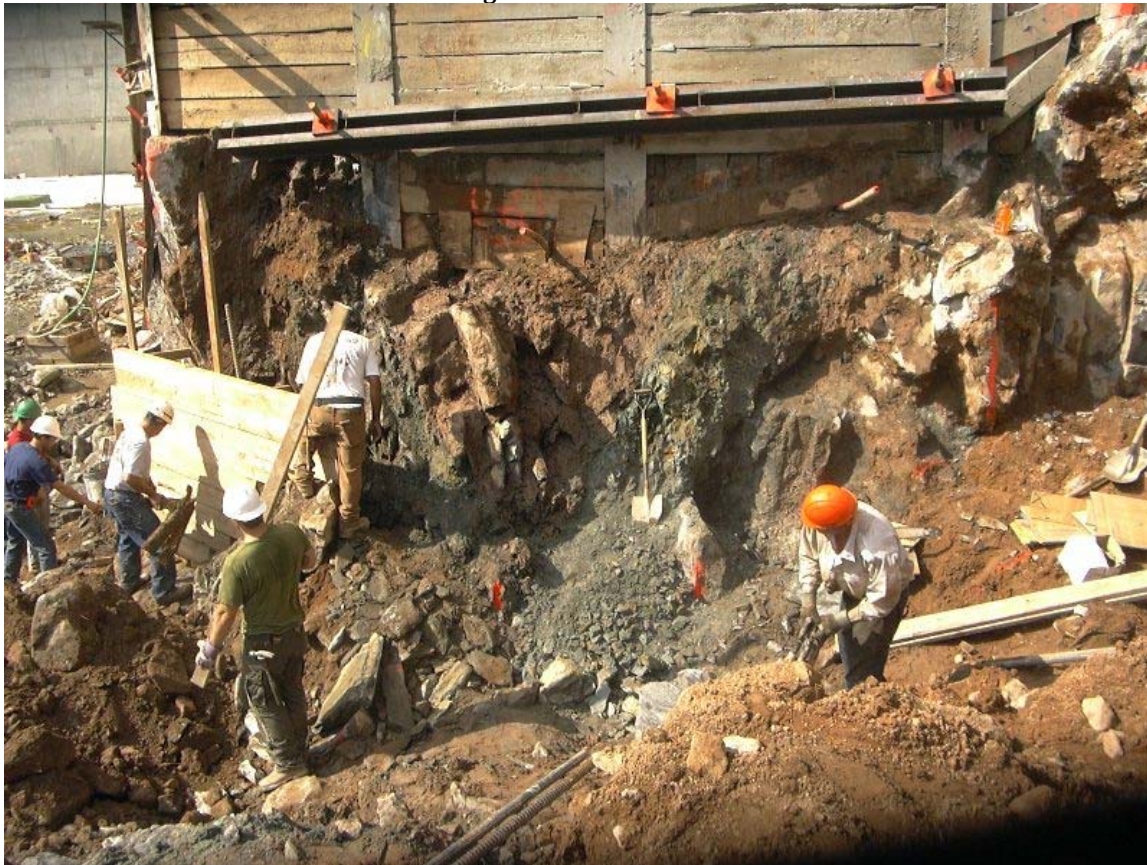
**Photo 7 New Sheeting Installed Several Feet Away From Original. Note Weathered Condition of Rock**

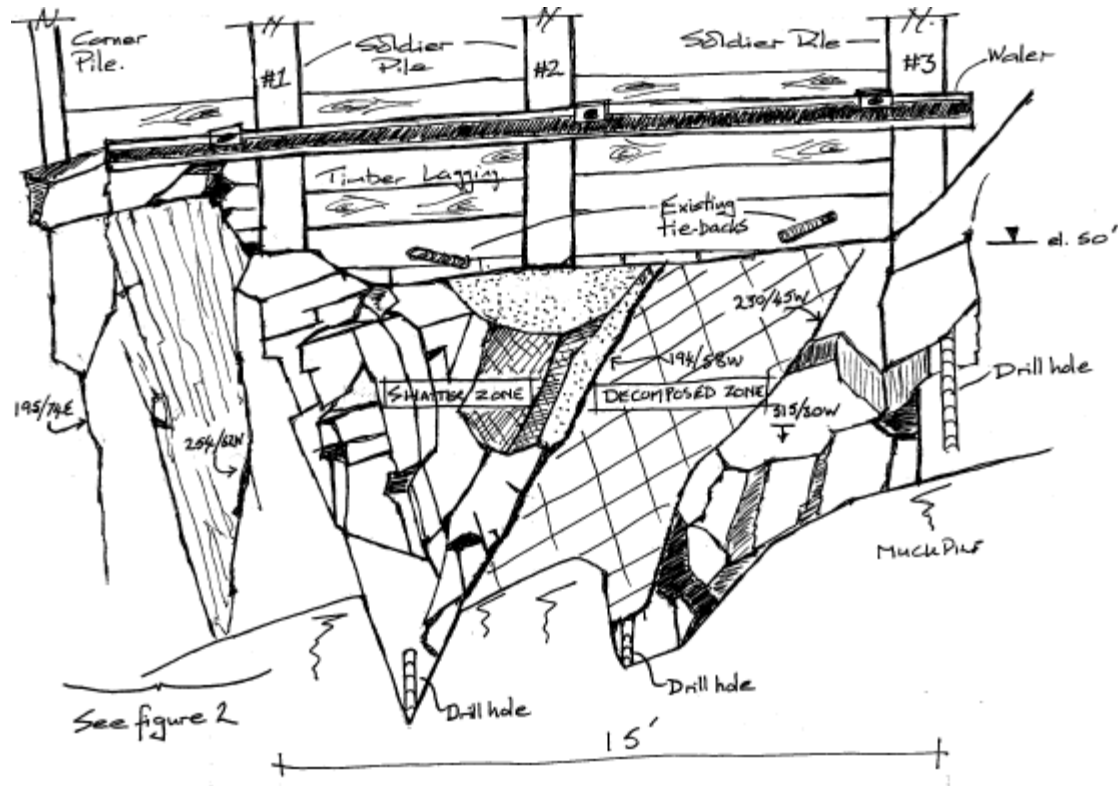
Figure 1.

The altered region is approximately 6 feet thick between #2 and #3 piles dipping between 50° and 60° to the southwest trending 194°. It is greenish grey, loose, highly to completely fractured and chloritic comprising silt to gravel-sized lithorelics with released quartz, plagioclase feldspar and mica. The quartz and feldspar are not discolored but the surface of the feldspar crystals is powdery and matte. The mica is dominantly biotite and softened, possibly transitioning to chlorite. There is evidence of oxidation of minerals and other mineralization that indicates accelerated decomposition due to exposure to near surface conditions but there may be a history of hydrothermal alteration in this zone as well.

**Figure 5 Sketch Rock Condition Under New Sheeting  
(several feet away from collapsed area)**

The weathered zone extends from the corner pile to pile #1 forming the westerly border of the altered region and is described as dark grey to black mica and possibly amphibole rich schist with extremely close to closely spaced, carbonate, hematite and chlorite coated sub-vertical fractures with sub-vertical conformable seams of decomposed mica schist and vertical convoluted foliation.

These conditions indicate a complex faulted region with significant drag and destruction. It is more than likely that this is an intersection of at least two faults with advanced decomposition and weathering. The product is an extremely weak rock mass with the properties of a loose soil in places.

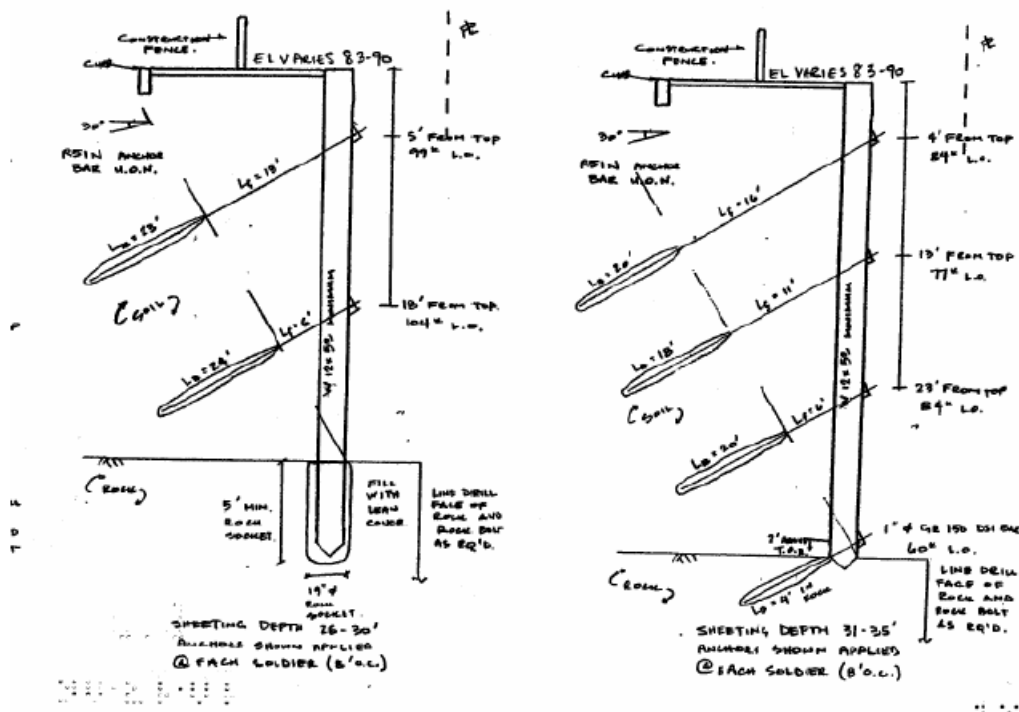
Figure 6 Sheeting Installation (from Drawing No. 2006-45-06s)

Figure shows the approximate bottom of piles obtained from observations of the debris. The drawings require four anchors be installed for piles at sheeting deeper than 30 feet (no socket). According to James Sheld, the piles were HP 12x74, grade 50.

Sheeting at piles #1, #2, #3 was approximately 35 feet. Post collapse investigation found that the piles (#1, #2, #3) were not set on competent rock. See 5.3. Sockets were not required by the design drawings for these piles; as a result, they were not installed. Socket marks were not found during the investigation, and it was revealed that the soil was not competent to sustain sockets. In addition, the pictures and measurements do not give a length of pile sufficient to fit a socket.

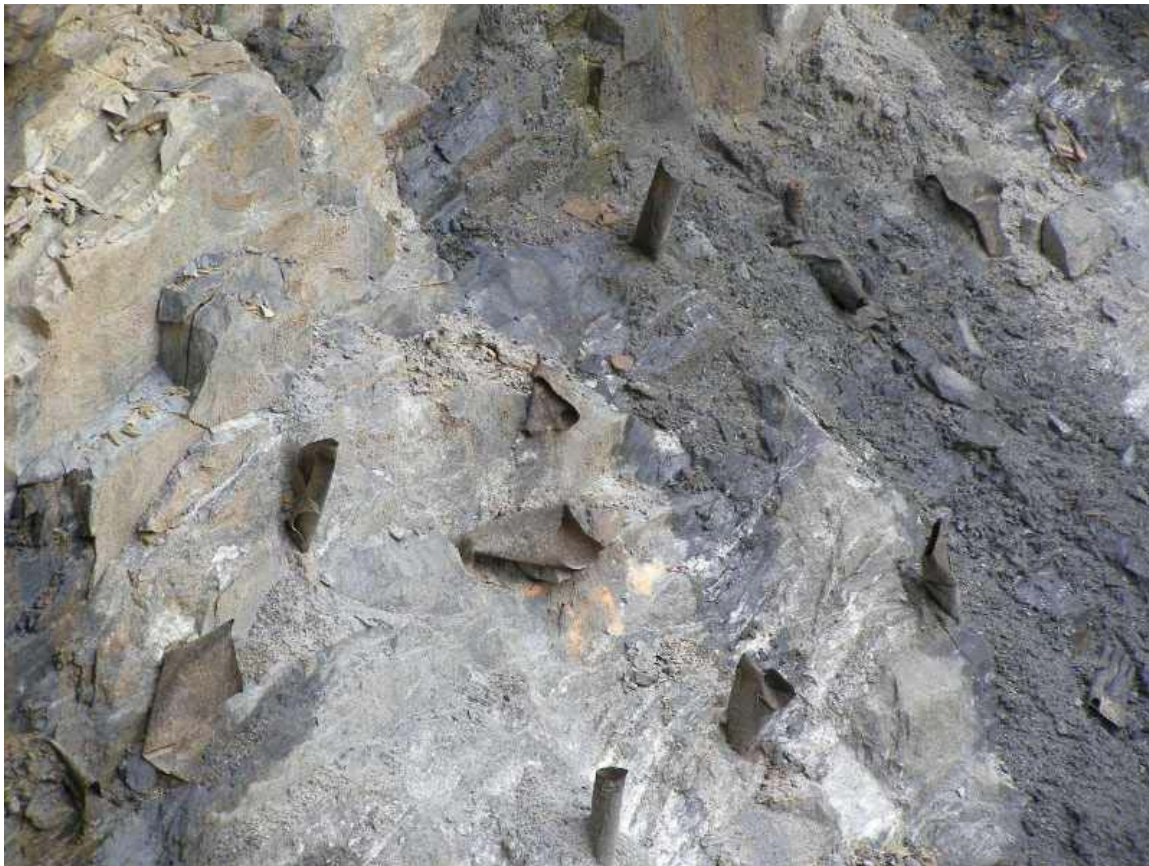
**Photo 9 – Marks of Drillings**

The bay was line drilled and all the blast holes were drilled and marked. The blaster noted during

drilling the blast holes that the ground was soft in the area of the failure. However, he did not consider it significant enough to alter the round or notify others.

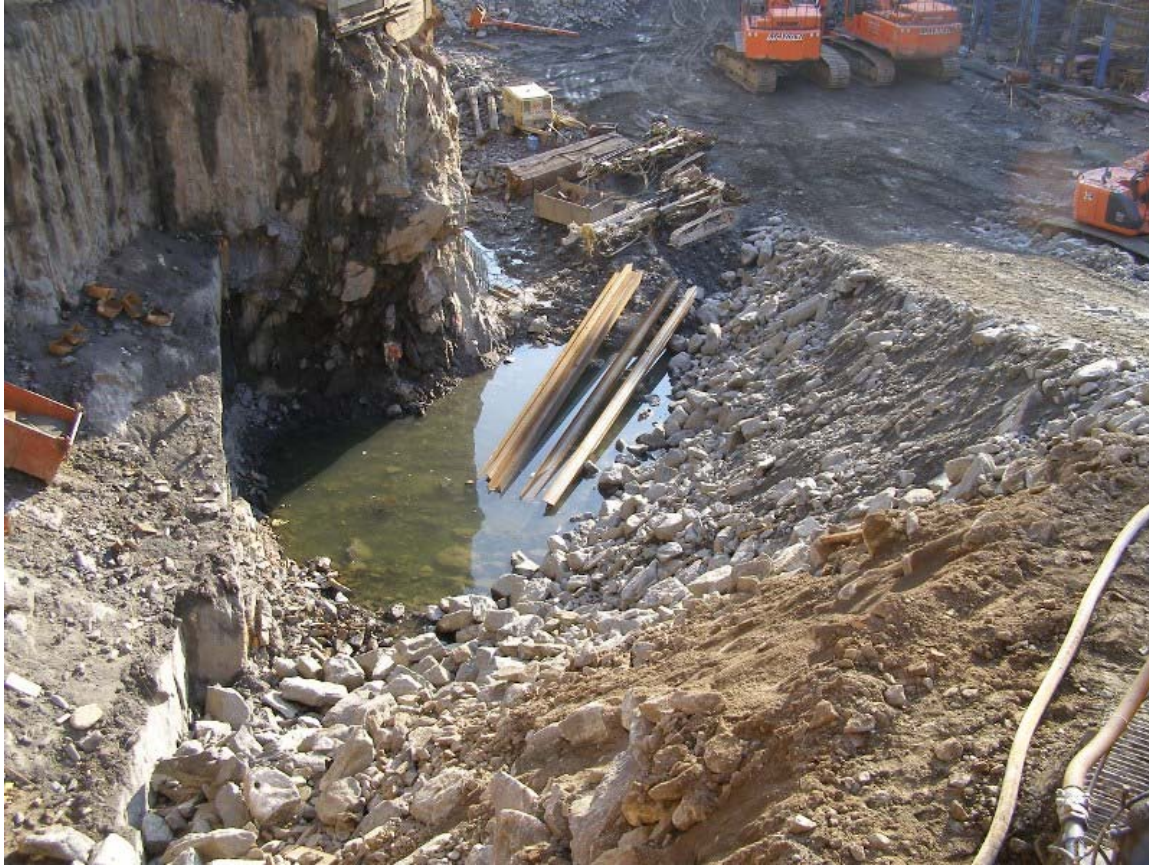
**Photo 10 – Face of Rock after Blasting on 7/25/07**

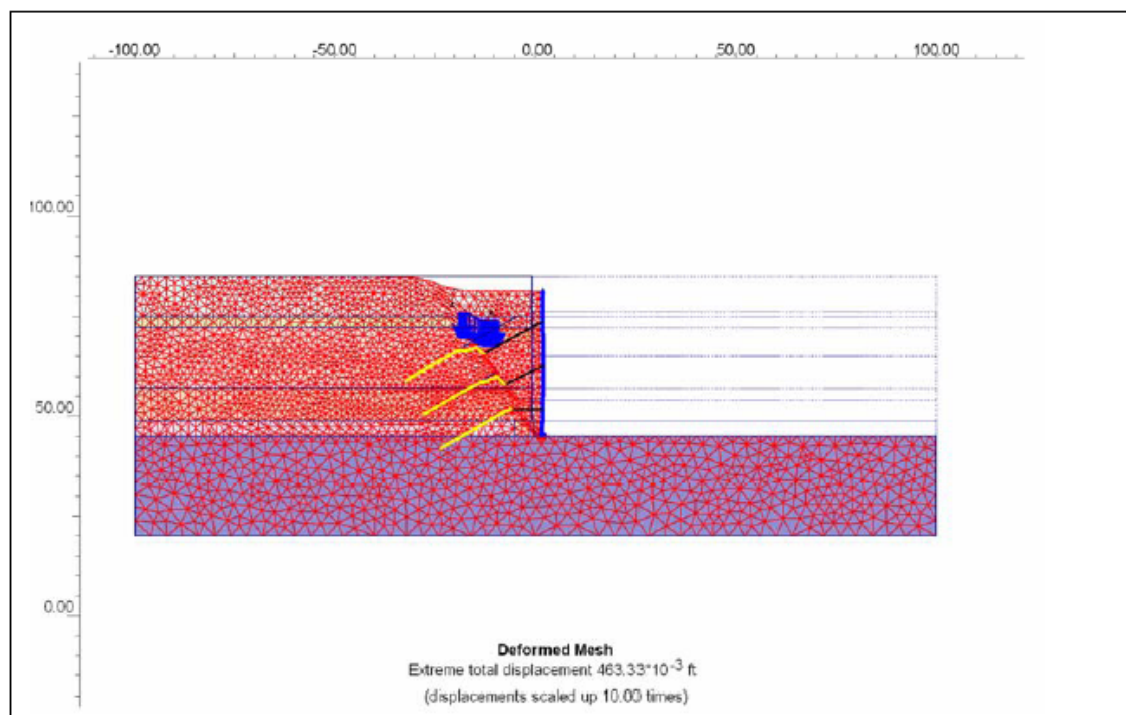
**Figure 15 –Plaxis Analysis Deformed Mesh for 6 inch prescribed settlement of the wall**

Both of these analyses show that the toe of the wall becomes unstable with the presence of the weak rock mass below the toe, causing downward and outward movement of the wall. This movement would have caused the bottom anchors to fail in tension or pullout, subsequently causing progressive failure of the middle and top anchors.

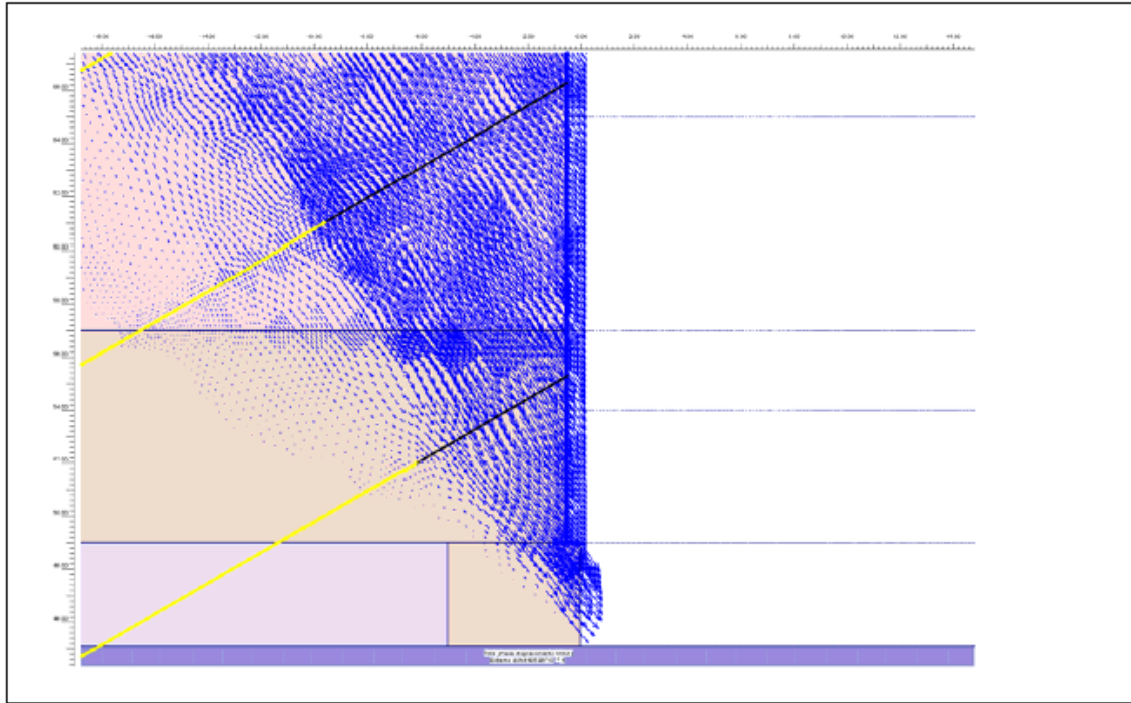
**Figure 16 Plaxis Analysis – Vector Displacement Vector for four additional feet of excavation**

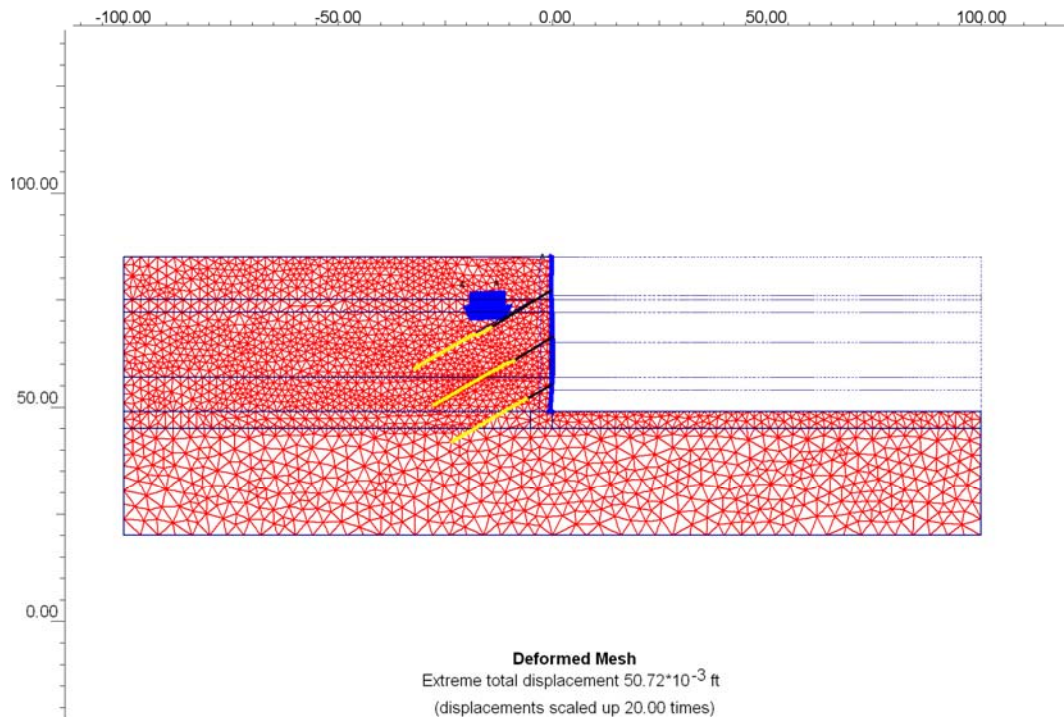
The second analysis simulates four more feet of excavation below the toe of the wall, replaces the material below the toe of the wall with soft elastic material and prescribes a 6-inches settlement to the wall. The deformed mesh of the analysis is shown below. The load in the bottom anchor is 302 kips.

**Figure 17 Plaxis Analysis –Deformed Mesh for excavation to bottom of pile**

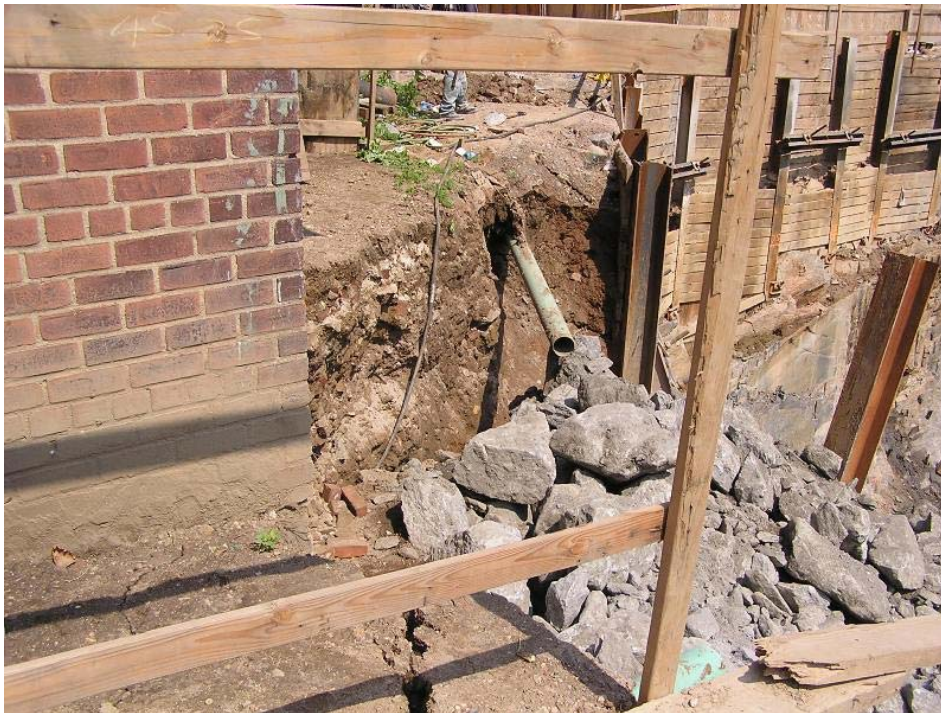
Water infiltration was present on the site, and a broken pipe was found in the incident area although it is not clear whether the breakage preceded the incident or not. In addition, two days before the incident there was a considerable rain with flash flood conditions throughout the region. Nevertheless, the setting of the sheeting boards was such that water could not have accumulated behind them. More importantly, calculations considering an increase of the hydrostatic pressure of 25% show that a sheeting system similar to the one in question would not have collapsed due to the presence of water.

**Photo 11 – Broken drainage pipe at collapse area**
