PROJECT NAME: NYC BOROUGH BASED JAILS SYSTEM, MANHATTAN  
FACILITY PROJECT

PROJECT OWNER: NYC DEPARTMENT OF DESIGN & CONSTRUCTION

PREPARED BY: TUTOR PERINI CORPORATION/O&G

# NOISE, VIBRATION & DUST MONITORING REPORT Number 003

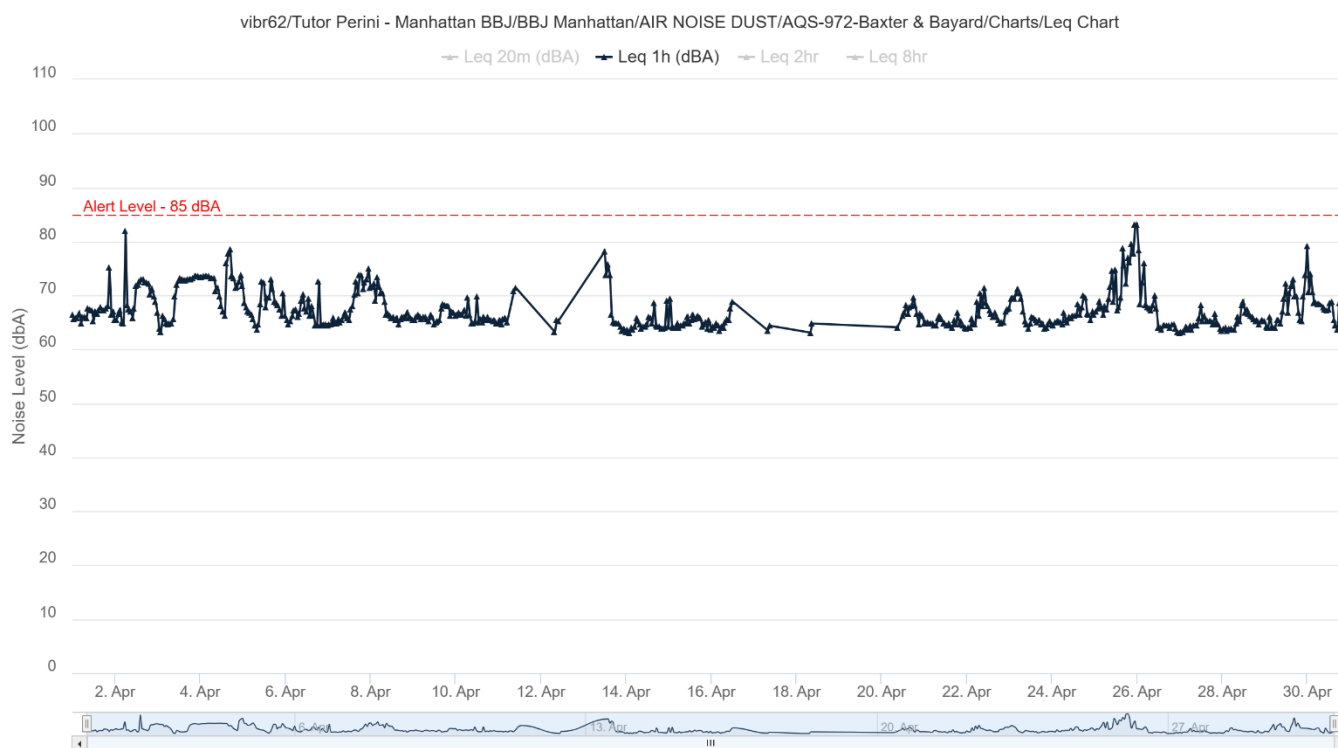
## Noise Monitoring Station #972 Leq – 1 hour

| 972 - APR-02-NIGHT | | 82 | | N/A | |
| 972 - APR-25-NIGHT | | 76.2 | | N/A | |
| 972 - APR-25-NIGHT | | 79.5 | | N/A | |
| 972 - APR-25-NIGHT | | 77.7 | | N/A | |
| 972 - APR-26-NIGHT | | 83.1 | | N/A | |

| 972 - APR-26-NIGHT | 83.2 | N/A | TPOG was not on site at the time, and the exceedance was not related to construction activities. |
| 972 - APR-26-NIGHT | 78.4 | N/A | TPOG was not on site at the time, and the exceedance was not related to construction activities. |
| 972 - APR-26-NIGHT | 75.9 | N/A | TPOG was not on site at the time, and the exceedance was not related to construction activities. |
| 972 - APR-30-NIGHT | 79.1 | N/A | TPOG was not on site at the time, and the exceedance was not related to construction activities. |

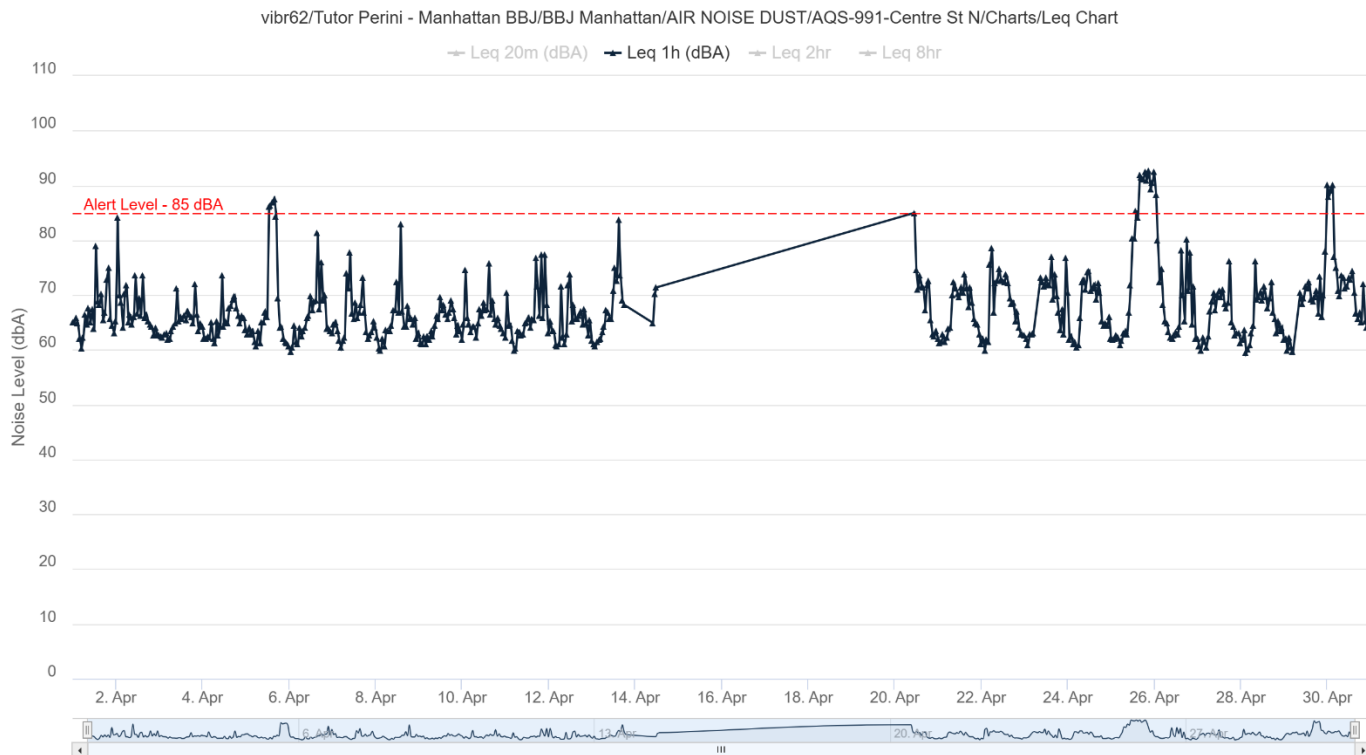
# Noise Monitoring Station #991 Leq – 1 hour

| 991-APR-02-NIGHT | 84.2 | N/A | TPOG was not on site at the time, and the exceedance was not related to construction activities. |
| 991-APR-05-DAY | 86.2 | N/A | TPOG was not on site at the time, and the exceedance was not related to construction activities. |
| 991-APR-05-DAY | 86.3 | N/A | TPOG was not on site at the time, and the exceedance was not related to construction activities. |
| 991-APR-05-DAY | 86.9 | N/A | TPOG was not on site at the time, and the exceedance was not related to construction activities. |
| 991-APR-05-DAY | 87.5 | N/A | TPOG was not on site at the time, and the exceedance was not related to construction activities. |
| 991-APR-11-NIGHT | 77.4 | N/A | TPOG was not on site at the time, and the exceedance was not related to construction activities. |
| 991-APR-22-NIGHT | 78.6 | N/A | TPOG was not on site at the time, and the exceedance was not related to construction activities. |
| 991-APR-23-NIGHT | 76.7 | N/A | TPOG was not on site at the time, and the exceedance was not related to construction activities. |
| 991-APR-25-DAY | 85.4 | N/A | TPOG was not on site at the time, and the exceedance was not related to construction activities. |

| 991-APR-25-DAY | 91.9 | N/A | TPOG was not on site at the time, and the exceedance was not related to construction activities. |
| 991-APR-25-DAY | 91.5 | N/A | TPOG was not on site at the time, and the exceedance was not related to construction activities. |
| 991-APR-25-DAY | 91.2 | N/A | TPOG was not on site at the time, and the exceedance was not related to construction activities. |
| 991-APR-25-DAY | 92.5 | N/A | TPOG was not on site at the time, and the exceedance was not related to construction activities. |
| 991-APR-25-NIGHT | 91 | N/A | TPOG was not on site at the time, and the exceedance was not related to construction activities. |
| 991-APR-25-NIGHT | 92.7 | N/A | TPOG was not on site at the time, and the exceedance was not related to construction activities. |
| 991-APR-25-NIGHT | 89.3 | N/A | TPOG was not on site at the time, and the exceedance was not related to construction activities. |
| 991-APR-25-NIGHT | 90.5 | N/A | TPOG was not on site at the time, and the exceedance was not related to construction activities. |
| 991-APR-26-NIGHT | 92.4 | N/A | TPOG was not on site at the time, and the exceedance was not related to construction activities. |
| 991-APR-26-NIGHT | 88.4 | N/A | TPOG was not on site at the time, and the exceedance was not related to construction activities. |
| 991-APR-26-NIGHT | 79.9 | N/A | TPOG was not on site at the time, and the exceedance was not related to construction activities. |
| 991-APR-26-NIGHT | 77.8 | N/A | TPOG was not on site at the time, and the exceedance was not related to construction activities. |
| 991-APR-29-NIGHT | 78 | N/A | TPOG was not on site at the time, and the exceedance was not related to construction activities. |

| 991-APR-30-NIGHT | 90.1 | N/A | TPOG was not on site at the time, and the exceedance was not related to construction activities. |
| 991-APR-30-NIGHT | 88 | N/A | TPOG was not on site at the time, and the exceedance was not related to construction activities. |
| 991-APR-30-NIGHT | 89.2 | N/A | TPOG was not on site at the time, and the exceedance was not related to construction activities. |
| 991-APR-30-NIGHT | 76.9 | N/A | TPOG was not on site at the time, and the exceedance was not related to construction activities. |

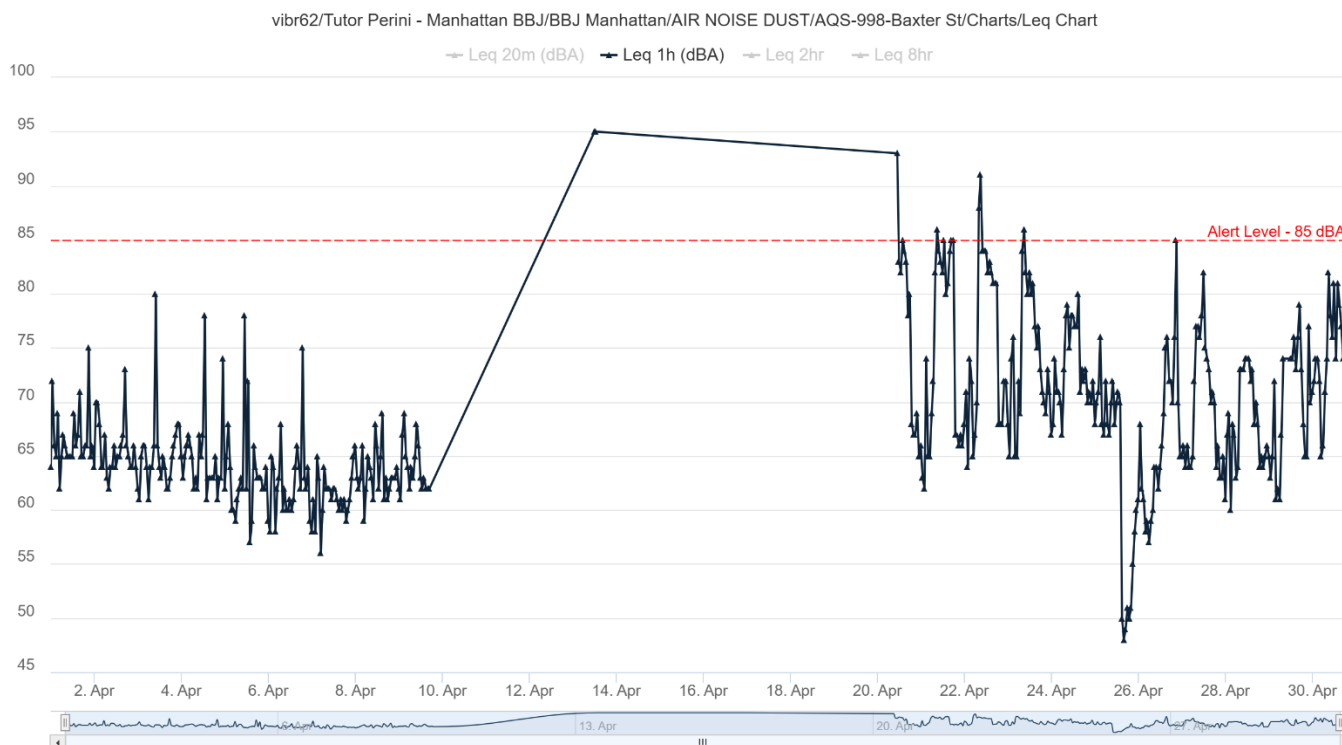
## Noise Monitoring Station #998 Leq – 1 hour

| 998-APR-13-DAY | 95 | N/A | This noise meter was powered down prior to and after this singular reading occurred. This reading is likely due to power issues on the device. Site work preparation and mobilization activities occurred across the project site on April 13, 2026. No noise monitoring equipment at any location recorded an exceedance during these activities. |
| 998-APR-20-DAY | 93 | N/A | The construction team conducted work involving jackhammers, which resulted in elevated noise levels. Once the issue was identified, mitigation efforts were analyzed, and the subcontractor began implementing sound barriers and other appropriate noise control measures. Moving forward, all jackhammering and other high-noise activities will be performed with noise barriers in place to minimize impact. |
| 998-APR-21-DAY | 86 | N/A | The construction team conducted work involving jackhammers, which resulted in elevated noise levels. Once the issue was identified, mitigation efforts were analyzed, and the subcontractor began implementing sound barriers and other appropriate noise control measures. Moving forward, all jackhammering and other high-noise activities will be performed with noise barriers in place to minimize impact. |
| 998-APR-22-DAY | 88 | N/A | The construction team conducted work involving jackhammers, which resulted in elevated noise levels. Once the issue was identified, mitigation efforts were |

| | | | analyzed, and the subcontractor began implementing sound barriers and other appropriate noise control measures. Moving forward, all jackhammering and other high-noise activities will be performed with noise barriers in place to minimize impact. |
| 998-APR-22-DAY | 91 | N/A | The construction team conducted work involving jackhammers, which resulted in elevated noise levels. Once the issue was identified, mitigation efforts were analyzed, and the subcontractor began implementing sound barriers and other appropriate noise control measures. Moving forward, all jackhammering and other high-noise activities will be performed with noise barriers in place to minimize impact. |
| 998-APR-23-DAY | 86 | 82 | Based on a review of site operations, construction activities were not the dominant contributor to the exceedance. The exceedance was primarily attributed to early temp SOE work & background urban noise sources such as vehicular traffic and other off-site ambient conditions. Sound barriers installation along Baxter Street were completed on this day. |

Between April 20, 2026, and April 22, 2026, four noise exceedances occurred due to construction-related activities. Additional readings approached the allowable limit but did not exceed it. During this period, the construction team performed demolition activities involving jackhammering. These activities occurred during the reported timeframes, and noise barriers should have been in place.

Once the elevated noise levels were identified, mitigation efforts were analyzed, and the subcontractor was directed to implement appropriate noise control measures, including the installation of sound barriers to reduce impacts.

The construction team has since installed sound barriers along the construction fence on Baxter Street and Centre Street, as well as implementing localized sound barriers at noise-generating activities. Since implementing these measures, noise levels have dropped significantly. Moving forward, jackhammering and secant pile drilling activities will be performed with noise barriers in place.

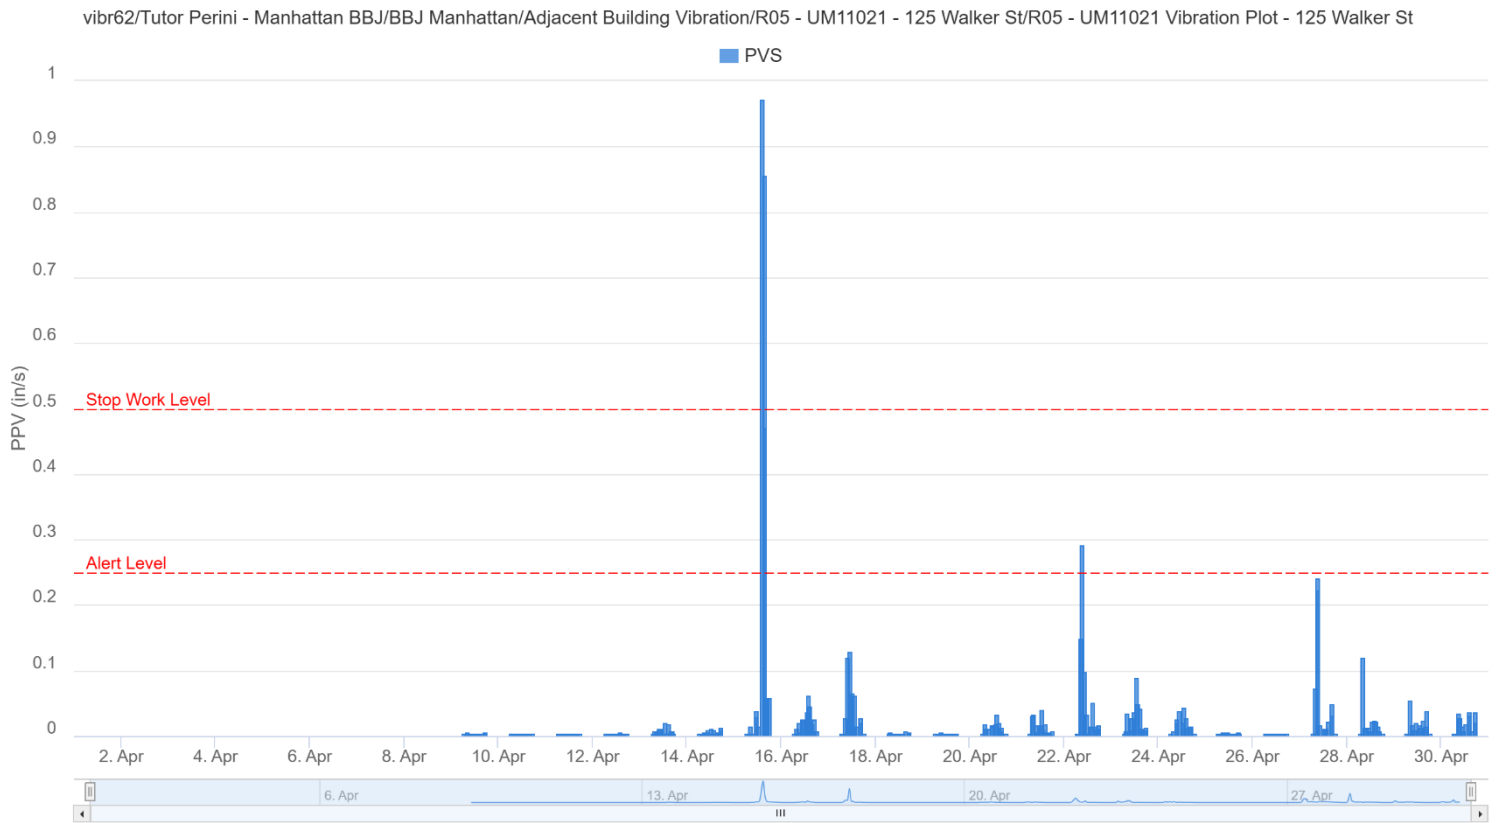
## R05

| Date: Time | Maximum Vibration Level before Corrective Action (in/sec) | Maximum Vibration Level after Corrective Action (in/sec) | Corrective Action |
|---|---|---|---|
| APR 15 – R05 | 0.971 | N/A | During the exceedance, Early temp SOE work was performed near Monitor R06, which did not register any alerts or exceedances. Monitor R04 also showed no exceedance. A site visit by the Engineer of Record on April 23, 2026, identified no issues in the area. |

Monitor R05 at Chung Pak recorded a single exceedance on April 15, 2026, while the other monitors in the same building (R04 and R06) did not register any stop-work exceedances. Early temp SOE Work was occurring near Monitor R06 at the time without triggering an exceedance. Following identification of the event, the Engineer of Record inspected the installation and surrounding area on April 23, 2026, and found no issues. The exceedance at R05 may be attributed to vibration or external environmental factors at the installation location.

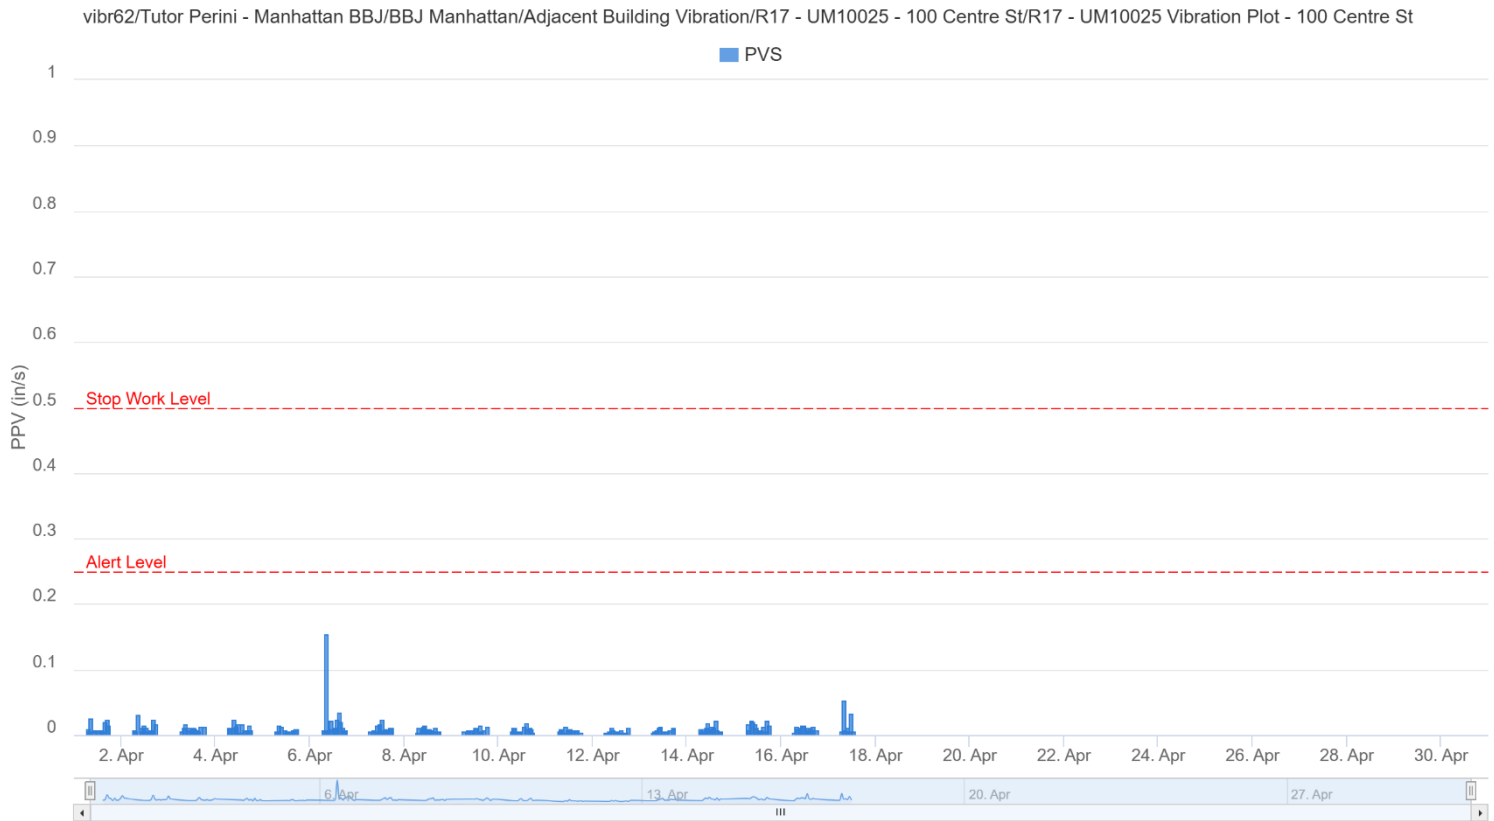
## R17

The R17 vibration monitor at 100 Centre Street was temporarily offline from April 17<sup>th</sup> to May 21<sup>st</sup> due to a modem failure. The modem was replaced on May 21, 2026. A Vibranalysis site representative was present during the outage and collected raw data directly at the device location. Review of the raw data indicates that no vibration exceedances occurred during this period for the month.

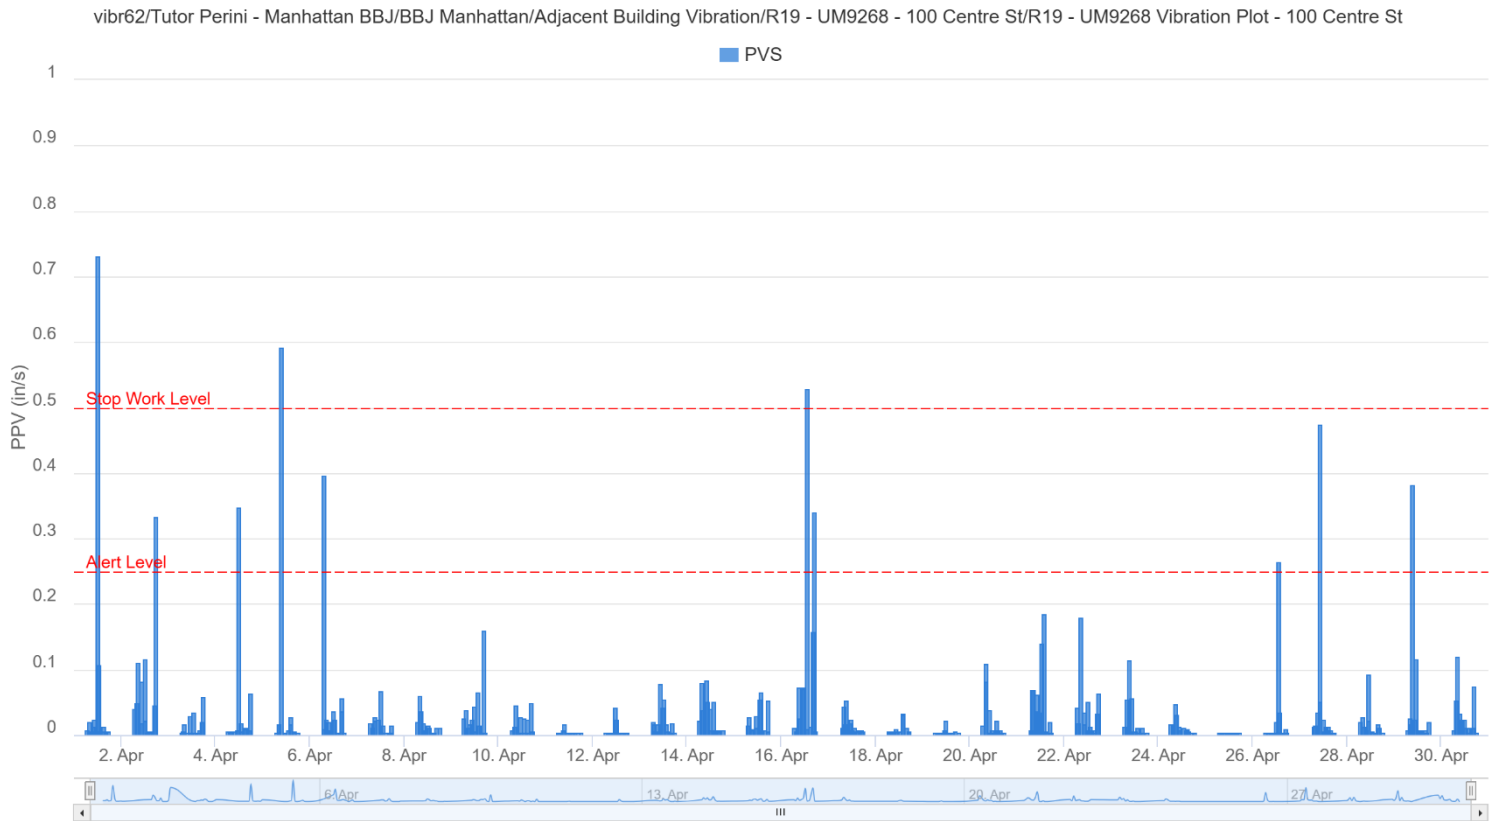
## R19

| Date: Time | Maximum Vibration Level before Corrective Action (in/sec) | Maximum Vibration Level after Corrective Action (in/sec) | Corrective Action |
|---|---|---|---|
| APR 1 - R19 | 0.73 | N/A | No action required. Vibration caused by exercise equipment and free weights. |
| APR 5 – R19 | 0.591 | N/A | No action required. Vibration caused by exercise equipment and free weights. |
| APR 19 – R19 | 0.528 | N/A | No action required. Vibration caused by exercise equipment and free weights. |

Four stop work exceedances occurred in April 2026. Vibration monitor R19 installed at 100 Centre St is in an area known for elevated vibration levels primarily caused by exercise equipment and free weights. This monitor will be relocated in the month of May.
