PROJECT NAME: NYC BOROUGH BASED JAILS SYSTEM, MANHATTAN  
FACILITY PROJECT

# NOISE, VIBRATION & DUST MONITORING REPORT Number 005

| DDC. Project ID: | | BBJ-MN-FAC | | Period Start: 06/01/26 End: 06/30/26 | |
| Project Name: | | Manhattan Borough-Based Jail Facility | | | |

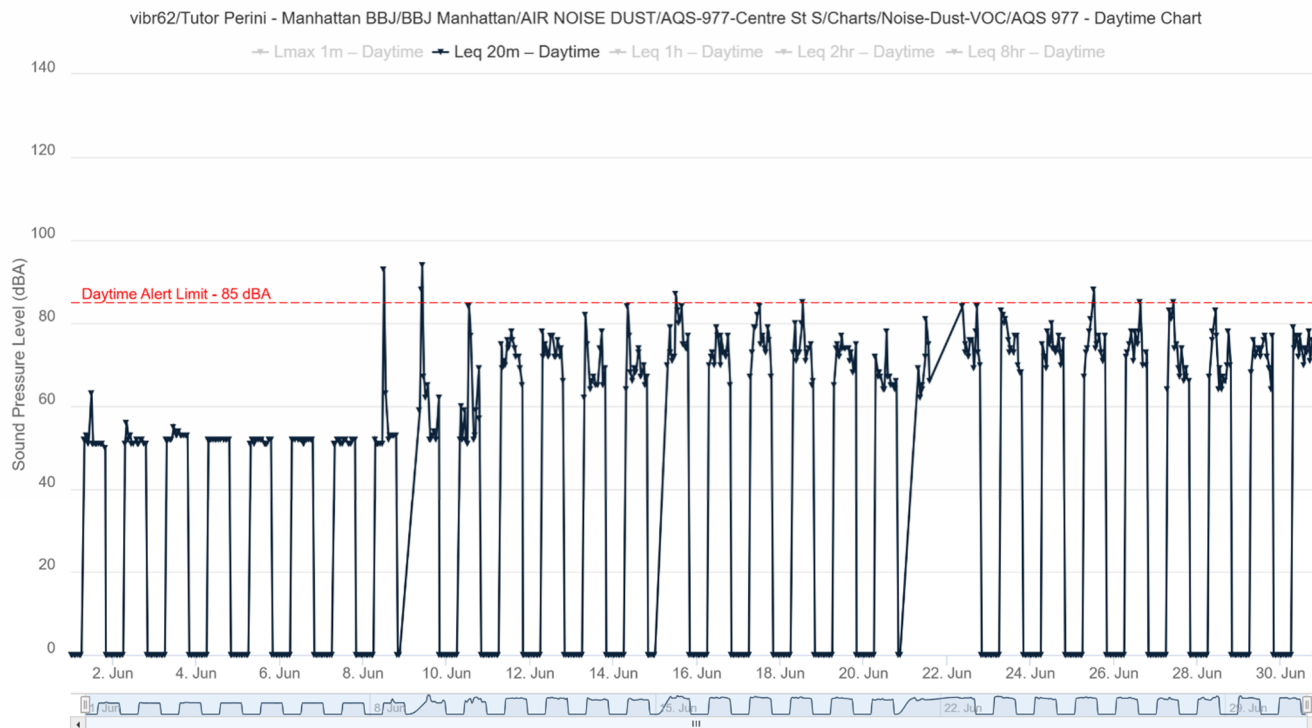
## Noise Monitoring Station #977 Leq – 20minute - Daytime

| 977 - JUNE-09-DAY | 93 | N/A | Based on a review of site operations, construction activities were not identified as the dominant contributor to the noise exceedance. During this period, early support-of-excavation activities were underway, including excavation, installation of bracing systems, secant pile drilling and concrete placement, and removal of existing foundations. Noise levels returned to normal immediately following the isolated spike, indicating that the exceedance was short in duration and likely influenced by a combination of construction and ambient urban noise sources. | | |

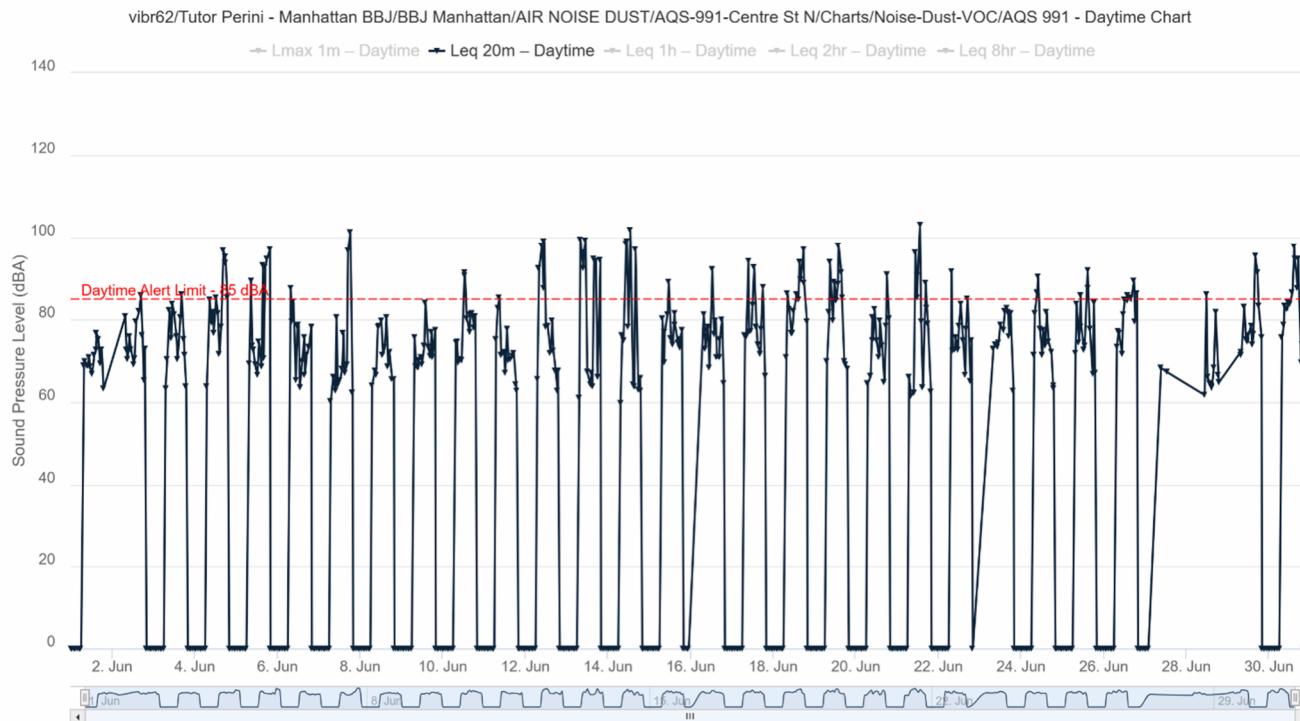
## Noise Monitoring Station #991 Leq – 20minute - Daytime

| 991 - JUNE-04-DAY | 91.4 | N/A | Based on a review of site operations, noise exceedance was attributed to a combination of construction activities and off-site ambient noise sources. Secant pile drilling and pipe pile foundation removal were ongoing throughout the day without triggering exceedances. These observations suggest that construction activities were not the dominant contributor to the exceedance. Noise exceedance levels continued past working hours indicating an external source of noise. |
| 991 - JUNE-04-DAY | 93 | N/A | Based on a review of site operations, noise exceedance was attributed to a combination of construction activities and off-site ambient noise sources. At the time, the construction team was performing secant pile drilling on the west side of the site and removing pipe pile foundations at the northwest corner. These activities had been ongoing throughout the day without triggering exceedance. The isolated exceedance occurred during daily demobilization activities. Noise exceedance levels continued past working hours indicating an external source of noise. |

| 991 - JUNE-05-DAY | 86.3 | N/A | Based on a review of site operations, the noise exceedance was attributed to a combination of construction activities and off-site ambient noise sources. Secant pile drilling and pipe pile foundation removal were ongoing throughout the day without generating exceedances, indicating that construction activities were not the dominant contributor to the isolated event. This isolated exceedance took place around 9:00AM. The 1-hour LEQ returned to acceptable levels by 10:00AM while continuing the same construction activities. |
| 991 - JUNE-05-DAY | 86.8 | N/A | Based on a review of site operations, the noise exceedance was attributed to a combination of construction activities and off-site ambient noise sources. Secant pile drilling and pipe pile foundation removal were ongoing throughout the day without generating exceedances, indicating that construction activities were not the dominant contributor to the isolated event. |
| 991 - JUNE-05-DAY | 89.9 | N/A | Based on a review of site operations, the noise exceedance was attributed to a combination of construction activities and off-site ambient noise sources. Secant pile drilling and pipe pile foundation removal were ongoing throughout the day without generating exceedances, indicating that construction activities were not the dominant contributor to the isolated event. |
| 991 - JUNE-05-DAY | 98.8 | N/A | Based on a review of site operations, the noise exceedance was attributed to a combination of construction activities and background urban noise. Secant pile drilling and pipe pile foundation removal were ongoing throughout the day without triggering exceedances. This exceedance occurred during daily demobilization activities. Noise exceedance levels continued past working hours indicating an external source of noise. |

| 991 - JUNE-06-DAY | 90.1 | N/A | During this monitoring period, TPOG was onsite installing sound blankets on the Chung Pak Building. This work is performed with manlifts hand tools and does not generate significant noise. Based on a review of site activities and monitoring data, the exceedance was primarily attributed to background urban noise sources, including vehicular traffic and other off-site ambient conditions, rather than construction-related operations. |
| 991 - JUNE-06-DAY | 90.9 | N/A | During this monitoring period, TPOG was onsite installing sound blankets on the Chung Pak Building. This work is not typically associated with elevated noise generation. Based on a review of site activities and monitoring data, the exceedance was primarily attributed to background urban noise sources, including vehicular traffic and other off-site ambient conditions, rather than construction-related operations. |

| 991 - JUNE-10-DAY | 85.2 | N/A | Based on a review of site operations, construction activities were not identified as the primary source of the noise exceedance. The elevated noise levels were instead attributed to background urban noise sources, including vehicular traffic and other off-site ambient conditions. At the time of the exceedance, early support-of-excavation activities were underway, including excavation, installation of bracing systems, secant pile drilling and concrete placement, and removal of existing foundations. Hand-held measurements taken between monitoring intervals did not indicate elevated noise levels. Additionally, similar construction activities performed along Baxter Street during the same period did not result in any noise exceedances, further supporting the conclusion that site operations were not the dominant contributor to the event. |

| 991 - JUNE-10-DAY | 89.6 | N/A | Based on a review of site operations, construction activities were not identified as the primary source of the noise exceedance. The elevated noise levels were instead attributed to background urban noise sources, including vehicular traffic and other off-site ambient conditions. At the time of the exceedance, early support-of-excavation activities were underway, including excavation, installation of bracing systems, secant pile drilling and concrete placement, and removal of existing foundations. Handheld measurements taken between monitoring intervals did not indicate elevated noise levels. Additionally, similar construction activities performed along Baxter Street during the same period did not result in any noise exceedances, further supporting the conclusion that site operations were not the dominant contributor to the event. |
| 991 - JUNE-10-DAY | 90.3 | N/A | Based on a review of site operations, construction activities were not identified as the primary source of the noise exceedance. The elevated noise levels were instead attributed to background urban noise sources, including vehicular traffic and other off-site ambient conditions. At the time of the exceedance, early support-of-excavation activities were underway, including excavation, installation of bracing systems, secant pile drilling and concrete placement, and removal of existing foundations. Handheld measurements taken between monitoring intervals did not indicate elevated noise levels. Additionally, similar construction activities performed along Baxter Street during the same period did not result in any noise exceedances, further supporting the conclusion that site operations were not the dominant contributor to the event. |

| 991 - JUNE-12-DAY | 86.8 | N/A | Based on a review of site operations, construction activities were not identified as the primary source of the noise exceedance. The elevated noise levels were instead attributed to background urban noise sources, including vehicular traffic and other off-site ambient conditions. At the time of the exceedance, early support- |

| | | | of-excavation activities were underway, including excavation, installation of bracing systems, secant pile drilling and concrete placement, and removal of existing foundations. Handheld measurements taken between monitoring intervals did not indicate elevated noise levels. Additionally, similar construction activities performed along Baxter Street during the same period did not result in any noise exceedances, further supporting the conclusion that site operations were not the dominant contributor to the event. |
| 991 - JUNE-12-DAY | 91.2 | N/A | Based on a review of site operations, construction activities were not identified as the primary source of the noise exceedance. The elevated noise levels were instead attributed to background urban noise sources, including vehicular traffic and other off-site ambient conditions. At the time of the exceedance, early support-of-excavation activities were underway, including excavation, installation of bracing systems, secant pile drilling and concrete placement, and removal of existing foundations. Handheld measurements taken between monitoring intervals did not indicate elevated noise levels. Additionally, similar construction activities performed along Baxter Street during the same period did not result in any noise exceedances, further supporting the conclusion that site operations were not the dominant contributor to the event. |
| 991 - JUNE-12-DAY | 98.7 | N/A | Based on a review of site operations, construction activities were not identified as the primary source of the noise exceedance. The elevated noise levels were instead attributed to background urban noise sources, including vehicular traffic and other off-site ambient conditions. At the time of the exceedance, early support-of-excavation activities were underway, including excavation, installation of bracing systems, secant pile drilling and concrete placement, and removal of existing foundations. Handheld measurements taken between monitoring intervals did not indicate elevated noise levels. Additionally, similar construction activities performed along Baxter Street during the same period did not result in any noise exceedances, further supporting the conclusion that site operations were not the dominant contributor to the event. |

| 991 - JUNE-12-DAY | 99.3 | N/A | Based on a review of site operations, construction activities were not identified as the primary source of the noise exceedance. The elevated noise levels were instead attributed to background urban noise sources, including vehicular traffic and other off-site ambient conditions. At the time of the exceedance, early support-of-excavation activities were underway, including excavation, installation of bracing systems, secant pile drilling and concrete placement, and removal of existing foundations. Handheld measurements taken between monitoring intervals did not indicate elevated noise levels. Additionally, similar construction activities performed along Baxter Street during the same period did not result in any noise exceedances, further supporting the conclusion that site operations were not the dominant contributor to the event. |

| 991 - JUNE-15-DAY | 87.7 | N/A | Based on a review of site operations, construction activities were not identified as the primary source of the noise exceedance. The elevated noise levels were instead attributed to background urban noise sources, including vehicular traffic and other off-site ambient conditions. At the time of the exceedance, early support- |

| | | | of-excavation activities were underway, including excavation, installation of bracing systems, secant pile drilling and concrete placement, and removal of existing foundations. Handheld measurements taken between monitoring intervals did not indicate elevated noise levels. Additionally, similar construction activities performed along Baxter Street during the same period did not result in any noise exceedances, further supporting the conclusion that site operations were not the dominant contributor to the event. |
| 991 - JUNE-16-DAY | 91.3 | N/A | Based on a review of site operations, construction activities were not identified as the primary source of the noise exceedance. The elevated noise levels were instead attributed to background urban noise sources, including vehicular traffic and other off-site ambient conditions. At the time of the exceedance, early support-of-excavation activities were underway, including excavation, installation of bracing systems, secant pile drilling and concrete placement, and removal of existing foundations. Handheld measurements taken between monitoring intervals did not indicate elevated noise levels. Additionally, similar construction activities performed along Baxter Street during the same period did not result in any noise exceedances, further supporting the conclusion that site operations were not the dominant contributor to the event. |
| 991 - JUNE-16-DAY | 86.2 | N/A | Based on a review of site operations, construction activities were not identified as the primary source of the noise exceedance. The elevated noise levels were instead attributed to background urban noise sources, including vehicular traffic and other off-site ambient conditions. At the time of the exceedance, early support-of-excavation activities were underway, including excavation, installation of bracing systems, secant pile drilling and concrete placement, and removal of existing foundations. Handheld measurements taken between monitoring intervals did not indicate elevated noise levels. Additionally, similar construction activities performed along Baxter Street during the same period did not result in any noise exceedances, further supporting the conclusion that site operations were not the dominant contributor to the event. |

| 991 - JUNE-17-DAY | 88.4 | N/A | Based on a review of site operations, construction activities were not identified as the primary source of the noise exceedance. The elevated noise levels were instead attributed to background urban noise sources, including vehicular traffic and other off-site ambient conditions. At the time of the exceedance, early support-of-excavation activities were underway, including excavation, installation of bracing systems, secant pile drilling and concrete placement, and removal of existing foundations. Handheld measurements taken between monitoring intervals did not indicate elevated noise levels. Additionally, similar construction activities performed along Baxter Street during the same period did not result in any noise exceedances, further supporting the conclusion that site operations were not the dominant contributor to the event. |
| 991 - JUNE-17-DAY | 91 | N/A | Based on a review of site operations, construction activities were not identified as the primary source of the noise exceedance. The elevated noise levels were instead attributed to background urban noise sources, including vehicular traffic and other off-site ambient conditions. At the time of the exceedance, early support-of-excavation activities were underway, including excavation, installation of bracing systems, secant pile drilling and concrete placement, and removal of existing foundations. Handheld measurements taken between monitoring intervals did not indicate elevated noise levels. Additionally, similar construction activities performed along Baxter Street during the same period did not result in any noise exceedances, further supporting the conclusion that site operations were not the dominant contributor to the event. |
| 991 - JUNE-18-DAY | 87.5 | N/A | Based on a review of site operations, construction activities were not identified as the primary source of the noise exceedance. The elevated noise levels were instead attributed to background urban noise sources, including vehicular traffic and other off-site ambient conditions. At the time of the exceedance, early support-of-excavation activities were underway, including excavation, installation of bracing systems, secant pile drilling and concrete placement, and removal of existing foundations. Handheld measurements taken between monitoring intervals did not indicate elevated noise levels. Additionally, similar construction activities performed along Baxter Street during the same period |

| 991 - JUNE-18-DAY | 91.8 | N/A | Based on a review of site operations, construction activities were not identified as the primary source of the noise exceedance. The elevated noise levels were instead attributed to background urban noise sources, including vehicular traffic and other off-site ambient conditions. At the time of the exceedance, early support-of-excavation activities were underway, including excavation, installation of bracing systems, secant pile drilling and concrete placement, and removal of existing foundations. Handheld measurements taken between monitoring intervals did not indicate elevated noise levels. Additionally, similar construction activities performed along Baxter Street during the same period did not result in any noise exceedances, further supporting the conclusion that site operations were not the dominant contributor to the event. |
| 991 - JUNE-18-DAY | 94.5 | N/A | Based on a review of site operations, construction activities were not identified as the primary source of the noise exceedance. The elevated noise levels were instead attributed to background urban noise sources, including vehicular traffic and other off-site ambient conditions. At the time of the exceedance, early support-of-excavation activities were underway, including excavation, installation of bracing systems, secant pile drilling and concrete placement, and removal of existing foundations. Handheld measurements taken between monitoring intervals did not indicate elevated noise levels. Additionally, similar construction activities performed along Baxter Street during the same period did not result in any noise exceedances, further supporting the conclusion that site operations were not the dominant contributor to the event. |
| 991 - JUNE-18-DAY | 94.4 | N/A | Based on a review of site operations, construction activities were not identified as the primary source of the noise exceedance. The elevated noise levels were instead attributed to background urban noise sources, including vehicular traffic and other off-site ambient conditions. At the time of the exceedance, early support-of-excavation activities were underway, including excavation, installation of bracing systems, secant pile drilling and concrete placement, and removal of existing |

| | | | foundations. Handheld measurements taken between monitoring intervals did not indicate elevated noise levels. Additionally, similar construction activities performed along Baxter Street during the same period did not result in any noise exceedances, further supporting the conclusion that site operations were not the dominant contributor to the event. |
| 991 - JUNE-19-DAY | 92.4 | N/A | Based on a review of site operations, construction activities were not identified as the primary source of the noise exceedance. The elevated noise levels were instead attributed to background urban noise sources, including vehicular traffic and other off-site ambient conditions. At the time of the exceedance, early support-of-excavation activities were underway, including excavation, installation of bracing systems, secant pile drilling and concrete placement, and removal of existing foundations. Handheld measurements taken between monitoring intervals did not indicate elevated noise levels. Additionally, similar construction activities performed along Baxter Street during the same period did not result in any noise exceedances, further supporting the conclusion that site operations were not the dominant contributor to the event. |
| 991 - JUNE-19-DAY | 89.6 | N/A | Based on a review of site operations, construction activities were not identified as the primary source of the noise exceedance. The elevated noise levels were instead attributed to background urban noise sources, including vehicular traffic and other off-site ambient conditions. At the time of the exceedance, early support-of-excavation activities were underway, including excavation, installation of bracing systems, secant pile |

| | | | drilling and concrete placement, and removal of existing foundations. Handheld measurements taken between monitoring intervals did not indicate elevated noise levels. Additionally, similar construction activities performed along Baxter Street during the same period did not result in any noise exceedances, further supporting the conclusion that site operations were not the dominant contributor to the event. |
| 991 - JUNE-19-DAY | 85.8 | N/A | Based on a review of site operations, construction activities were not identified as the primary source of the noise exceedance. The elevated noise levels were instead attributed to background urban noise sources, including vehicular traffic and other off-site ambient conditions. At the time of the exceedance, early support-of-excavation activities were underway, including excavation, installation of bracing systems, secant pile drilling and concrete placement, and removal of existing foundations. Handheld measurements taken between monitoring intervals did not indicate elevated noise levels. Additionally, similar construction activities performed along Baxter Street during the same period did not result in any noise exceedances, further supporting the conclusion that site operations were not the dominant contributor to the event. |
| 991 - JUNE-19-DAY | 86.9 | N/A | Based on a review of site operations, construction activities were not identified as the primary source of the noise exceedance. The elevated noise levels were instead attributed to background urban noise sources, including vehicular traffic and other off-site ambient conditions. At the time of the exceedance, early support-of-excavation activities were underway, including excavation, installation of bracing systems, secant pile drilling and concrete placement, and removal of existing foundations. Handheld measurements taken between monitoring intervals did not indicate elevated noise levels. Additionally, similar construction activities performed along Baxter Street during the same period did not result in any noise exceedances, further supporting the conclusion that site operations were not the dominant contributor to the event. |

| | | | conditions. At the time of the exceedance, early support-of-excavation activities were underway, including excavation, installation of bracing systems, secant pile drilling and concrete placement, and removal of existing foundations. Handheld measurements taken between monitoring intervals did not indicate elevated noise levels. Additionally, similar construction activities performed along Baxter Street during the same period did not result in any noise exceedances, further supporting the conclusion that site operations were not the dominant contributor to the event. |
| 991 - JUNE-19-DAY | 93 | N/A | Based on a review of site operations, construction activities were not identified as the primary source of the noise exceedance. The elevated noise levels were instead attributed to background urban noise sources, including vehicular traffic and other off-site ambient conditions. At the time of the exceedance, early support-of-excavation activities were underway, including excavation, installation of bracing systems, secant pile drilling and concrete placement, and removal of existing foundations. Handheld measurements taken between monitoring intervals did not indicate elevated noise levels. Additionally, similar construction activities performed along Baxter Street during the same period did not result in any noise exceedances, further supporting the conclusion that site operations were not the dominant contributor to the event. |
| 991 - JUNE-19-DAY | 94.7 | N/A | Based on a review of site operations, construction activities were not identified as the primary source of the noise exceedance. The elevated noise levels were instead attributed to background urban noise sources, including vehicular traffic and other off-site ambient conditions. At the time of the exceedance, early support-of-excavation activities were underway, including excavation, installation of bracing systems, secant pile drilling and concrete placement, and removal of existing foundations. Handheld measurements taken between monitoring intervals did not indicate elevated noise levels. Additionally, similar construction activities performed along Baxter Street during the same period did not result in any noise exceedances, further supporting the conclusion that site operations were not the dominant contributor to the event. |

| 991 - JUNE-19-DAY | 93.6 | N/A | Based on a review of site operations, construction activities were not identified as the primary source of the noise exceedance. The elevated noise levels were instead attributed to background urban noise sources, including vehicular traffic and other off-site ambient conditions. At the time of the exceedance, early support-of-excavation activities were underway, including excavation, installation of bracing systems, secant pile drilling and concrete placement, and removal of existing foundations. Handheld measurements taken between monitoring intervals did not indicate elevated noise levels. Additionally, similar construction activities performed along Baxter Street during the same period did not result in any noise exceedances, further supporting the conclusion that site operations were not the dominant contributor to the event. |

| 991 - JUNE-22-DAY | 86.6 | N/A | Based on a review of site operations, construction activities were not identified as the primary source of the noise exceedance. The elevated noise levels were instead attributed to background urban noise sources, including vehicular traffic and other off-site ambient conditions. At the time of the exceedance, early support- |

| 991 - JUNE-22-DAY | 86.4 | N/A | Based on a review of site operations, construction activities were not identified as the primary source of the noise exceedance. The elevated noise levels were instead attributed to background urban noise sources, including vehicular traffic and other off-site ambient conditions. At the time of the exceedance, early support-of-excavation activities were underway, including excavation, installation of bracing systems, secant pile drilling and concrete placement, and removal of existing foundations. Handheld measurements taken between monitoring intervals did not indicate elevated noise levels. Additionally, similar construction activities performed along Baxter Street during the same period did not result in any noise exceedances, further supporting the conclusion that site operations were not the dominant contributor to the event. |

| 991 - JUNE-24-DAY | 86.5 | N/A | Based on a review of site operations, construction activities were not identified as the primary source of the noise exceedance. The elevated noise levels were instead attributed to background urban noise sources, including vehicular traffic and other off-site ambient conditions. At the time of the exceedance, early support-of-excavation activities were underway, including excavation, installation of bracing systems, secant pile drilling and concrete placement, and removal of existing foundations. Handheld measurements taken between monitoring intervals did not indicate elevated noise levels. Additionally, similar construction activities performed along Baxter Street during the same period did not result in any noise exceedances, further supporting the conclusion that site operations were not the dominant contributor to the event. |
| 991 - JUNE-25-DAY | 87.5 | N/A | Based on a review of site operations, construction activities were not identified as the primary source of the noise exceedance. The elevated noise levels were instead attributed to background urban noise sources, including vehicular traffic and other off-site ambient conditions. At the time of the exceedance, early support-of-excavation activities were underway, including excavation, installation of bracing systems, secant pile drilling and concrete placement, and removal of existing foundations. Handheld measurements taken between monitoring intervals did not indicate elevated noise levels. Additionally, similar construction activities performed along Baxter Street during the same period did not result in any noise exceedances, further supporting the conclusion that site operations were not the dominant contributor to the event. |

| 991 - JUNE-26-DAY | 89.5 | N/A | Based on a review of site operations, construction activities were not identified as the primary source of the noise exceedance. The elevated noise levels were instead attributed to background urban noise sources, including vehicular traffic and other off-site ambient conditions. At the time of the exceedance, early support-of-excavation activities were underway, including excavation, installation of bracing systems, secant pile drilling and concrete placement, and removal of existing foundations. Handheld measurements taken between monitoring intervals did not indicate elevated noise levels. Additionally, similar construction activities performed along Baxter Street during the same period did not result in any noise exceedances, further supporting the conclusion that site operations were not the dominant contributor to the event. |
| 991 - JUNE-26-DAY | 86.9 | N/A | Based on a review of site operations, construction activities were not identified as the primary source of the noise exceedance. The elevated noise levels were instead attributed to background urban noise sources, including vehicular traffic and other off-site ambient conditions. At the time of the exceedance, early support-of-excavation activities were underway, including excavation, installation of bracing systems, secant pile drilling and concrete placement, and removal of existing foundations. Handheld measurements taken between monitoring intervals did not indicate elevated noise levels. Additionally, similar construction activities performed along Baxter Street during the same period did not result in any noise exceedances, further supporting the conclusion that site operations were not the dominant contributor to the event. |
| 991 - JUNE-26-DAY | 85.8 | N/A | Based on a review of site operations, construction activities were not identified as the primary source of the noise exceedance. The elevated noise levels were instead attributed to background urban noise sources, including vehicular traffic and other off-site ambient conditions. At the time of the exceedance, early support-of-excavation activities were underway, including excavation, installation of bracing systems, secant pile drilling and concrete placement, and removal of existing foundations. Handheld measurements taken between monitoring intervals did not indicate elevated noise levels. Additionally, similar construction activities performed along Baxter Street during the same period |

| 991 – JUNE-29-DAY | 93.3 | N/A | Based on a review of site operations, construction activities were not identified as the primary source of the noise exceedance. The elevated noise levels were instead attributed to background urban noise sources, including vehicular traffic and other off-site ambient conditions. At the time of the exceedance, early support-of-excavation activities were underway, including excavation, installation of bracing systems, secant pile drilling and concrete placement, and removal of existing foundations. Handheld measurements taken between monitoring intervals did not indicate elevated noise levels. Additionally, similar construction activities performed along Baxter Street during the same period did not result in any noise exceedances, further supporting the conclusion that site operations were not the dominant contributor to the event. |

| 991 – JUNE-29-DAY | 88.4 | N/A | Based on a review of site operations, construction activities were not identified as the primary source of the noise exceedance. The elevated noise levels were instead attributed to background urban noise sources, including vehicular traffic and other off-site ambient conditions. At the time of the exceedance, early support-of-excavation activities were underway, including excavation, installation of bracing systems, secant pile drilling and concrete placement, and removal of existing foundations. Handheld measurements taken between monitoring intervals did not indicate elevated noise levels. Additionally, similar construction activities performed along Baxter Street during the same period did not result in any noise exceedances, further supporting the conclusion that site operations were not the dominant contributor to the event. |
| 991 – JUNE-29-DAY | 93.3 | N/A | Based on a review of site operations, construction activities were not identified as the primary source of the noise exceedance. The elevated noise levels were instead attributed to background urban noise sources, including vehicular traffic and other off-site ambient conditions. At the time of the exceedance, early support-of-excavation activities were underway, including excavation, installation of bracing systems, secant pile drilling and concrete placement, and removal of existing foundations. Handheld measurements taken between monitoring intervals did not indicate elevated noise levels. Additionally, similar construction activities performed along Baxter Street during the same period did not result in any noise exceedances, further supporting the conclusion that site operations were not the dominant contributor to the event. |
| 991 – JUNE-29-DAY | 88.9 | N/A | Based on a review of site operations, construction activities were not identified as the primary source of the noise exceedance. The elevated noise levels were instead attributed to background urban noise sources, including vehicular traffic and other off-site ambient conditions. At the time of the exceedance, early support-of-excavation activities were underway, including excavation, installation of bracing systems, secant pile drilling and concrete placement, and removal of existing foundations. Handheld measurements taken between monitoring intervals did not indicate elevated noise levels. Additionally, similar construction activities performed along Baxter Street during the same period |

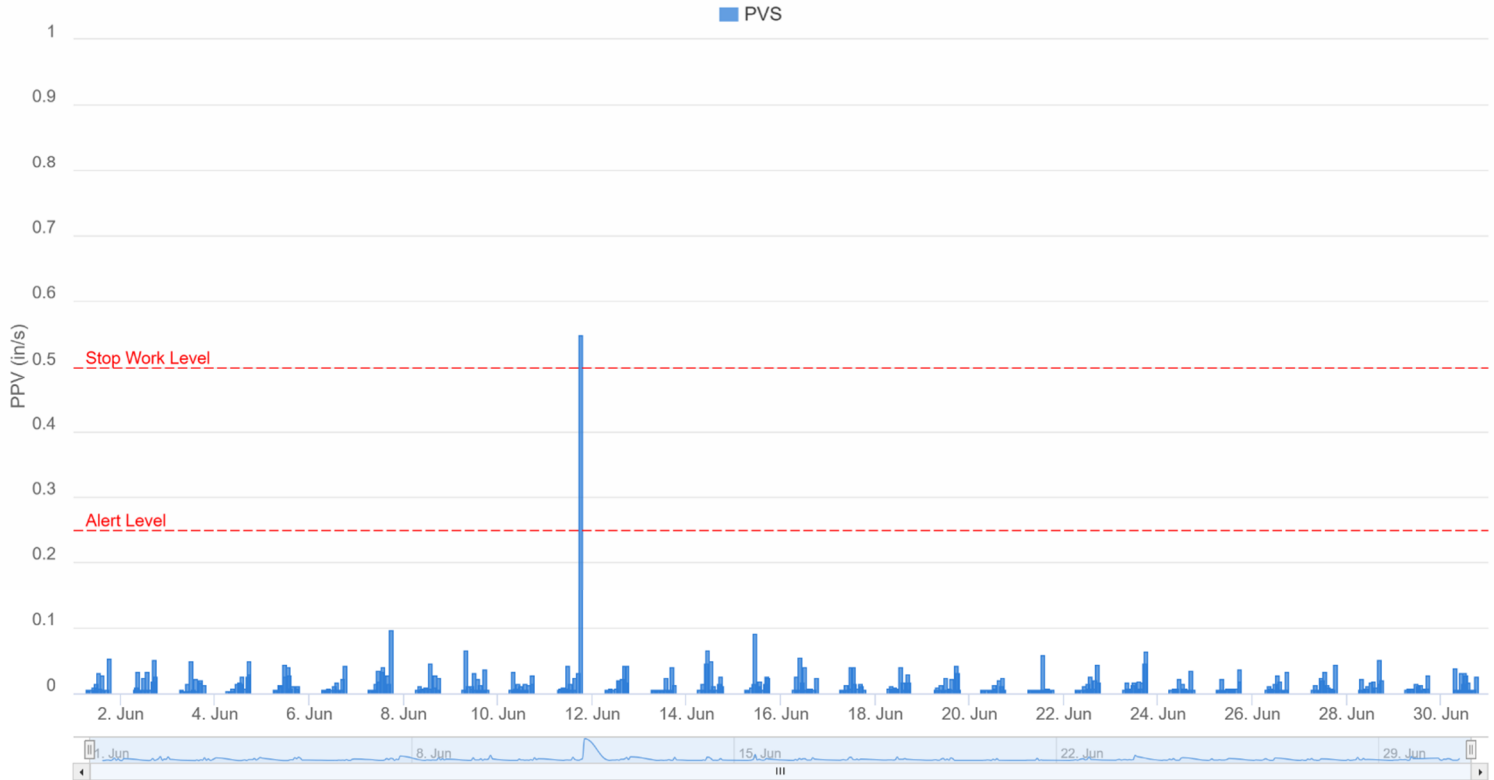
## R16

| Date-Device-Location | Maximum Vibration Level before Corrective Action (in/sec) | Maximum Vibration Level after Corrective Action (in/sec) | Corrective Action |
|---|---|---|---|
| June 11 – R16 – 100 Centre St | 0.548 | N/A | No action required. Exceedance caused by external impact. |
