CONSTRUCTION ADVISORY:

**PROBLEMATIC
CHARACTERISTIC
OF BRICK FAÇADE:
DIAGONAL HEADERS**

ISSUE: 2024-001

**CRACKED, DELAMINATED, AND
OUT-OF-PLUMB MASONRY
WALLS CAN LEAD TO UNSAFE
CONDITIONS AND RESULT IN
CATASTROPHIC EVENTS**

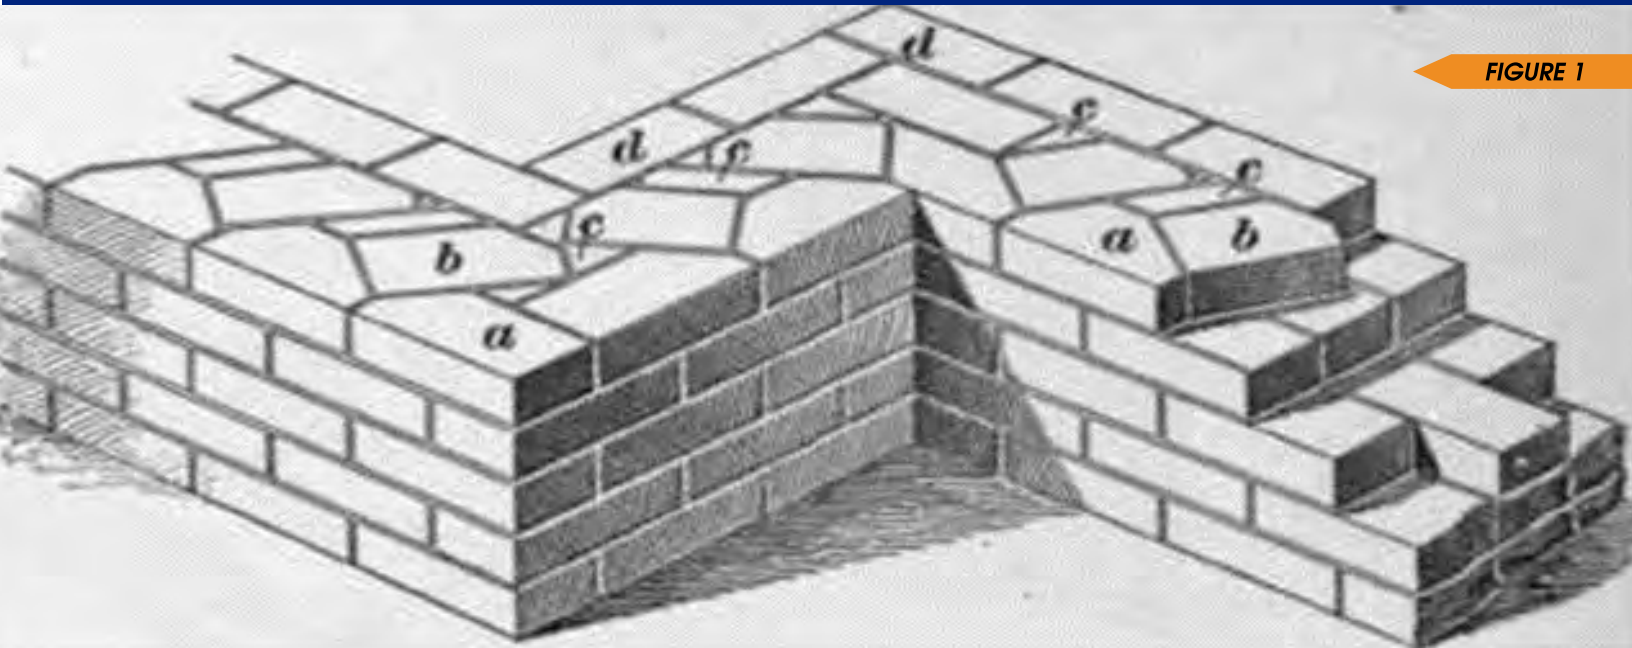
FIGURE 1

Figure 1 shows a 12-inch wall with the face brick bonded to the common brick by what is known as a diagonal, or herringbone, bond. At **a** is shown the front brick cut at the angles; at **b**, the bonding brick laid diagonally; at **c**, the different-shaped bats laid to form the closers of the bond brick; and at **d**, the inside course of stretchers. It is customary to lay an inside course of headers immediately over the course shown in Figure 5.

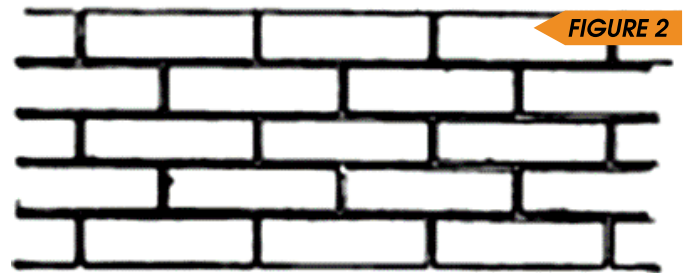
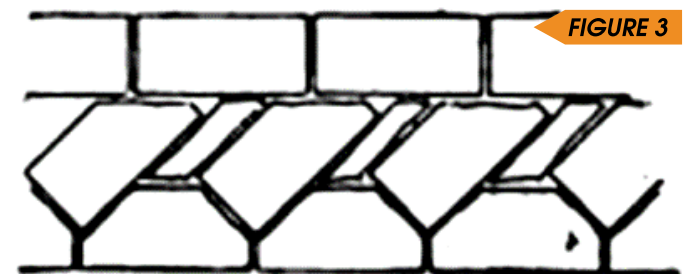
Figures 2 & 3 show running bond brick wall front and cross-section view. Brick units installed at an angle with the corner of the units in the face brick clipped off to accommodate the diagonal unit.

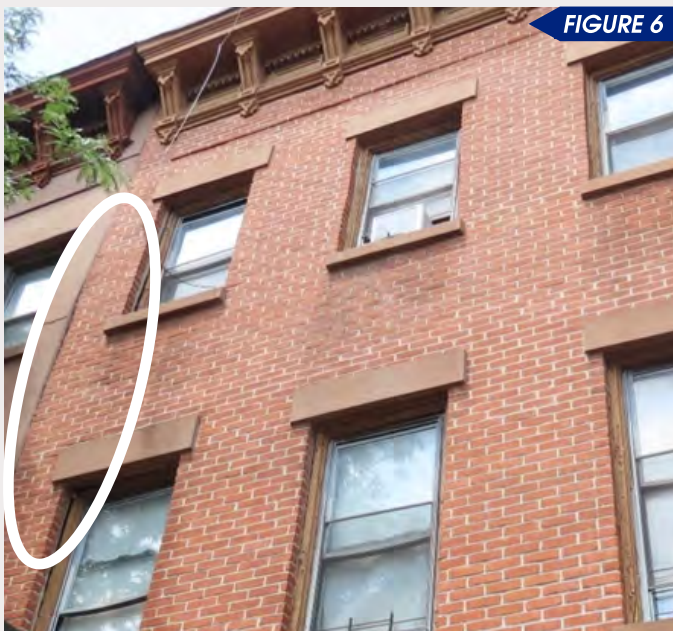
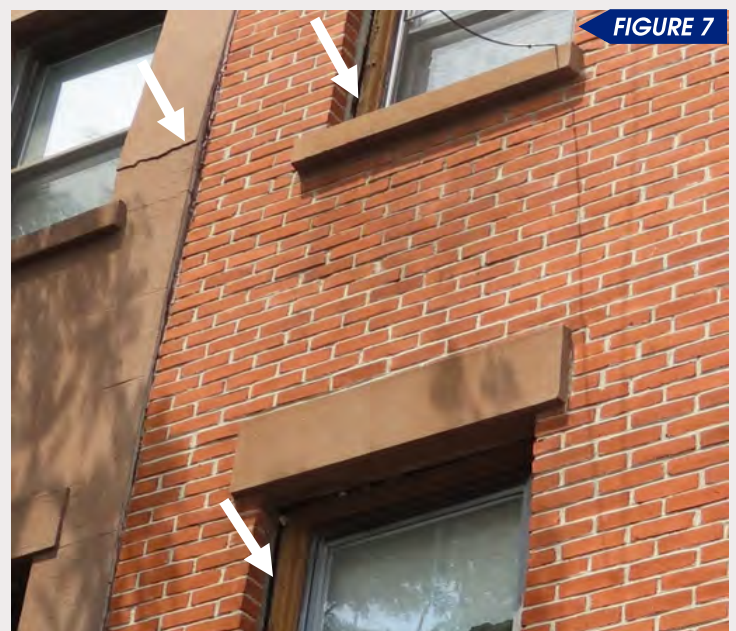
Figures 6 & 7 show bowing of a historic façade wall on typical New York City row houses. Voids are visible in the backup wythes and behind the face brick.

Masonry walls cracked, delaminated, and out-of-plumb can lead to unsafe conditions and result in catastrophic events. It is important to have a Registered Design Professional inspect the building façade and arrange for repair immediately under a permit from the New York City Department of Buildings if any of the following is observed:

- loose bricks and other façade parts
- gap appears between the backup wall and façade wall at windows
- brick wall cracks, and bulges outward with visible deflection
- if out-of-plane movement is occurring
- if you suspect that the face brick was installed without proper anchorage/tie

If any of these conditions are discovered please install public protection immediately and repair the unsafe condition under permit.

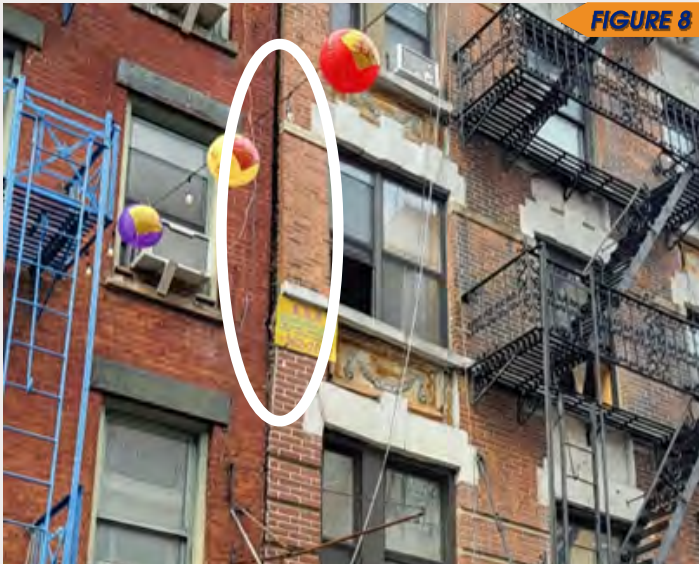
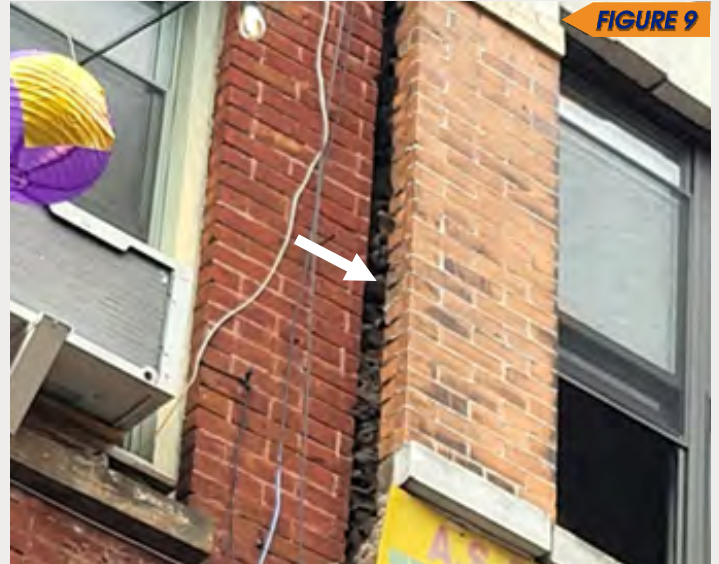
Diagonal or blind headers are usually found in New York City rowhouses and low-rise multiple dwellings. With diagonal or blind headers, the face wythe is bonded to the structural backup wall through a small triangular section set in mortar. Over time, these connections often deteriorated, leading to the face brick delaminating from the structural backup wall (Fig. 6 - 9). Consequently, the face wythe separates, deflects, and bulges outward, potentially leading to partial or full collapse as the connections between wythes fail.

Figures 8 & 9 show exterior façade brick bulged outward.
