NYCTM

CONSTRUCTION ADVISORY:

**COMMON EXTERIOR
INSULATION & FINISH
SYSTEMS ISSUES**

ISSUE: 2023-003

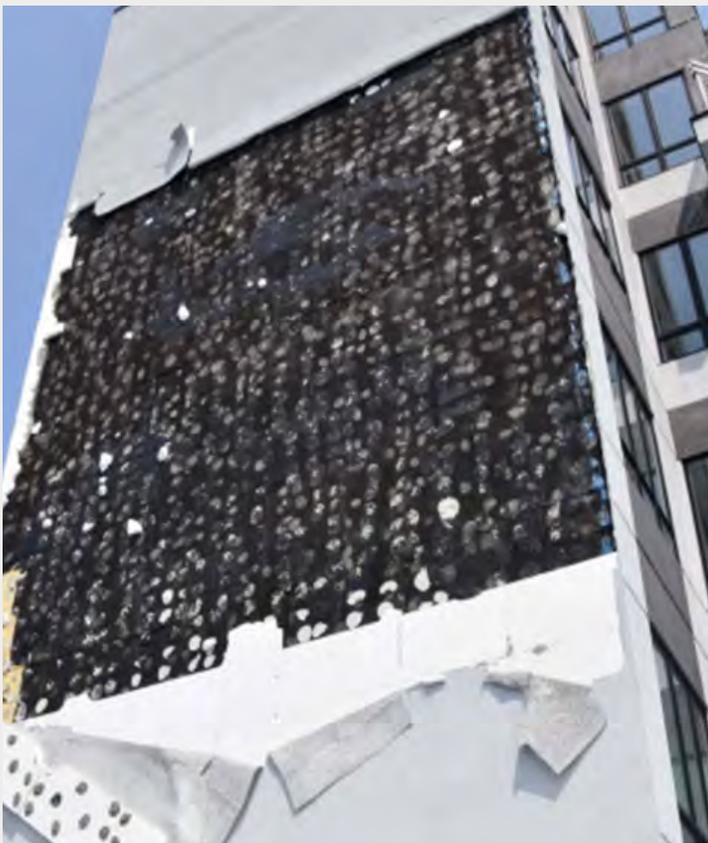
FIGURE 1: Failure in adhesively attached EIFS (Image Source: NYC Department of Buildings (DOB) 2020)

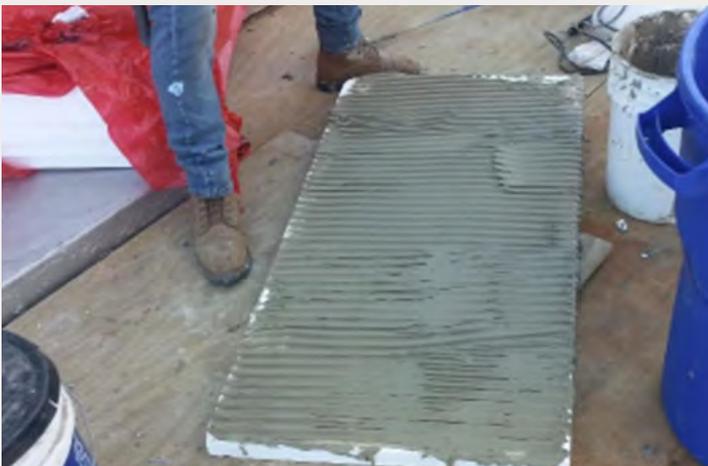
FIGURE 2: Barrier EIFS ready to be installed directly over a CMU substrate (Source: QEWI photo 2021. DOB archives)

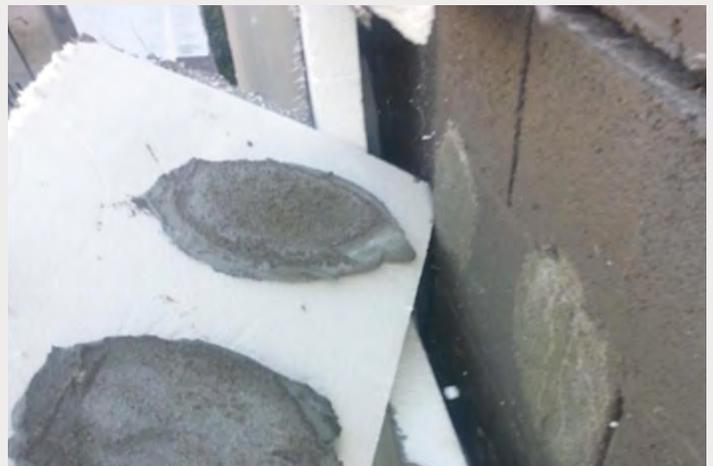
In adhesively attached EIFS, the compatibility of the substrate's surface with the adhesive is critical. The adhesive must be specifically formulated for that substrate and installation must follow manufacturer's instructions, including those for the preparation of the substrate, the correct temperature at the time of application, sufficient curing time, etc. (**Figure 2**) When adhesively bonded EIFS fails, the adhesive is often found to remain attached to the EIFS, suggesting issues with substrate type or preparation are at least partially to blame. (**Figure 3**)

FIGURE 3: Traditional/barrier EIFS was adhesively attached to CMU substrate (Source: QEWI photo 2021. DOB archives)

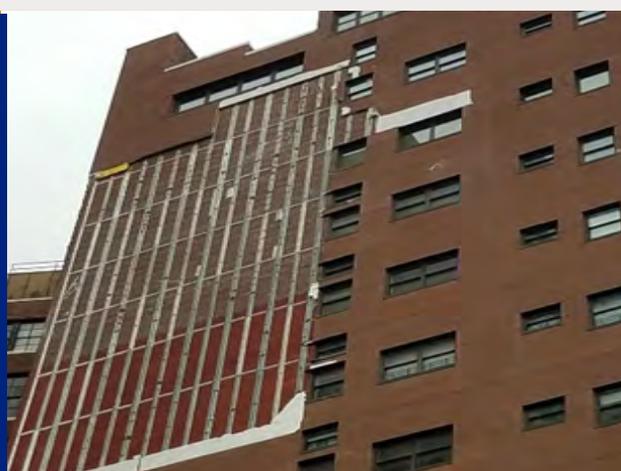
FIGURE 7: EIFS failure in mechanically attached EIFS (Source: DOB, 2020)

During a high wind event on August 2020, an 1,800 sf section of EIFS collapsed from a side façade of a 13-story apartment building. (**Figure 7**)

It was concluded that an insufficient number of fasteners had been provided. Additionally, water seepage through the elastomeric coating had caused significant deterioration in the gypsum boards and corrosion to the metal components (**Figures 10 & 11**). Together these defects caused the EIFS panels to loosen when subjected to wind forces well below Code-prescribed design loads. The absence of vertical and horizontal control breaks allowed the initially localized failure at the building corner to propagate over a very large surface area. Research into the repair and maintenance history of the building revealed the EIFS panels had been installed on the original masonry wall 20

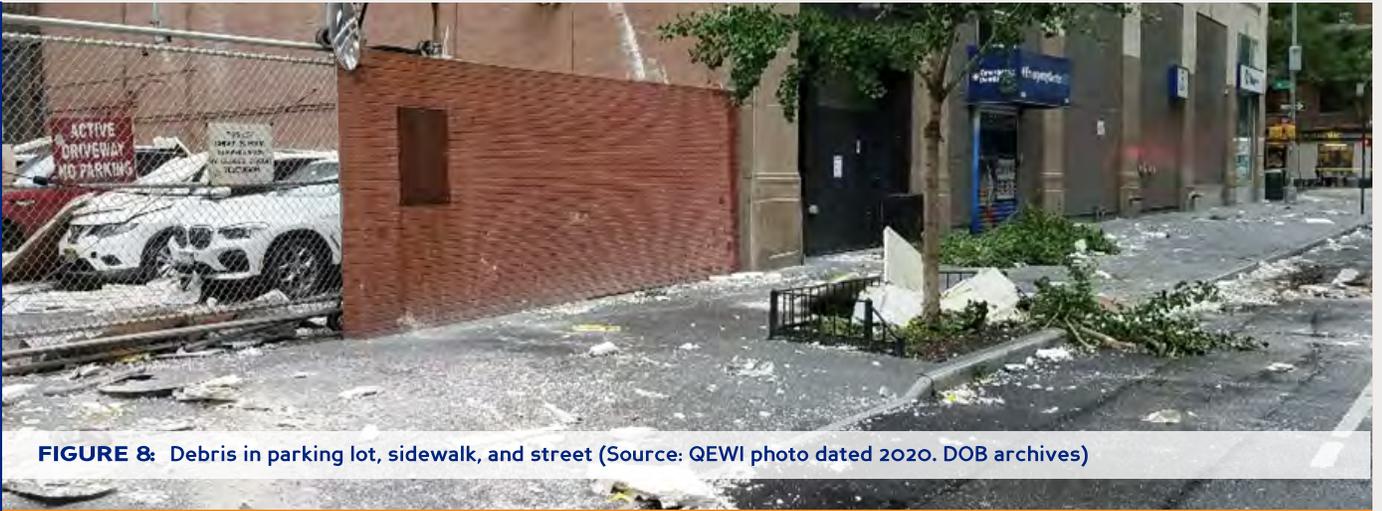
Inspectors from DOB's Façades Unit and Emergency Response Team responded on site by closing the street, issuing a vacate order for a parking lot directly below the façade (**Figure 8**), a violation to provide public protection, an emergency work order to make the façade safe, including a violation requiring

FIGURE 8: Debris in parking lot, sidewalk, and street (Source: QEWI photo dated 2020. DOB archives)

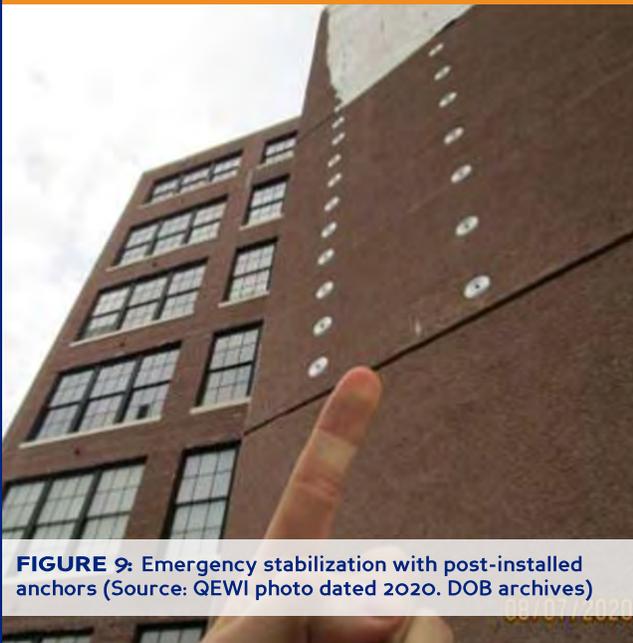
FIGURE 9: Emergency stabilization with post-installed anchors (Source: QEWI photo dated 2020. DOB archives)

A sidewalk shed was installed immediately, and the emergency stabilization was completed within 4 days of the incident, allowing DOB to lift the vacate order on the parking lot and for the street to re-open. Emergency stabilization consisted of removing all loose materials and debris and securing the remaining EIFS with post-installed anchors (**Figure 9**).

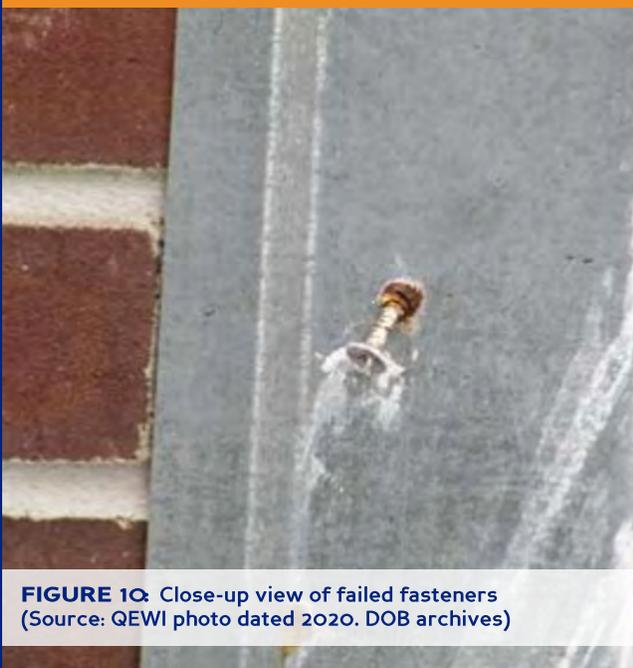
FIGURE 10: Close-up view of failed fasteners (Source: QEWI photo dated 2020. DOB archives)

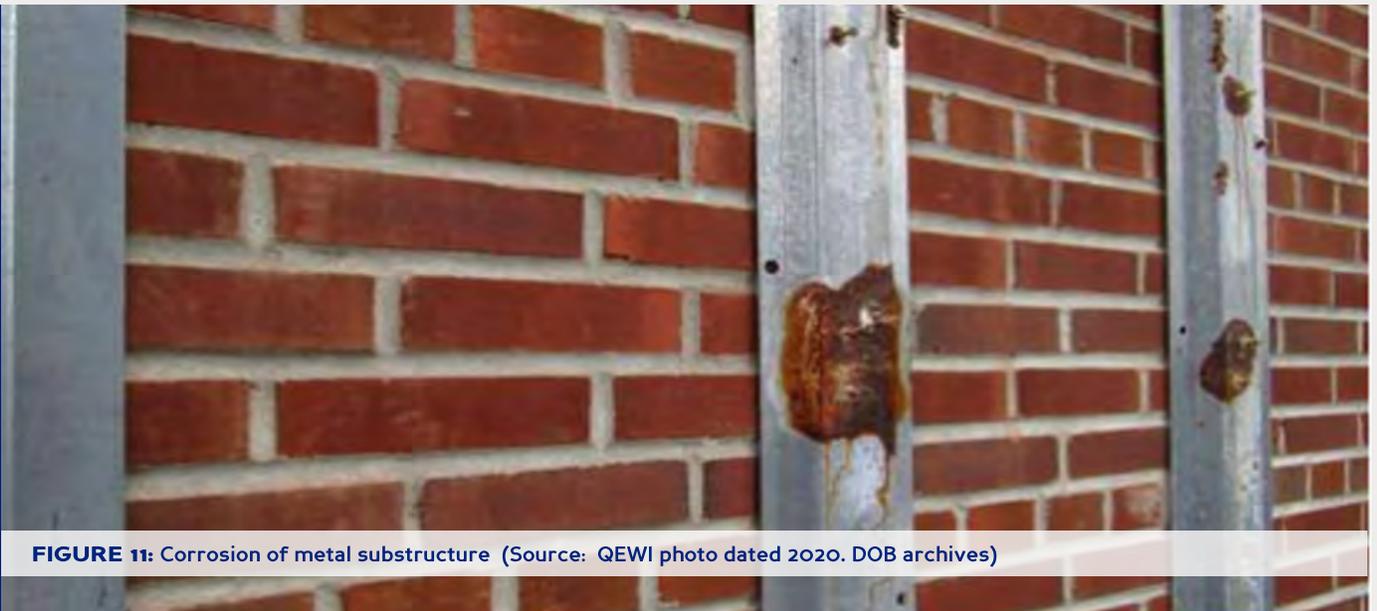
FIGURE 11: Corrosion of metal substructure (Source: QEWI photo dated 2020. DOB archives)

The completed repair, as documented in the amended report, consisted of the removal of all EIFS cladding from the east façade, and restoration of the original brick masonry, window lintel/sill replacement, and recaulking of the window perimeters.

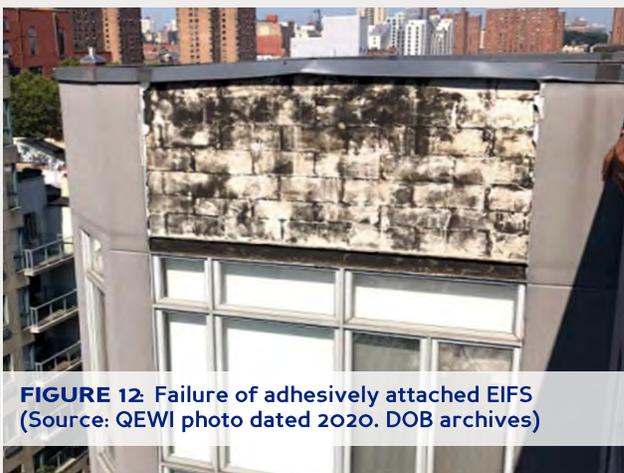
FIGURE 12: Failure of adhesively attached EIFS (Source: QEWI photo dated 2020. DOB archives)

It was revealed the EIFS installation did not follow any known manufacturer instructions: irregularly distributed dollops of adhesive had been applied to the back of the EIFS panels which were directly adhered onto liquid-applied vapor barrier - an incompatible surface for the adhesive. Lack of flashing at the window heads allowed water to penetrate the wall construction, causing deterioration of the EIFS components and adhesive, possibly contributing to the failure of the panels. Pull tests were performed to identify panels unable to withstand Code mandated wind loads.

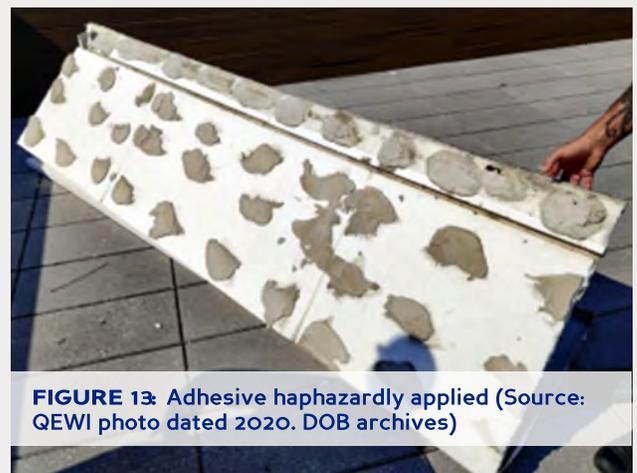
FIGURE 13: Adhesive haphazardly applied (Source: QEWI photo dated 2020. DOB archives)

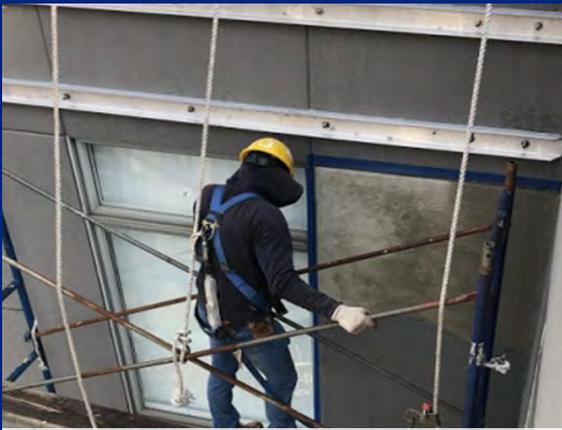
FIGURE 14. Reinforcement of the existing EIFS panels using brushed aluminum channels (Source: QEWI photo dated 2020. DOB archives)

Corrective repairs consisted of reinforcing the existing EIFS panels through a grid of aluminum channels installed around the perimeter of the building, these were fastened to the concrete masonry substrate with stainless steel bolts (**Figures 14**).

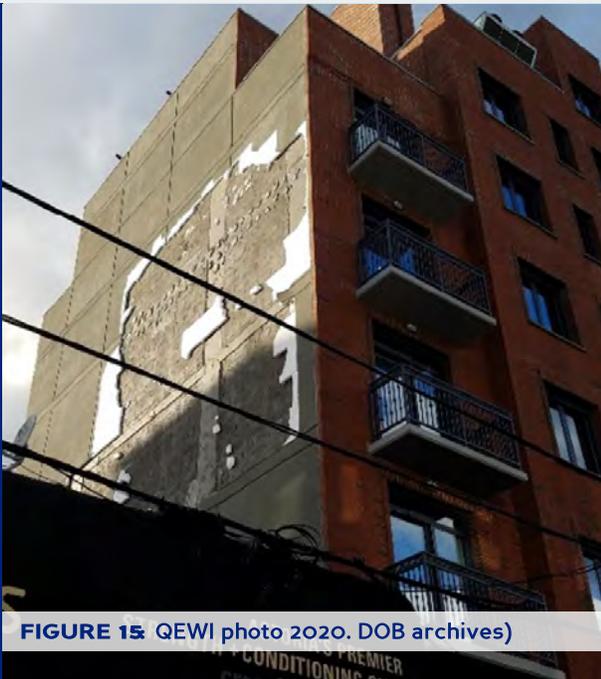
FIGURE 15. QEWI photo 2020. DOB archives)

A sidewalk shed was provided on the street to protect the public from any additional loose EIFS. All the remaining EIFS removed from the South façade. The primary cause of failure had been either incompatibility between the adhesive used and the coating on the CMU, or the adhesive had been applied

Unfortunately, preventive action was not taken quickly enough: in March 2021 a 16'x16' section of EIFS cladding fell off the North façade onto the roof of the adjoining building (**Figure 15**). Vacate orders were needed for the entire rear yard as well as the roof of the neighboring building. Ultimately, both the South and North facades were entirely stripped of their original adhesively attached EIFS panels and re-clad in new mechanically attached EIFS.

to wet surfaces. He recommended that the EIFS on the entirety of the south elevation be replaced with a mechanically fastened system and that mechanical anchors be added to the EIFS cladding on the North façade.
