# CONSTRUCTION SAFETY REPORT CARD

© 2020 New York City Department of Buildings

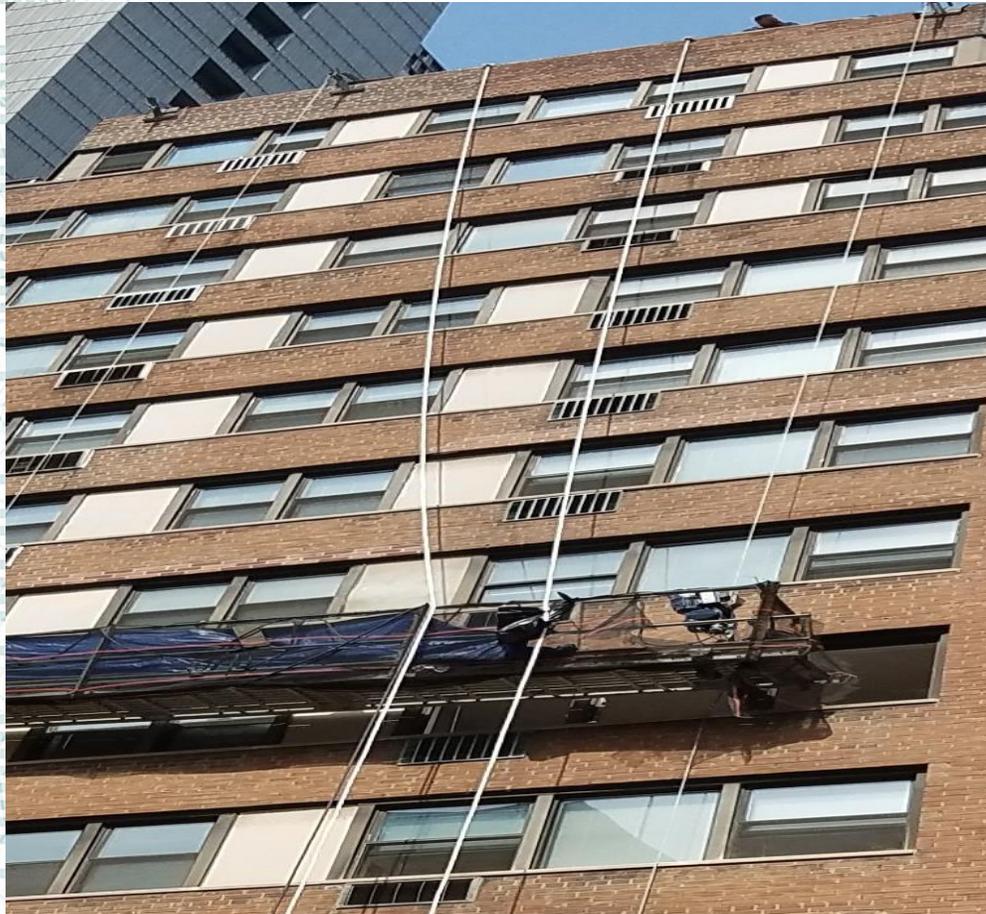
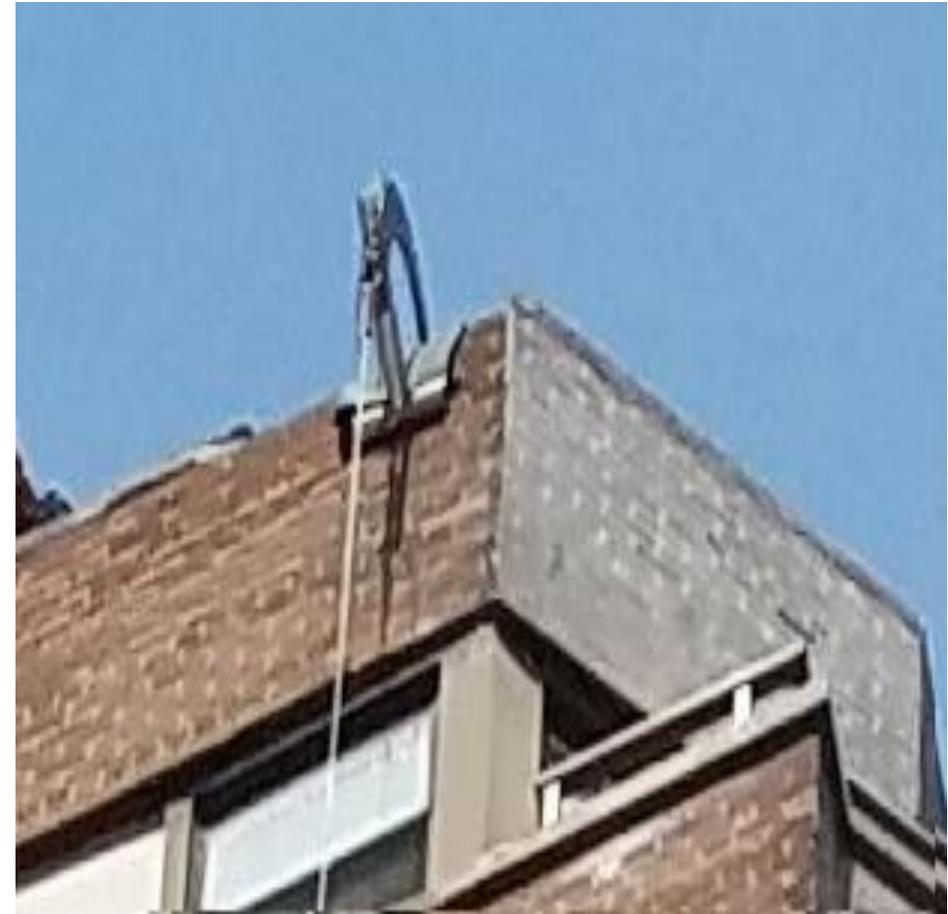
# FAÇADE REPAIR STANDOFF FAILURE 04/08/19

The first fatality of 2019 was located at 311 East 50<sup>th</sup> Street in Manhattan. On April 8 a crew was doing façade repairs from a suspended scaffold and they placed a standoff bracket on the C-hook, seen in the photograph on the right, to increase distance from the facade. While lowering the scaffold, the bracket slipped causing the C-hook to move forward – impacting the coping stone on top of the parapet wall. The impact pushed the stone off the top of the wall. It fell onto the head of the scaffold worker, killing him.

*Failure to protect the coping stone and improper use of a standoff bracket from impact led to the death.*

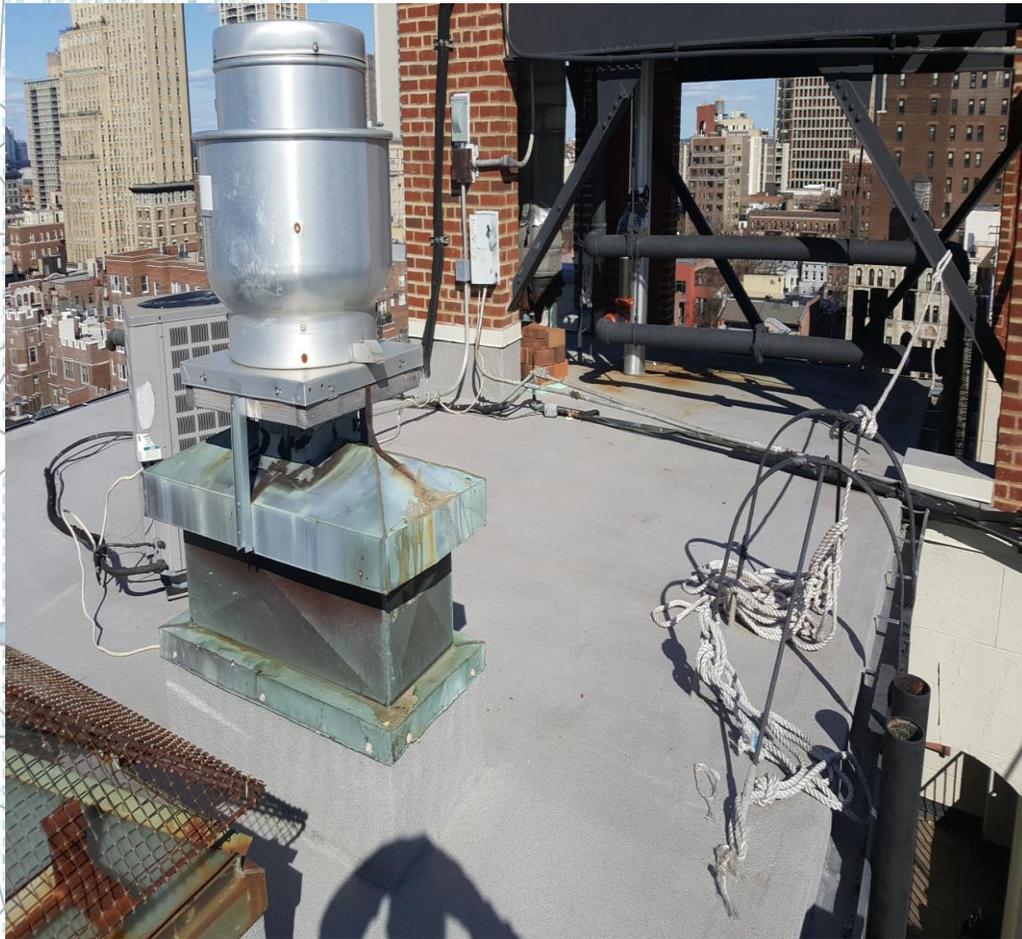
# WATER LEAK REPAIR 04/10/19

On April 10, two workers were completing roofing and brick column encasement repairs on the roof of a 12-story building at 1 Pierrepont Street in Brooklyn. While one of the workers set bricks the other worker was moving scaffold sections and other materials near the edge of the roof. No guardrails or parapet were located at the roof level. It was a high wind event day and it appears the worker was blown off the roof and fell to his death. Although harnesses were on site, the workers did not put them on. Failure to tie-off led to the death.

*Lack of guardrails, failure to tie-off, and working in high wind conditions were all contributing factors.*

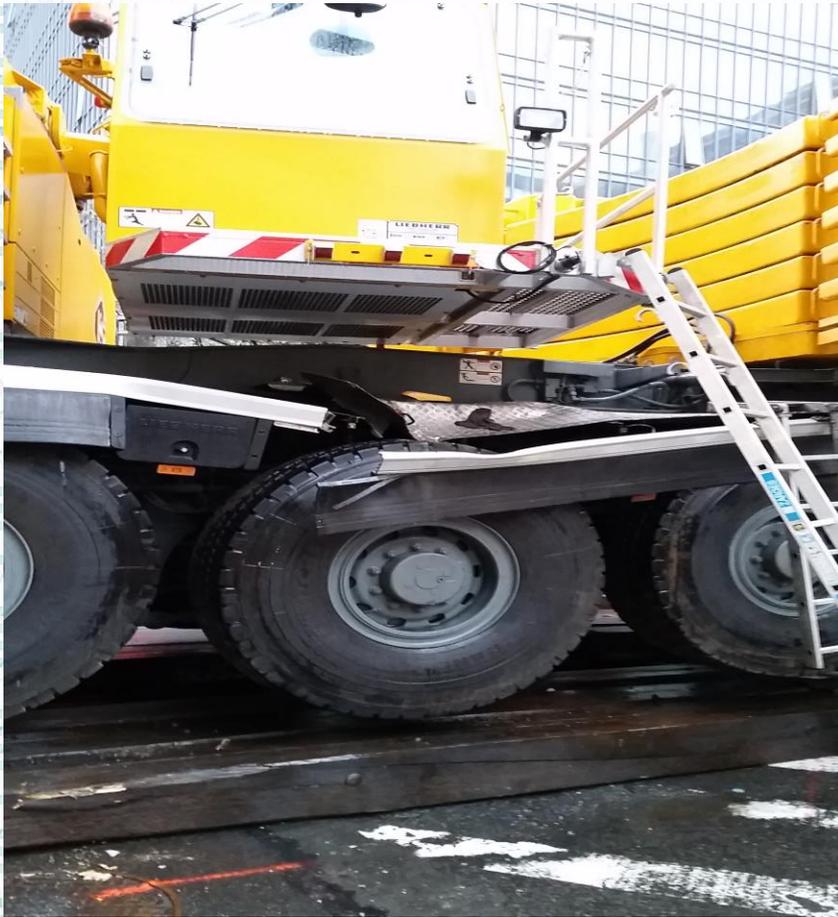
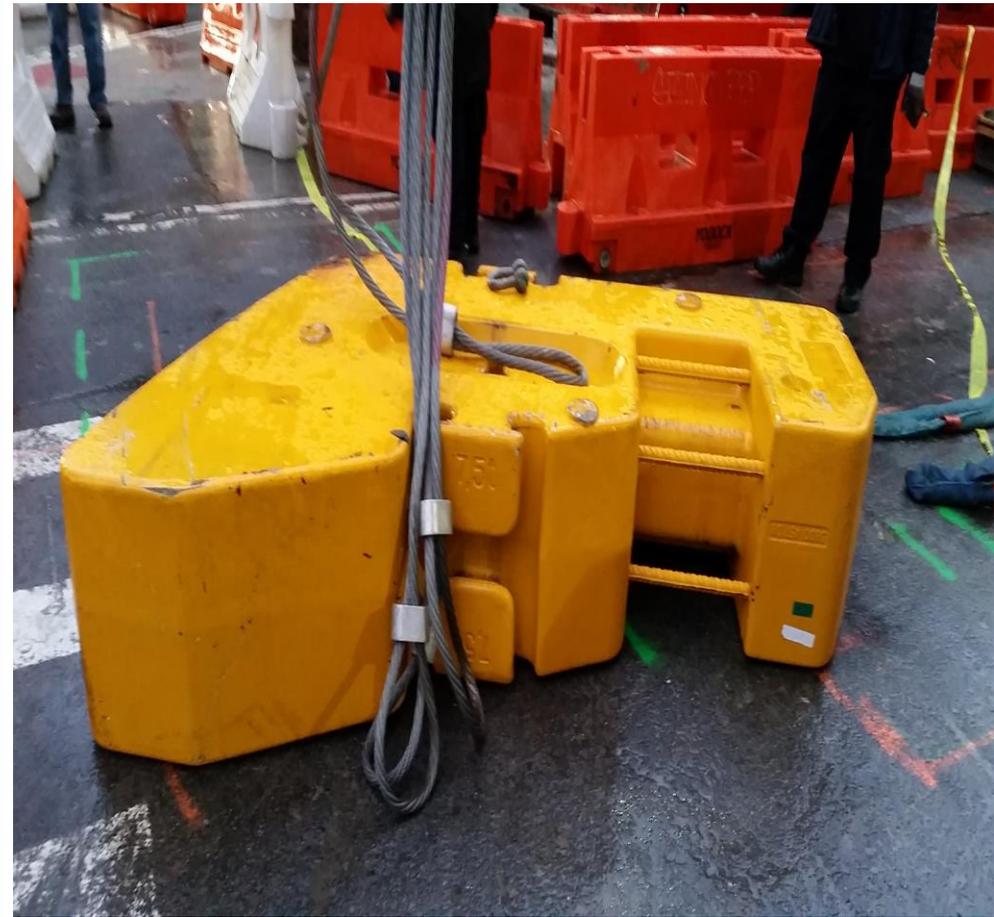
# CRANE ASSEMBLY 04/13/19

On April 13, at 373 Broome Street in Manhattan, a team of workers were assembling a mobile crane to hoist mechanical equipment to the roof and an assist crane was lifting the counterweights into place. After placing one of the counterweights on the back of the crane using two of the three ropes attached to the hook, the crane operator lifted the ropes away from the weight. The third rope caught the lifting lug and pulled the weight into the air. The worker attempted to jump off the crane deck but the weight struck the deck and knocked the worker to the ground. The worker died from his injuries.

*Failure to remove the excess rope not needed for the pick was the contributing factor.*

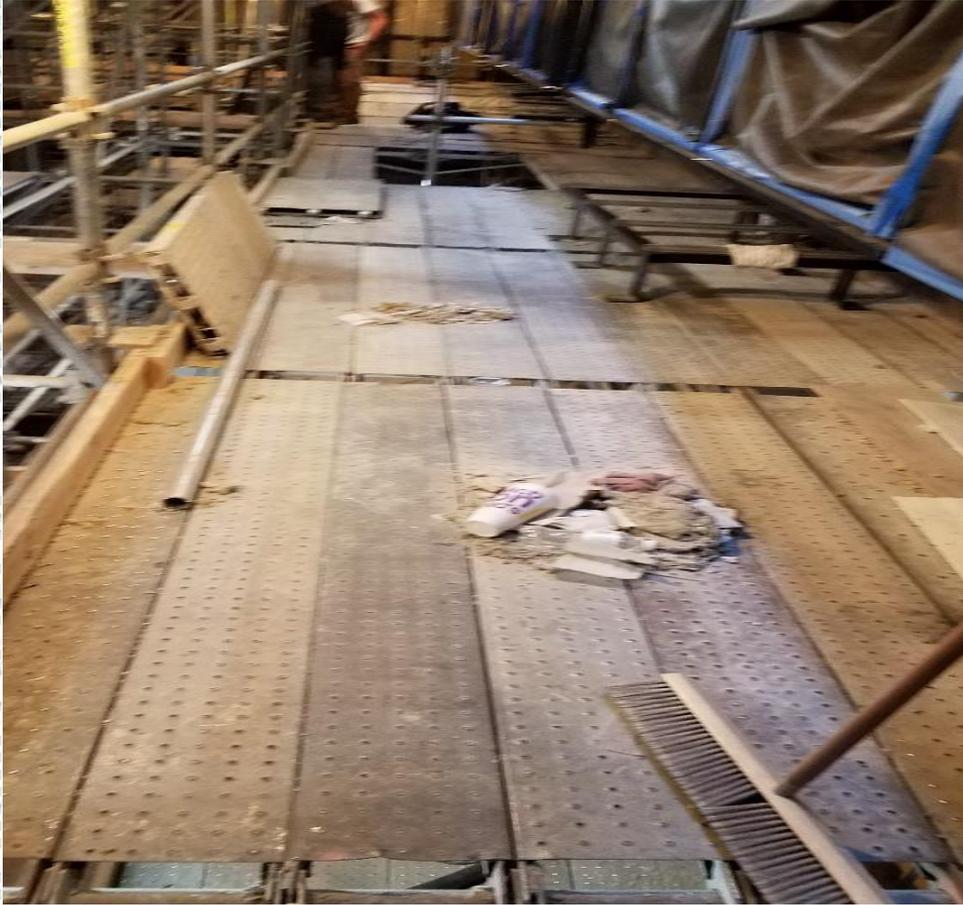
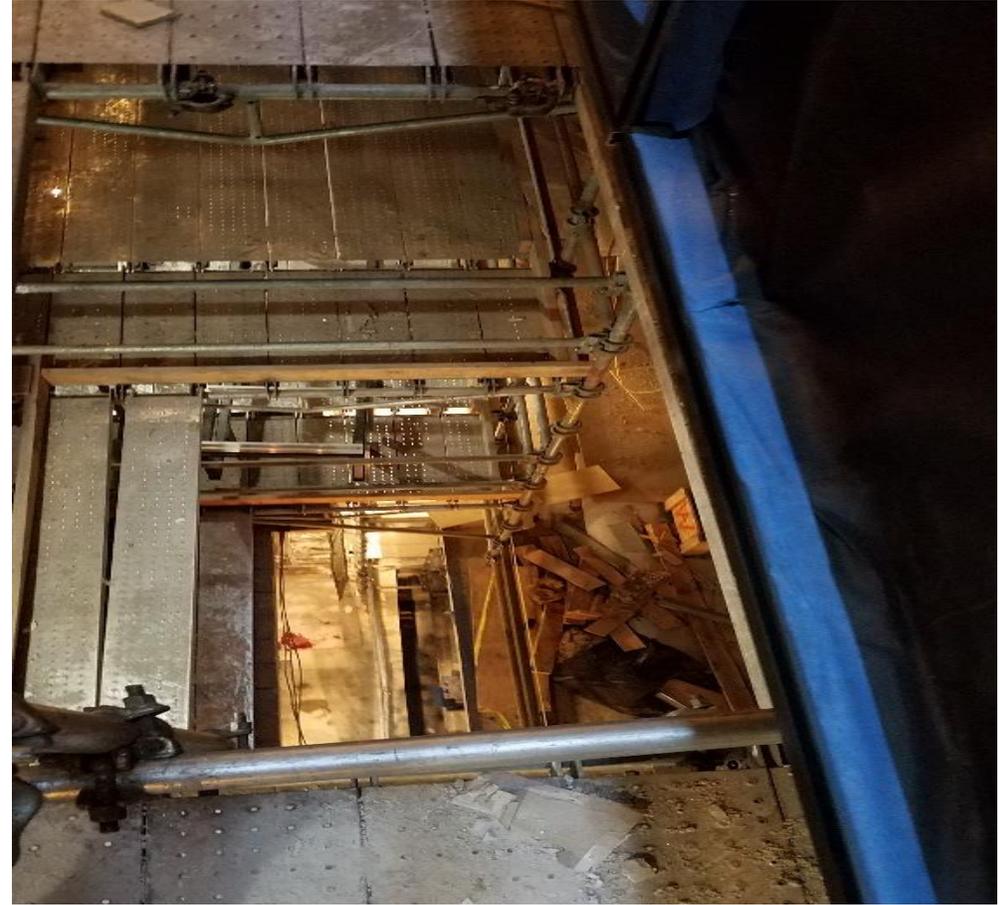
# CLEANUP RAILING REMOVED 05/18/19

On May 18, 2019, a cleanup crew was brought in to clean a site where an overnight shift had been installing curtain wall pieces at 335 Madison Avenue in Manhattan. The overnight crew removed the guardrails surrounding a floor opening used for hoisting to make their work more efficient (seen in the photo on the left) and failed to replace the railings. As a cleaning crew member swept the deck, he walked backwards into the hoisting shaft (seen in the photo on the right) and fell 3-stories to his death.

*Failure to maintain the railings in place led to the fatality.*

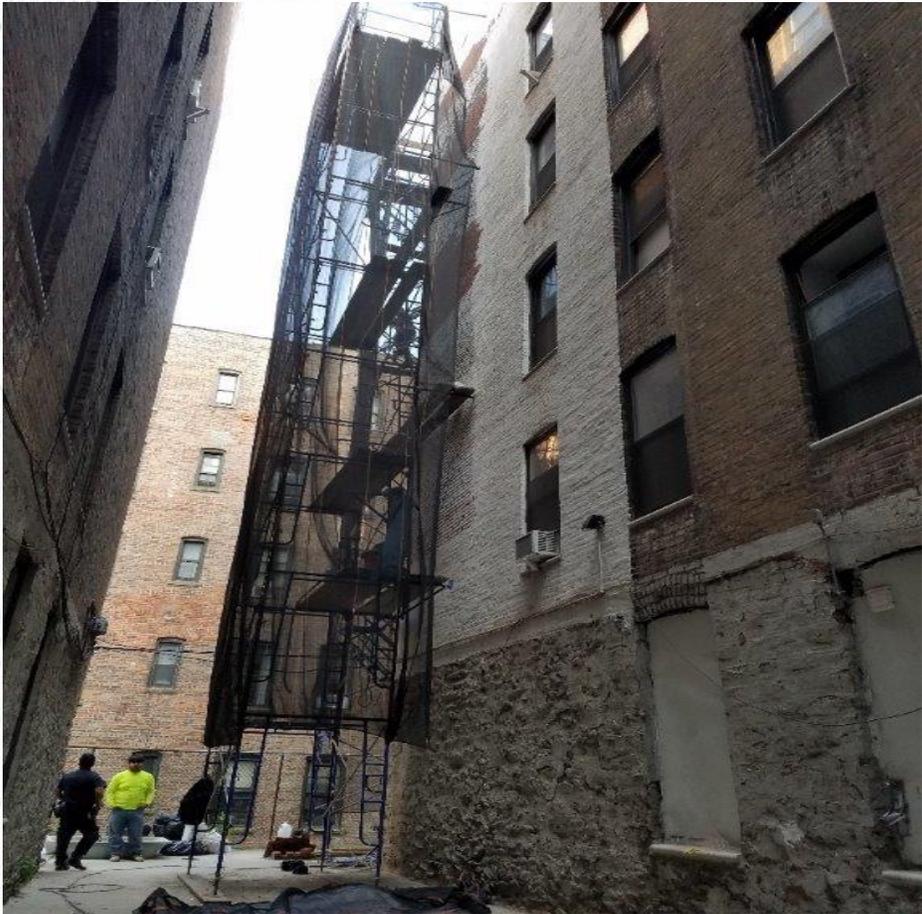
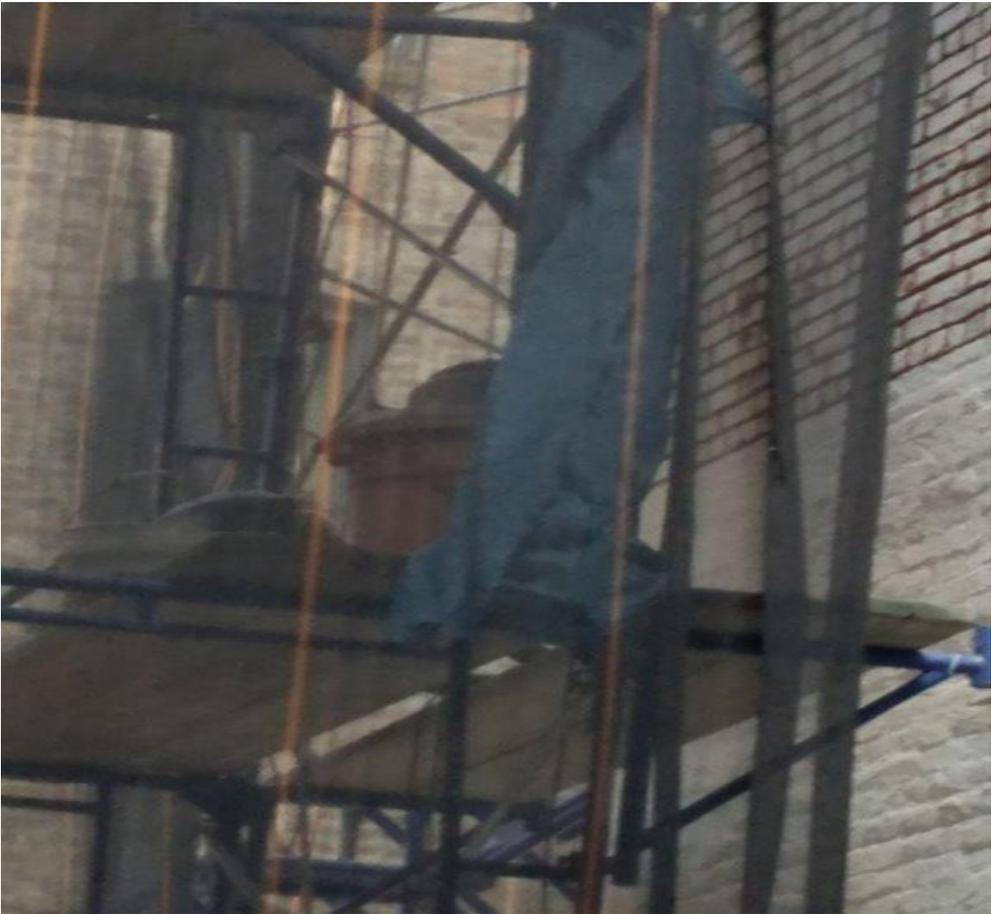
# SCAFFOLD FALL 06/22/19

On June 22, workers doing façade work at 880 Saint Nicholas Avenue in Manhattan took a break for lunch. One of the workers went back up the scaffold to retrieve an item and fell to his death. The scaffold exceeded 50 feet, was unpermitted and improperly installed lacking deck boards and guardrails.

*Lack of proper installation was a key contributing factor.*

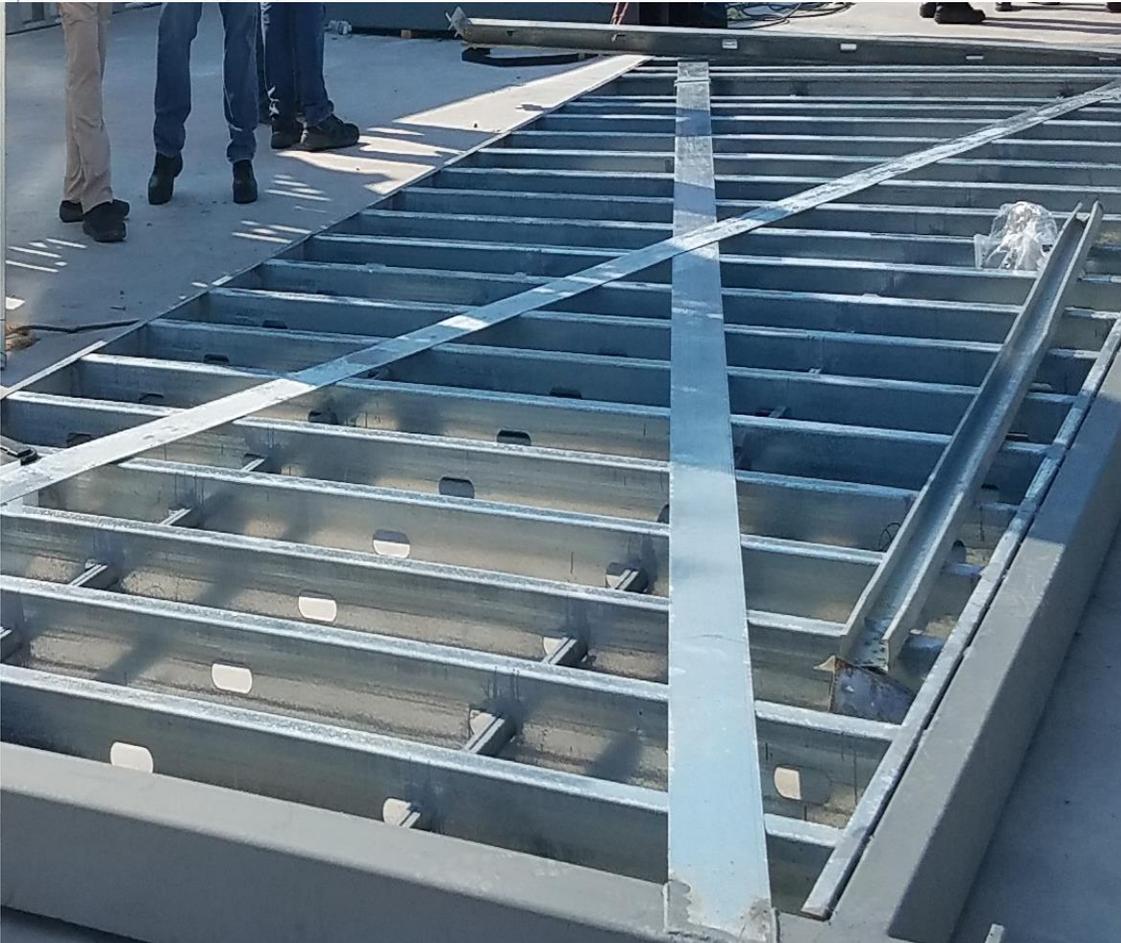
# WALL PLACEMENT 07/20/19

On July 20, workers were installing pre-assembled wall sections at 68-04 Tides Road, Rockaway using a mobile crane. While placing a wall section in between two previously installed wall sections, the assembly bumped into one of the installed sections causing it to break loose from its hold down brackets and crushed a worker.

*Sequencing, failure to shore and brace installed sections and lack of proper communications were all contributing factors.*

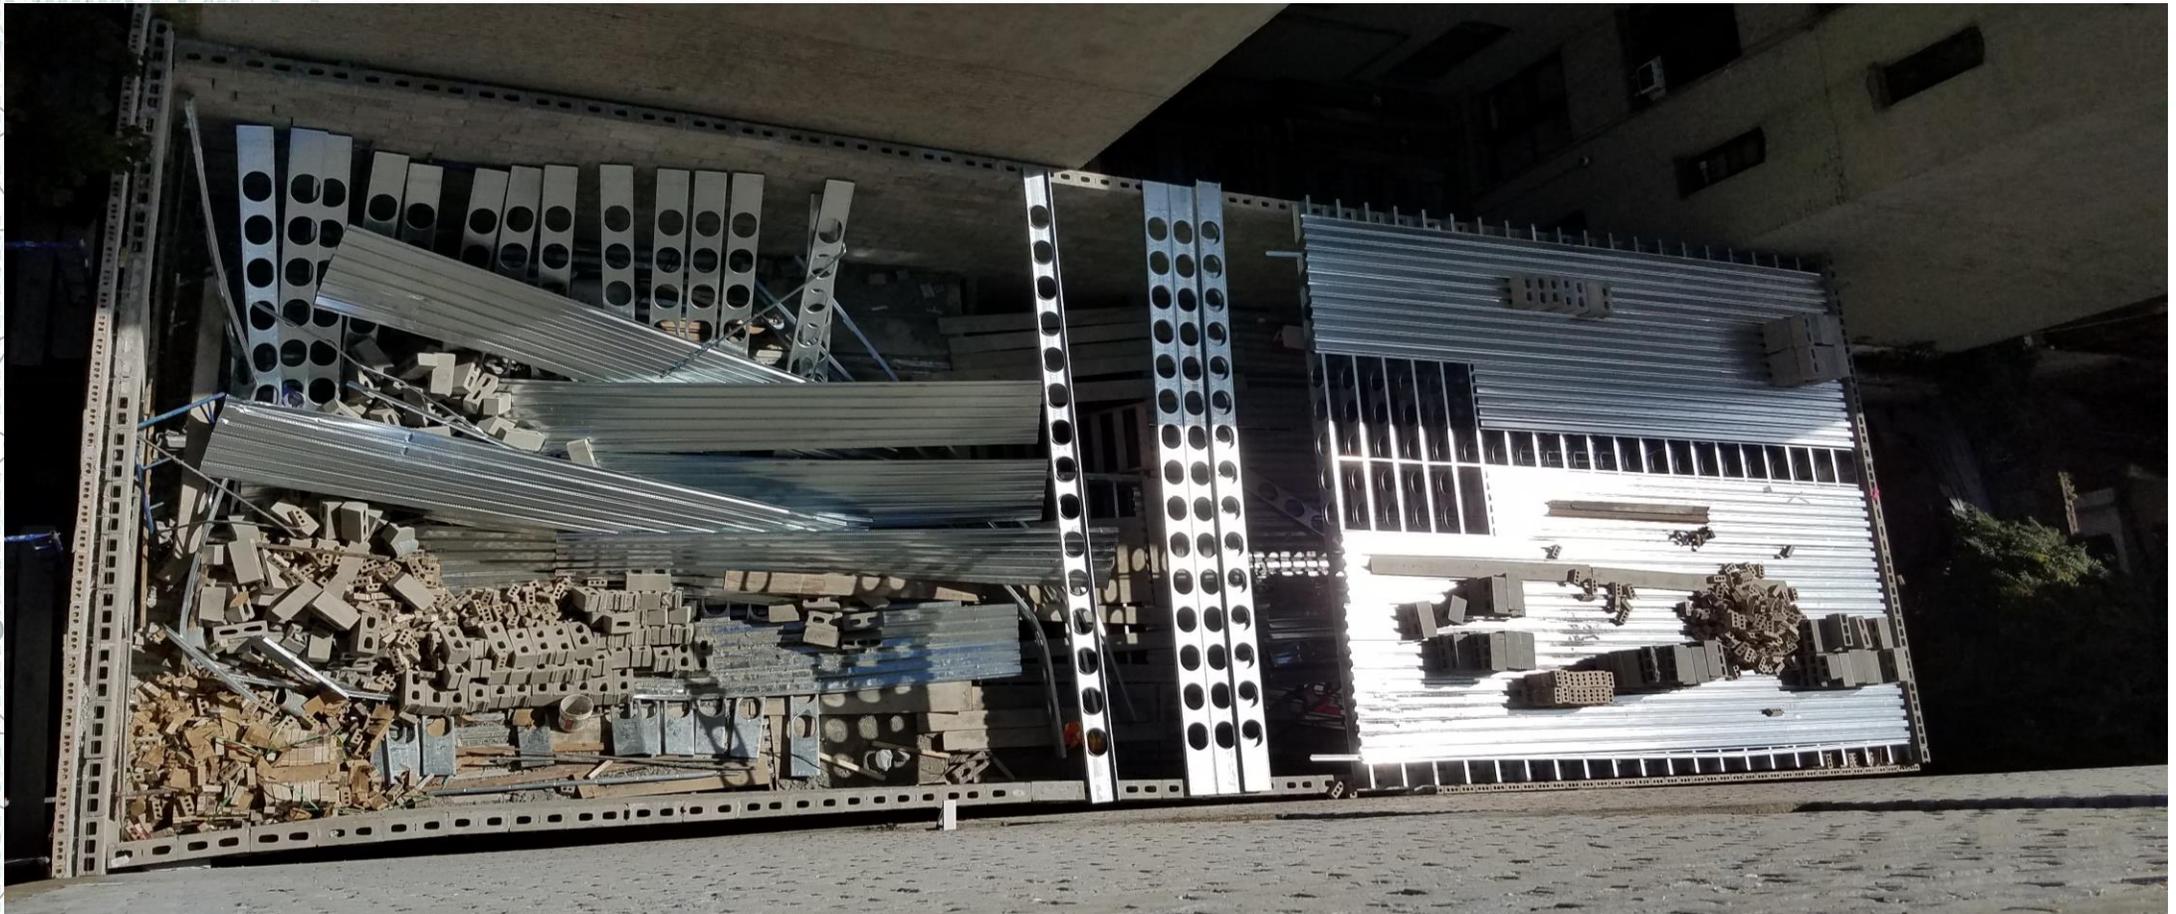
# COLD FORM STEEL FAILURE 08/27/19

On August 27 workers building a 4-story structure at 94 East 208th Street in the Bronx. After placing q deck on the 3<sup>rd</sup> floor deck, the contractor accepted delivery of masonry materials onto the deck to continue construction. A week earlier, a Special Inspector had warned the contractor in writing that he needed to pour the first and second floor decks before continuing to support the loads and to provide structural rigidity to the floor and surrounding walls. Shortly after the material delivery the 3<sup>rd</sup> floor deck collapsed killing 1 worker and injuring 5 others.

*Failure to brace the deck, lack of oversight by the Construction Super, failure to follow the Special Inspector instructions, lack of knowledge surrounding the requirements of cold form steel construction and lack of bracing of the cold form steel were the major contributing factors.*

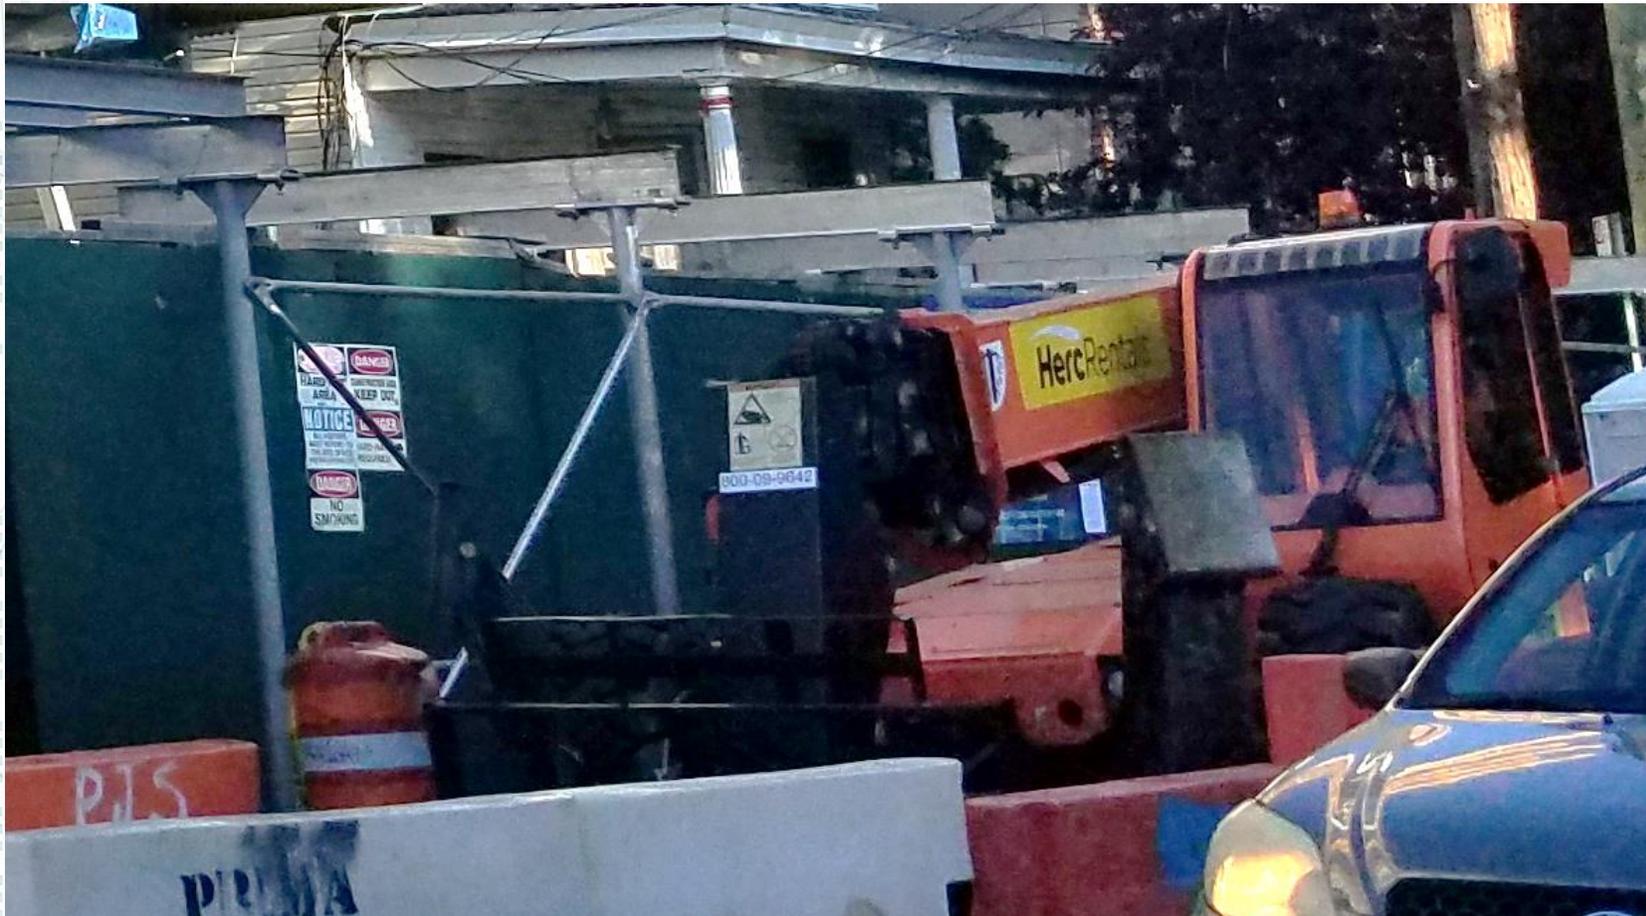
# SHED INSTALLATION 08/30/19

On August 30, workers were assembling a sidewalk shed at 34-49 107th Street, Queens. A worker was passing materials from the back of the flatbed truck to other workers erecting the shed. After handing materials to the other workers on the shed, the decedent placed one foot on the crossmember of the shed and the other foot on the truck bed in what appeared to be an attempt to climb onto the shed. Losing his balance, he grabbed a junior beam off the shed which was not yet secured to the shed frame. The I-beam slid back, hitting him in the face and causing him to fall between the shed and the truck. The beam followed him to the ground into the gap. He succumbed to his injuries.

*Failure to properly gain access to the shed was a key factor.*

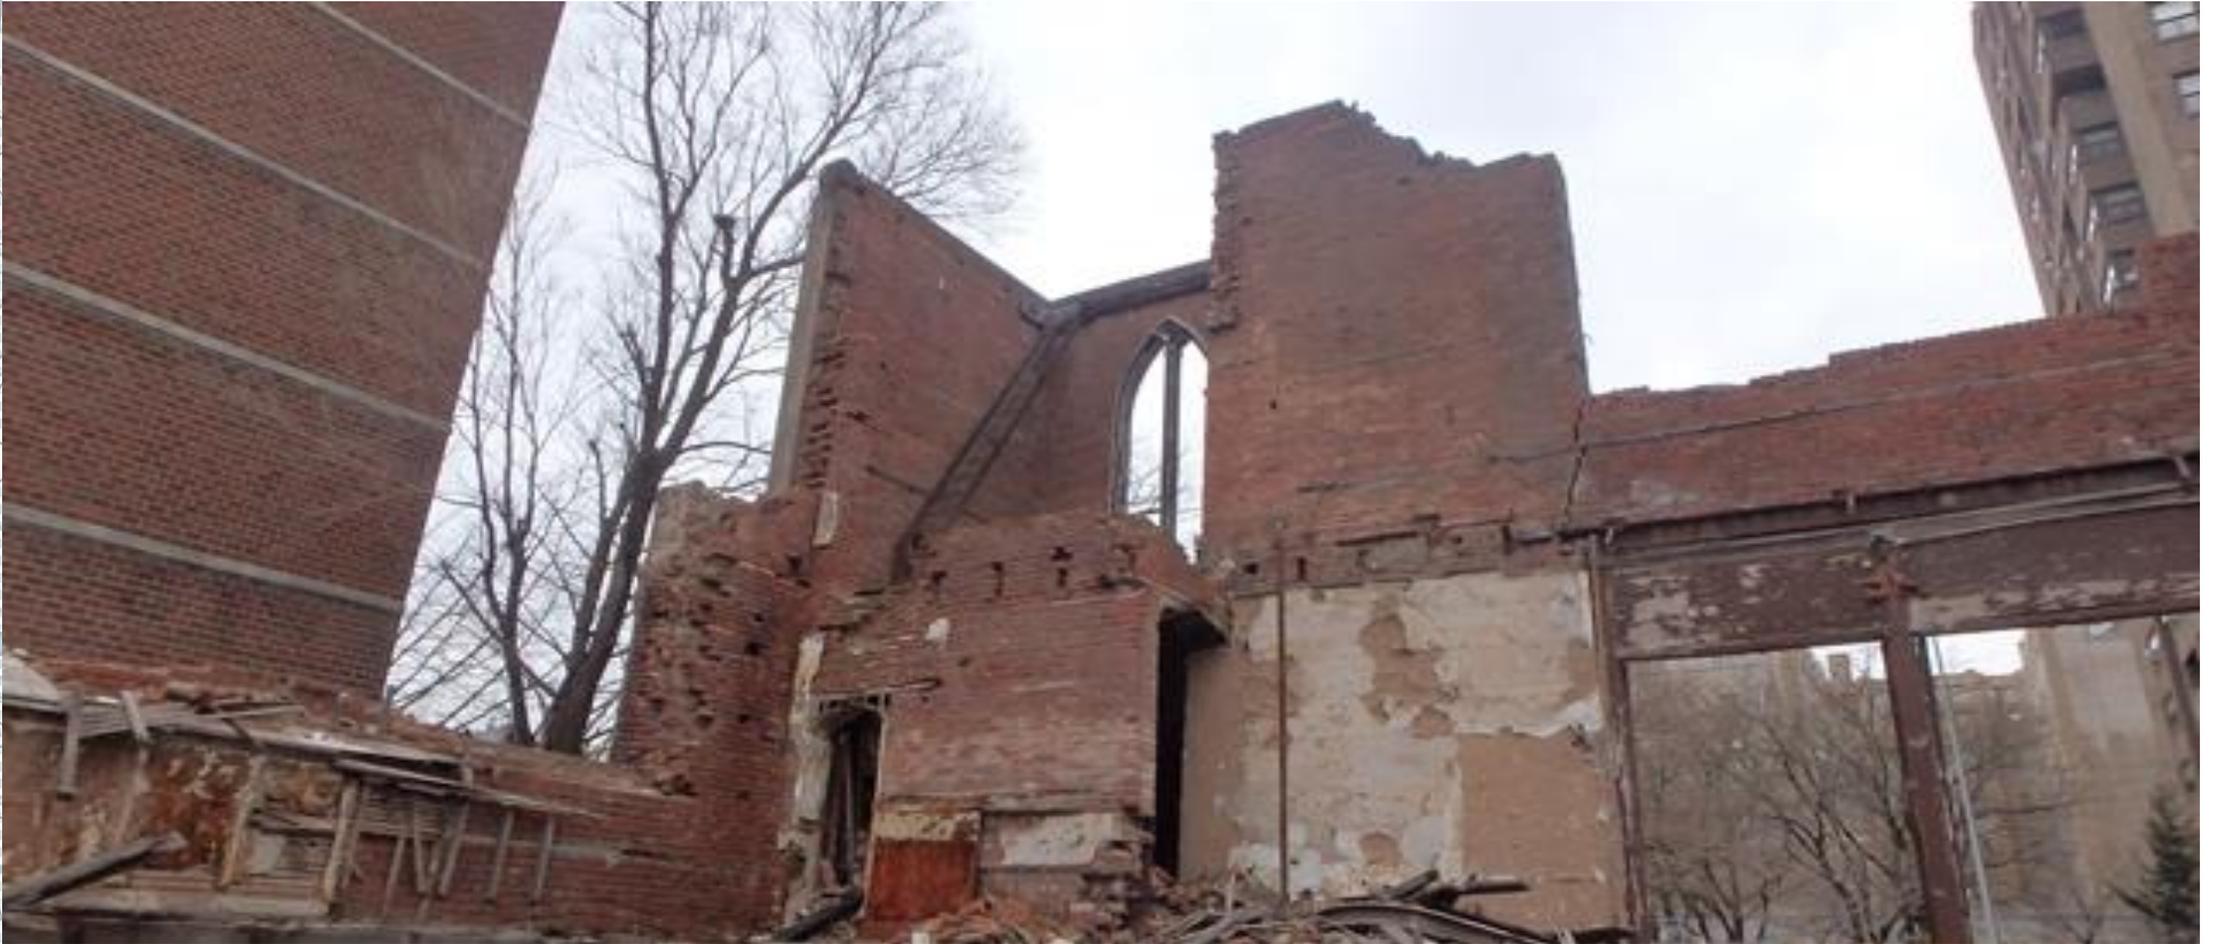
# ASBESTOS CLEANUP 10/21/19

On October 21, workers were doing asbestos abatement cleanup at 60 Norfolk Street in Manhattan. The site was the scene of a fire a year earlier and plans to begin construction of a new structure were hampered by the asbestos debris onsite. Two workers were standing underneath an archway (seen in the photo on the right) placing water on the debris piles to control the dust. The workers were using an excavator with crawler treads and a grappler hook, as well as a bobcat to move the debris. The vibrations from the machinery caused an existing piece of façade to collapse in on the two workers holding the hose, trapping one and fatally striking the other.

*Failure to shore and brace the existing façade and improper use of the equipment lead to the collapse.*

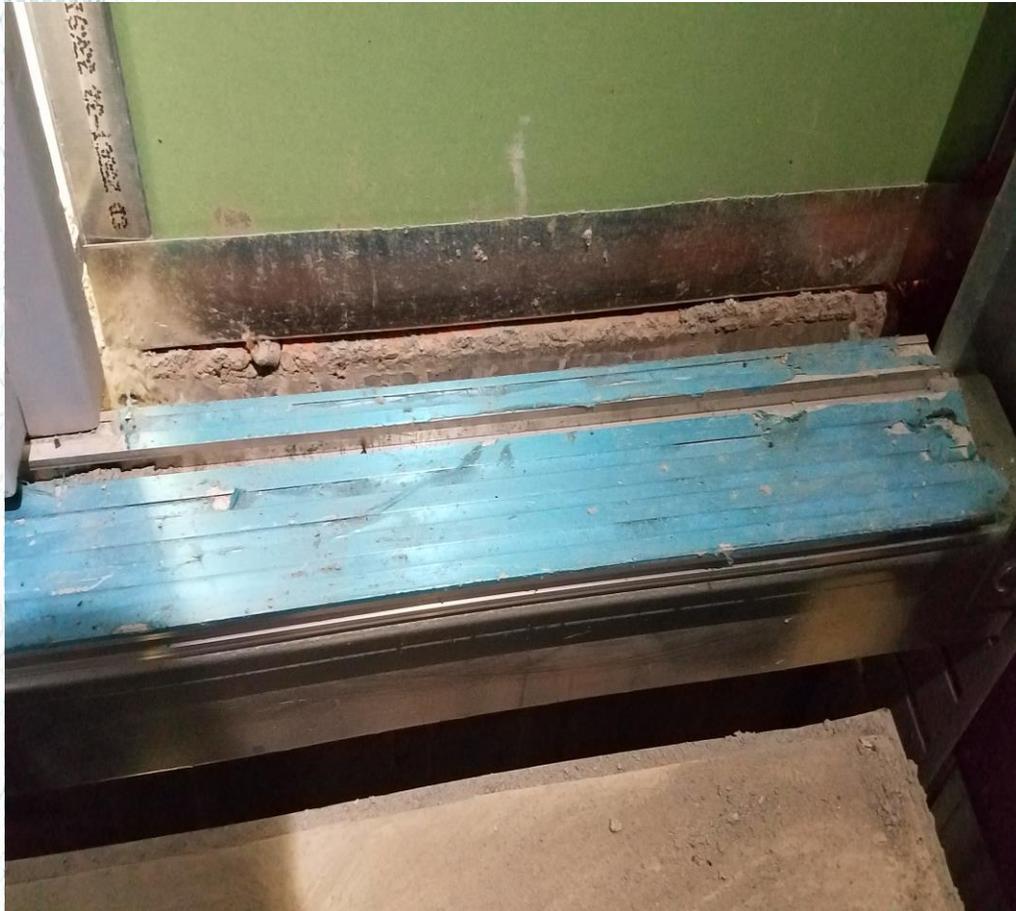
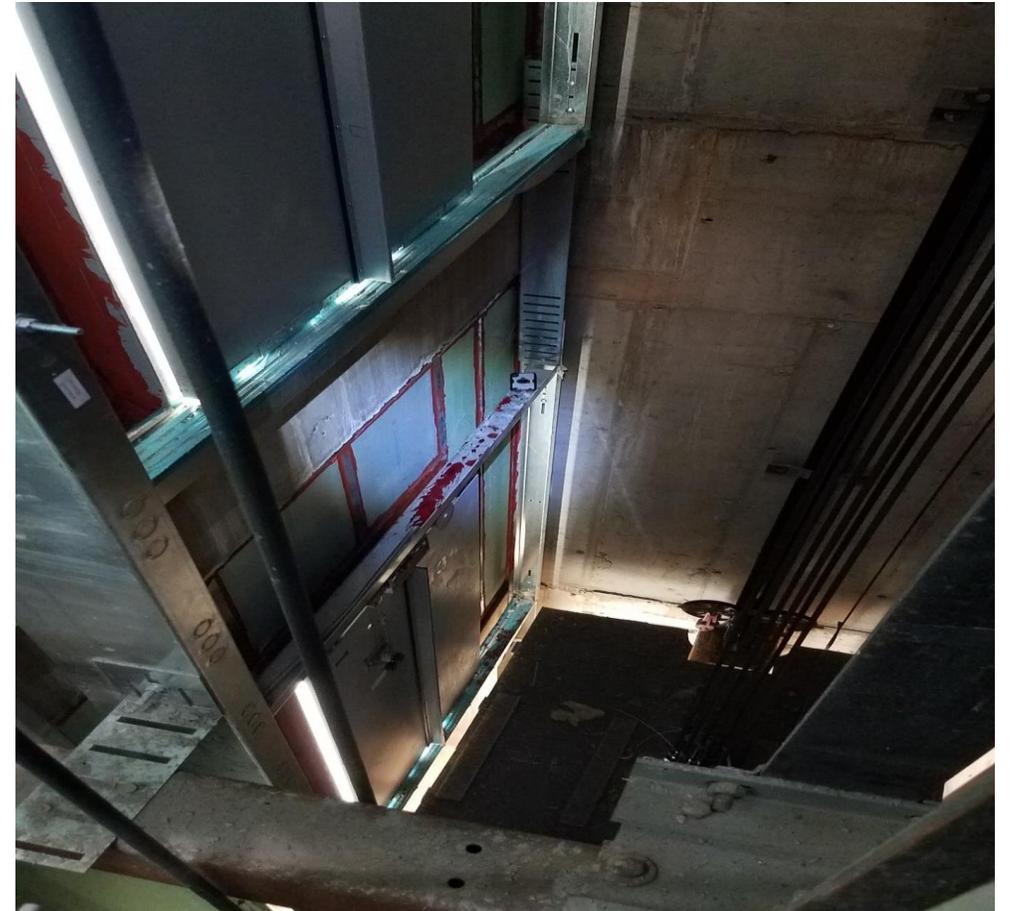
# MISUSE OF PLATFORM 10/24/19

On October 24, workers were going up to the 35th floor of a new 38-story hotel at 1227 Broadway in Manhattan to perform lobby fireproofing. Rather than wait for the hoist, the workers took control of a temporary elevator platform that was awaiting cab installation. As they neared the 32nd floor, one of the workers using his cell phone dropped it and it landed on the top of the door frame ledge (seen in the center of the photo on the right). The worker laid down on the deck of the platform to retrieve his phone. As he reached down, his skull contacted the deck (seen in the photo on the left) on the 33rd floor and he was pinned between the platform and the deck. He died instantly.

*Failure to secure the temporary elevator platform and use by an untrained worker were the contributing factors.*

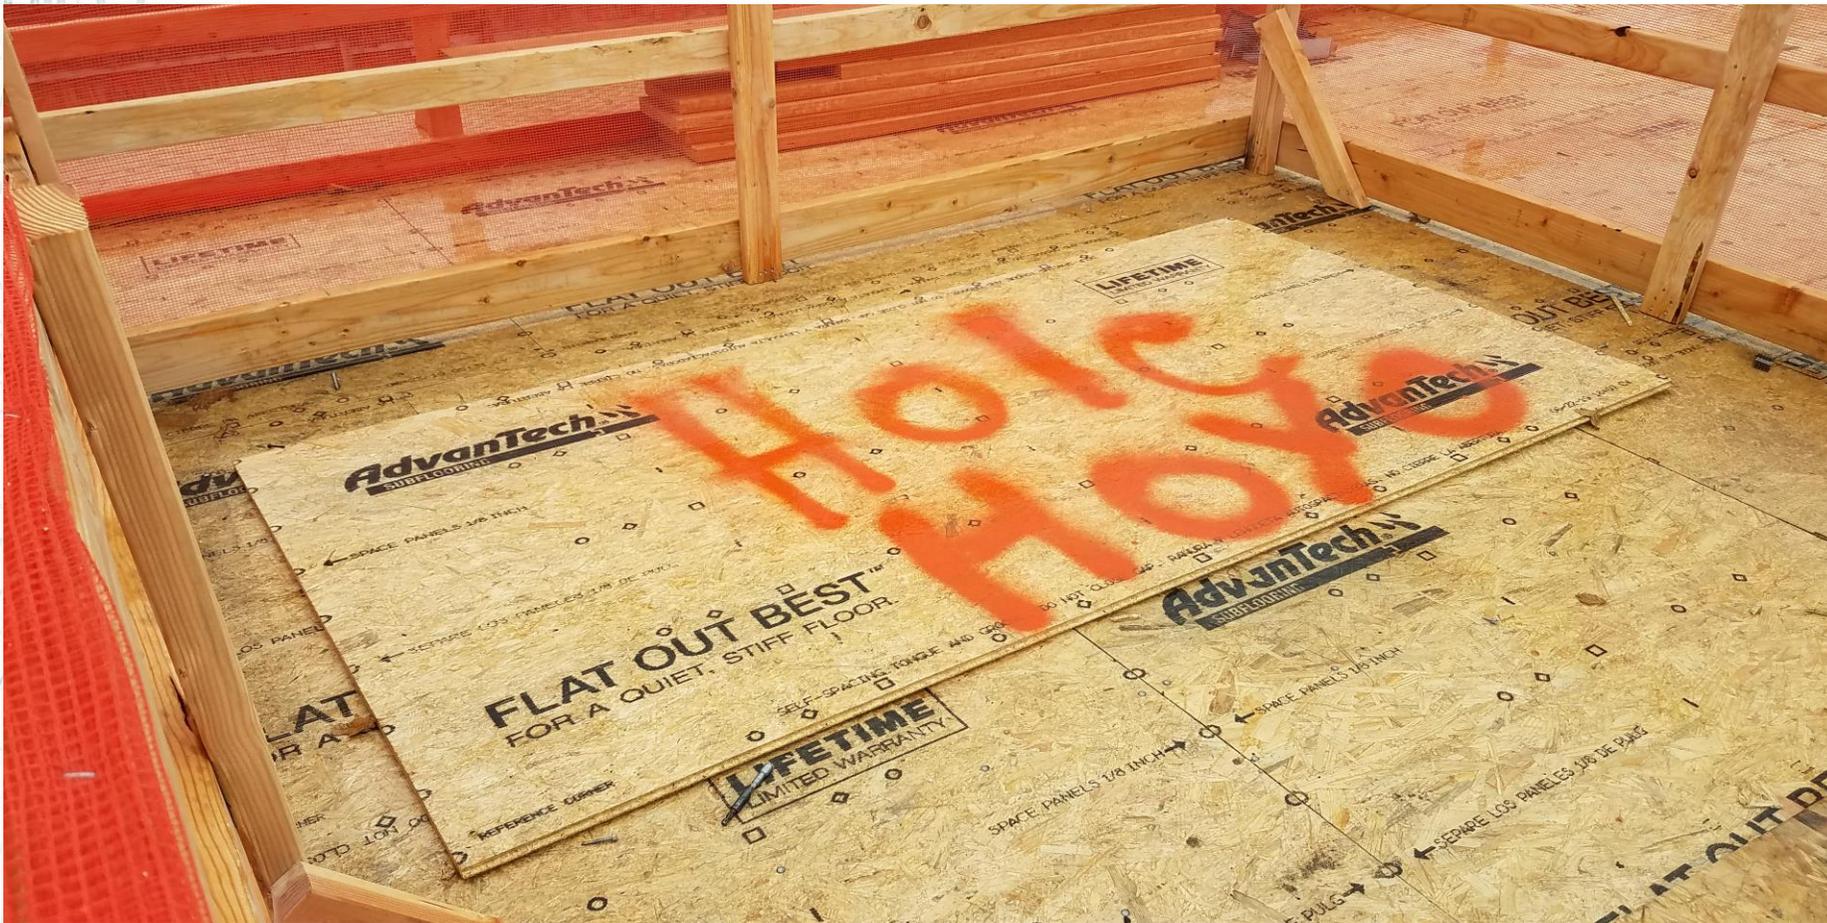
# NO CONTROLLED ACCESS ZONE 11/11/19

On November 11, a newly hired worker was assigned to move a stack of plywood on the second-floor deck of a residential project at 3420 Bedford Avenue in Brooklyn. He was not aware that the bottom panel of plywood covered a yet to be constructed stairwell and was unsecured to the deck. There was no controlled access zone around the plywood stack nor any warnings of the stairwell opening. The worker began lifting the plywood and moving it to another area. When he lifted the last piece, he walked forward and stepped into the unmarked stairway well falling three stories to the basement floor. He died of massive trauma.

*Failure to secure the opening cover, lack of pre-task planning and failure to set up a controlled access zone were the contributing factors.*

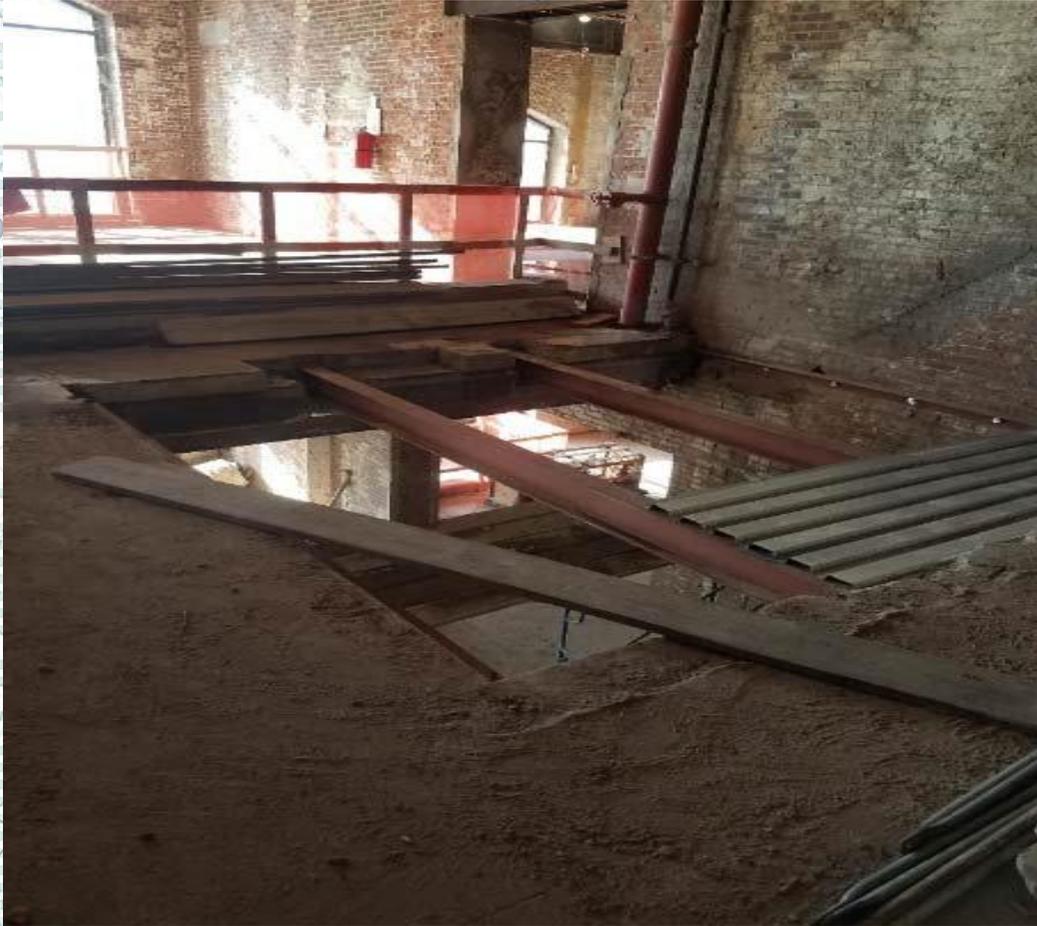
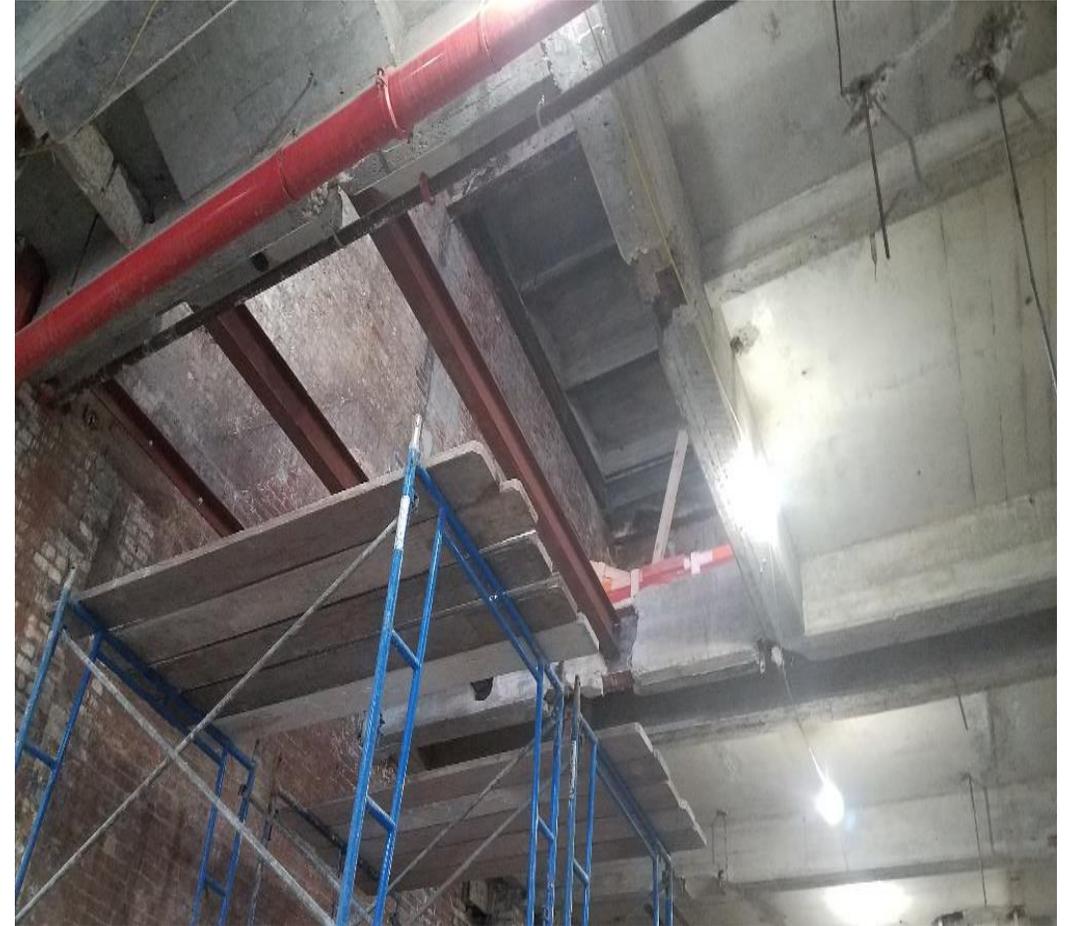
# CONTROLLED ACCESS ZONE 12/20/19

On December 20, a worker was assisting another worker building a scaffold at 20 Bruckner Boulevard in the Bronx. The worker on the scaffold wanted another plank. Although there were other planks nearby, the decedent entered a controlled access zone on the floor above (seen in the photo on the left) and fell through the opening landing 20 feet below. He was removed to the hospital where he died two weeks later from his injuries.

*Allowing access to the Controlled Access Zone without proper tie-off equipment was a key factor.*
