# CONSTRUCTION SAFETY REPORT CARD

© 2020 New York City Department of Buildings

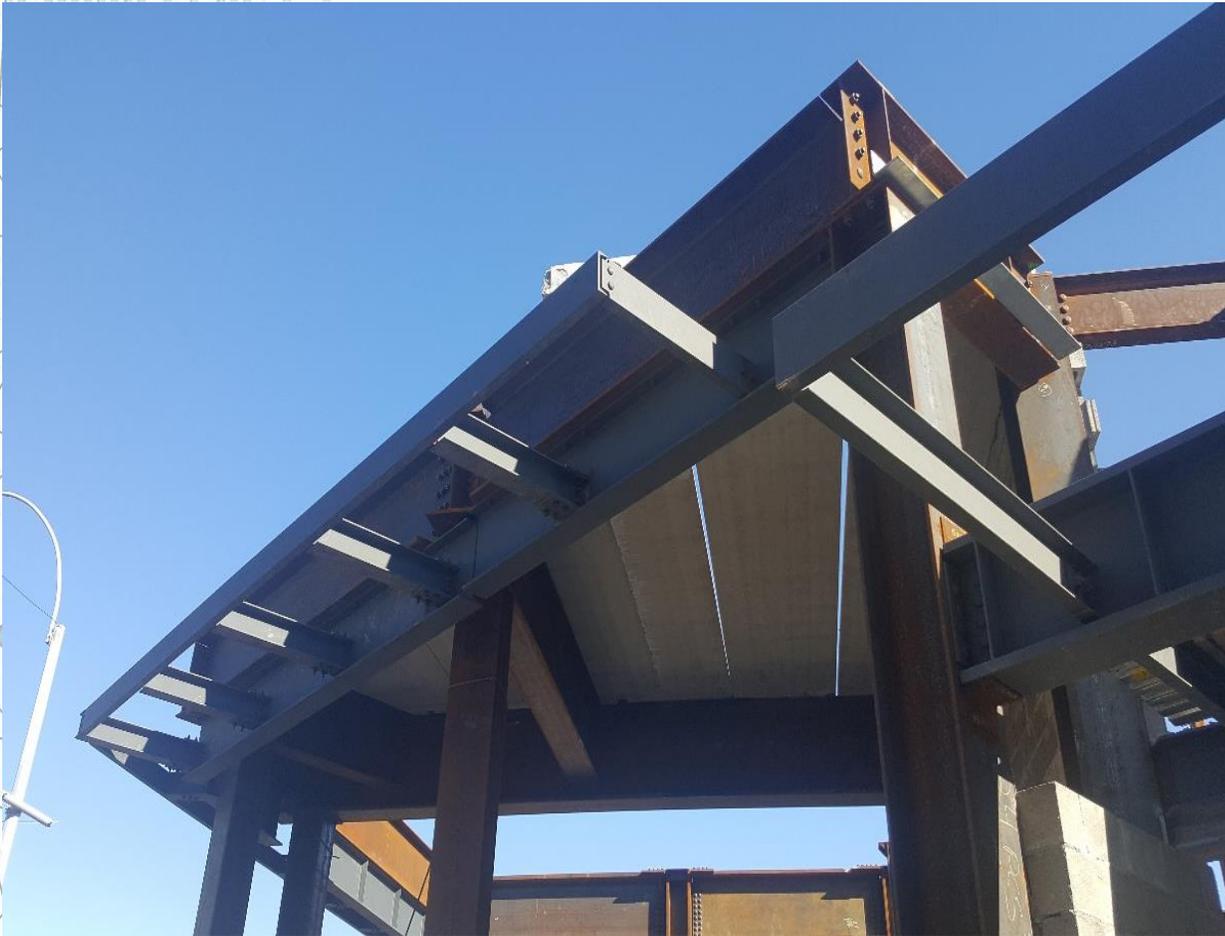
# WORKER FALL 02/16/19

On February 16, a steel worker was installing a beam for the third-floor deck at 556 Bergen Avenue in the Bronx. He slipped off the beam and was stopped from falling by his harness. He sustained some non-life-threatening injuries as he hit a beam during the fall.

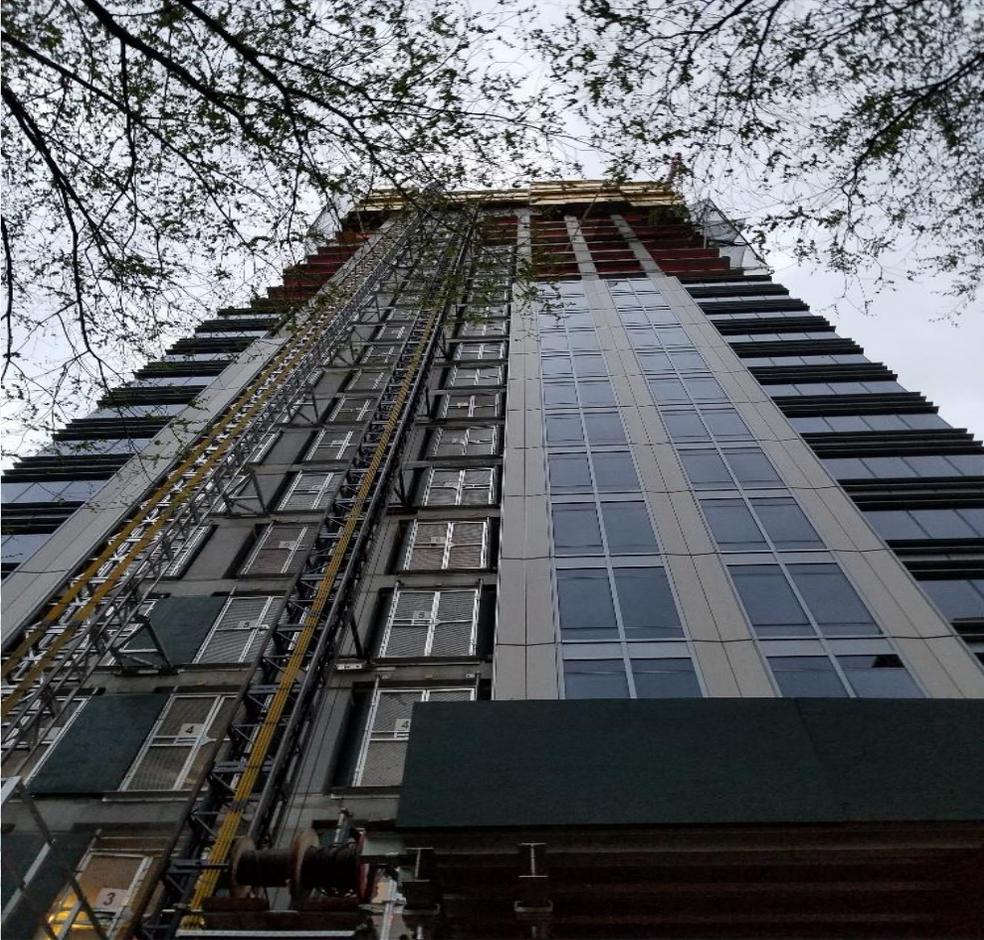
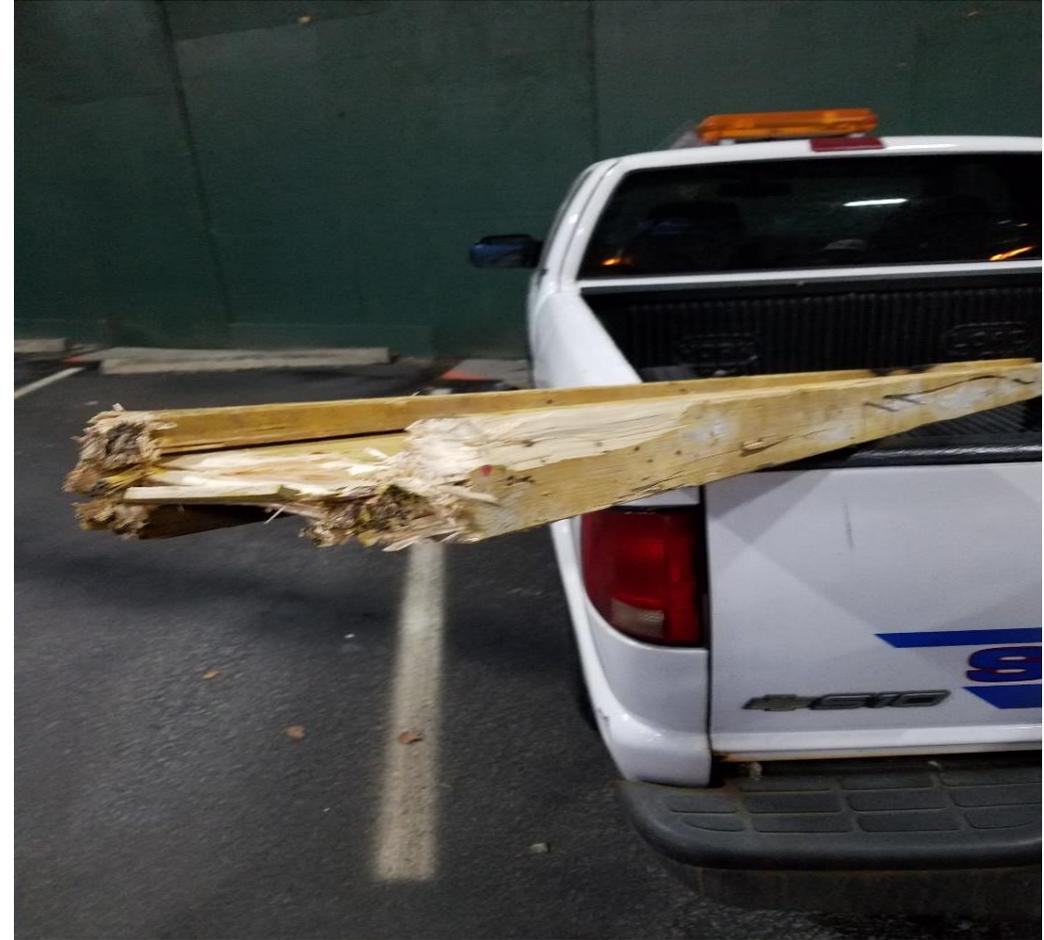
# MATERIAL FALL 04/16/19

On April 16, at a high-rise project located at 200 Amsterdam Avenue in Manhattan, workers were stripping material in the vicinity of the 26th floor. A worker lost control of the formwork and it fell below the DOKA system and through a net landing on West 69<sup>th</sup> Street. The 8' piece of formwork is visible in the photo on the right after it was retrieved. No injuries.

*Failure to maintain control of the formwork and improper netting led to the incident.*

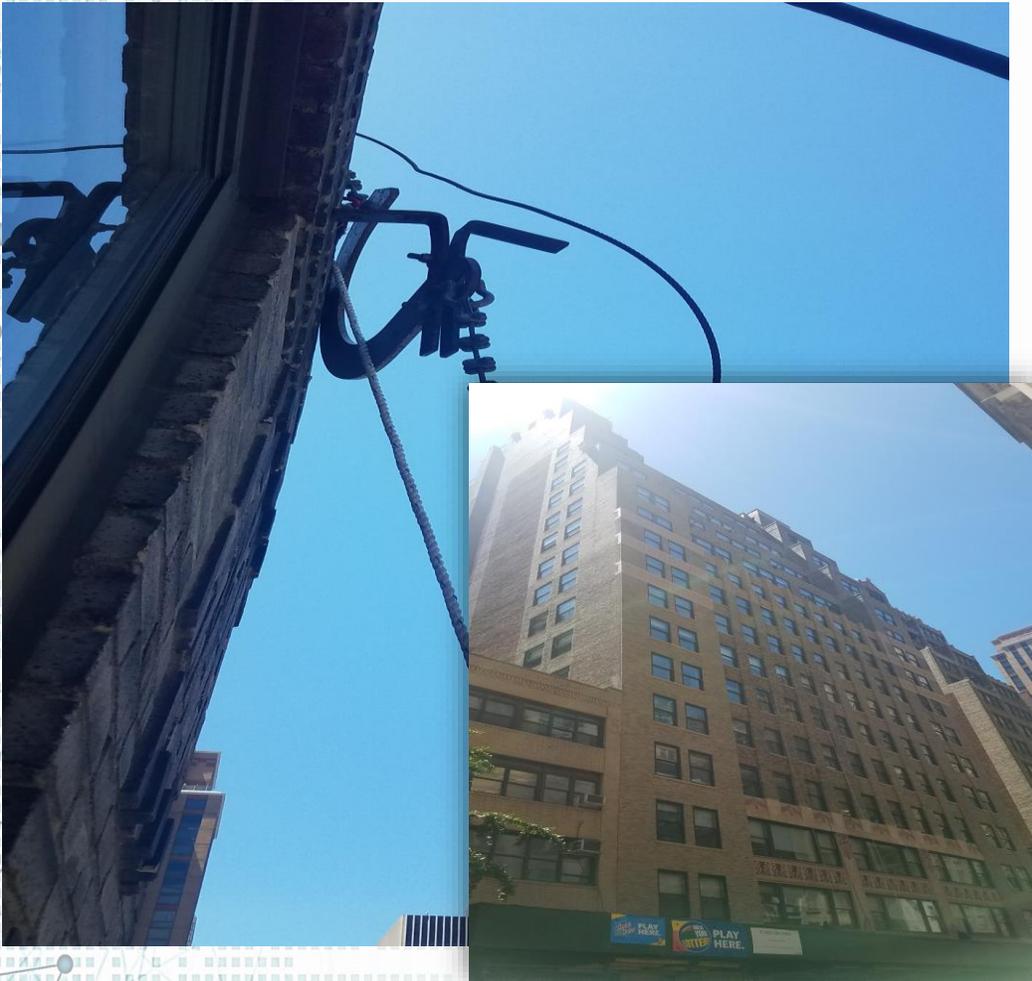
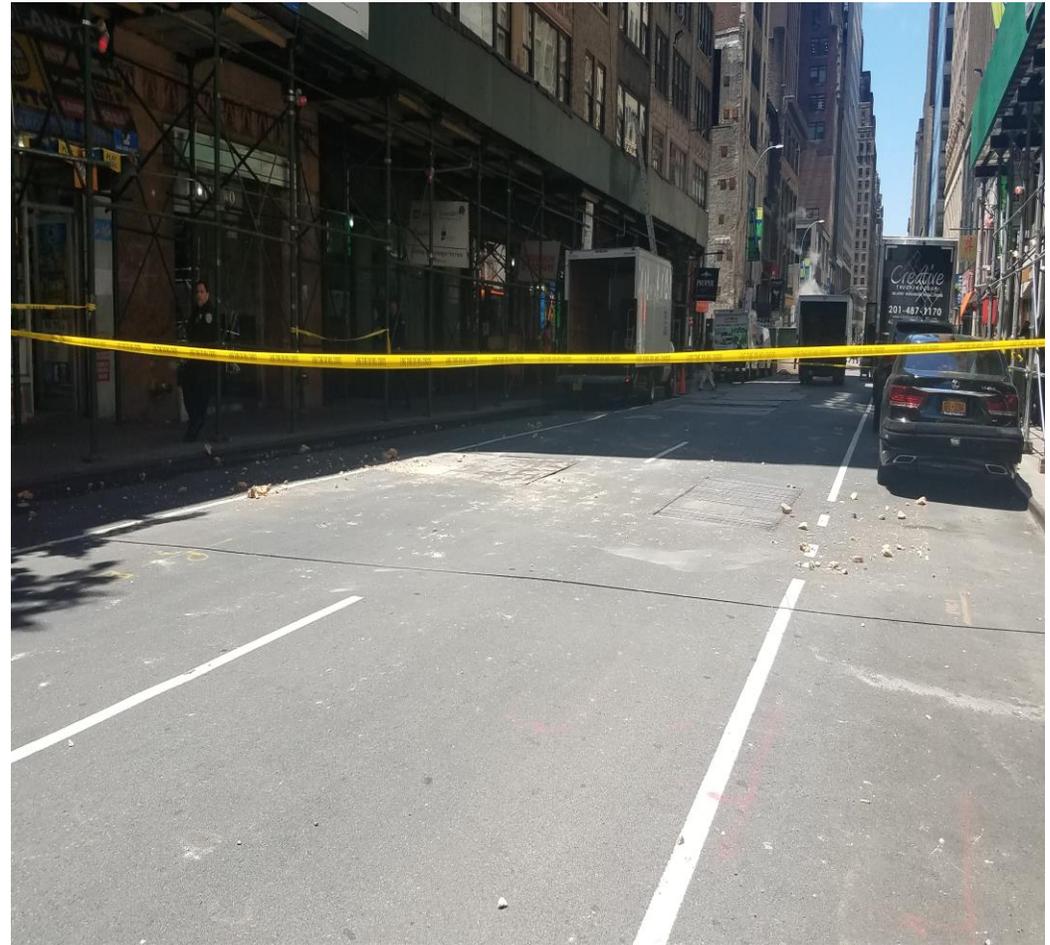
# STANDOFF BRACKET SLIP 06/01/19

On June 1, DOB responded to another standoff bracket failure at 42 West 39th Street in Manhattan. Workers were moving the suspended scaffold over a terrace projection which angled the rig when the standoff bracket slipped impacting the coping stone and causing it to rain down into the middle of West 39th Street (seen in the photo on the right). The inset photo on the left shows the height of the building and the main photo on the left shows the twisted standoff bracket and C-hook. Due to these recent incidents with standoff brackets, we met with the Special Riggers Association and prohibited their use pending further study.

*Failure to protect the coping stone from impact, not checking the supporting surface for the loads imposed and misuse of the suspended scaffold led to the incident.*

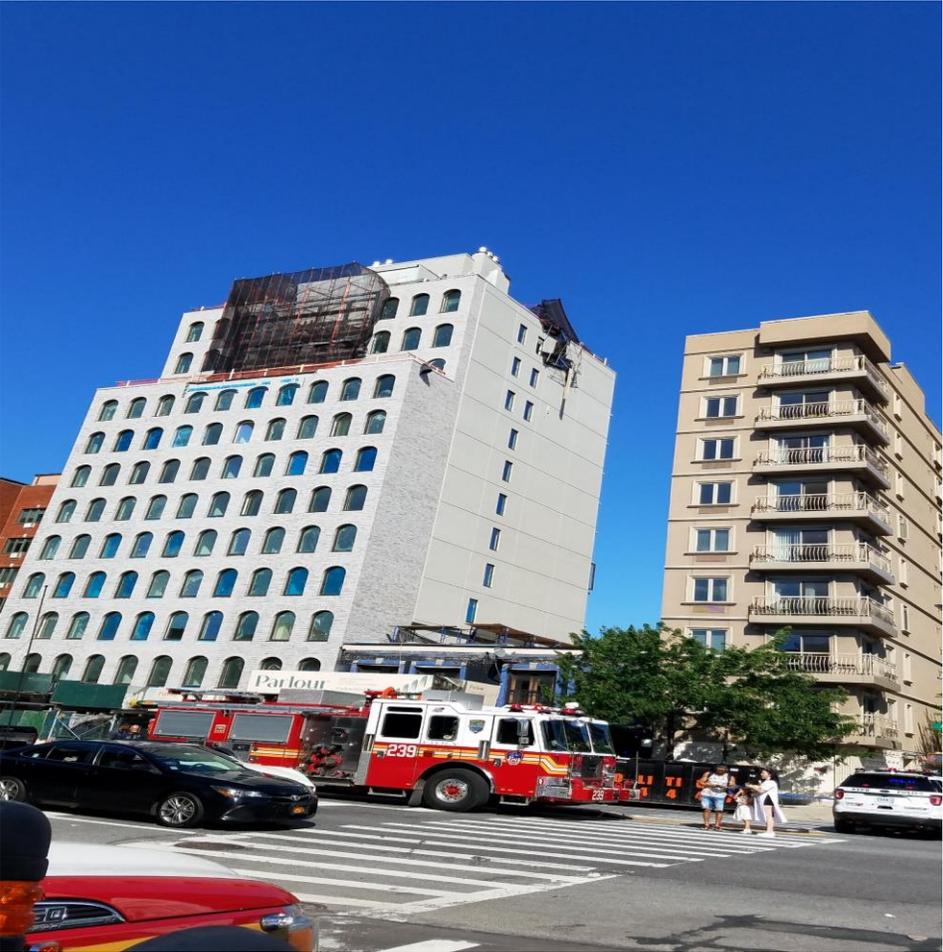
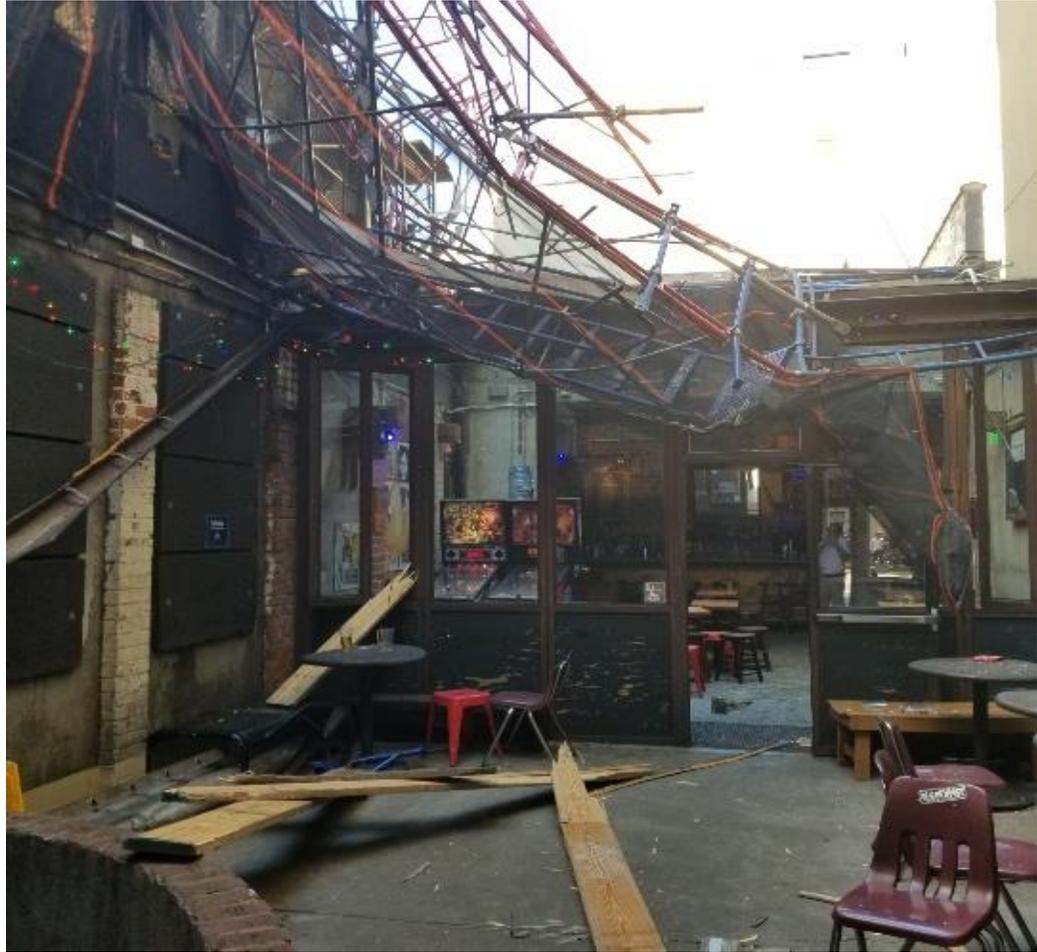
# SCAFFOLD COLLAPSE 06/11/19

On June 11, the scaffold located at 243 4th Avenue in Brooklyn was experiencing a high wind event that was subject of a warning from DOB the previous day. Suddenly, the scaffold was blown off the bulkhead and rained down onto an outdoor café located next door to the construction site. Sitting in the café were several people, one of which was struck in the head by one of the planks. She sustained serious injuries but survived. An investigation revealed that the ties used to stabilize the scaffold had been removed and the scaffold was awaiting a sub-contractor, who was notified over two weeks earlier, to dismantle it.

*Failure to safeguard the site was a major factor.*

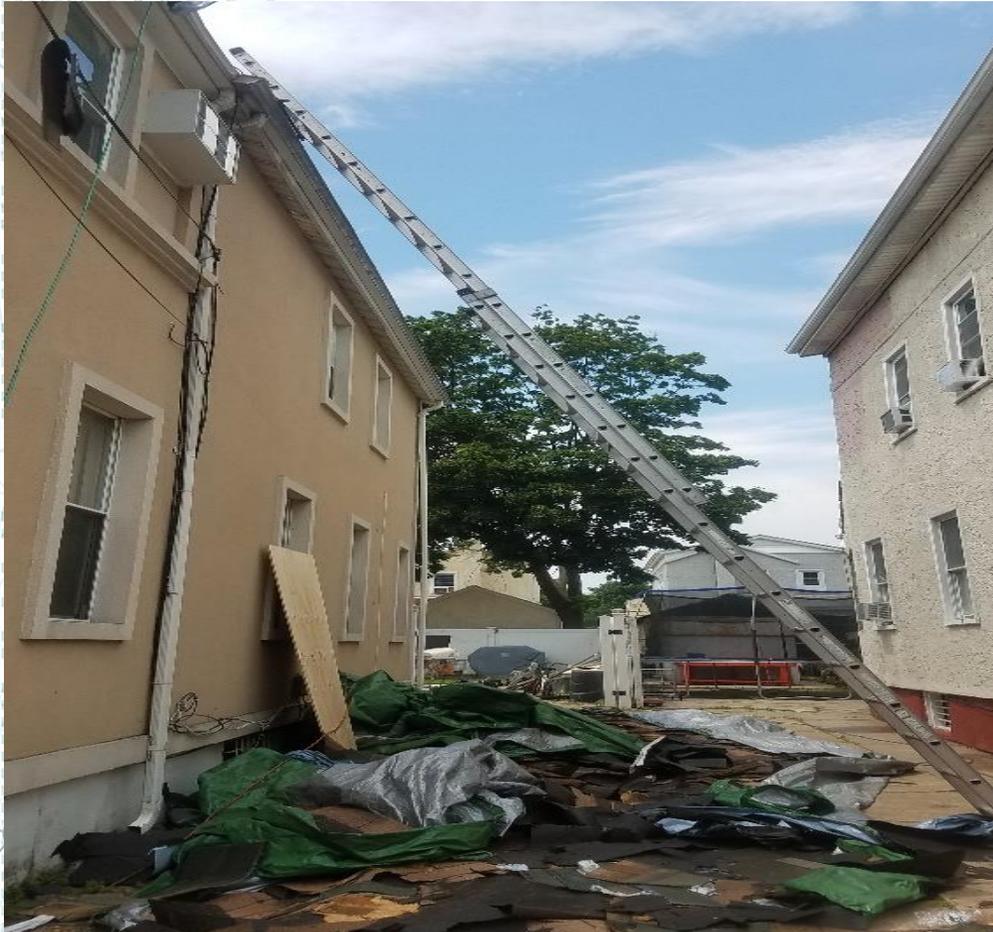
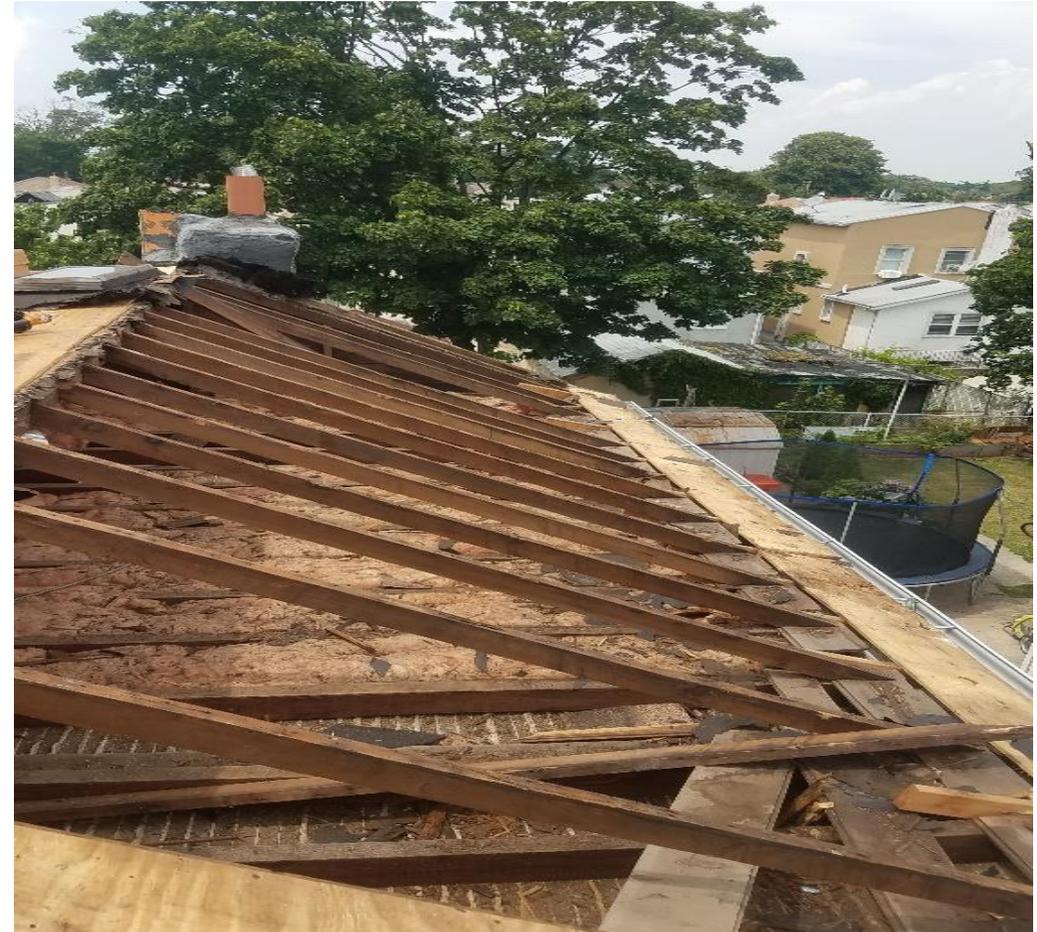
# ROOFER FALL 07/17/19

On July 17, a roofer was replacing roofing materials at a residence at 138-24 233 Street in Queens, including the underlying plywood sheathing. Working close to the edge, the roofer failed to tie-off and slipped off the roof falling 2 ½ stories.

*Failure to tie-off led to the incident.*

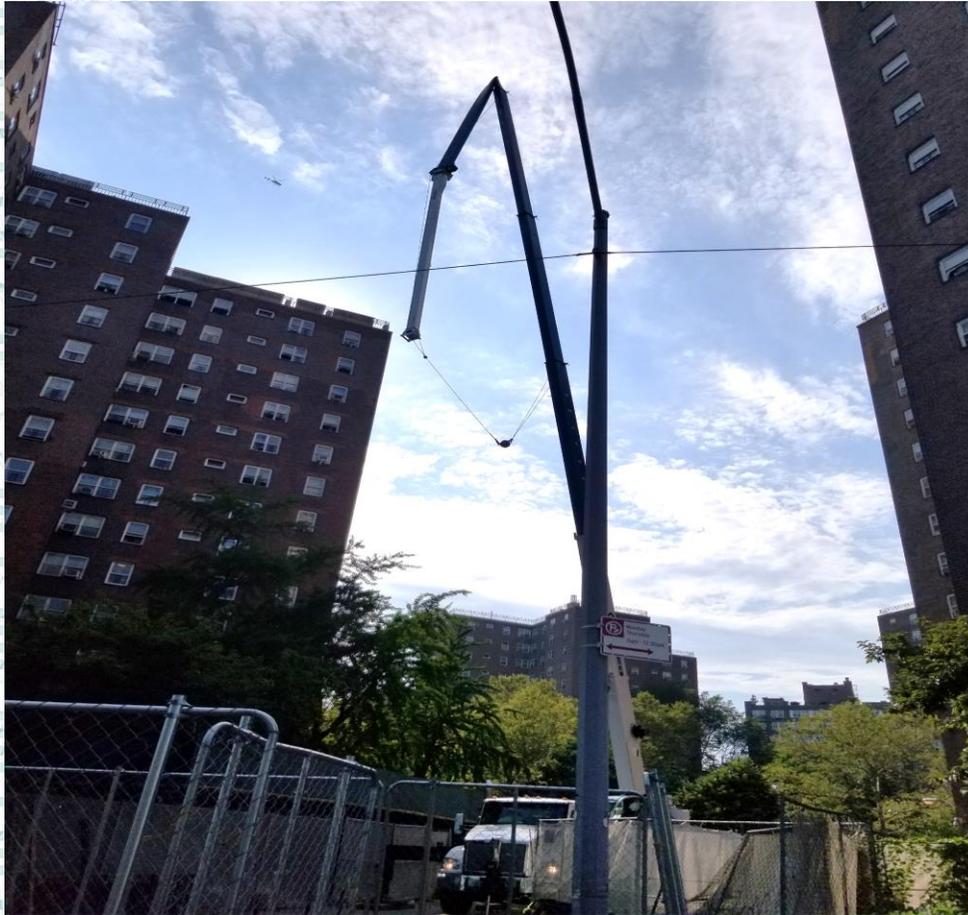
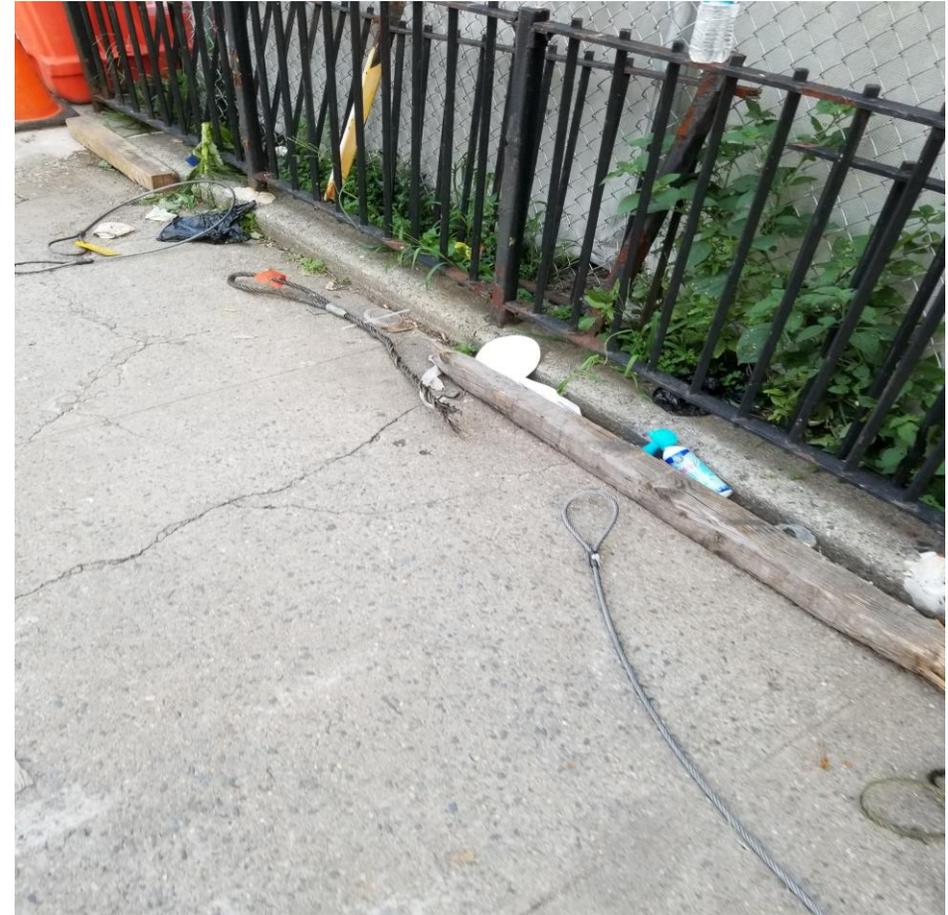
# CRANE OVERLOAD 07/30/19

On July 30 workers were using a crane to place roofing materials and steel dunnage onto the roof of a NYCHA building at 749 FDR Drive in Manhattan. During the pick the crane operator bypassed the safety features, lost control of the load and dropped the steel down to the street level onto the FDR Drive service road. The crane boom was bent at close to a 90-degree angle, as depicted in the photo on the left, requiring closure of the FDR Drive and additional cranes to dismantle the damaged unit. An investigation revealed the operator overloaded the crane and exceeded the pick radius. Additionally, slings not rated to lift the load were used, causing them to break (seen in the photo on the right). There were a few minor injuries.

*Improper planning, failure to use certified slings, by-passing machine safeties, failure to obtain weight of the load and using a crane that was not rated for the pick as designed were all key factors.*

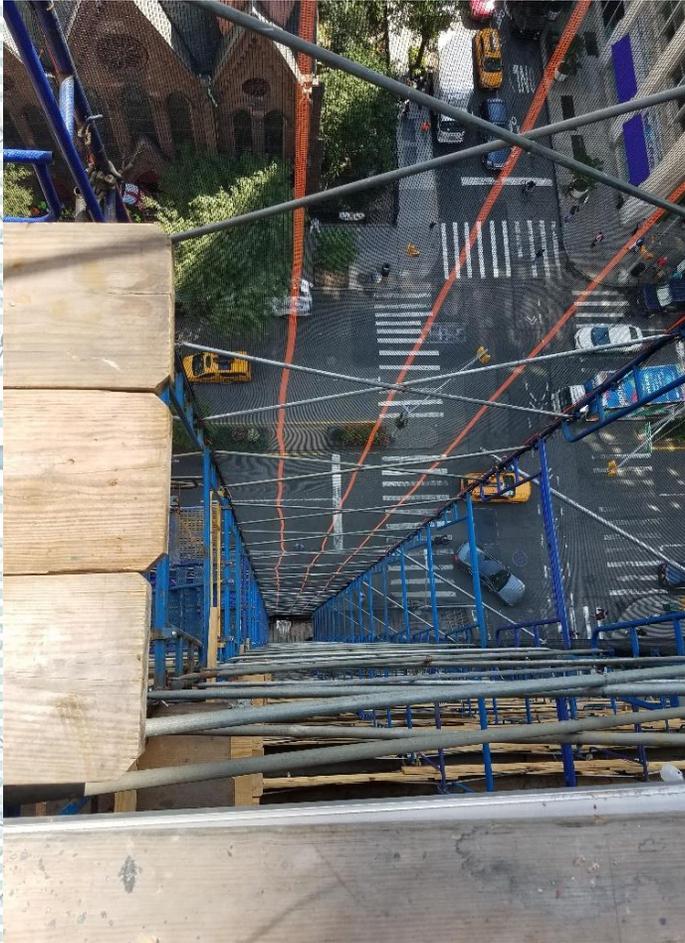
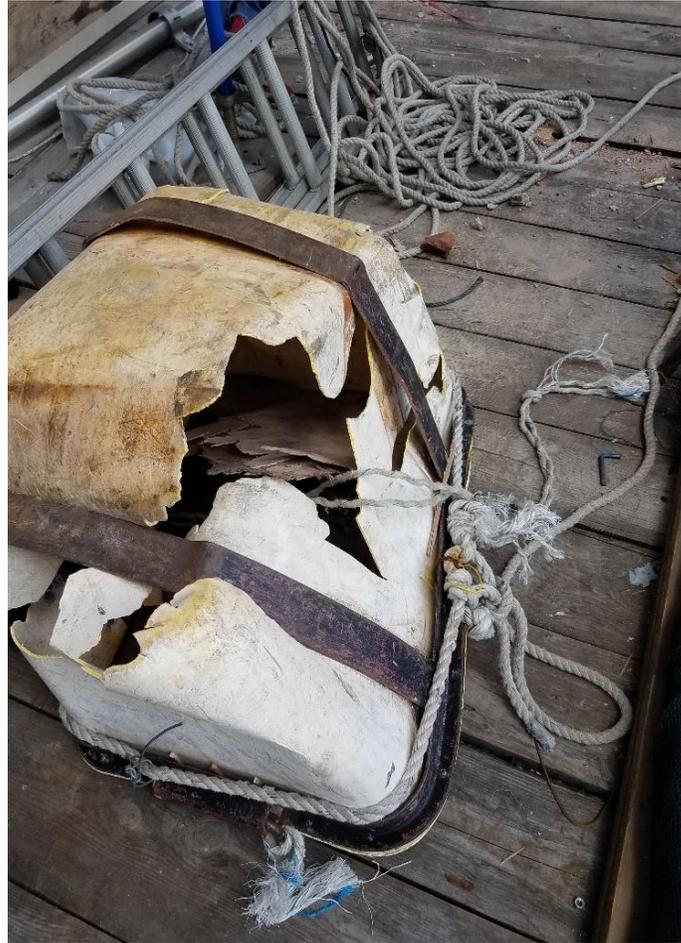
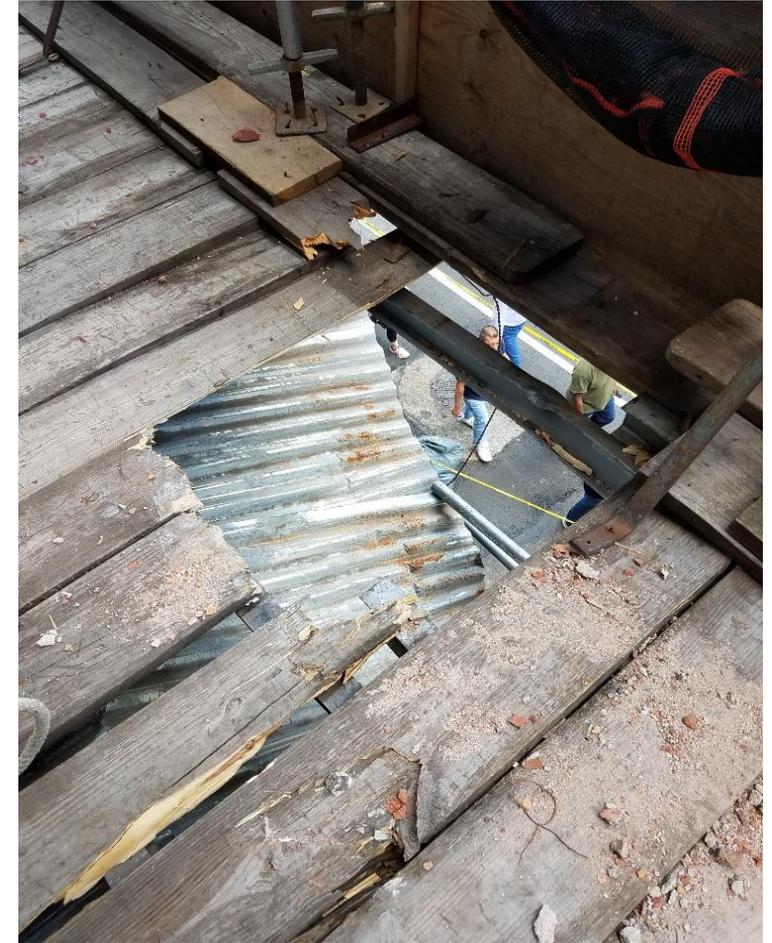
# MATERIAL HOIST FAILURE 9/13/19

On September 13, workers were lowering debris in a canvas bucket using a power winch at 270 Park Avenue in Manhattan. The workers overloaded the basket causing the cable to snap and dropped the load 10 stories. The load went through the sidewalk shed and nearly hit a pedestrian.

*Failure to inspect the cables of the power winch and overloading the basket were the key factors in the incident.*

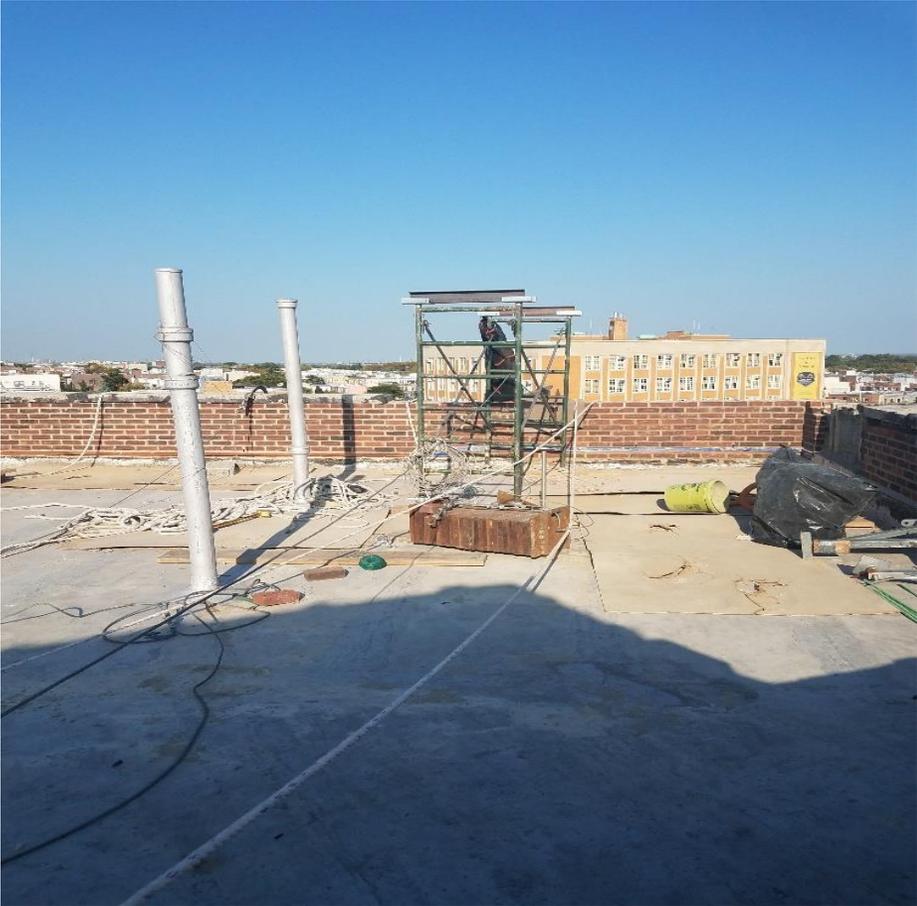
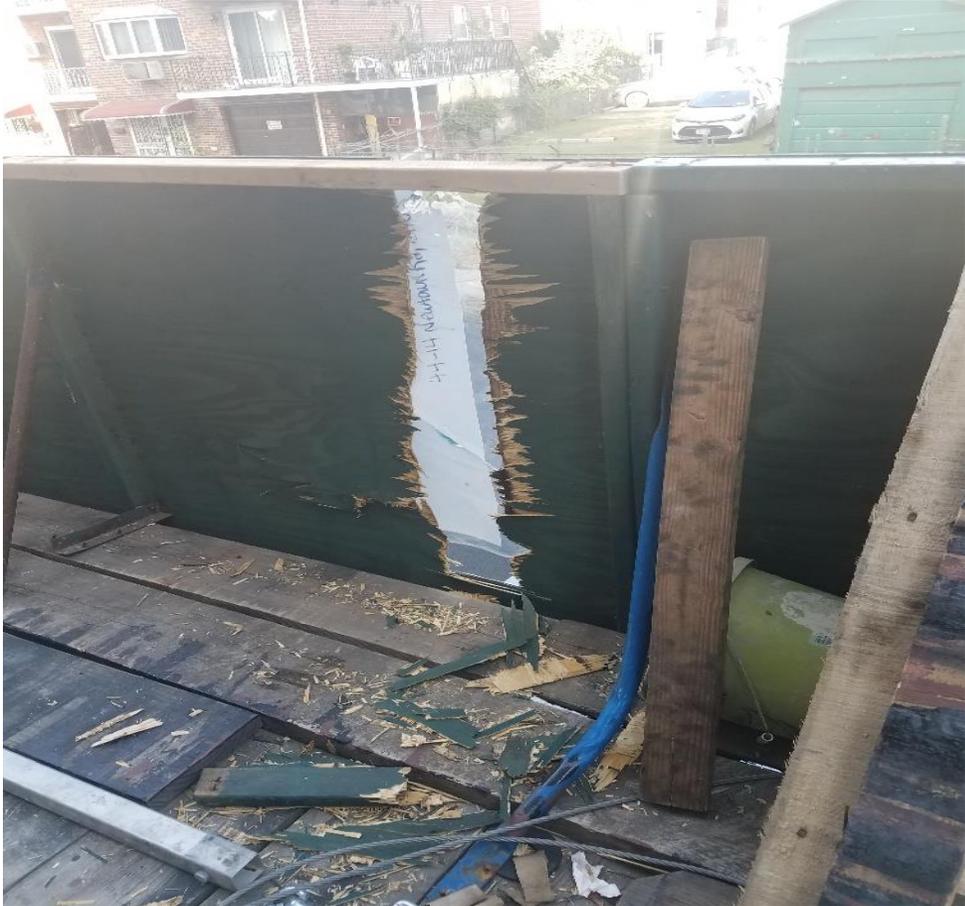
# OUTRIGGER FAILURE 10/01/19

On October 1, workers were unloading debris onto the sidewalk shed from a suspended scaffold at 44-14 Newtown Road in Queens. Unexpectedly, one of the outriggers for the scaffold was torn from its mount on the roof (seen in the photo on the left) and spiraled down to the shed below piercing the parapet wall of the shed (seen in the photo on the right).

*Improper set up on the primary counterweight support and improper set up of the tie back were the contributing factors.*
