Fracture of Glass Panels

Yegal Shamash, P.E.

Assistant Commissioner, Investigative Engineering Services

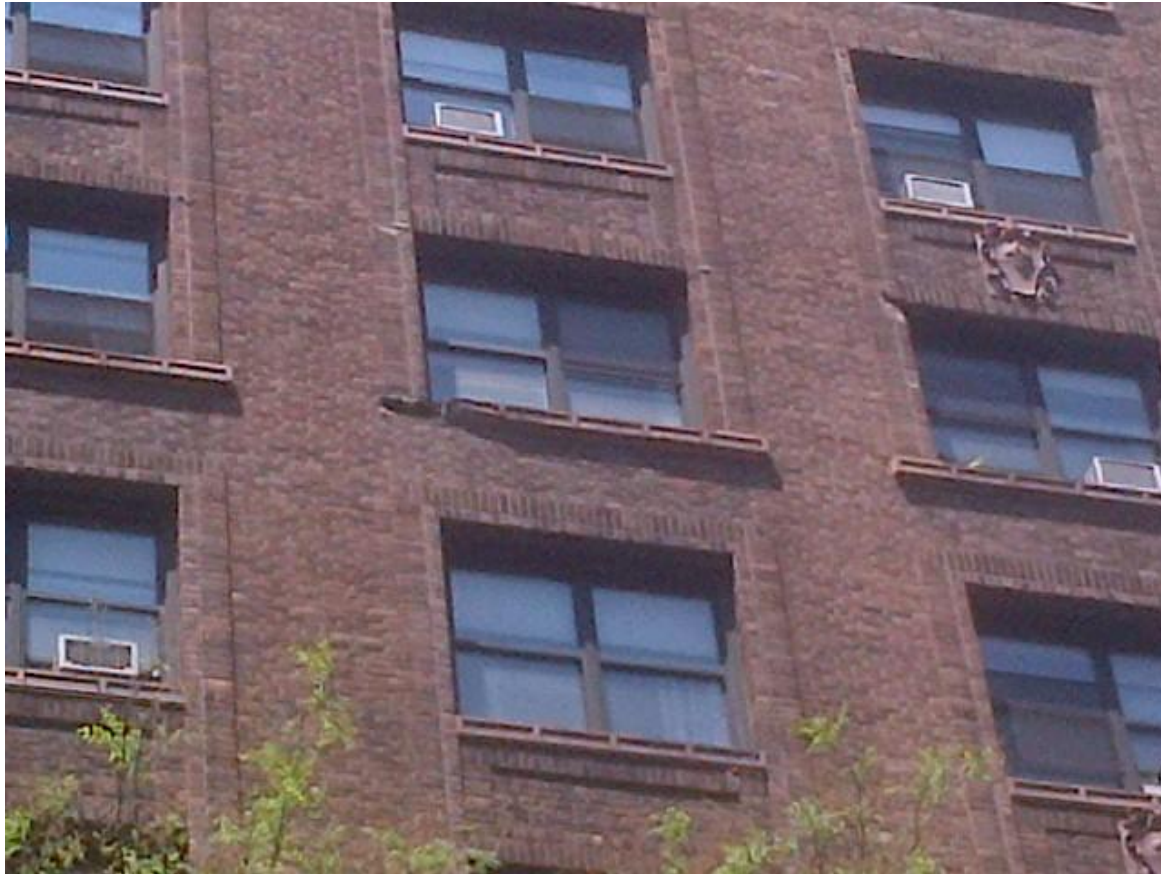
Filed SAFE: T/C sill fell - fatality

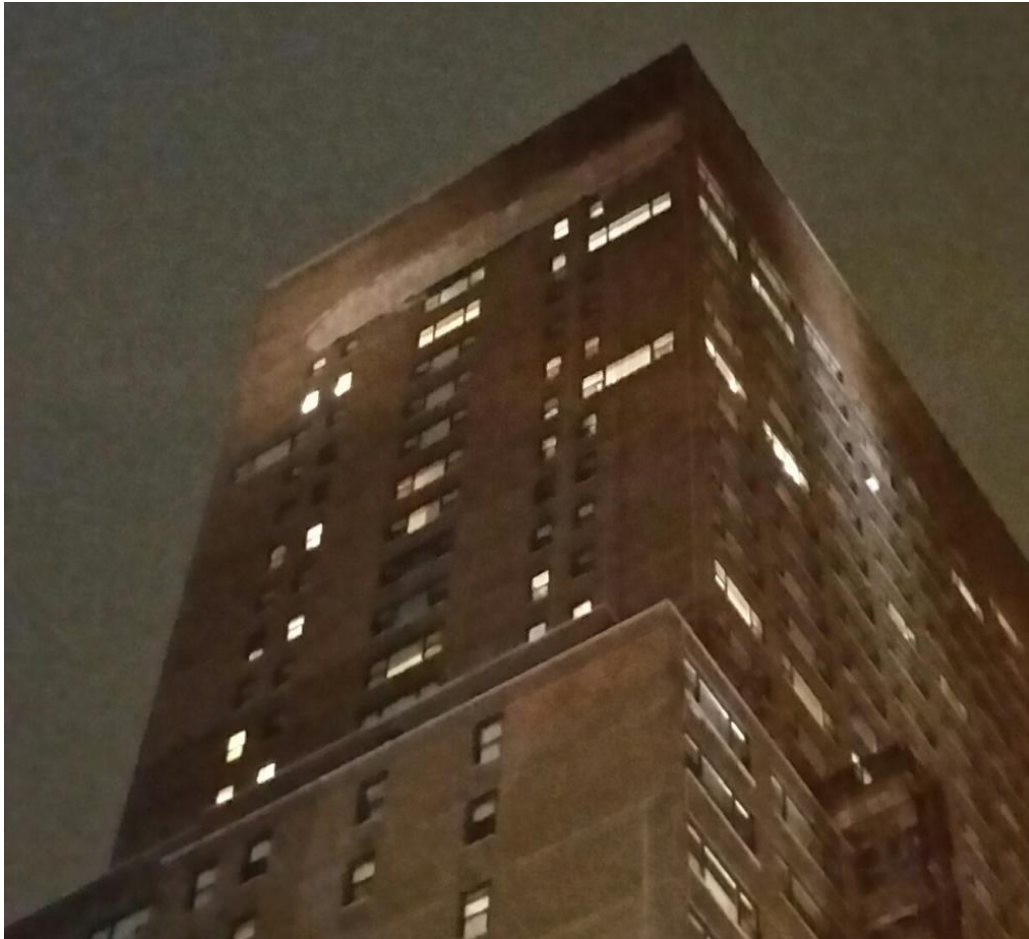
Problem jobs: cavity wall failures

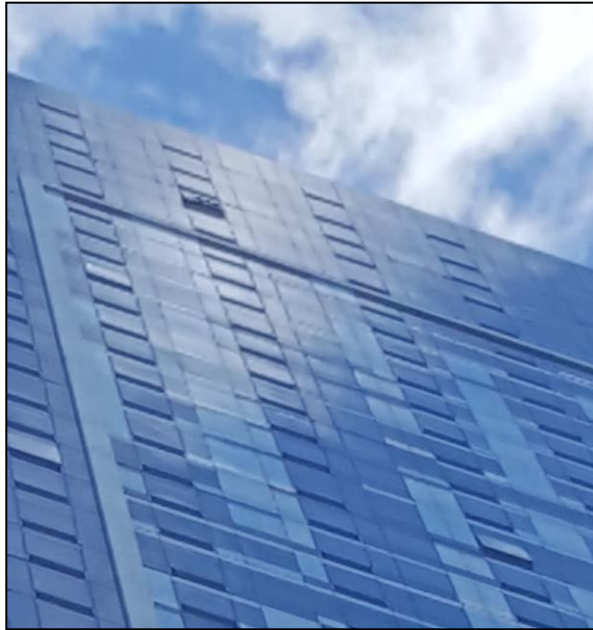
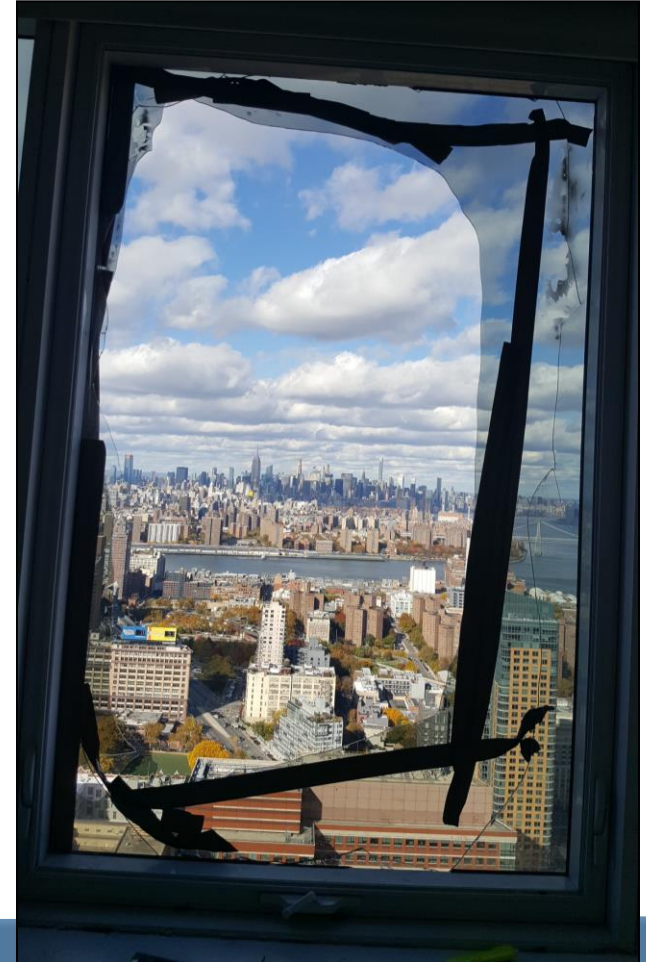
Case #1: Failure due to Impact

- FDNY responds to report of debris falling from a façade; requests DOB
- What we found:

- It was determined the initial crack was caused by the house window washing rig
- DOB inspectors found similar cracks on other panels
- Full repair pending

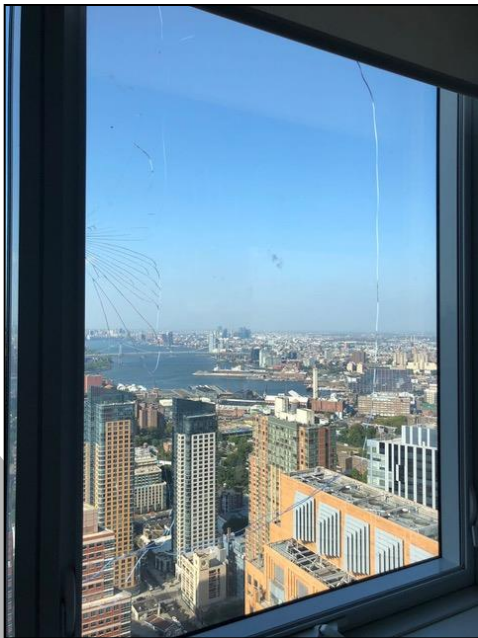
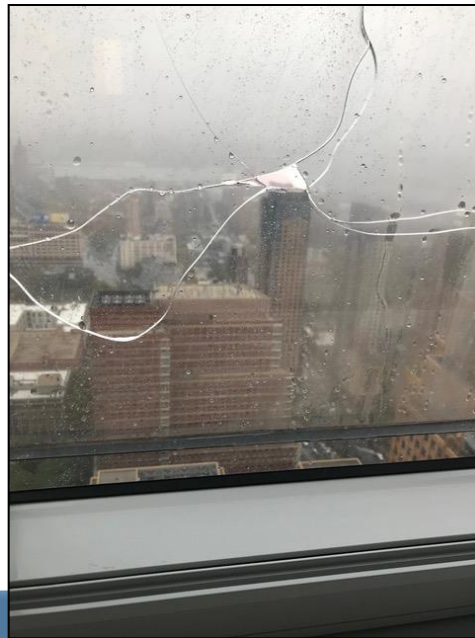
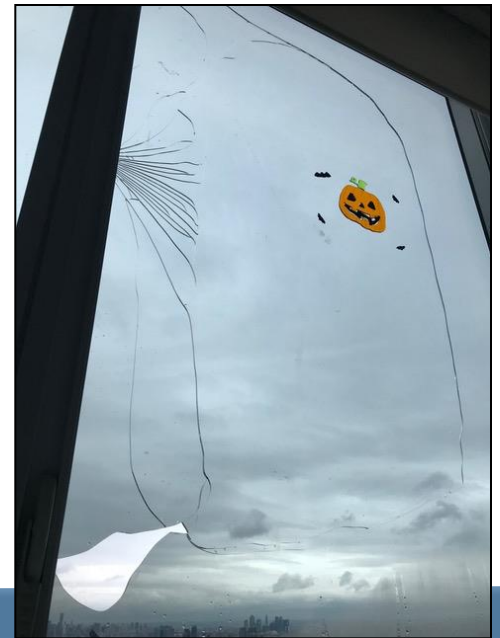
- FISP unit orders 100% hands on inspection by professional and assessment of possible causes
- In the meantime...DOB receives email from occupant of the apartment with these photos

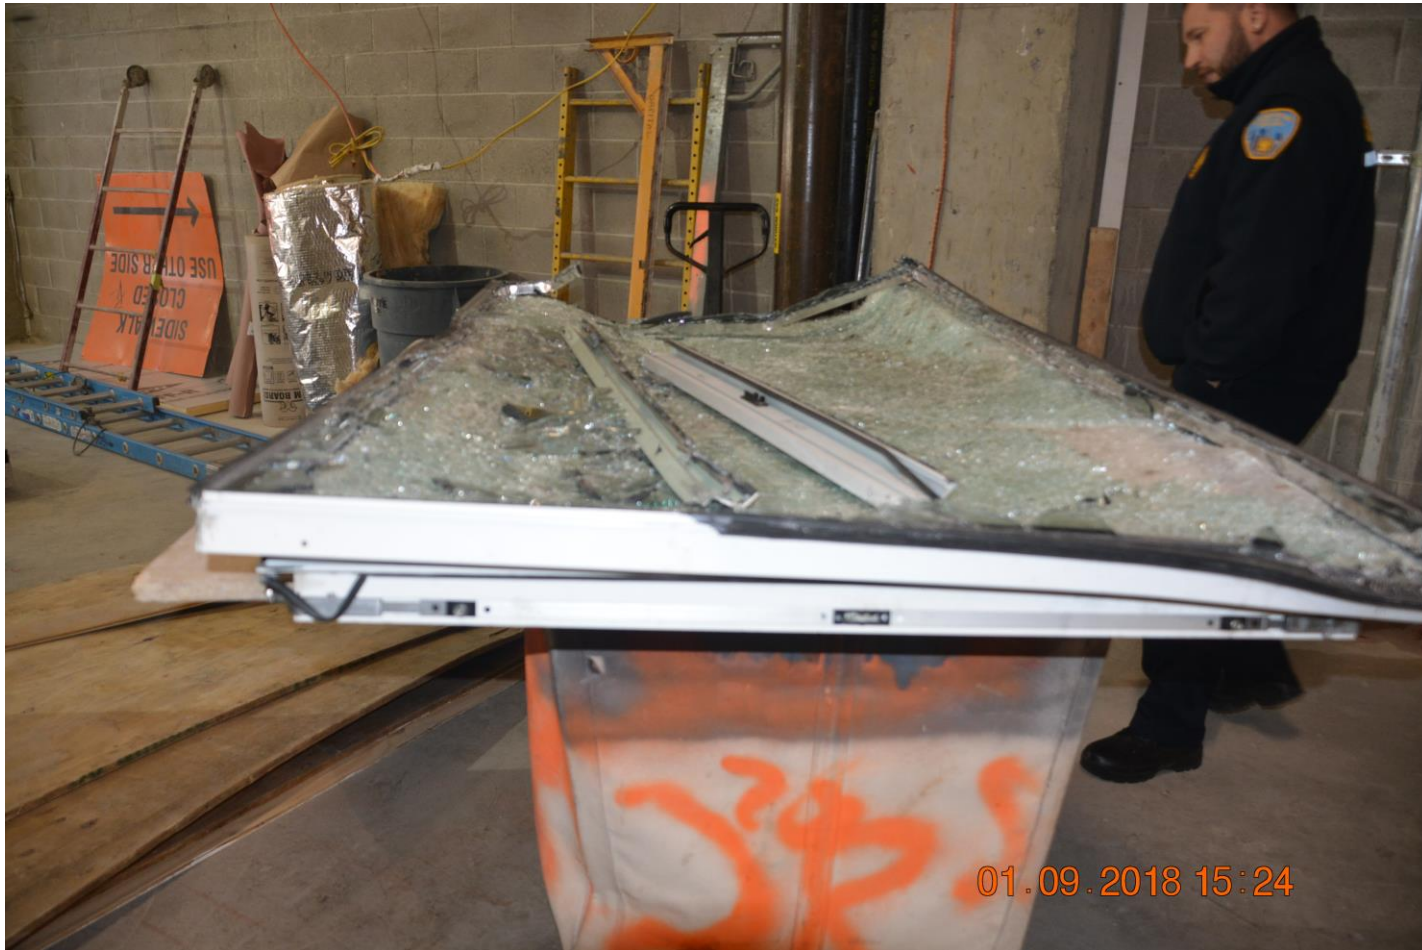
Case #2: Inspection

- Site Safety Manager reports 6th Floor window “blew out”
- Building was undergoing repair – DOB BEST squad serves partial Stop Work Order
- Glass and frame had blown off the building

- Within 2 months after incident, all windows inspected and maintenance repairs completed
- Overall 60% of rain shed gaskets replaced
- No structural damage
- It was determined the incident was due to hardware failure

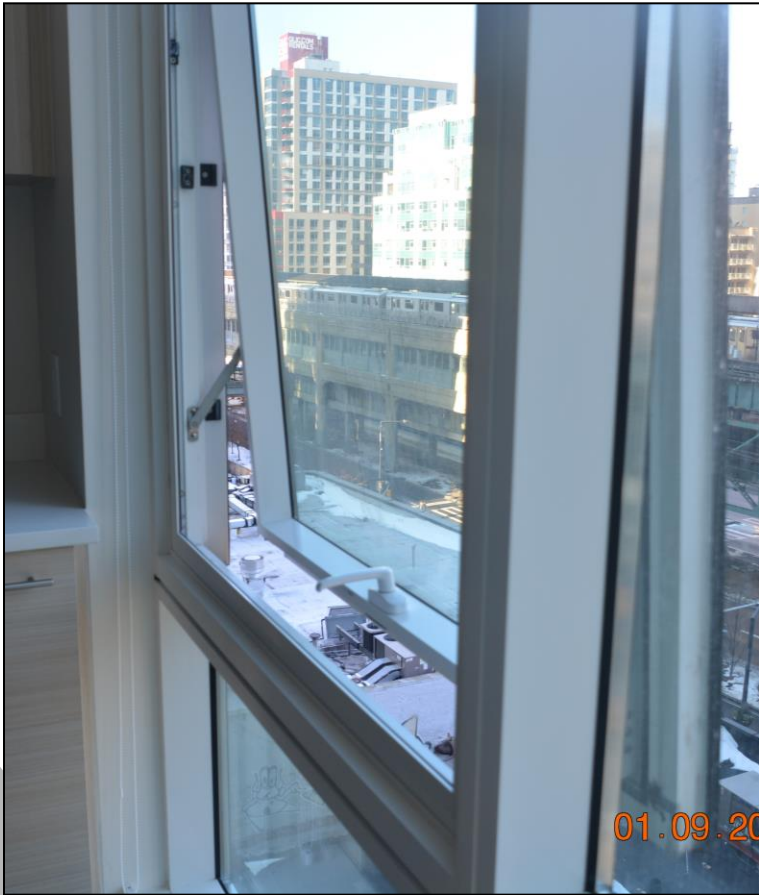
Window had been left in “open” position – 4”

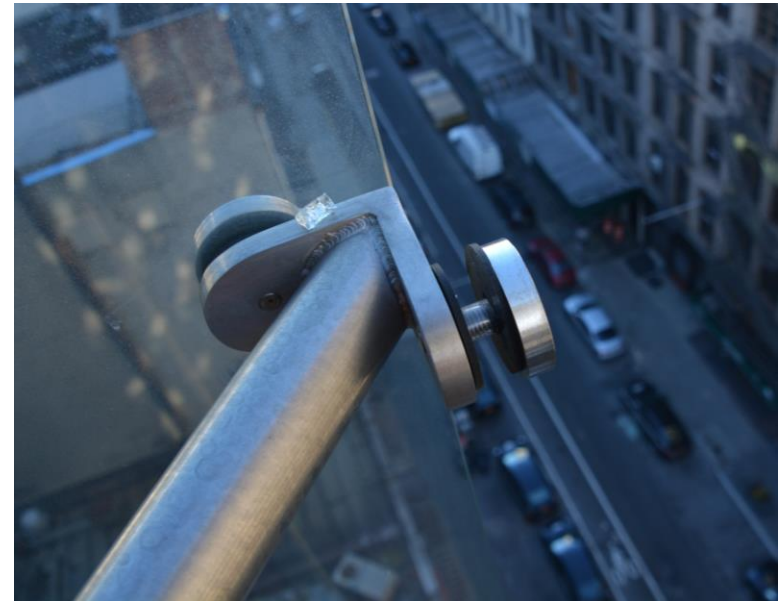
Almost all conditions varied:

- No. and size of rubber gaskets
- height and angle of glass panels
- Tightness of screws

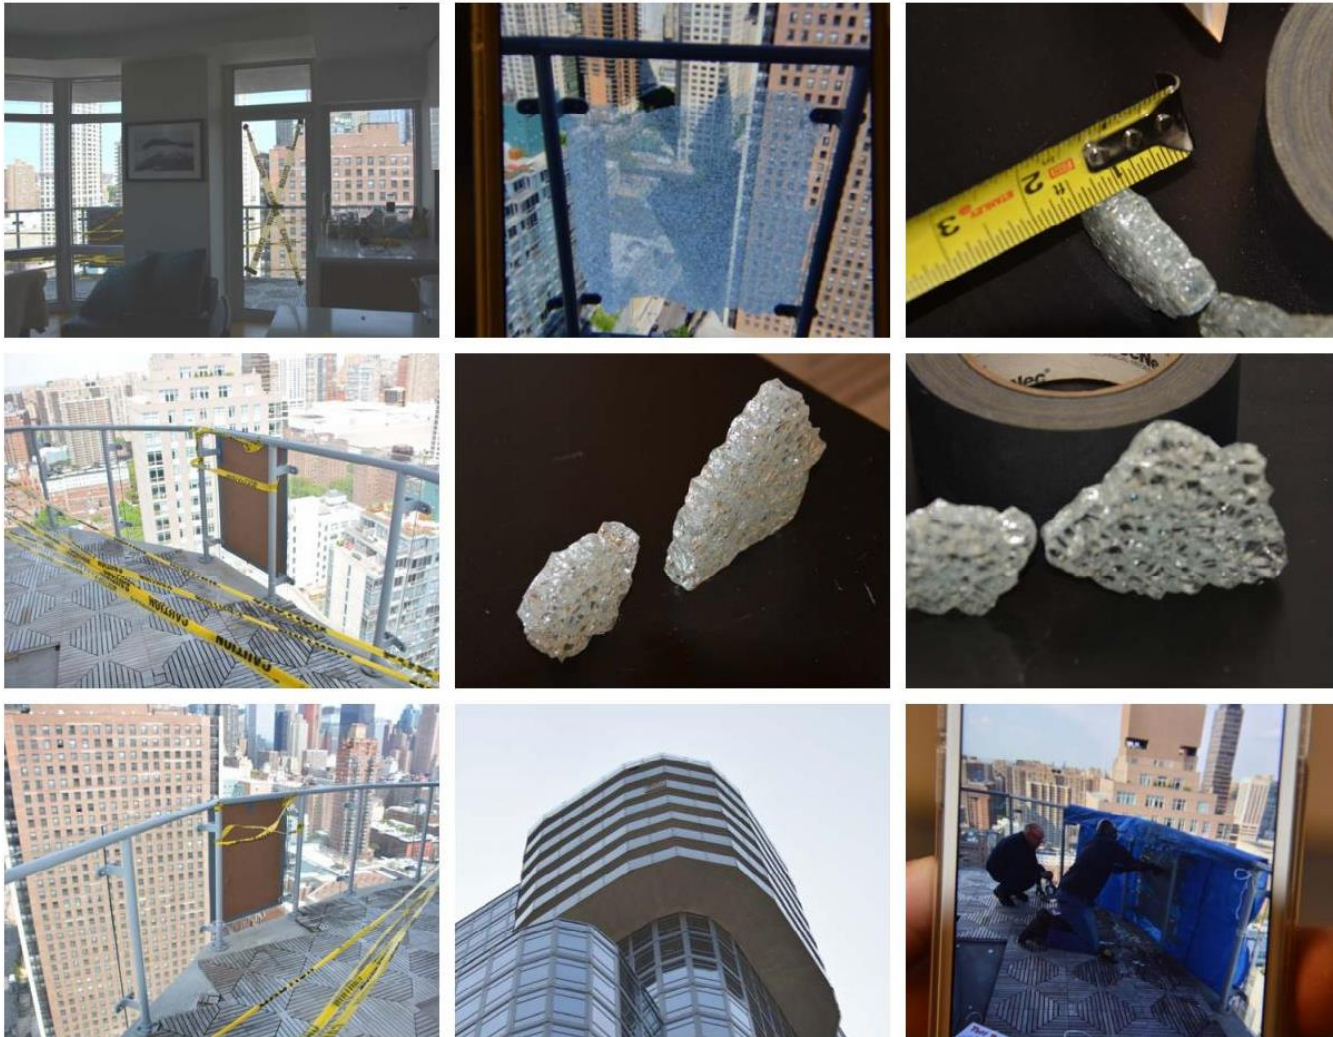
Case #4: Failure due to Poor Construction

- Displaced/short gaskets
- Spalled concrete in close proximity to glass panel
- Many cases of distance between concrete slab and glass panel = $\frac{1}{4}$ " (Design called for 2")
- Deflection of balconies touching glass

- 15 glass panels replaced
- Gaskets repaired at 51 locations
- Removed and reinstalled 132 glass panels to patch concrete spalls

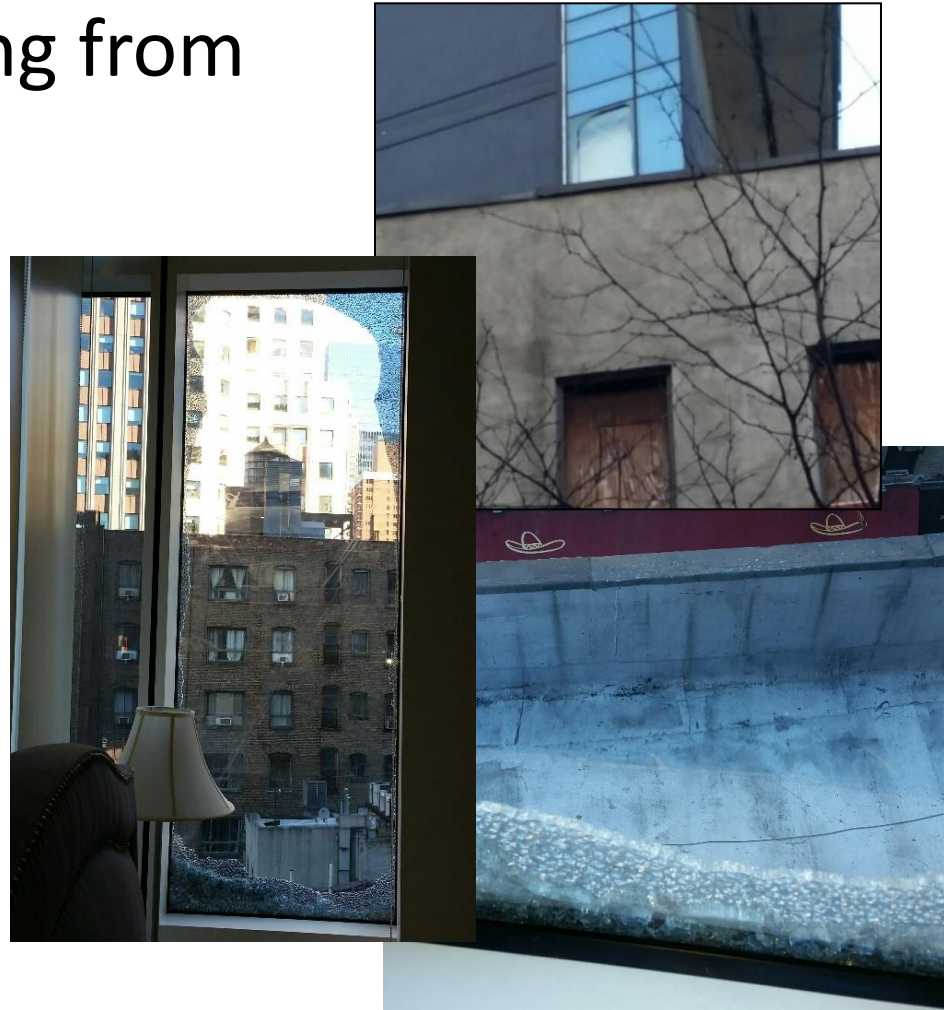
EOC report of glass falling from penthouse of a building

“Double pane insulated glass, approximately 2'X 5' had exterior pane shatter and fall onto adjacent roof”

- *Likely* NiS inclusion
- Difficult to pinpoint as a cause
- In any case this building's glass breakage rates were about 0.08%
- Impact on evaluating legislation
