# NYC WASTEWATER RESILIENCY PLAN

## CLIMATE RISK ASSESSMENT AND ADAPTATION STUDY

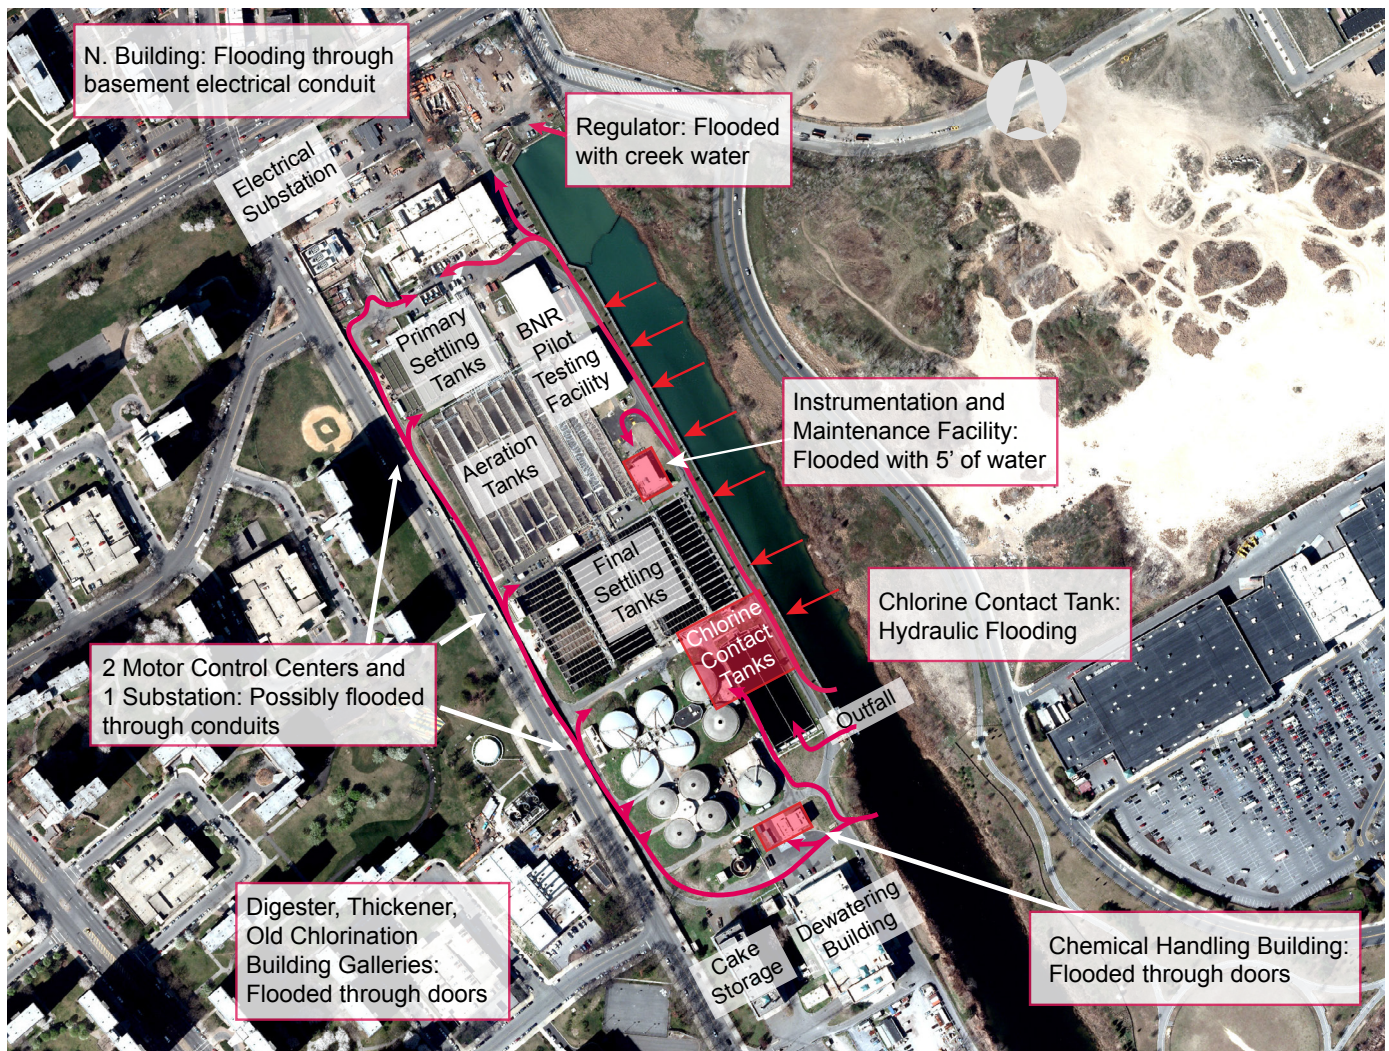
Plant staff worked actively before, during, and after the storm to protect the plant and bring it back to normal operation. Electrical power was proactively shut off throughout the plant during the storm surge, except in the North Building, to prevent short circuiting as the water level continued to rise. After the storm, all flooded areas were dewatered and flooded motors and electrical equipment were cleaned, dried, and repaired or replaced depending on their condition.

Flood pathways and areas flooded during Hurricane Sandy are highlighted in red.

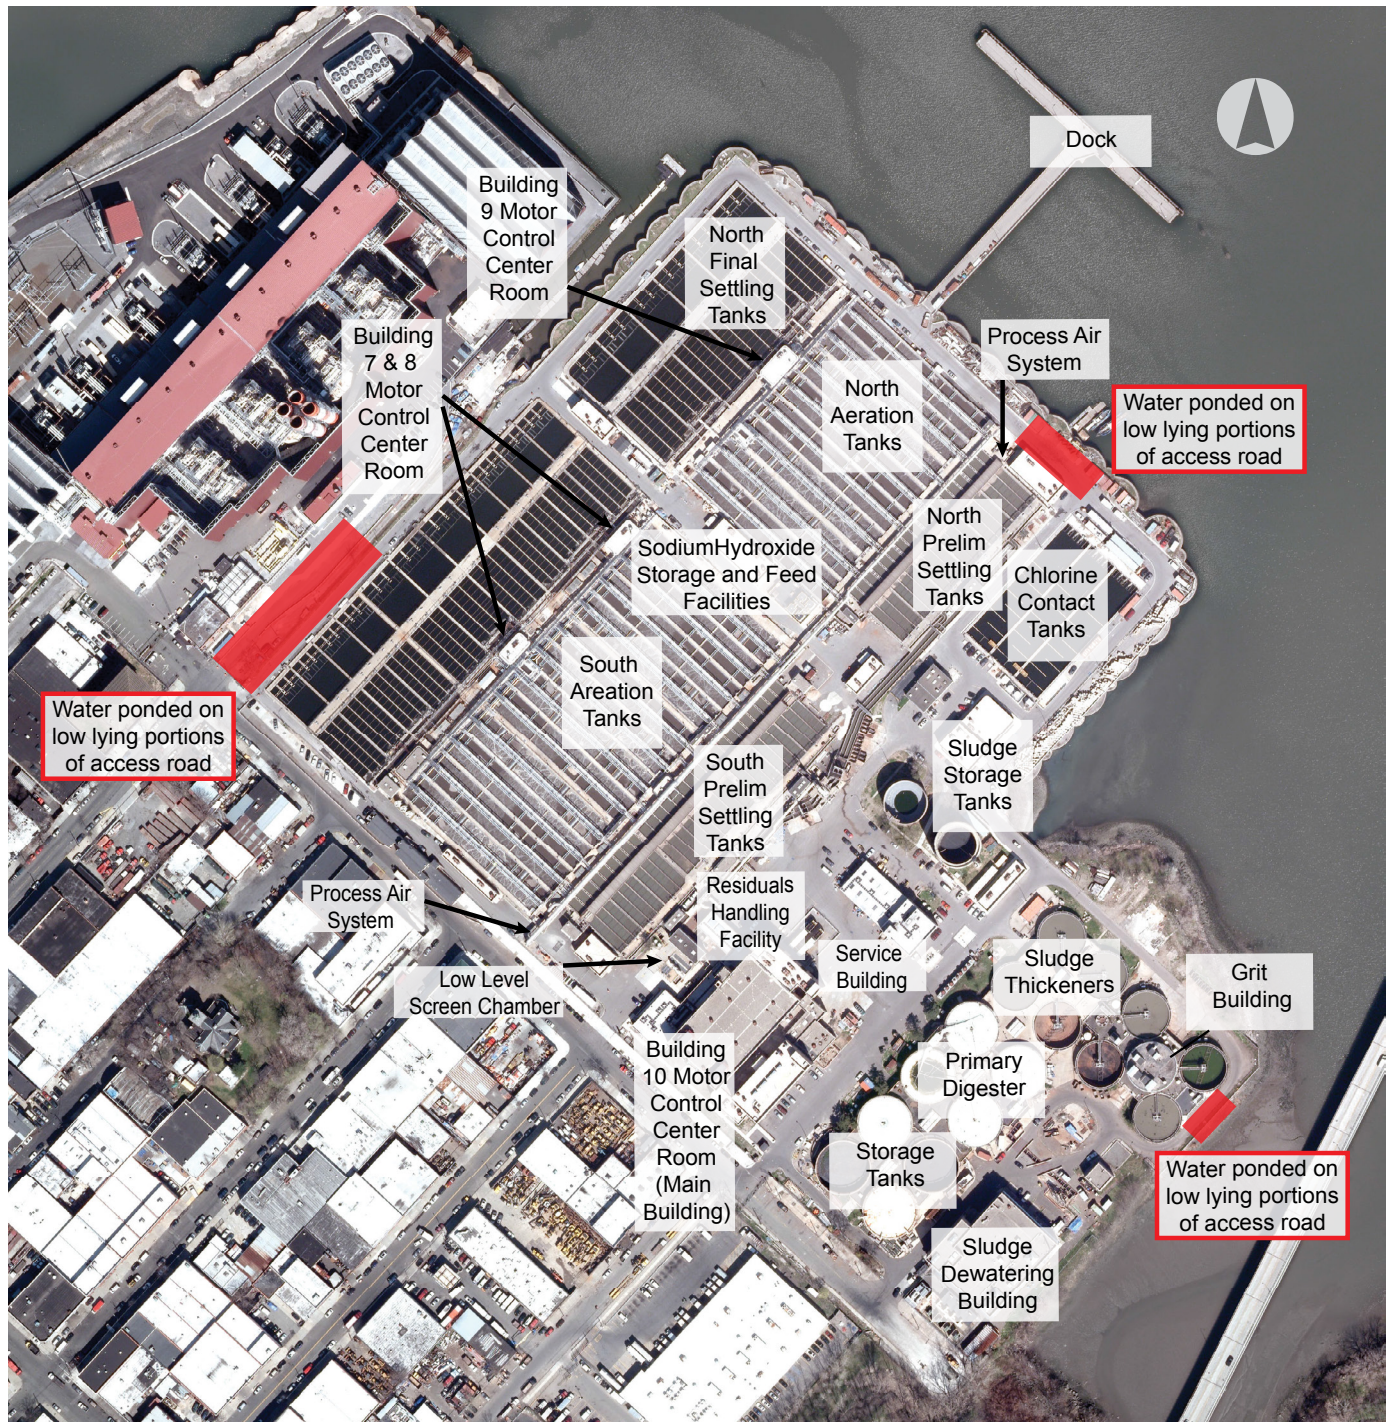
storm surge caused minor damage to several temporary contractor office trailers, several storage sheds, and the barge dock. Plant staff took precautions ahead of the storm, which included sandbagging buildings and other routine emergency preparation procedures outlined in the plant's Wet Weather Operations Plan. The plant maintained electrical power and continued normal wet weather operation throughout the storm.

Flood pathways and areas flooded during Hurricane Sandy are highlighted in red.

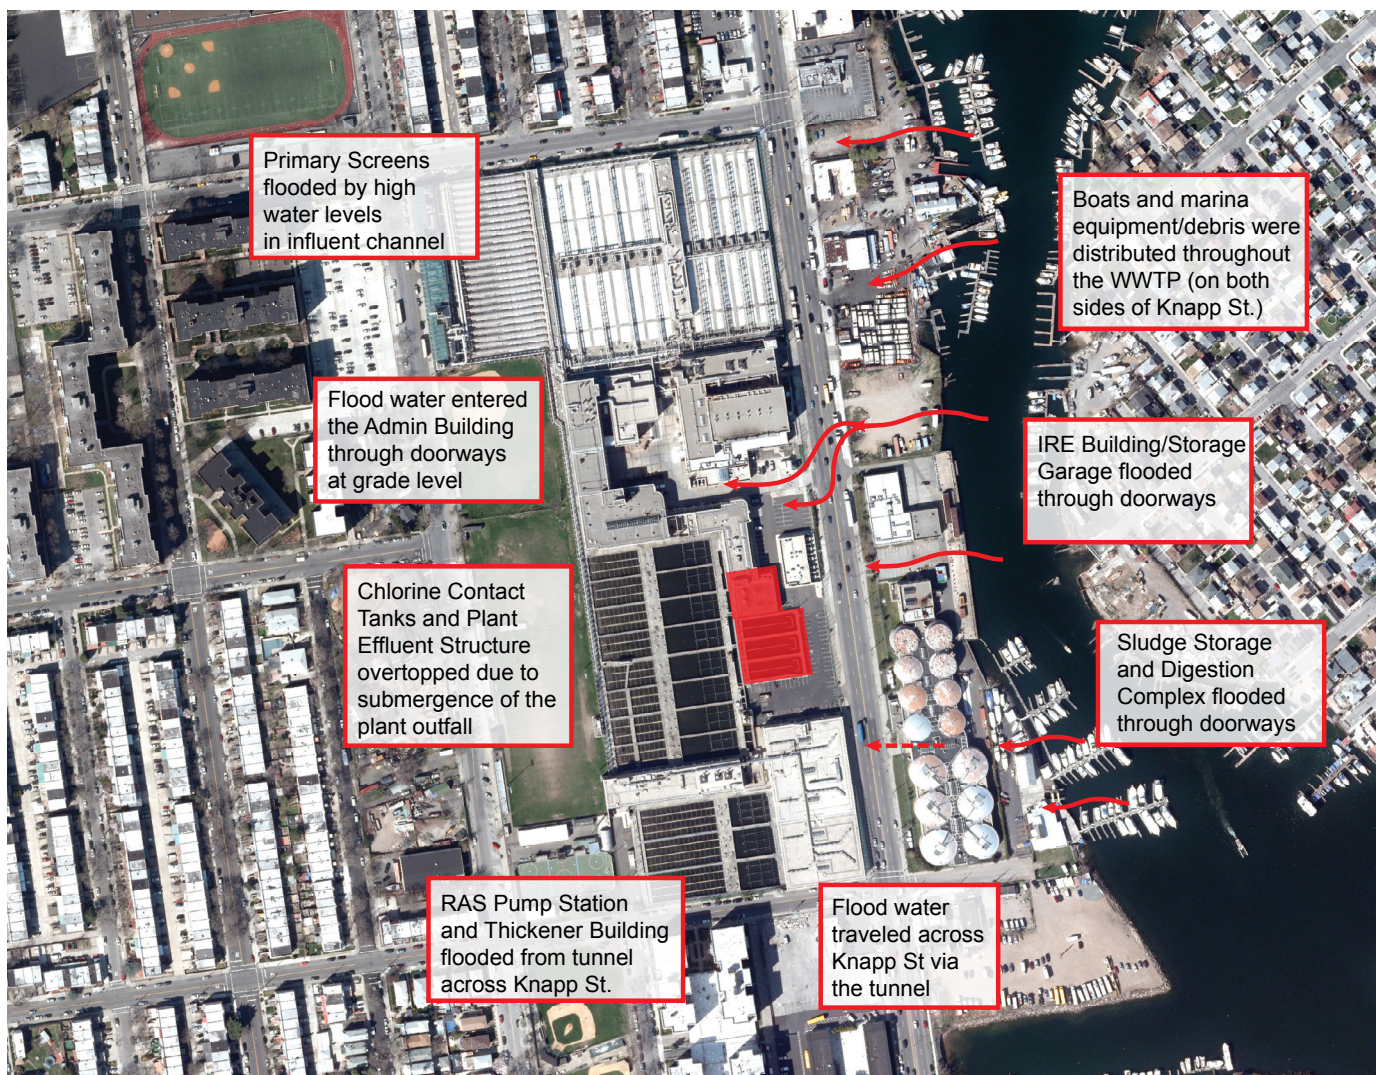
The plant staff took precautions ahead of the storm, which included sandbagging low-lying buildings, relocating some of the portable equipment, filling chemical tanks, ensuring emergency power equipment was operational, closing certain inflow pipes to reduce inflow of combined sewage to the plant, and other procedures outlined in their Wet Weather Operations Plan. Despite the damage, the plant maintained normal wet weather operation through the storm event.

Flood pathways and areas flooded during Hurricane Sandy are highlighted in red.

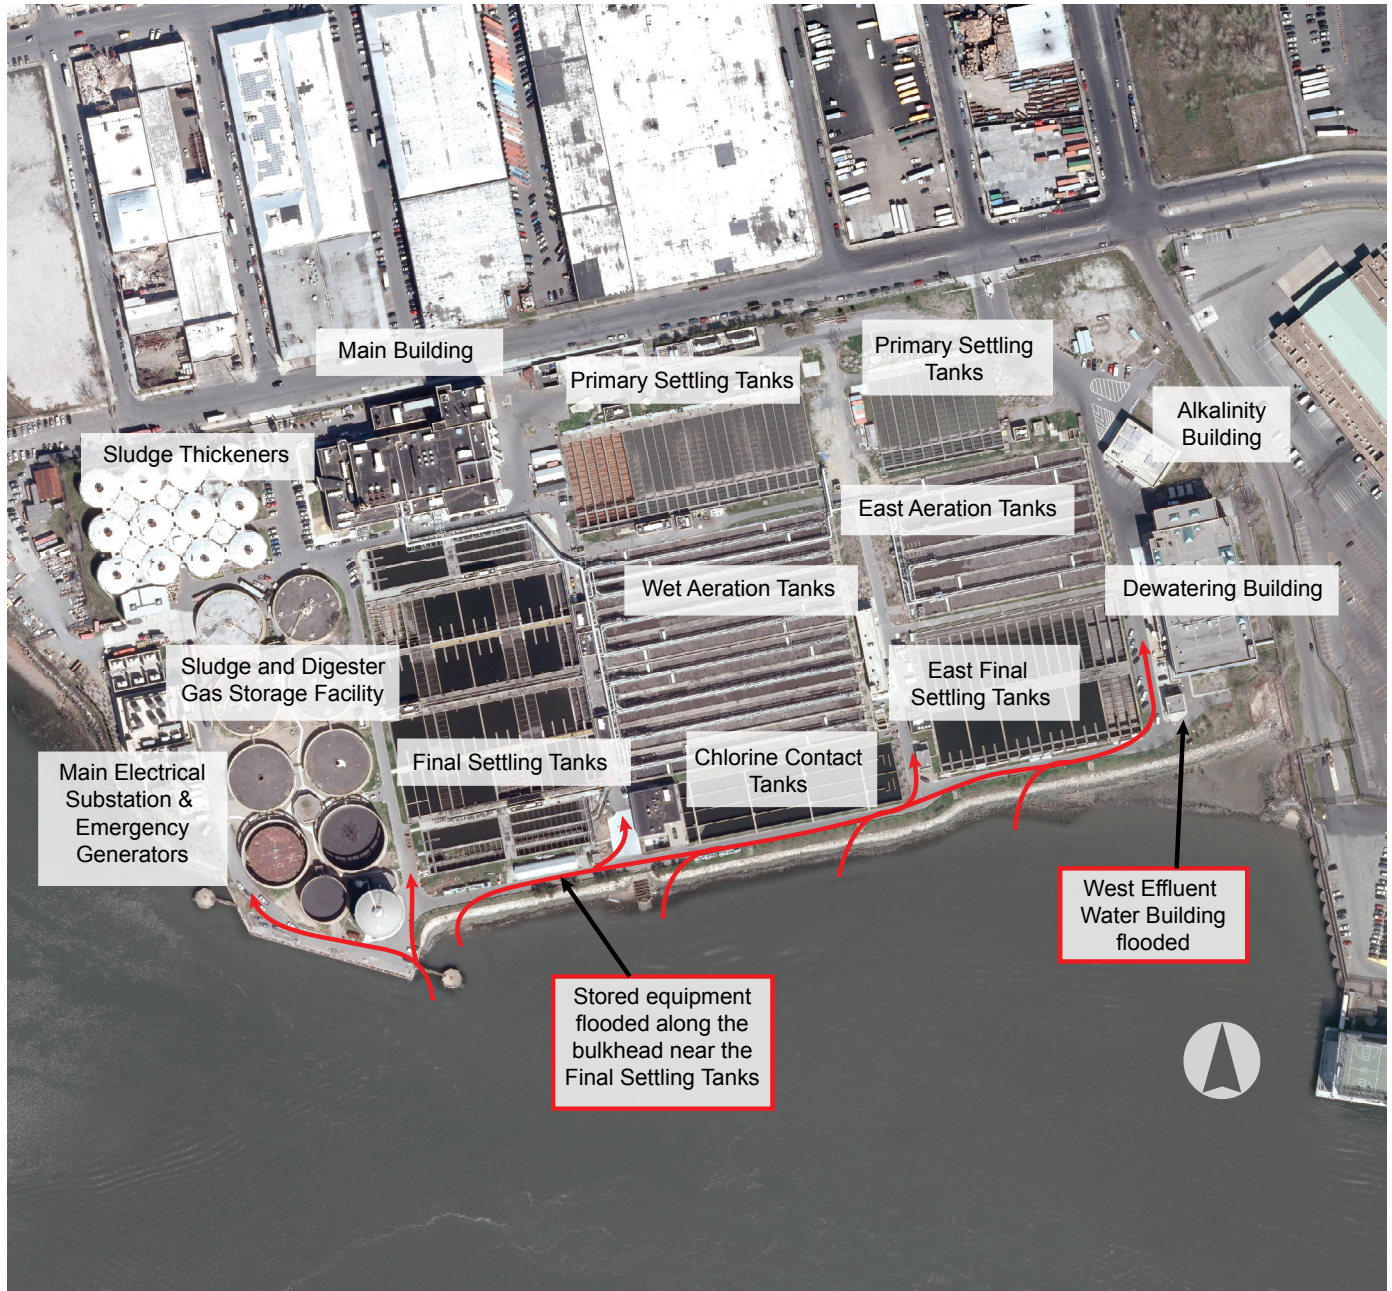
Water Building flooded and many electrical components, including motors, were damaged. Equipment in the storage buildings behind the South Final Settling Tanks was also damaged. The plant maintained normal wet weather treatment operation during and after the storm.

Flood pathways and areas flooded during Hurricane Sandy are highlighted in red.

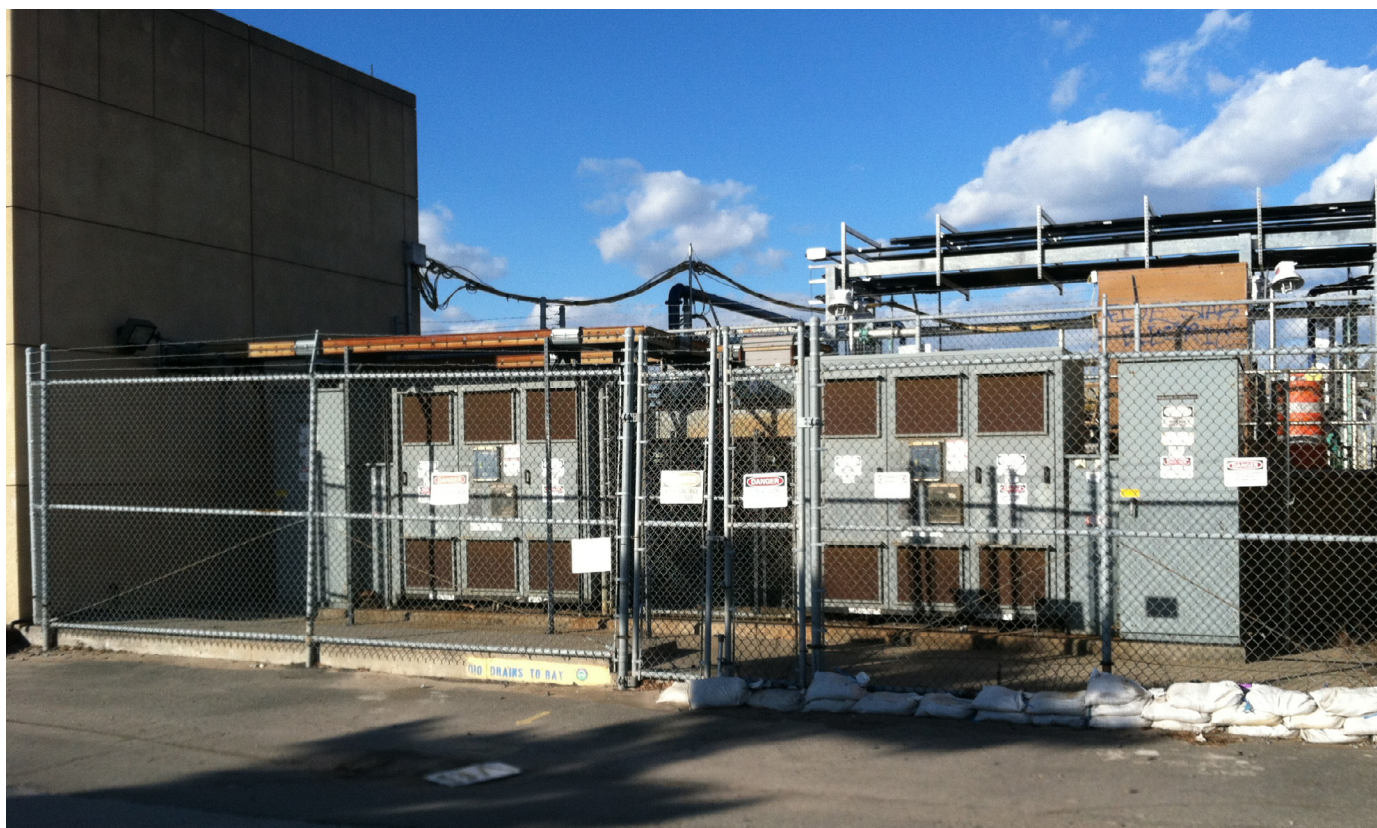
The Unit Substation (USS 1533) is currently protected with sandbags.

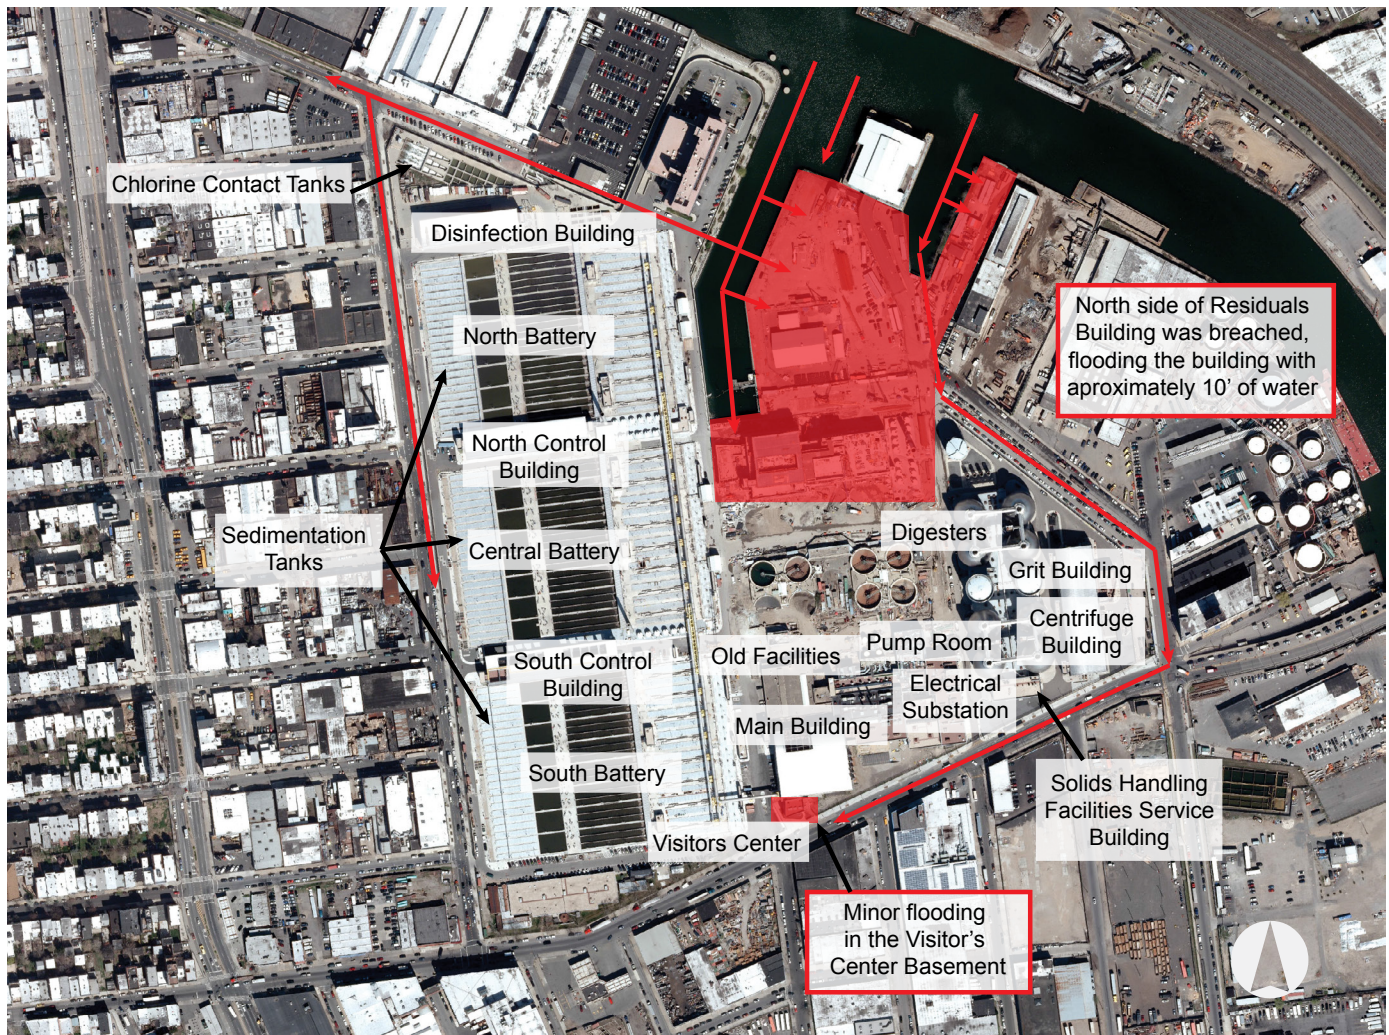
Flood pathways and areas flooded during Hurricane Sandy are highlighted in red.

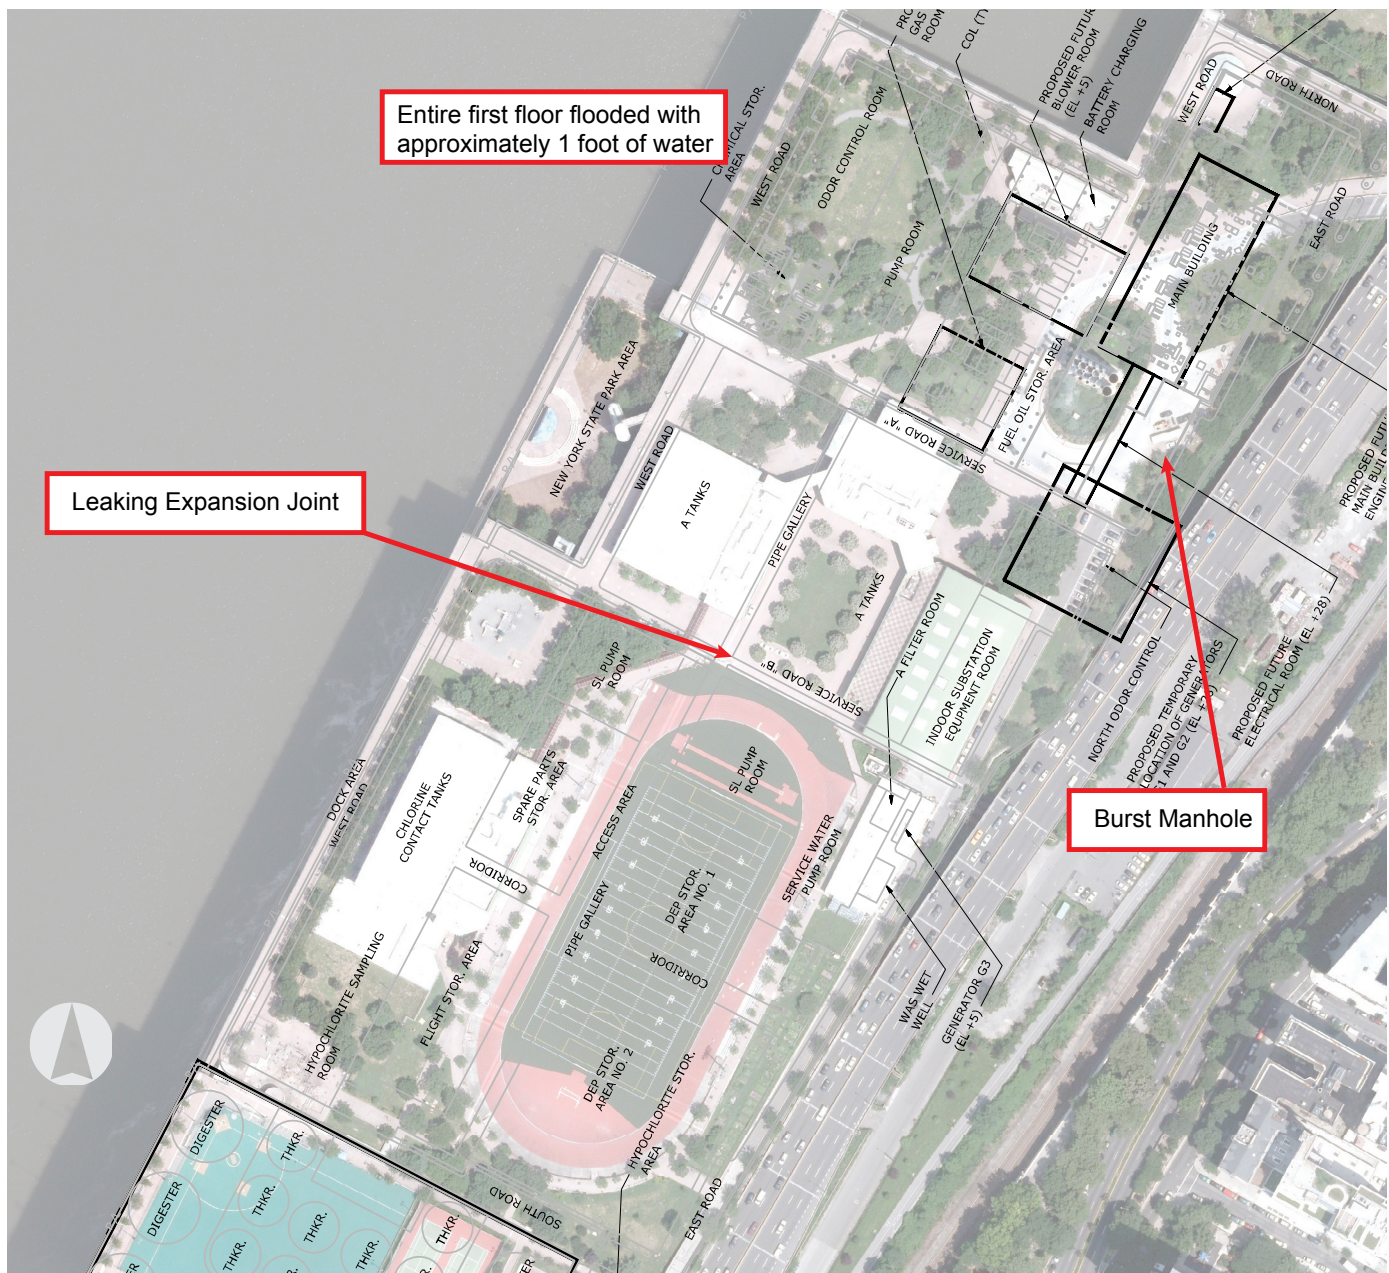
Flood pathways and areas flooded during Hurricane Sandy are highlighted in red.

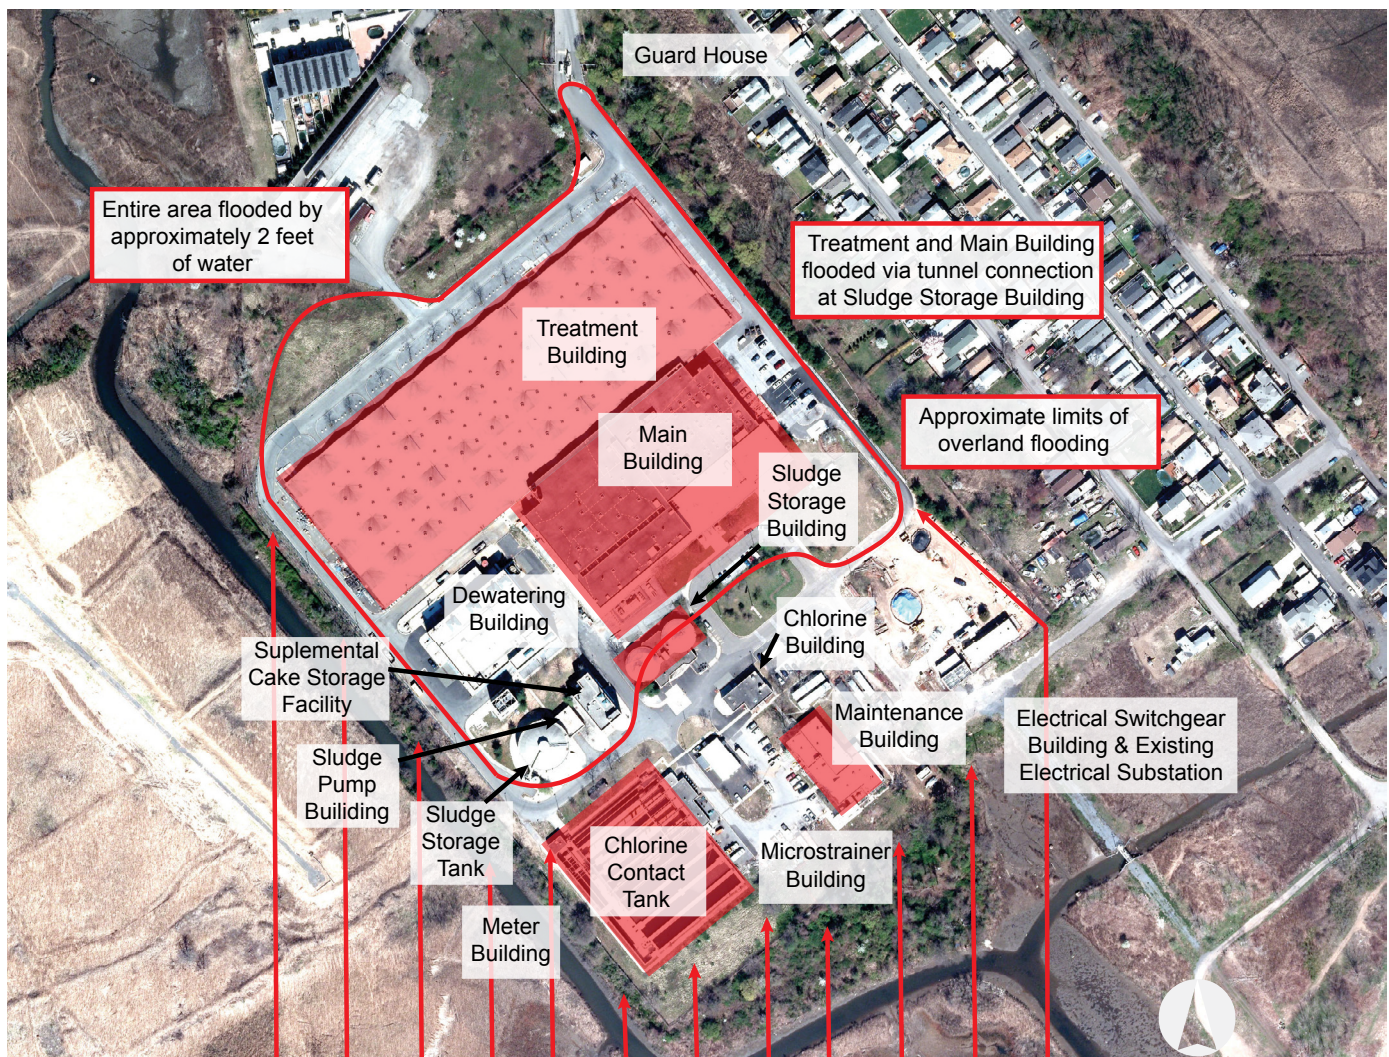
Flood pathways and areas flooded during Hurricane Sandy are highlighted in red.

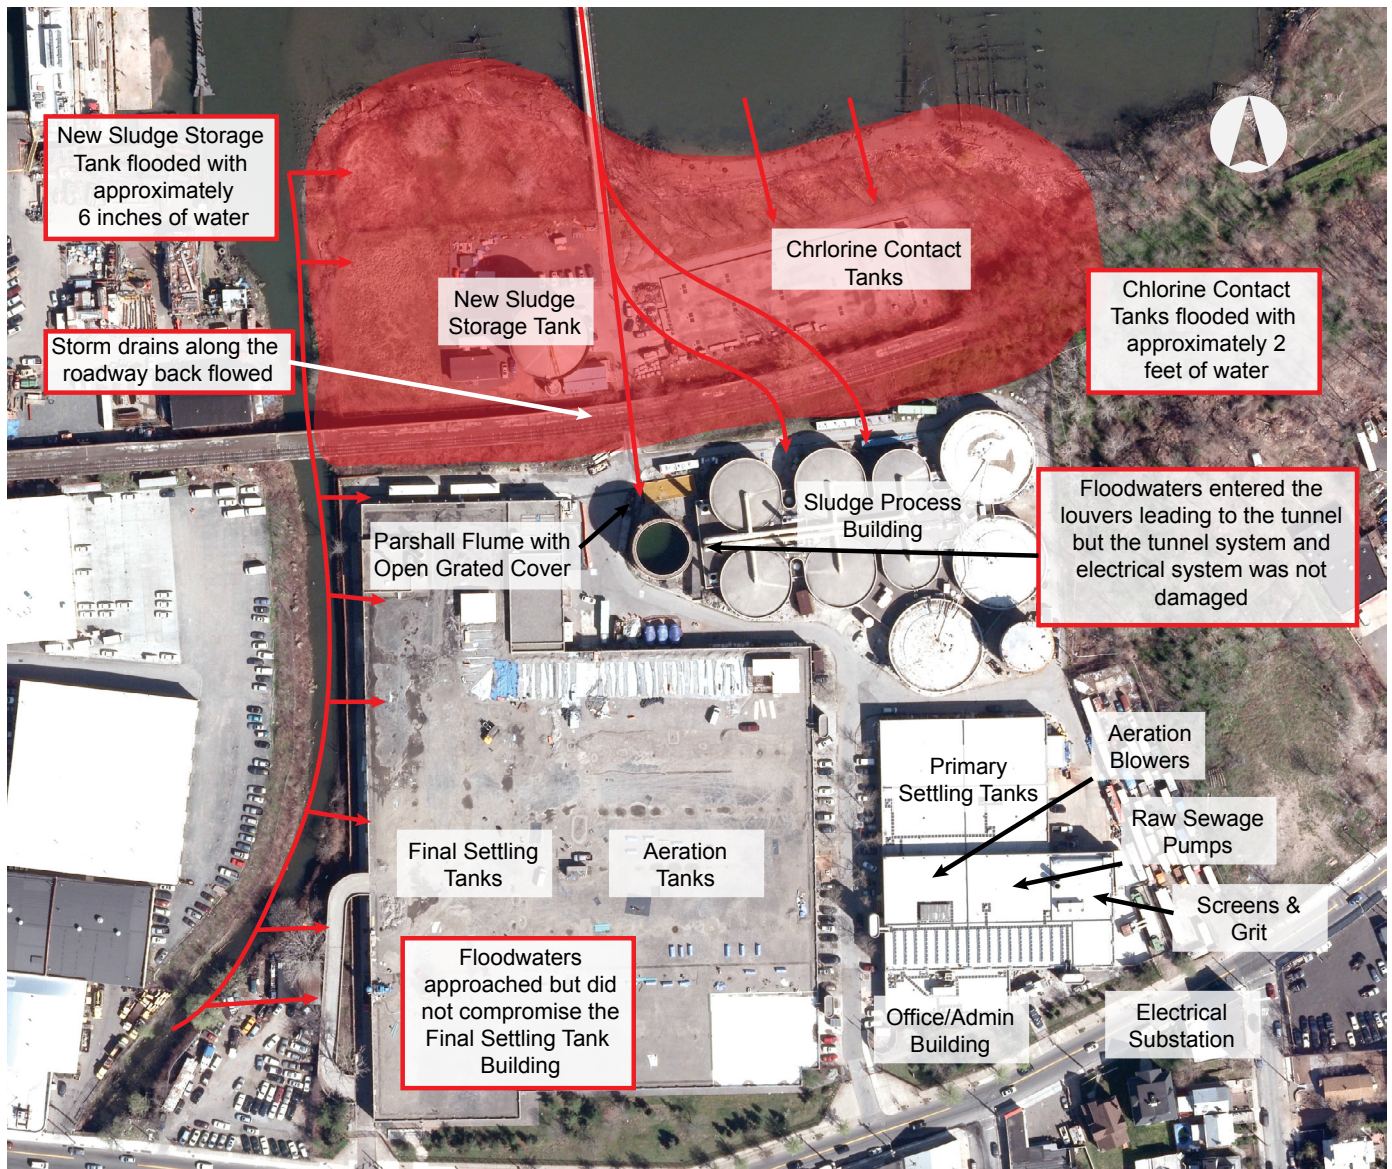
Flood pathways and areas flooded during Hurricane Sandy are highlighted in red.

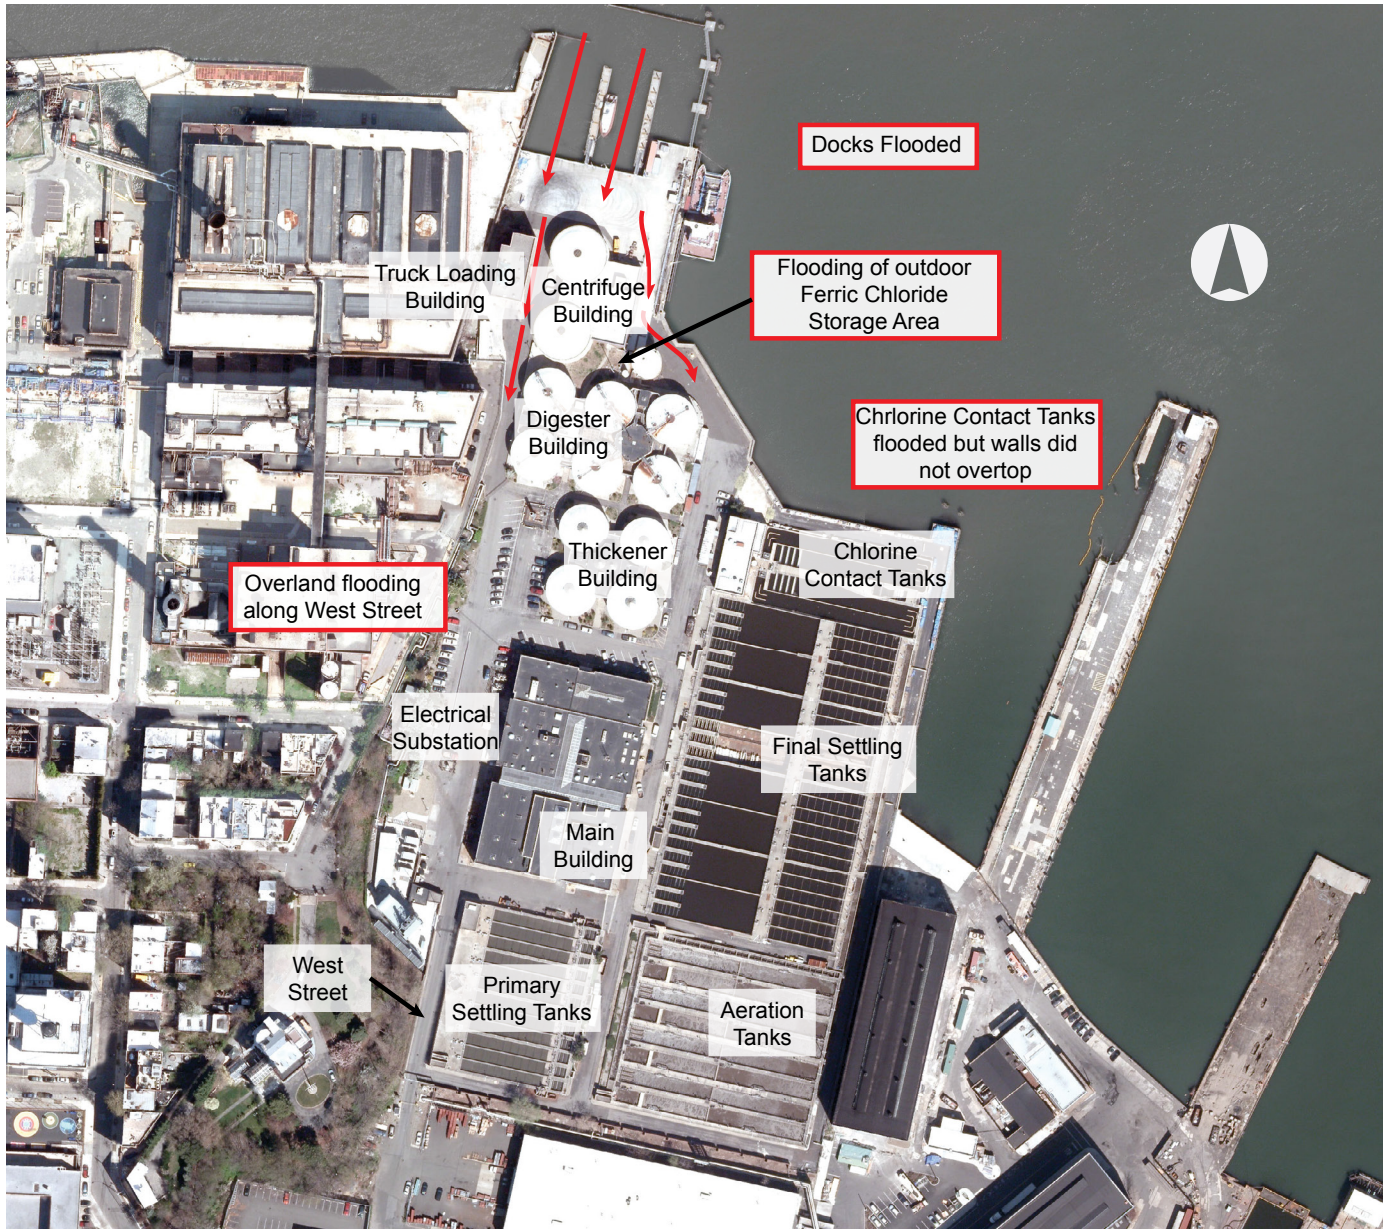
Flood pathways and areas flooded during Hurricane Sandy are highlighted in red.

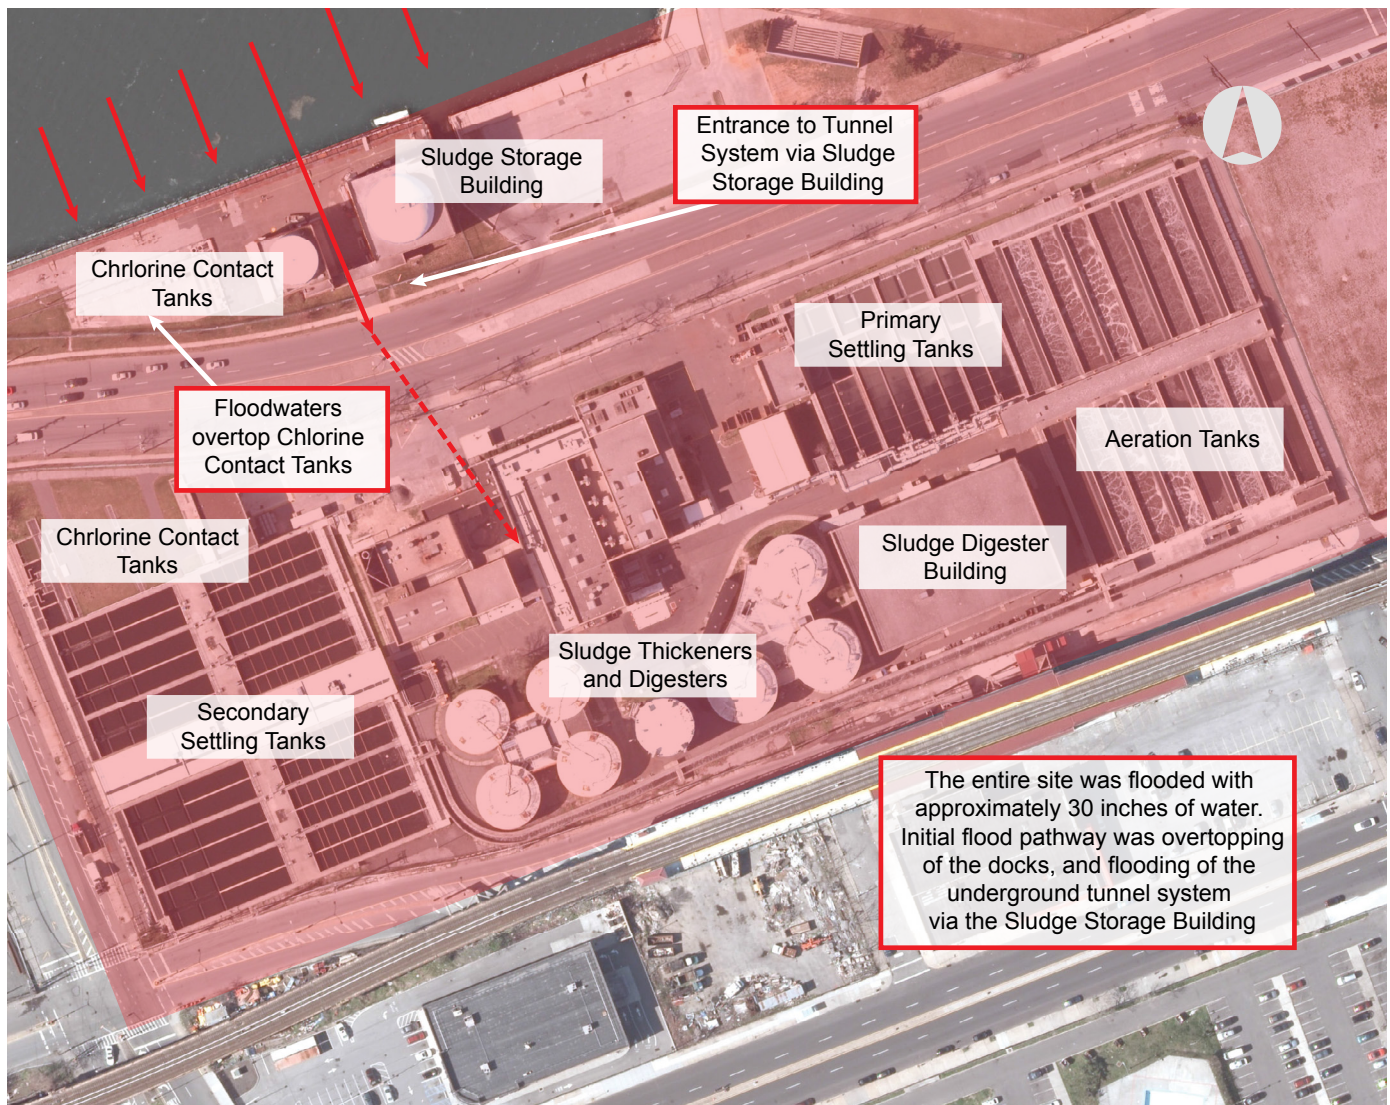
Flood pathways and areas flooded during Hurricane Sandy are highlighted in red.

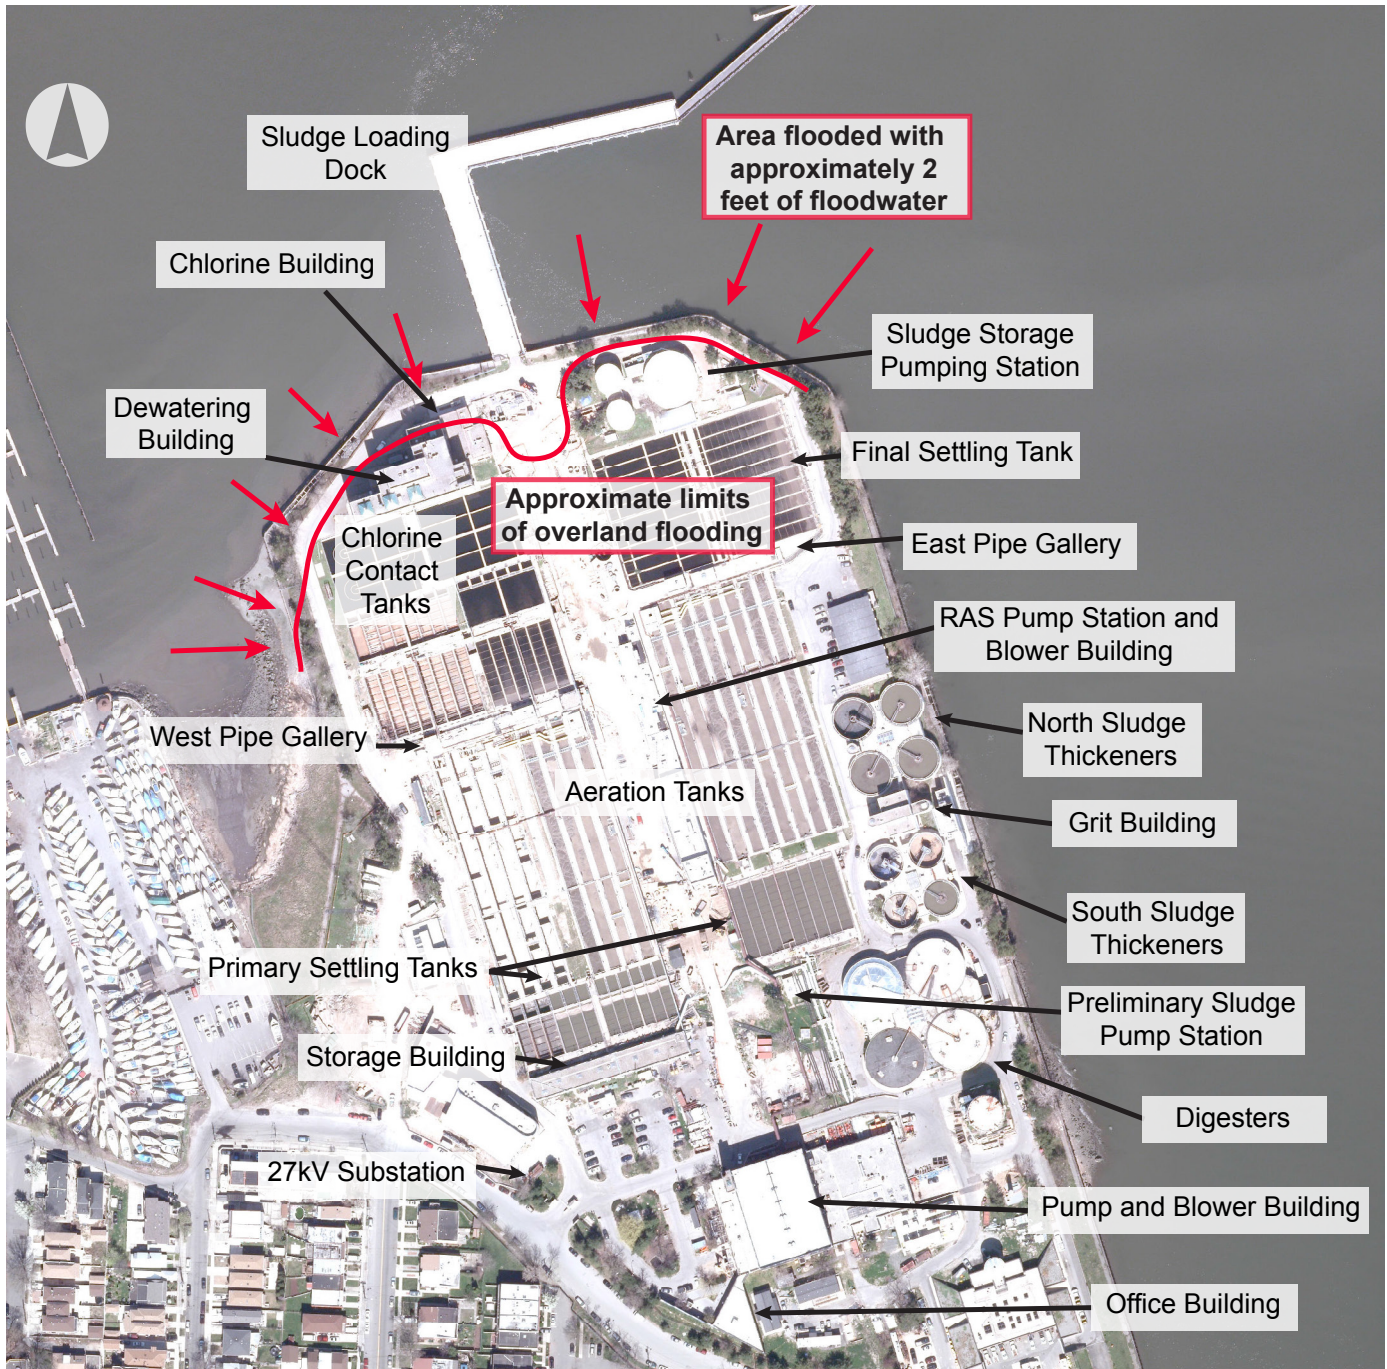
Flood pathways and areas flooded during Hurricane Sandy are highlighted in red.

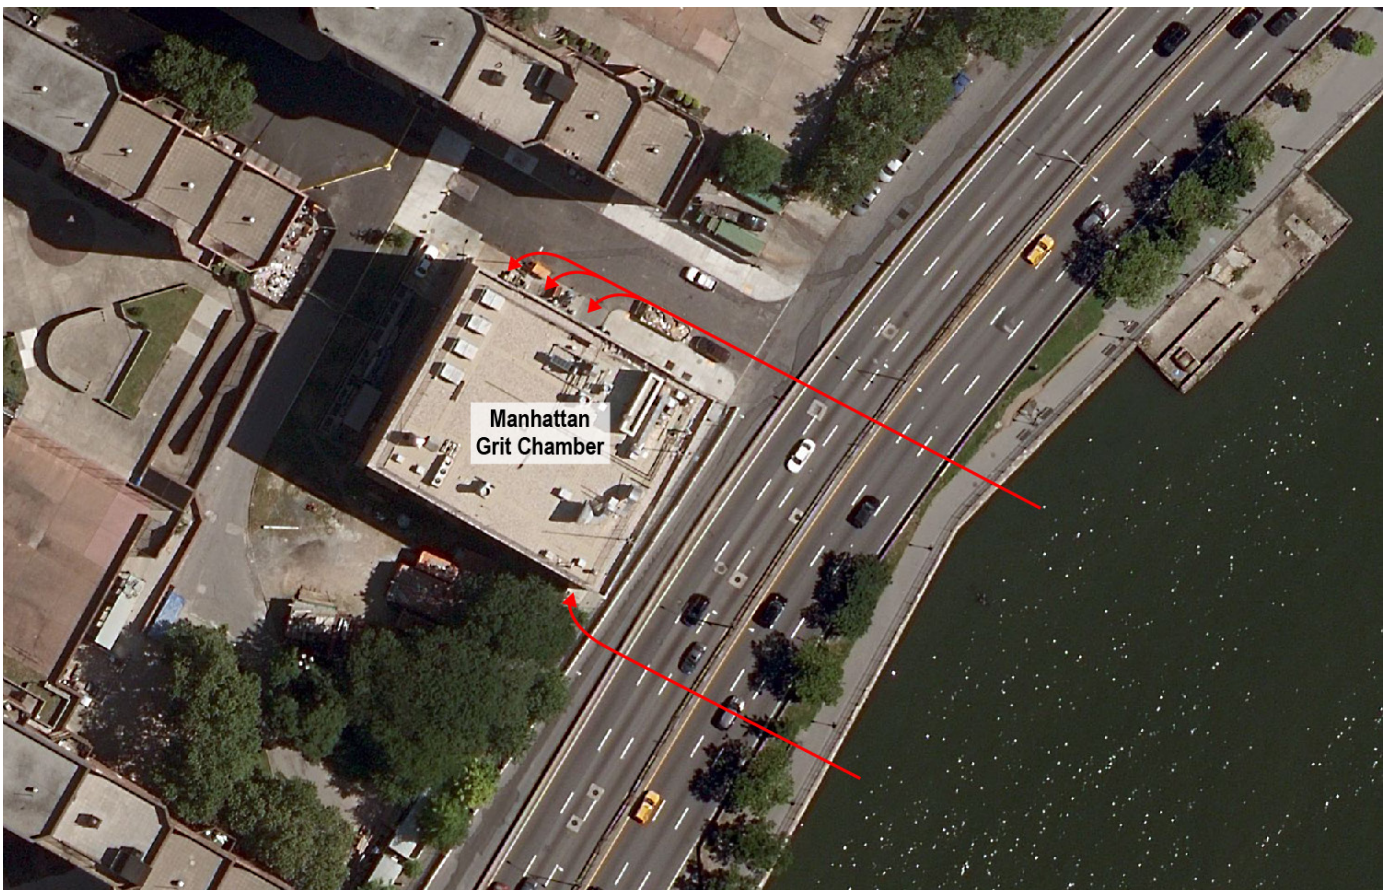
Flood pathways and areas flooded during Hurricane Sandy are highlighted in red.
