Angela M. De Lillo, P.E.
Deputy Commissioner
Bureau of Wastewater
Treatment

Re: Integrated Sentinel Monitoring Report Calendar Year 2023

INTEGRATED SENTINEL MONITORING REPORT CALENDAR YEAR 2023

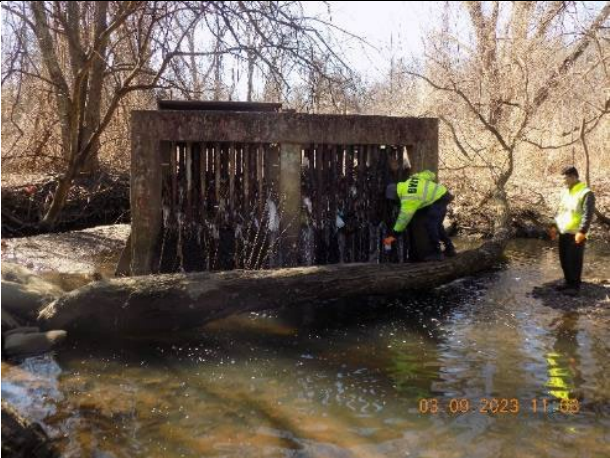
CMS conducting a sewer walk in the sewer to Alley Creek	CMS conducting sewer walk in Alley Creek area

CMS collecting samples in the sewer area	CMS collecting samples at TI-684 outfall.

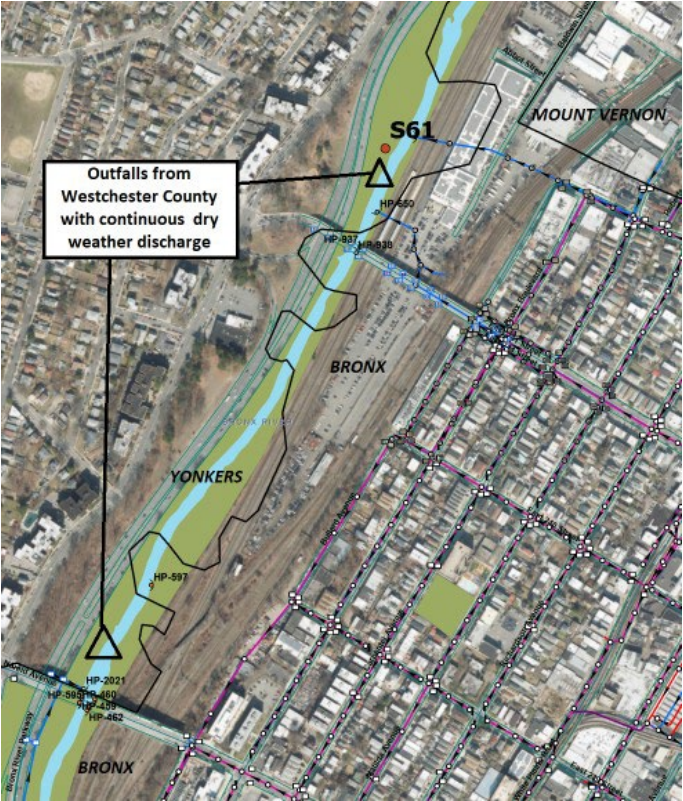
An outfall belonging to Yonkers at Nereid Avenue, discharging during dry weather.

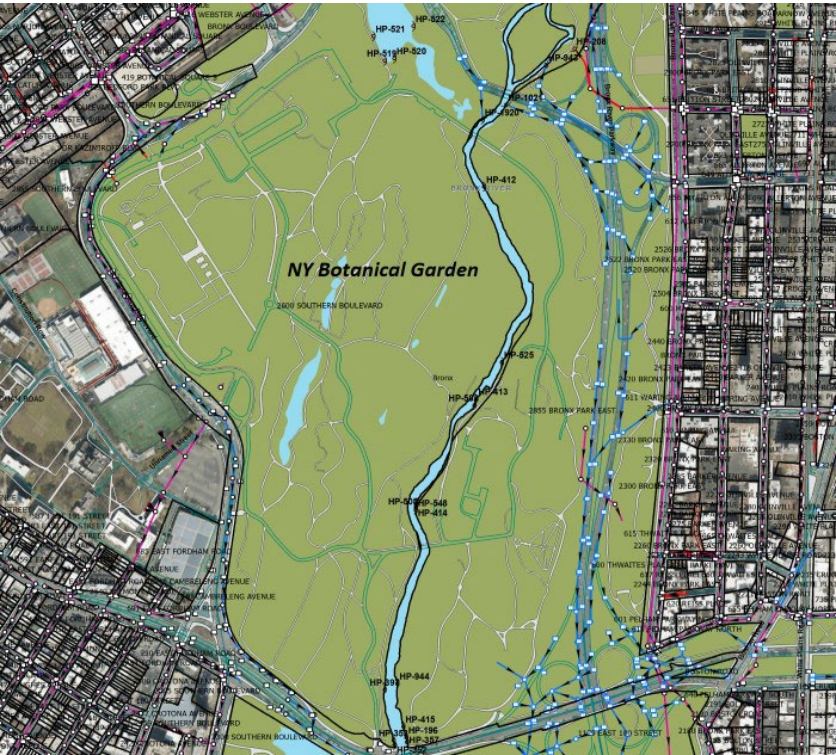
New York Botanical Garden :

Influence on the Bronx River through numerous outfalls owned by the property

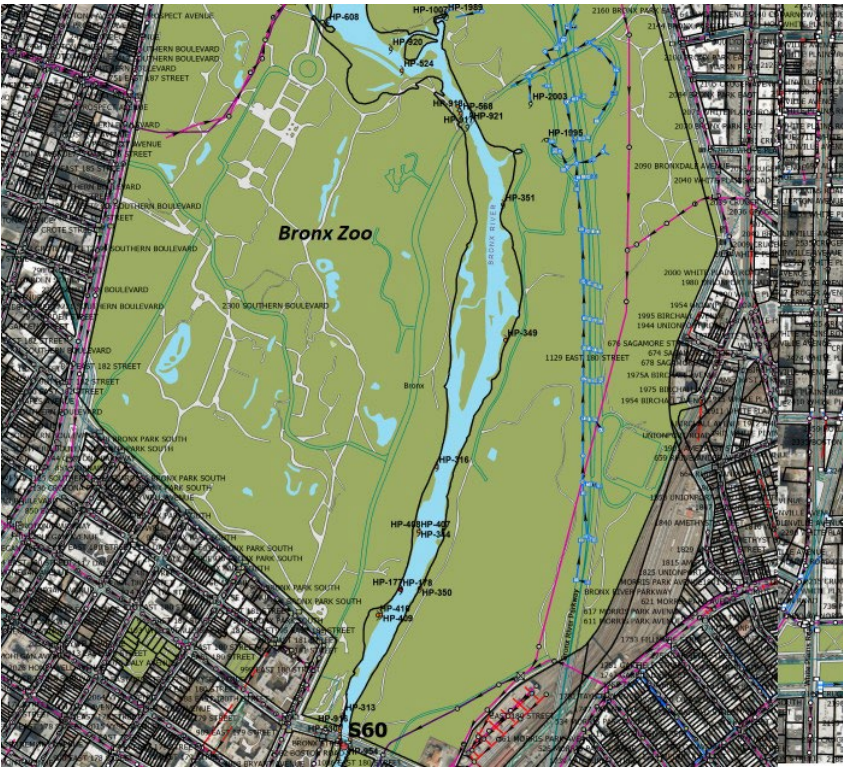
Bronx Zoo & S60

- Dry weather discharges to the Bronx River via activities at Bronx Zoo were previously found by CMS personnel.
- Multiple outfalls belonging to the Bronx Zoo are observed along the Bronx River which are a possible influence to S-60 sentinel station in south

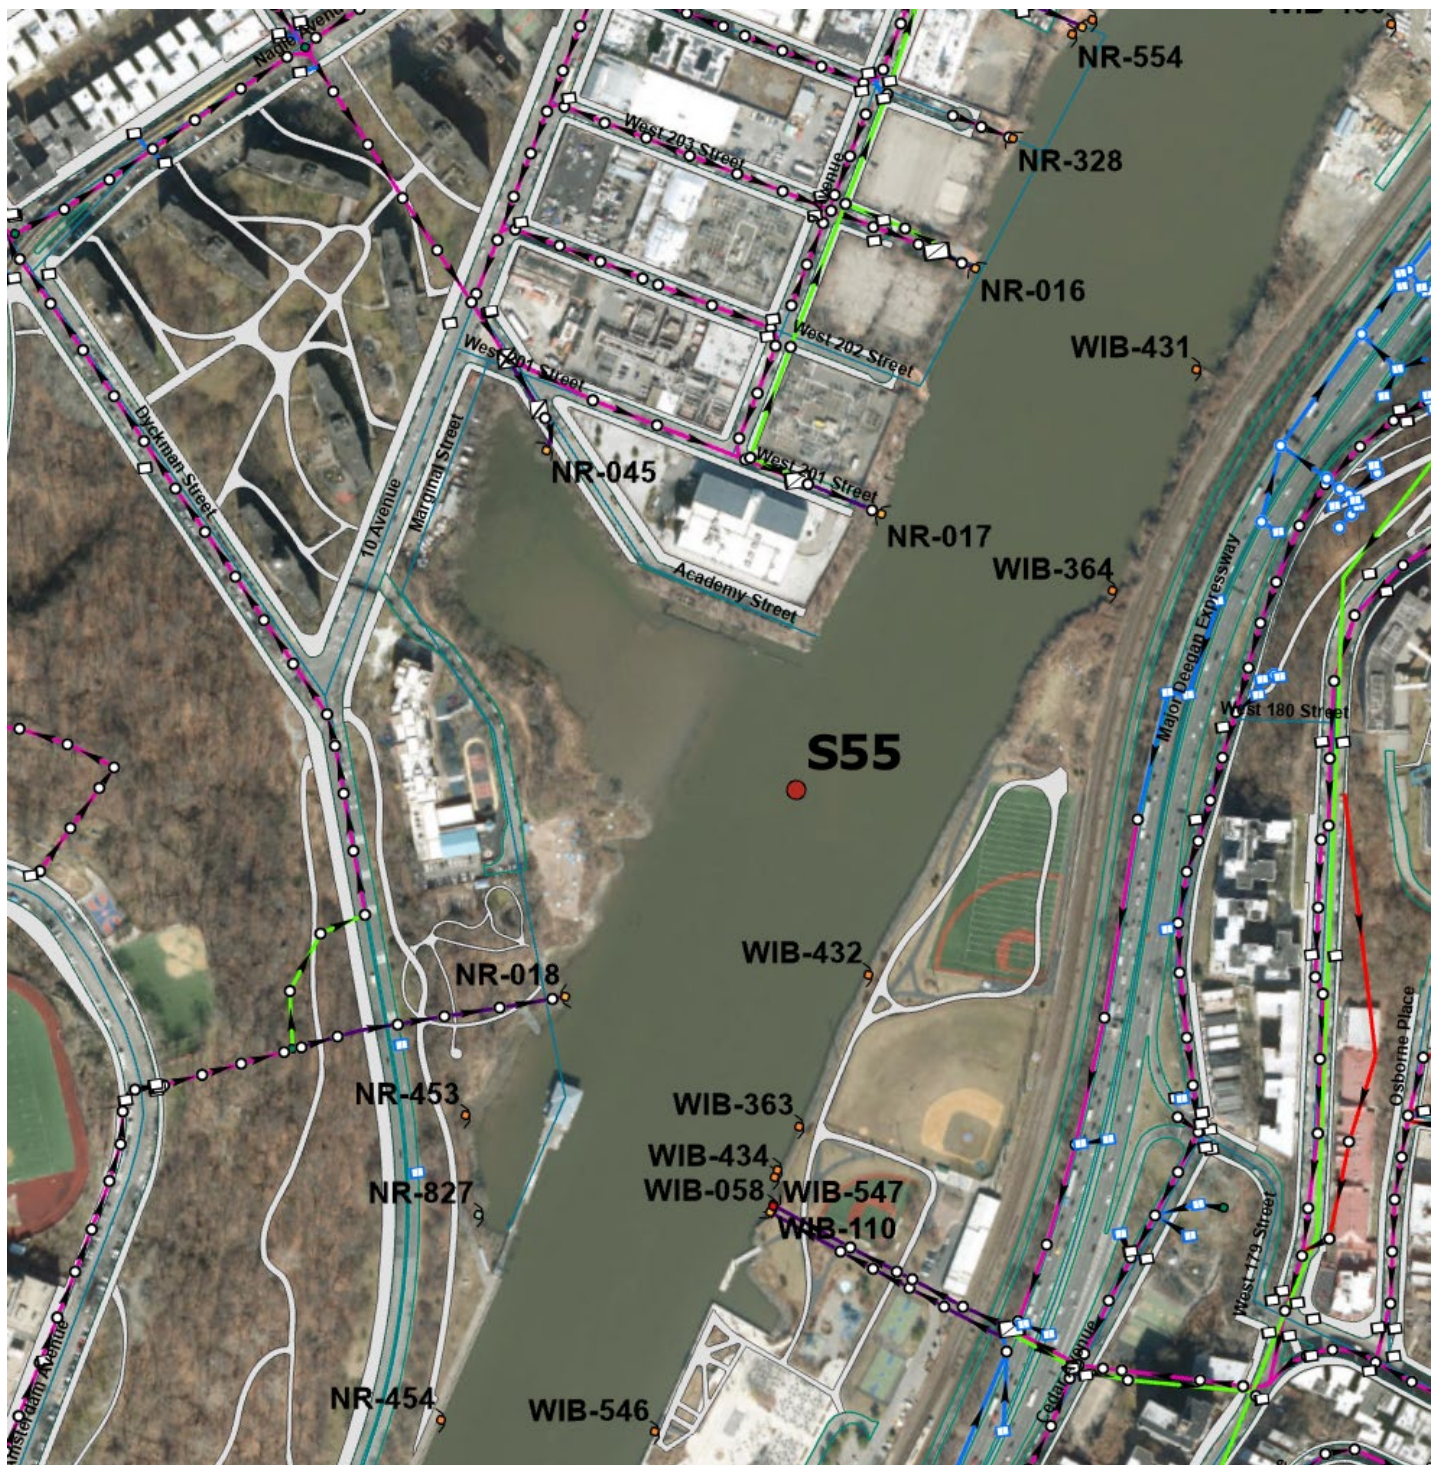
S55 and the CSO sewers in the area leading to the sentinel station.

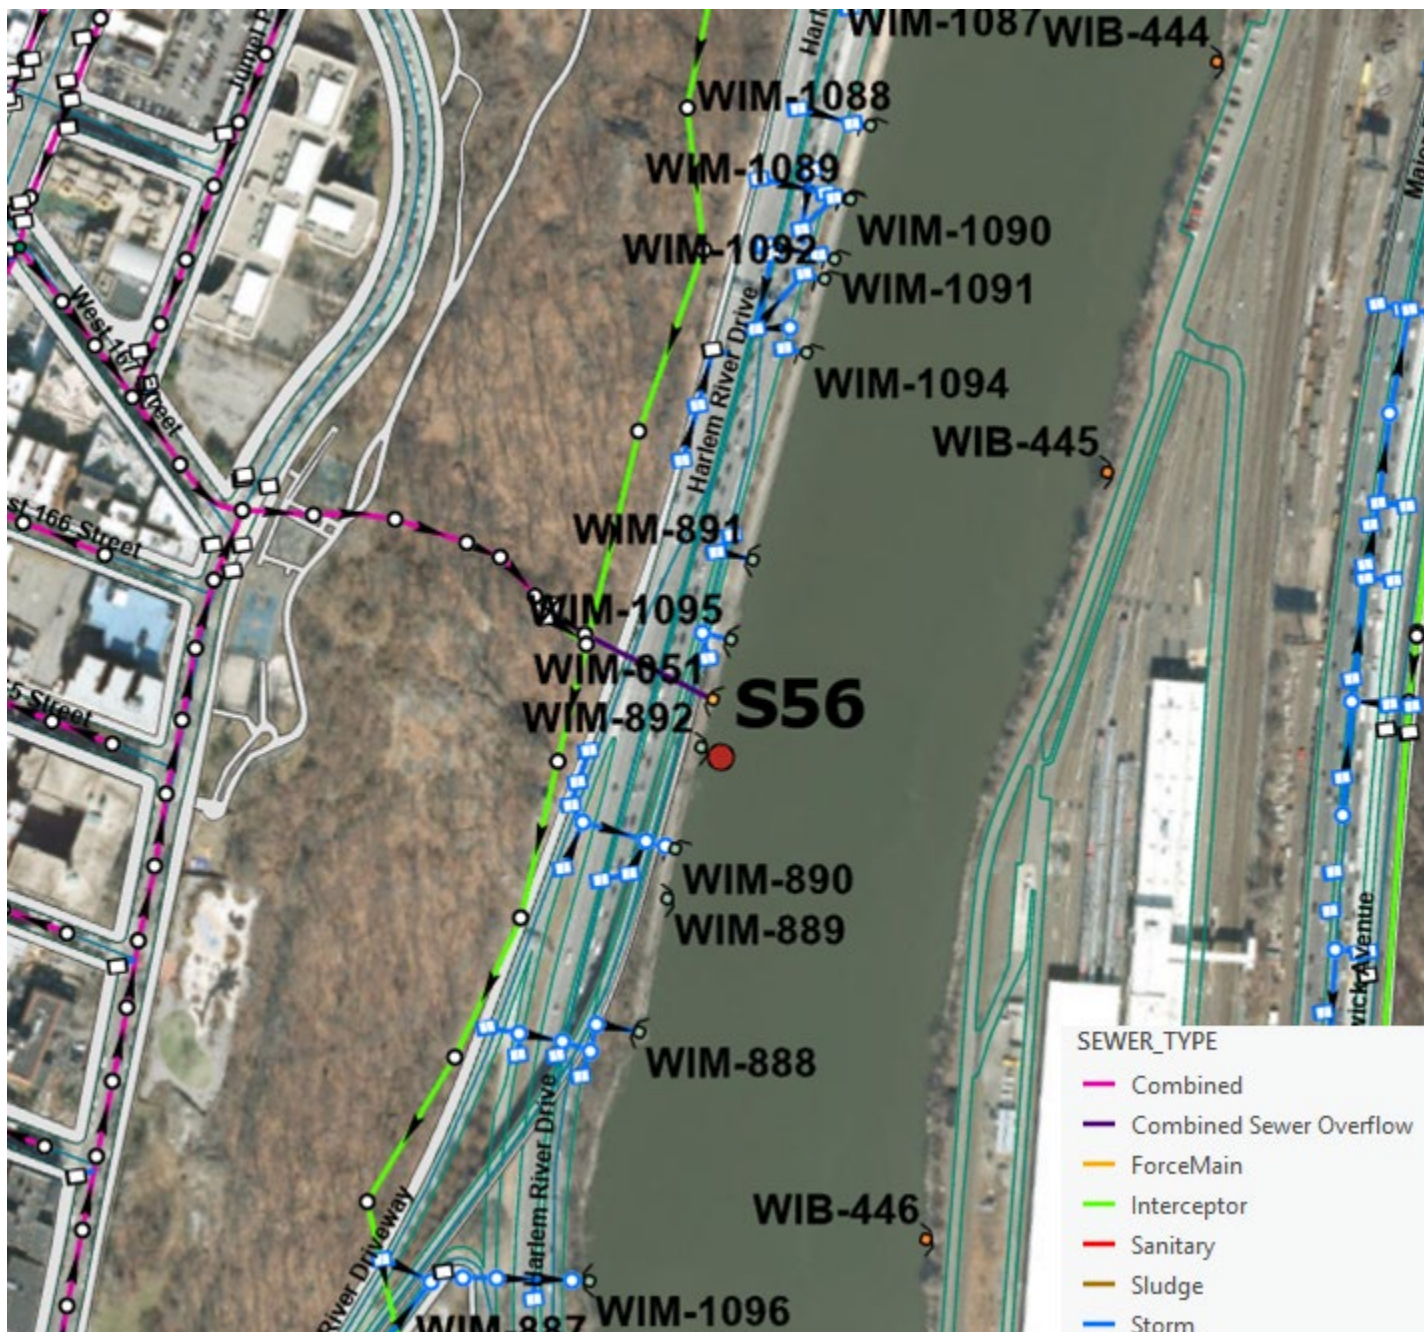
S56 and the CSO and MS4 outfalls in the area

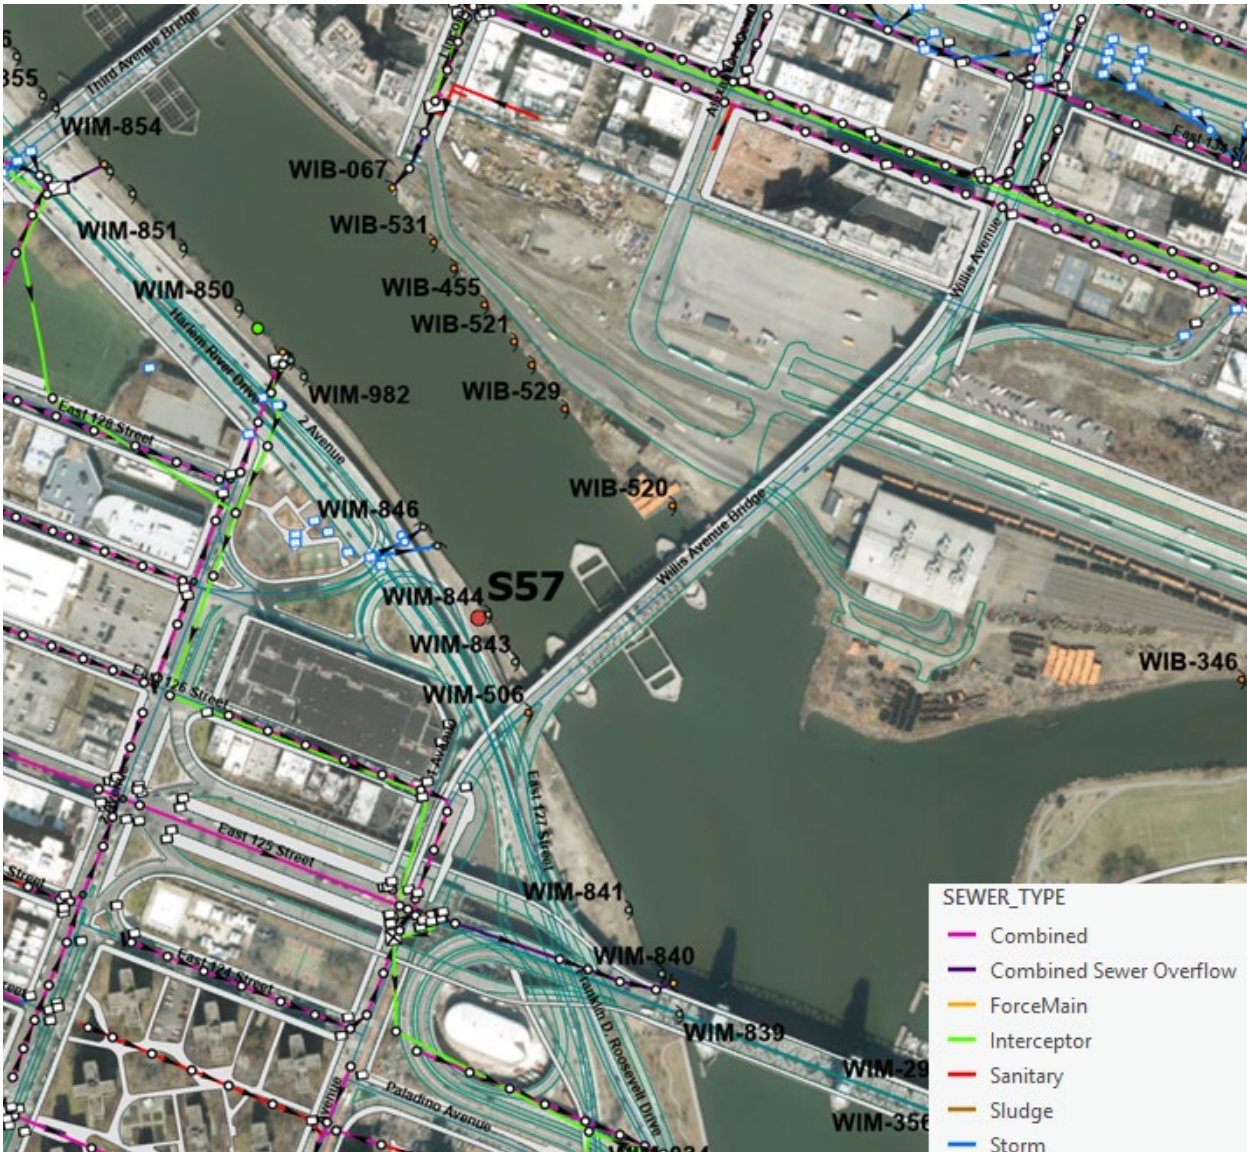
S57 and the outfalls in the area.

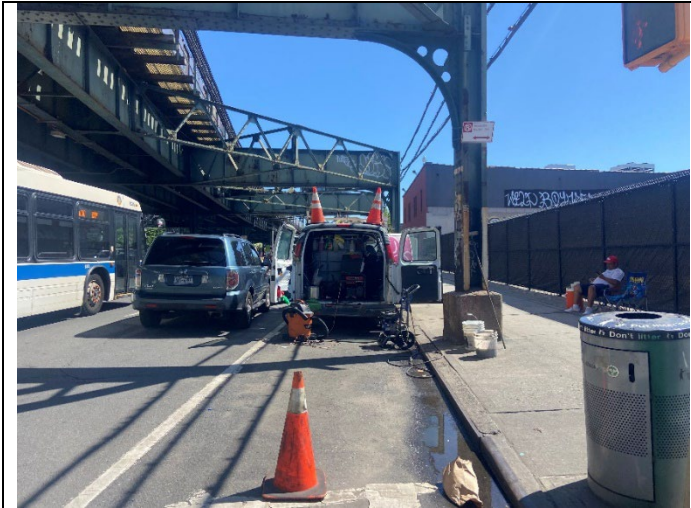
10th Ave between W 207th St to W 215th St (Car wash on the Street)

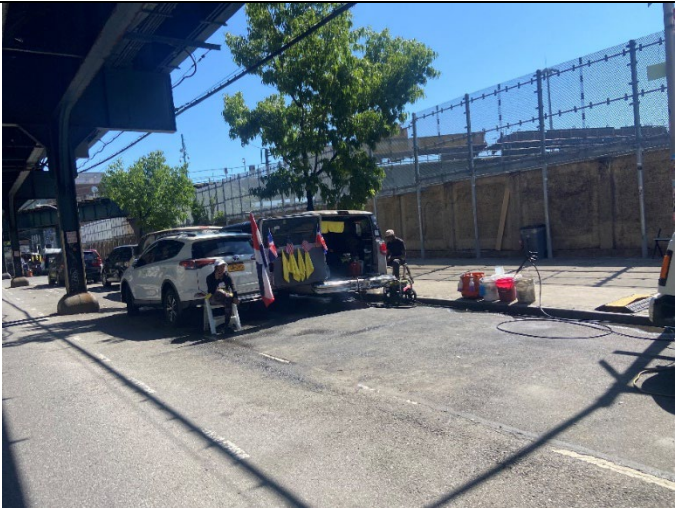
10th Ave between W 207th St to W 215th St (Car wash on the Street)

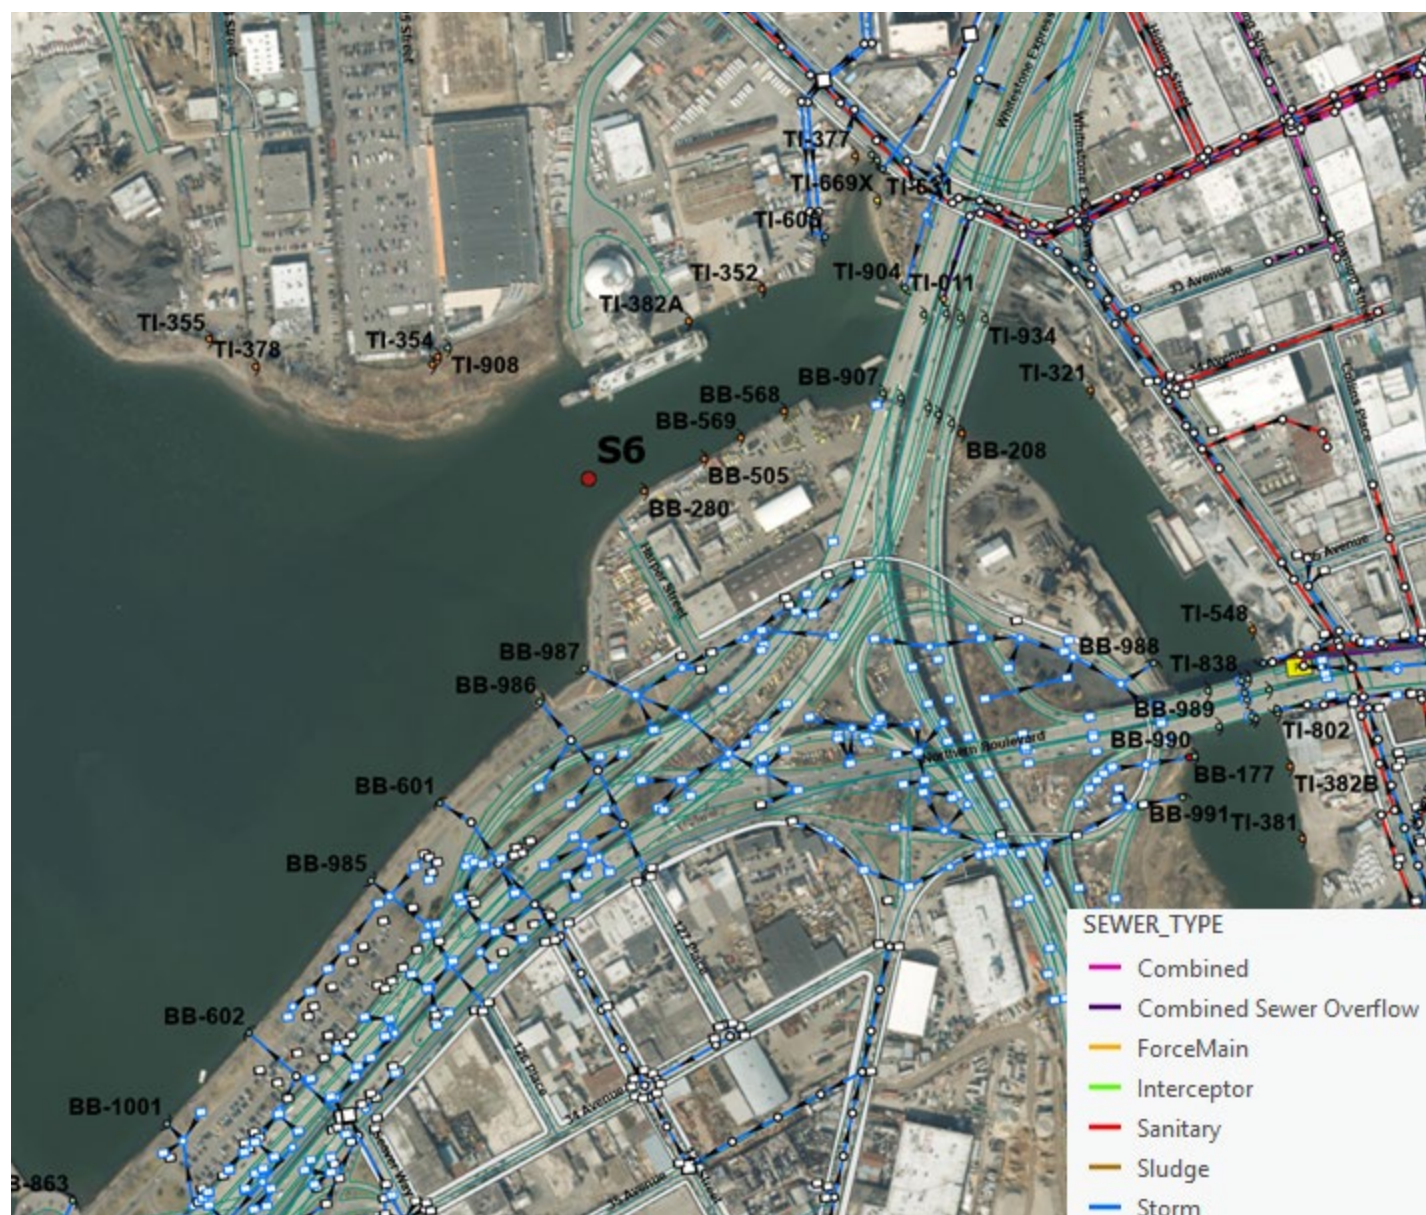
S6 and the outfalls in the sentinel station area.

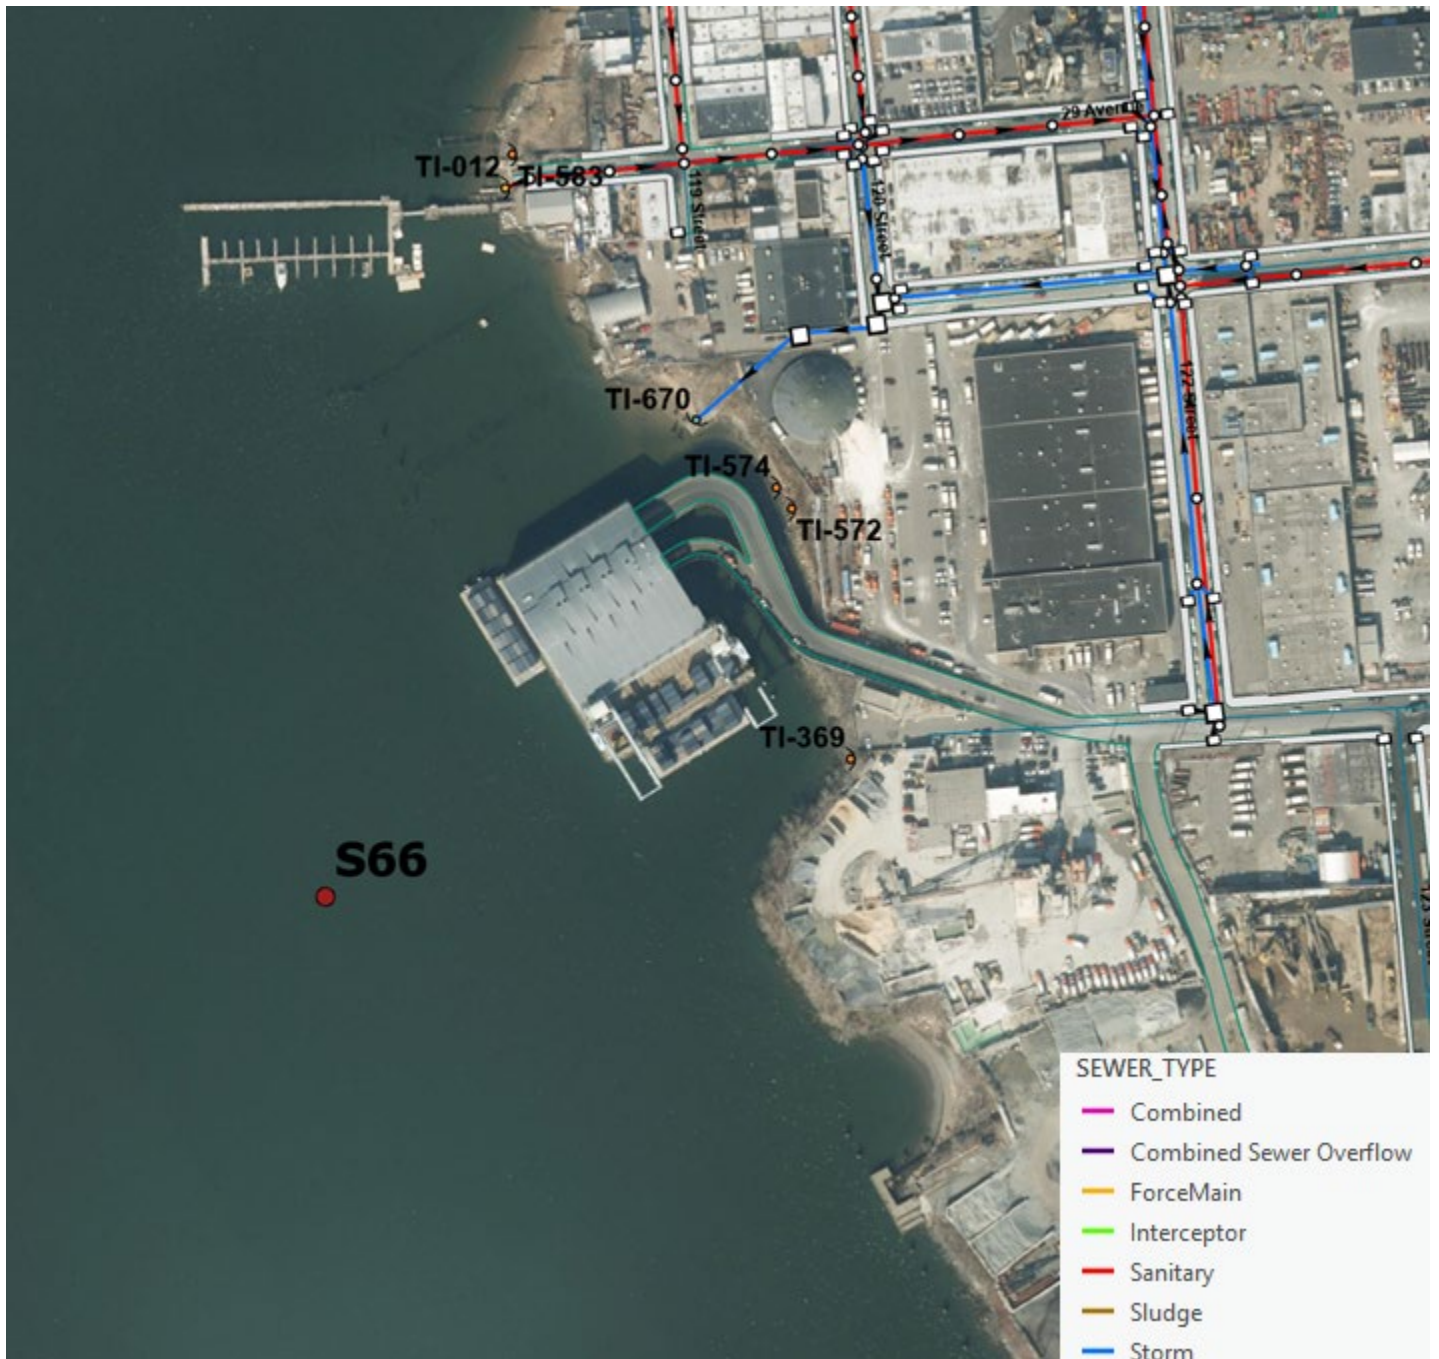
S66 and the lack of sewers in the sentinel station area

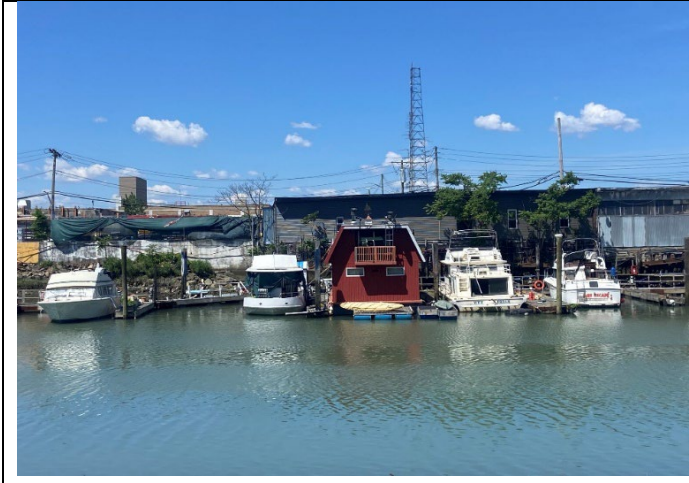
Westchester Creek (House Boats)

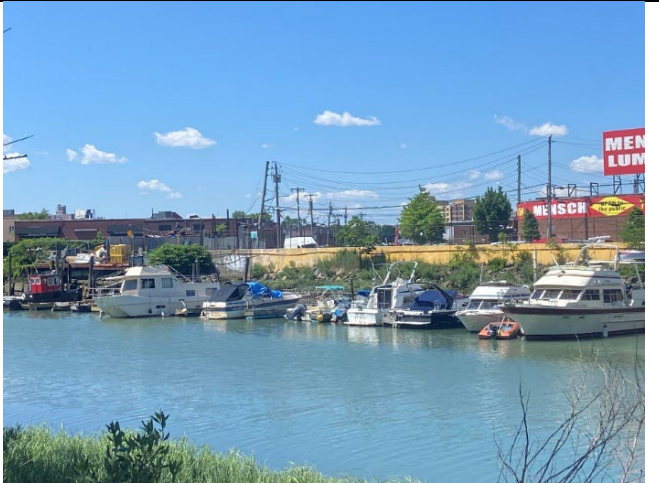
Westchester Creek (House Boats)

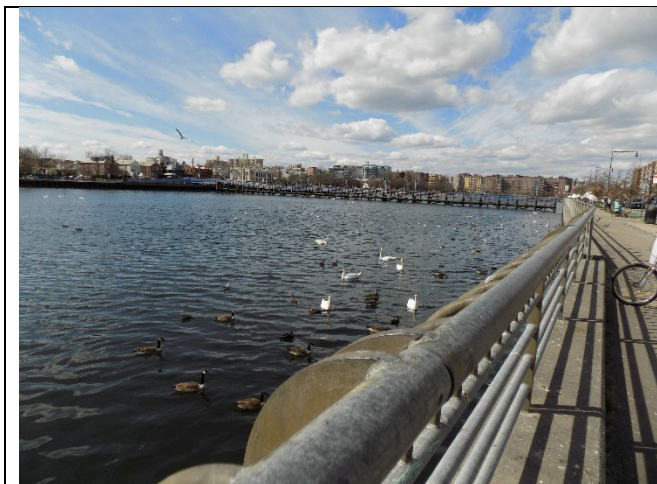
S82 and Sheepshead Bay. Abundant birds are present in the waterbody.

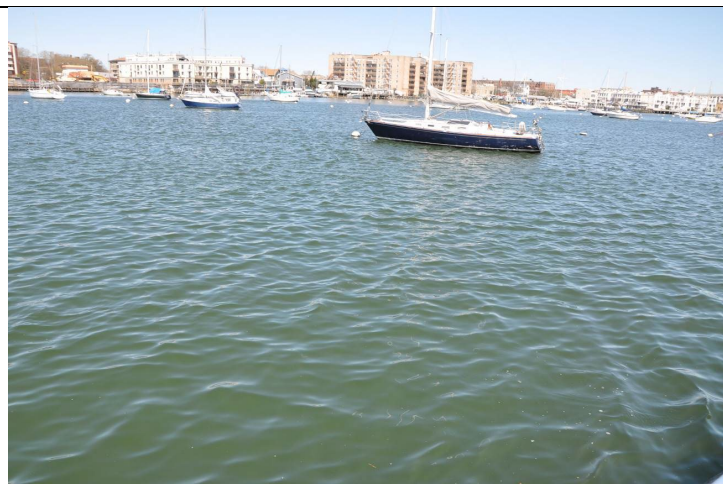
Boats located in Sheepshead Bay

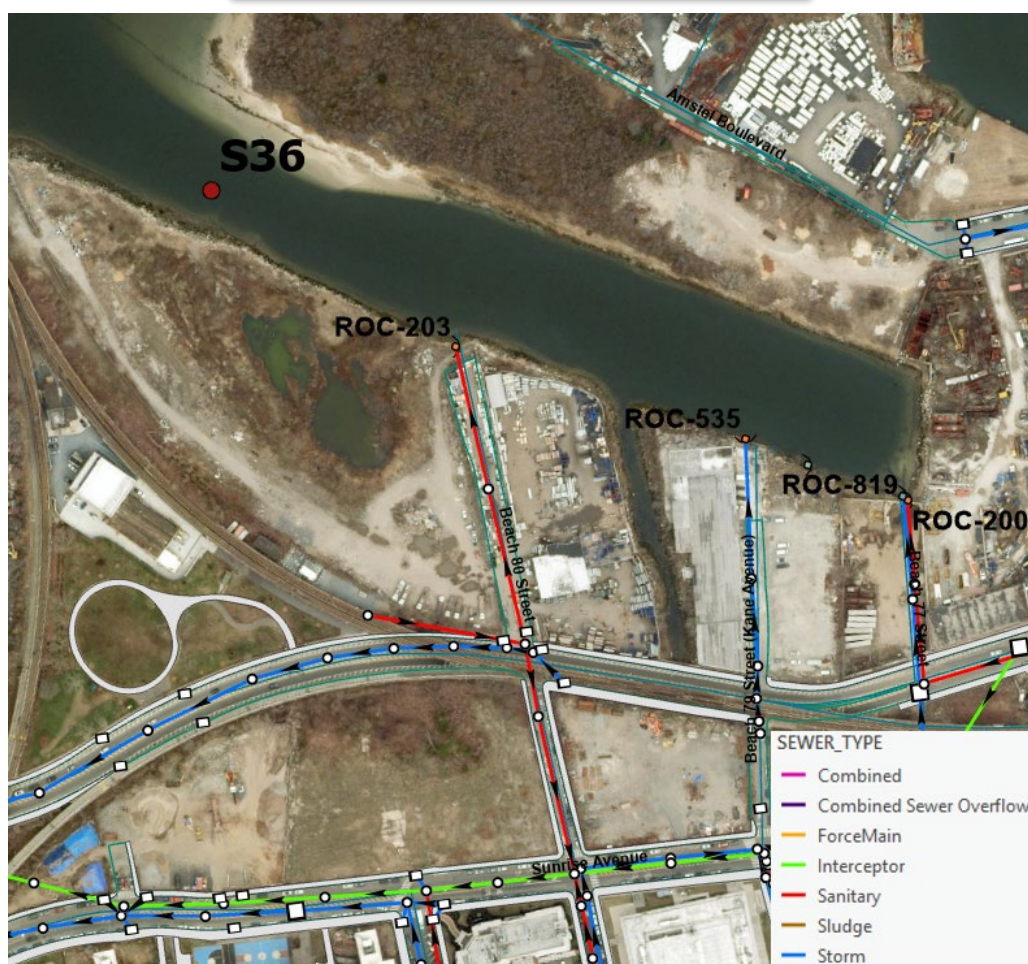
S36 and the sewers in the sentinel station area. The sewer map requires changing.

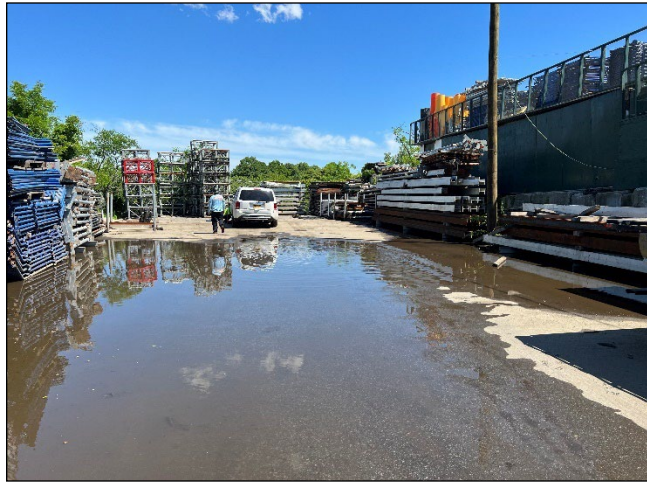
Industrial activity occurring in the Barbadoes Basin drainage area.

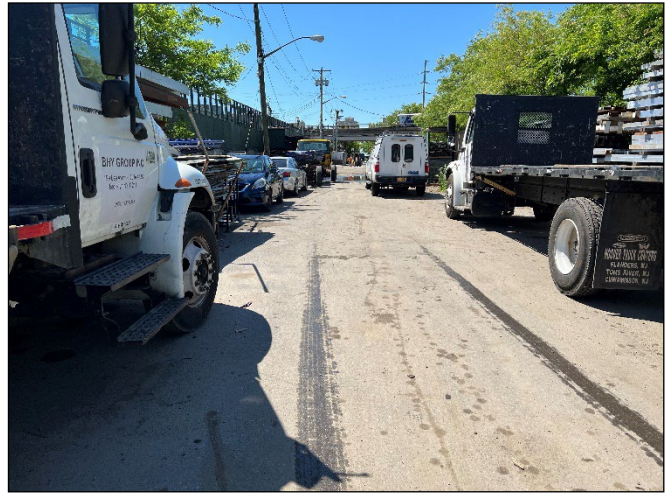
Industrial activity occurring in the Barbadoes Basin drainage area.
