Re: Integrated Sentinel Monitoring Report Calendar Year 2024

INTEGRATED SENTINEL MONITORING REPORT CALENDAR YEAR 2024

NYC
Environmental
Protection

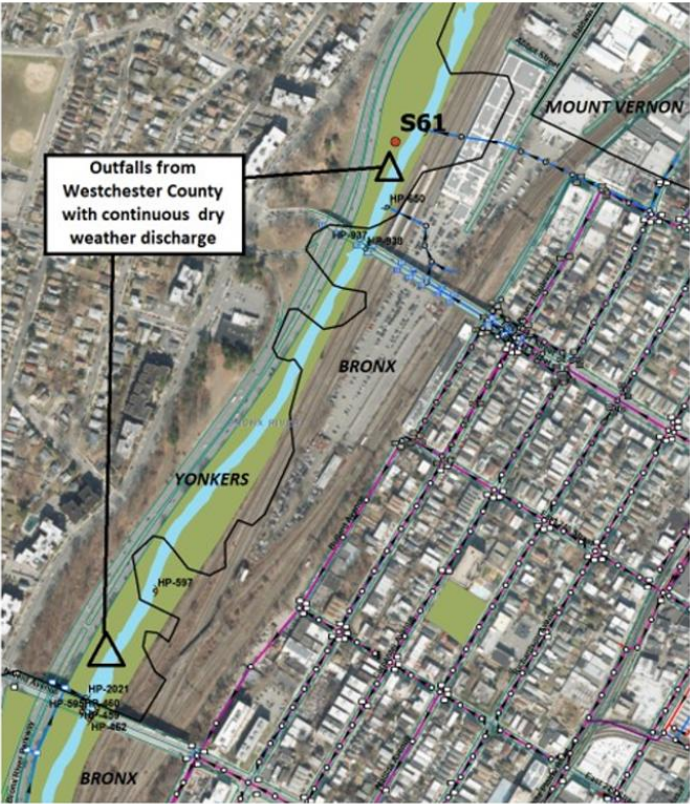
An outfall belonging to Yonkers at Nereid Avenue, discharging during dry weather.

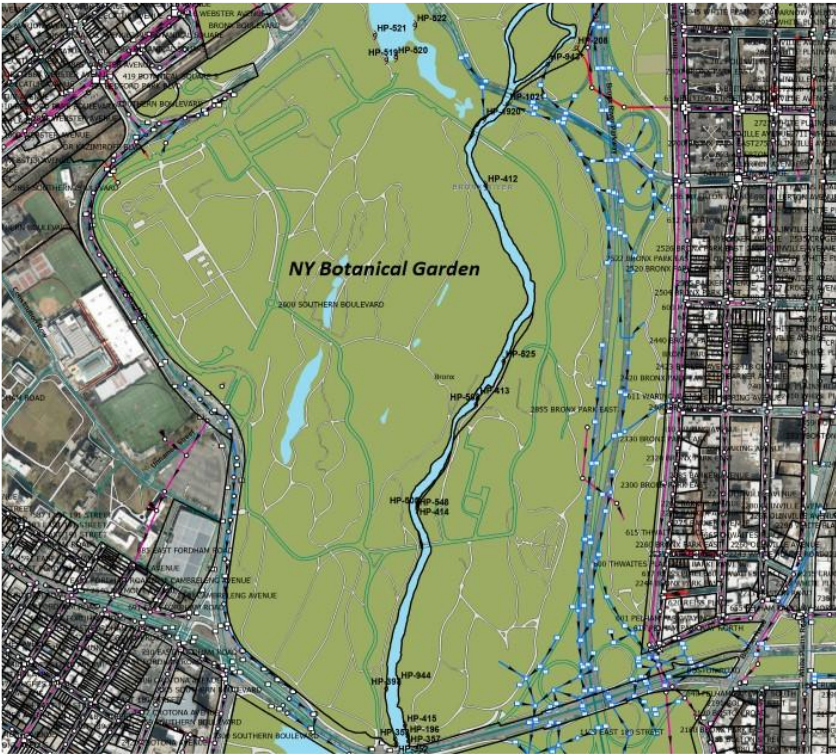
New York Botanical Garden :

Influence on the Bronx River through numerous outfalls owned by the property

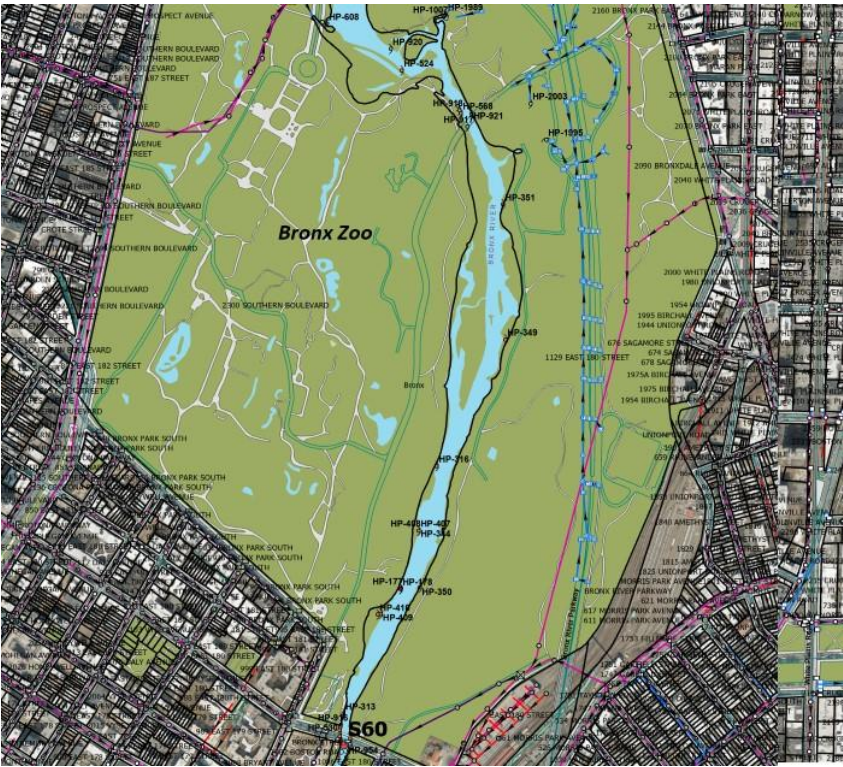
Bronx Zoo & S60

- Dry weather discharges to the Bronx River via activities at Bronx Zoo were previously found by CMS personnel.
- Multiple outfalls belonging to the Bronx Zoo are observed along the Bronx River which are a possible influence to S-60 sentinel station in south

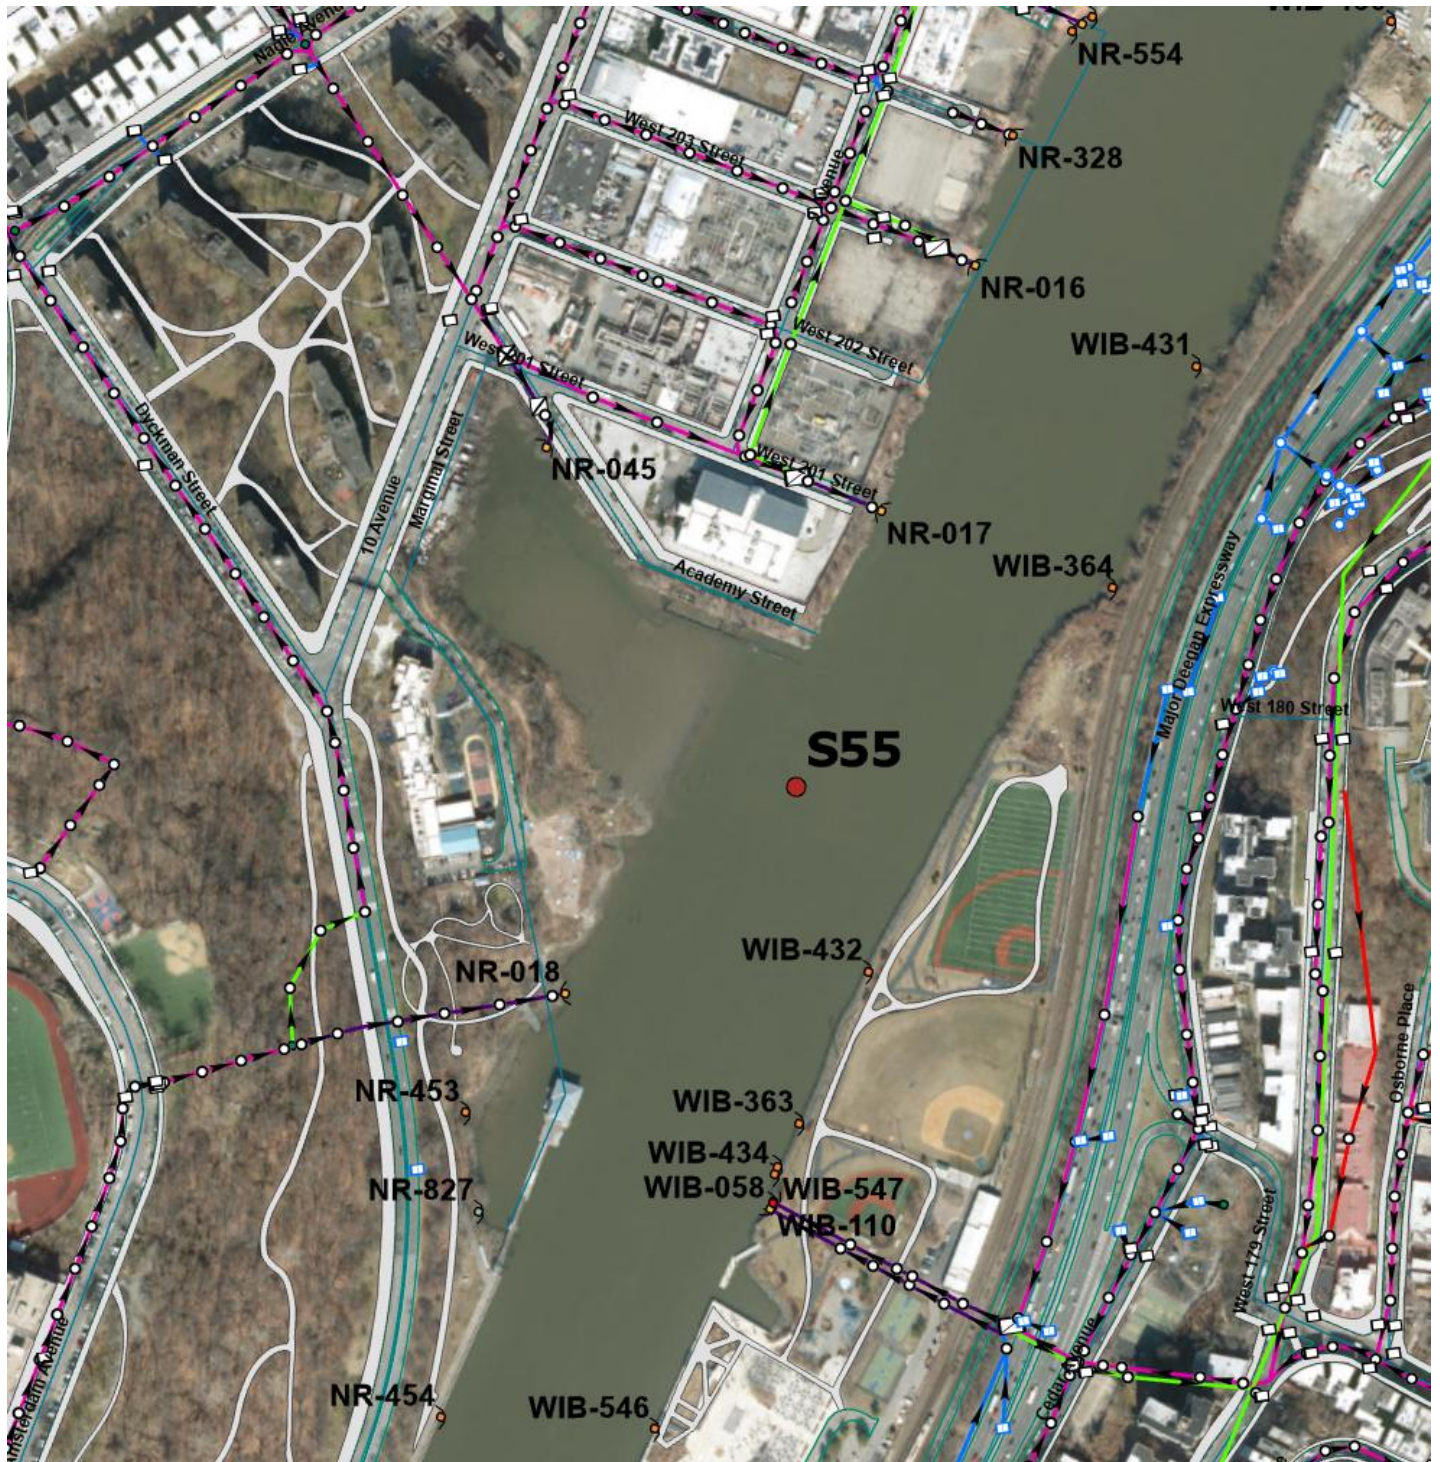
S55 and the CSO sewers in the area leading to the sentinel station.

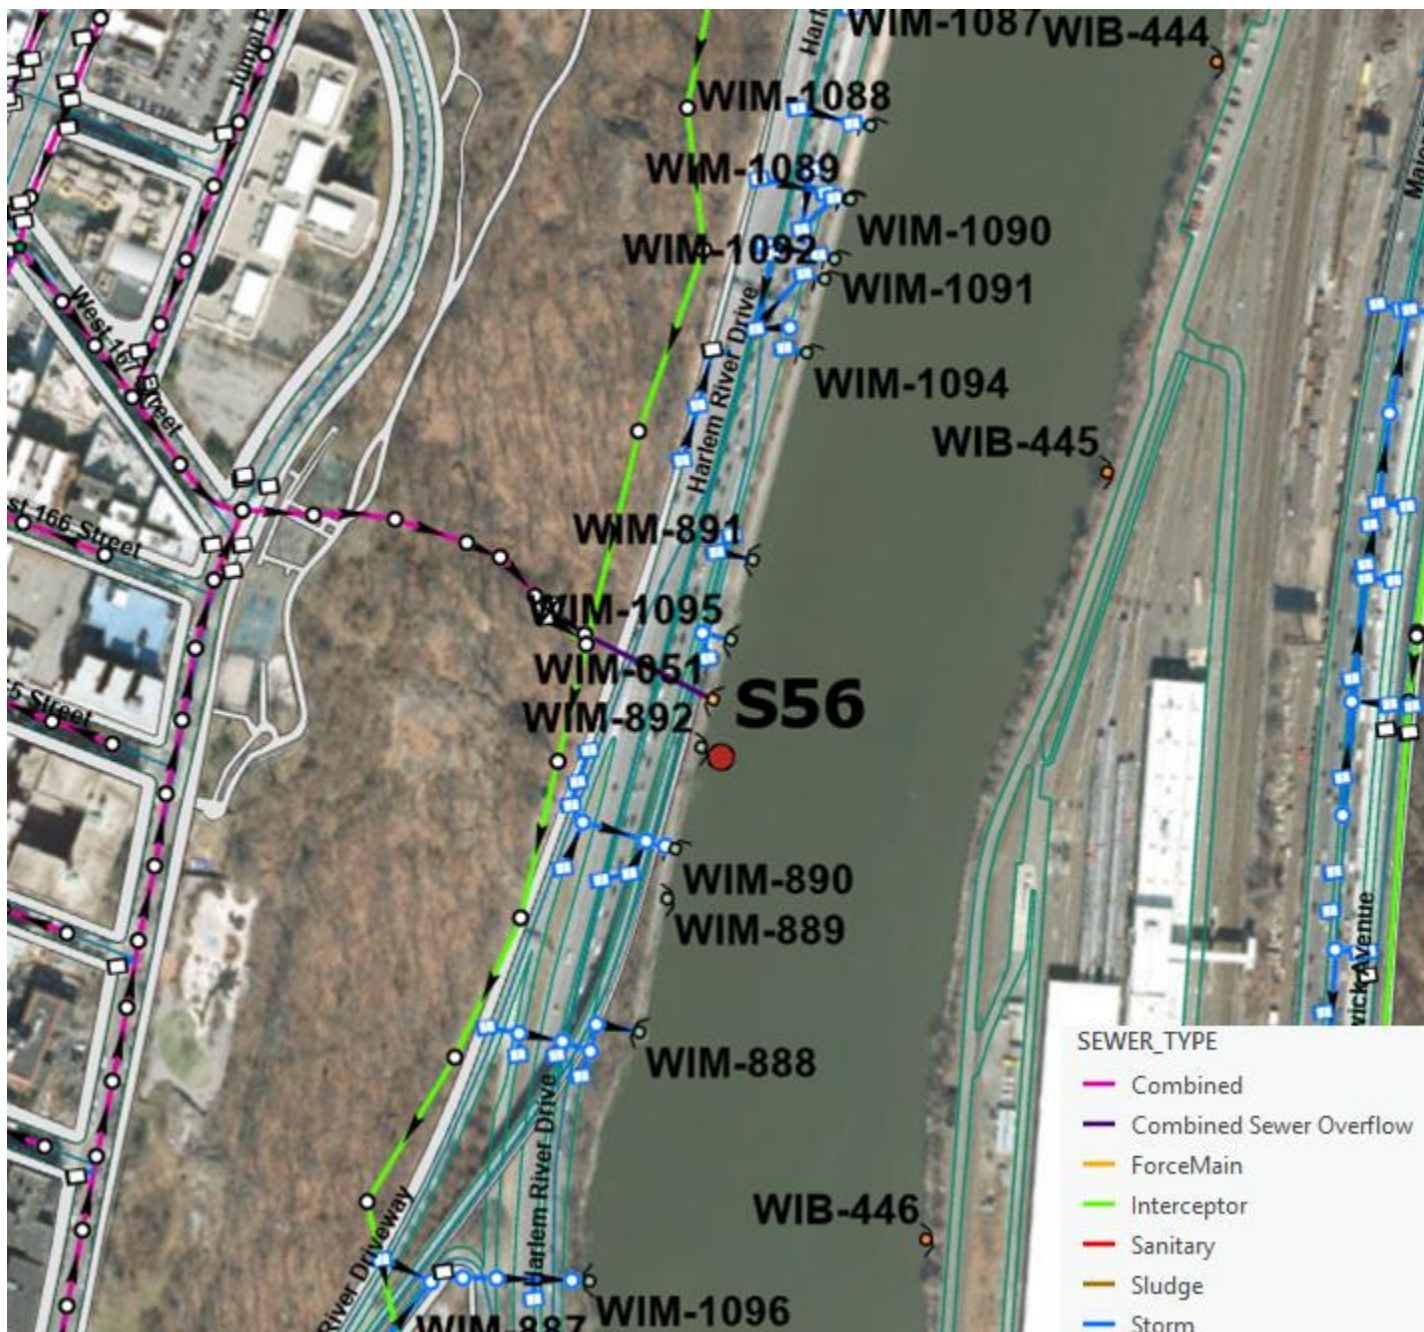
S56 and the CSO and MS4 outfalls in the area

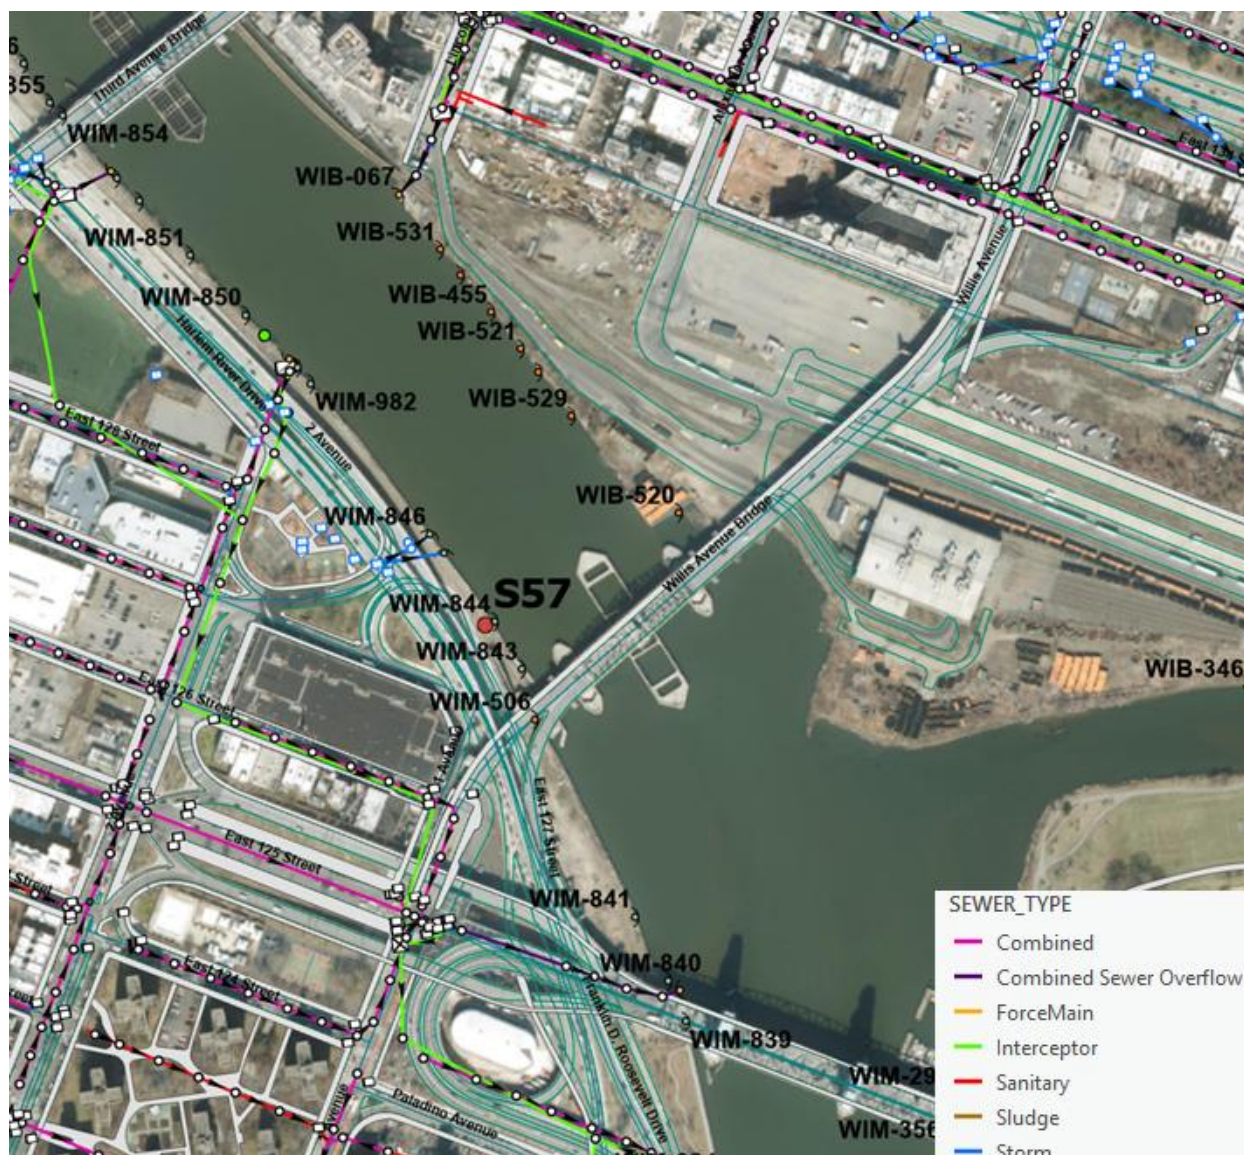
S57 and the outfalls in the area.

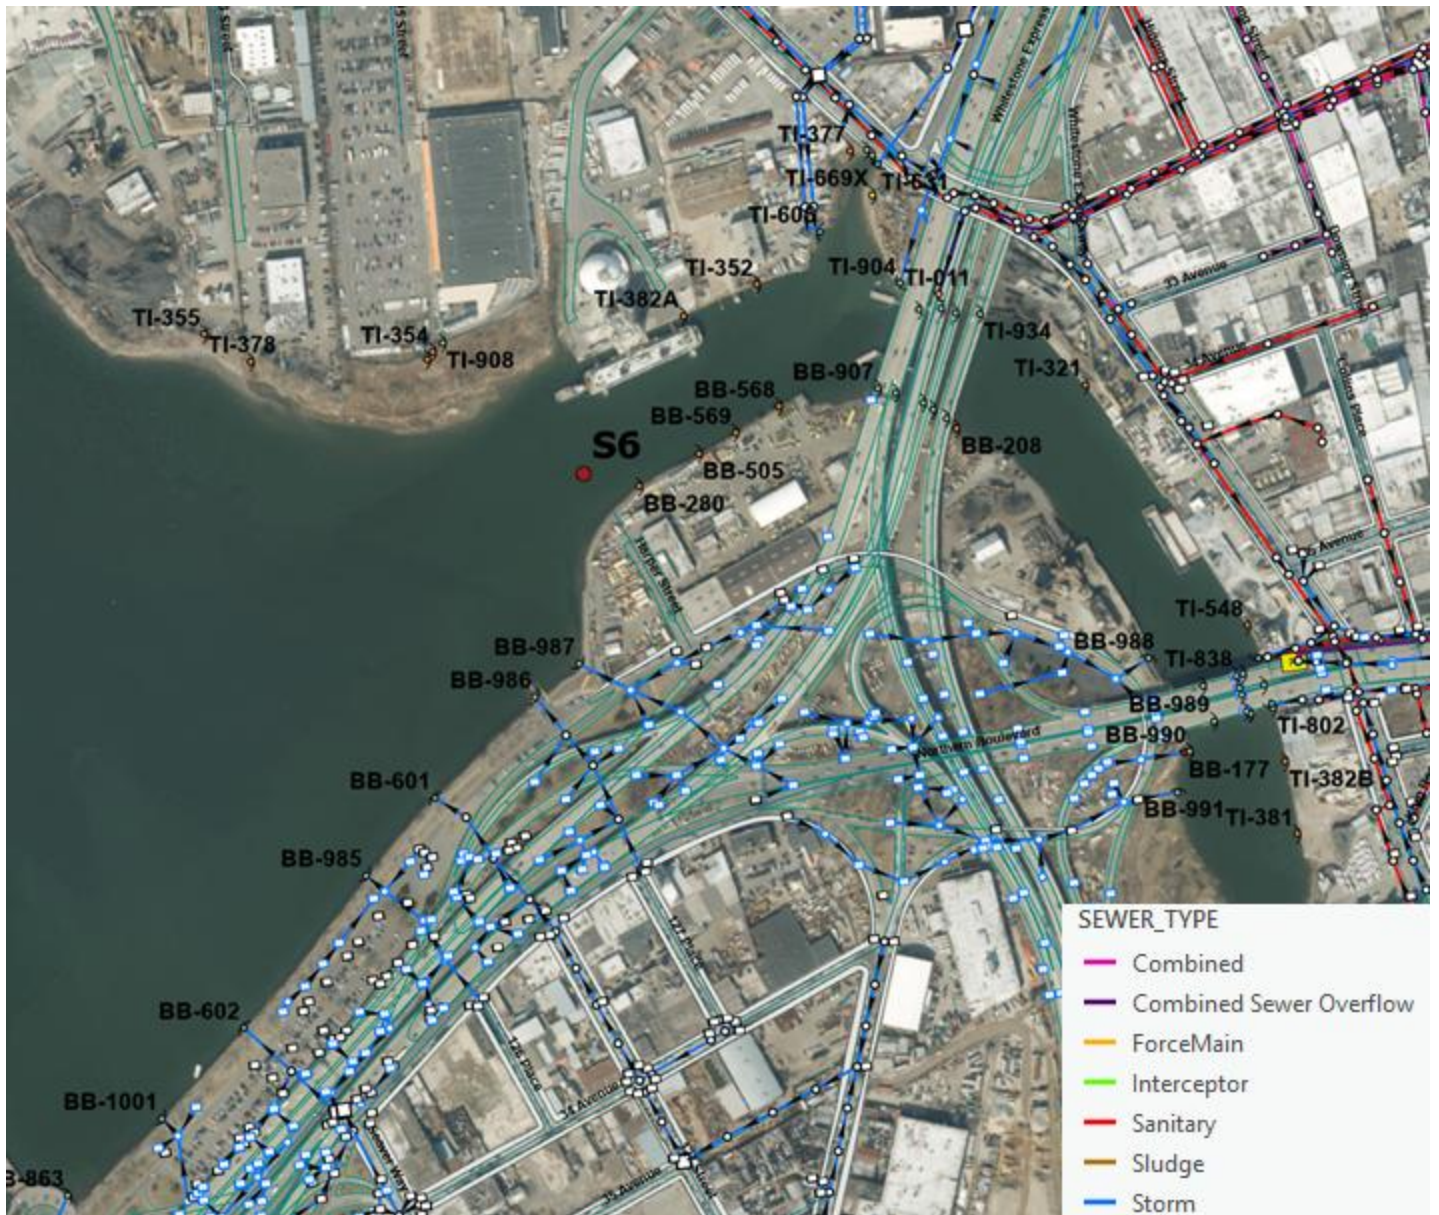
No sanitary sewers exist in the S6 sentinel station area. The area is being rebuilt.

S6 and the outfalls in the sentinel station area.

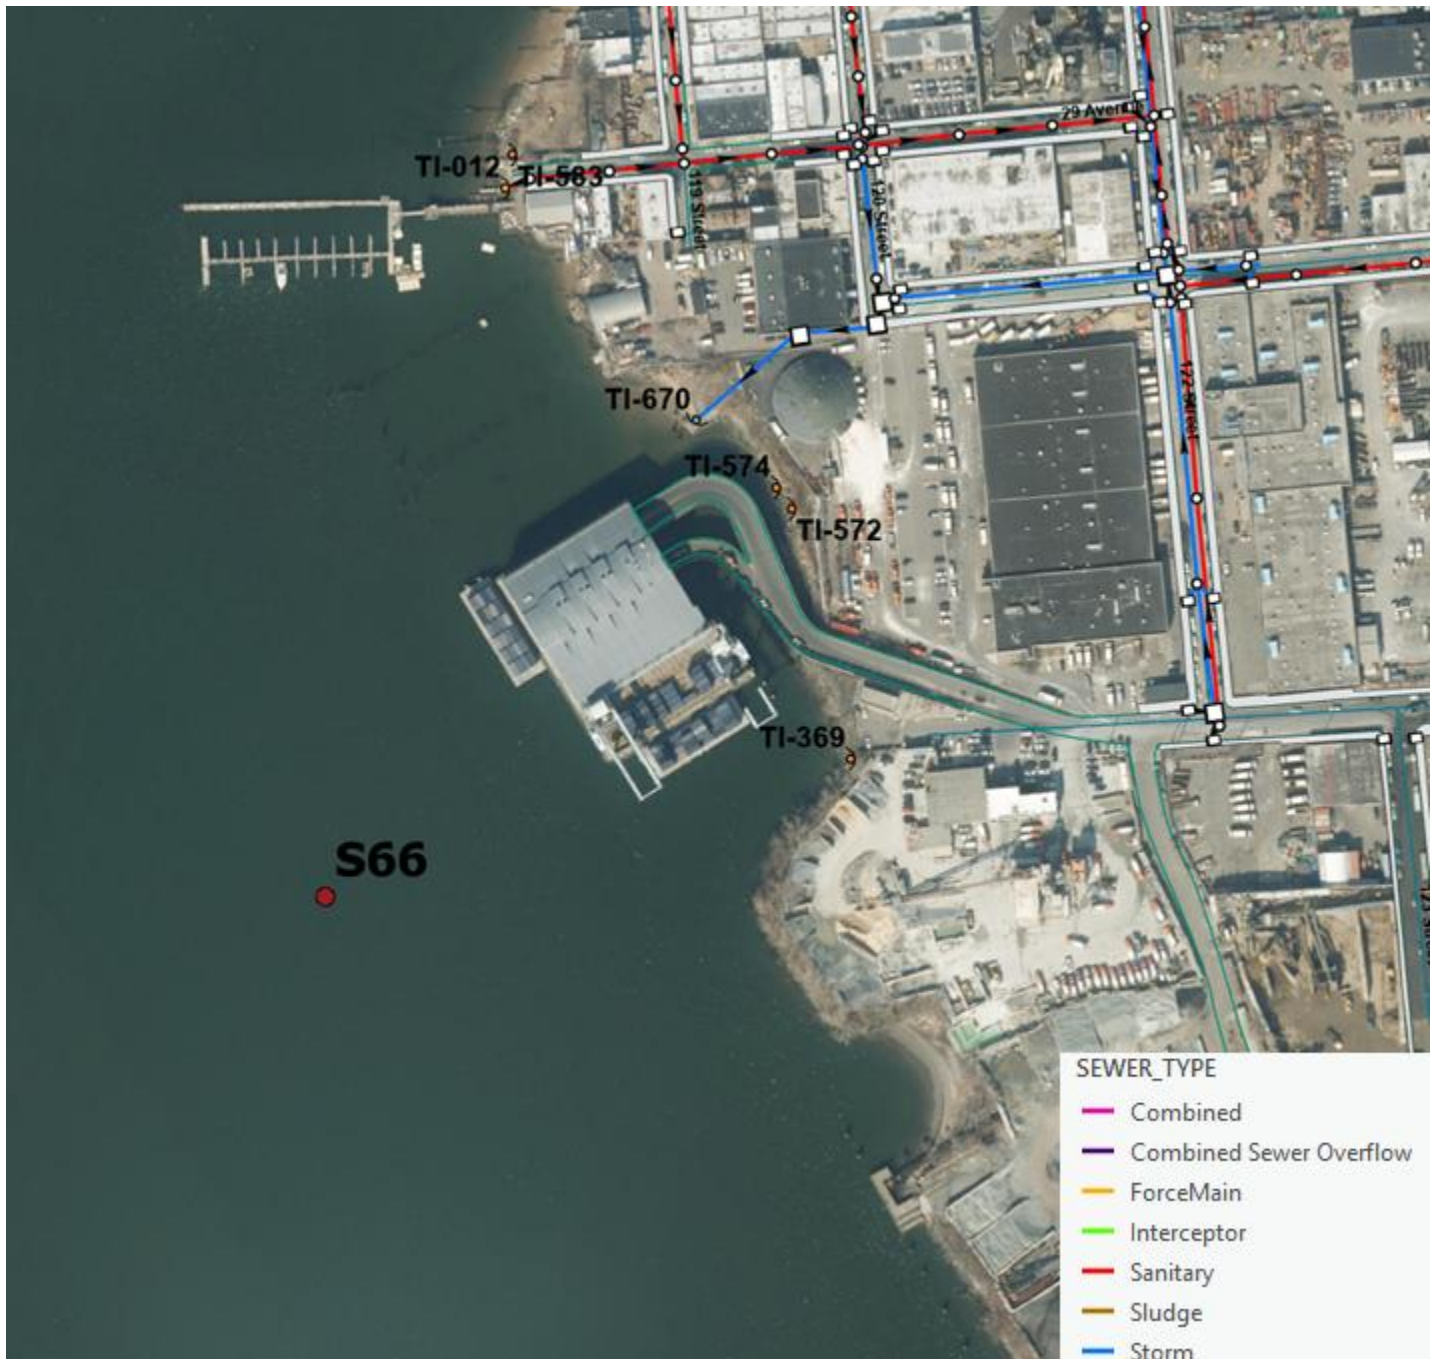
S66 and the lack of sewers in the sentinel station area

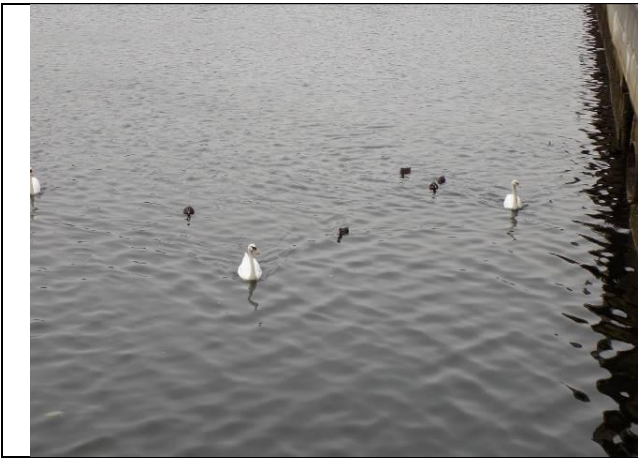
Sentinel monitoring stations S74 and S82 exhibit exceedance in fecal coliform values as per baseline values. No active cases are present in the waterbody. Sheepshead Bay contains multiple boats, and discharge from boaters affects fecal coliform values in the waterway; in addition, an abundance of birds contributes to the elevated fecal bacteria in the waterway.

S82 and Sheepshead Bay. Abundant birds are present in the waterbody.

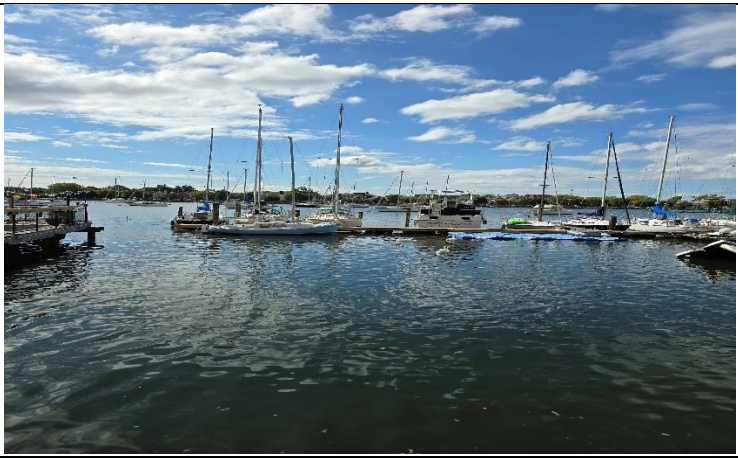
Boats located in Sheepshead Bay

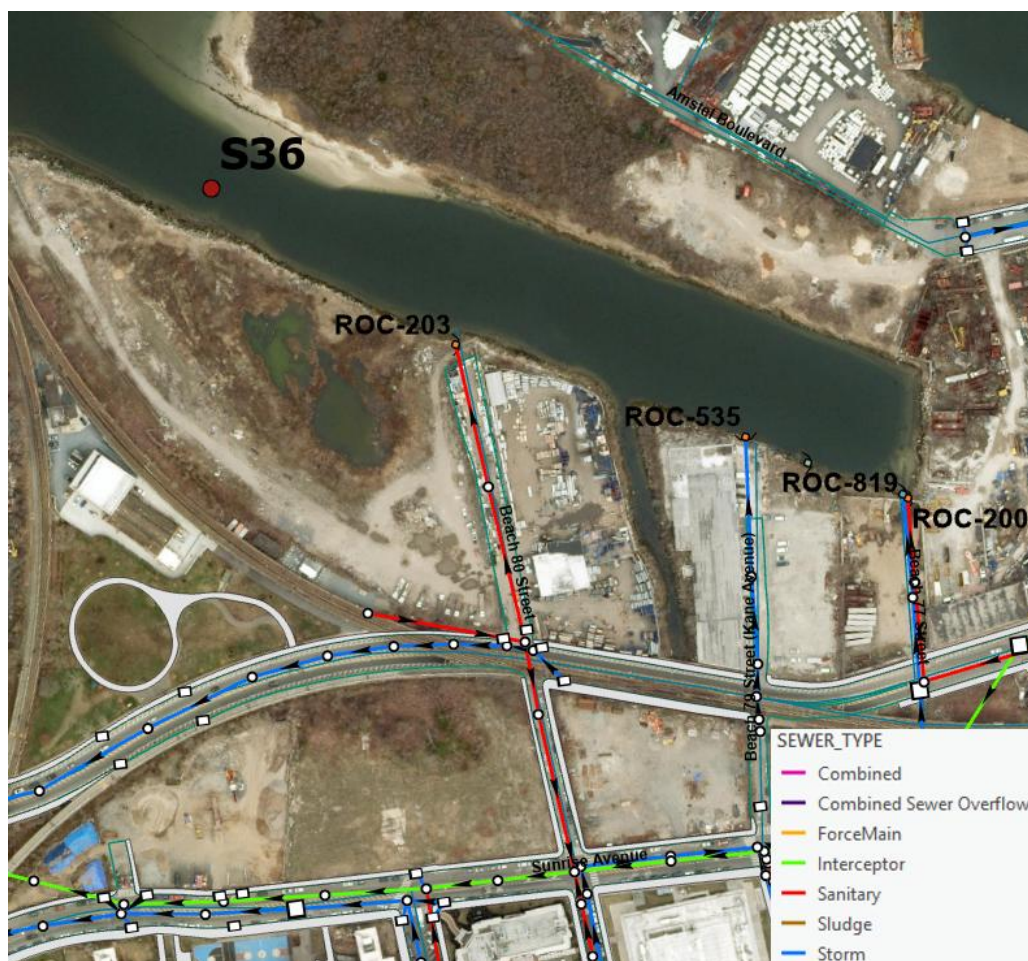
S36 and the sewers in the sentinel station area. The sewer map requires changing.

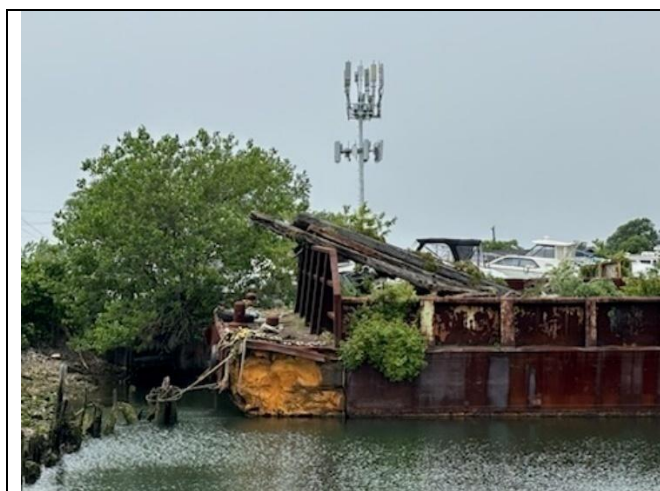
Industrial activity occurring in the Barbadoes Basin drainage area.

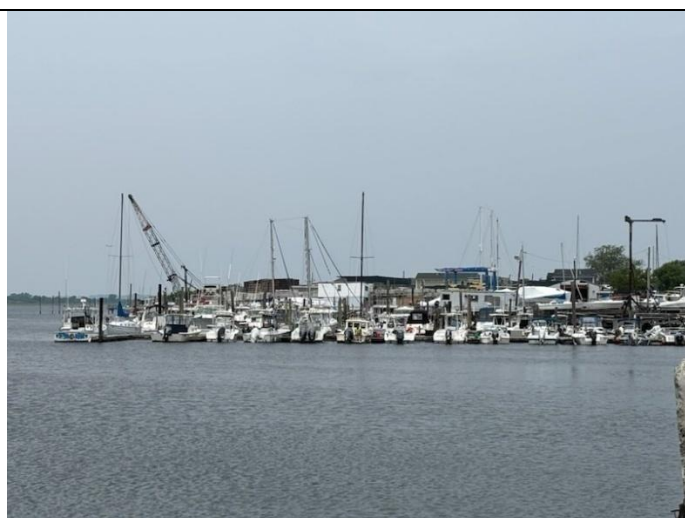
Boats docked along Barbadoes Basin drainage area.

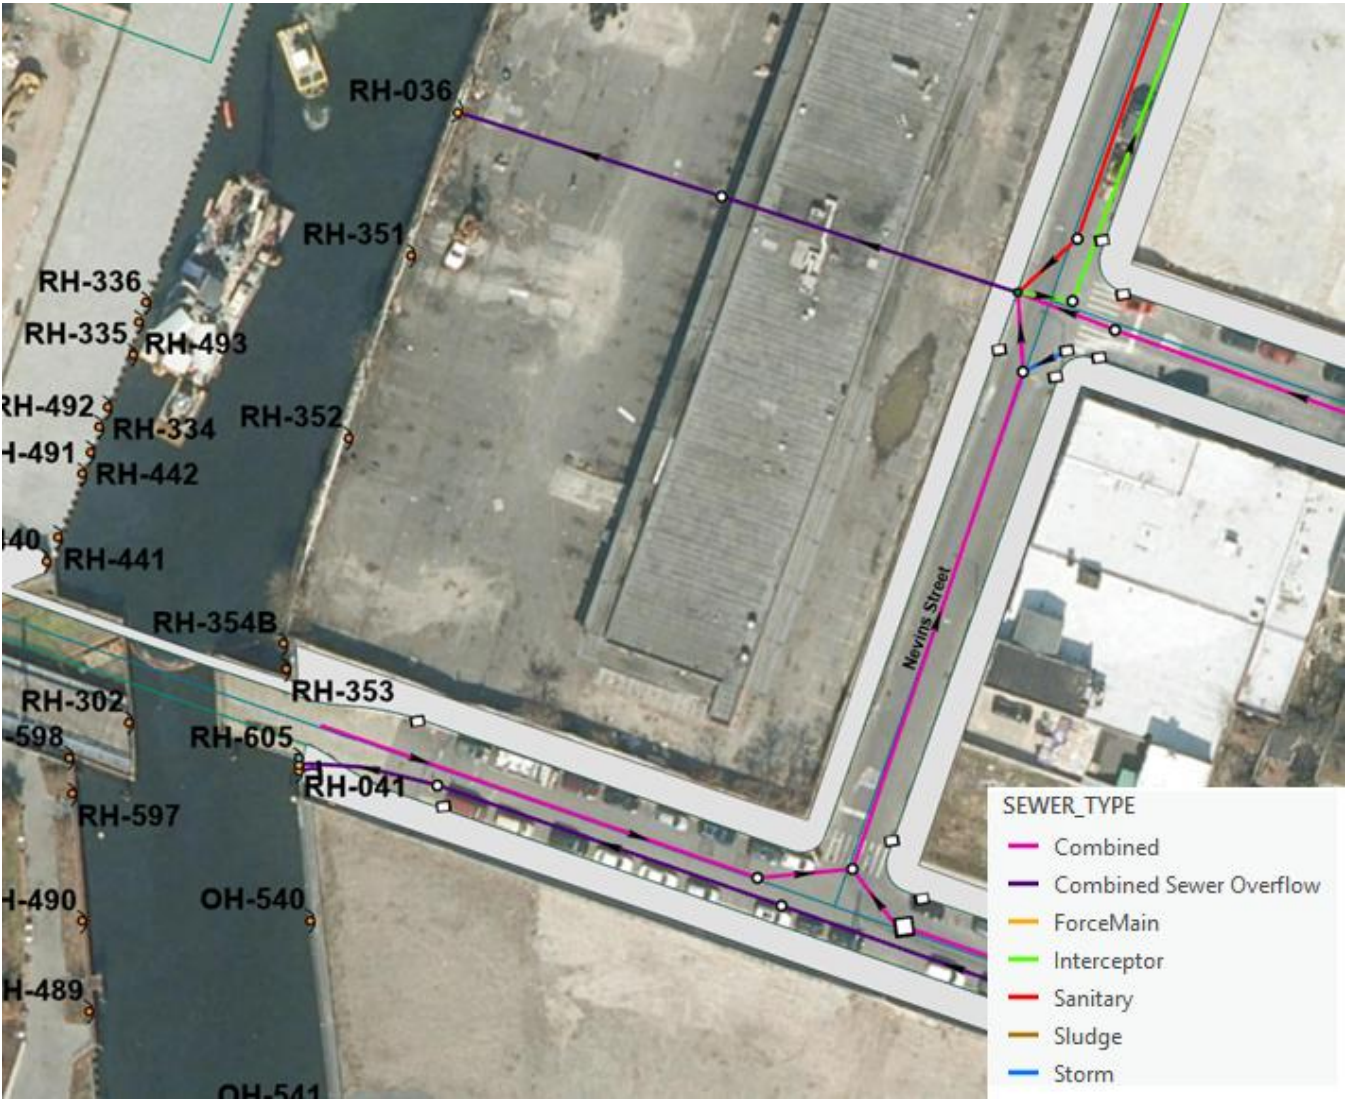
Sentinel monitoring station S68 exhibits exceedance in fecal coliform values as per baseline values. No active cases are present in Gowanus Canal. Heavy commercial and residential construction is underway in Gowanus Canal including the development of a combined sewer overflow tank by DEP at the head of the canal.

The sewers on Carroll Street are to be upgraded
