# **Soldiers & Sailors Monument Restoration**

## **Project M071-323M**

### **Public Design Commission Review**

October 2024

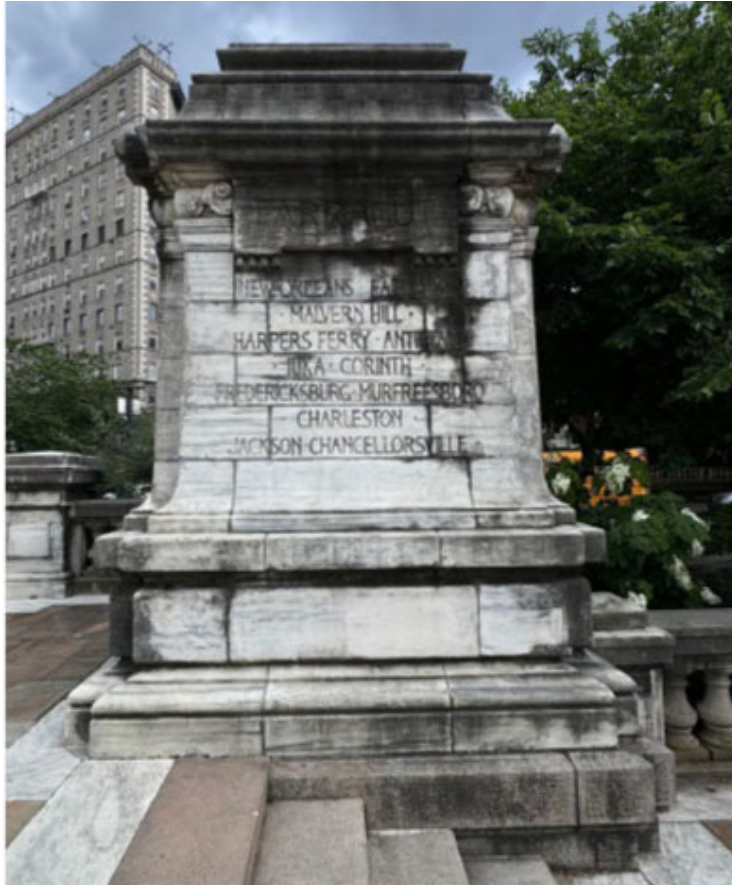
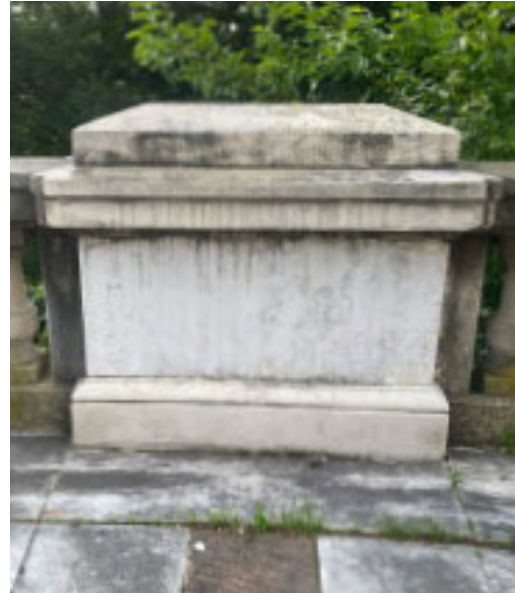
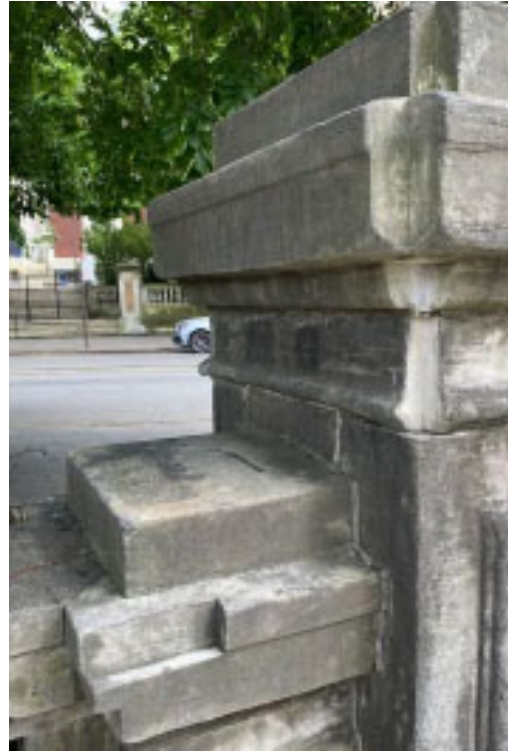
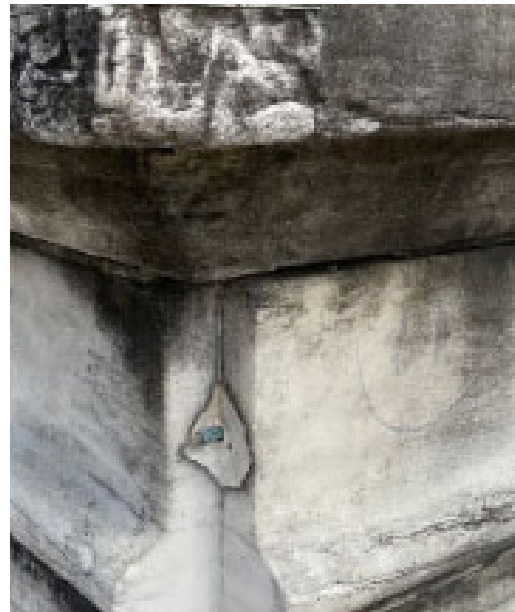
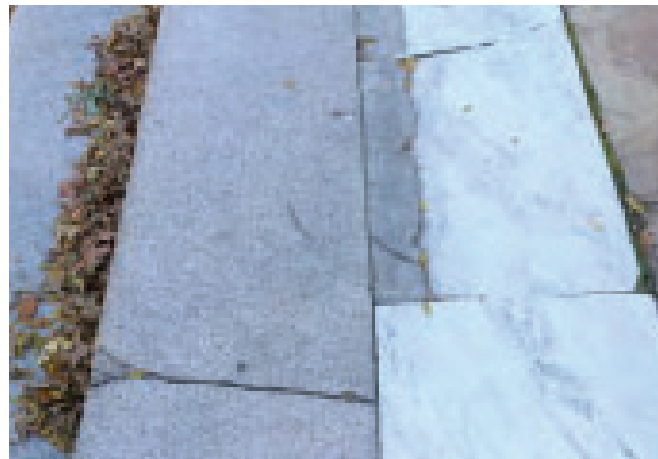
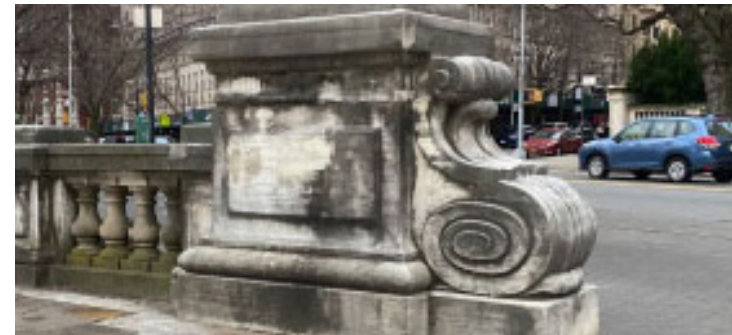
## Plazas: Pylons and Piers

- Marble surface suffers from atmospheric soiling, staining, graffiti and overpainting - - cleaning and paint removal is needed. Micro-abrasive cleaning, supplemented with limited ph-neutral paint stripping is anticipated (dependent on successful results of field mockups during Construction).
- Most 1960s Dutchman repairs are missing or damaged, requiring replacement with new.

In coordination with new drainage scope, marble pavers to be removed and salvaged for reuse. Any units too damaged for paving reuse to be salvaged for Dutchman elsewhere. Any new units to match size and properties of the original.

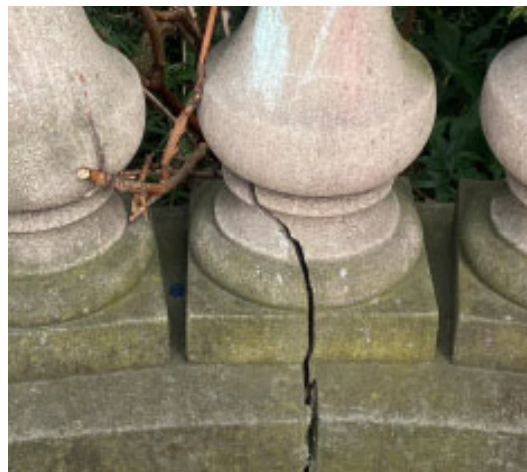
**Full Unit Limestone Crack**

- Marble balustrades at the plazas were replaced with Indiana Limestone during the 1960s restoration campaign.
- Any balusters cracked horizontally through the neck or near the base will be replaced with matching balusters salvaged from openings created for the new ADA access points to the site.
- Remaining limestone balustrade is in overall good condition and shall be cleaned and preserved. Micro-abrasive cleaning is anticipated. All joints to be re-pointed with compatible mortar based on results of testing.

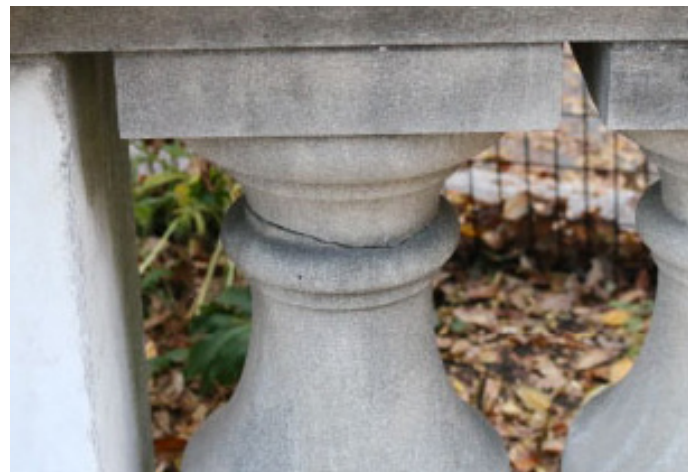
**Full Unit Limestone Crack**

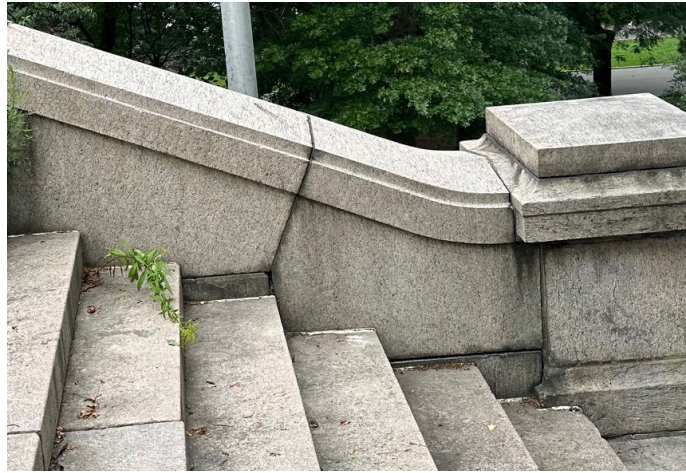
### Milford Pink Granite, Mass.

Milford Pink Granite is found on the north approach stair assembly and is in good condition it will be preserved.

- Any spalls shall be replaced with matching Dutchman repairs.
- All joints to be 100% repointed.

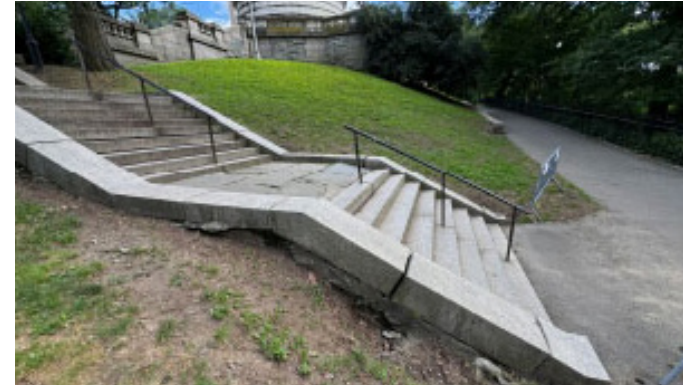
Northwest stairs and cheekwalls

- Overall, granite is in good condition exhibiting selective areas of loss, which will be replaced with matching Dutchman repairs.
- Joints will be 100% repointed with compatible mortar based on testing.
- Dimensional stair treads exhibit displacement, cracks and selective cementitious patches.
- Steps to be removed and reset, coordinated with plaza drainage system. Severely deteriorated stair treads to be replaced with matching granite.

- Any spalls shall be replaced with matching Dutchman repairs.
- All joints to be 100% repointed. Contractor is responsible to update mortar testing for replacement mortar at each distinct masonry material. Final approvals shall be dependent on approved samples and successful field mockups during construction.

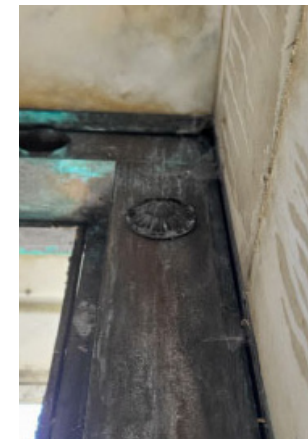
Extant and Missing Rosette.

- Remove door to off-site facility by qualified Contractor.
- Reset threshold.
- Strip all coatings with abrasive methods and patinate to an antique/statuary bronze finish (conditional of approved mockup samples) and hot-waxed with a cold wax coating
- Repair door hinge mechanism.
- Cast and re-install missing trim and rosettes.
- Replace non-historic steel plate with louvered assembly based on historic drawings.
- Install missing glazing (accessible by unscrewing interior trim)

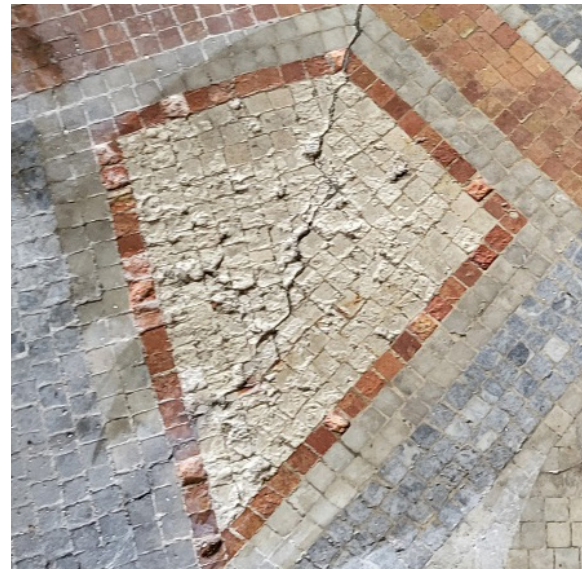
The floor finish of the Monument interior is comprised of patterned stone mosaic tesserae which has been damaged related to long-term water infiltration issues. The floor exhibits cracking and substantial loss and erosion of individual mosaic units. The damaged and missing stone tesserae are to be replaced in kind and set in compatible concrete setting bed.

**Floor Crack and Material Lost**

Prior to replacement, Contractor shall submit samples for review and approval, to be followed by field mockups.

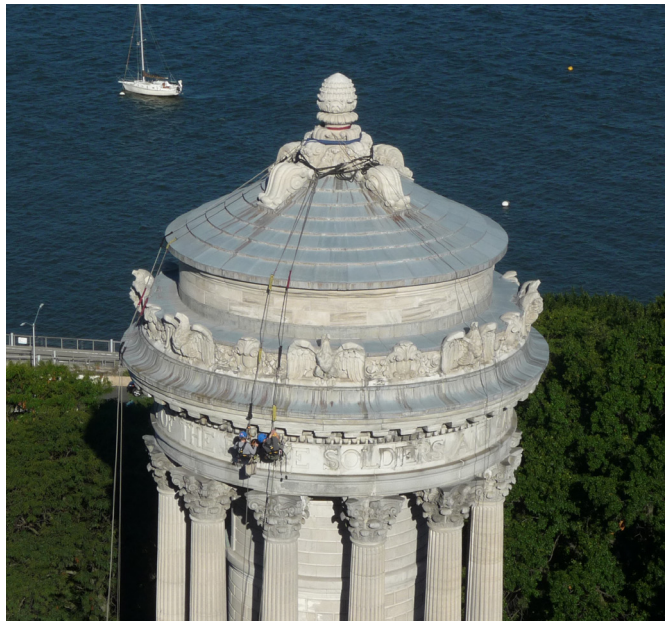
Main Roof and the Entablature

- Loose and failed solder joints, typ.
- Corrosion pin holes and loss of surface material.
- Vandalism tears at base of Drum.

Remove and replace lead roofing assemblies in-kind. Base of drum (concealed from public view) to be treated with Kemper.

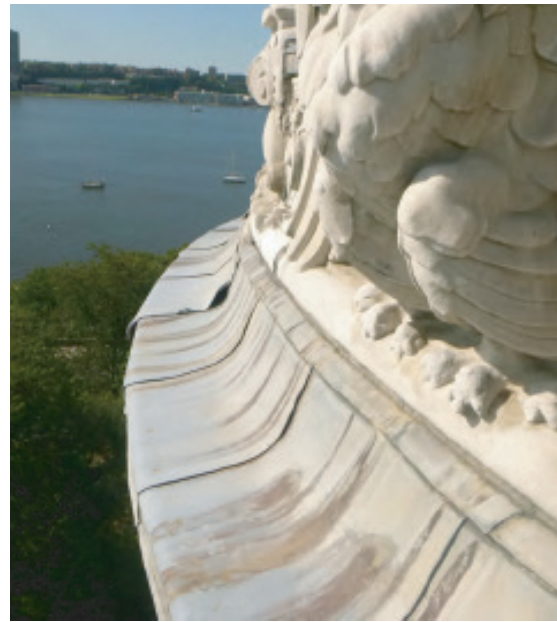
Loose Seams

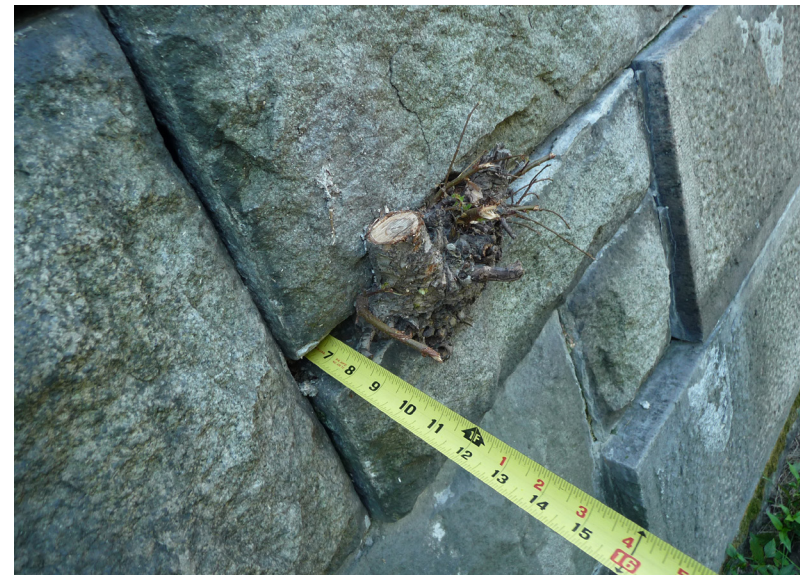
Biological Growth and Displacement

The exposed ashlar foundation stone is locally quarried schist. Overall the stones themselves are in good condition. Deterioration relates to drainage and biological growth.

- Mortar joints are 100% deteriorated.
- Biological growth in joints is typical.
- Localized displacement

- Remove all biological growth from joints and face of stones.
- Repoint with compatible mortar based on testing.
- Reset loose and displaced stones.
