NEW YORK CITY DEPARTMENT OF CORRECTION

Joseph Ponte, Commissioner

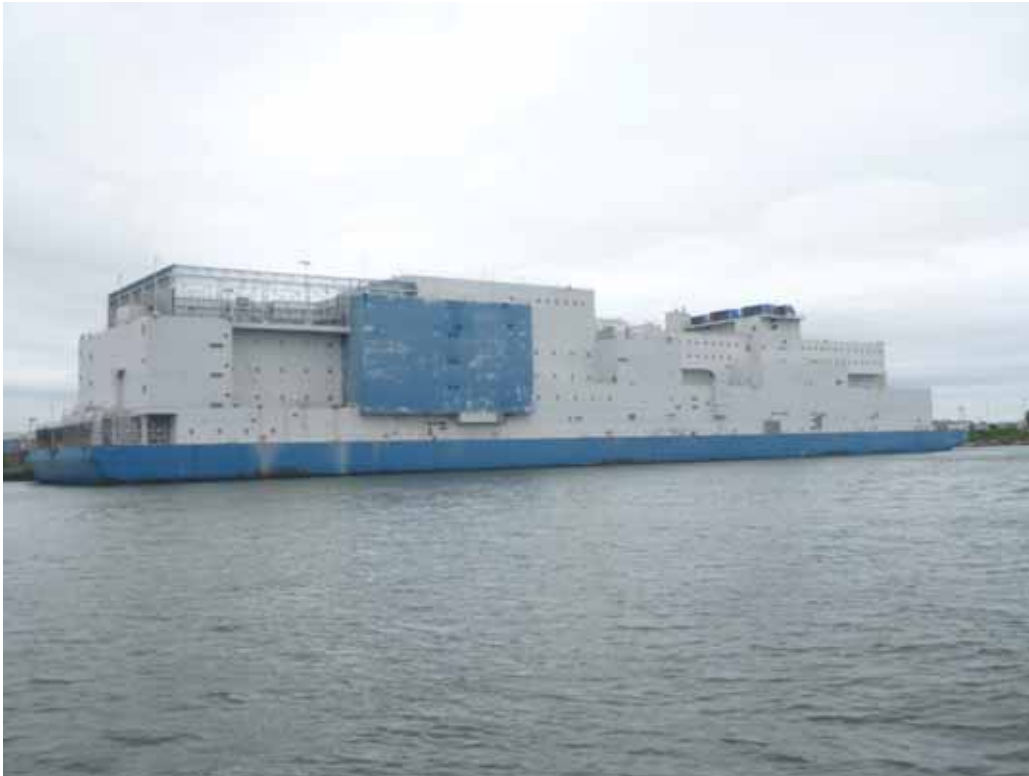
**Existing Conditions Report  
Underwater Investigation  
& Landside Inspection  
Vernon C. Bain Center  
Hunts Point, New York**

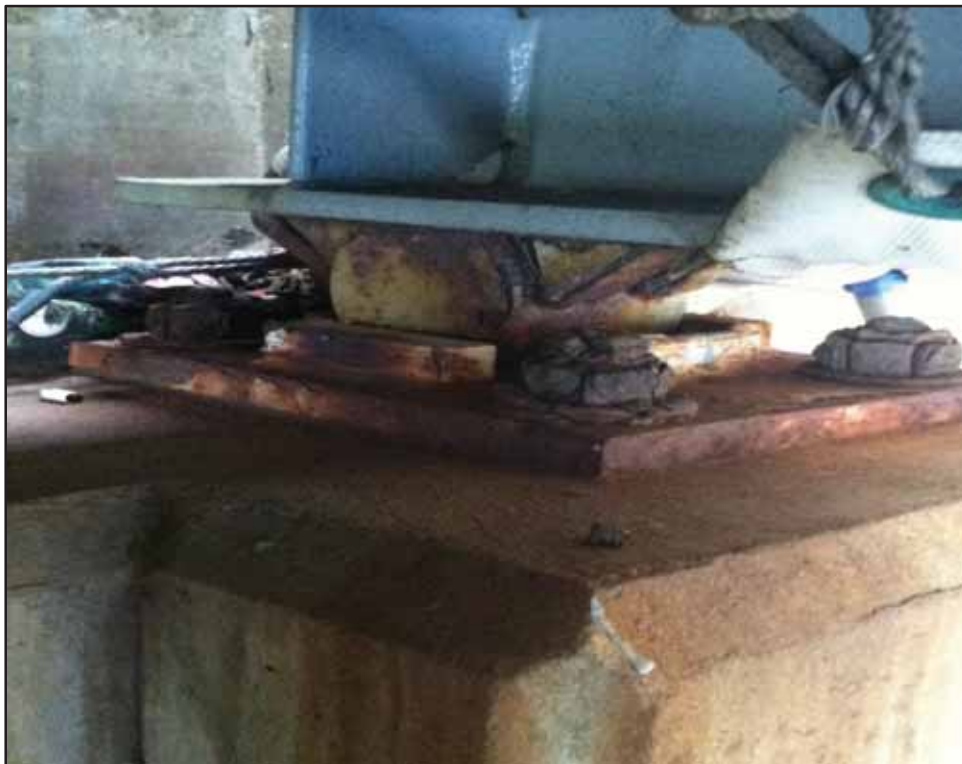
Photo 2-Gangway bearing plate and hardware corrosion at Station 3+10

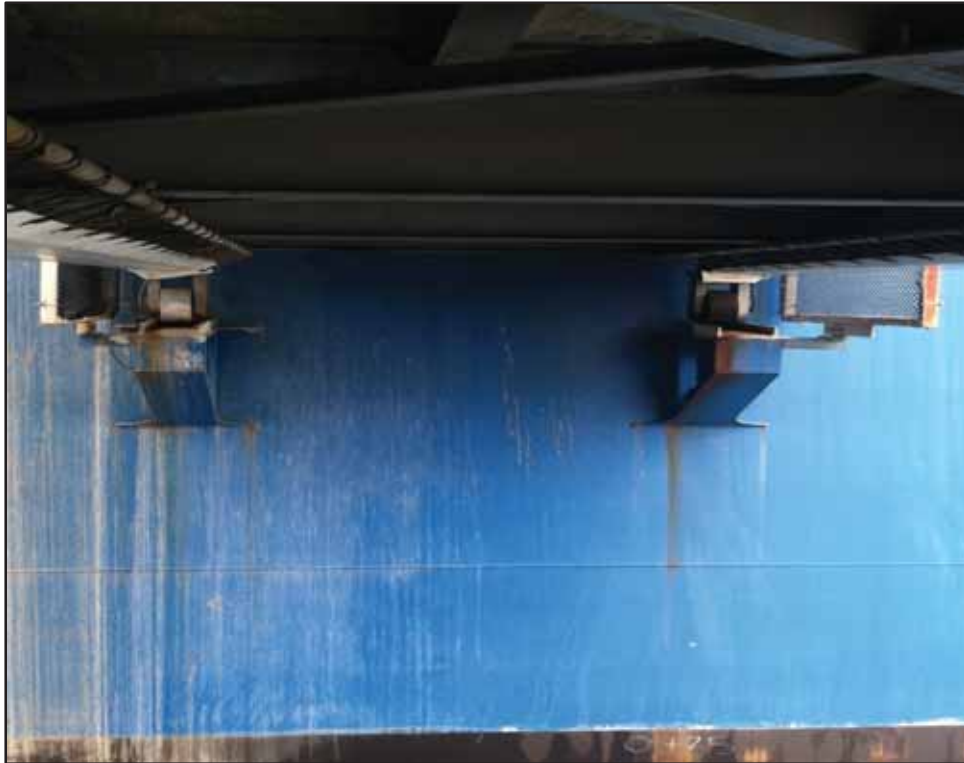
Photo 3-Rollers of gangway at Station 3 + 10

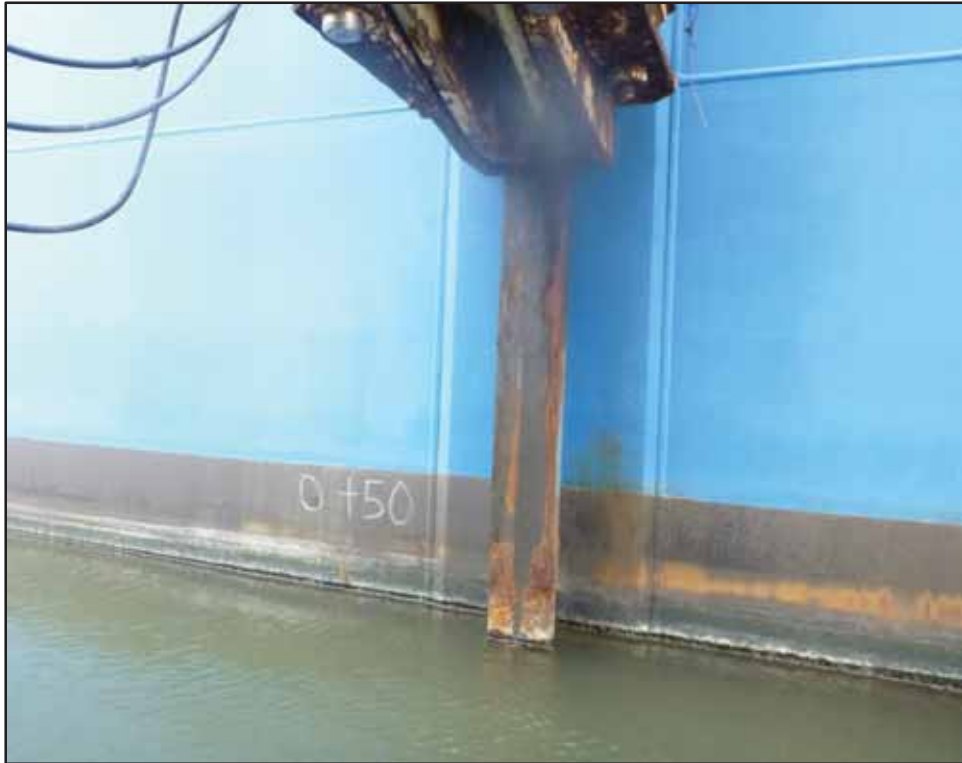
Photo 9-Corrosion of T-Beam in splash zone of single mooring connection at Station 3 + 22

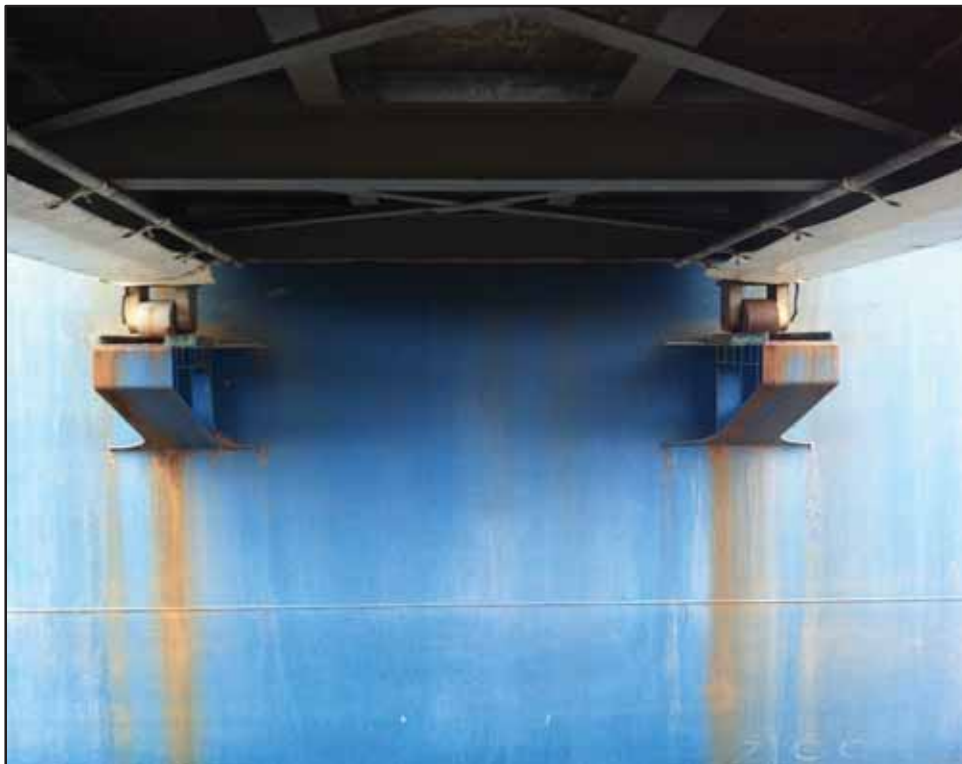
Photo 10-Underdeck and rollers of gangway at Station 4 + 90

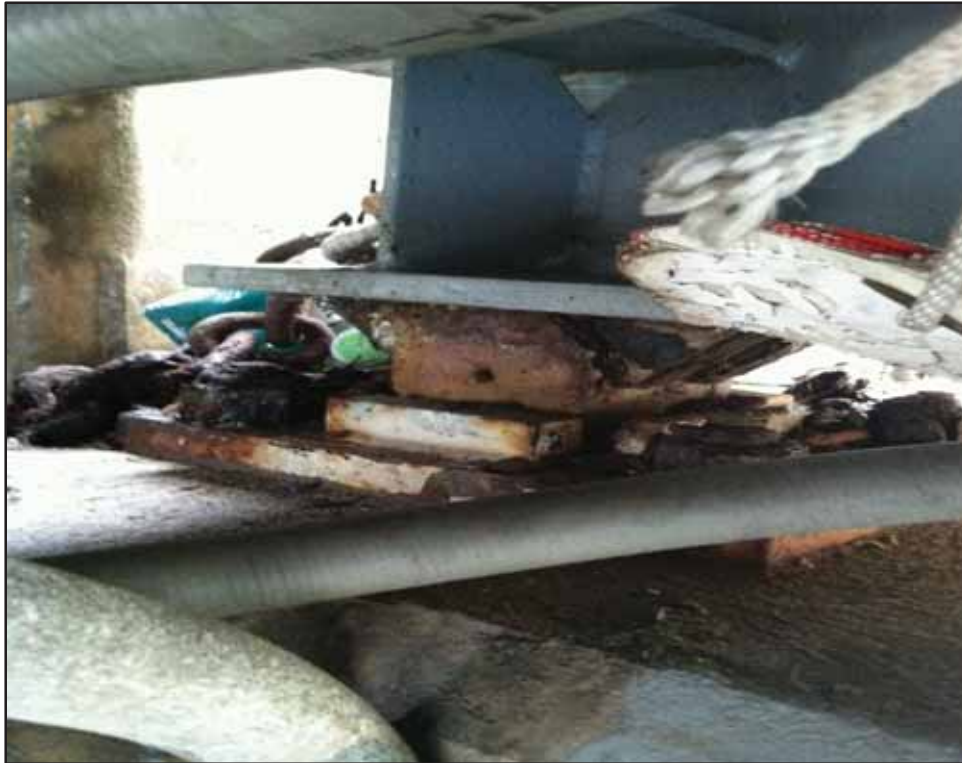
Photo 11-Typical corrosion of landside of gangways at Station 4 + 90

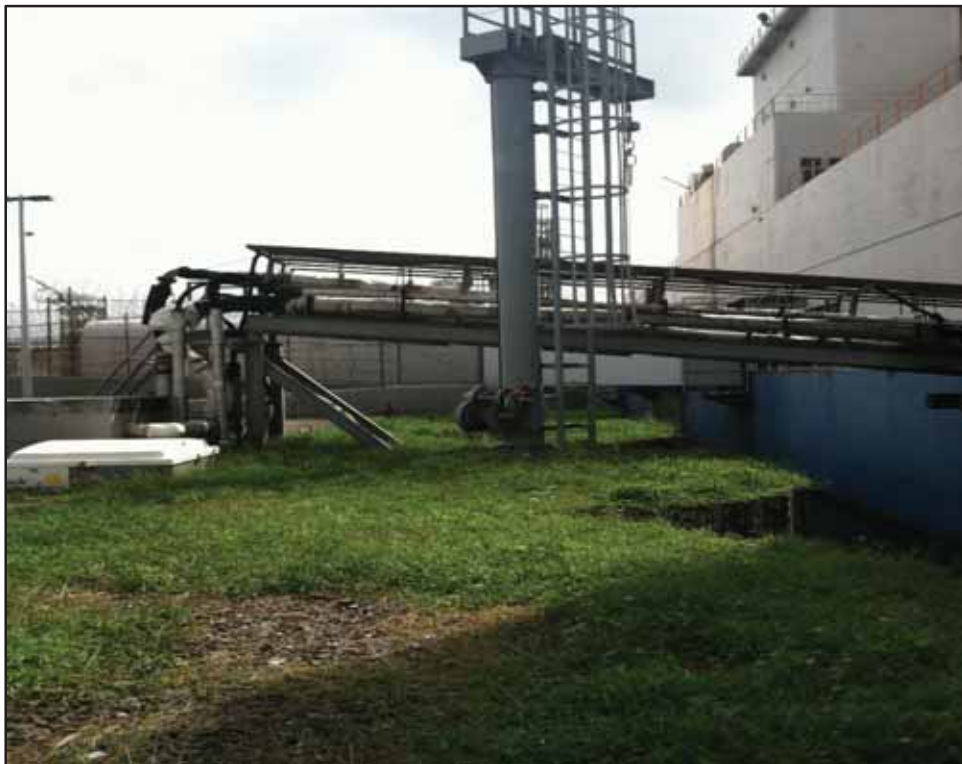
Photo 12-Utility gangway at Station 6 + 71

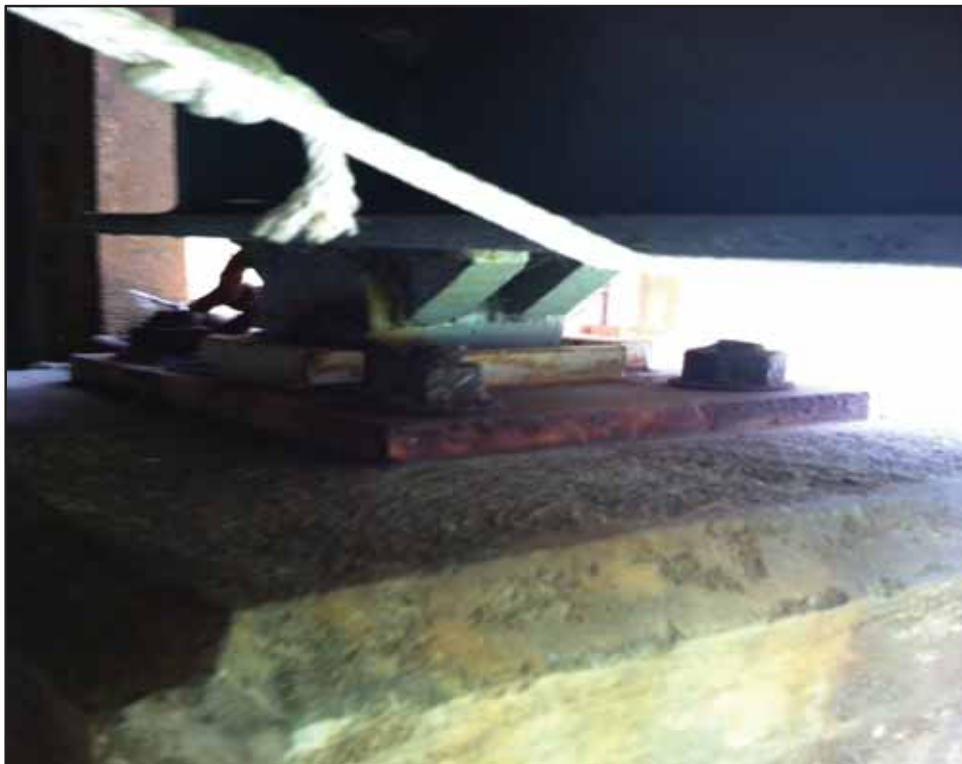
Photo 14-Typical bearing pad corrosion of gangway at Station 7 + 10

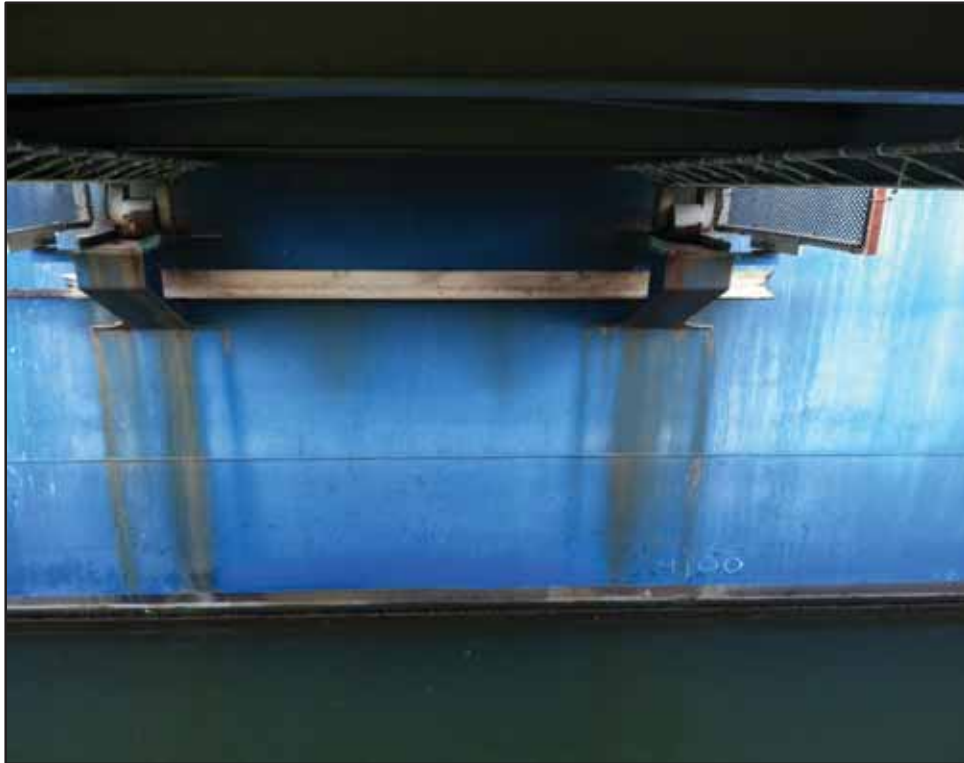
Photo 15-Rollers and underdeck of gangway at Station 7 + 10

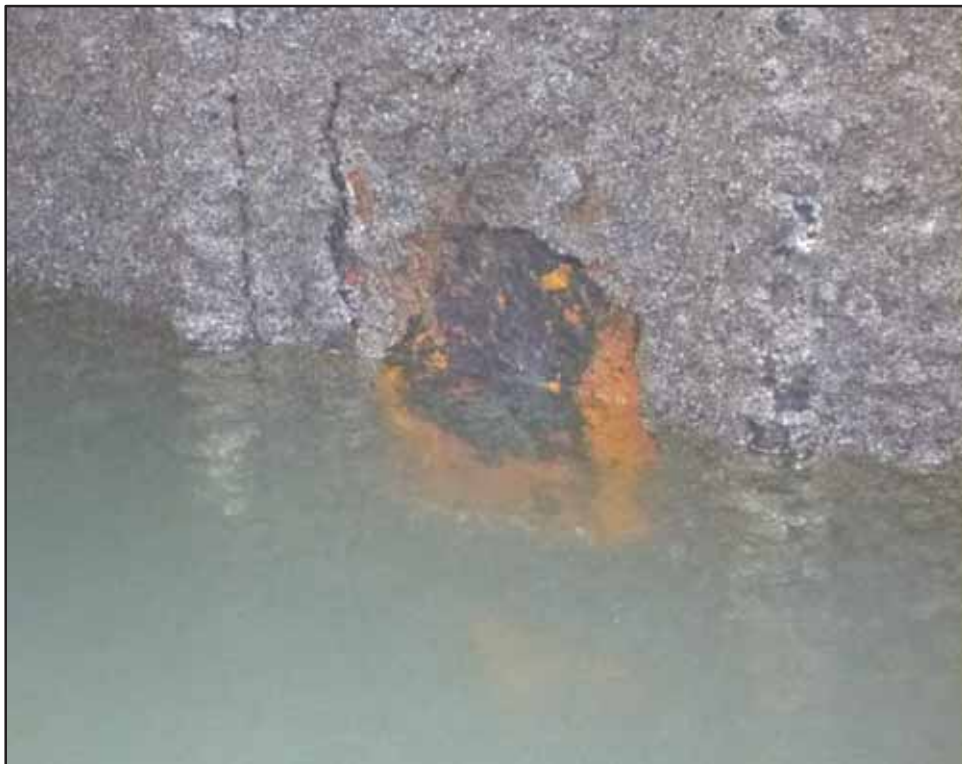
Photo 38-Deteriorated area on south side of steel sheet pile bulkhead

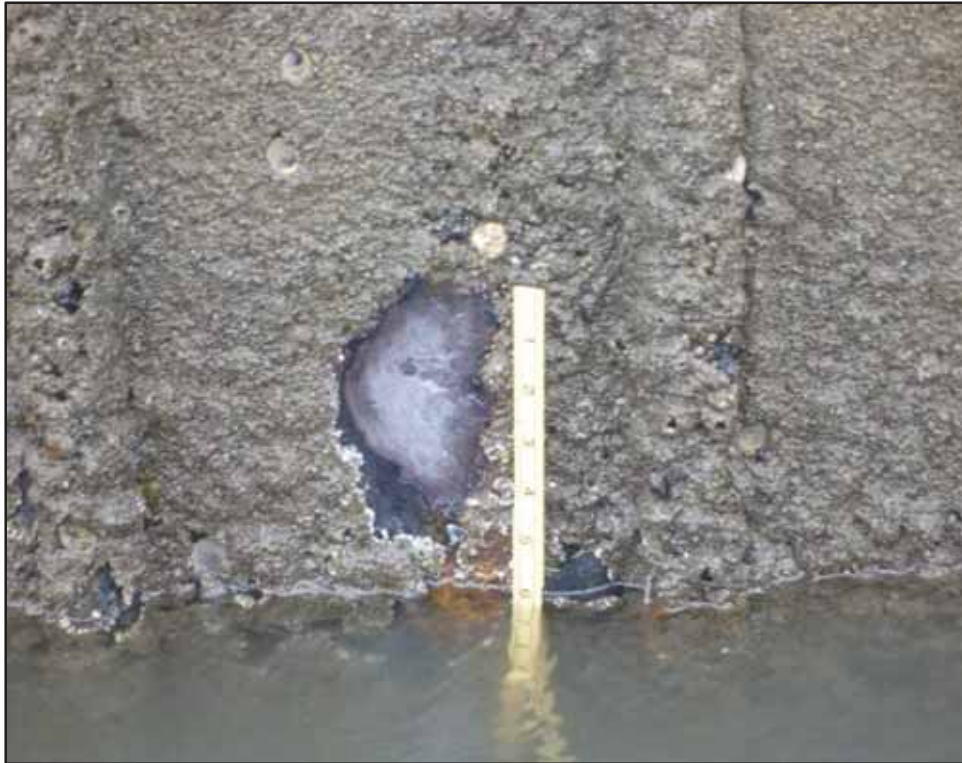
Photo 39-5''H x 3.5''W hole in sheet on west side of bulkhead

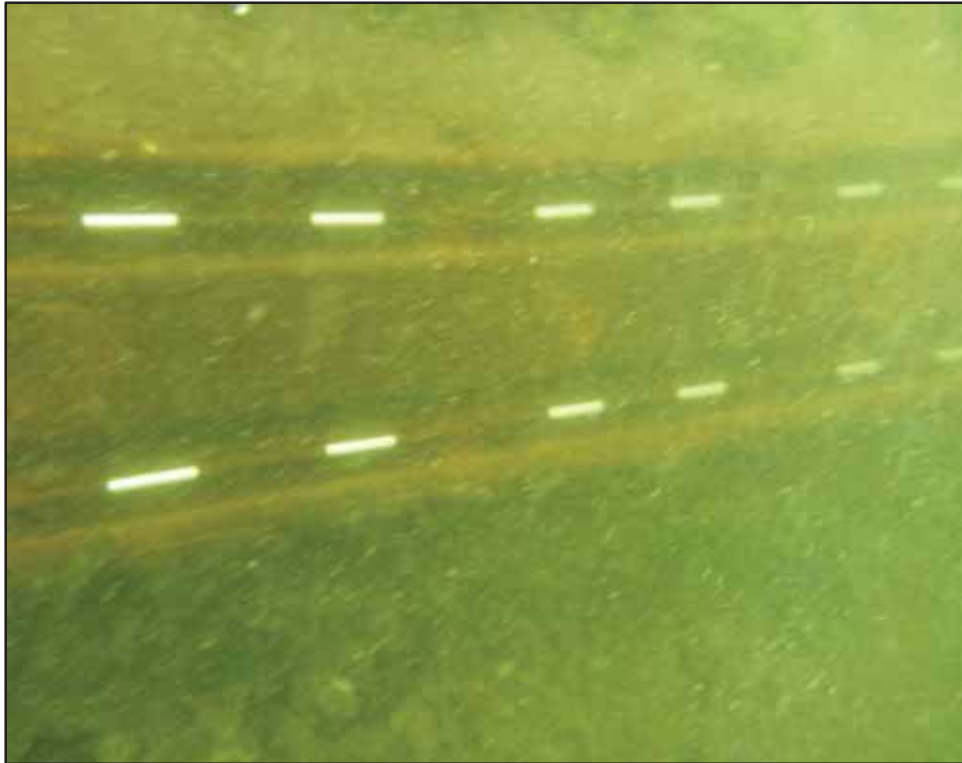
Photo 41-Active cathodic protection system observed below water

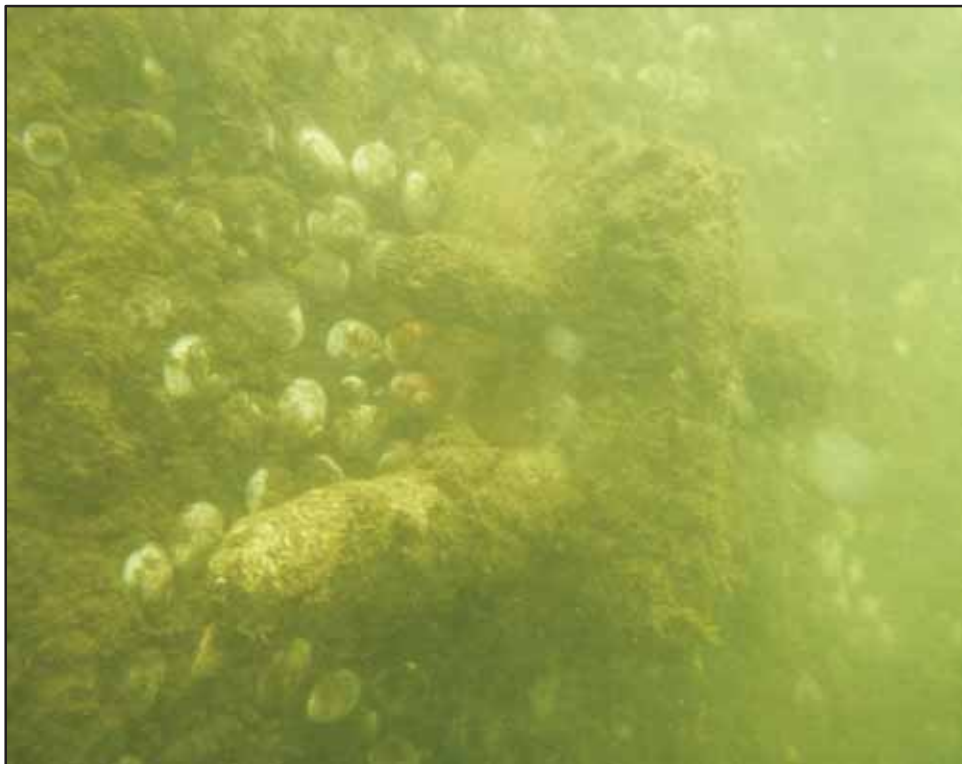
Photo 42-Deteriorated timber bumper at cathodic protection system

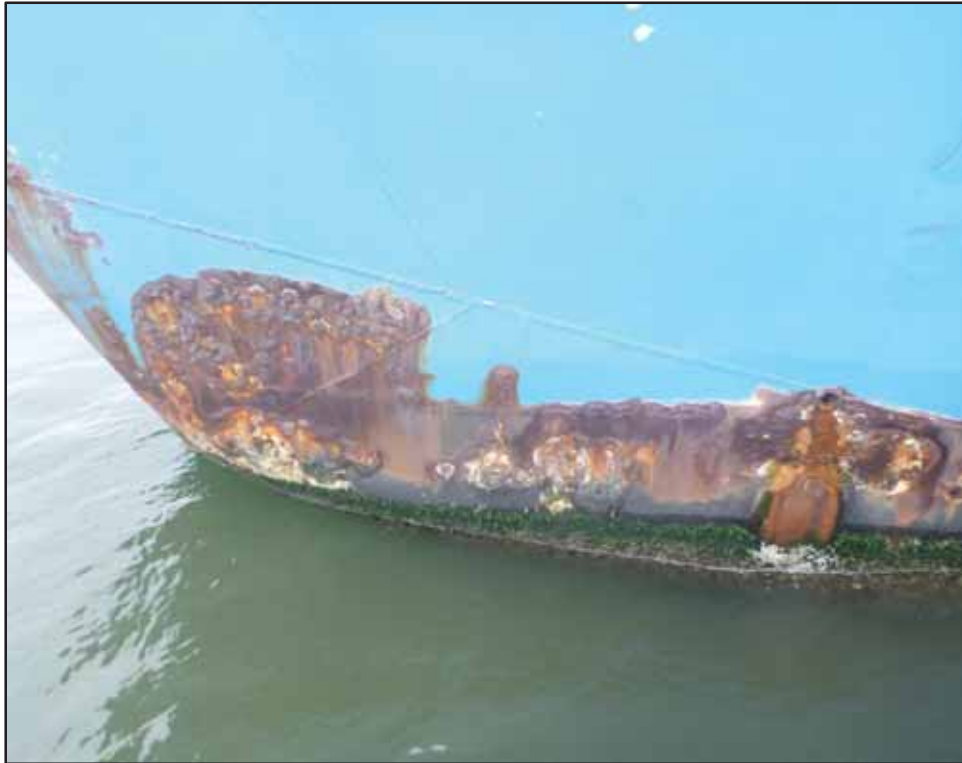
Photo 43-Coating loss in splash zone at Station 0 + 00 on south side of barge
