New York City Department of Investigation

Safety Issues Relating to Garbage Hoists Utilized at Certain NYCHA Facilities

May 2015

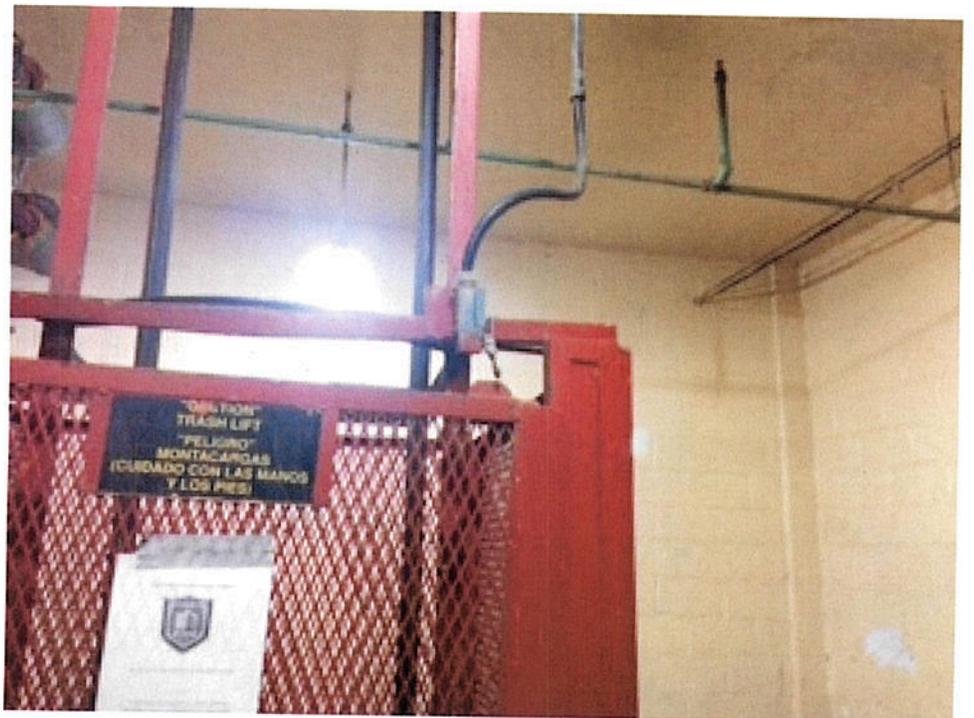
PHOTO #1

On April 6, 2015, DOI investigators visited and inspected the basement compactor room, the garbage hoist system, and the ground level transfer room. During this inspection, DOI made the following observations: at the basement level, the hoistway terminates in a red metal mesh cage with a door designed to be secured with a bolt, but the locking mechanism is broken. The cage is marked with two identical signs warning in English "CAUTION - TRASH LIFT," and in Spanish

“PELIGRO - MONTACARGAS (CUIDADO CON LAS MANOS Y LOS PIES).”⁴ See Appendix A, Photos #1 and #2. The cage is equipped with a safety cage interlock switch that is designed to break the electrical circuit and prevent the hoist car from moving when the cage door is open. However, the cage door is damaged and bent so that it does not make contact with the safety cage switch. See Appendix A, Photos #3 and #4. The hoist car travels up from the basement level, through a hole in the basement ceiling/ground level floor. See Appendix A, Photo #5. DOI observed that there is no operating switch for the hoist at the basement level.

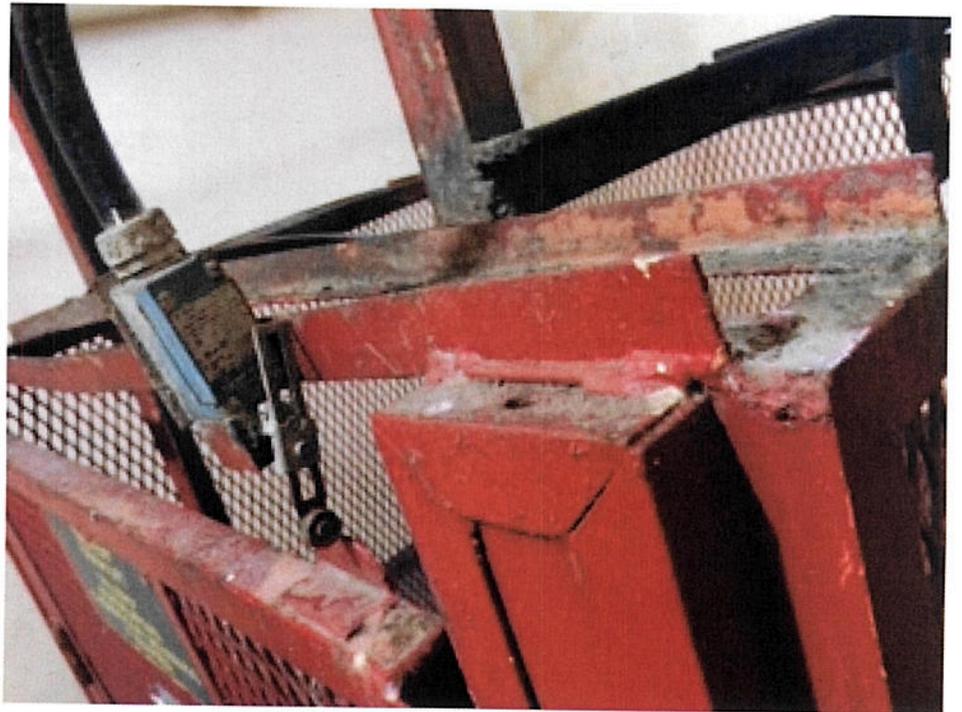
PHOTO #3

The hoist car measures approximately 2’ square by 4’ tall. The car has two doors that bolt closed and are designed to swing only in an outward direction, but the hinges are broken so that the doors can also swing inward. See Appendix A, Photo #6. The hoist, model #37874 or 3Z874, is powered by a 1-ton Dayton motor, #9K602F. See Appendix A, Photo #7. Investigators observed that the hook connecting the car to the hoist chain is enclosed in duct tape. See Appendix A, Photo #8.
