Re: NYSDEC Permit 2-6106-00002/00022 Ren 4 (Permit) Southwest Brooklyn Marine Transfer Station (MTS) New York City Department of Sanitation (DSNY) 2024 Bulkhead Inspection Report

ROUTINE INSPECTION

SOUTHWEST BROOKLYN MARINE TRANSFER STATION – FENDER SYSTEM

APRIL 11 2025

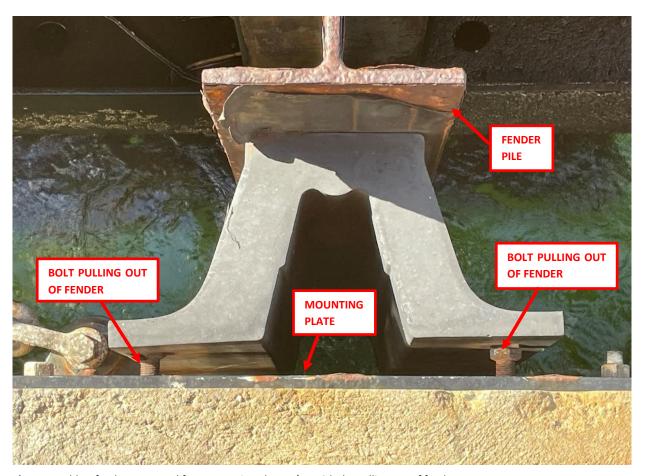
full or partial height. One or more bolt holes of rubber fender are worn and enlarged with the bolt head already pulled out of the bolt hole due to separation of fender or in the process of pulling out of the bolt hole due to tensile stresses in the rubber fender.

Photo 1: Rubber fender separated from mounting plate w/ top 2 bolts pulling out of fender.

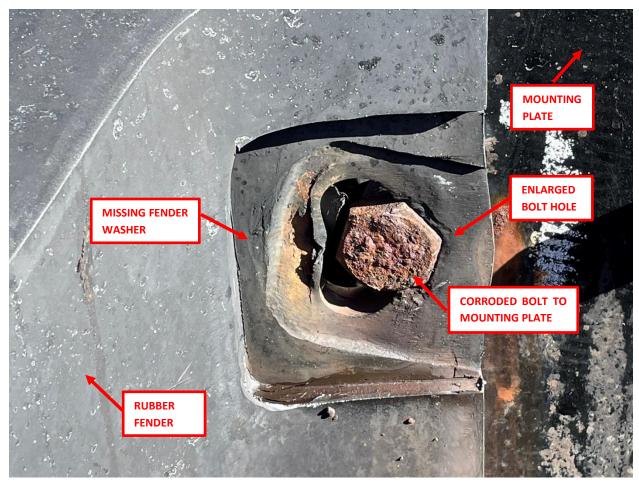
Bolts connecting the rubber fender to fender pile typically exhibit Major coating loss and surface corrosion, but no significant section loss. Bolts and washers connecting rubber fender to the mounting plate typically exhibit Minor to Moderate coating loss and surface corrosion with Minor section loss or damage. Bottom bolts and washers exhibit greater coating loss and corrosion. One or more washer of bolts connecting rubber fender to the mounting plate is typically loose or missing. Head of one or more bolt to the mounting plate has pulled out or is pulling out of the rubber fender bolt hole at a typical rubber fender. See Photos 1 and 2 for Typical Condition of rubber fender and their connecting bolts.

Photo 2: Rubber fender bolt connecting fender to mounting plate.

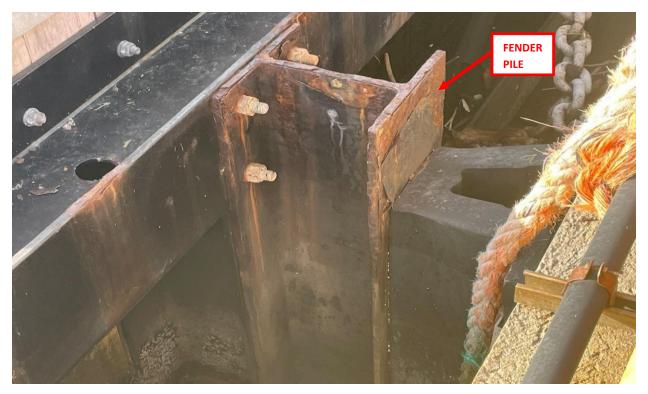
Fender Piles – Two (2) coal tar epoxy coated HP12 fender piles support each Fender. Top 18 to 24 inches of a typical fender pile exhibits Moderate coating loss and surface corrosion. Coating has peeled off in this area of piles. Coating loss and surface corrosion extends further down to the mid-wale of fender panel along the flanges of fender piles. See Photos 3 & 4 for the Typical Condition of fender piles. Coating is intact below water with heavy, soft marine growth. No visible section loss, no significant knife edging (thinning) of pile flanges or necking (reduction in width) of flanges was observed in fender piles under water.

Photo 3: Fender pile with coating loss & corrosion at top approx. 18". Corrosion of flange edges continues further down.

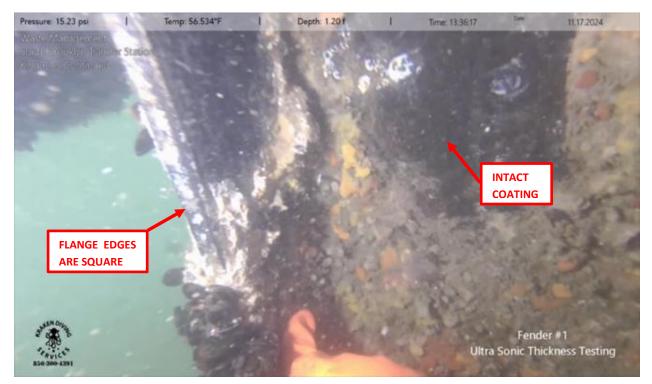
Photo 4: Coating of fender pile below water is intact. Flange edges are square with no necking or knife edging.

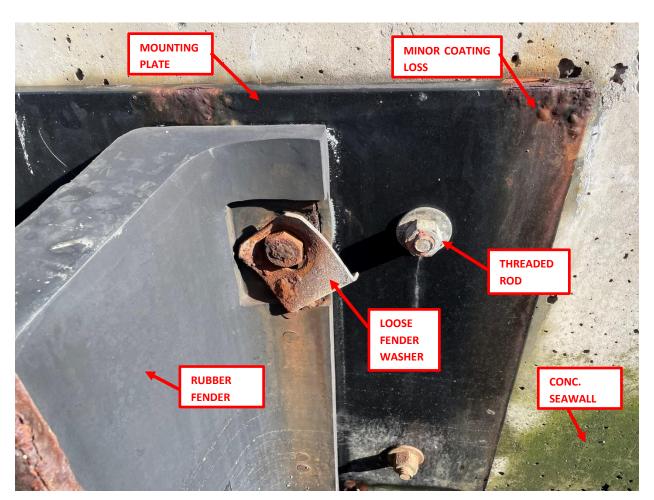
Top and mid threaded rods anchoring the mounting plate to concrete seawall are intact with Minor to Moderate coating loss and surface corrosion. Bottom threaded rods typically exhibit Major coating loss and surface corrosion. Nuts of threaded rods are generally tight. See Photos 5 & 10 for Typical Condition of mounting plate.

Photo 5: Typical Condition of mounting plate

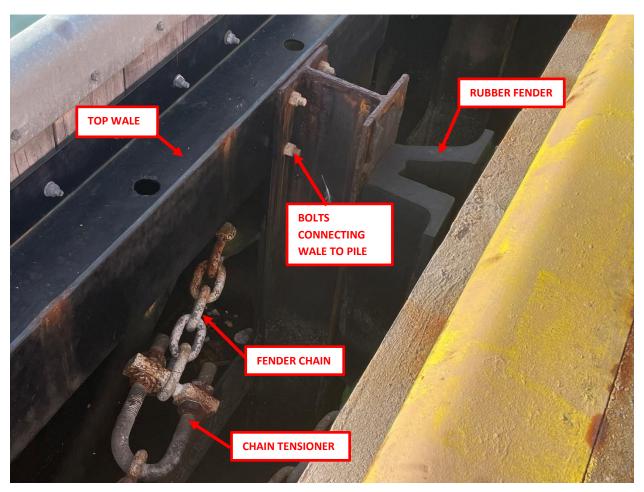
Four (4) galvanized bolts connect each wale to each fender pile. Bolts connecting top wale to fender piles exhibit Minor to Moderate coating loss and surface corrosion, but no significant section loss. Bolts connecting the mid and lower wale exhibit greater coating loss and corrosion, but no significant section loss. One or more bolt is loose. See Photos 6 & 7 for Typical Condition of Wales.

Photo 6: Typical Condition of Wale. Also note Typical Condition of top fender chain.

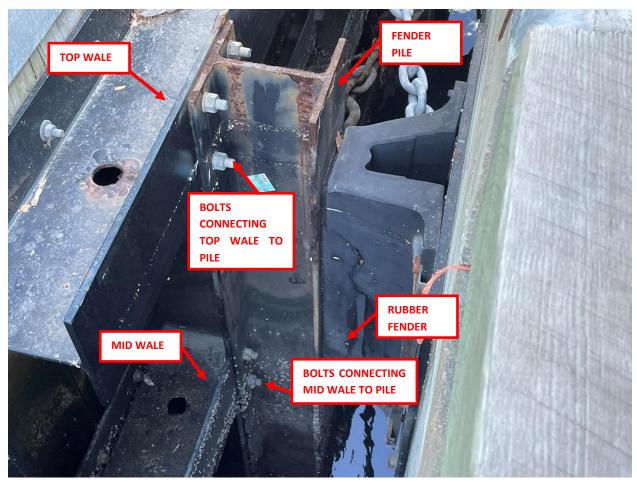
Photo 7: Typical Wale Construction

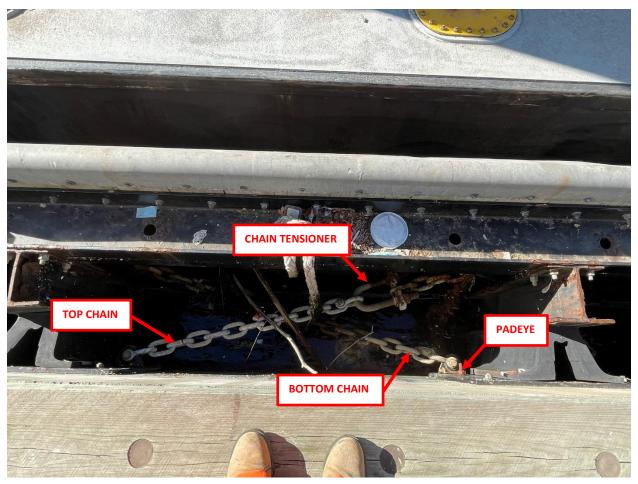
Fender Chain Assemblies – Two galvanized shear chains exist at each Fender. Each chain is equipped with galvanized shackles and a chain tensioner. Lower fender chain and hardware exhibit Moderate to Major (50% to 90%) coating loss and surface corrosion. The top fender chain and hardware exhibit Minor to Moderate (10% to 25%) coating loss and surface corrosion. All hardware including padeyes, shackles, and chain tensioner are intact. Lower chain is sagging while the upper chain is generally tight. Welds of padeyes are intact with Minor coating loss and surface corrosion. See Photos 6 & 8 for Typical Condition of fender chains.

Photo 8: Typical Condition of top & bottom fender chains. Lower chain is typically sagging.

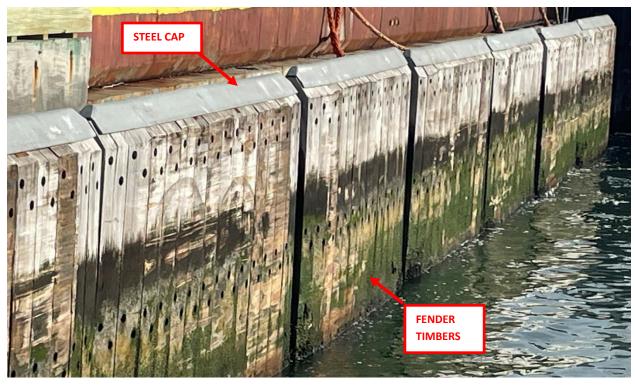
Timber Fender Panels – Fifteen (15) - 10x12 timbers are mounted on the outshore face of Wales to form the timber fender panel. Timbers of the panel are intact and not missing, broken, or split. Timbers exhibit checks, some gouging, and normal abrasion due to vessel contact. Two (2) galvanized bolts connect each timber to each wale. Bolts exhibit Minor to Moderate surface corrosion and coating loss but no significant section loss. One or more bolt is loose.

A galvanized rolled steel cap exists on top of fender timbers at each fender panel. The coating of cap is intact with no corrosion. The cap is in place but one or more of the fifteen (15) bolts connecting the cap to timbers are loose. See Photo 9 for Typical Condition of fender timbers and cap.

Photo 9: Typical Condition of fender timbers

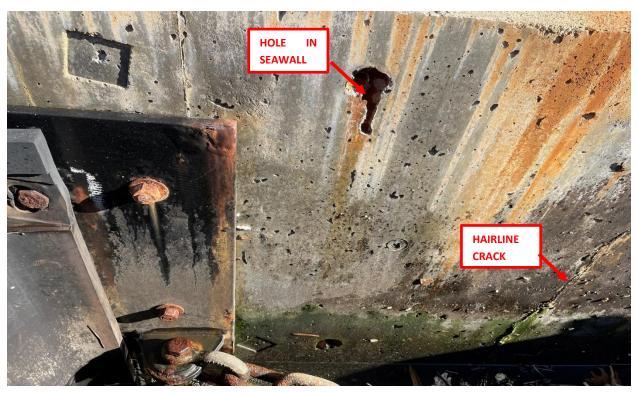
Above water, the concrete seawall exhibits minor spalling along the top outer edge. Seawall also exhibits hairline cracks, which extend down along the outer face of seawall. Random, up to 3" diameter and up to 2" deep voids exist in seawall.

Photo 10: Typical Condition of concrete seawall above water

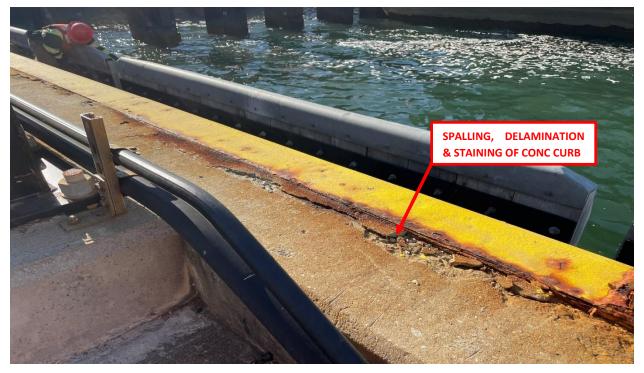
18" wide x 12" tall concrete curb exists along the outer edge of seawall behind Fender #s 15 thru 20. A curved steel plate forms the top outer edge of curbs. The plate extends down approximately 30" to form the outer top face of seawall. The plate exhibits surface corrosion. The top surface of concrete curb exhibits delamination and spalling of concrete along steel plate. Rust stains are also visible on curb.

Photo 12: Typical Condition of concrete curb behind Fender #s 15 thru 20

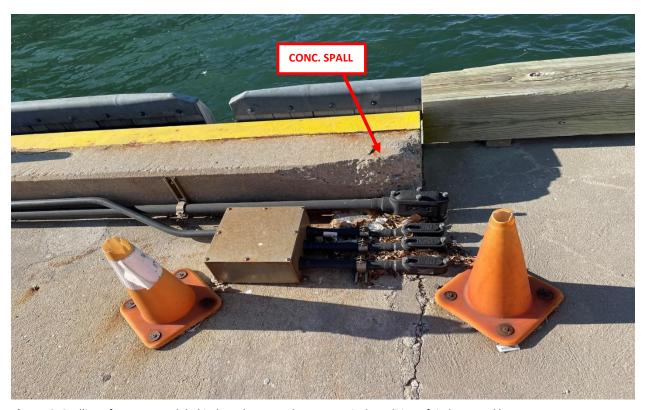
Photo 13: Spalling of concrete curb behind Fender # 15. Also note Typical condition of timber guard log

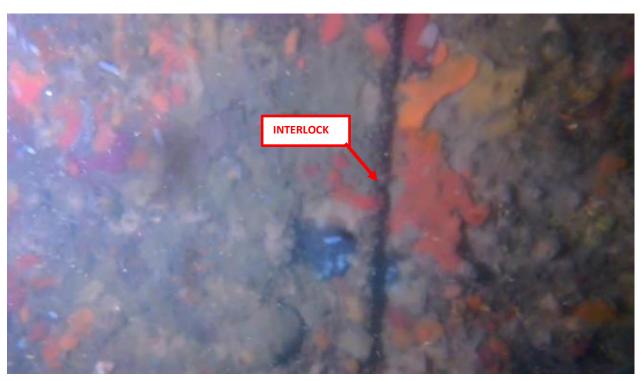
Sheet Pile Bulkhead – Coal tar epoxy coated steel sheet pile bulkhead exists below the concrete seawall, inboard of the North Bulkhead Fender Systems. Sheet piles are not visible above water. Sheet piles are generally plumb with no visible lean or bulging. Minor (5%) coating loss with surface corrosion and up to 1" thick, soft marine growth was observed on sheet piles. Corrosion blisters and pitting corrosion were not observed in sheet piles. Inspected sheet pile interlocks were found to be intact with no tenting. See Photo 14 for typical underwater condition of steel sheet piles.

Photo 14: Typical condition of steel sheet piles below water

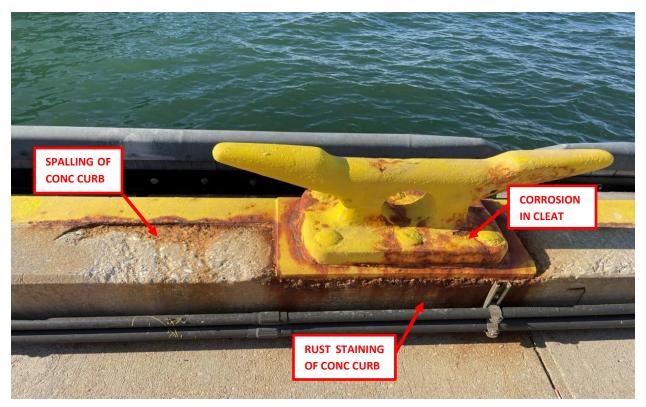
Mooring Hardware – Mooring hardware in the form of cleats, bollards, winches, roller chocks, and sheaves exist along the outer edge of concrete seawall. The hardware is painted yellow and mounted on concrete pedestals. Concrete pedestals are intact with no significant cracks and spalling but have rust stains, indicating that the mooring hardware was significantly corroded prior to paint application. Mooring hardware is intact with some of them exhibiting Minor to Moderate (up to 50%) corrosion. Corrosion seems to have been painted over which did not allow visual inspection of mooring hardware steel. The connecting hardware of mooring hardware was not visible for inspection. See Photos 15 & 16 for typical condition of mooring hardware.

Photo 15: Typical condition of mooring cleat. Also note spalling of conc curb

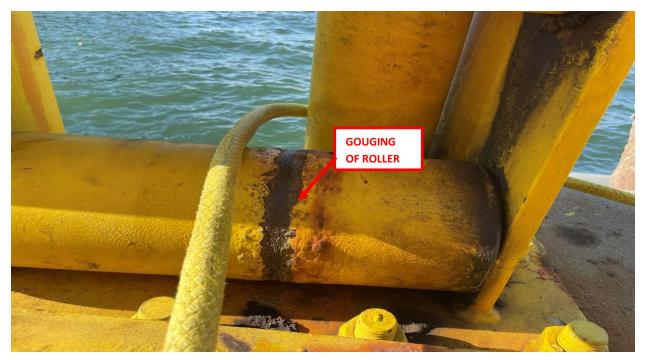
Photo 16: Typical condition of roller chocks. Note gouging of horizontal roller at the location of mooring line

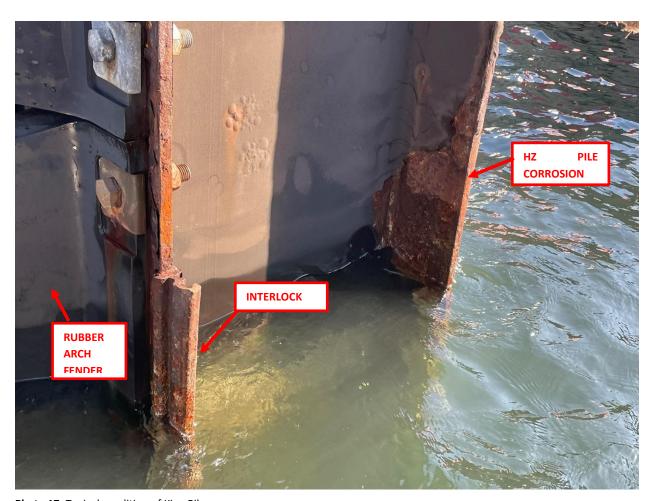
King Piles - Typically, the king piles are plumb with no impact damage. Below the approximate elevation of +8'-6" MLW, the king piles exhibit coating loss and surface corrosion along flange edges. The area of coating loss and corrosion extends into the

face of flanges and web below the approx. elevation of +6'-0" MLW. The interlocks have moderate coating loss and surface corrosion above water. Below MLW, all components are covered with heavy marine growth. The king piles have approximately 20% coating loss, with no visible section loss. The interlocks between the king piles and between the king piles and sheet piles are tight and not separating. No noticeable scouring was observed at the bottom of king piles.

Photo 17: Typical condition of King Pile.

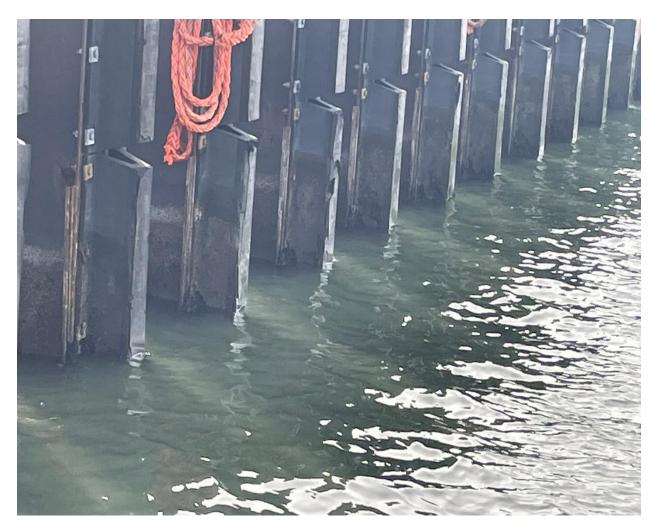
Top Rubber Arch Fender – A Typical top rubber Arch fender is intact with no significant damage to the rubber. The bottom of top rubber fender has abrasion marks. The galvanized bolts connecting rubber fender to the king piles have negligible coating loss and are intact. Bolts are tight unless noted otherwise in Tables 21 thru 56.

Bottom Rubber Arch Fender – Top of a Typical bottom rubber Arch fender has abrasion marks but no significant damage to the rubber. Galvanized bolts in the top two (2) rows, connecting the rubber fender to the king piles, have negligible to minor coating loss and are intact. Bolts in the bottom two rows of lower Arch fender exhibit Minor to Moderate coating loss and surface corrosion, but no significant section loss. All bolts are tight unless noted otherwise in Tables 21 thru 56. Below MLW, the lower fender is covered in marine growth up to the second bolt from the bottom.

Photo 18: Typical condition of top and bottom arch rubber fenders.

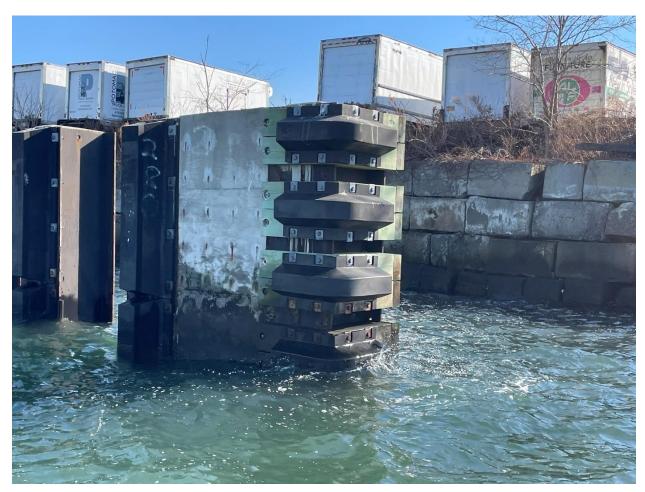
Corner Rubber Arch Fenders – The concrete cap, corner arch fenders, and timbers of the End Fender are in "as new" condition. The bolts and washers of the lowest and the 2nd from bottom rubber fenders exhibit Moderate coating loss and surface corrosion but no section loss.

Photo 19: Condition of End Fender.

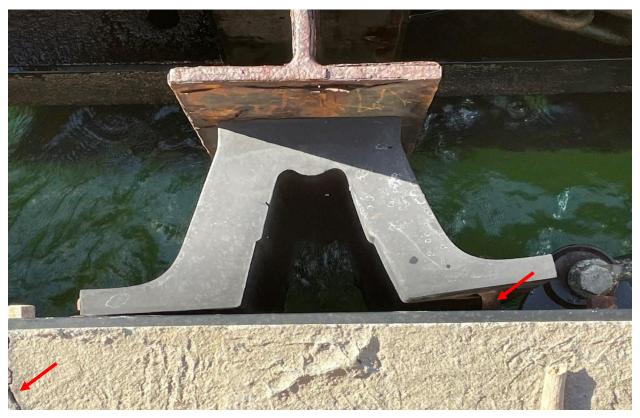
Photo 2: West flange of a rubber fender separated from mounting plate. Note the pulled-out bolt and crack in seawall.

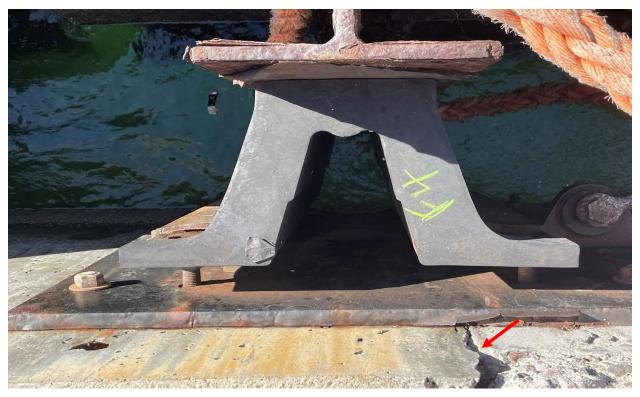
Photo 3: Rubber fender of Pile 34 at Fender #17 completely separated from mounting plate. Also note crack in seawall.

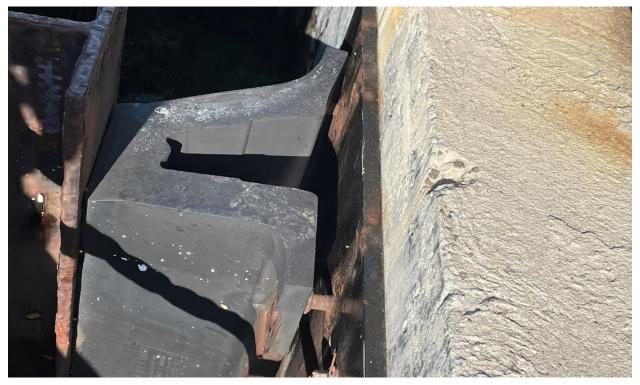
Photo 4: Rubber fender separated from mounting plate with bolts pulled out.

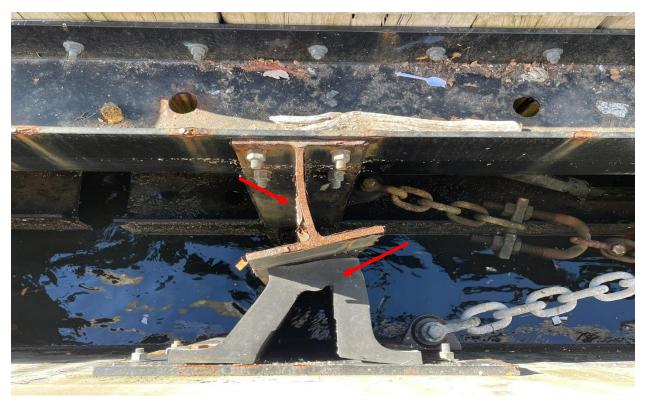
Photo 5: Pile P18 of Fender #9 is buckled with rubber fender stretched and distorted.

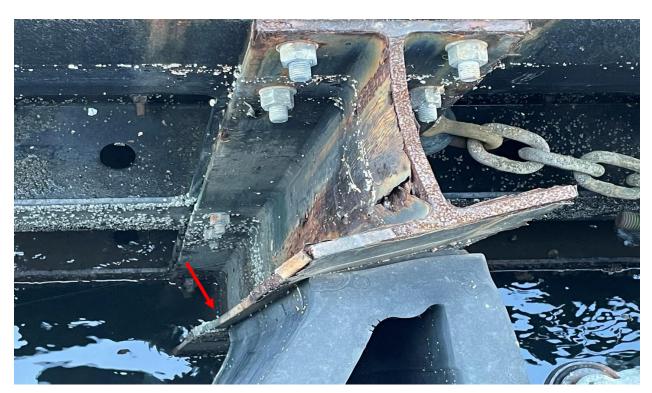
Photo 6: Inner flange of Pile P18 of Fender #9 is rotated and damaged at top approx. 5 ft.

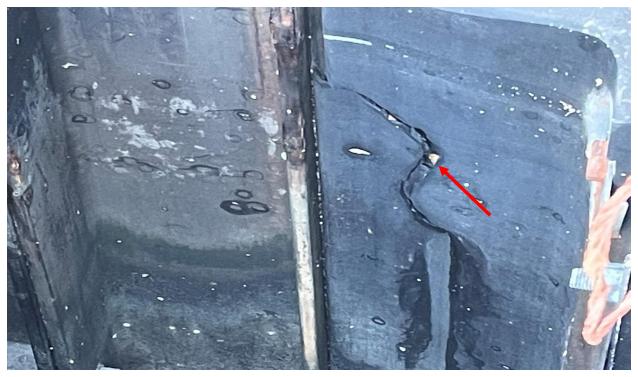
Photo 7: Rubber fender at Pile P16 of Fender #8 is cut/torn on its East and West faces.

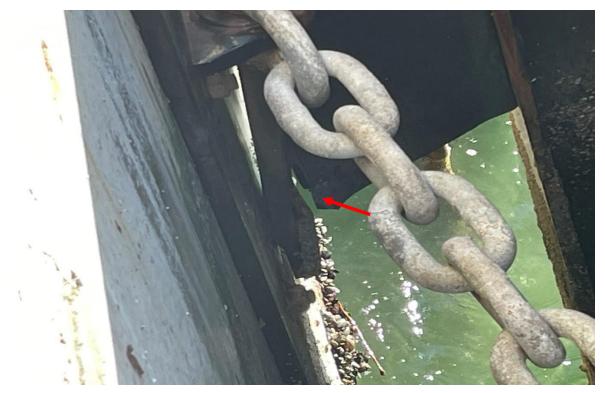
Photo 8: Rubber fender at Pile P22 of Fender #11 torn at bottom separated.

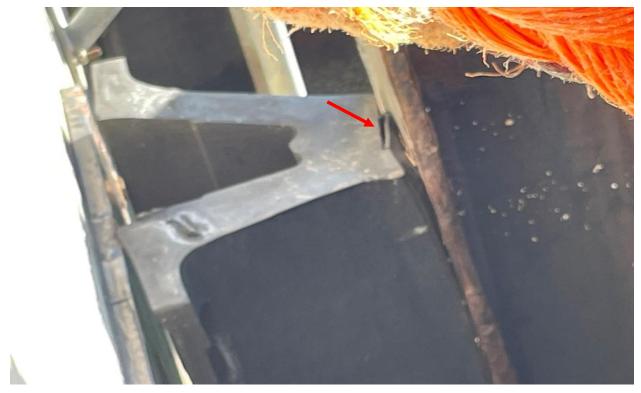
Photo 9: Rubber fender at Pile P22 of Fender #11 is separated with damage to its' front face at interface with fender pile.

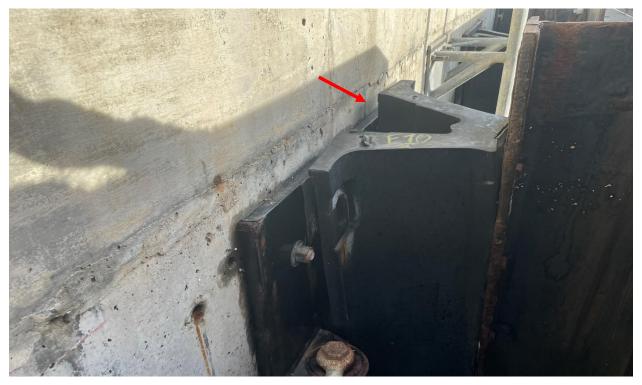
Photo 10: Rubber fender at Pile P22 of Fender #11 is lifted up above the mounting plate.

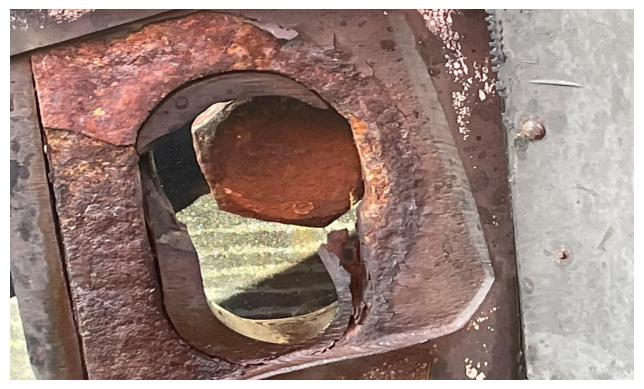
Photo 11: Rubber fender bolt hole damaged due to pulling out of bolt connecting fender to mounting plate.

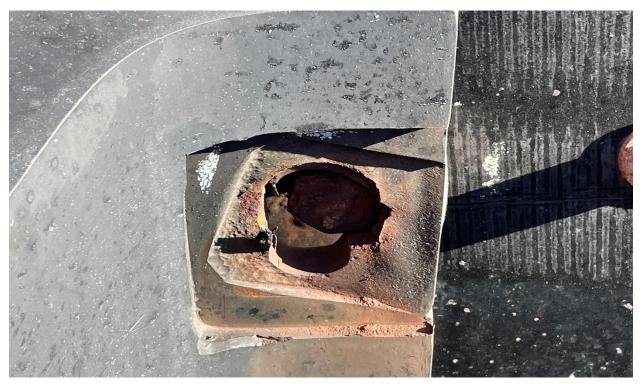
Photo 12: Rubber fender bolt hole damaged due to pulling out of bolt connecting fender to mounting plate.

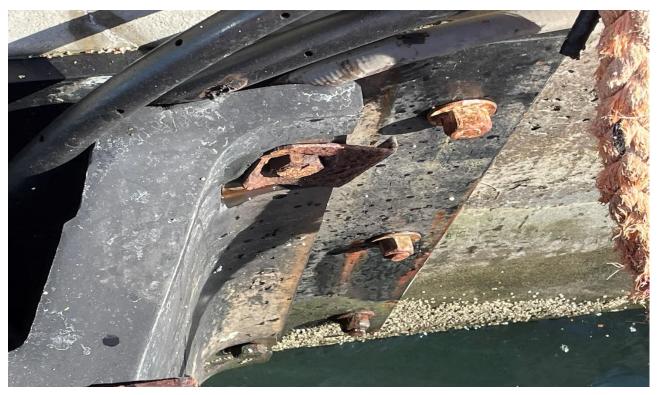
Photo 13: Bolts connecting rubber fender to mounting plate & threaded rods connecting mounting plate to seawall are corroded at Pile P40.

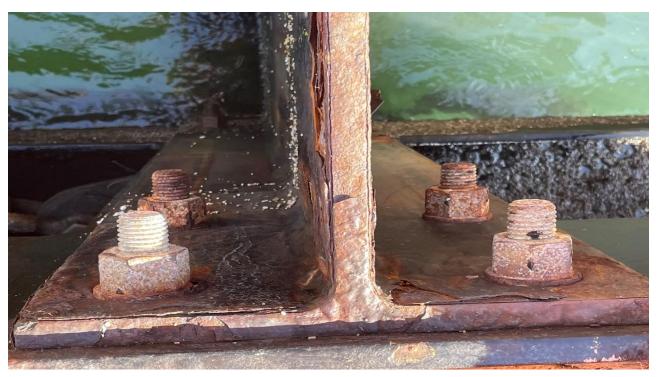
Photo 14: Corroded bolts of top wale connection to fender pile at Pile P40.

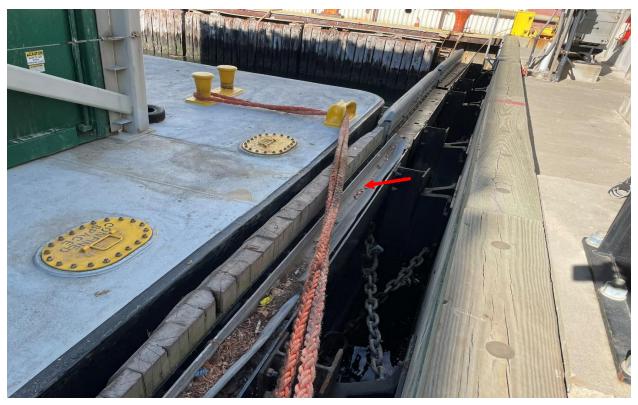
Cross Bracing Members	Typical	Х		Minor coating loss & corrosion at top			
Timber Fender Panel							
Сар	Typical	Х		Missing and sitting on top wale.			
Face Timbers	Typical			Minor checking			
Concrete Seawall							
Above Waterline	Typical	Х		Small holes and hairline cracks.			
Below Waterline	Typical			Heavy marine growth.			
Sheetpile Bulkhead	Typical			Heavy marine growth. No scouring at Mudline

Photo 15: Steel cap of Fender #3 is dislodged and sitting in web of top wale.

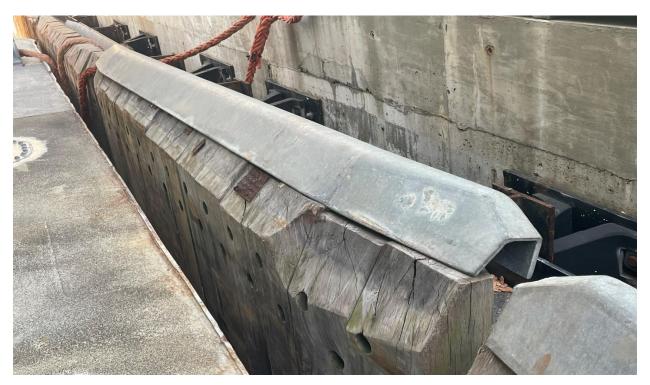
Photo 16: Steel cap of Fender #4 is displaced and rotated.

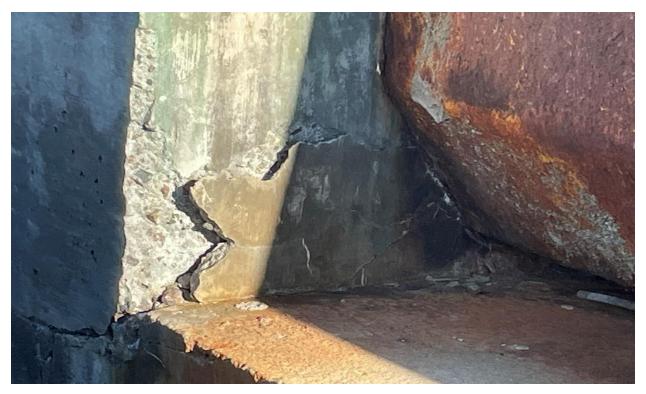
Photo 17: Spalling of concrete seawall behind Fender #15.

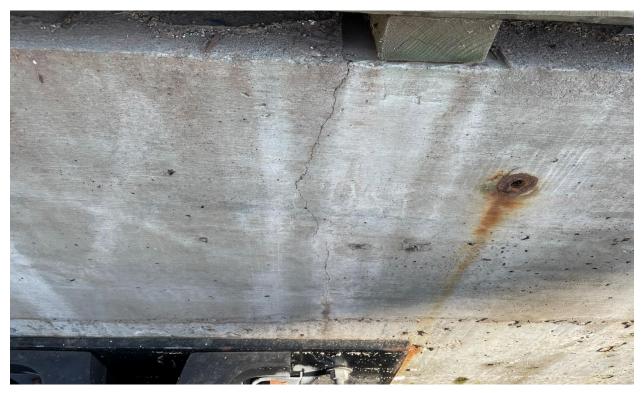
Photo 18: Typical hairline crack at fenders.

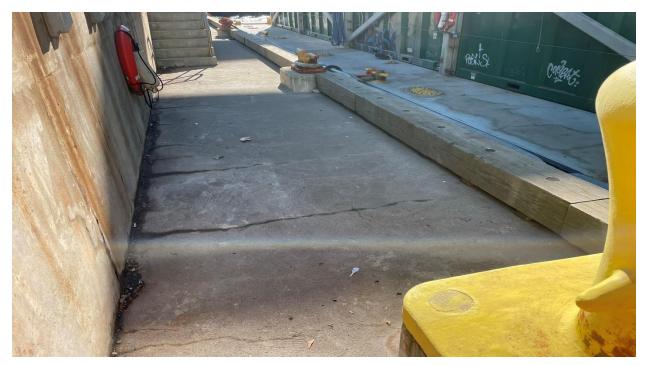
Photo 19: Typical cracks in the concrete deck of dock.

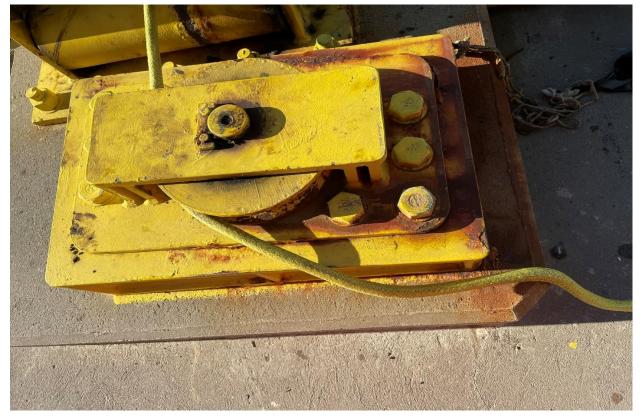
Photo 20: Corrosion of sheave. Note rust stain in concrete pedestal below.

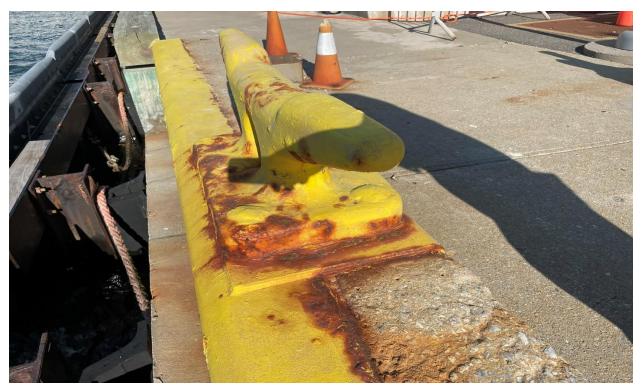
Photo 21: Corrosion of mooring cleat. Note rust stain at the base of cleat.

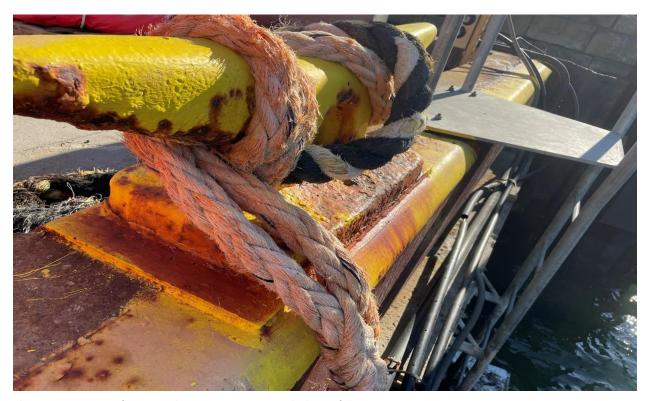
Photo 22: Corrosion of mooring cleat. Note rust stain at the base of cleat.

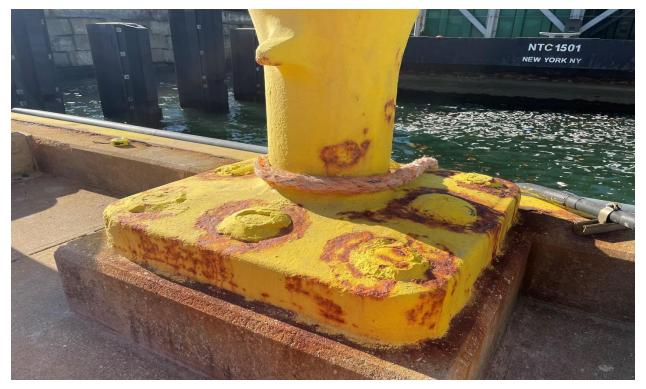
Photo 23: Corrosion of mooring bollard. Note rust stain at the base of bollard and concrete pedestal.

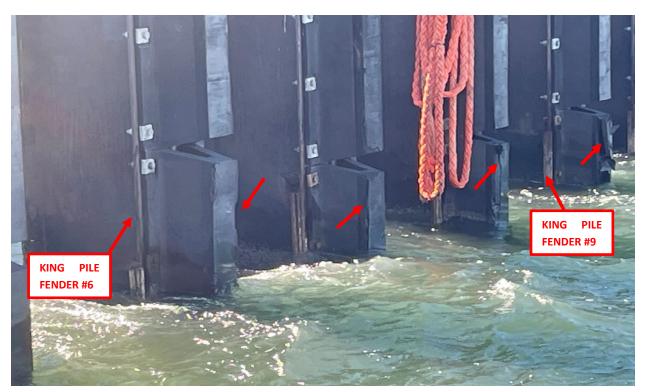
Photo 26: Damage to the lower fenders of King Pile Fender #s 6, 7, 8, and 9.

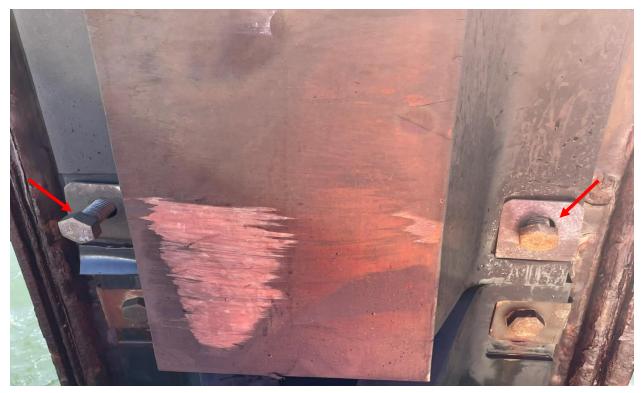
Photo 27: Loose bottom bolts of top rubber fender of King Pile Fender #32.

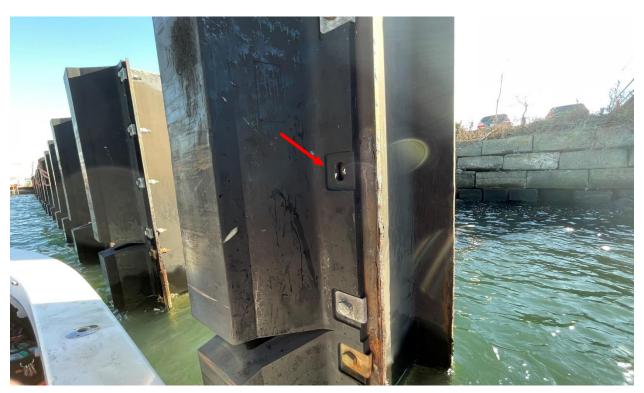
Photo 28: Missing bolt of top rubber fender of King Pile Fender #30.

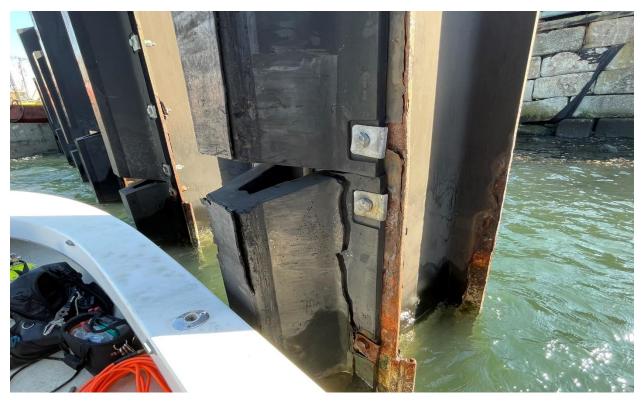
Photo 29: Damaged and torn lower rubber fender of King Pile Fender #6.

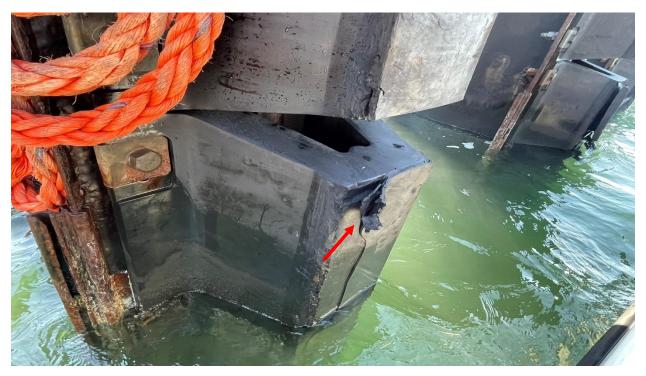
Photo 30: Damaged and cracked lower rubber fender of King Pile Fender #8.

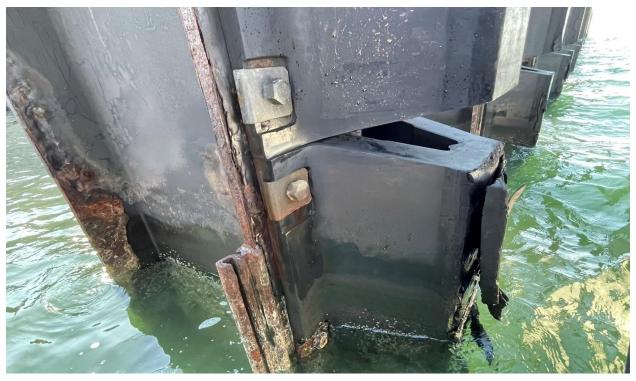
Photo 31: Damaged and peeled lower rubber fender of King Pile Fender #9.

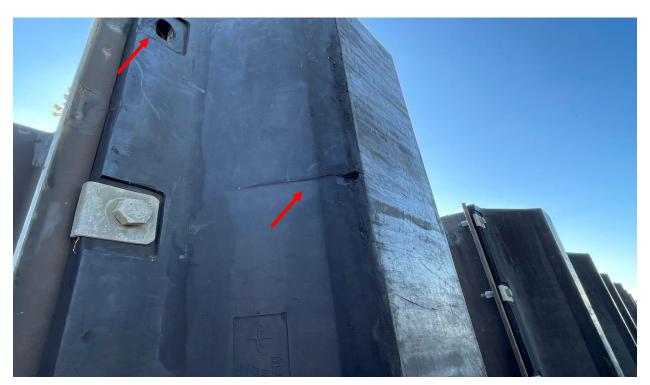
Photo 32: Cut in the North face of upper rubber fender of King Pile Fender #9. Also note the missing bolt at top.

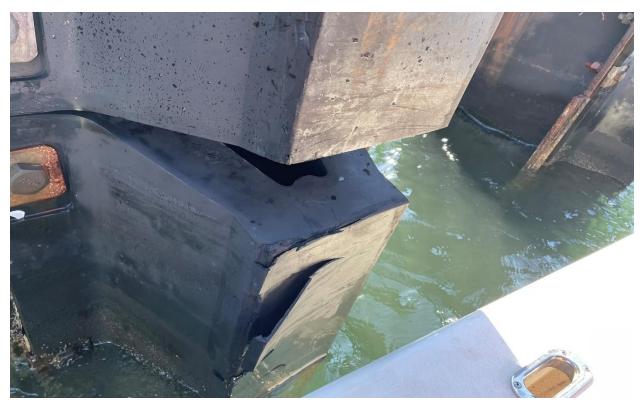
Photo 33: Damaged and peeled front face of lower rubber fender of King Pile Fender #11.

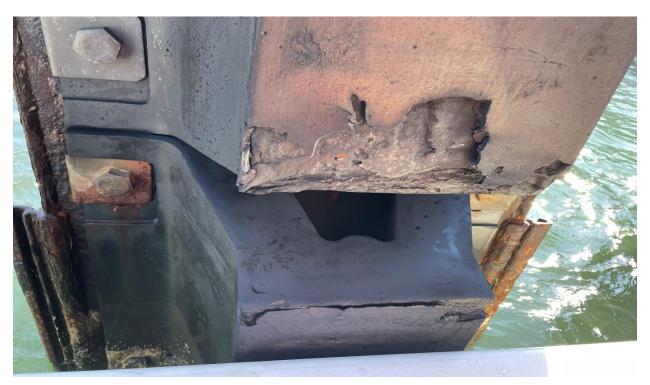
Photo 34: Damaged upper and lower rubber fenders of King Pile Fender #18.
