Re: NYSDEC Permit 2-6106-00002/00022 Ren 4 (Permit)  
Southwest Brooklyn Marine Transfer Station (MTS)  
New York City Department of Sanitation (DSNY)  
2025 Marine Inspection Report

# ROUTINE INSPECTION REPORT

## MARINE FENDER SYSTEM

### SOUTHWEST BROOKLYN MARINE TRANSFER STATION

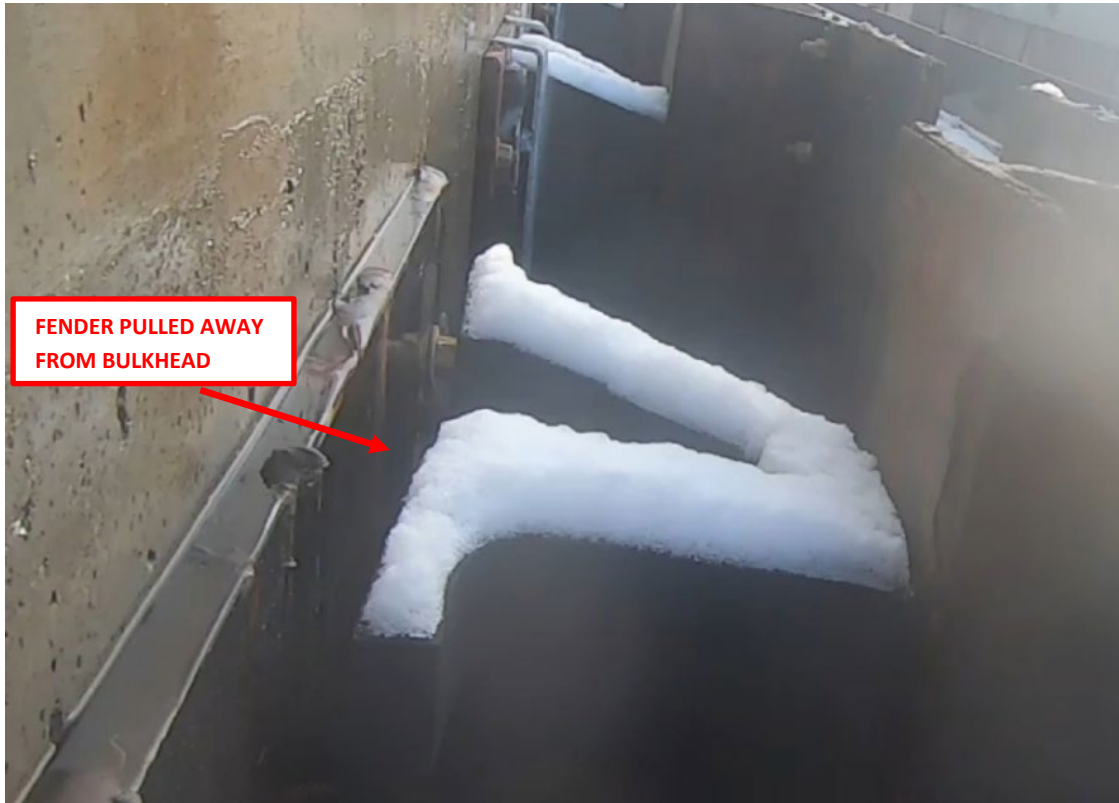
Typically, the rubber fenders are intact with no cuts or tears, except at Fenders #8 and #13 (torn). However, it is also true that the rubber fender has partially or fully separated from the mounting plate for their full or partial height in multiple locations. Likewise, it is typical for one or more bolt holes of rubber fender to be worn and enlarged and, in some instances, for the bolt head to be fully or partially pulled out of the bolt hole due to tensile stresses in the rubber fender.

FENDER PULLED AWAY  
FROM BULKHEAD

**Photo 1:** Rubber fender separated from mounting plate w/ top 2 bolts pulling out of fender.

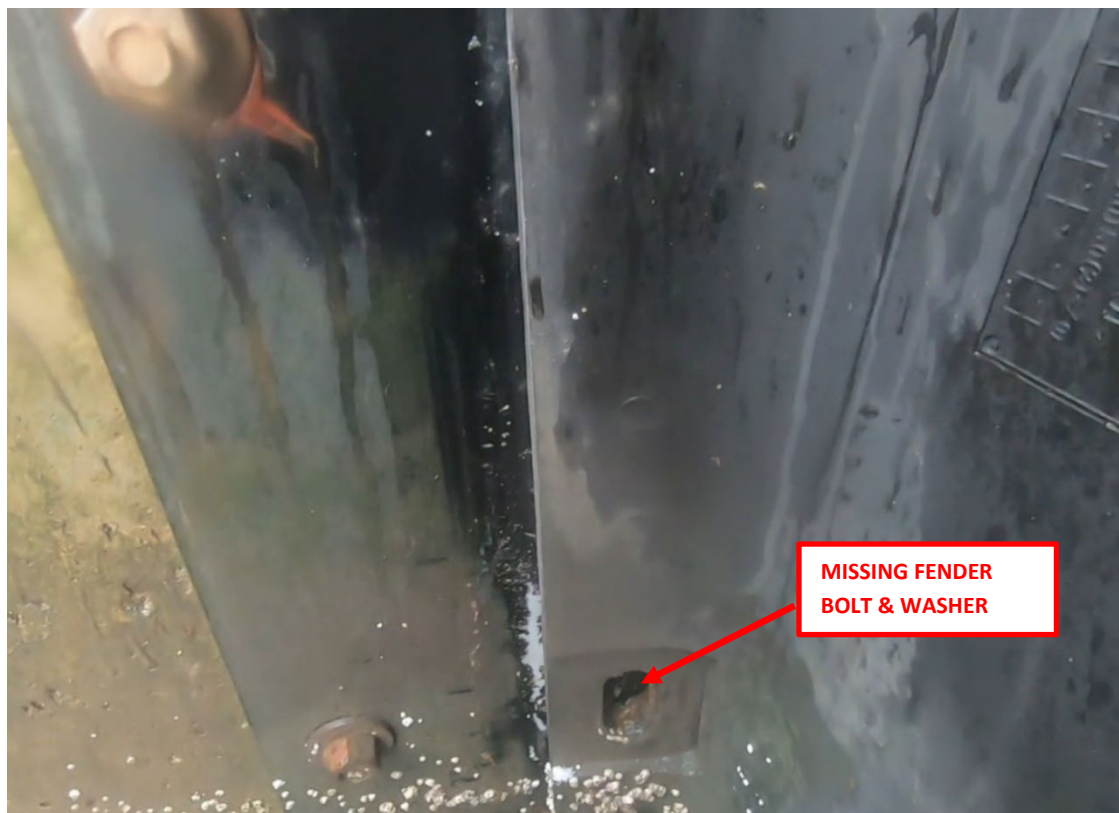
Bolts connecting the rubber fender to fender pile typically exhibit Major coating loss and surface corrosion, but no significant section loss. Bolts and washers connecting rubber fenders to the mounting plate typically exhibit Minor to Moderate coating loss and surface corrosion with Minor section loss or damage. Bottom bolts and washers exhibit greater coating loss and corrosion. One or more washers of bolts connecting the rubber fender to the mounting plate are typically loose or missing. As noted above, heads of one or more bolts to the mounting plate have pulled out or are pulling out of the rubber fender bolt hole at a typical rubber fender. See Photos 1 and 2 for Typical Condition of rubber fender and their connecting bolts.

MISSING FENDER  
BOLT & WASHER

**Photo 2:** Rubber fender bolt connecting fender to mounting plate.

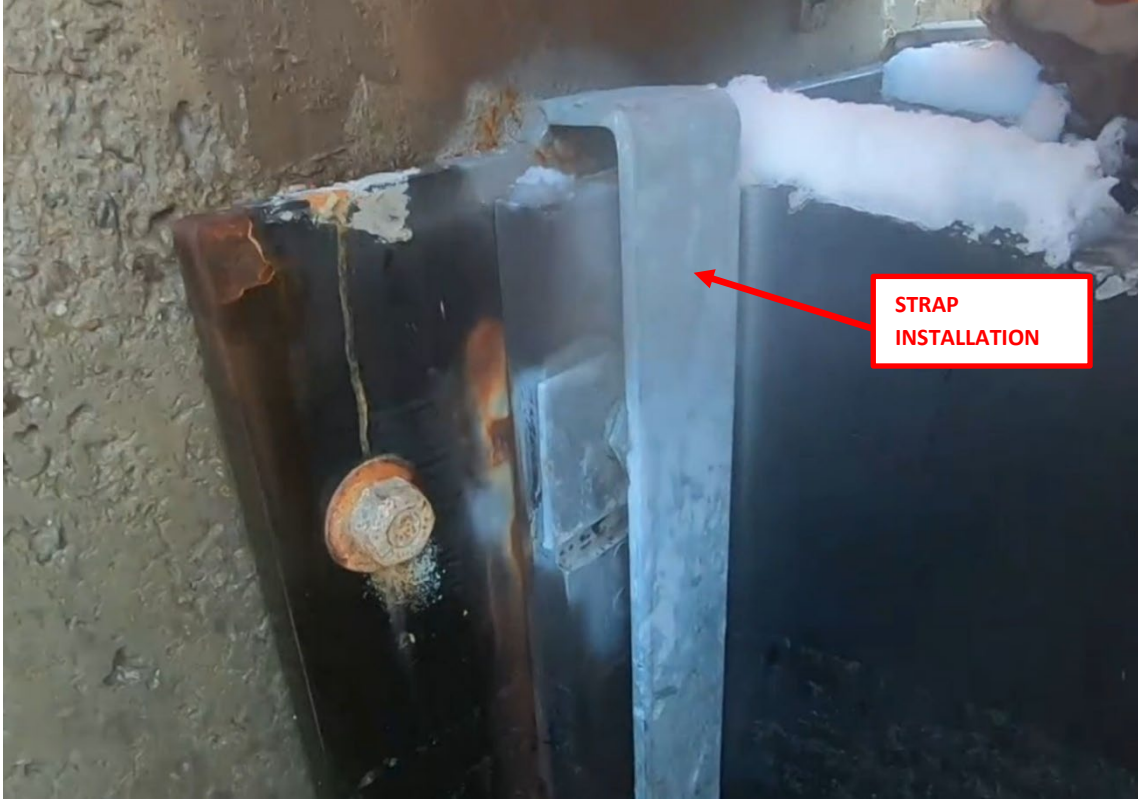
It is noted that Fender systems #15-#20 were repaired during September 2025. The bolts and washers were replaced with new. Additionally, a strap which extended from the top of the bulkhead backing plate to the bottom of the plate was welded in place at those points and to the head of the head of each bolt. This was done not only to replace the defective bolts and

washers but to add the strap to distribute the pull on the fender. This appears to have provided relief to this issue. Photo #3 illustrates a typical strap improvement.

**Photo 3:** Typical strap repair.

It is noted that a fender repair scope was implemented in September 2025 at Piles P29-40. As described earlier in this report, the repair included replacement of all fender bolts and washers and installation of a band over the end of the bolts to reduce the imparted stress. This solution has performed well to date, except for one location (P37), where the threads in the backing plate have failed and the new bolts were released. Bowman recommends that this solution be installed at all fender locations.

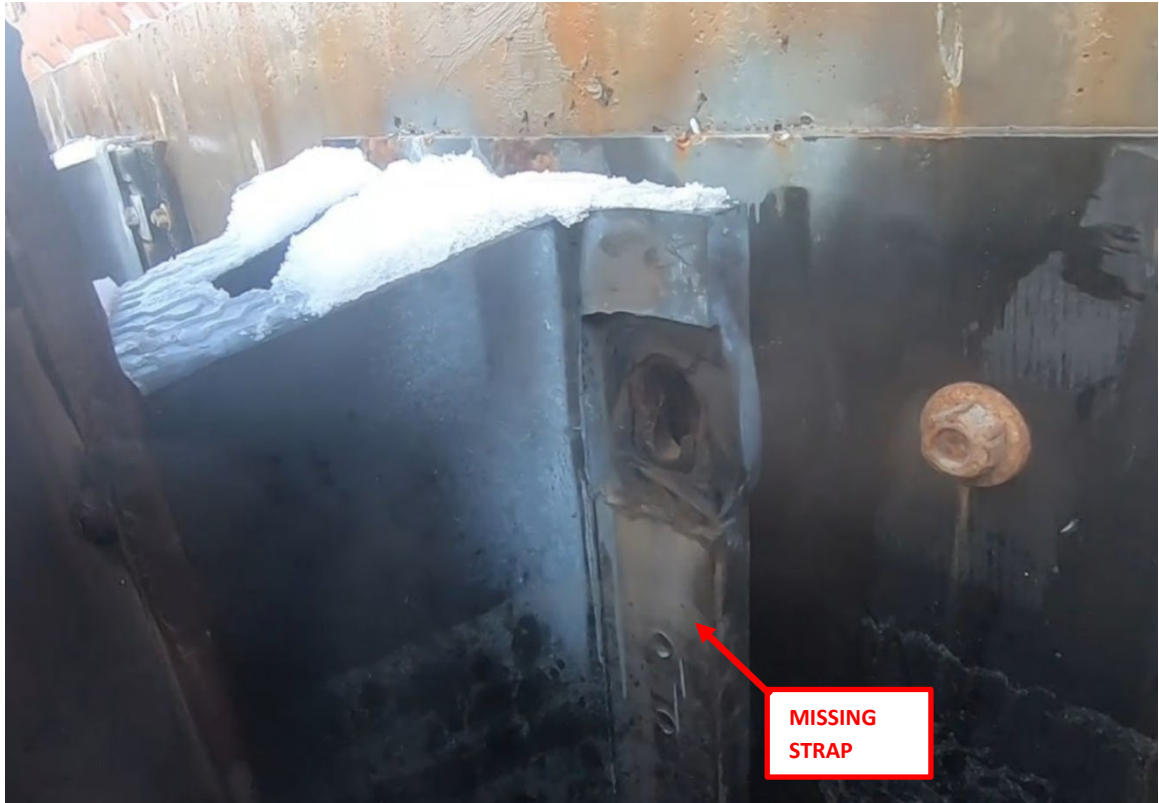
A failure of the strap has occurred at Fender #19 where the bolts released from the backing plate and pulled the strap off. Upon examination it appears that the threads inside the bulkhead plate should be repaired with a) installing a larger bolt or b) welding studs in place. An illustration of the Fender #19 failure is presented in Photo 4.

**Photo 4:** Strap repair failure at Fender #19.

- ✓ Implementation of "strap" improvements to the North Fender System's rubber fenders for the balance of fenders that were not improved in September 2025. This repair should include Fender #19, which was improved in September 2025.

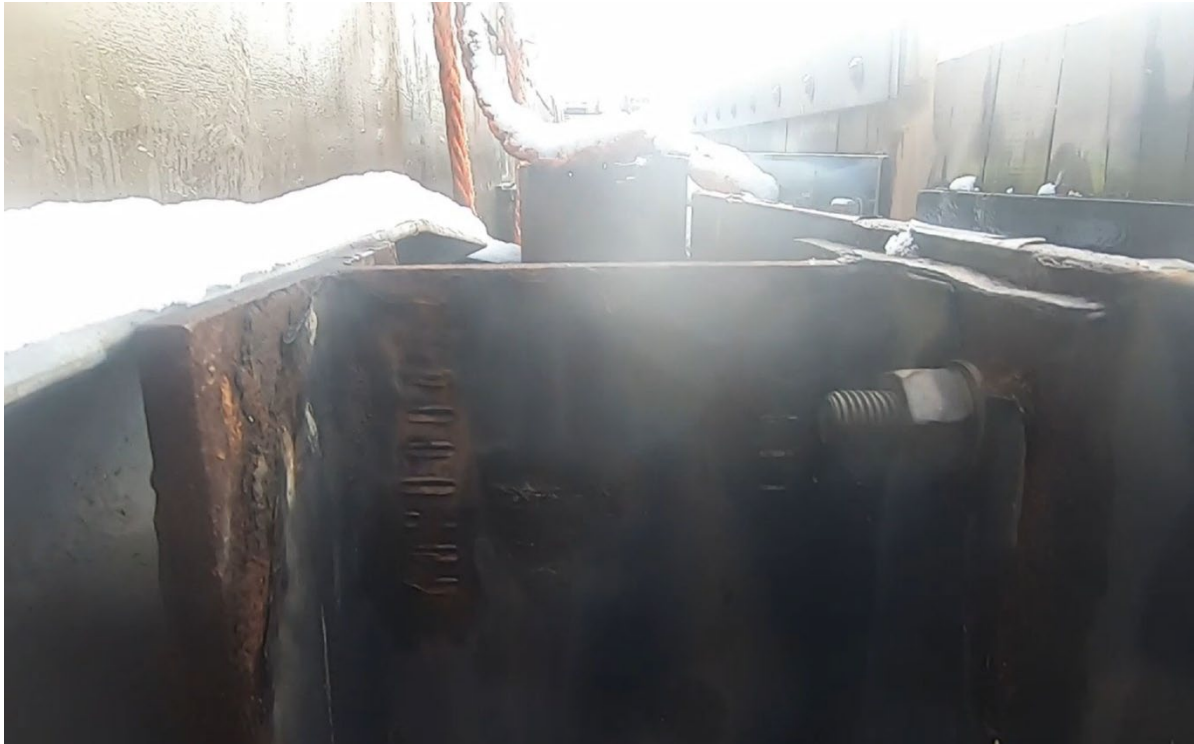
The HP12 fender piles that support each fender frame typically exhibit moderate coating loss and surface corrosion along their top 18 to 24 inches of a typical fender pile, including coating “peeling” loss. Coating loss and surface corrosion of the piles’ flanges extend further down these piles to the mid-wale location (i.e. through the intertidal splash zone); however, it is not accompanied with any concerning loss of steel thickness. See Photos 5 & 6 for the Typical Condition of fender piles. Coating is intact below water with heavy, soft marine growth. No visible section loss, no significant knife edging (thinning) of pile flanges or necking (reduction in width) of flanges was observed in fender piles under water.

**Photo 5:** Fender pile with heavy coating loss & moderate corrosion at top of pile. Corrosion of flange edges continues further down.

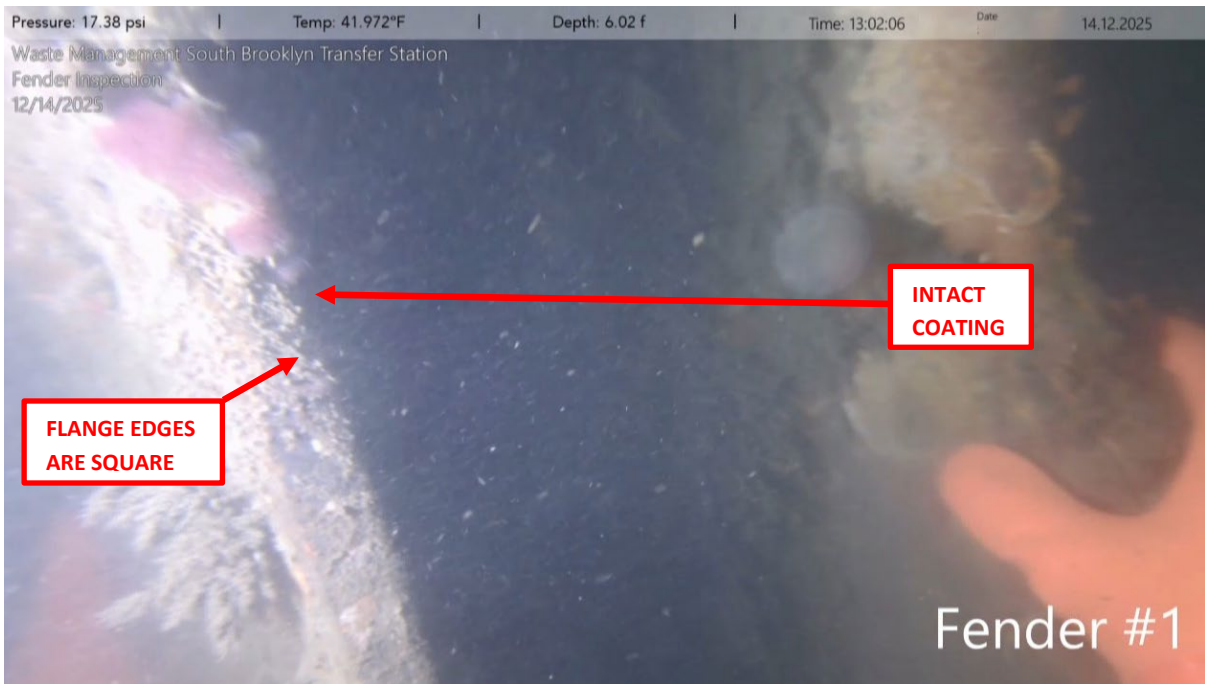
**Photo 6:** Coating of fender pile below water is intact. Flange edges are square with no necking or knife edging.

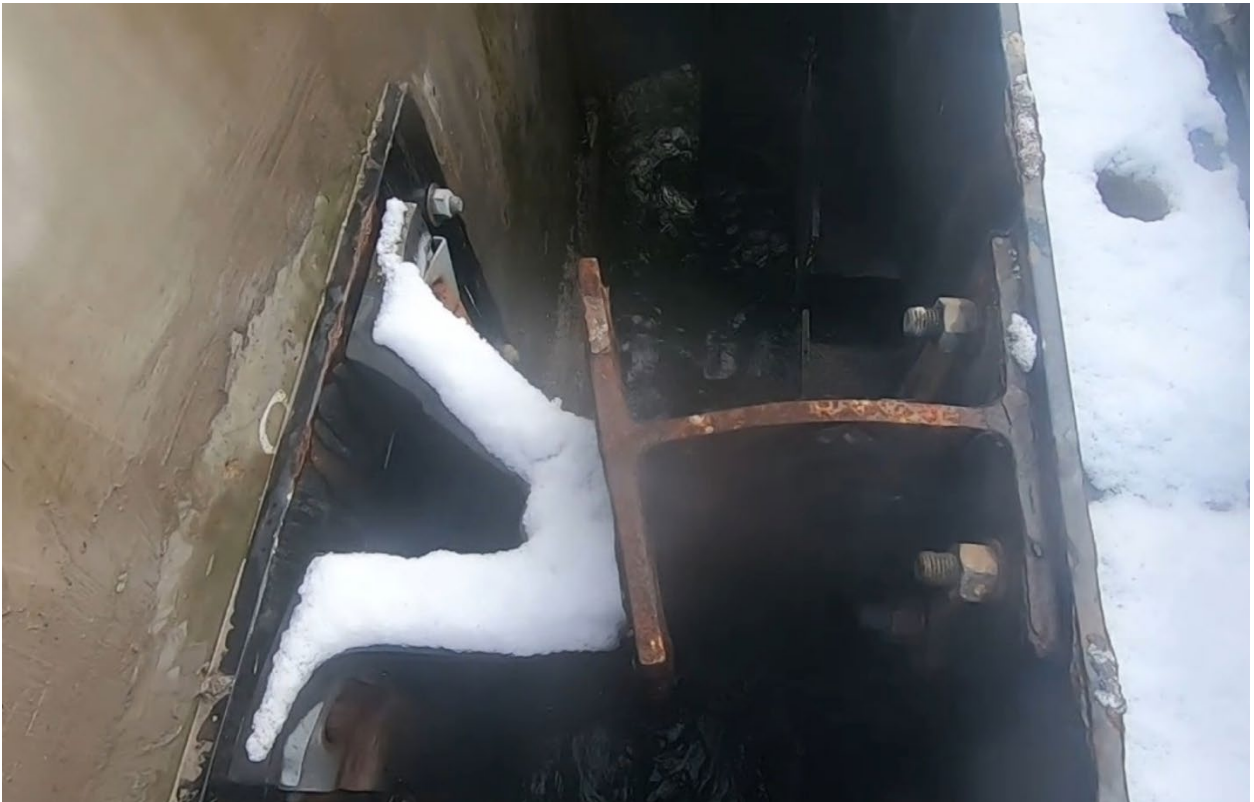
Notable exception to the pile conditions are at Fender #9 where the South Pile has deflected (see Photo 7) and Fender #12 where the North Fender exhibits a twist that is pulling on the south rubber fender face.

**Photo 7:** Deflection of Fender 9 South Pile.

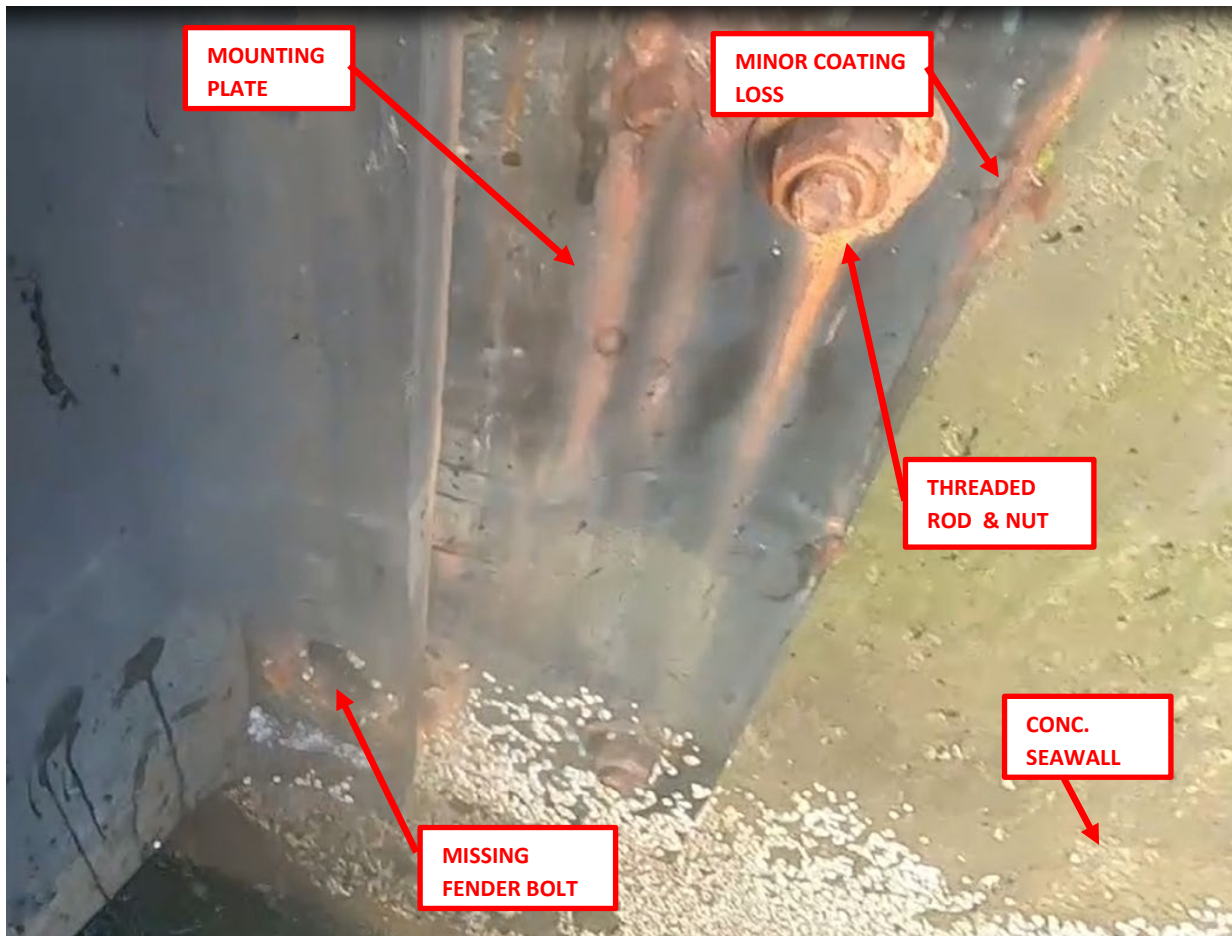
The coal tar epoxy coated steel mounting plates for the rubber fenders are anchored to the concrete seawall with six galvanized threaded rods arranged in 3 rows. The mounting plates has experienced Moderate coating loss and surface corrosion with no significant section loss. Mounting plates are in place and not rotated or separated from seawall. The top and bottom rows of threaded rods and nuts are intact with Moderate to Severe coating loss and surface corrosion. Nuts of threaded rods are generally tight. See Photo 8 for Typical Condition of the mounting plates.

**Photo 8:** Typical Condition of mounting plate

Mounting plates are in serviceable condition. Threaded rods anchoring mounting plate to the concrete wall exhibit varying degree of coating loss and surface corrosion. Significant section loss was generally not observed. Recoating with marine coating may prolong their life.

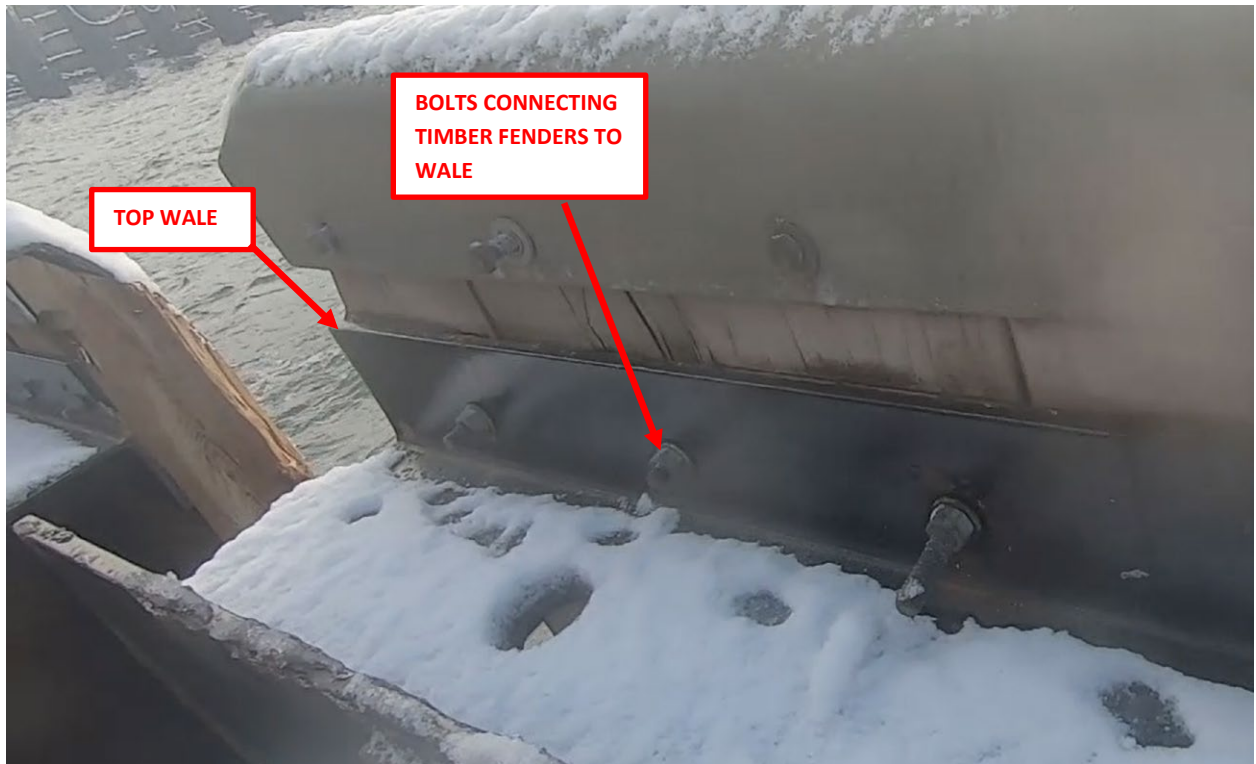
Four galvanized bolts connect each wale to each fender pile. Bolts connecting top wale to fender piles exhibit Minor to Moderate coating loss and surface corrosion, but no significant section loss. Bolts connecting the mid and lower wale exhibit greater coating loss and corrosion, but no significant section loss. Observation of select loose bolts was noted. See Photos 9 & 10 for Typical Condition of Wales.

**Photo 9:** Typical Condition of top Wale.

Existing Wales are W14 steel beams and not W12, as shown in historical drawings. Wales are in serviceable condition. Cleaning and re-coating areas with coating loss and corrosion will prolong their life. Several bolts connecting Wales to fender piles are loose. The loosening of bolts may be due to repeat impact loads from barges. Installing lock nuts/washers may alleviate the loosening of bolts in future.

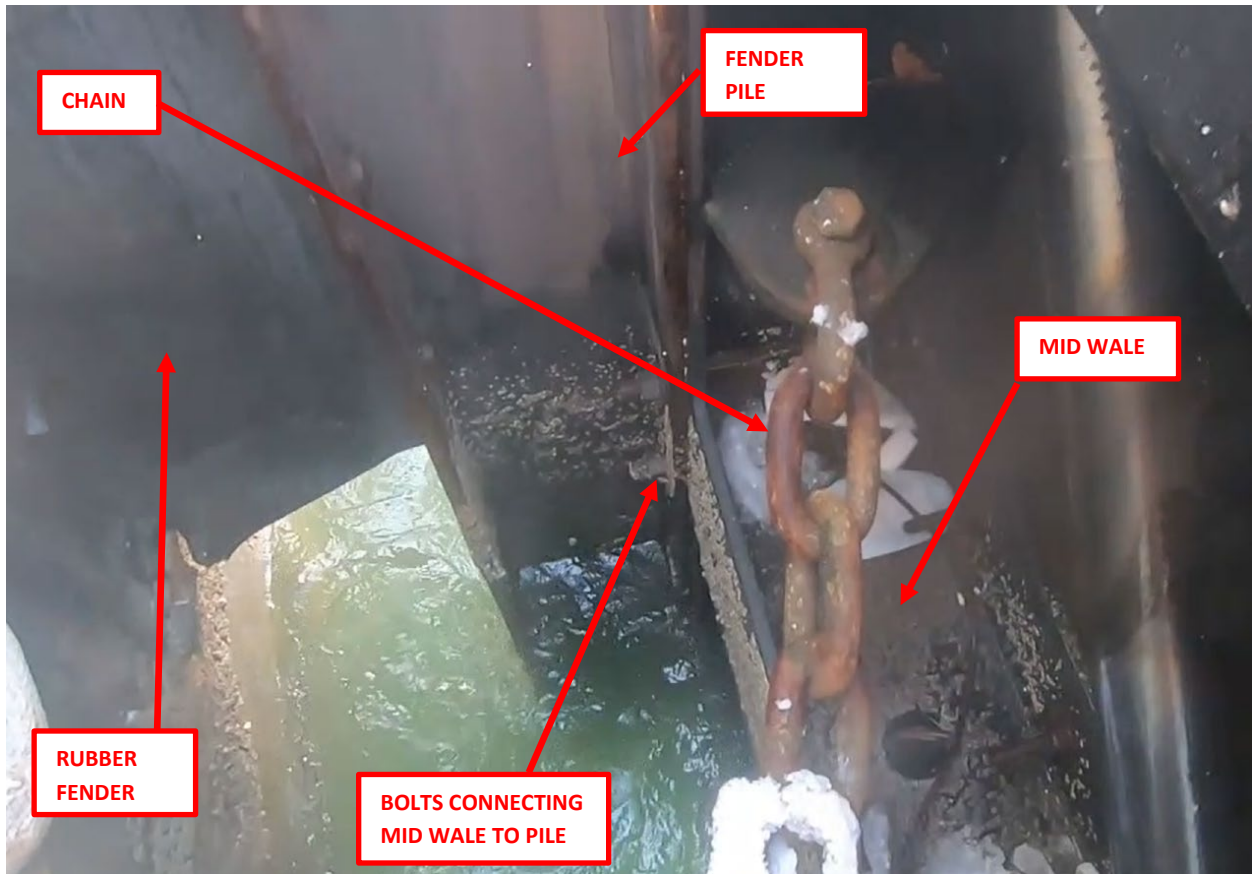
**Photo 10: Typical Wale Construction**

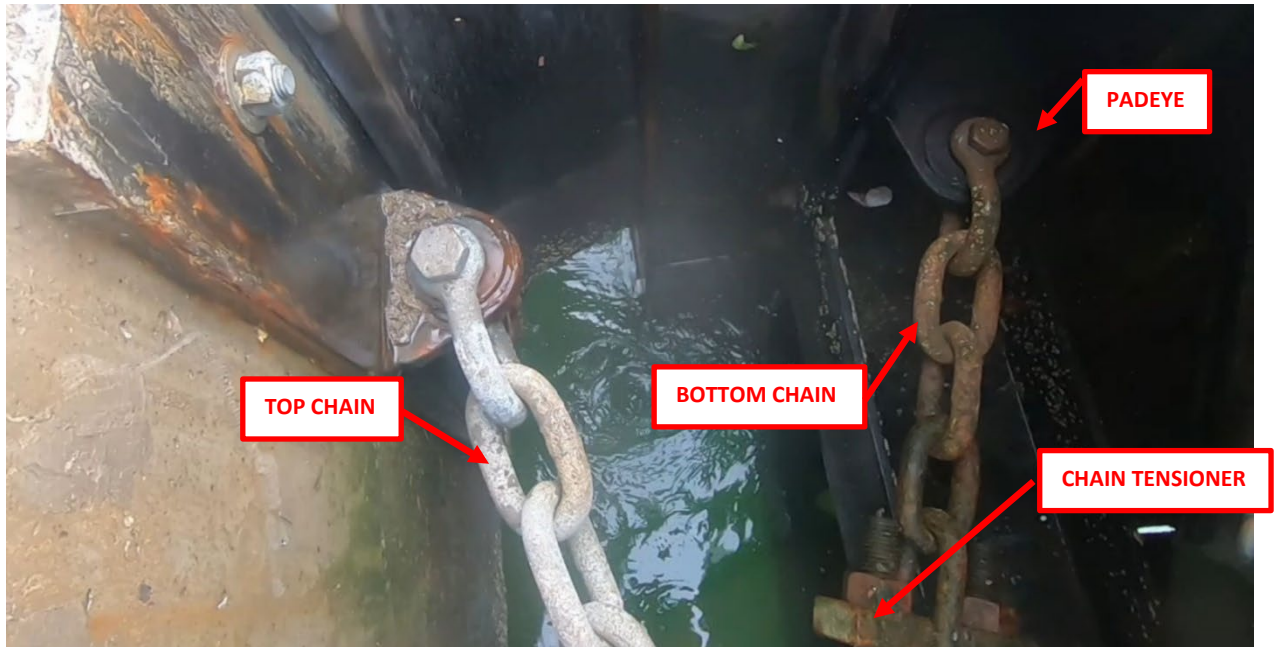
Two galvanized shear chains exist at each Fender. Each chain is equipped with galvanized shackles and a chain tensioner. Lower fender chain and hardware exhibit Moderate to Major coating loss and surface corrosion. The top fender chain and hardware exhibit Minor to Moderate coating loss and surface corrosion. All hardware including padeyes, shackles, and chain tensioner are intact. Lower chain is sagging while the upper chain is generally tight. Welds of padeyes are intact with Minor coating loss and surface corrosion. See Photos 10 & 11 for Typical Condition of fender chains.

**Photo 11:** Typical Condition of chains.

Chain assemblies are intact. Most lower fender chains were found to be sagging. The slack in fender chains may allow greater deflection in Fenders, resulting in damage to rubber fenders and piles.

- ✓ Tighten all chains on the North Fender System.
  - ✓ Replace missing North Fender System timber caps.
  - ✓ Replace three severely damaged and/or missing East Fender System rubber fenders.

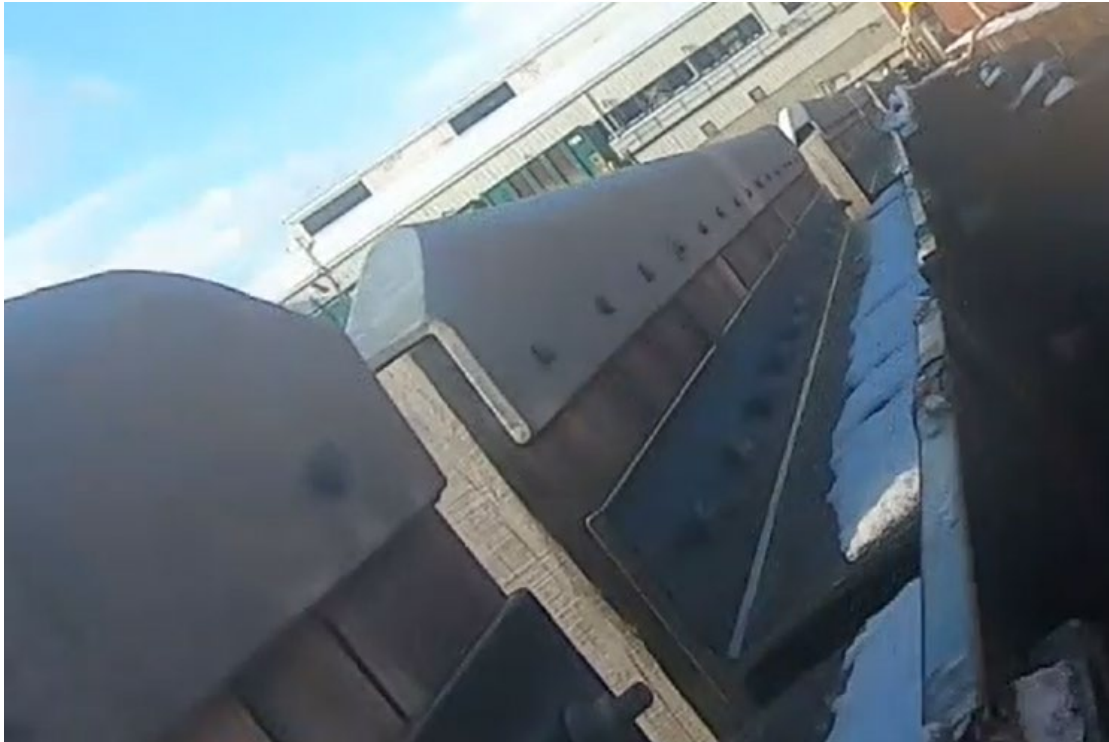
The timbers that form the outer surface of the fender panels are intact and typically not broken or split. Timbers exhibit checks, some gouging, and normal abrasion due to vessel contact. Two galvanized bolts connect each timber to each wale. Bolts exhibit Minor to Moderate surface corrosion and coating loss but no significant section loss. Bolts and nuts are loose or missing throughout the system. Likewise, one timber face panel is missing at Panel 12.

**Photo 12:** Typical Condition of fender timbers from interior side.

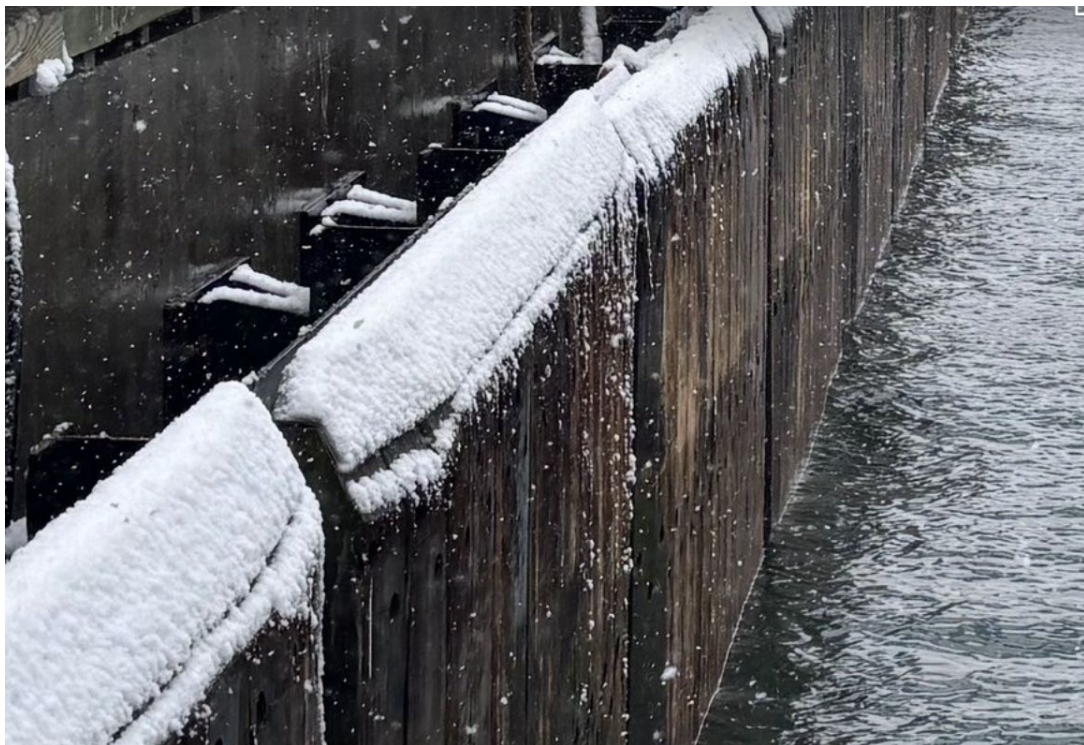
A galvanized rolled steel cap exists on top of fender timbers at each fender panel. The coating of cap is intact with Minor corrosion or absence of corrosion. The cap is in place, except at Fenders 3, 4 and 7. Many of the fifteen bolts that connect each cap to timbers are loose, missing or have broken inside the timber. See Photos 12 & 13 for Typical Condition of fender timbers and cap.

**Photo 13:** Typical Condition of fender timbers from exterior side

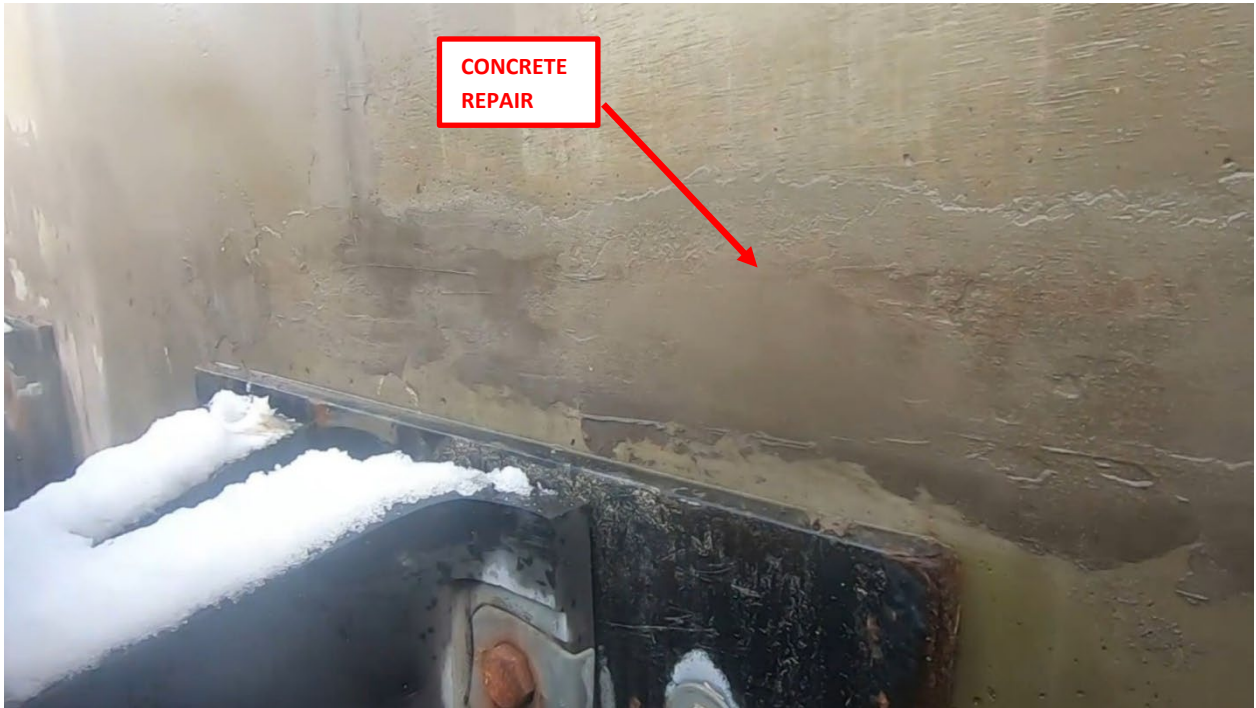
Above water, the concrete seawall is characterized by a 2025 repair of previously identified cracks and voids (see Figures 14 and 15).

**Photo 14:** Typical concrete seawall repairs.

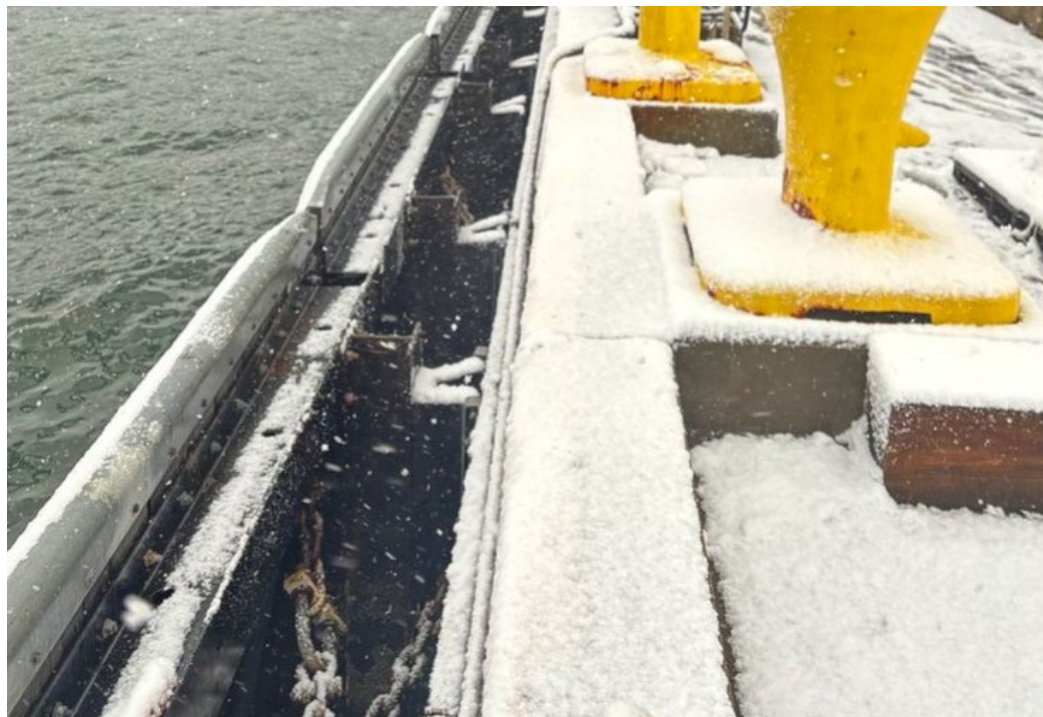
An 18" wide x 12" tall concrete curb exists along the outer edge of seawall behind Fender #s 15 thru 20. A curved steel plate forms the top outer edge of curbs. The plate extends down approximately 30" to form the outer top face of seawall. The plate exhibits surface corrosion.

**Photo 16:** Typical Condition of concrete curb behind Fender #s 15 thru 20

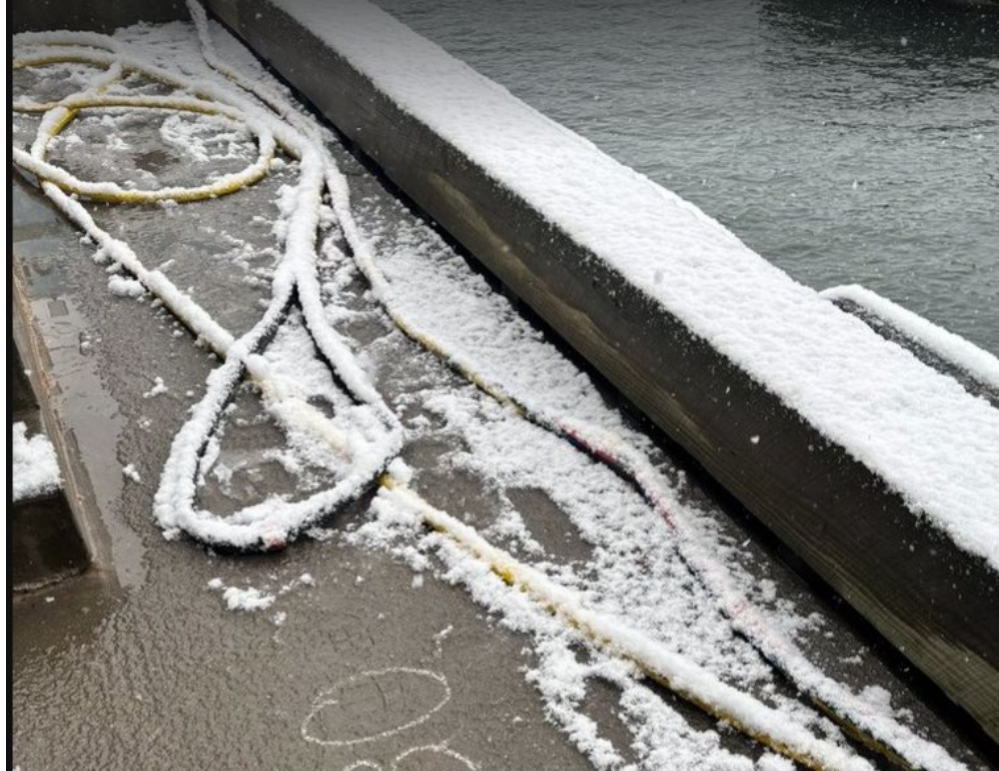
A 10x12 timber guard log exists along the outer edge of seawall behind Fender #s 1 through 15. Guard log timbers are checked with no section loss and are intact. See Photos 14 through 17 for typical condition of concrete seawall and curb.

**Photo 17:** Typical condition of timber curb behind Fenders #1 through #15.

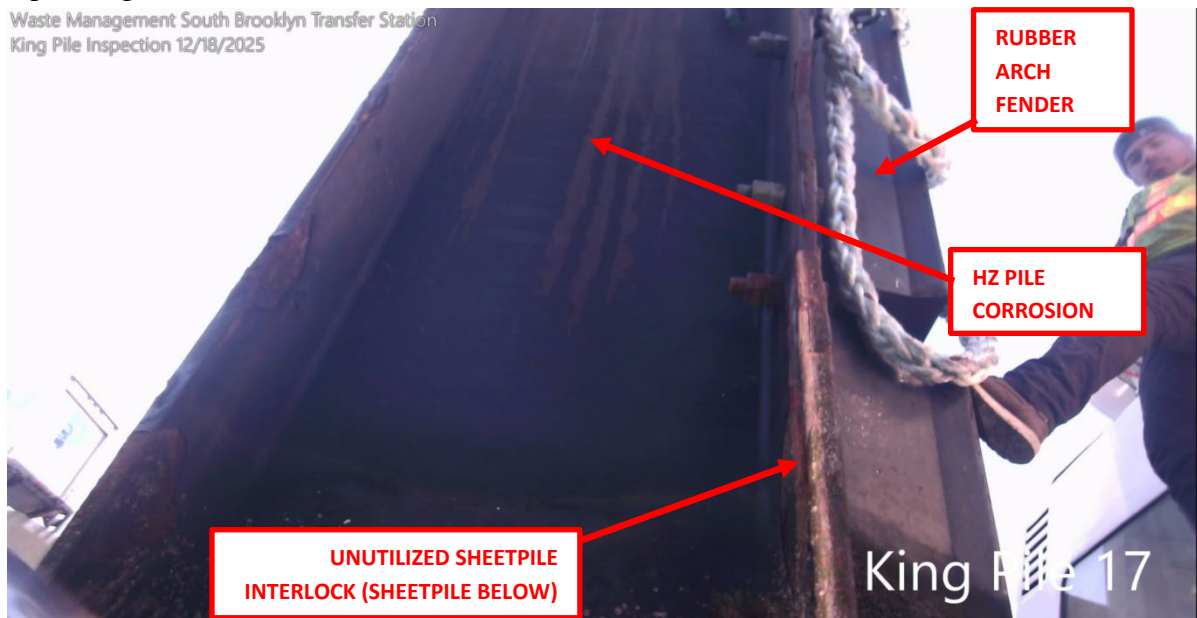
Typically, the king piles are plumb with no impact damage. Below the approximate elevation of +8’-6” MLW, the king piles exhibit coating loss and surface corrosion along flange edges. The area of coating loss and corrosion extends into the face of flanges and web below the approx. elevation of +6’-0” MLW. The interlocks have moderate coating loss and surface corrosion above water. Below MLW, all components are covered with heavy marine growth. The king piles have approximately 20% coating loss, with no visible section loss. The interlocks between the king piles and between the king piles and sheet piles are tight and not separating.

**Photo 18:** Typical condition of King Pile.

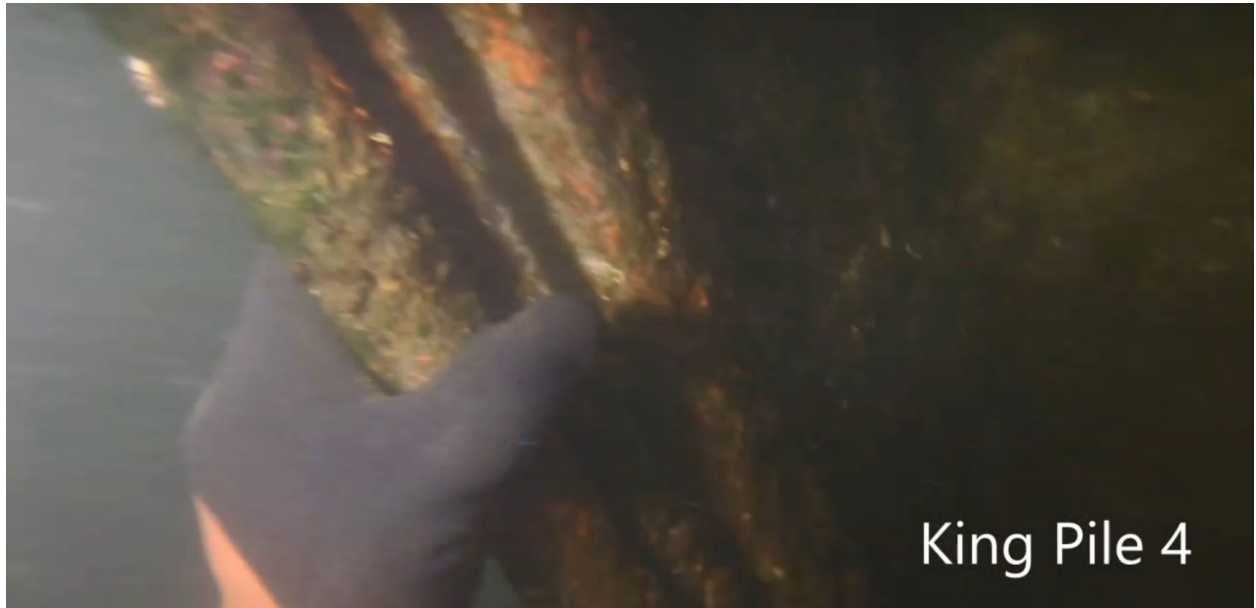
The steel sheet piles installed between the king piles are not visible above water. Typical sheet pile is generally plumb with no bulge or lean. Up to 1” thick, soft marine growth exists with negligible coating loss and corrosion. Sheet pile penetrates mudline and the interlocks are intact with no tenting.

**Photo 19:** Typical condition of Sheet Pile (divers' hand is on interlock).

Ultrasonic thickness measurements of steel thicknesses were measured for select sheet piles. The steel sheetpile thickness measurements ranged from 0.47 inches to 0.67 inches in the web and 0.43 inches to 0.57 inches in the flange. The original thickness of a PZC 26 sheetpile pile is 0.60 inches at the flange and 0.53 inches at the web. The thickness measurements suggest that Moderate corrosion has occurred. Therefore, future monitoring should occur regularly.

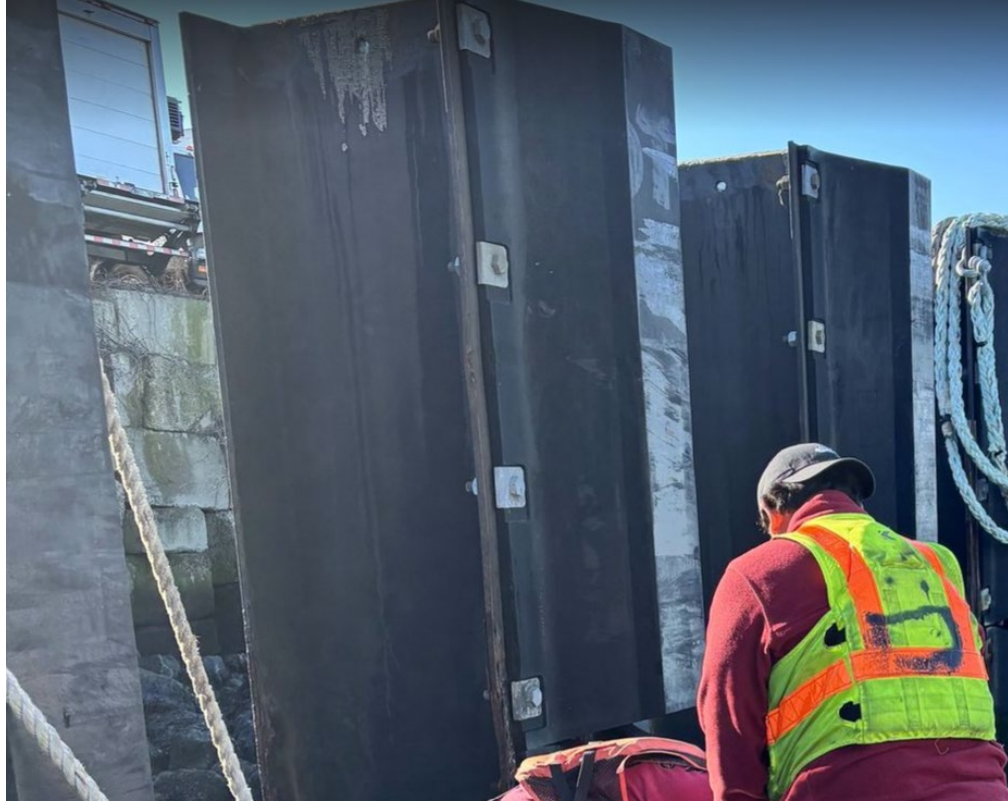
A Typical top rubber Arch fender is intact with no significant damage to the rubber. The bottom of top rubber fender has abrasion marks. The galvanized bolts connecting rubber fender to the king piles have negligible coating loss and are intact. A substantial number of bolts are loose

**Photo 20:** Typical condition of Upper Rubber Arch Fender.

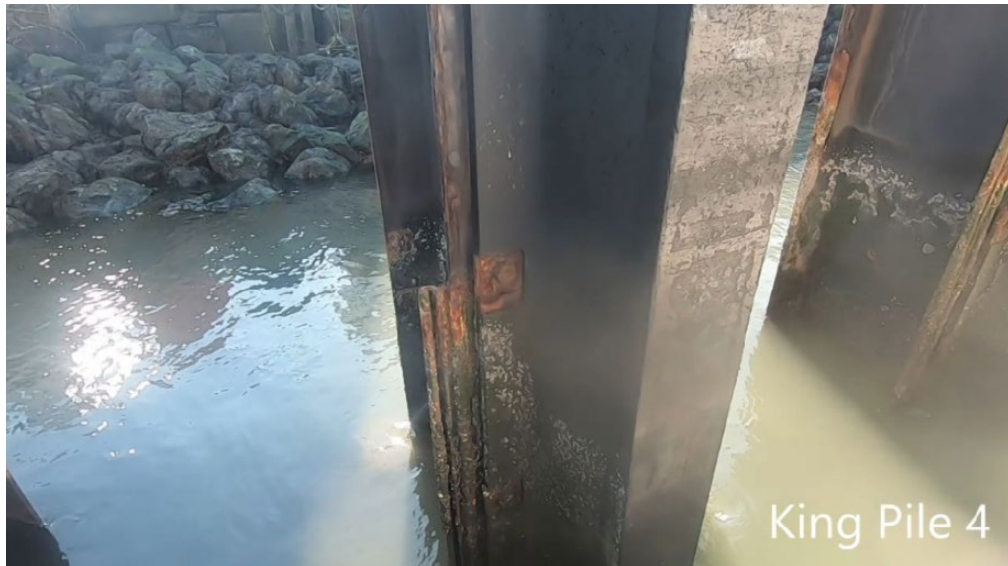
Top of a Typical bottom rubber Arch fender has abrasion marks but no significant damage to the rubber. Galvanized bolts in the top two rows, connecting the rubber fender to the king piles, have negligible to minor coating loss and are intact. Bolts in the bottom two rows of lower Arch fender exhibit Minor to Moderate coating loss and surface corrosion, but no significant section loss. A substantial number of bolts are loose or missing as Itemized Inspection Findings Tables presented in Appendix D. Below MLW, the lower fender is covered in marine growth up to the second bolt from the bottom.

**Photo 21:** Typical condition of Bottom Rubber Arch Fender.

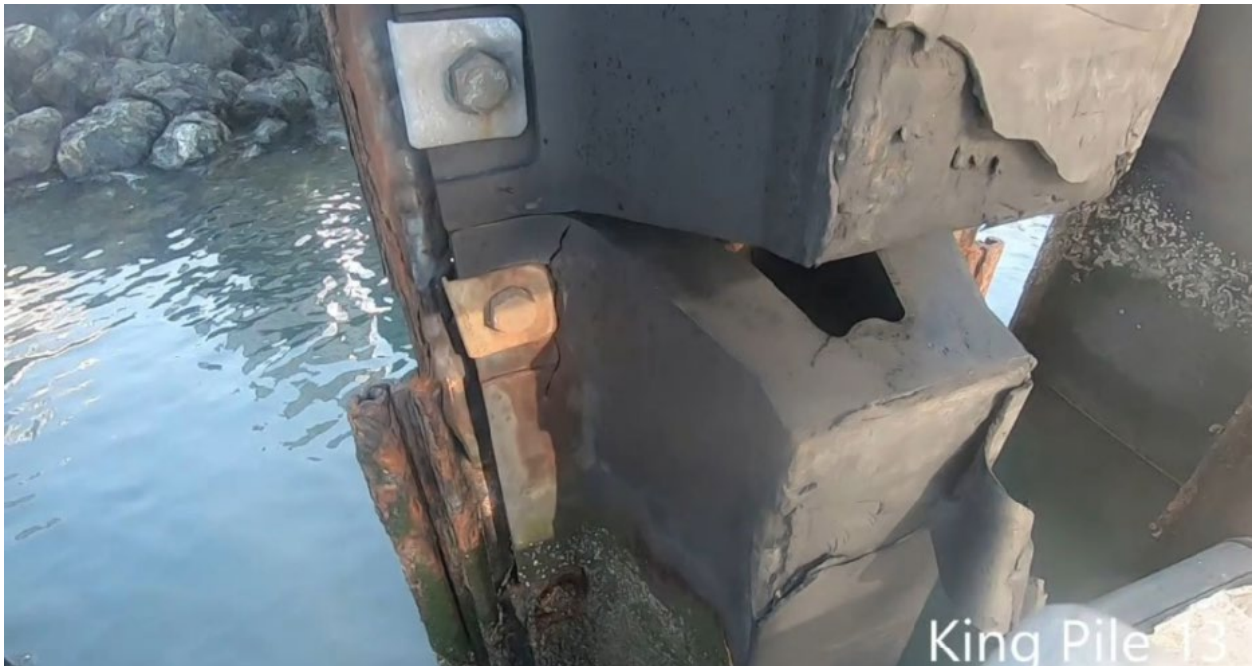
It was noted that each rubber fender is attached to king piles using 8 bolts and not 10, as shown in historical drawings. Twenty-seven (or 37.5%) of the existing 72 fenders were found to be damaged (predominantly the Bottom Fenders) during our inspection and one located on King Pile #6 is missing completely.

**Photo 22:** Typical fender damage (King Pile 13).

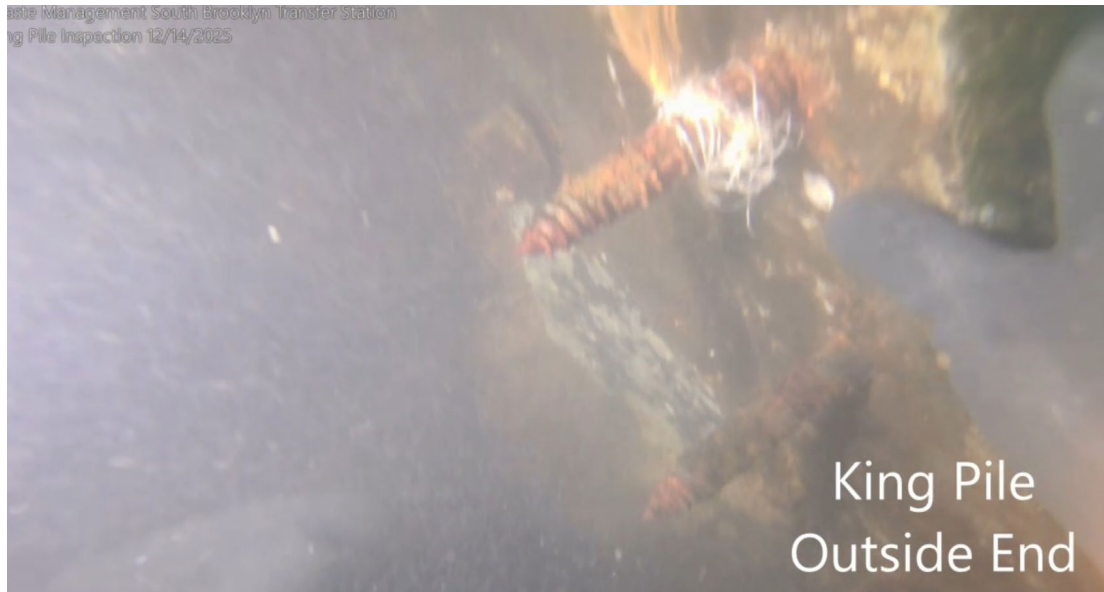
**Photo 23:** Exposed lag bolts at missing timber support / fender.

- ✓ Provide rock scour protection at the base of the concrete cap of the East Fender System's End Fender.
  - ✓ Replace the bottom two corner fenders and associated timber supports for the East Fender System's End Fender.
