Re: NYSDEC Permit 2-6106-00002/00022 Ren 4 (Permit)  
Southwest Brooklyn Marine Transfer Station (MTS)  
New York City Department of Sanitation (DSNY)  
2025 Marine Inspection Report

# ROUTINE INSPECTION REPORT

## MARINE FENDER SYSTEM

### SOUTHWEST BROOKLYN MARINE TRANSFER STATION

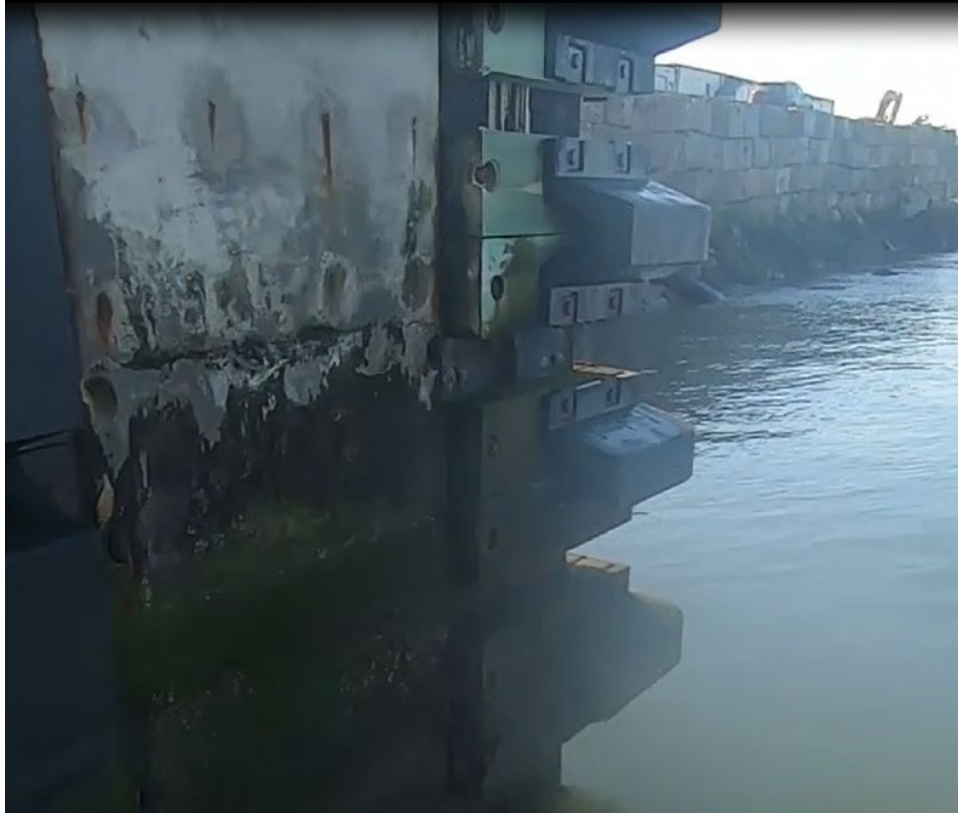
The concrete cap of the end fender remains in Fair condition, some Moderate spalling and voids existing at the structure's lower seam. Scour has developed under the concrete cap, exposing one (or potentially more) of the steel H-Pile foundations. The lowest two corner arch fenders and timber supports are missing. The balance of fenders and timber supports are in place, and without substantial defects.

**Photo 24:** Above-water condition of End Fender.

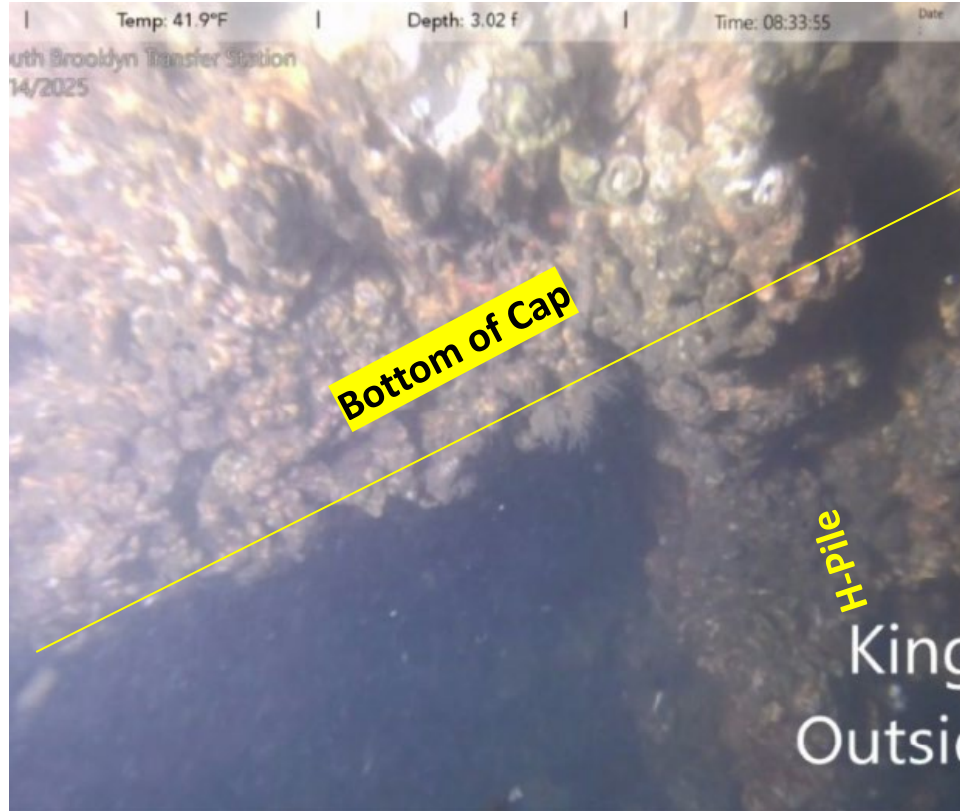
- A comparison of the 2024 and 2025 inspections reveals modest changes. Key differences include the following:
  - Scour has occurred at the East Fender System’s concrete cap, causing the steel H-Pile foundation to become exposed.

**Photo 25:** Exposed bottom of Concrete Cap.

- ✓ Provide rock scour protection at the base of the concrete cap of the East Fender System's End Fender.
  - ✓ Replace the bottom two corner fenders and associated timber supports for the East Fender System's End Fender.
