**Public Notice Regarding Section 106 Review of
Proposed Supportive and Affordable Housing Project at 839 St. Marks Avenue, Brooklyn NY
Seeking Public Comment**

EXISTING CONDITIONS ASSESSMENT
for
839 ST. MARK'S AVENUE
CROWN HEIGHTS
BROOKLYN, NY 11213

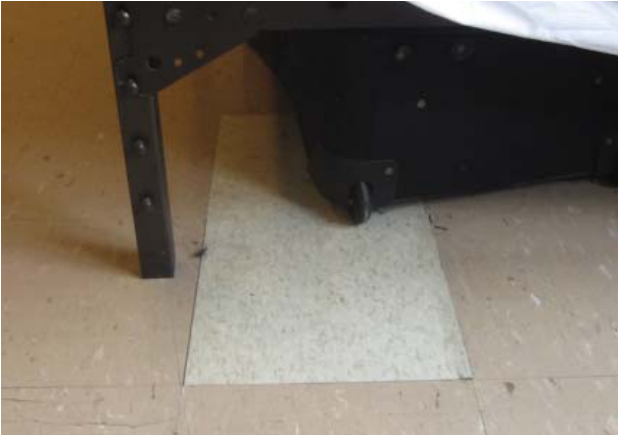
Fig. III-C-112 Room 301 Bedroom replacement floor tiles

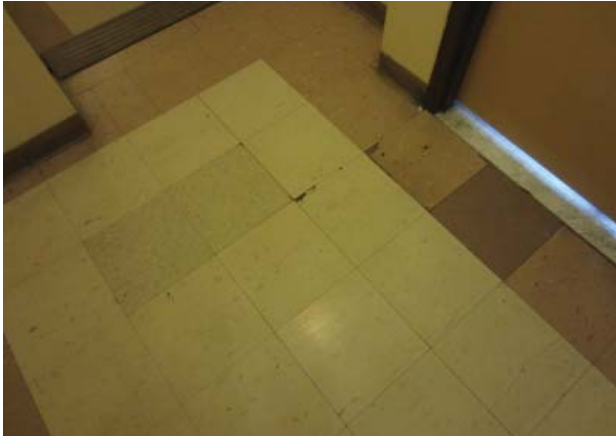
Fig. III-C-125 Room 305 Corridor areas of replacement tiles

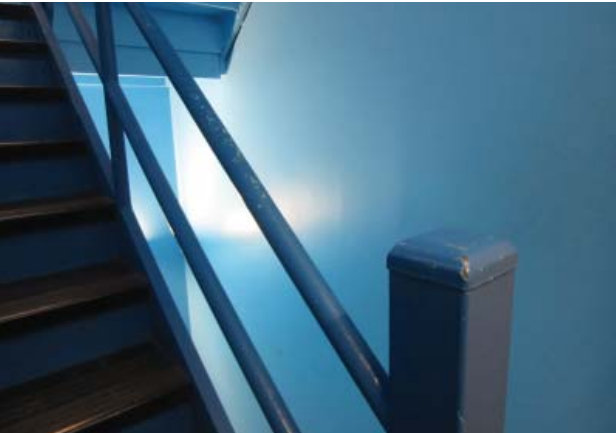
Fig. III-C-158 Stairwell B, Room 209, paint peeling on railing

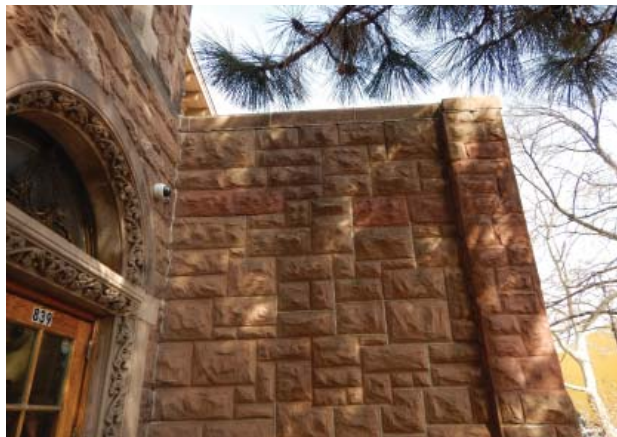
Fig. III-C-183 South Elevation crack between facade plane and one story projecting addition

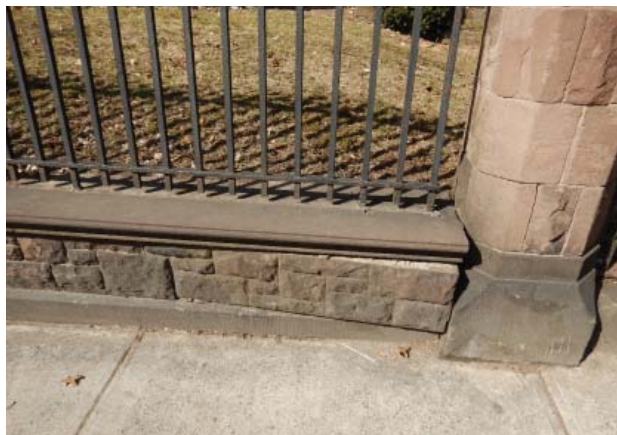
Fig. III-C-187 South Elevation displacement at fence knee wall and newels

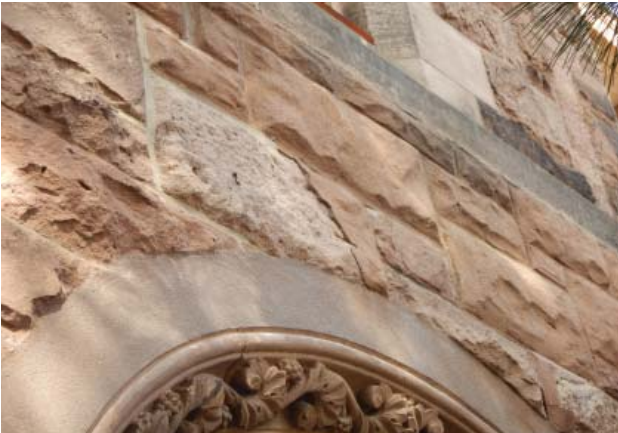
Fig. III-C-193 South Elevation detail of masonry deterioration

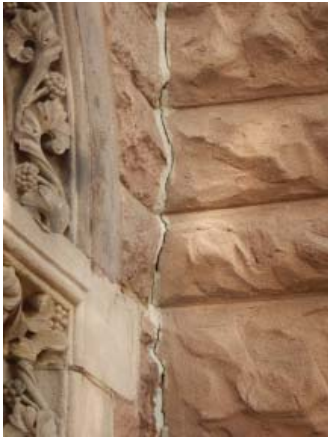
Fig. III-C-194 South Elevation detail of large scale crack between facade plane and one story projecting addition
