# Saint Bartholomew's Church and Community House

**Landmarks Presentation for Restoration and Continued Maintenance**

Prepared for the Landmarks Preservation Commission

Acheson  
Doyle  
Partners Architects

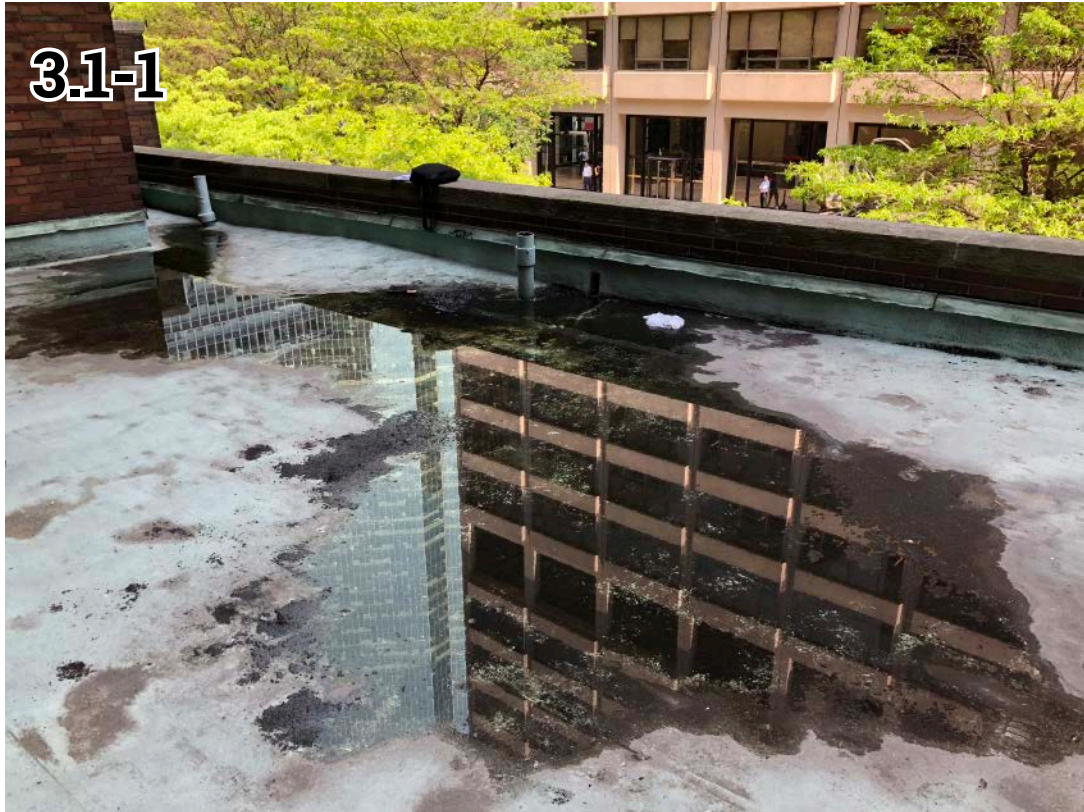
### 3.1-1 Lower Flat Church Roof

- Blocked Scupper
- New Kemper Roof Completed in 2013
- Ponding Water
- Insufficient Sloping

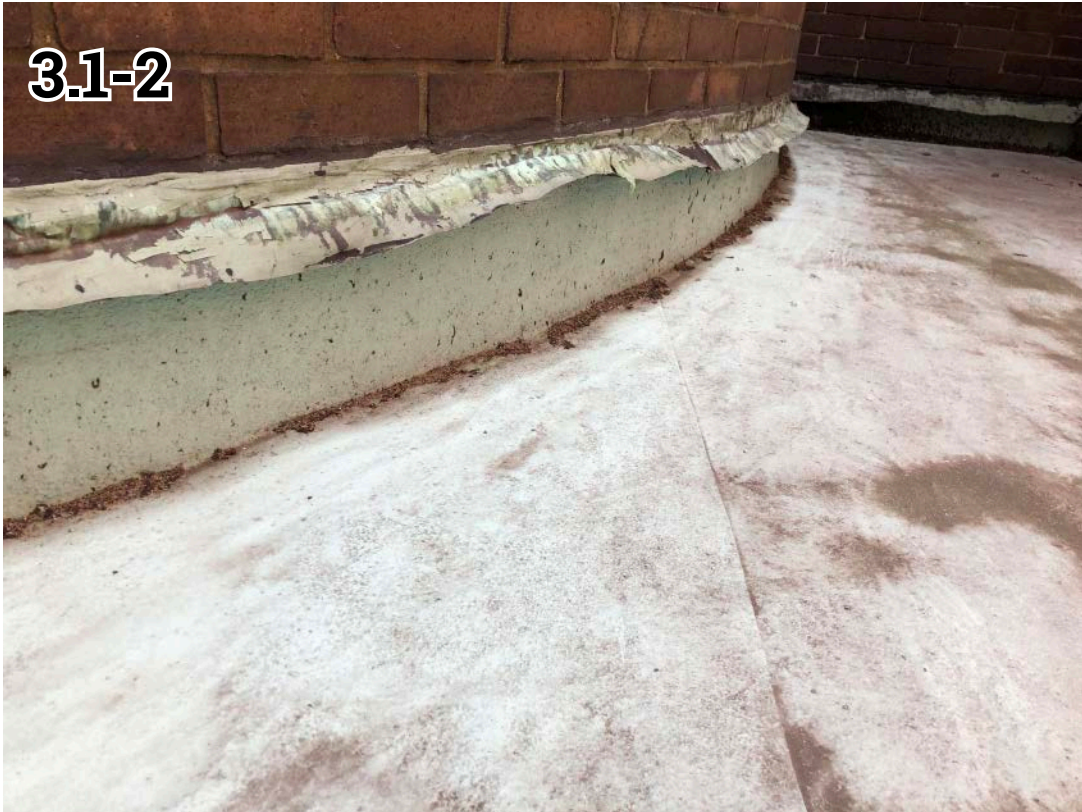
### 3.1-2 Lower Flat Church Roof

- Raised Flashing

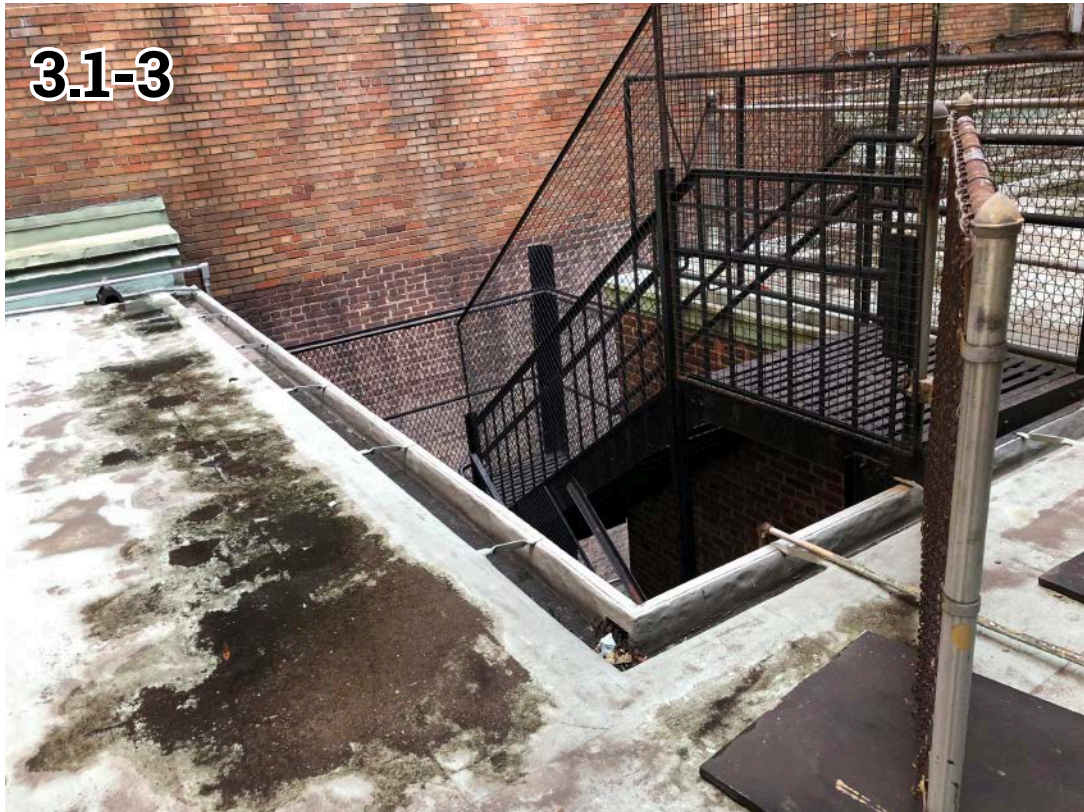
### 3.1-3 Lower Flat Church Roof

- Missing Parapet / Railing

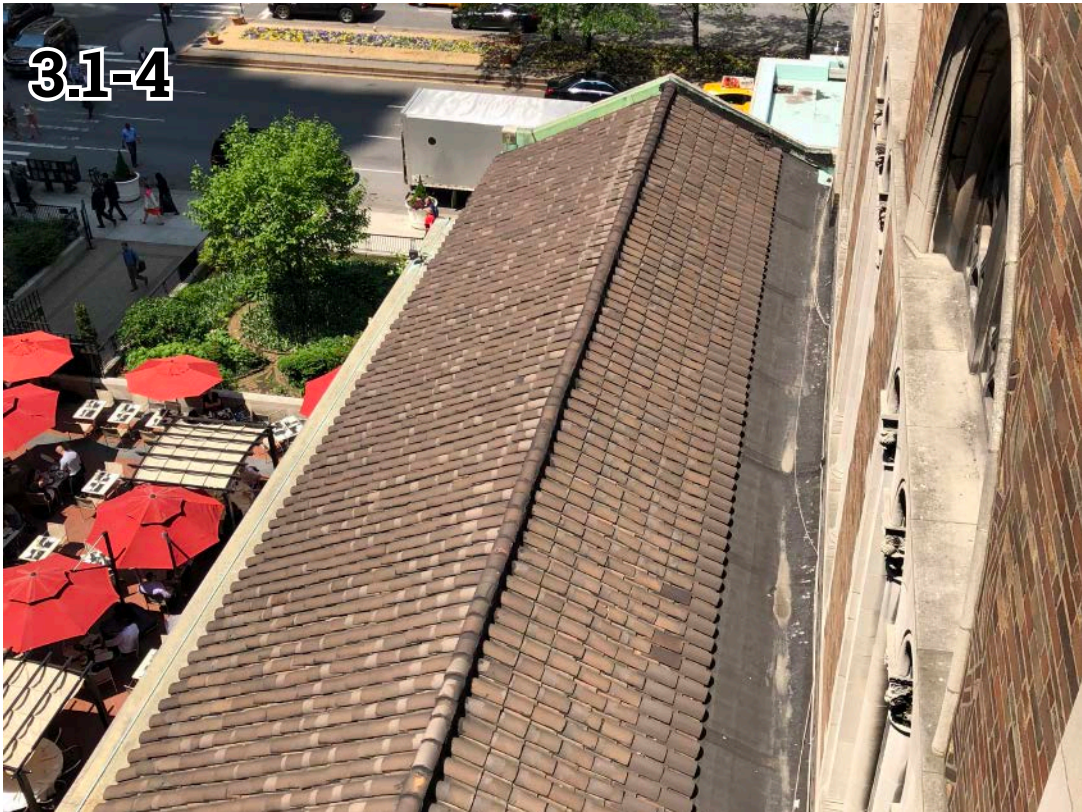
### 3.1-4 Leaking Chapel Terra-cotta Roof

- Deteriorating lower Terra-cotta Roof

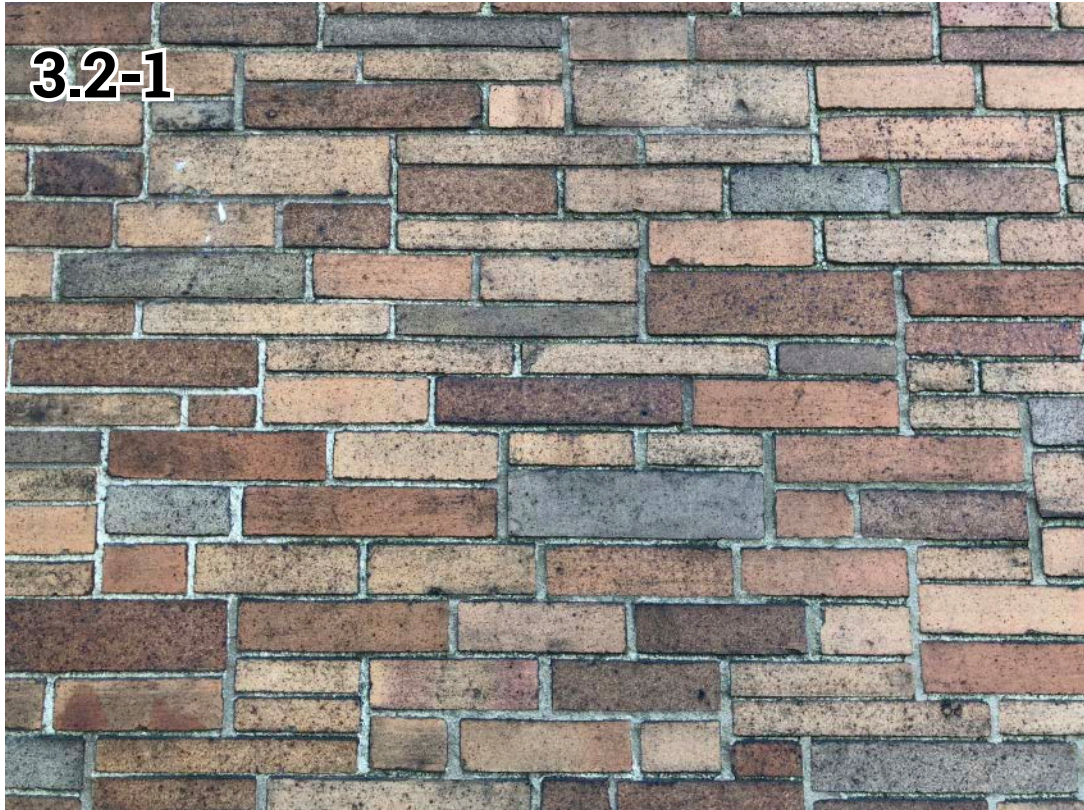
### 3.2-1 Church Brick, Fair Condition

The brick masonry is unique in that it includes brick in several sizes rather than a standard dimensioned brick unit. The church building exterior is a rich collection of mottled brick colors, sizes, and brick patterns.

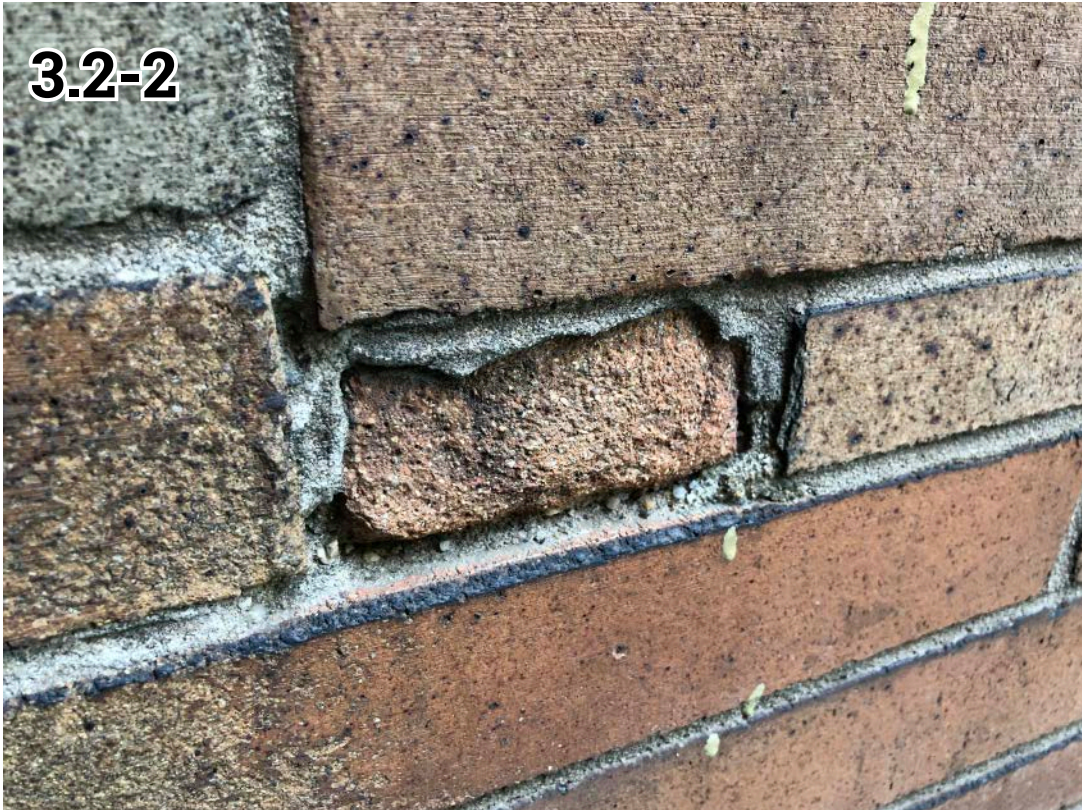
### 3.2-2 Heavily Deteriorated Brick

- Popping Face-brick, Typical Throughout

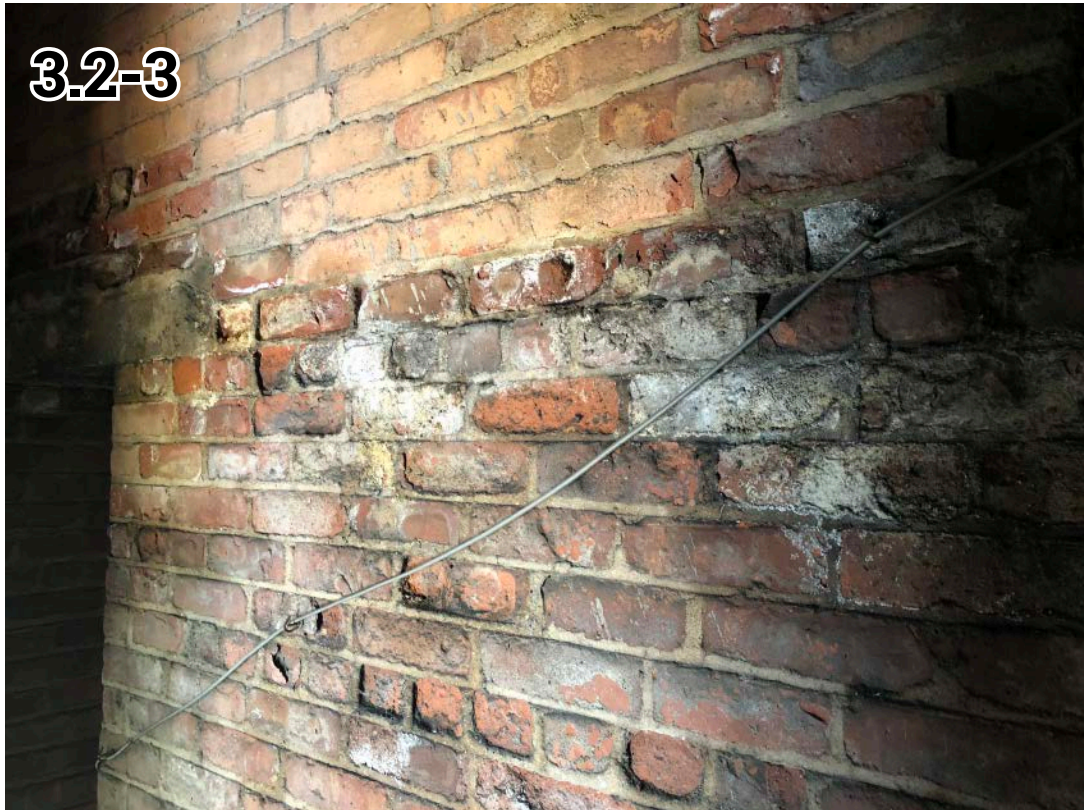
### 3.2-3 Heavily Deteriorated Mortar, Gallery Walk

- Internal Masonry Water Infiltration
- Mortar Joint Failure

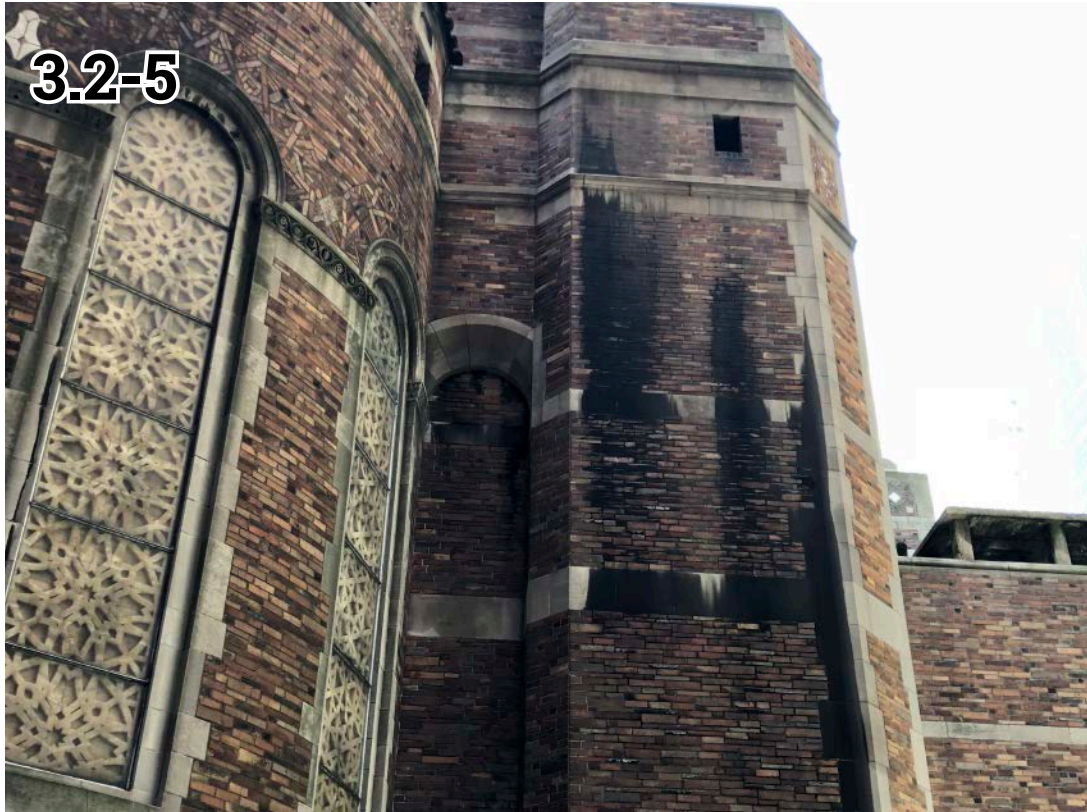
### 3.2-5 Church Facade

- Carbon Deposits and Dirt Accumulation

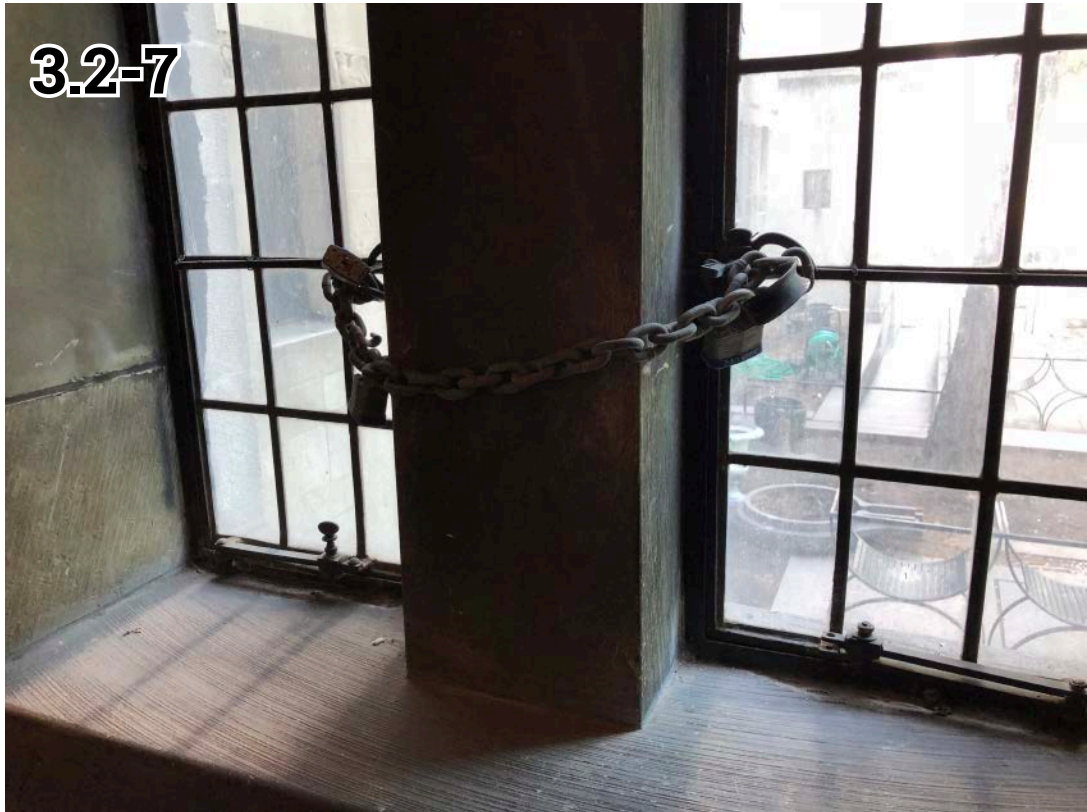
### 3.2-7 Standard Vision Glass Window

- Throughout the building's less prominent street facades are standard metal windows with lead mullions and standard vision glass.

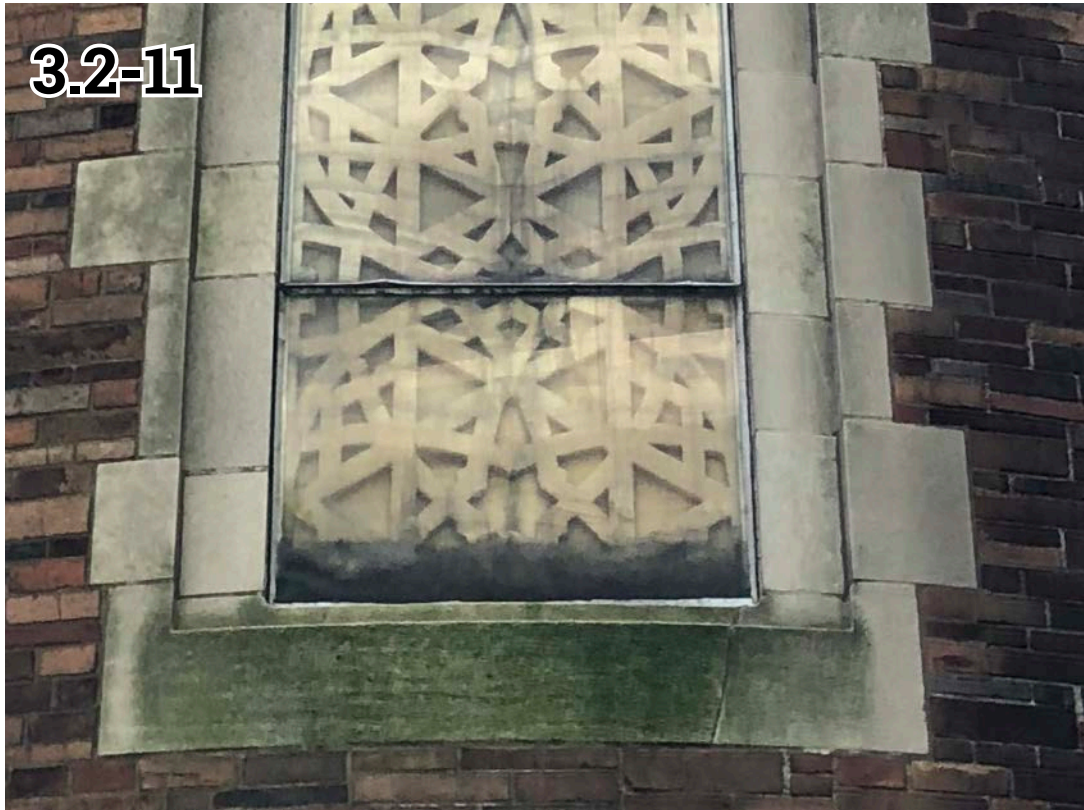
### 3.2-11 Nave Stained Glass Windows

- Missing or Damaged Bird Netting

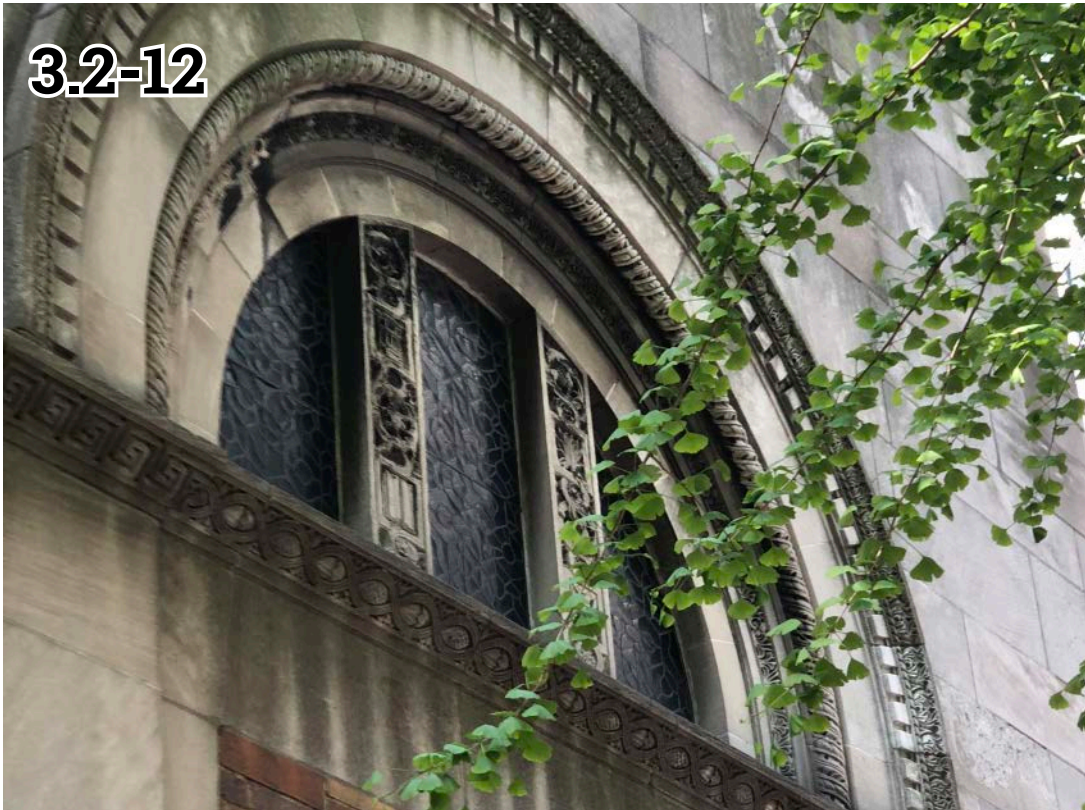
### 3.2-12 Clerestory Window

- Unprotected Stained Glass Window
- Minor Glazing and Mullion Deterioration
- Dirt and Debris Accumulation
- Lack of Bird Net

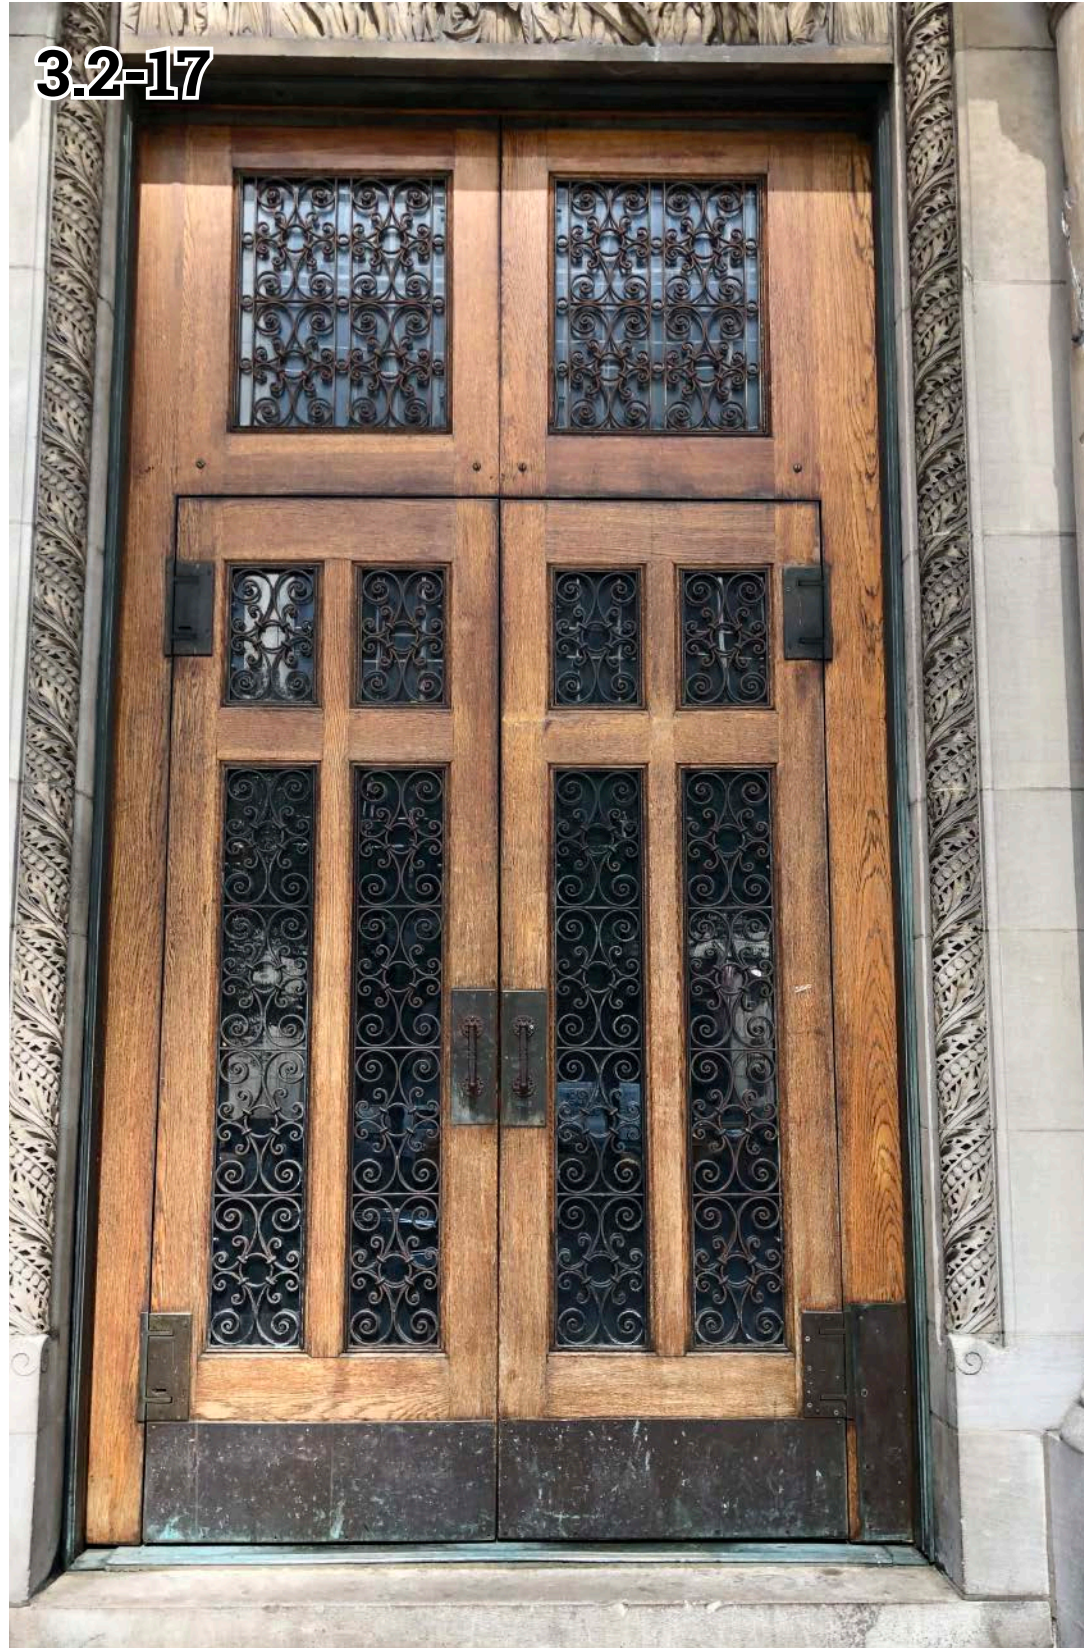
### 3.2-17 North Entrance Wood Doors

- Severe deterioration to both the natural wood and metal frame.
- Pocket operation no longer functions, and the movable frame is fixed in place.

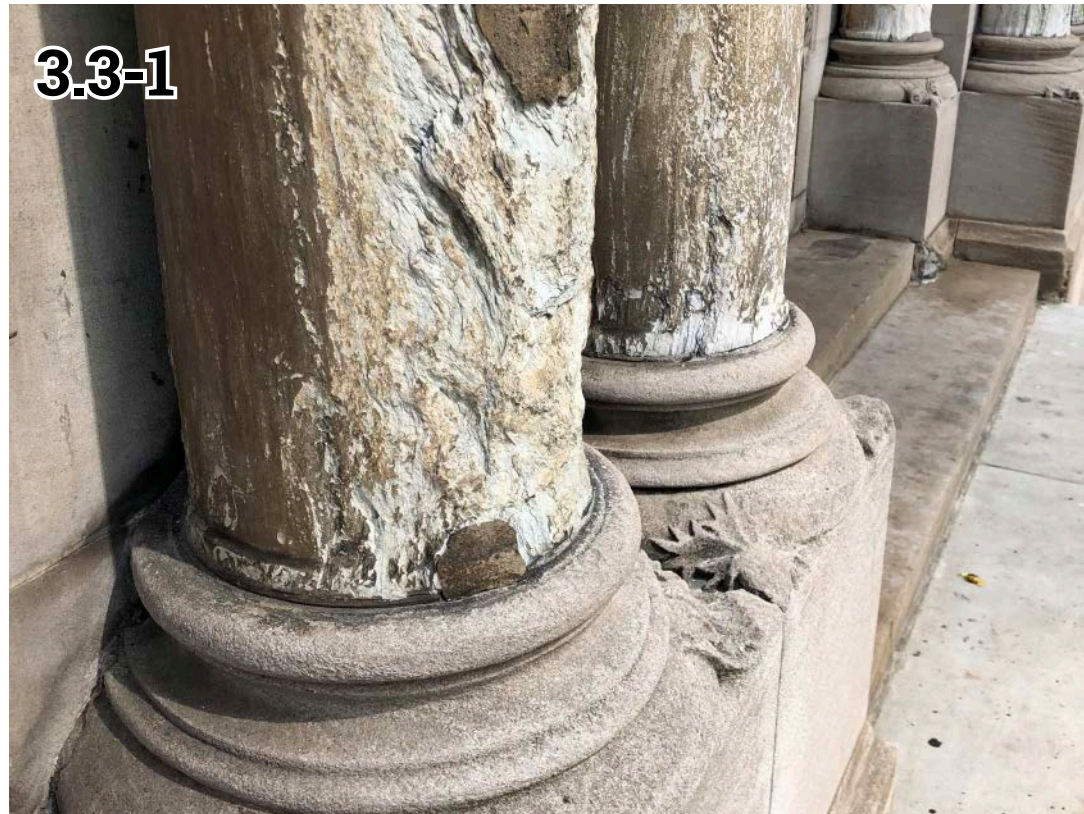
### 3.3-1 Columns

- Deteriorating Marble Columns

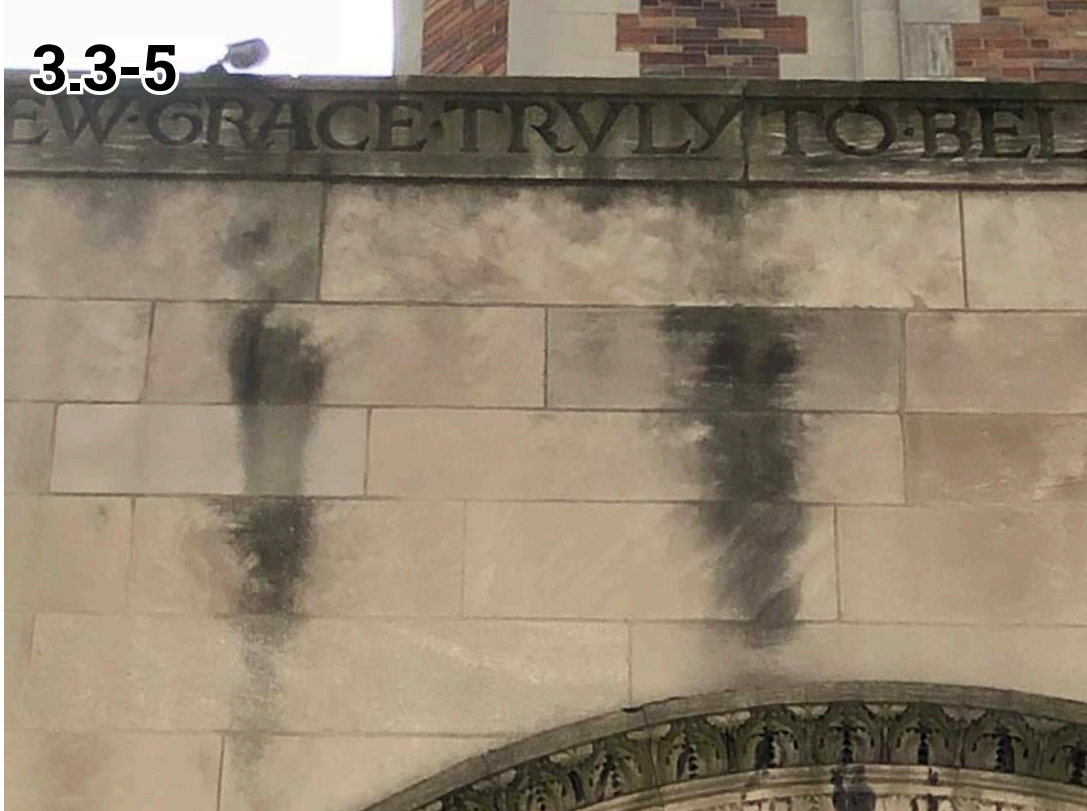
### 2.3-5 Inspiration Band

- Deteriorated Open Joint
- Carbon Deposits Caused by Open Mortar Joints Above

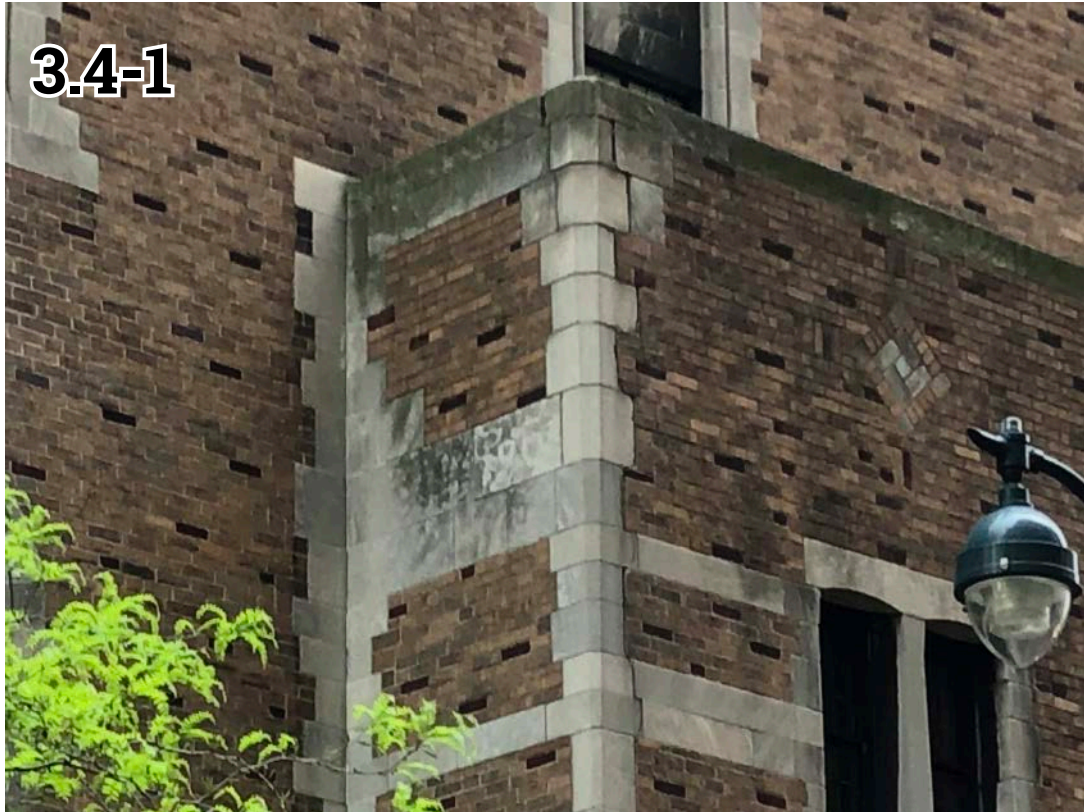
### 3.4-1 South Facade Corner

- Biological Growth, Typical
- Cracked Brick
- Failing Mortar Joints
- Cracked Stone

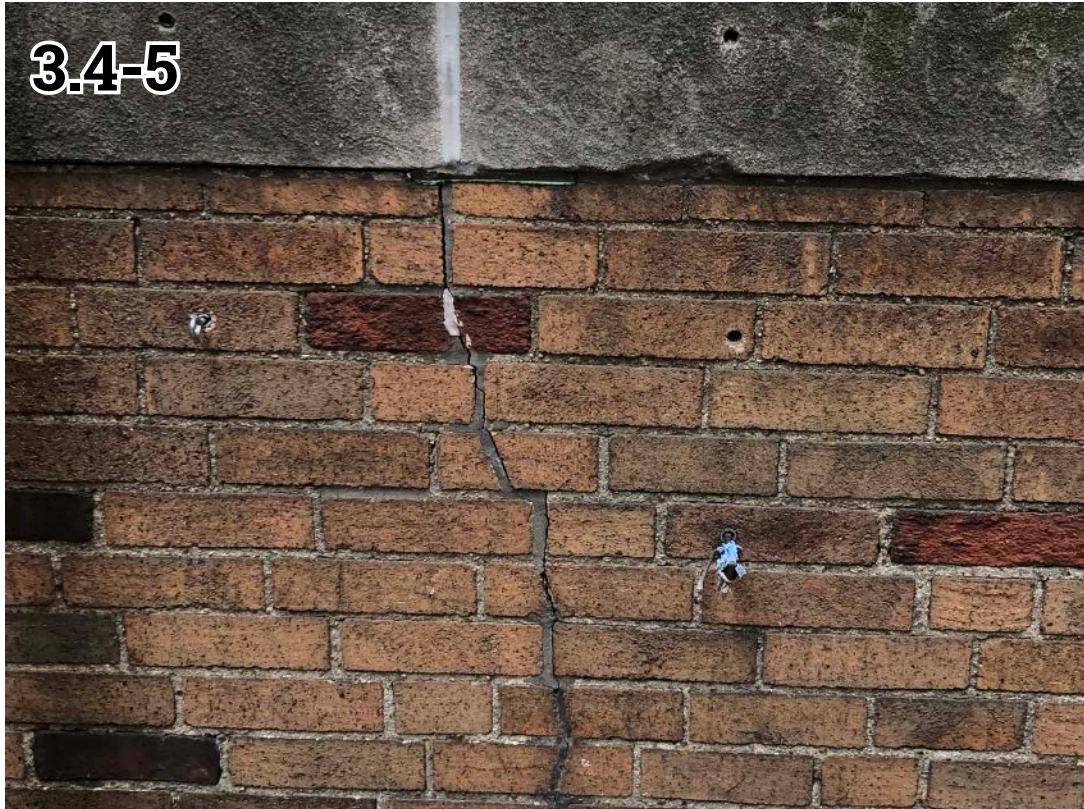
**3.4-5 Parapet**  
• Cracked Brick

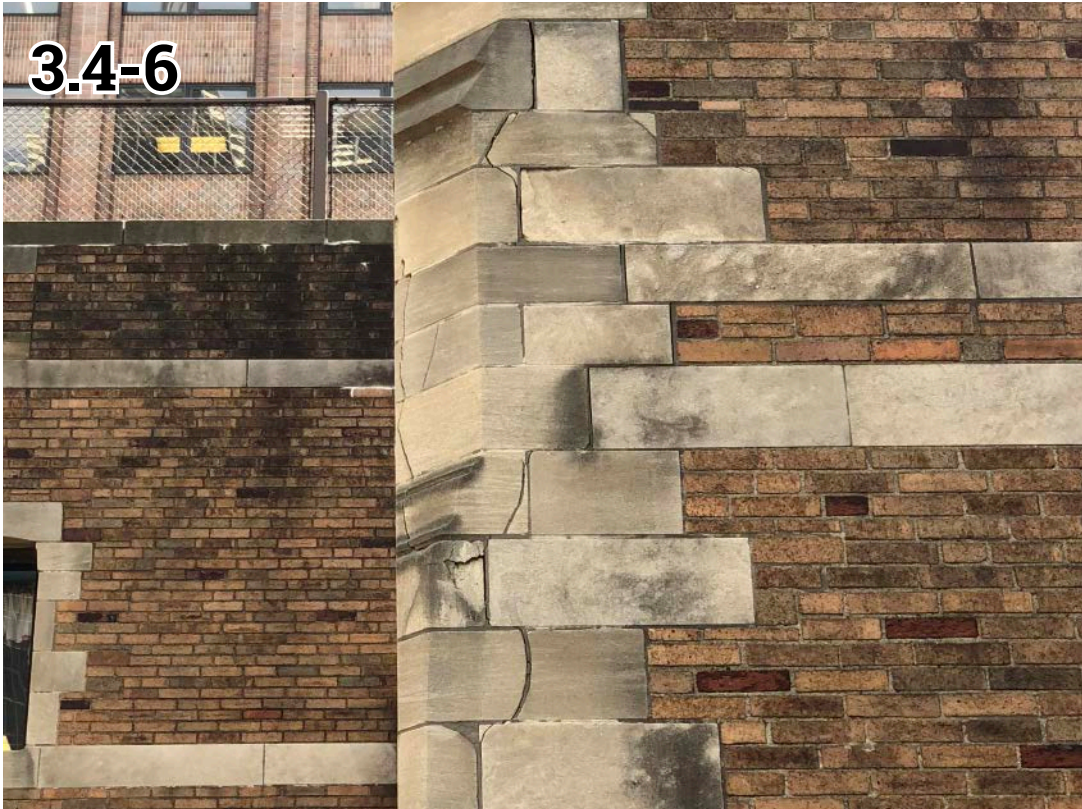
**3.4-6 North Facade**  
• Failing Mortar Joints  
• Cracked Stone

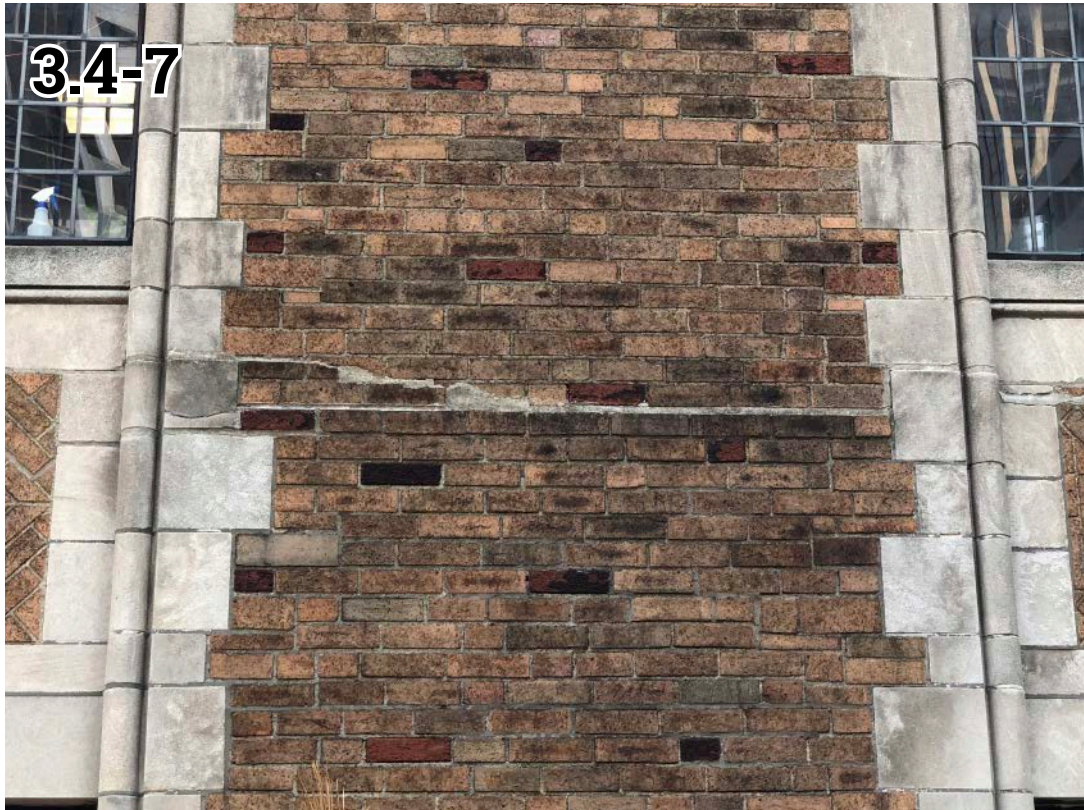
**3.4-7 West Facade Detail**  
• Rust Jacking

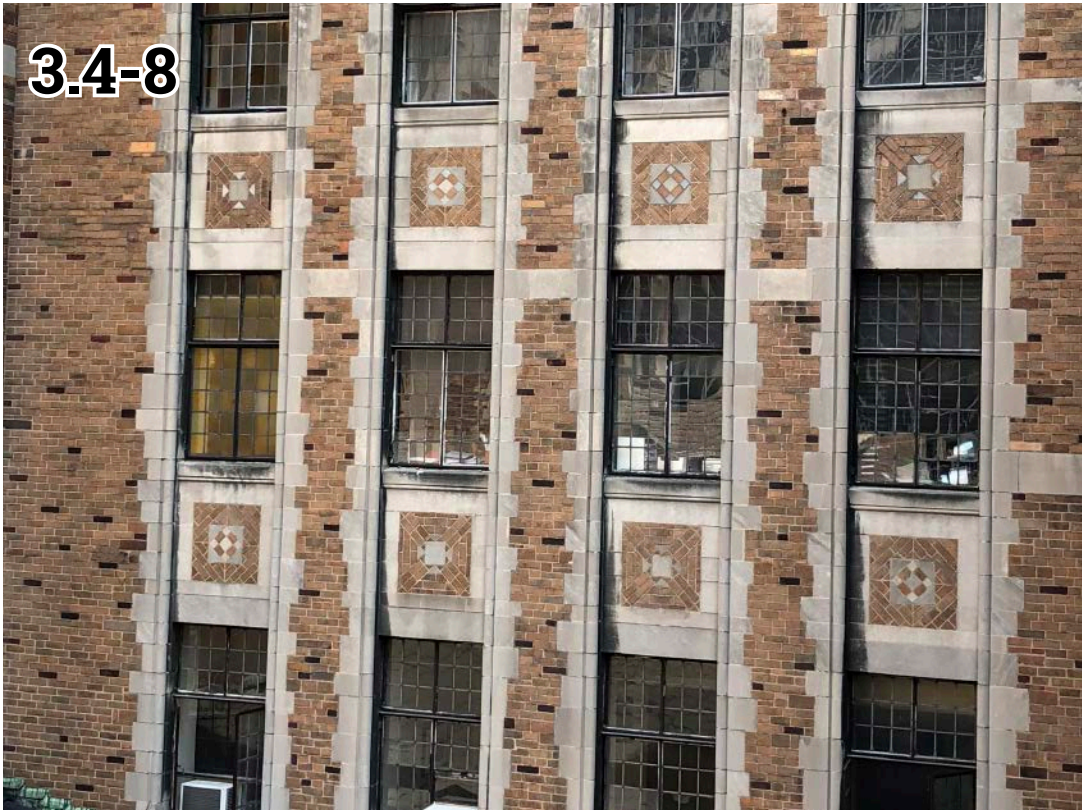
**3.4-8 Community House Facade**  
• Inefficient and Damaged Windows

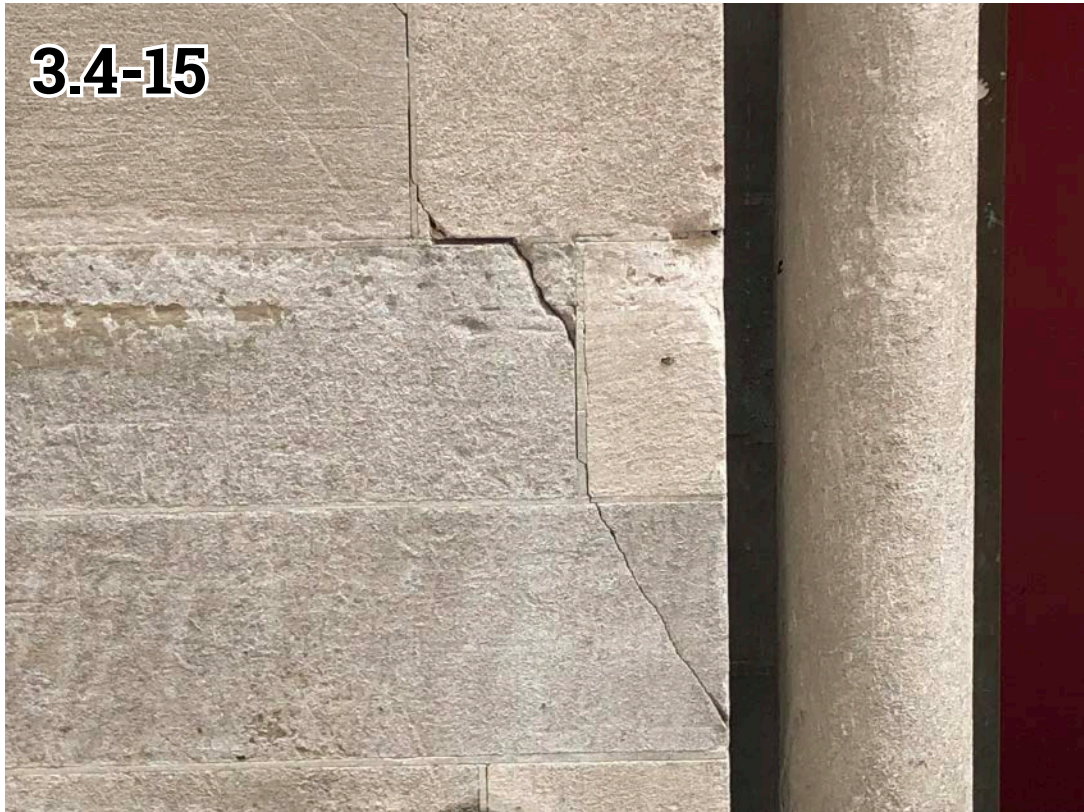
**3.4-15 Community House Entrance**

- Cracked Limestone

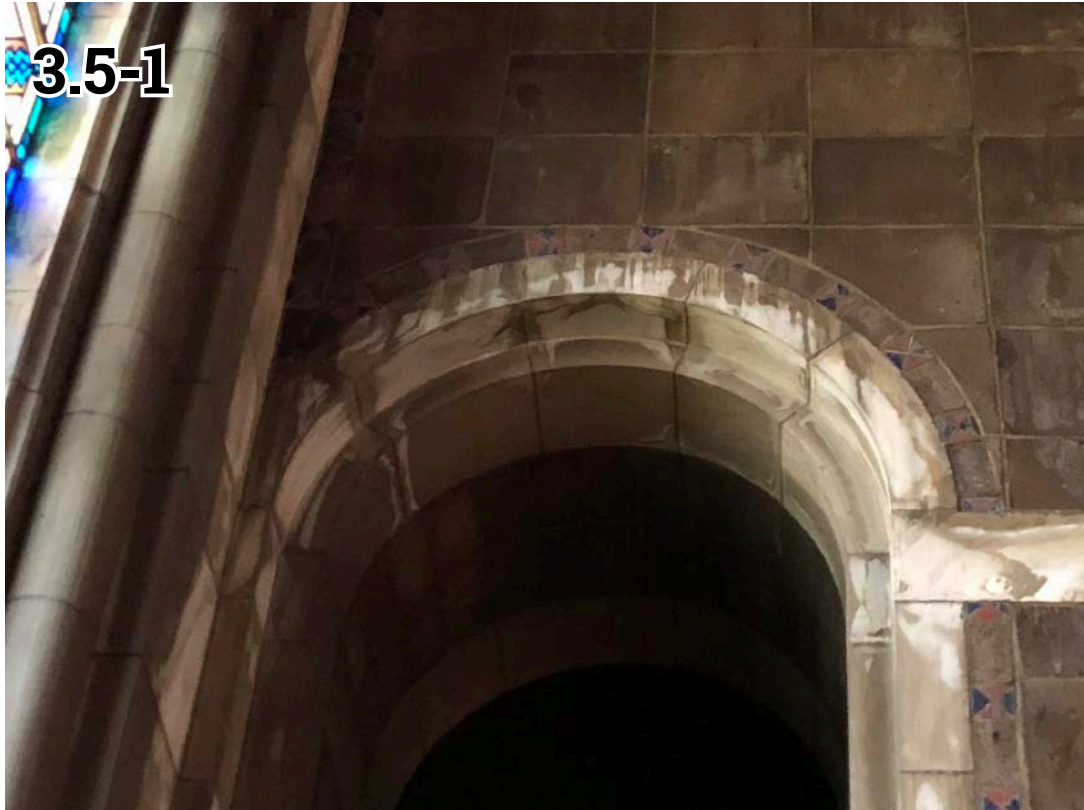
**3.5-1 Interior Water Damage**  
• Interior Damage Caused by Leaking Above

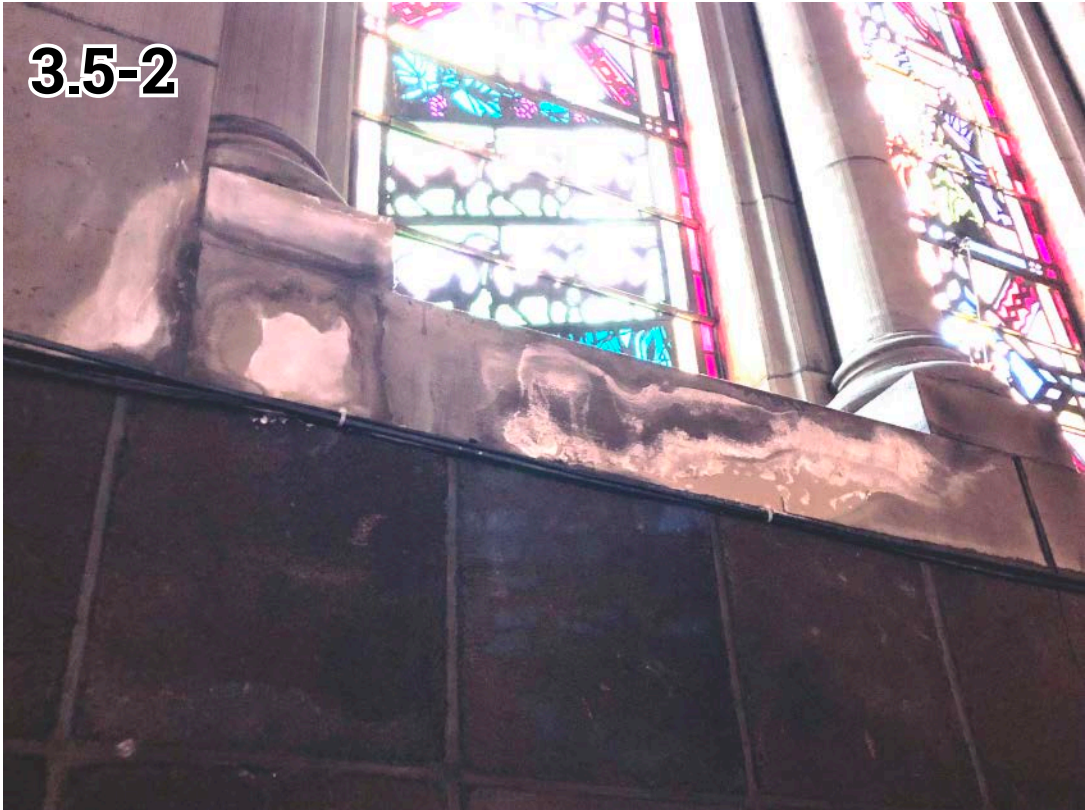
**3.5-2 Stained Glass Window**  
• At many stained-glass window locations, water infiltration is made apparent from visible staining at the window sill.

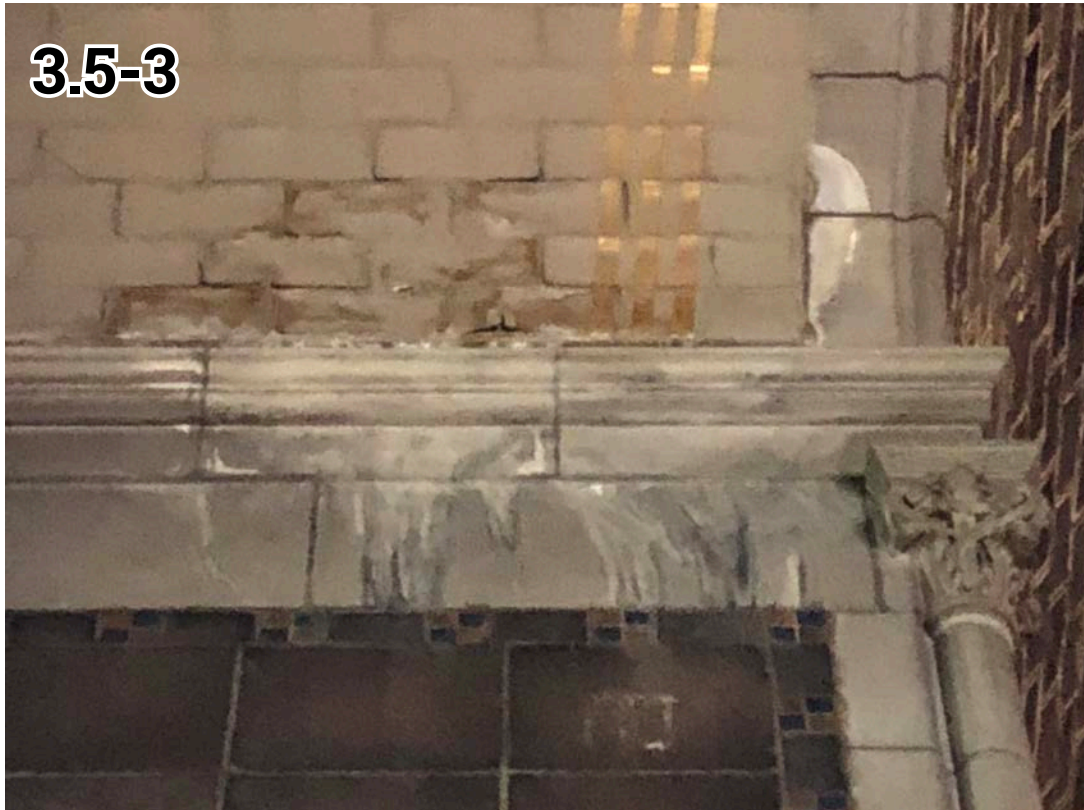
**3.5-3 Interior Water Damage**  
• Interior Damage Caused by Leaking Roof Above

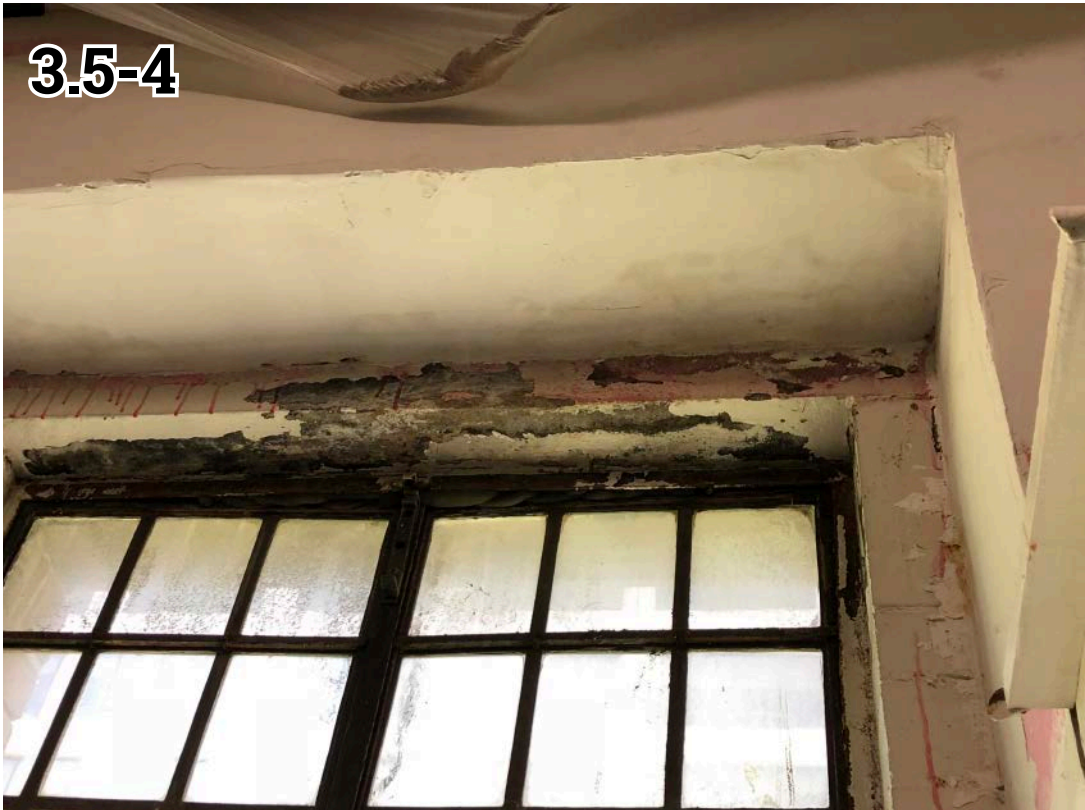
**3.5-4 Interior Water Damage**  
• Interior Damage Caused by Leaking At Lintel
