**CENTRAL SYNAGOGUE
CONDITIONS & MAINTENANCE OF
DESIGNATED LANDMARK**

LPC PRESENTATION

ADDRESS
652 LEXINGTON AVE
NEW YORK, NY 10022

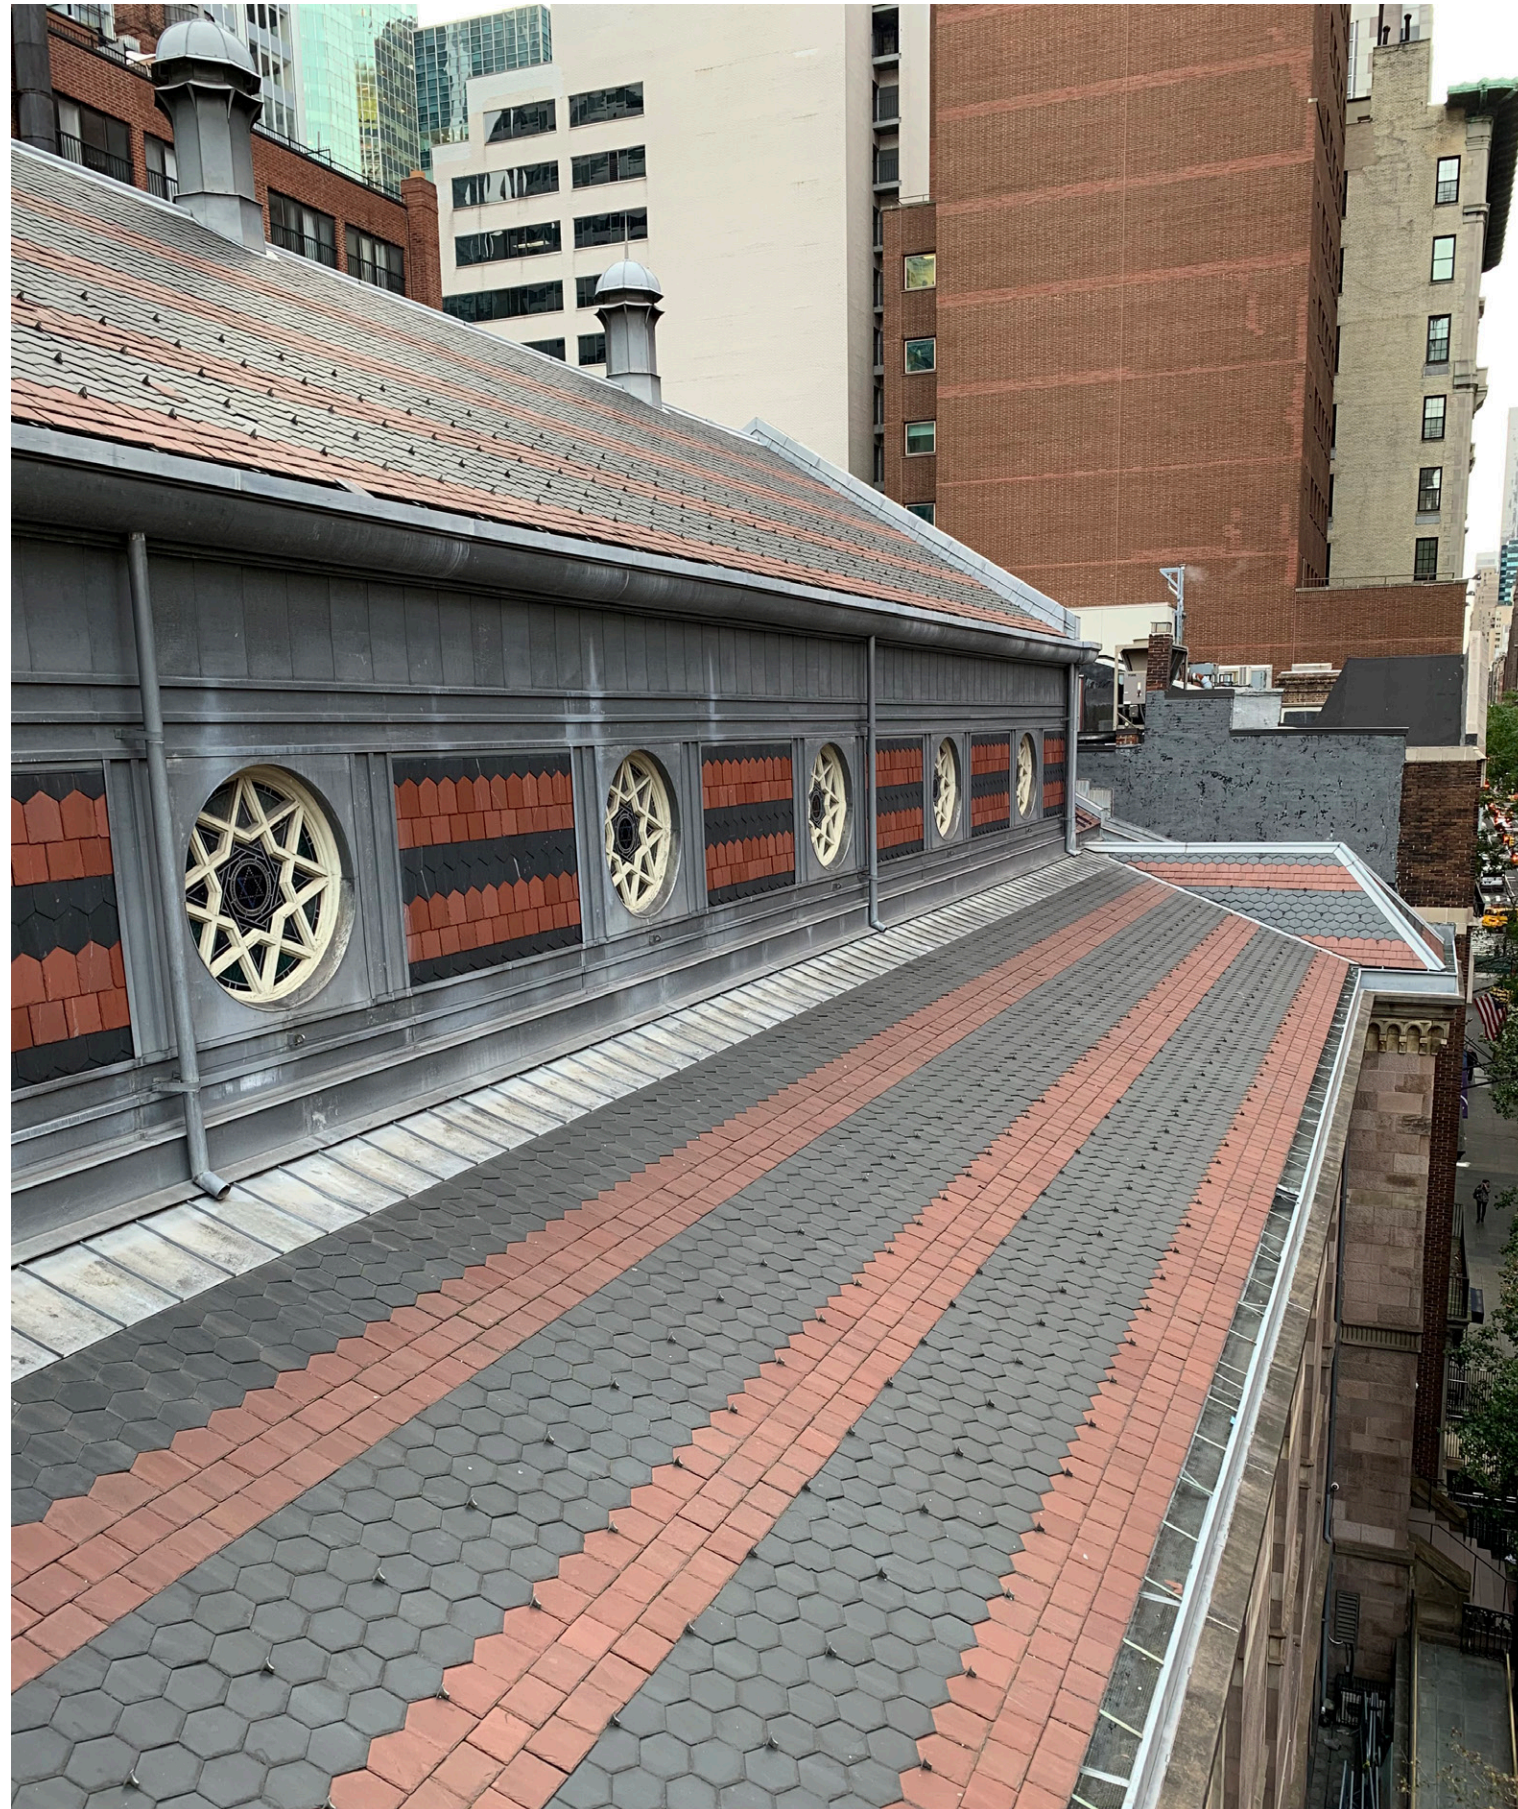
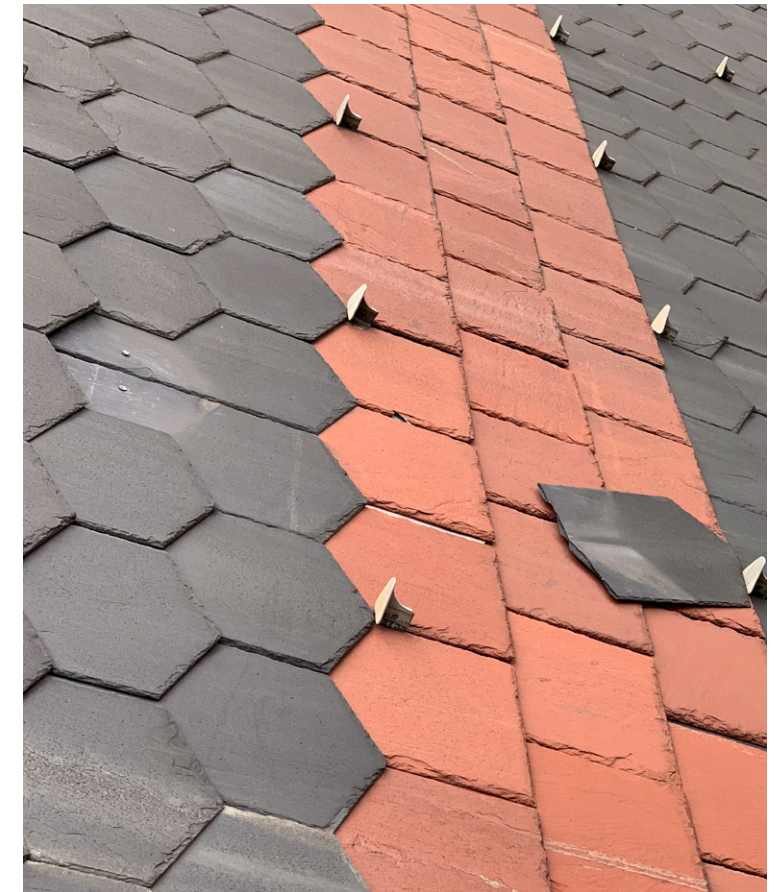
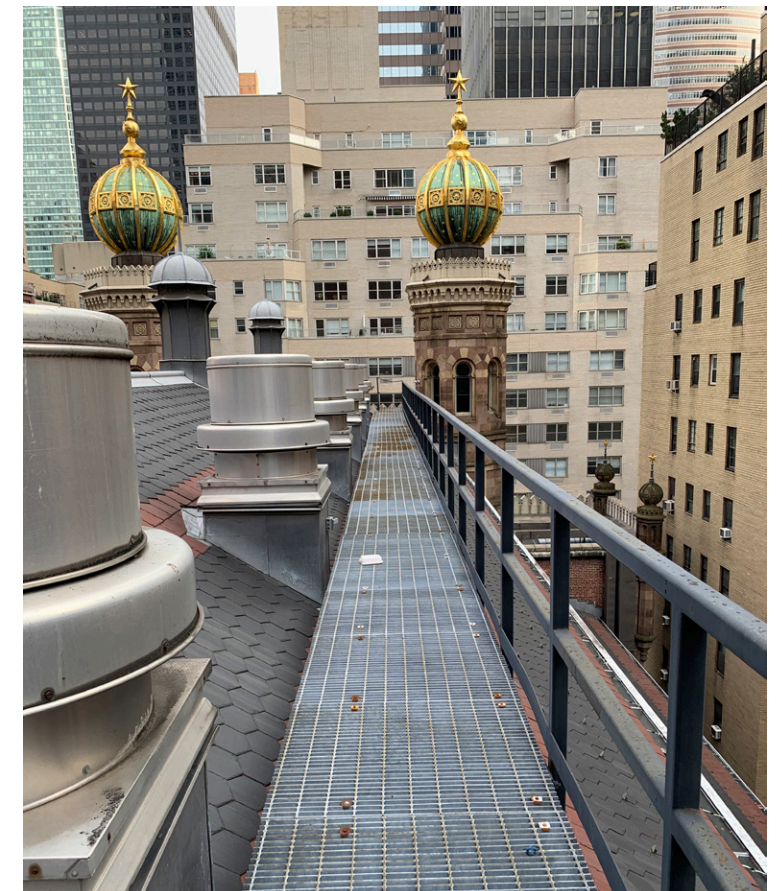
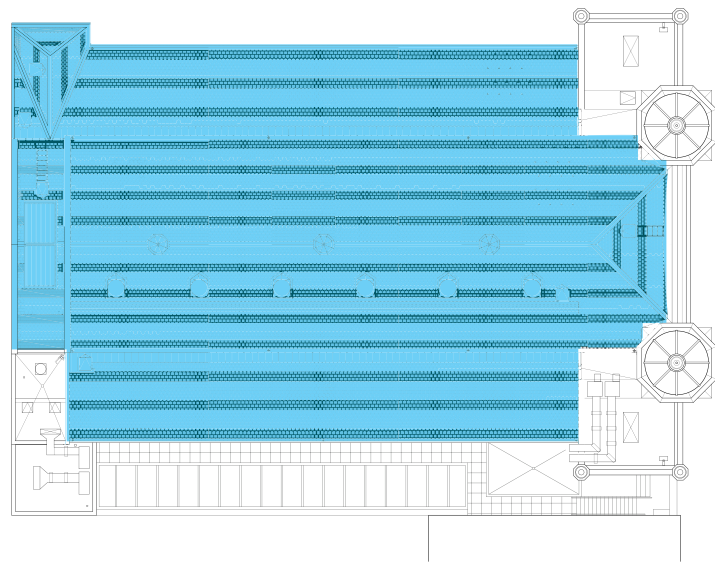
Main Slate Roofs

Condition: Good-to-Fair

- Existing conditions include damaged/displaced shingles, clogged gutters/downspouts, guardrail paint failure & rusted anchors at steel platform
- Selective maintenance & localized slate & flashing repairs recommended within 1-5 years
- Existing roof should last for 50 years before needing replacement; ancillary roofs should be replaced in 5-10 years

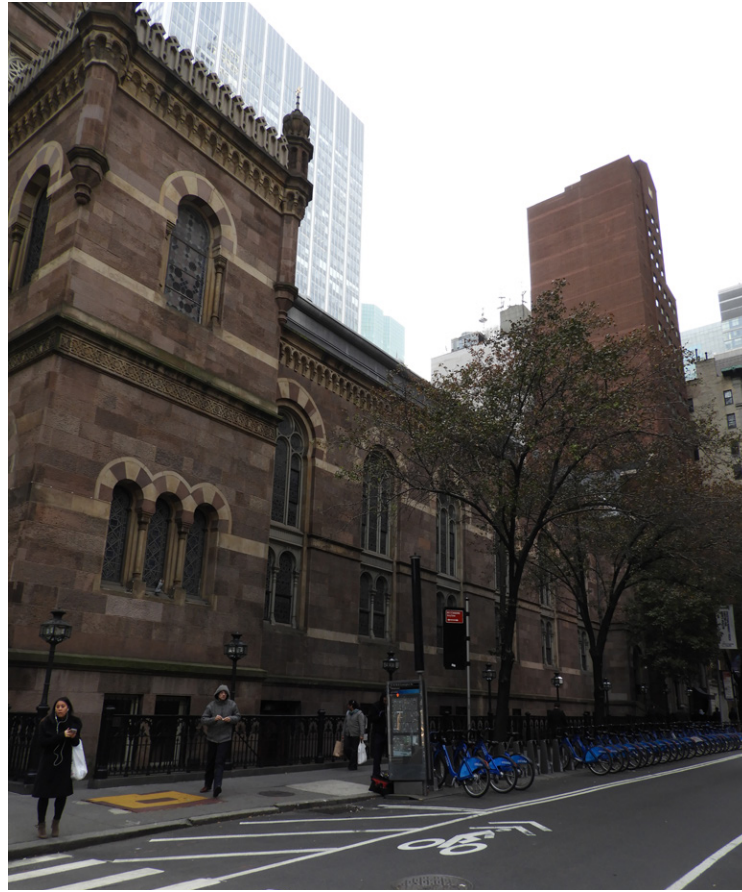
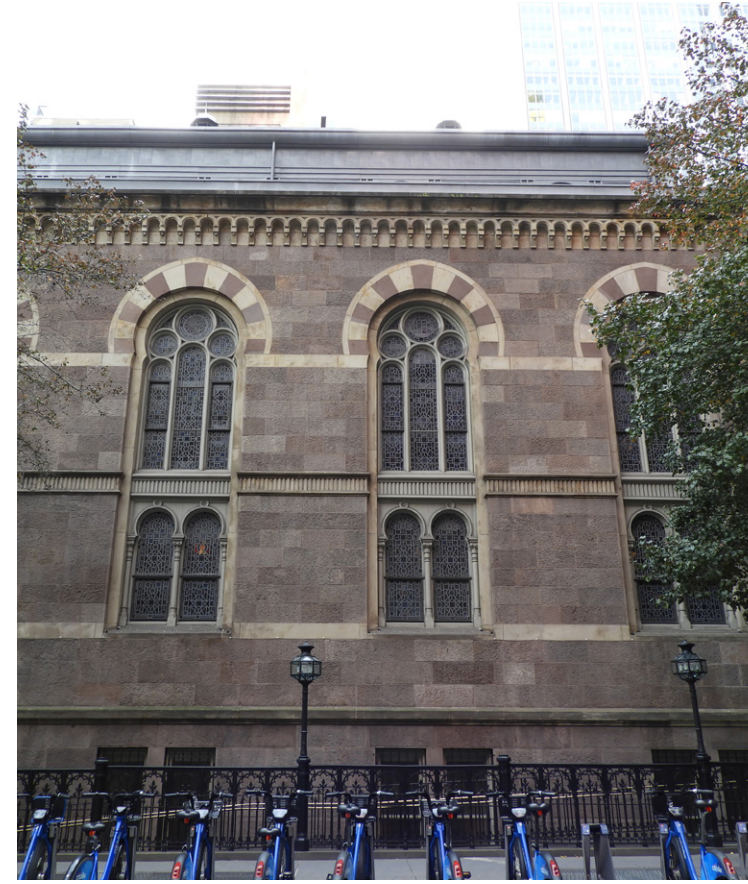
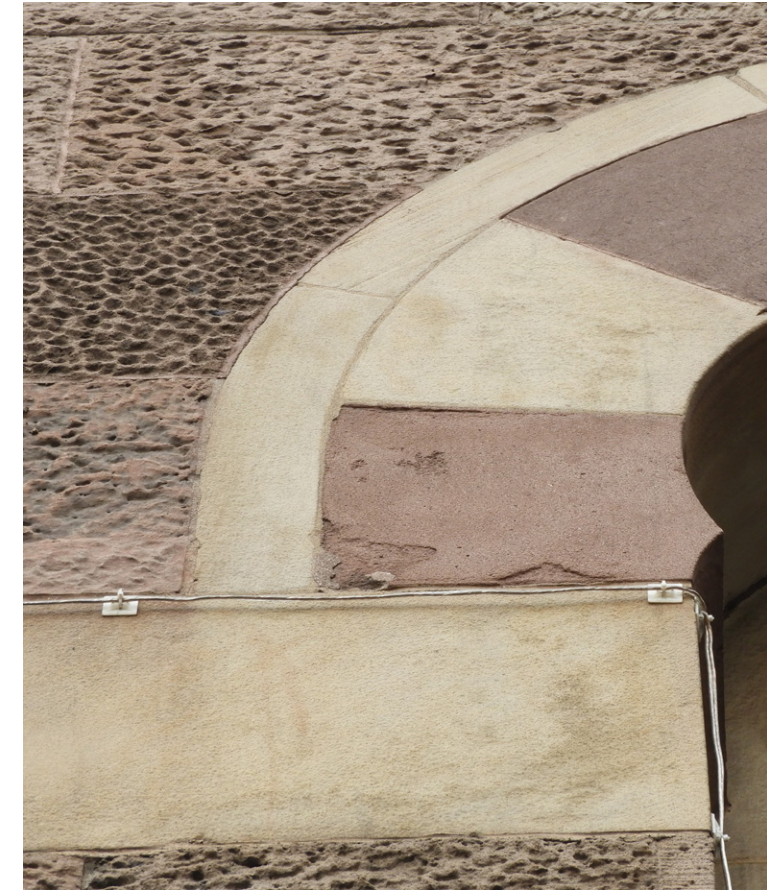
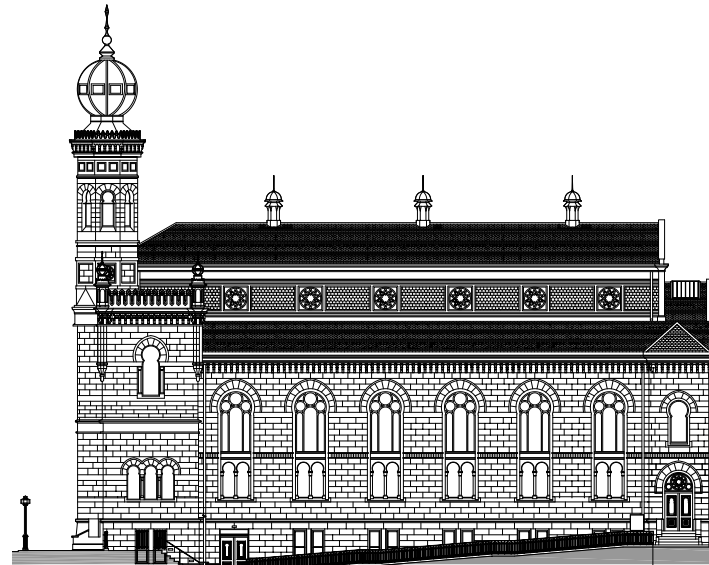
55th Street - North Elevation

Condition: Good-to-Fair

- Masonry shows areas of weathering and deterioration, with areas of cracked/spalled stone, open/cracked mortar joints, and soiled/stained masonry
- Selective maintenance & localized repairs recommended within 1-5 years
- Repairs should be anticipated every 5 years

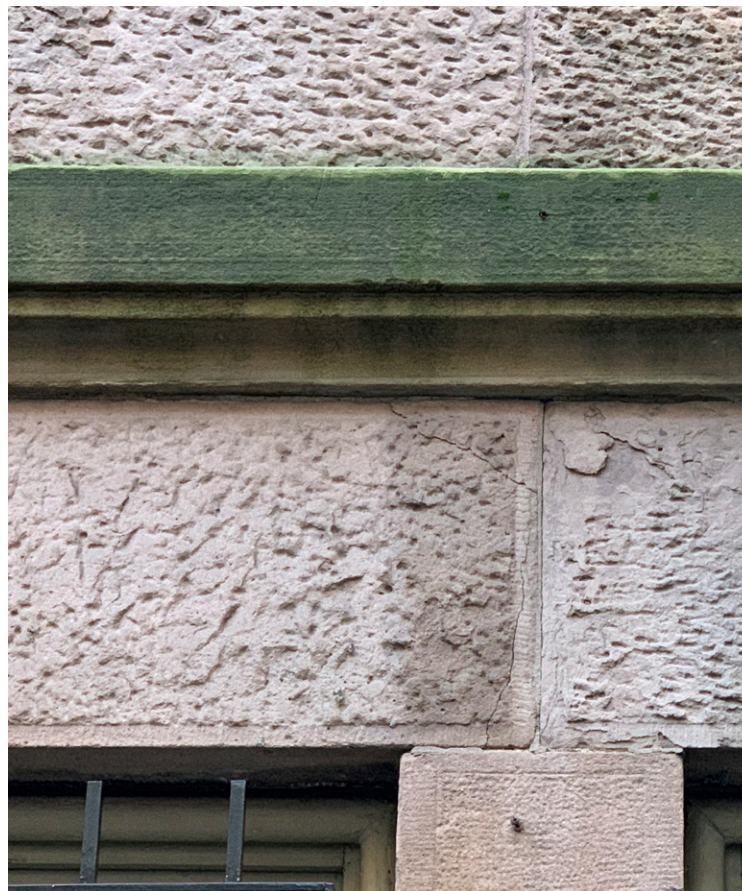
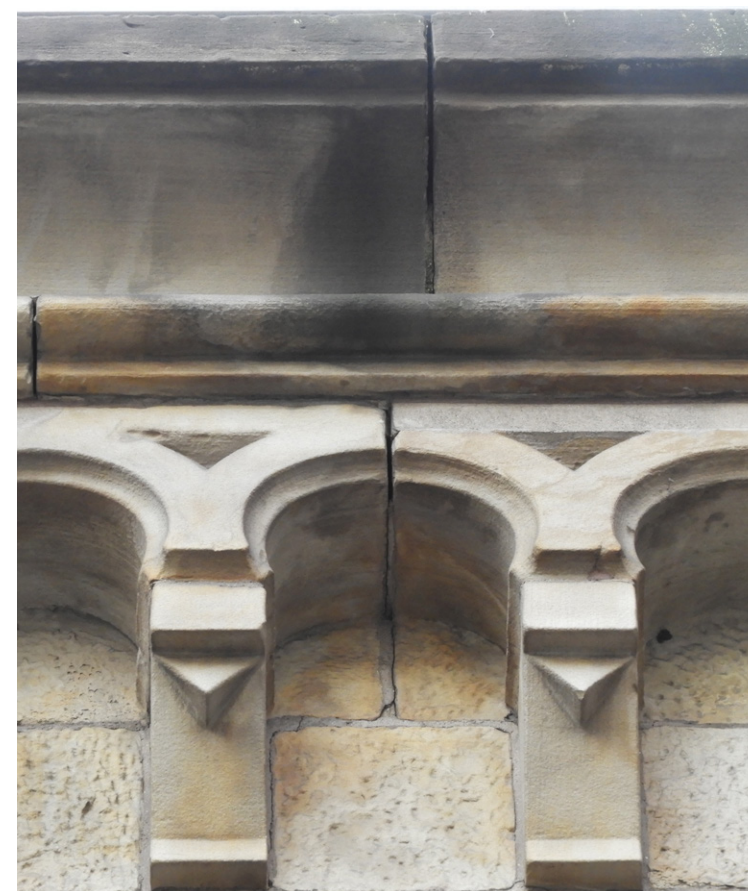
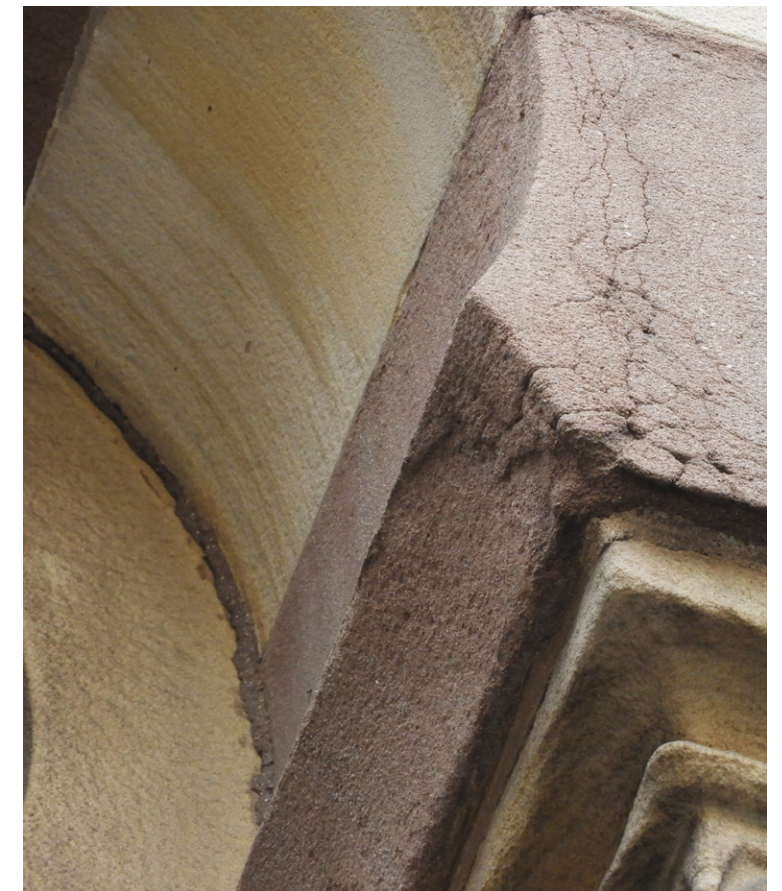
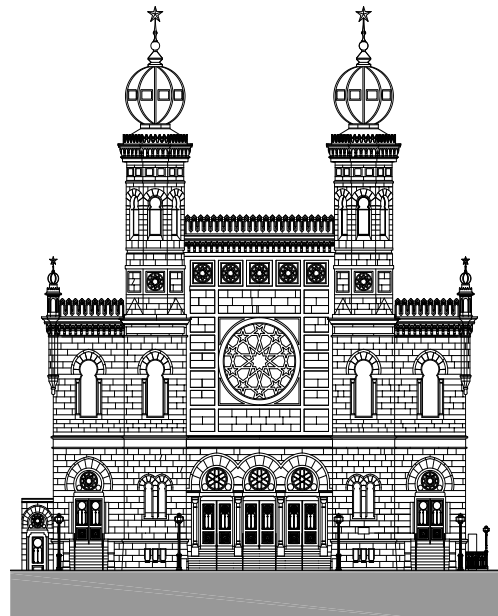
Lexington Ave - East Elevation

Condition: Good-to-Fair

- Masonry shows areas of weathering and deterioration, with areas of cracked/spalled stone, open/cracked mortar joints, and soiled/stained masonry
- Selective maintenance & localized repairs recommended within 1-5 years
- Repairs should be anticipated every 5 years
