Re: West-Park Presbyterian Church  
165 West 86<sup>th</sup> Street, Manhattan  
(Block 1217, Lot 1) ("Property")

West Park Presbyterian Church  
165 West 86<sup>th</sup> Street, Manhattan  
Block 1217, Lot 1

Application to Landmarks Preservation Commission  
Pursuant to Administrative Code § 25-309 for a Notice to Proceed  
Authorizing Demolition on the Grounds of Insufficient Return

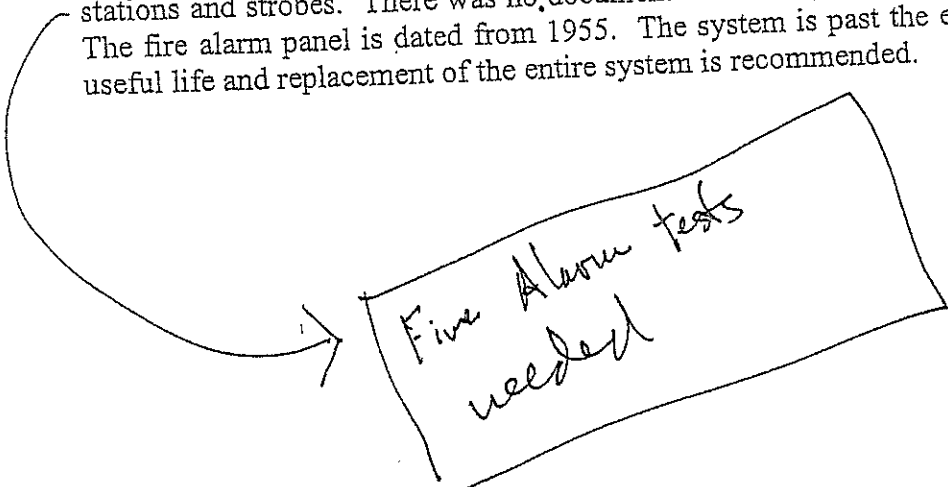
The building is provided with a fire alarm system. Some areas are provided with pull stations and strobes. There was no documentation of any recent overall system tests. The fire alarm panel is dated from 1955. The system is past the end of its expected useful life and replacement of the entire system is recommended.

Fire Alarm tests  
needed

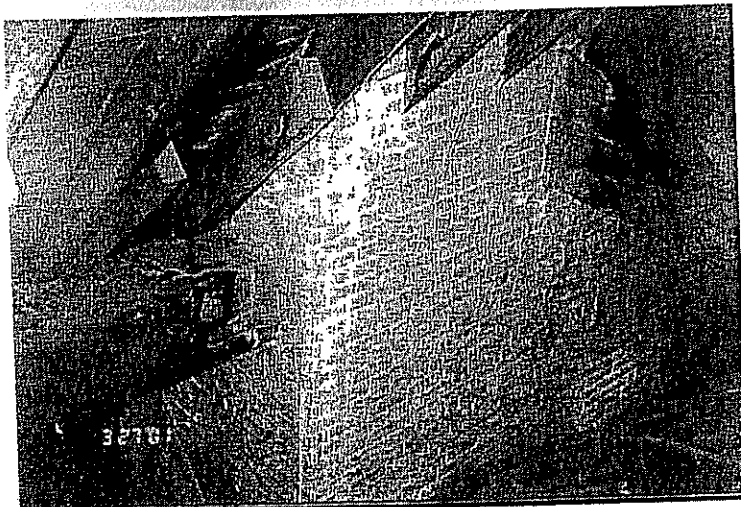
Photo S2: Water staining

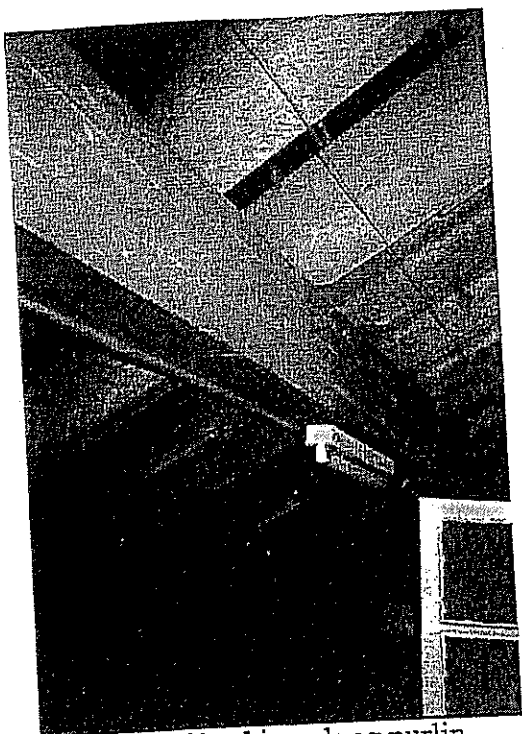
Photo S3: Checking along purlin.

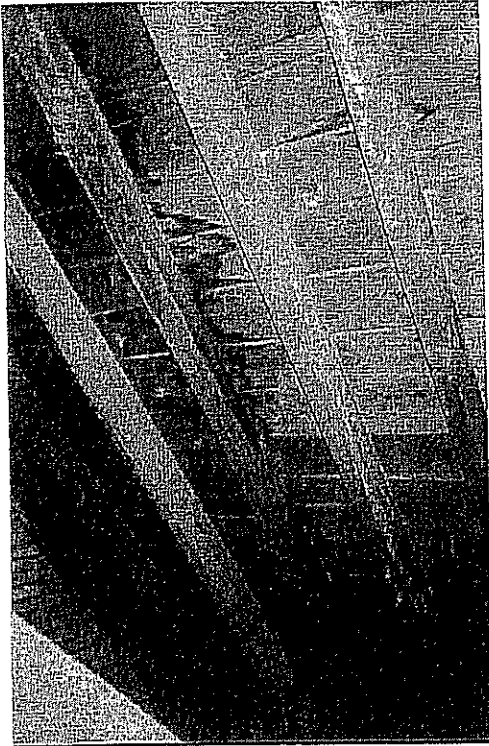
Photo 1: Water staining at roof planks, typical.

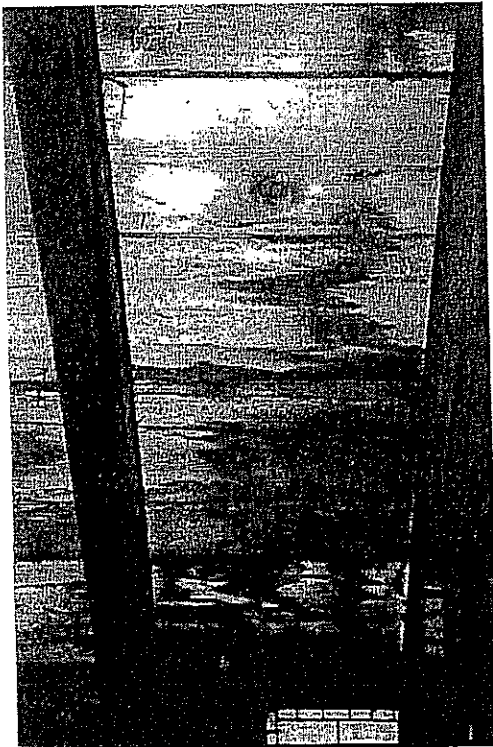
Photo 2: Concentrated water staining at small southeast dormer.

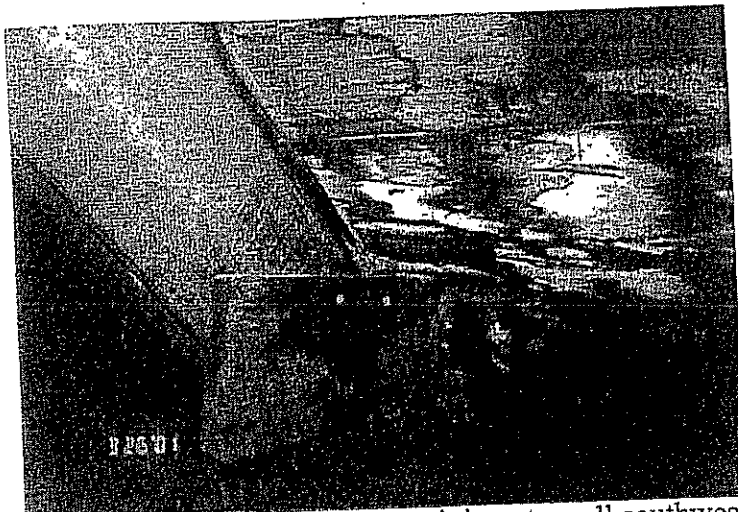
Photo 3: Concentrated water staining at small southwest dormer.

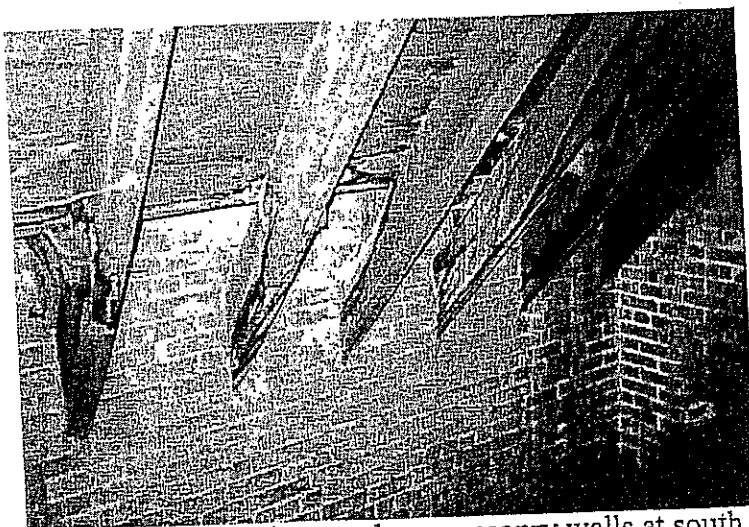
Photo 5: Water stains run down masonry walls at south face.

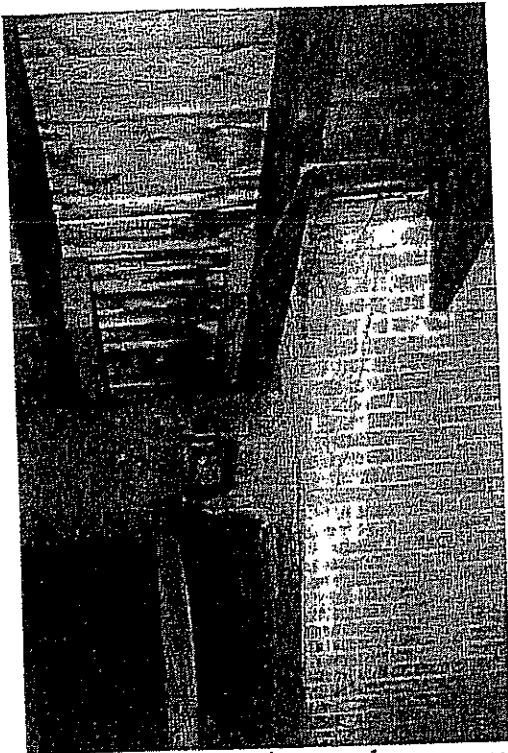
Photo 6: Water stains run down masonry walls at bell tower.

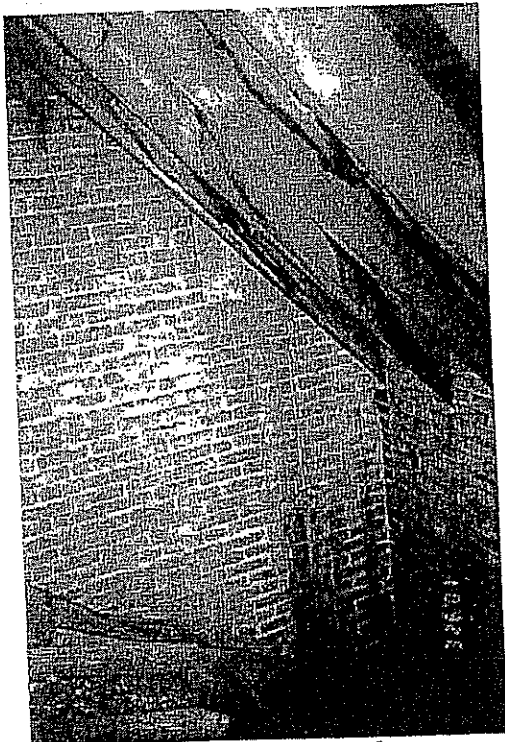
Photo 7: Water stains run down masonry walls at northwest stair tower.

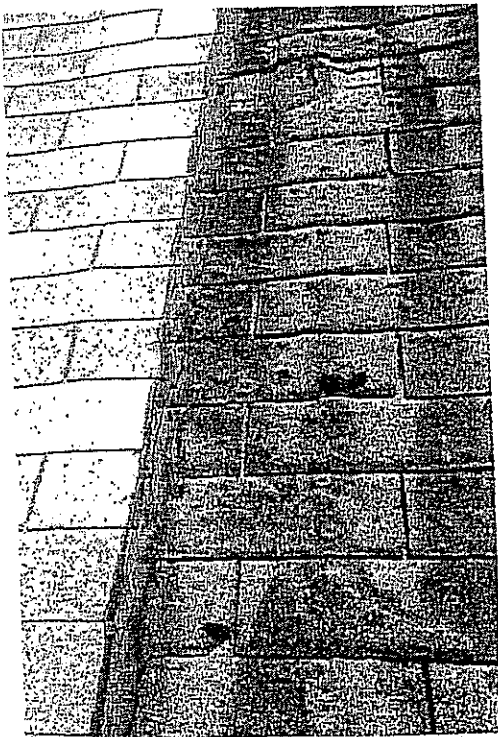
Photo 11: Deteriorated asphalt shingles, poor asphalt patching, and poor sealant between old and new shingles.

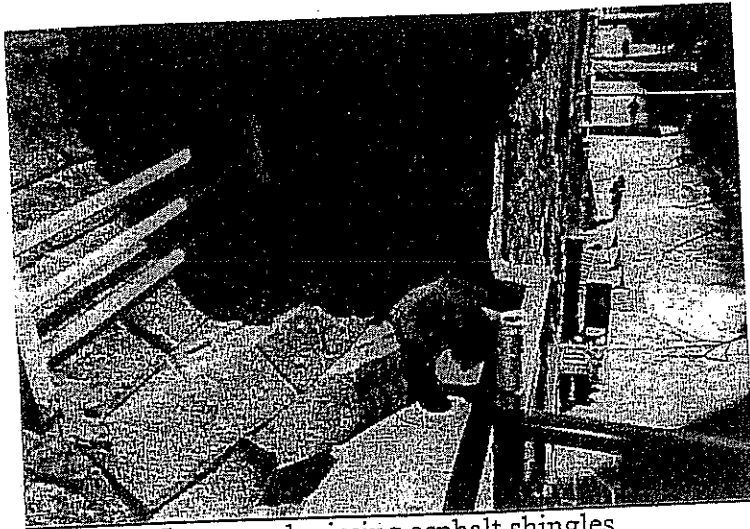
Photo 12: Loose and missing asphalt shingles.

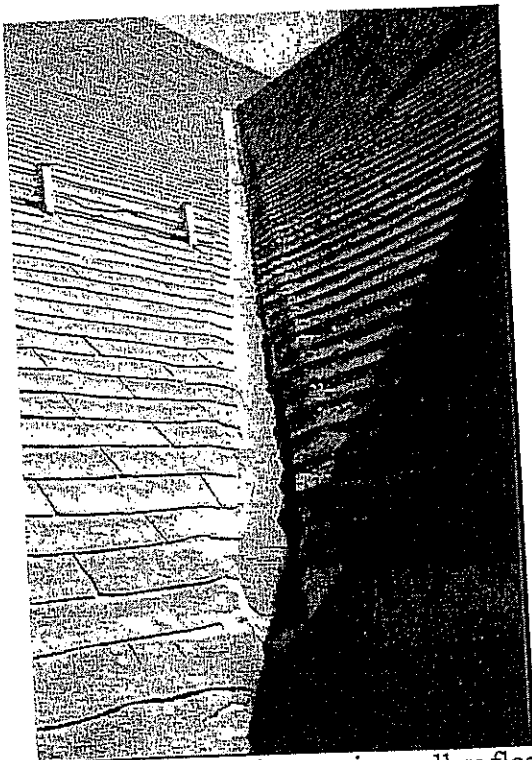
Photo 13: Asphalt covering valley flashing.

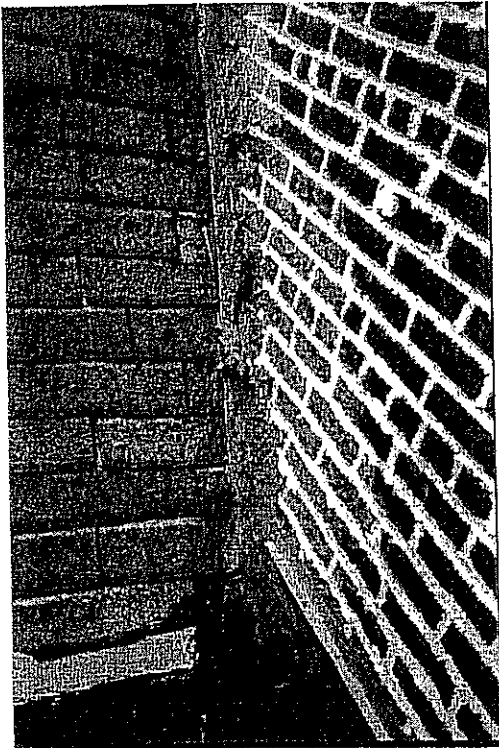
Photo 15: Damaged counterflashing and poor sealant.

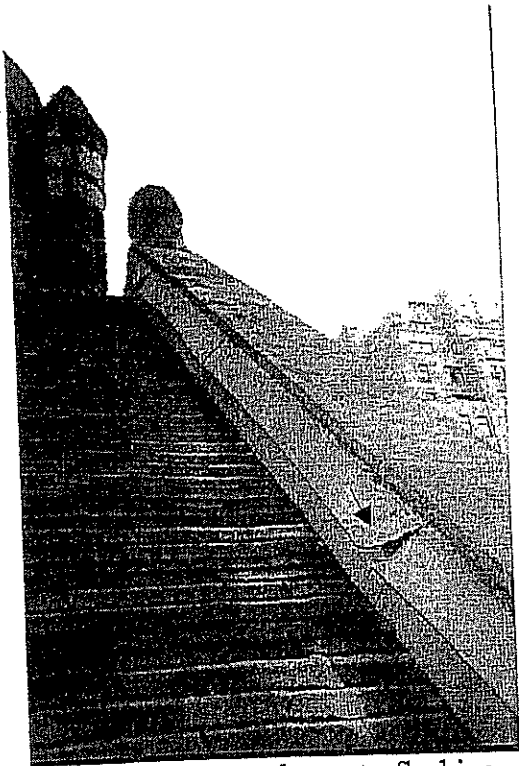
Photo 16: Damaged counterflashing.

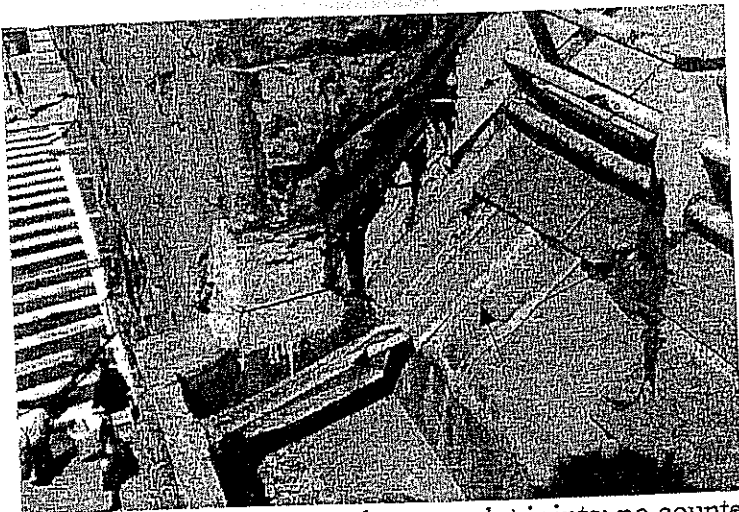
Photo 17: Asphalt mopped over reglet joints; no counterflashing around snow guard roof penetration; roof flashing flat seams pulling apart; gutter tie back seams split open.

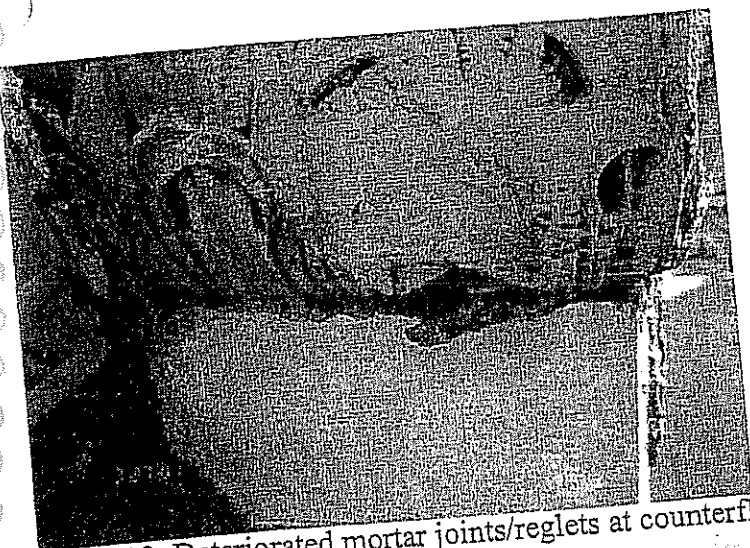
Photo 18: Deteriorated mortar joints/reglets at counterflashing.

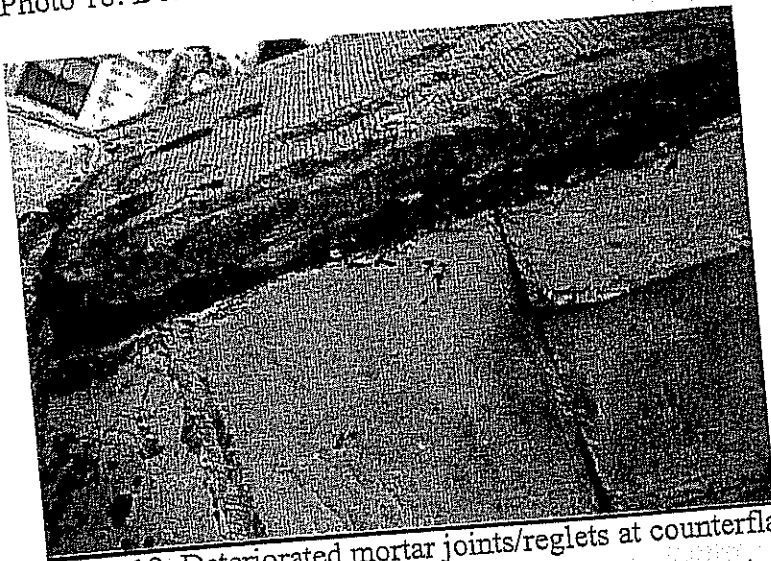
Photo 19: Deteriorated mortar joints/reglets at counterflashing.

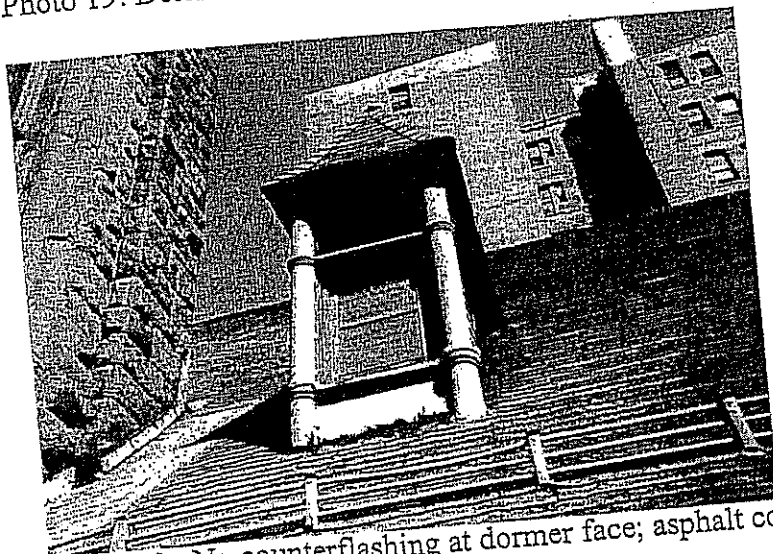
Photo 20: No counterflashing at dormer face; asphalt covering mopped over intersection.

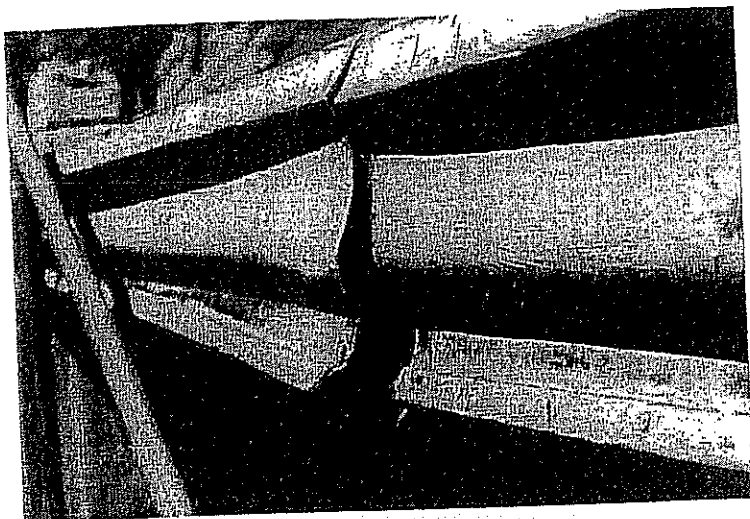
Photo 21: Loose gutter.

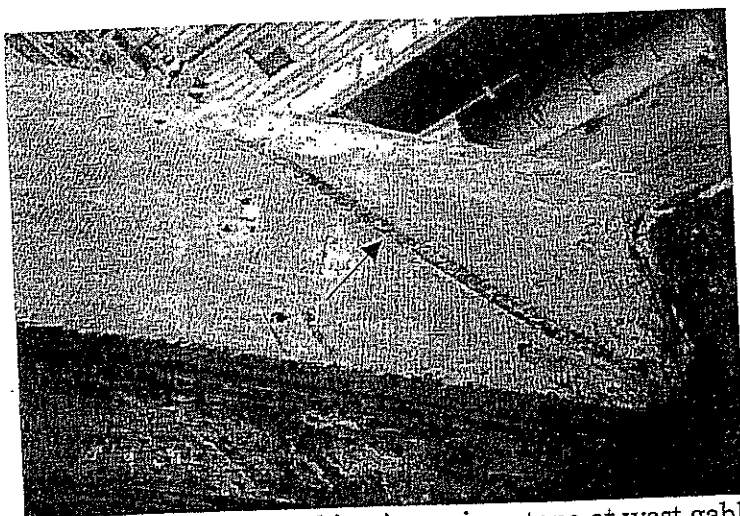
Photo 22: Severe cracking in coping stone at west gable.

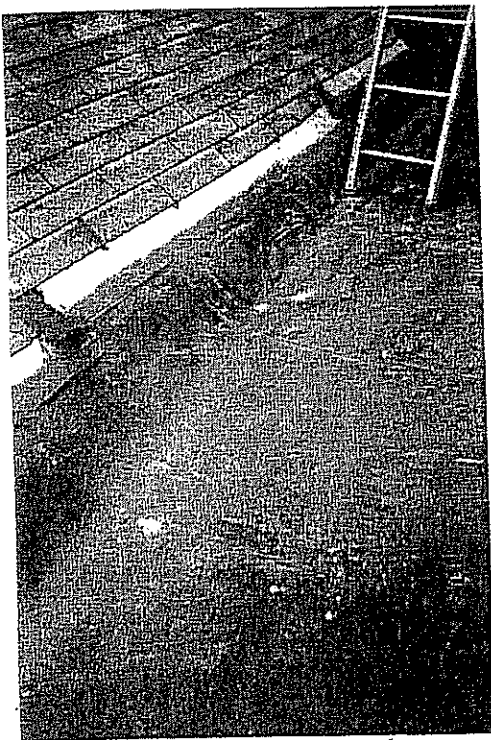
Photo 23: Warped roof membrane with soft spots at north gutter area.

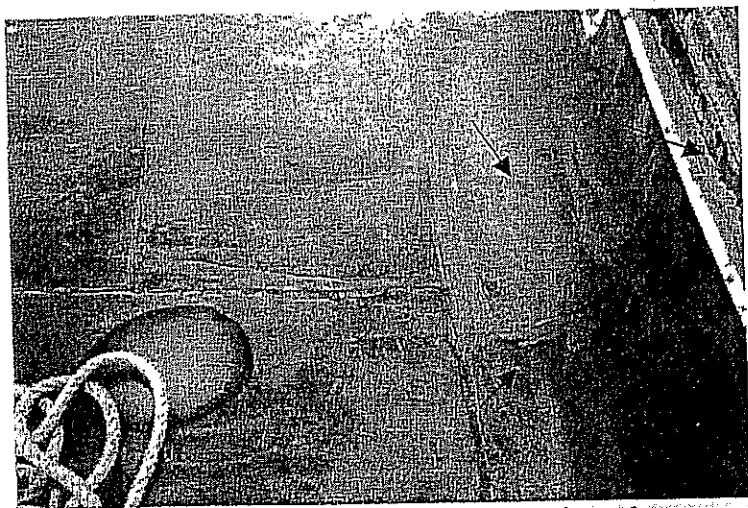
Photo 28: Roof membrane and asphalt sealant show cracking and poor pliability.

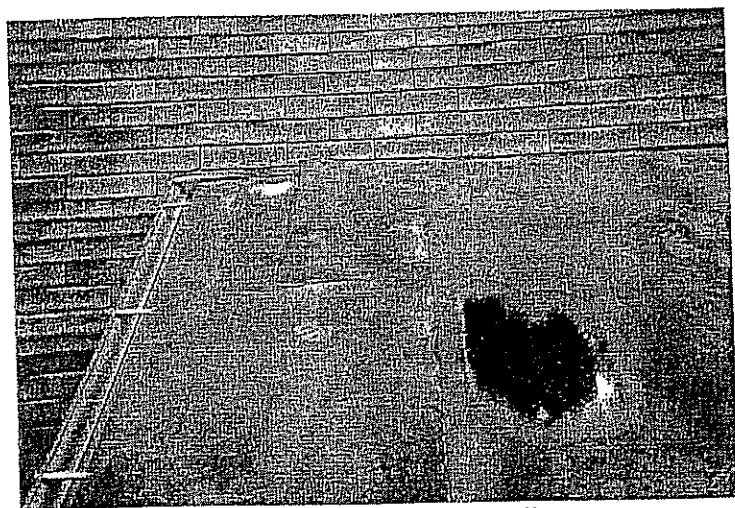
Photo 29: Inappropriate slope and ponding water.

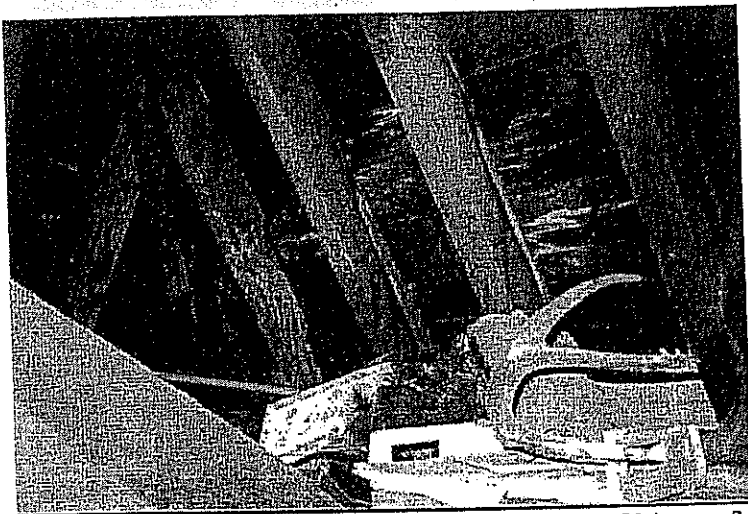
Photo 31: Water staining at northeast corner of hip roof.

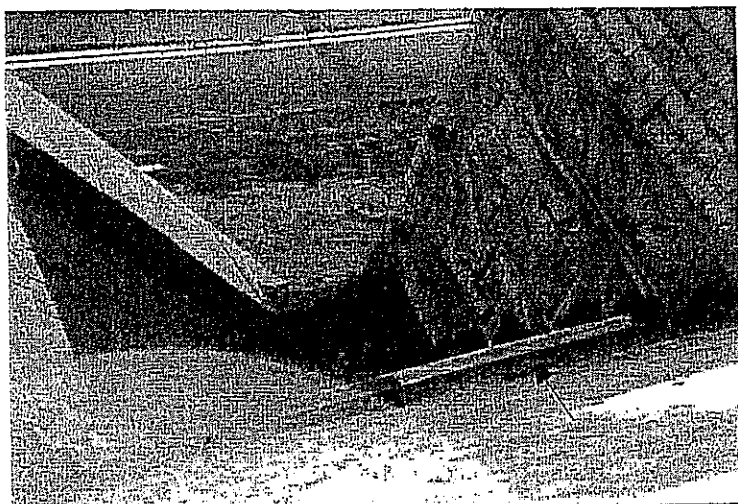
Photo 34: No cricket at skylight curb.

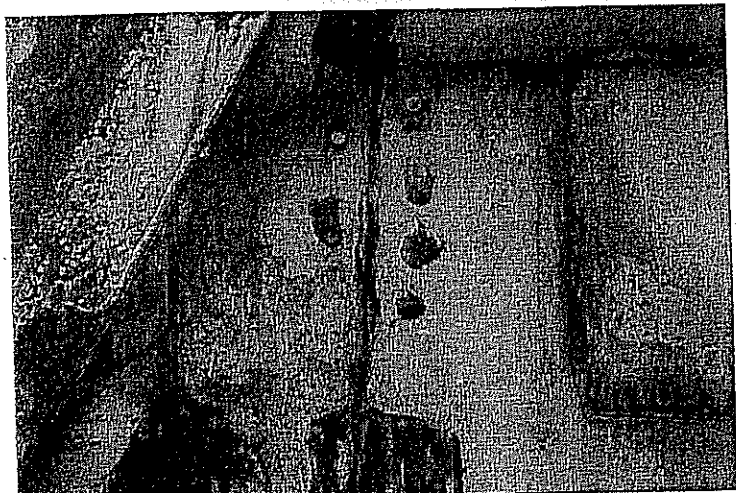
a sounding hammer, the northeast corner and east face appear to be in worse condition. Although difficult to sound in place, the slate was easily dented with only light action of the plastic headed hammer. The slate exhibits high surface flaking and heavy erosion is visible, often creating holes all the way through the slate tile. Additionally, the copper ridge covers show heavy damage with many holes and poor sealant (See Photos 35 & 36).

Photo 36: Poor repairs at slate tile.

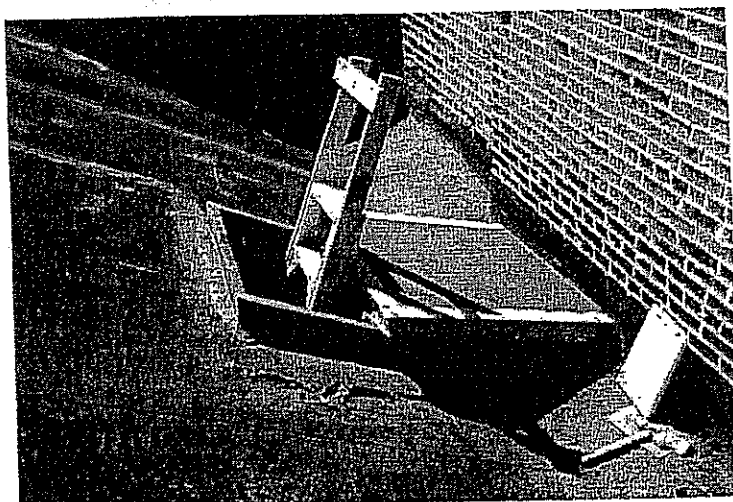
The main shallow gable, covering the northern portion of the administrative wing, is covered in asphalt roll roofing. At the east and west sides are large flat gutter areas covered by similar asphalt roll roofing, which taper towards the leaders and downspouts at the north end of the gable. In addition to the roof hatch, two skylights penetrate the roof, near the ridge, and an area covered in standing seam copper, which was probably an older skylight, also at the ridge. The skylights and area of standing seam copper appear to be in generally good condition, however, the skylight curbs include no cricket for water drainage and pooling water was present. The roof hatch includes asphalt sheet flashing, which is now torn and pulling away. No cricket was included at the top edge of the hatch, allowing water running down the gable to crash into the curb and penetrate under the hatch, rather than be diverted. Sediment is visible collecting along the top edge of the curb (See Photo 37).

Photo 37: Sediment at roof hatch curb; no cricket at curb.

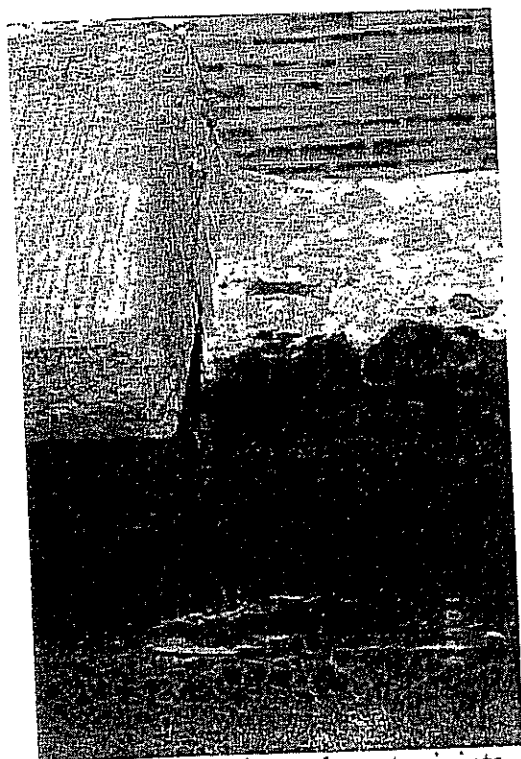
Photo 38: Deteriorated mortar joints, flashing, and asphalt sealant.

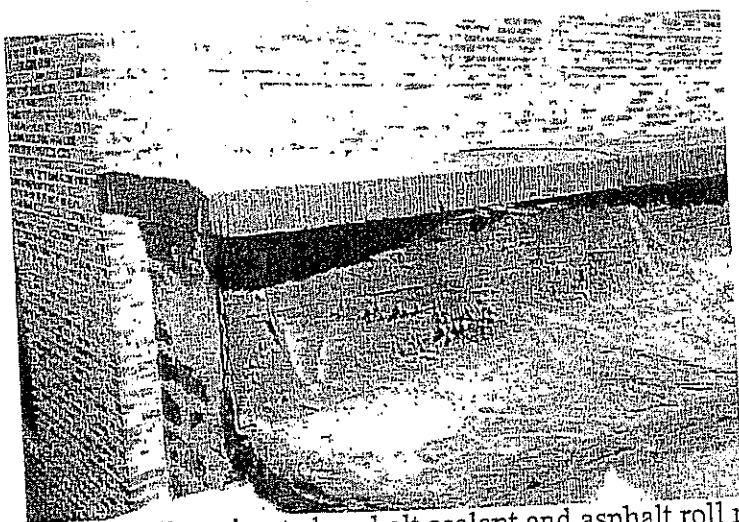
Photo 39: Deteriorated asphalt sealant and asphalt roll roofing.

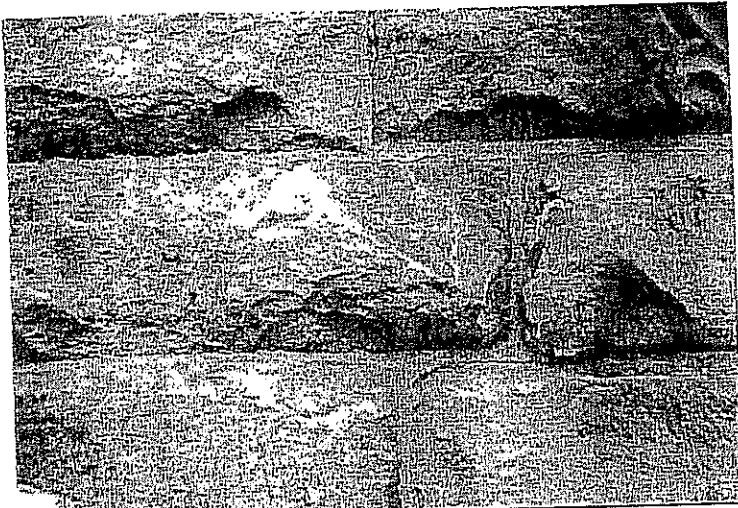
Photo 42: Deteriorated brownstone.

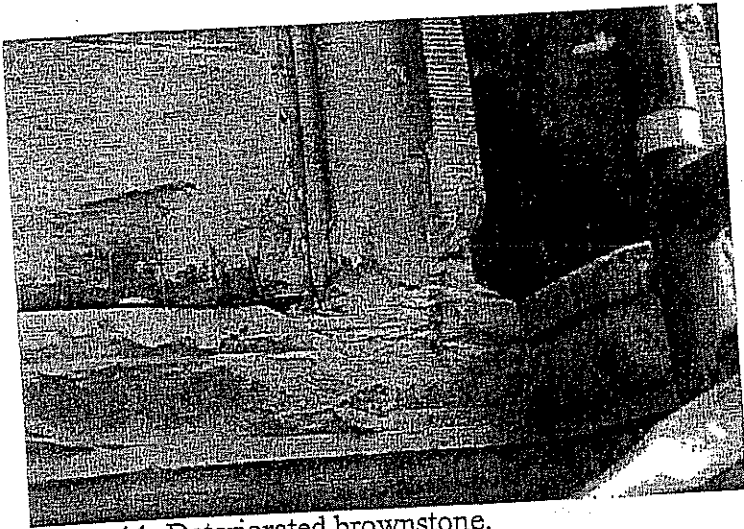
Photo 44: Deteriorated brownstone.

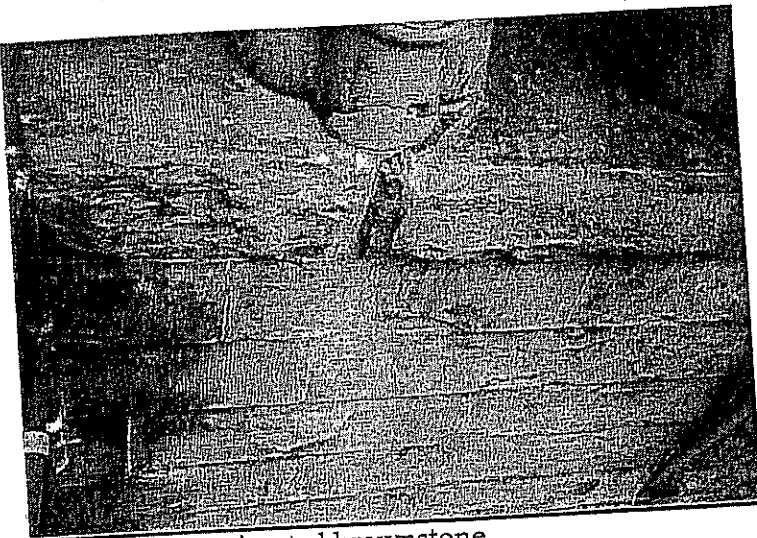
Photo 45: Deteriorated brownstone.

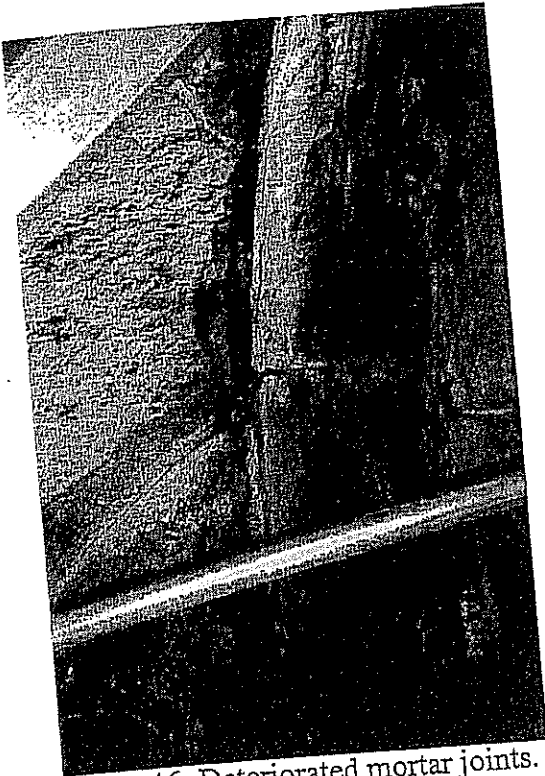
Photo 46: Deteriorated mortar joints.

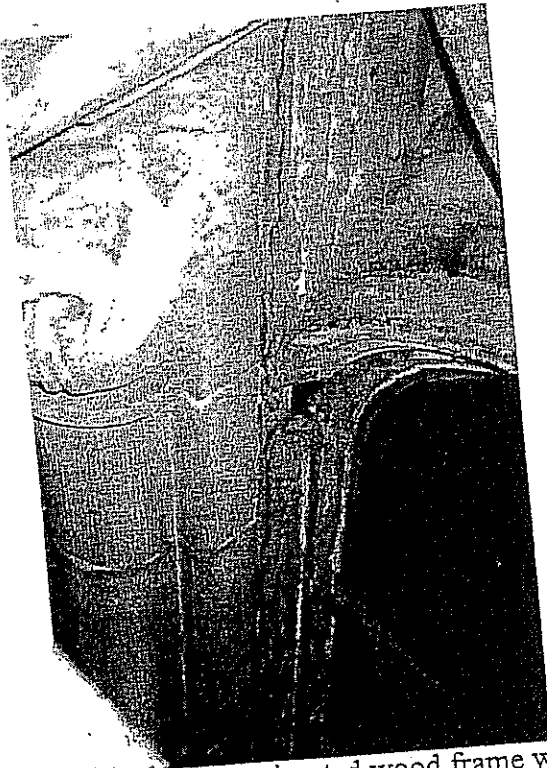
Photo 47: Deteriorated wood frame windows in danger of falling out.

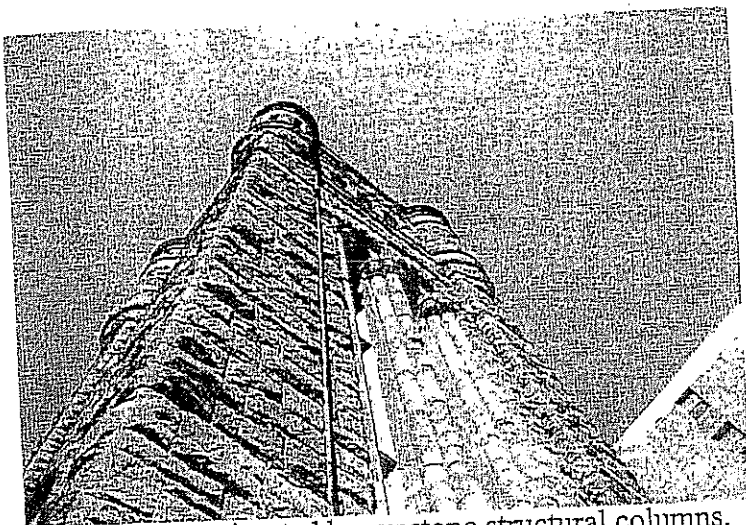
Photo 48: Deteriorated brownstone structural columns.

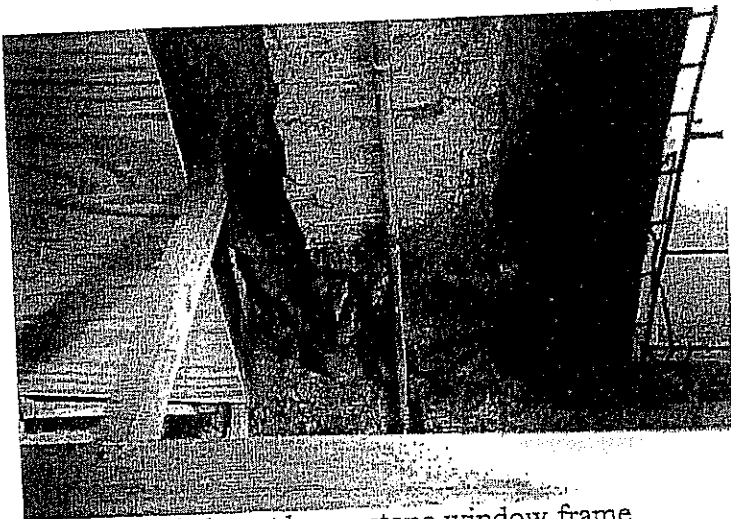
Photo 49: Undercut brownstone window frame.

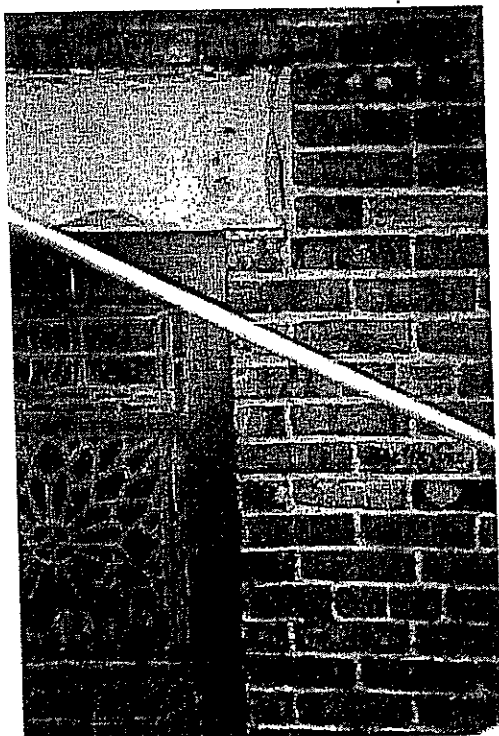
Photo 51: Cracks through masonry, running from head to sill.

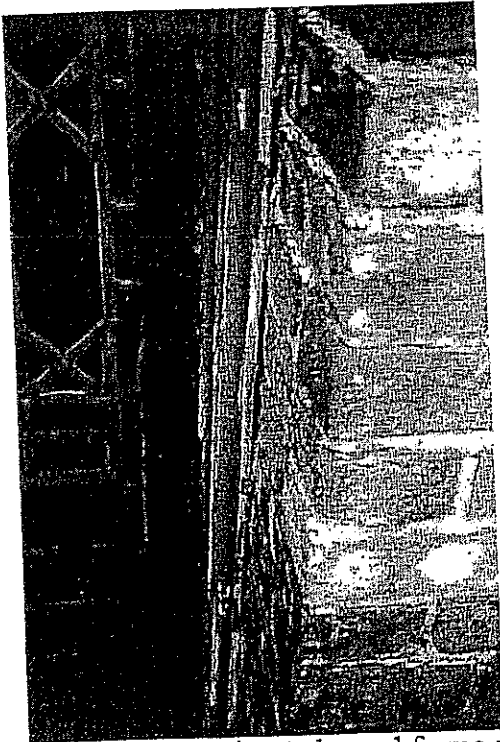
Photo 52: Deteriorated wood frame and sealant; very little is holding glass back.

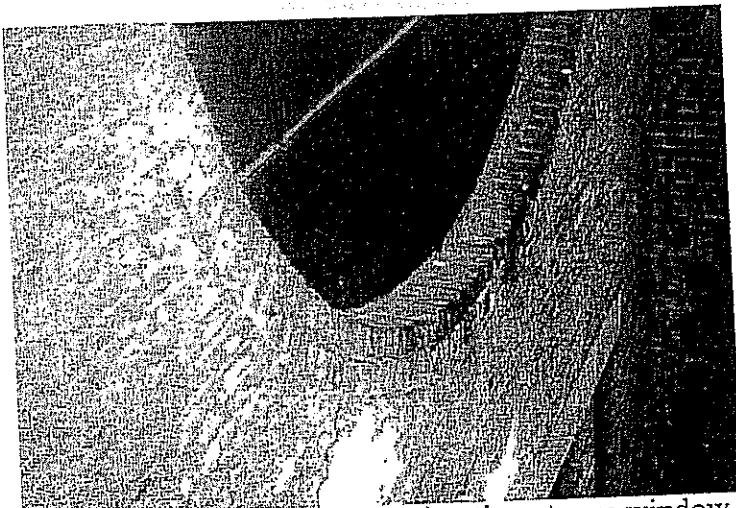
Photo 53: Brick and joint deterioration at rose window sill.

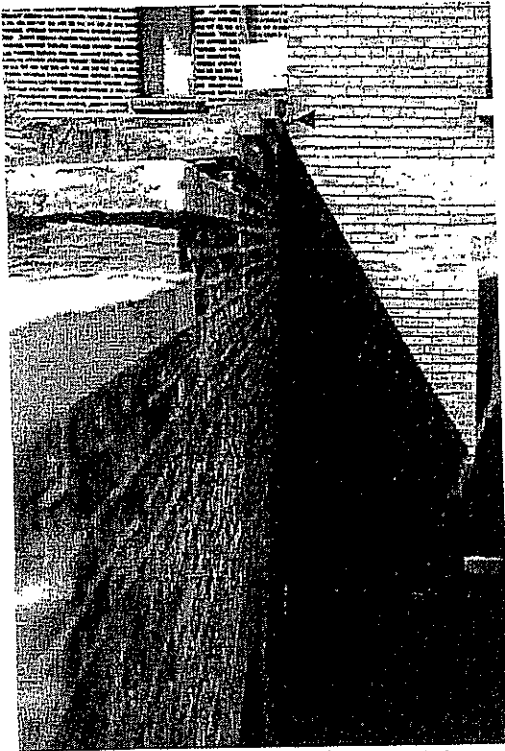
Photo 54: Wall and parapet lean inwards.

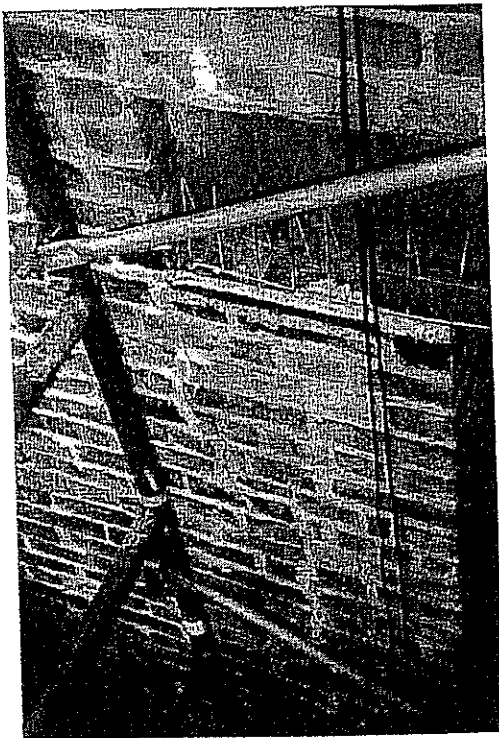
Photo 55: Cracks through brick running from head to sill to head; corroded steel lintel.

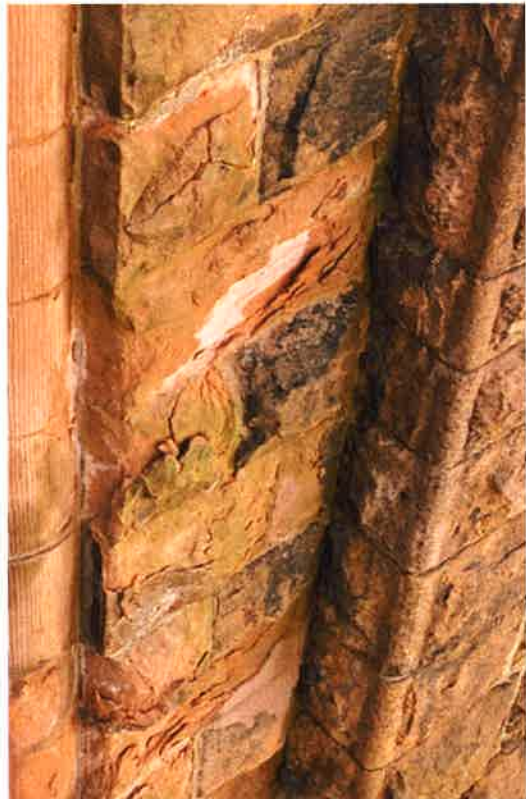
North Tower – Spalled Stones

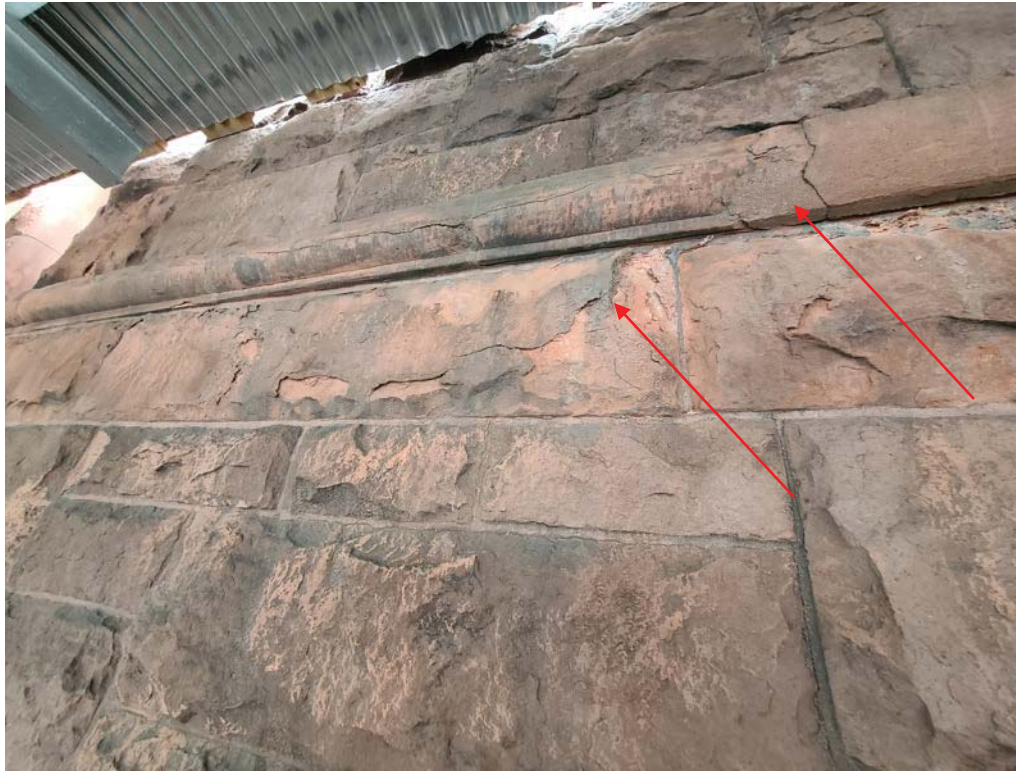
**PHOTO 3: TYPICAL FACADE CONDITION**

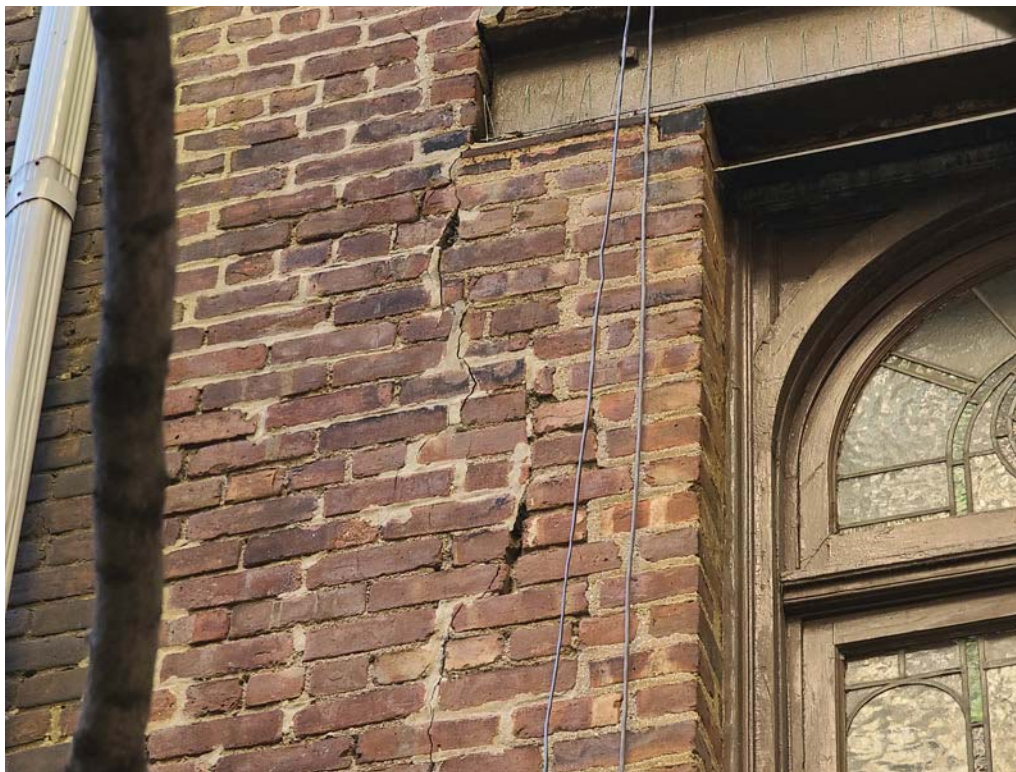
- o The brick façade is cracked and shows signs of trapped moisture. There are three voids in existing brick bearing walls, with a total area of approximately 25 square feet. Brick deterioration affects 5-10% of the surface of the north and east walls. This condition is a structural concern.

**PHOTO 4: CRACKS IN BRICK EXTERIOR BEARING WALL**

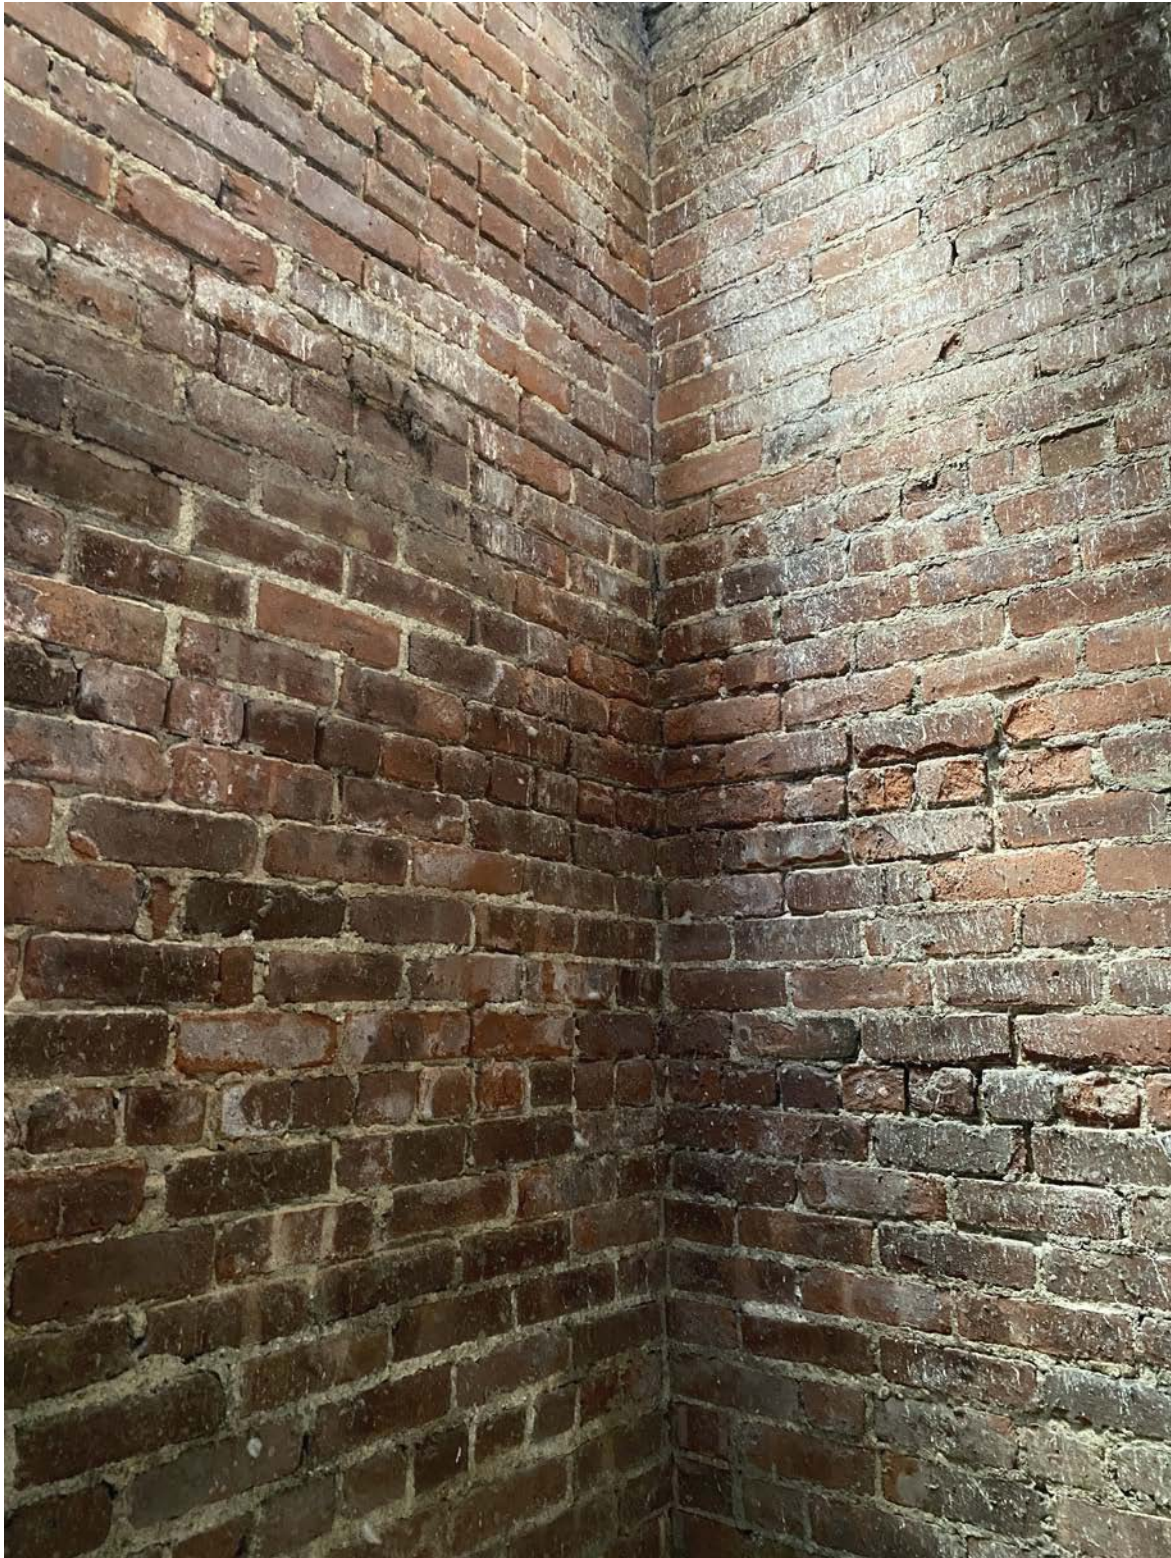
**PHOTO 11: BELL TOWER BRICK REQUIRES POINTING**
