**Preservation Department – Item 9, LPC-22-02413**

**231-233 West 74th Street – West End - Collegiate Historic  
District Extension  
Borough of Manhattan**

# **Façade Reconstruction 231 & 233 West 74<sup>th</sup> Streets**

**This presentation seeks to demonstrate that the deterioration of the primary (south) facades of the above buildings is so advanced that restoration work is not be possible to perform safely or effectively. MVN therefore seeks permission from LPC to perform reconstruction of the primary facades using salvaged original masonry brick and stone units to the greatest extent possible, and new materials to match the existing, where existing materials are not able to be salvaged.**

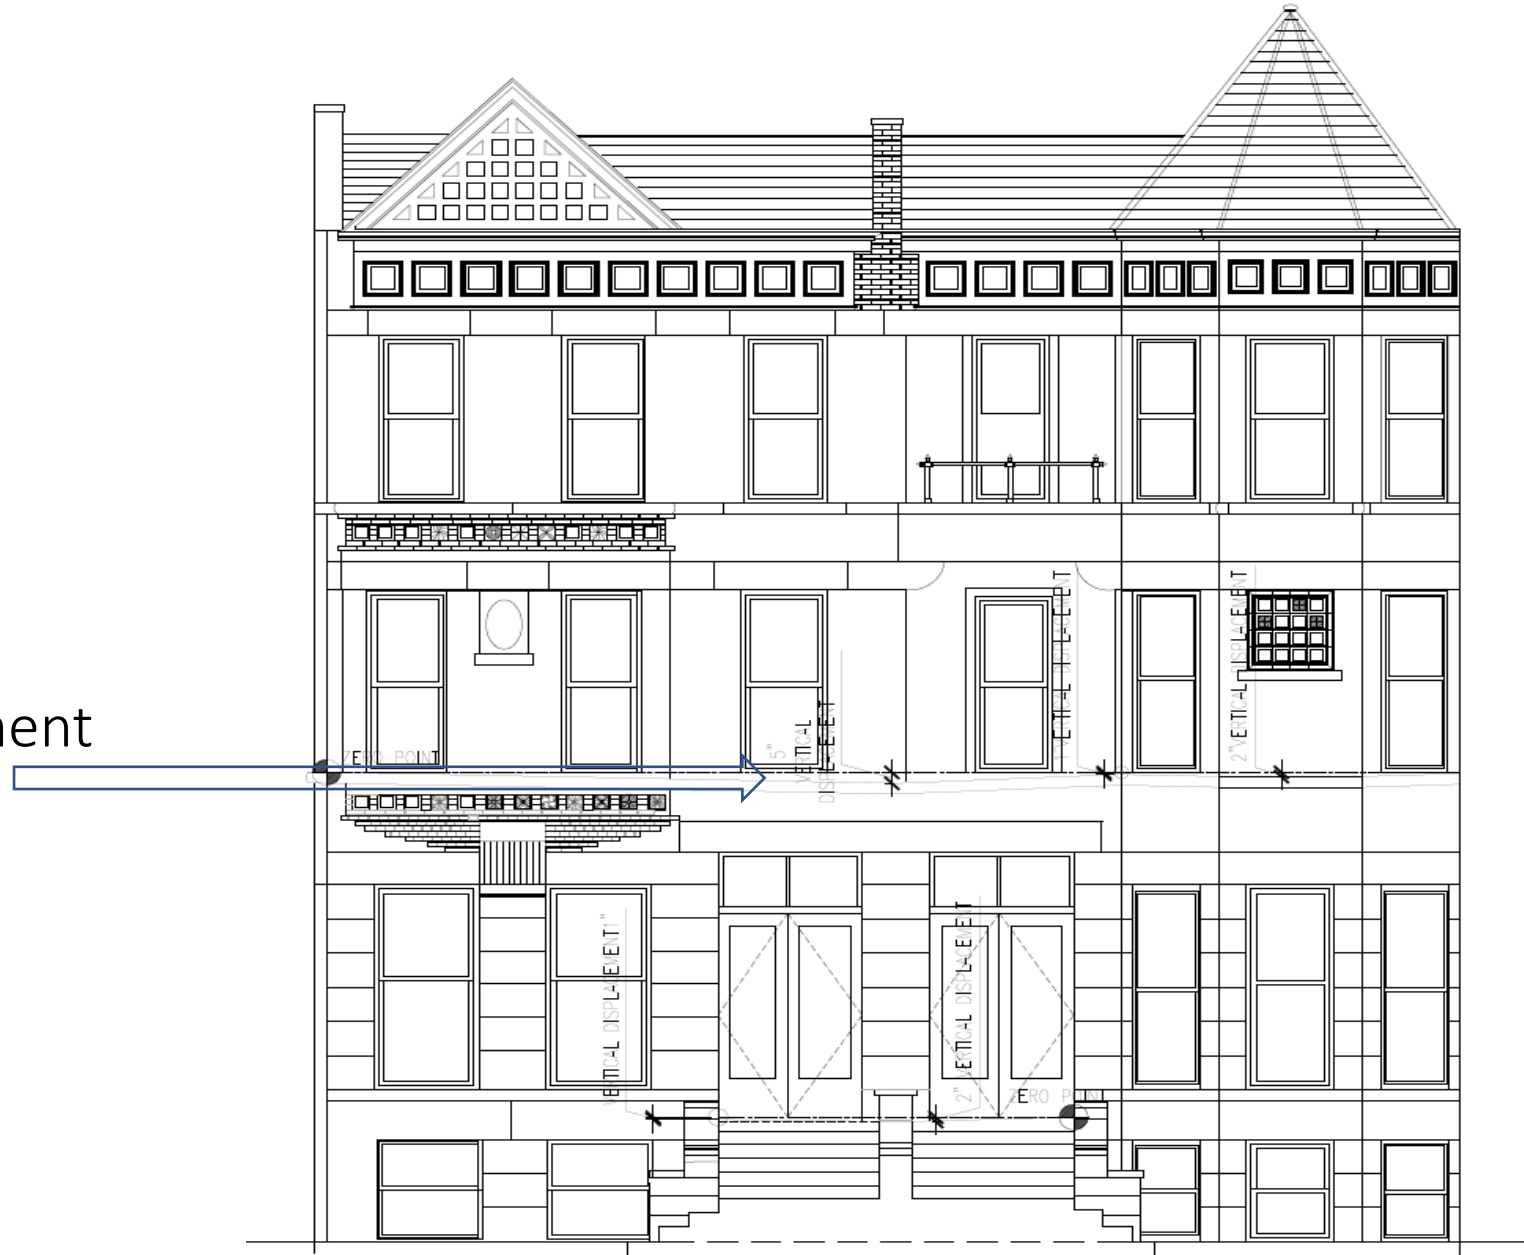
5" displacement

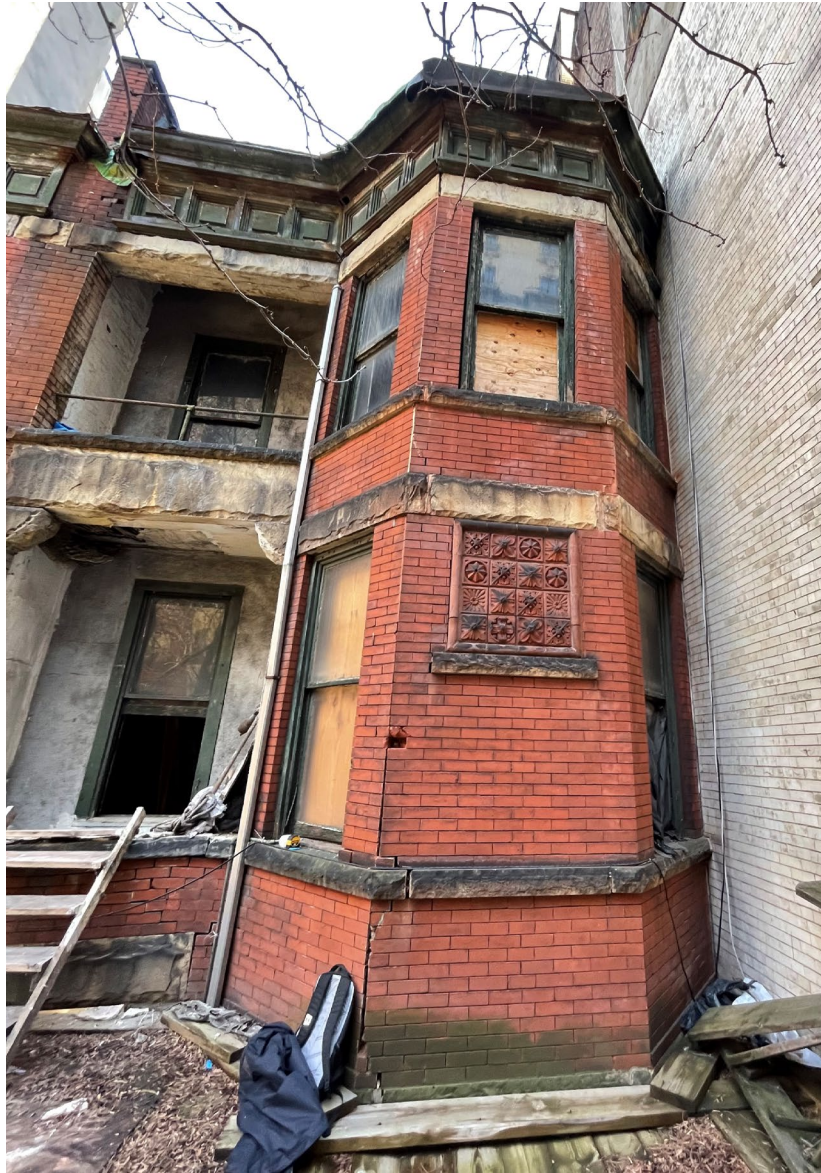
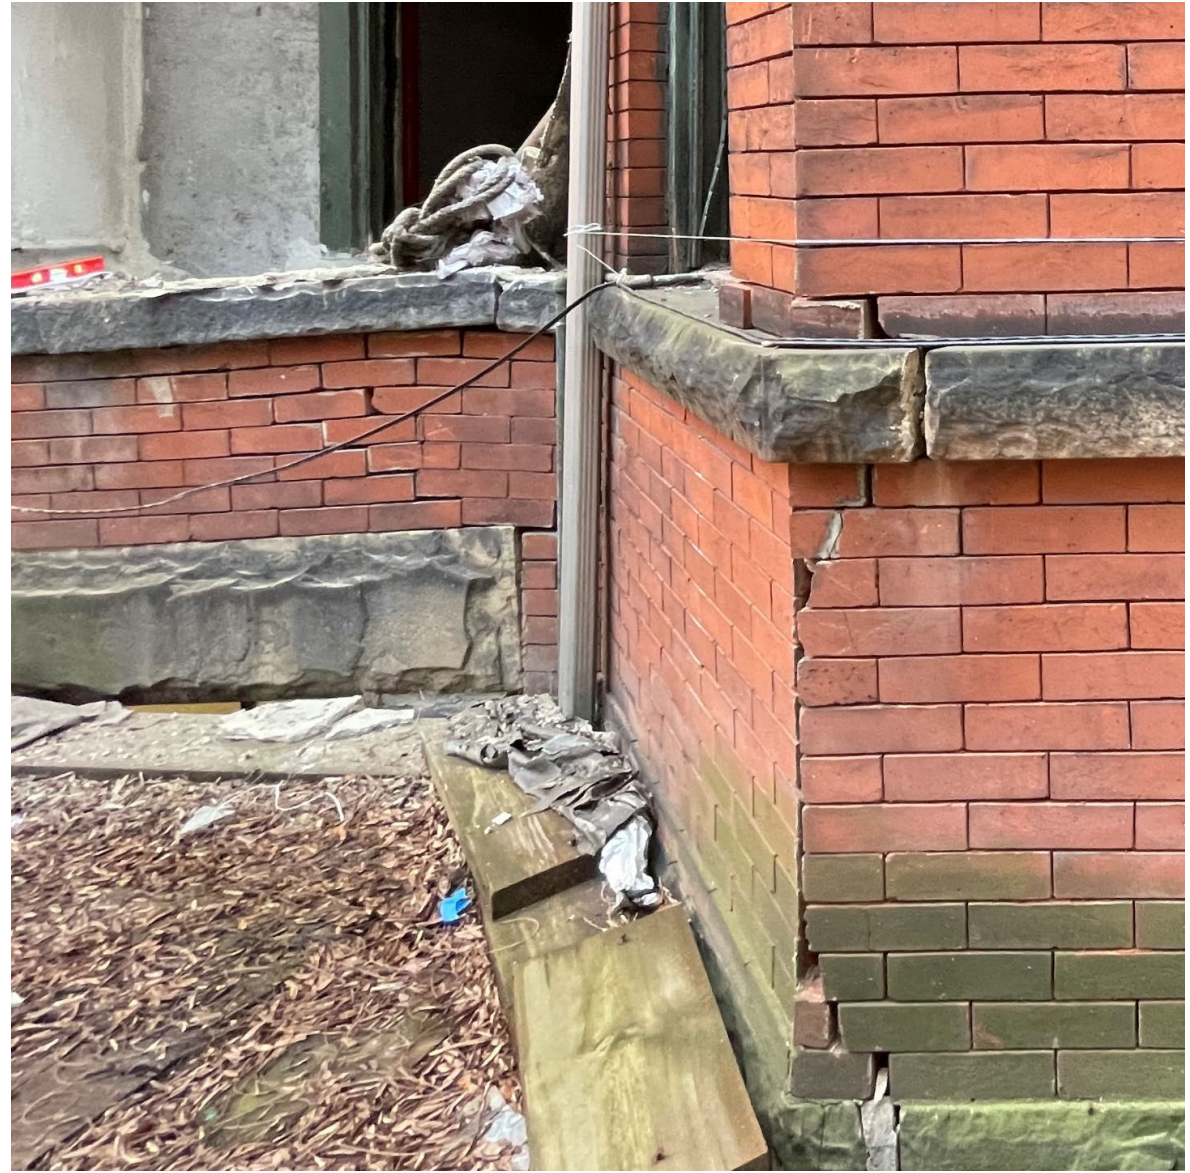
**231 West 75<sup>th</sup> Street (Bay window segment coming apart at corner and cracked vertically from settlement.)**

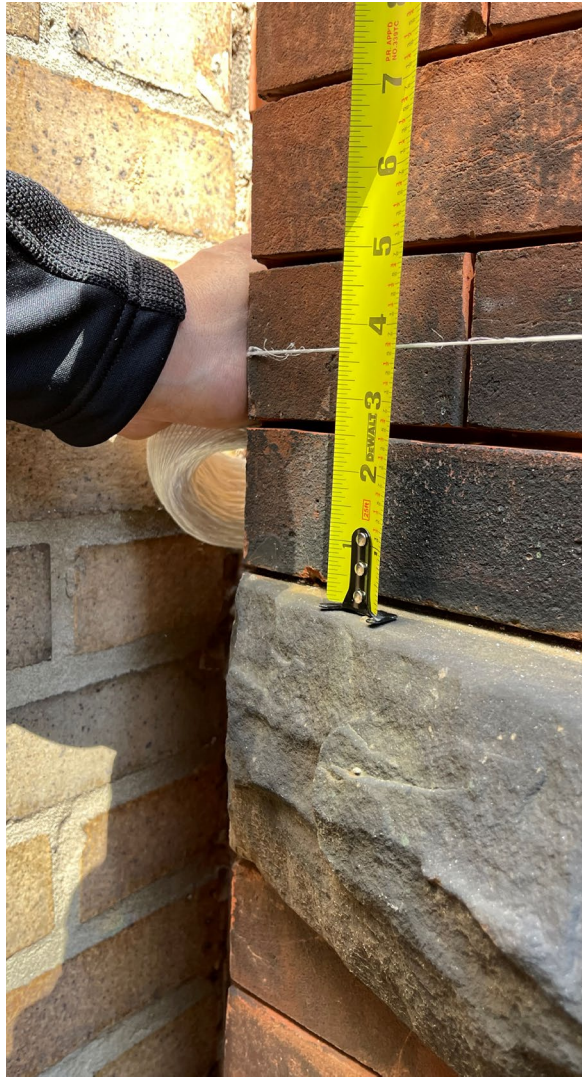
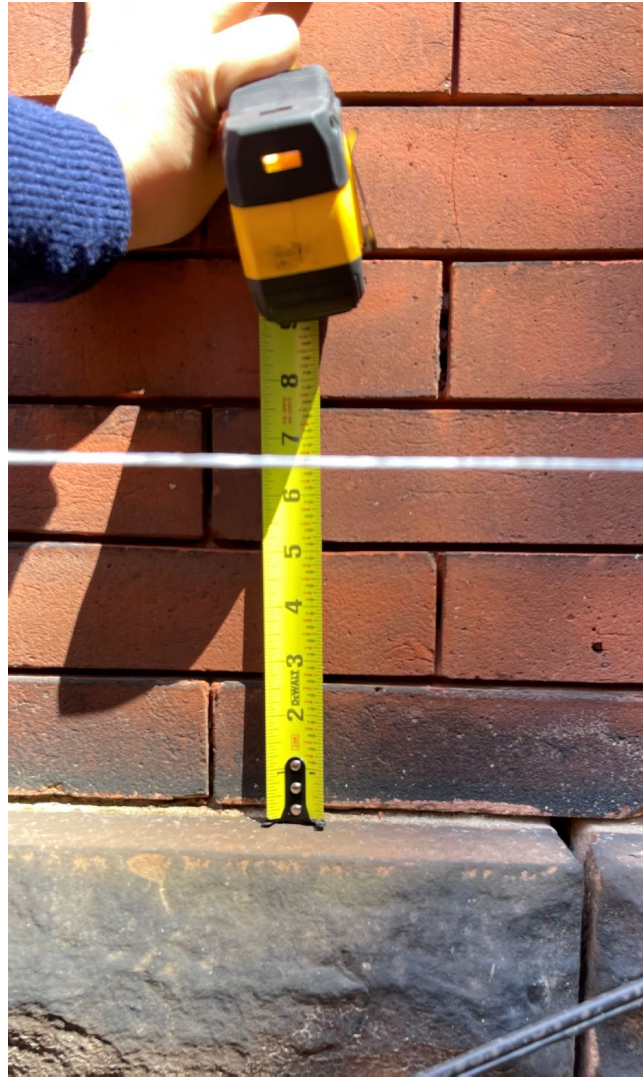
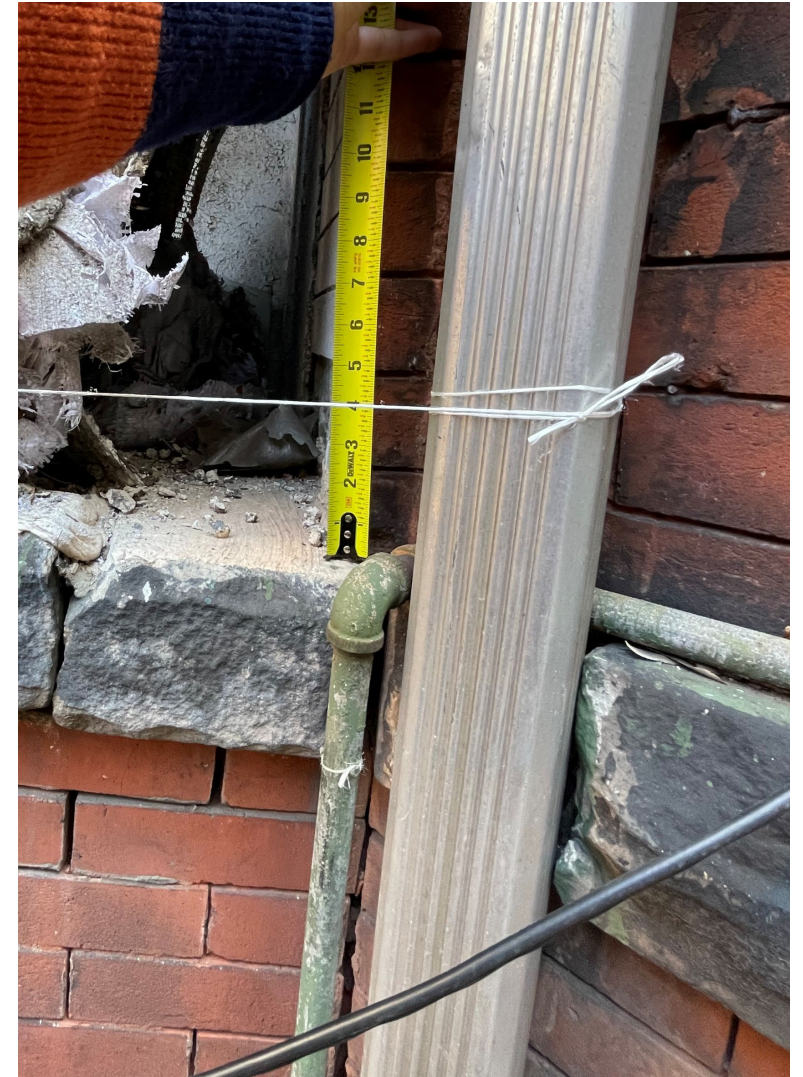
**String Level indicates that portion of building adjacent to party wall between (2) buildings has settled close to 3 inches relative to West end of 233 and East end of 231.) Photos taken 2022**

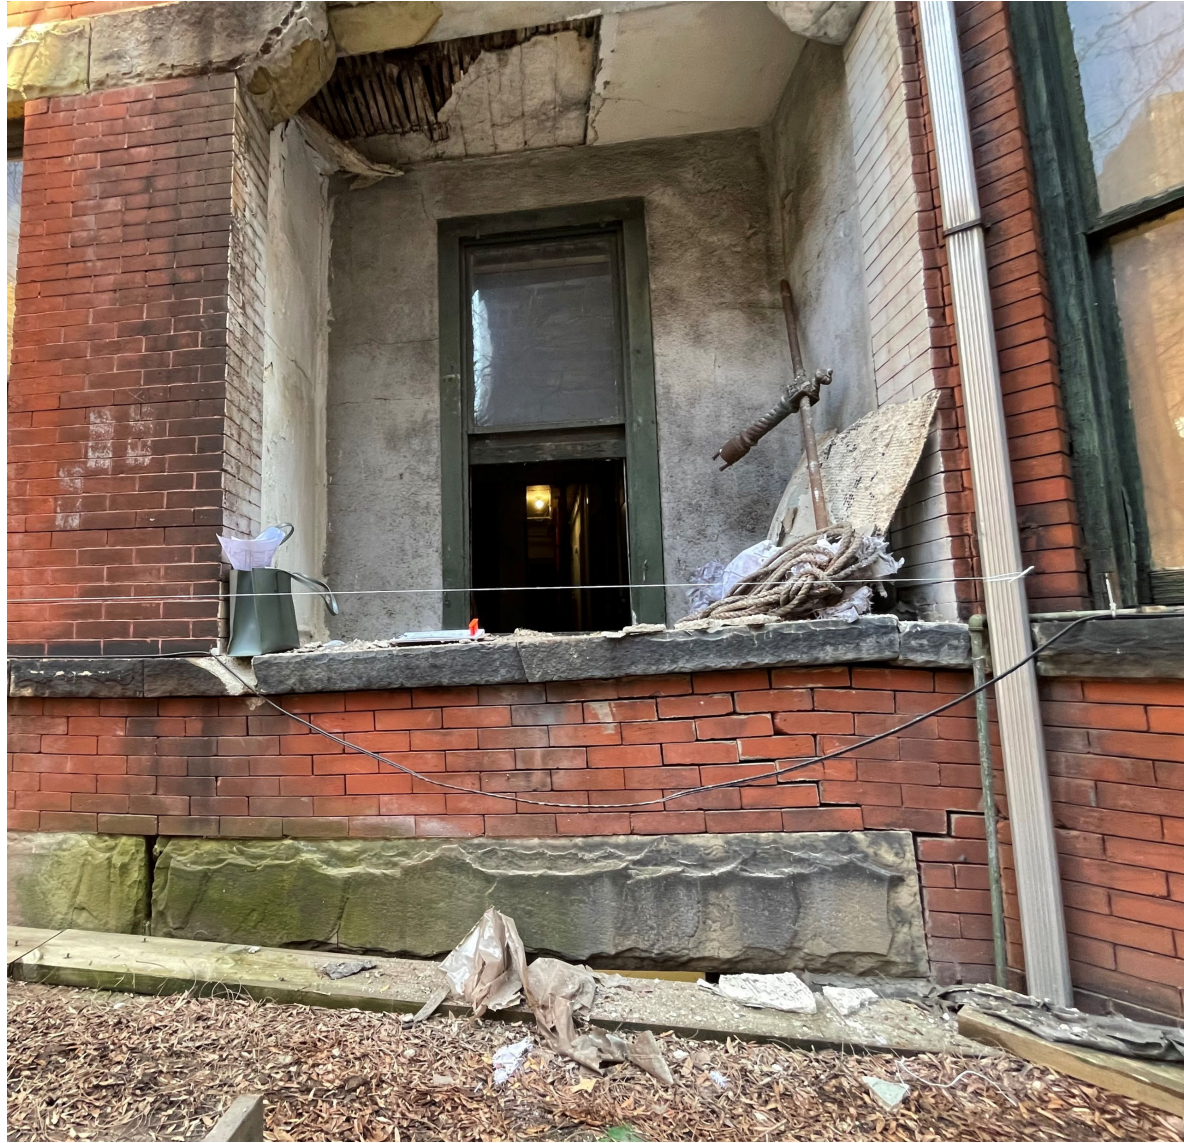
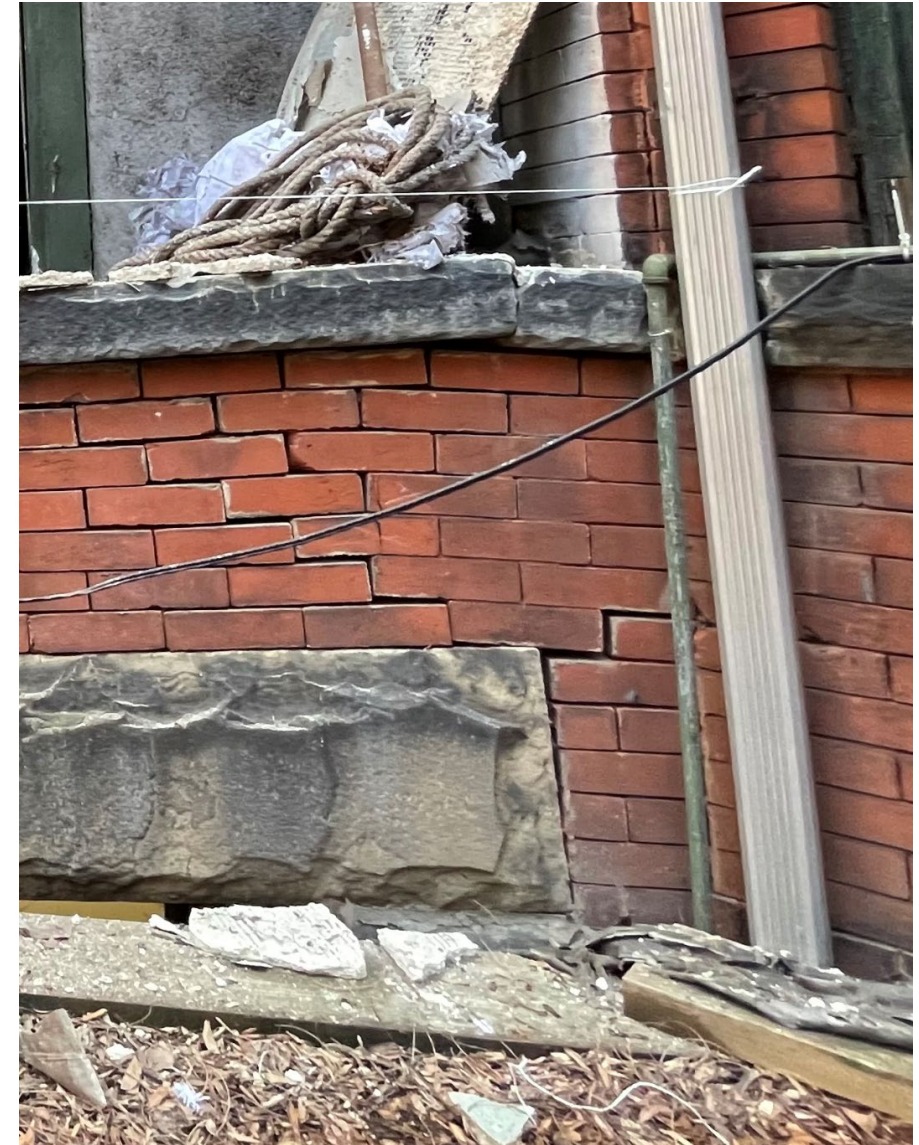
**231 West 74<sup>th</sup> Street (Lintel above main Entrance severely deformed from façade settlement) 2022**

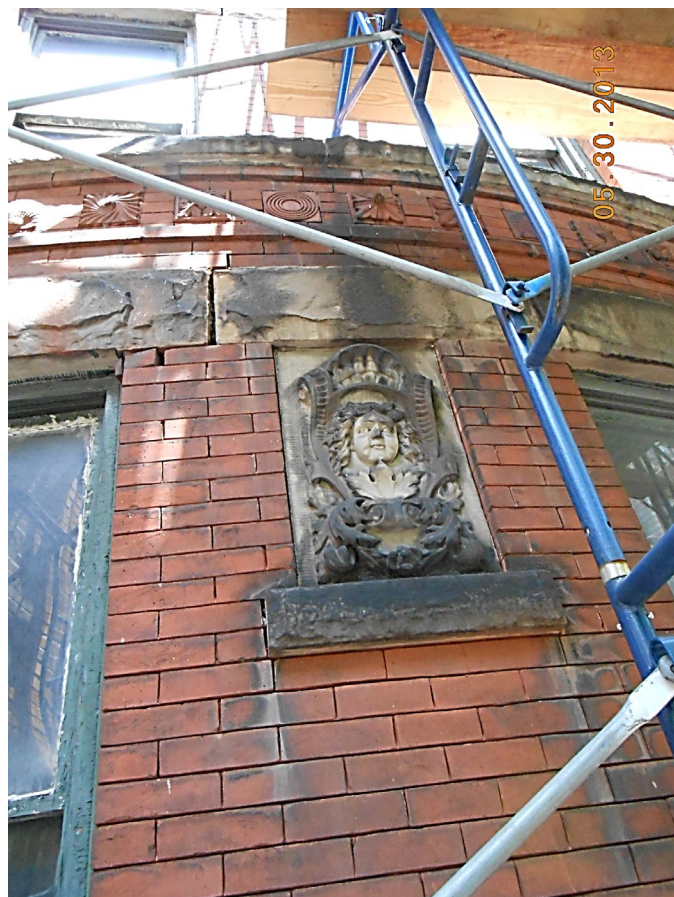
Photo taken 2012 shows separation and lateral displacement at the top the bow window at 233

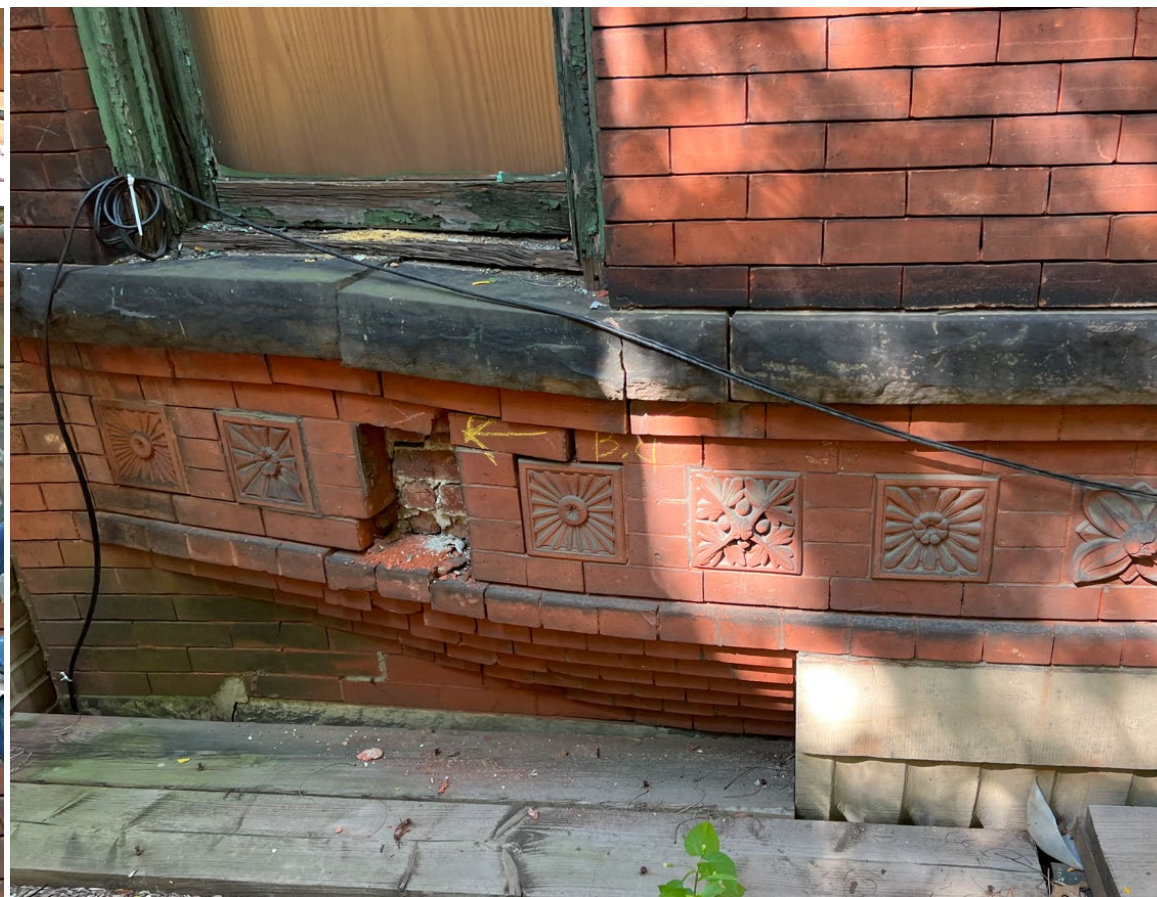
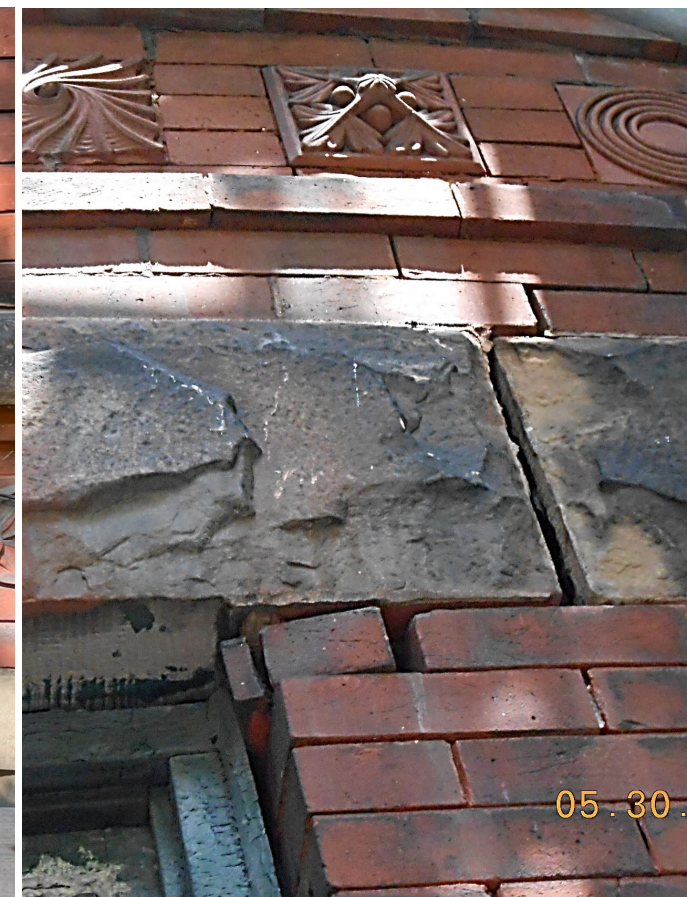
Photo taken 2022 shows increased lateral displacement of the corbelled brick base of the bow window at 233.

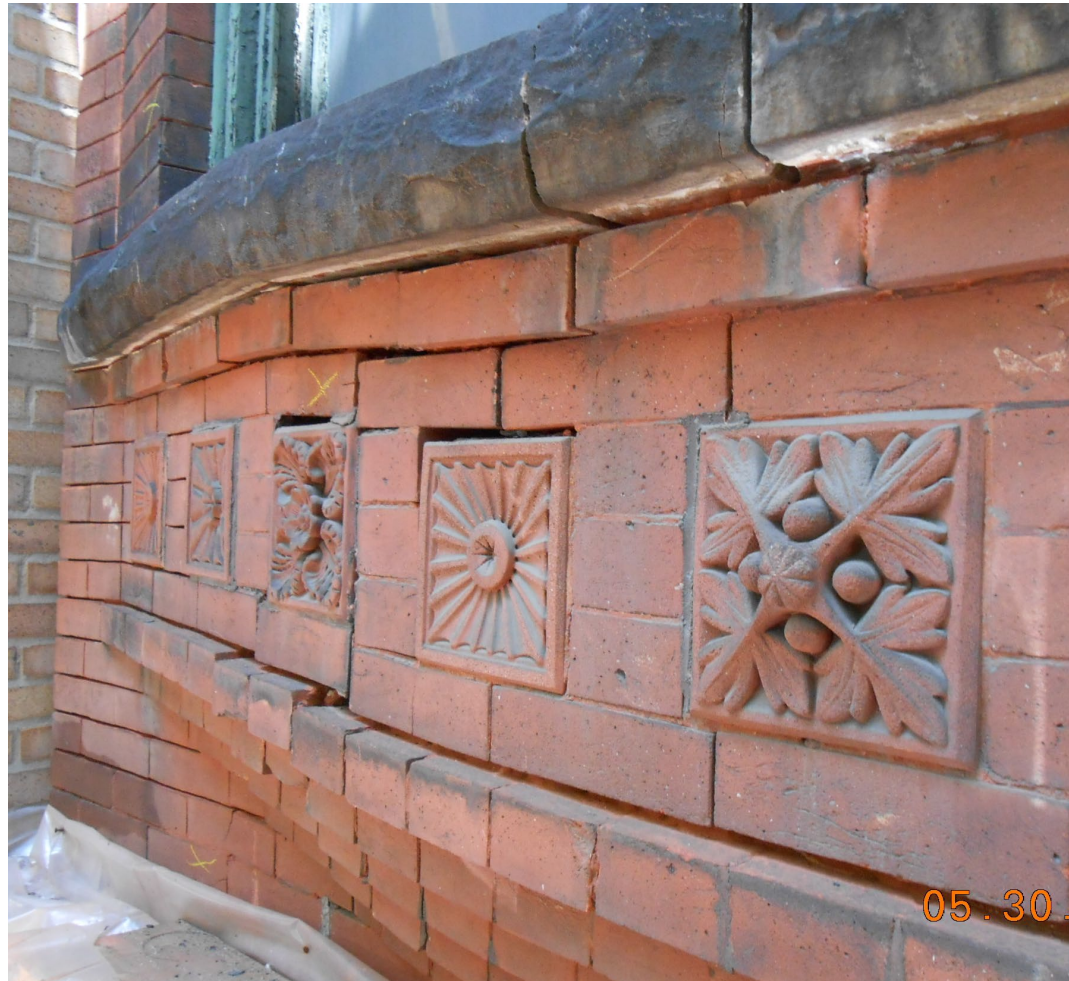
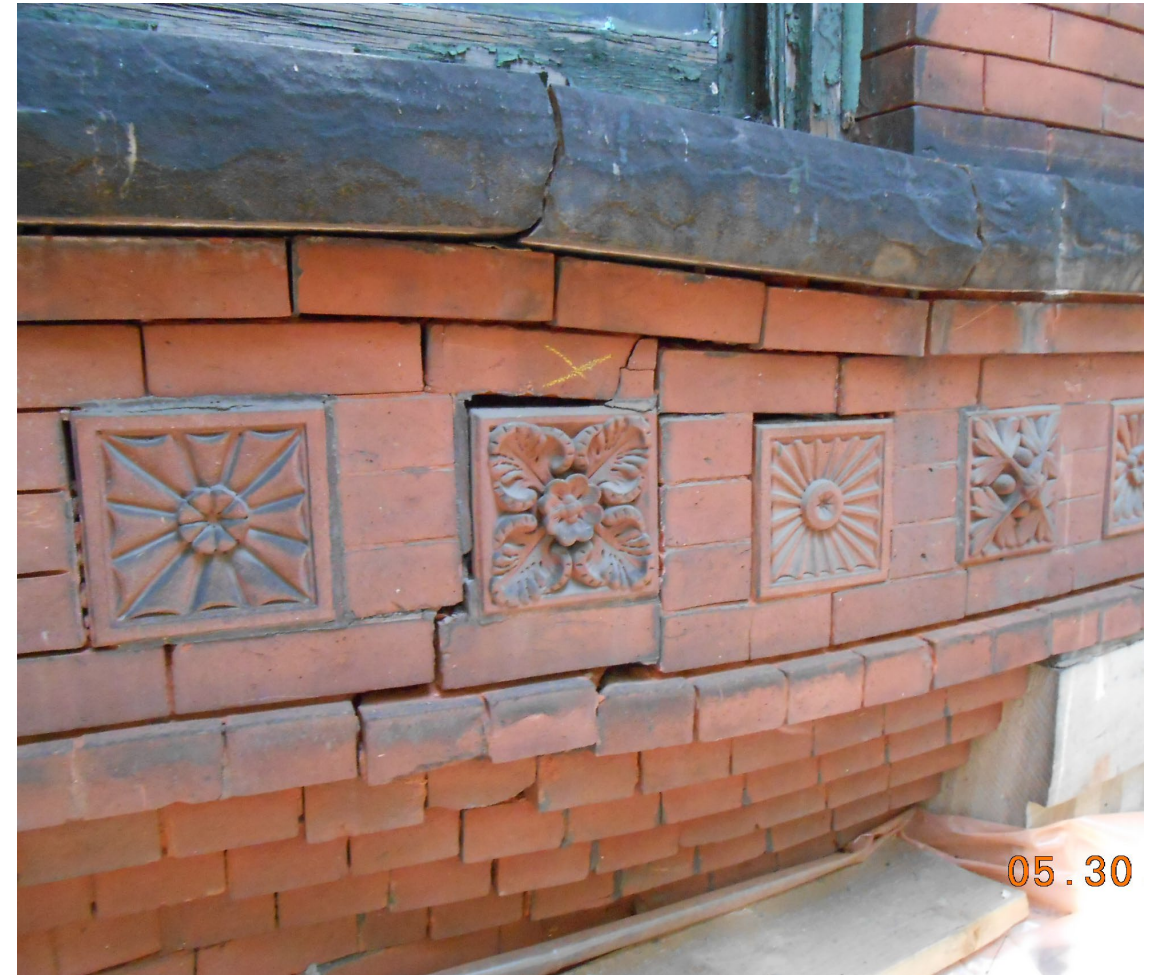
233 West 75<sup>th</sup> Street (Projecting bow window. masonry severely displaced vertically and horizontally from settlement of the facades)  
Photos taken 2012

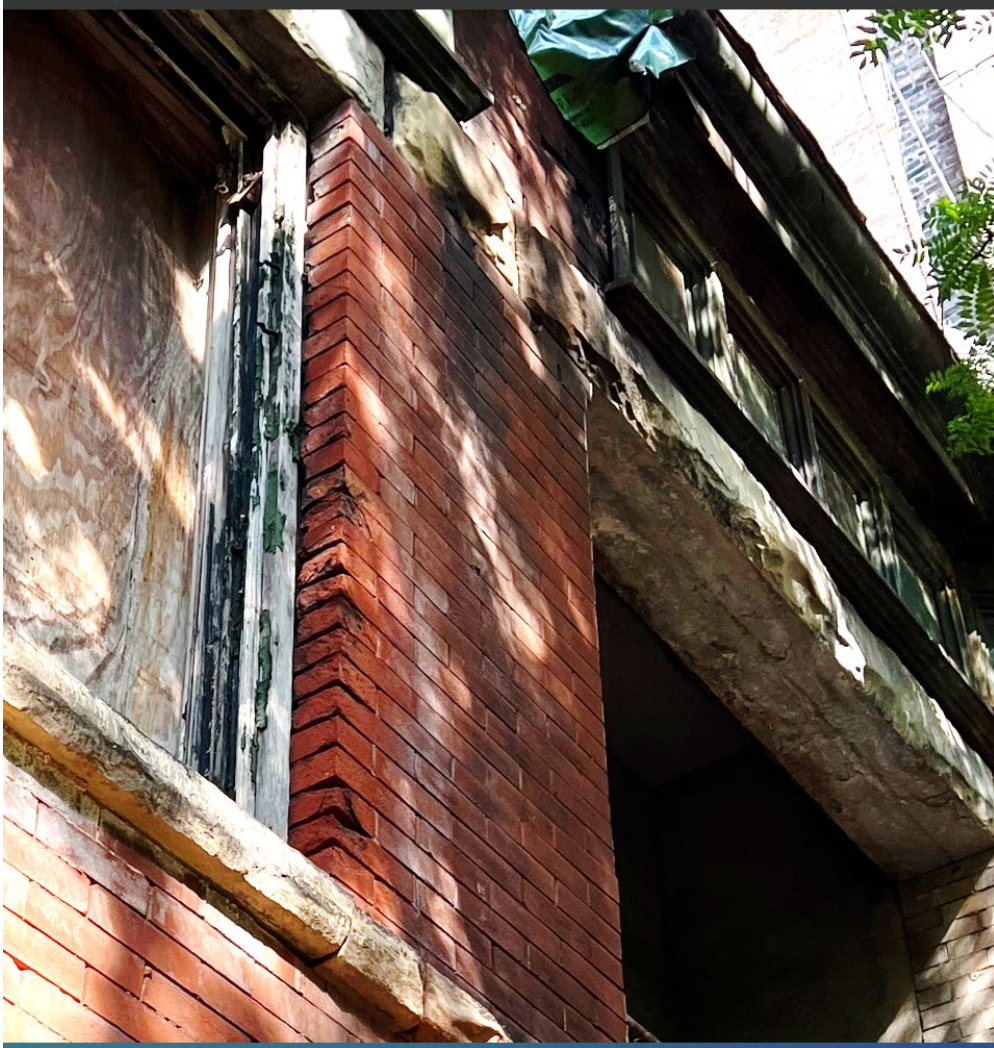
Pier between 233 & 231  
exhibits lateral displacement –  
it is leaning towards the street

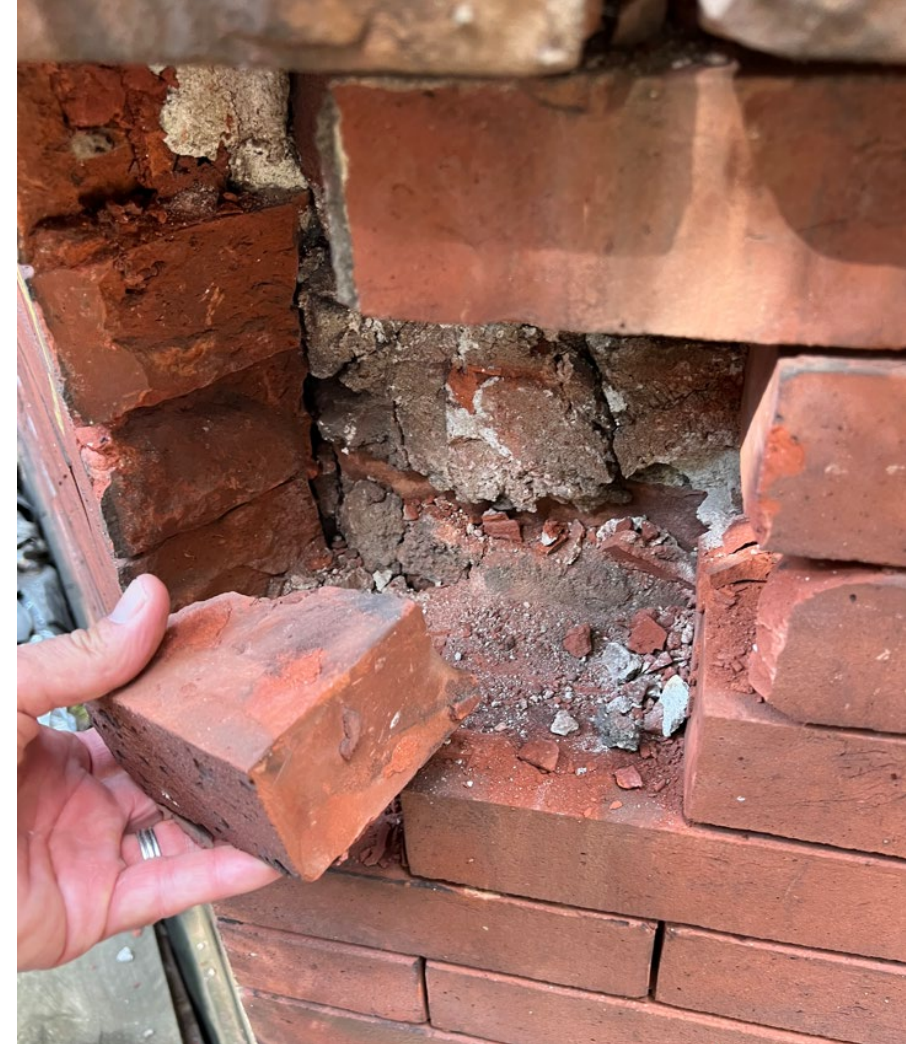
Mortar at facebrick throughout has lost its tensile  
strength and is easily dislodged making restoration  
infeasible and reconstruction necessary.

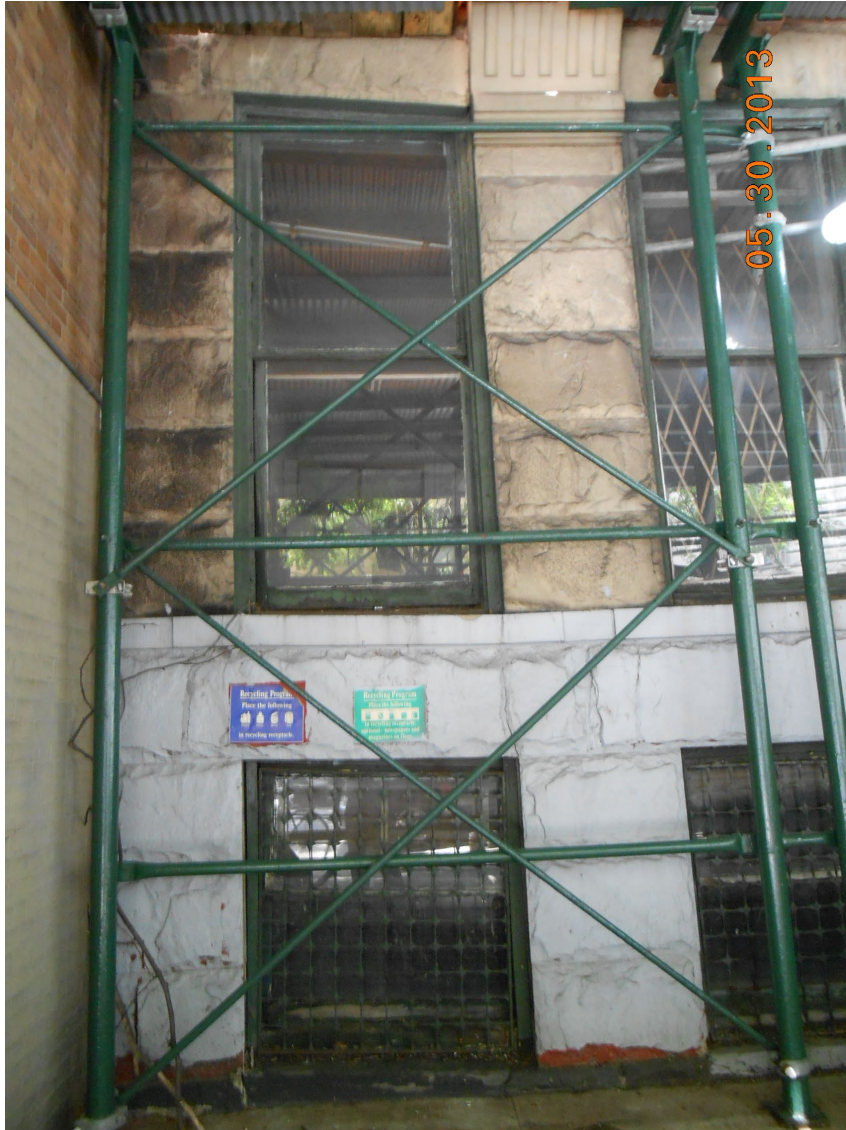
**233 W 75<sup>th</sup> St (Displacement of Wdw. Ltl.)**

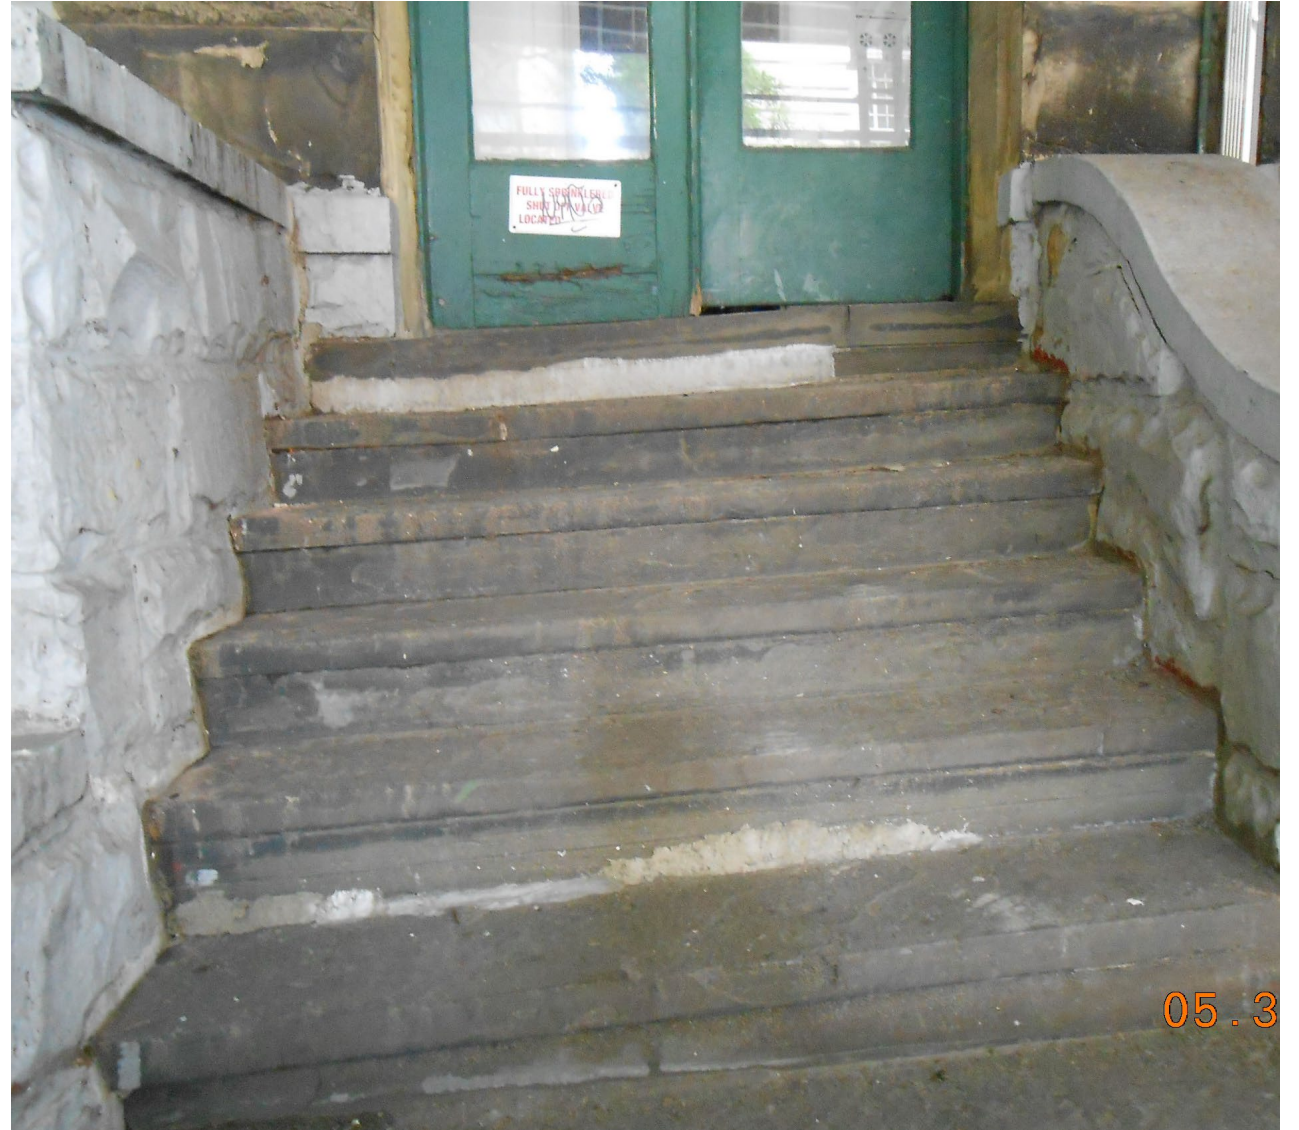
**231 W 75<sup>th</sup> St (Displacement at Stoop)- Photos taken 2012**

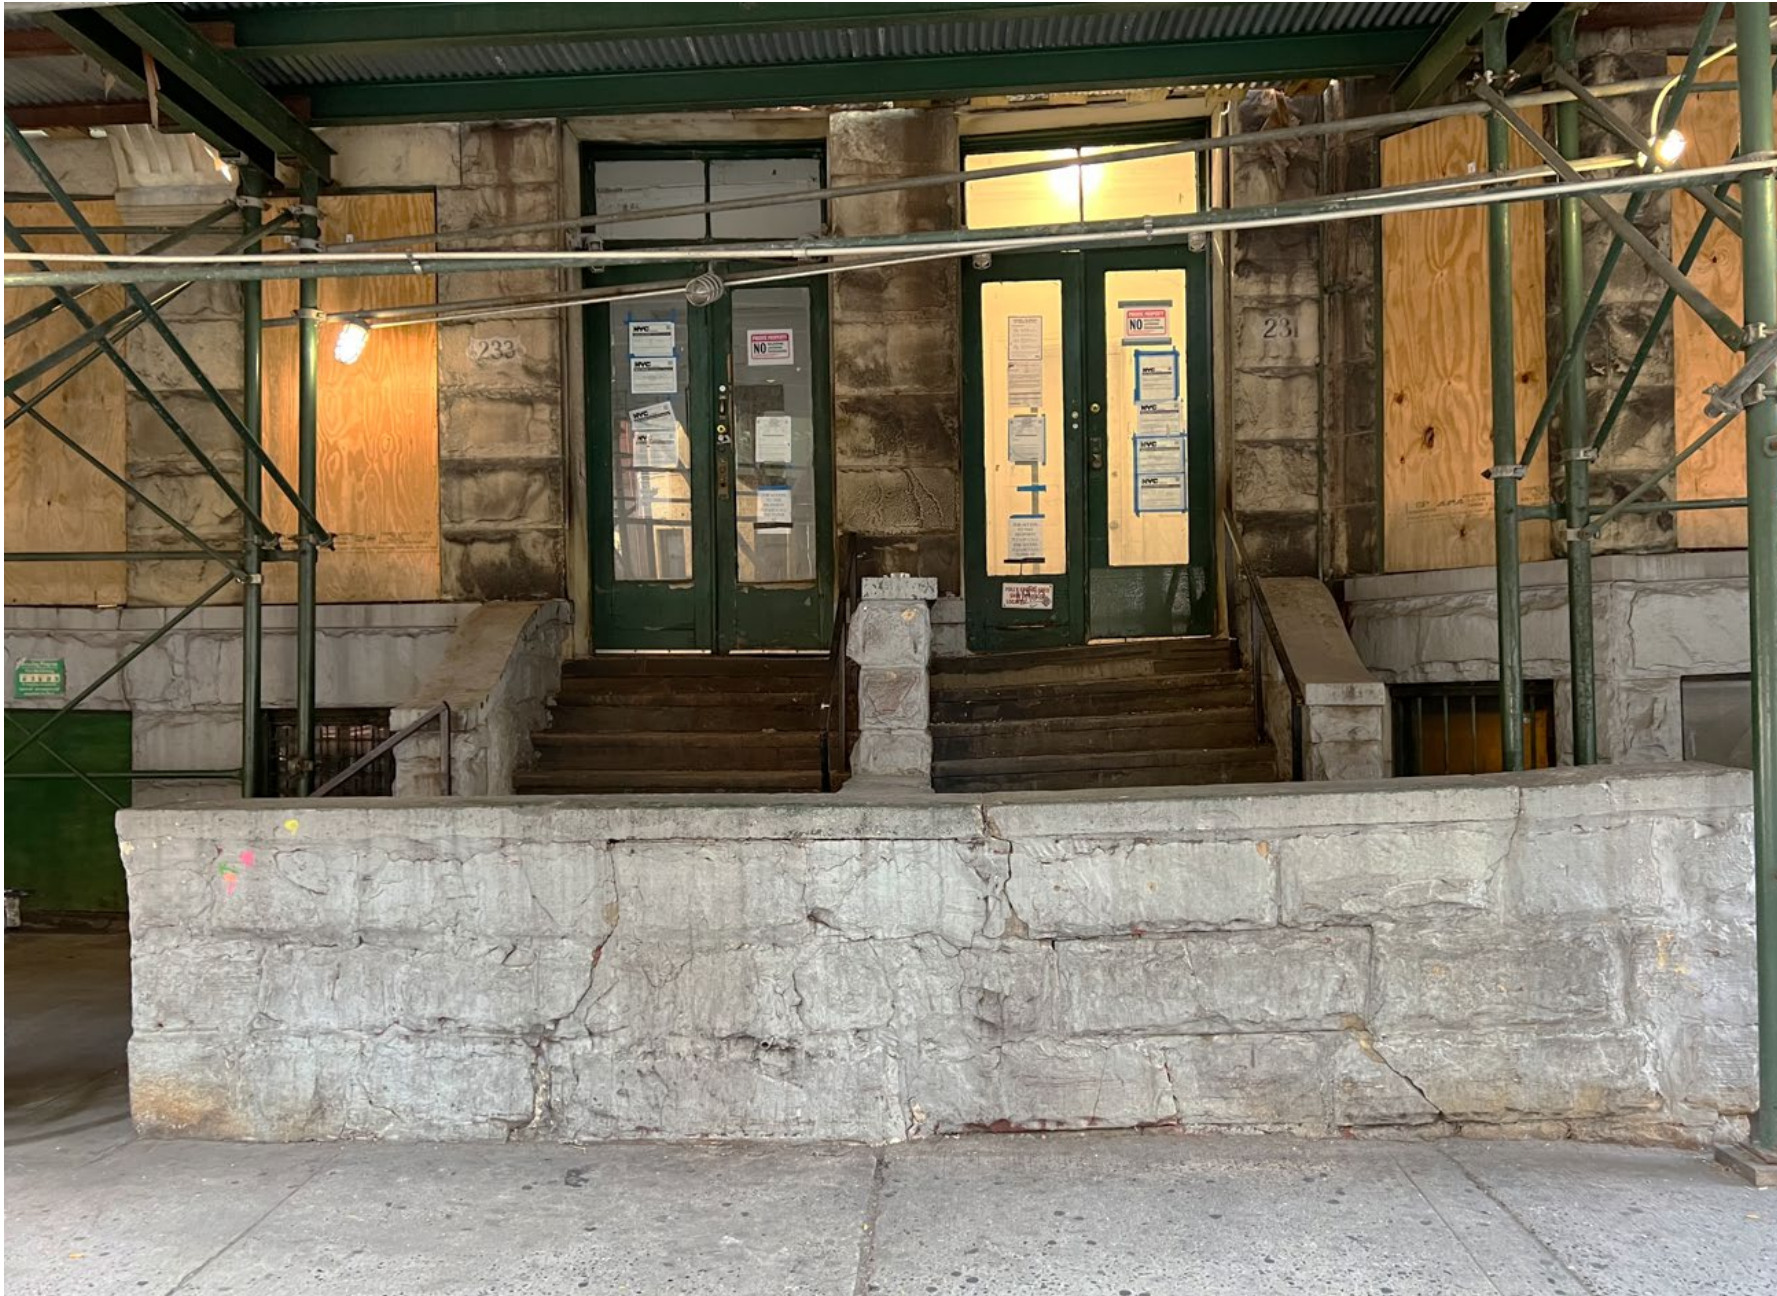
231 W 75<sup>th</sup> St  
(Displacement at street  
wall fronting steps)-  
Photo taken 2022  
reconstruction of this  
wall will be necessary.

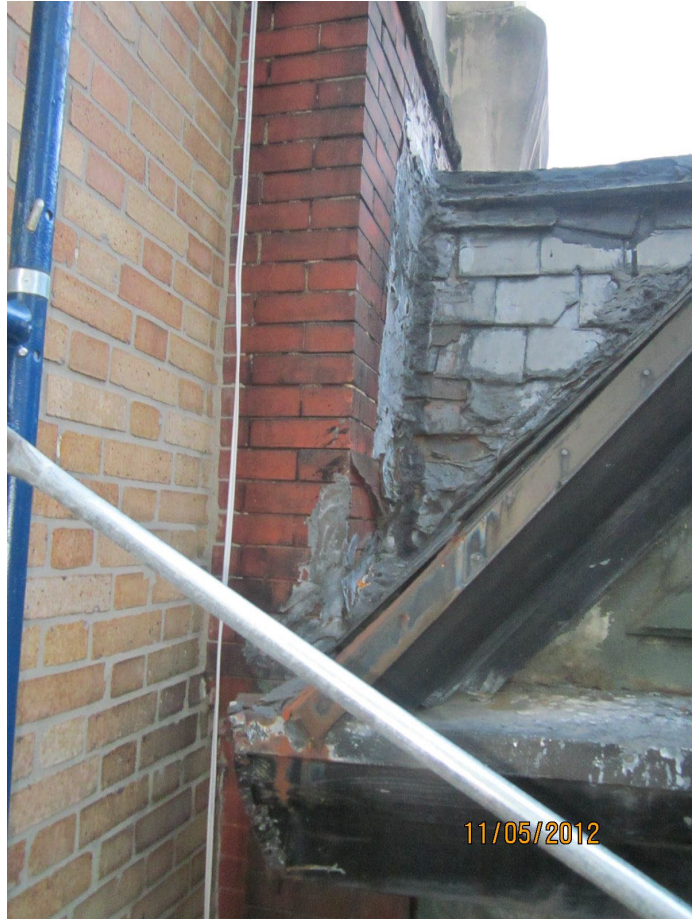
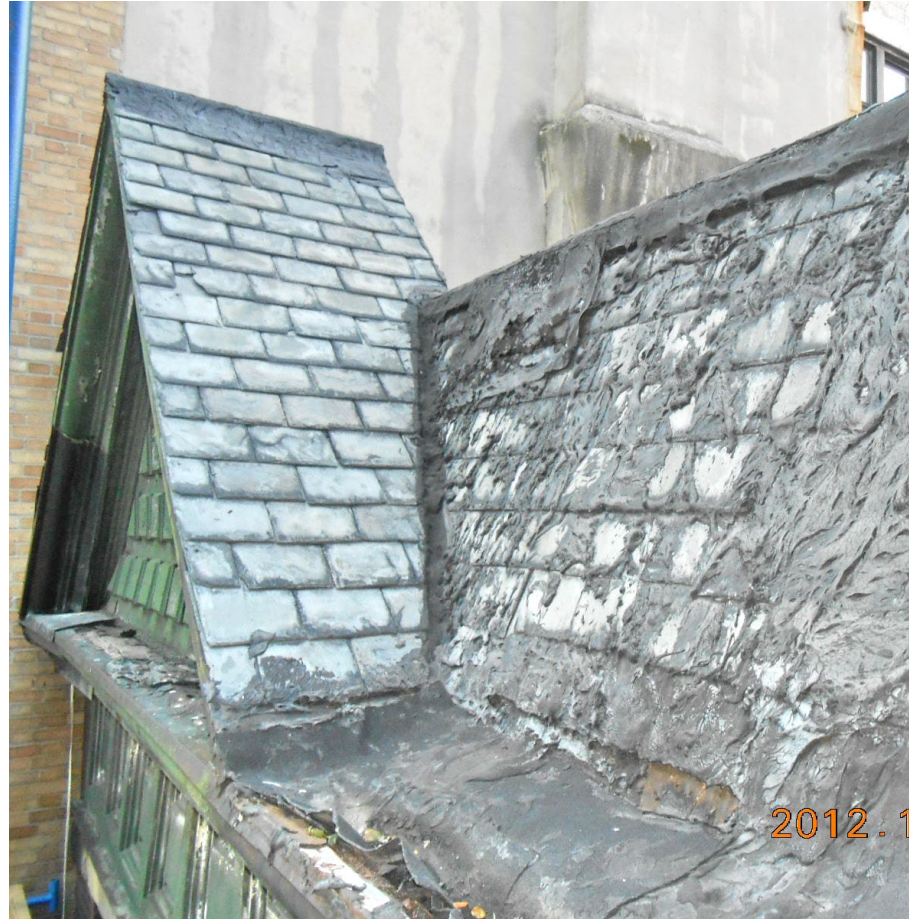
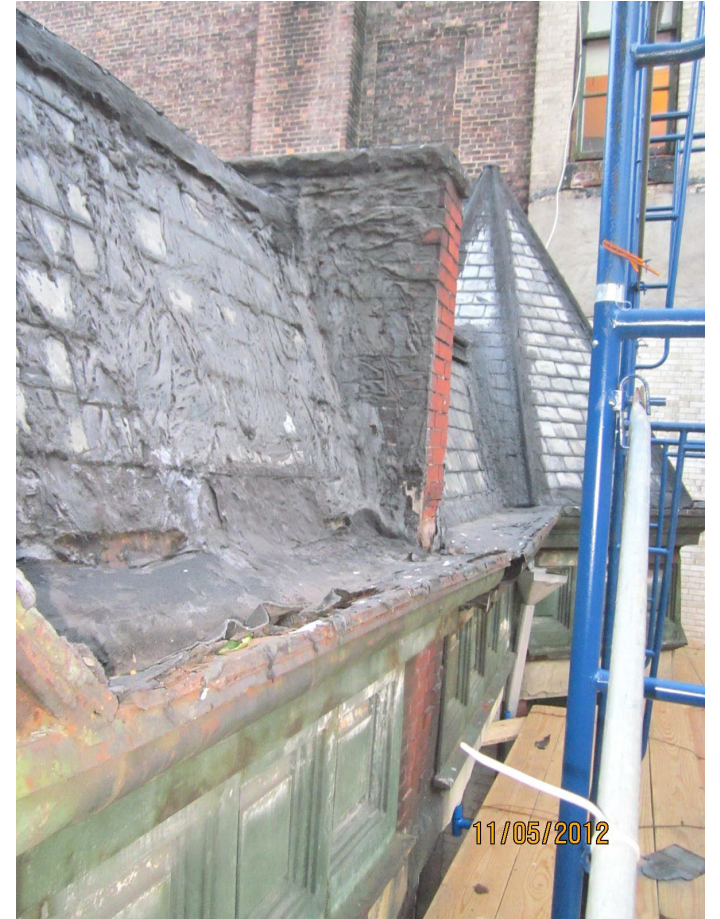
**233 West 75<sup>th</sup> Street (Severe deterioration of Mansard and Gable Roofs and Integral gutter)**  
**Photos taken 2012**
