**Preservation Department – Item 9, LPC-22-02413**

**231-233 West 74th Street – West End - Collegiate Historic  
District Extension  
Borough of Manhattan**

# **Façade Reconstruction 231 & 233 West 74<sup>th</sup> Streets**

**This presentation seeks to demonstrate that the deterioration of the primary (south) facades of the above buildings is so advanced that restoration work is not be possible to perform safely or effectively. MVN therefore seeks permission from LPC to perform reconstruction of the primary facades using salvaged original masonry brick and stone units to the greatest extent possible, and new materials to match the existing, where existing materials are not able to be salvaged.**

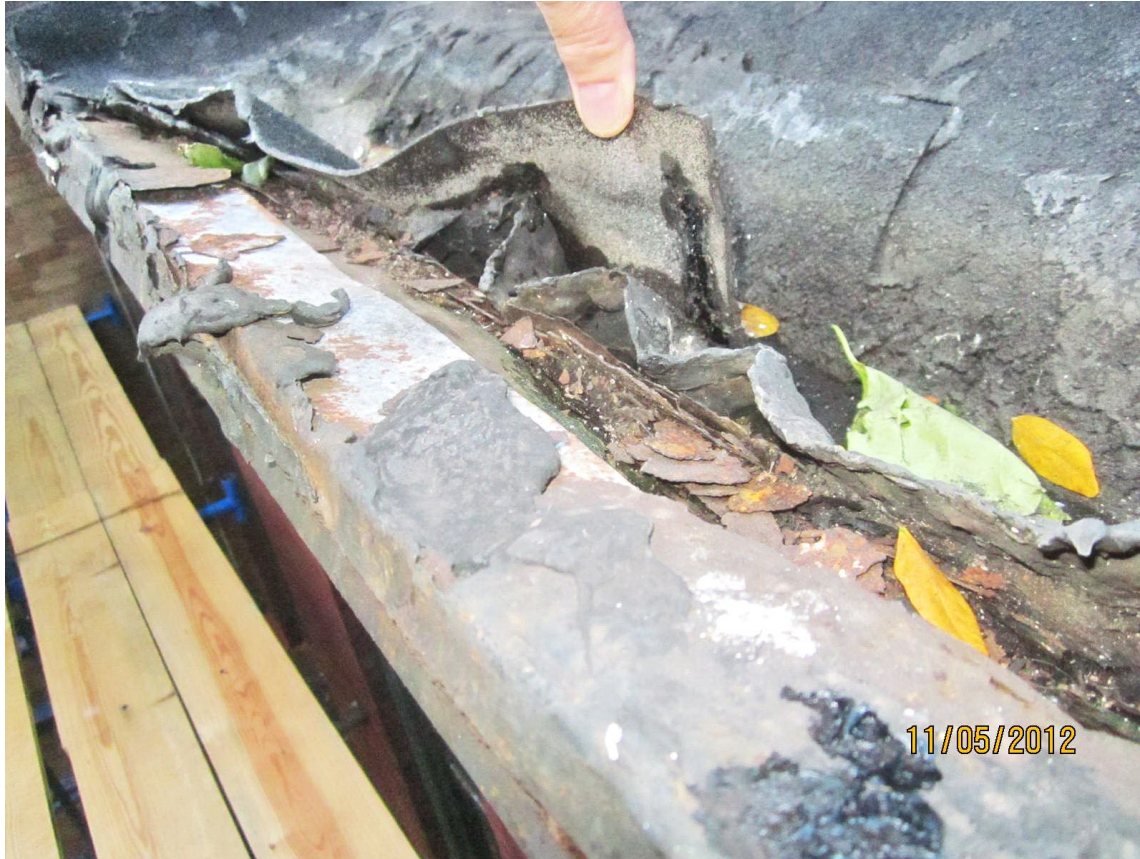
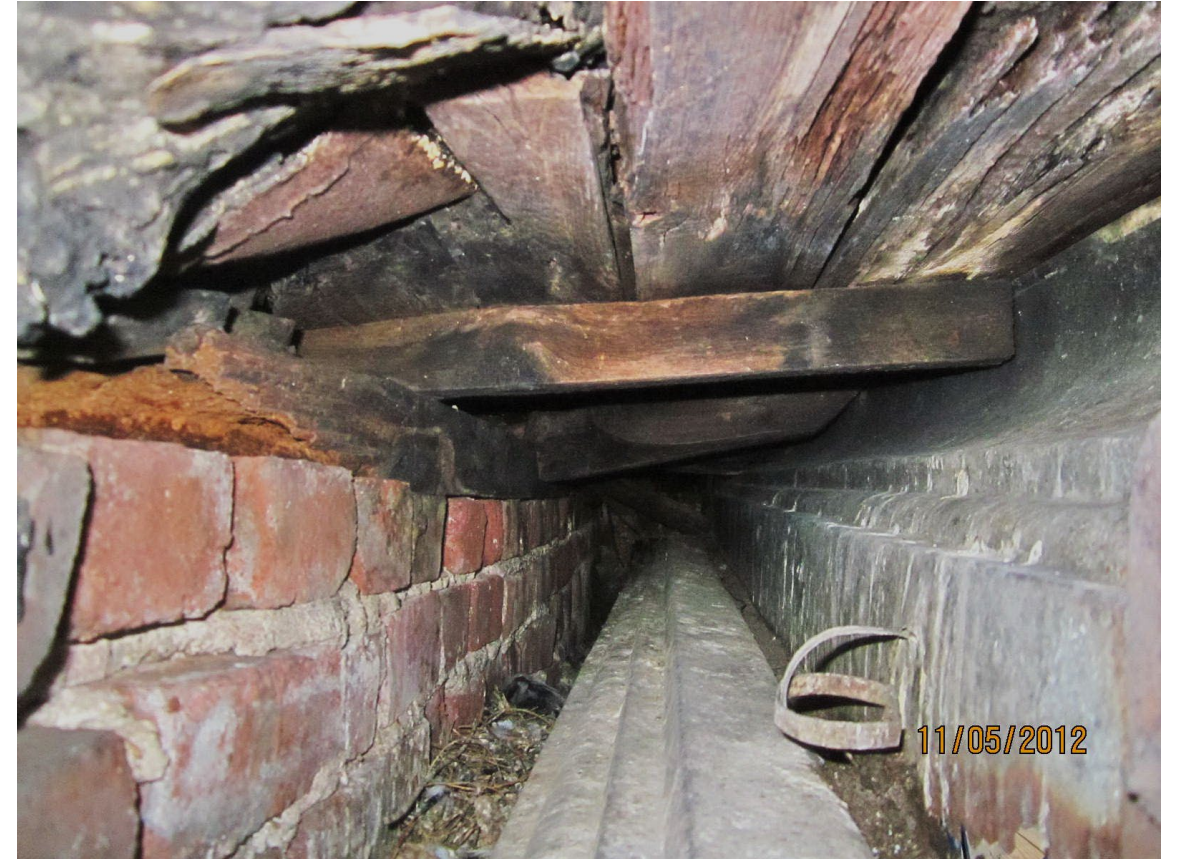
**233 West 75<sup>th</sup> Street (Severe deterioration at Mansard Roof and underlying brick masonry)**

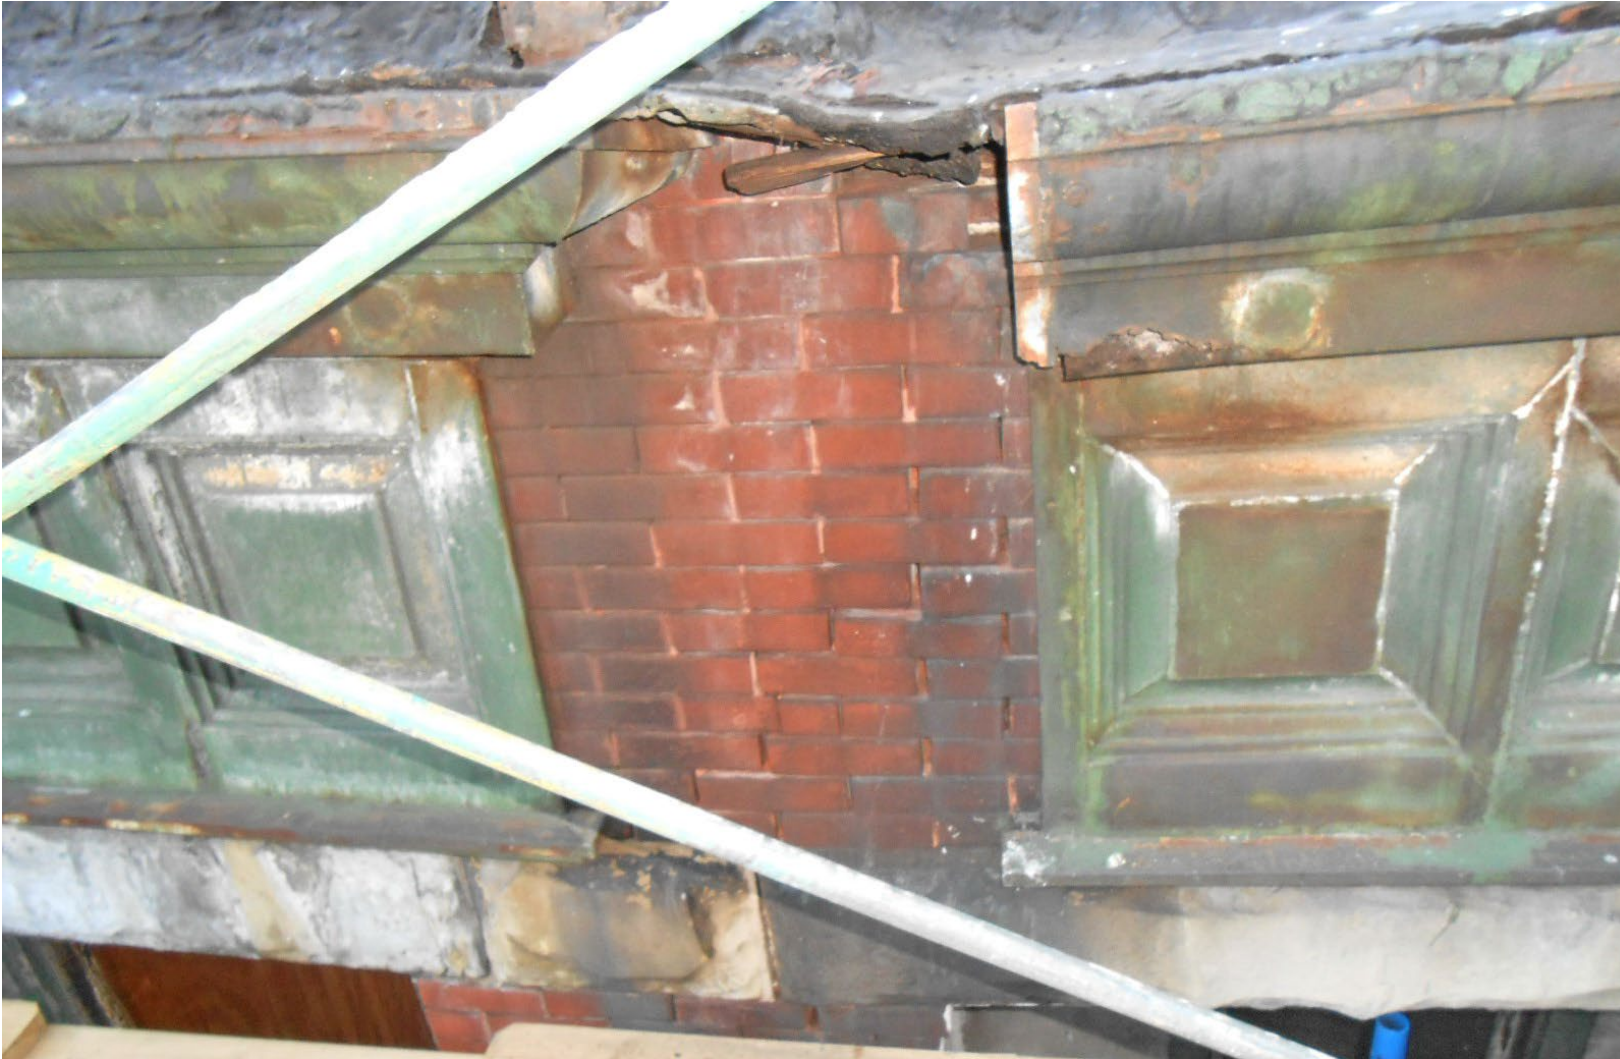
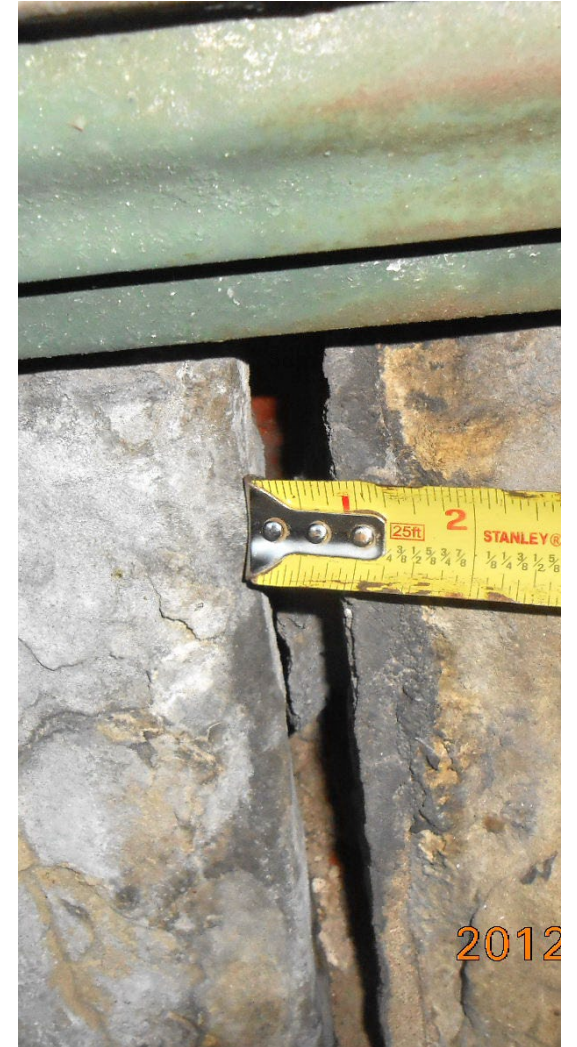
**231 / 233 West 75<sup>th</sup> Street (Differential Façade Settlement visible at misaligned gutters and mortar joint widths )**

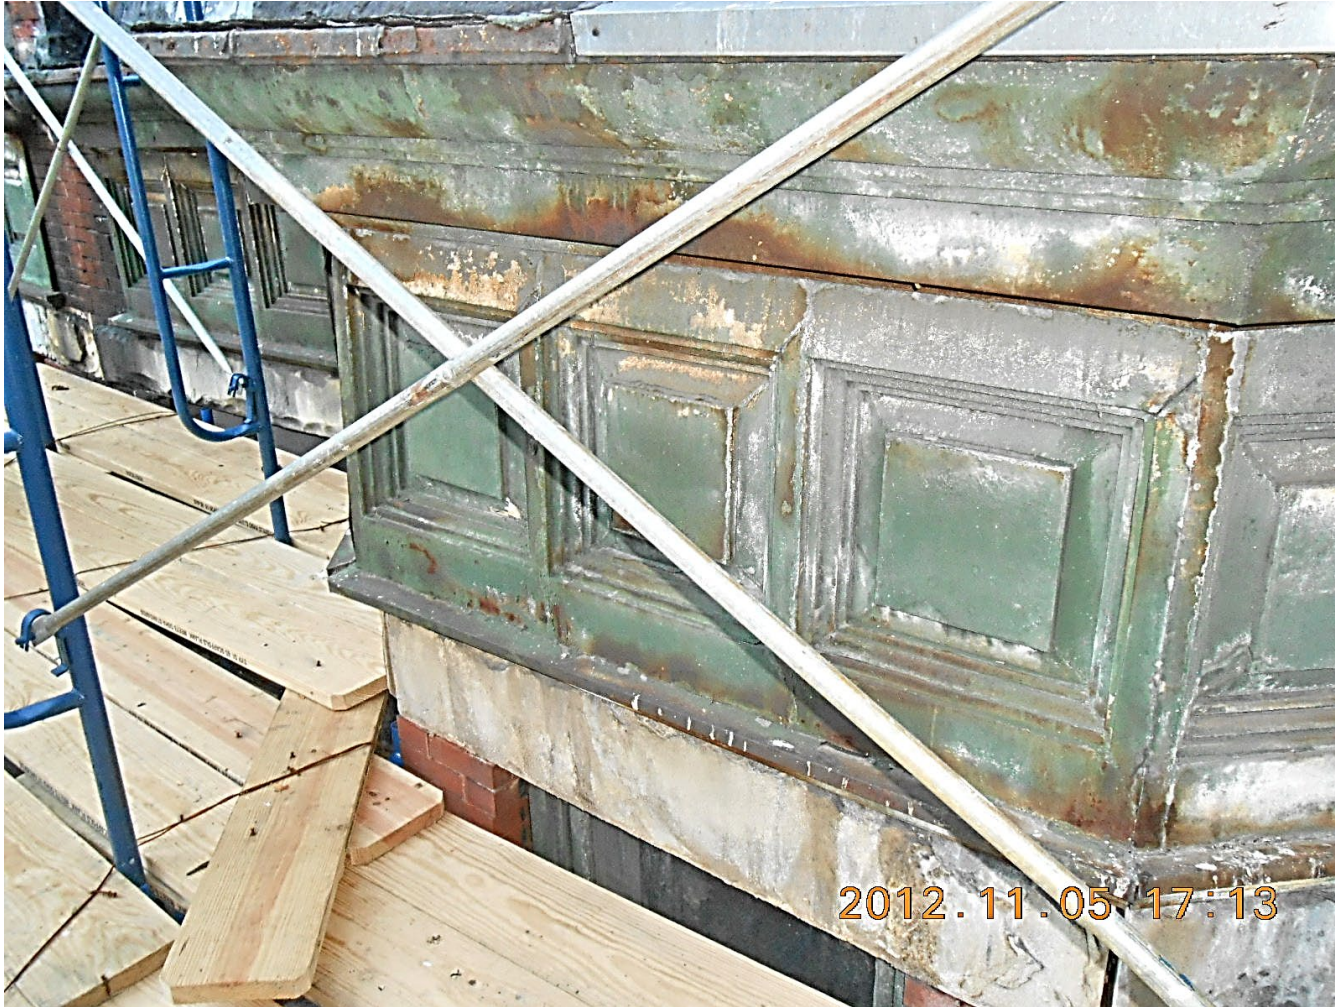
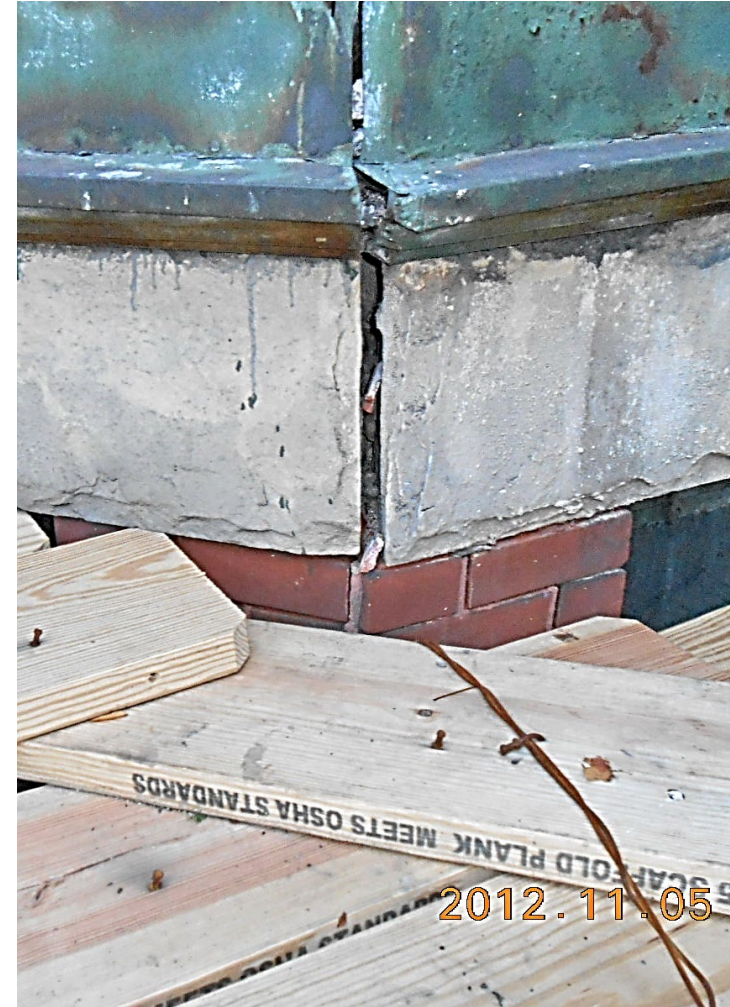
**231 West 75<sup>th</sup> Street (Differential Façade Settlement visible where bay window segments pulling apart)**

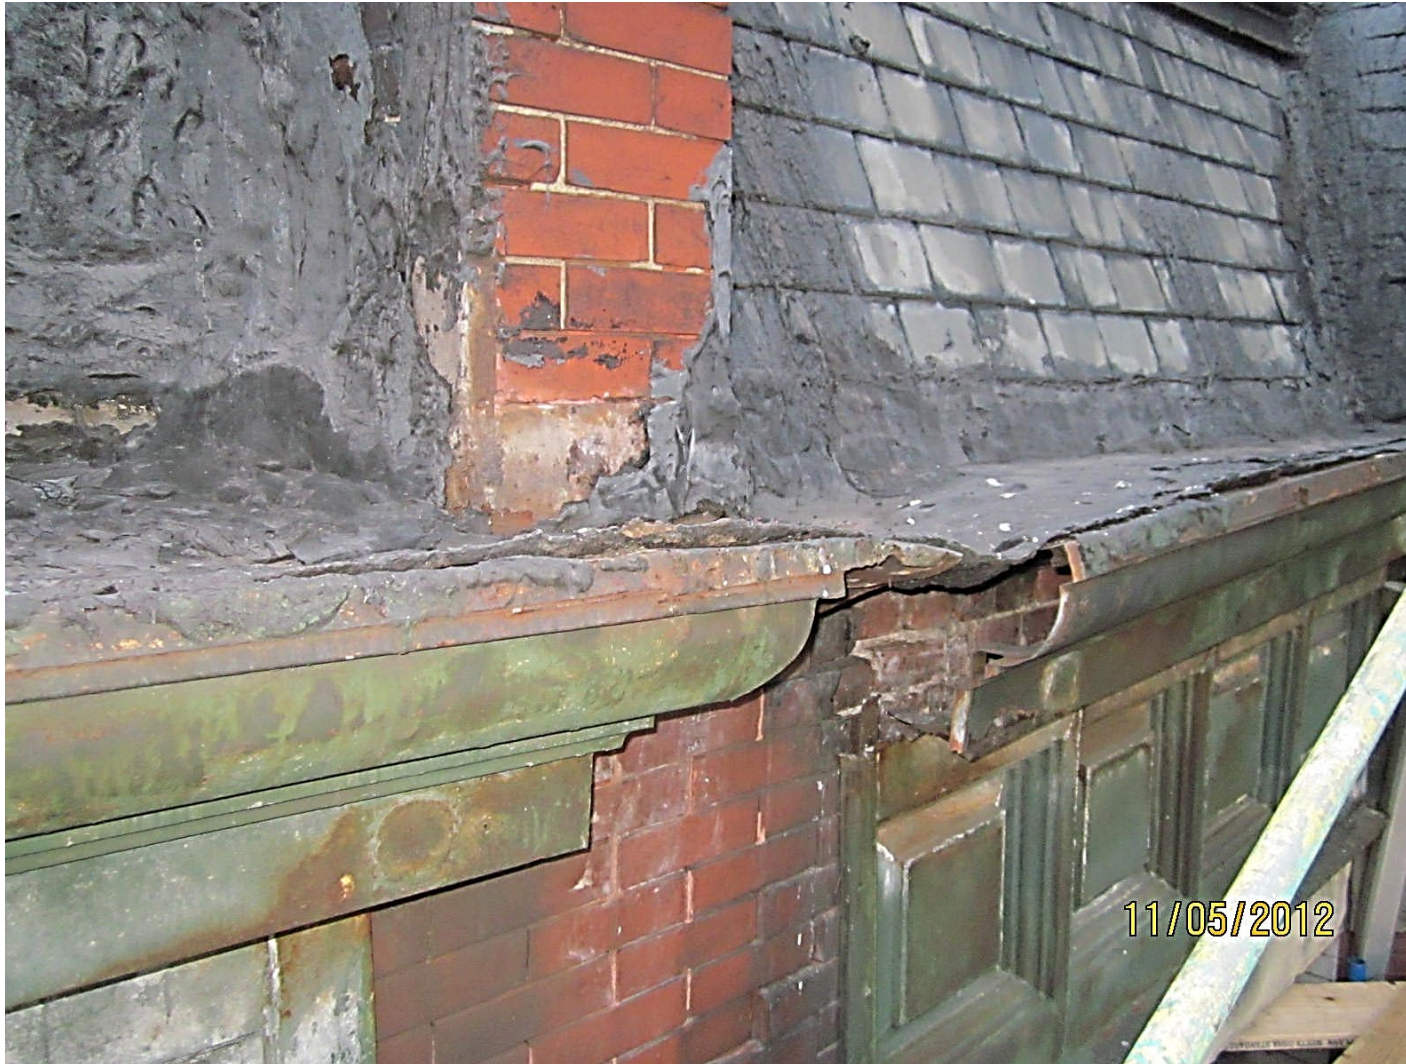
**231 West 75<sup>th</sup> Street (Severe deterioration of underlying brick at Mansard and Turret Roof Differential Façade Settlement visible at misaligned gutters.)**
