Preservation Department – Item 1, LPC-22-02413

231-233 West 74th Street – West End - Collegiate Historic

Façade Reconstruction

231 & 233 West 74th Streets

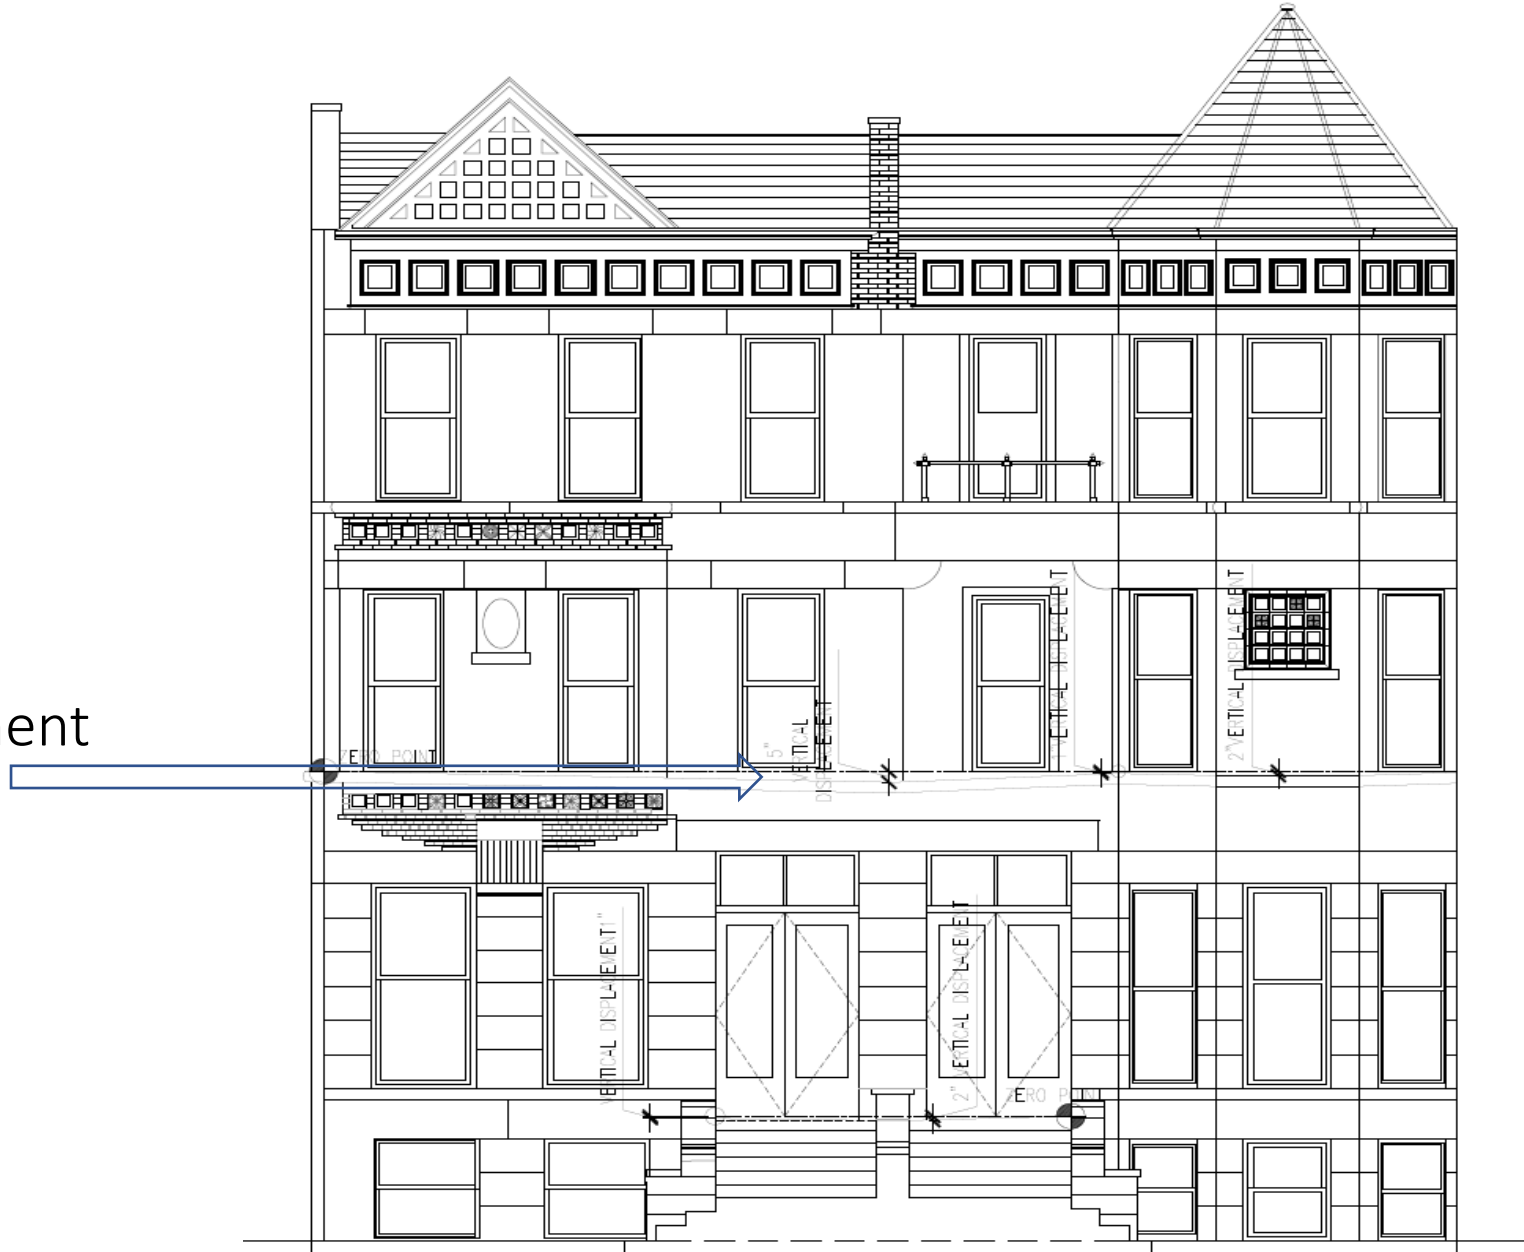
Existing Displacement - 2022

5" displacement

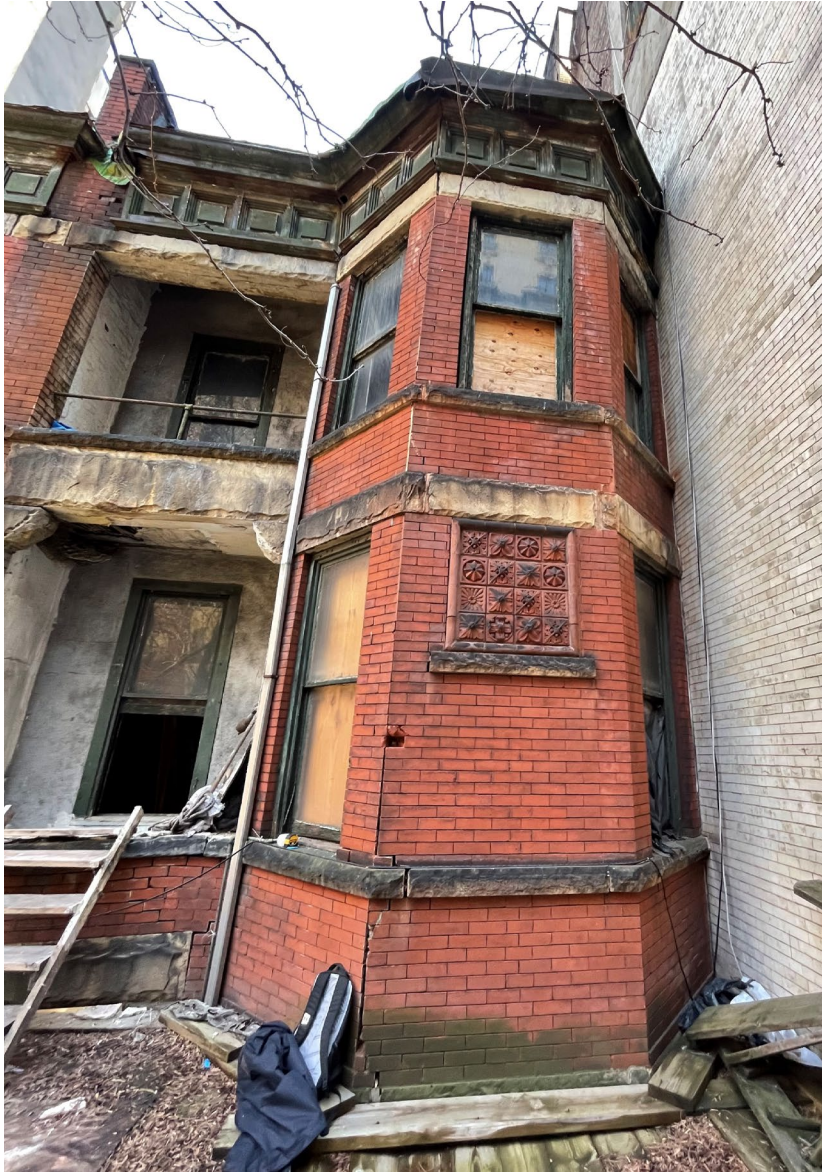
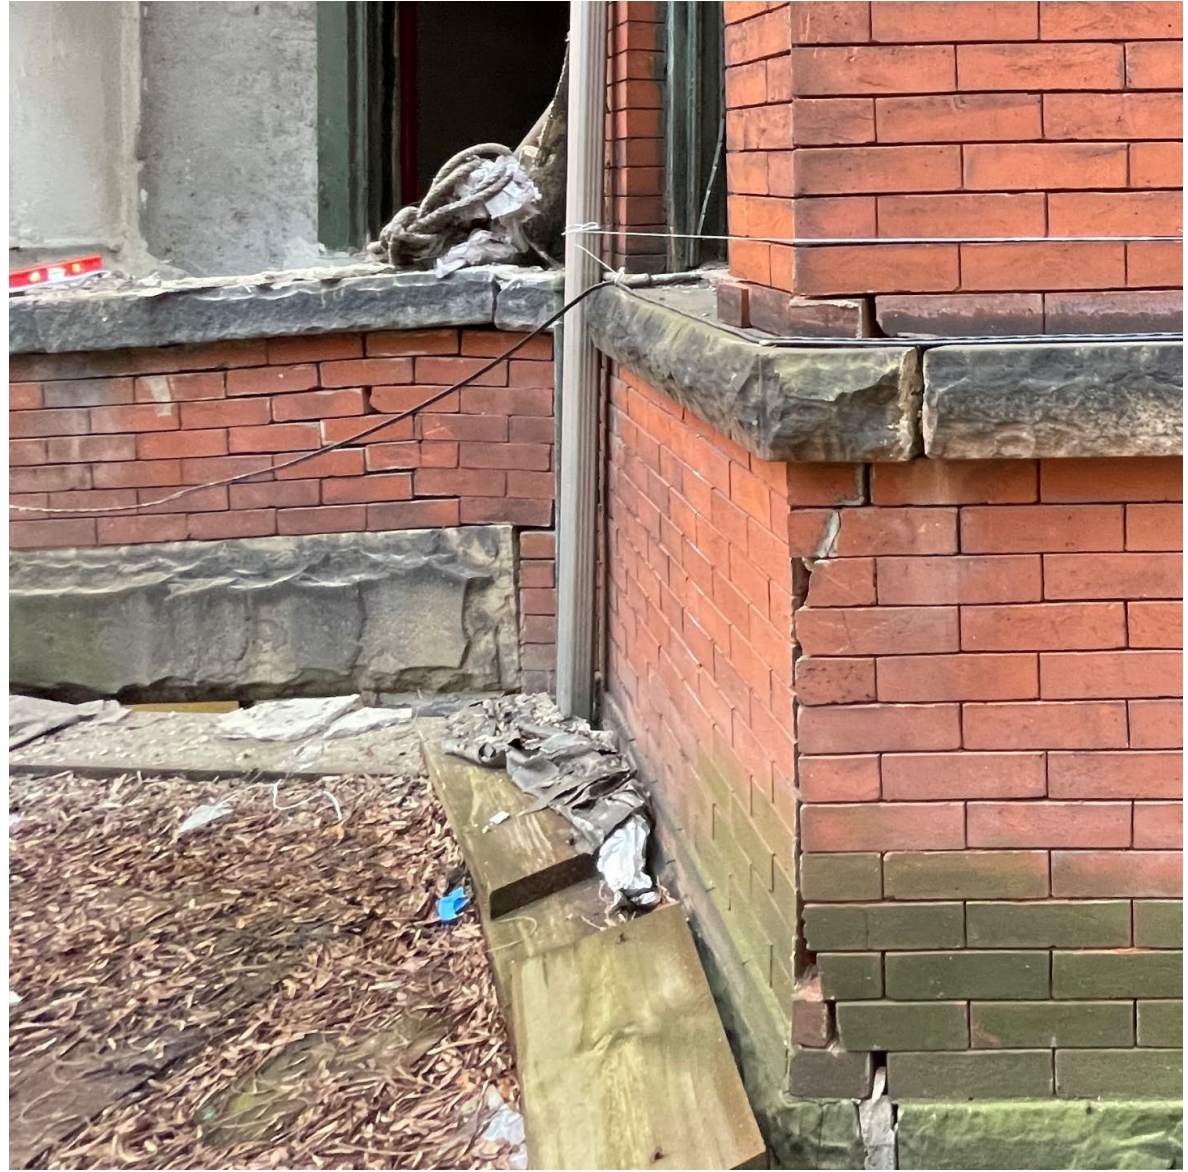
Photo taken 2022

231 West 75th Street (Bay window segment coming apart at corner and cracked vertically from settlement.)

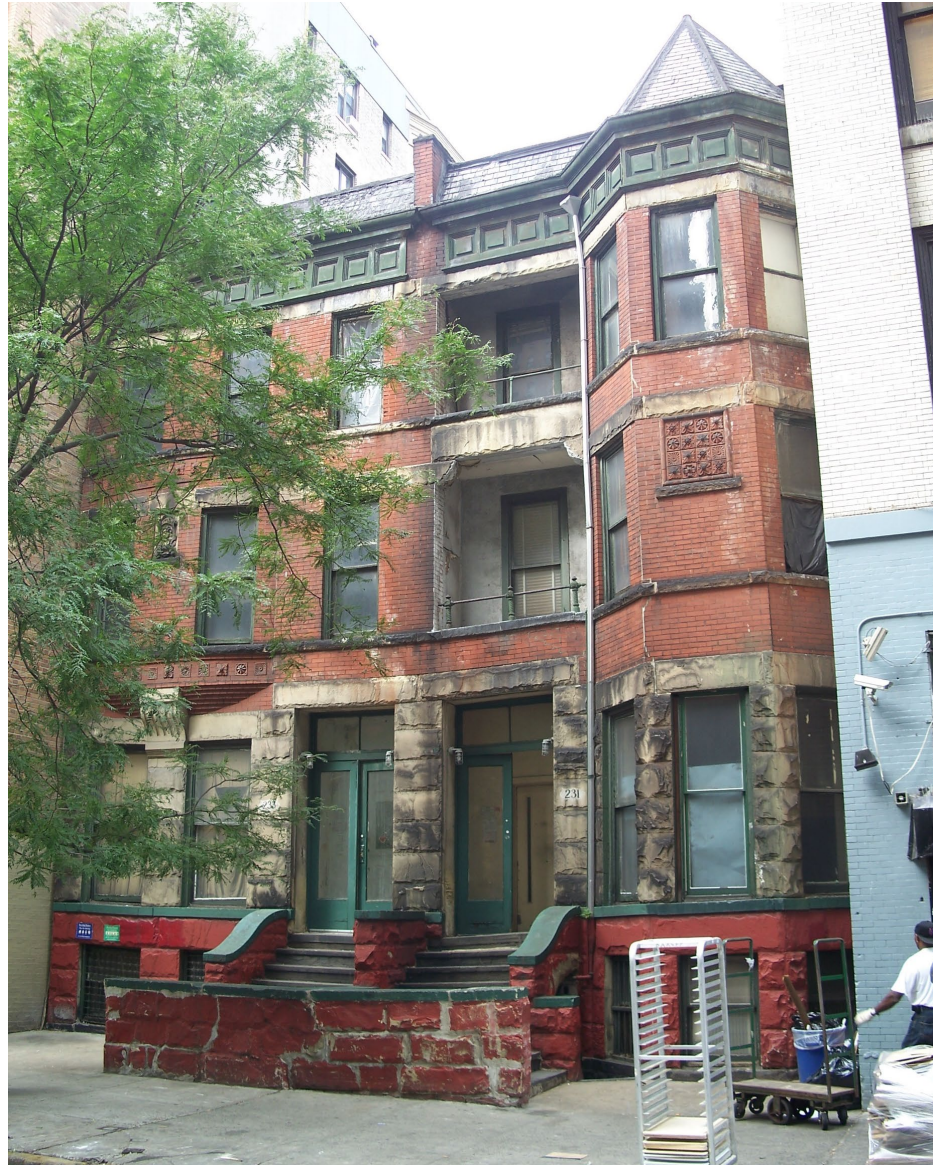
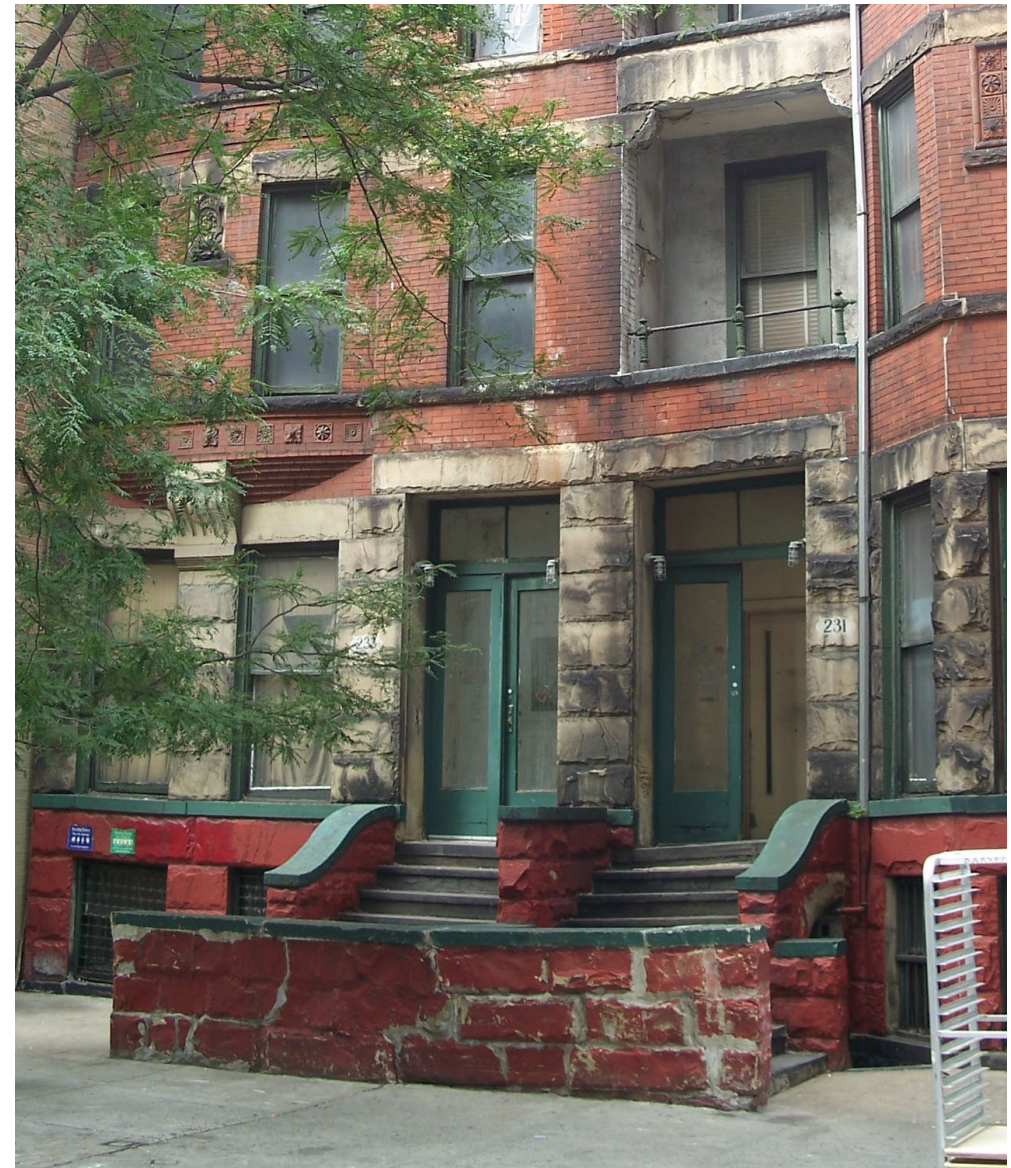
PHOTOS TAKEN 2007

PHOTOS-2007 – displacement is evident

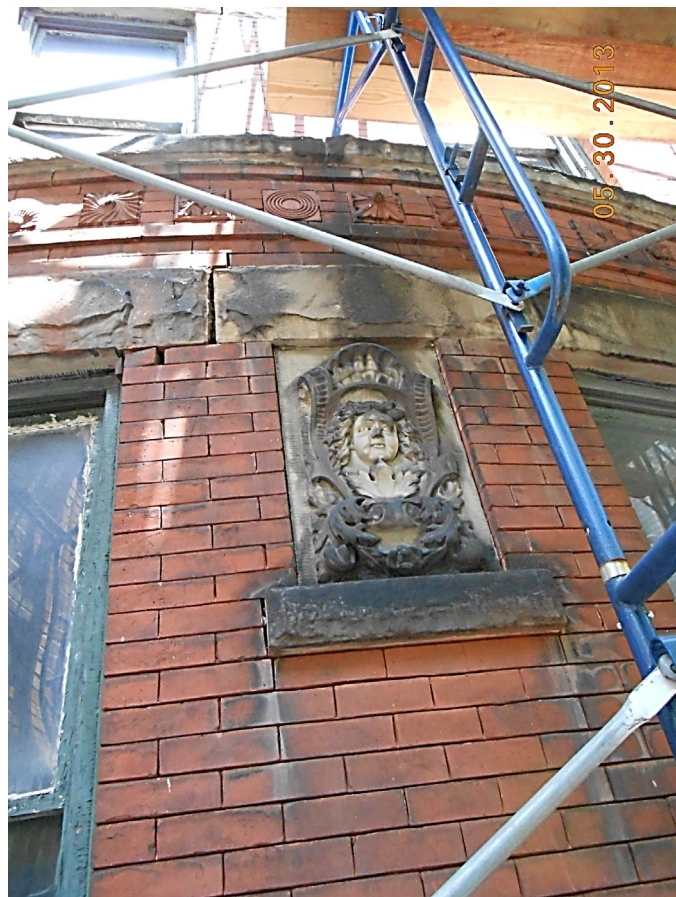
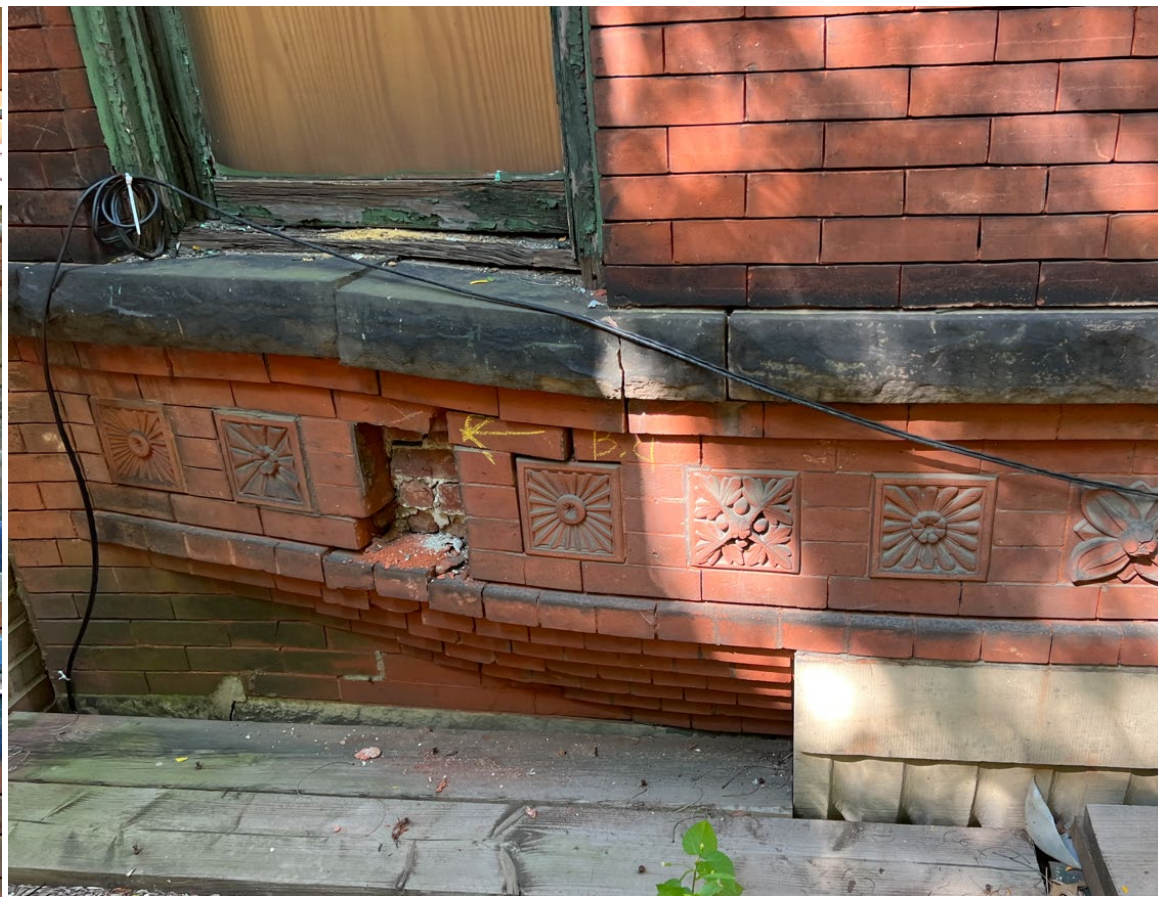
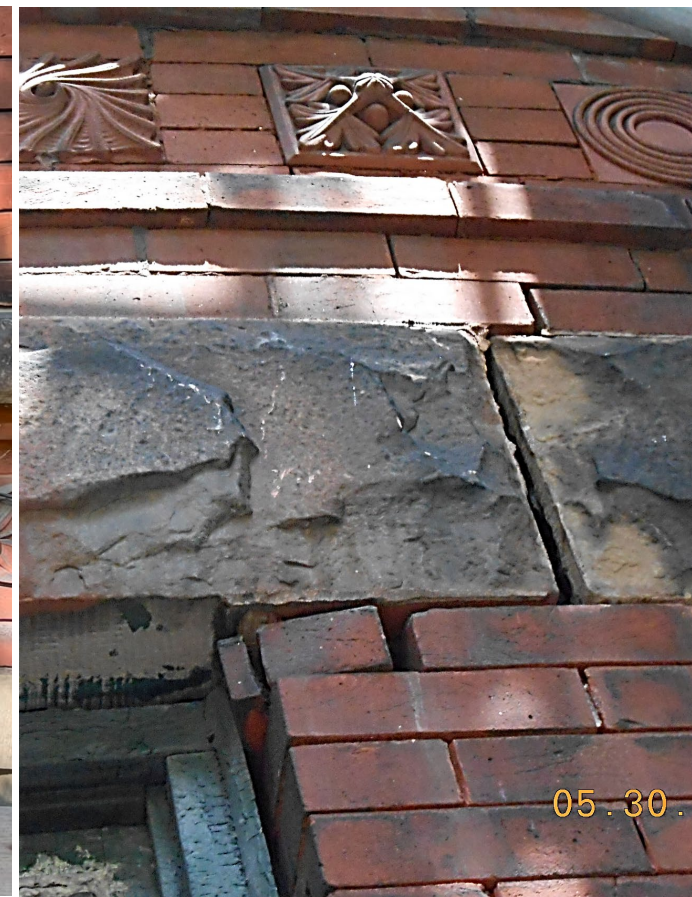
Photo taken 2012 shows separation and lateral displacement at the top the bow window at 233

Photo taken 2022 shows increased lateral displacement of the corbelled brick base of the bow window at 233.

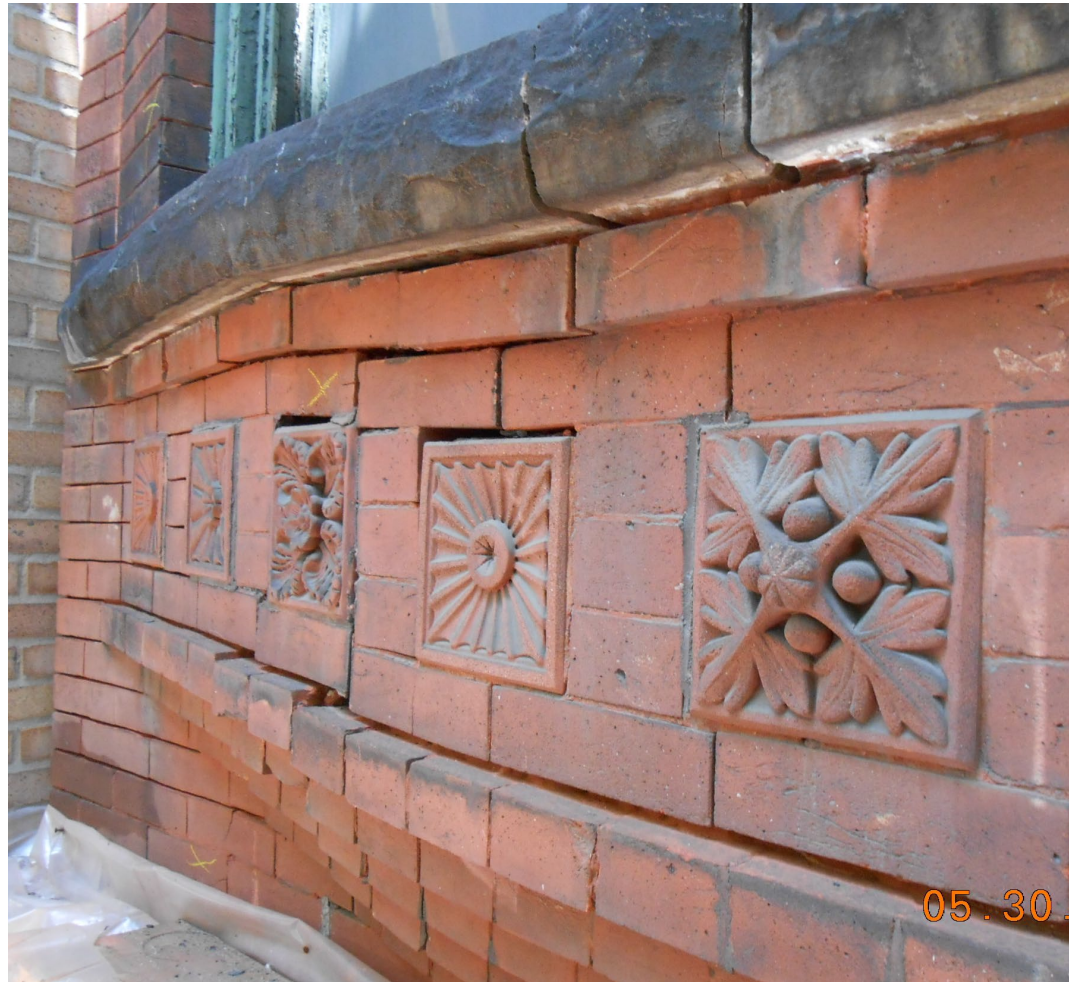
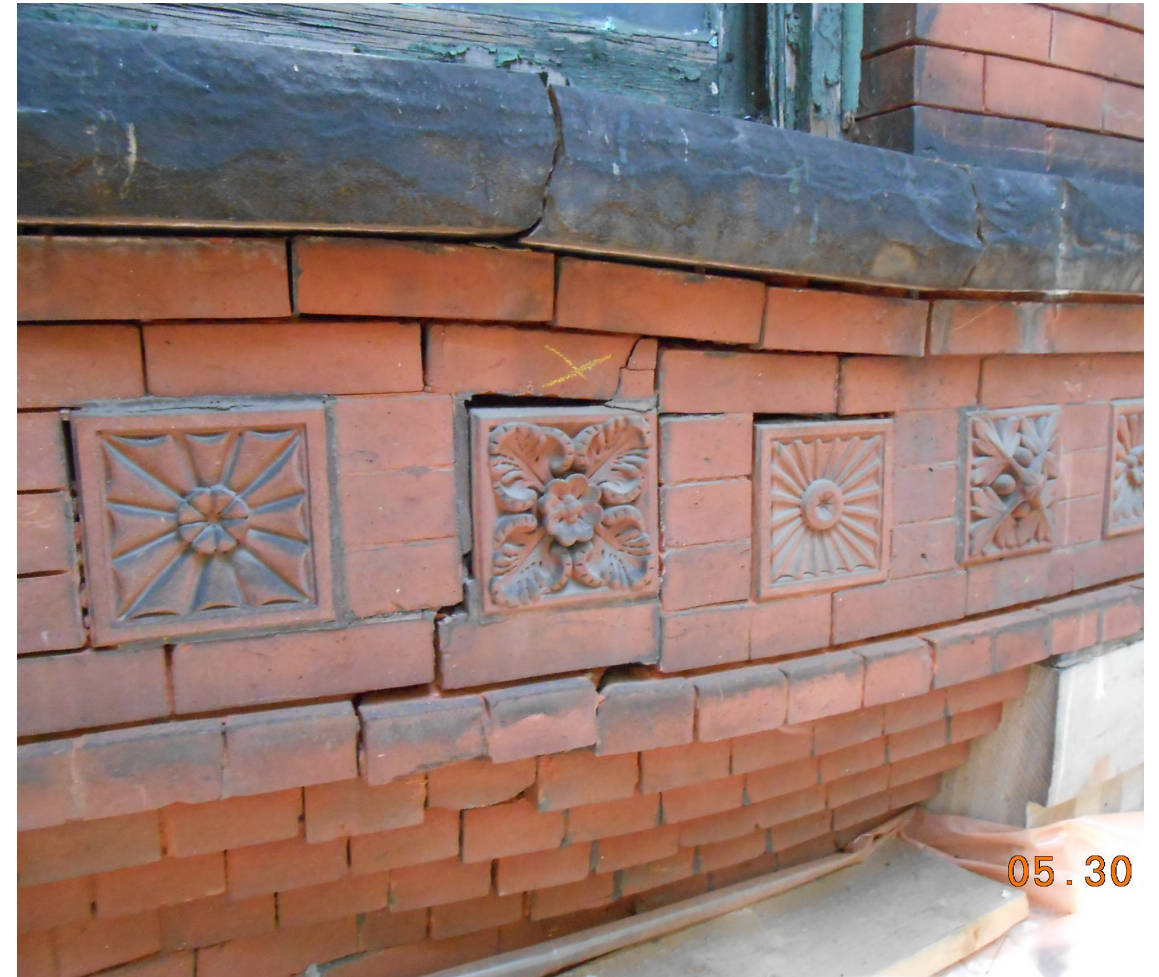
233 West 75th Street (Projecting bow window. masonry severely displaced vertically and horizontally from settlement of the facades)
Photos taken 2012

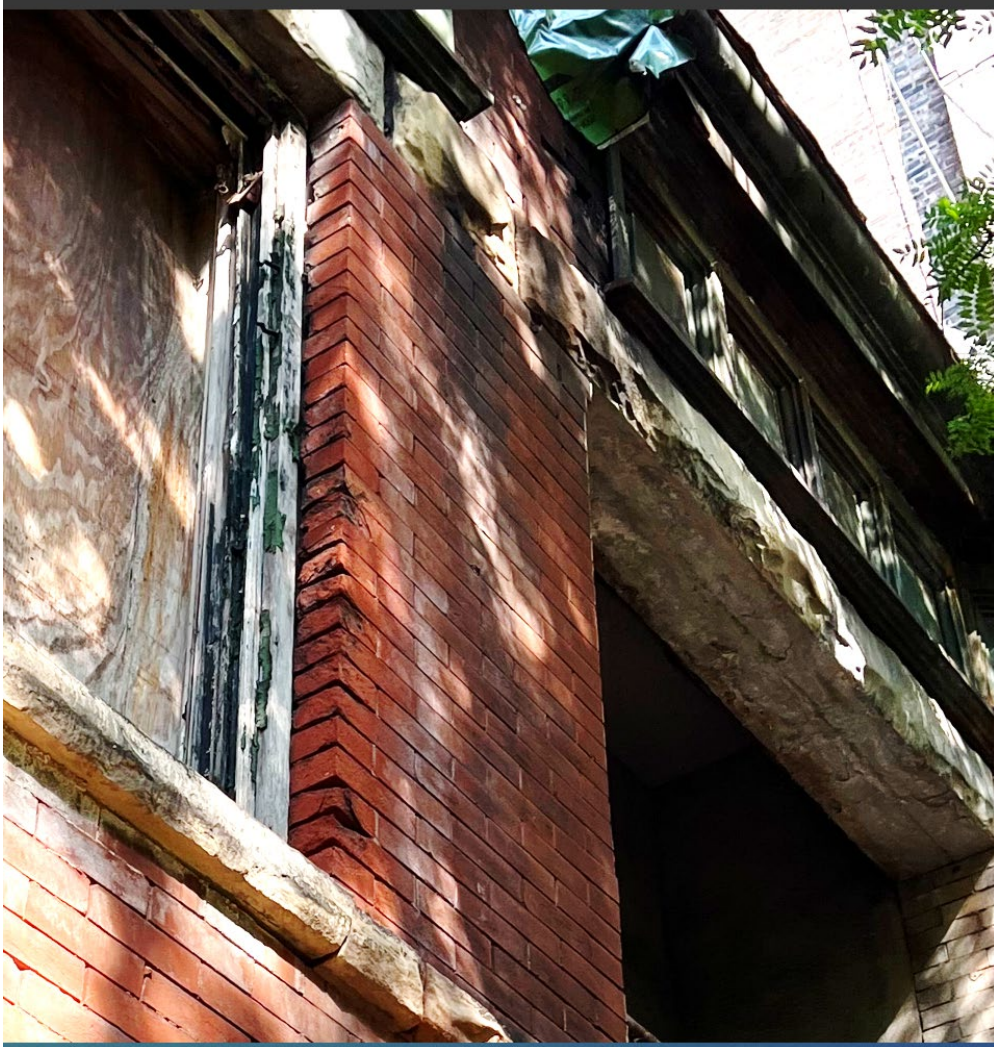
Pier between 233 & 231 exhibits lateral displacement – it is leaning towards the street

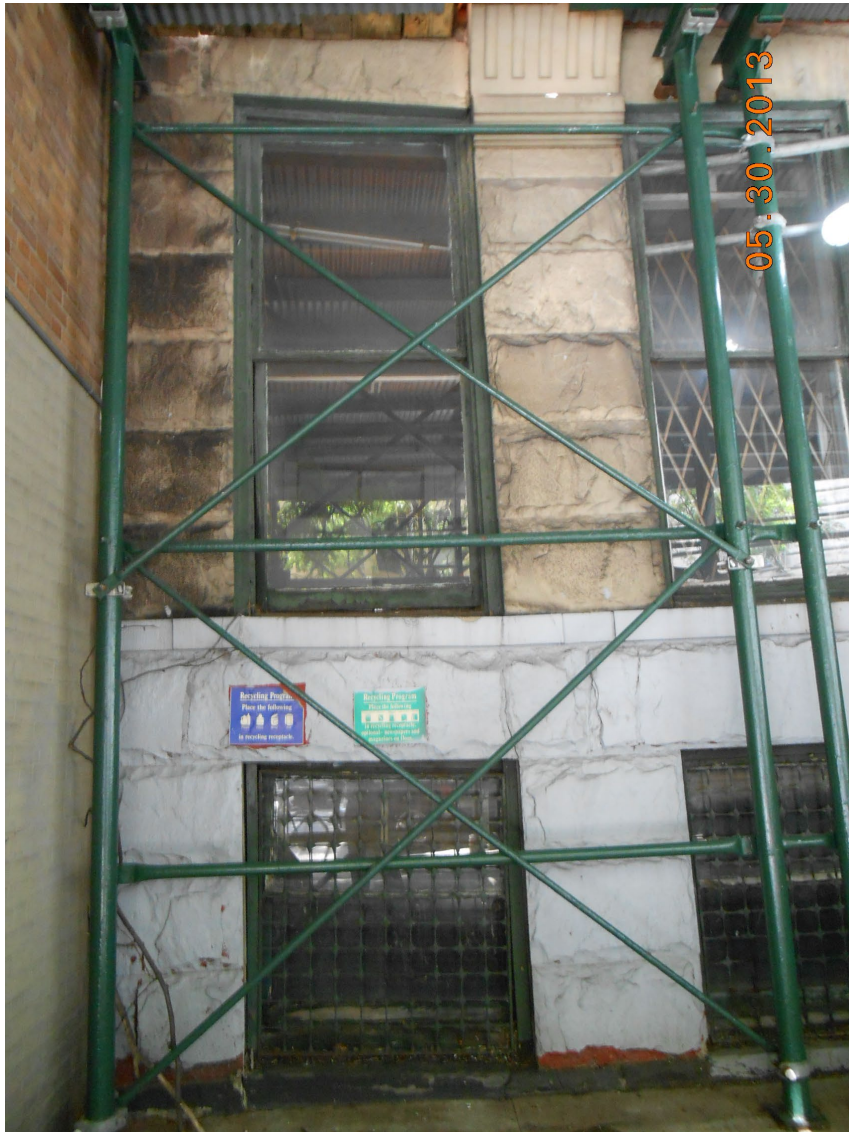
233 W 75th St (Displacement of Wdw. Ltl.)

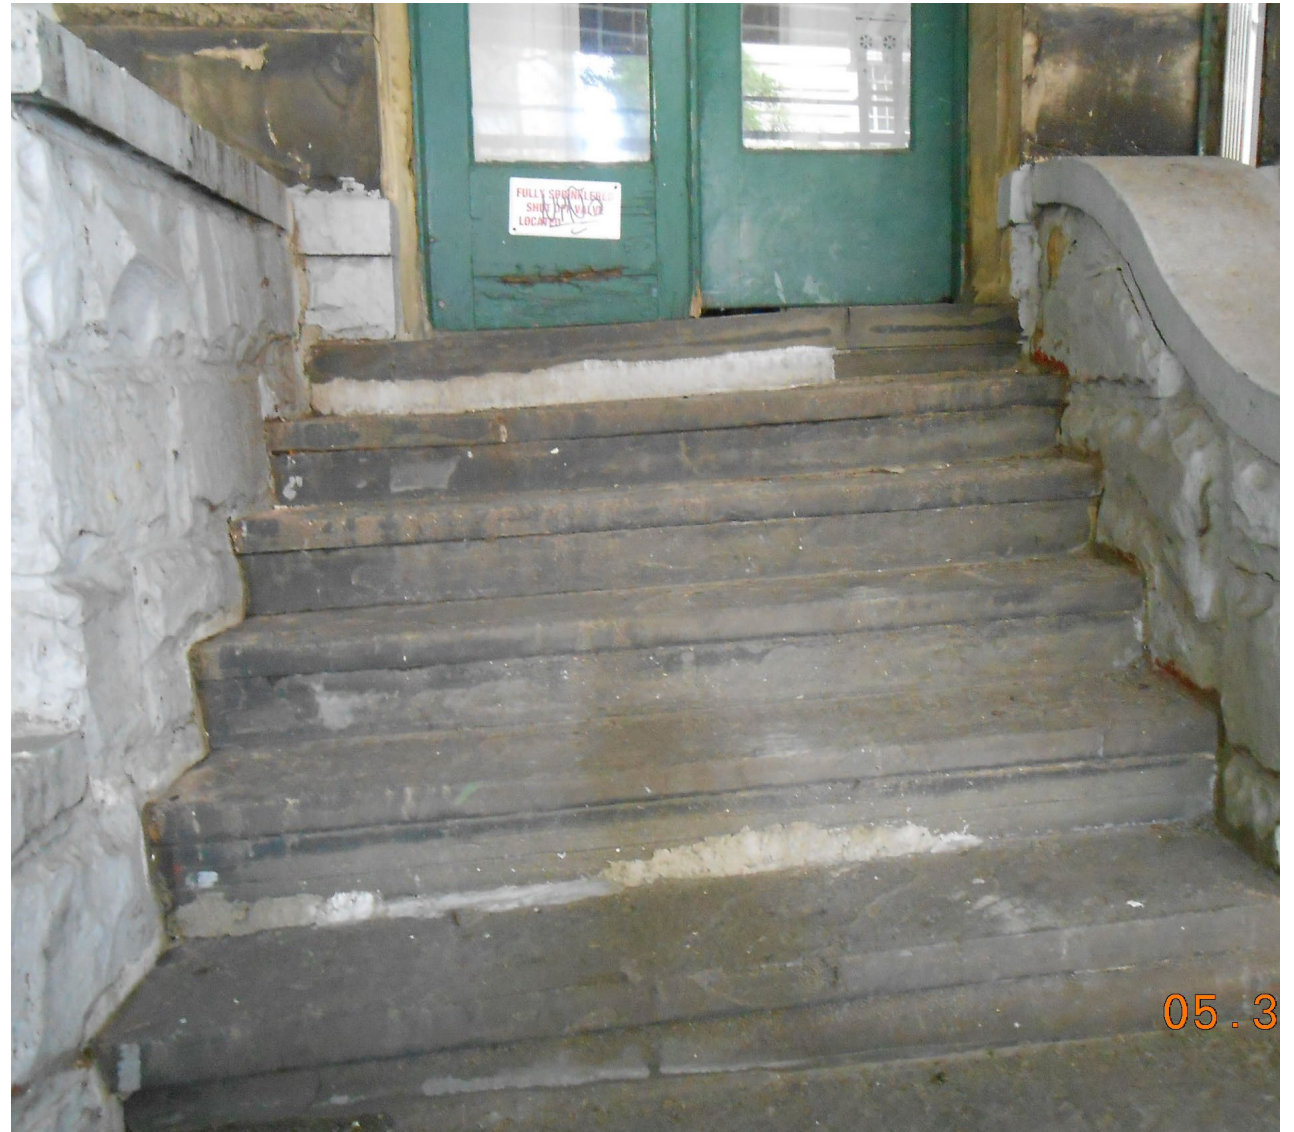
231 W 75th St (Displacement at Stoop)- Photos taken 2012

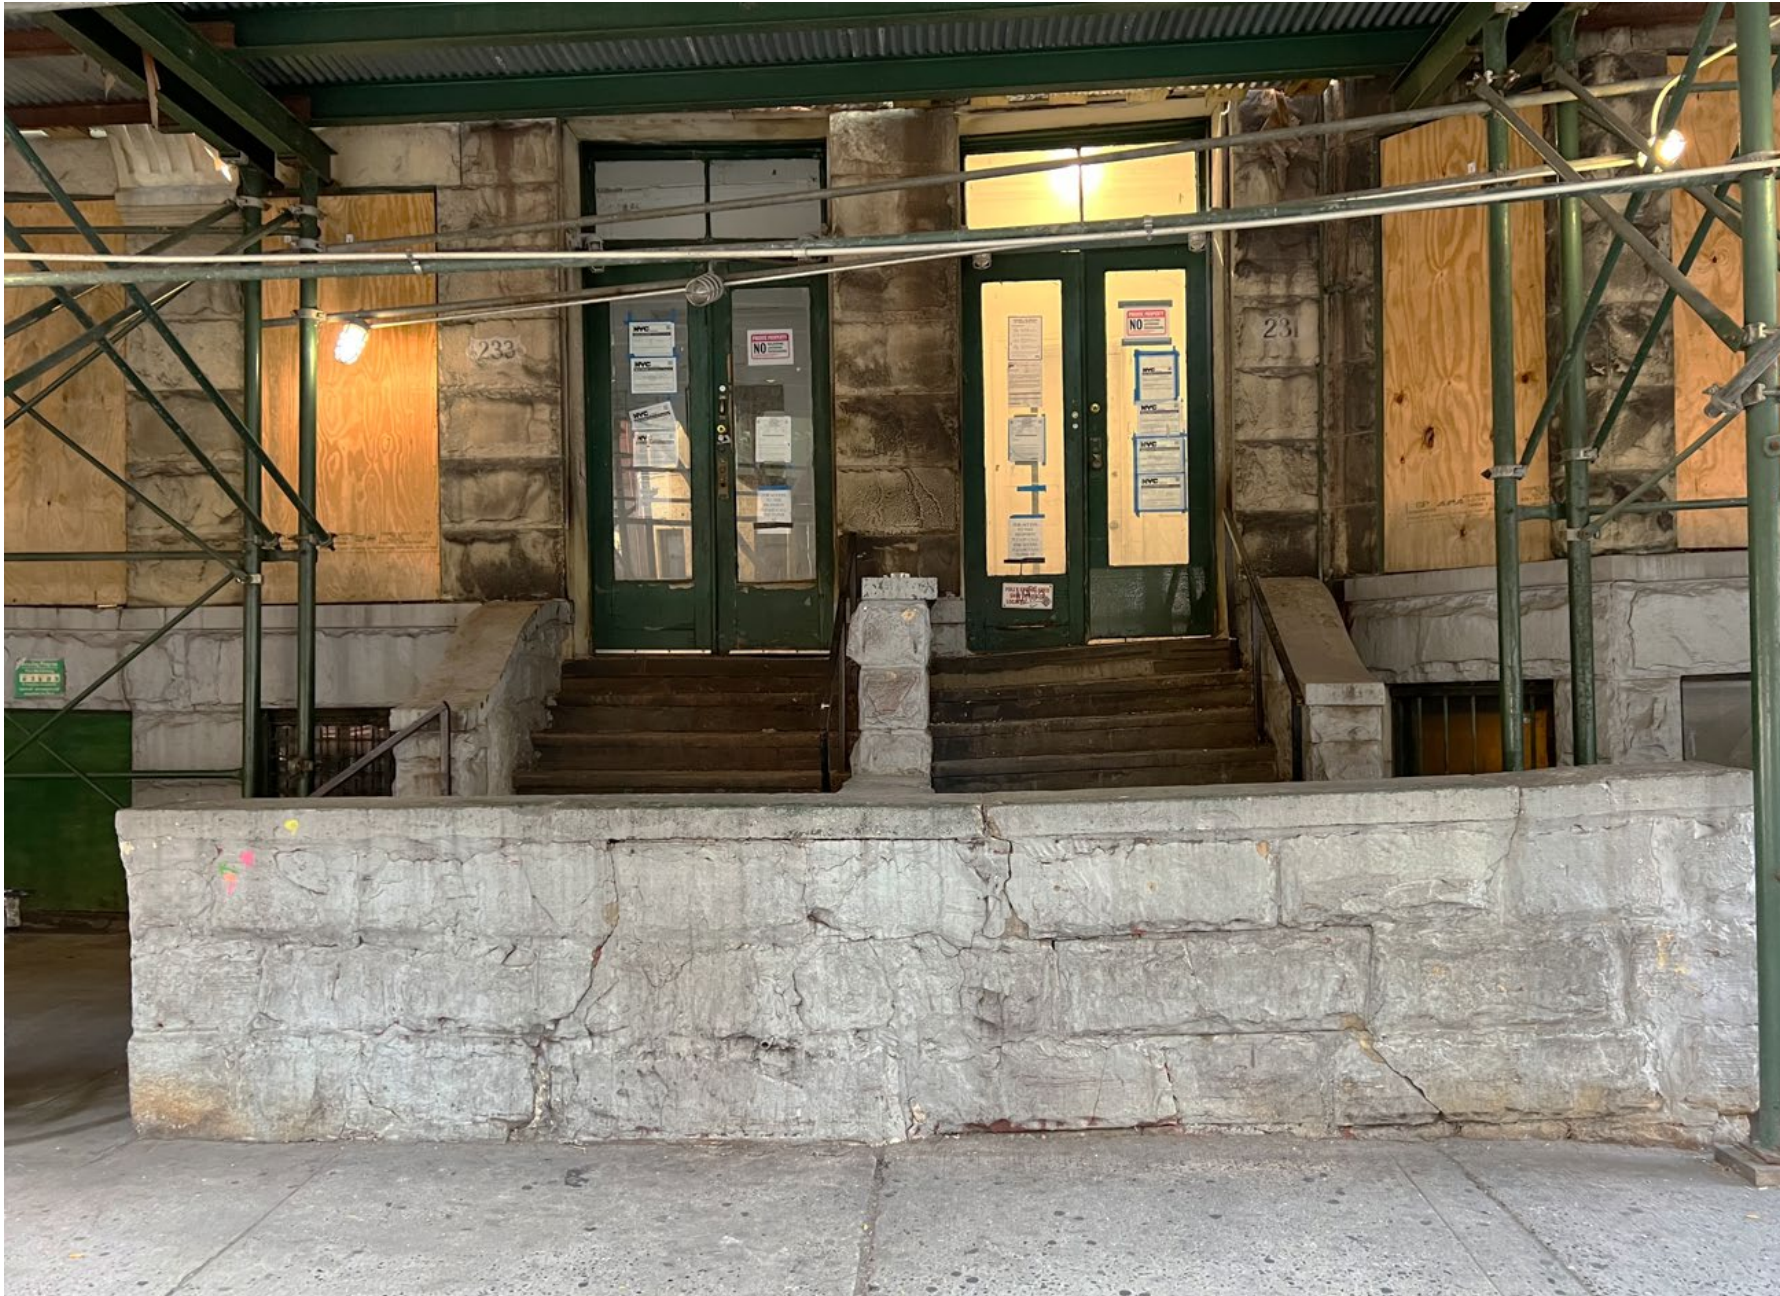
231 W 75th St
(Displacement at street
wall fronting steps)-
Photo taken 2022
reconstruction of this
wall will be necessary.

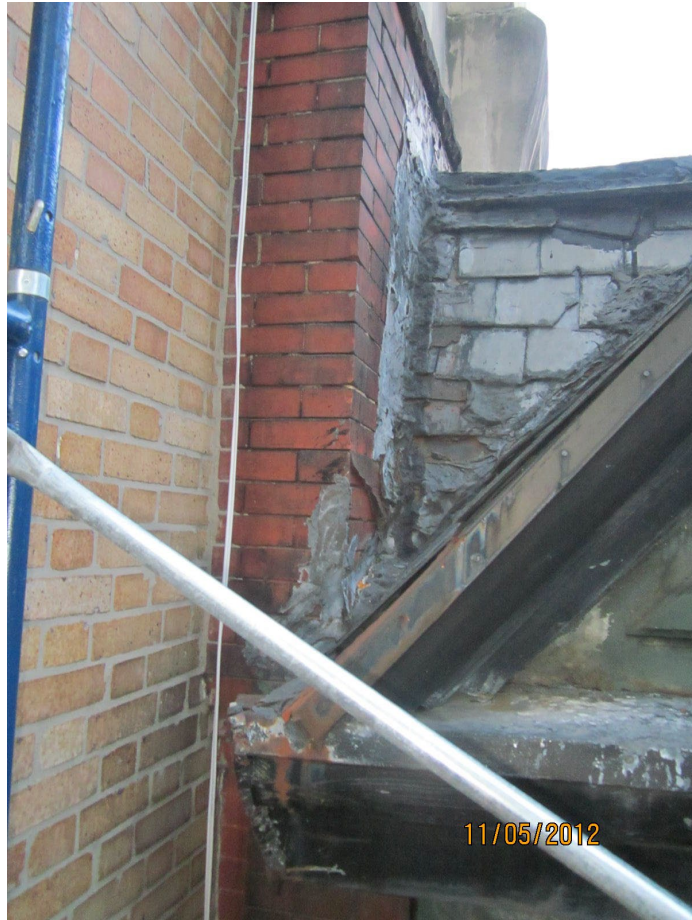
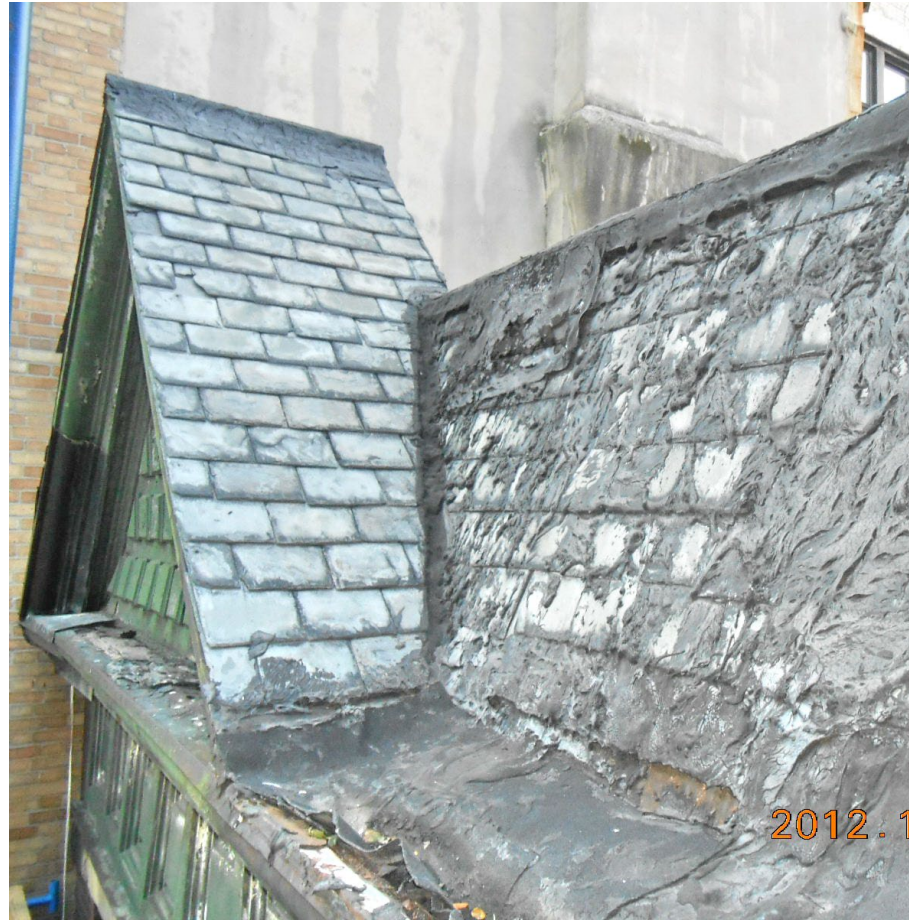
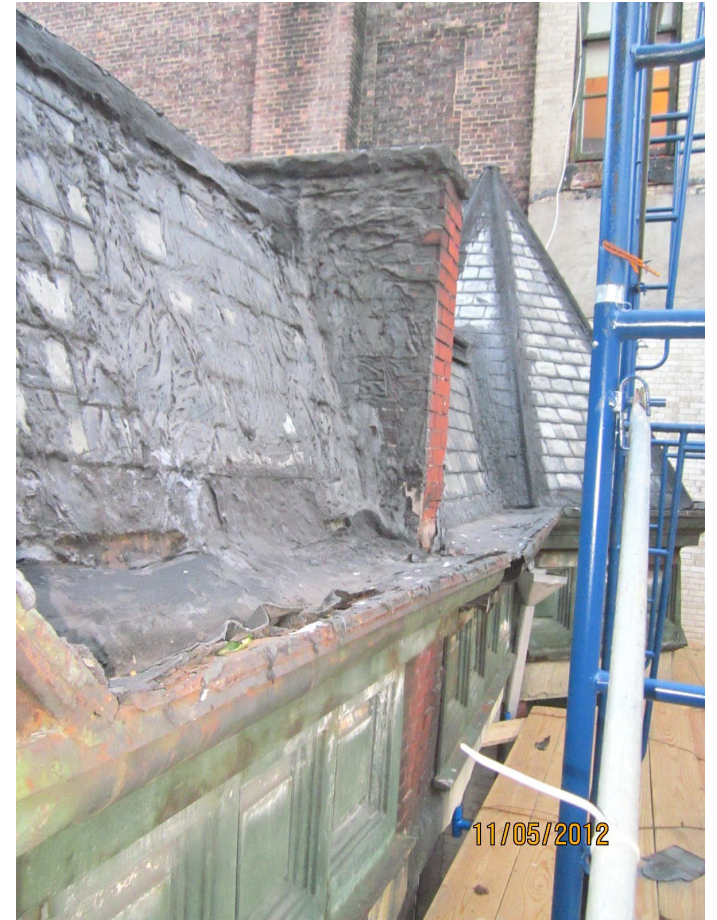
**233 West 75th Street (Severe deterioration of Mansard and Gable Roofs and Integral gutter)
Photos taken 2012**

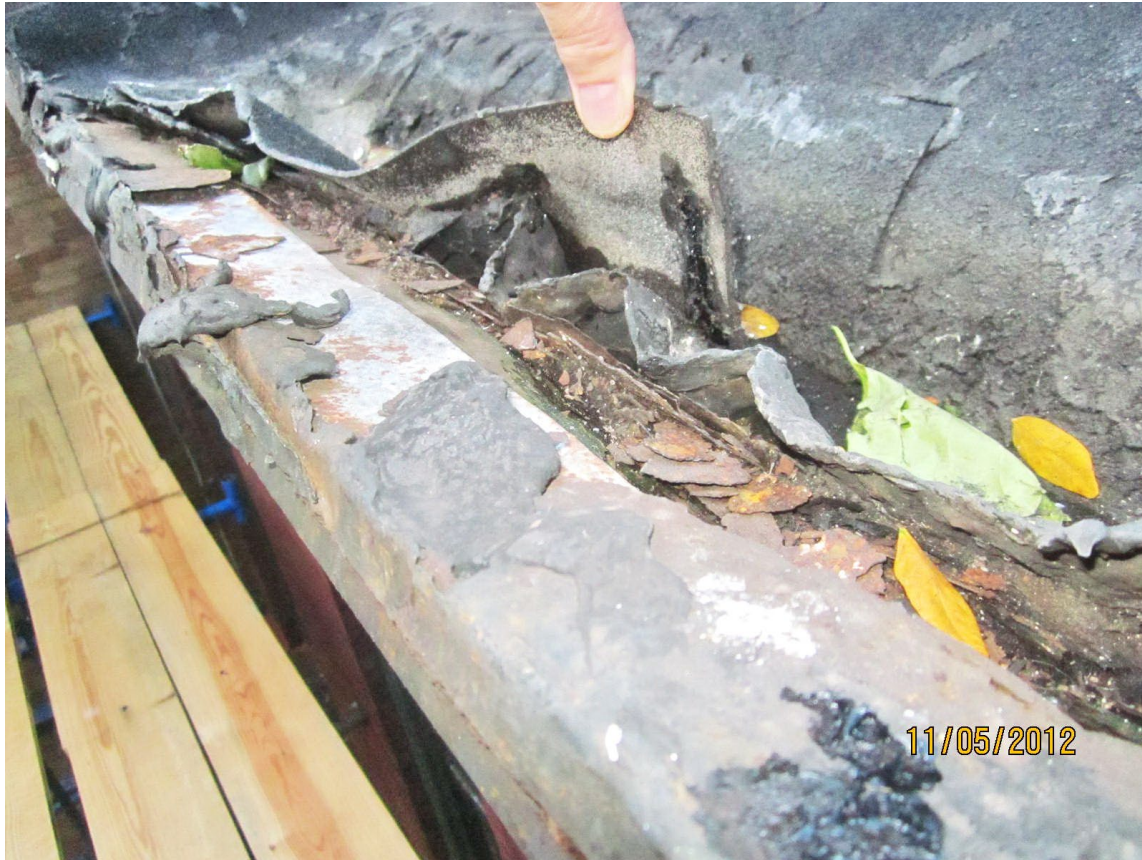
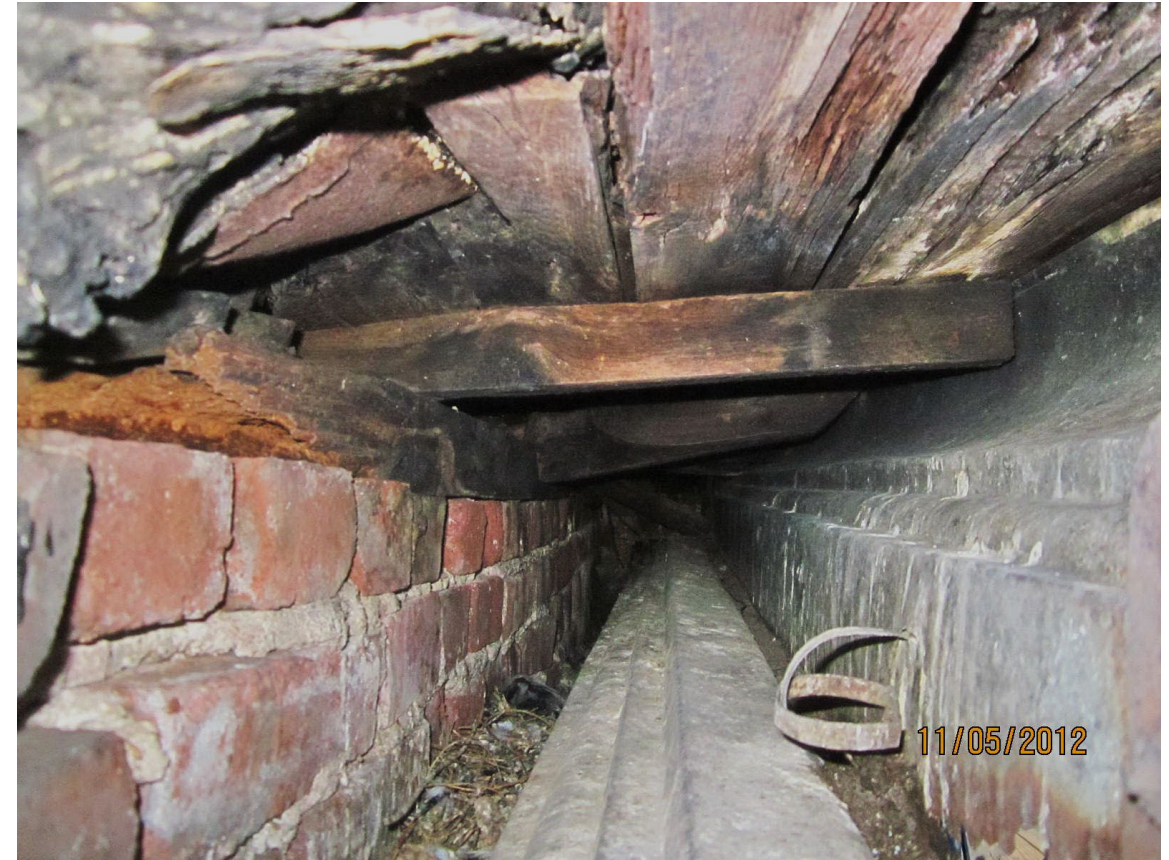
Photos Taken 2012

233 West 75th Street (Severe deterioration at Mansard Roof and underlying brick masonry)

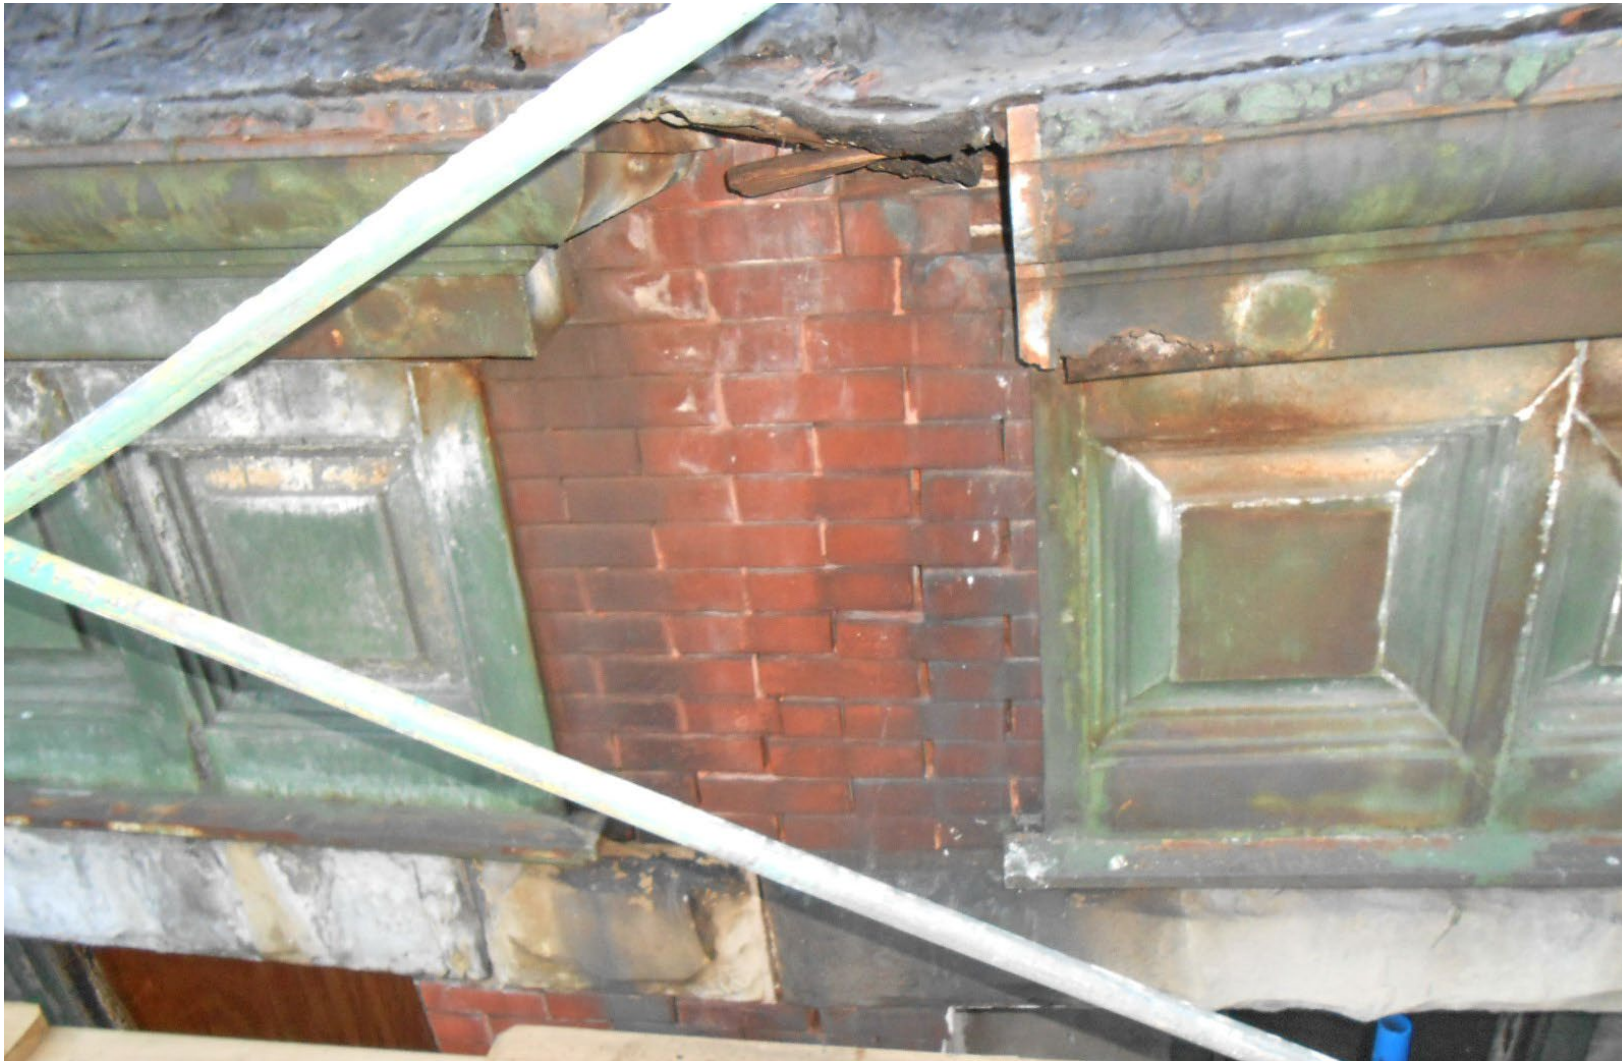
Photos Taken 2012

231 / 233 West 75th Street (Differential Façade Settlement visible at misaligned gutters and mortar joint widths)
