Preservation Department – Item 1, LPC-22-02413

231-233 West 74th Street – West End - Collegiate Historic

Façade Reconstruction

231 & 233 West 74th Streets

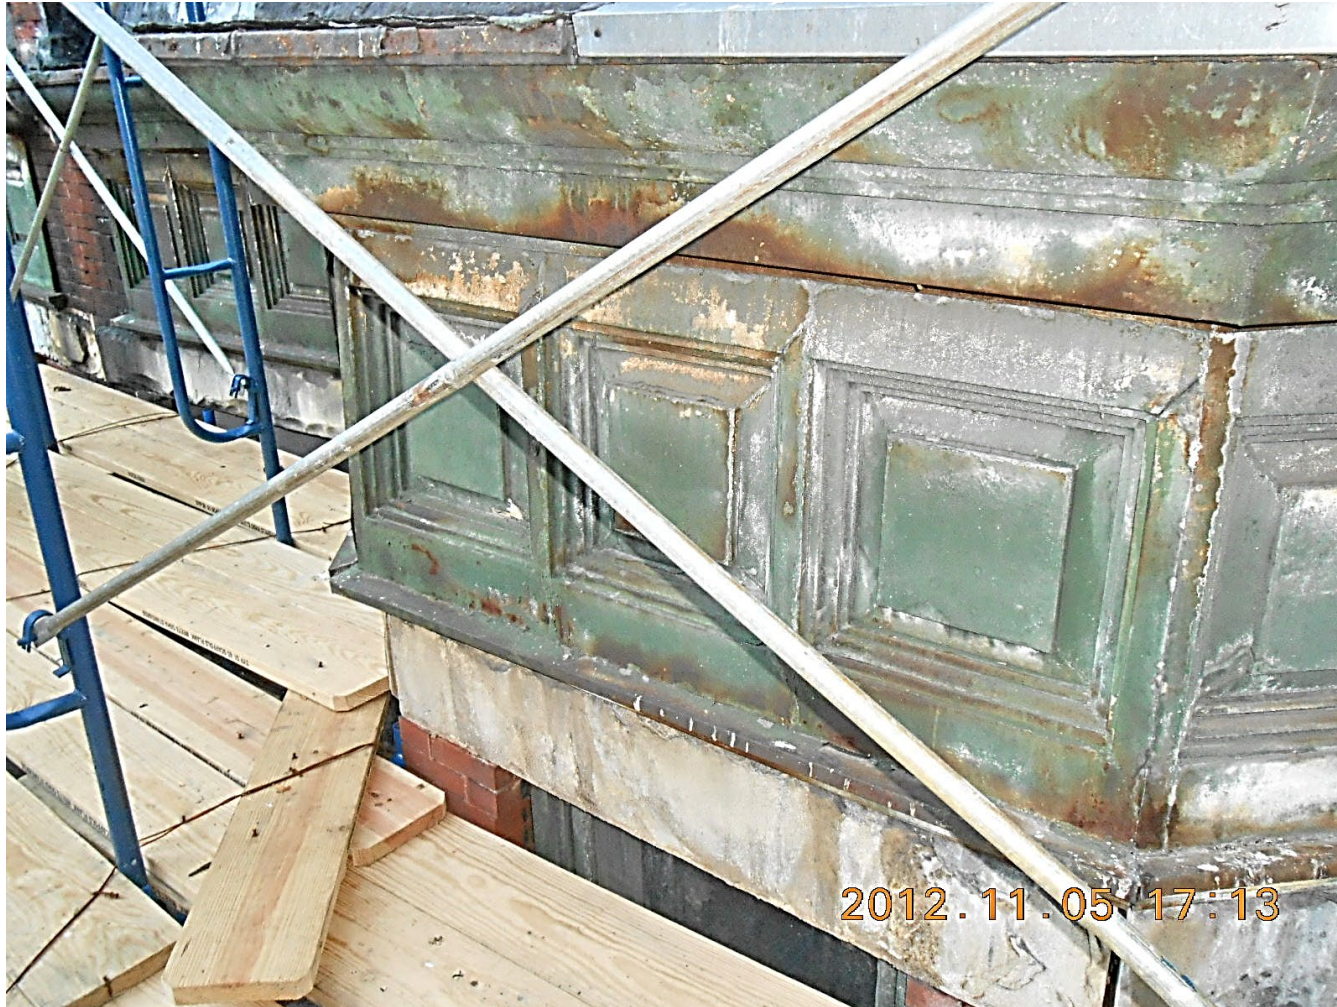
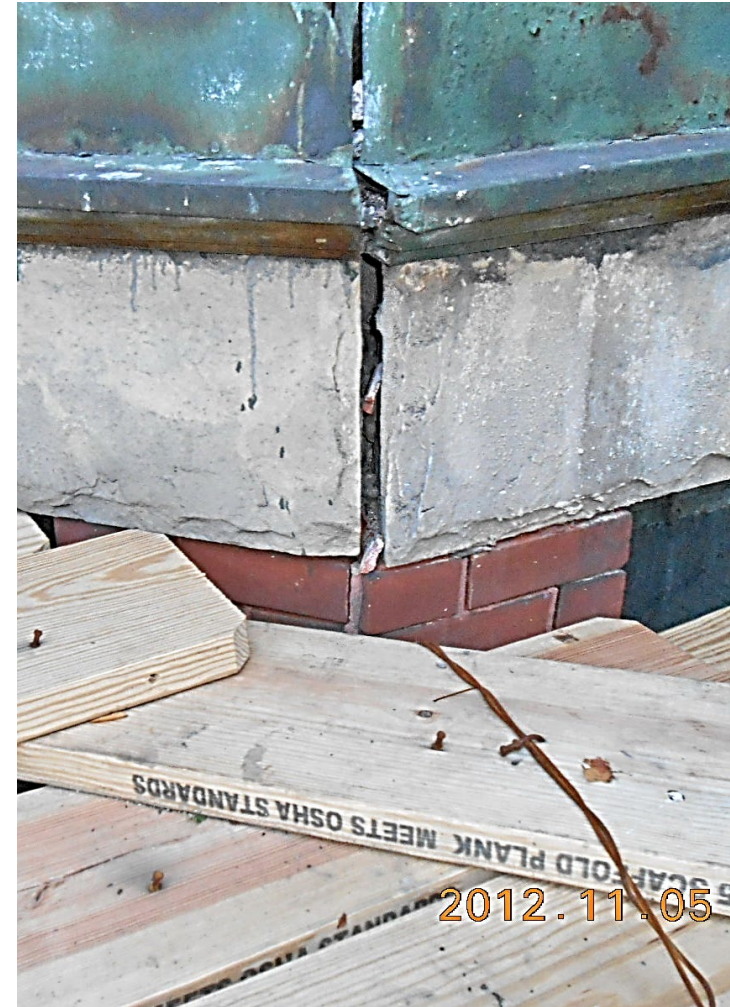
231 West 75th Street (Differential Façade Settlement visible where bay window segments pulling apart)
Photos taken 2012

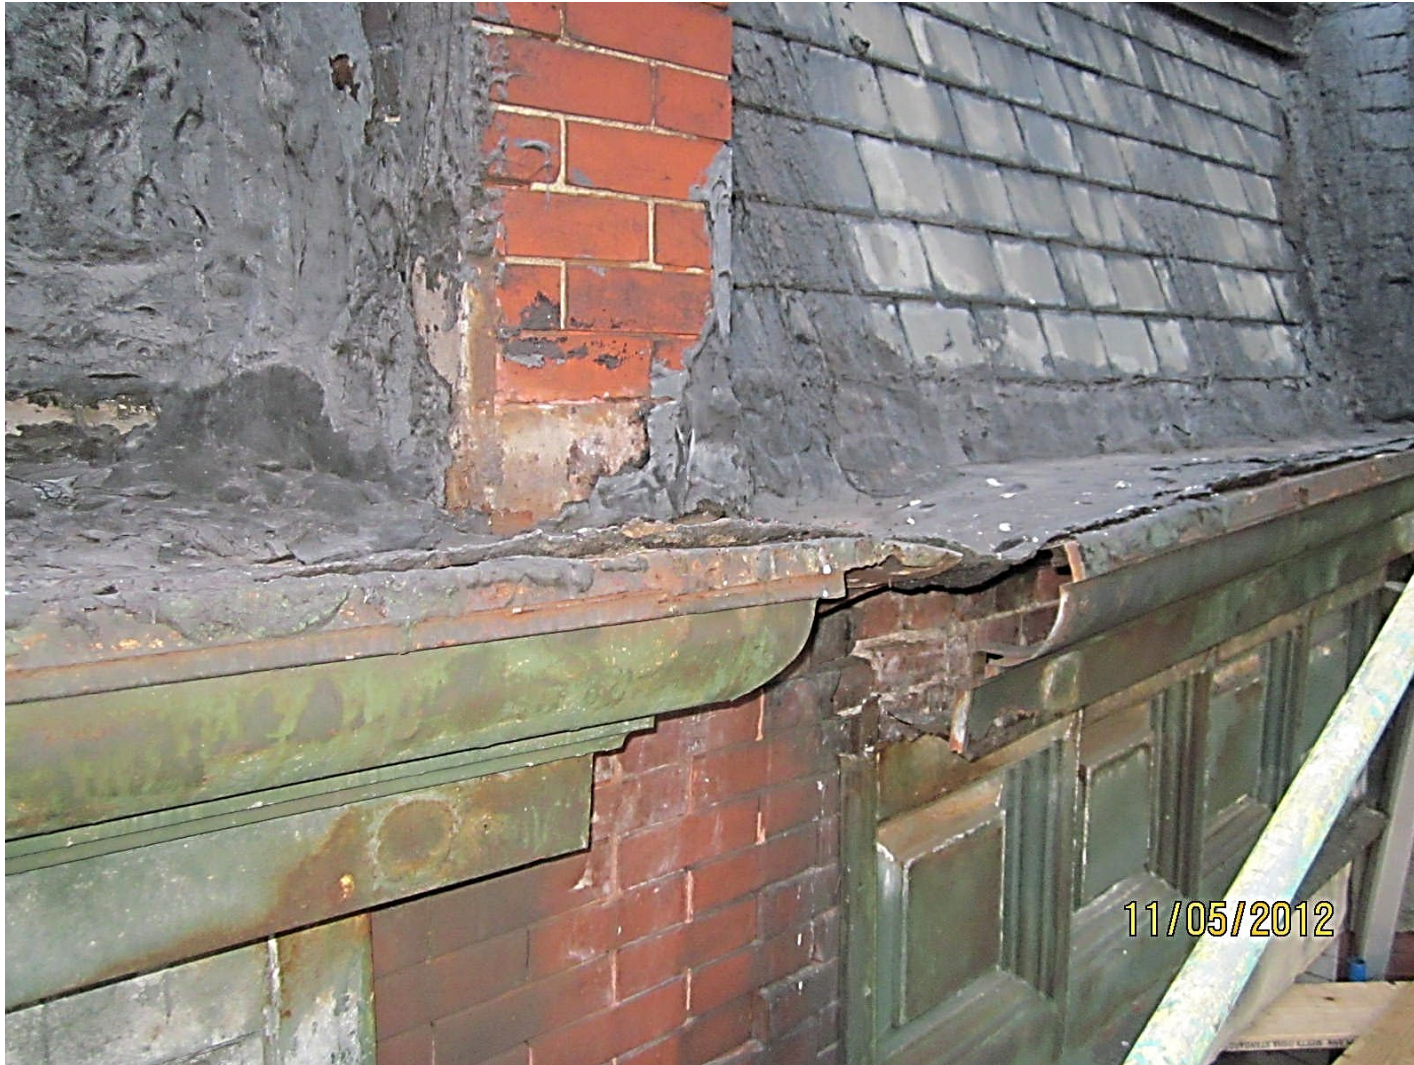
Photo taken 2012

231 West 75th Street (Severe deterioration of underlying brick at Mansard and Turret Roof Differential Façade Settlement visible at misaligned gutters.)
