Preservation Department – Item 8, LPC-23-03274

**768 Fifth Avenue – The Plaza Hotel – Individual and Interior
Landmark
Borough of Manhattan**

Howard L. Zimmerman Architects & Engineers - Architect and Engineer of Record
Acheson Doyle Partners Architects - Preservation Consultant

Landmarks Preservation Commission Public Hearing
November 01, 2022

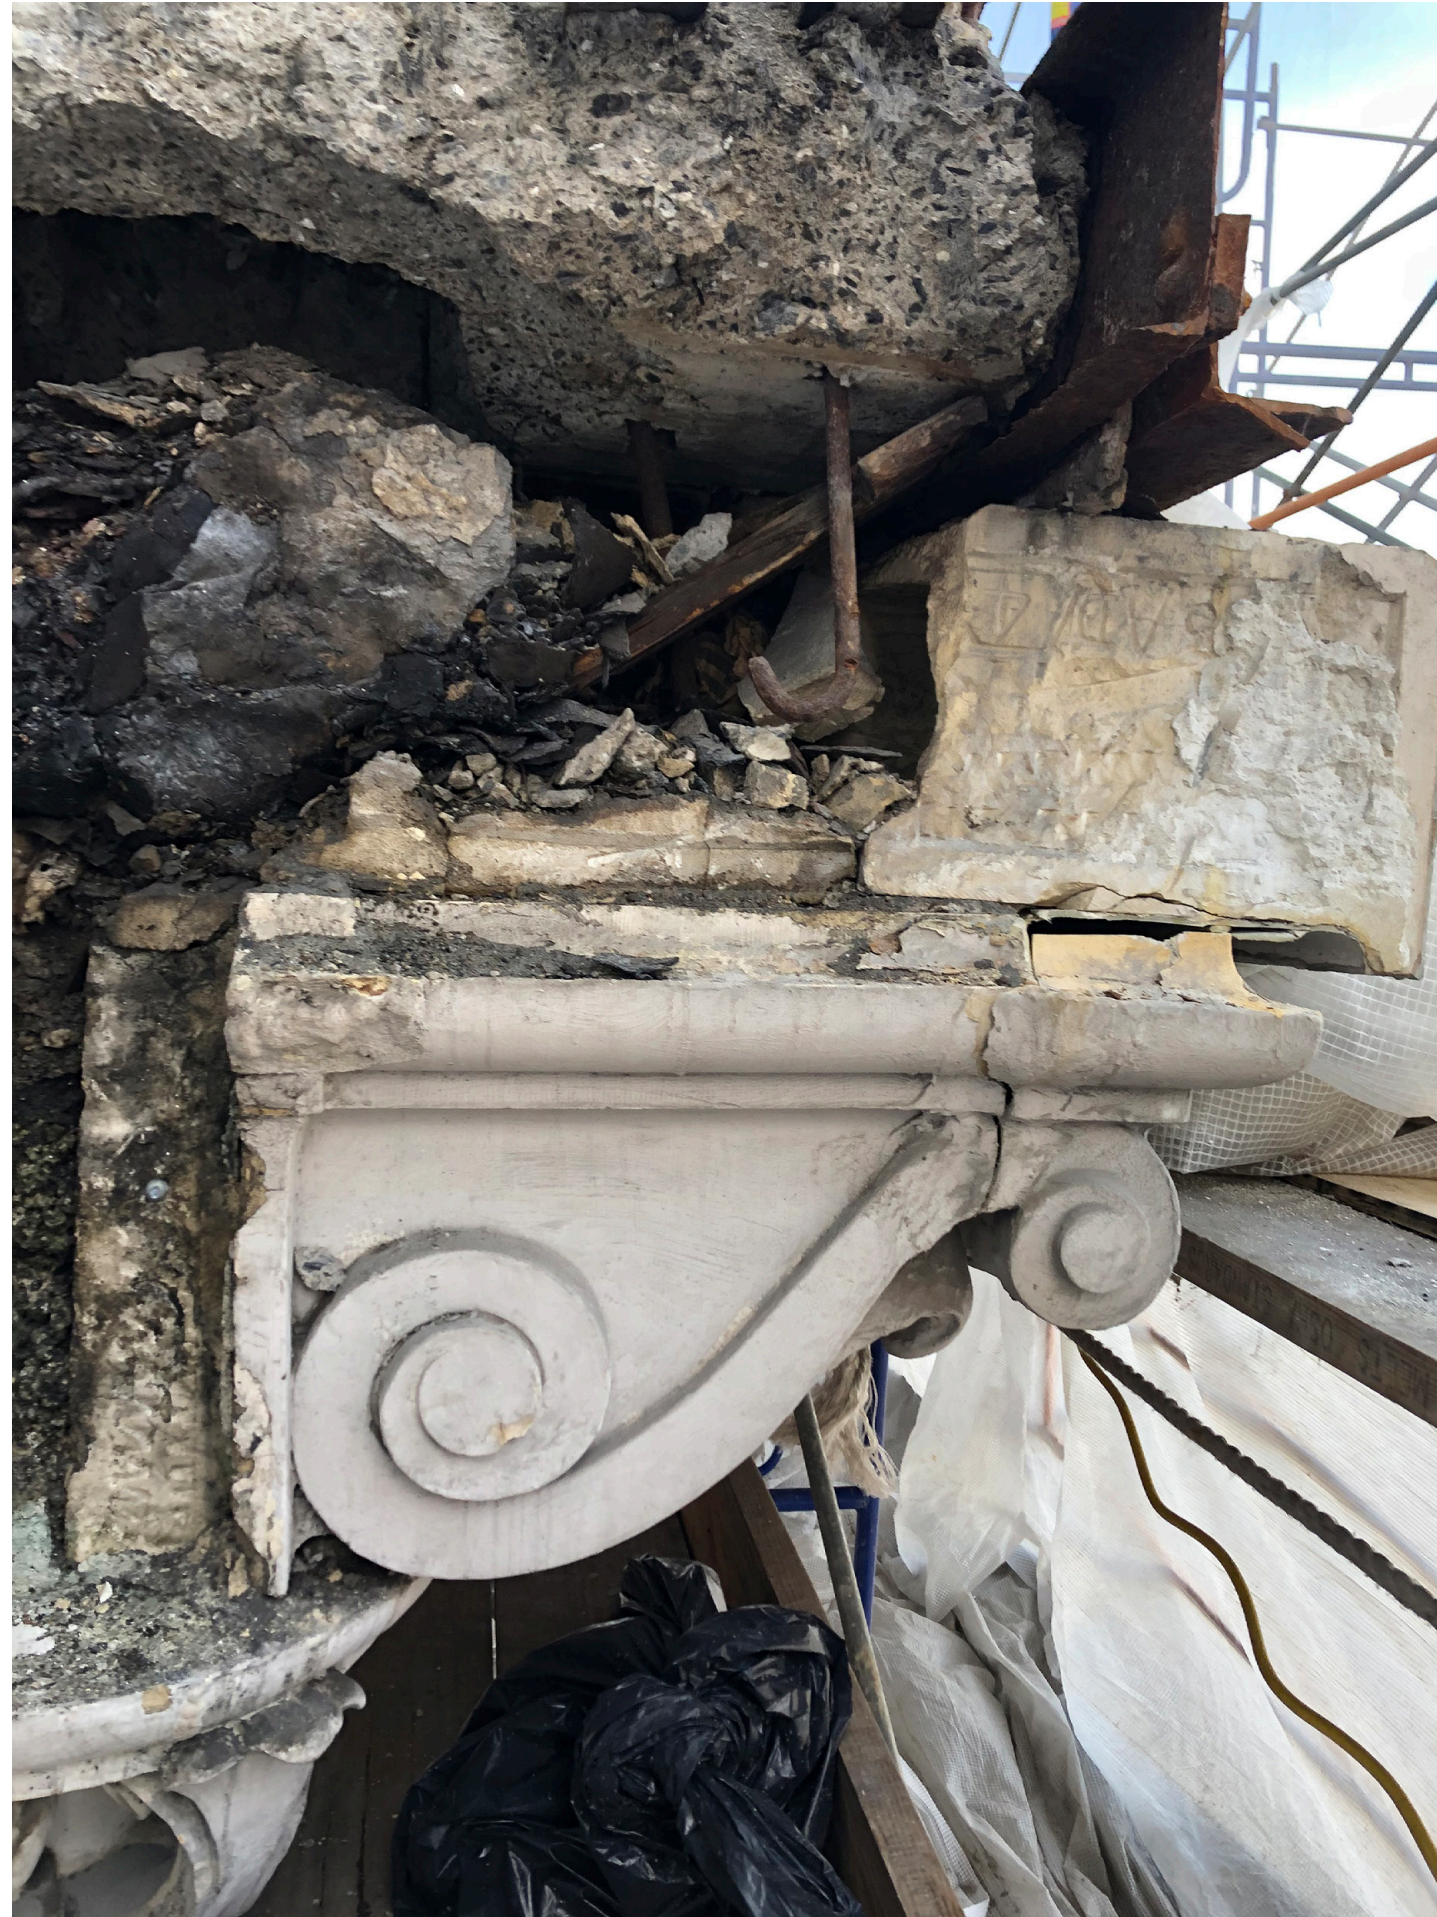
**Cross-Section View of
Balcony showing detached
metal tie rods and cracked
terracotta**

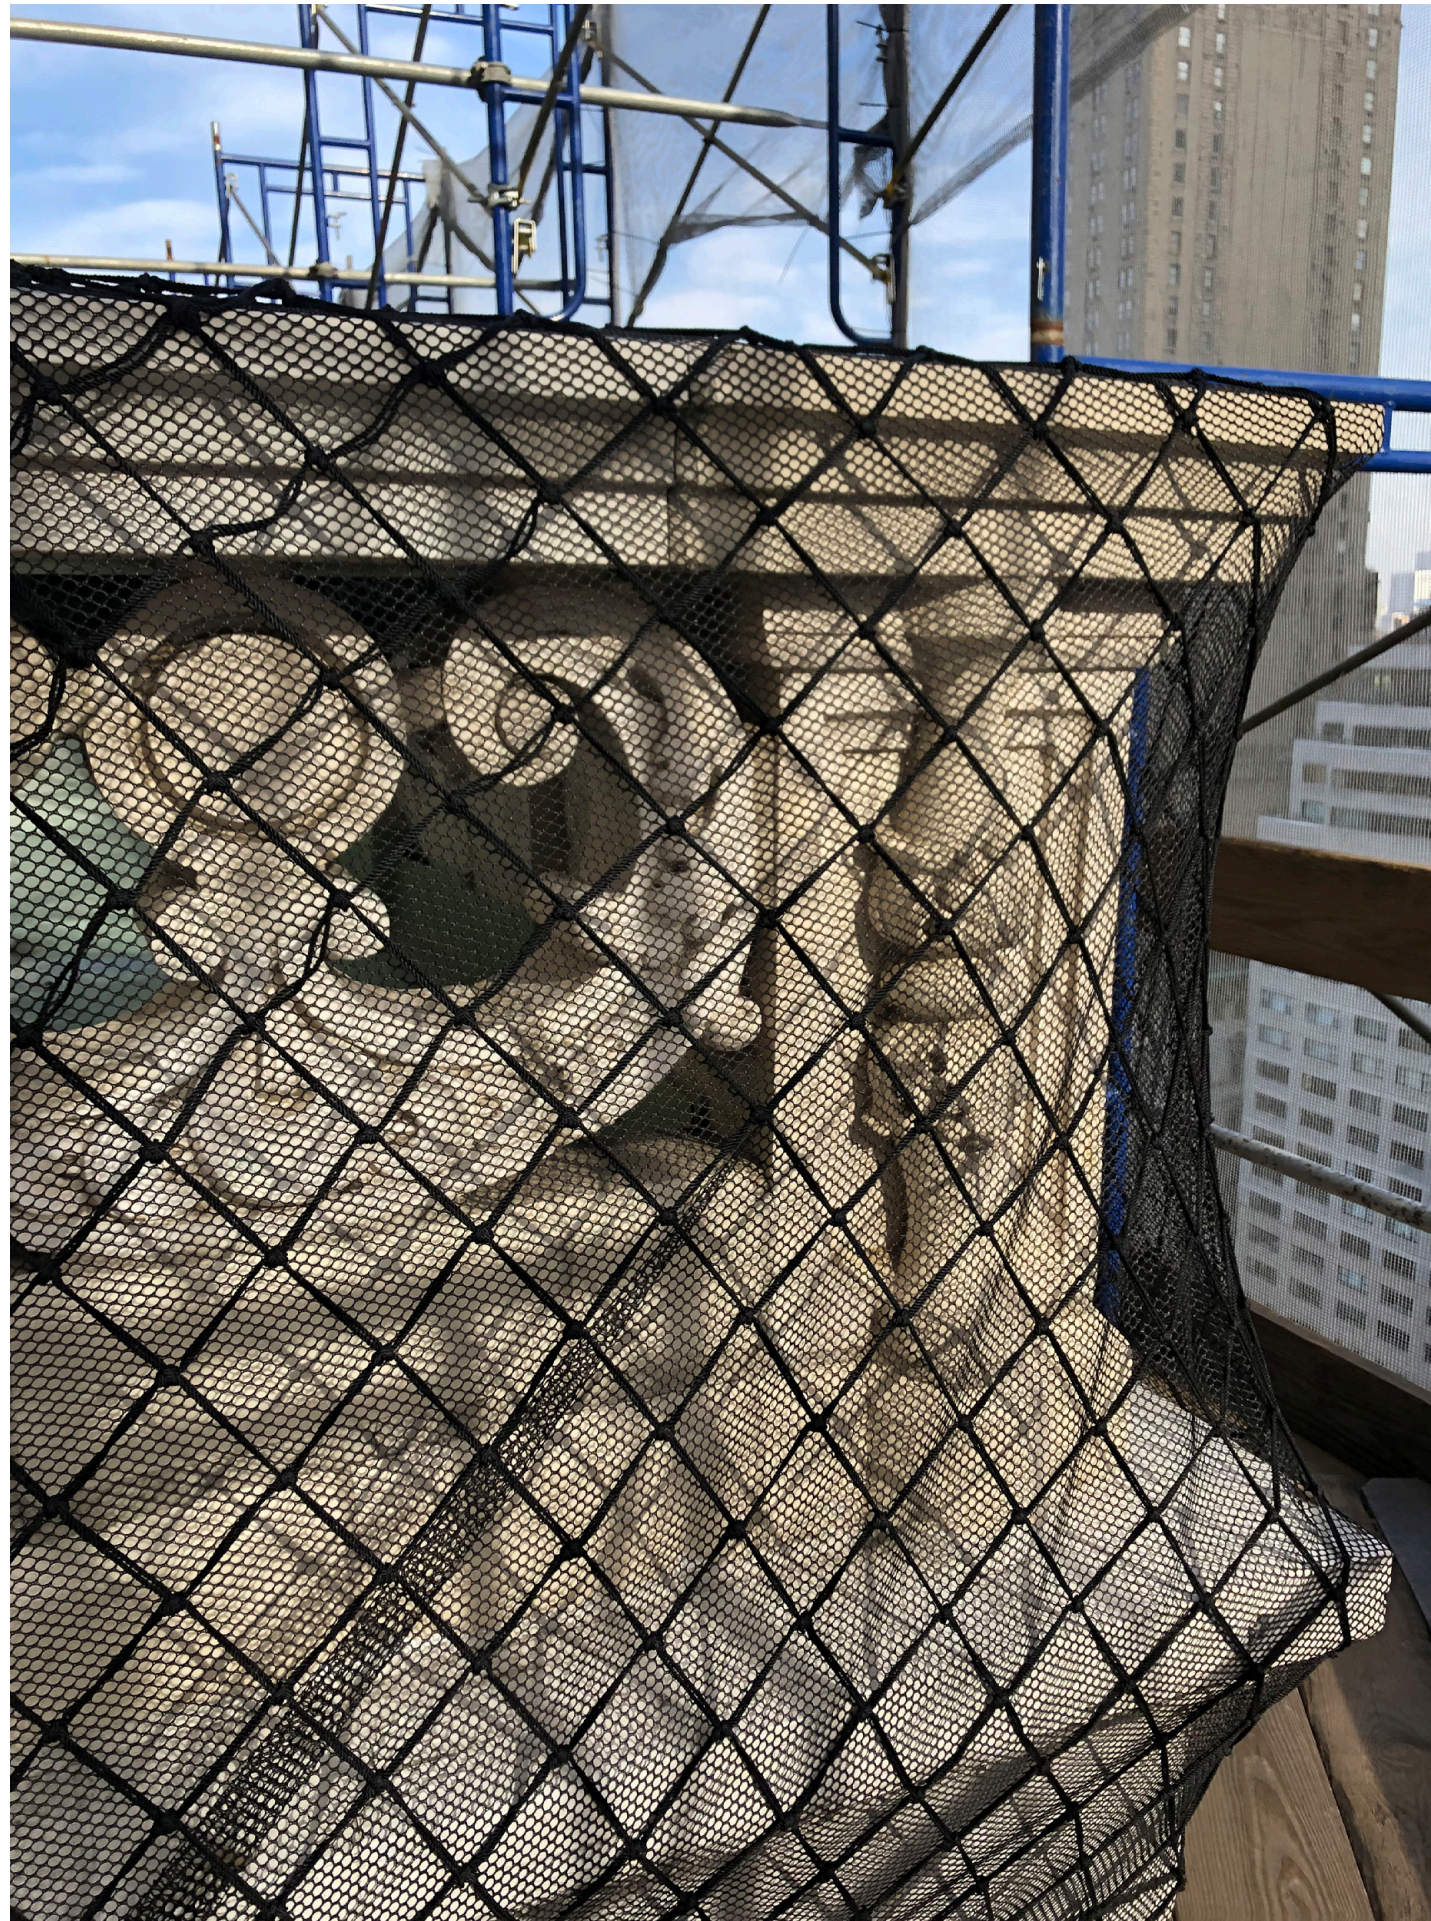
**Current Balcony Condition
at Grand Army Plaza-
Protective Netting Around
Deteriorated Terracotta**

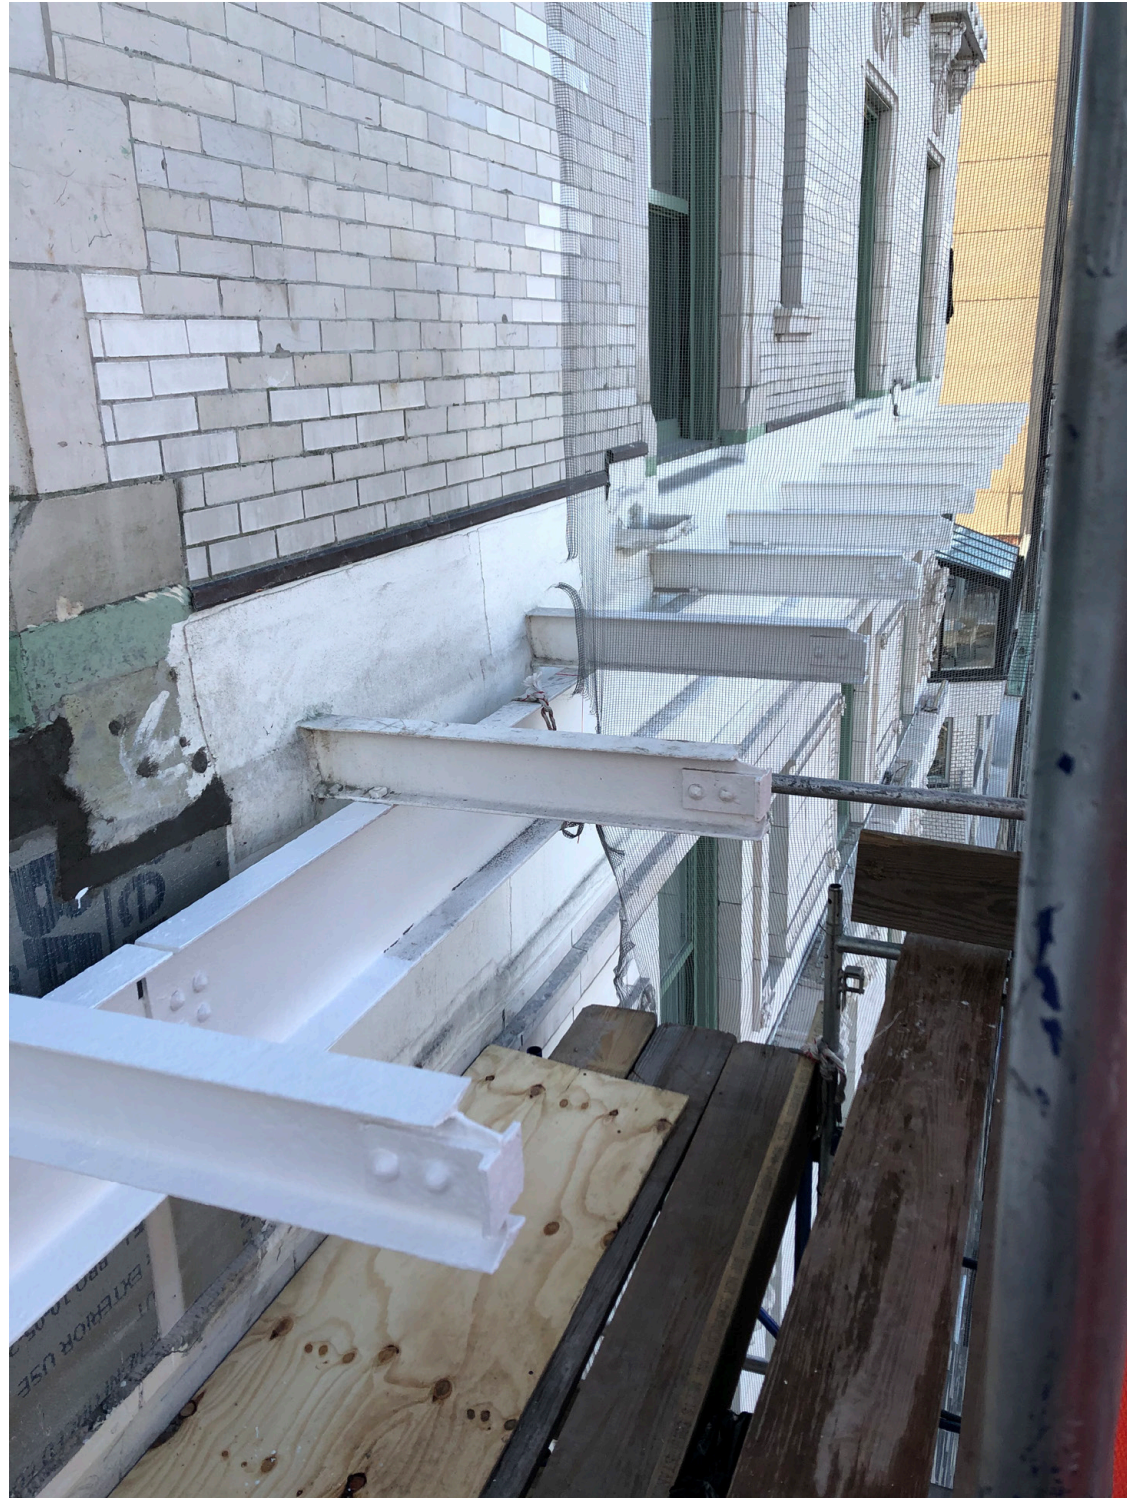
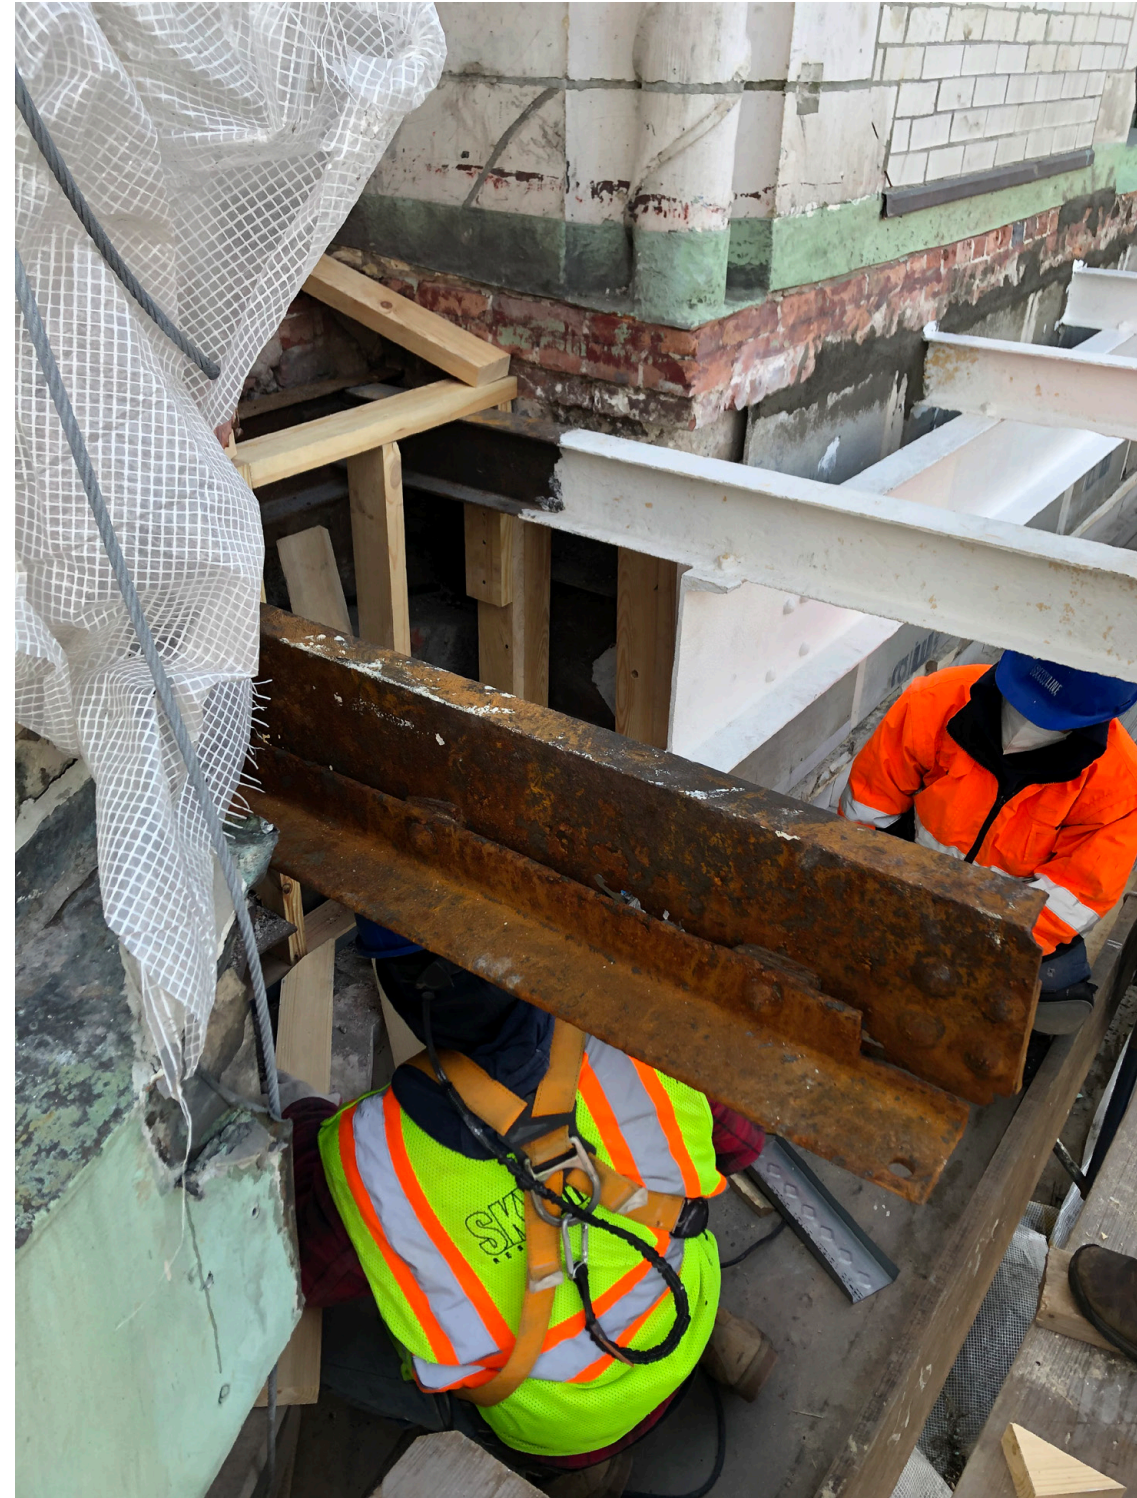
Existing Balcony Structure: C-Channel and Outriggers

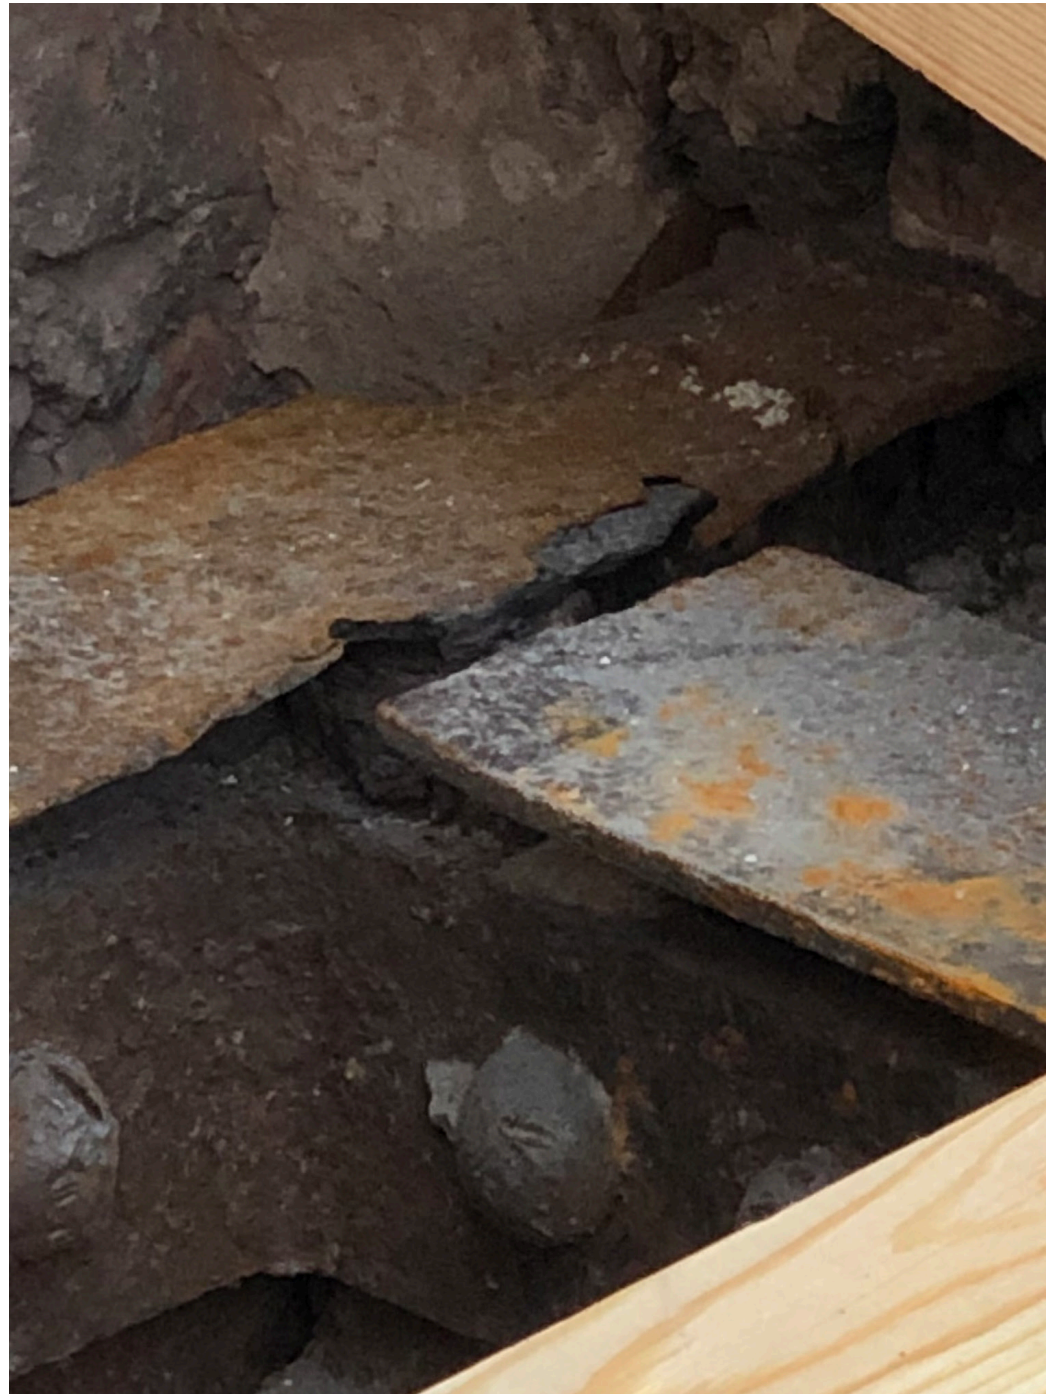
**Existing Balcony Structural
Deterioration:
Outrigger Completely Detached From
C-Channel**

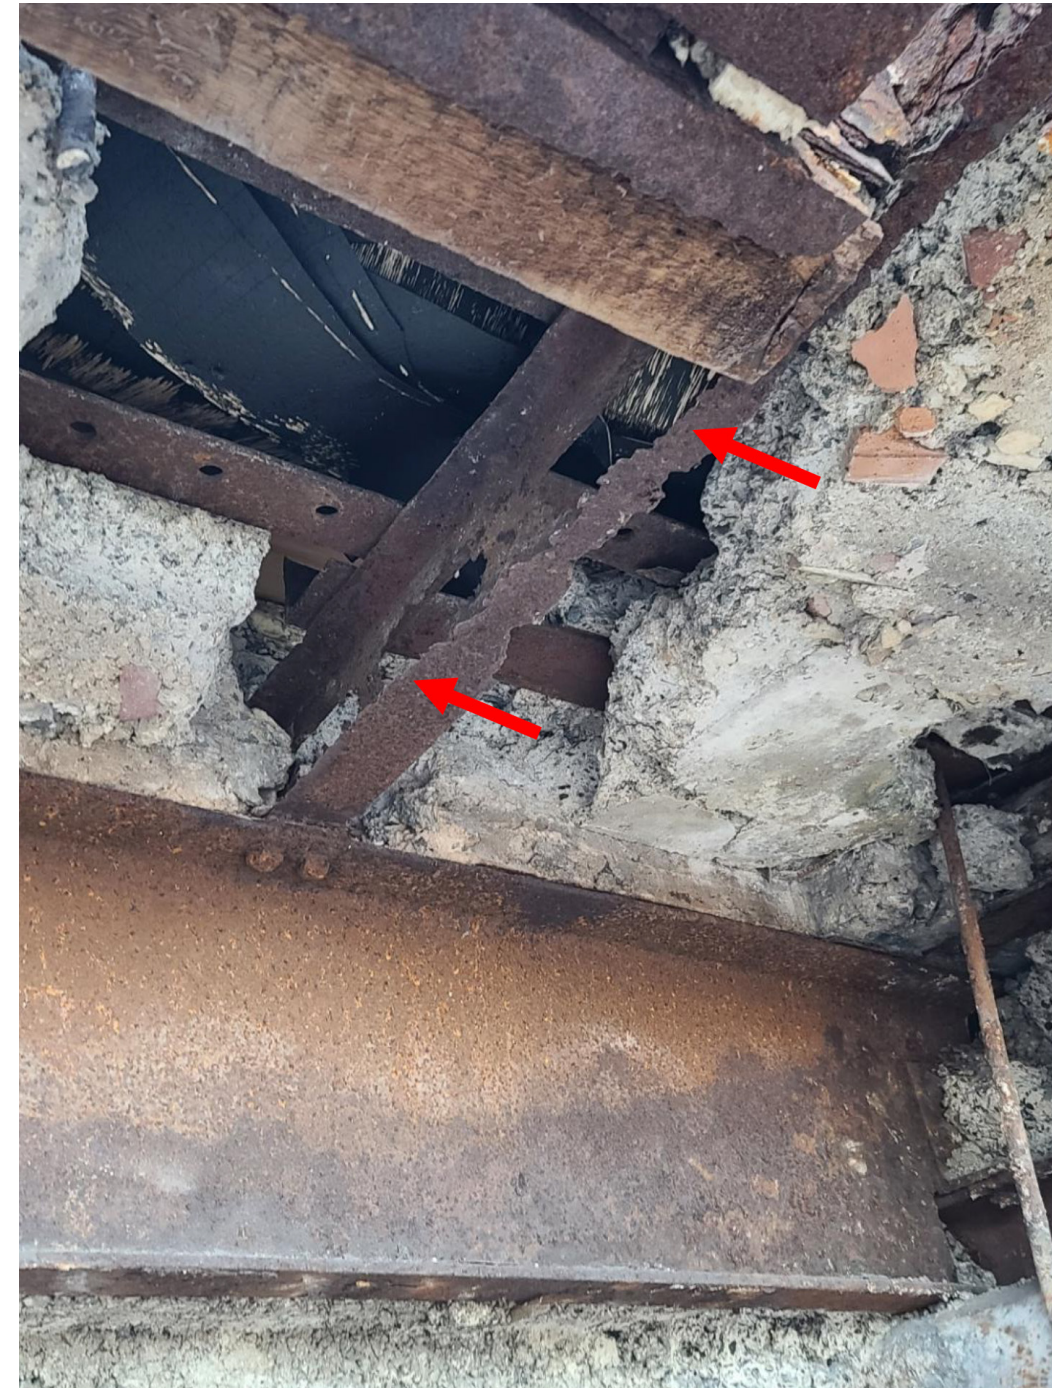
**Typical Condition of Outrigger Beam
Supporting the Balcony Deck and
Terracotta Super Structure.
Section was Formerly a W8" x3" Beam**

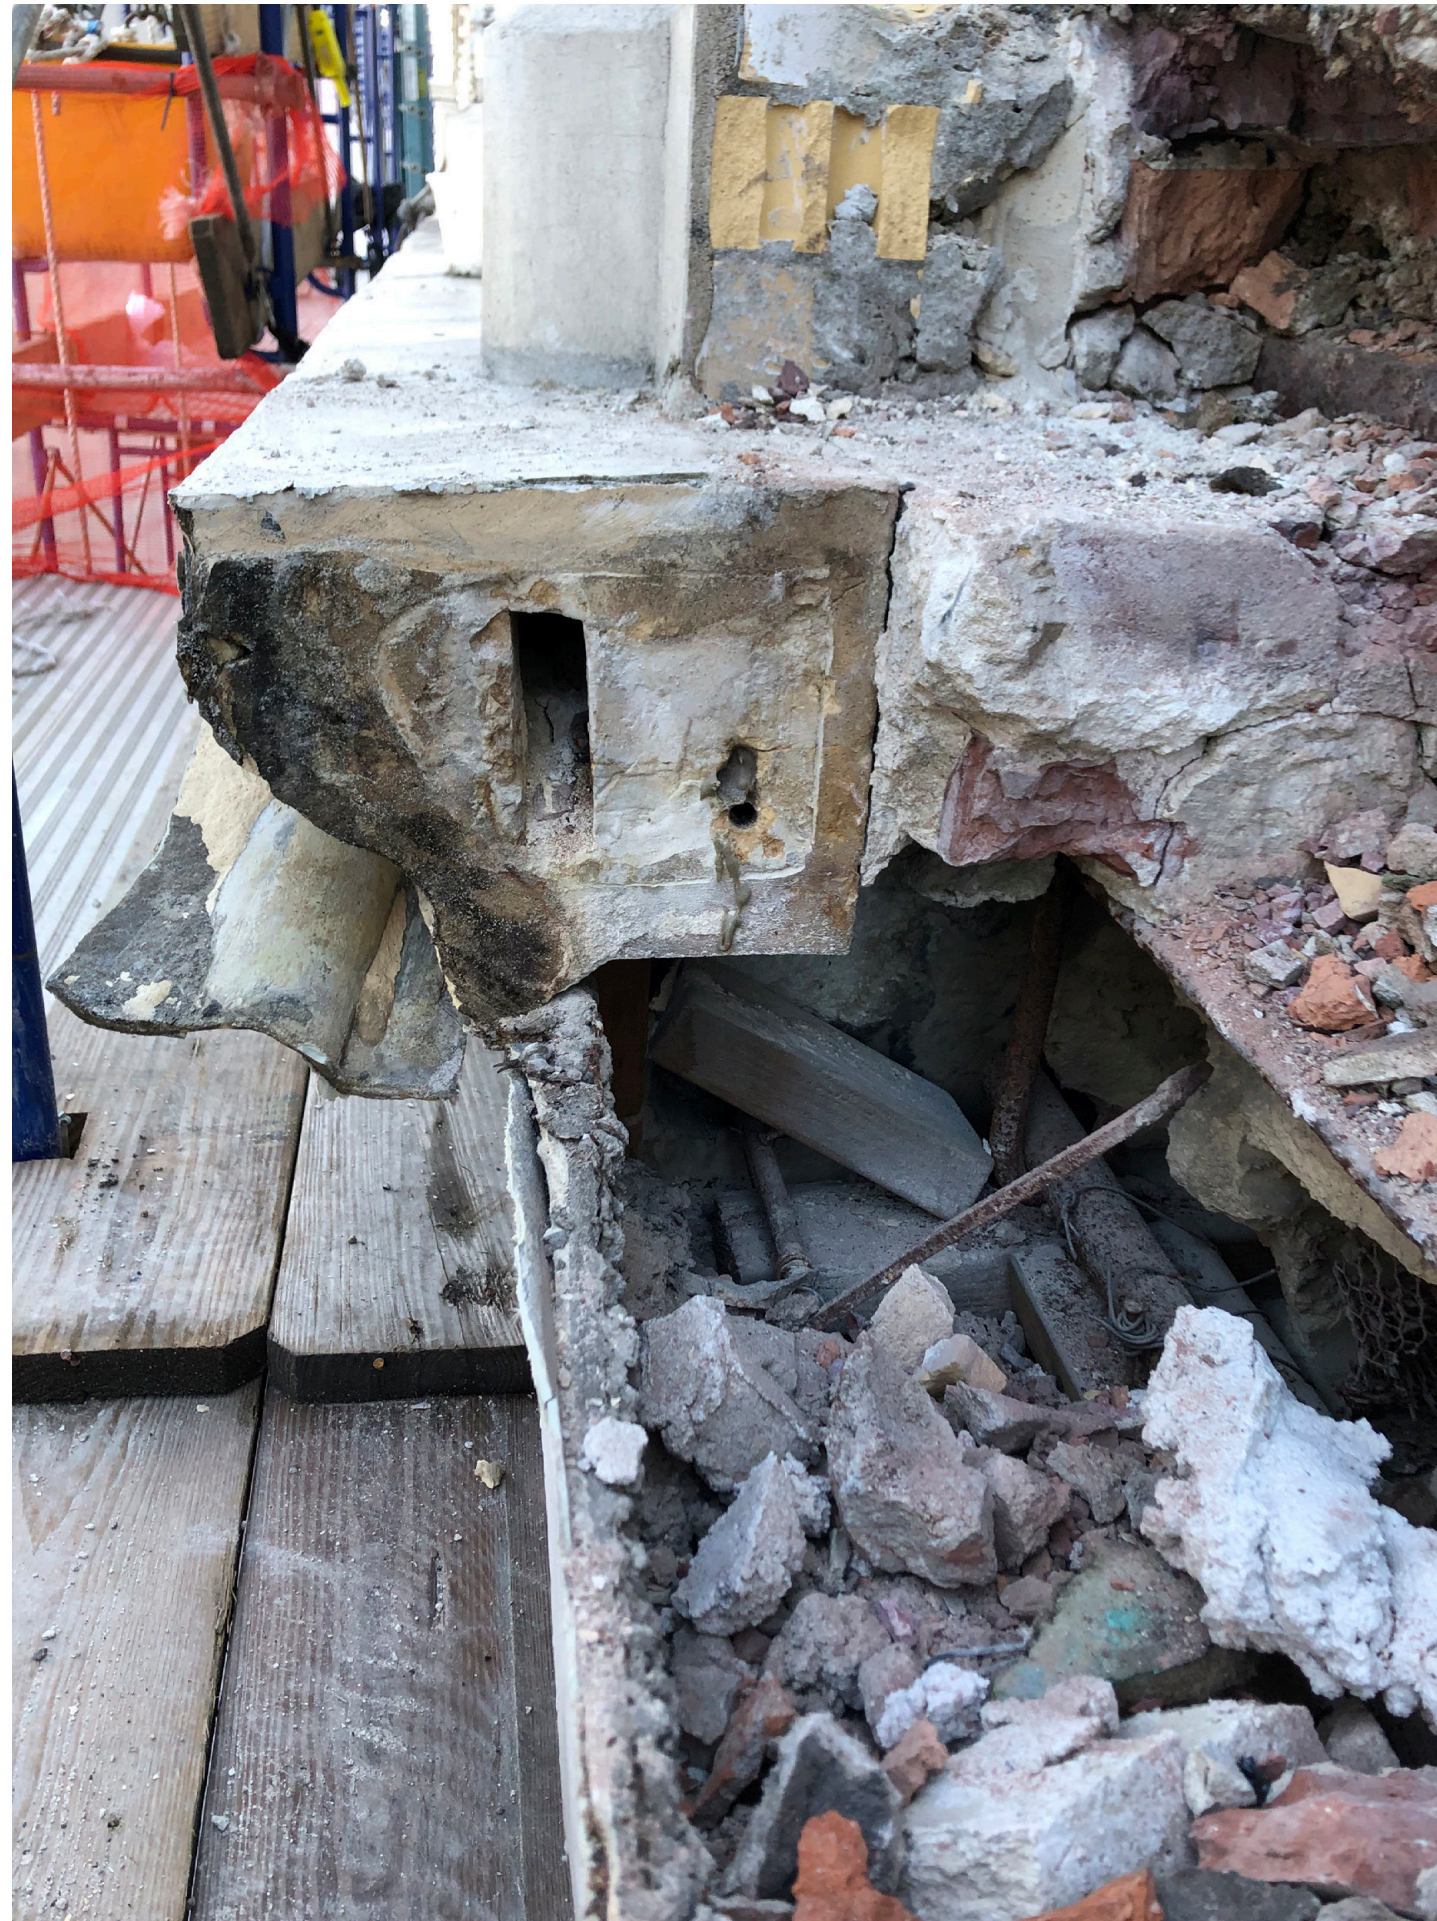
**Cross-Section View of
Balcony showing detached
metal tie rods and cracked
terracotta**

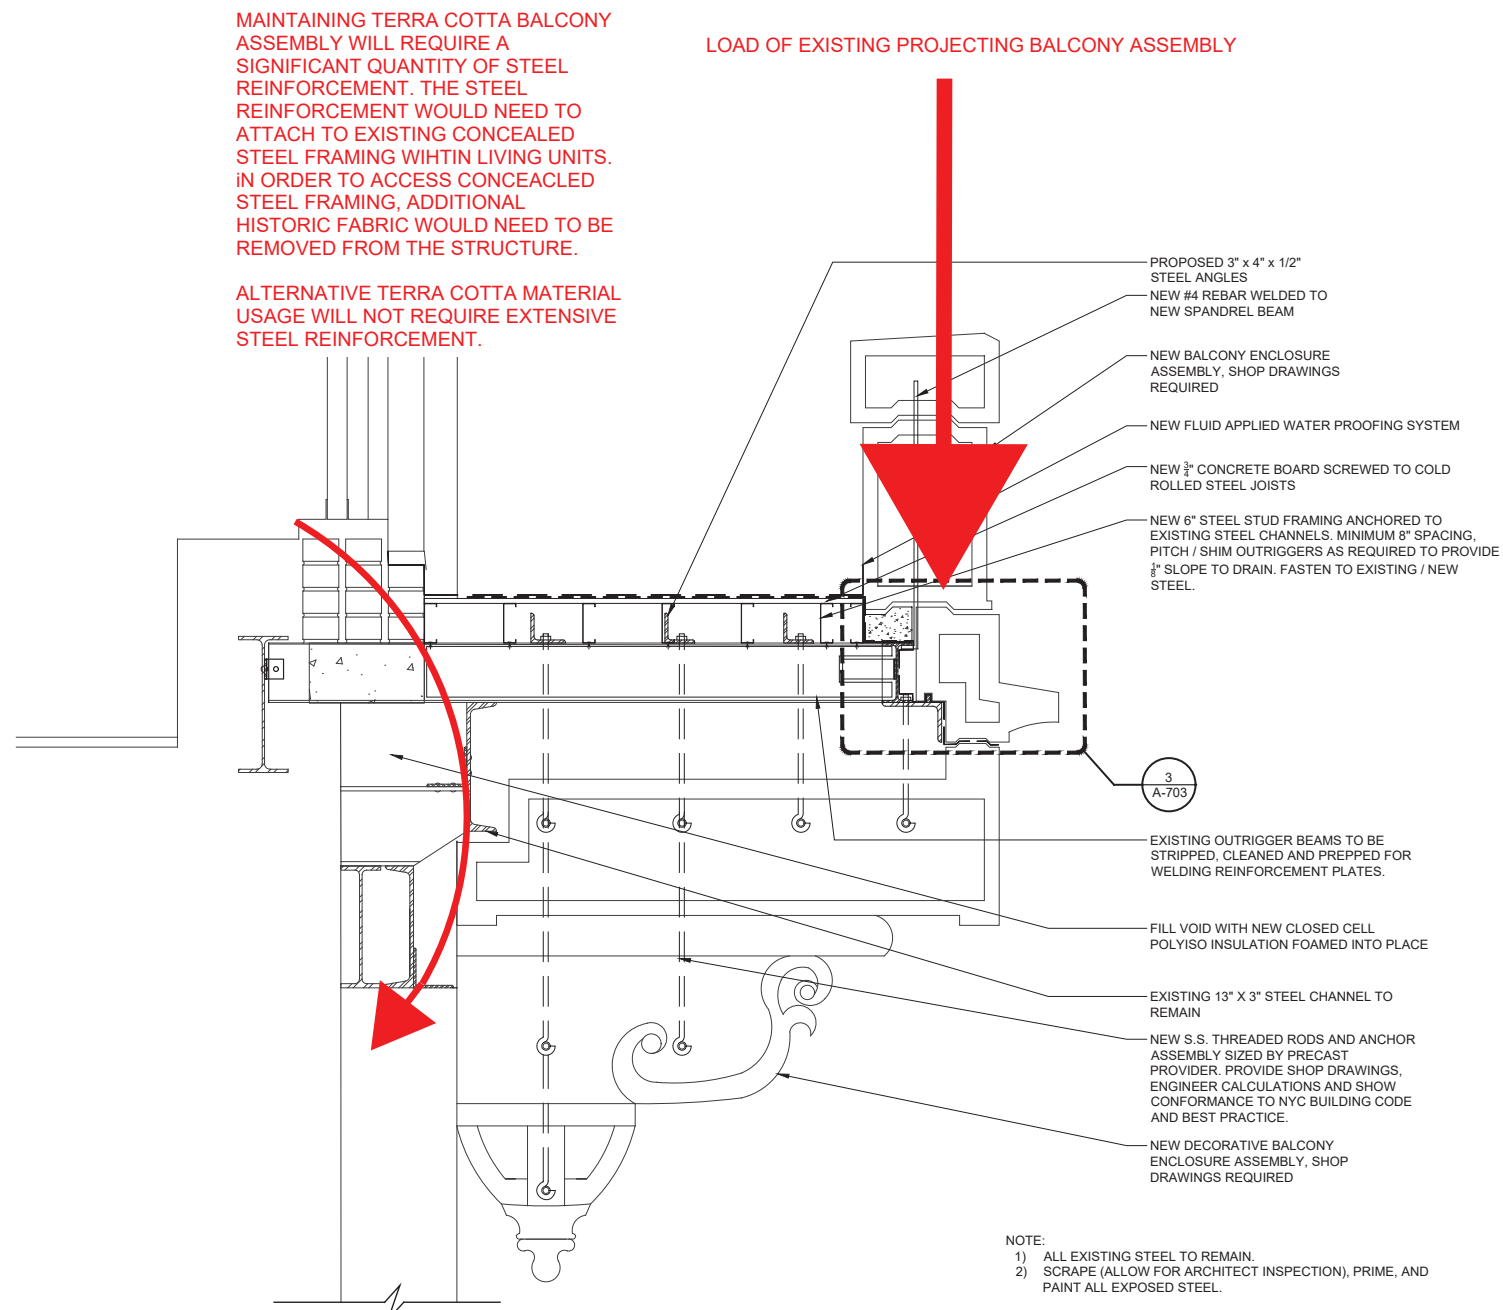
6 15TH FLOOR BALCONY REPAIR DETAIL
 1" = 1'-0"

MAINTAINING TERRA COTTA BALCONY ASSEMBLY WILL REQUIRE A SIGNIFICANT QUANTITY OF STEEL REINFORCEMENT. THE STEEL REINFORCEMENT WOULD NEED TO ATTACH TO EXISTING CONCEALED STEEL FRAMING WITHIN LIVING UNITS. IN ORDER TO ACCESS CONCEALED STEEL FRAMING, ADDITIONAL HISTORIC FABRIC WOULD NEED TO BE REMOVED FROM THE STRUCTURE.

ALTERNATIVE TERRA COTTA MATERIAL USAGE WILL NOT REQUIRE EXTENSIVE STEEL REINFORCEMENT.

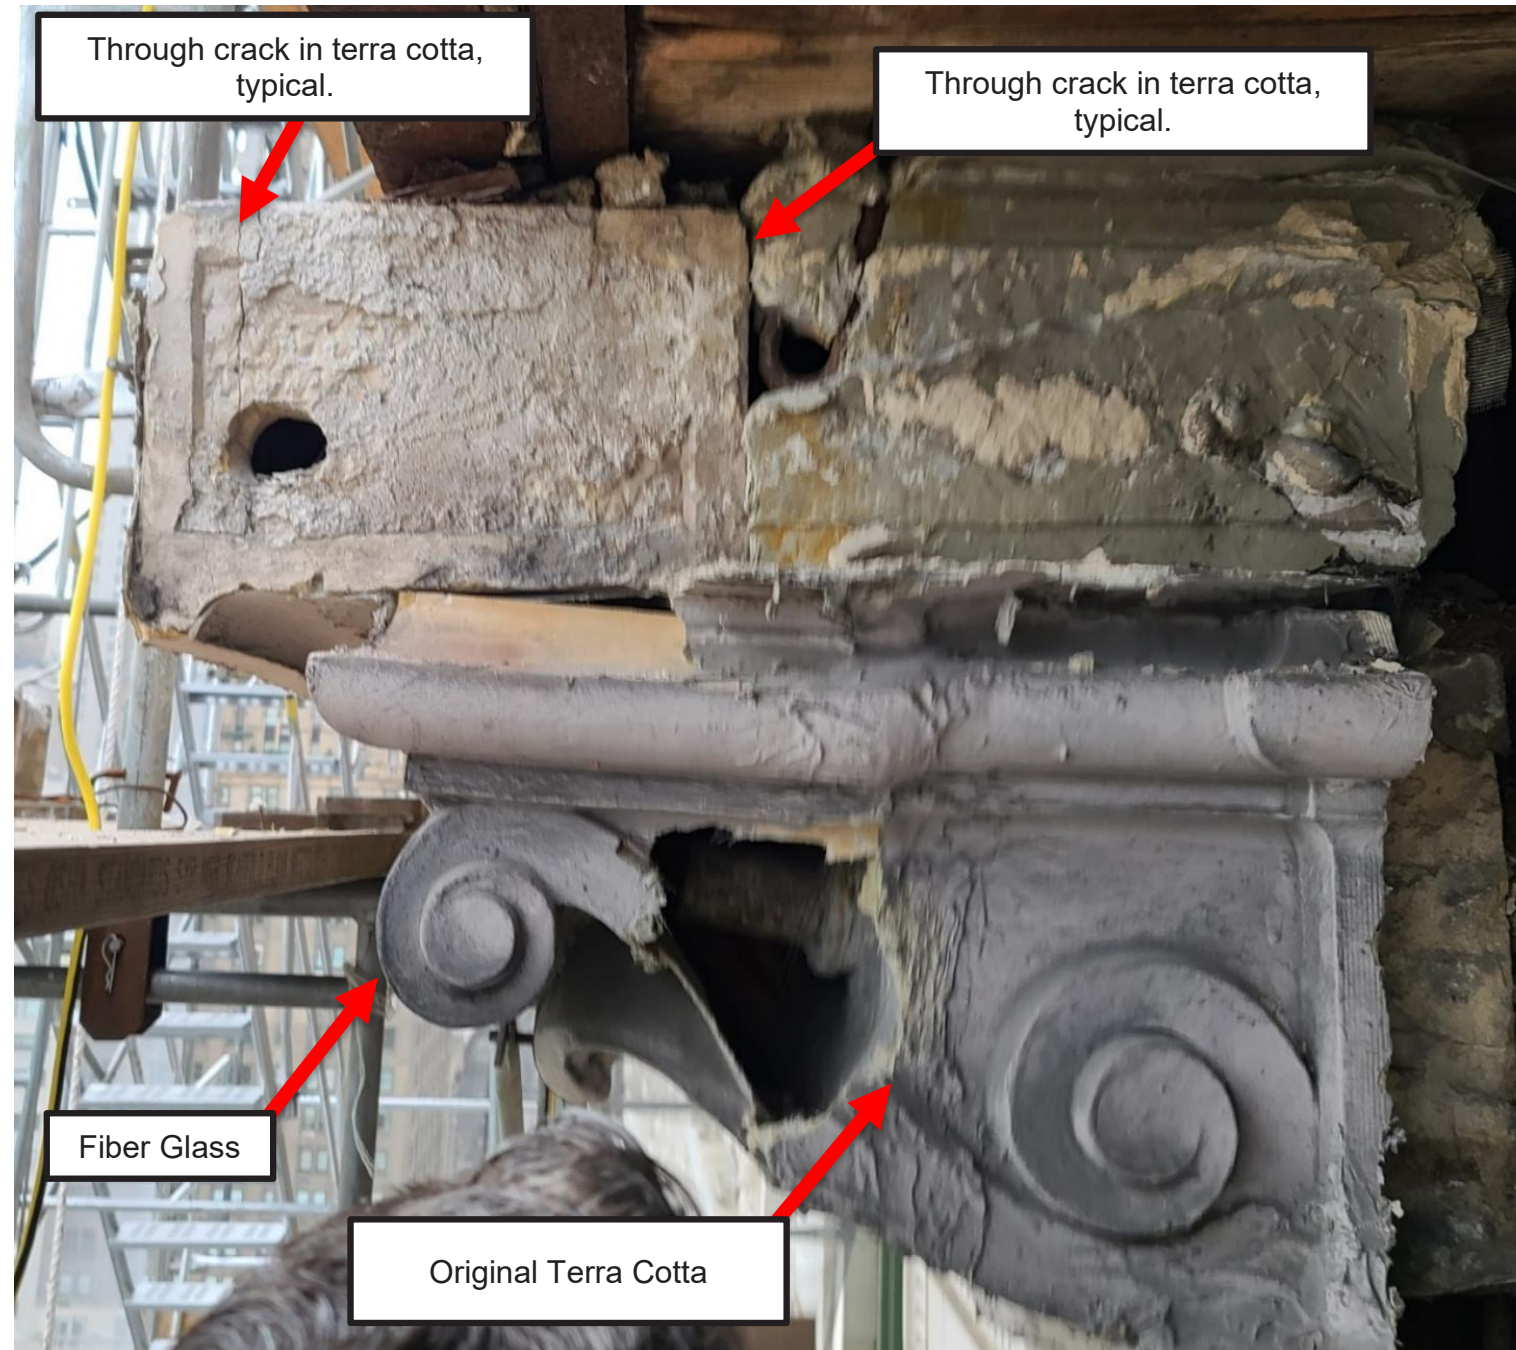
Deteriorated Terracotta with Underlying Decorative Fiber Glass Scroll

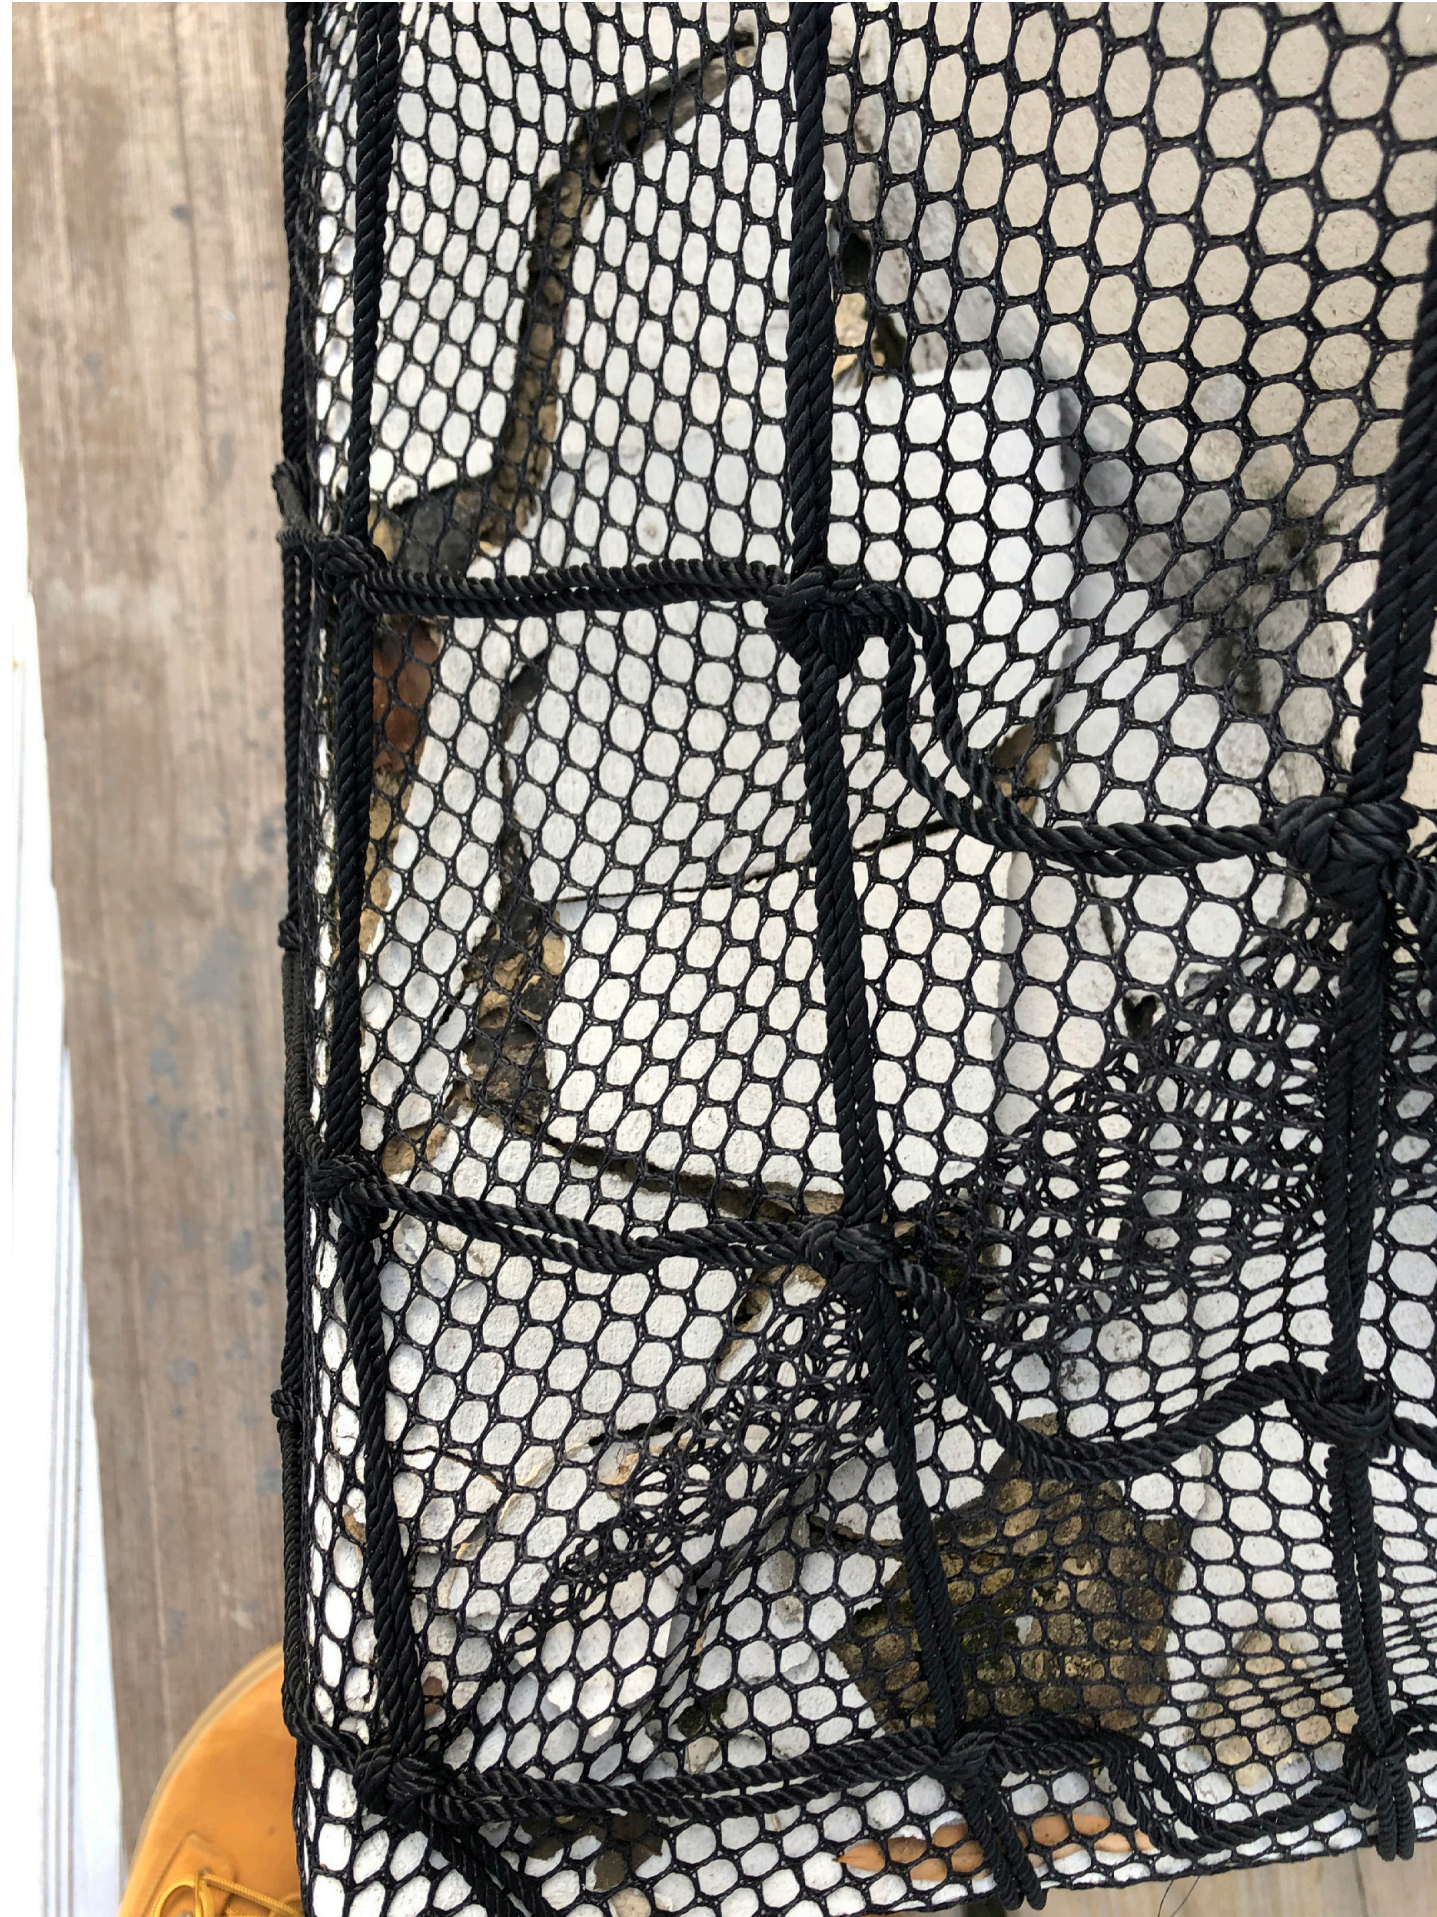
**Cracked and Spalled
Terracotta:
Typical Condition
Across Balcony**
