Preservation Department – Item 8, LPC-23-03274

**768 Fifth Avenue – The Plaza Hotel – Individual and Interior
Landmark
Borough of Manhattan**

Howard L. Zimmerman Architects & Engineers - Architect and Engineer of Record
Acheson Doyle Partners Architects - Preservation Consultant

Landmarks Preservation Commission Public Hearing
November 01, 2022

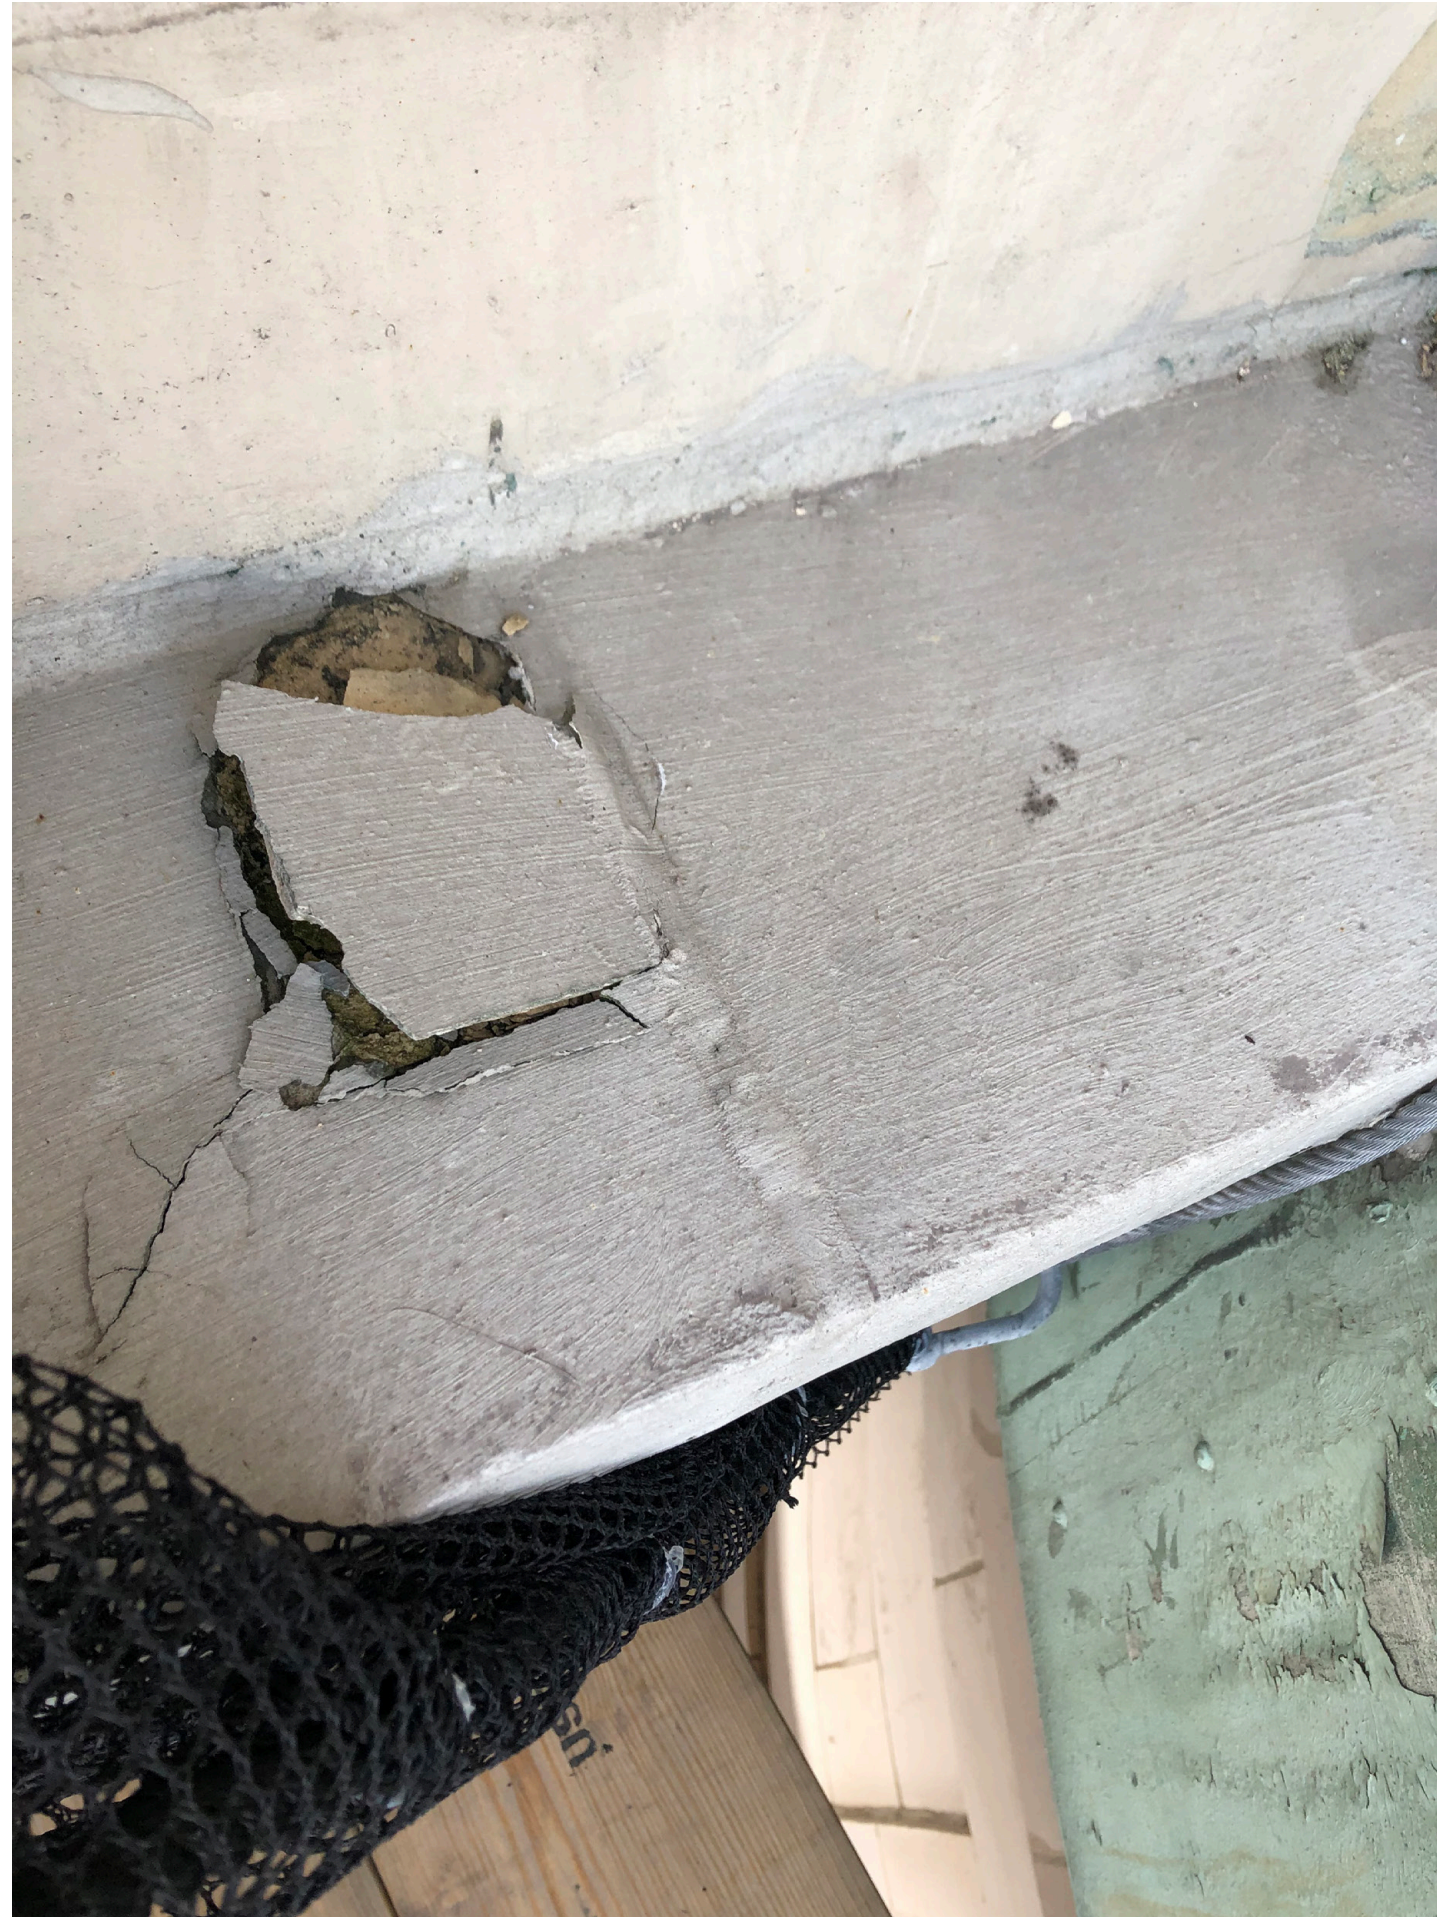
**Cracked and Spalled
Terracotta:
Typical Condition
Across Balcony**

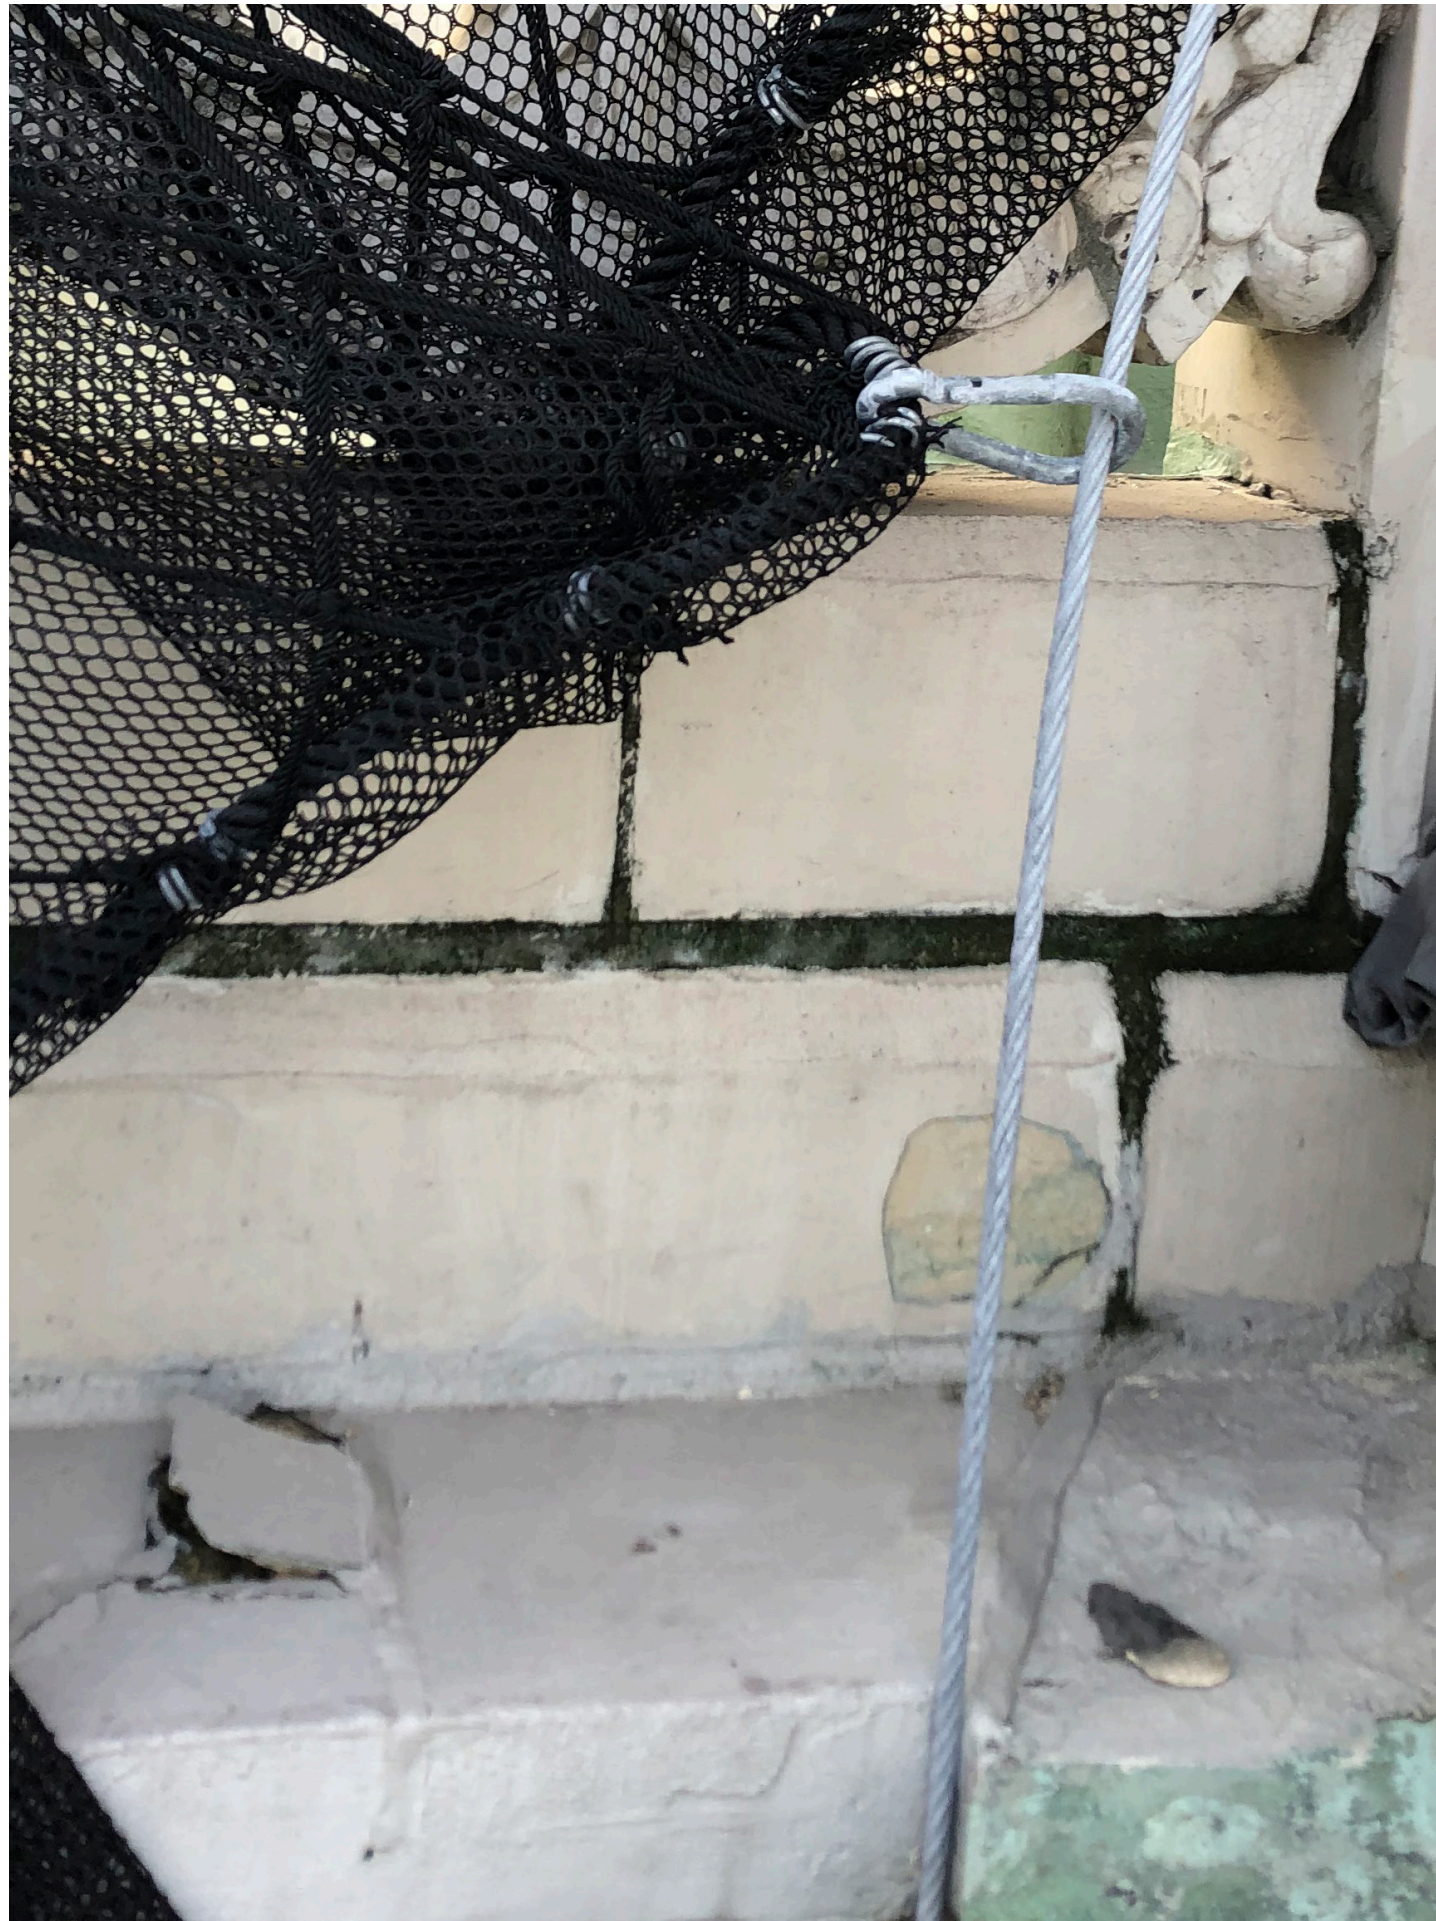
**Cracked and Spalled
Terracotta:
Typical Condition
Across Balcony**

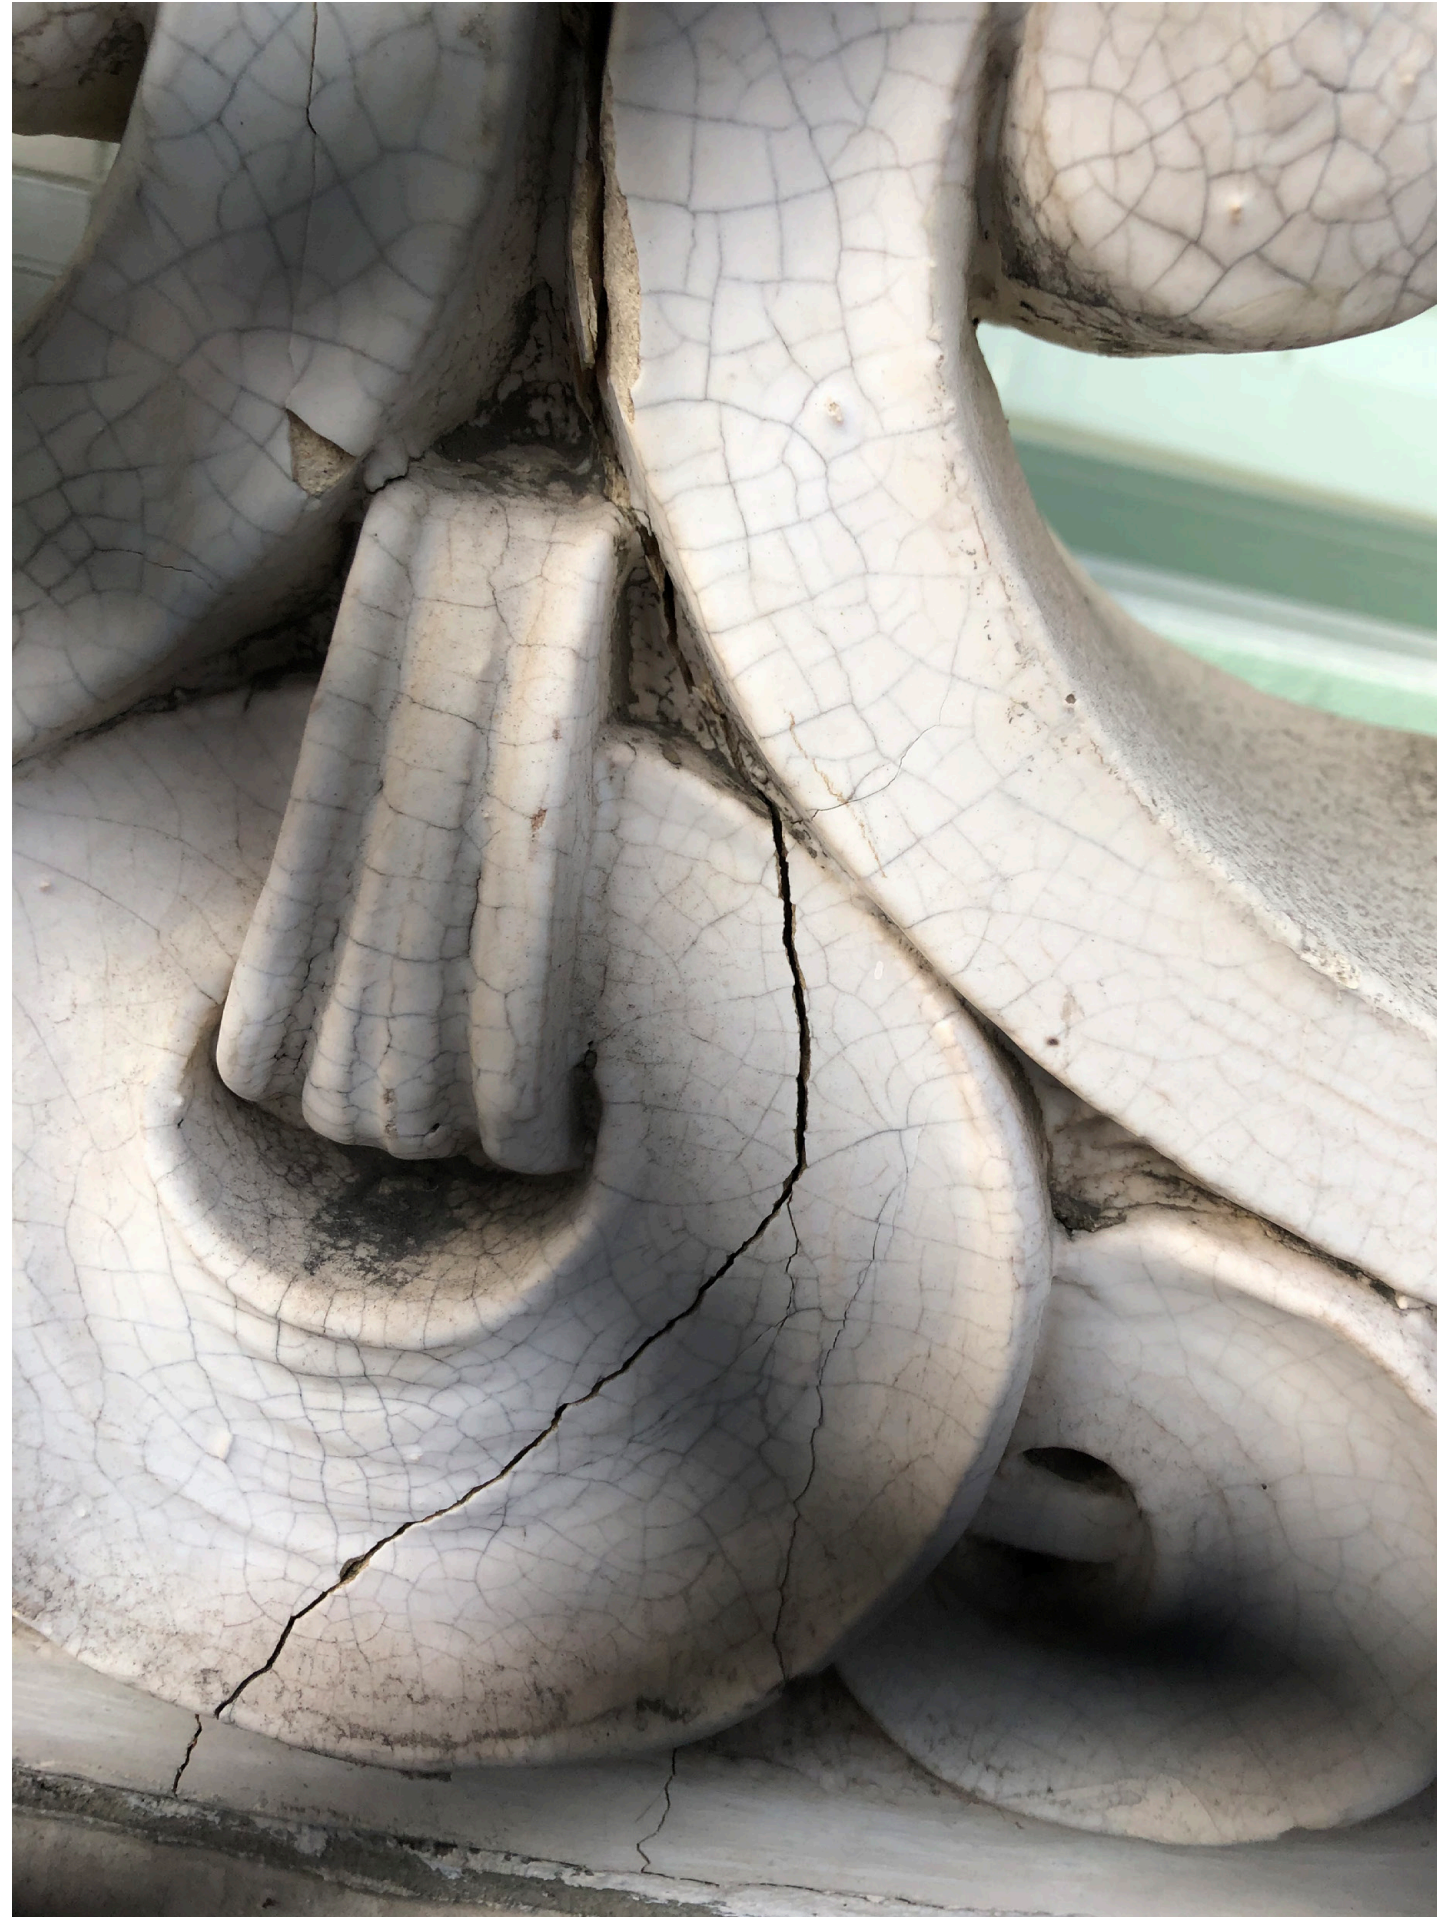
**Cracked and Spalled
Terracotta:
Typical Condition
Across Balcony**

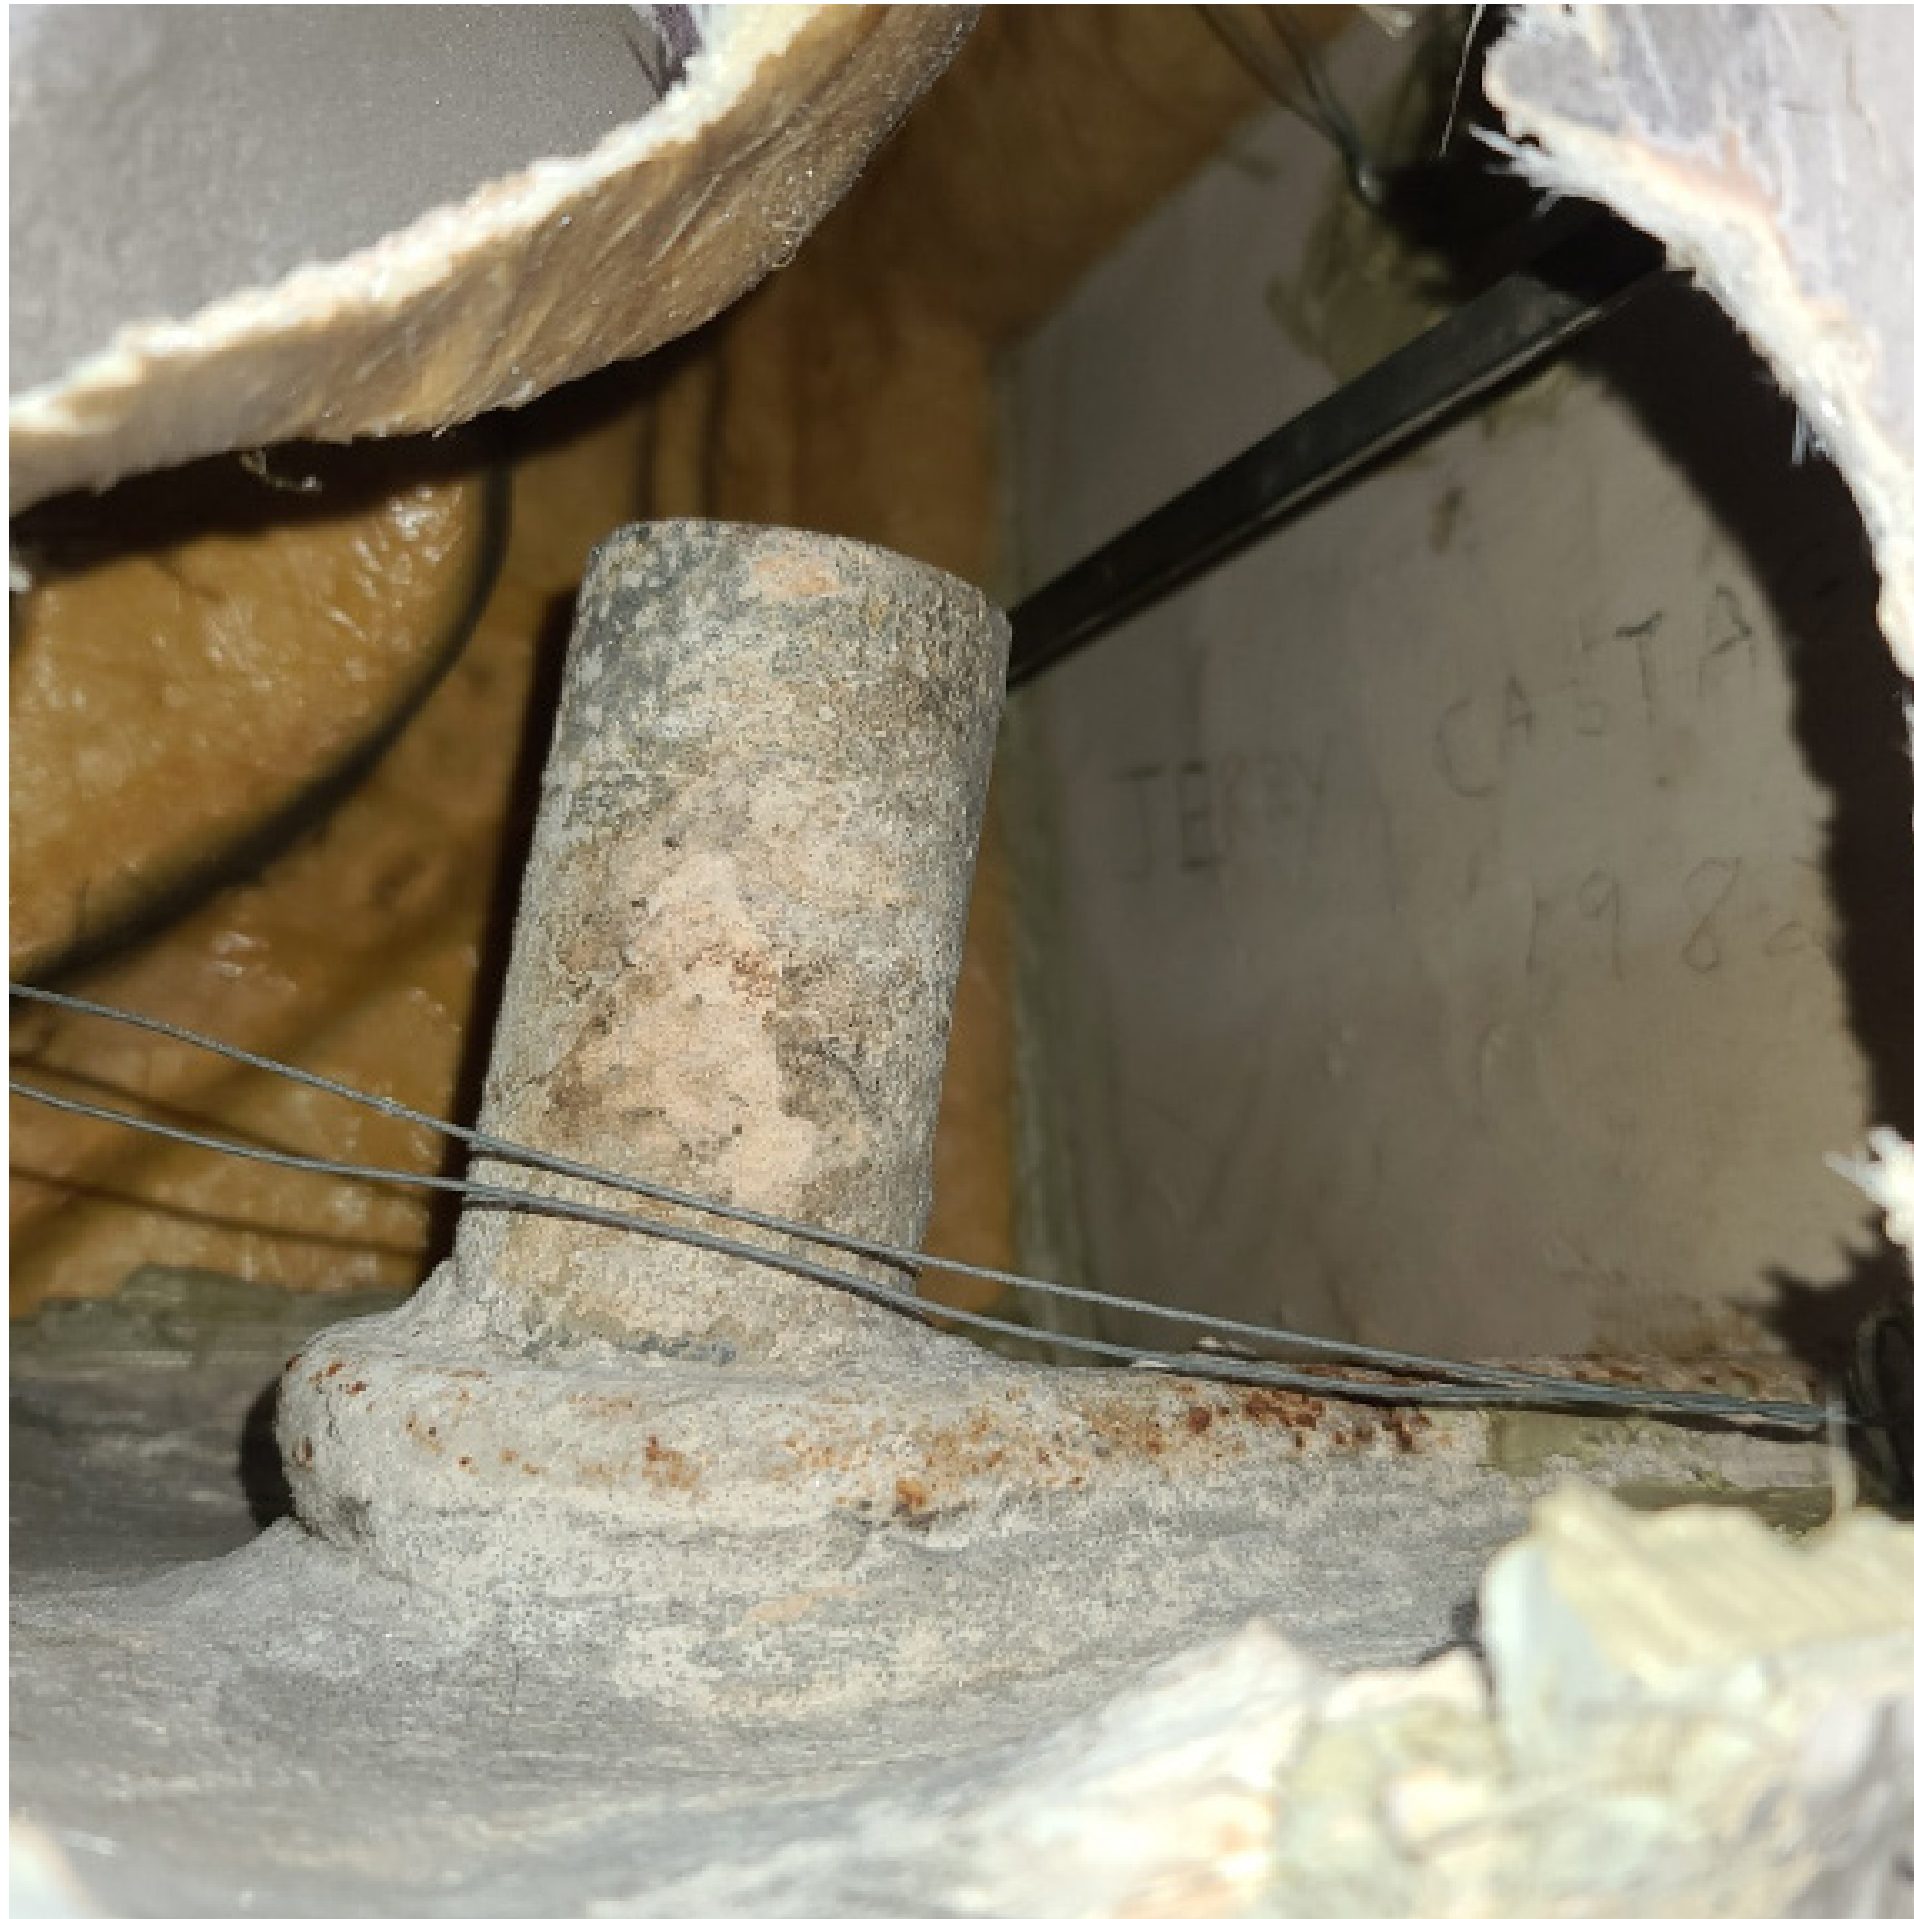
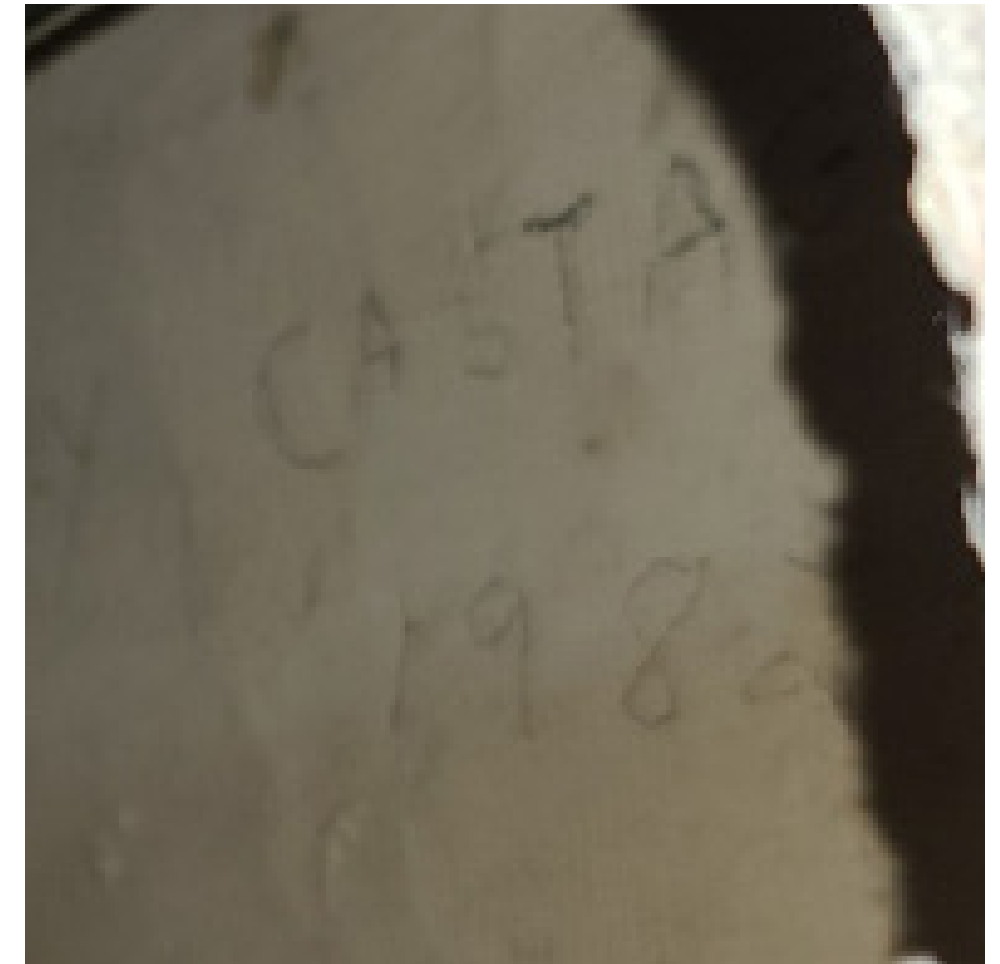
**Existing Fiberglass Replacement
for Terracotta Piece Dated 1982**

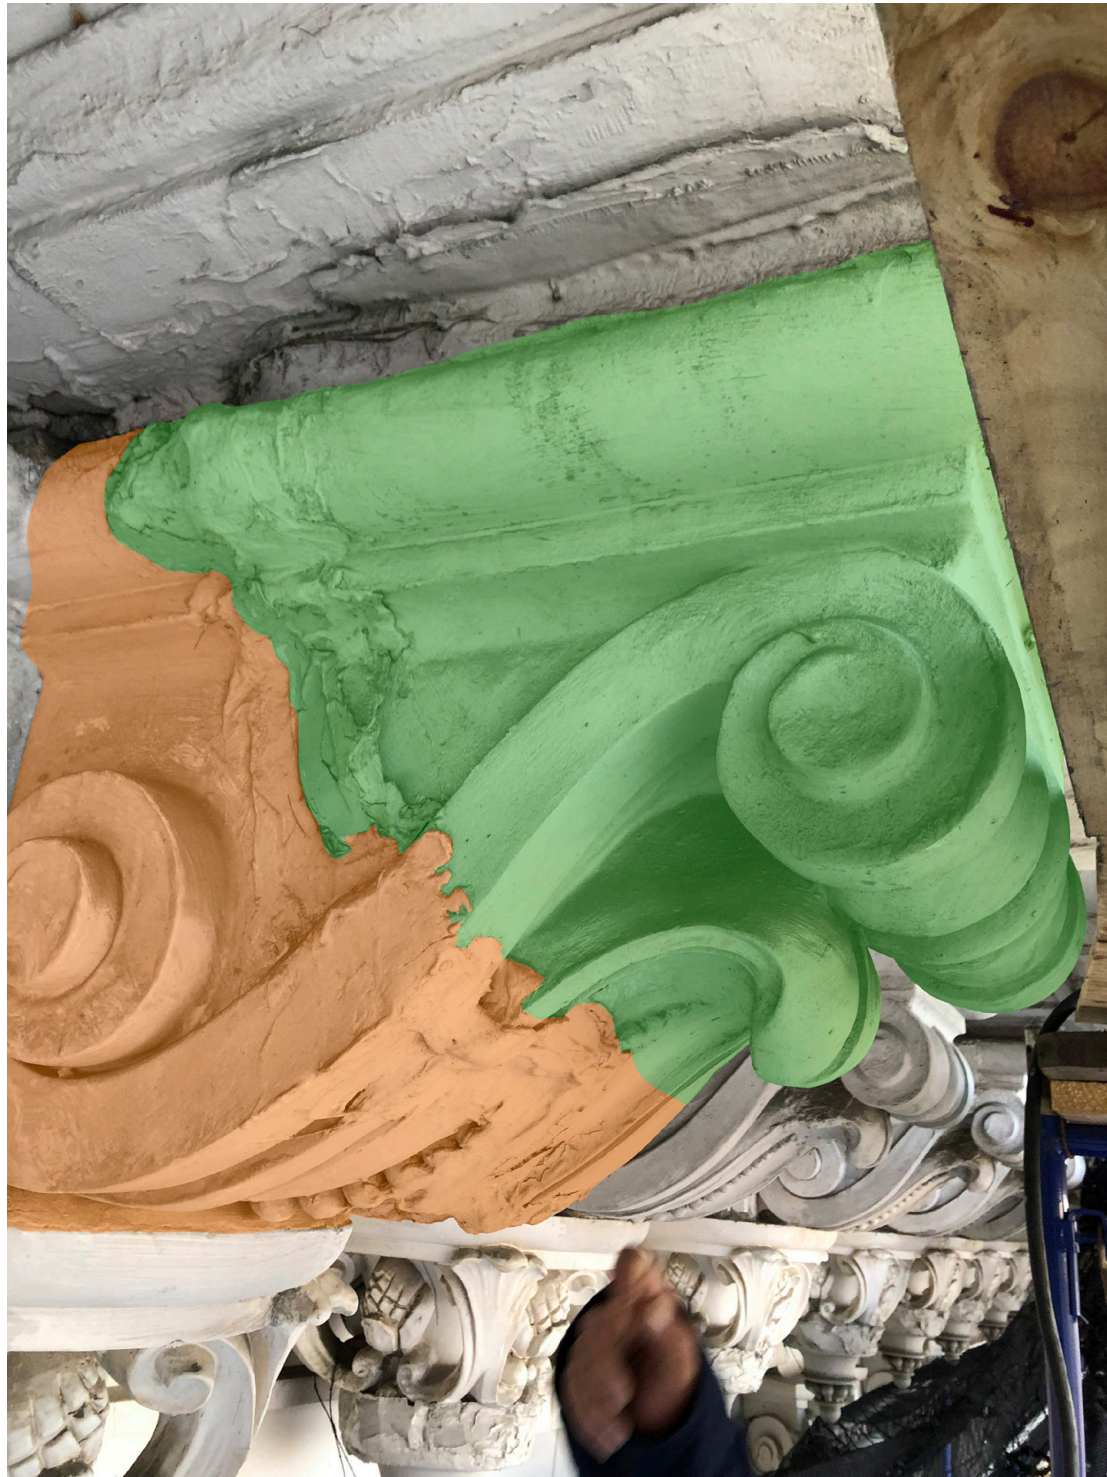
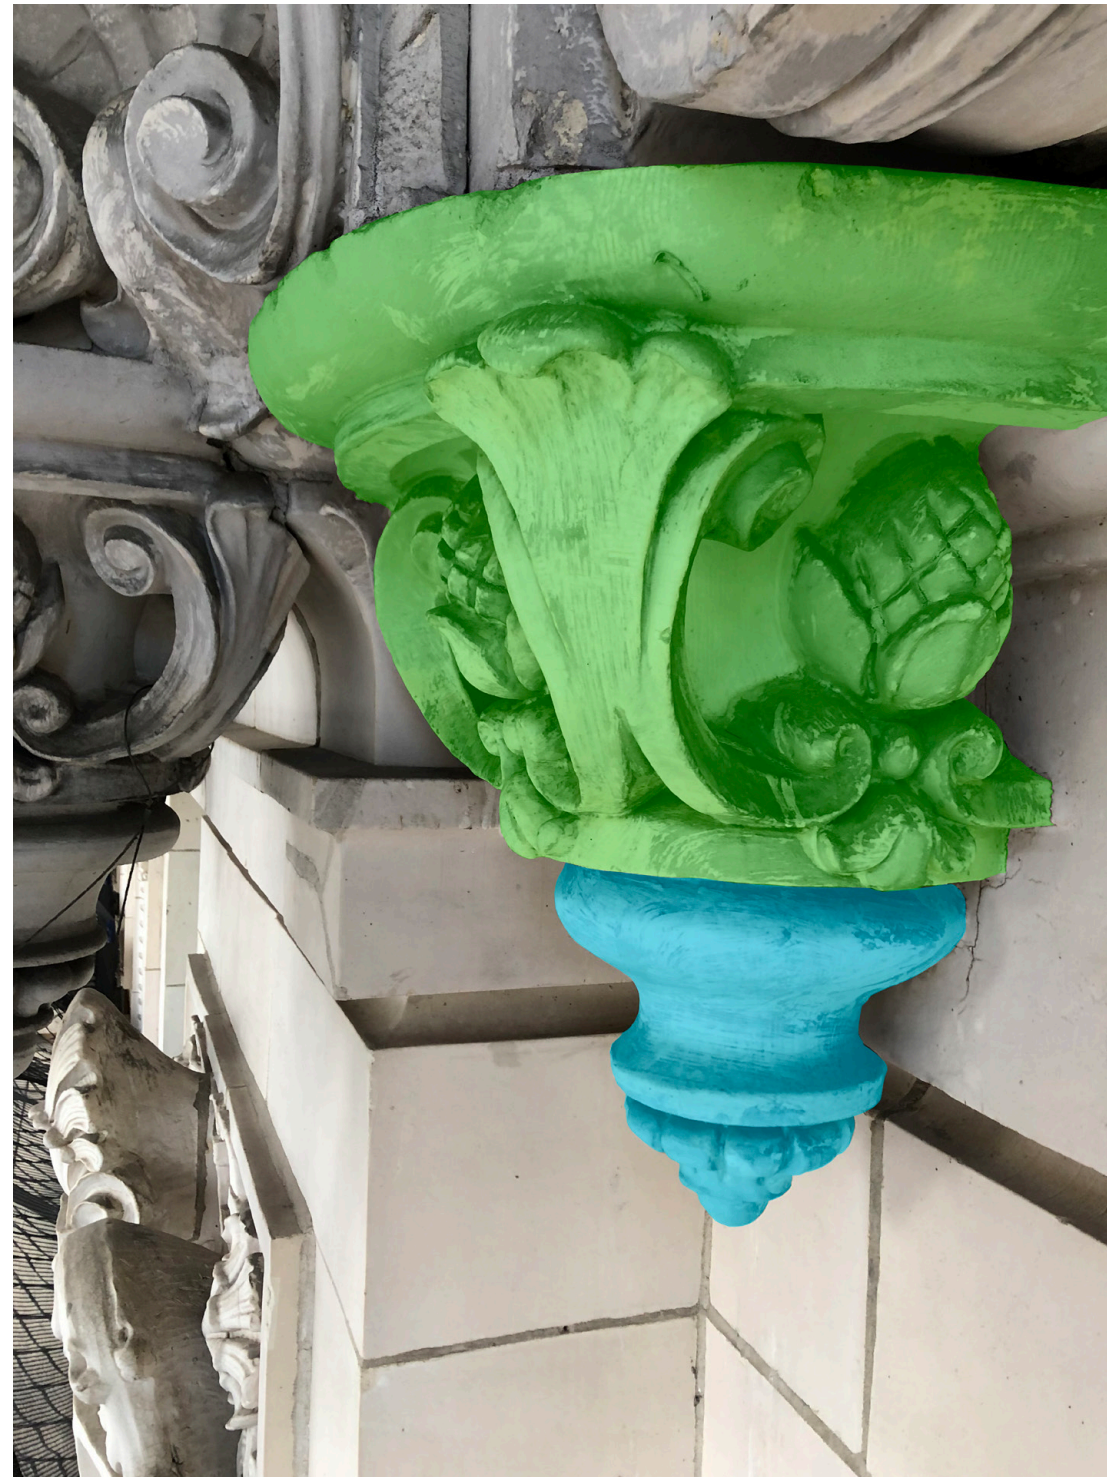
Typical Fiberglass Corbel.
Many of the terracotta corbels have been replaced with fiberglass casts
