Preservation Department – Item 3, LPC-23-02975

112 2nd Avenue – East Village/Lower East Side Historic District Borough of Manhattan

MIDDLE COLLEGIATE CHURCH

STRUCTURAL SAFETY ASSESMENT

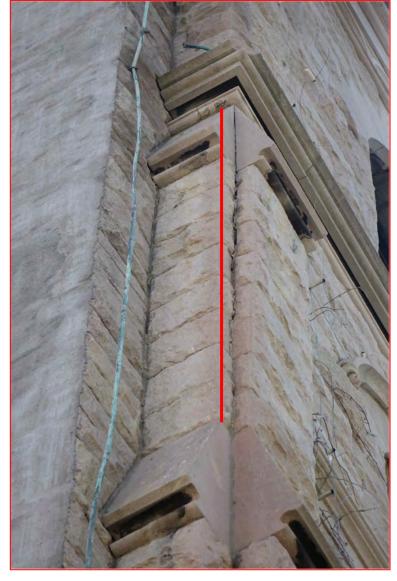
LIMESTONE SEPERATING AT BUTRESS

WATER INFILTRATION AND FREEZE THAW LIKELYHOOD

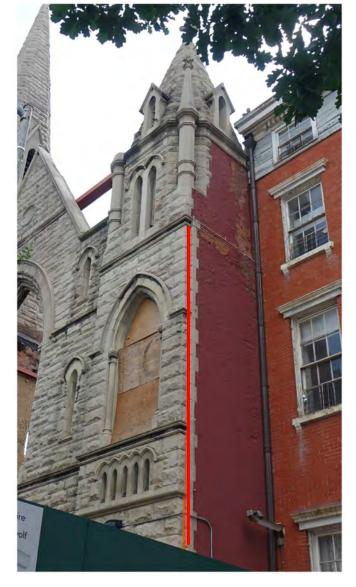
LIMESTONE SEPERATING AT SOUTH WALL

WATER INFILTRATION AND FREEZE THAW LIKELYHOOD

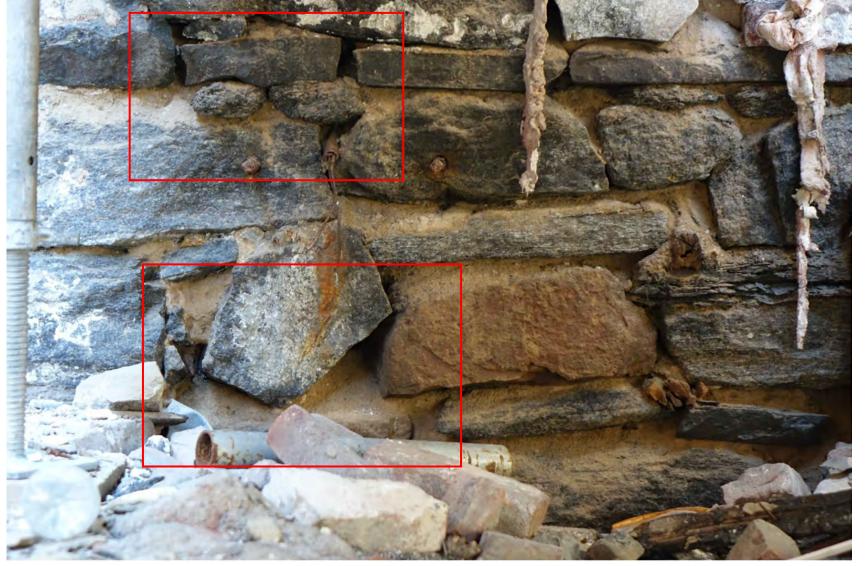
1. FOUNDATION WALL - 2nd Ave. FACADE

RUBBLE STONE

DETERIORATING MORTAR

MISSING MORTAR

POROUS, HISTORY OF WATER LEAKS

TEMPOPARILY STABILIZED BY **RUBBLE BERM**

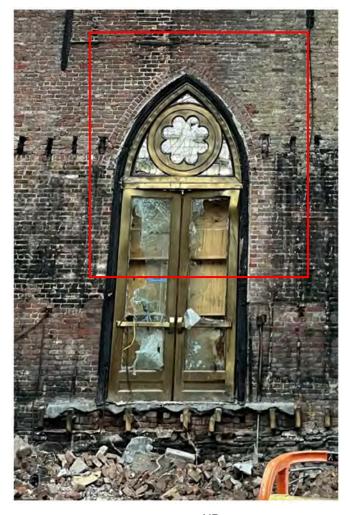
2. BACK OF 2ND Ave. ENTRANCE

DIMENSIONAL STONE FRACTURED

MORTAR MISSING

MASONRY DAMAGED BY THERMAL SHOCK

BRONZE ENTRANCE WARPED AND BUCKLING

RUBBLE BERM AGAINST FOUNDATION WALL

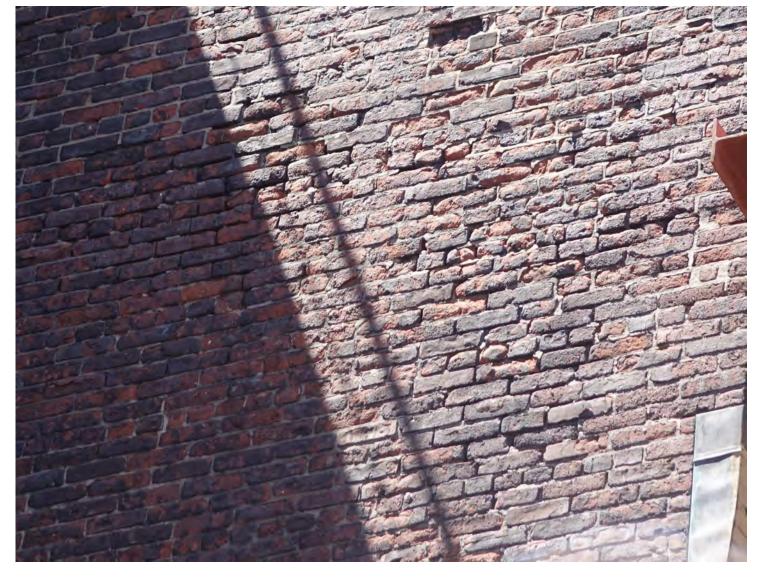
3. VIEW OF SOUTH TOWER MASONRY

SPALLING BRICK DUE TO THERMAL SHOCK

MISSING MORTAR

MISSING BRICKS

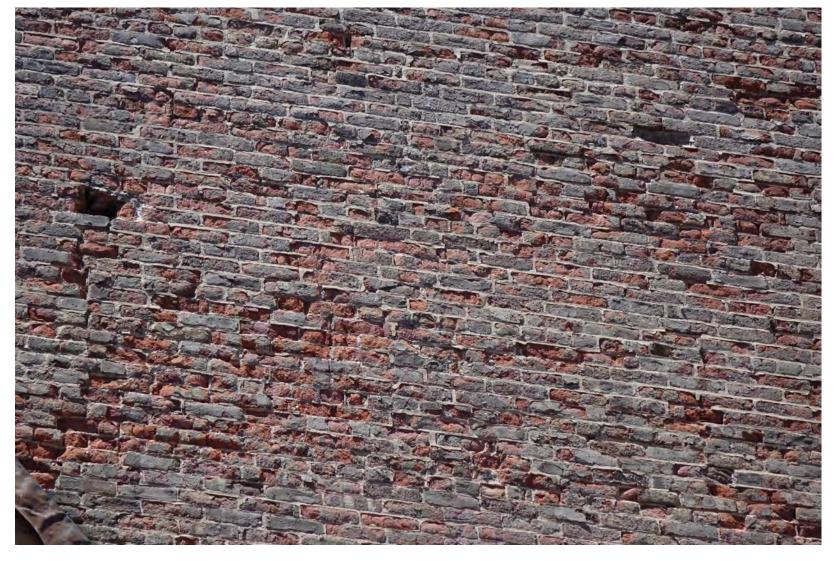
4. VIEW OF NORTH TOWER MASONRY

SPALLING BRICK DUE TO THERMAL SHOCK

MISSING MORTAR

MISSING BRICKS

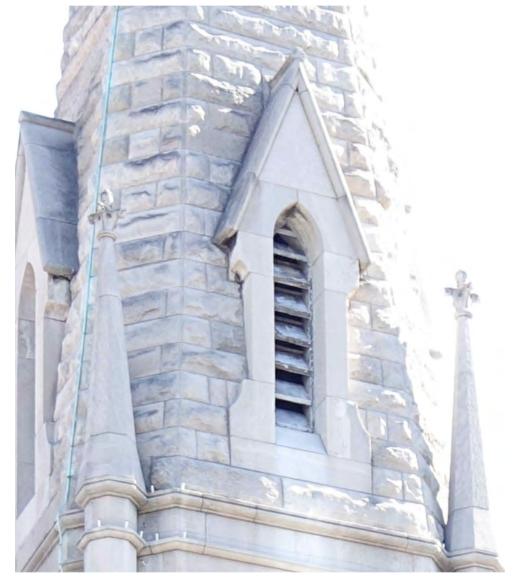
LIMESTONE SPALLING FROM THERMAL SHOCK

LIMESTONE FRACTURED

LIMESTONE LOOSE

FINIALS DAMAGED

LIMESTONE HELD IN PLACE BY GRAVITY AND/OR FRICTION

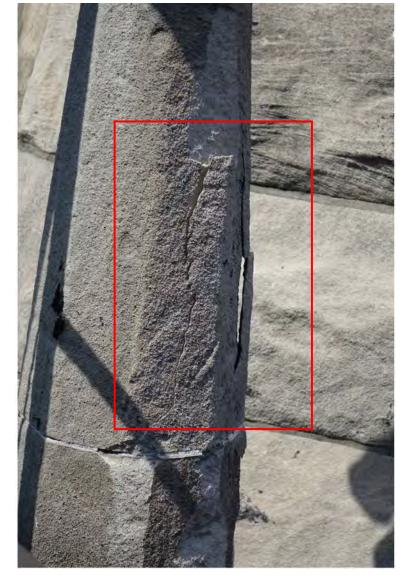
LIMESTONE SPALLING FROM THERMAL SHOCK

LIMESTONE FRACTURED

LIMESTONE LOOSE

FINIALS DAMAGED

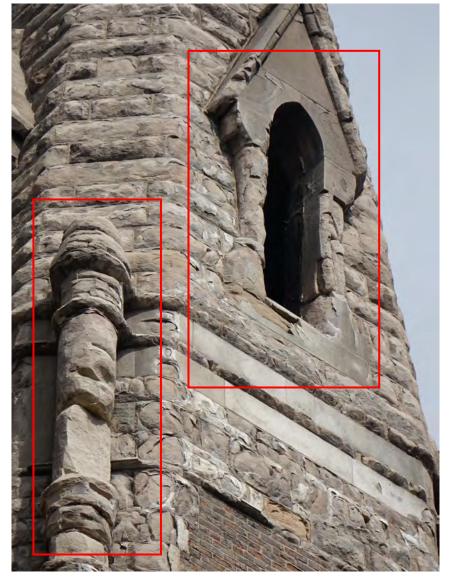
6. NORTH SPIRE POST-FIRE

LIMESTONE SPALLING FROM THERMAL SHOCK

LIMESTONE FRACTURED

LIMESTONE LOOSE

FINIALS DESTROYED

LIMESTONE HELD IN PLACE BY GRAVITY AND/OR FRICTION

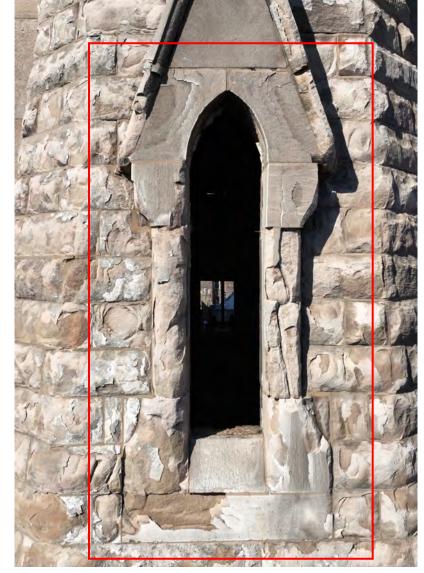
6. NORTH TOWER WINDOW

LIMESTONE SPALLING FROM THERMAL SHOCK

LIMESTONE FRACTURED

LIMESTONE LOOSE

FINIALS DESTROYED

LIMESTONE HELD IN PLACE BY GRAVITY AND/OR FRICTION

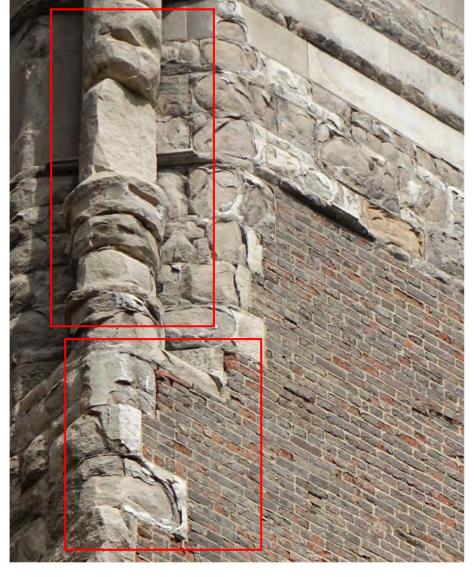
6. NORTH TOWER, FINIAL BASE

LOCALIZED DESTABILIZATION - LIMESTONE

LIMESTONE SPALLING FROM THERMAL SHOCK

LIMESTONE FRACTUREED

LIMESTONE LOOSE

FINIAL BASE DESTROYED

LIMESTONE HELD IN PLACE BY GRAVITY AND/OR FRICTION

SEPARATION BETWEEEN LIMESTONE AND MASONRY

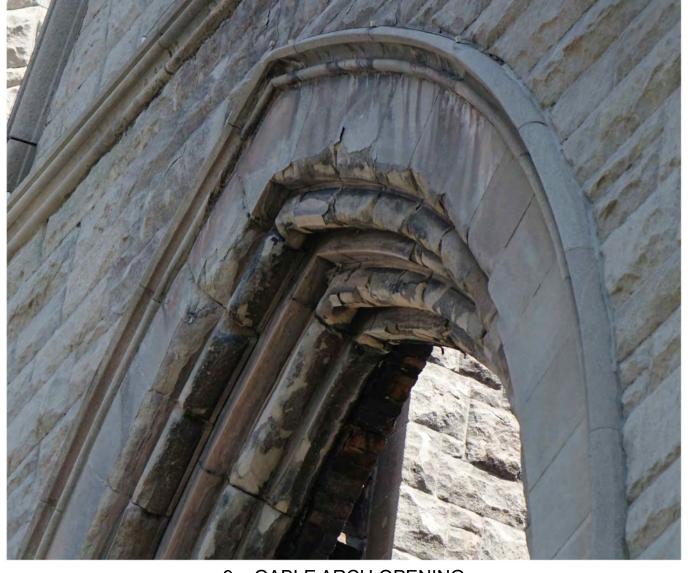
9. GABLE ARCH OPENING

LIMESTONE SPALLING FROM THERMAL SHOCK

LIMESTONE BROKEN

THE ONLY ACCESS TO THE SITE IS BELOW THE BROKEN SILL AND ARCH LIMESTONE

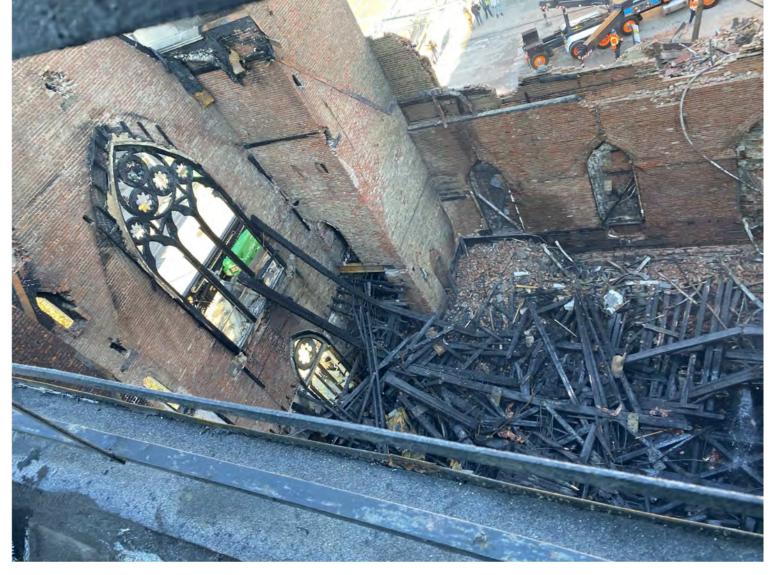
VIEW FROM ROOF OF HOPPER HOUSE

NORTH WALL REMOVED TO ALLOW ACCESS

WOOD TRACERY REMOVED DUE TO MOVEMENT

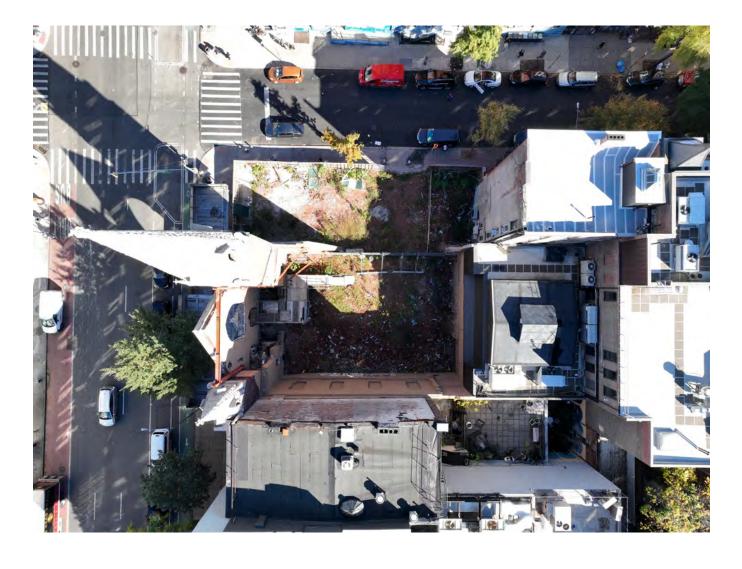
CURRENT AERIAL VIEW

CORNER SITE CLEARED

FAÇADE TEMPORARILY BRACED

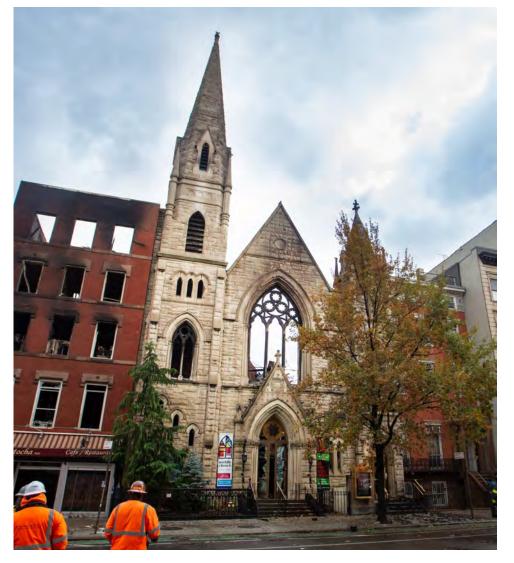
2ND Ave. ELEVATION – POST FIRE

RUSTICATED INDIANA LIMESTONE FAÇADE — *DAMAGED AND LOCALLY DESTABILIZED*

LIMESTONE BUTTRESSES – CRACKS FORMED

LIMESTONE FINIALS – DAMAGED AND DESTROYED

ELABORATE STAINED GLASS WINDOWS (POSSIBLY TIFFANY GLASS) – DESTROYED

WOOD AND BRONZE TRACERY – DAMAGED, AND REMOVED BY ORDER NYC DOB

GABLED THREE STORY CENTRAL BAY – DAMAGED AND LOCALLY DESTABILIZED

FIVE STORY TOWER AT NORTHERN BAY WITH HEXAGONAL LIMESTONE SPIRE – MASONRY DAMAGED, LIMESTONE FRACTURED AND LOCALLY DESTABILIZED

FOUR STORY TOWER AT SOUTHERN BAY WITH HEXAGONAL LIMESTONE SPIRE – MASONRY DAMAGED, LIMESTONE FRACTURED AND LOCALLY DESTABILIZED
