Preservation Department – Item 5, LPC-23-02975

**112 2nd Avenue – East Village/Lower East Side Historic District
Borough of Manhattan**

MIDDLE COLLEGIATE CHURCH
112 SECOND AVENUE, NEW YORK, NY 10003

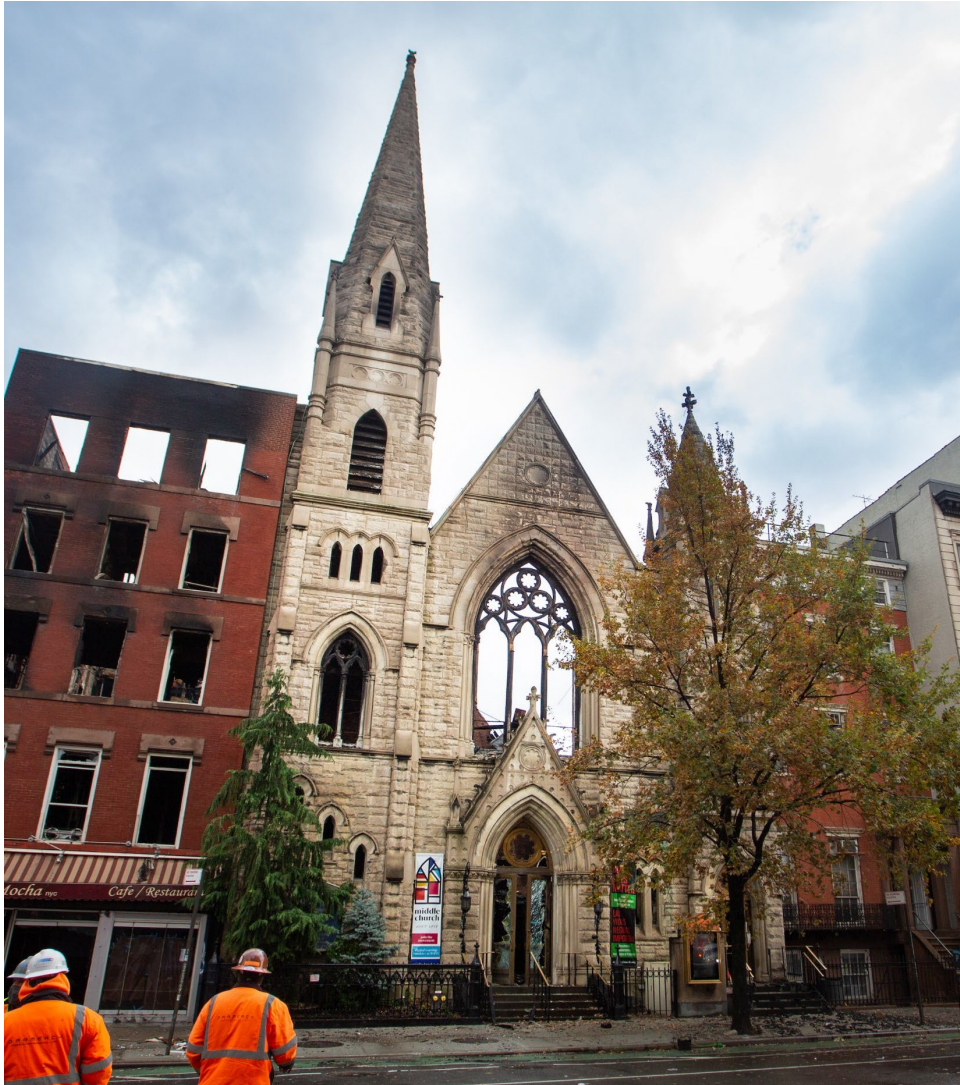
2ND Ave. FACADE – POST FIRE

INDIANA LIMESTONE FAÇADE – *DAMAGED AND LOCALLY DESTABILIZED*

LIMESTONE BUTTRESSES – *CRACKS FORMED*

LIMESTONE FINIALS – *DAMAGED AND DESTROYED*

STAINED GLASS WINDOWS (POSSIBLY TIFFANY GLASS) – *DESTROYED*

WOOD AND BRONZE TRACERY – *DAMAGED, AND REMOVED BY ORDER NYC DOB*

GABLED CENTRAL BAY – *DAMAGED AND LOCALLY DESTABILIZED*

NORTHERN TOWER AND SPIRE – *MASONRY DAMAGED, LIMESTONE FRACTURED AND LOCALLY DESTABILIZED*

SOUTHERN TOWER AND SPIRE – *MASONRY DAMAGED, LIMESTONE FRACTURED AND LOCALLY DESTABILIZED*

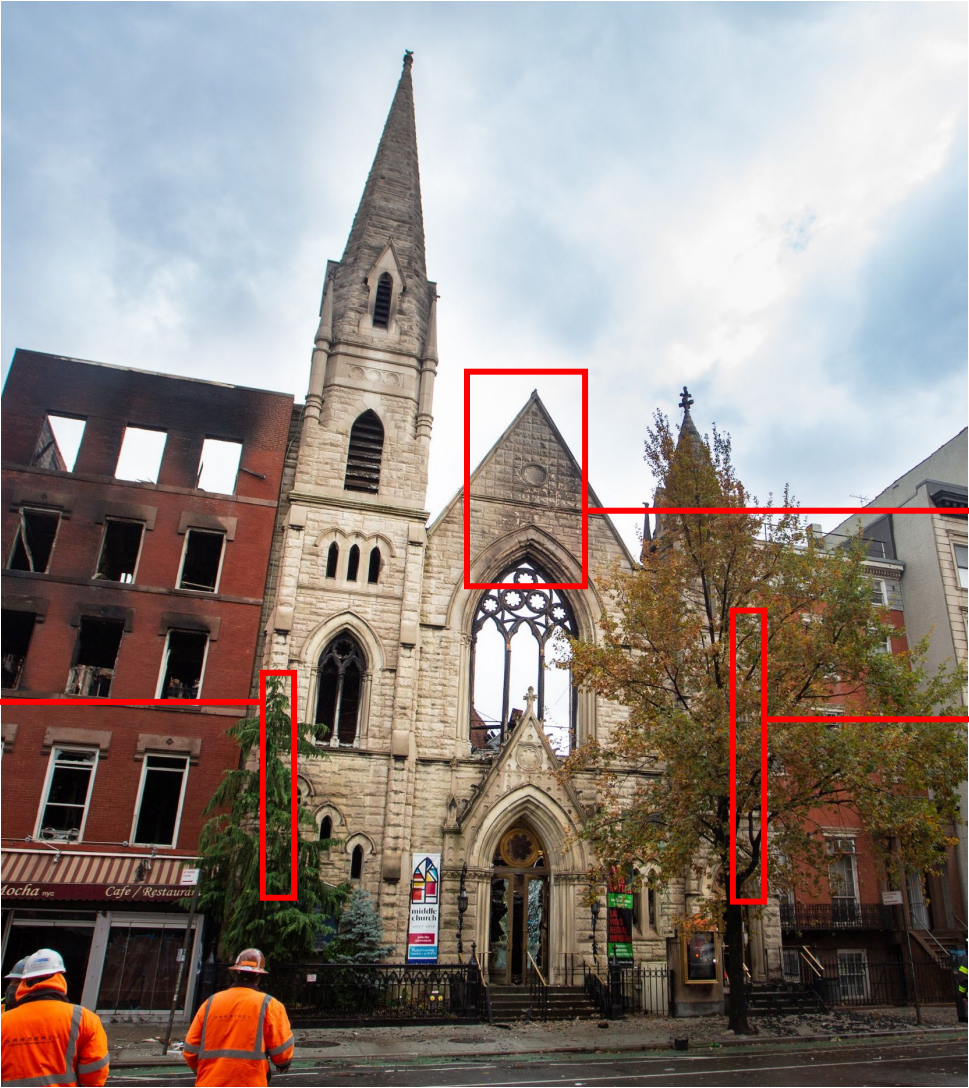
NORTH TOWER CRACK

GABLE ARCH

SOUTH TOWER CRACK

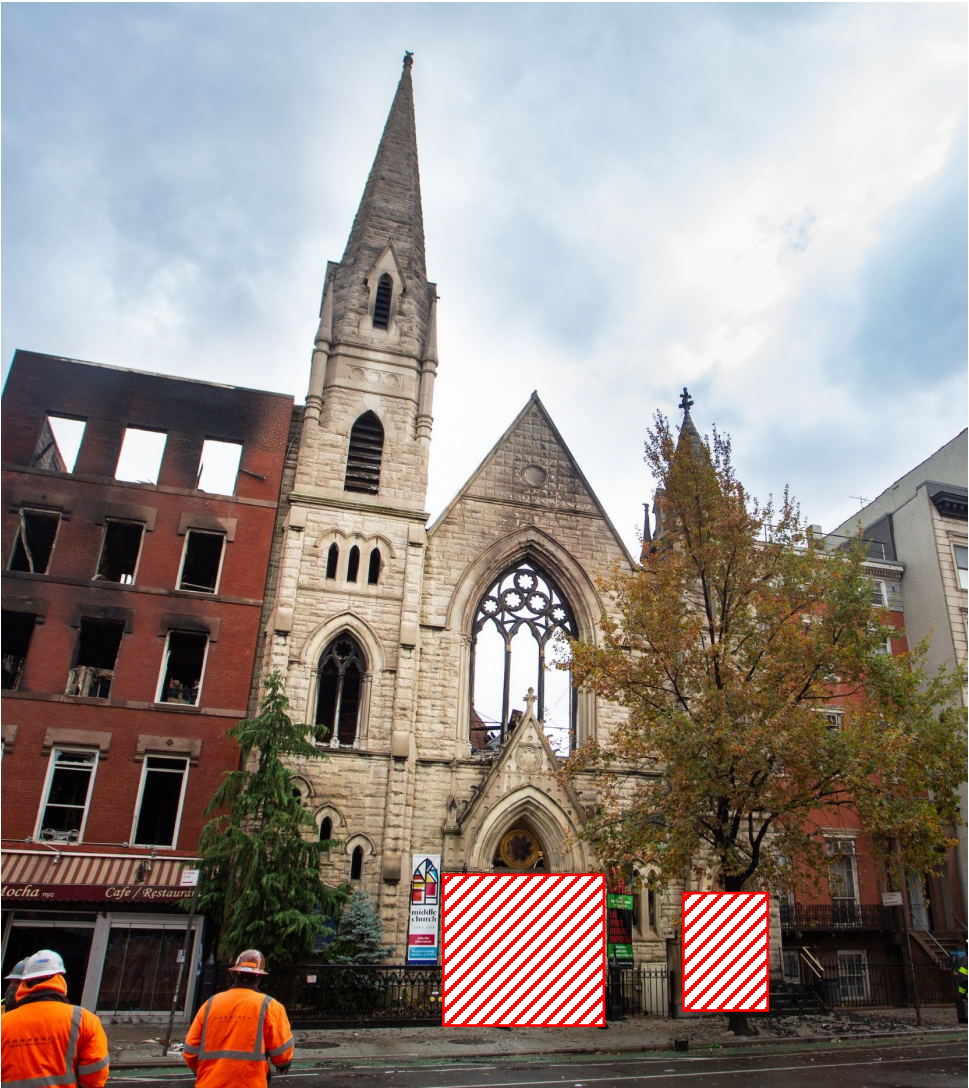
HISTORIC FABRIC TO BE REMOVED

2ND Ave. FAÇADE MODIFICATIONS REQUIRED FOR EGRESS BY NYC CODE

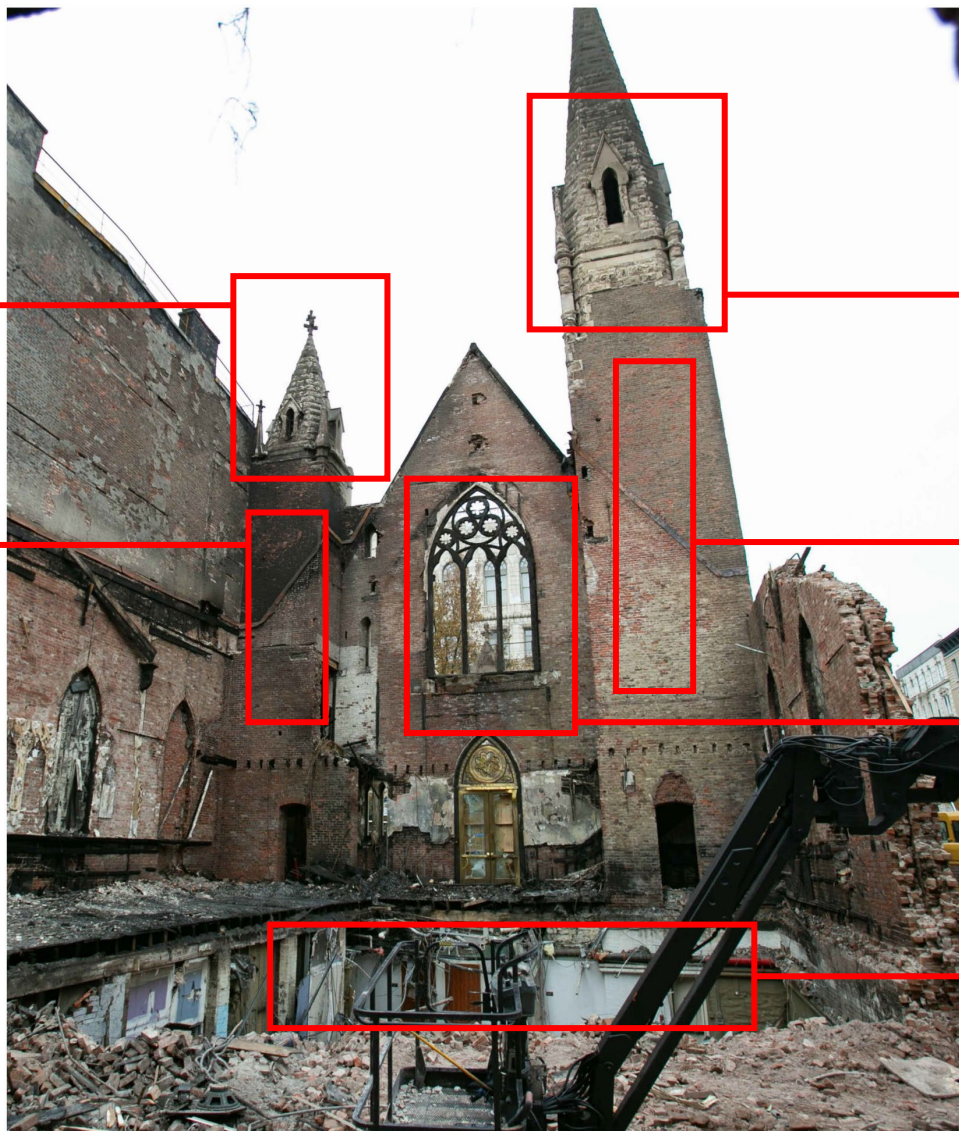
BACK SIDE OF 2ND Ave. FACADE

SOUTH SPIRE LIMESTONE

NORTH SPIRE LIMESTONE

SOUTH TOWER MASONRY

NORTH TOWER MASONRY

GABLE SILL AND ARCH

FOUNDATION WALL

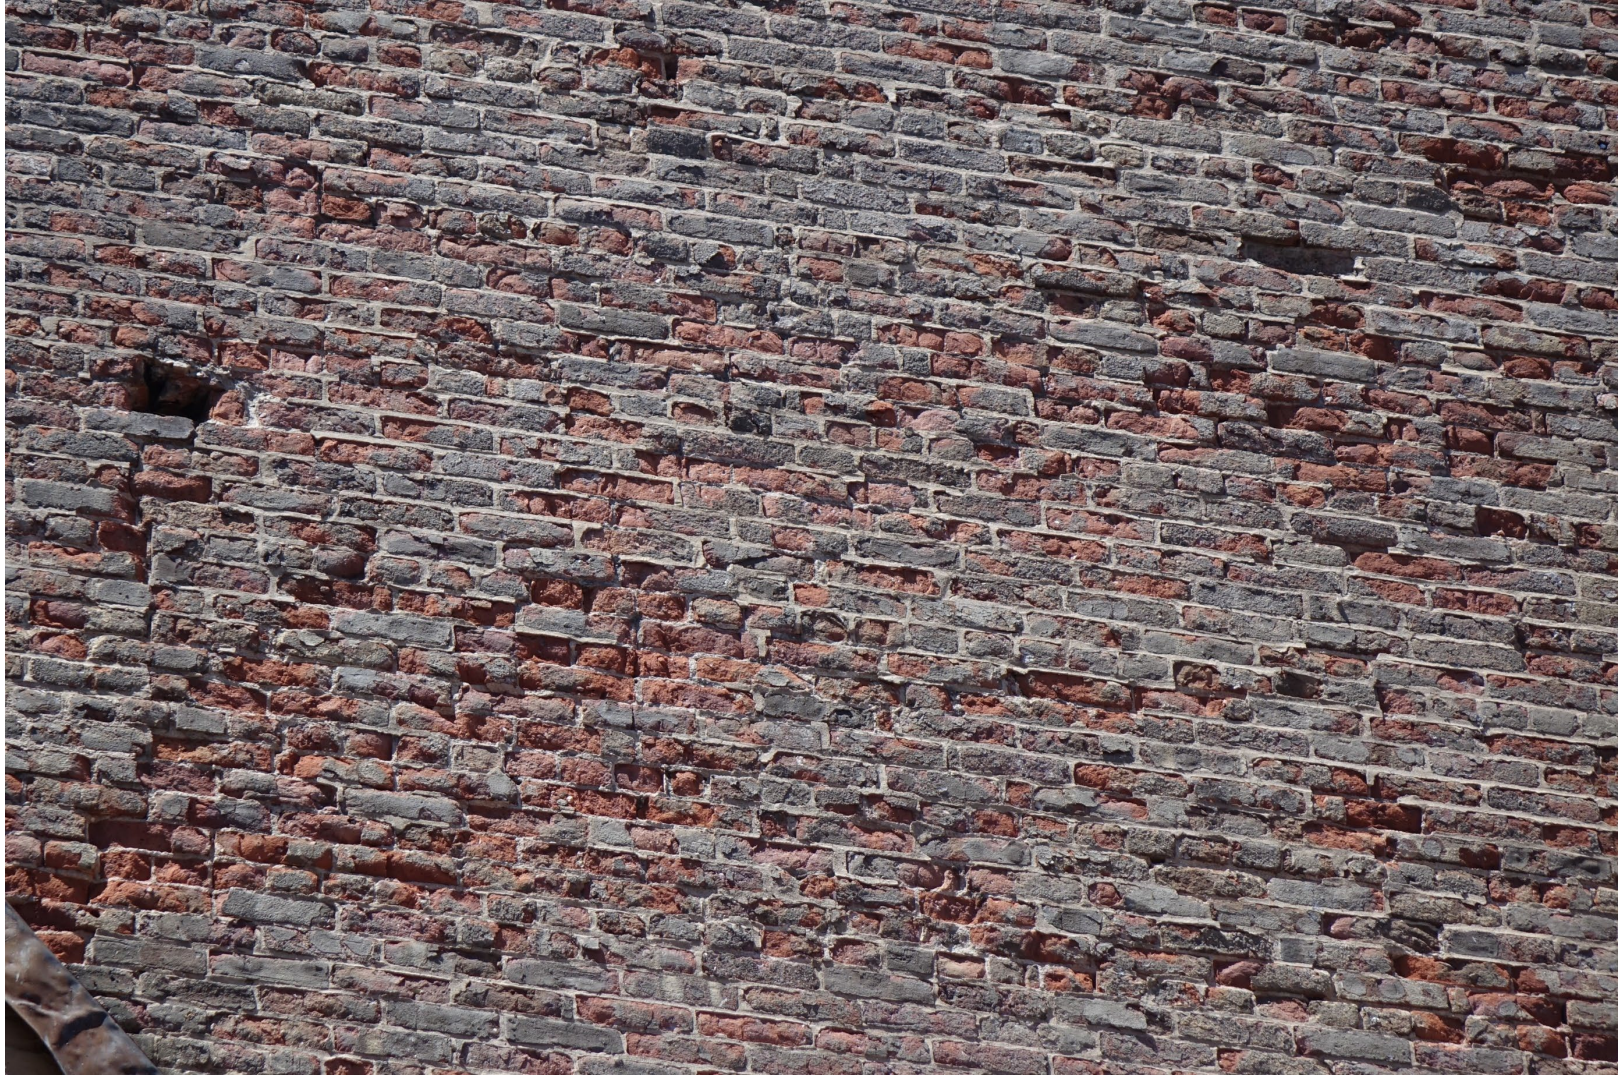
VIEW OF TYPICAL MASONRY

LOCALIZED DESTABILIZATION

SPALLING BRICK DUE TO
THERMAL SHOCK

MISSING MORTAR

MISSING BRICKS

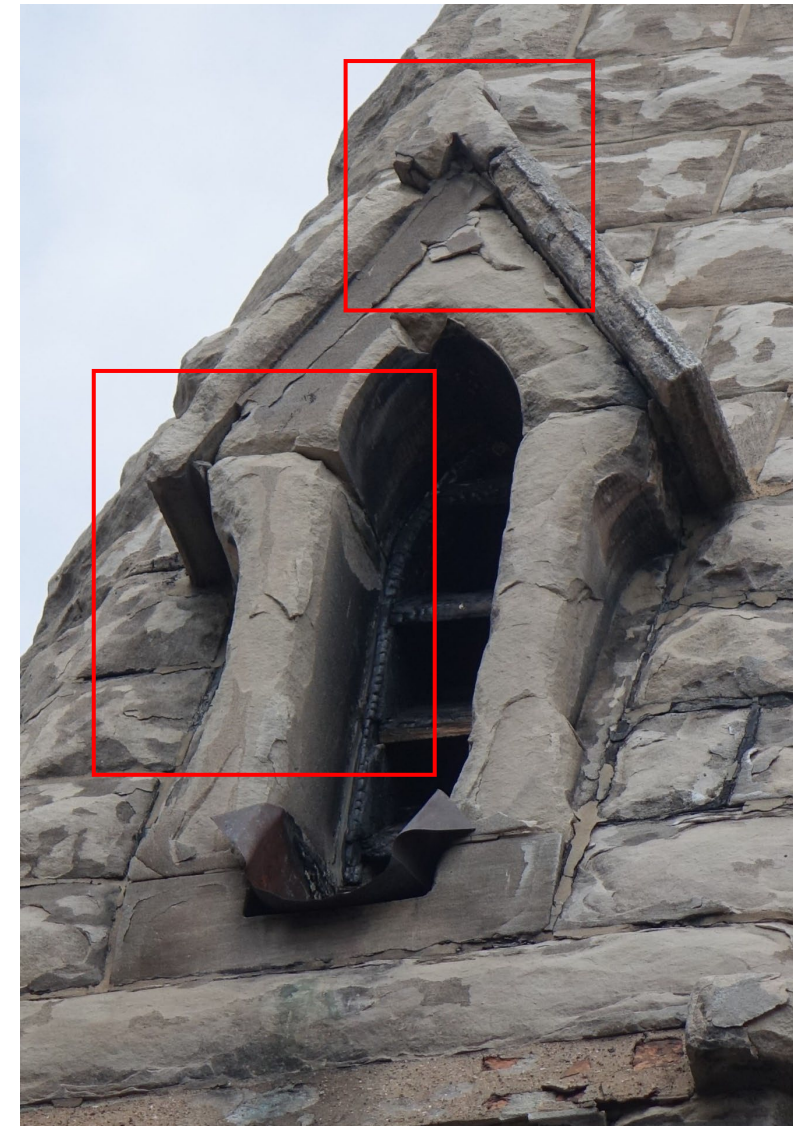
SOUTH SPIRE POST-FIRE

LOCALIZED DESTABILIZATION

LIMESTONE SPALLING FROM
THERMAL SHOCK

LIMESTONE FRACTURED

LIMESTONE LOOSE

FINIALS DAMAGED

LIMESTONE HELD IN PLACE BY
GRAVITY AND/OR FRICTION

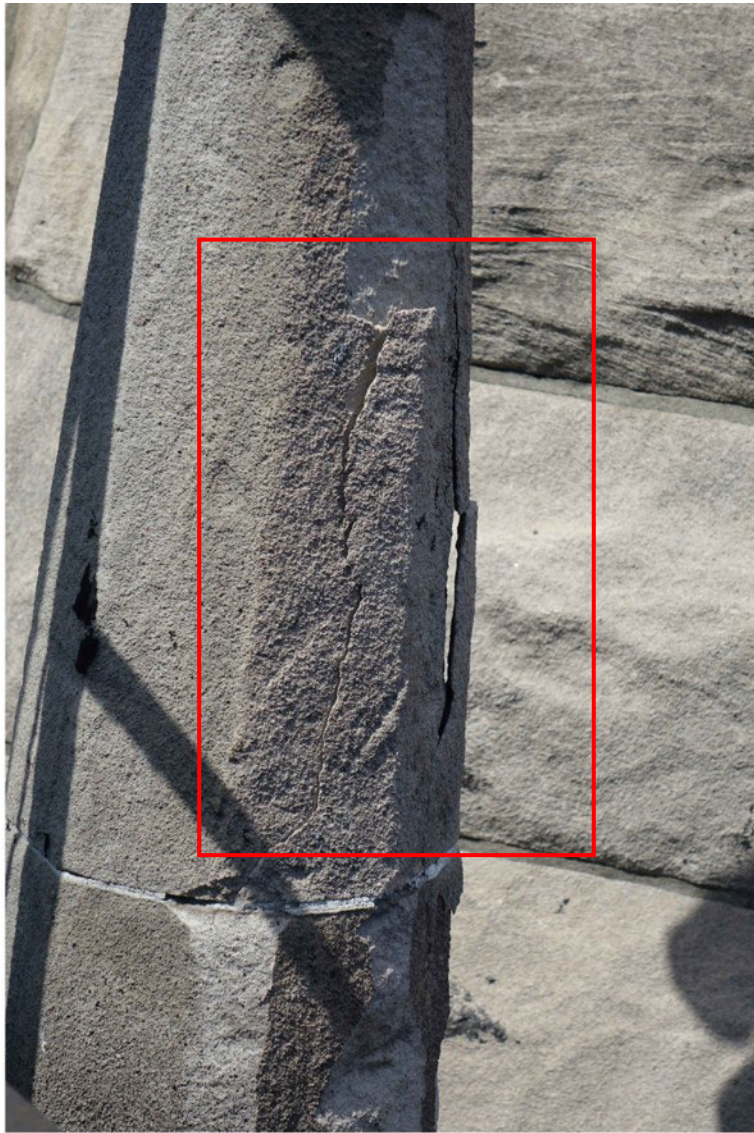
SOUTH SPIRE

LOCALIZED DESTABILIZATION

LIMESTONE SPALLING FROM
THERMAL SHOCK

LIMESTONE FRACTURED

LIMESTONE LOOSE

FINIALS DAMAGED

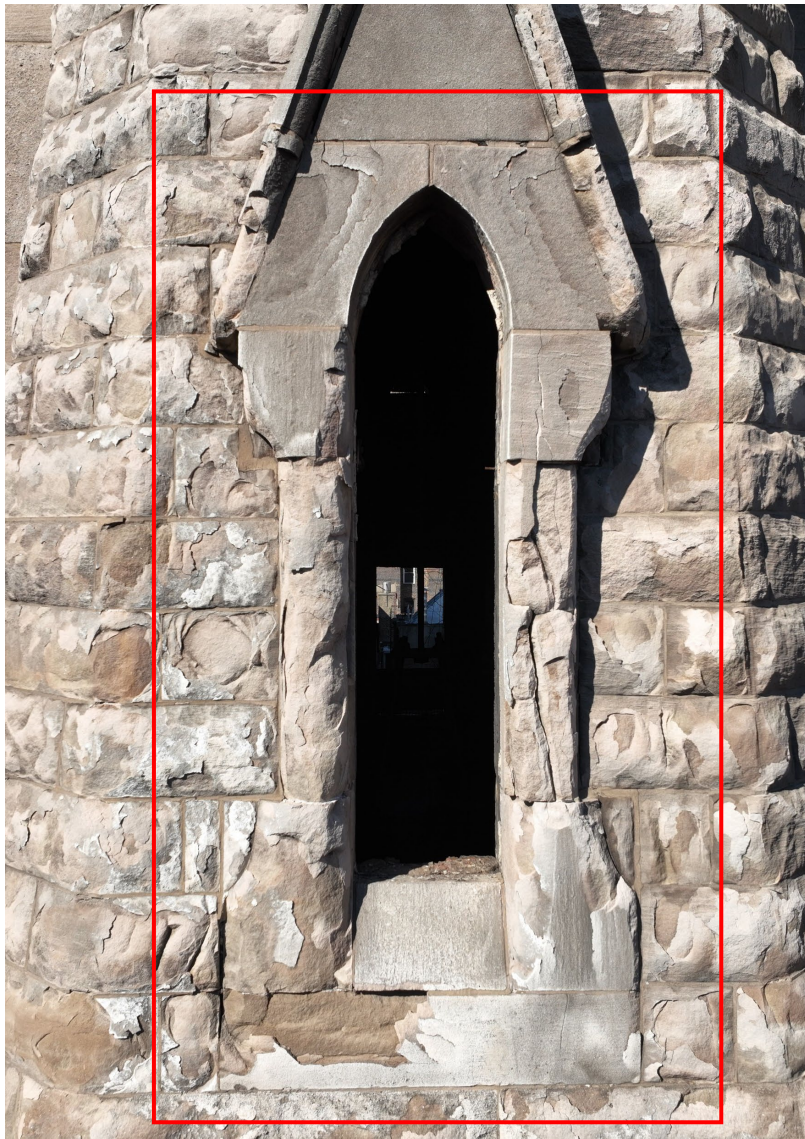
NORTH TOWER WINDOW

LOCALIZED DESTABILIZATION

LIMESTONE SPALLING FROM
THERMAL SHOCK

LIMESTONE FRACTURED

LIMESTONE LOOSE

LIMESTONE HELD IN PLACE BY
GRAVITY AND/OR FRICTION

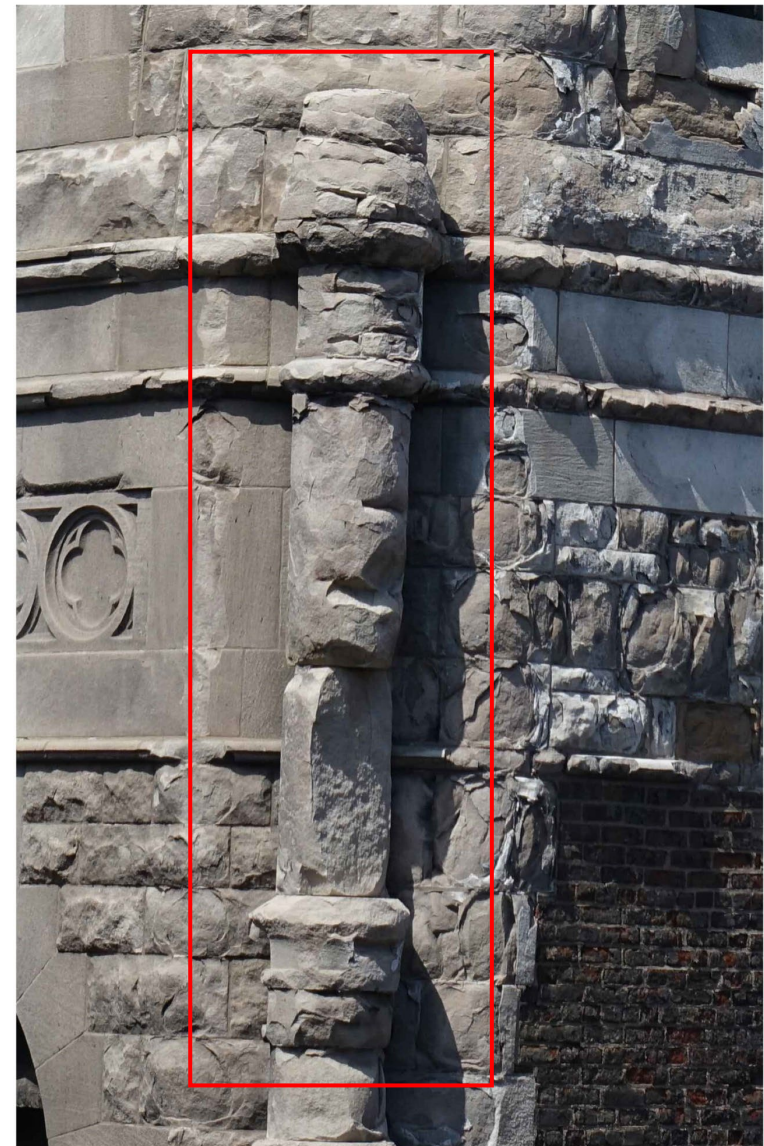
NORTH TOWER FINIAL

FINIALS DESTROYED

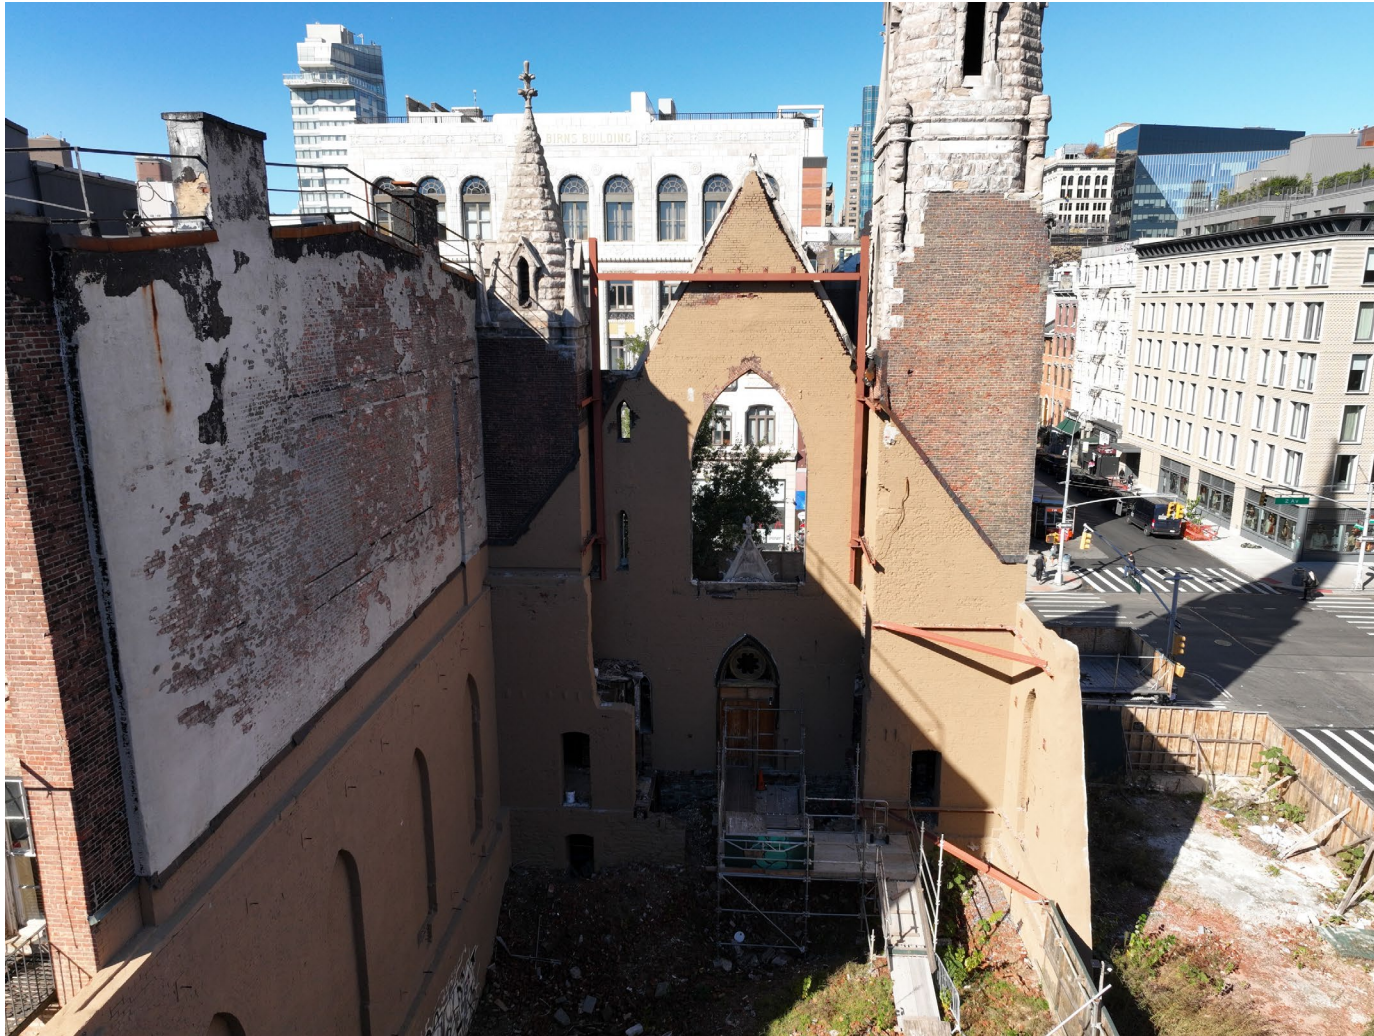
CURRENT AERIAL VIEW

CORNER SITE CLEARED

FAÇADE TEMPORARILY BRACED

NORTH WALL REMOVED FOR TEMPORARY ACCESS

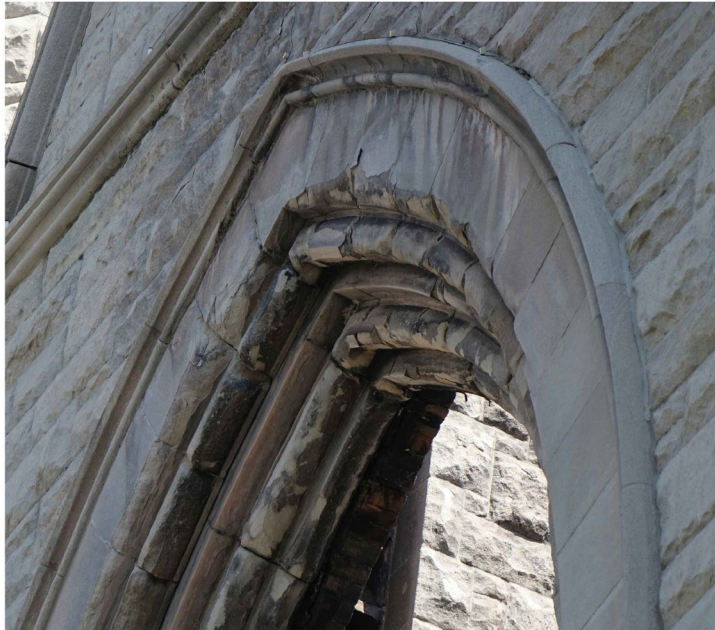
GABLE ARCH

LOCALIZED DESTABILIZATION

DIMENSIONAL STONE
FRACTURED

MORTAR MISSING

MASONRY DAMAGED BY
THERMAL SHOCK

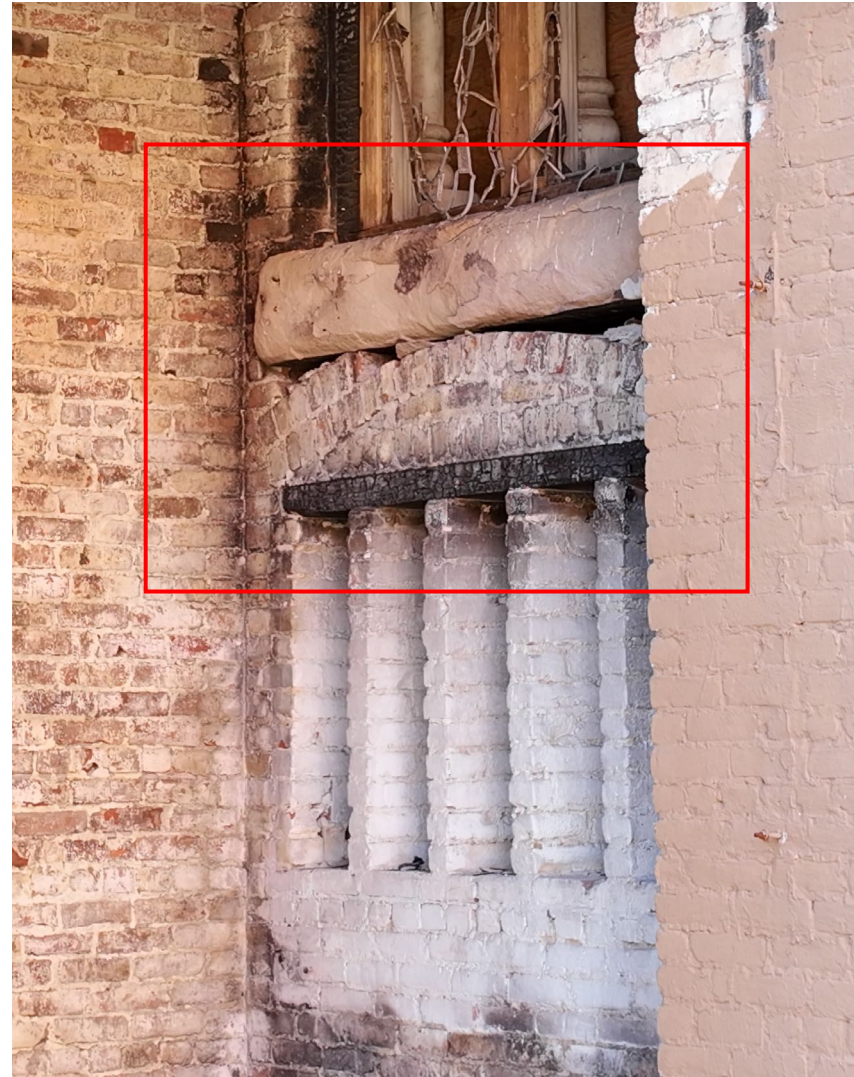
VIEW INSIDE SOUTH TOWER

LOCALIZED DESTABILIZATION

SPALLING LIMESTONE DUE TO
THERMAL SHOCK

MISSING MASONRY

CHARRED WOOD SUPPORT

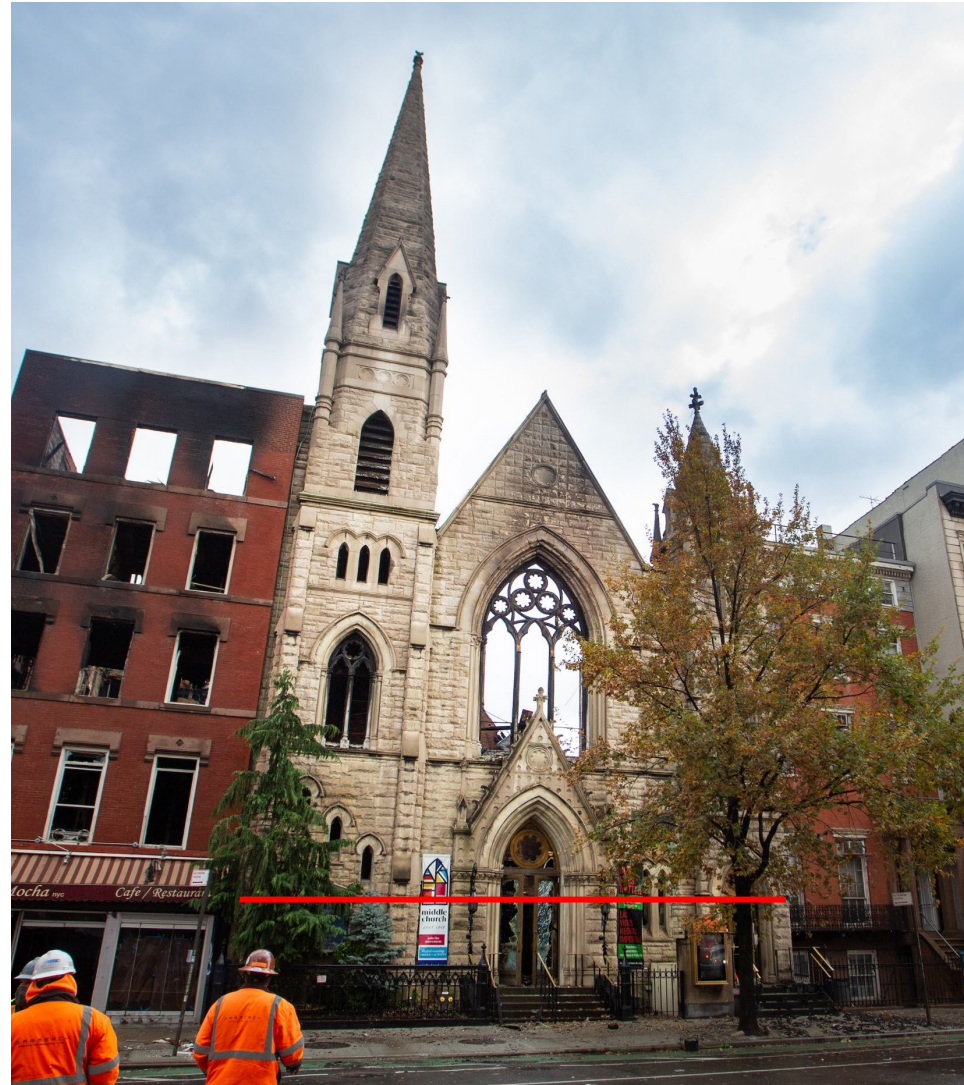
POSSIBLE SALVAGE OF STONE BELOW 8'-0"

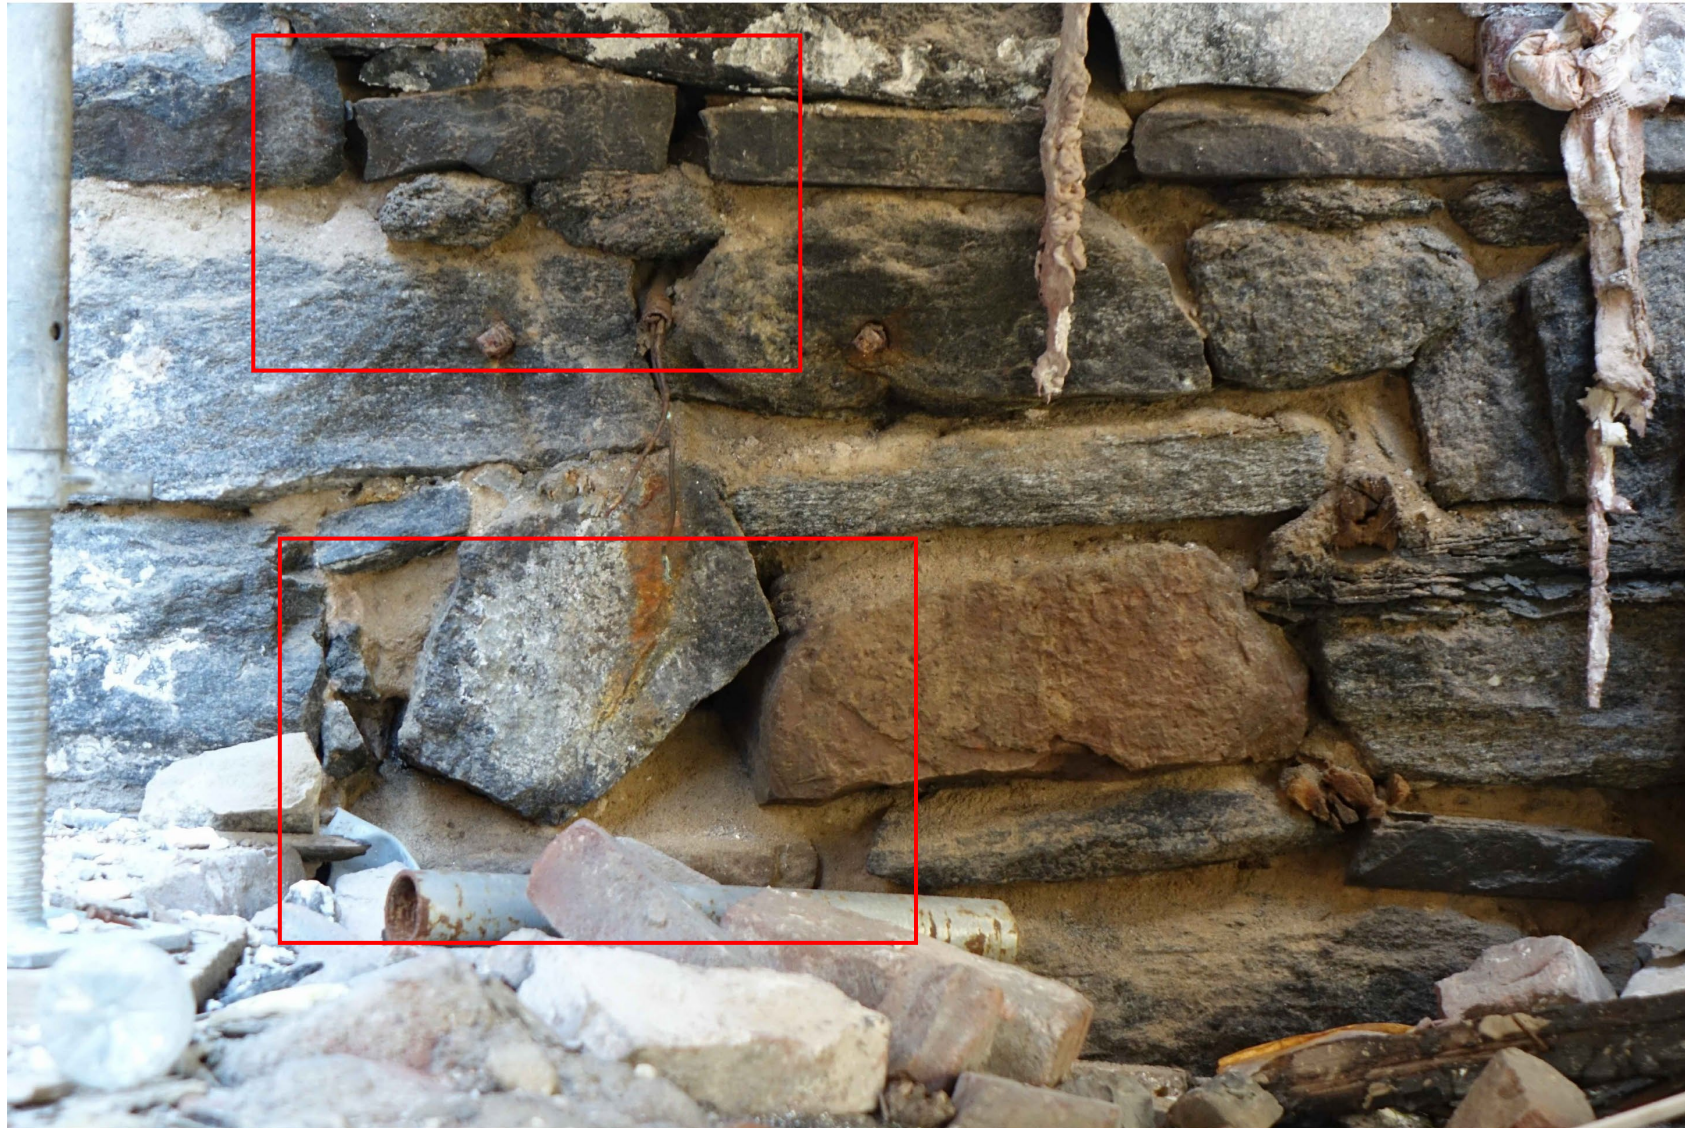
1. FOUNDATION WALL - 2nd Ave. FACADE

LOCALIZED DESTABILIZATION

RUBBLE STONE

DETERIORATING MORTAR

MISSING MORTAR

POROUS, HISTORY OF WATER LEAKS

TEMPORARILY STABILIZED BY
RUBBLE BERM

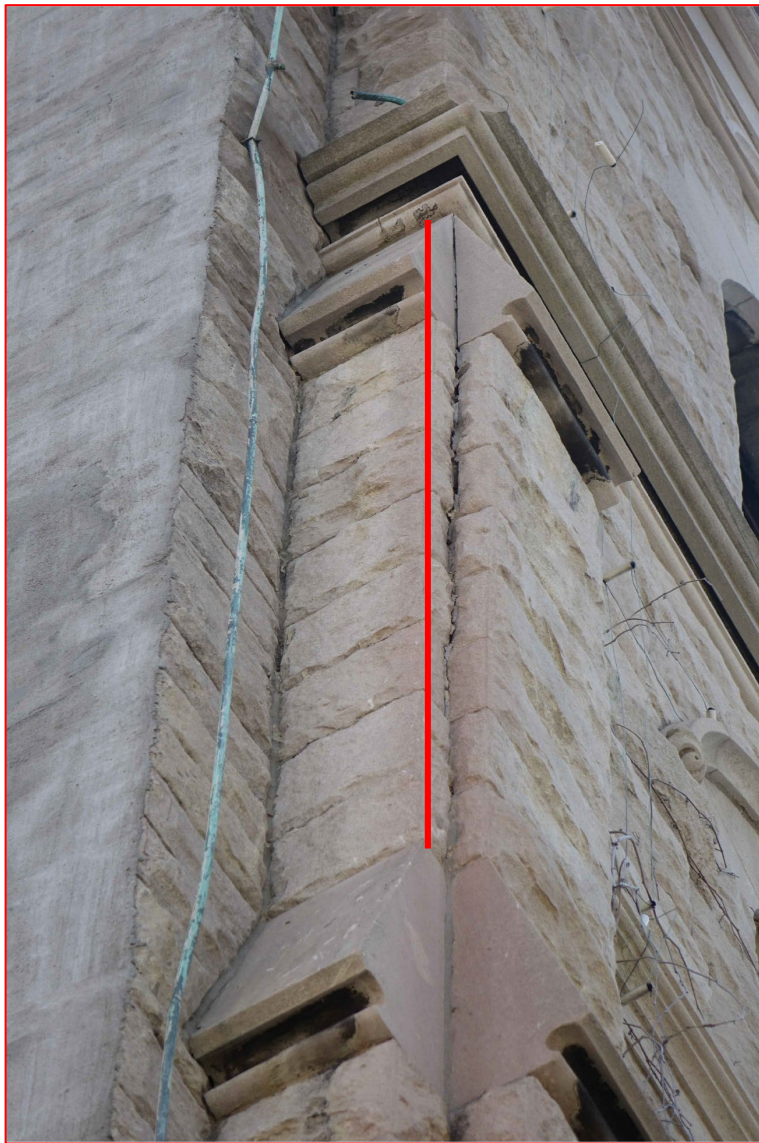
7. NORTH TOWER – EXTENT OF LIMESTONE CRACK

LOCALIZED DESTABILIZATION

LIMESTONE SEPARATING AT BUTRESS

WATER INFILTRATION AND FREEZE THAW LIKELYHOOD

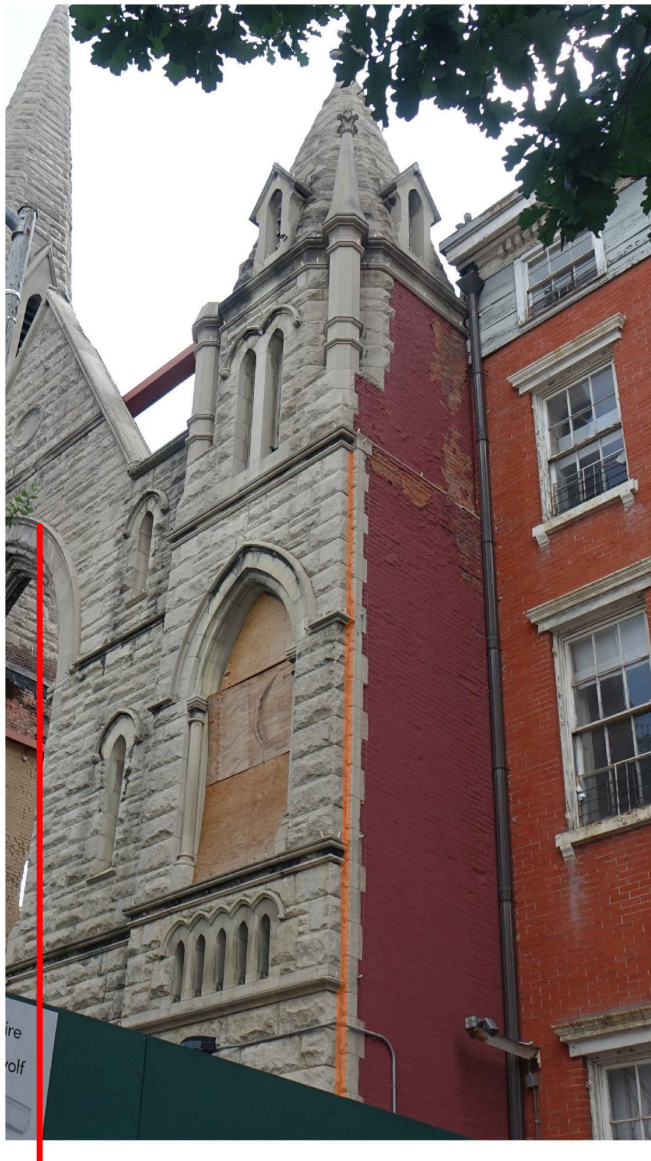
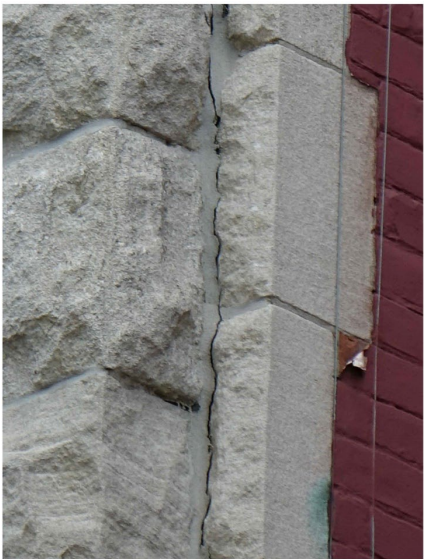
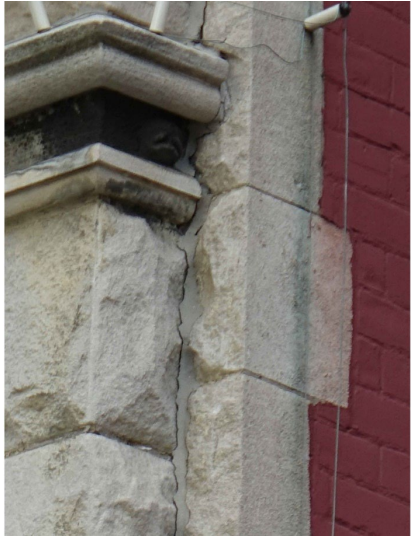
8. SOUTH TOWER – EXTENT OF LIMESTONE CRACK

LOCALIZED DESTABILIZATION

LIMESTONE SEPARATING AT
SOUTH WALL

WATER INFILTRATION AND
FREEZE THAW LIKELYHOOD
