Preservation Department – Item 2, LPC-23-02975

**112 2nd Avenue – East Village/Lower East Side Historic District  
Borough of Manhattan**

SUPPLEMENTAL PRESENTATION IN SUPPORT OF MCC APPLICATION

MIDDLE COLLEGIATE CHURCH

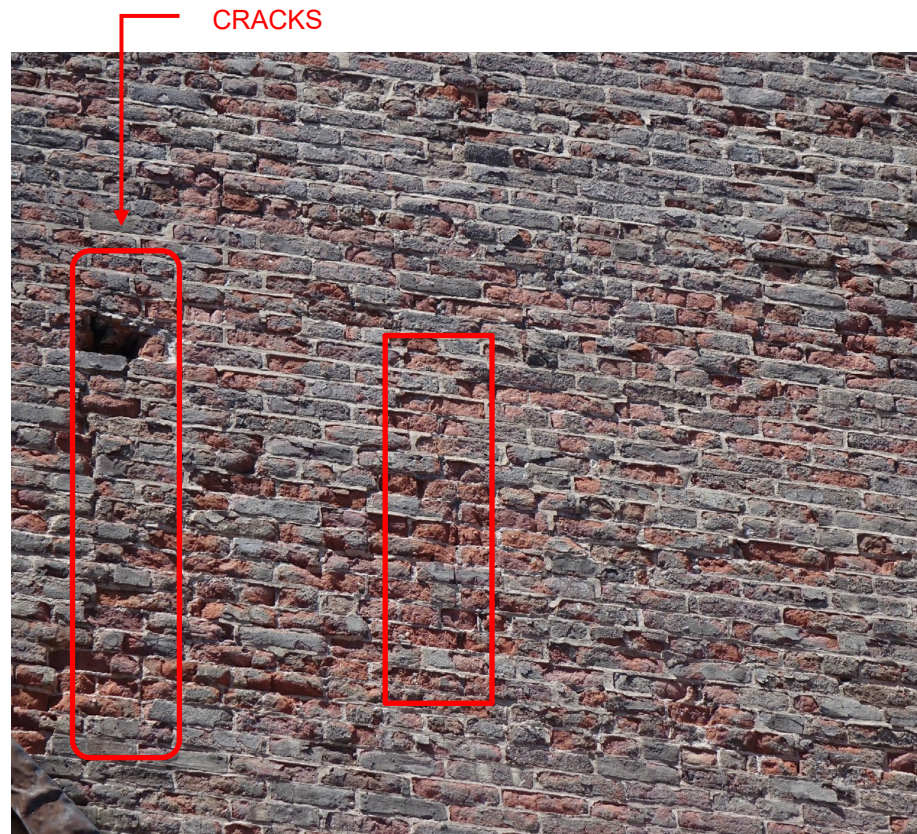
REPRESENTATIVE IMAGE OF DETERIORATED MASONRY

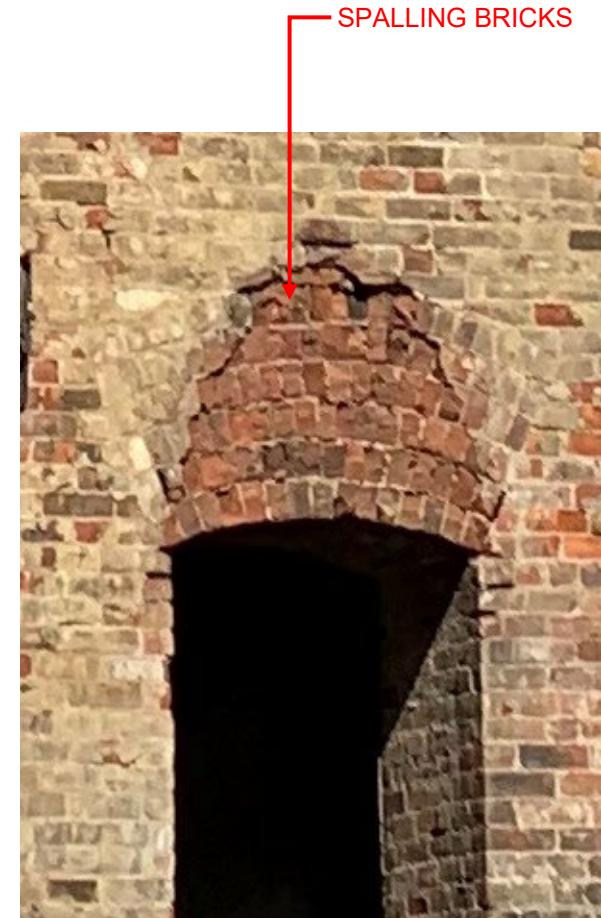
DETERIORATED MASONRY

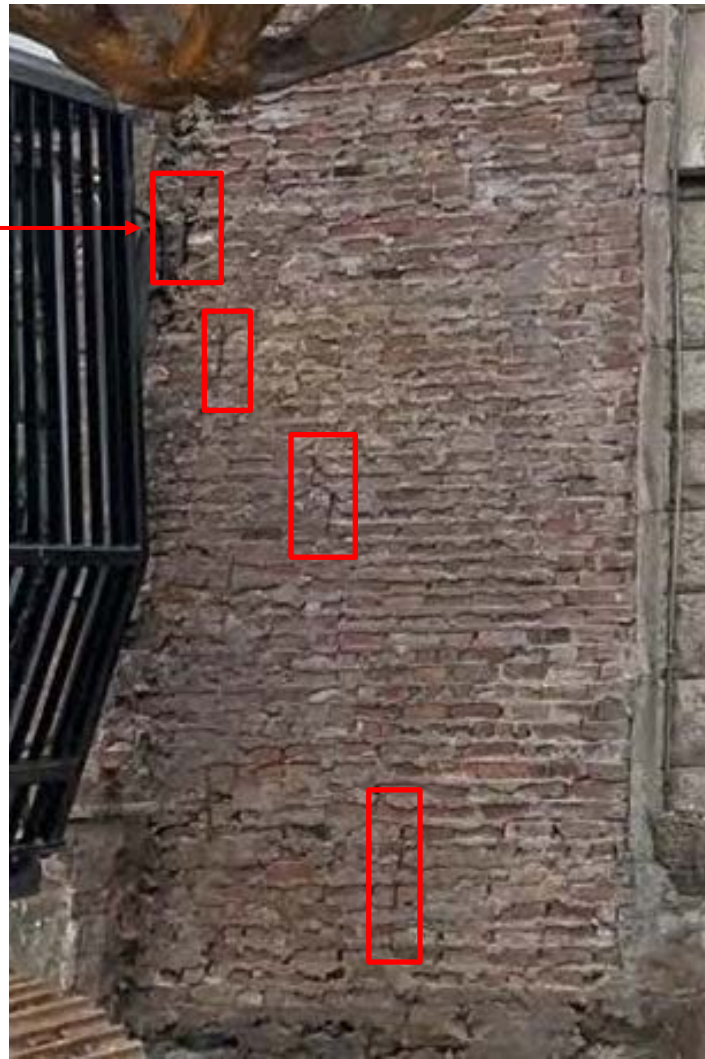
VISIBLE MASONRY CRACKS

There is a visible masonry crack at the steel transfer beam on the south tower. There are cracks in the east face of the north tower. There are cracks in the masonry on the north face of the north tower. See supplemental slides R-3, 5, 7 and 9.

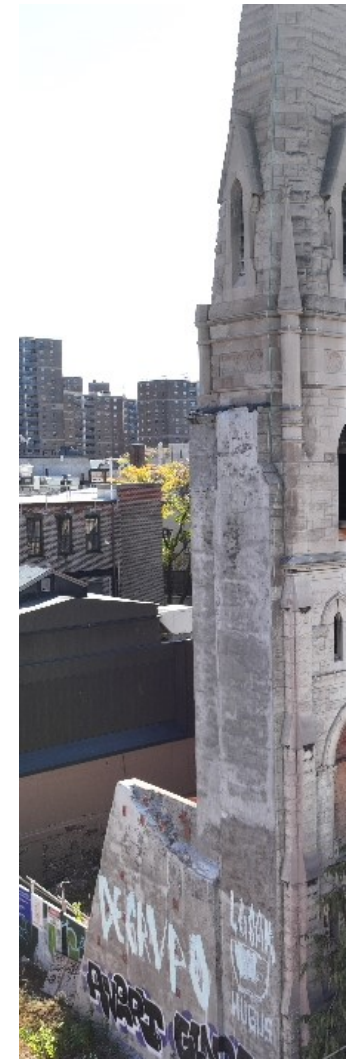
NORTH TOWER – WITH PARGE

## NORTH TOWER MASONRY – CURRENTLY COVERED BY CEMENT PARGE

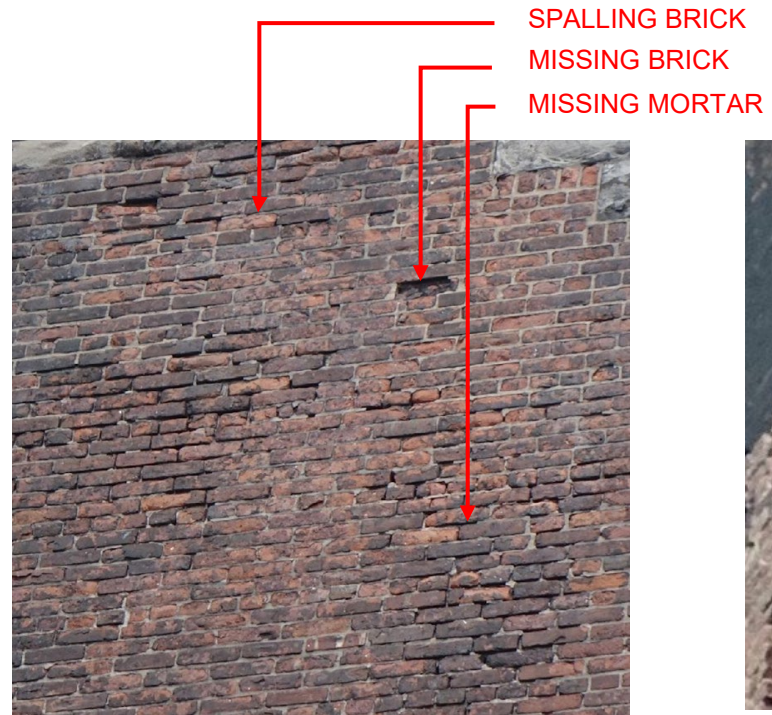
REPRESENTATIVE IMAGE OF DETERIORATED MASONRY

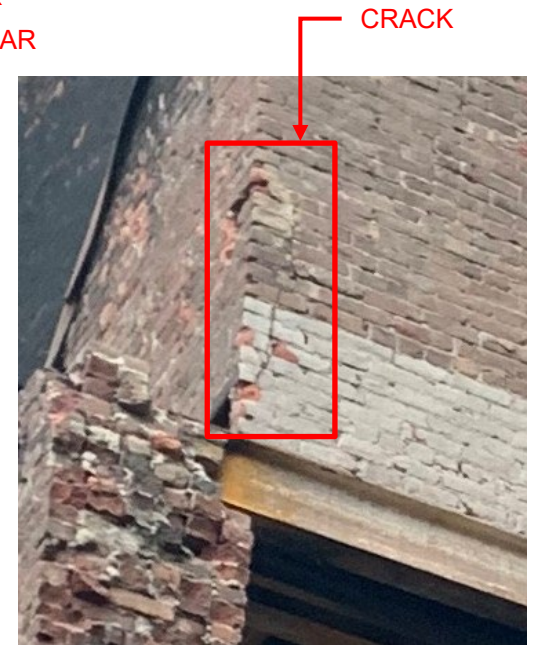
CRACK AT STEEL TRANSFER

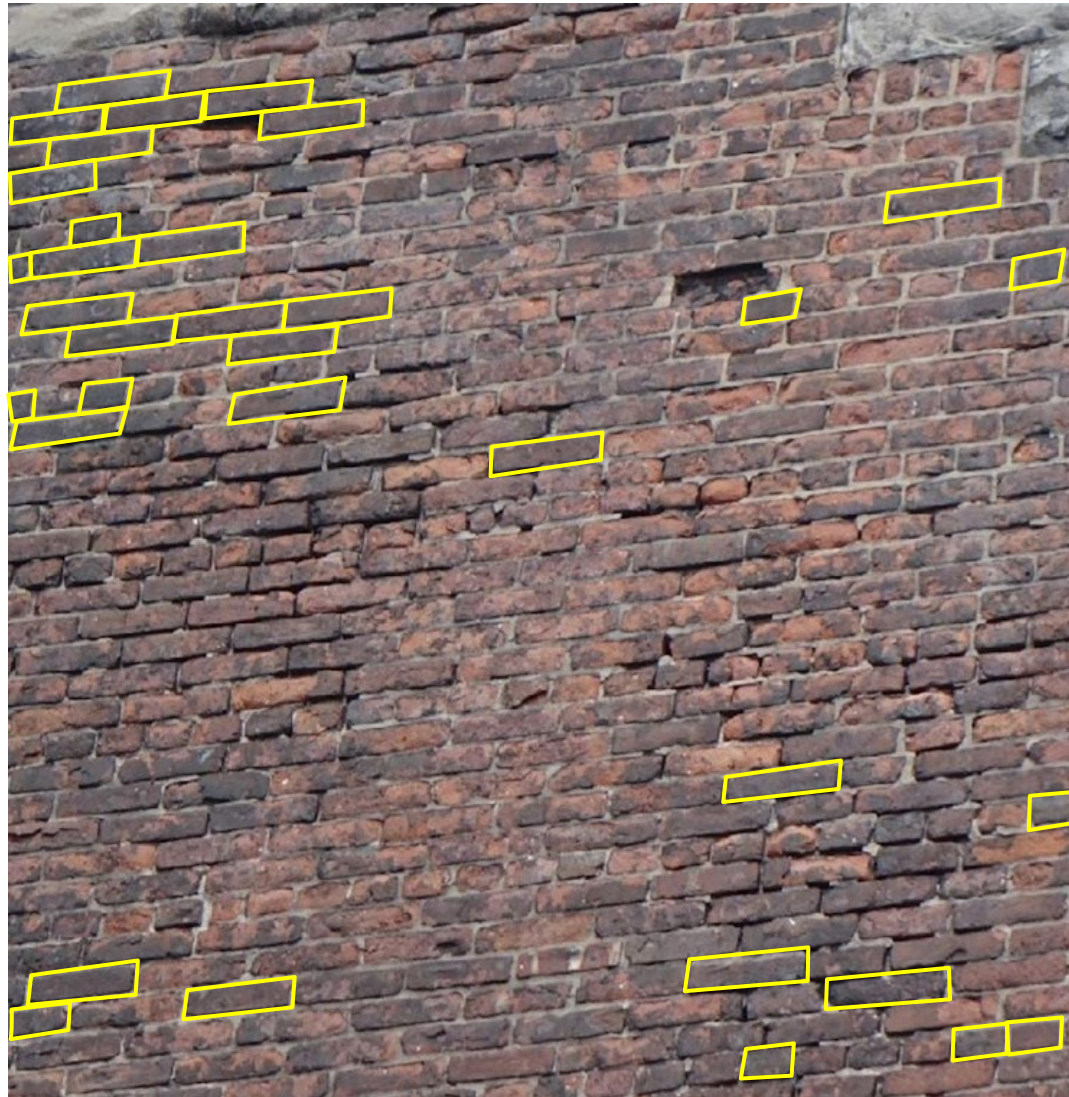
SOUTH TOWER MASONRY – POST FIRE CONDITION - ENLARGED

35 BRICKS WITHOUT VISIBLE SURFACE DAMAGE

322 DAMAGED BRICKS

90% DAMAGED BRICKS

IMAGE IS APPROXIMATELY 25% OF TOWER FACE

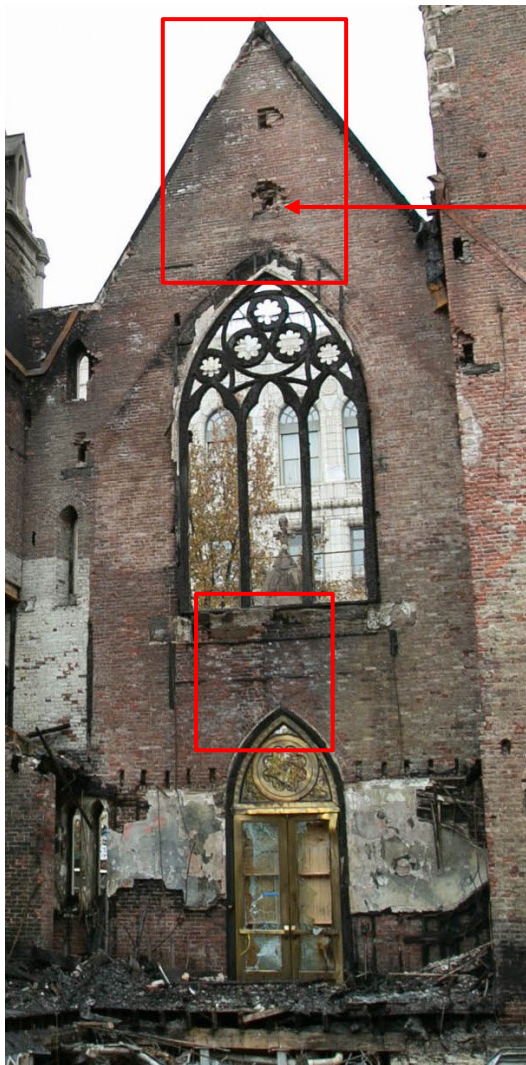
GABLE – BACK OF FACADE

TRUSS BEARING

DAMAGED COPING

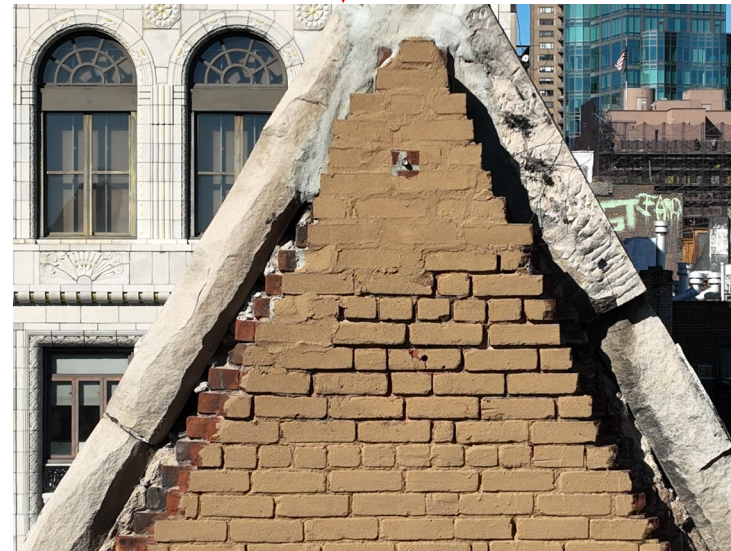
GABLE COPING DAMAGED STONE

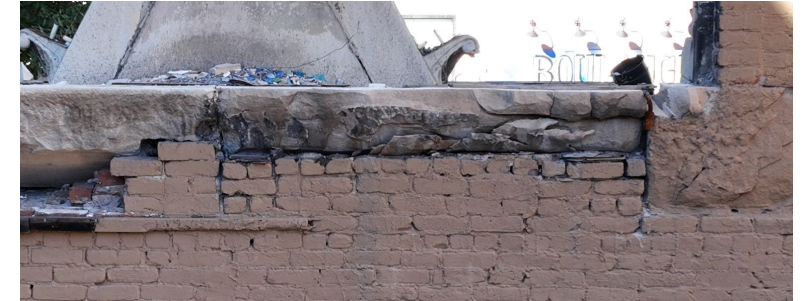
GABLE SILL FRACTURED STONE

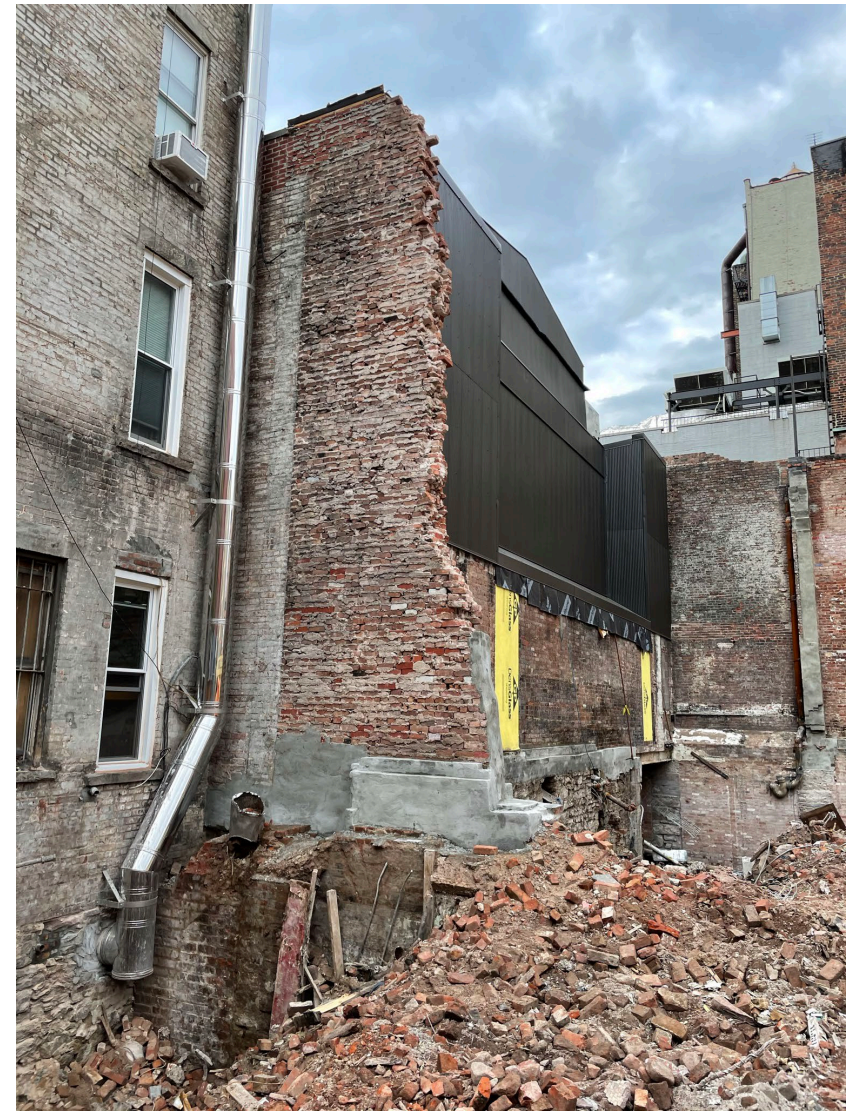
EAST WALL REMOVED PER DOB ORDER

This is factually incorrect. The east/rear wall did not remain after the fire. .The wall was extensively damaged and was ordered demolished by DOB. What is visible today was installed after the fire. See, supplemental slide R-10.

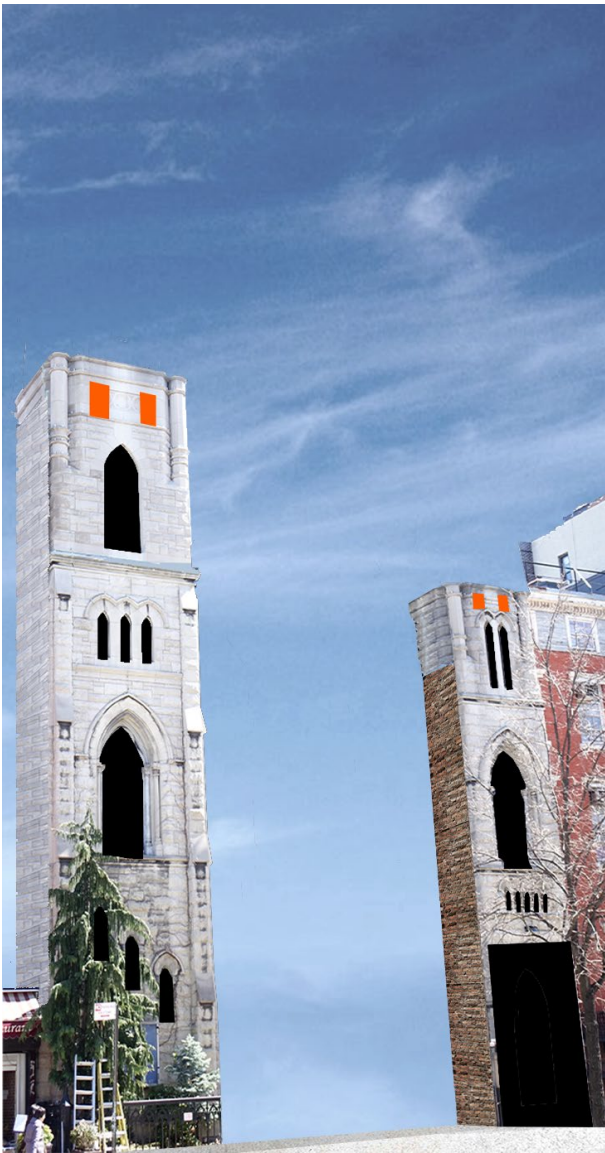
FRONT - 65% ORIGINAL MATERIAL LOST

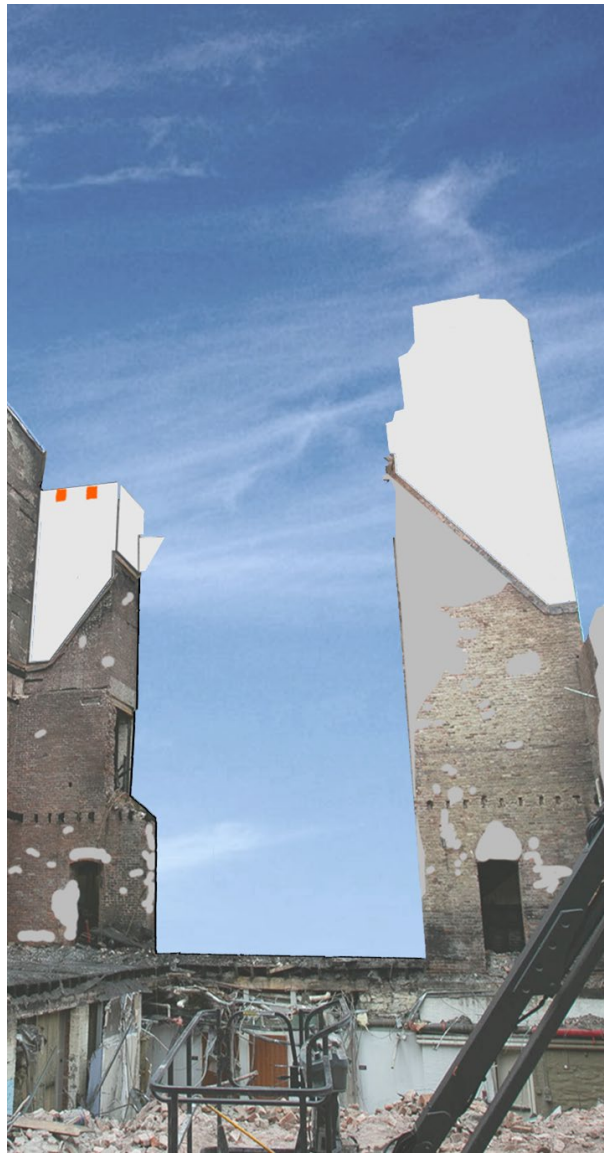
BACK - 60% ORIGINAL MATERIAL LOST

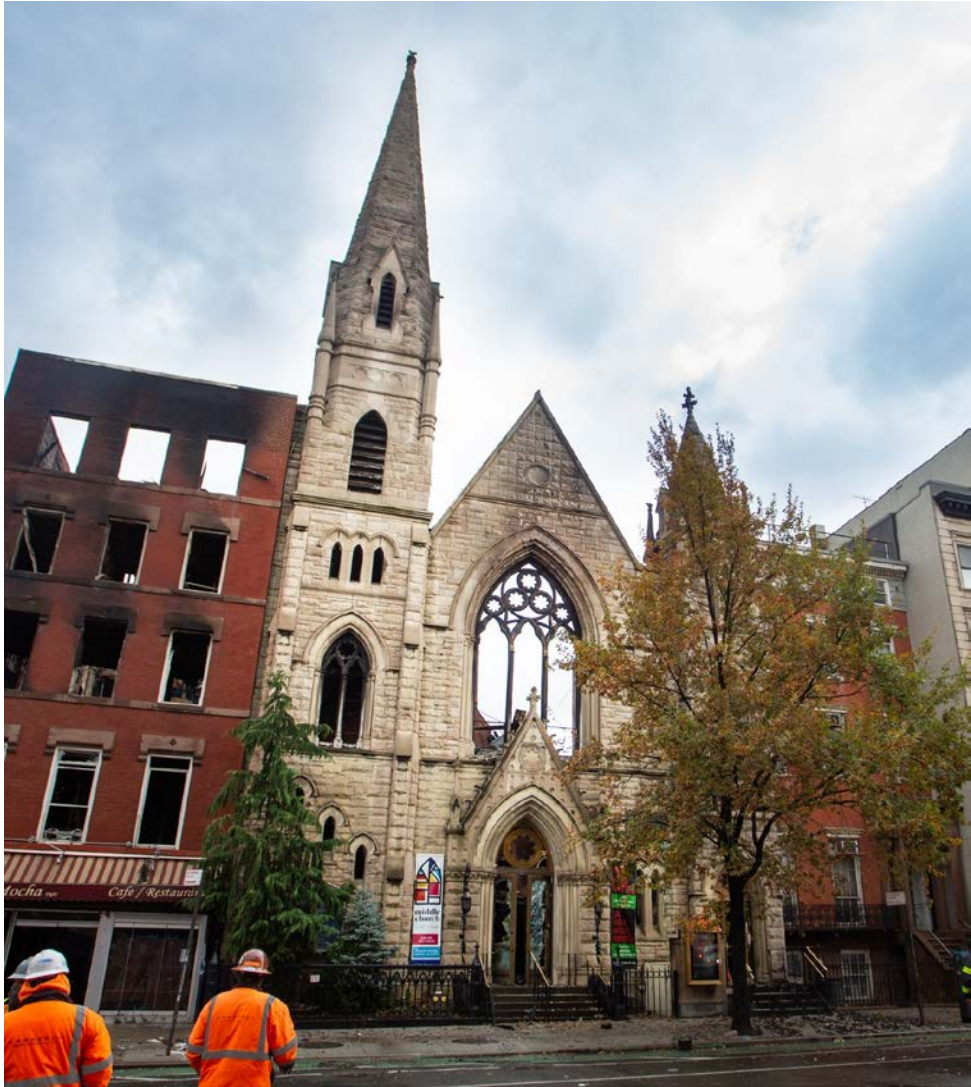
2<sup>ND</sup> Ave. FACADE – POST FIRE

INDIANA LIMESTONE FAÇADE – *DAMAGED AND LOCALLY DESTABILIZED*

LIMESTONE BUTTRESSES – *CRACKS FORMED*

LIMESTONE FINIALS – *DAMAGED AND DESTROYED*

STAINED GLASS WINDOWS (POSSIBLY TIFFANY GLASS) – *DESTROYED*

WOOD AND BRONZE TRACERY – *DAMAGED, AND REMOVED BY ORDER NYC DOB*

GABLED CENTRAL BAY – *DAMAGED AND LOCALLY DESTABILIZED*

NORTHERN TOWER AND SPIRE – *MASONRY DAMAGED, LIMESTONE FRACTURED AND LOCALLY DESTABILIZED*

SOUTHERN TOWER AND SPIRE – *MASONRY DAMAGED, LIMESTONE FRACTURED AND LOCALLY DESTABILIZED*

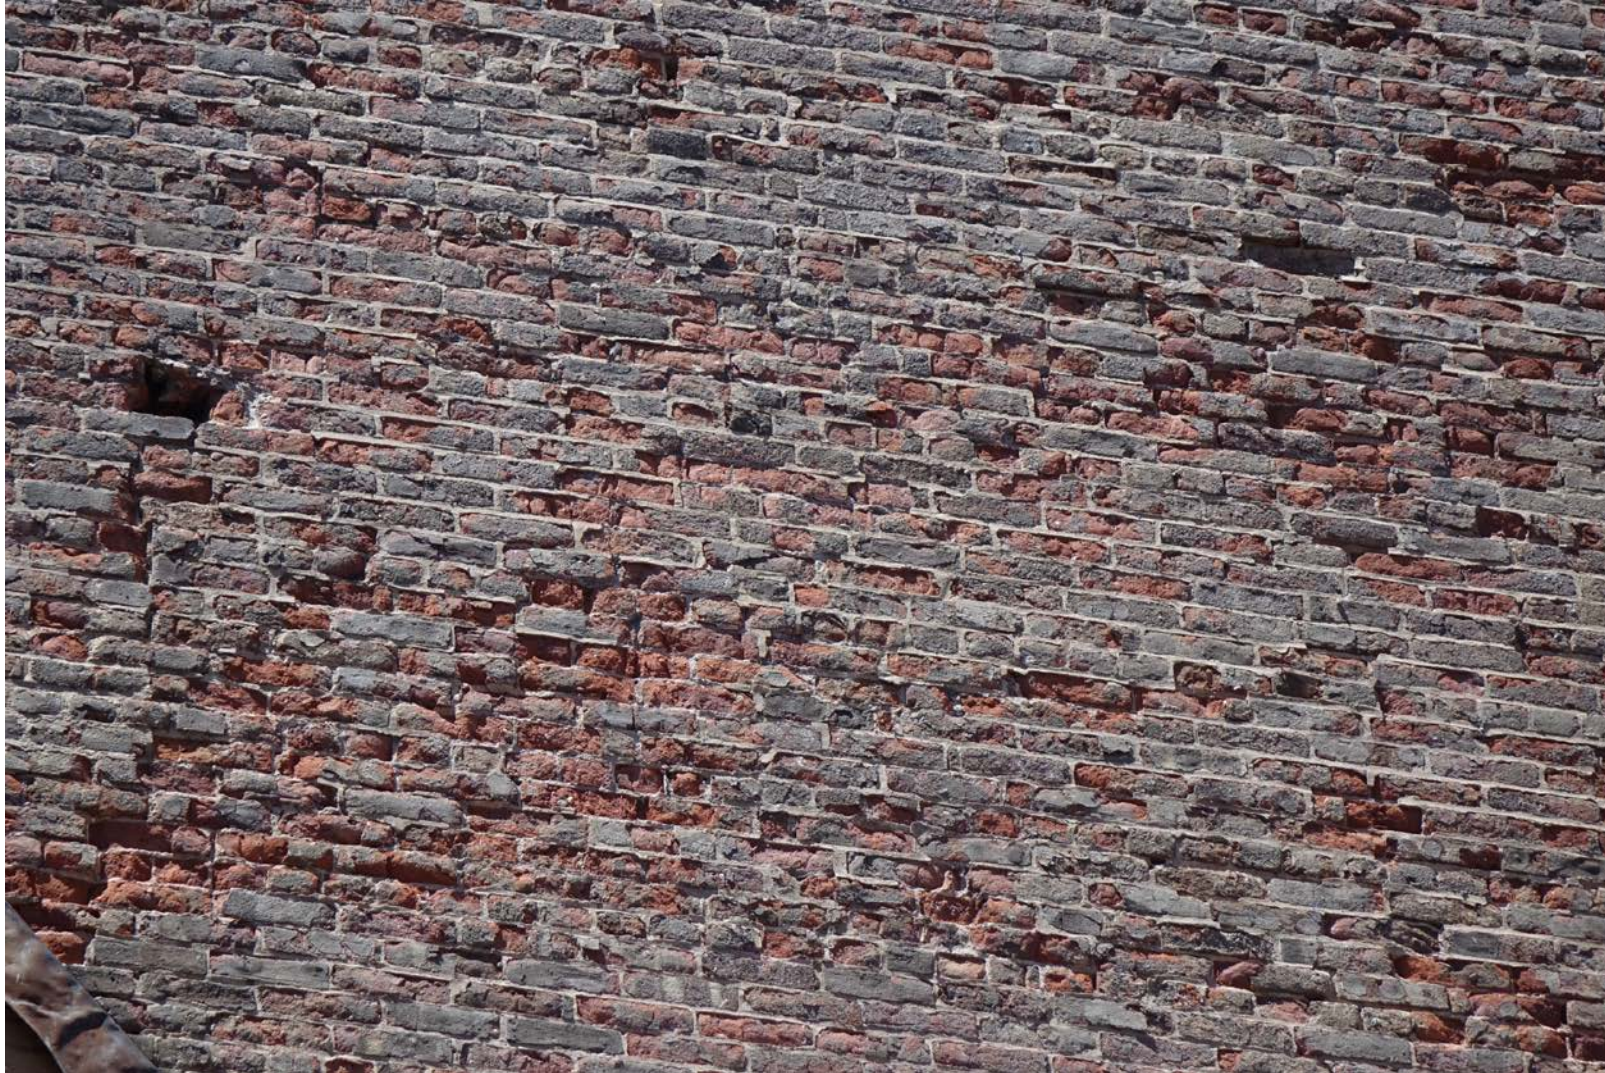
**LOCALIZED DESTABILIZATION**

SPALLING BRICK DUE TO  
THERMAL SHOCK

MISSING MORTAR

MISSING BRICKS

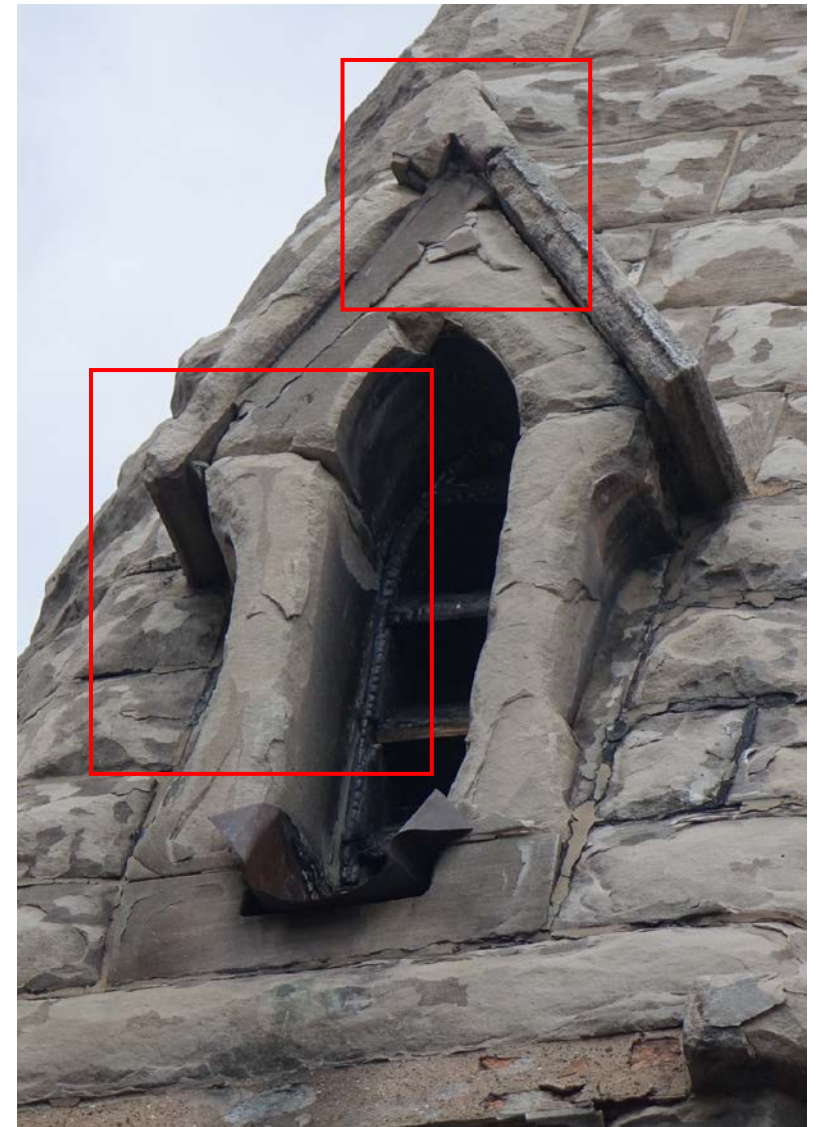
SOUTH SPIRE POST-FIRE

**LOCALIZED DESTABILIZATION**

LIMESTONE SPALLING FROM THERMAL SHOCK

LIMESTONE FRACTURED

LIMESTONE LOOSE

FINIALS DAMAGED

LIMESTONE HELD IN PLACE BY GRAVITY AND/OR FRICTION

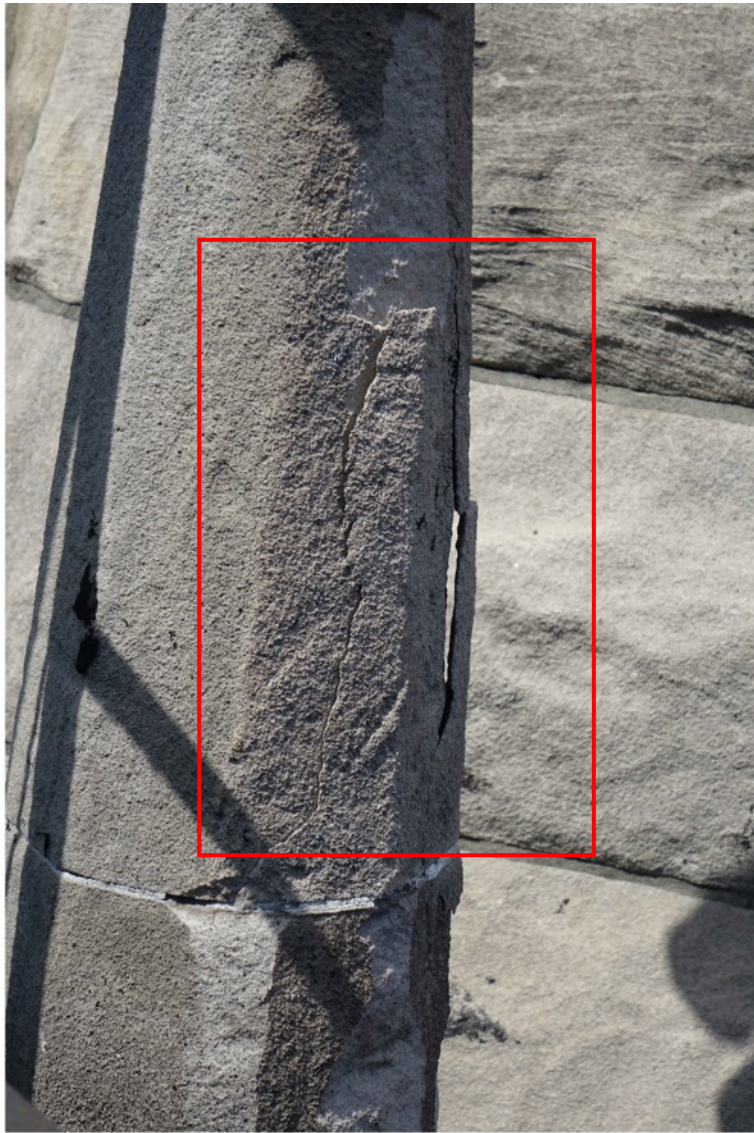
SOUTH SPIRE

**LOCALIZED DESTABILIZATION**

LIMESTONE SPALLING FROM  
THERMAL SHOCK

LIMESTONE FRACTURED

LIMESTONE LOOSE

FINIALS DAMAGED

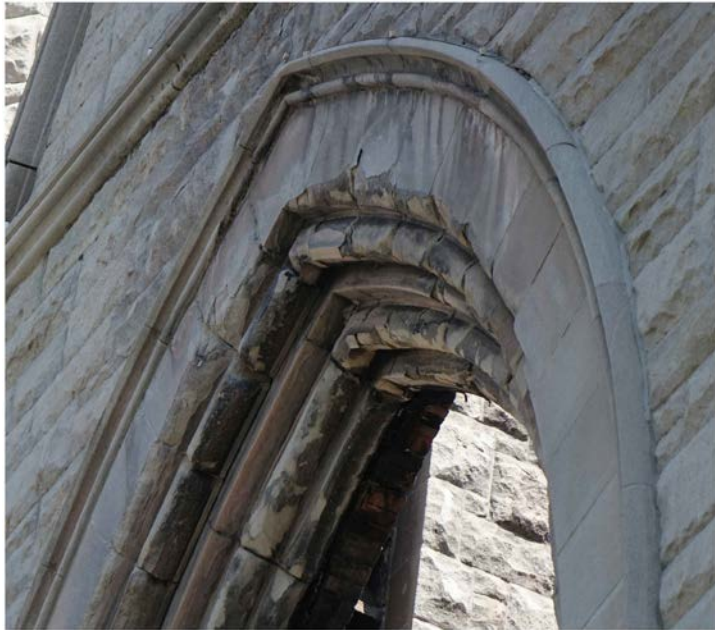
**LOCALIZED DESTABILIZATION**

DIMENSIONAL STONE  
FRACTURED

MORTAR MISSING

MASONRY DAMAGED BY  
THERMAL SHOCK

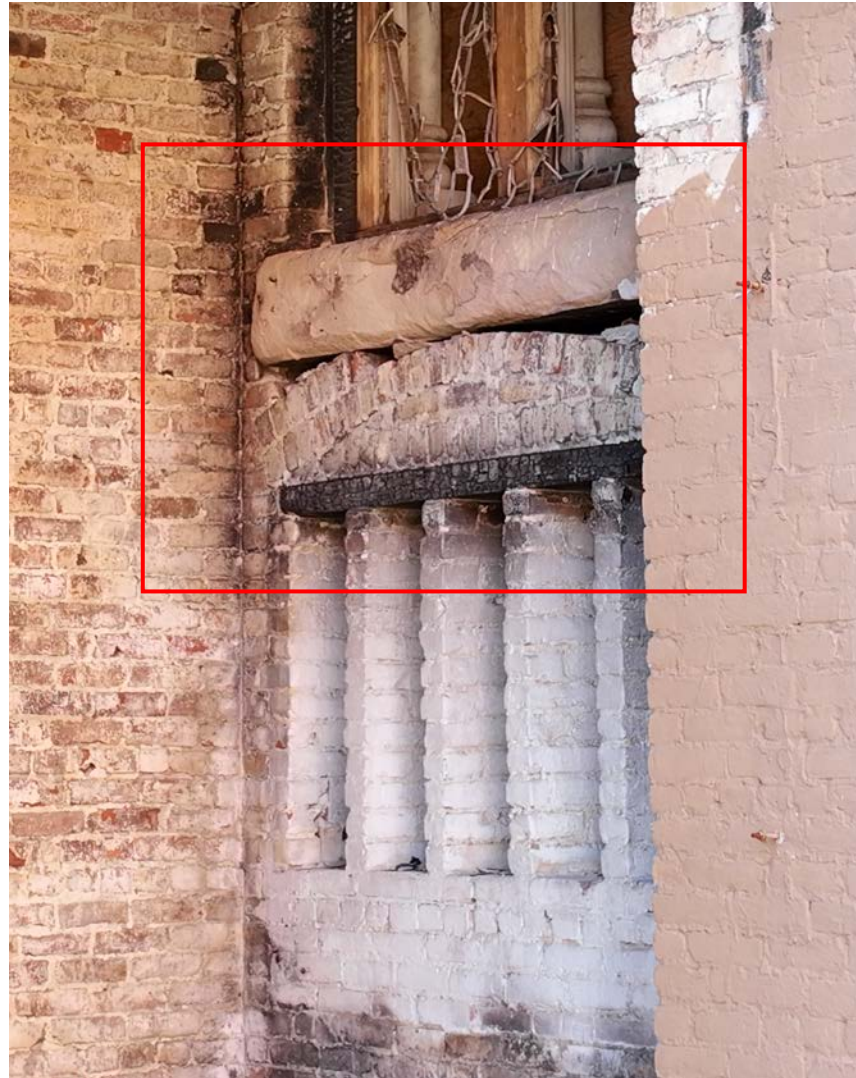
**LOCALIZED DESTABILIZATION**

SPALLING LIMESTONE DUE TO  
THERMAL SHOCK

MISSING MASONRY

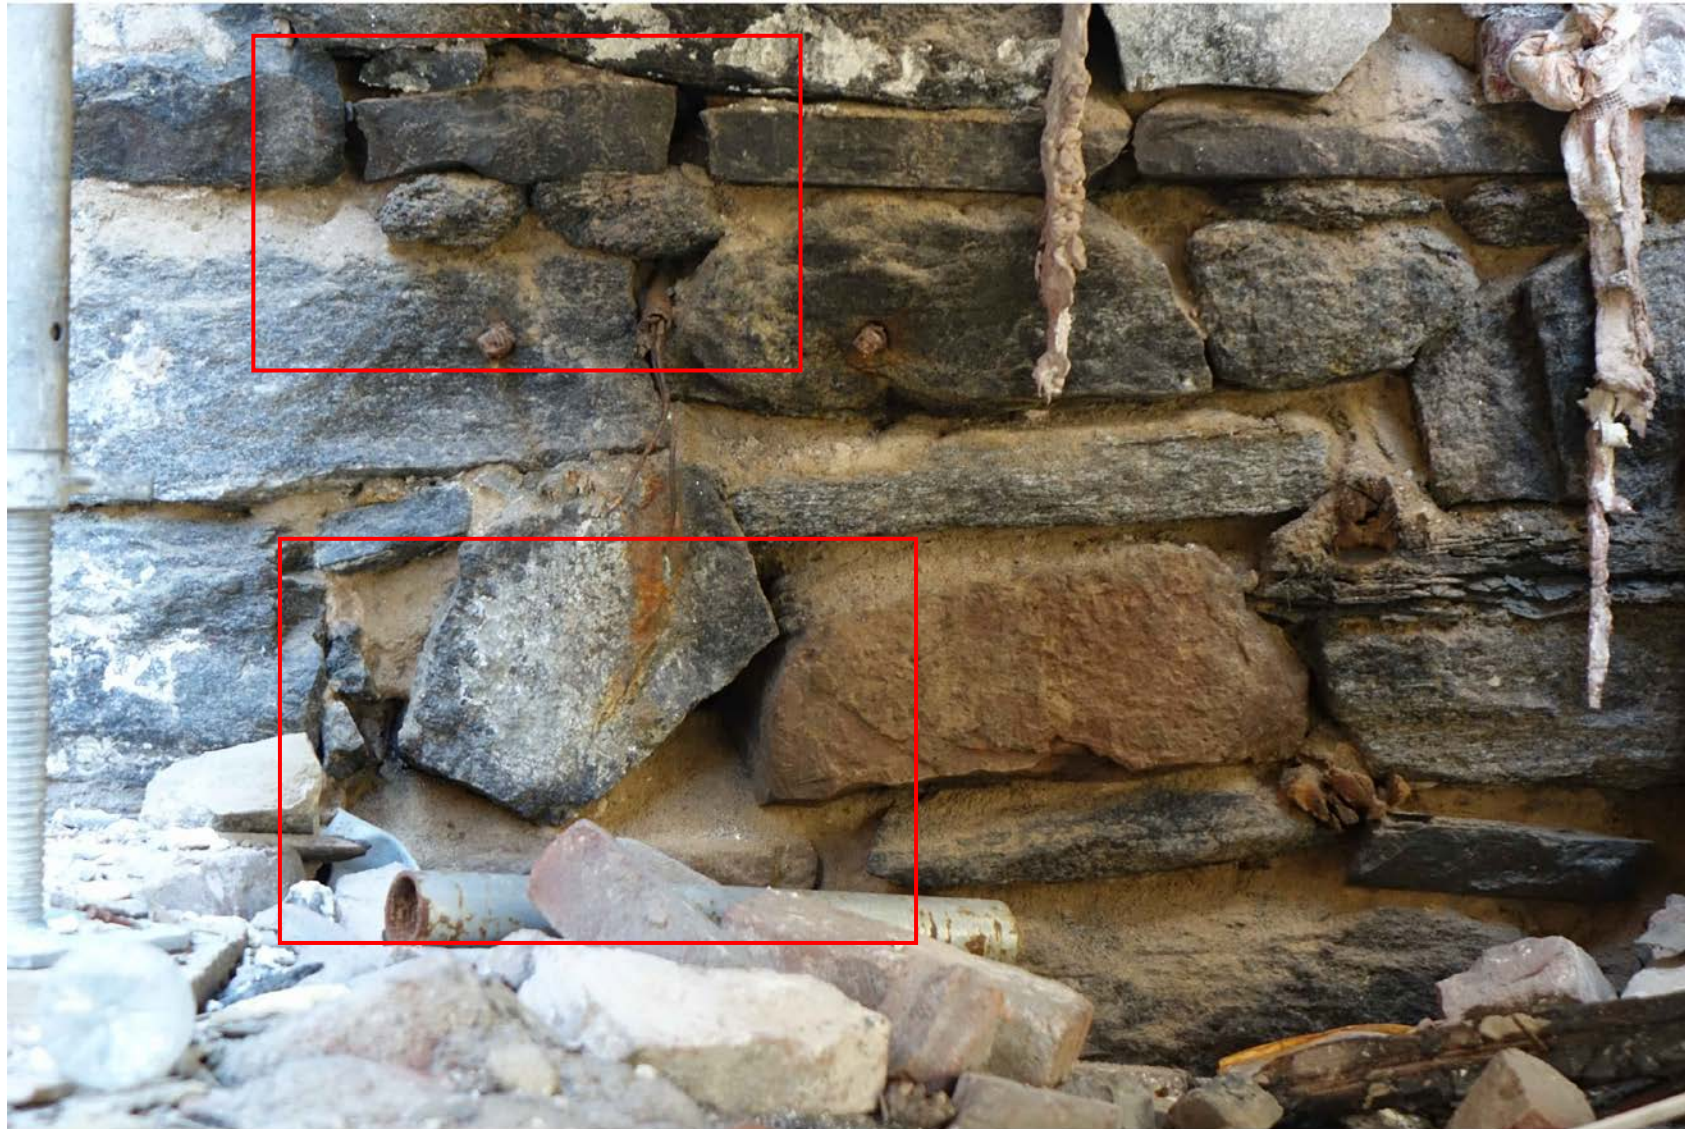
1. FOUNDATION WALL - 2<sup>nd</sup> Ave. FACADE

**LOCALIZED DESTABILIZATION**

RUBBLE STONE

DETERIORATING MORTAR

MISSING MORTAR

POROUS, HISTORY OF WATER LEAKS

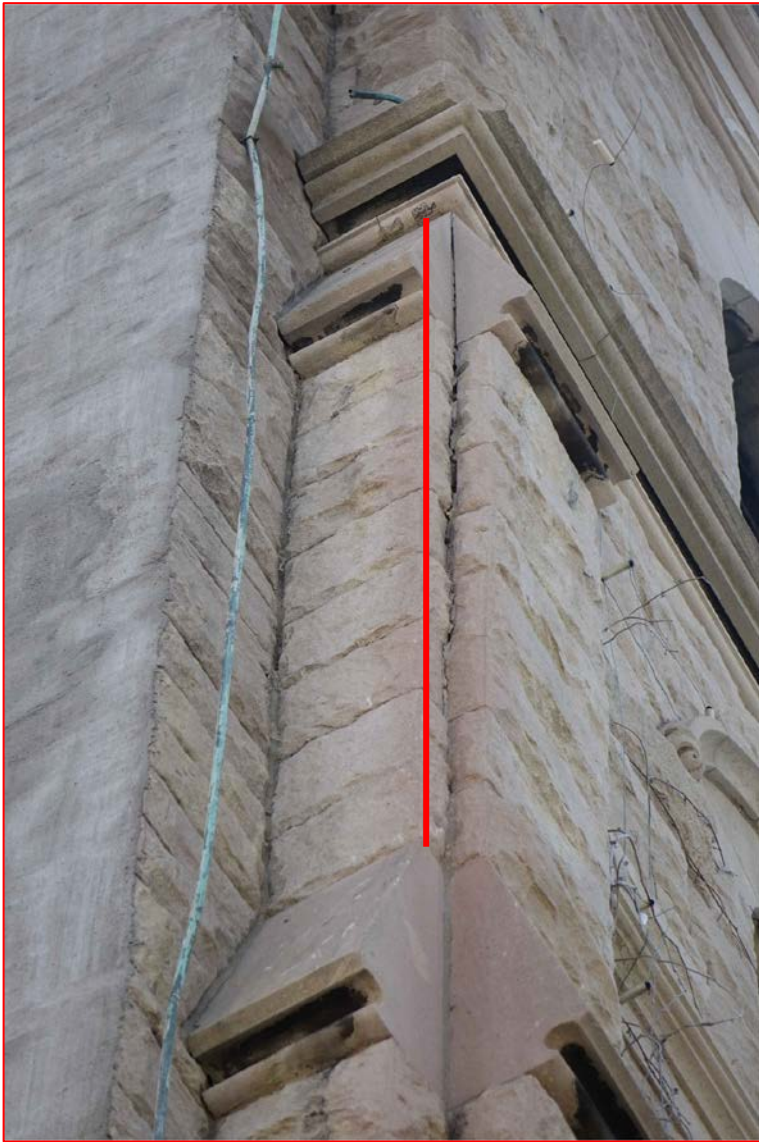
7. NORTH TOWER – EXTENT OF LIMESTONE CRACK

**LOCALIZED DESTABILIZATION**

LIMESTONE SEPARATING AT BUTRESS

WATER INFILTRATION AND FREEZE THAW LIKELYHOOD
