Preservation Department – Item 2, LPC-23-02975

**112 2nd Avenue – East Village/Lower East Side Historic District
Borough of Manhattan**

SUPPLEMENTAL PRESENTATION IN SUPPORT OF MCC APPLICATION

MIDDLE COLLEGIATE CHURCH

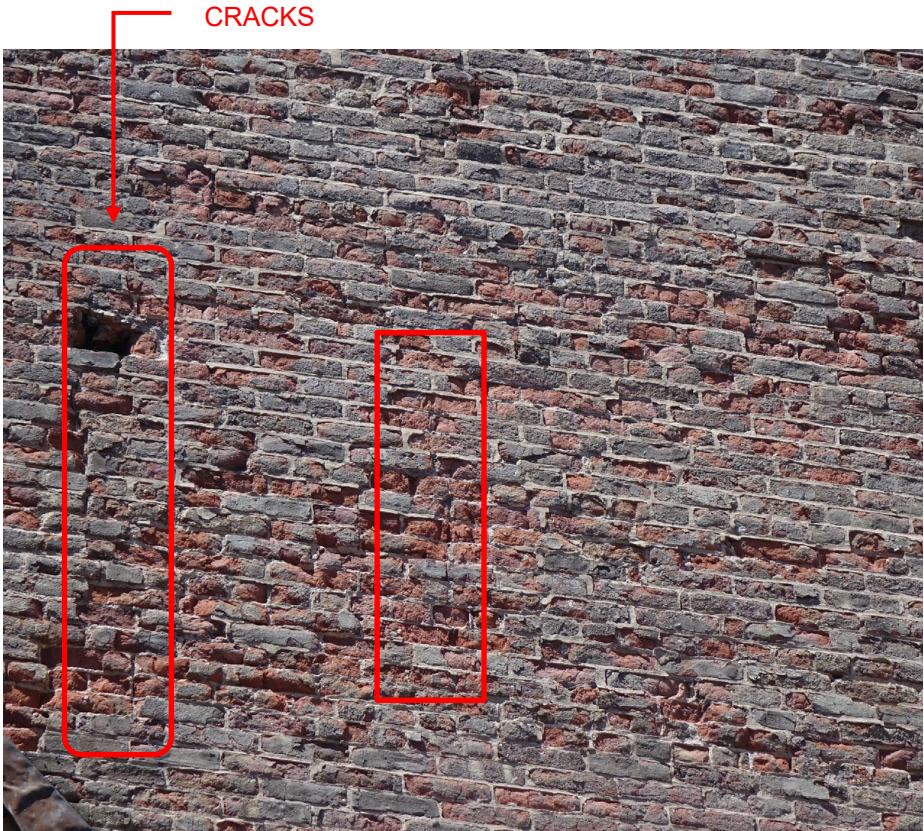
REPRESENTATIVE IMAGE OF DETERIORATED MASONRY

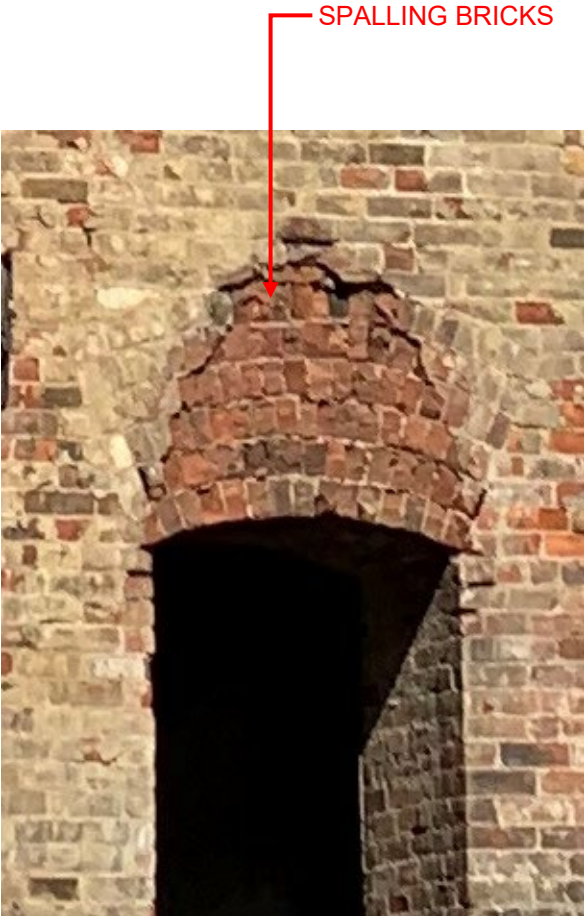
NORTH TOWER

DETERIORATED MASONRY

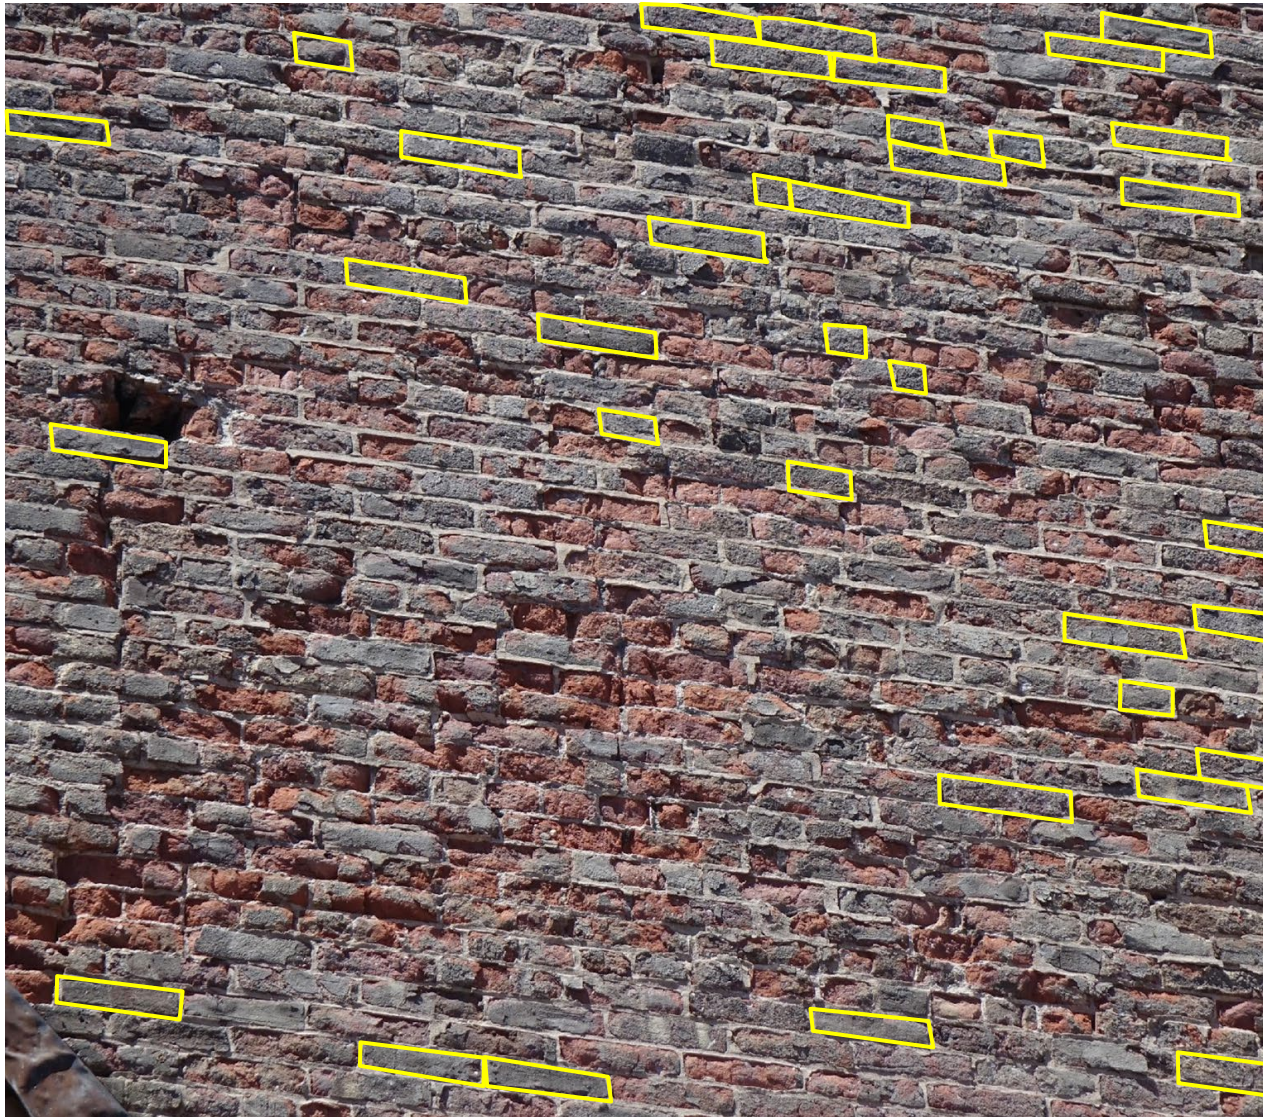
NORTH TOWER MASONRY – POST FIRE CONDITION - ENLARGED

35 BRICKS WITHOUT VISIBLE SURFACE DAMAGE
-

386 DAMAGED BRICKS
- 88% DAMAGED BRICKS

IMAGE IS APPROXIMATELY 15% OF TOWER FACE

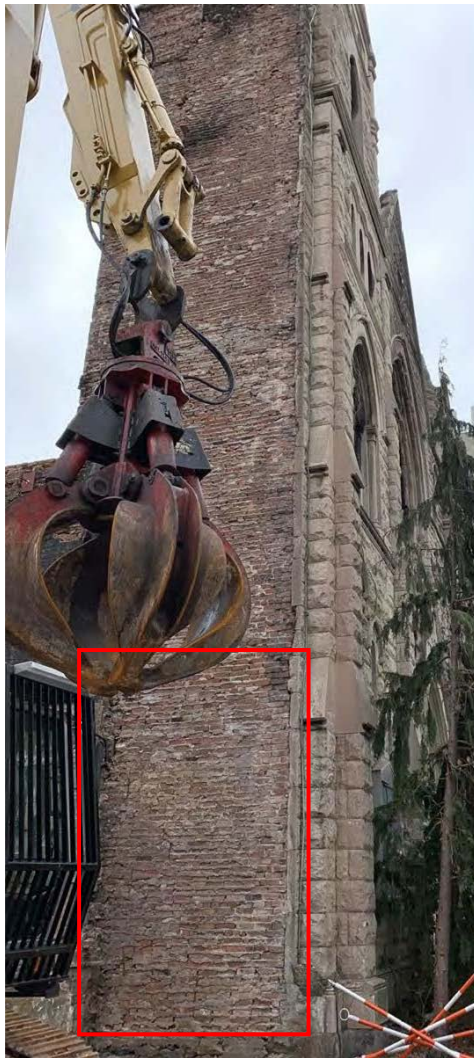
NORTH TOWER – NORTH WALL

CRACKS

There is a visible masonry crack at the steel transfer beam on the south tower. There are cracks in the east face of the north tower. There are cracks in the masonry on the north face of the north tower. See supplemental slides R-3, 5, 7 and 9.

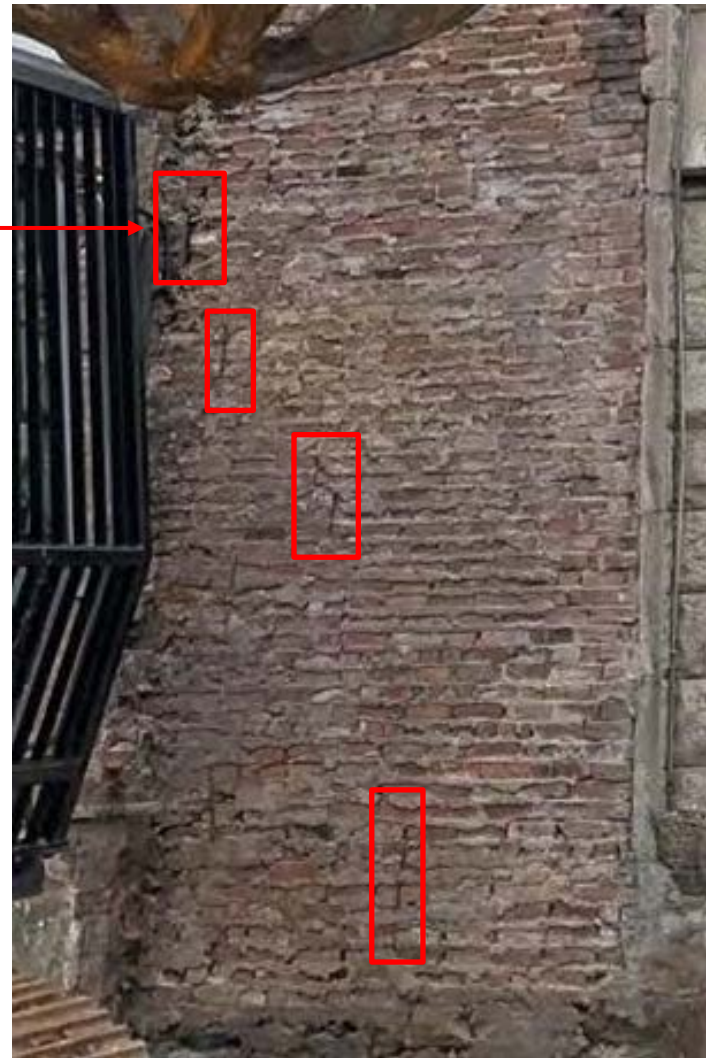
VISIBLE MASONRY CRACKS

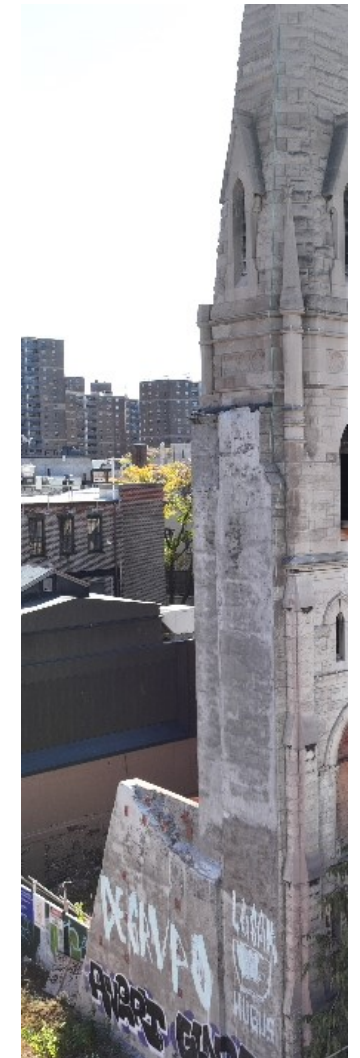
NORTH TOWER – WITH PARGE

NORTH TOWER MASONRY – CURRENTLY COVERED BY CEMENT PARGE

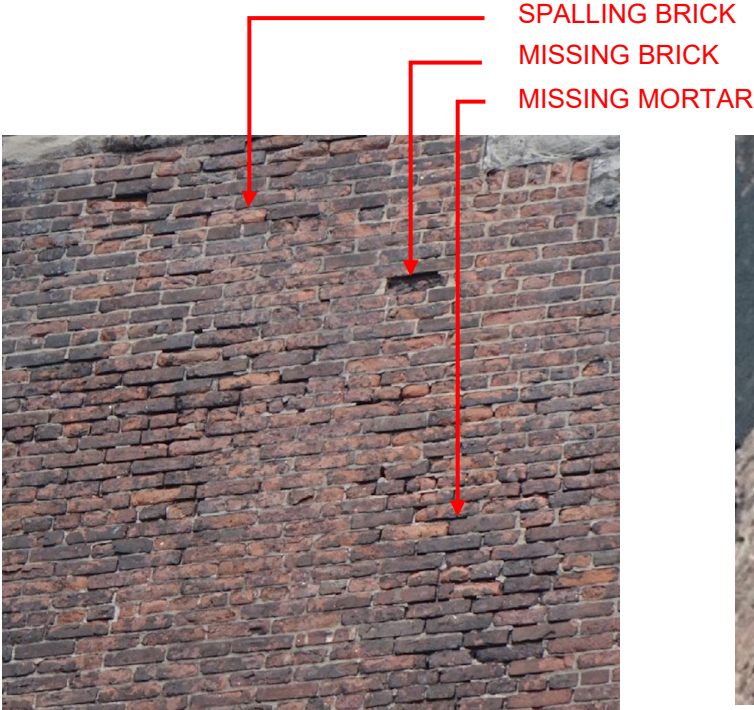
REPRESENTATIVE IMAGE OF DETERIORATED MASONRY
SOUTH TOWER

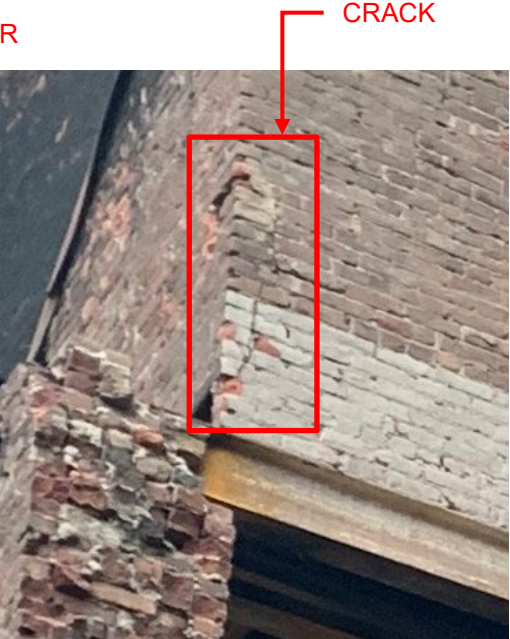
CRACK AT STEEL TRANSFER

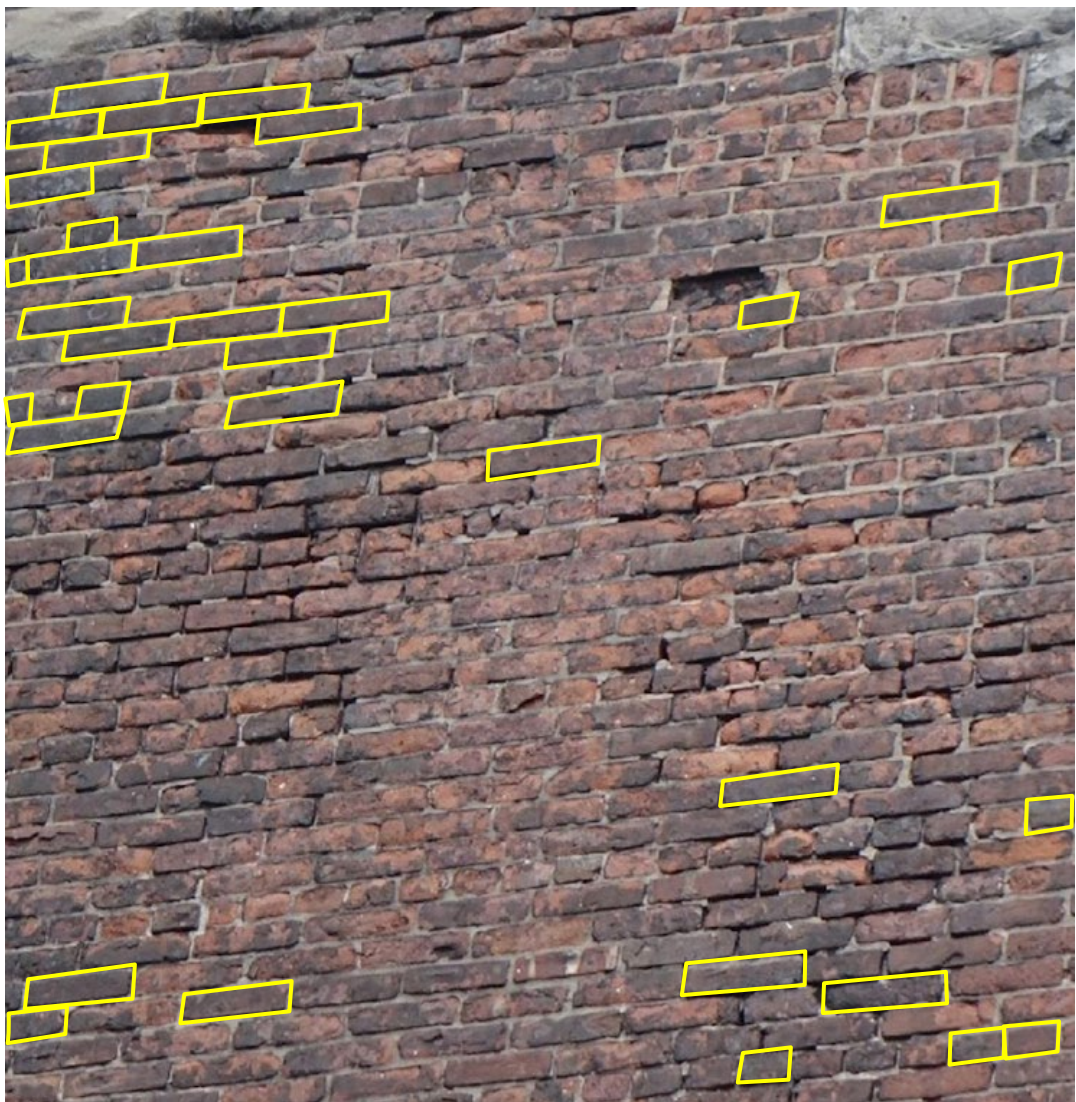
SOUTH TOWER MASONRY – POST FIRE CONDITION - ENLARGED

35 BRICKS WITHOUT VISIBLE SURFACE DAMAGE

322 DAMAGED BRICKS

90% DAMAGED BRICKS

IMAGE IS APPROXIMATELY 25% OF TOWER FACE

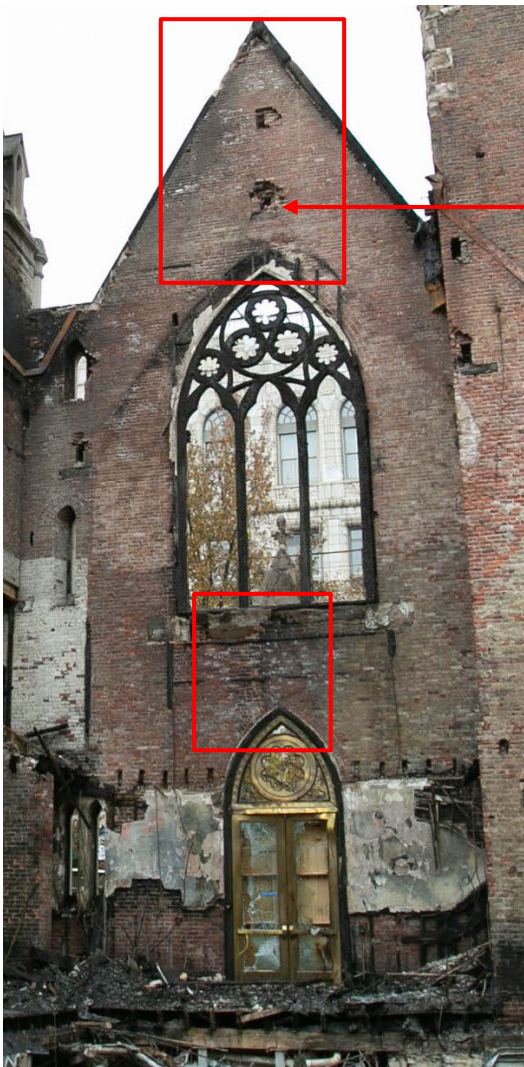
GABLE – BACK OF FACADE

TRUSS BEARING

DAMAGED COPING

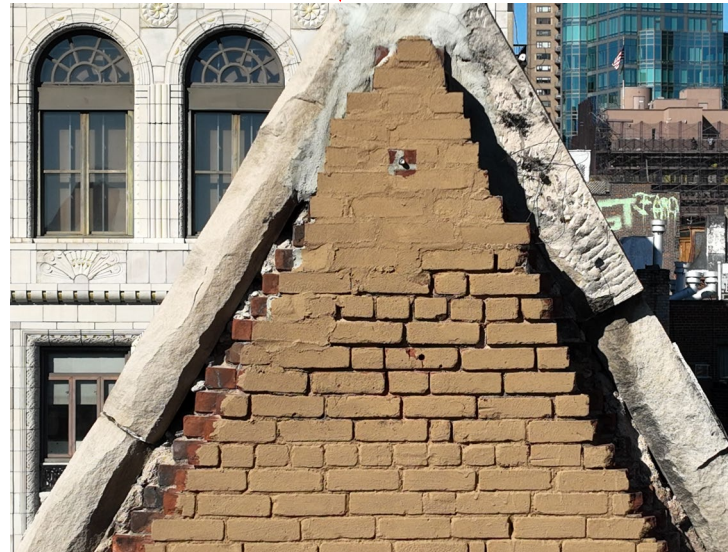
GABLE COPING DAMAGED STONE

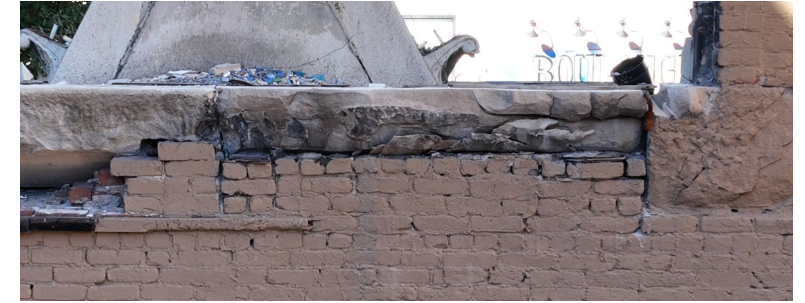
GABLE SILL FRACTURED STONE

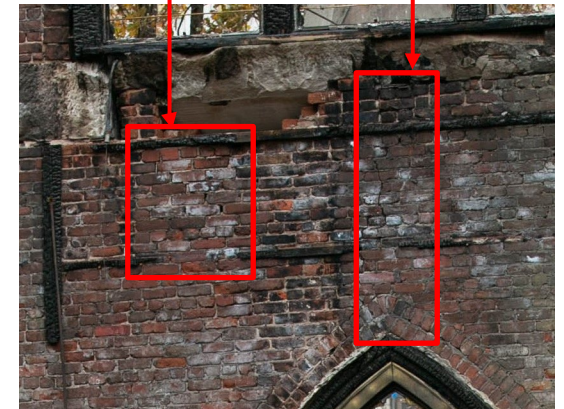
CRACKS

GABLE MASONRY CRACKS

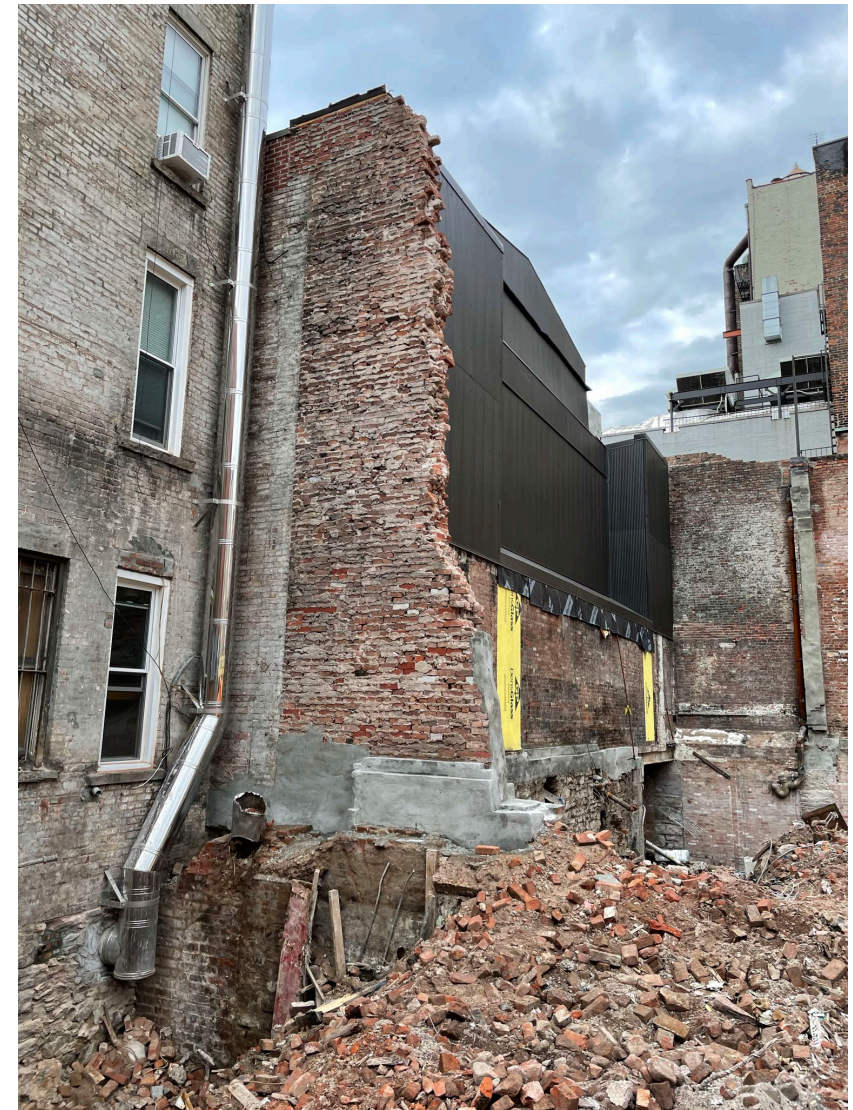
EAST WALL REMOVED PER DOB ORDER

This is factually incorrect. The east/rear wall did not remain after the fire. The wall was extensively damaged and was ordered demolished by DOB. What is visible today was installed after the fire. See, supplemental slide R-10.

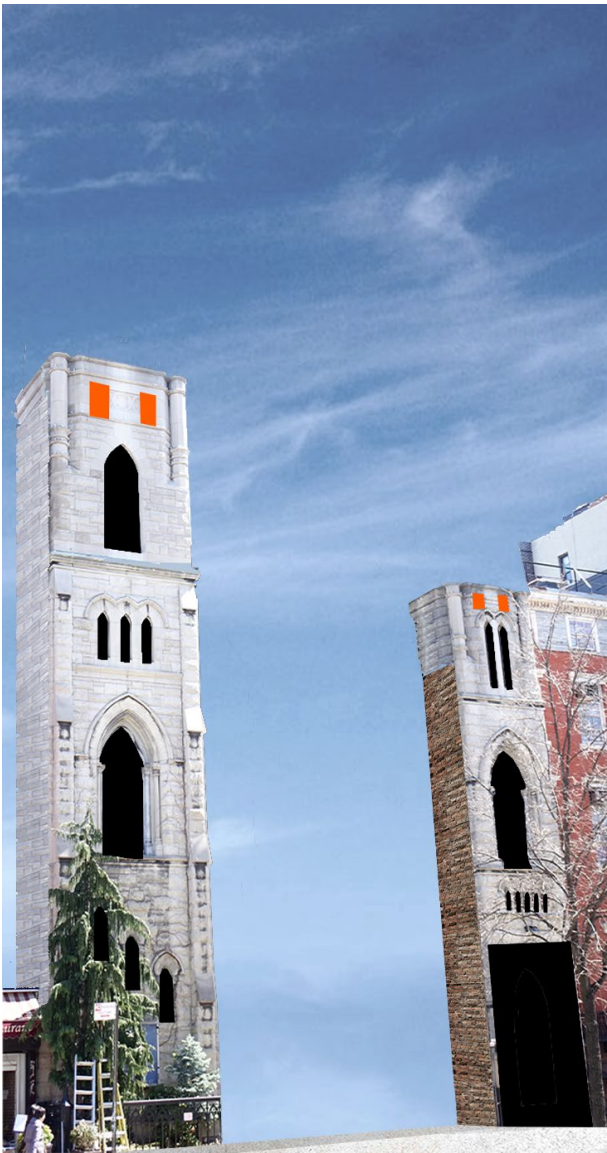
FRONT - 65% ORIGINAL MATERIAL LOST

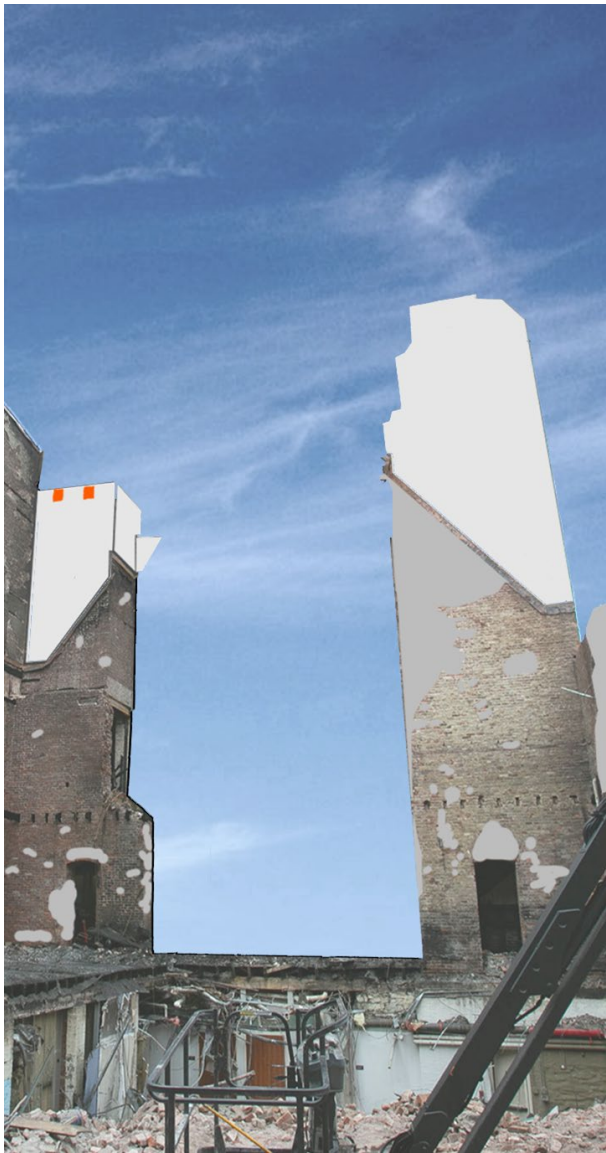
BACK - 60% ORIGINAL MATERIAL LOST

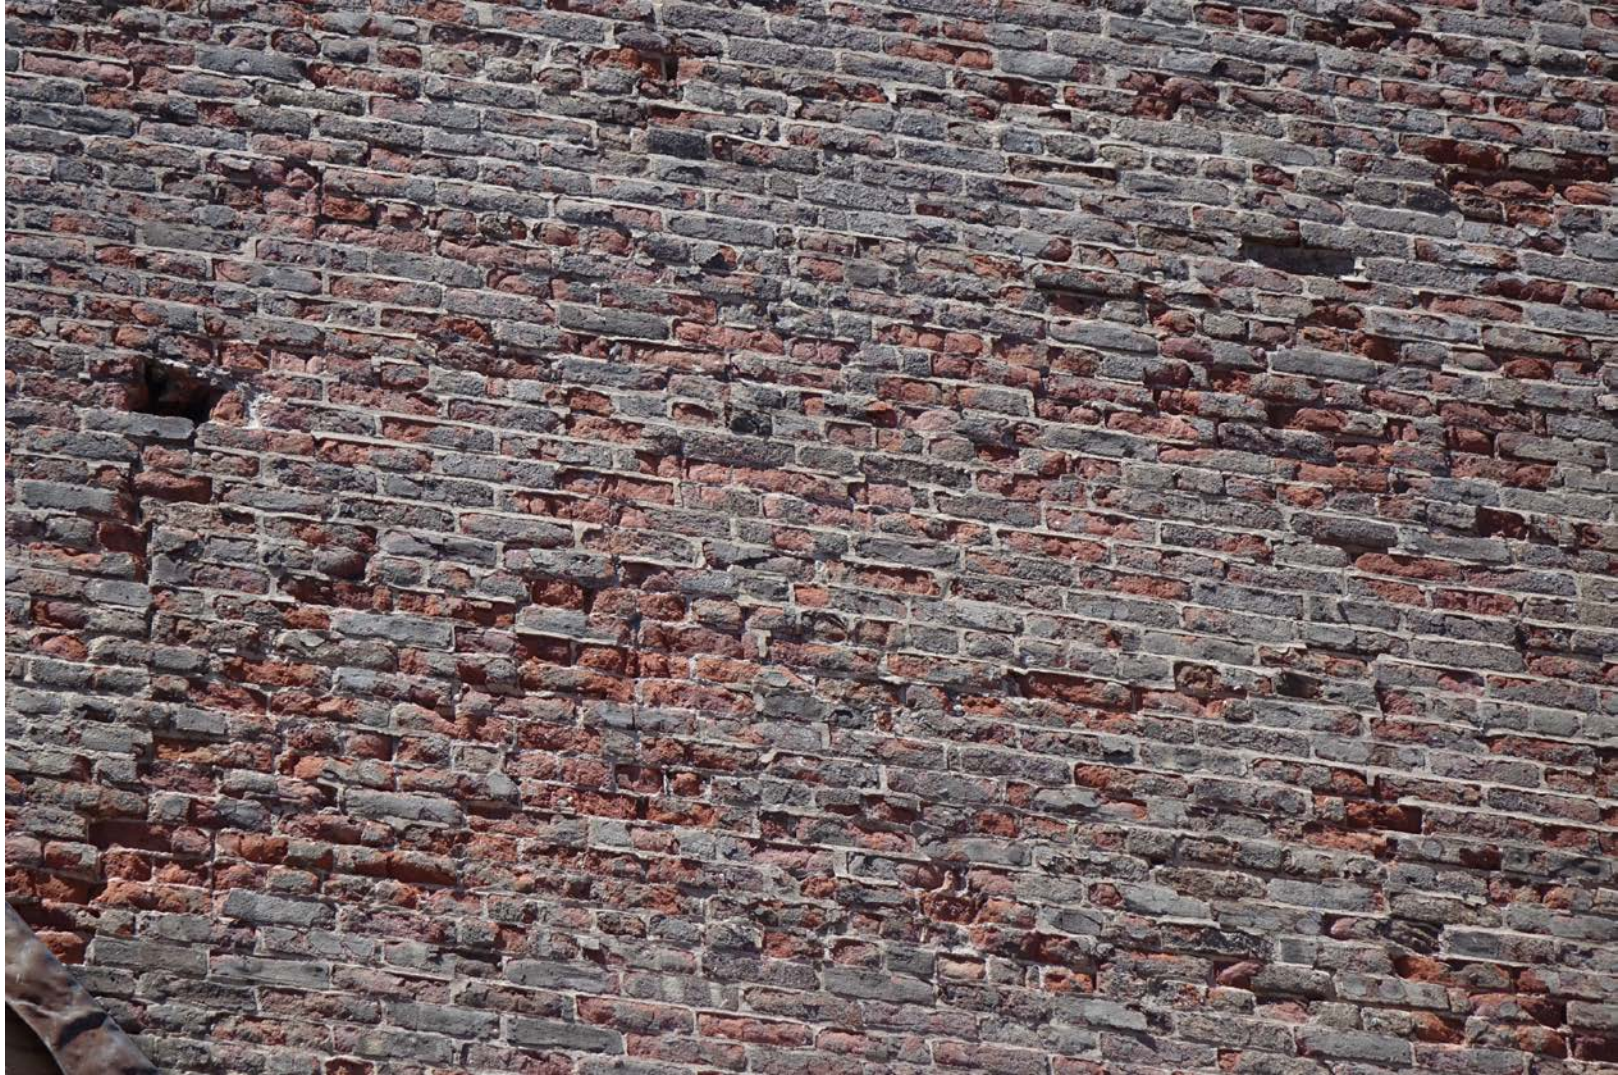
VIEW OF TYPICAL MASONRY

LOCALIZED DESTABILIZATION

SPALLING BRICK DUE TO
THERMAL SHOCK

MISSING MORTAR

MISSING BRICKS

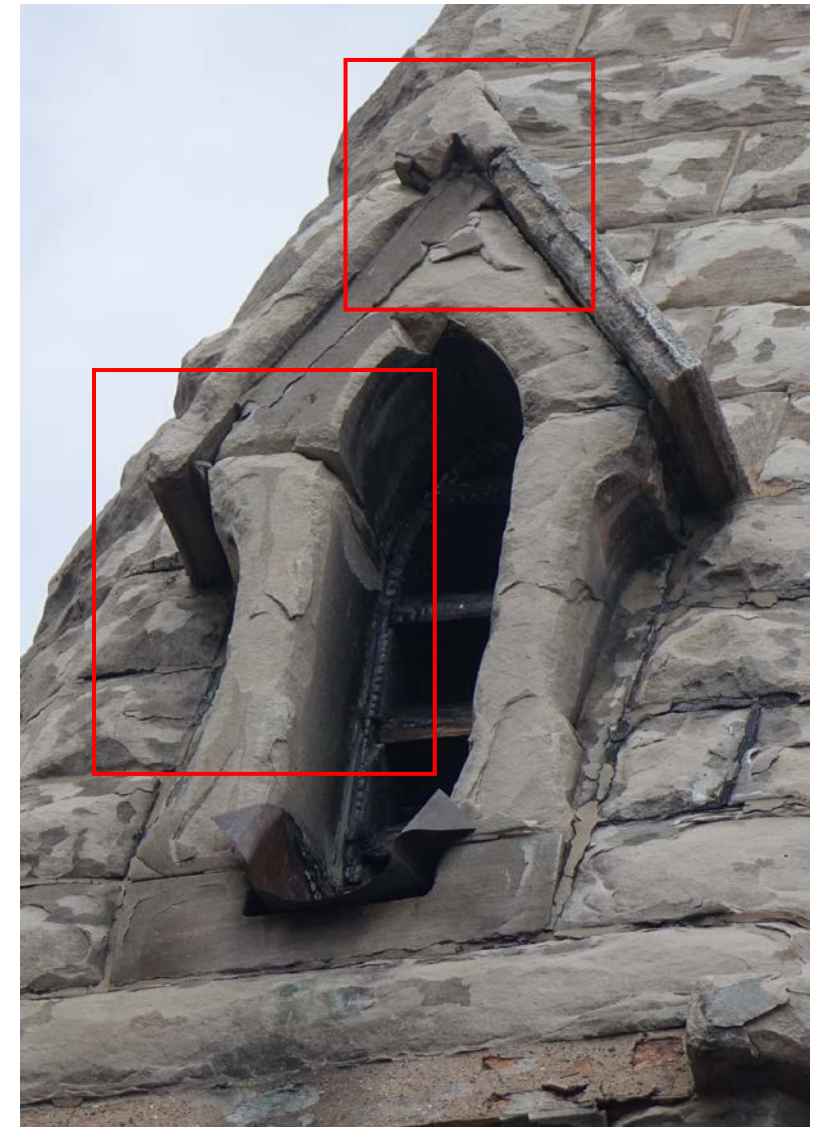
SOUTH SPIRE POST-FIRE

LOCALIZED DESTABILIZATION

LIMESTONE SPALLING FROM
THERMAL SHOCK

LIMESTONE FRACTURED

LIMESTONE LOOSE

FINIALS DAMAGED

LIMESTONE HELD IN PLACE BY
GRAVITY AND/OR FRICTION

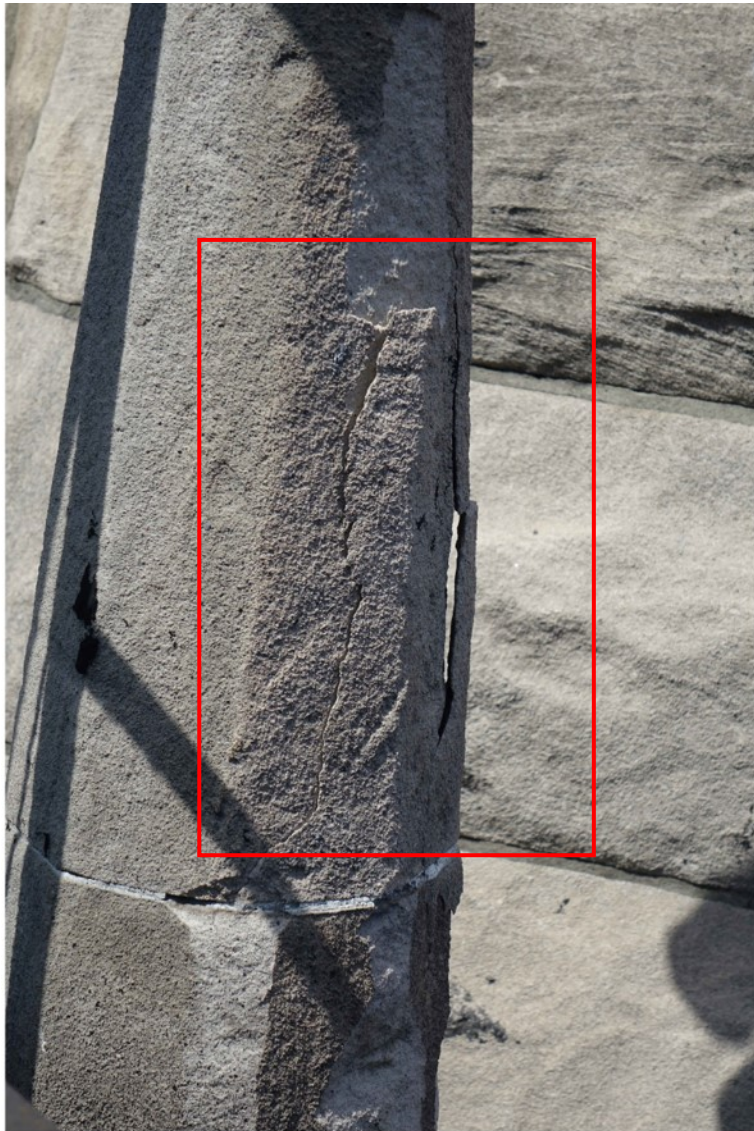
SOUTH SPIRE

LOCALIZED DESTABILIZATION

LIMESTONE SPALLING FROM
THERMAL SHOCK

LIMESTONE FRACTURED

LIMESTONE LOOSE

FINIALS DAMAGED

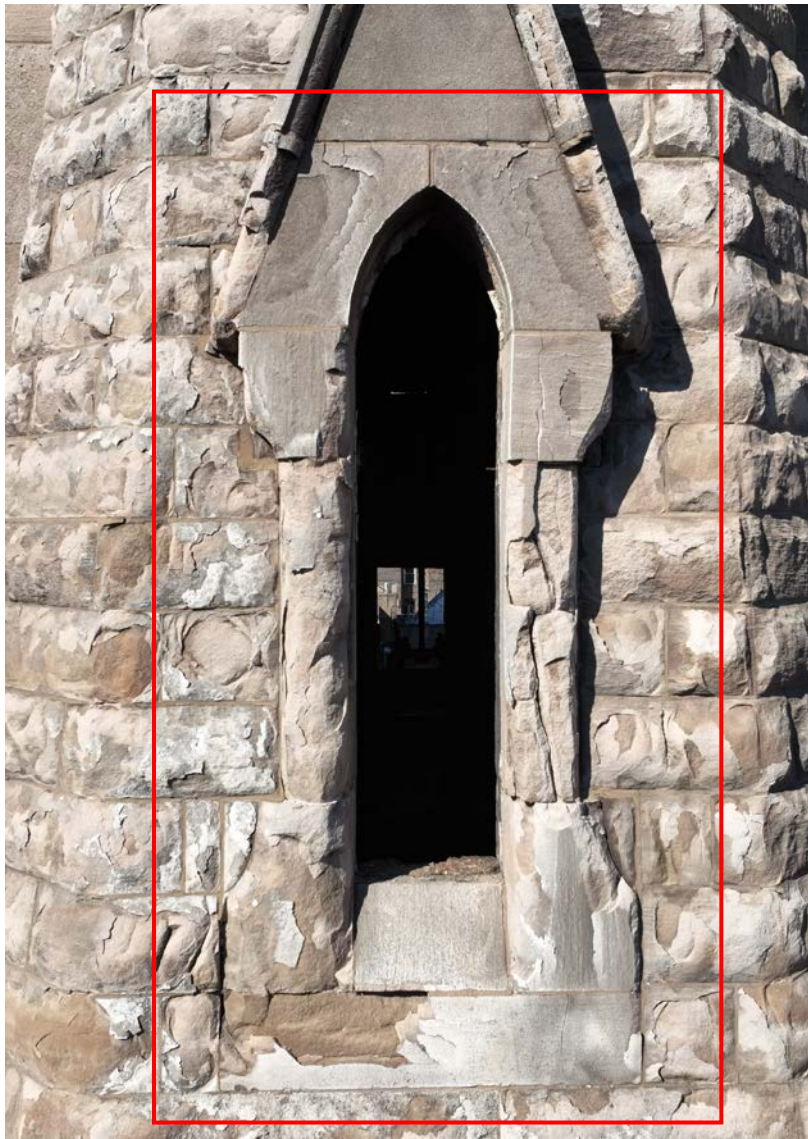
NORTH TOWER WINDOW

LOCALIZED DESTABILIZATION

LIMESTONE SPALLING FROM
THERMAL SHOCK

LIMESTONE FRACTURED

LIMESTONE LOOSE

FINIALS DESTROYED

LIMESTONE HELD IN PLACE BY
GRAVITY AND/OR FRICTION

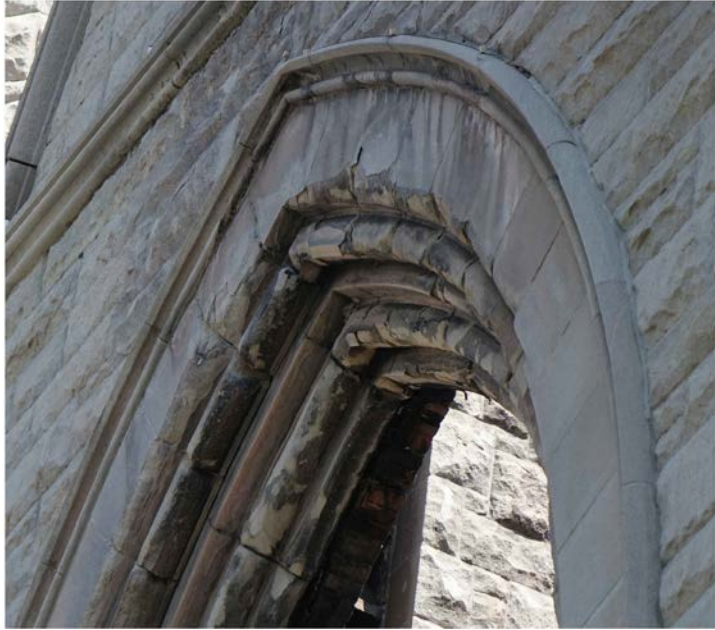
GABLE ARCH

LOCALIZED DESTABILIZATION

DIMENSIONAL STONE
FRACTURED

MORTAR MISSING

MASONRY DAMAGED BY
THERMAL SHOCK

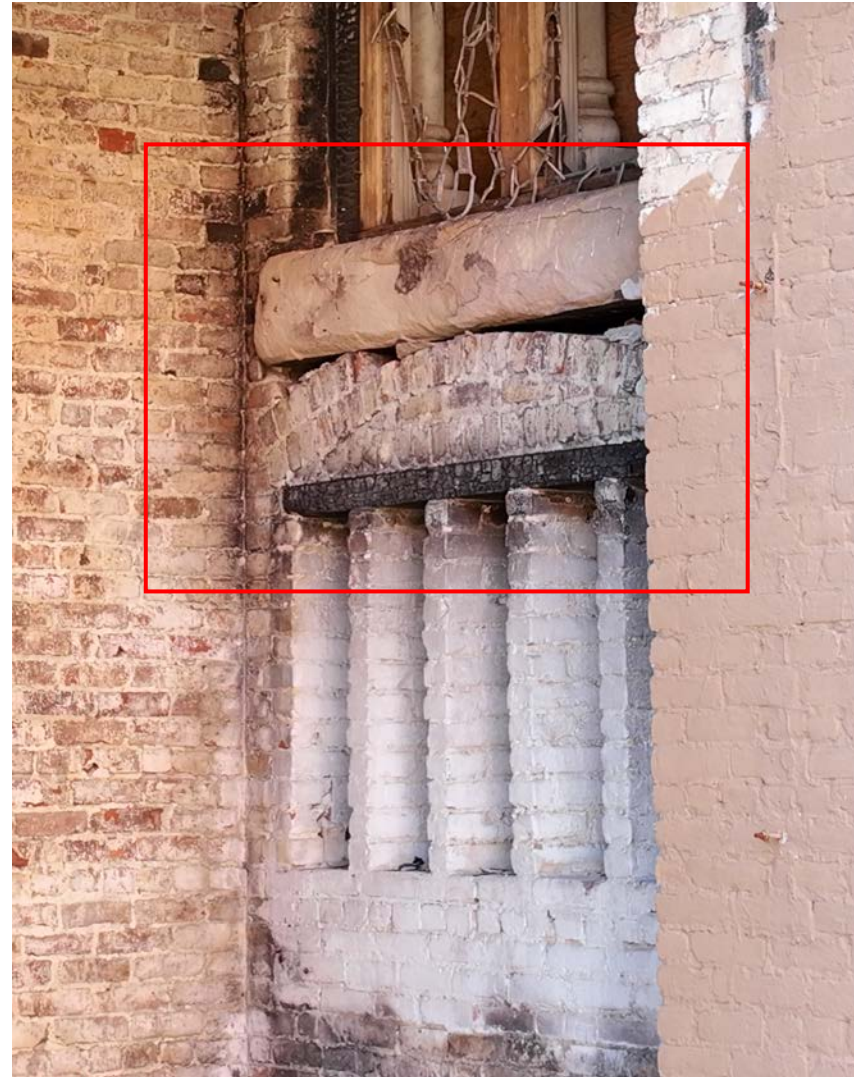
VIEW INSIDE SOUTH TOWER

LOCALIZED DESTABILIZATION

SPALLING LIMESTONE DUE TO
THERMAL SHOCK

MISSING MASONRY

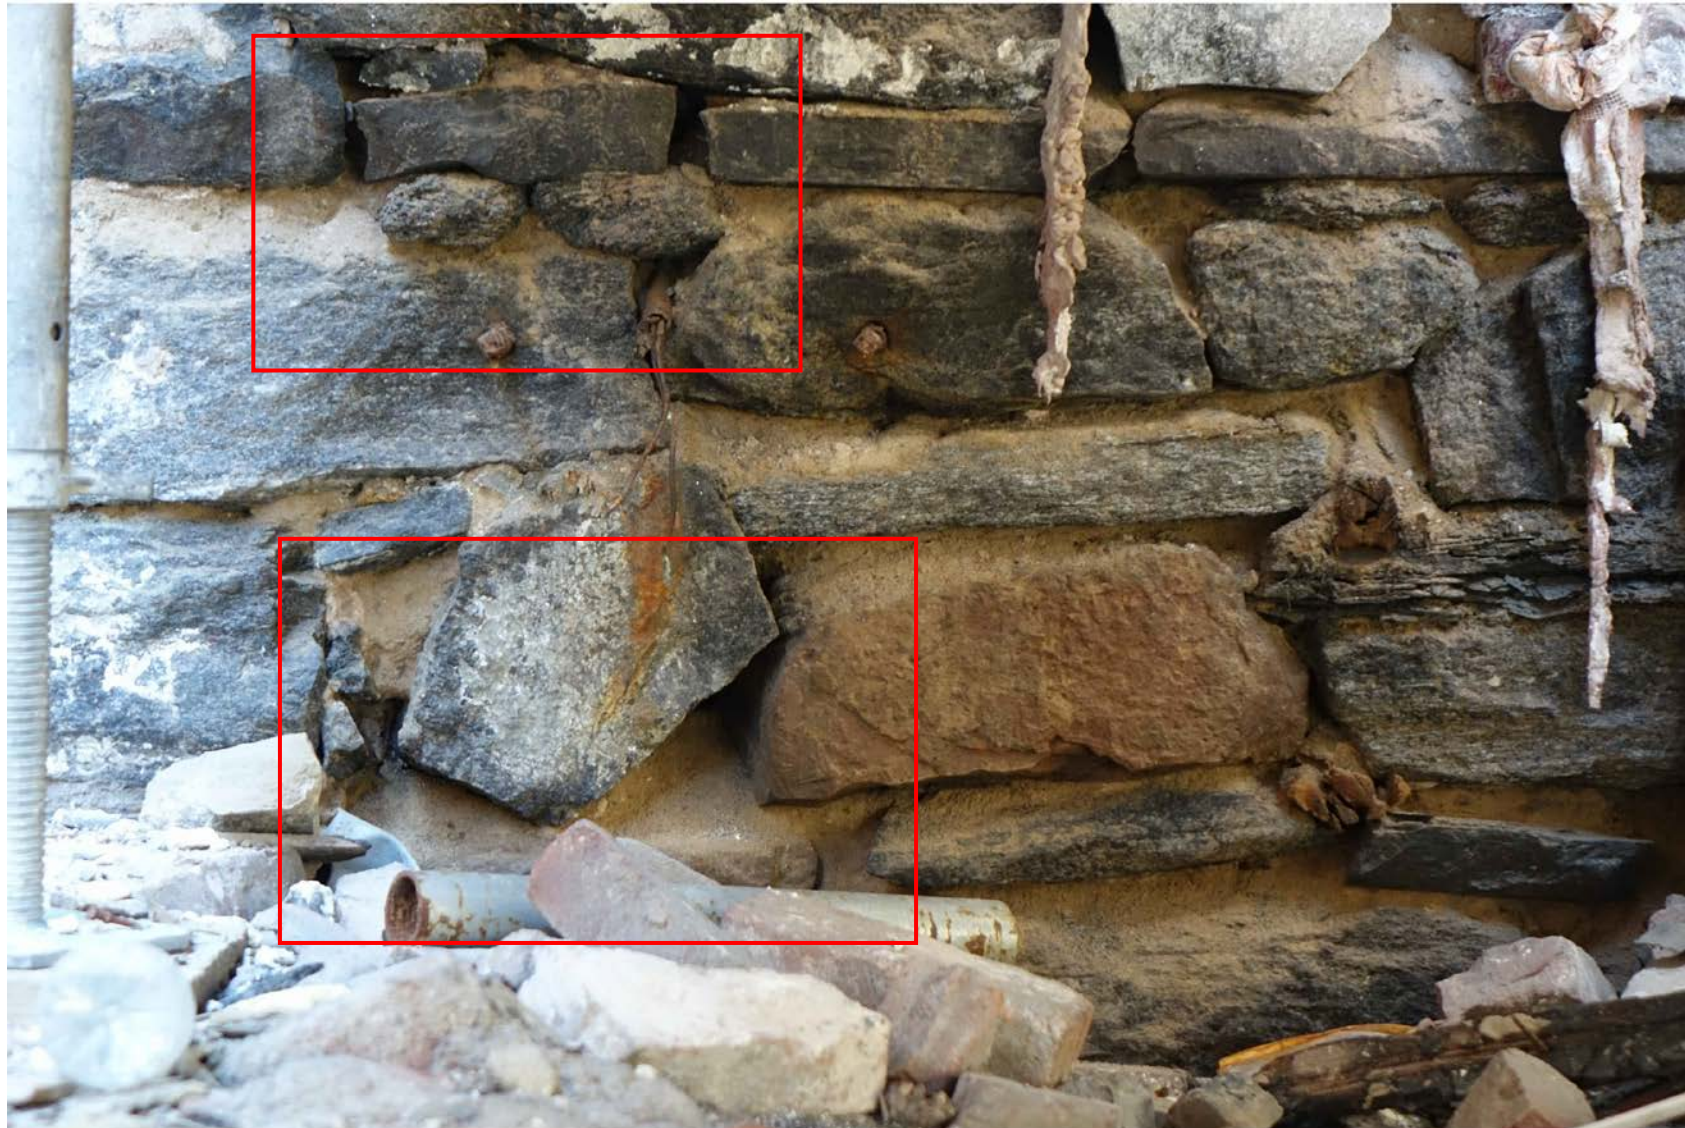
1. FOUNDATION WALL - 2nd Ave. FACADE

LOCALIZED DESTABILIZATION

RUBBLE STONE

DETERIORATING MORTAR

MISSING MORTAR

POROUS, HISTORY OF WATER LEAKS

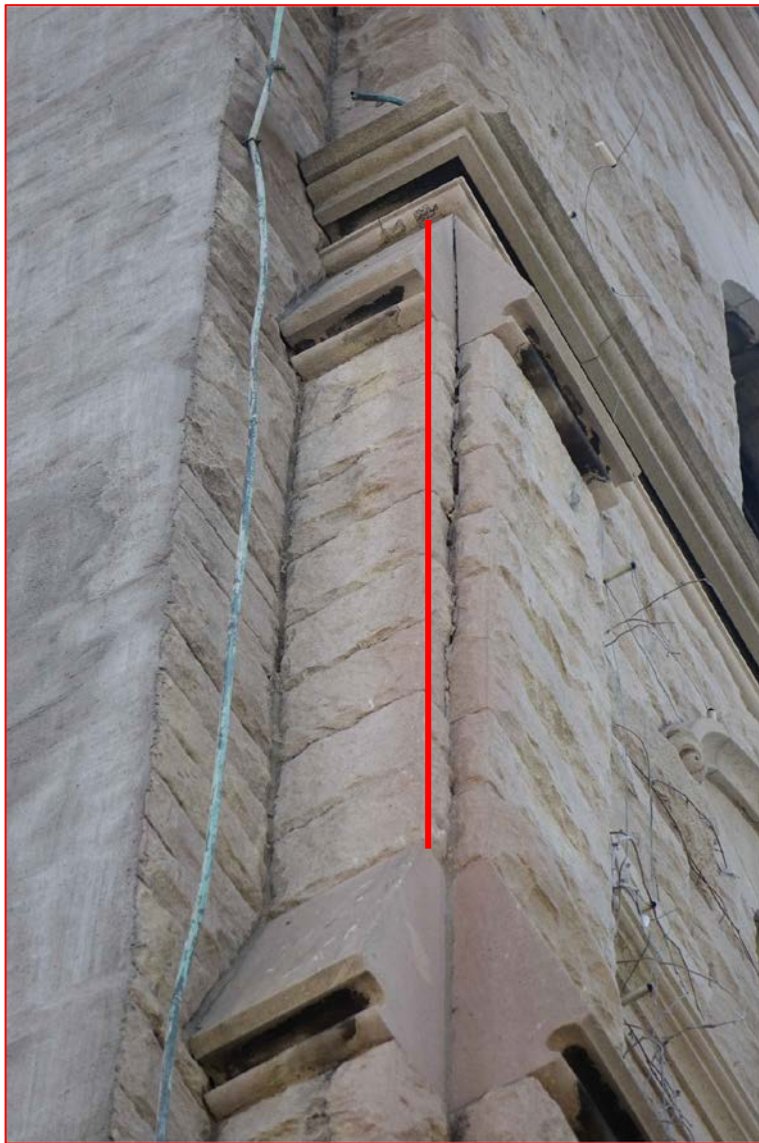
7. NORTH TOWER – EXTENT OF LIMESTONE CRACK

LOCALIZED DESTABILIZATION

LIMESTONE SEPARATING AT BUTRESS

WATER INFILTRATION AND FREEZE THAW LIKELYHOOD

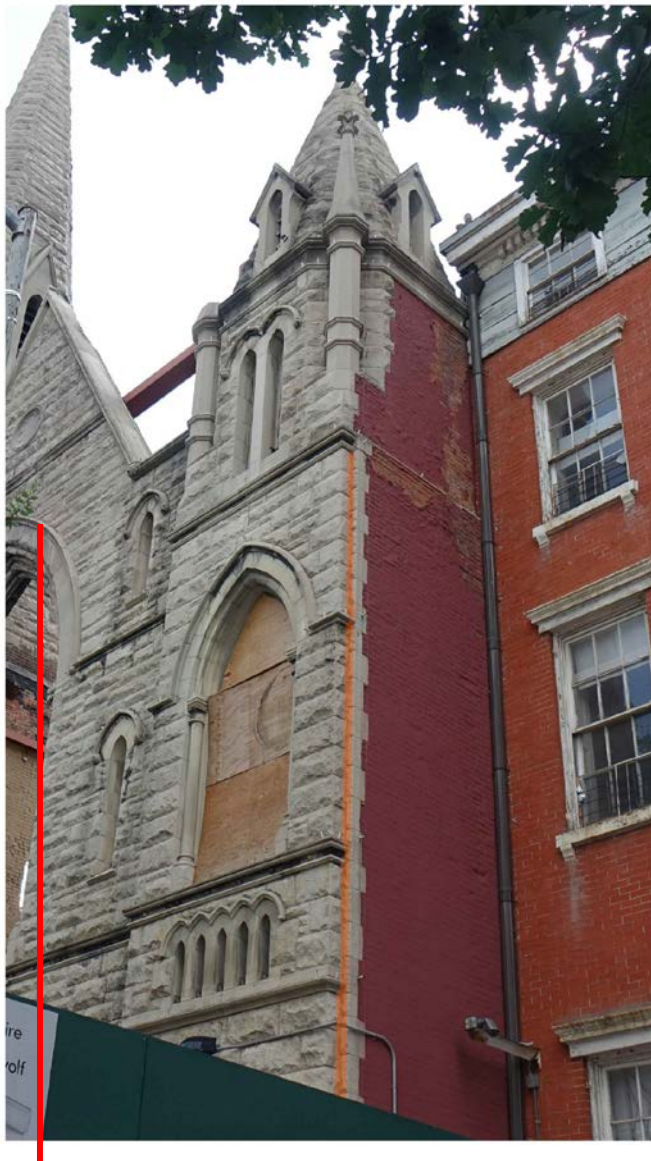
LOCALIZED DESTABILIZATION

LIMESTONE SEPARATING AT
SOUTH WALL

WATER INFILTRATION AND
FREEZE THAW LIKELYHOOD

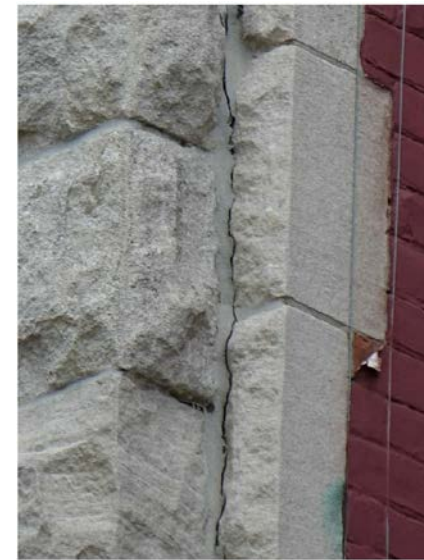
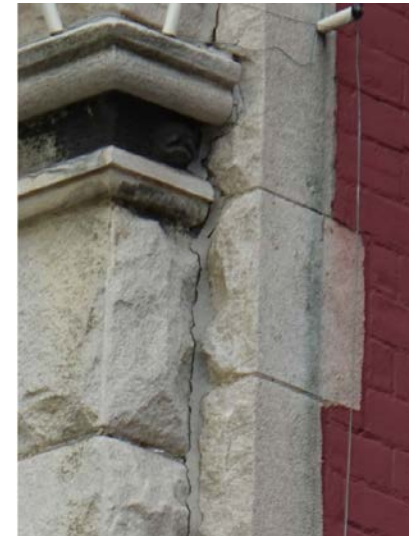
8. SOUTH TOWER – EXTENT OF LIMESTONE CRACK

8. SOUTH TOWER – CRACK ENLARGED
