Preservation Department – Item 9, LPC-23-03274

768 Fifth Avenue – The Plaza Hotel – Individual and Interior

The Plaza Hotel

Landmarks Preservation Commission Public Meeting
January 31, 2023

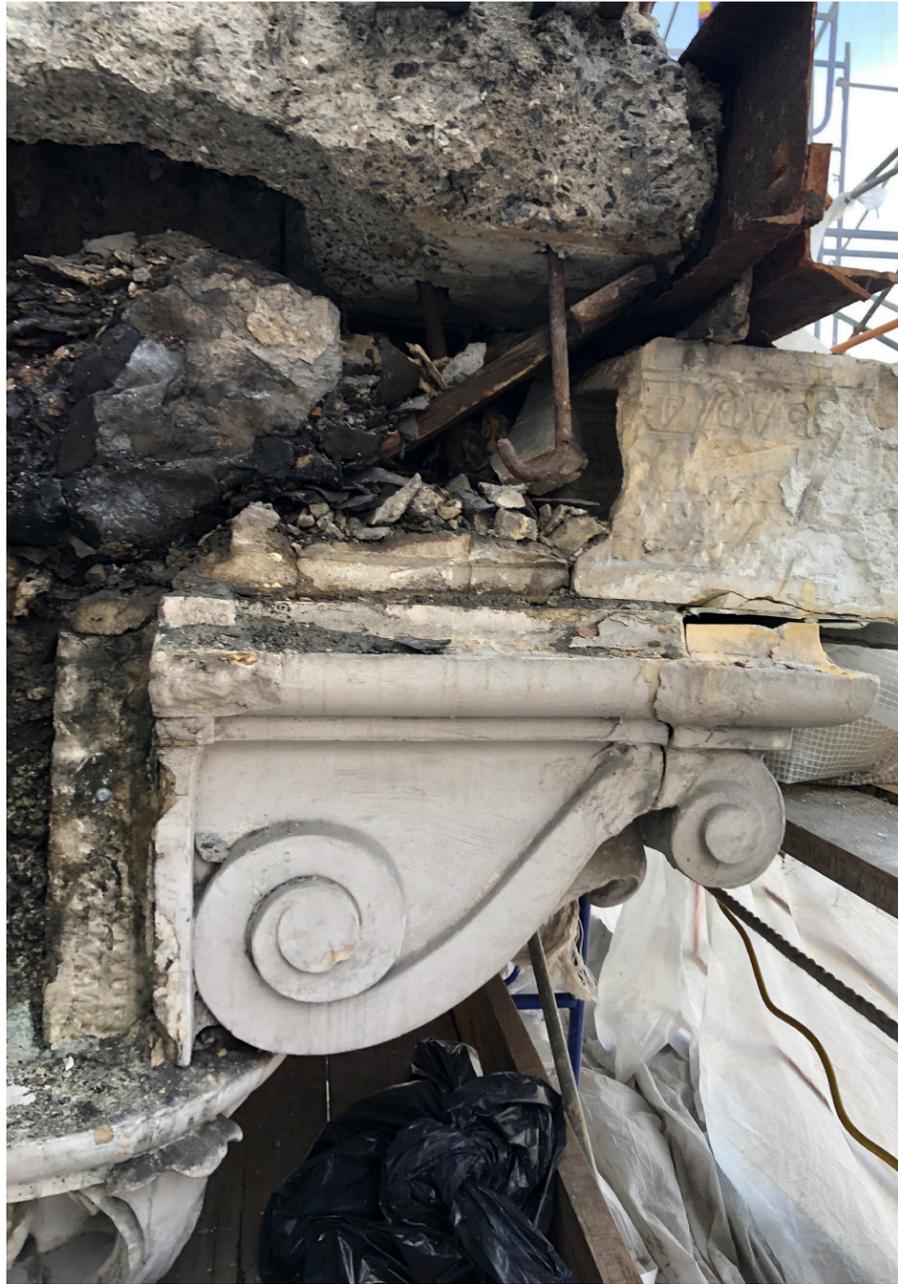
Damaged Terra Cotta

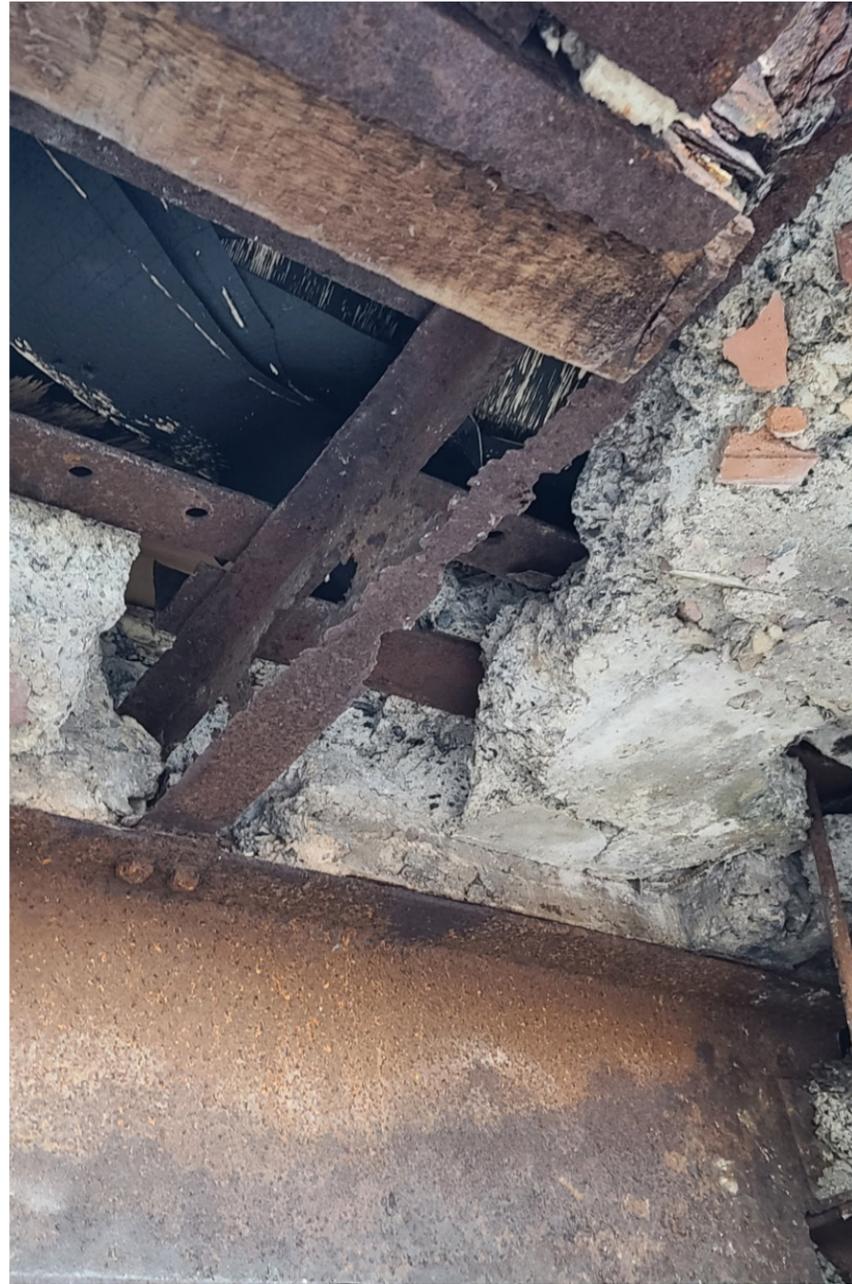
Deteriorated Steel Outrigger

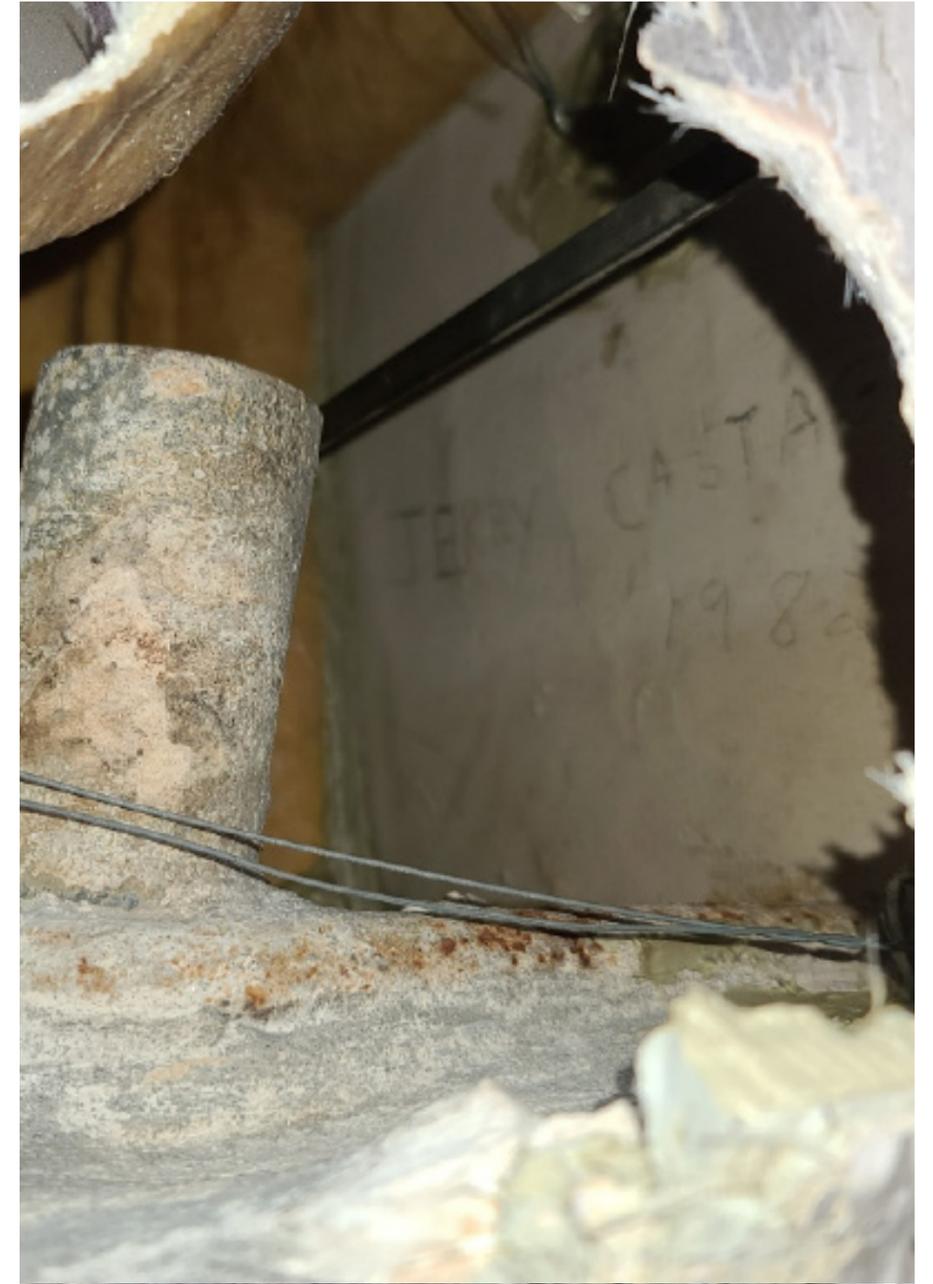
Fiberglass Repair - 1982

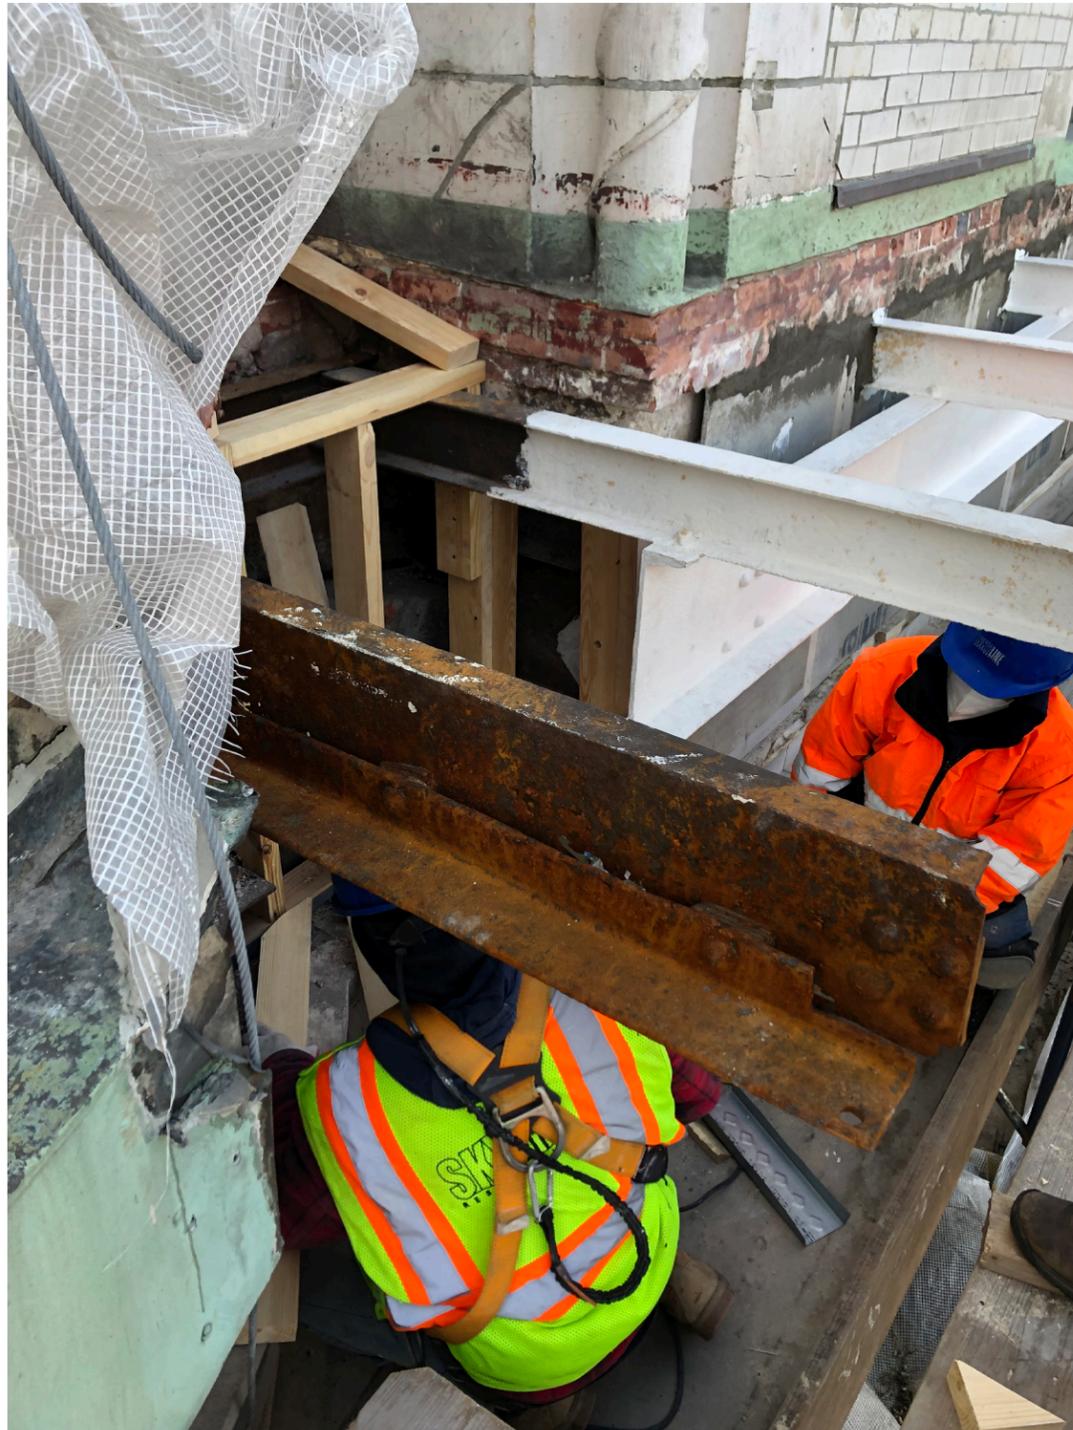
Minor Section Loss

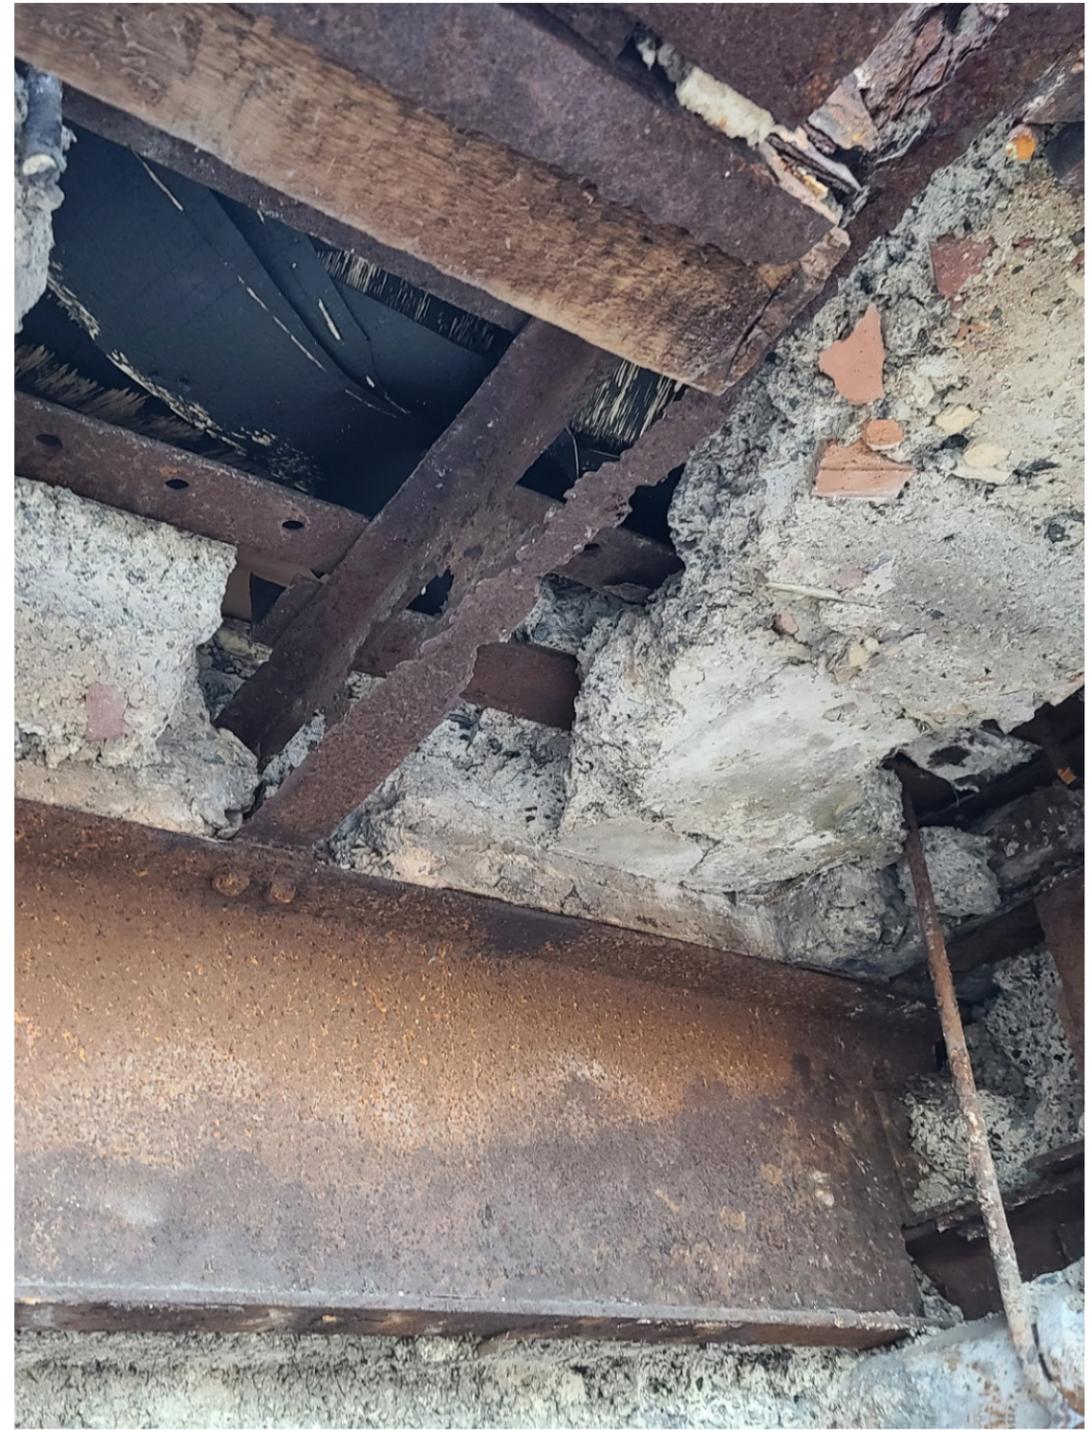
Significant Section Loss

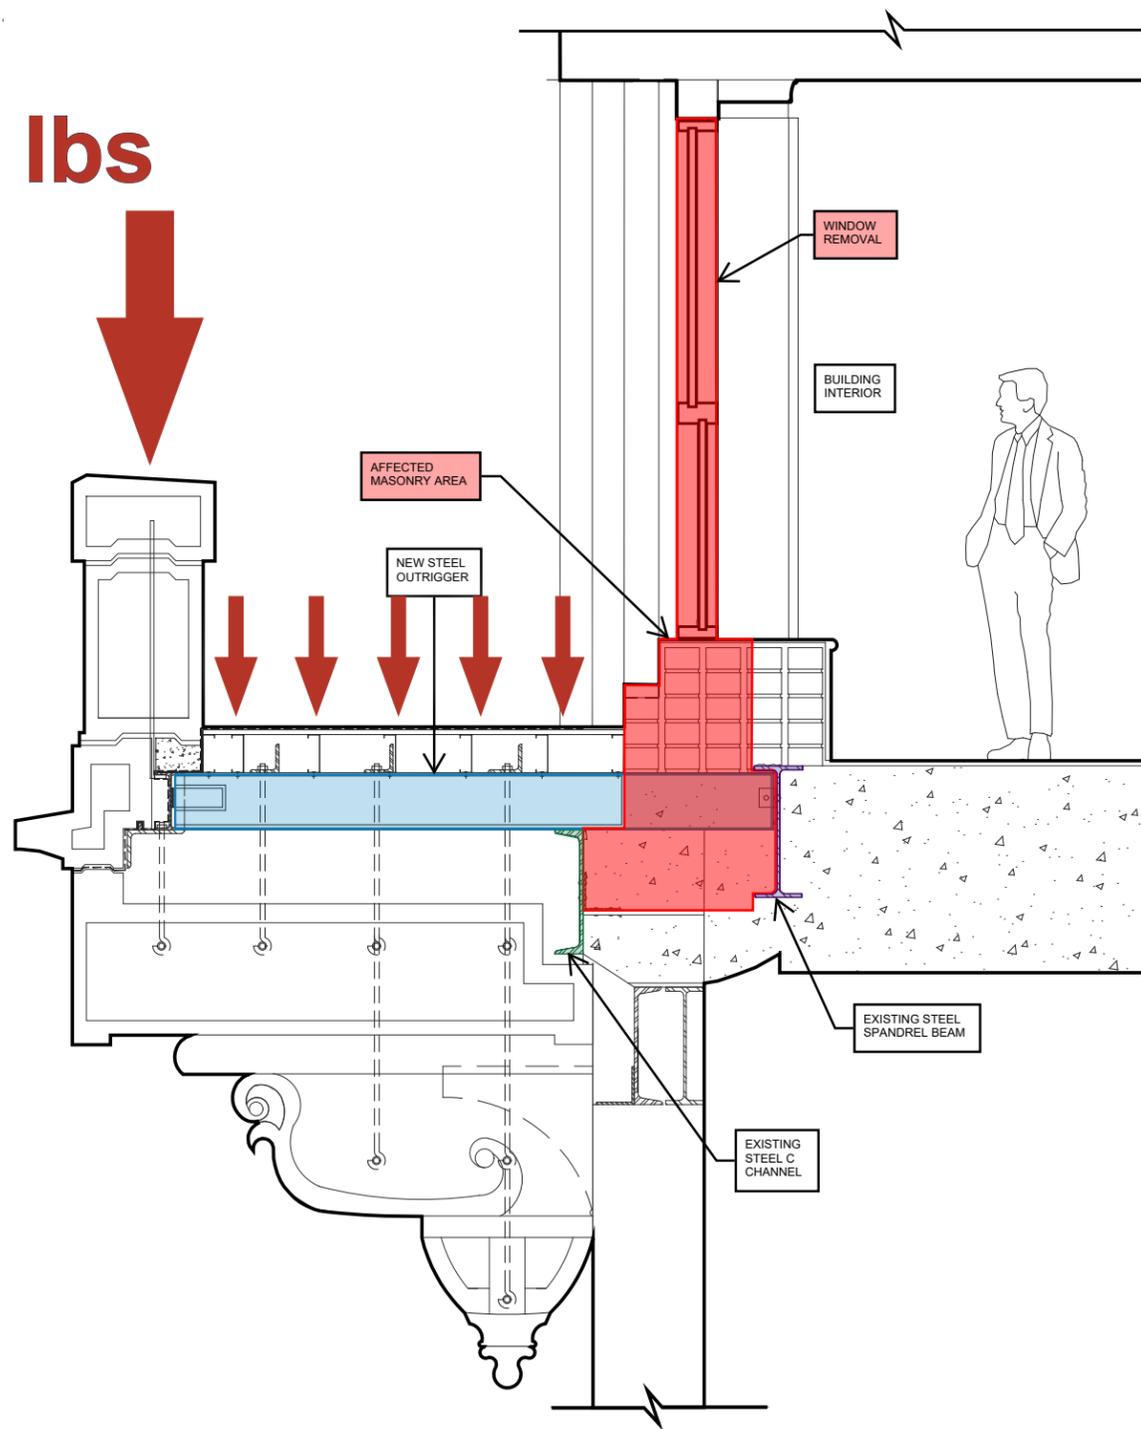
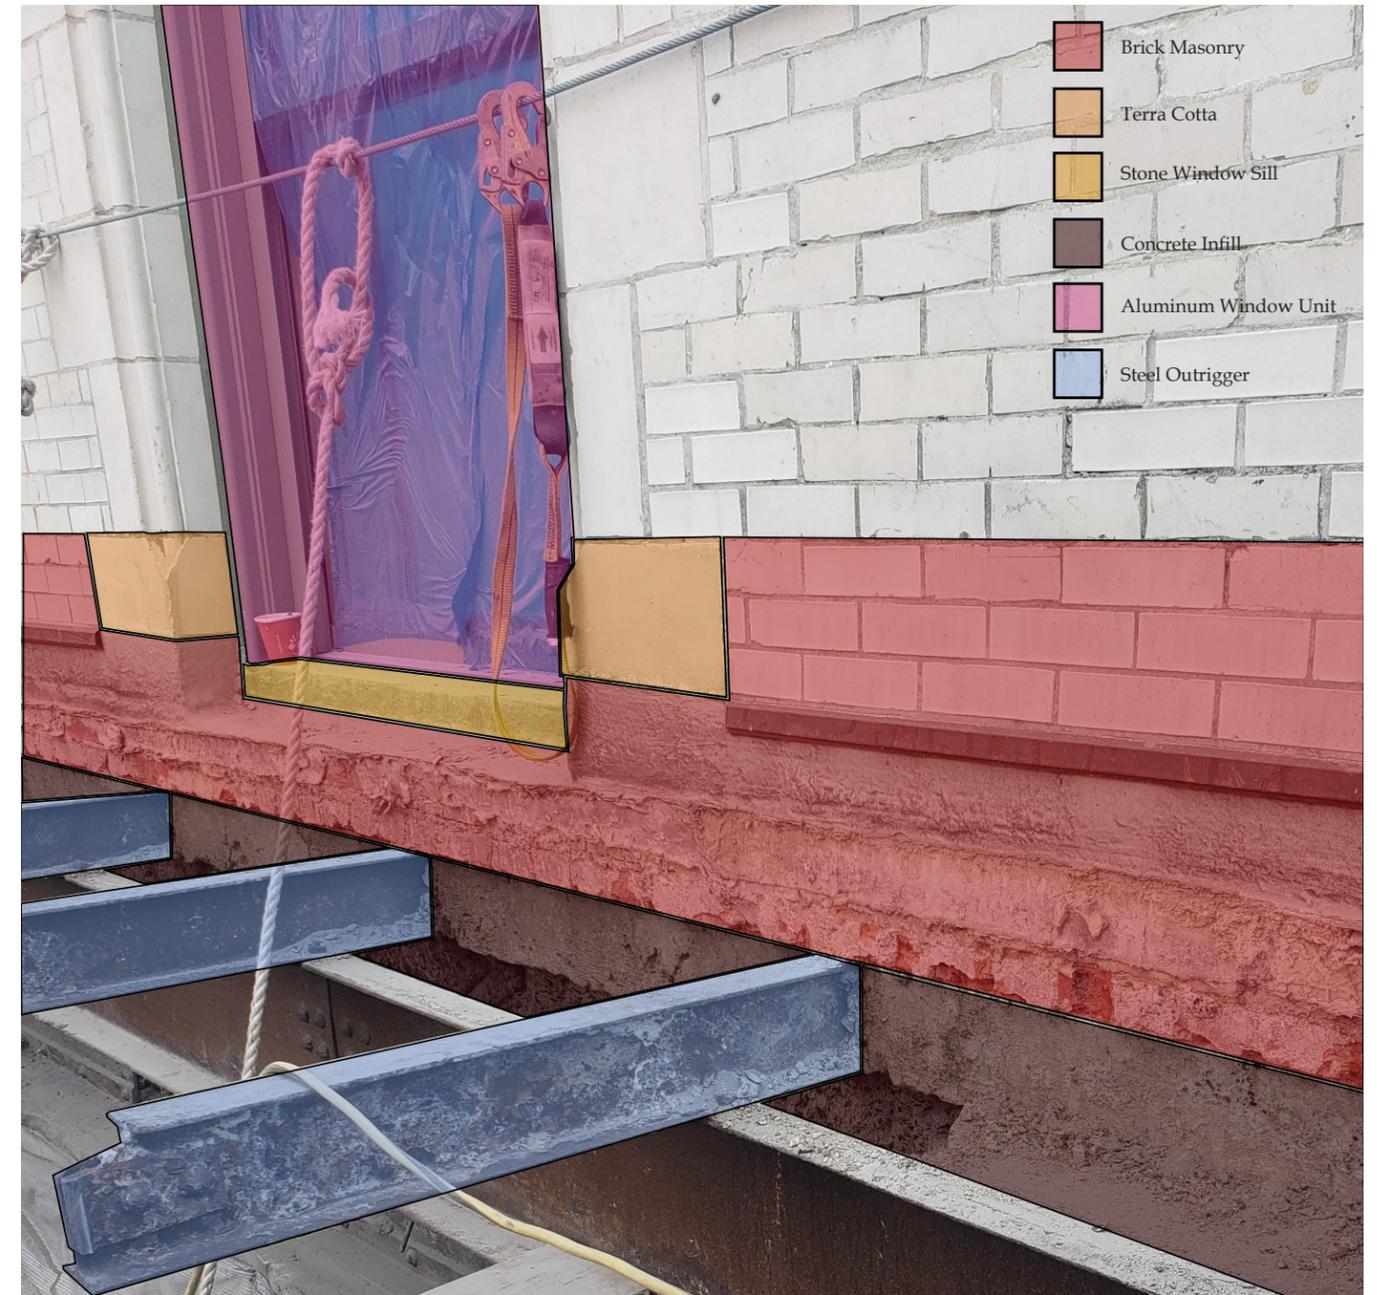
Terracotta - Outrigger Replacement

NOTE: FOR TERRACOTTA USE 70% OF ALL OUTRIGGERS REQUIRE REPLACEMENT
