Cary Building  
105 Chambers Street Façade Restoration

Localized Cast Iron Replacement

NYC Landmarks Preservation Commission Presentation

August 29<sup>th</sup>, 2023

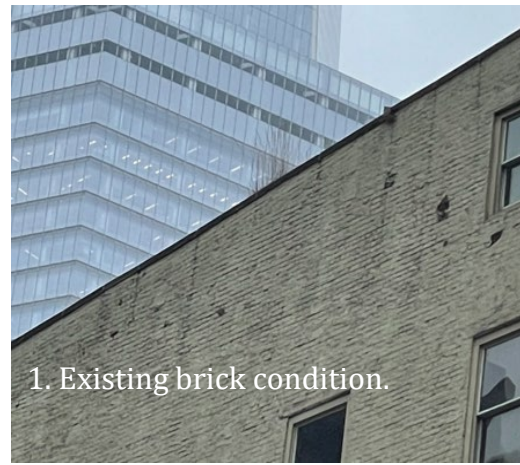
1. Existing brick condition.

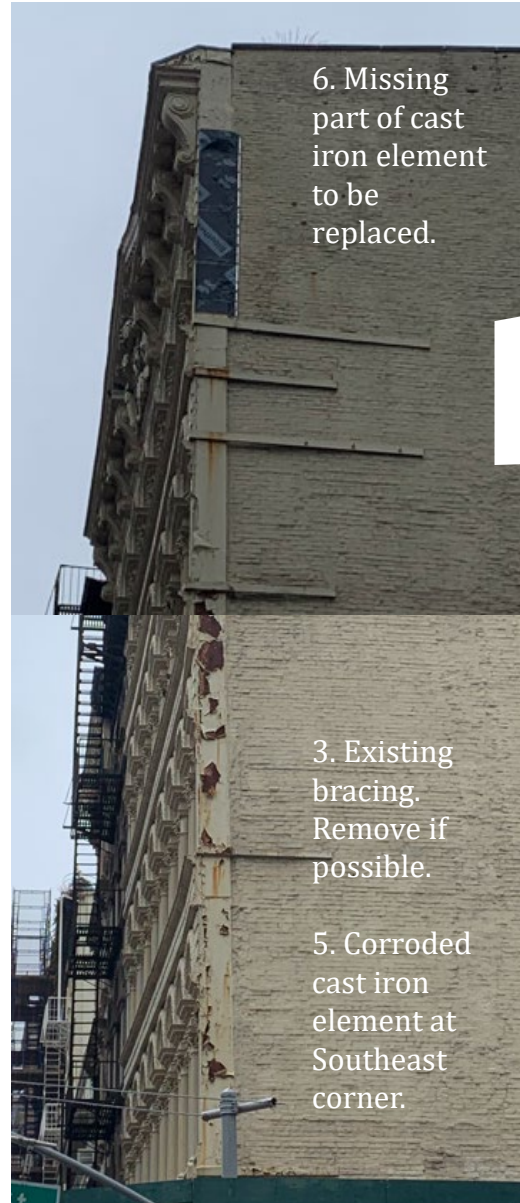
6. Missing part of cast iron element to be replaced.

Cast iron failure. Repair/Replace cast iron elements as needed.

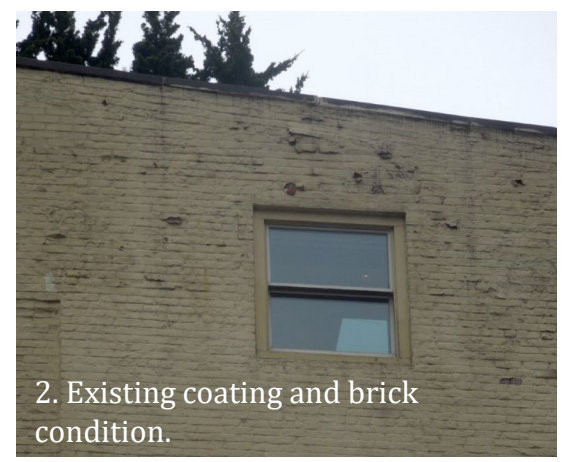
2. Existing coating and brick condition.

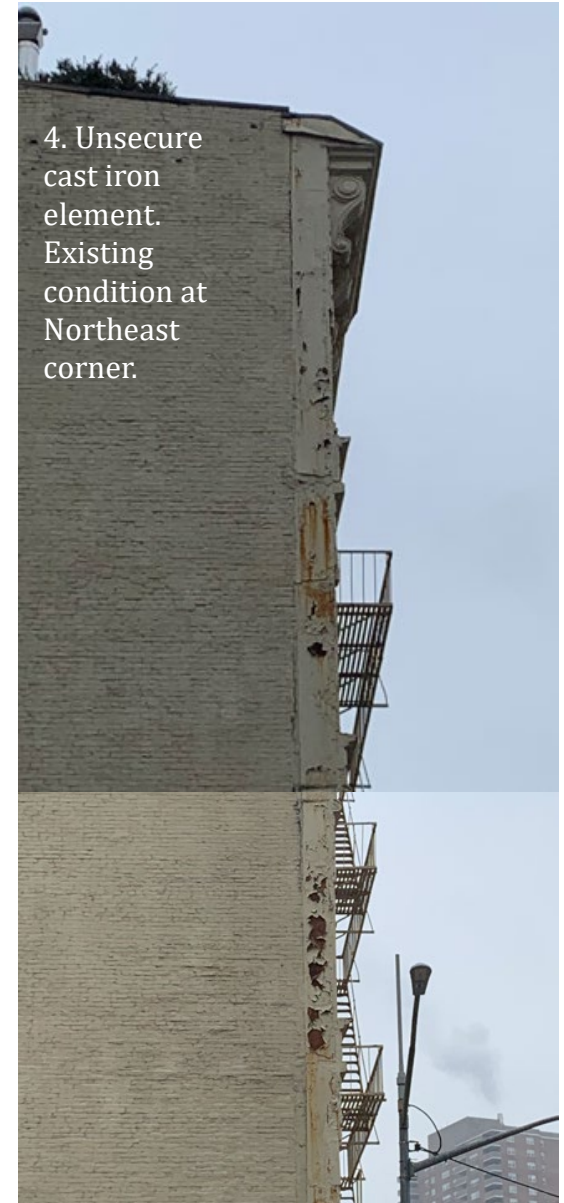
4. Unsecure cast iron element. Existing condition at Northeast corner.

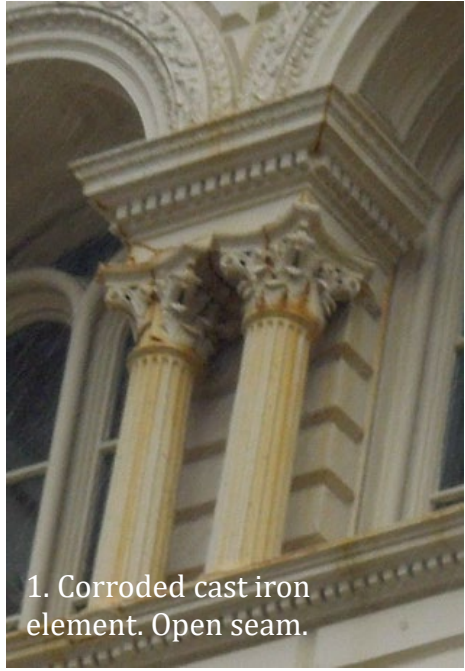
1. Corroded cast iron element. Open seam.

Cast iron failure. Repair/Replace cast iron elements as needed.

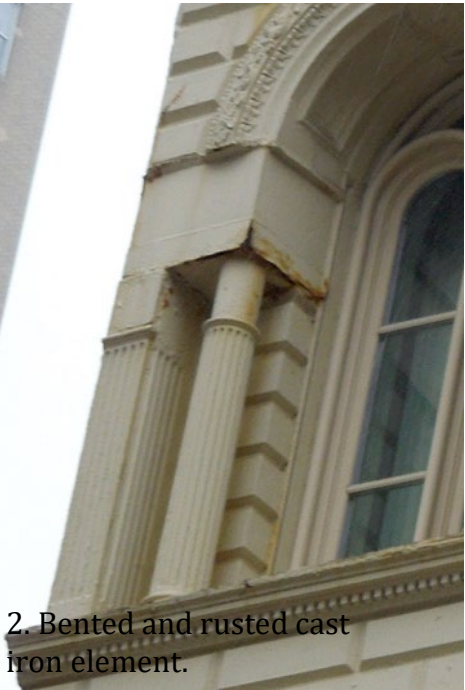
2. Bented and rusted cast iron element.

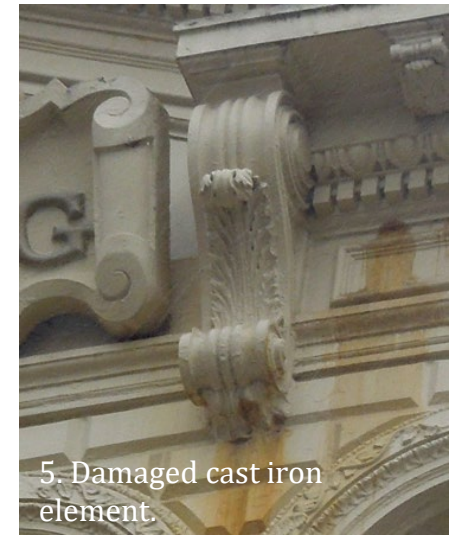
5. Damaged cast iron element.

Cast iron failure. Repair/Replace cast iron elements as needed.

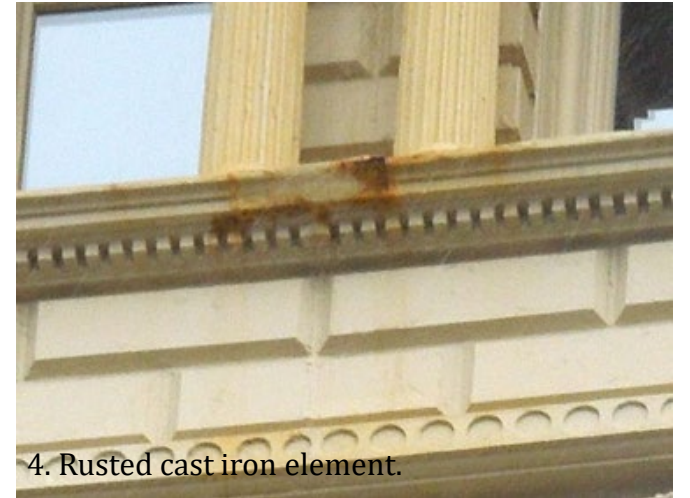
4. Rusted cast iron element.

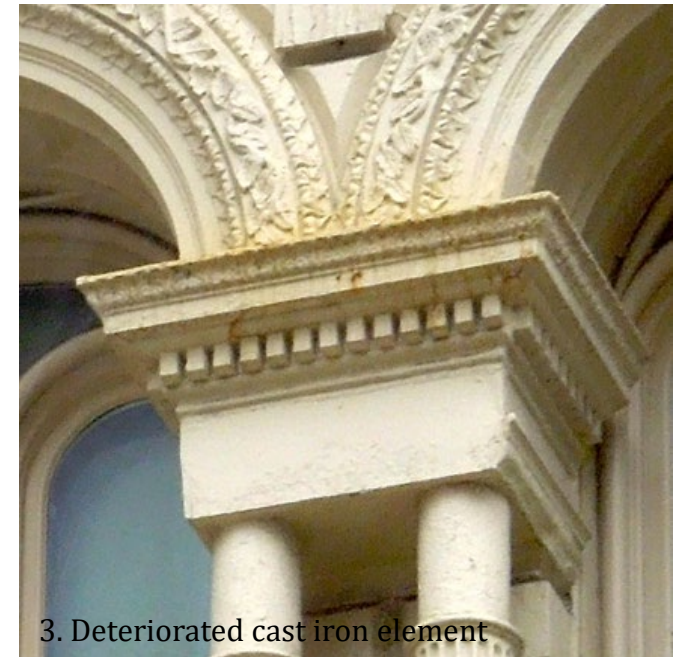
3. Deteriorated cast iron element

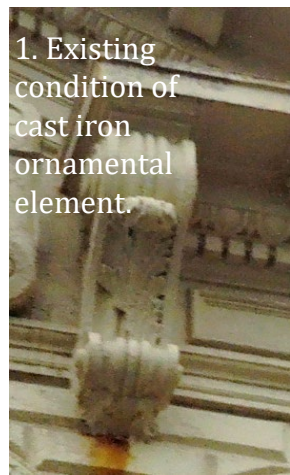
1. Existing condition of cast iron ornamental element.

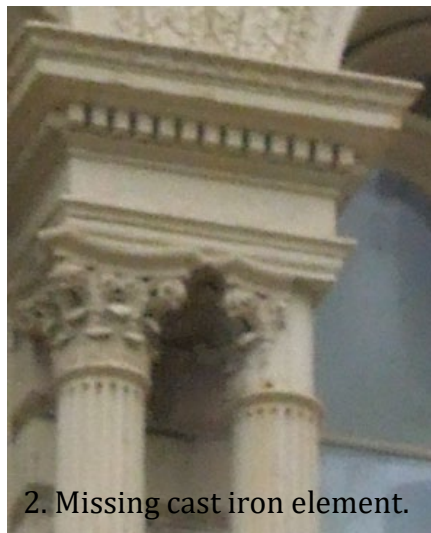
2. Missing cast iron element.

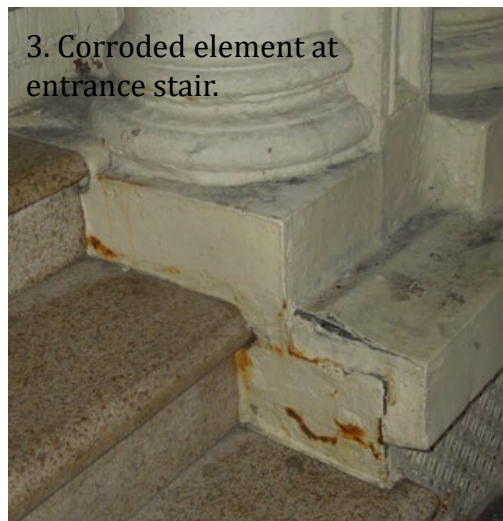
3. Corroded element at entrance stair.

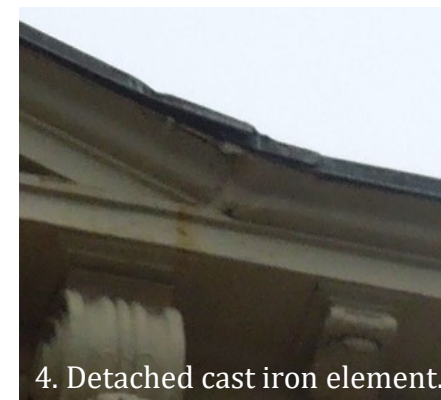
4. Detached cast iron element.

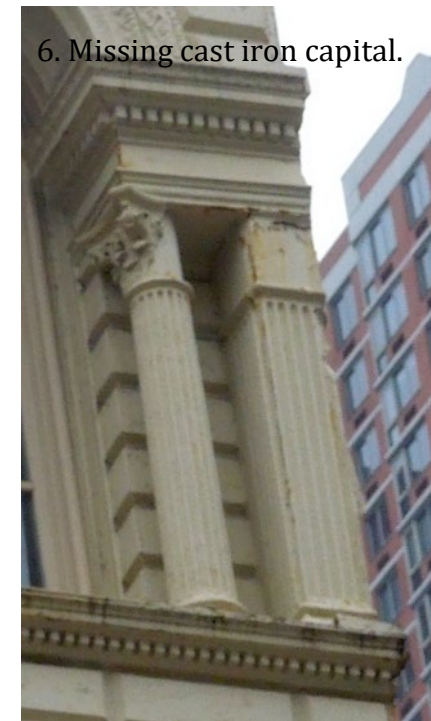
6. Missing cast iron capital.

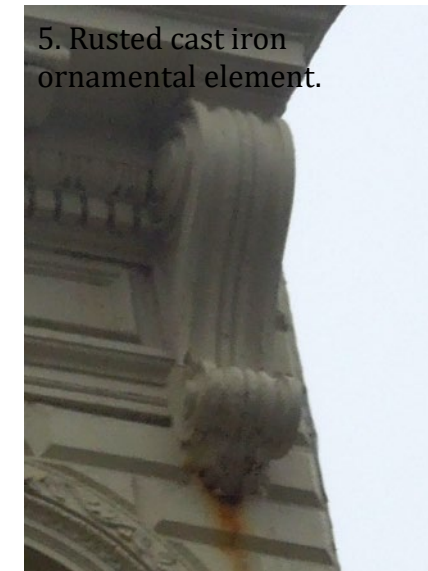
5. Rusted cast iron ornamental element.

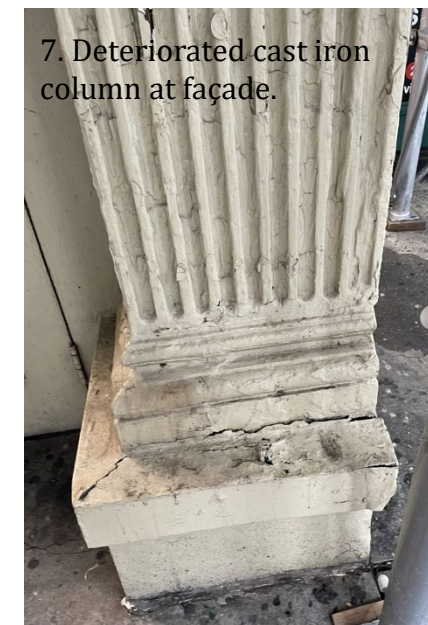
7. Deteriorated cast iron column at façade.

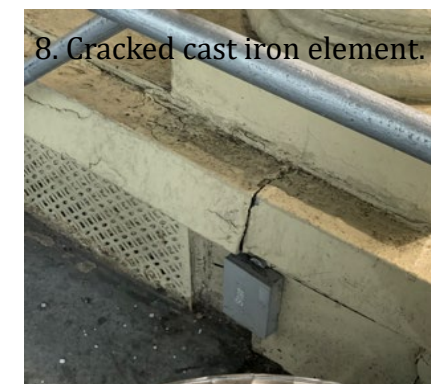
8. Cracked cast iron element.

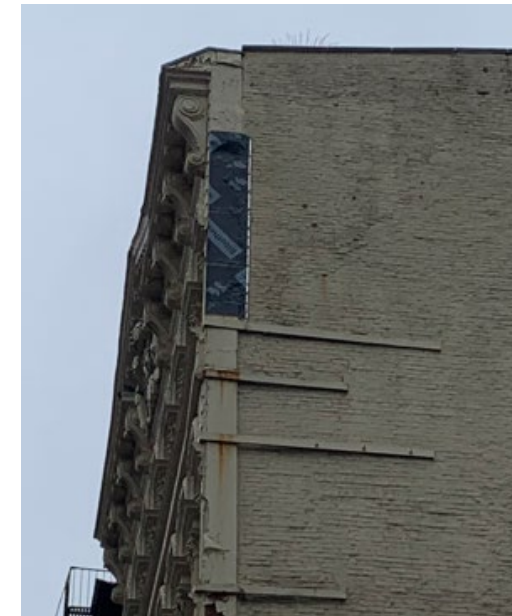
Church St - Southeast corner missing cast iron element . Replacement to match Northeast corner design.

Proposed fiberglass to match existing cast iron elements in color, design and dimension.
