Preservation Department – Item 9, LPC-25-08773

1466 Broadway – Knickerbocker Hotel – Individual Landmark Borough of Manhattan

Scope of Work Statement and Conditions Assessment for the Knickerbocker Hotel

Request for Terra Cotta Unit Replacement in Cast Stone

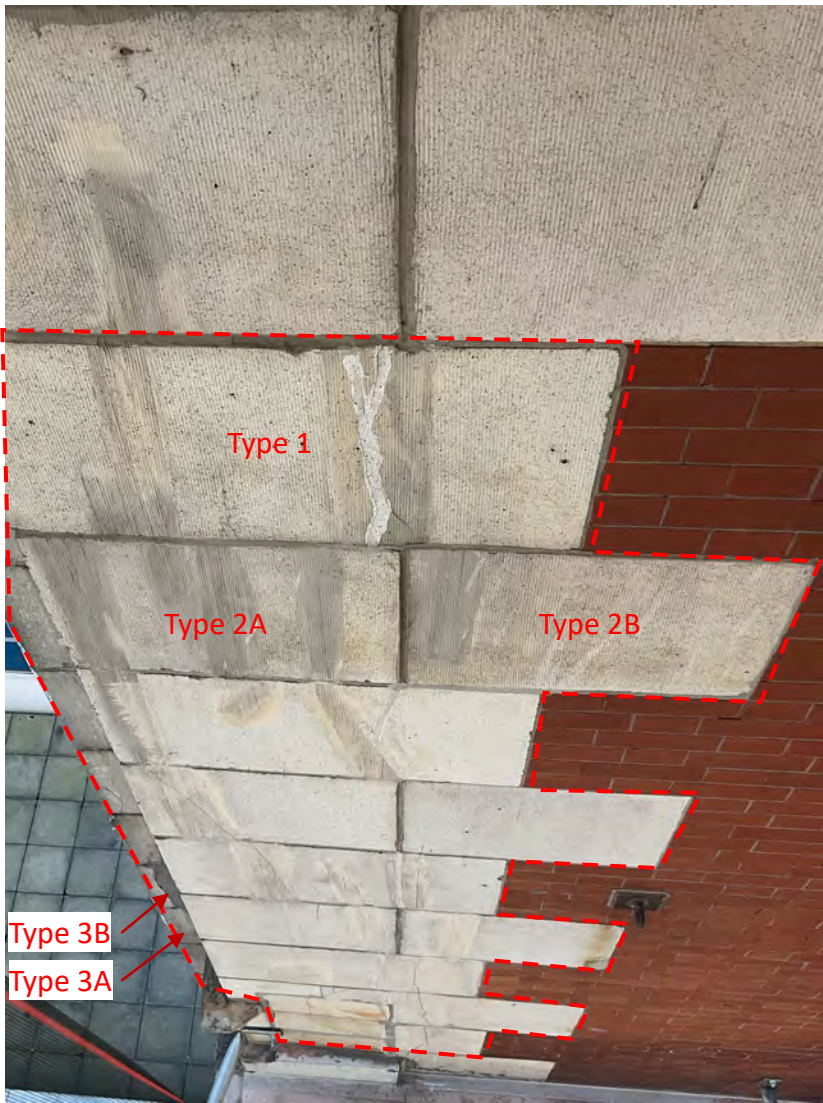
Photo: 1

North Elevation: 10/18/2024
 Northeast Corner.
 Overall view: **Type 1, 2A, 2B, 3A, and 3B.**
 Replacement in Cast Stone.

- Prior crack or patch repair failures
- New cracks at terra cotta
- Multiple repairs per unit
- Open mortar joints

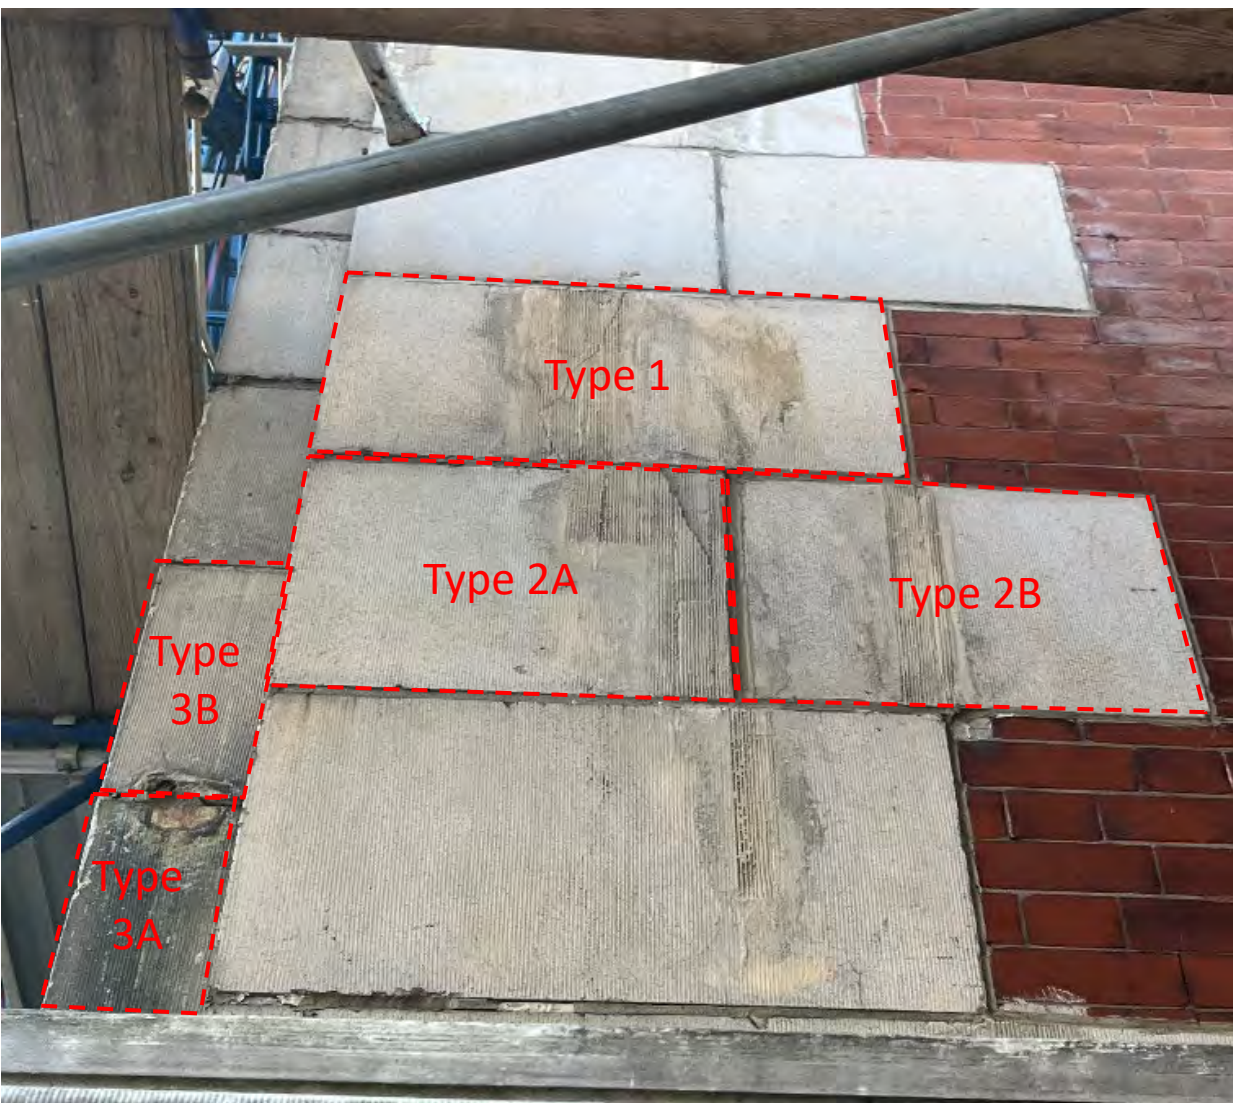
Photo: 2

North Elevation: 2/26/2025
 Northeast Corner.
 Close-up view: **Type 1, 2A, 2B, 3A, and 3B.**
 Replacement in Cast Stone.

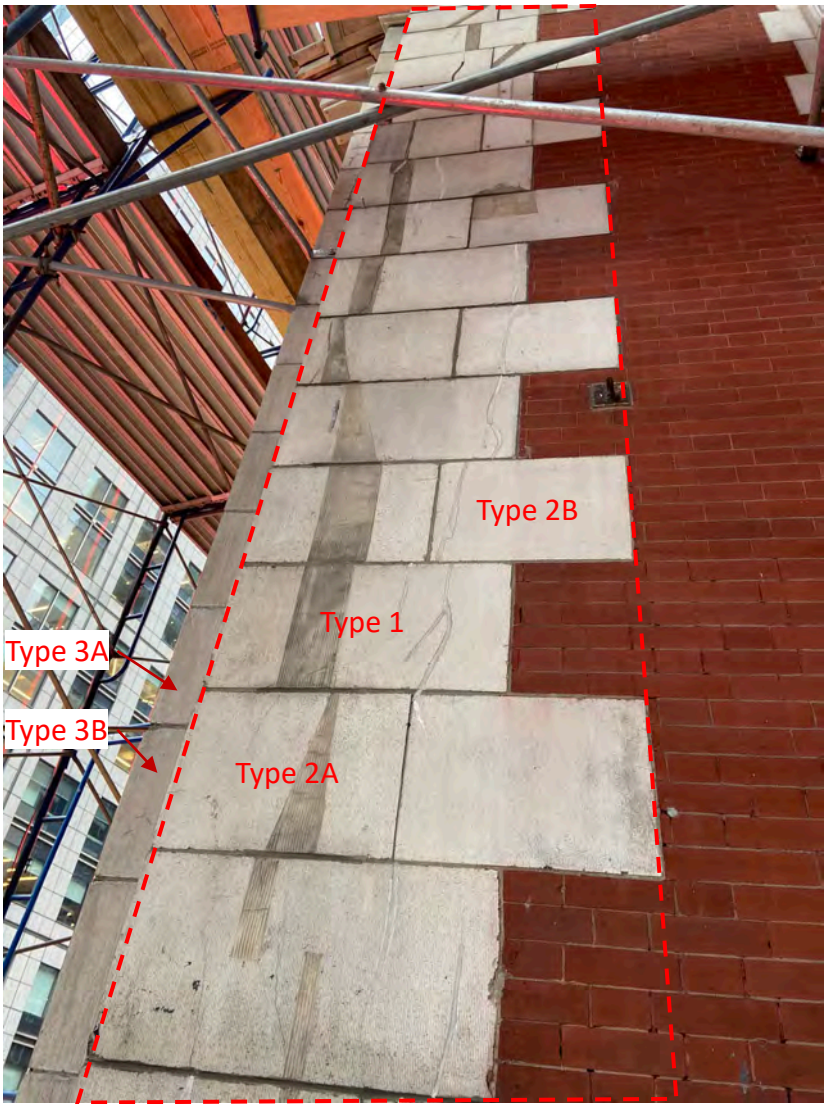
Photo: 3

West Elevation: 10/18/2024

Northwest Corner.

Overall view: **Type 1, 2A, 2B, 3A, and 3B.**

- Prior crack or patch repair failures
- New cracks at terra cotta
- Multiple repairs per unit
- Open mortar joints

Replacement in Cast Stone.

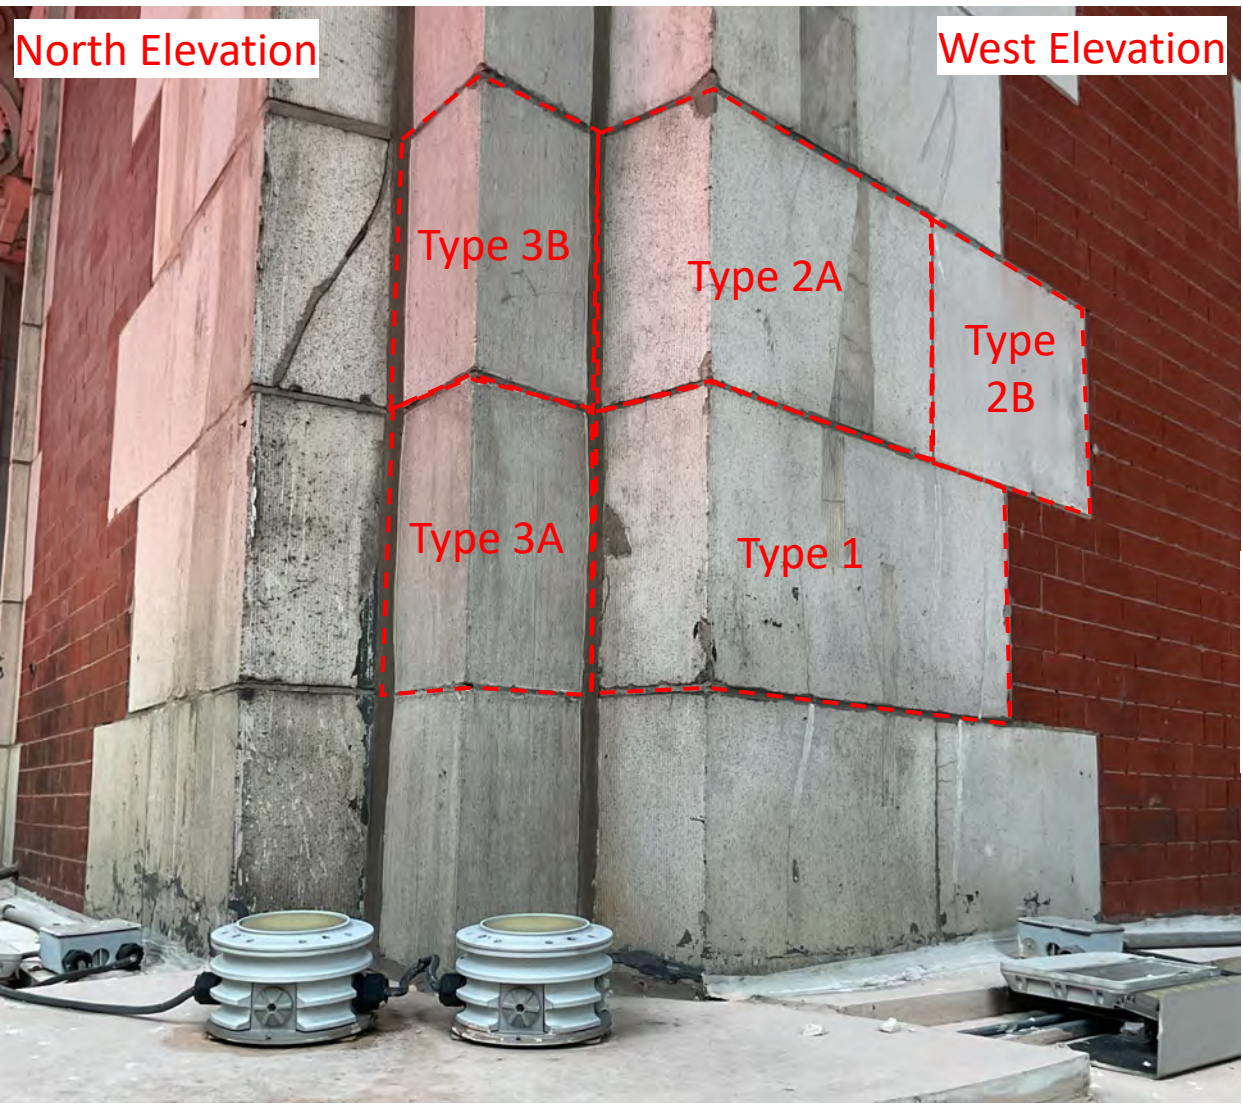
Photo: 4

West Elevation: 10/18/2024

Northwest Corner.

Close-up view: **Type 1, 2A, 2B, 3A, and 3B.**

Replacement in Cast Stone.

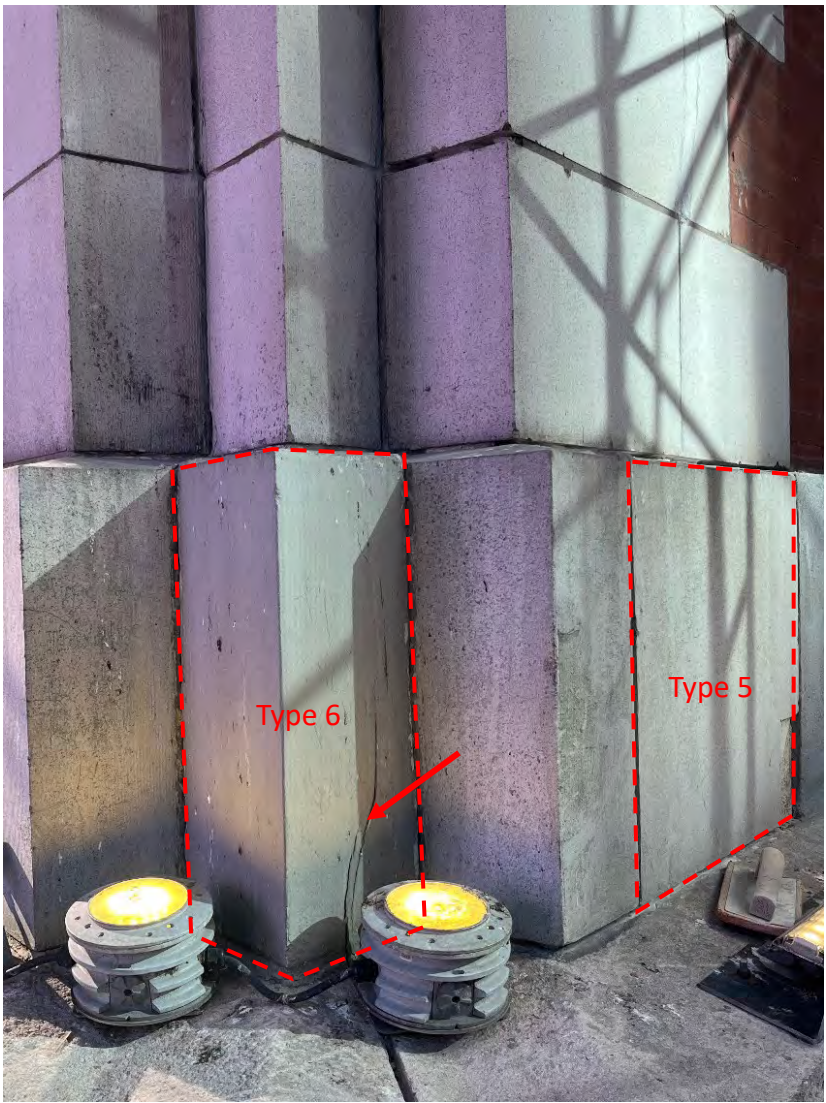
Photo: 5
 North Elevation: 2/26/2025
 Northwest Corner.
 Overall view: **Type 5 and 6.**
 Replacement in Cast Stone.

- Cracked terra cotta
- Spalled patch
- Unsound unit

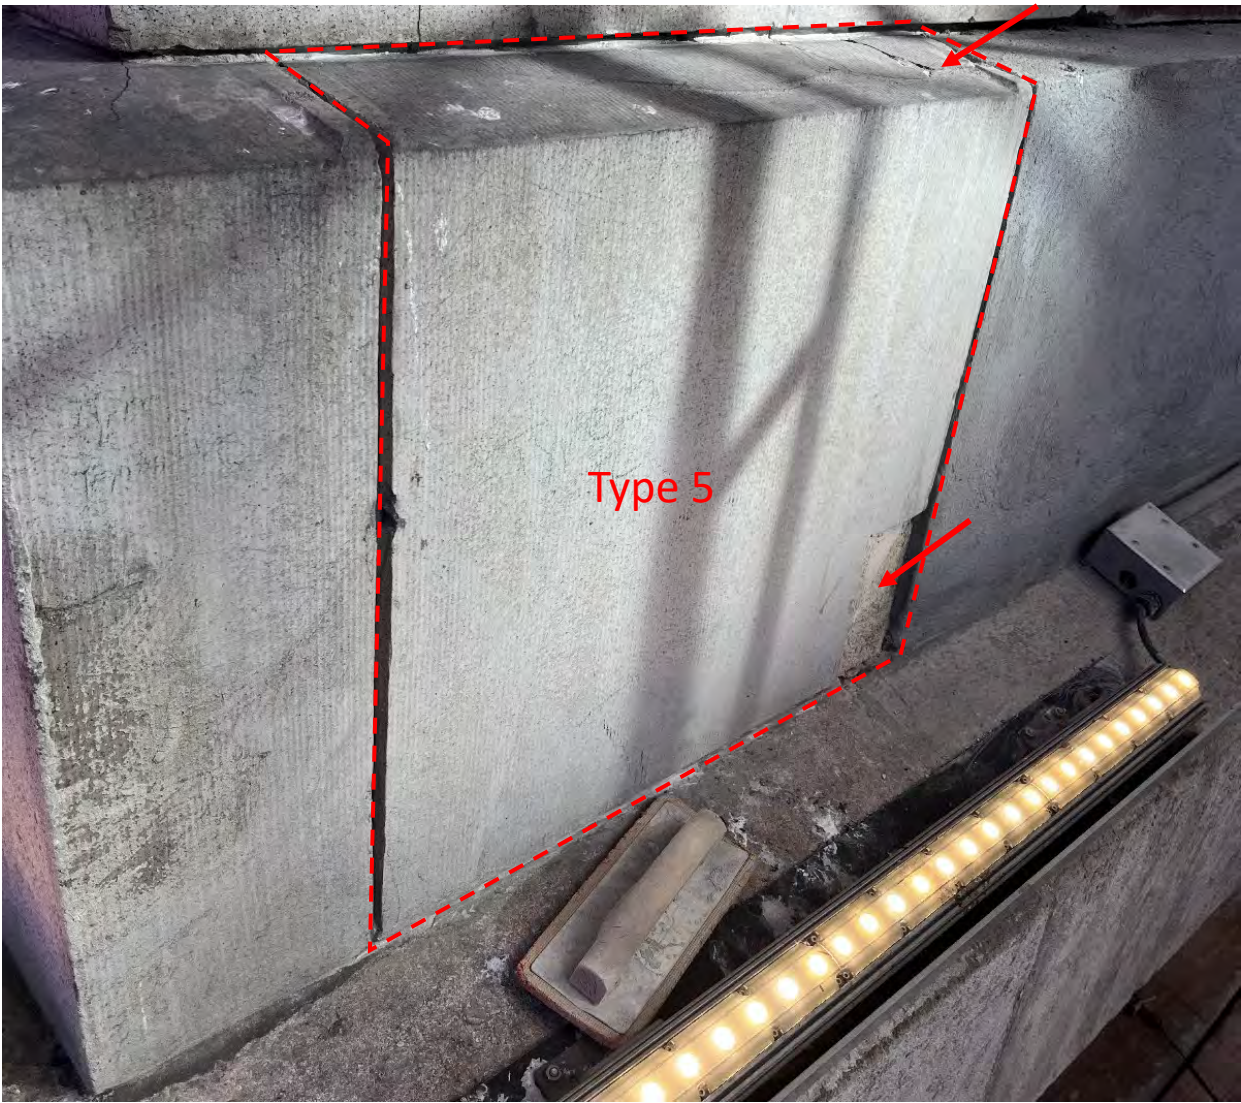
Photo: 6
 North Elevation: 2/26/2025
 Northwest Corner.
 Close-up view: **Type 5.**
 Replacement in Cast Stone.

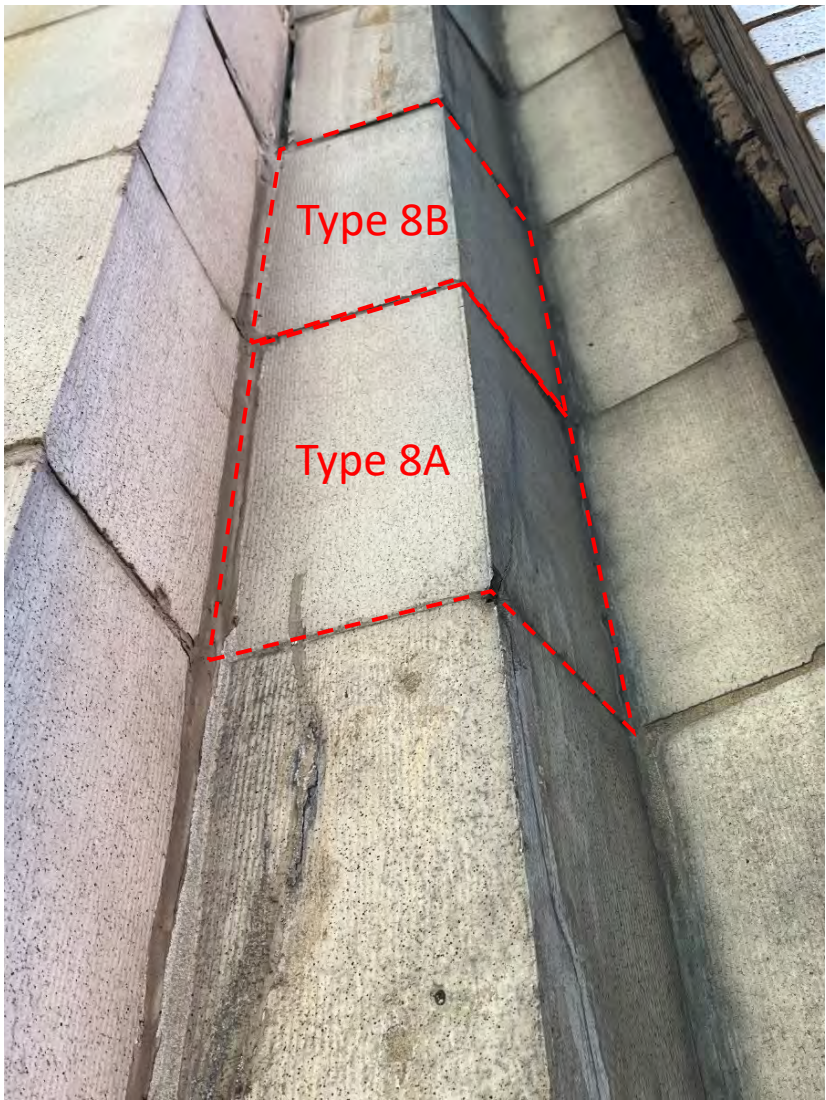
Photo: 7

West Elevation: 10/18/2024

Southwest Corner.

Overall view: Type 8A and 8B.

- Prior crack repair failures
- New cracks at terra cotta
- Separating vertical cracks

Replacement in Cast Stone.

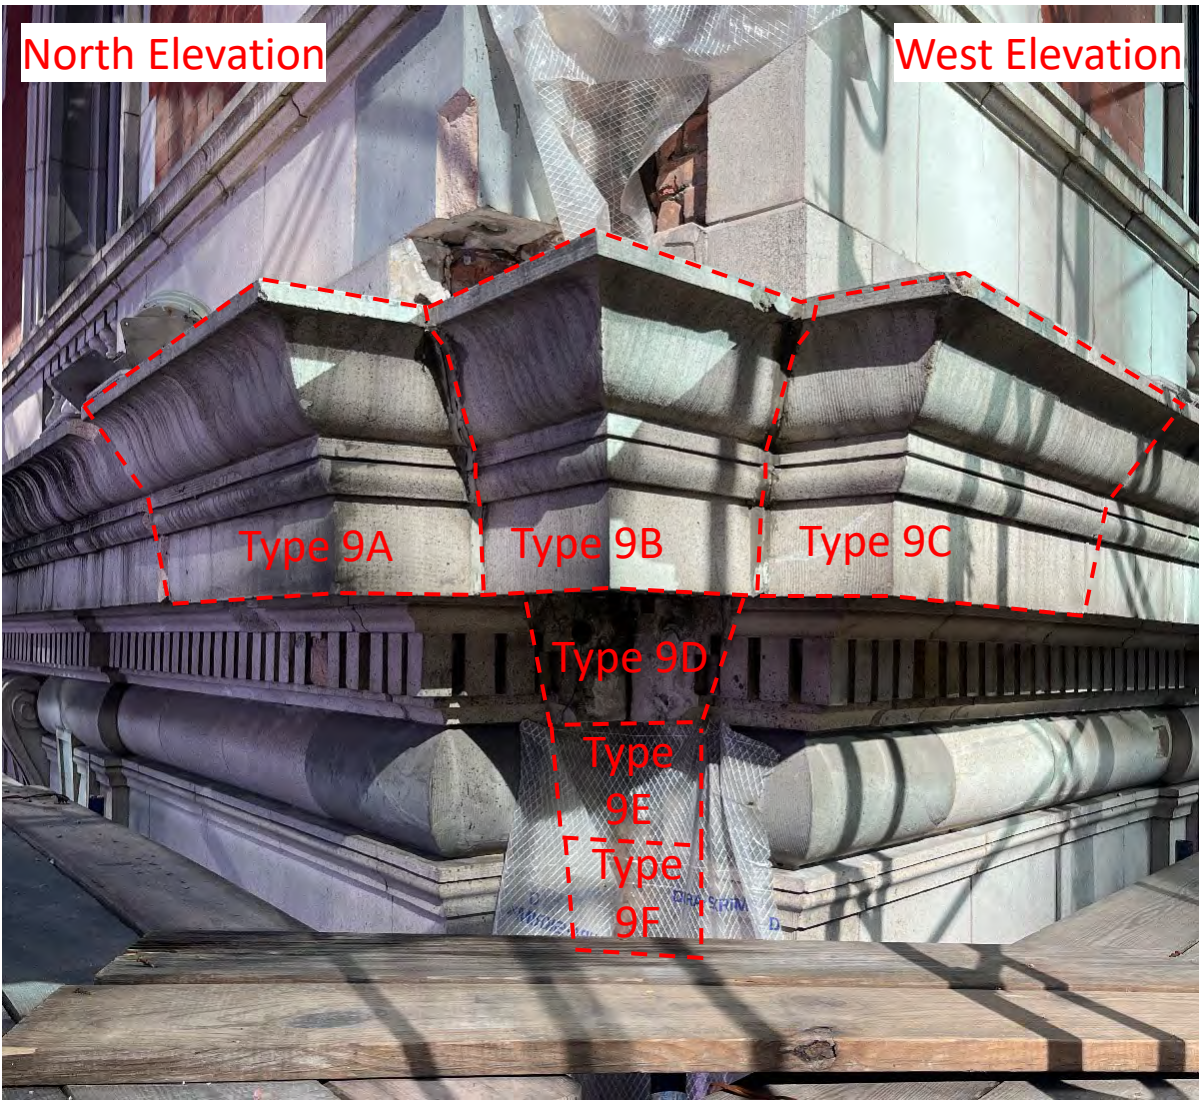
Photo: 8

North and West Elevation: 9/24/2024

Northwest Corner.

Overall view: Type 9A, 9B, 9C, 9D, and 9E.

Replacement in Cast Stone.

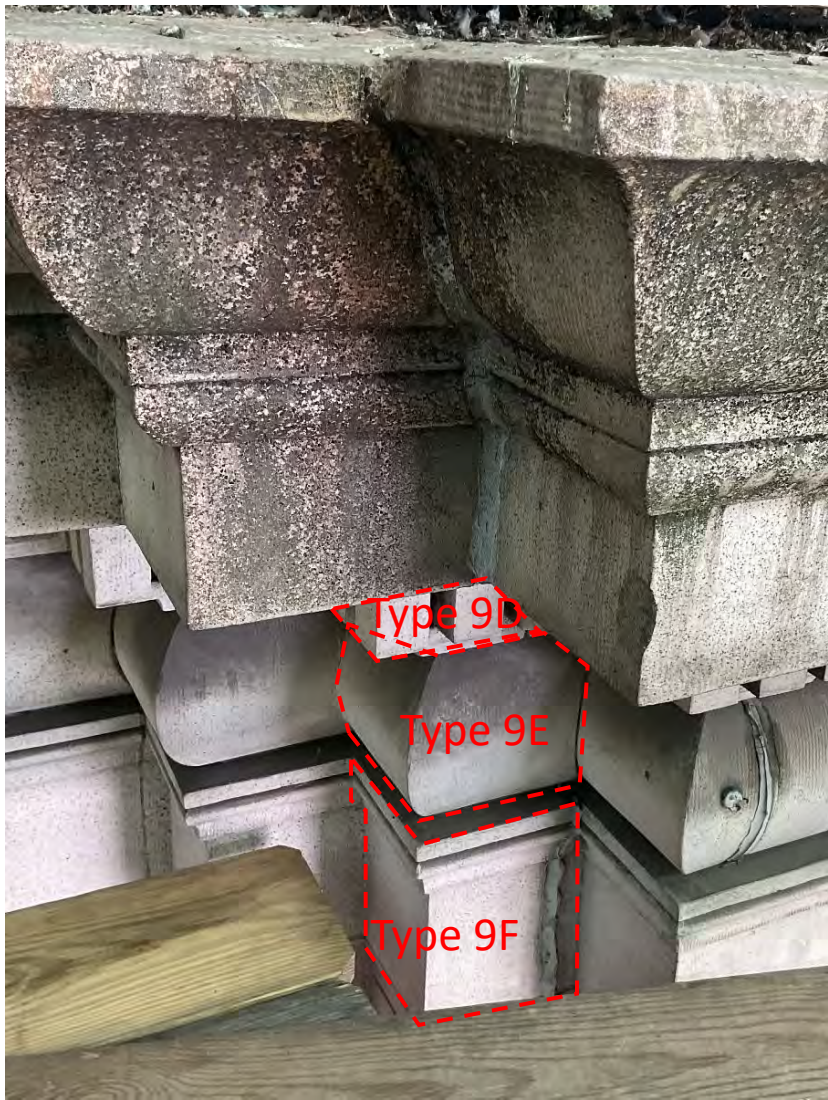
Photo: 9
 North Elevation: 10/21/2024
 North Setback Corner.
 Overall view: Type 9D, 9E, and 9F.
 Replacement in Cast Stone.

- Conditions:**
- Prior crack repair failures
 - New cracks at terra cotta
 - Separating vertical cracks

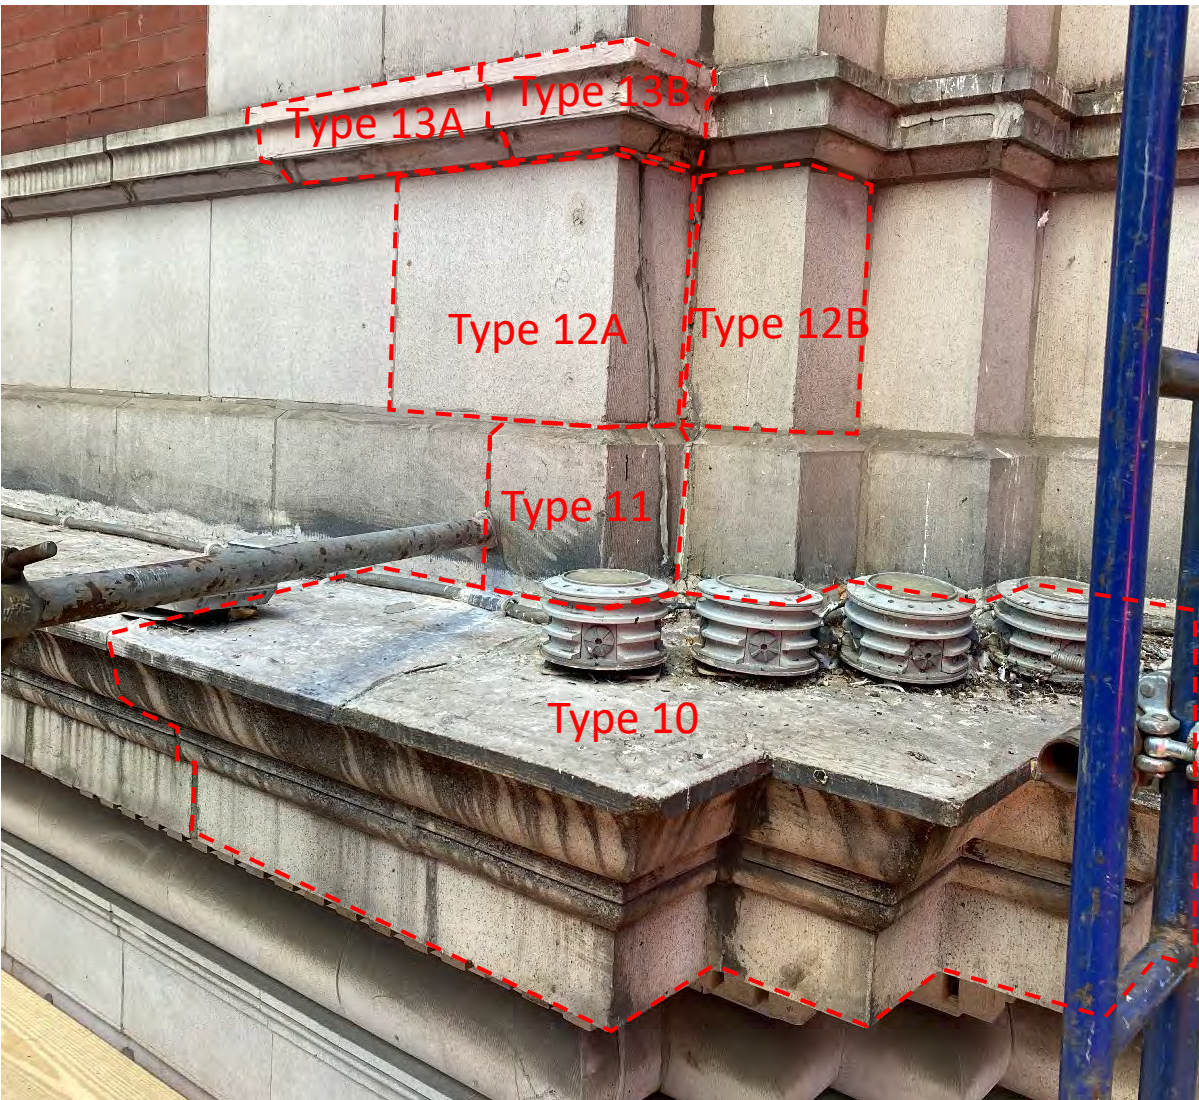
Photo: 10
 North Elevation: 10/21/2024
 North Setback Corner.
 Overall view: Type 10, 11, 12A, 12B, 13A, and 13B.
 Replacement in Cast Stone.

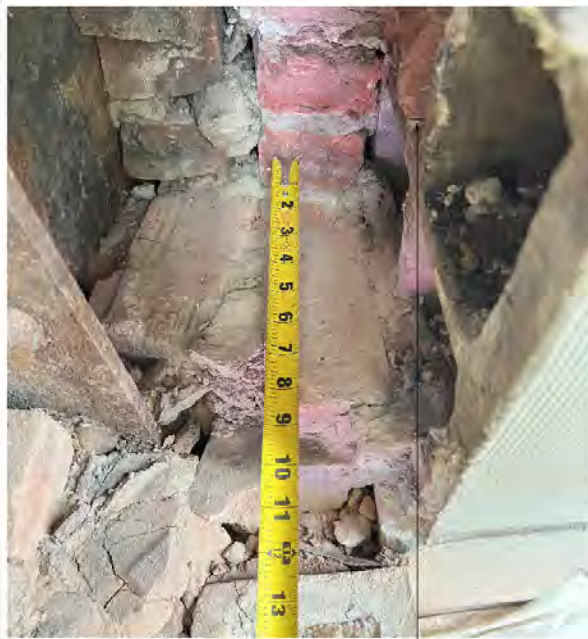
4 MASONRY INFILL AT THE WEB OF THE TERRA COTTA
SCALE: N.T.S.

- At the existing installation, the web/ voids in the existing terra cotta units were infilled with brick masonry and mortar, which allowed the units to better bear their own load. The proposed installation of cast stone as a solid material will allow the replacement units and existing infilled terra cotta units to remain to be a fully solid assembly and move and work together as a homogenous application, similar to the original assembly . This will reduce differential movement and cracking.

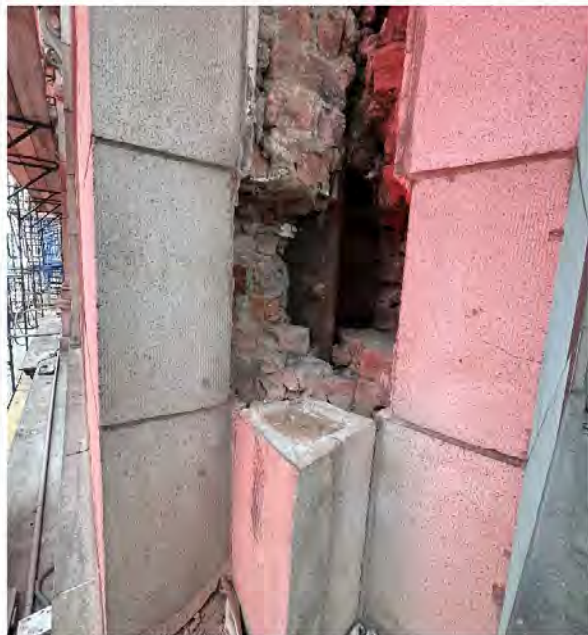
3 PROBE: EXISTING INSTALLATION OF TERRA COTTA AND STEEL CONDITION
SCALE: N.T.S.

- The existing terra cotta installed at the building has masonry installed at the web, tying in with the back-up masonry to create a mass masonry solid corner assembly. The façade was built from ground up, with full access simultaneously at interior and exterior to be able to set the terra cotta units and key them in to the back-up wall.

- Cast stone units, when designed to the existing building configurations, allows for specific embedment of stainless steel anchors in epoxy at the back of the new unit during fabrication and allows for installation of the units directly to the backup behind.

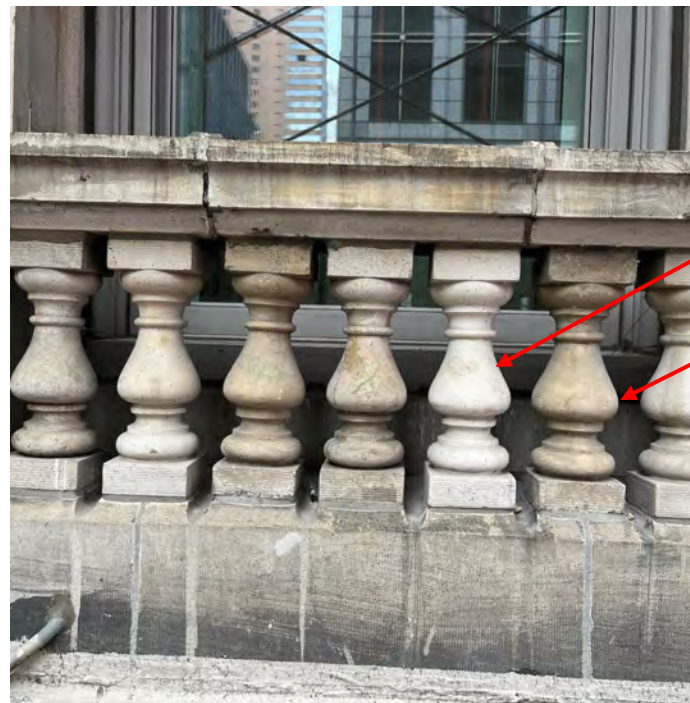
Balustrade Units
North Elevation.

- **Cast Stone vs. GFRC:** Typically GFRC, while light weight with its the thin outer wall construction and internal reinforcement, is not load bearing, and installation procedure would be difficult (similar to the issues with installing terra cotta). GFRC previously installed here has cracked at the corner, due to inability to support the terra cotta above.

Previously replaced GFRC unit.

Existing historic terra cotta unit.
