**1 East 60th Street – Upper East Side Historic District
Borough of Manhattan**

The Metropolitan Club

Presentation for Landmark Restoration and Proposed Capital Work

4.0 Appendix A: Existing Conditions Report

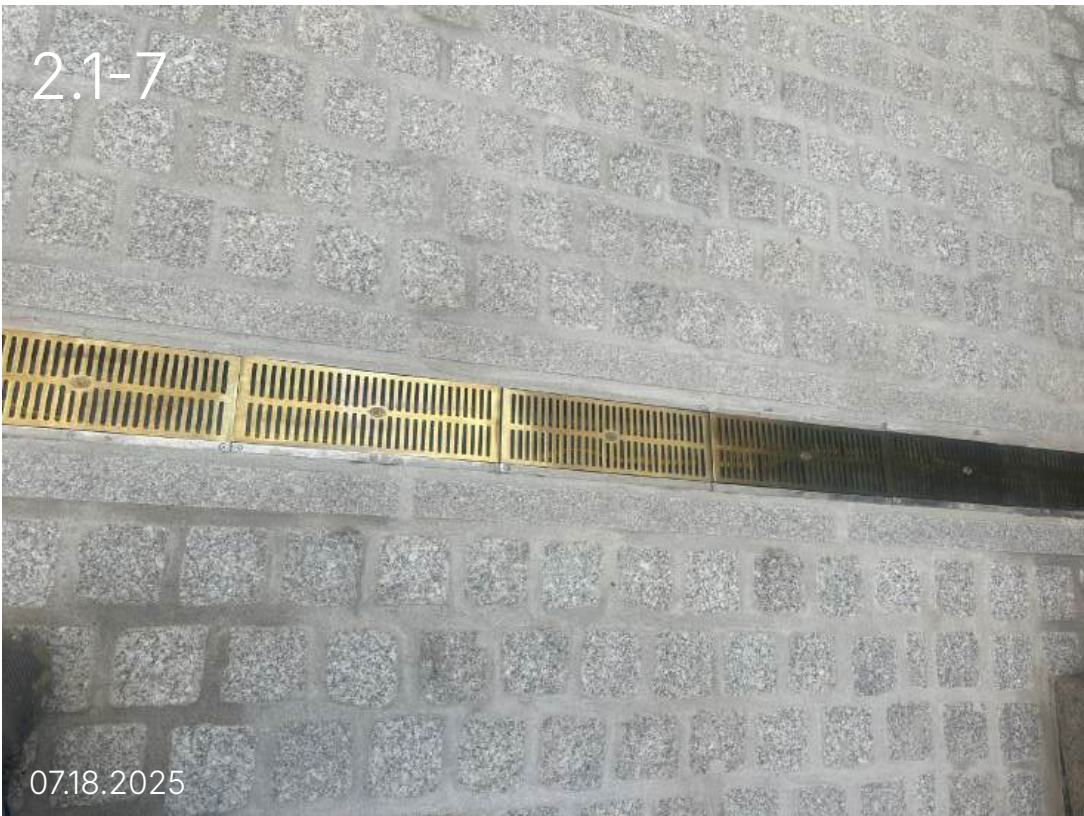
- 2.1-7 Courtyard Drain**
- Replaced undersized drain at courtyard portico with bronze trench drain to prevent water spilling from courtyard to the street.
 - New drain also provides additional drainage for the building and prevents cellar water infiltration.

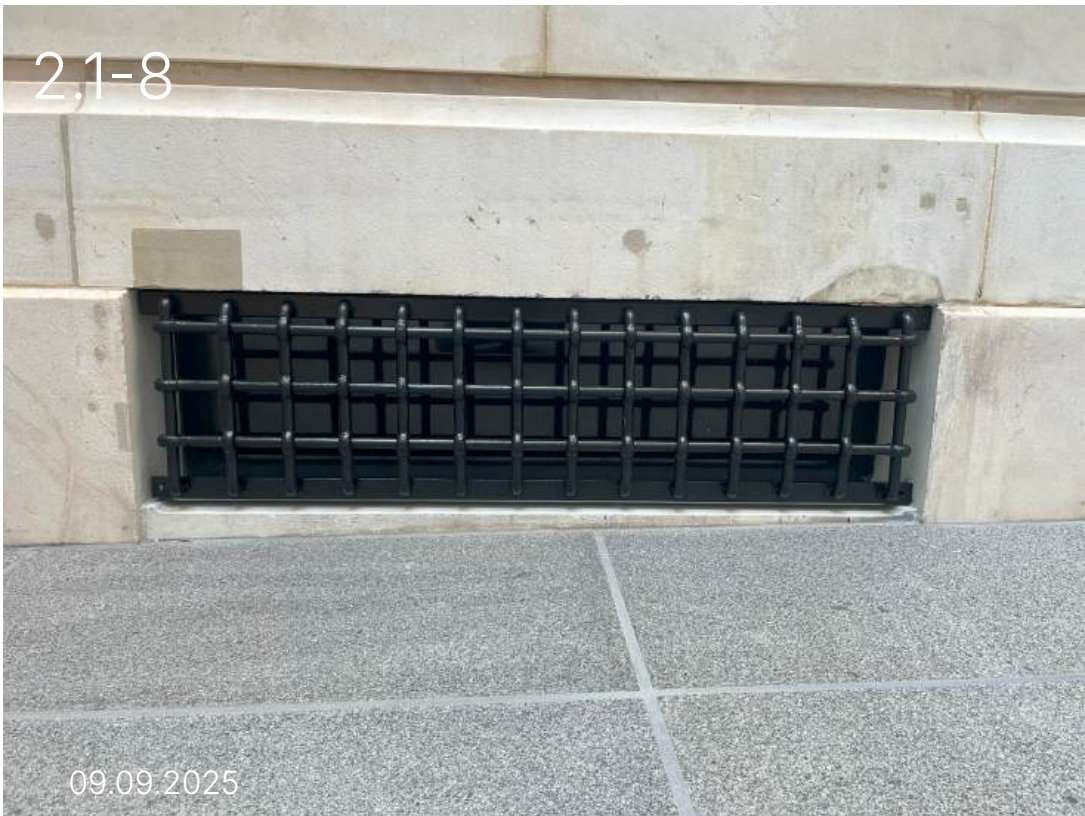
- 2.1-8 Low Windows**
- Removed ad hoc conduit at low windows.
 - Removed ahistorical security booth.
 - Window grilles cleaned and restored.

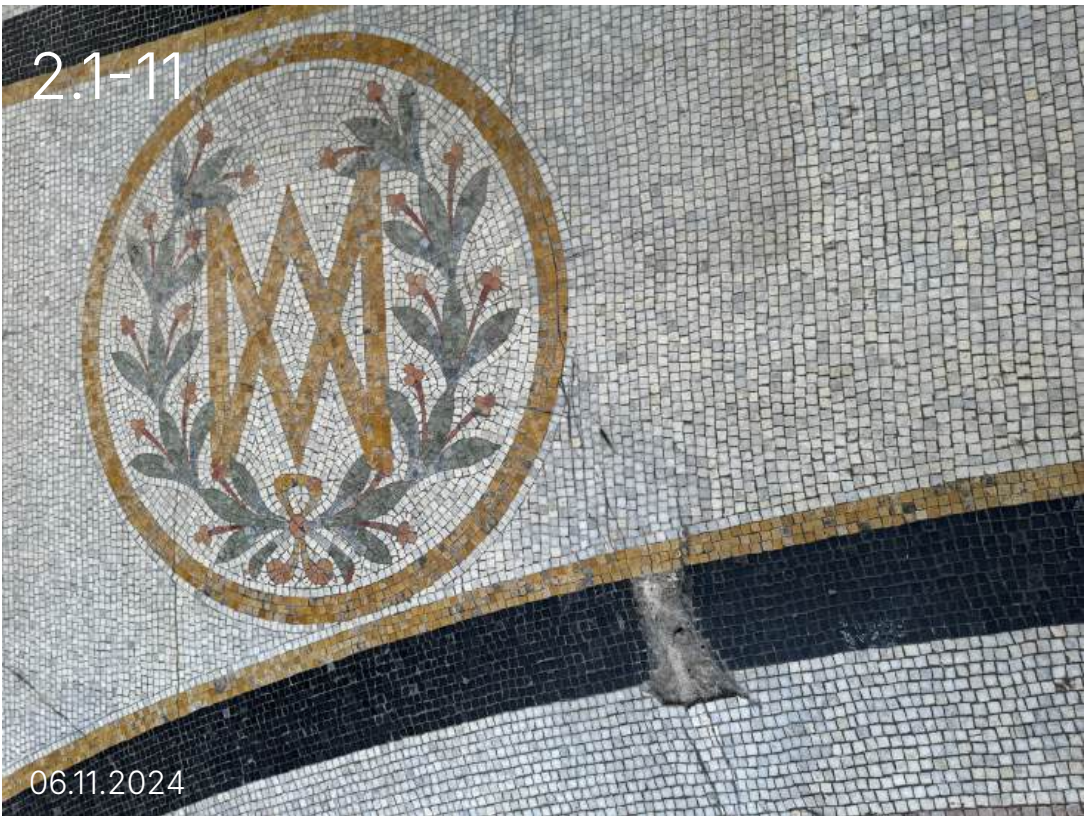
- 2.1-11 East Porch**
- Missing tiles to be replaced.
 - Significant cracking throughout to be repaired.
 - Stained tiles to be cleaned.
 - Restoration currently before LPC and Department of Buildings.

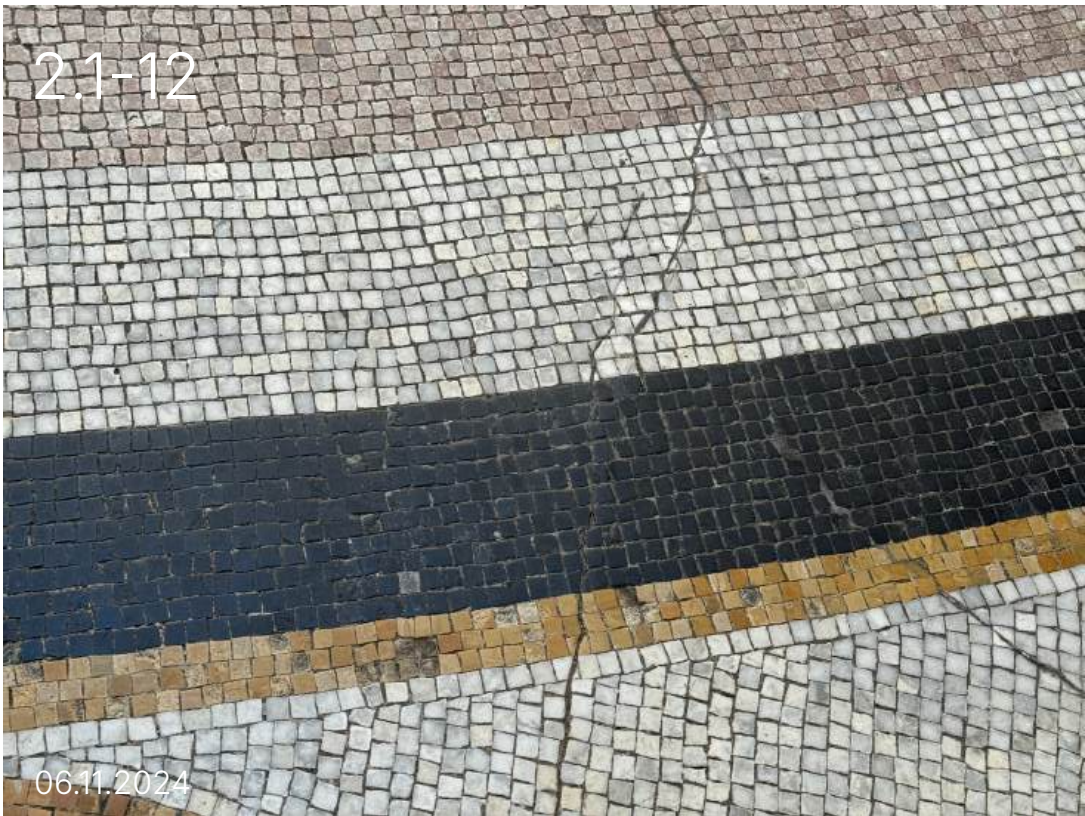
- 2.1-12 East Porch**
- Significant cracking throughout to be repaired.
 - Missing tiles to be replaced.
 - Restoration currently before LPC and Department of Buildings.

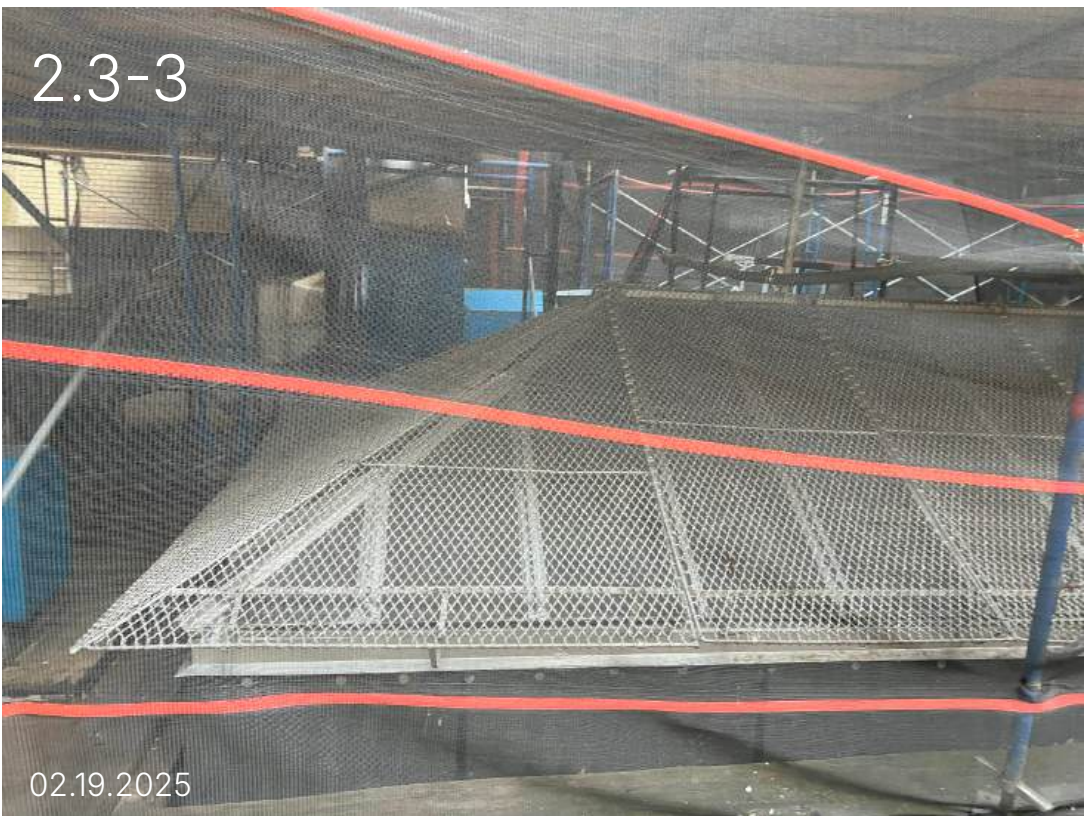
- 2.3-3 Library Roof - Skylight**
- Skylight under temporary protection due to ongoing work at the adjacent Hotel Pierre.
 - Adjacent flashing and waterproofing appeared to be in fair condition.

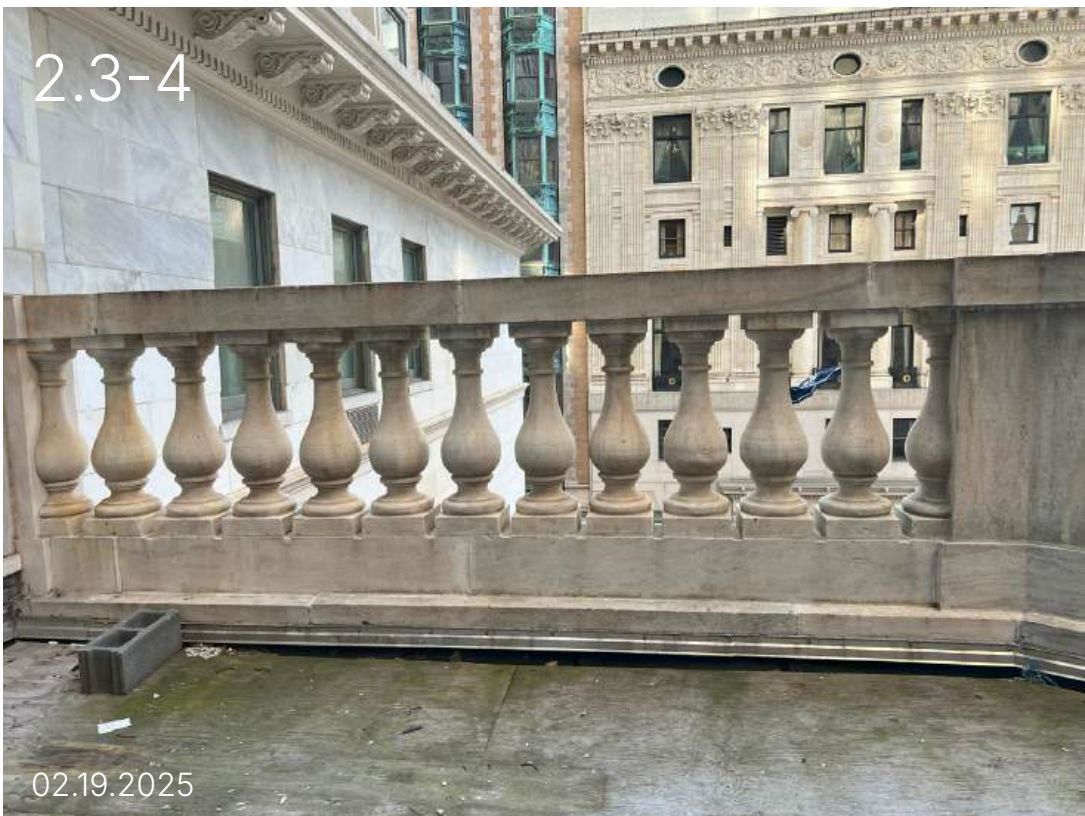
- 2.3-4 Library Roof - Balustrade**
- Courtyard facing balustrade restored and cleaned in 2023 and is in good condition.
 - Potential lighting behind balustrade planned.

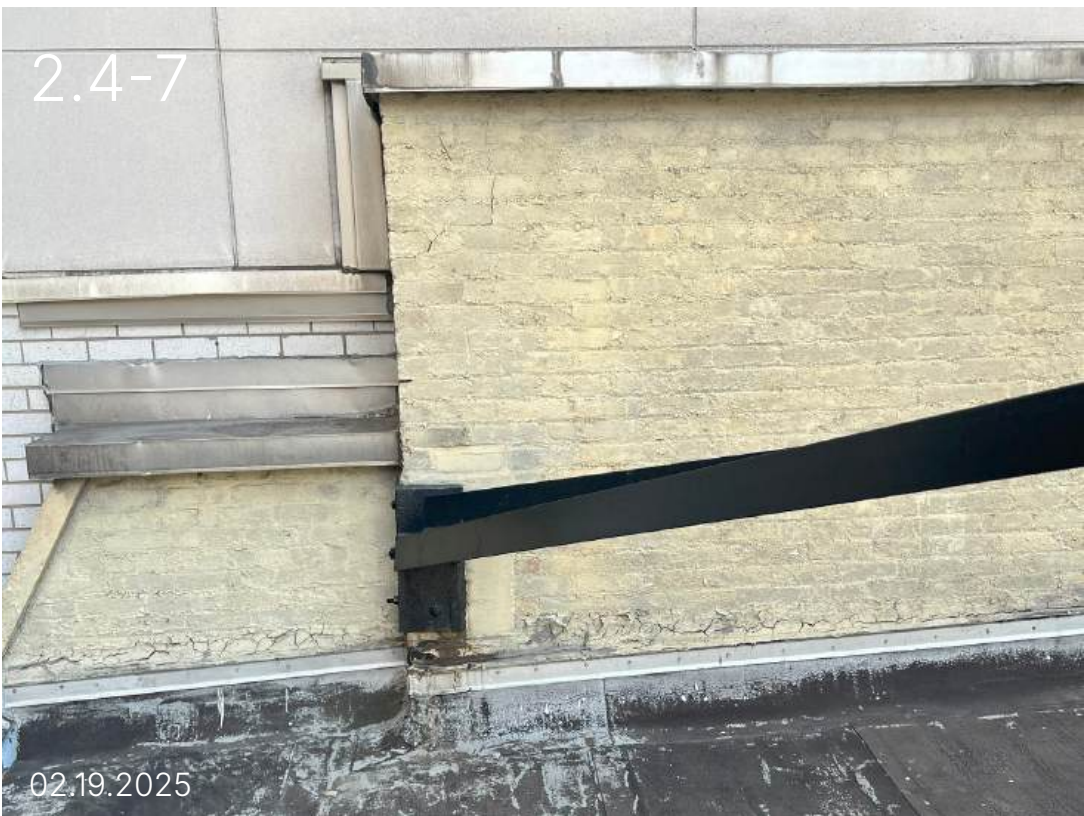
- 2.4-7 Roof - Parapet**
- Coping in good condition.
 - Paint peeling at select locations. Repaint as required.
 - Rust staining at select locations. Clean as required.
 - Flashing in good condition.

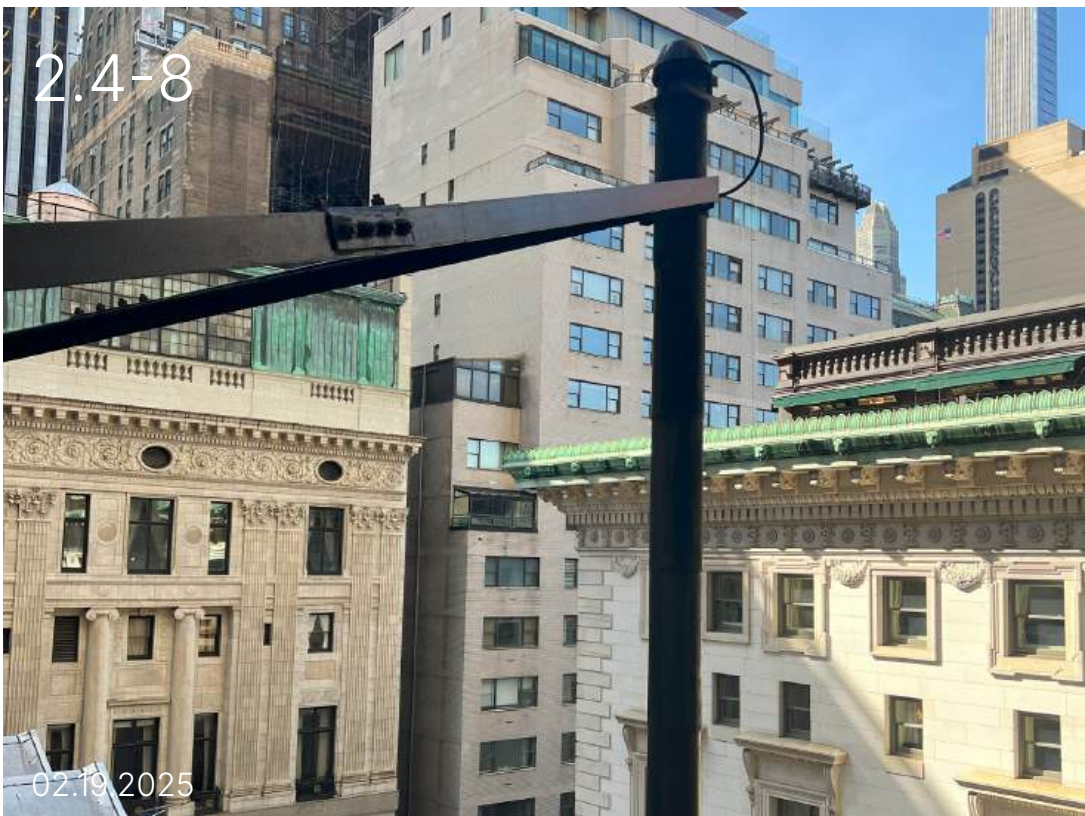
- 2.4-8 Roof - Chimney and Support**
- Support observed to be in good condition.
 - Slight rusting on structural support.
 - Chimney observed to be in good condition.

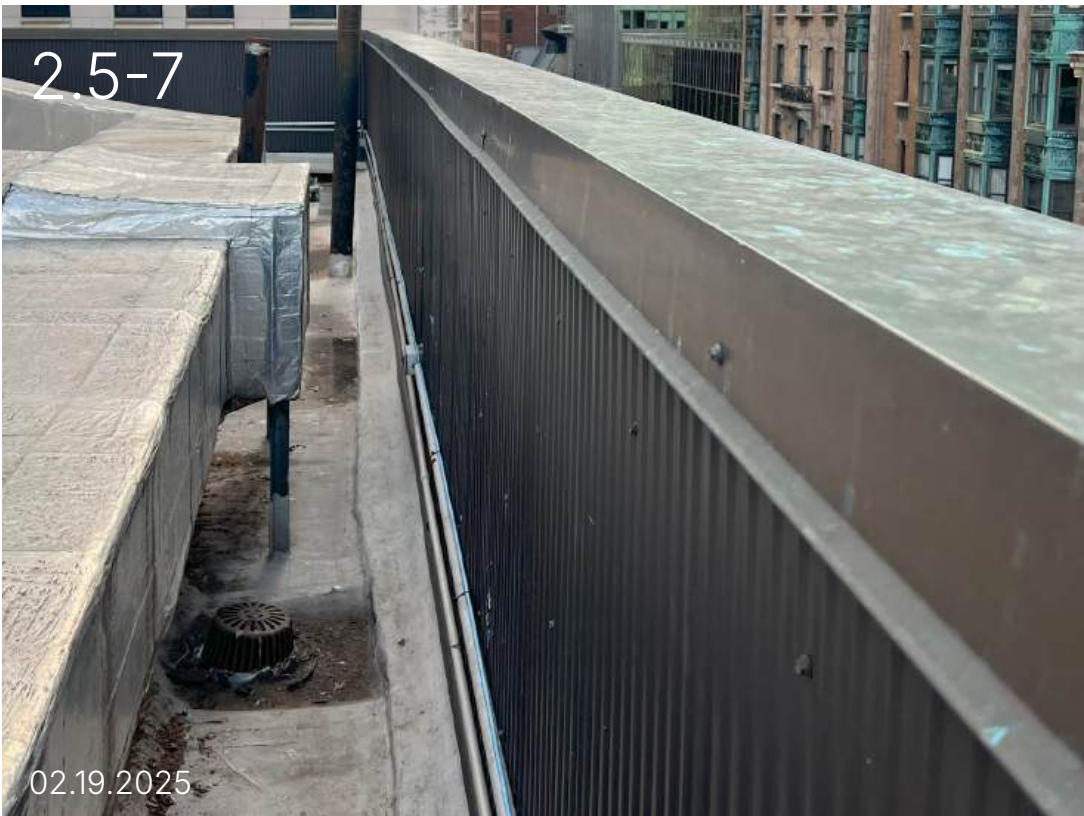
- 2.5-7 Roof Parapet**
- Cladding, coping and waterproofing in generally good condition.
 - Light selective cleaning in the future.

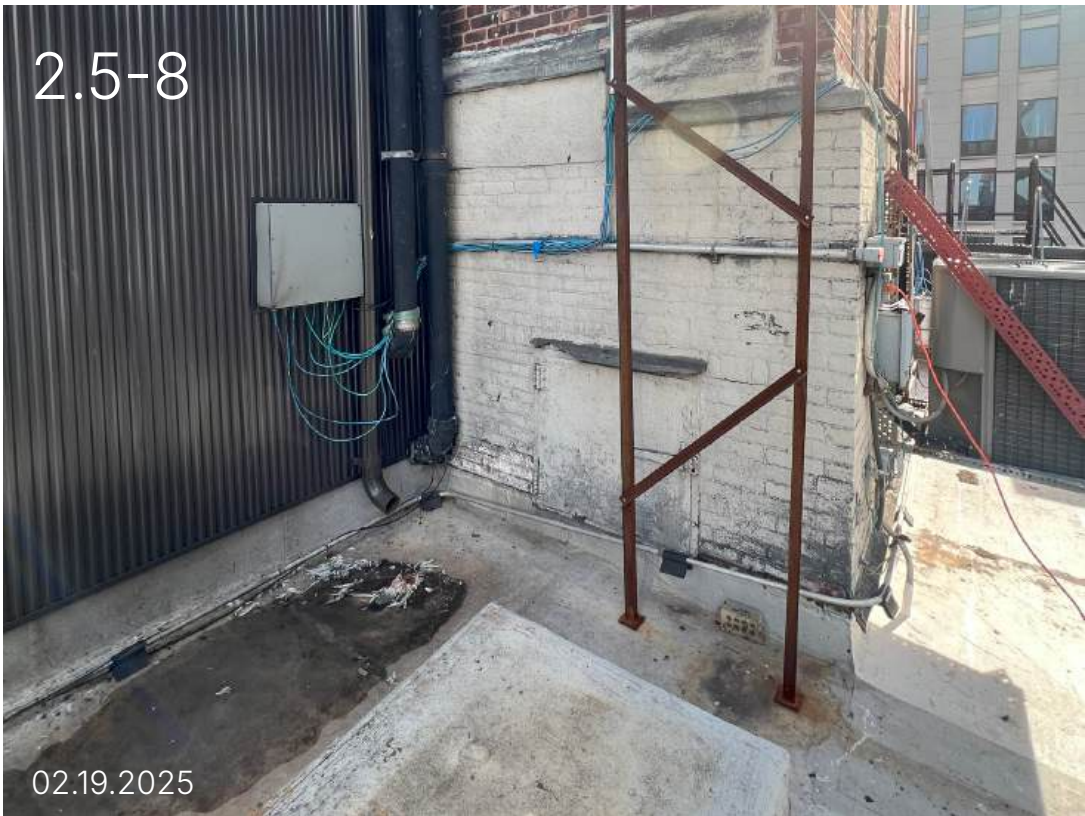
- 2.5-8 Roof at Bulkhead**
- Waterproofing in good condition.
 - Ponding in select locations.
 - Waterproofing and coping in good condition.
 - Peeling paint on brick. Repaint as required.
 - Wiring to be concealed and protected.

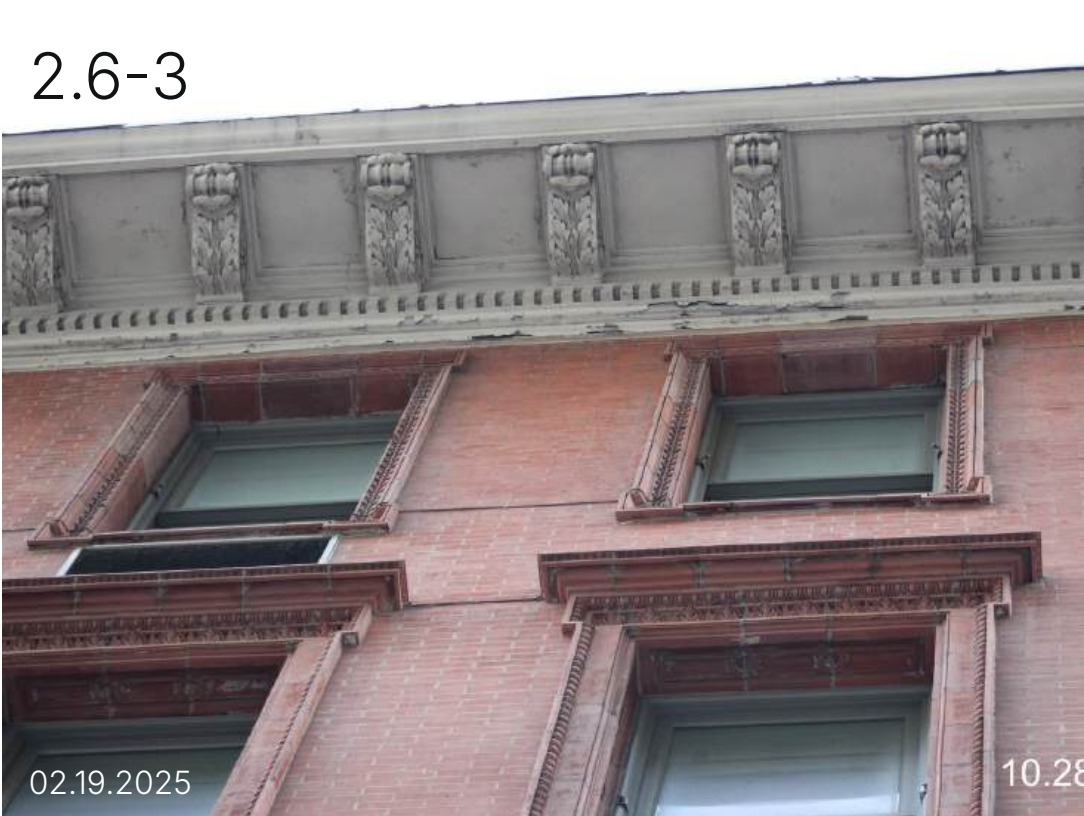
- 2.6-3 Annex - South Facade**
- Repaint cornice.
 - Brick in generally good condition. Repoint as required.
 - Terracotta window surrounds in fair condition. Repair/patch as required.

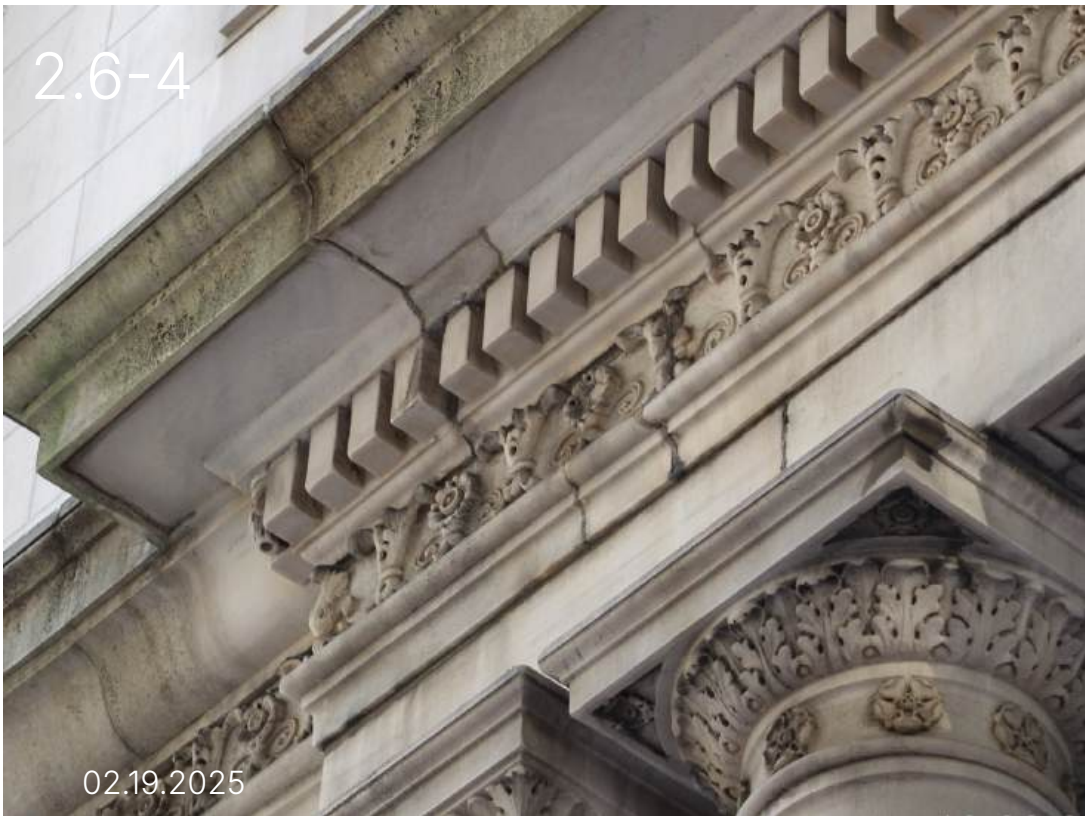
- 2.6-4 Portico Cornice**
- Masonry in generally good condition.
 - Repoint joints as required.
 - Clean dirt on cornice.
 - Patch spalls in stone ornament/reform reliefwork as required.

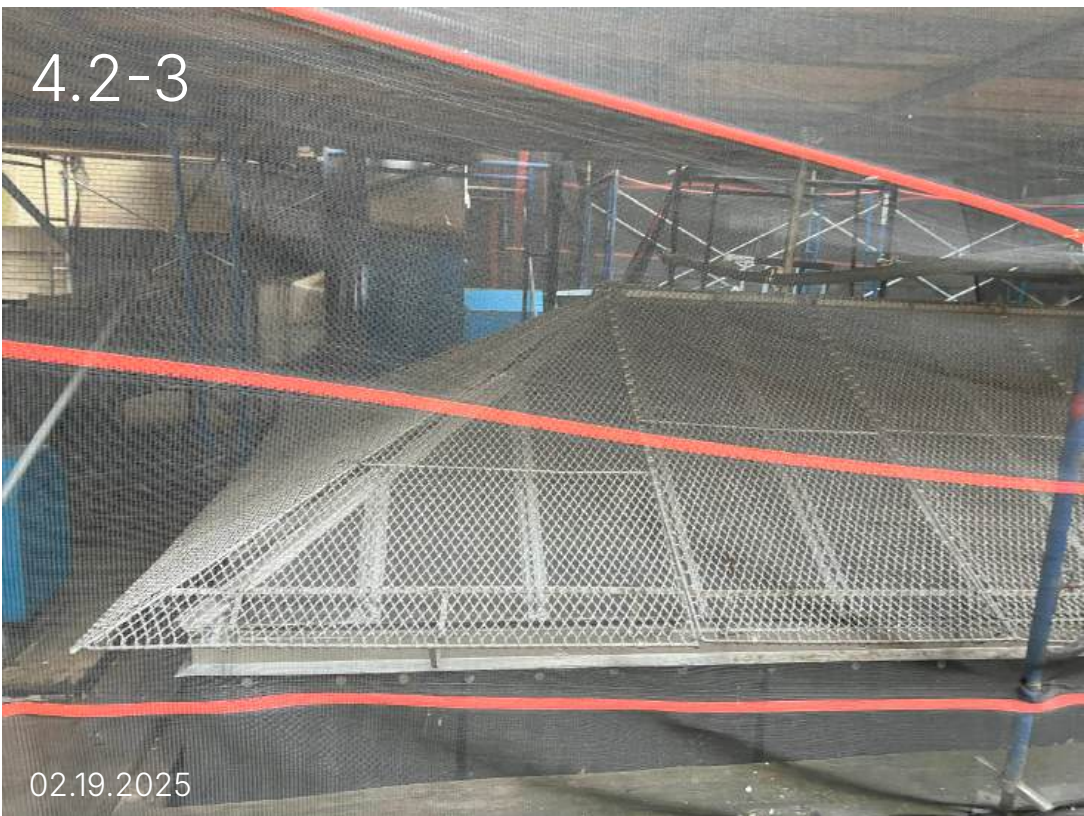
- 4.2-3 Library Roof - Skylight**
- Skylight under temporary protection due to ongoing work at the adjacent Hotel Pierre.
 - Adjacent flashing and waterproofing appeared to be in fair condition.

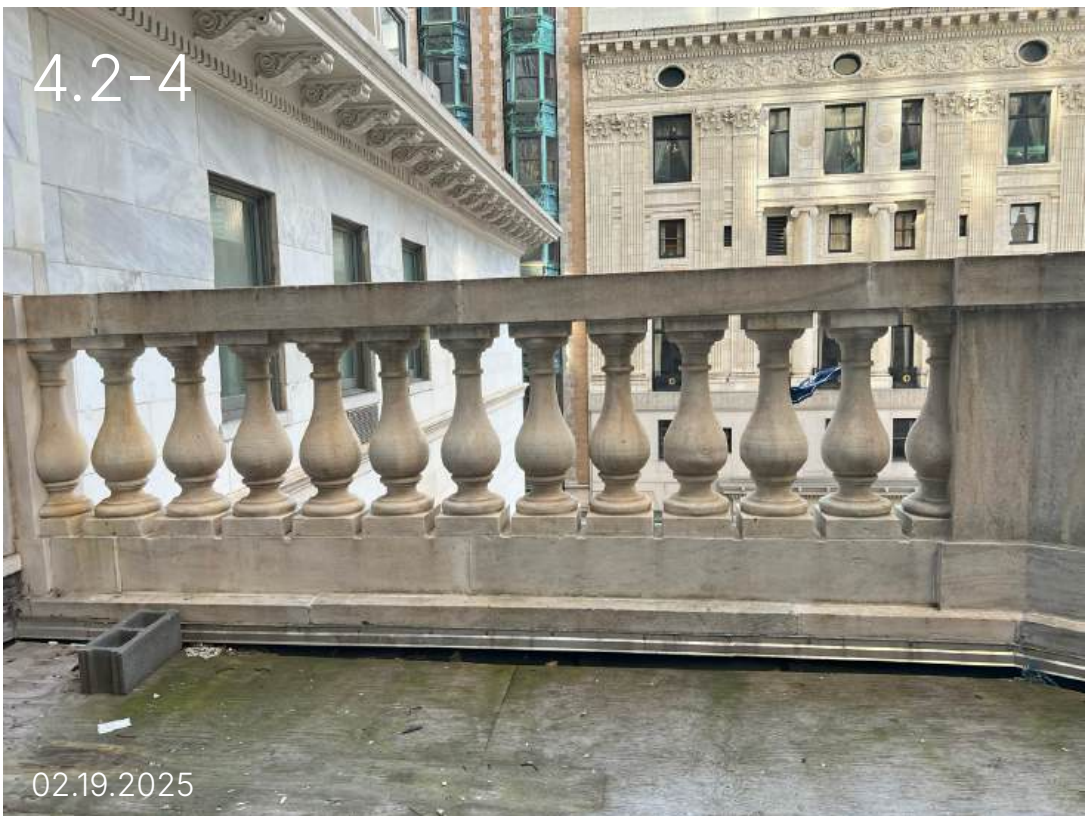
- 4.2-4 Library Roof - Balustrade**
- Courtyard facing balustrade restored and cleaned in 2023 and is in good condition.
 - Potential lighting behind balustrade planned.

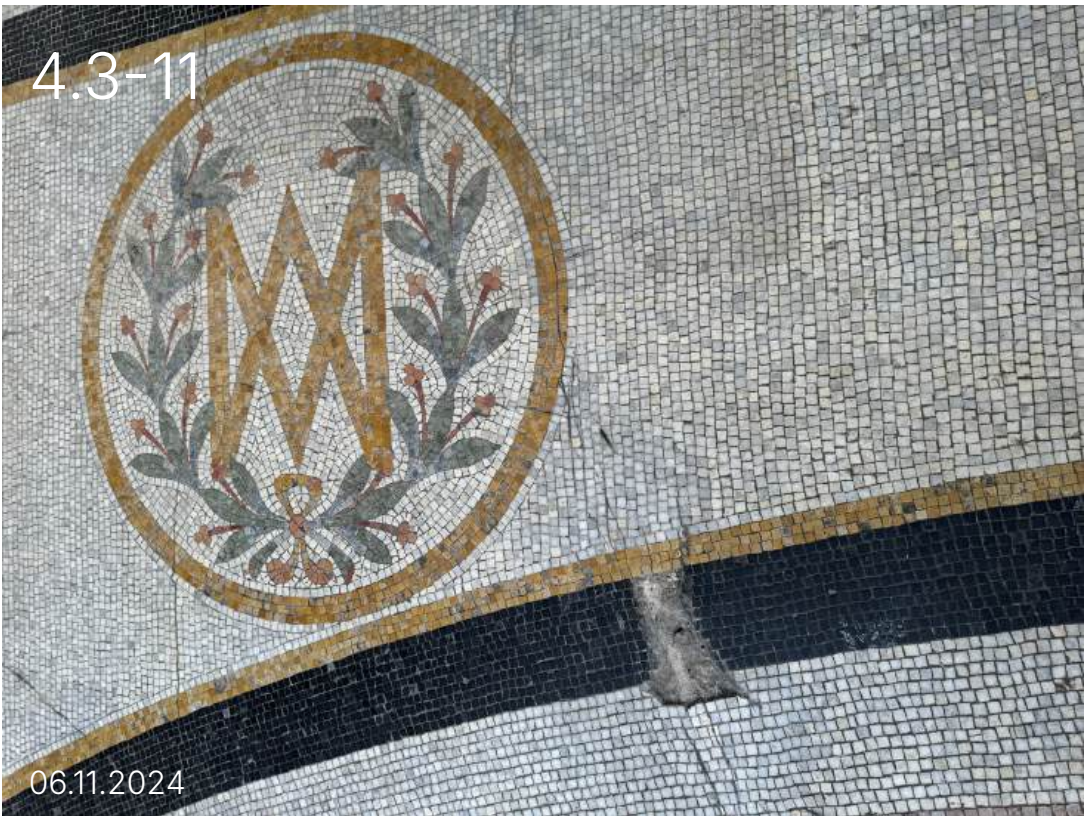
- 4.3-11 East Porch**
- Large areas of missing tiles
 - Significant cracking throughout.
 - Stained tiles.
 - Restoration currently before LPC and Department of Buildings.

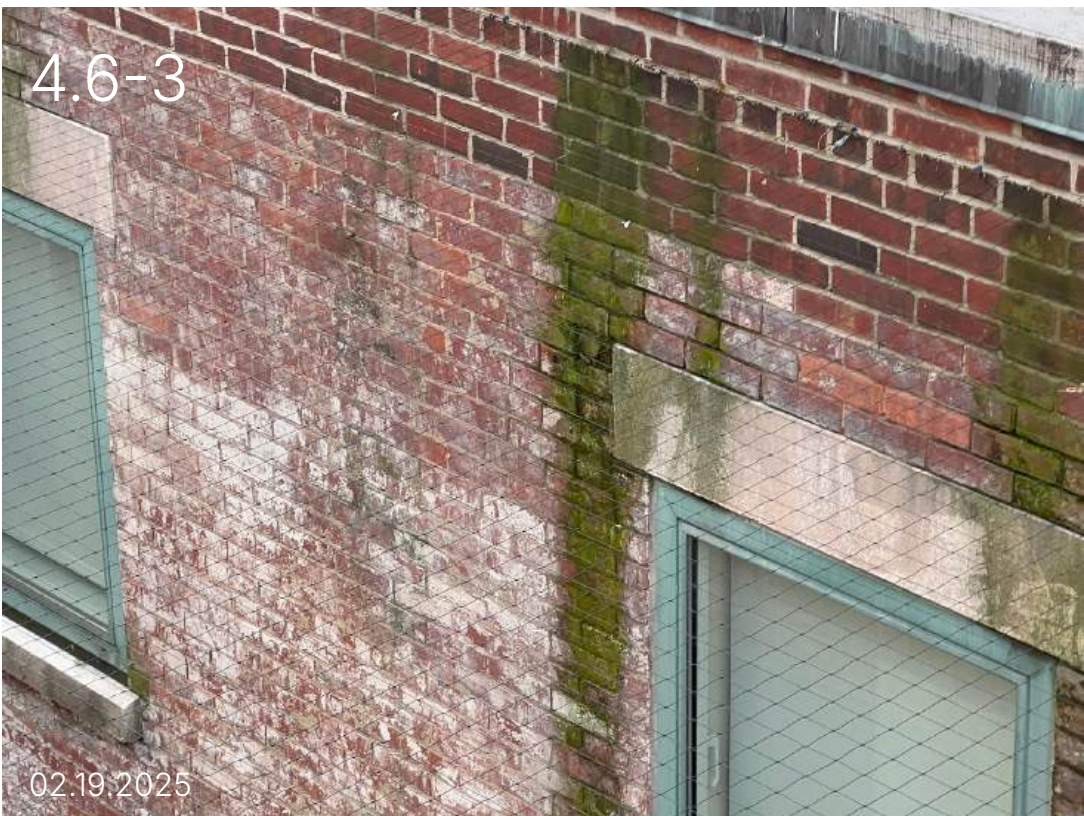
- 4.6-3 Light well Facade
- Organic growth observed
 - Efflorescence
 - Mortar deterioration in select areas

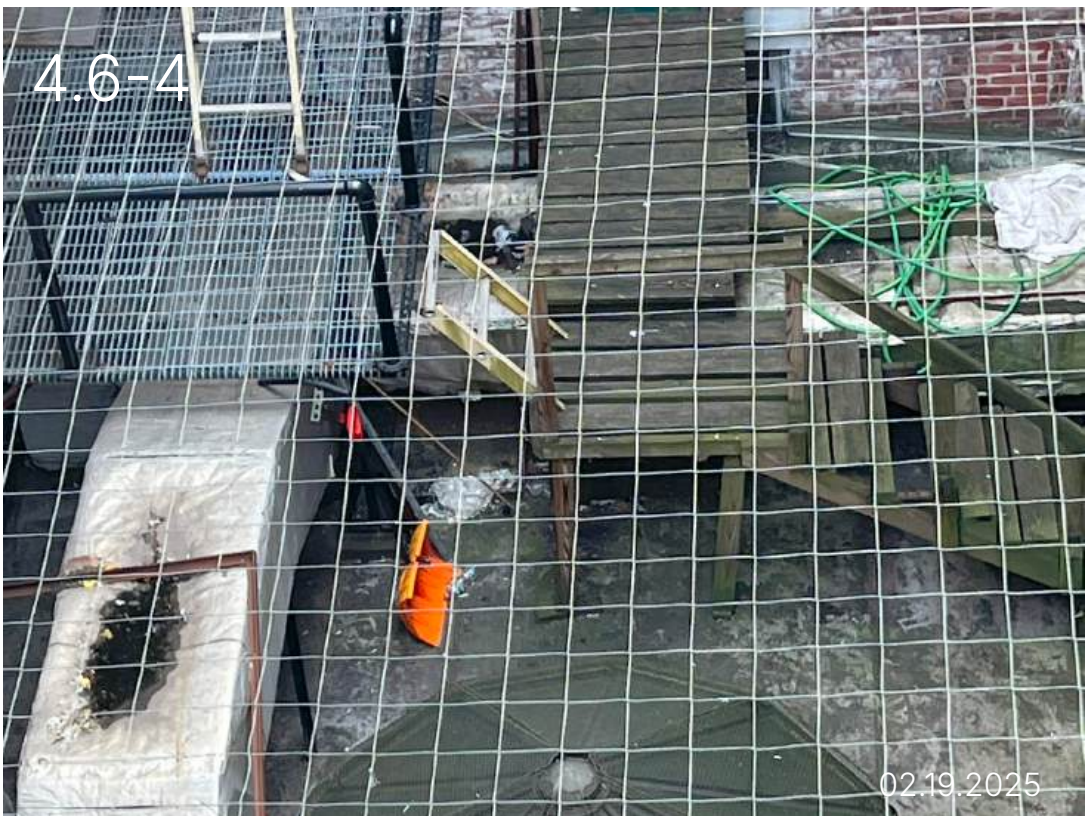
- 4.6-4 Light well
- Wooden duct access platform requires repair.
 - Ponding on duct run and depressed duct insulation.
 - Skylight protection and waterproofing observed to be in good condition.
 - Future plans to electrically illuminate skylights for evening events.

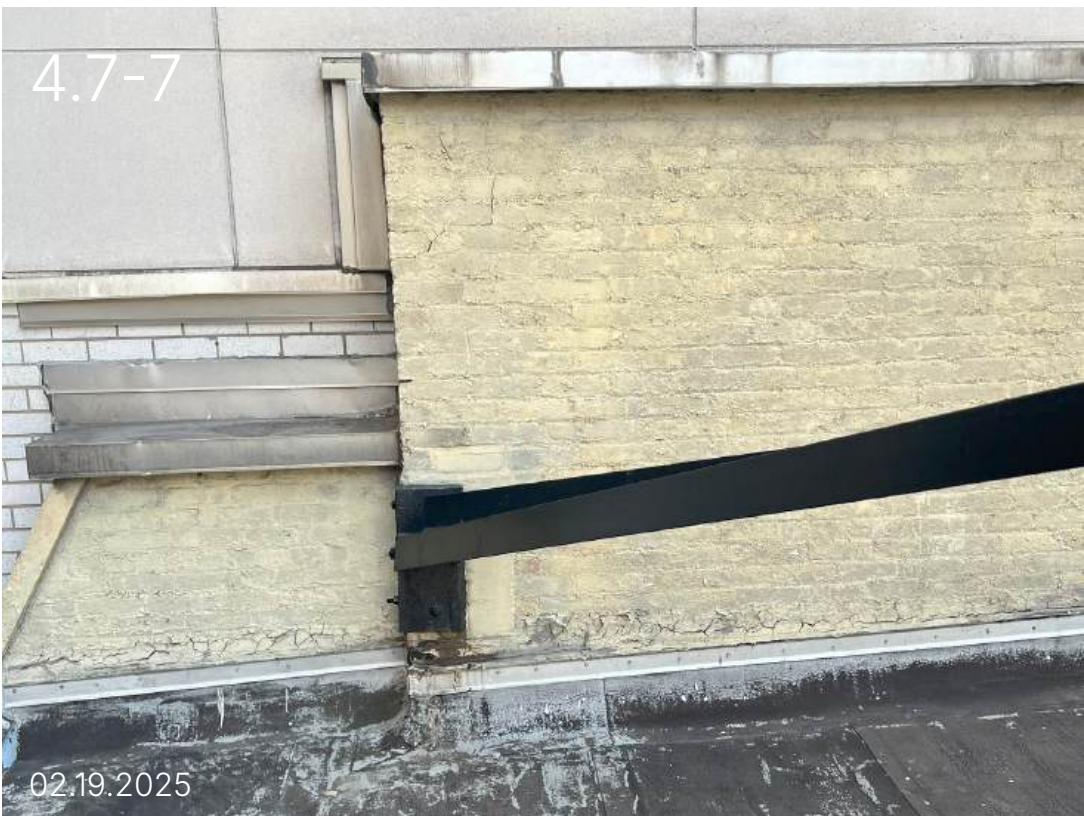
- 4.7-7 Roof - Parapet**
- Coping in good condition.
 - Paint peeling at select locations.
 - Rust staining at select locations.
 - Flashing in good condition.

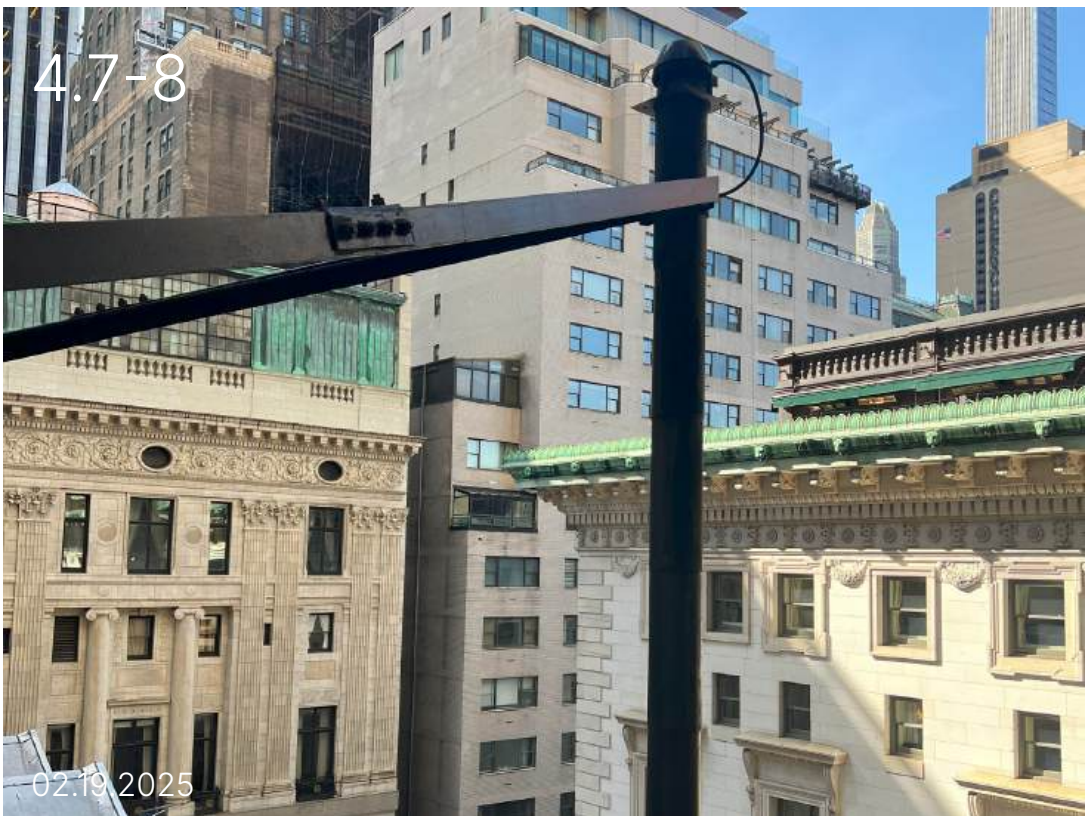
- 4.7-8 Roof - Chimney and Support**
- Support observed to be in good condition.
 - Slight rusting on structural support.
 - Chimney observed to be in good condition.

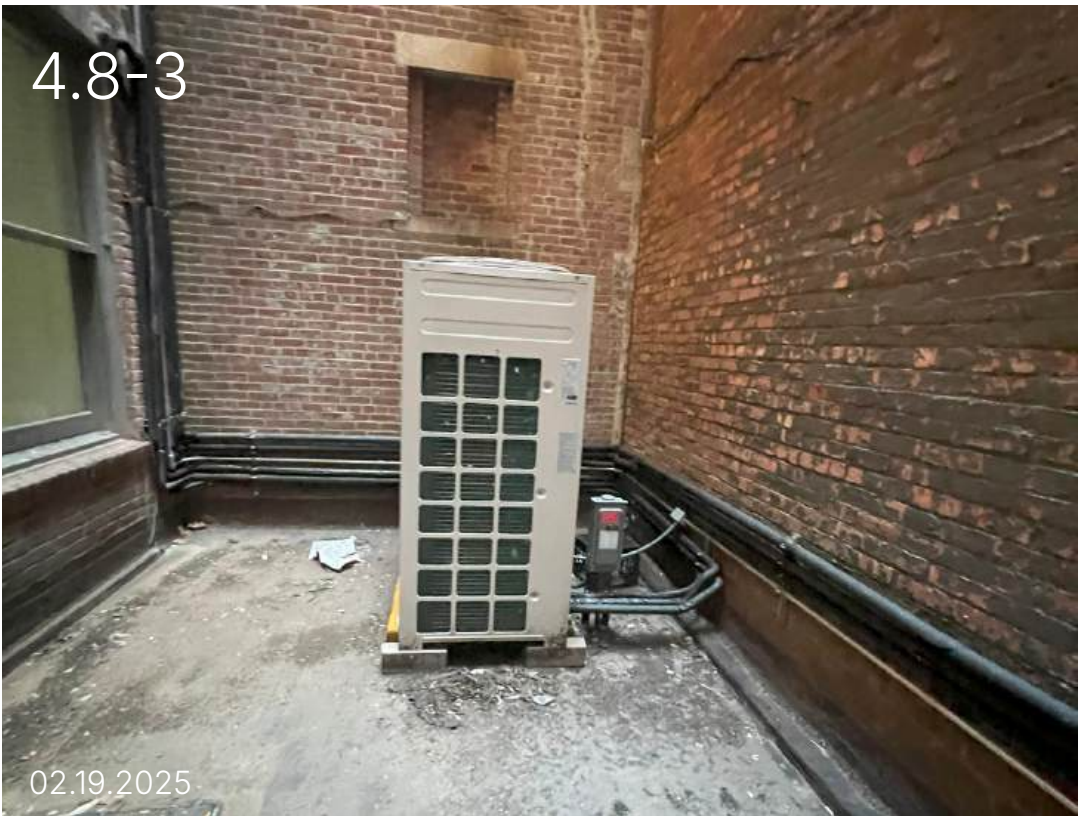
- 4.8-3 Annex Wing Rear Facade
- Back areaway in reasonable condition.
 - Mechanical equipment in good condition.

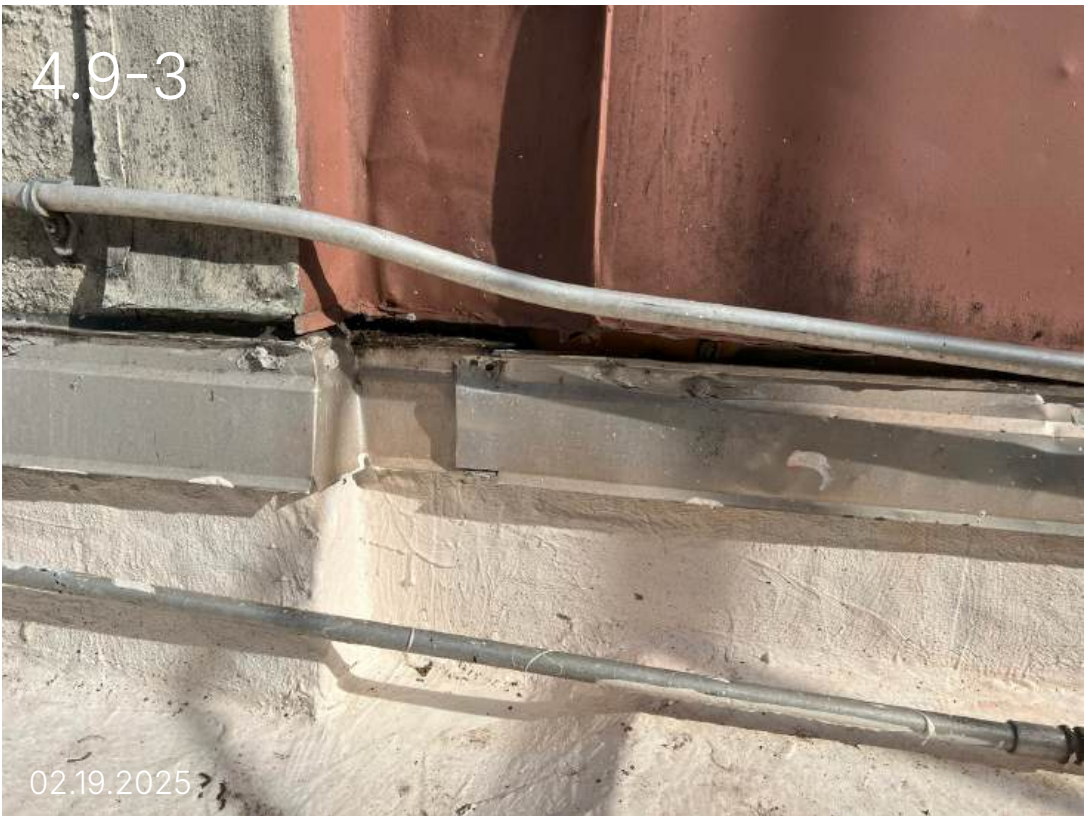
- 4.9-3 Bulkhead
- Base flashing in good condition.

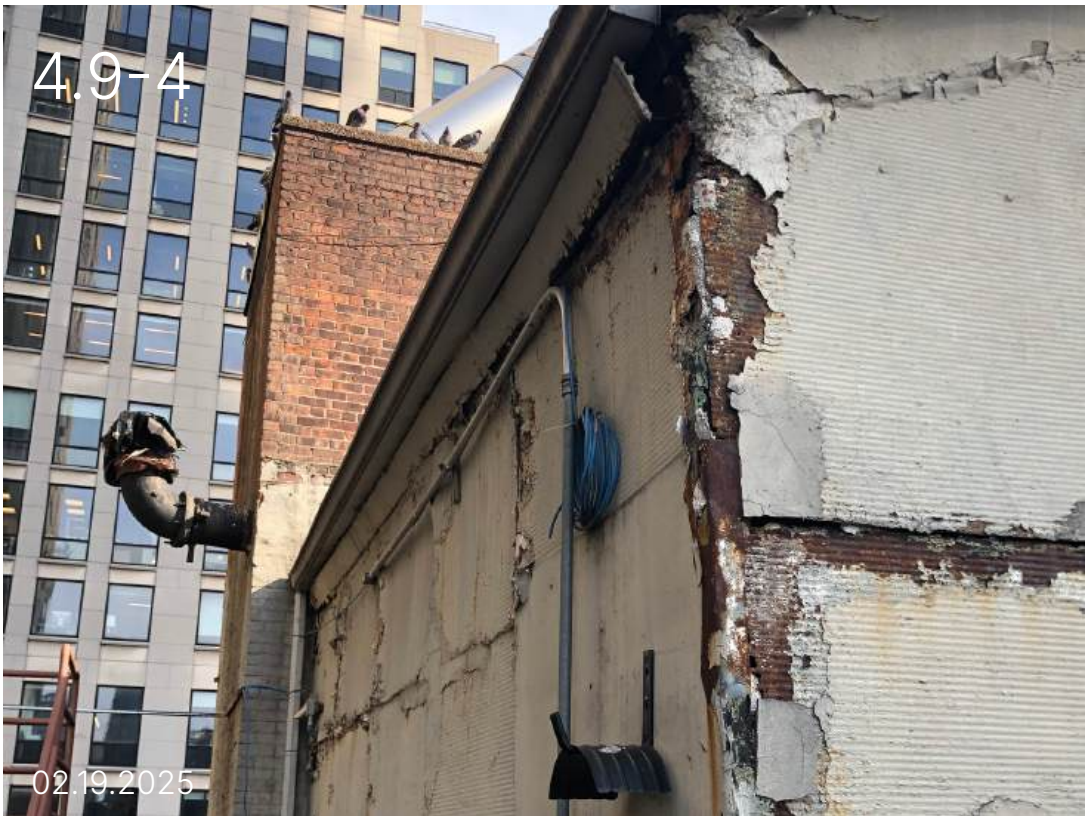
- 4.9-4 Bulkhead
- Deteriorated stucco to be repaired.
 - Delaminating fascia to be repaired.
 - Cracked brick to be restored as required.
 - Damaged MEP systems to be replaced.

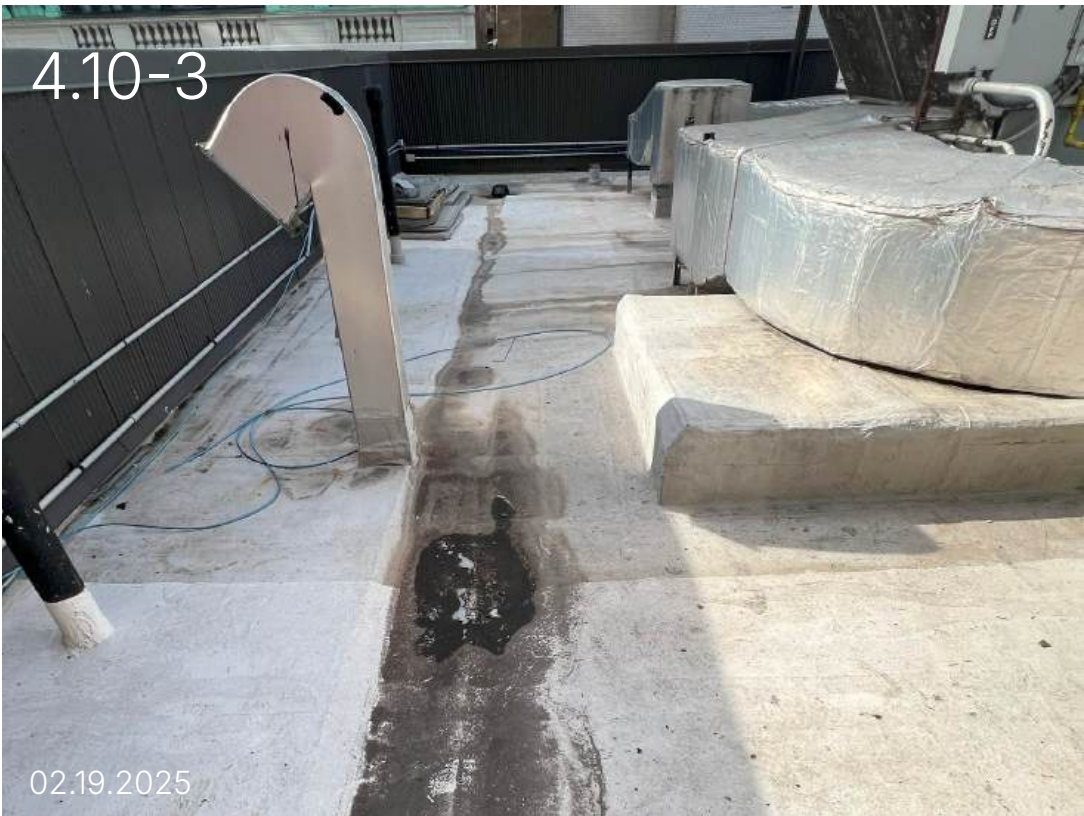
- 4.10-3 Roof
- Waterproofing and HVAC equipment in good condition.
 - Some ponding along direction to drain.

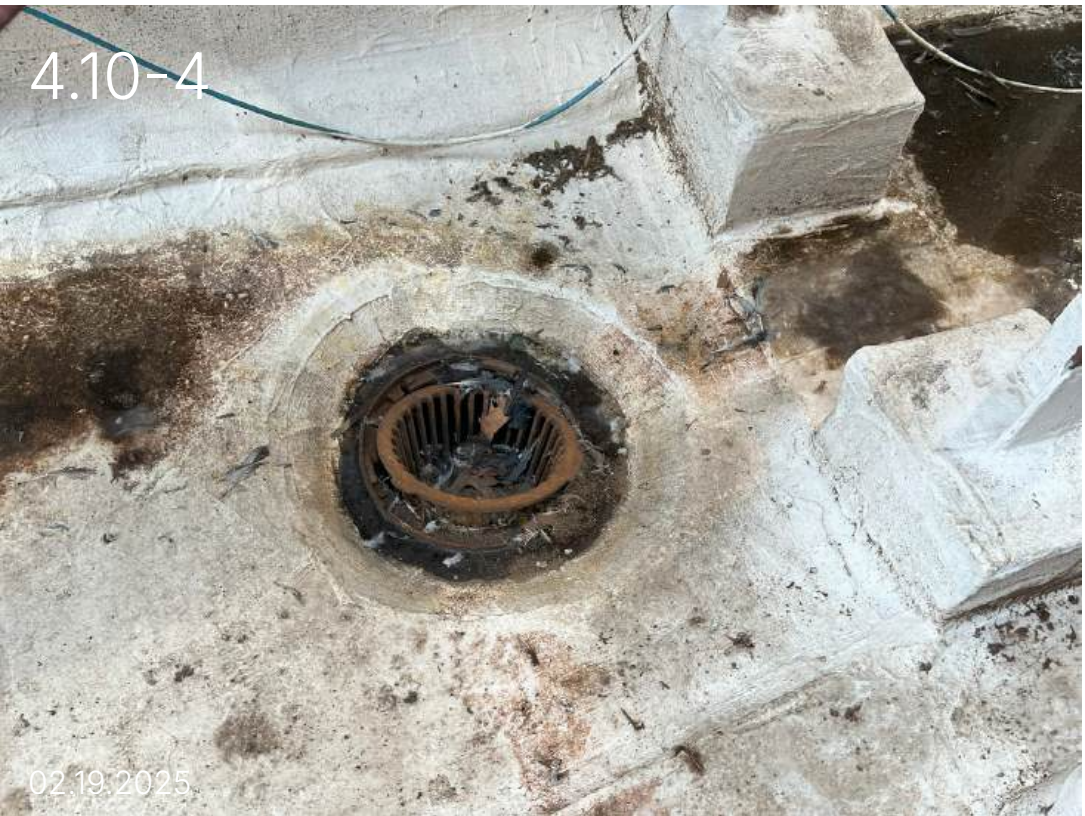
- 4.10-4 Roof
- Drain scupper overturned at one location.
 - Waterproofing in good condition.
 - Cracked brick.
 - Damaged MEP systems.
