**1 East 60th Street – Upper East Side Historic District
Borough of Manhattan**

The Metropolitan Club

Presentation for Landmark Restoration and Proposed Capital Work

4.0 Appendix A: Existing Conditions Report

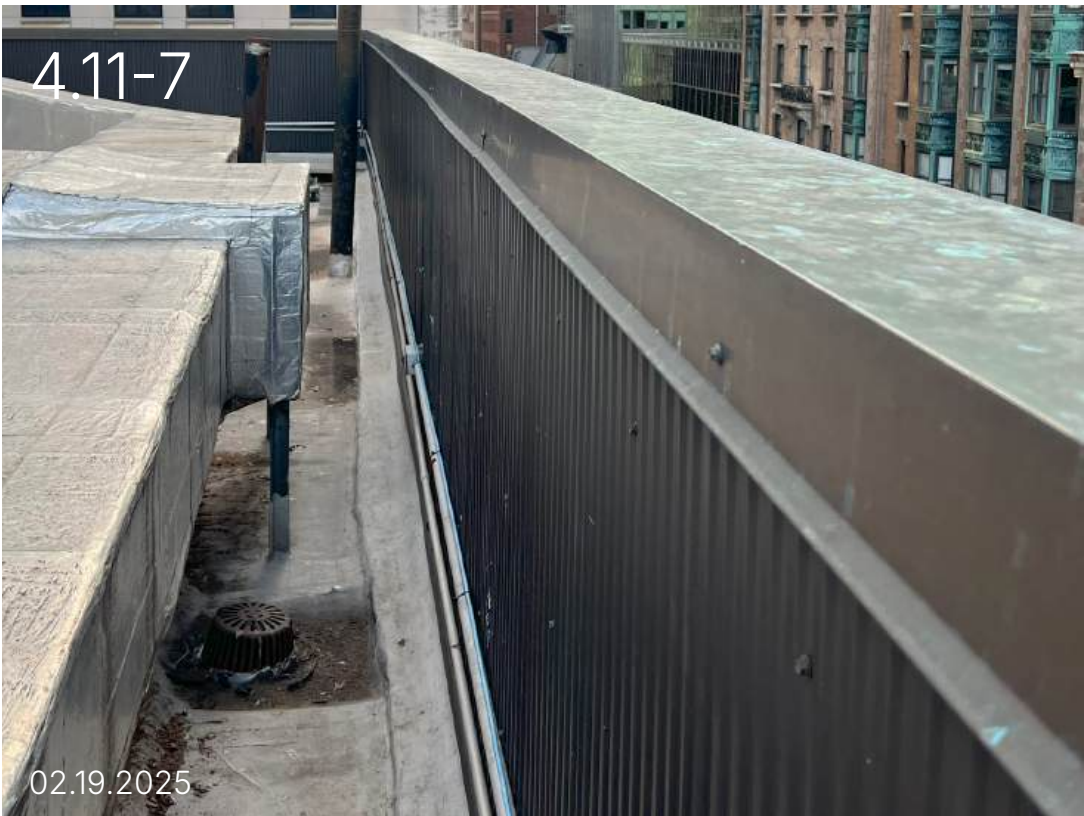
- 4.11-7 Roof Parapet**
- Cladding, coping and waterproofing in generally good condition.
 - Light selective cleaning in the future.

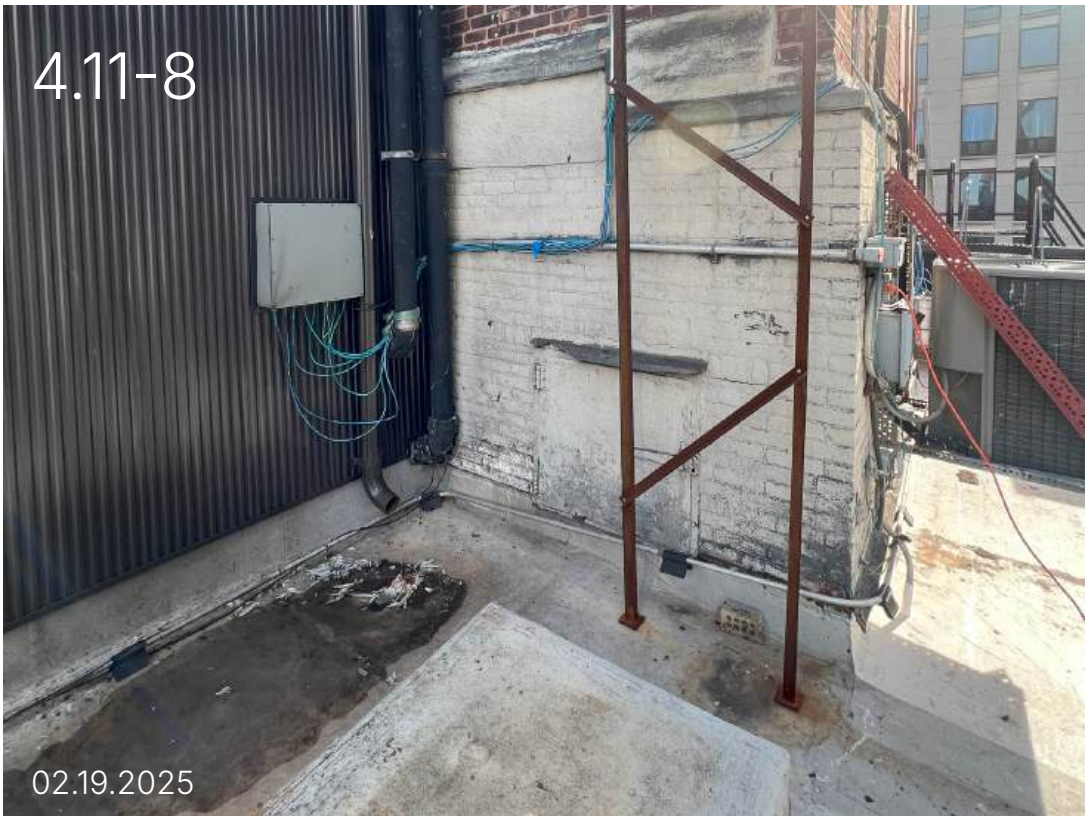
- 4.11-8 Roof at Bulkhead**
- Waterproofing in good condition.
 - Ponding in select locations.
 - Waterproofing and coping in good condition.
 - Peeling paint on brick.
 - Wiring to be concealed and protected.

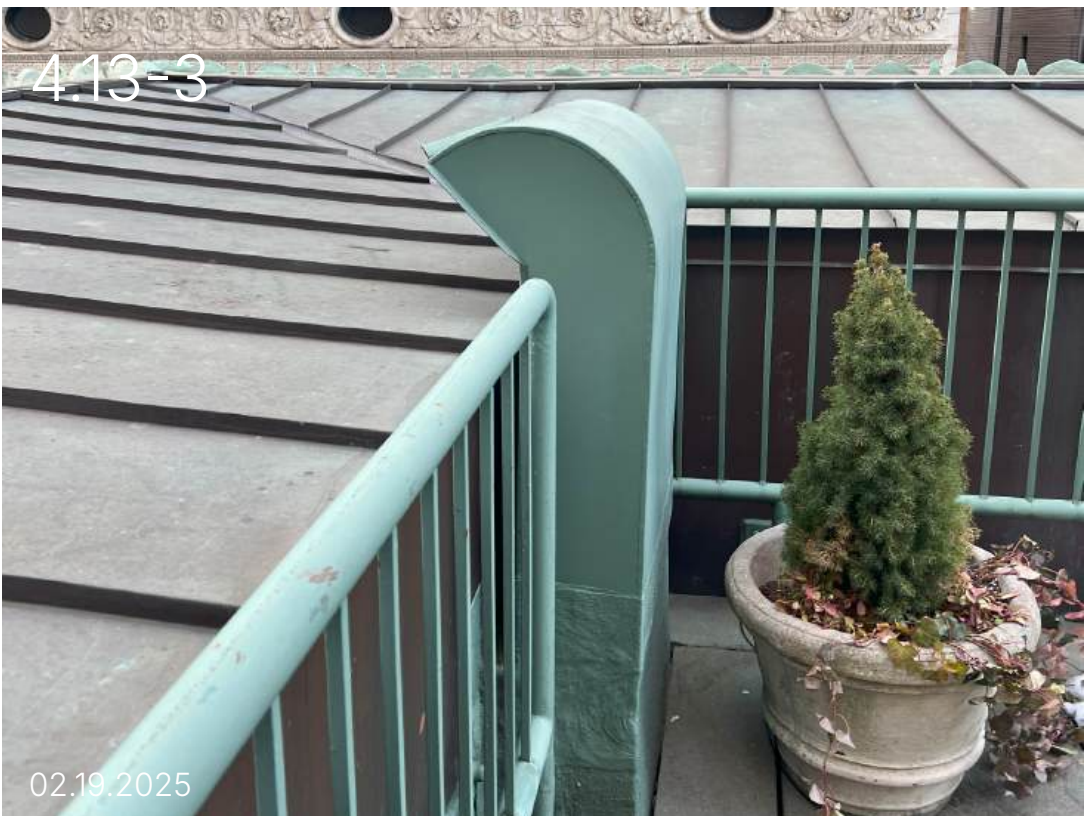
- 4.13-3 6th Floor Terrace**
- Flashing, Ductwork, and cornice in good condition.
 - Selective repainting of guard rail in the future.
