Preservation Department – Item 8, LPC-26-02128

# 390 Fifth Avenue – Gorham Building – Individual Landmark Borough of Manhattan

#### **ZR Section 75-422**

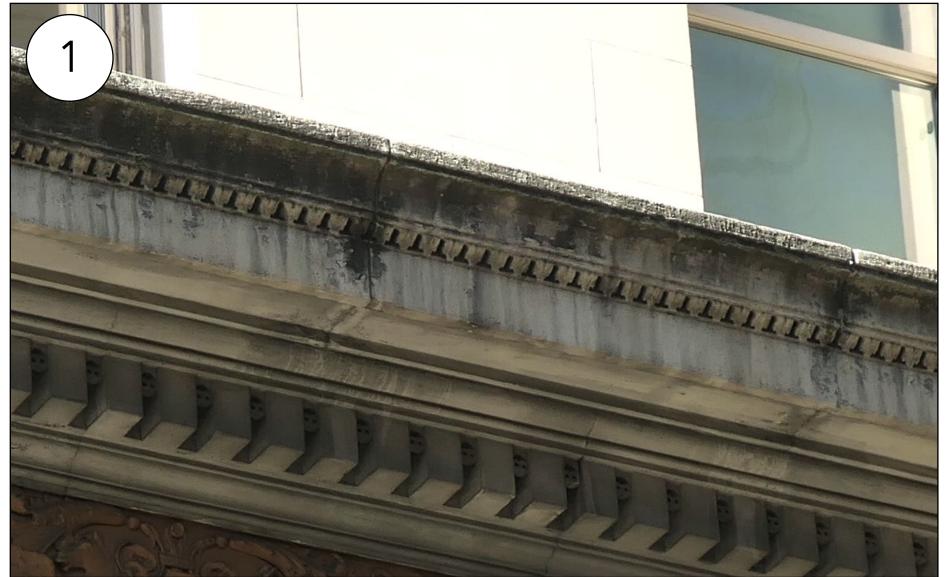
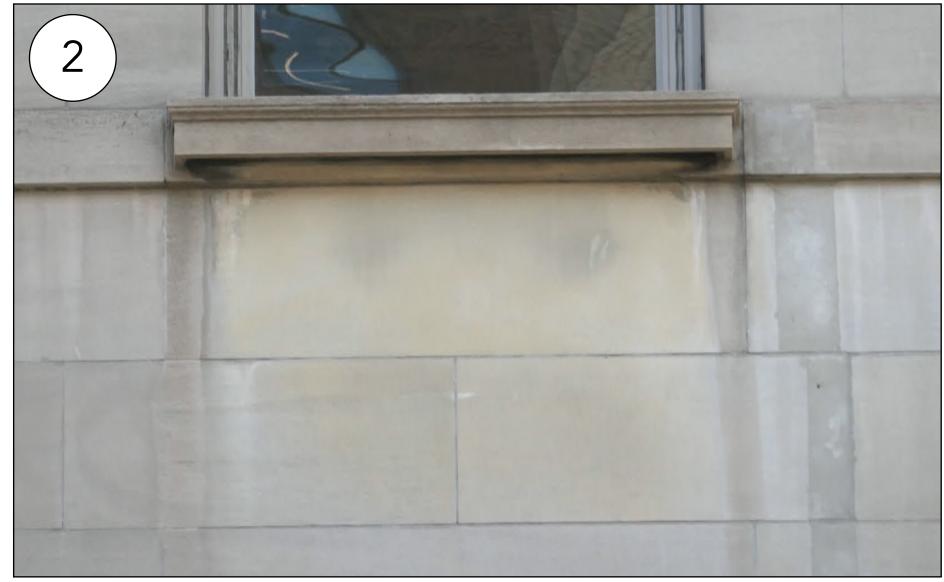
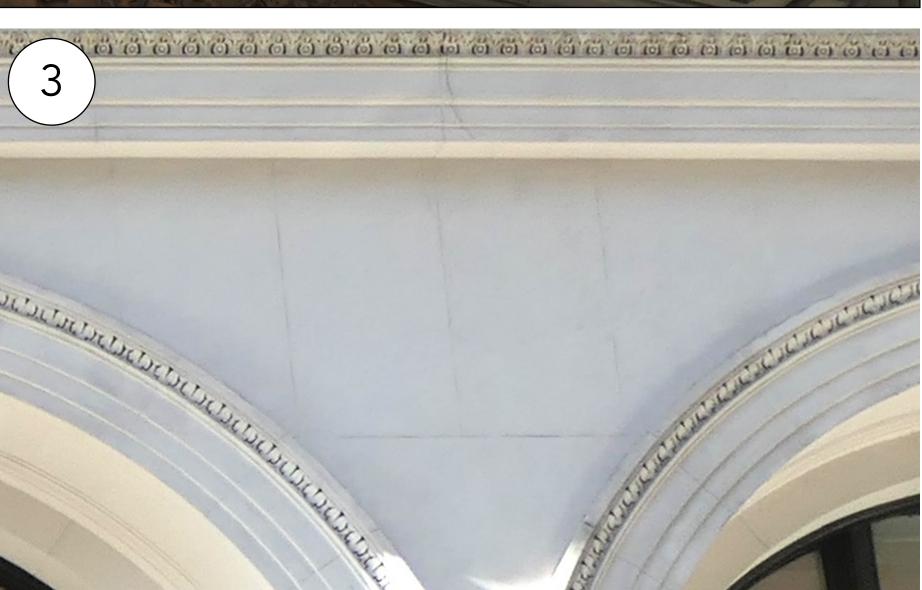
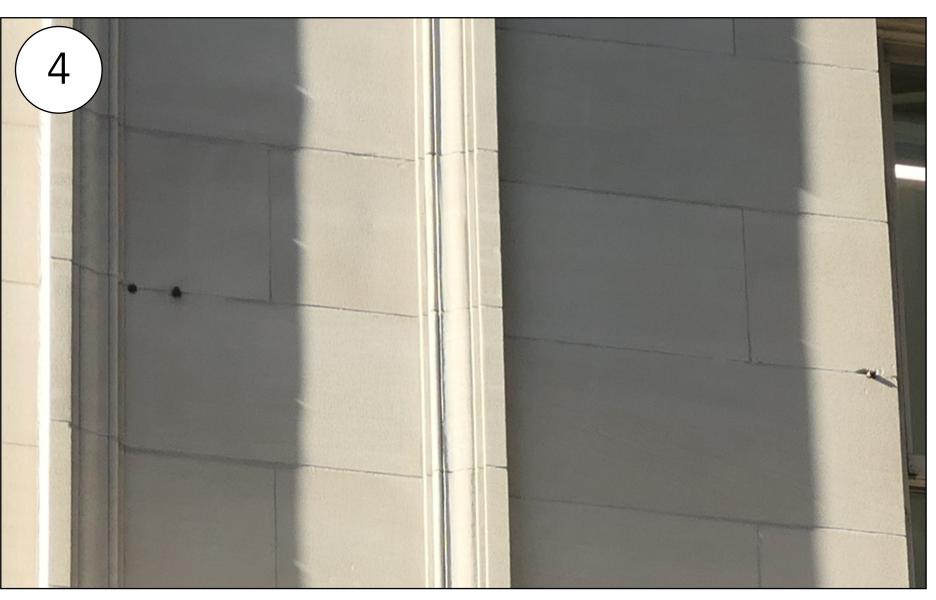
#### **LIMESTONE CONDITIONS**

- Coating deterioration, carbon deposits, and biological growth are evident at the limestone storefront cornice.
- 2 Staining and discoloration are visible at limestone units throughout the facades.
- Limestone cracking is visible through coated limestone at the building base.
- Anchor holes and un-used metal anchors are found throughout the facades.

- O Remove coating, soiling, and biological growth at limestone elements with appropriate paint stripper and chemical cleaner(s)
- Repair cracked and/or spalled limestone with restoration-grade repair mortar
- Repoint limestone joints with mortar matching the historic (a mortar analysis will be required)
- O Remove coating at bronze frieze with appropriate paint stripper and restore original bronze finish
- O At corner of storefront cornice, paint concrete patch to match adjacent material

- Repair cracked and/or spalled limestone units with restoration-grade repair mortar
- o Replace limestone units damaged beyond repair with new limestone dutchmen
- O Replace non-matching limestone unit repairs with new patches or limestone dutchmen
- Repoint limestone joints, as required, with mortar matching the historic (a mortar analysis will be required)
- O Remove misc. metal anchors and repair holes

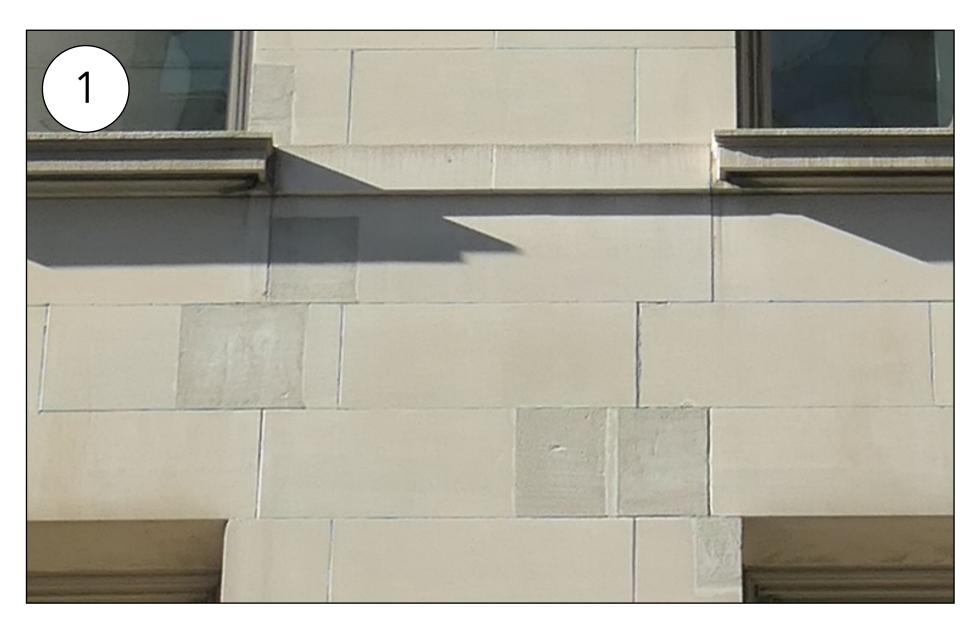
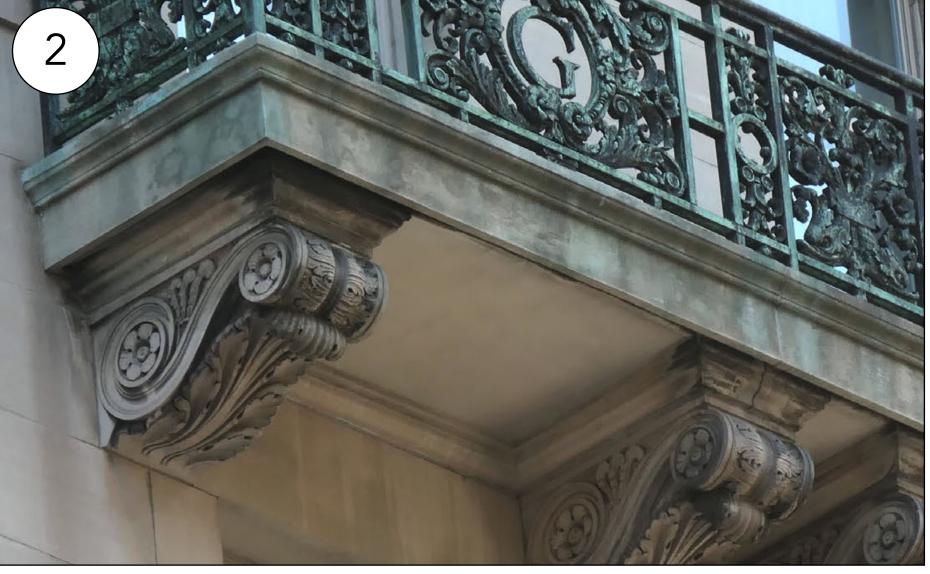
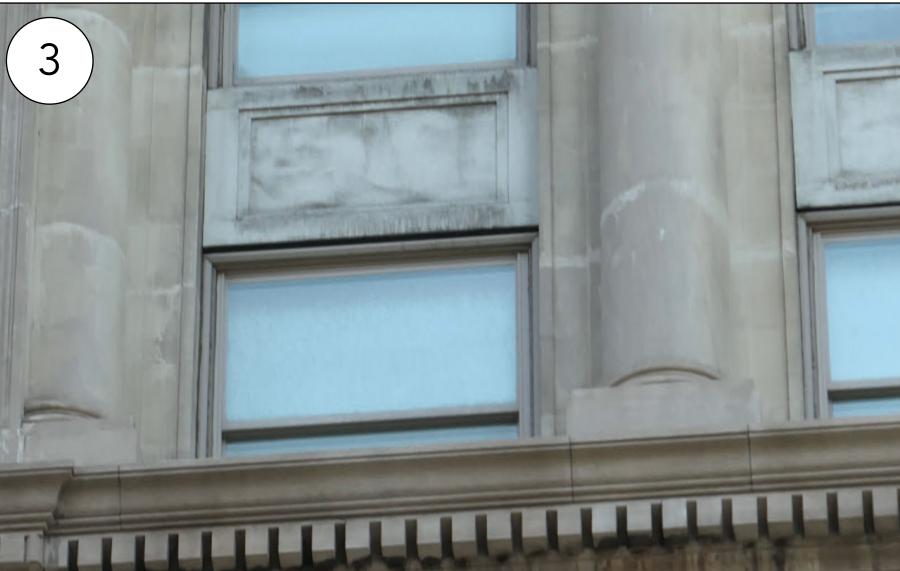
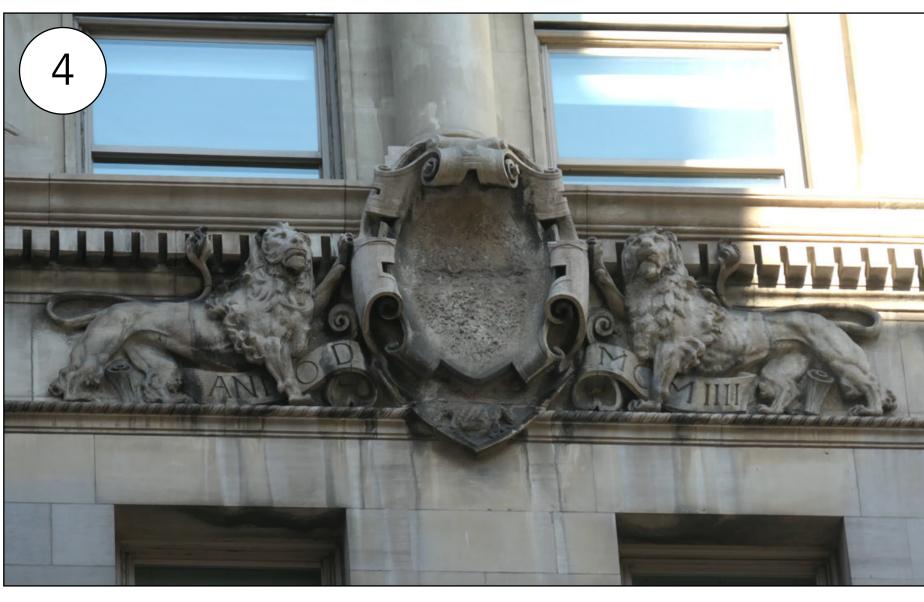
#### **LIMESTONE CONDITIONS**

- Previous patch repairs do not match the existing limestone, and open joints are evident throughout the facades.
- 2 Runoff from patinated bronze balcony railings is staining the limestone platforms and brackets.
- Limestone spandrel panels at the loggia have been coated and do not match the historic limestone facade.
- Limestone facade ornament is soiled, particularly at the cartouche on Fifth Avenue.

- Remove soiling and biological growth at limestone throughout entire facade with appropriate chemical cleaner(s)
- O Remove coating from loggia spandrel panels (between floors 7 and 8) with appropriate paint stripper
- o Install new sealant at window perimeters

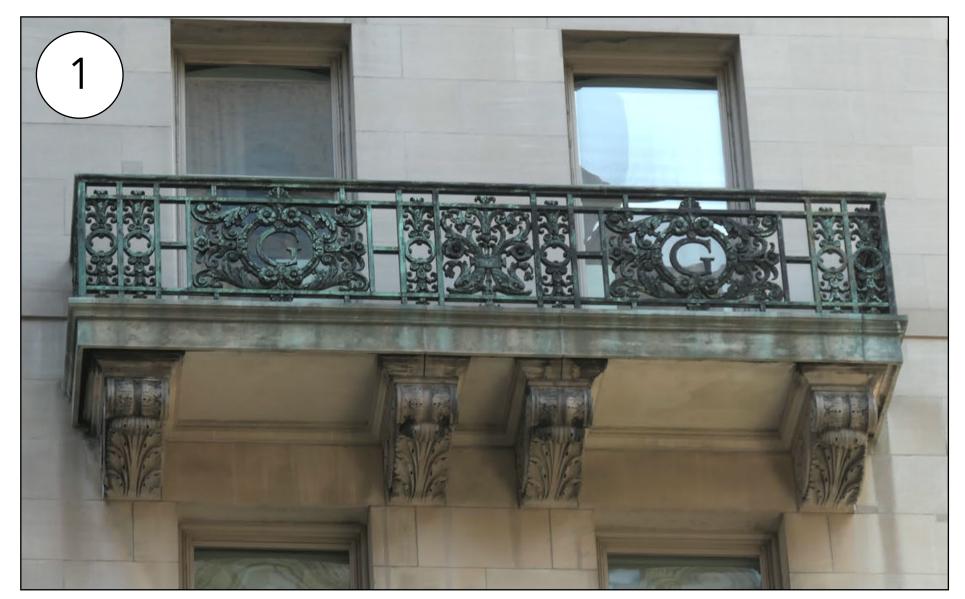
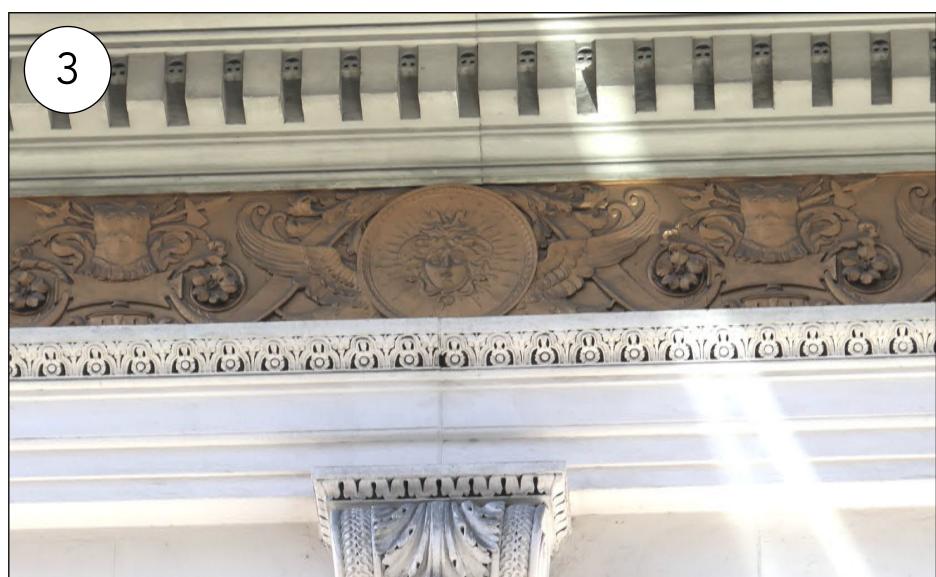
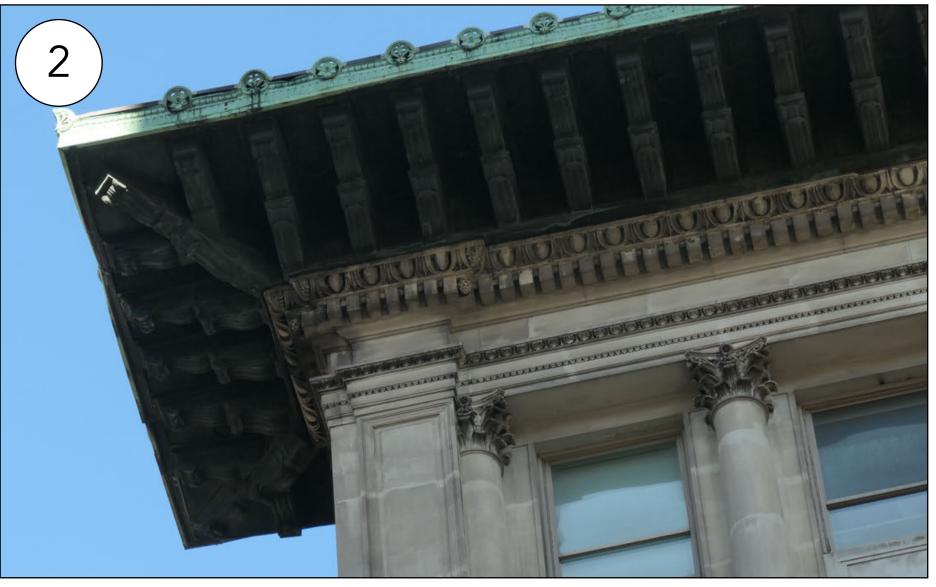
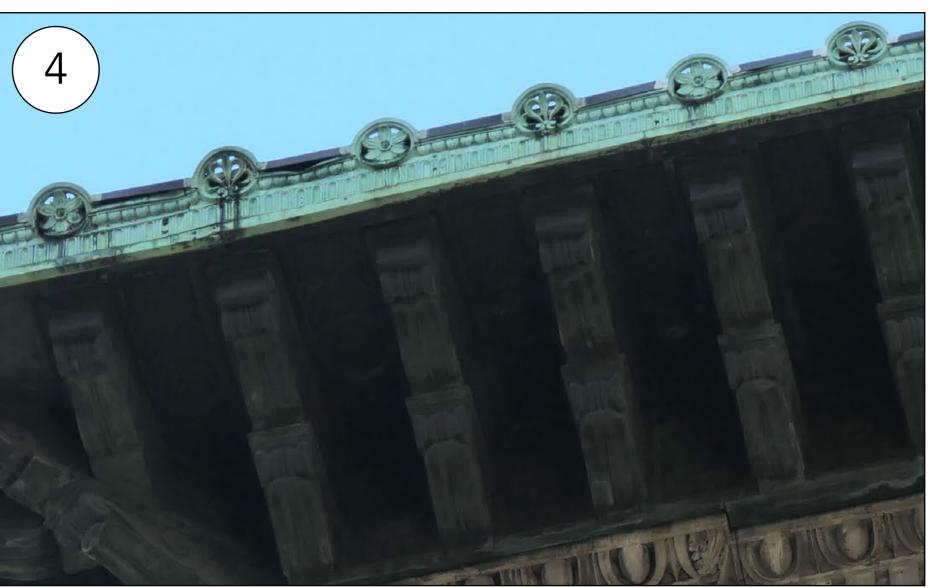
#### **METALWORK CONDITIONS**

- Bronze balcony railings are weathered and patinated, and run-off is staining the surrounding limestone.
- The copper cornice is weathered and patinated green.
- The bronze frieze at the storefront cornice has been coated.
- Some cornice elements are bent out of plane, creating holes where water can intrude into the roof system.

- Remove patina from bronze balcony railings and restore historic finish
- O Repair bent elements, holes, and missing fasteners in copper cornice, as required
- Reinstate polychromy and gilding at underside of copper cornice (a finishes analysis will be required)
- o Install new waterproofing and flashings at balconies and copper cornice

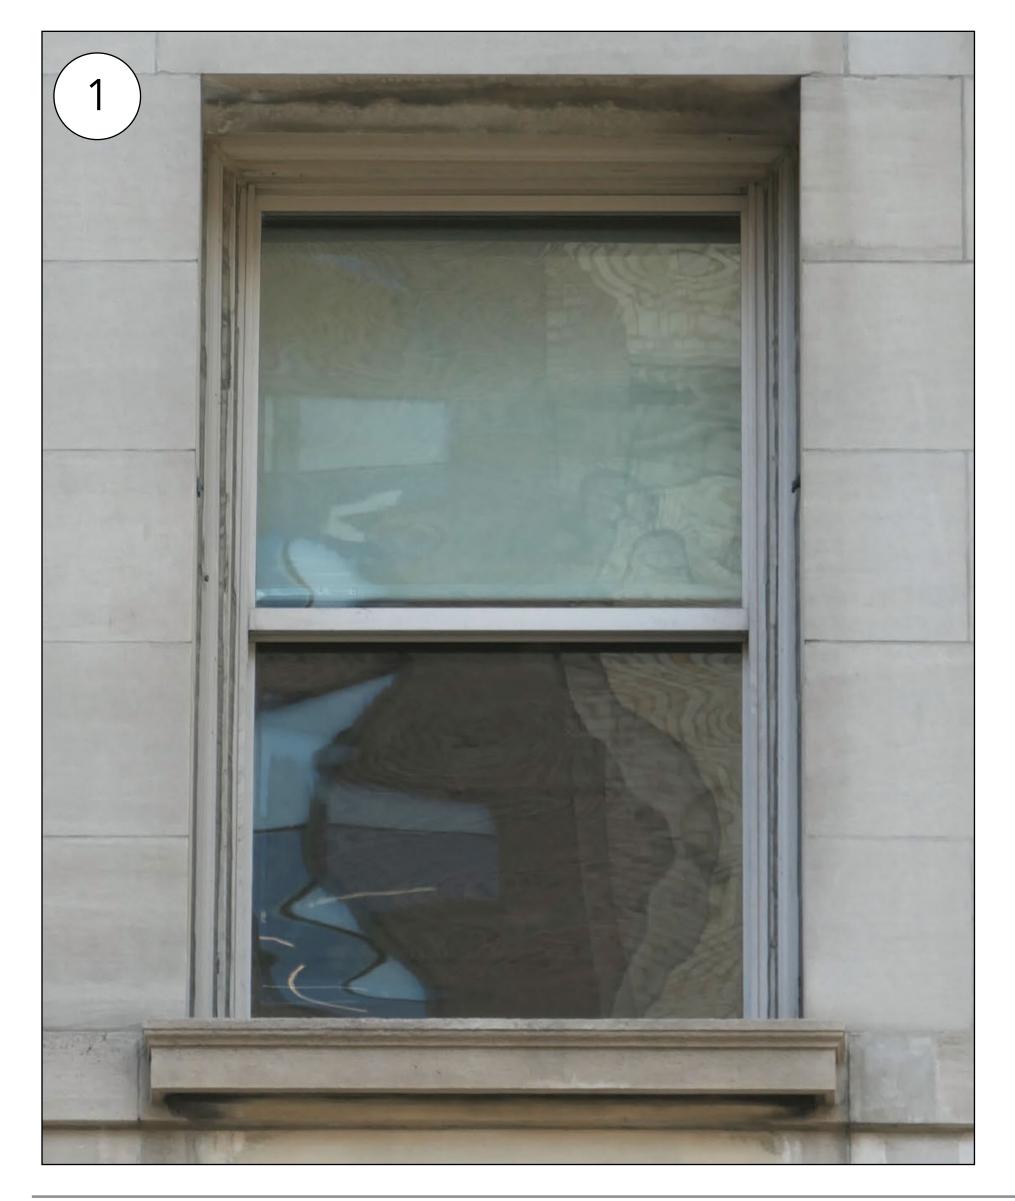
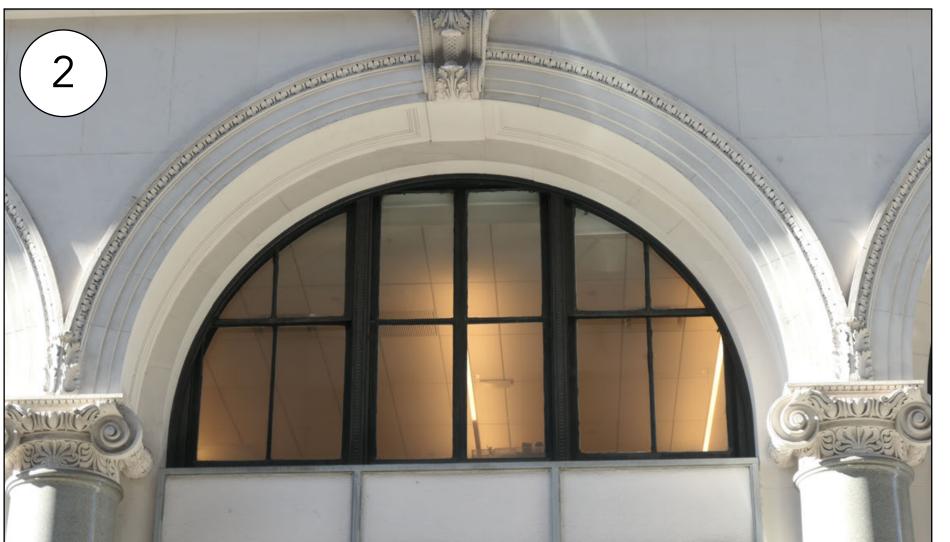
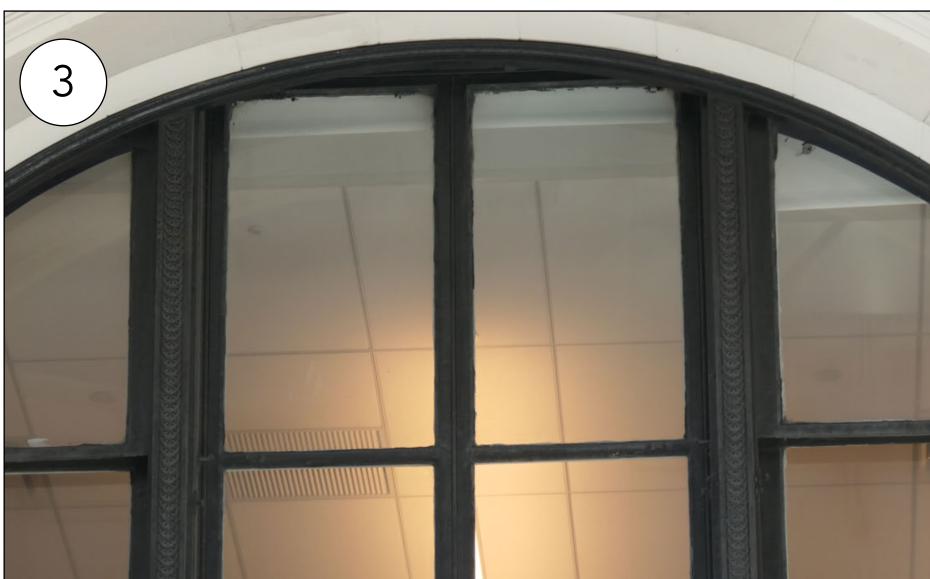
#### WINDOW CONDITIONS

- Sealant joints around aluminum window perimeters require maintenance, typical at upper floors.
- 2 Sealant joints and glazing putty require maintenance at historic steel windows located at building base.
- Excess paint is visible on the glass of historic steel windows located at building base.

• Remove paint, clean glazing, and repaint historic arched windows on 36th Street, color to match historic (a finishes analysis will be required)

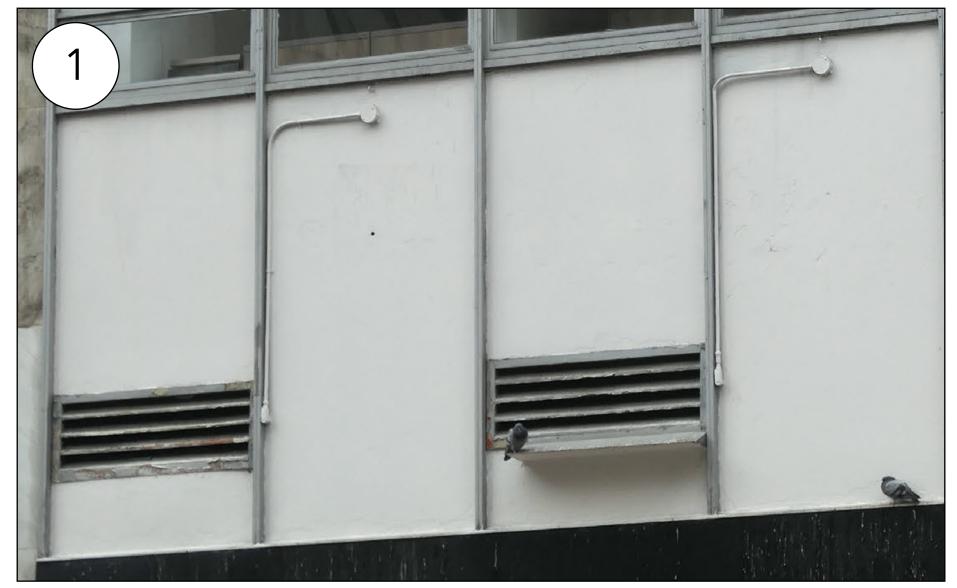
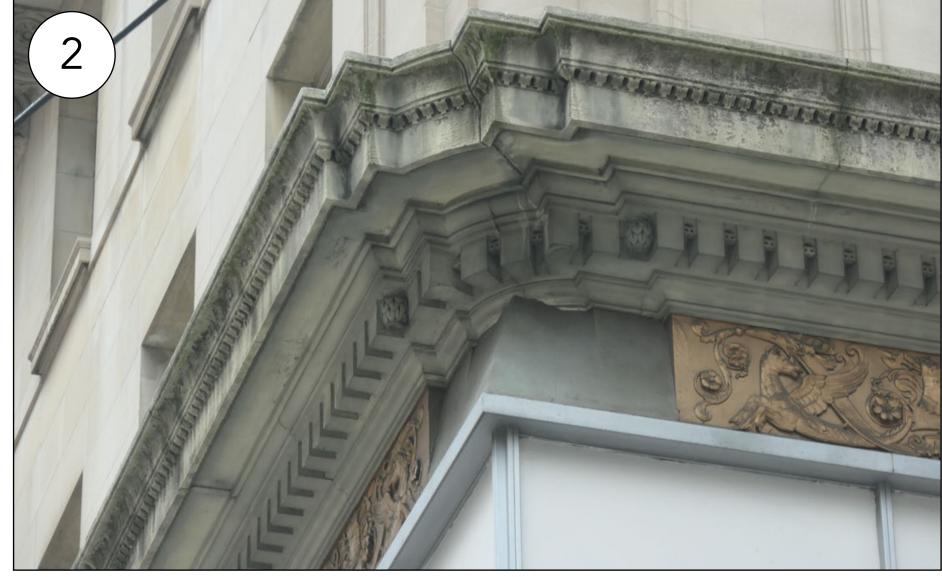
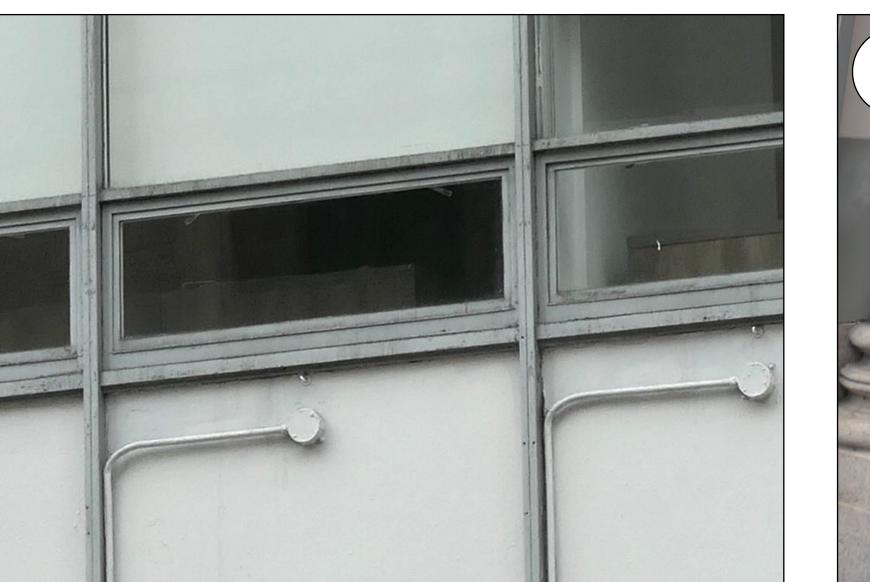
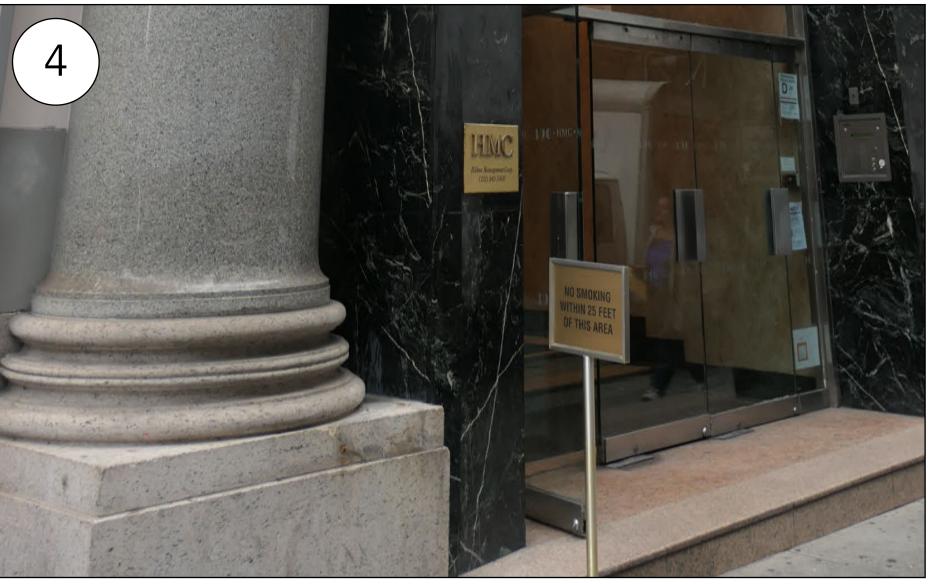
#### **MISCELLANEOUS CONDITIONS**

- 1 Louvers installed within storefront spandrel panels are deteriorated and require maintenance or replacement. Un-used conduit remains from previous light fixture installations throughout.
- The corner of the bronze frieze was removed in the 1960s and a concrete patch was installed. The concrete is exhibiting localized cracking and should be assessed.
- The aluminum storefront system shows signs of staining and deterioration. Fasteners should be checked and maintained throughout.
- The granite columns on 36th Street are exhibiting staining at the bases. Cracking is also evident at anchor locations.

- O Clean and refinish existing c.1960s aluminum framing across base
- O Remove unused conduit across base
- Re-finish or replace through-spandrel louvers
- Replace plywood with new marble cladding, matching existing, at pier on 36th Street
- Repair damaged/soiled marble cladding at two piers (one on Fifth Avenue and one on 36th Street)

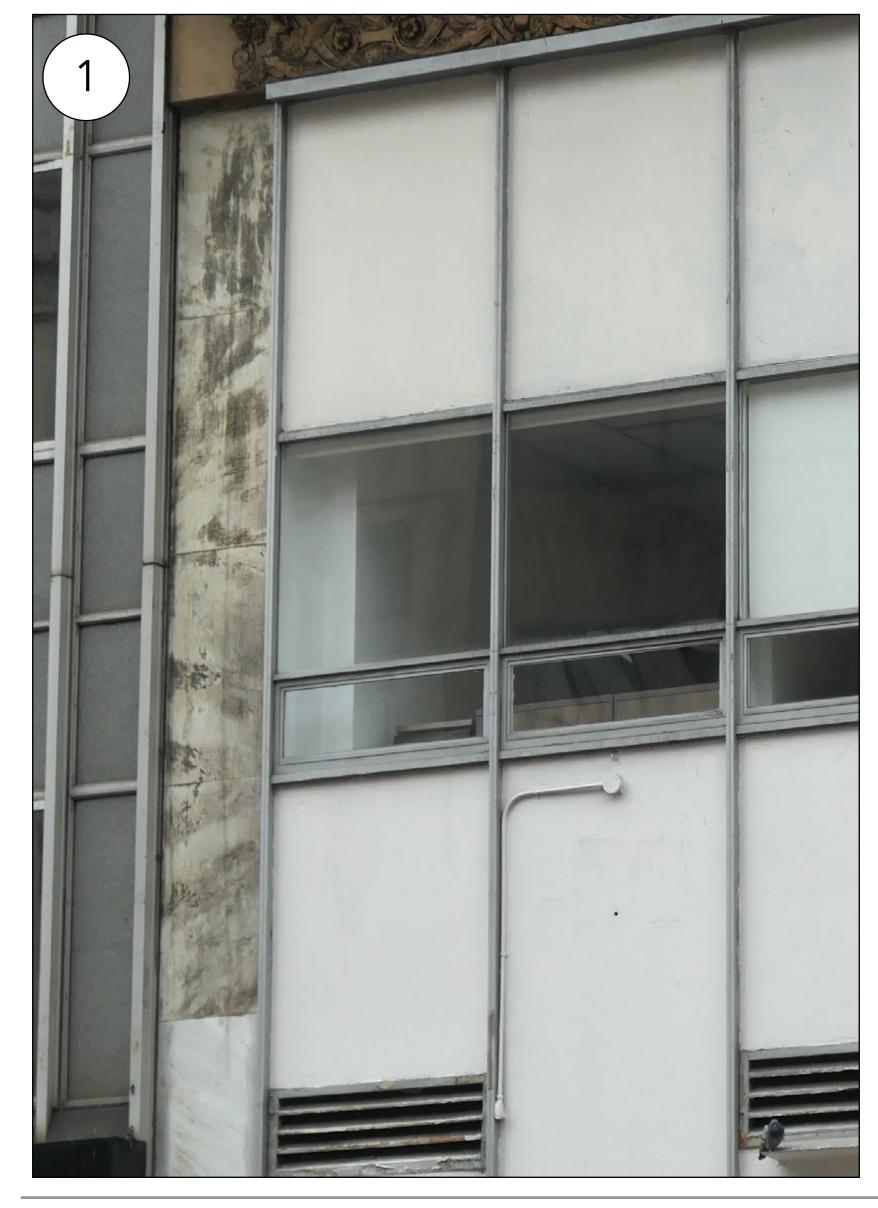
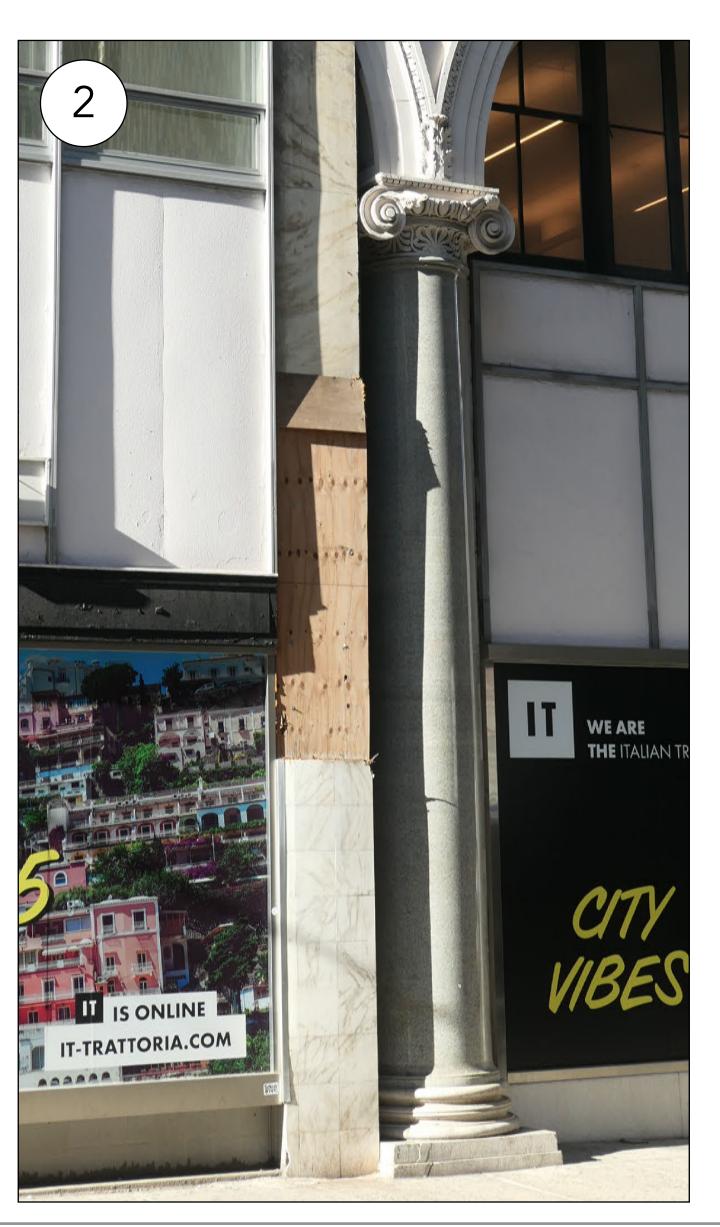
#### MISCELLANEOUS CONDITIONS

- Marble cladding is soiled and damaged at the south pier on Fifth Avenue.
- Plywood has been installed in place of marble at the east pier on 36th Street. Above and below, the marble cladding is soiled and damaged.
